# Scottish Sanitary Survey Project

## Restricted Sanitary Survey Report Eriska Shoal AB 490 February 2010

Eriska Shoal  
AB 490

## Shoreline Survey Report

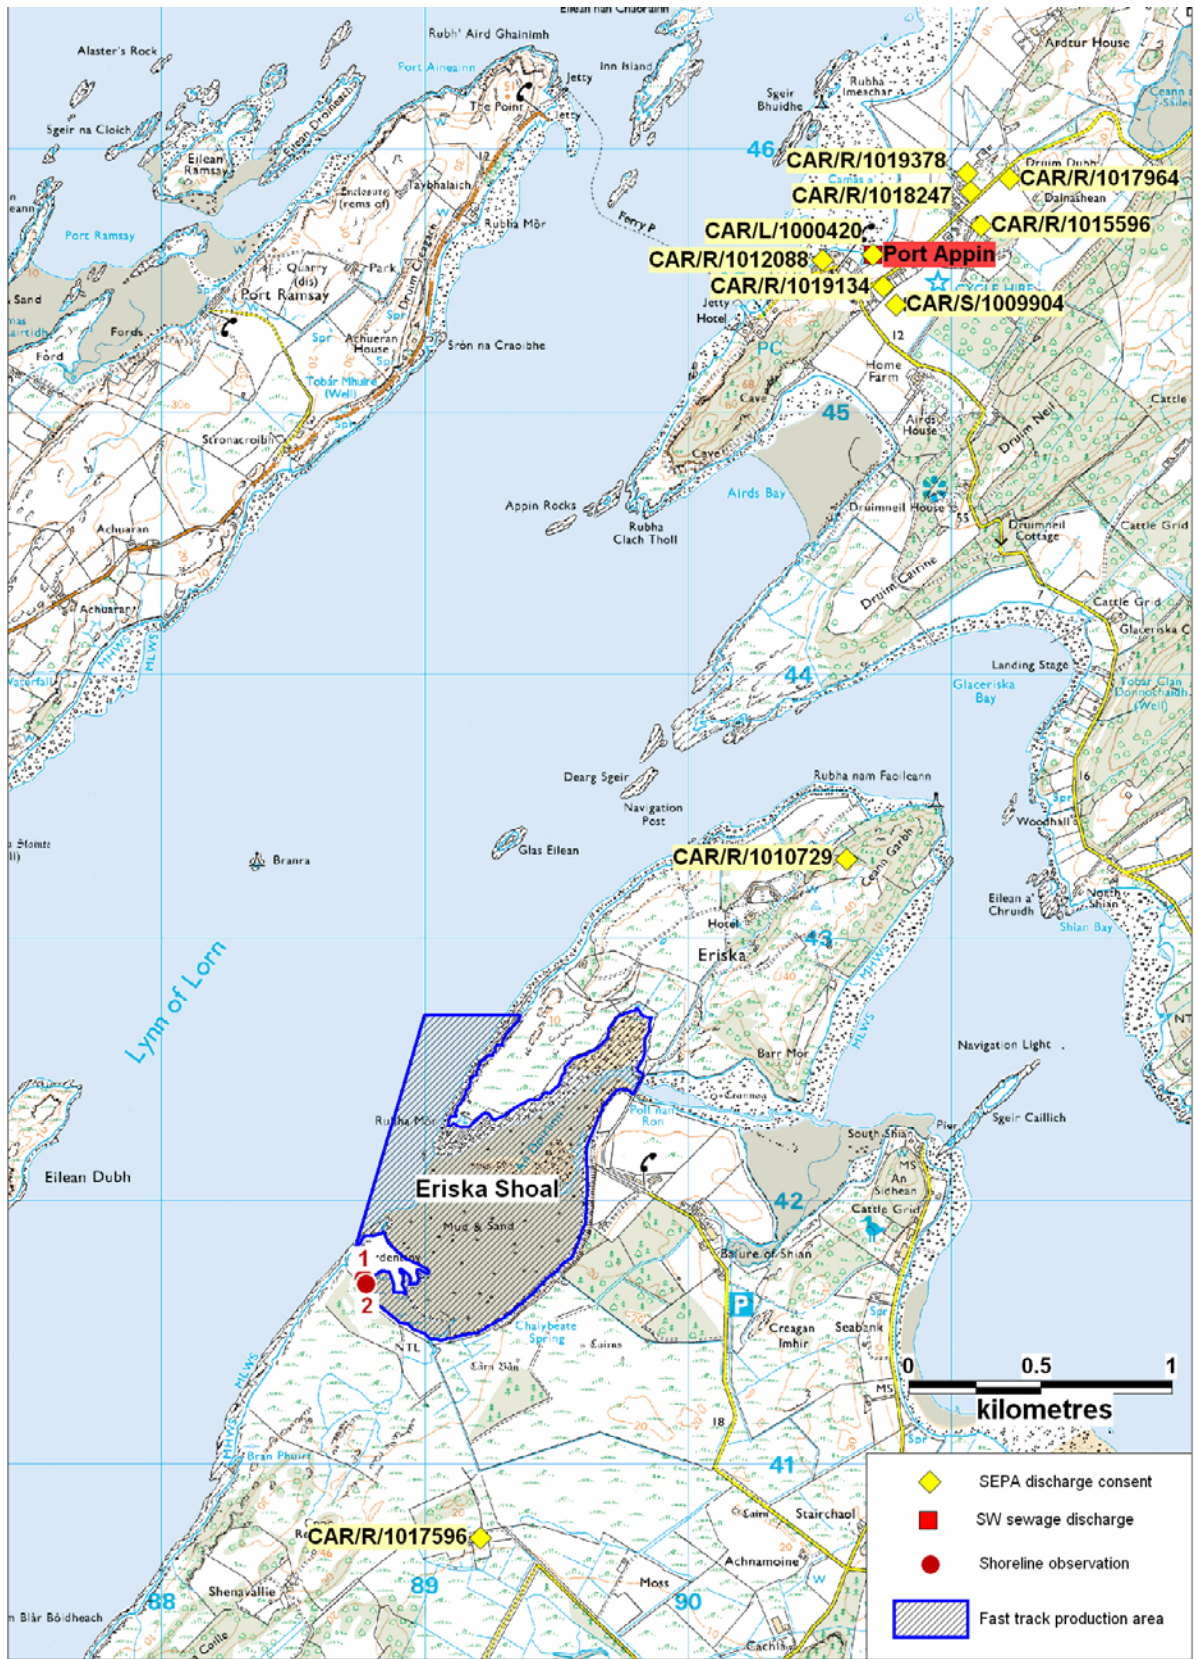
Figure 3.1 Sewage discharges at Eriska Shoal

A septic tank and an inspection chamber were also observed during the shoreline survey and these are listed in Table 3.3. Their locations have been included in the mapped discharges in Figure 3.1. Further details can be found in the shoreline survey report in the appendix.

No.	Date	NGR	Description of potential sewage discharge
1	04/06/2009	NM 88768 41707	Inspection chamber – empty
2	04/06/2009	NM 88780 41688	Balmoral private septic tank, serves one dwelling, no outlet pipe observed

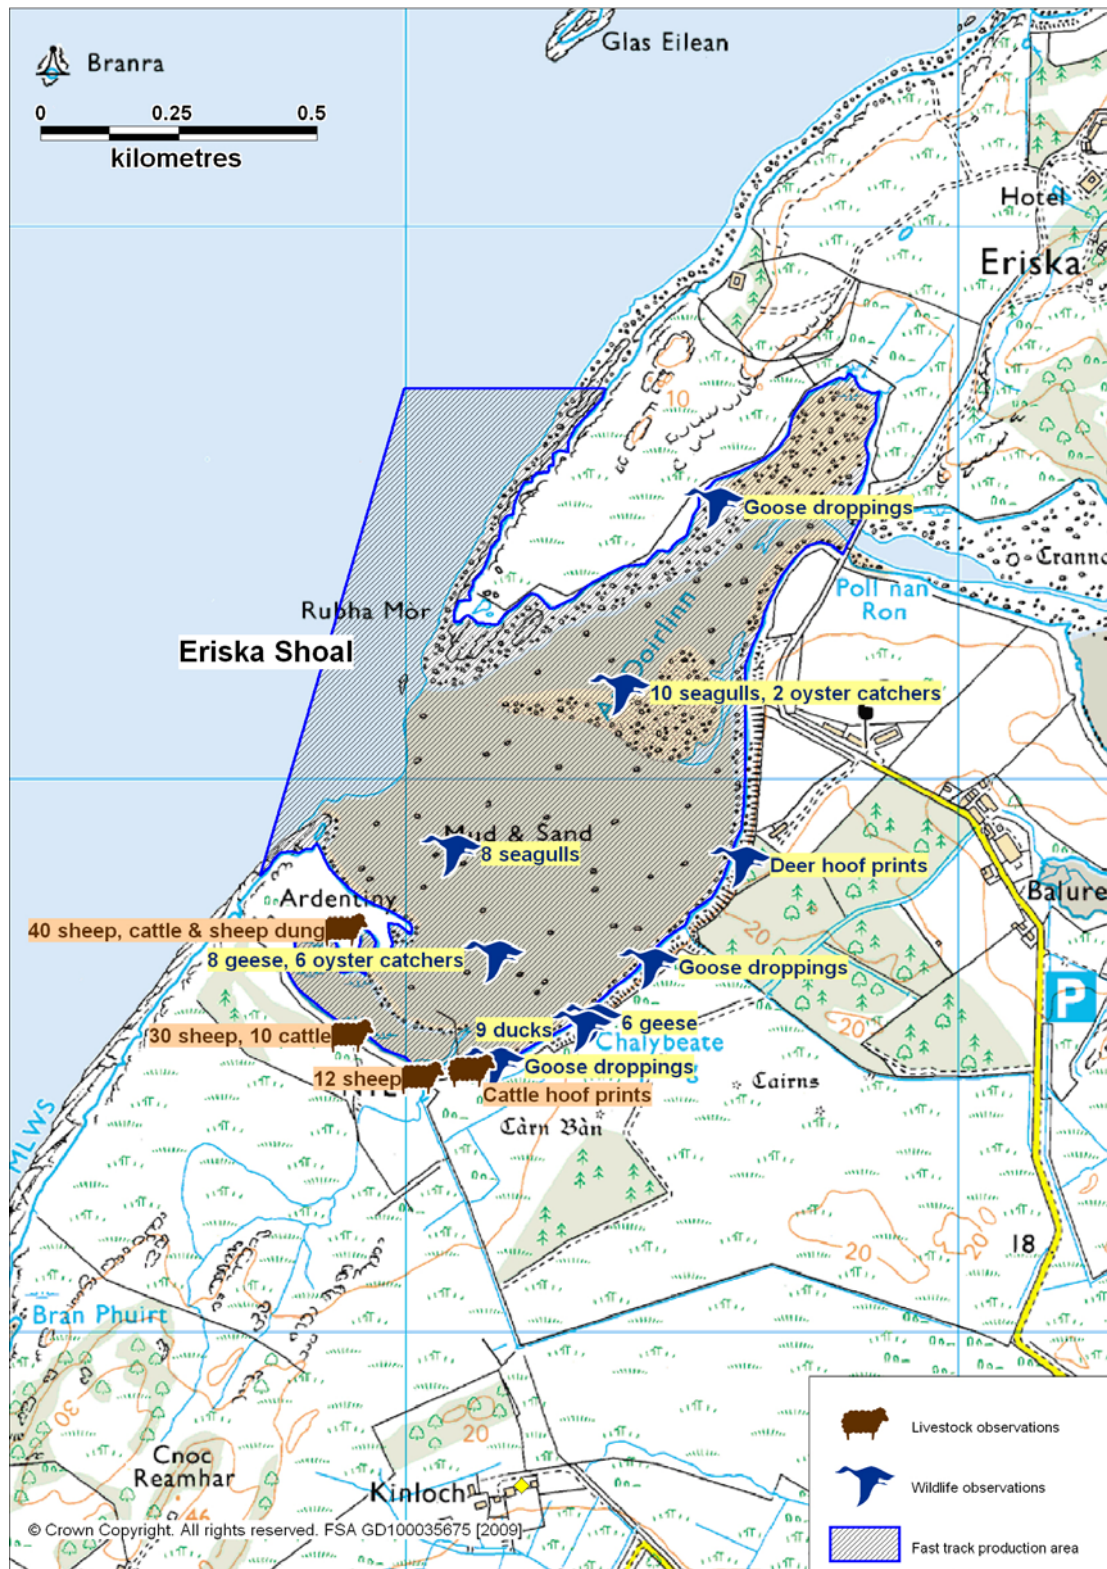
Figure 4.1 Livestock and wildlife present in Eriska Shoal

During the shoreline survey, ten cattle were observed close to the shoreline at the southern end of the Eriska Shoal production area (see Figure 4.1). Thirty sheep were also observed in the same location as the cattle. A larger flock of forty sheep were observed close to the shoreline at the south west end of the shellfish bed and another flock of twelve sheep (and some cattle hoof prints) were observed at the south east end. No livestock were observed anywhere along the shoreline north of Chalybeate Spring or on the Isle of Eriska.

No other wildlife was observed at the time of the shoreline survey, although deer hoof prints were observed in the sand on the eastern side of the shellfish bed, indicating their presence. Although no animals were seen at the time of the survey, it is likely that other animals including seals and otters may be present in the area. However, the distribution and numbers of these species is unknown.

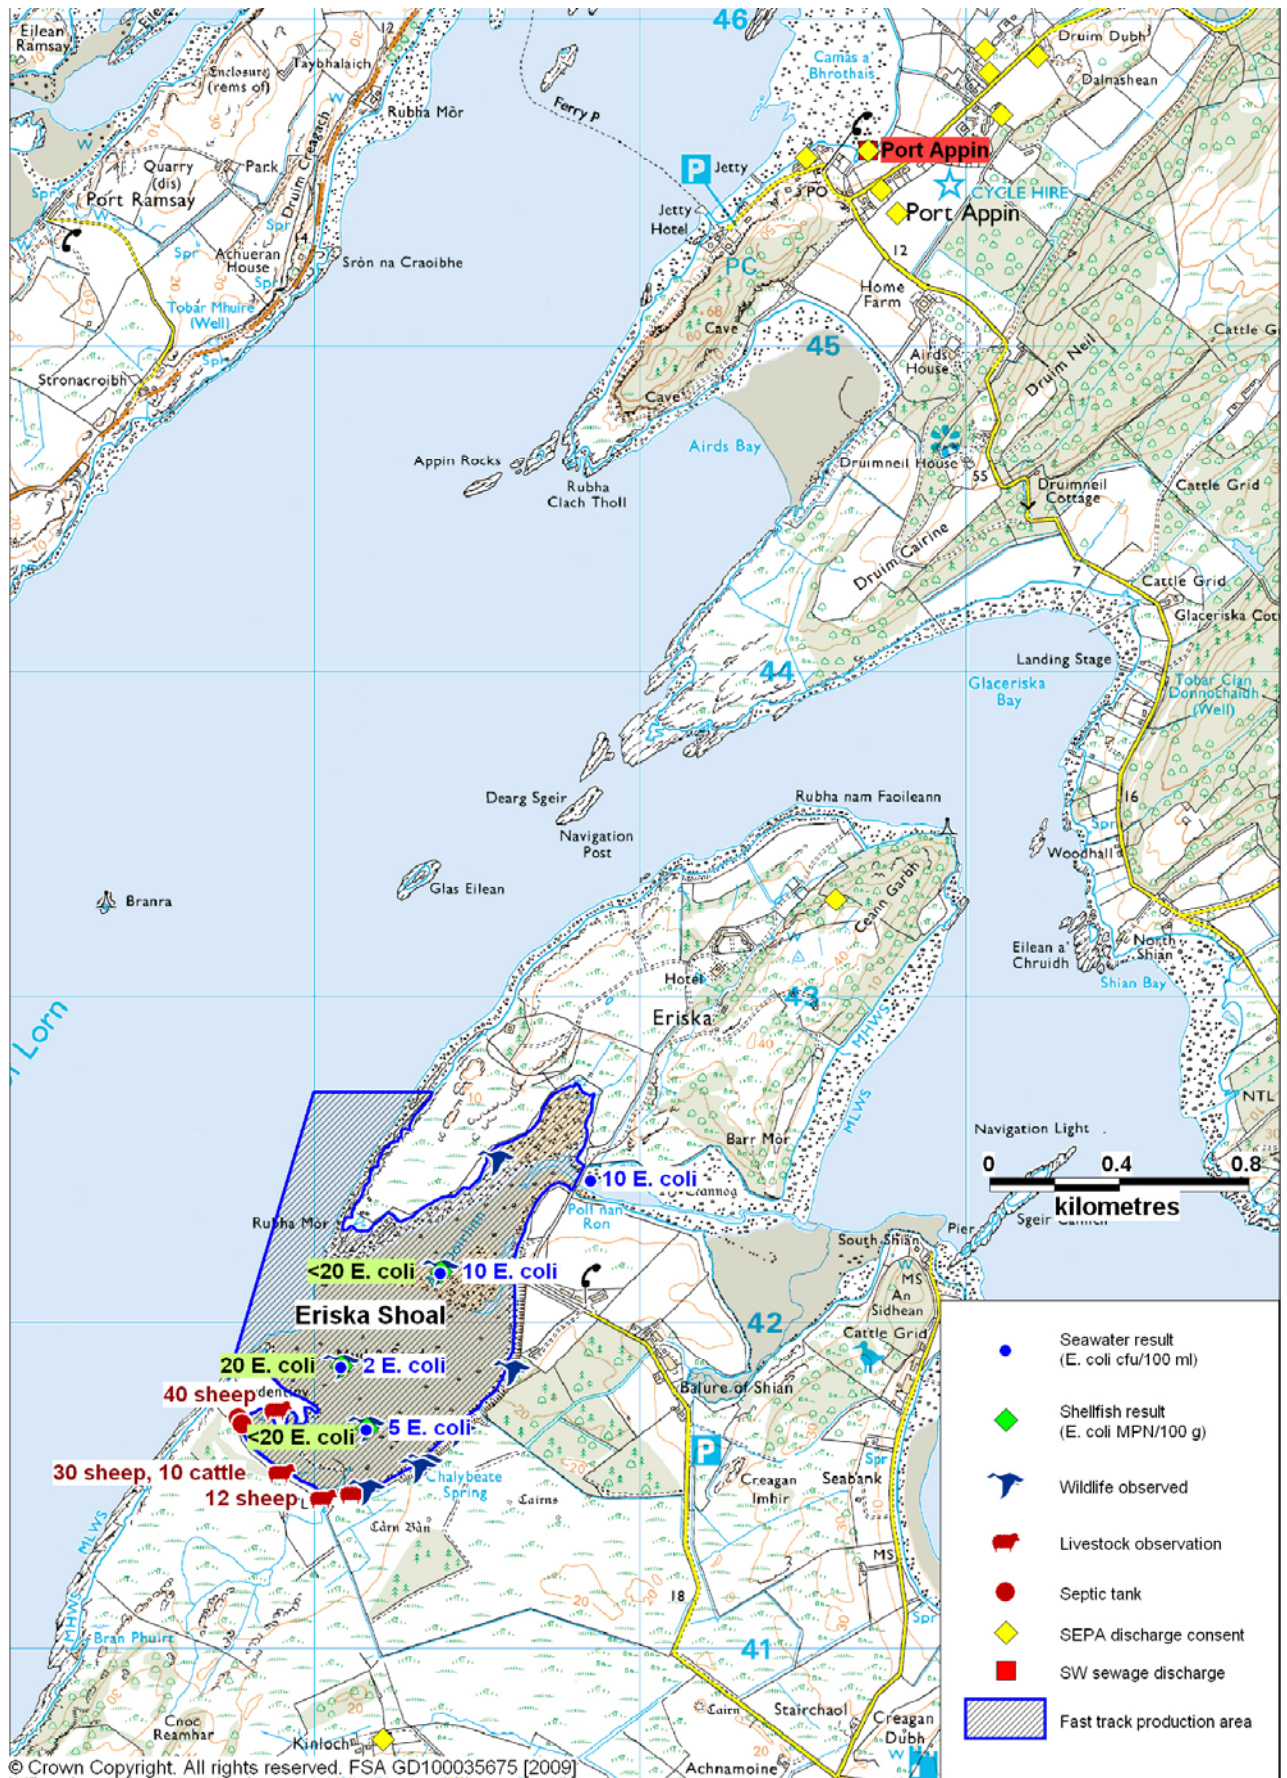
Figure 9.1 Summary of shoreline observations

A map is provided in Figure 9.1 that shows the relative locations of the most significant findings of the shoreline survey. Where the bacterial concentration is labelled, the scientific notation is written in digital format, as this is the only format recognised by the mapping software. So, where normal scientific notation for 1000 is  $1 \times 10^3$ , in this case it would be written as 1E+3.

In summary, identified sources of potentially significant contamination are:

- Contaminated freshwater streams in the area
- Livestock grazing on the southern shoreline
- Balmoral private septic tank

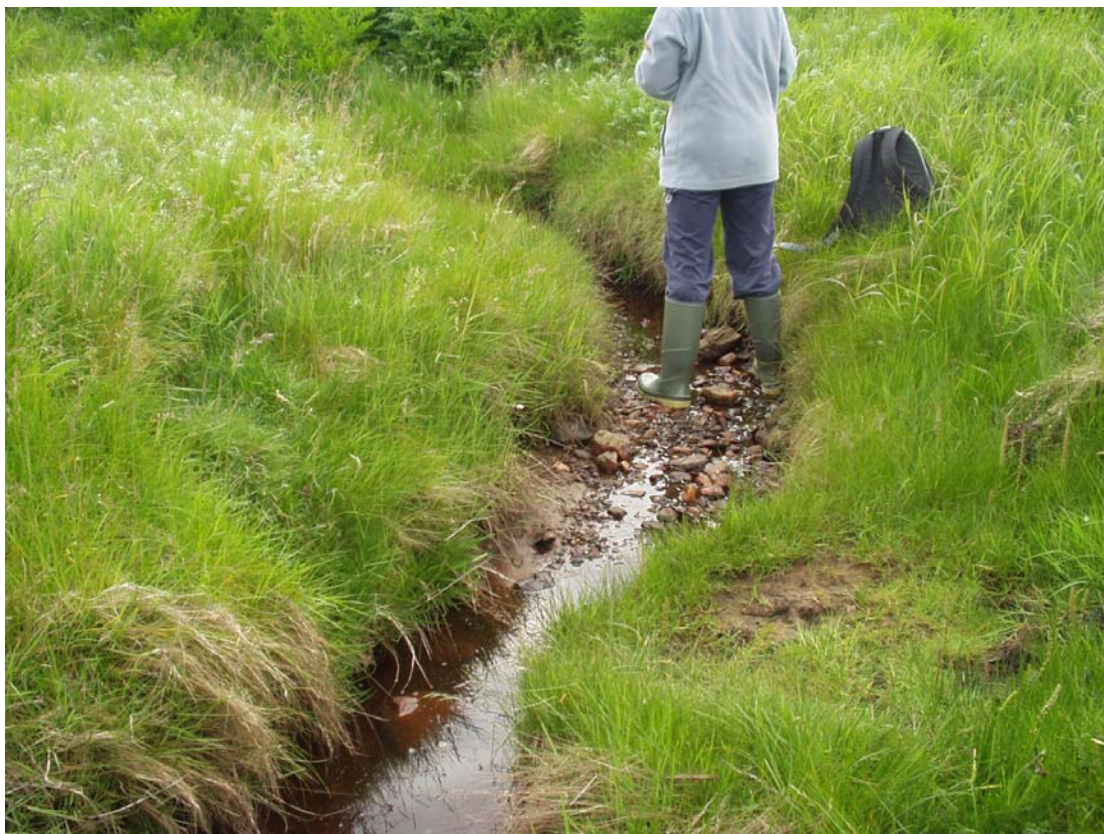
8	04/06/2009	09:54	NM 89492 41702	189492	741702		Small stream, flowing, 11 cm x 2 cm x 0.16. Eriska fresh water sample 4.
9	04/06/2009	10:01	NM 89470 41674	189470	741674		Small stream, barely flowing, not measurable. Eriska fresh water sample 5.
10	04/06/2009	10:02	NM 89441 41658	189441	741658		Geese droppings.
11	04/06/2009	10:05	NM 89351 41573	189351	741573		Ground water running from bank.
12	04/06/2009	10:06	NM 89338 41557	189338	741557		Small stream, flowing, 10 cm x 2 cm x 0.363. Eriska fresh water sample 6. 6 geese observed.
13	04/06/2009	10:11	NM 89320 41545	189320	741545	Figure 8	Spring, Eriska fresh water sample 7. 9 ducks.
14	04/06/2009	10:16	NM 89162 41478	189162	741478		Geese droppings.
15	04/06/2009	10:17	NM 89147 41463	189147	741463		Very small stream, barely flowing, not measurable.
16	04/06/2009	10:18	NM 89120 41470	189120	741470		Cattle hoof prints.
17	04/06/2009	10:21	NM 89028 41457	189028	741457	Figure 9	Stream, barely flowing, not measurable. Eriska fresh water sample 8. Cattle and deer prints. 12 sheep in fenced field behind.

Figure 4. Small stream, water sample 4

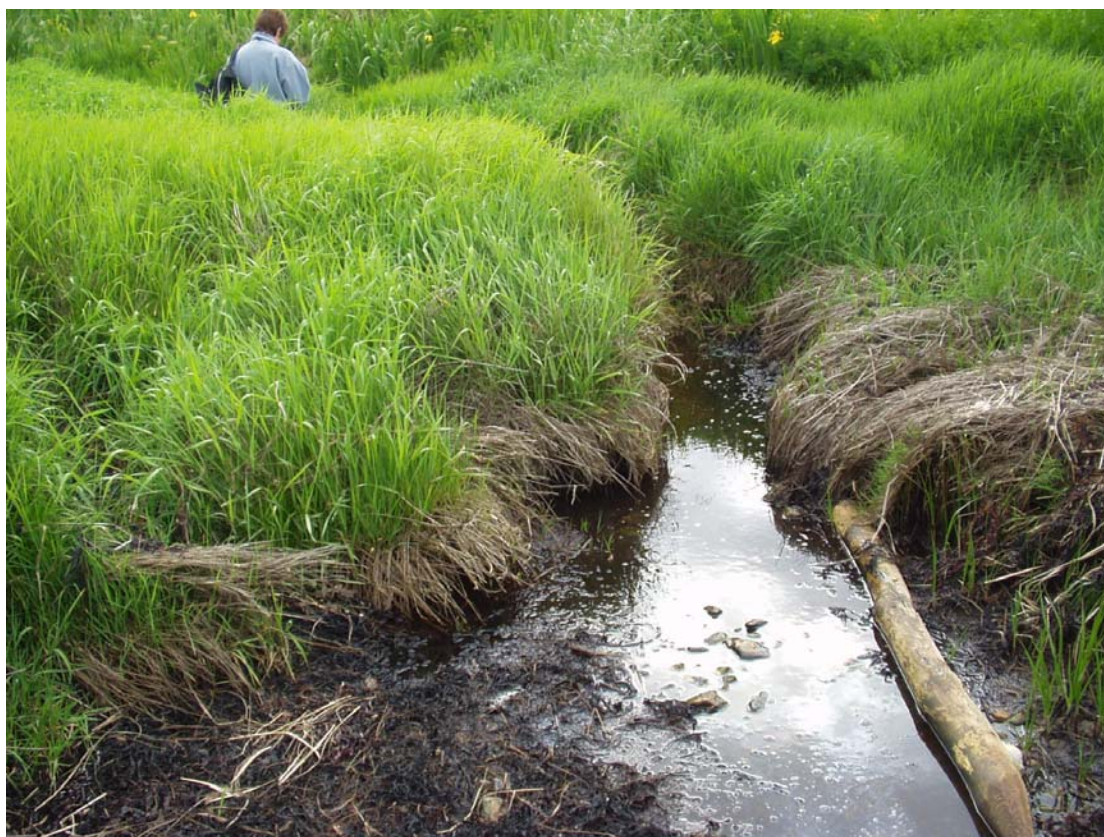
Figure 5. Small stream, water sample 5

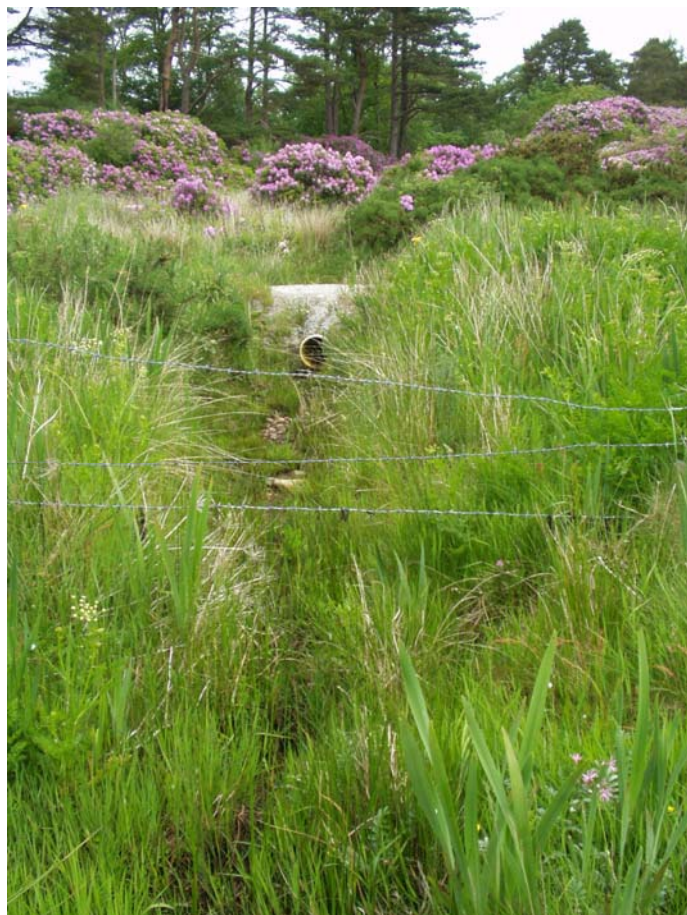
Figure 6. Drainage pipe under road, not flowing

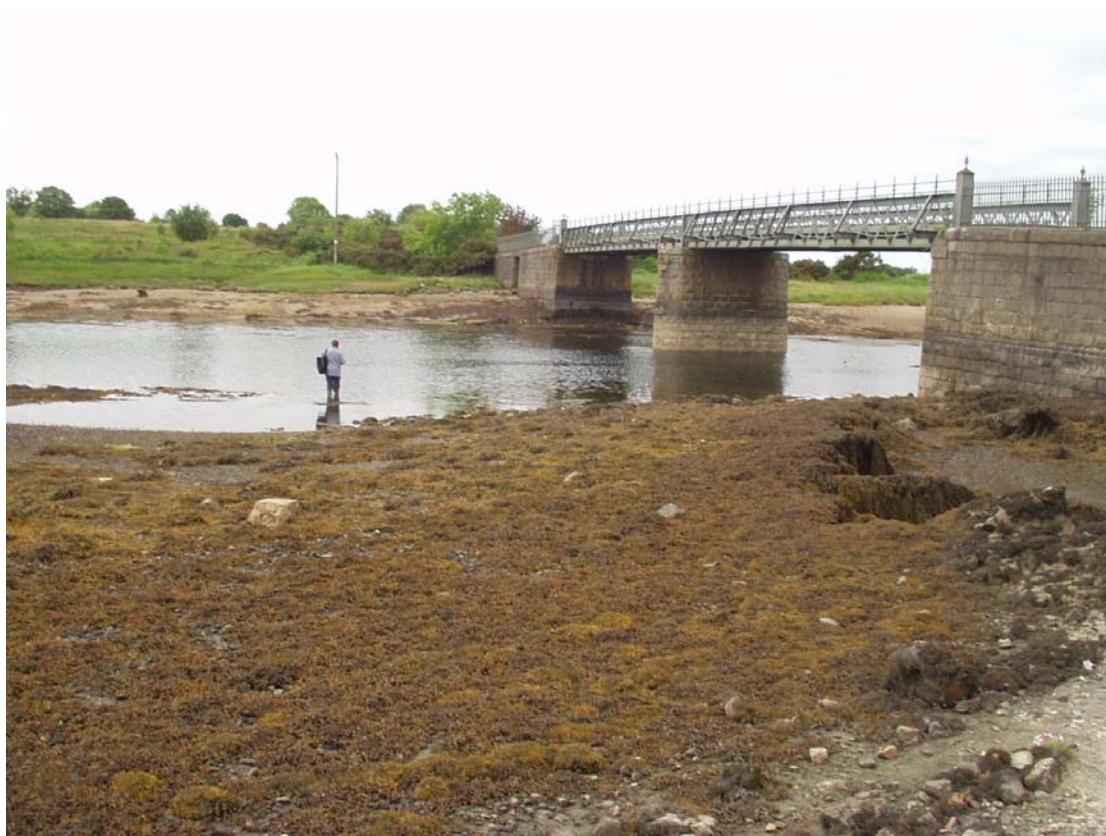
Figure 7. Tidal channel at bridge, water sample 6

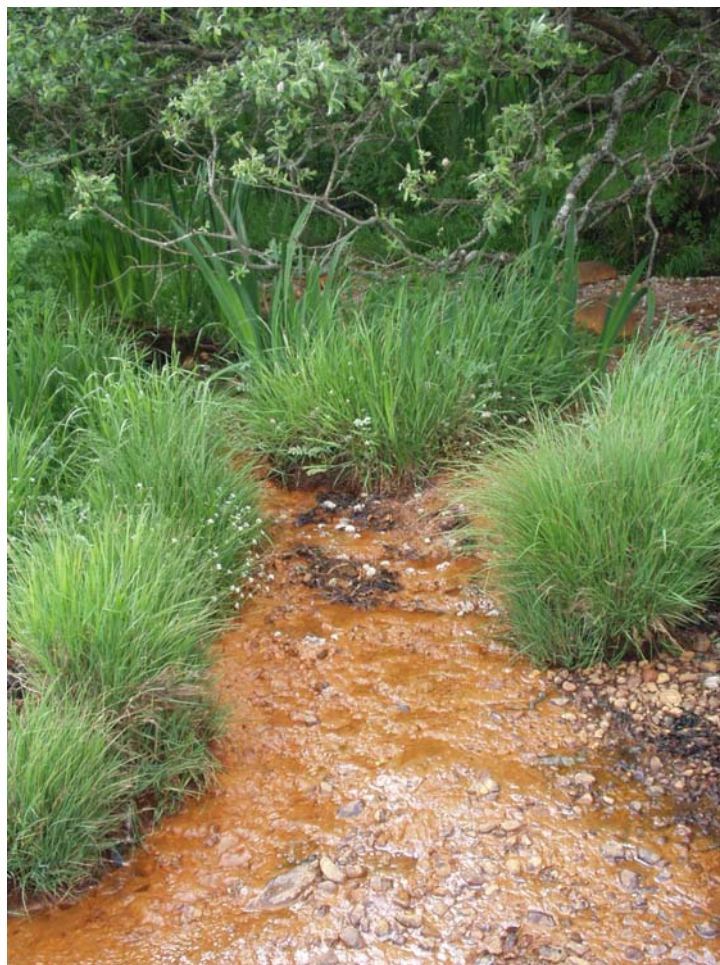
Figure 8. Spring, water sample 10

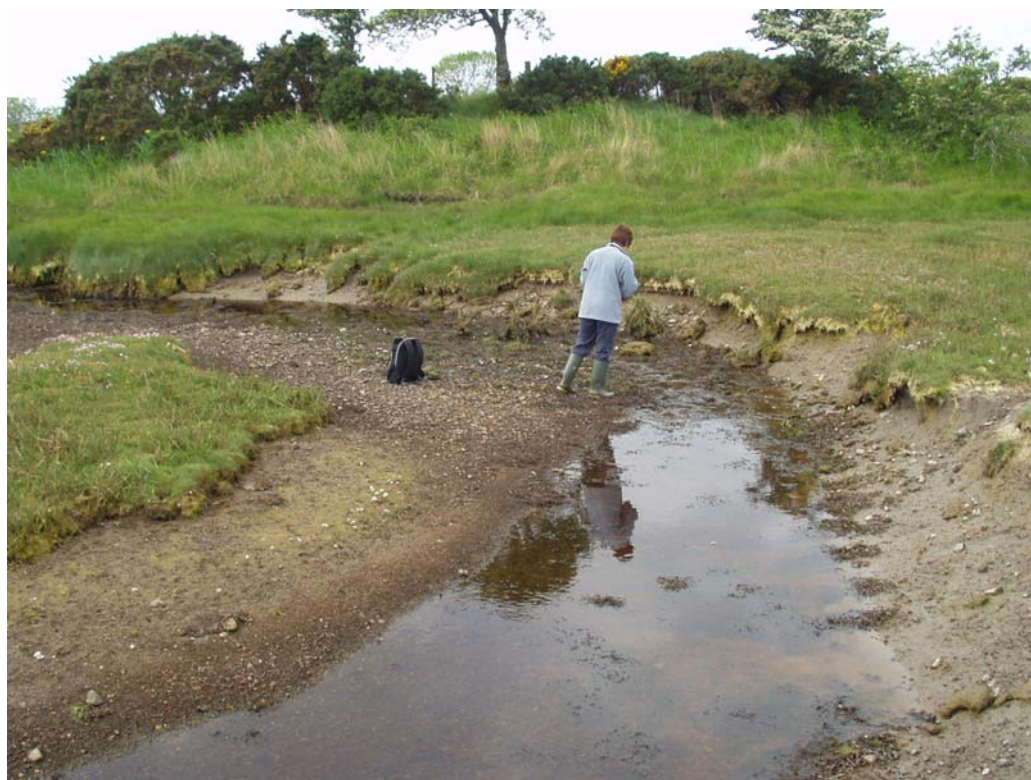
Figure 9. Stream, water sample 11

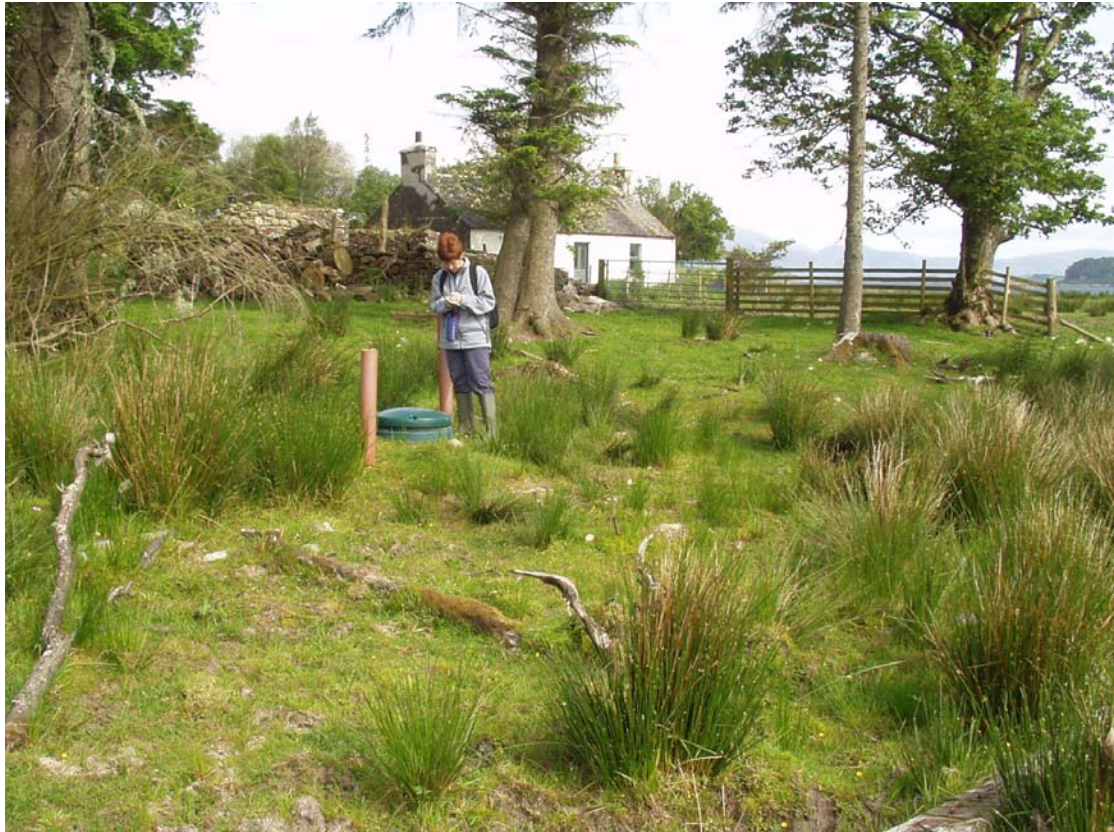
18	04/06/2009	10:26	NM 88900 41534	188900	741534		Cattle hoof prints. 30 sheep in fenced field. 10 cattle in fenced field.
19	04/06/2009	10:33	NM 88889 41725	188889	741725		40 sheep in field. Significant cattle and sheep dung in field.
20	04/06/2009	10:35	NM 88769 41723	188769	741723	Figure 10	House, no permanent occupants.
21	04/06/2009	10:38	NM 88768 41707	188768	741707		Inspection chamber – empty.
22	04/06/2009	10:39	NM 88780 41688	188780	741688	Figure 10	Balmoral septic tank, no outlet pipe observed.

Figure 10. House and Balmoral septic tank

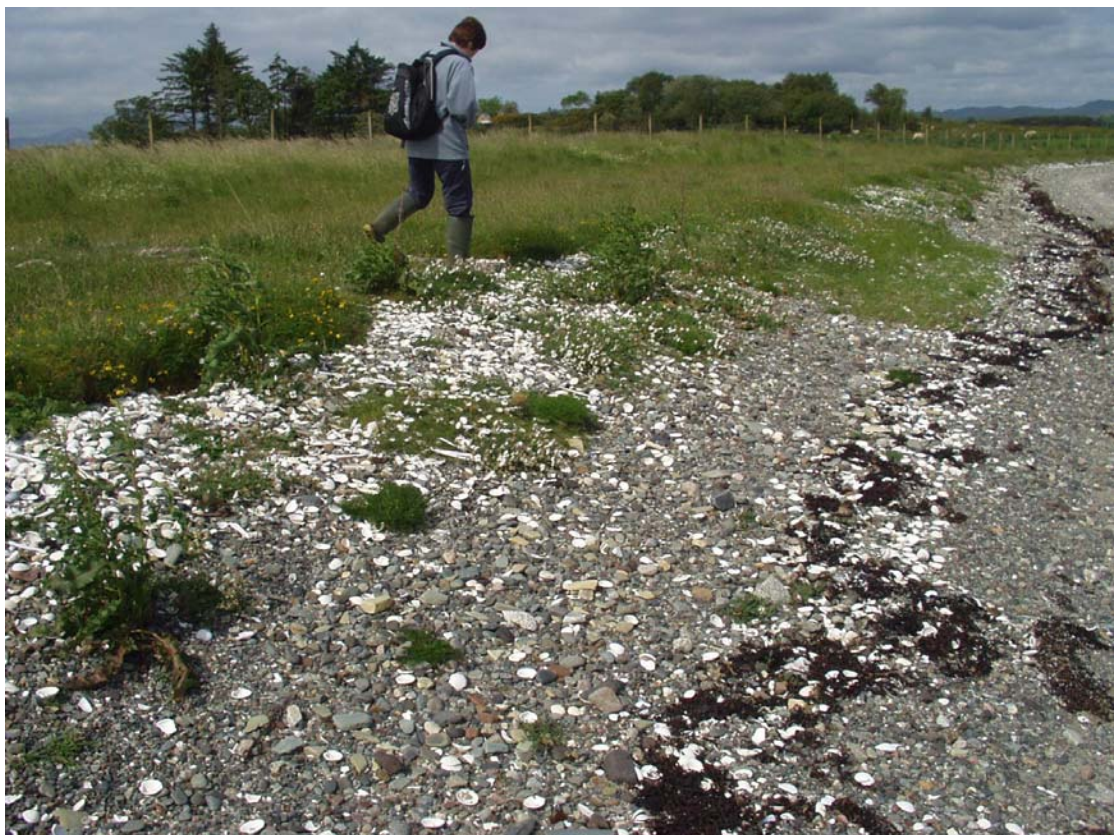
No.	Date	Time	NGR	East	North	Associated photograph	Description
23	04/06/2009	10:44	NM 88970 41730	188970	741730	Figure 11	Empty shells (small clams, razors, cockles, mussels, whelks, scallops). End of shoreline walk.
24	04/06/2009	09:50	NM 89389 42154	189389	742154		Eriska cockle sample 1 (30 cockles found fairly easily). Eriska cockle seawater 1. Salinity = 36 ppt Significant empty shells (native oysters & cockles). 10 seagulls, 2 oysters catchers
25	04/06/2009	10:20	NM 89160 41671	189160	741671		Eriska Cockles Sample 2 (17 cockles).Cockles harder to find here than samples 1 and 3. Eriska Cockle Seawater 2. Salinity = 36 ppt. 20 seagulls, 8 geese, 6 oyster catchers.
26	04/06/2009	10:40	NM 89084 41863	189084	741863		Eriska Cockle Sample 3. (30 Cockles found fairly easily). Eriska Cockle Seawater 3. Salinity = 34 ppt. 8 Seagulls.

Figure 11. Empty shells on the shoreline
