Scottish Sanitary Survey Review

Seil Sound

AB-247

Report Title	Seil Sound Sanitary Survey Review
Project Name	Scottish Sanitary Survey
Client/Customer	Food Standards Agency Scotland
Cefas Project Reference	C6316B
Document Number	C6316B_2014_21
Revision	V1.0
Date	10/04/2015

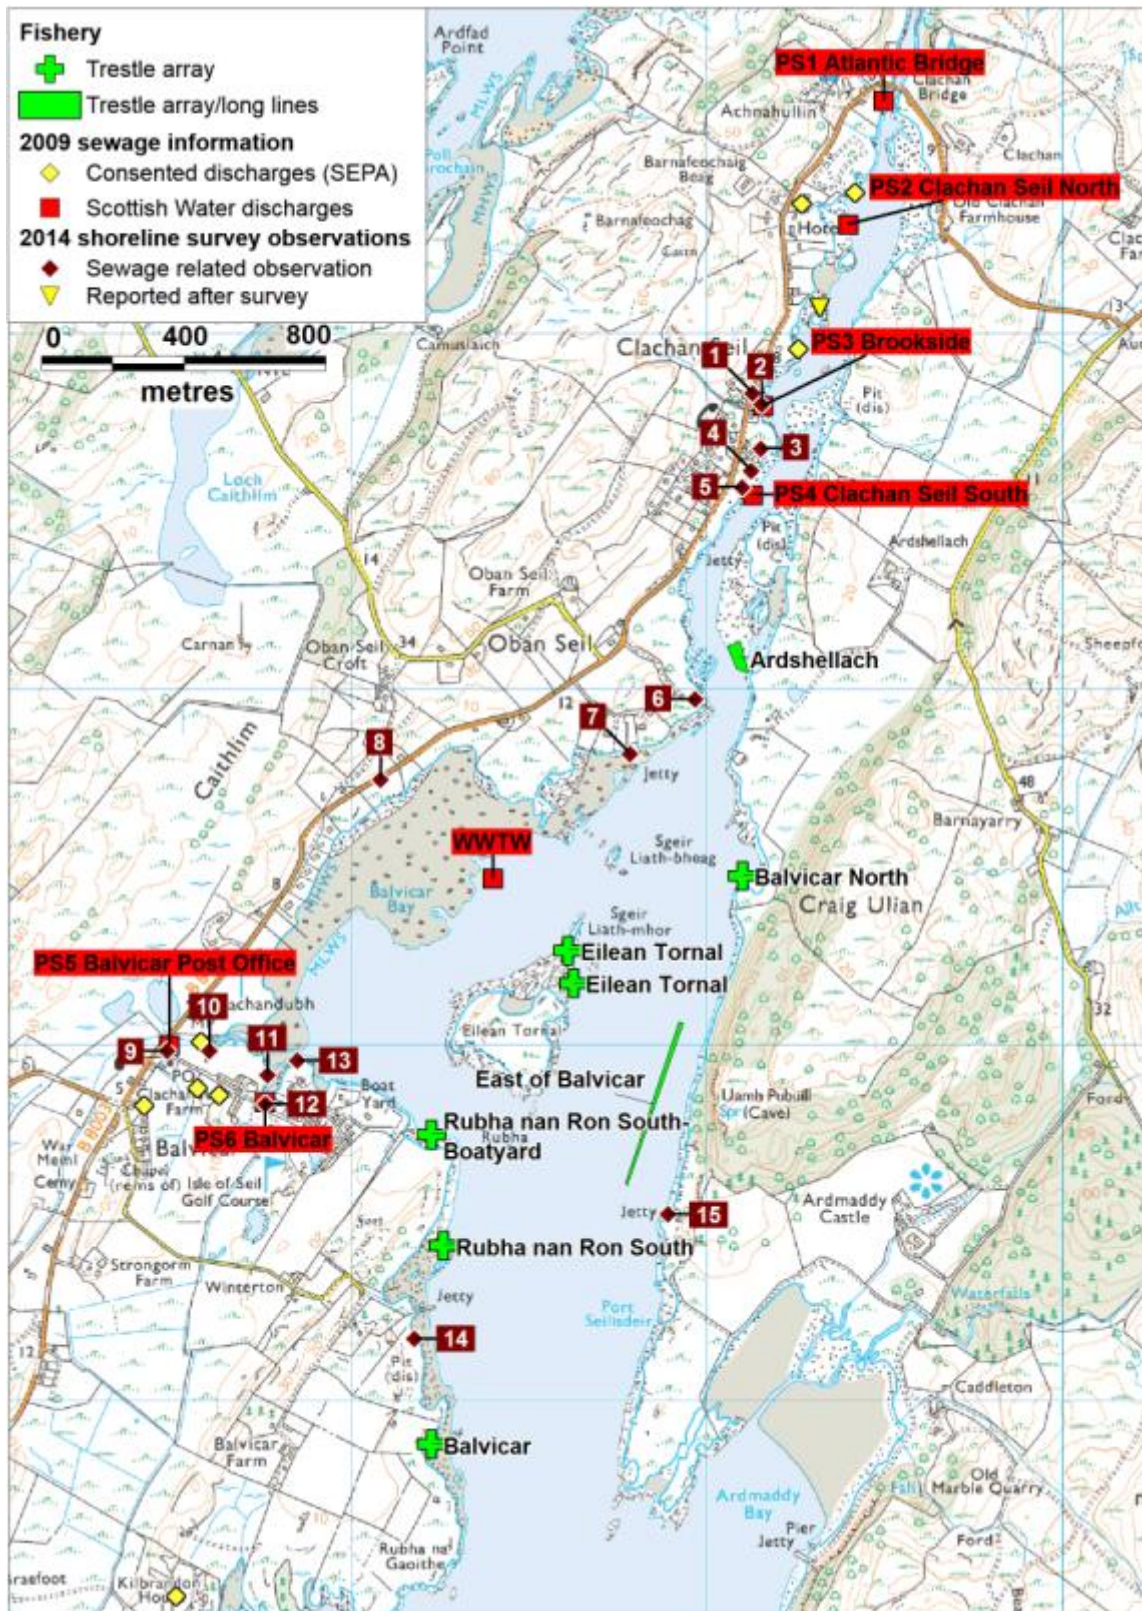
© Crown Copyright and Database 2015. All rights reserved. Ordnance Survey Licence number [GD100035675]
Figure 2.2 Map of sewage discharges in the Seil Sound area

The majority of sewage- related observations made during the 2014 shoreline survey were in the Clachan Seil and Balvicar areas and were associated with the sewage network: Brookside PS (waypoint 1&2), Clachan Seil South PS (waypoint 5), Balvicar Post Office PS (waypoint 9), and Balvicar PS (waypoint 11&12). Balvicar WwTW was observed on the shore adjacent to the outfall location given by Scottish Water.

Significantly fewer private sewage inputs enter Seil Sound since upgrades to the sewage network were completed in June 2009. No additional information has been found on the performance of the sewage network and so it is not known whether the predicted low spill frequency and volume for the WwTW CSO has been achieved. Small, private sewage discharges remain at the upper end of the sound, at Oban Seil and at Balvicar. A contaminated discharge was observed at the shore in the vicinity of the southern end of the mussel lines.

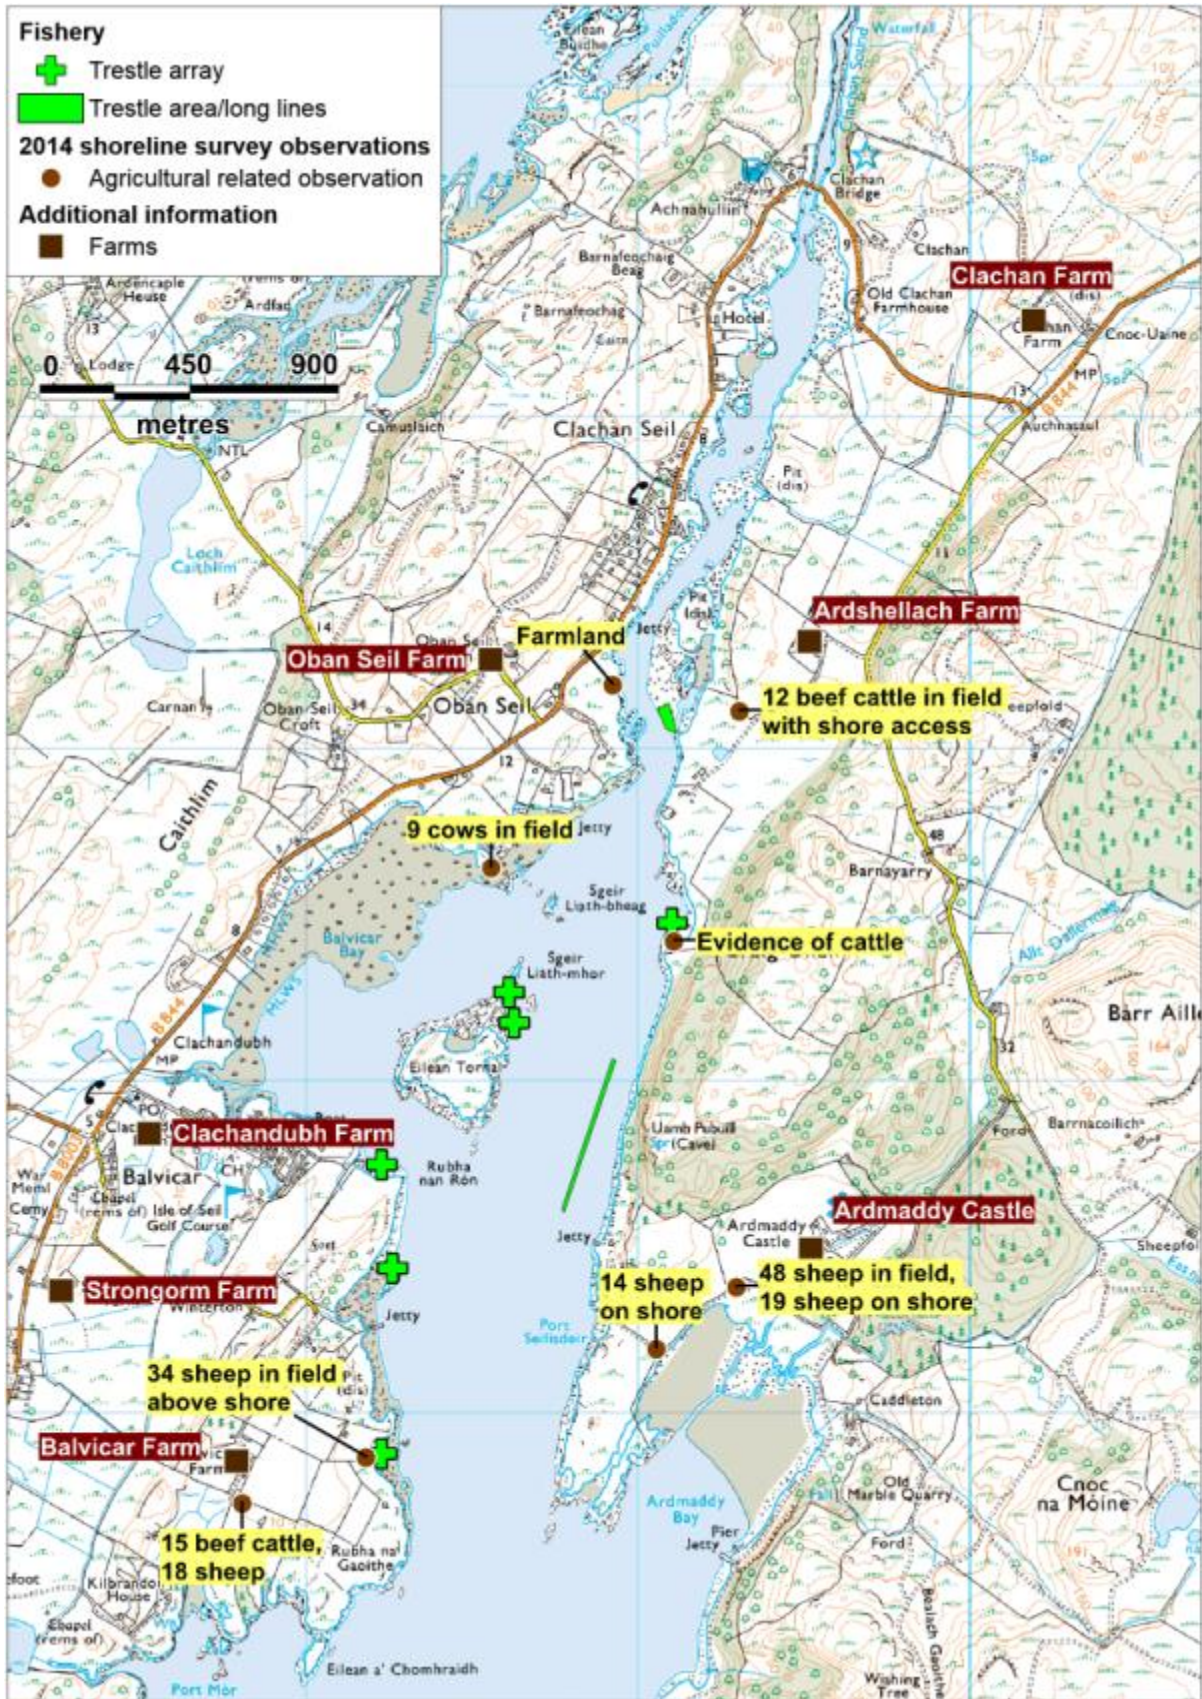
Figure 3.1 Map of farm animal - associated observations made during the 2014 shoreline survey

The 2014 shoreline survey noted that livestock (sheep and cattle) were concentrated on the southwestern side of the sound at Balvicar Farm and on the southeastern side around Ardmaddy Bay. Evidence of cattle was also noted on land near the Craig Ulian site. Two small herds of cattle in fields were also observed; one at Oban-Seil and one at Ardshellach. The presence of other working farms was also noted (see Figure 3.1).

Sheep and cattle remain significant potential sources of faecal contamination to the sound. These are likely to have the greatest impact on the oysters located on the western and eastern shores of the sound. Contamination from livestock kept near Ardmaddy Castle may also impact on the southern end of the mussel lines in Seil Sound: East.

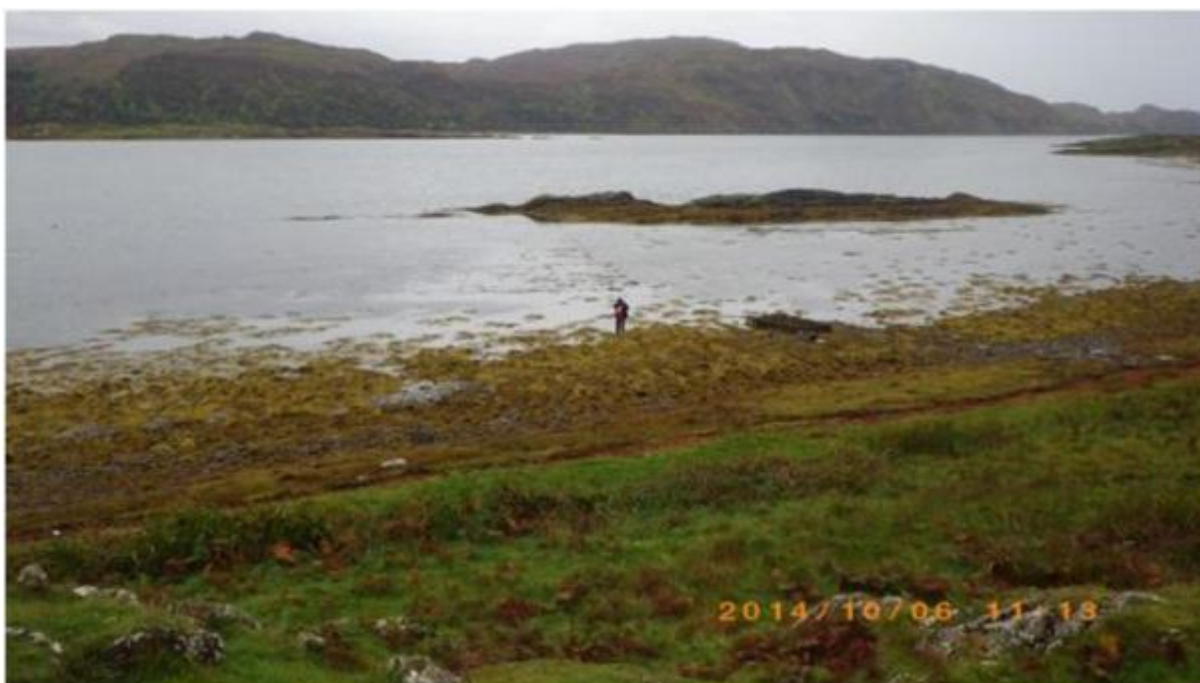
Figure 6. Seil Sound South, Rubha nan Ron south, oyster trestles by Balvicar Chalets. The tide level is just at the top of some of the bags seen beyond the standing figure on the shore. Site of planned seawater sample SSSW2. Waypoint 19.

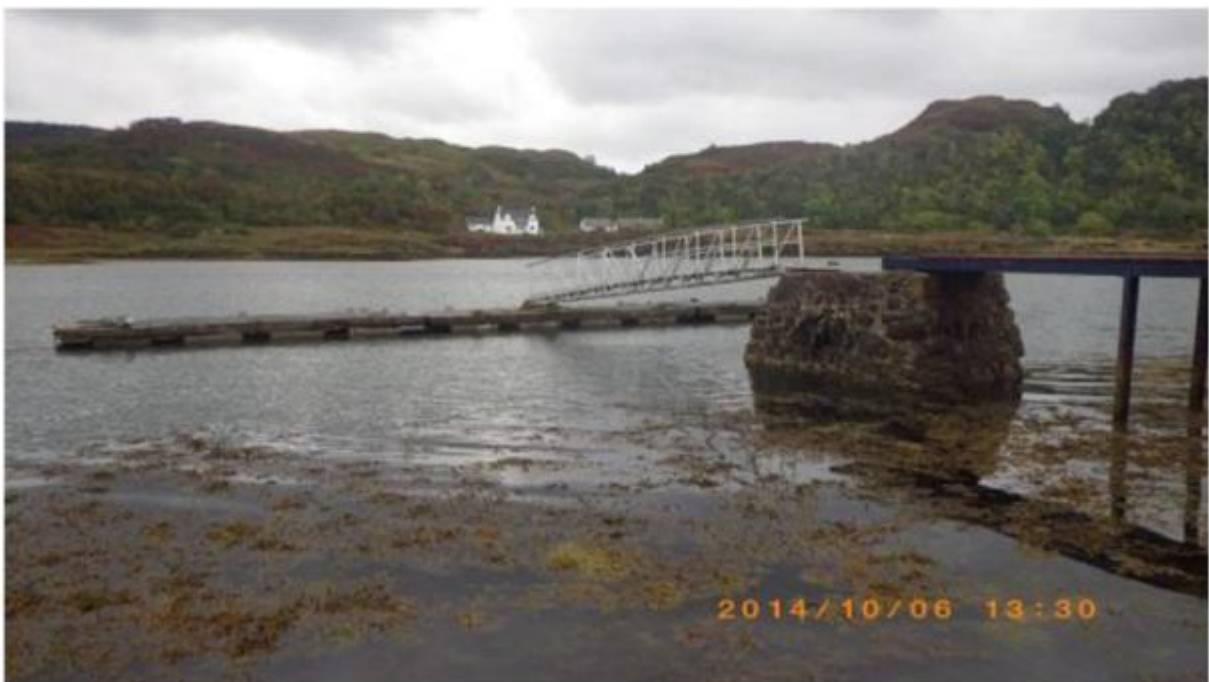
During the 2014 shoreline survey a small group of new build houses was observed adjacent to the Ardshellach site on the east coast of the sound. The surveyors were unable to determine whether the group comprised four houses or three houses and a garage. No planning applications were returned for this area and these houses were not identified during the 2008 shoreline survey. These houses are anticipated to have private sewage facilities as they are not within the vicinity of the public sewage network. They therefore represent a potentially significant source of contamination for the Ardshellach site with the actual risk dependent on the discharge arrangements.

Figure 10. Pontoon, Seil Sound North, west side. New build houses (4 of) in the distant background on the east side of the sound. Waypoint 43.

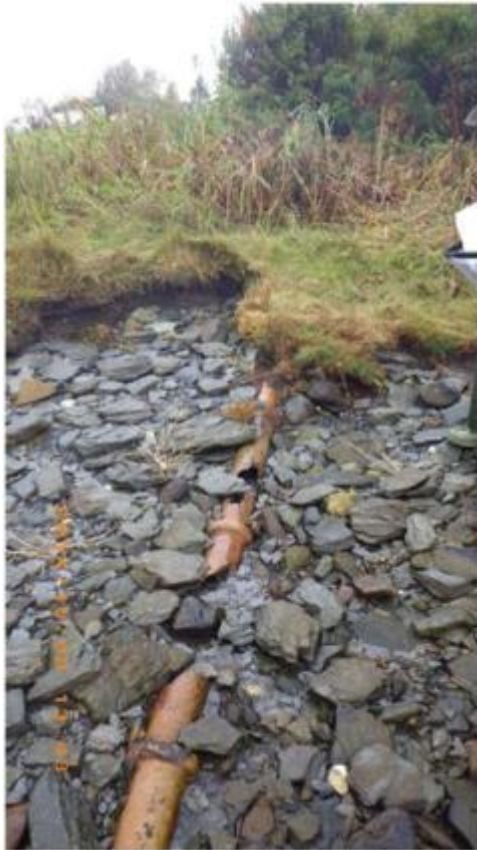
Figure 13. Broken ceramic pipe with flow. Site of unplanned freshwater sample SSFW8. Waypoint 48.

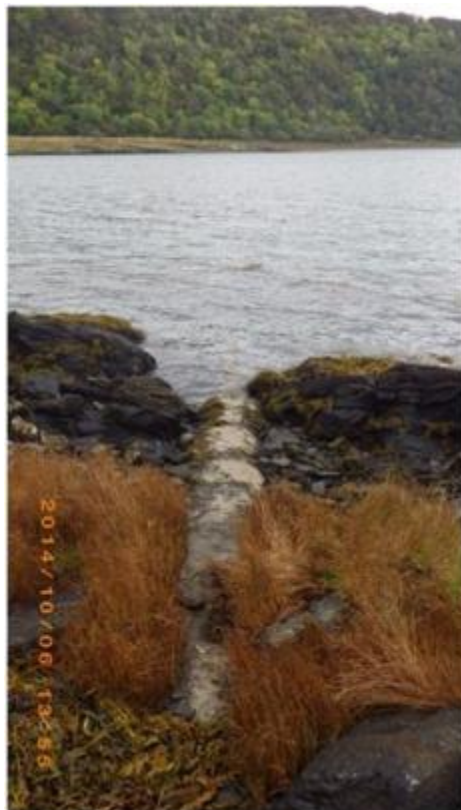
Figure 14. Concrete encased pipe near new pontoon pier. End underwater. Waypoint 50.

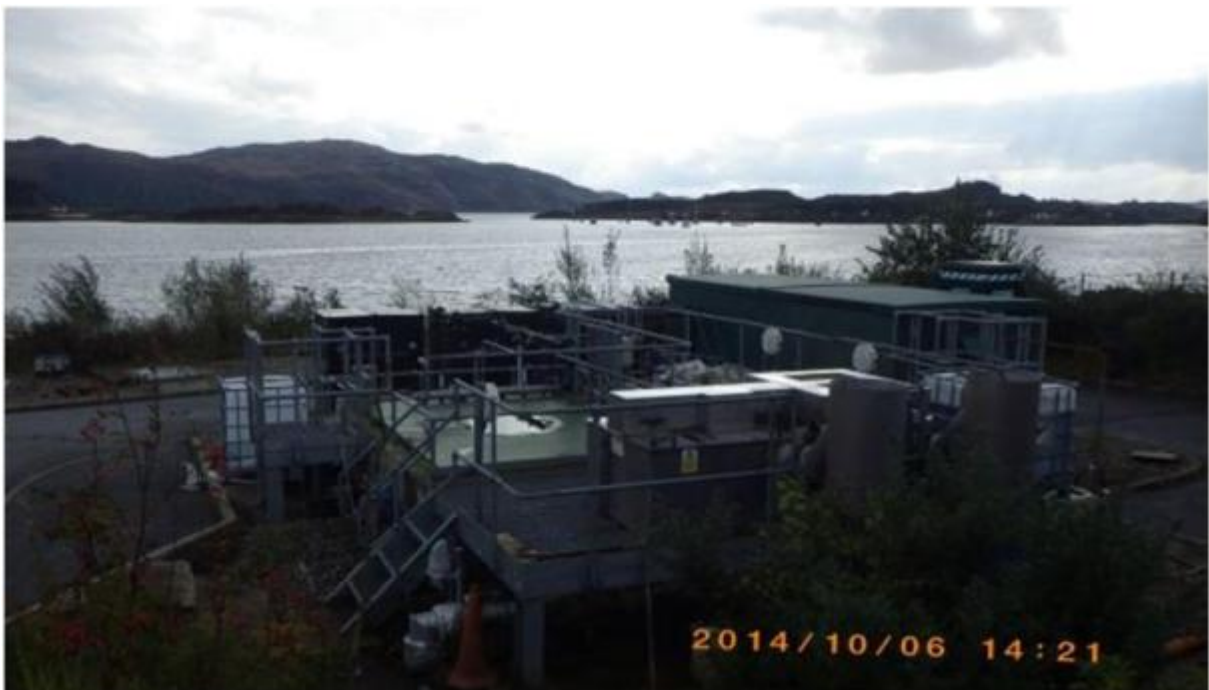
Figure 16. Scottish Water Balvicar Bay Waste Water Treatment Plant looking southeast from the B844. Balvicar village right distant and Eilean Tornal in the mouth of the bay left distance. Outfall pipe covered by tide. Waypoint 52.

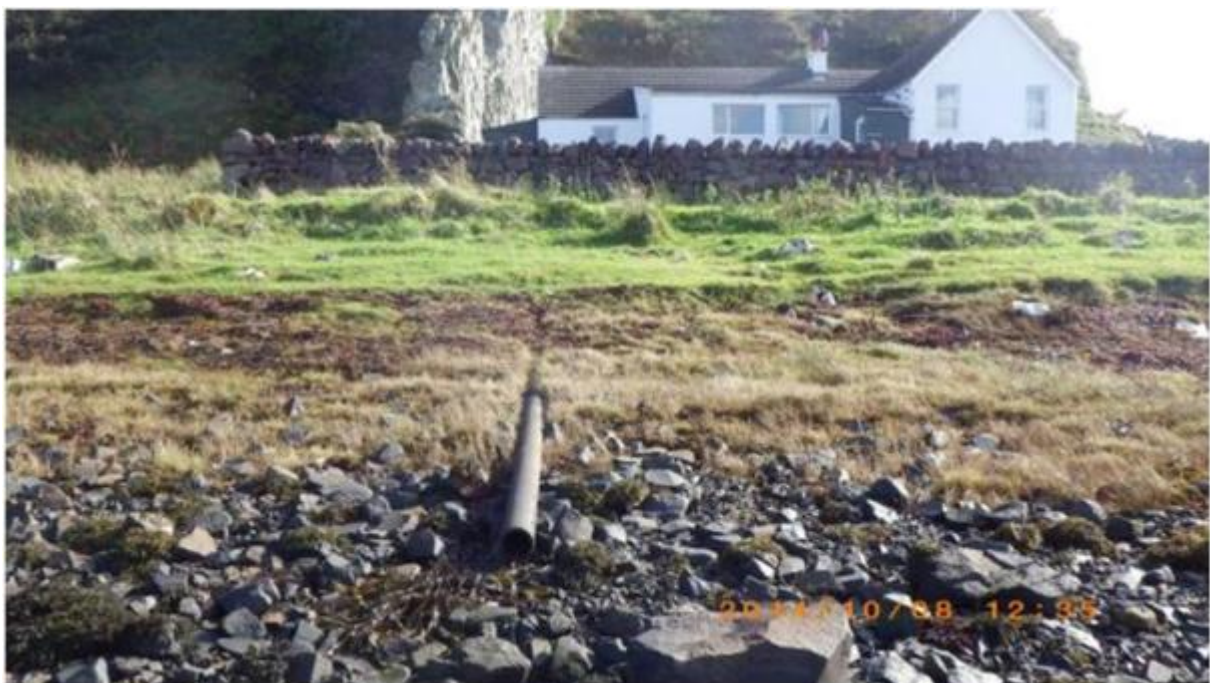
Figure 18. Holiday house by jetty near Seil Sound East mussel farm lines. Outfall pipe source of unplanned freshwater sample SSFW11. Waypoint 95.

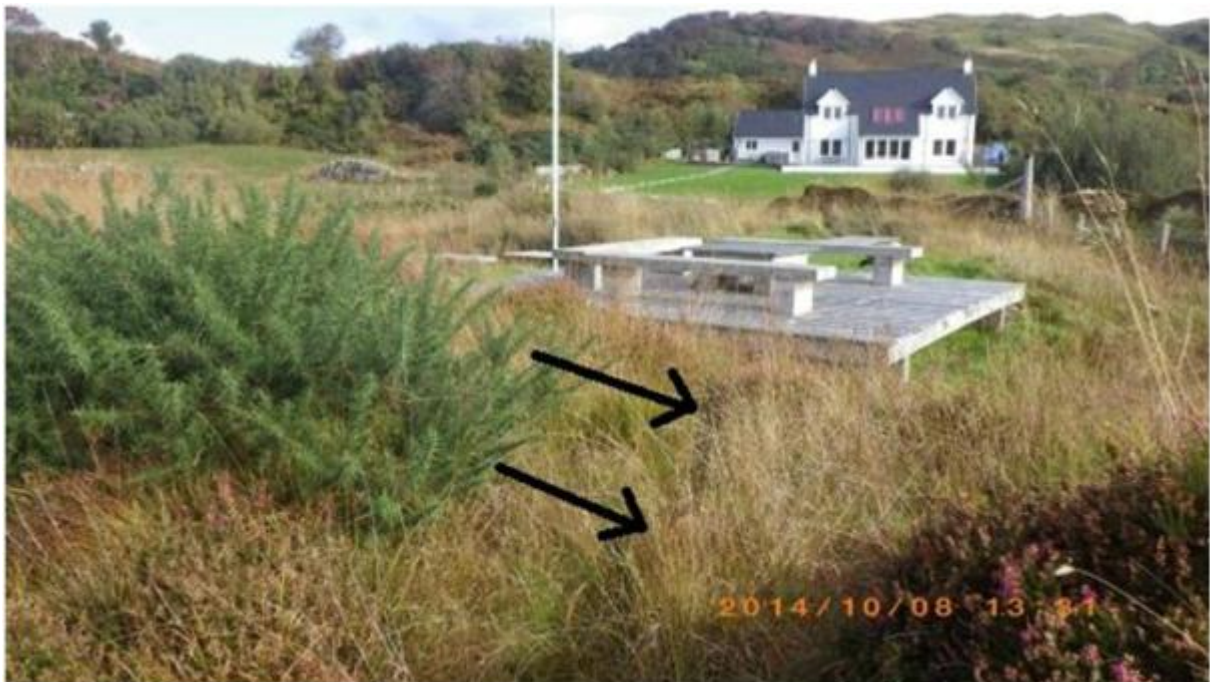
Anecdotal accounts indicate that otters reside within Seil Sound (Argyll Eggs & Balvicar Farm, 2015), though there remains a lack of accurate reports on numbers of otters in the area. Several otter trails were noted just north of the Ardshellach site during the 2014 shoreline survey.

Figure 19. Otter trail (arrowed) in deep grass above Seil Sound North, north east shore. One of four new houses in background. Waypoint 101.

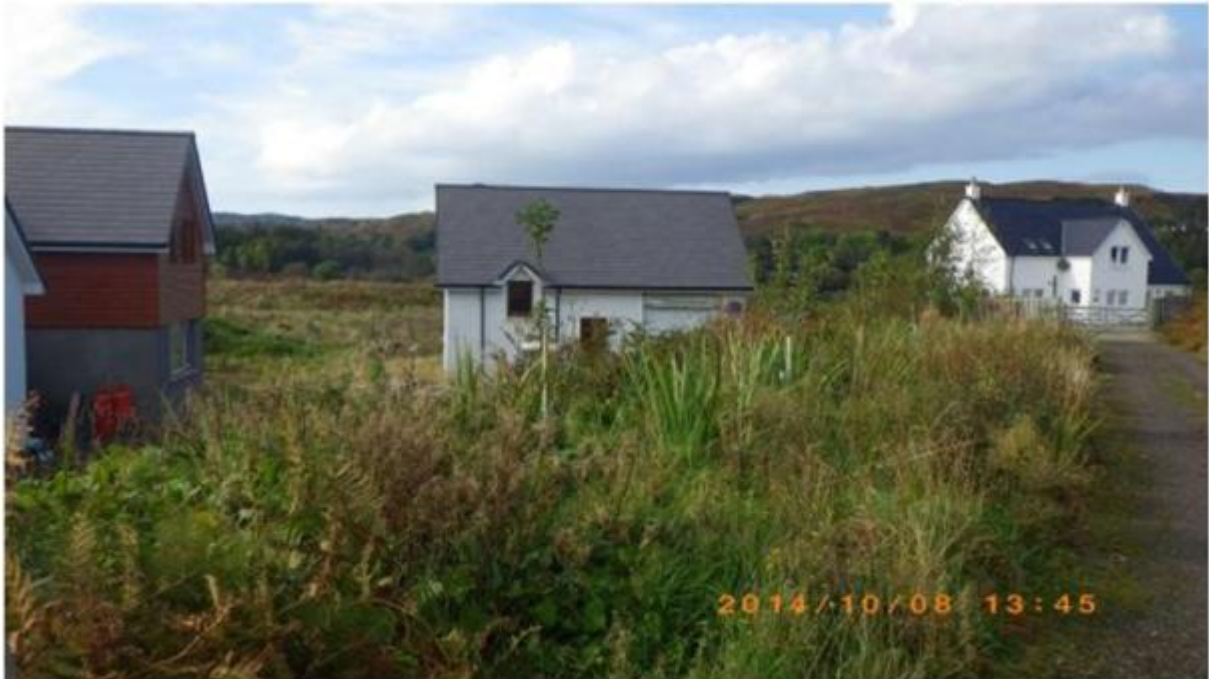
Figure21. Three of four new houses at the north east of Seil Sound. View west towards the sound. Waypoint 104.

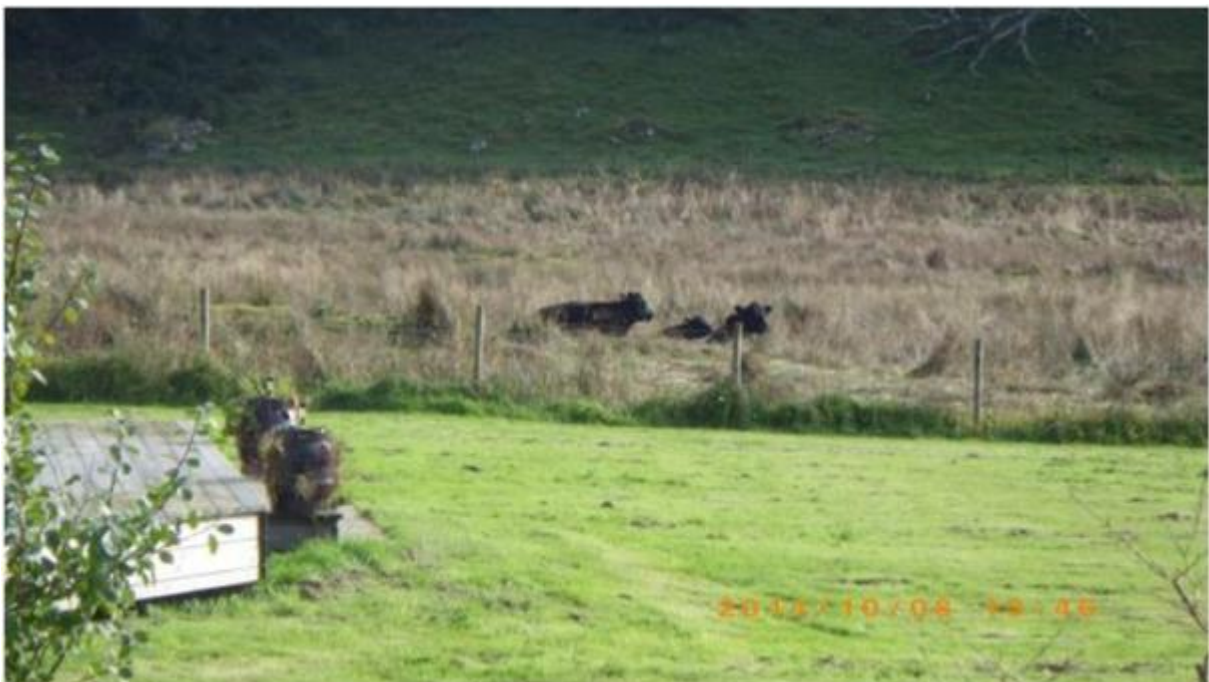
Figure 22. Three of twelve cattle in field by new housing at the north east of Seil Sound . Near Ardshellach Farm shore side road end. Waypoint 104.
