Scottish Sanitary Survey Review

Vaila Sound

SI-288 and SI-289

Report Title	Vaila Sound Sanitary Survey Review
Project Name	Scottish Sanitary Survey
Client/Customer	Food Standards Agency Scotland
Cefas Project Reference	C6316D
Document Number	C6316D_2014_18
Revision	V1.0
Date	27/02/2015

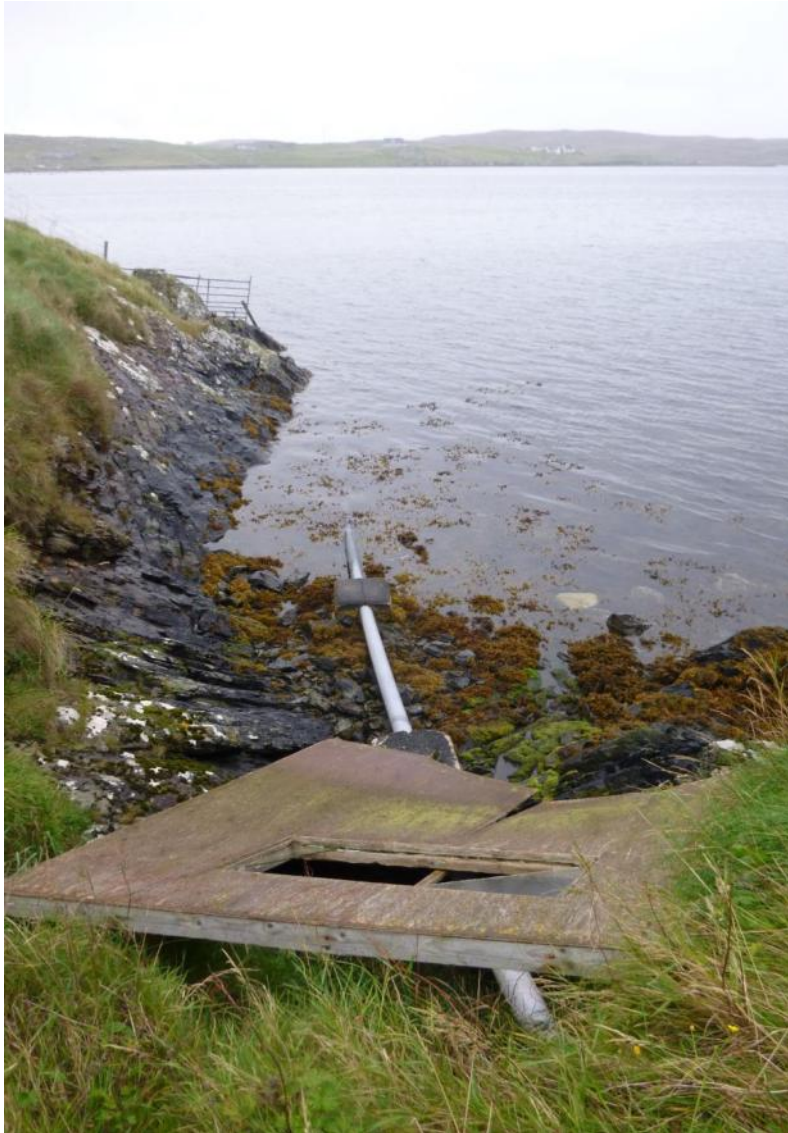
Figure 9 – A white plastic pipe receding underwater near Burrastow House.

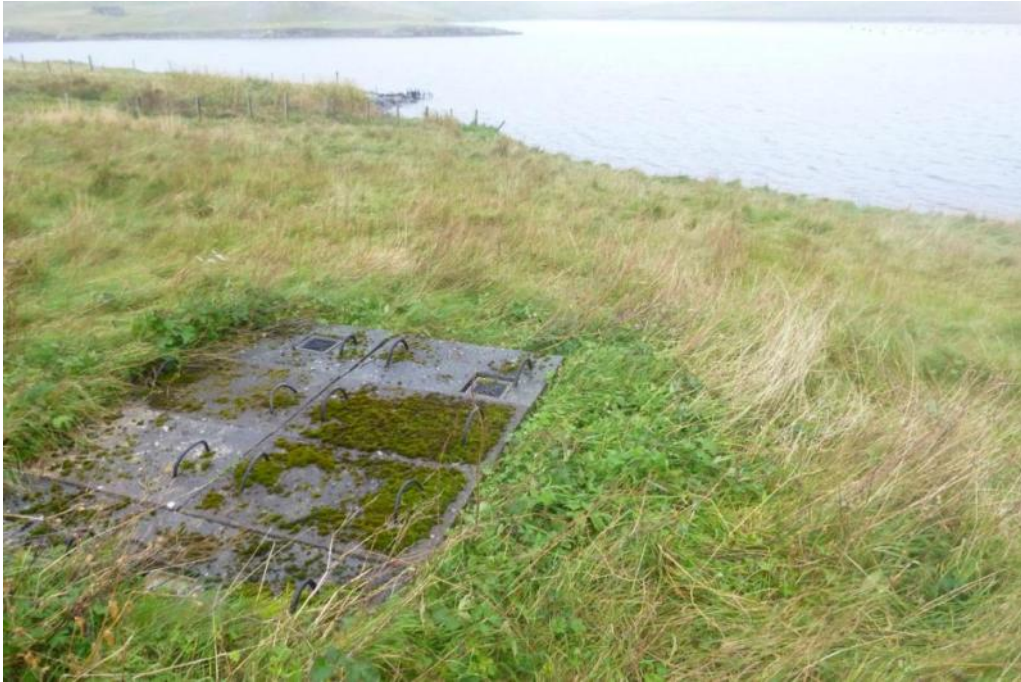
Figure 10 – A concrete septic tank on hill above the shore at Lera Voe.

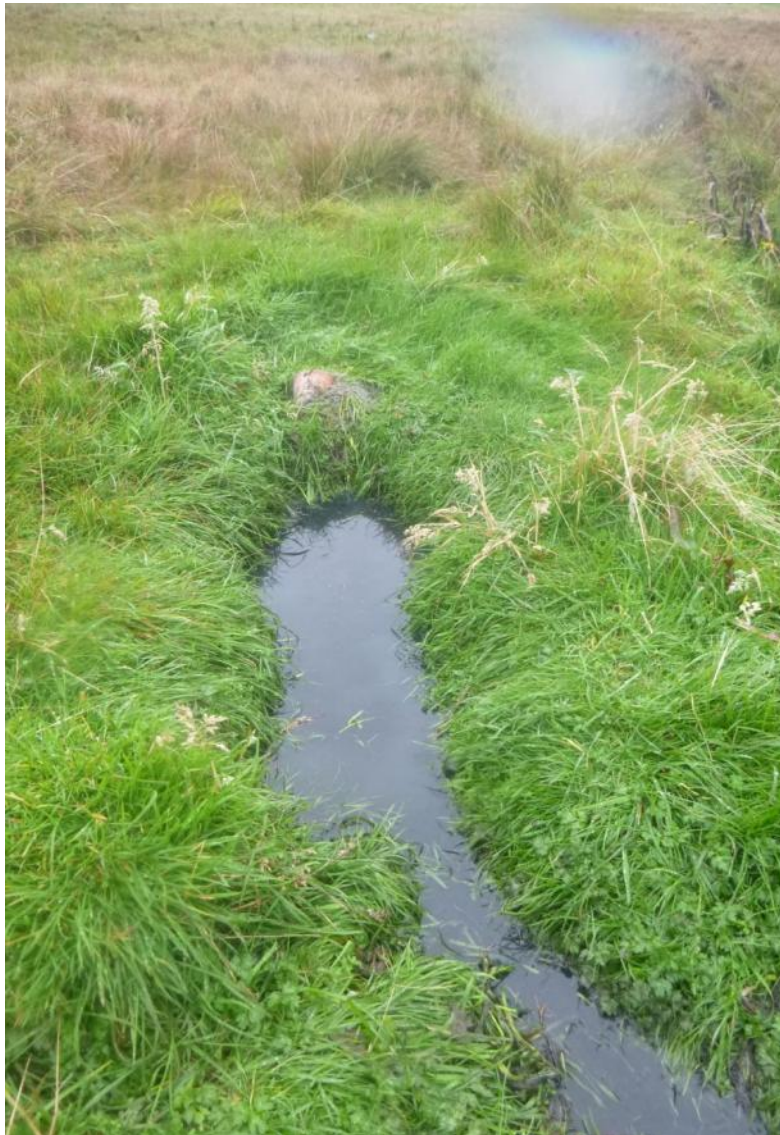
Figure 11 – Discoloured discharge from a septic tank at Lera Voe.

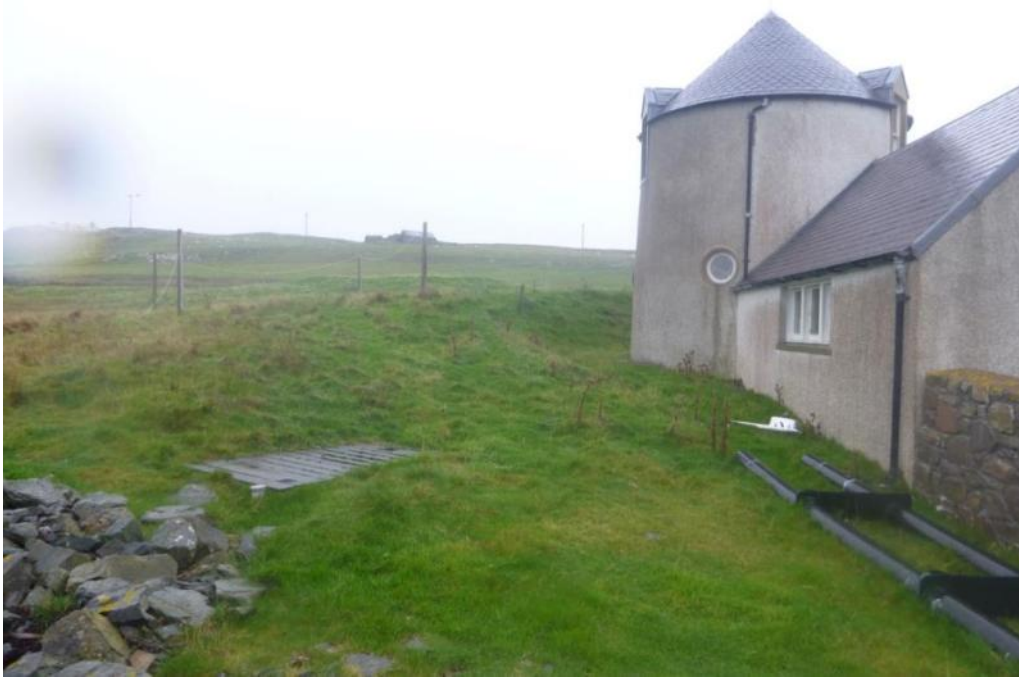
Figure 12 – A concrete septic tank with outflow to Lera Voe.

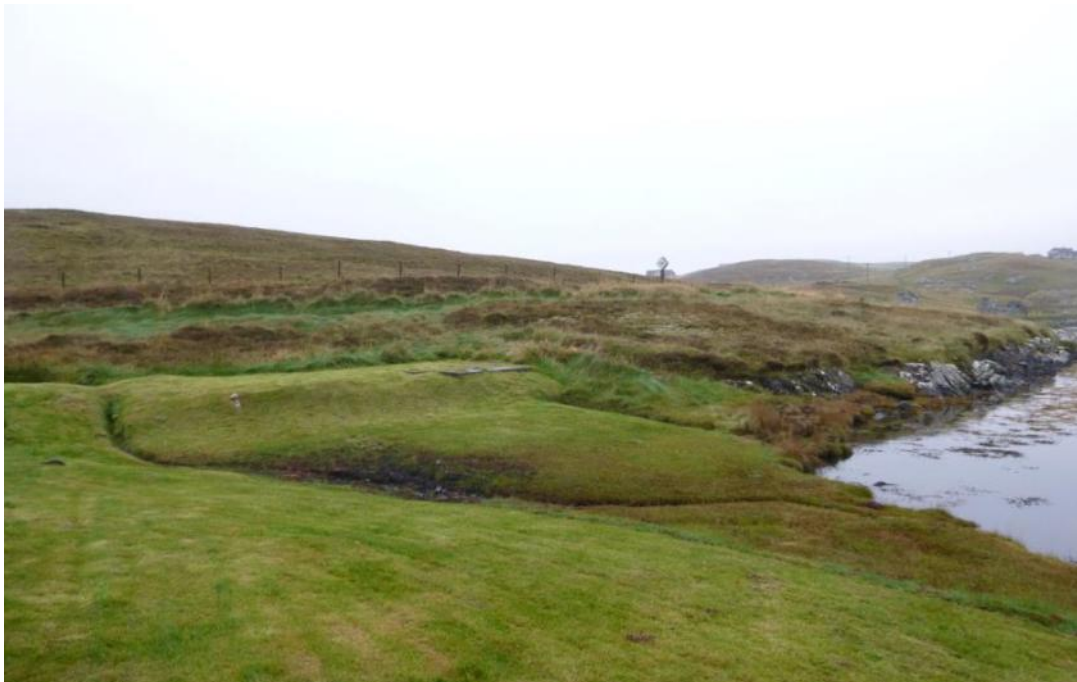
Figure 13 – A septic tank including channel leading to sea at the head of Lera Voe.

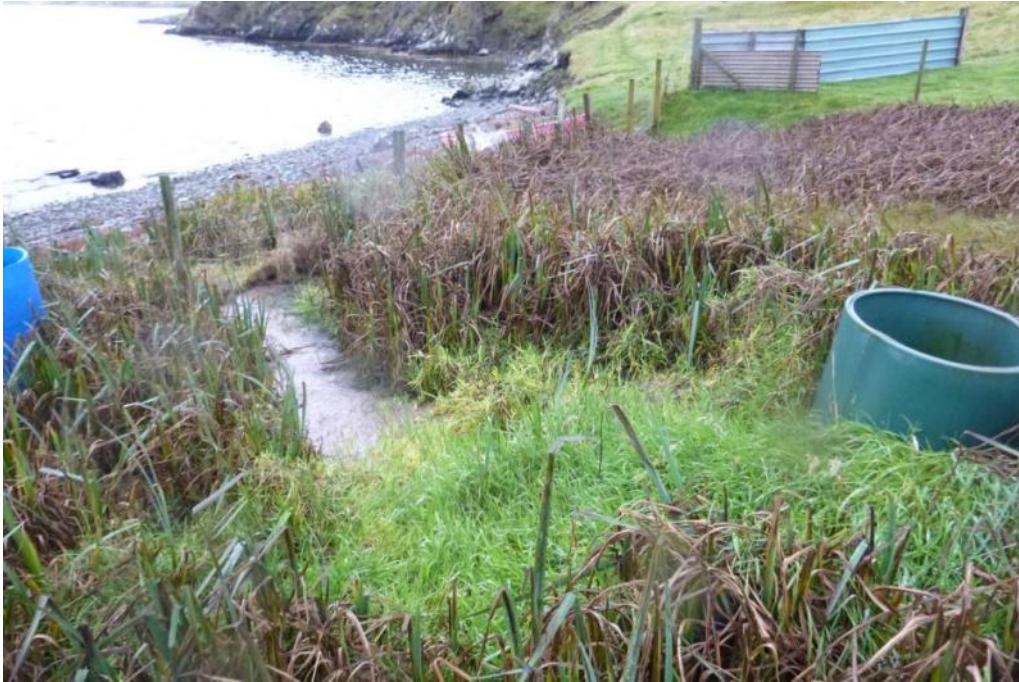
Figure 14 – Overflowing septic tank at Crookataing, a seawater sample was collected here.

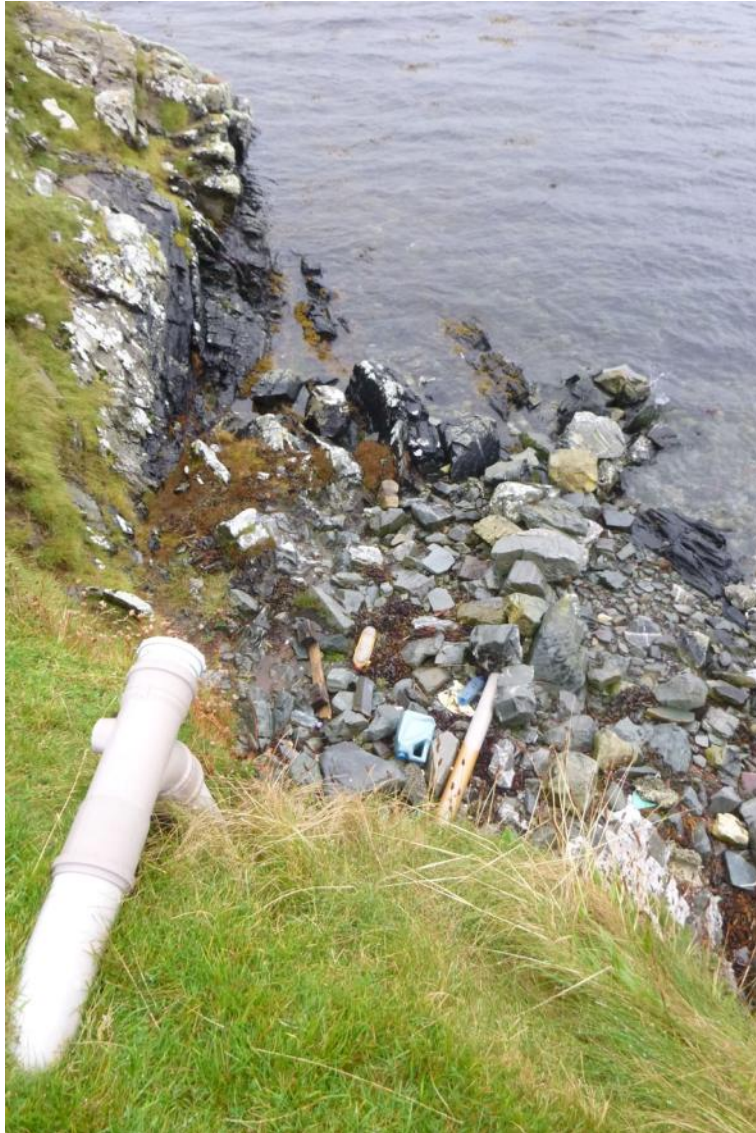
Figure 15 – A plastic pipe leading into the sea at Riskaness

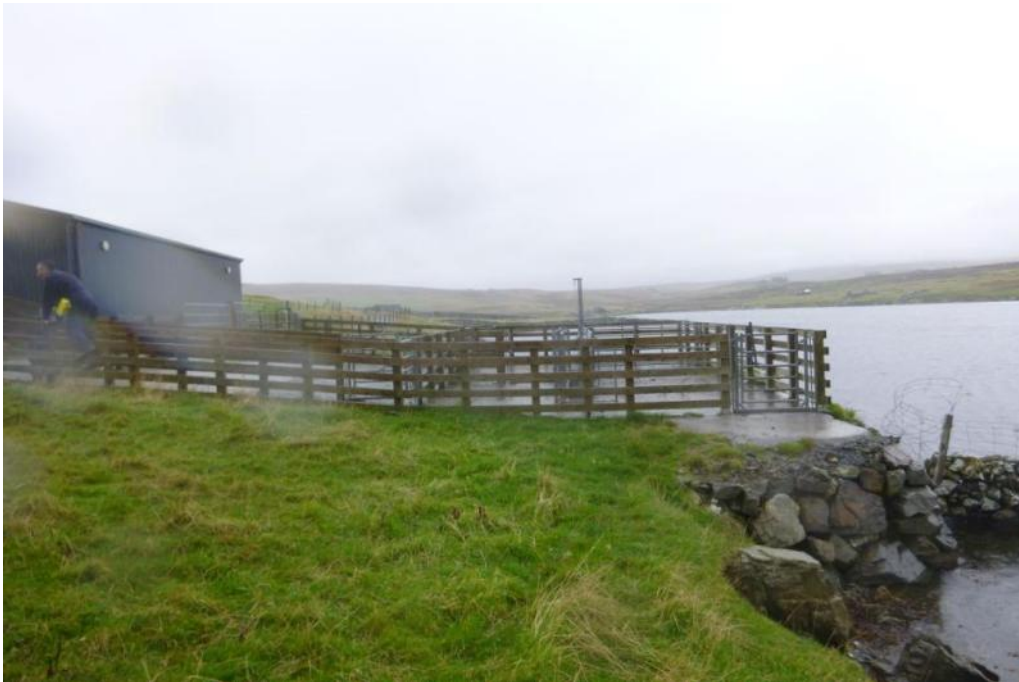
Figure 16 – Photo indicating proximity of agricultural buildings to sea at Loch of Vadill.

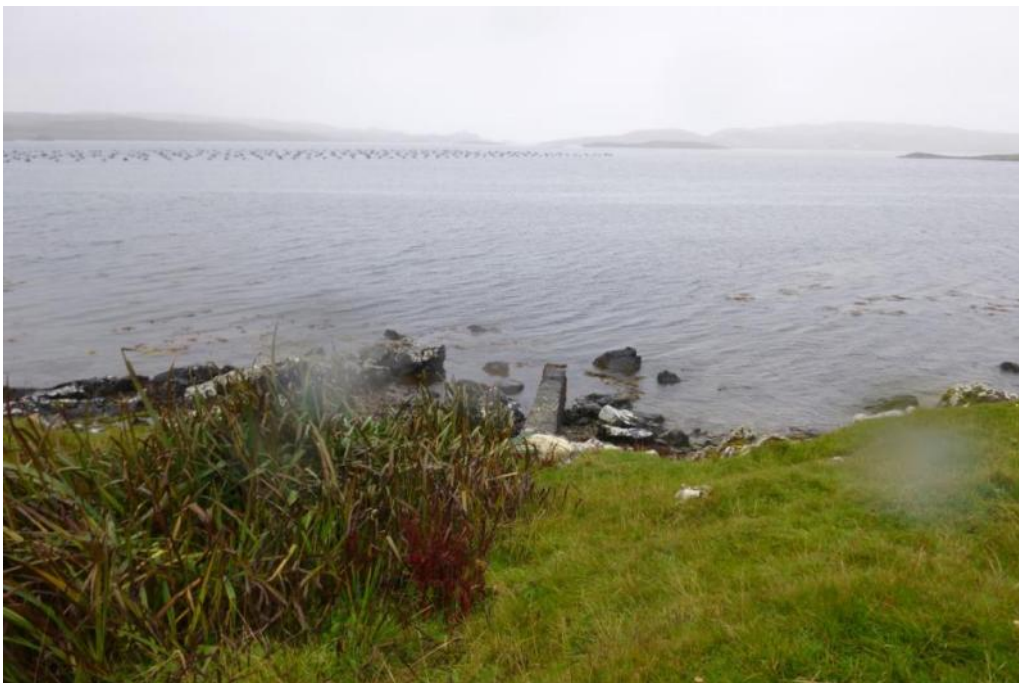
Figure 17 – Concrete ducting running into sea below Stapness.

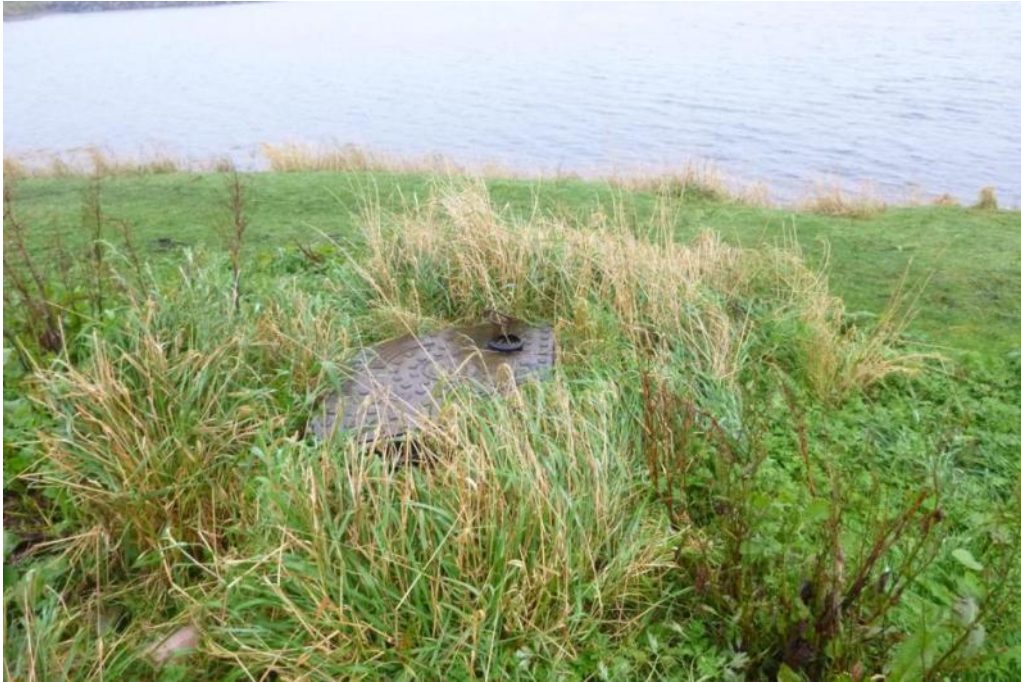
Figure 18 – A septic tank with plastic pipe disappearing underwater near Walls pier.

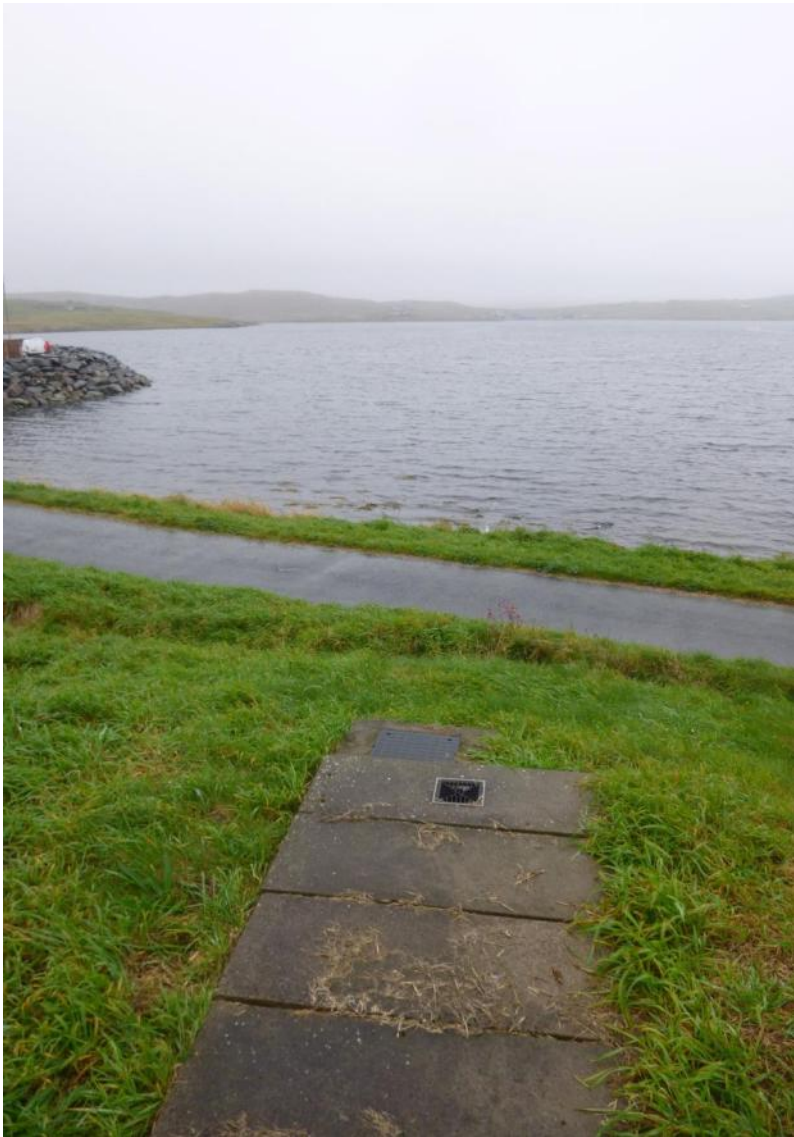
Figure 19 – Concrete septic tank near Walls pier.

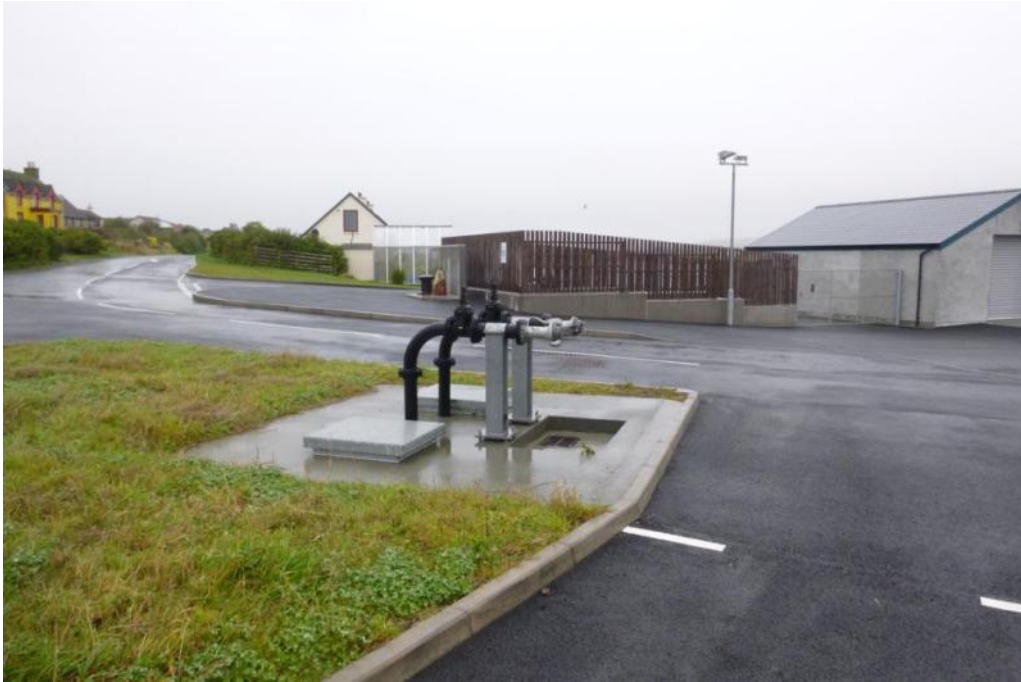
Figure 20 – The Walls septic tank at head of pier.

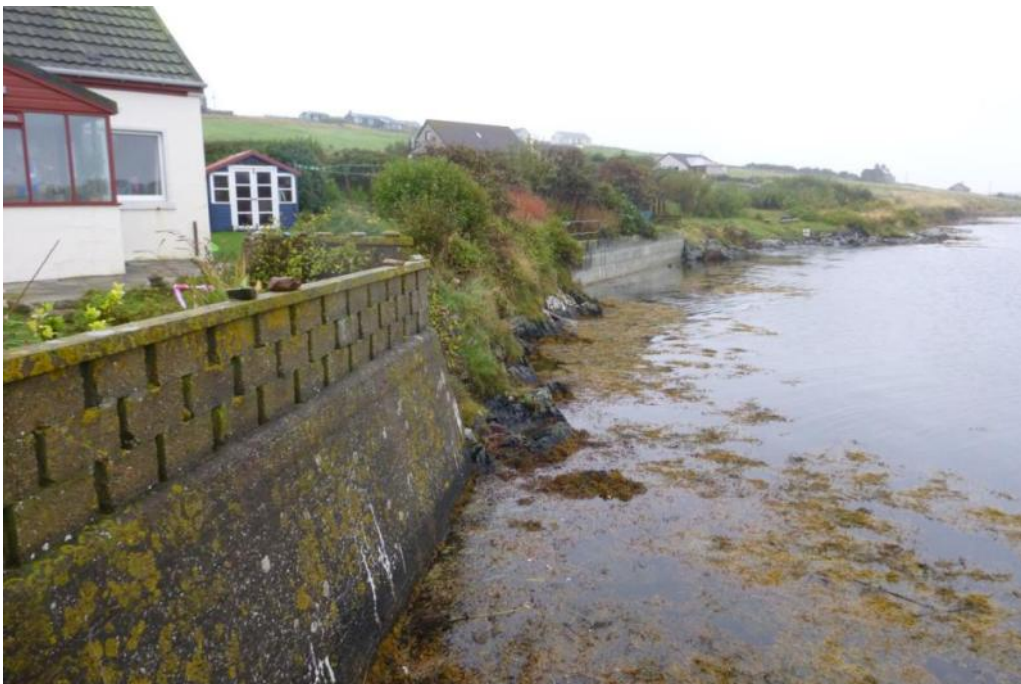
Figure 21 – A house in close proximity to shoreline at Pier Road.

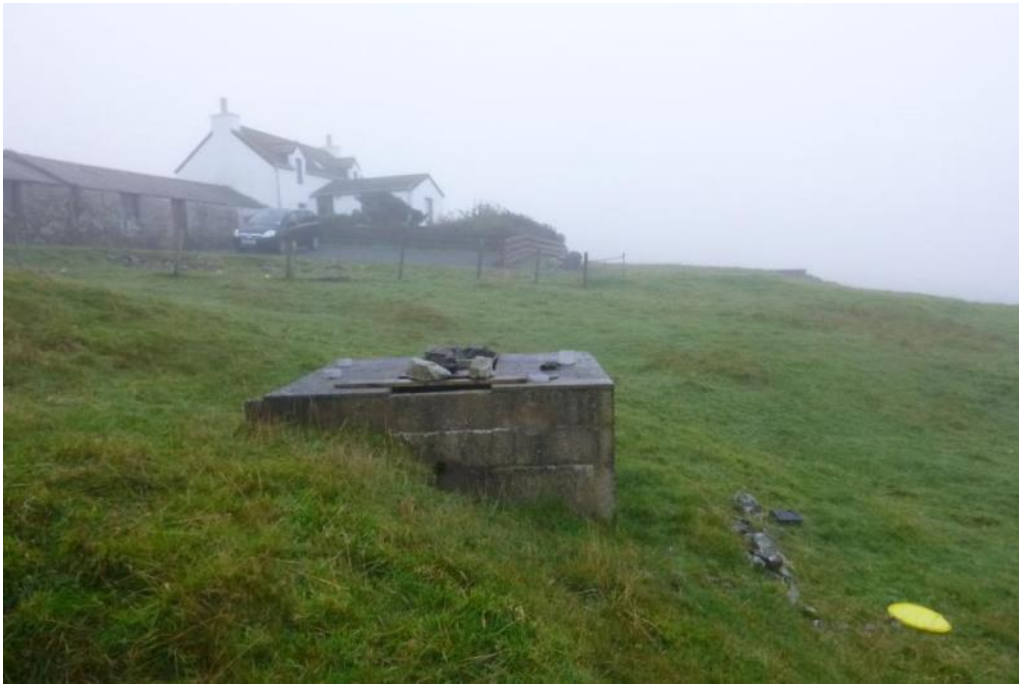
Figure 22 – A septic tank below house at West Banks, possibly disused.

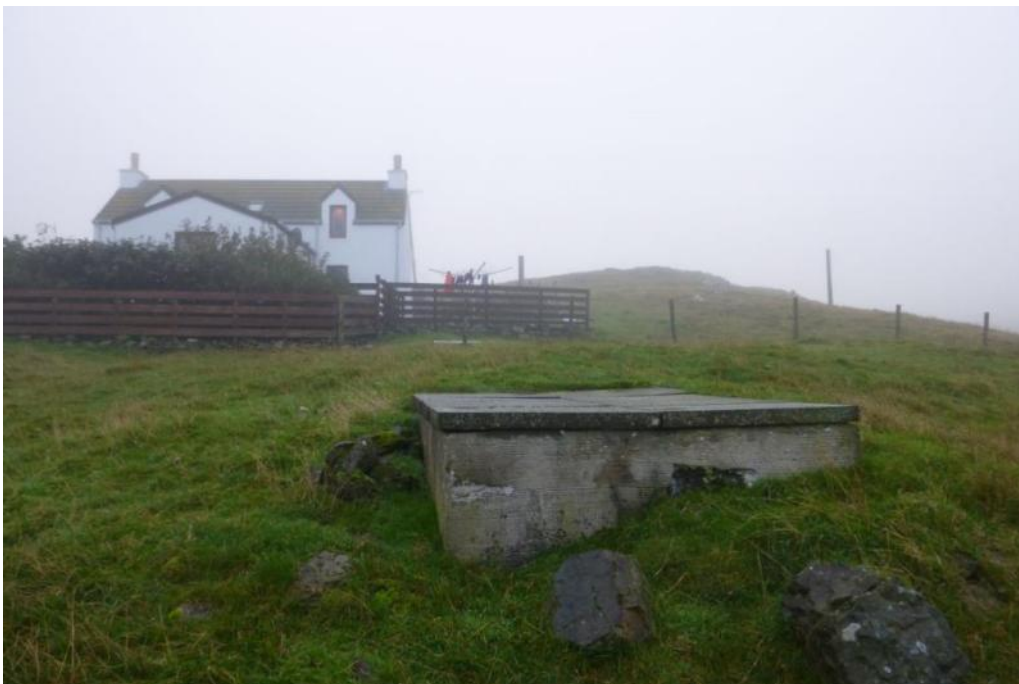
Figure 23 – A concrete septic tank with soakaway at West Banks.

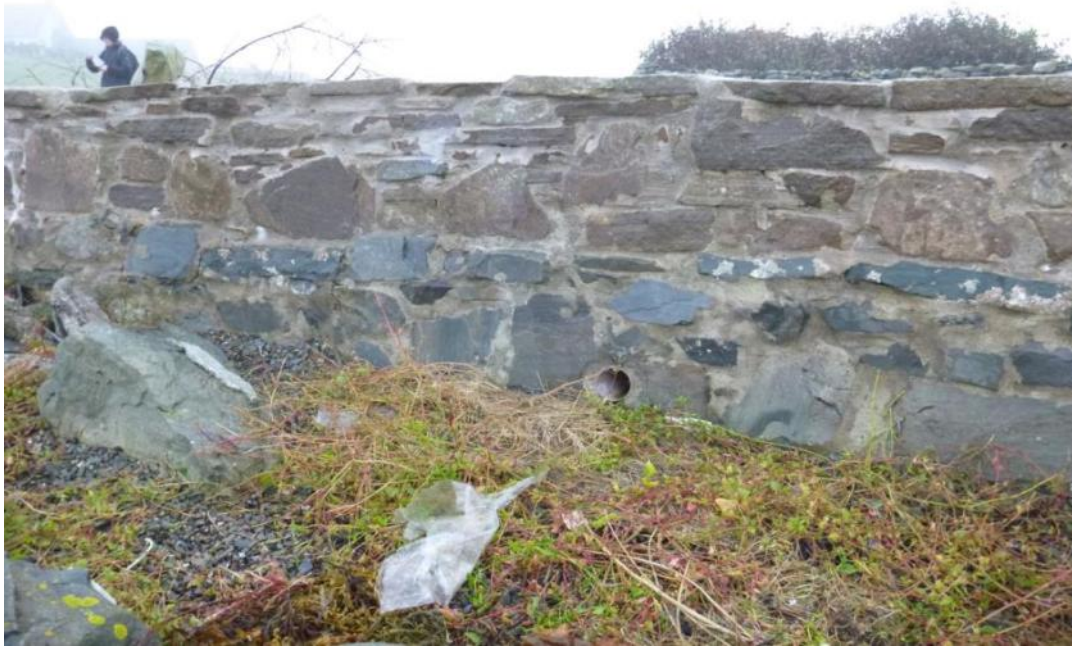
Figure 24 – Outflow pipe to beach at Vadlure, believed to be in use for kitchen wastewater only.

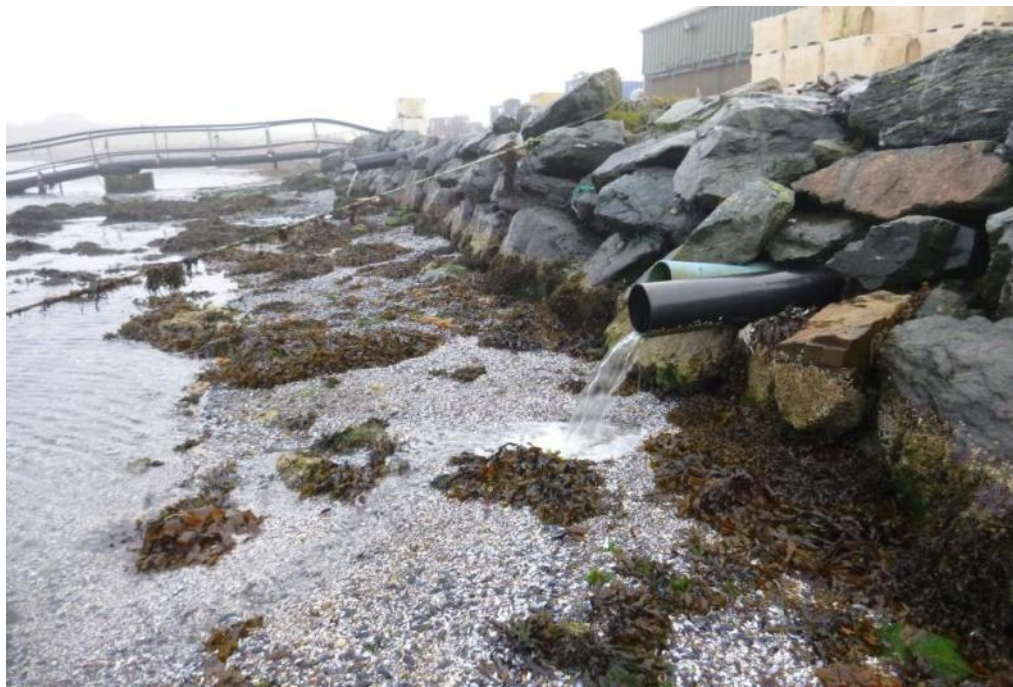
Figure 25 – Various pipes draining onto the beach at Vadlure, additional seawater sample collected.

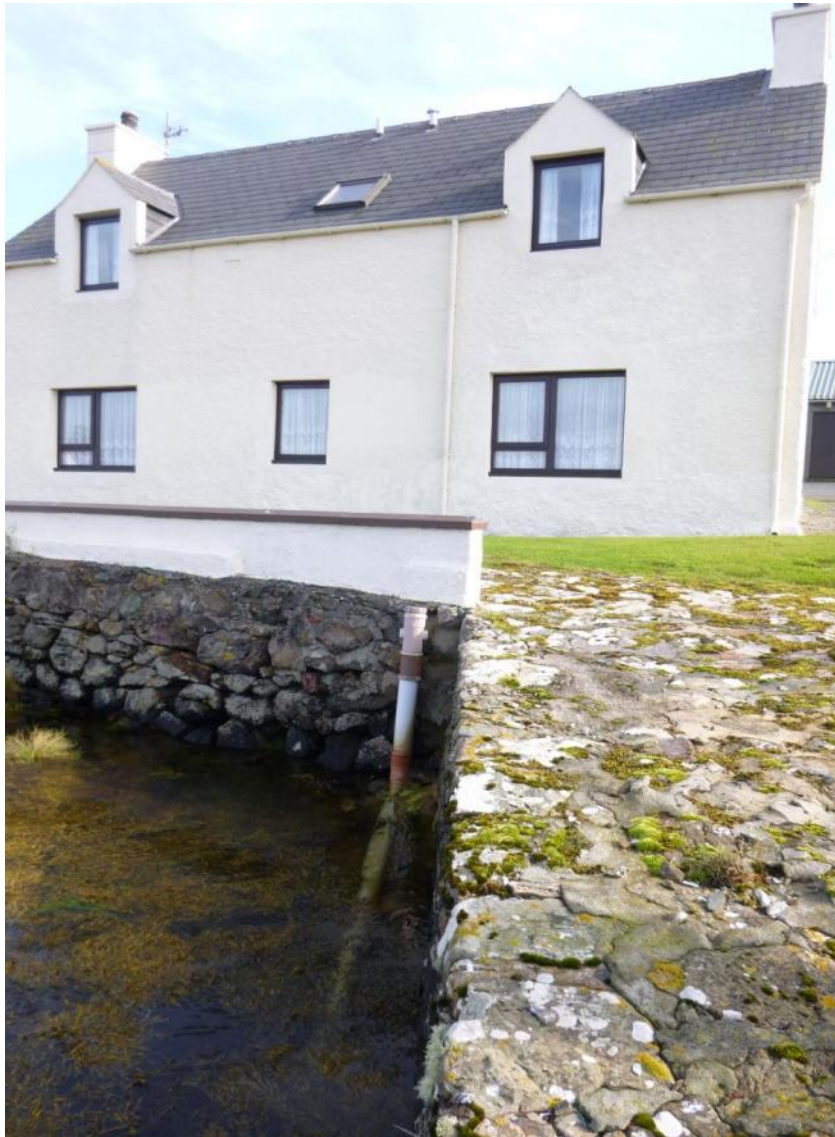
Figure 27 – A plastic pipe receding underwater below house at head of voe in Walls.

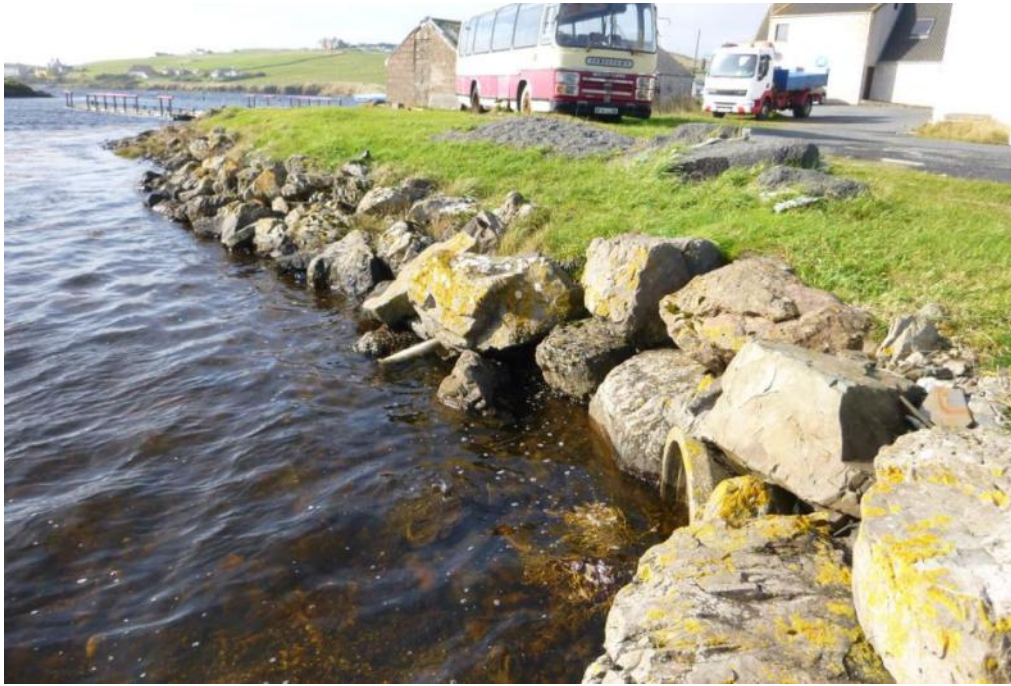
Figure 28 – A land drain and small pipe underwater opposite Walls marina.

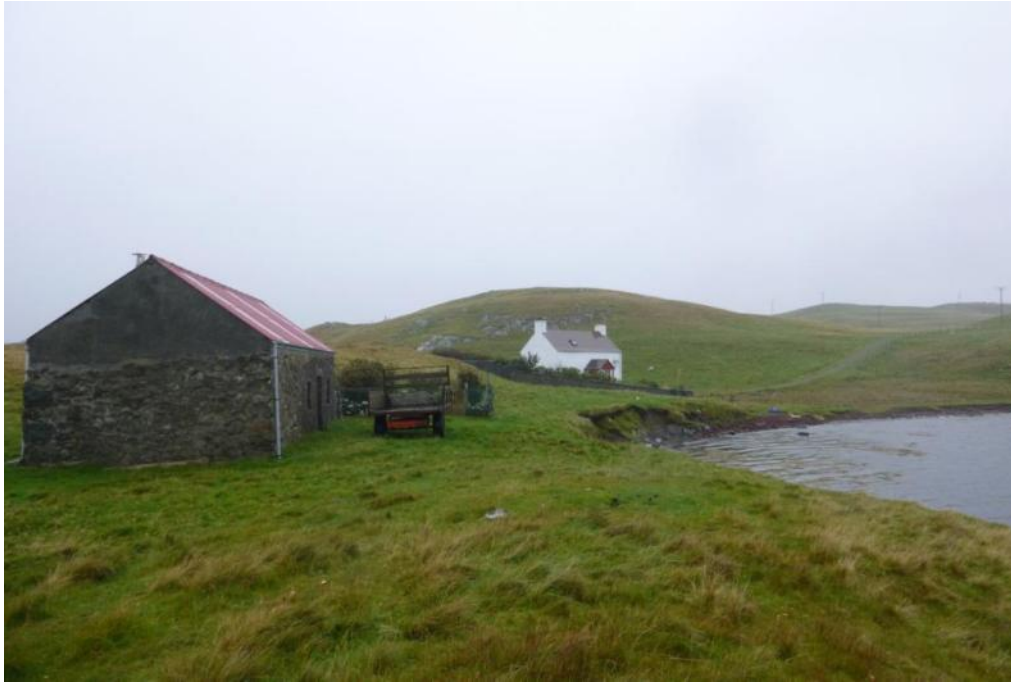
Figure 30 – An agricultural shed near shoreline at Pointataing.
