# CLASSIFICATION OF BIVALVE MOLLUSC PRODUCTION AREAS IN ENGLAND AND WALES

# SANITARY SURVEY REPORT Blackwater & Dengie

2013

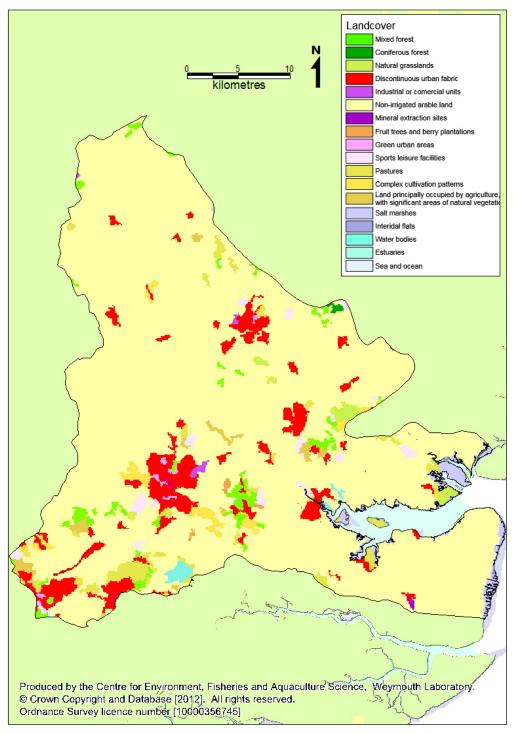
Figure 1.2 Land Cover in the Blackwater Estuary

The Blackwater catchment covers an approximate area of 1,200 km<sup>2</sup> of which around 70% is arable farmland (Figure 1.2). There are several clusters of urbanised land which represent the main towns of Chelmsford, Maldon, Braintree and Witham. Surrounding the urbanised regions are leisure facilities, mixed woodland and a few mineral extraction sites. Osea Island and Northey islands both connected to the main land by tidal causeways are largely uninhabited. Osea is a privately owned island with one settlement in the centre of the island and is predominantly pasture land. Northey Island has two houses situated on the western tip and is over 75% saltmarsh. The Dengie Peninsula is sparsely populated and is all used for arable farming.

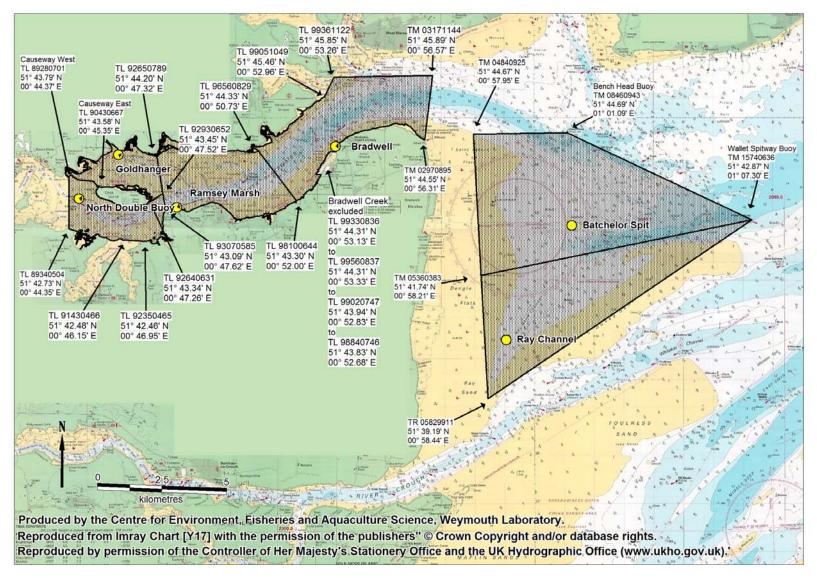
Figure 3.1 Recommended classification zone boundaries and RMP locations (native oysters)

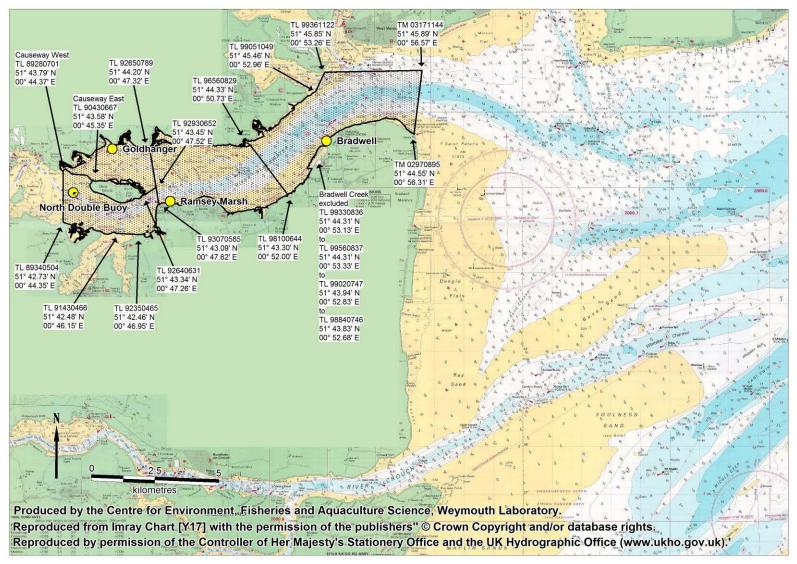
Figure 3.2 Recommended classification zone boundaries and RMP locations (Pacific oysters)

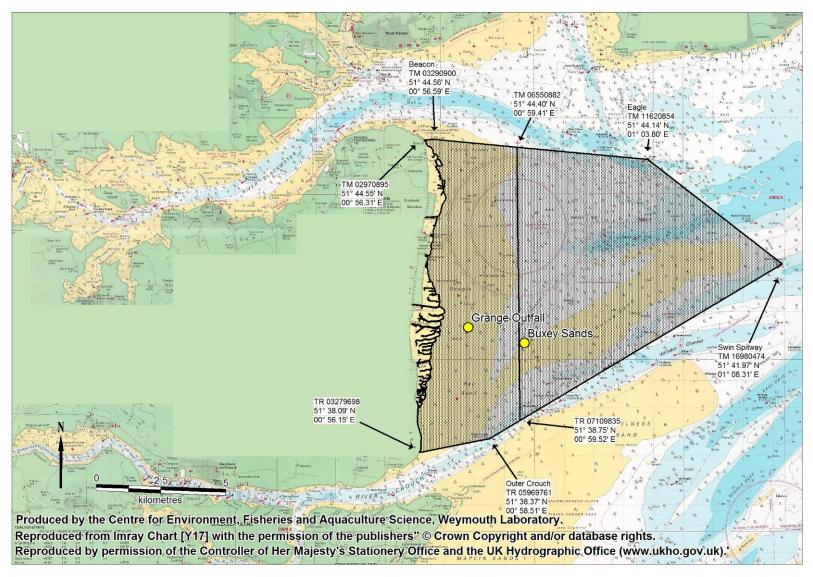
Figure 3.3 Recommended classification zone boundaries and RMP locations (cockles)

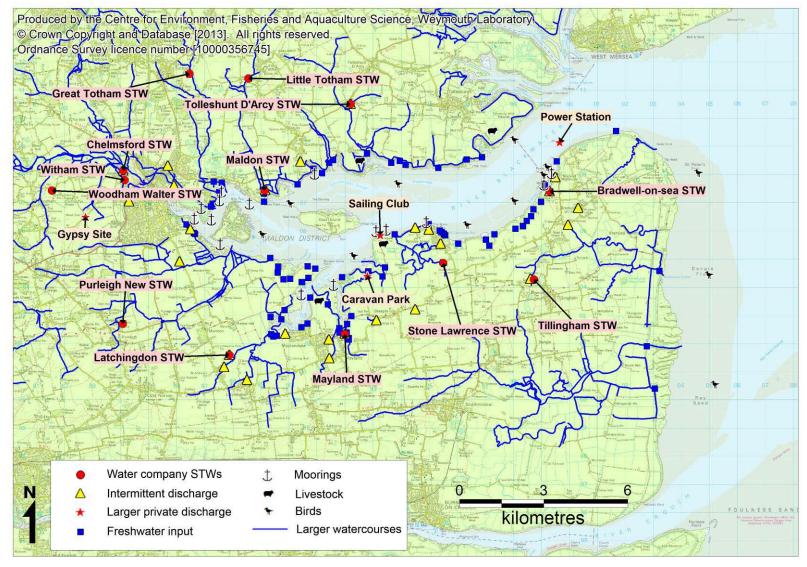
Figure 5.1 Significant sources of microbiological pollution to the area

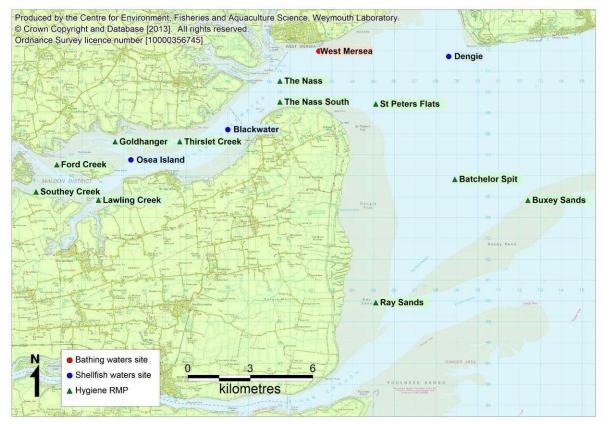
Figure 5.2 Location of microbiological sampling points referred to in this assessment.

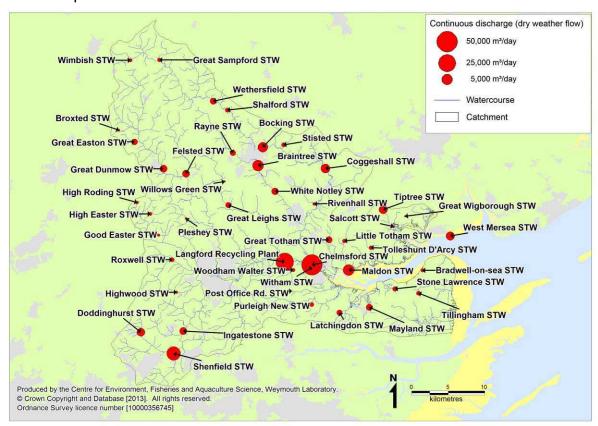
Figure II.1 Water company sewage treatment works discharging within the Blackwater estuary catchment and to nearby coastal waters

Details of all consented discharges within the Blackwater estuary hydrological catchment and nearby coastal waters were taken from the Environment Agency's national discharge database (July 2012). The locations of the water company owned sewage treatment works are shown in Figure II.1. Further details of these treatment works are presented in Table II.1.

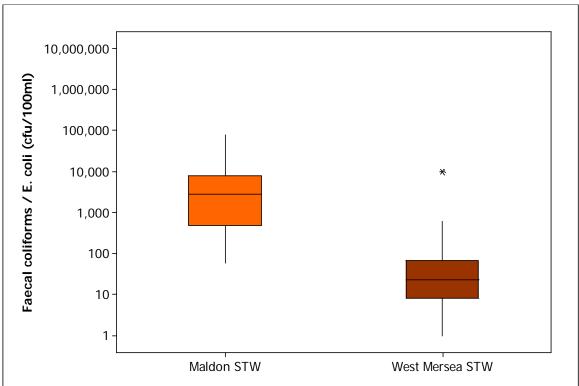
Figure II.2. Boxplot of bacterial concentrations measured in final effluent samples.

Those in orange are faecal coliforms and those in brown are E. coli.

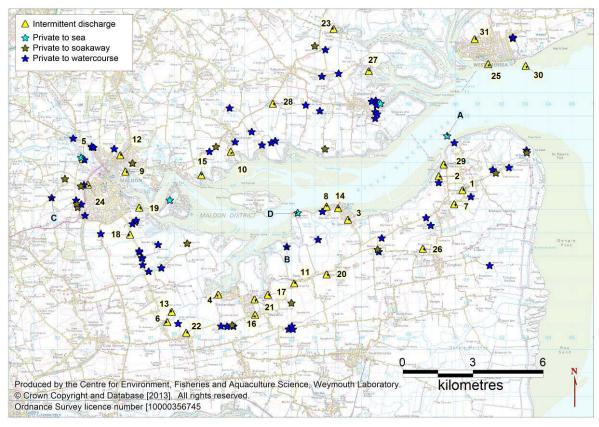
Figure II.3 Intermittent and private discharges within 2km of the survey area

The intermittent discharges are generally located around settled areas and most are by the south shore or to the very upper reaches of the estuary. There are clusters around the head of Lawling and Mayland Creeks, at St. Lawrence and at Bradwell. On the north shore, there are individual intermittent outfalls at Maldon STW, to a watercourse by Bounds Farm, and to a watercourse draining to the head of Thirslet Creek. Spill events may occur either under storm conditions when the sewers are inundated with runoff which may happen after intense rainfall events, or in the event of an emergency such as a pump failure or blockage which may occur at any time. Typically, spills are too infrequent for their impacts to be captured reliably under monthly classification sampling. Those with larger catchments and which receive larger amounts of surface water may be prone to spill larger volumes. No spill records from these discharges was available at the time of writing, so it is difficult to assess their significance aside from noting their location and their potential to discharge large volumes of untreated sewage.

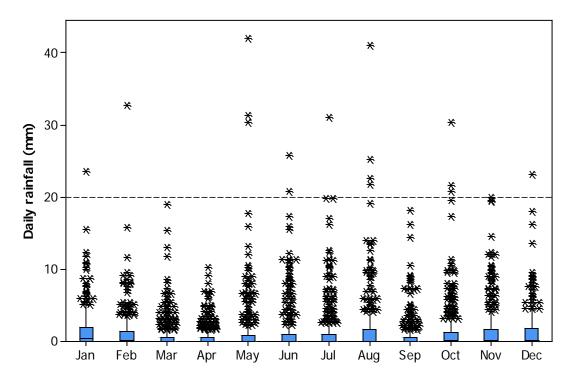
Figure II.1 Boxplot of daily rainfall totals at Mersea, January 2003 to August 2012.

Rainfall records from Mersea, which is representative of conditions in the vicinity of the shellfish beds, indicate relatively low seasonal variation in average rainfall. Rainfall was lowest on average in March, April and September and highest on average in November and August. Daily totals of over 20mm were recorded on 0.45% of days and 52.5% of days were dry. High rainfall events, whilst relatively rare, tended to occur most during the summer and autumn but events of over 20mm were recorded in all months apart from March, April September and November.

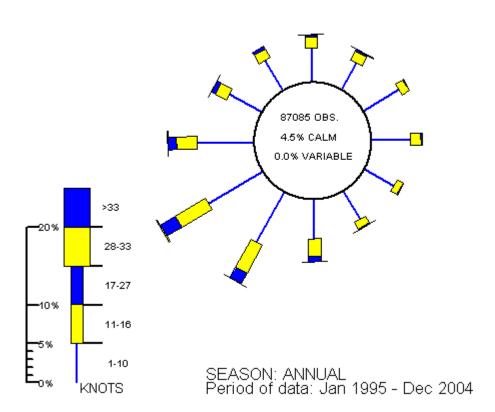
> WIND ROSE FOR COLTISHALL N.G.R: 6262E 3229N ALTITUDE: 17 metres a.m.s.l.

Figure VI.1 Wind rose for Coltishall

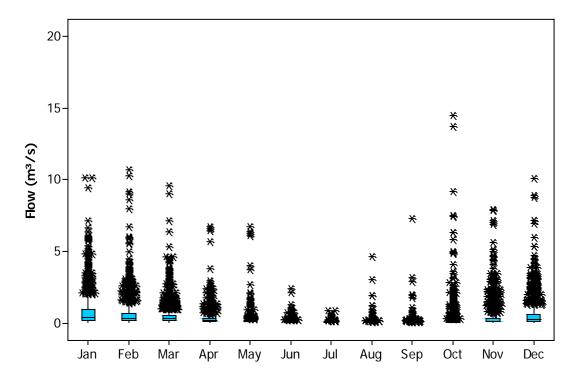
Figure VIII.2: Boxplots of mean daily flow records from the Churchend gauging station on the River Chelmer from 1963-2010 Data from the Environment Agency

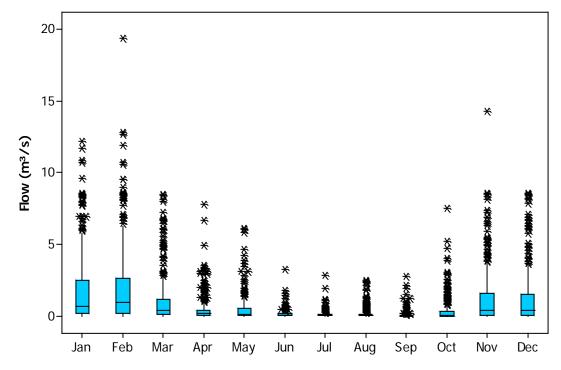
Figure VIII.3: Boxplots of mean daily flow records from the Langford gauging station on the River Blackwater from 2000-2009. Two data point from February 2009 were removed from the dataset. These data showed flows of 53 and 48 m³/s following heavy rainfall events. Data from the Environment Agency

Langford, which is the most downstream gauging station in the catchment area, flow rates hit a record flow of 53 m<sup>3</sup>/s in February 2009 following heavy rainfall events.

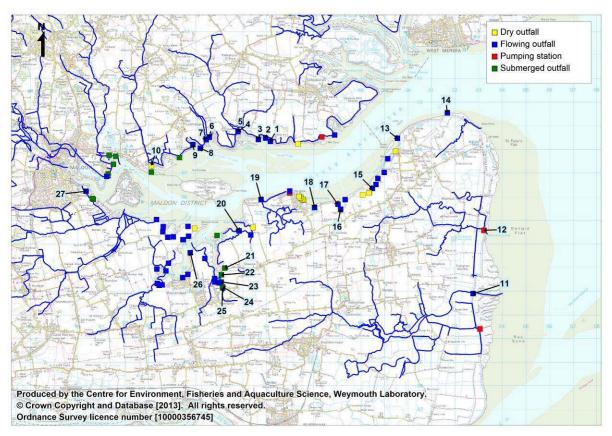
Figure VIII.4. Shoreline observations of freshwater inputs

Whilst the majority of freshwater inputs within the survey area are to the head of the Blackwater estuary, there are a series of smaller watercourses discharging at intervals along the shore of the estuary and to Dengie Flats. These are generally field drains and small streams which discharge via engineered outfalls. During the shoreline survey the locations of these were recorded, and where safe access was possible water samples and spot flow gaugings were undertaken. Figure VIII.4 shows their locations and Table VIII.2 present details of those which were sampled and/or measured. Most of the outfalls on the south shore were not sampled and measured, and those towards the western end of the north shore were covered by the tide at the time.

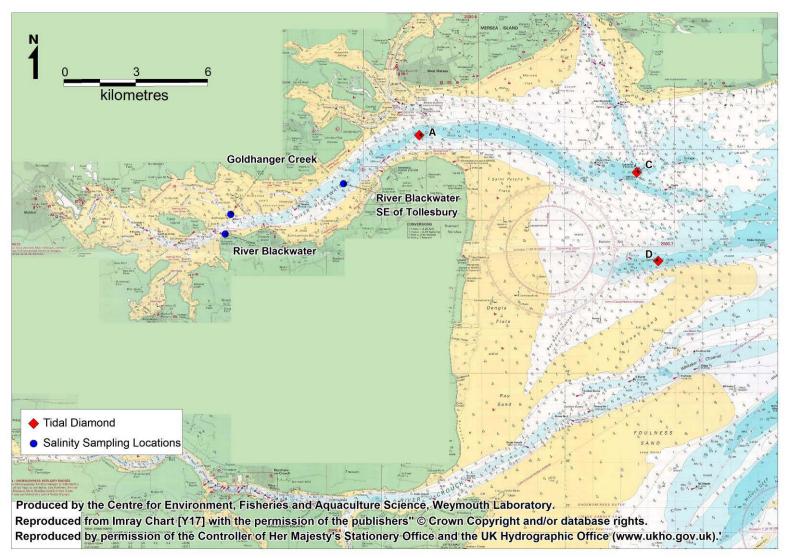
Figure IX.1 Bathymetry chart of the Blackwater and salinity locations

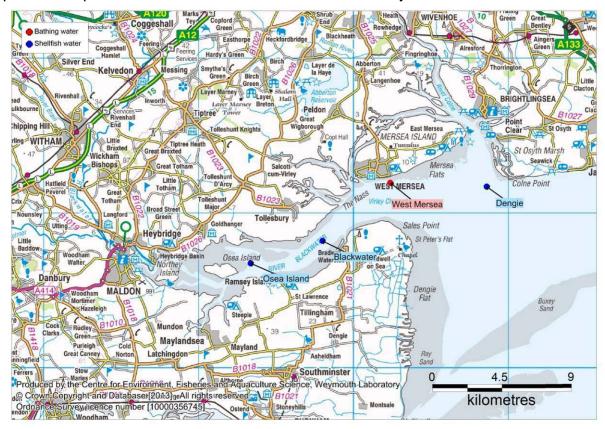
Figure X.1 Location of designated bathing water and shellfish water monitoring points at Blackwater.

The bathing waters site is at West Mersea, just north of the outer Blackwater/Dengie Twenty water samples were taken from here during each bathing season, which runs from the 15<sup>th</sup> May to the 30<sup>th</sup> September. Faecal coliforms (confirmed) were enumerated in all these samples. Summary statistics of all results from 2003 to 2011 are presented in Table X.1. Figure X.2 presents box plots of all results from the West Mersea bathing water site by year from 2003 to 2011.

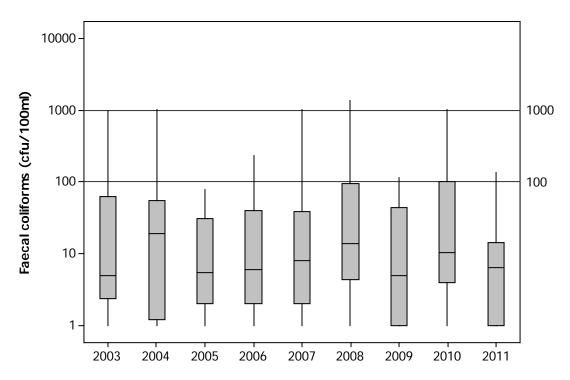
Figure X.2 Box-and-whisker plots of all faecal coliforms results by year Data from the Environment Agency

Comparisons of the results found no significant difference by year (1-way ANOVA, p=0.557). This indicates that the level of faecal coliforms found in these bathing waters does not change significantly from year to year.

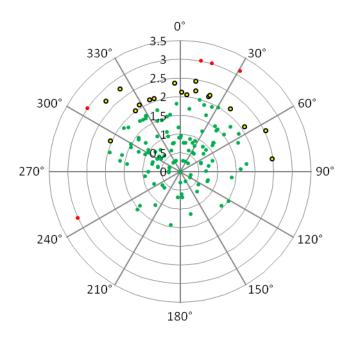
Figure XI.3. Polar plots of log<sub>10</sub> faecal coliforms against tidal state on the high/low tidal cycle for West Mersea bathing waters monitoring point Data from the Environment Agency

Sampling was targeted mostly towards high water. The levels of faecal coliforms found at the West Mersea bathing site appear to be lower during low tides than during high tides. Figure X.4 presents a polar plot of faecal coliform results against the lunar spring/neap cycle. Full/new moons occur at 0°, and half moons occur at 180°. The largest (spring) tides occur about 2 days after the full/new moon, or at about 45°, then decrease to the smallest (neap tides) at about 225°, then increase back to spring tides. Results of 100 faecal coliforms/100ml or less are plotted in green, those from 101 to 1000 are plotted in yellow, and those exceeding 1000 are plotted in red.

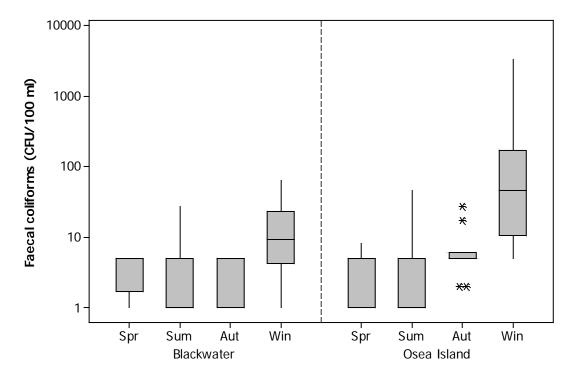
Figure X.5 Boxplot of shellfish growing waters faecal coliforms results by season Data from the Environment Agency

Figure X.5 indicates that there is some seasonality in levels of contamination in around the area, with highest results in the winter. Statistically significant differences were found between seasons at both sites (One-way ANOVA, p=0.012 and p<0.001 at Blackwater and Osea Island respectively). Post ANOVA tests (Tukey) showed that at Blackwater, winter had significantly higher levels of faecal coliforms than summer and autumn, but not spring. At Osea Island, there was significantly higher faecal coliform levels during the winter than all of the other seasons.

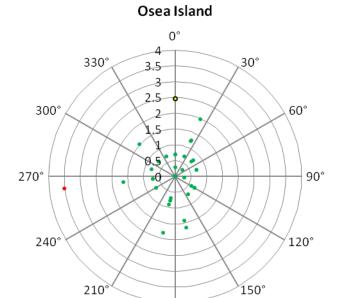
Figure X.6: Polar plots of log<sub>10</sub> faecal coliforms against tidal state on the spring/neap tidal cycle for Osea Island shellfish water monitoring point

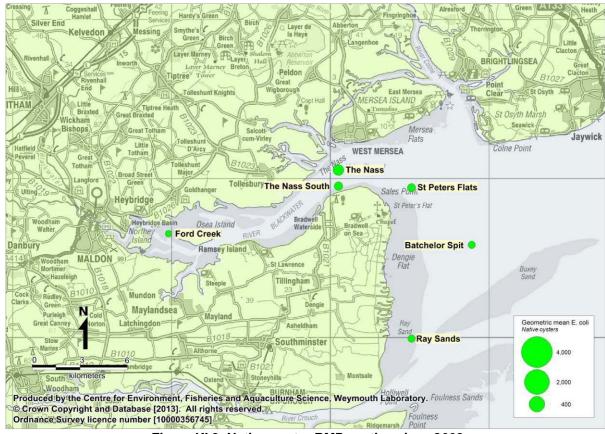
Figure XI.3 Native oyster RMPs active since 2003

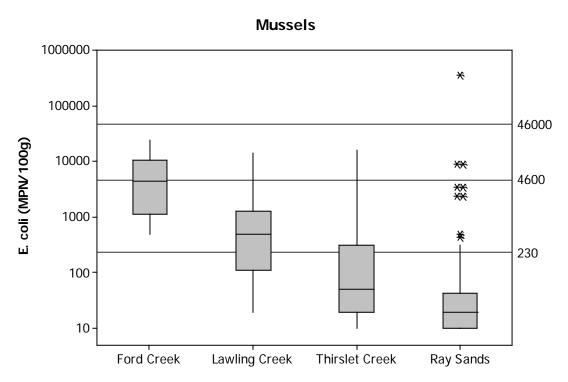
Figure XI.5 Boxplots of E. coli results from mussel RMPs sampled on 10 or more occasions from 2003 onwards.

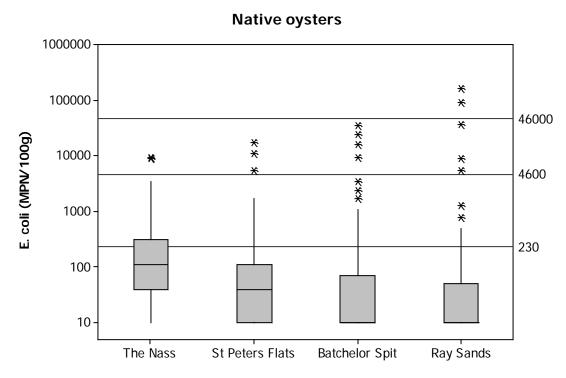
Figure XI.6 Boxplots of E. coli results from native oyster RMPs sampled on 10 or more occasions from 2003 onwards.

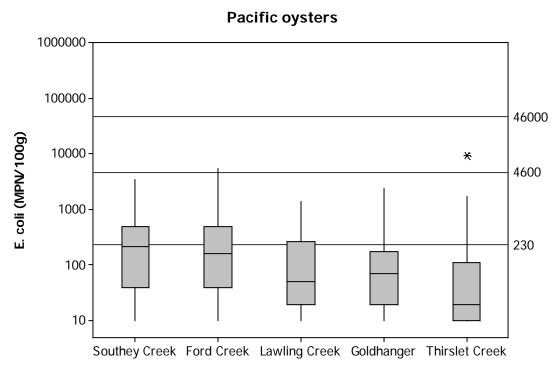
Figure XI.7 Boxplots of E. coli results from Pacific ovster RMPs sampled on 10 or more occasions from 2003 onwards.

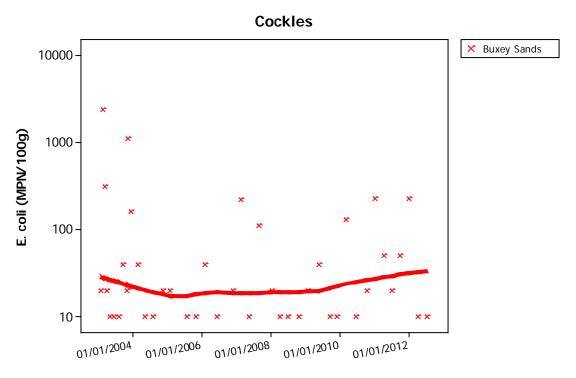
Figure XI.8 Scatterplot of E. coli results for cockles by RMP and date, overlaid with loess lines for each RMP

Figure XI.8 shows that over the years that cockles have been sampled, the level of E. coli found has remained quite consistent.

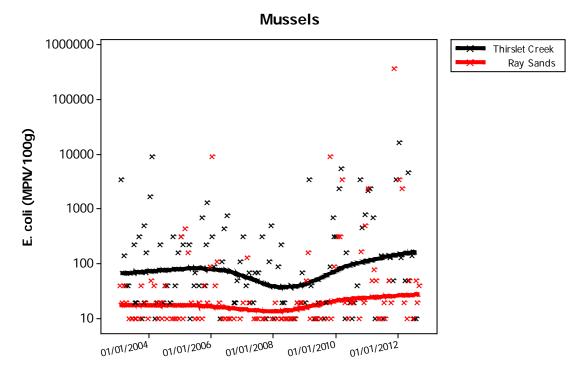
Figure XI.9 Scatterplot of E. coli results for mussels by RMP and date, overlaid with loess lines for each RMP

Figure XI.9 shows that the level of *E. coli* found in mussels has varied only slightly in both RMPs over the years that the data have been recorded.

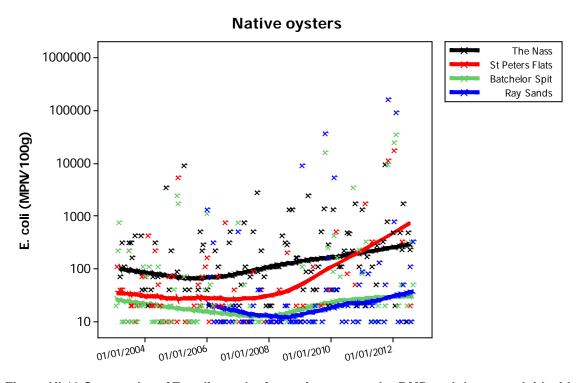
Figure XI.10 Scatterplot of E. coli results for native oysters by RMP and date, overlaid with loess lines for each RMP

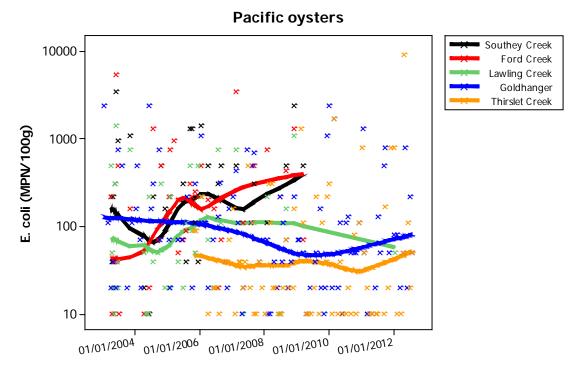
Figure XI.11 Scatterplot of E. coli results for Pacific oysters by RMP and date, overlaid with loess lines for each RMP

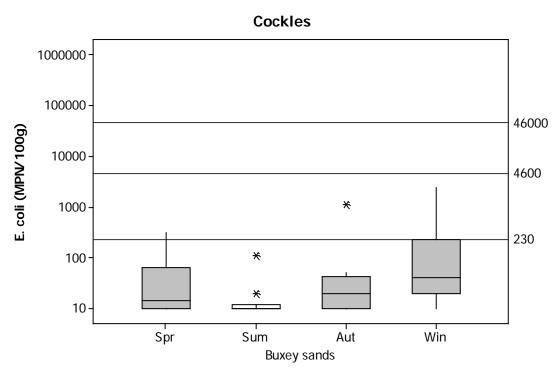
Figure XI.12 Boxplot of cockle E. coli results by RMP and season

There was significant seasonal variation at Buxey sands (One way ANOVA, p=0.049). A post ANOVA test (Tukey comparison) indicated that results were significantly higher in the winter than in the summer, but there were no differences between any other seasons.

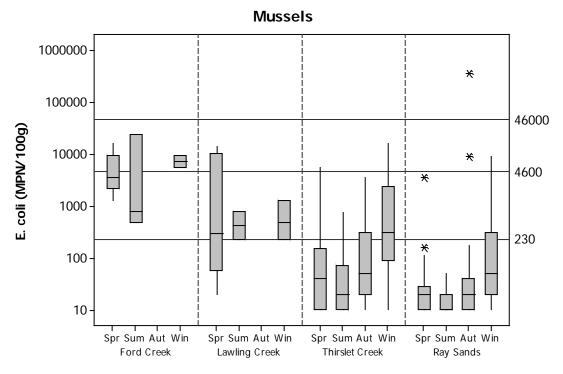
Figure XI.12 Boxplot of mussel E. coli results by RMP and season

Significant variation between seasons was found at the Thirslet Creek (p<0.001) and Ray Sands (p<0.001) mussel RMPs, but not Ford Creek (p=0.612) or Lawling Creek (p=0.993) (One-way ANOVA). Post ANOVA tests (Tukey) showed that at Thirslet Creek, levels of *E. coli* were significantly higher in the winter than in any other season. Similarly at Ray sands, E. coli levels were higher in the winter than in spring and summer, but not autumn.

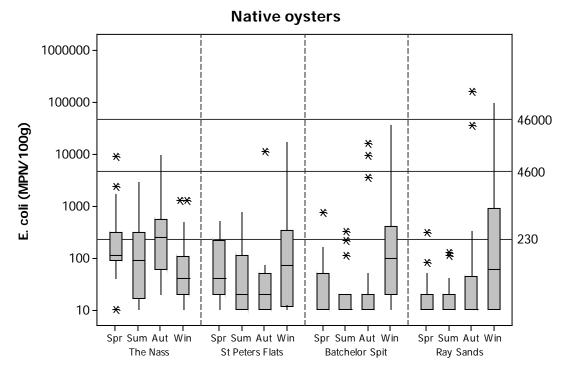
Figure XI.13 Boxplot of native oyster E. coli results by RMP and season

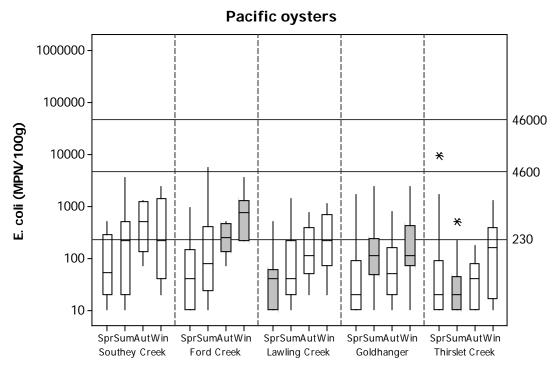
Figure XI.14 Boxplot of Pacific oyster E. coli results by RMP and season

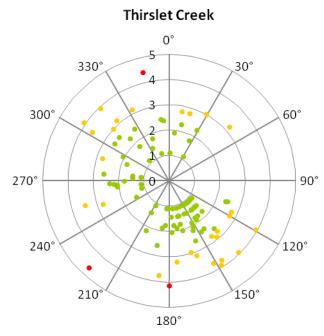
Figure XI.15 Polar plots of log<sub>10</sub> E. coli results (MPN/100g) against high/low tidal state for mussel RMPs

While significant correlations were found between E. coli numbers and tidal state for mussels at Thirslet creek, no strong patterns are apparent on the polar plot.

Figures XI.15 to XI.17 present polar plots of log<sub>10</sub> faecal coliform results against tidal states on the high/low cycle for the correlations indicating a statistically significant effect. High water at Osea is at 0° and low water is at 180°. Results of 230 E. coli MPN/100g or less are plotted in green, those from 231 to 4600 are plotted in yellow, and those exceeding 4600 are plotted in red.

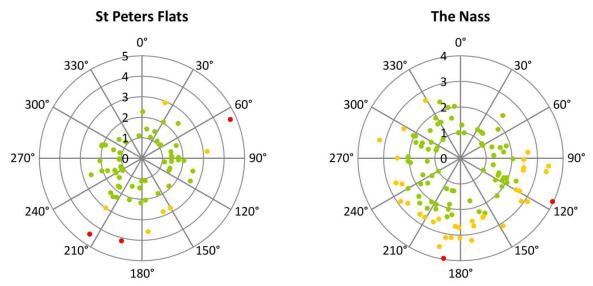
Figure XI.16 Polar plots of log<sub>10</sub> E. coli results (MPN/100g) against high/low tidal state for native oyster RMPs

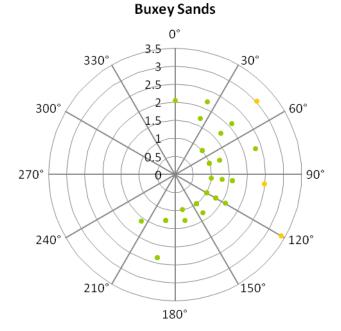
Figure XI.18 Polar plots of log<sub>10</sub> E. coli results (MPN/100g) against spring/neap tidal state for cockle RMPs

At Buxey Sands, the vast majority of samples were collected while tide size was decreasing from spring to neap tides. The higher levels of E. coli appear to occur on average around the spring tides. However more data points would be needed before a firm conclusion could be drawn about any patterns at this RMP.

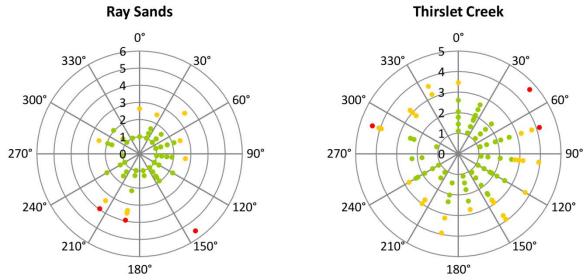
Figure XI.19 Polar plots of log<sub>10</sub> E. coli results (MPN/100g) against spring/neap tidal state for mussel RMPs

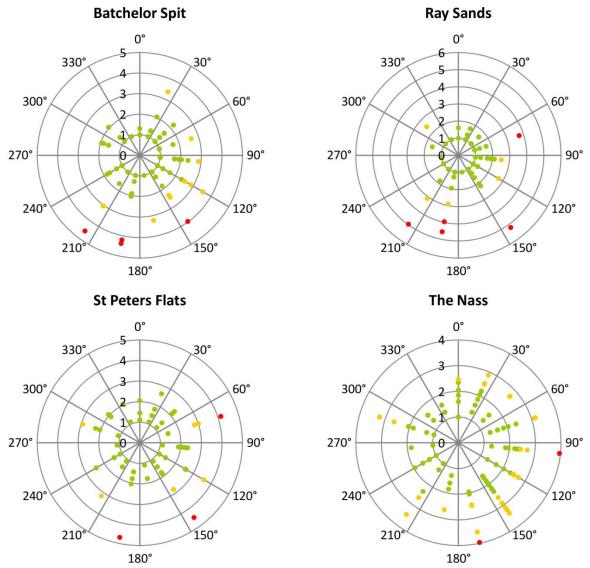
Figure XII.18 Polar plots of log<sub>10</sub> E. coli results (MPN/100g) against spring/neap tidal state for native oysters RMPs

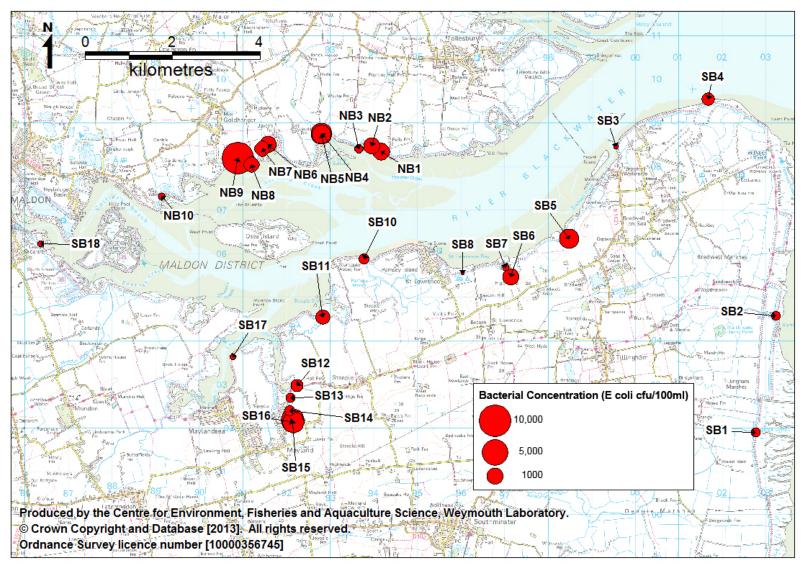
Figure XII.2: Water sample results
