Camel Sanitary Survey

Review

March 2015

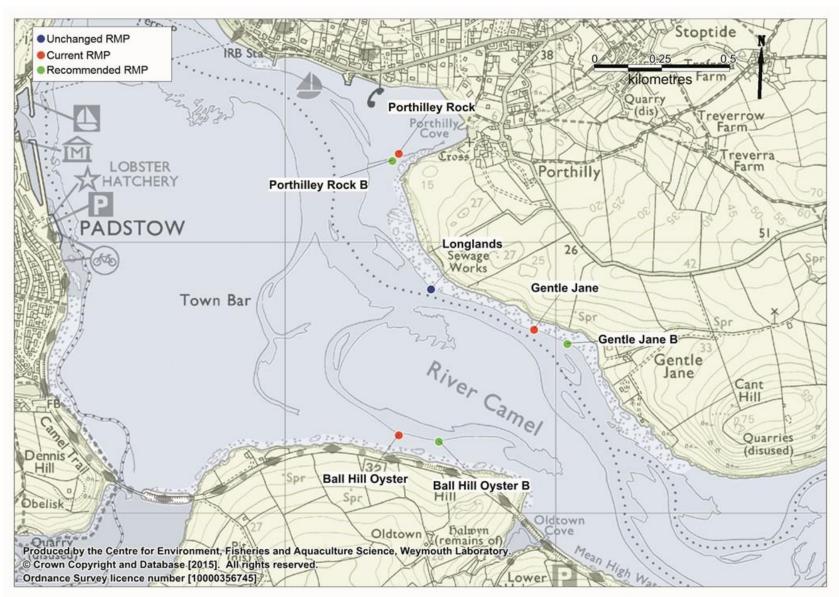
Figure 4.4: Current and recommended Pacific oyster RMPs. Longlands RMP remains unchanged

It is recommended that the RMP for Porthilley Rock oysters is situated south west of the current RMP so that it is positioned on the western extremity of the classification zone. This will more adequately capture contamination from up-estuary sources including Porthilley CSO and Harbour Lights CSO intermittent discharges which are located 40 m upstream from the classification zone and are likely to present irregular sources of contamination. The RMP is also positioned to capture contamination carried by Porthilley stream.

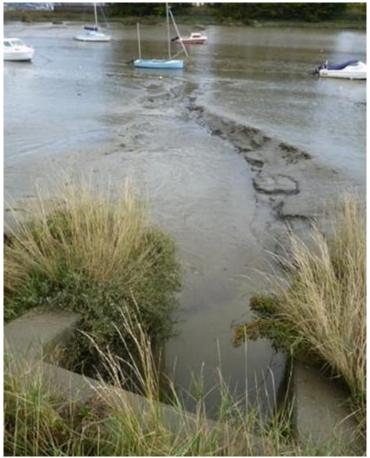
Observation	NGR	Date	Time	Description	Photo
No.					
1	SW9885472726	08/10/2014	08:48:27	Wadebridge PS & pipe with grid flowing, C01 & ~10 gulls	Figure I.3
2	SW9877772811	08/10/2014	08:55:39	Environment Agency sluice gate & dog walking along Camel Trail	
3	SW9821873287	08/10/2014	09:08:31	Sewage Works & pipe with flap flowing (flap being replaced at time of survey) & ~80 gulls on mudflats	Figure I.4
4	SW9813973415	08/10/2014	09:16:29	Possibly Wadebridge STW Pipe (~500mm with flap) flowing, C02 & smaller pipe, not flowing	Figure I.5
5	SW9790773677	08/10/2014	09:30:35	~30 gulls	
6	SW9692973896	08/10/2014	09:48:09	~40 birds	
7	SW9545573960	08/10/2014	10:22:34	Unnamed stream flowing (not accessible)	Figure I.6
8	SW9538873941	08/10/2014	10:27:13	Large rectangular structure (~ 15m) with stream flowing from it (not accessible)	Figure I.7
9	SW9458873605	08/10/2014	10:43:14	Pinkson Creek (not accessible)	Figure I.8
