# CLASSIFICATION OF BIVALVE MOLLUSC PRODUCTION AREAS IN ENGLAND AND WALES

## **SANITARY SURVEY REPORT**

**Chichester Harbour**

November 2013

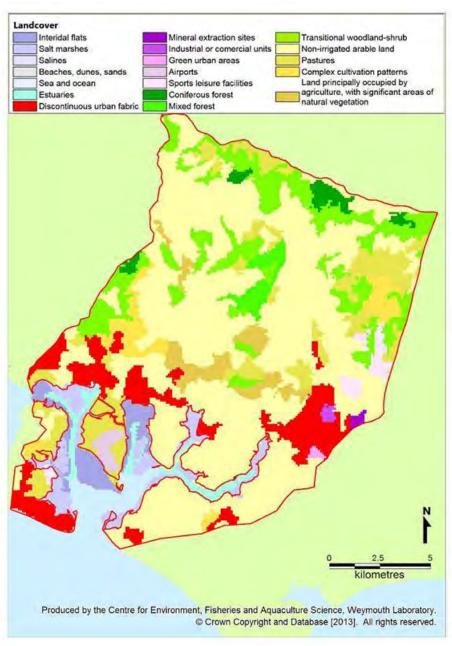
Figure 1.2: Landcover in Chichester Harbour catchment area

Figure 1.2 illustrates land cover within the Chichester Harbour catchment area which covers an area of approximately 242 km². There is a marked division of land use between the upper and lower catchment. The lower catchment is significantly more urbanised than the upper catchment which lies within the South Downs National Park and comprises of arable land with areas of mixed woodland, coniferous forest and woodland shrub. Smaller areas of agriculture and complex cultivation also exist within the upper catchment.

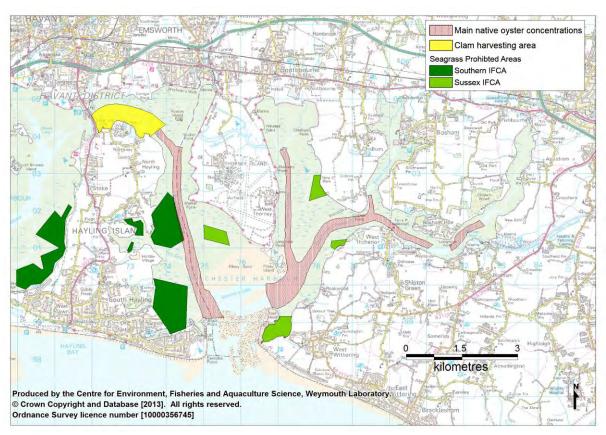
Figure 4.1: Overview of shellfisheries and seagrass protected areas within Chichester Harbour

Only native oysters (*Ostrea edulis*) are commercially exploited in Chichester Harbour at present, although there is also interest in harvesting Manila clams (*Tapes philippinarum*), American hard clams (*Mercenaria mercenaria*), native clams (*Tapes decussatus*) and cockles (*C. edule*). Oysters occur throughout the main subtidal channels, whereas the clams and cockles occur in the intertidal areas.

Four areas on the west side of the Emsworth Channel adjacent to Hayling Island are subject to a voluntary dredging ban to protect seagrass beds (Jury, 2013). As this voluntary ban has not been universally adhered to within the Solent area, Southern IFCA are also likely to prohibit all towed gear within these areas. Southern IFCA also intends to prohibit other activities likely to damage seagrass, including hand digging of shellfish within these areas. Both these byelaws are likely to be in force by the end of 2013. These will prevent any possible exploitation within the Hayling Island creeks, including the one at Eastoke. The seagrass beds infringe the oyster fishery but may hold significant stock of clams.

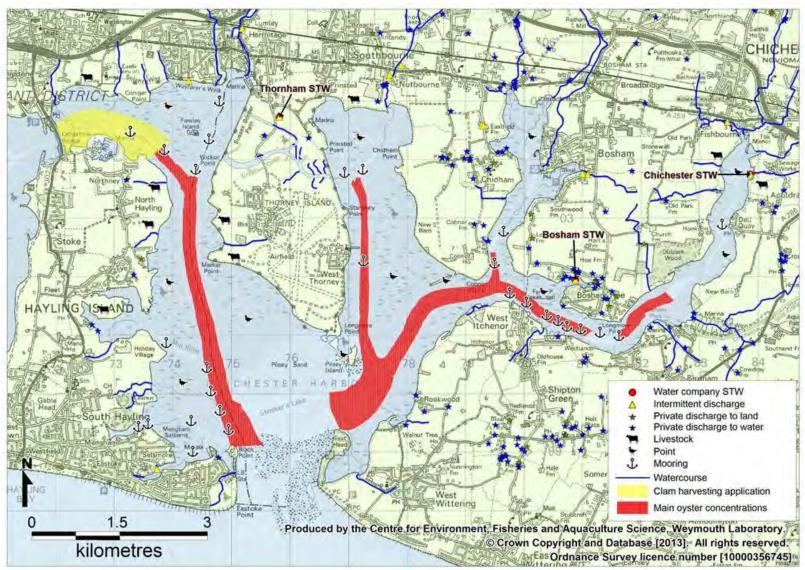
Figure 5.1: Summary of main contaminating influences

Red - high risk; orange - moderate risk; yellow - lower risk; white - little or no risk.

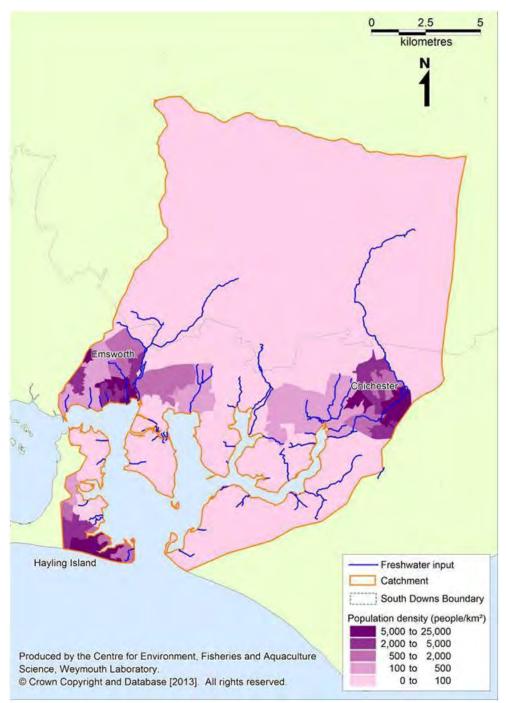
Figure I.1: Human population density in census areas in the Chichester Harbour catchment.

Total resident population within the Chichester Harbour catchment area was approximately 106,000 at the time of the last census. Figure I.1 indicates that population densities are highest on the north and west sides of the harbour around Hayling Island, Emsworth and Chichester. All of these areas exceed 5,000 people/km², but Chichester has the highest density with parts exceeding 16,600 people/km². Most of the population in the catchment is located at the northern end of the channels where rivers meet the harbour. These areas

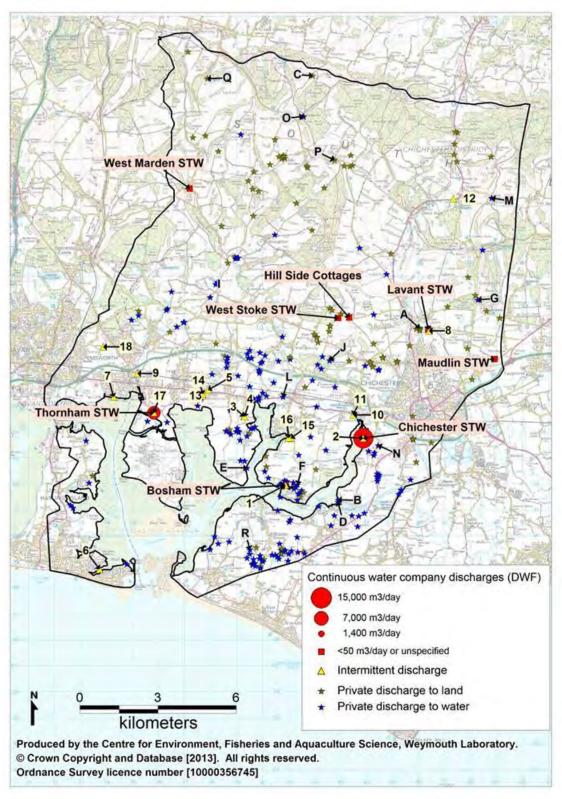
Figure II.1: Sewage discharges to the Chichester Harbour catchment

Details of all consented discharges in the Chichester Harbour Hydrological catchment were taken from the most recent update of the Environment Agency national permit database (December 2012). These are mapped in Figure II.1.

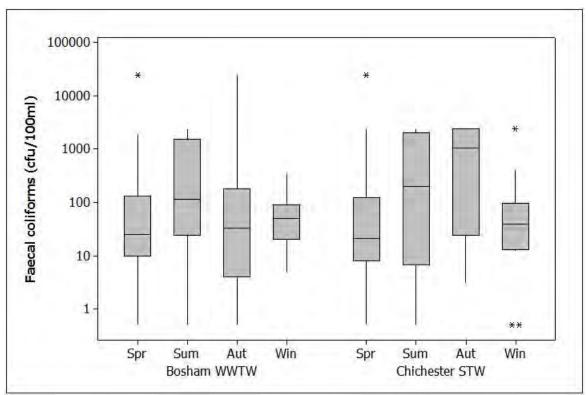
Figure II.2: Boxplot of faecal coliform concentrations in STW final effluent by season.

Some seasonality in faecal coliform concentrations was observed at both STWs, with higher average results in the summer at Bosham and in the summer and autumn at Chichester.

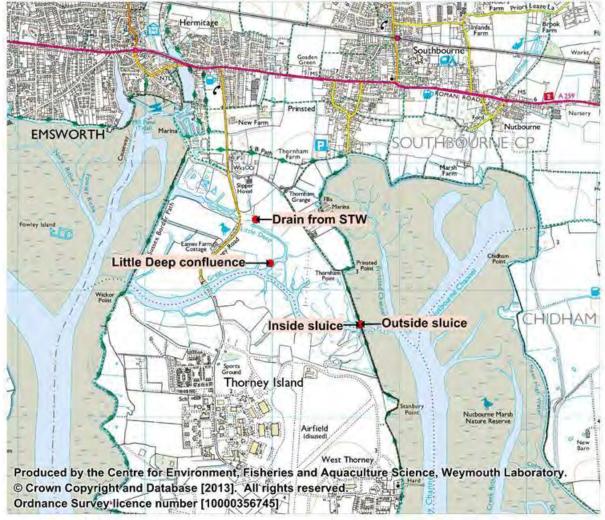
Figure II.3: Sampling locations within Great Deep

Another discharge of significance is the Thornham STW, which discharges to a drain which subsequently empties into the harbour in the upper reaches of Thornham Creek. This effectively provides additional lagoon treatment, which should significantly reduce faecal coliform loads received by the harbour. The extent to which this occurs will be largely dependent on the retention time. During the autumn of 2009 a series of samples were taken from four locations and tested for faecal coliforms (presumptive) to investigate the impacts of this sewage works. Between four and seven samples were taken from each location. Figure II.3 shows the sample locations and Figure II.4 shows boxplots of the results.

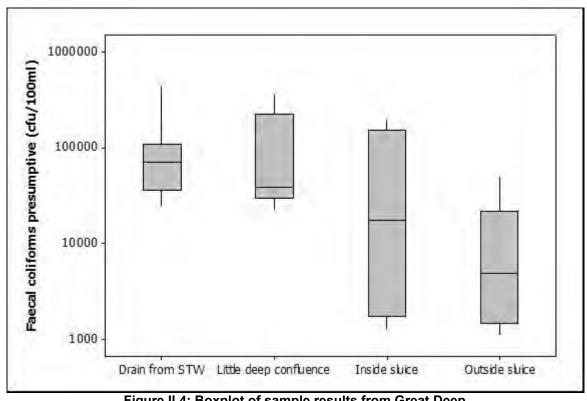
Figure II.4: Boxplot of sample results from Great Deep

A decrease in levels of faecal coliforms can be seen from the Little Deep confluence through to the sluice. High average levels of faecal coliforms were however still present within Great Deep just inside the sluice outfall (16,749 cfu/100ml). These samples were taken in late autumn when environmental conditions will be less favourable for bacterial dieoff. A sample taken just inside the sluice during the shoreline survey (late May) contained 730 *E. coli* cfu/100ml.

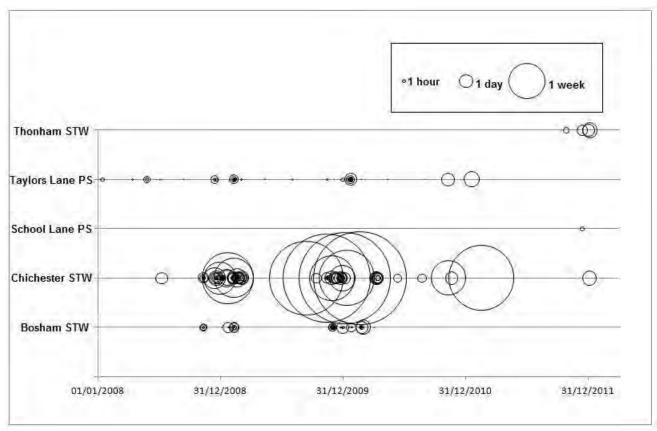
Figure II.5: Bubble plot of recorded spills

Of these five discharges, the most active by far was the Chichester STW discharge, which spilled for almost 20% of the period assessed. This discharge is therefore likely to be a significant influence, and should be captured during the course of a year's monthly monitoring. Marked seasonality was observed, with the discharge operational for much higher proportions of the time in autumn and winter (26.1 and 46.2% of the time respectively) compared to spring and summer (1.7 and 0.4% of the time respectively). This is unsurprising as the sewer network here is old and subject to significant infiltration when the water table is high. Only one spill event was recorded here during the dry winter of 2011/12. A series of 27 samples have been taken from the storm tanks by the Environment Agency since 2011. The geometric mean concentration of faecal coliforms (confirmed) within these samples was  $1.7 \times 10^6 / 100 \, \text{ml}$ , with a maximum and minimum of

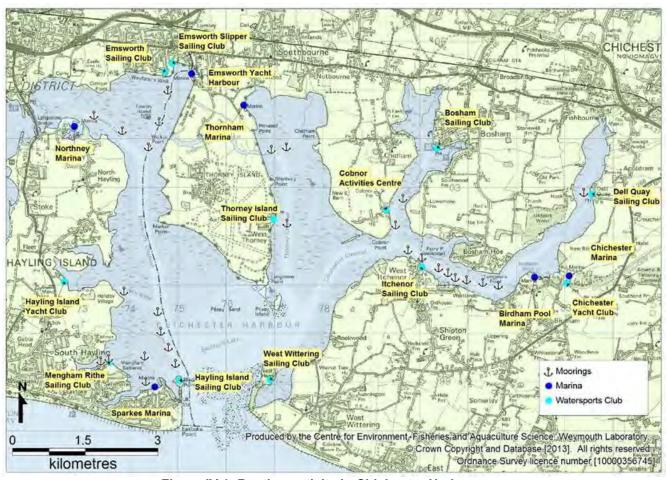
Figure IV.1: Boating activity in Chichester Harbour

The discharge of sewage from boats is potentially a significant source of bacterial contamination of shellfisheries within Chichester Harbour. There is significant boat traffic within the sheltered waters of Chichester Harbour. It hosts several marinas and is popular for both commercial fishing and pleasure boating; which are important for the local economy (Natural England, 2013). Figure IV.1 presents an overview of boating activity derived from the shoreline survey, satellite images and various internet sources.

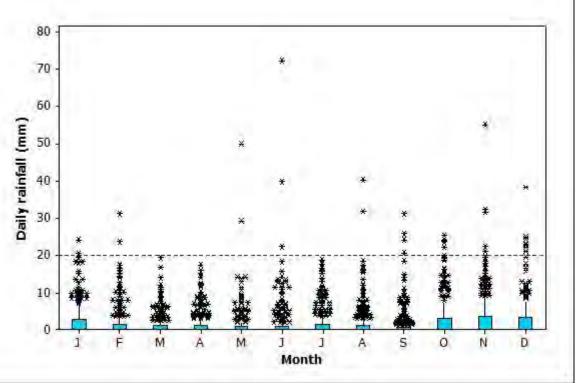
Figure VI.1: Boxplot of daily rainfall totals at Fishbourne, January 2003 to December 2012.

The Fishbourne weather station, received an average of 682 mm per year between 2003 and 2012. Figure VI.1 presents a boxplot of daily rainfall records by month at Fishbourne.

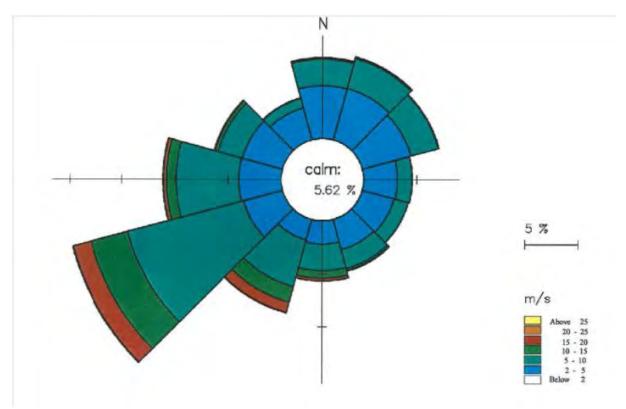
Figure VII.1: Wind Rose for Southampton Water Produced by ABPmer, 2007.

The prevailing wind direction is from the south west and the strongest winds usually blow from this direction (Figure VII.1). A higher frequency of north easterly winds occurs during spring.

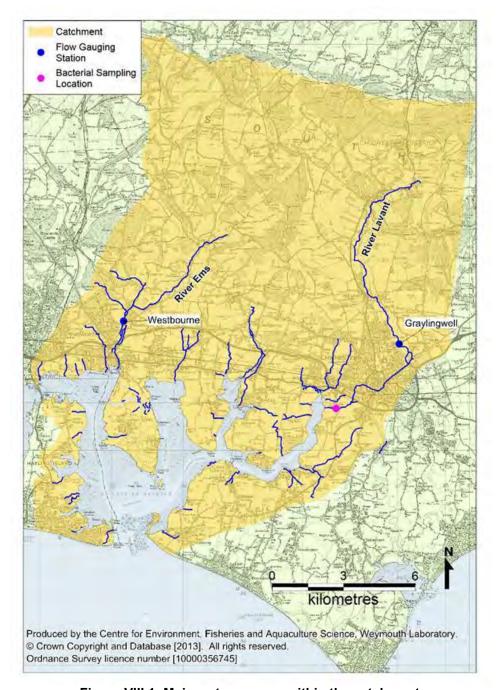
Figure VIII.1: Main watercourses within the catchment

All watercourses will carry some faecal indicator bacteria, potentially deriving from a range of point and diffuse sources such as STW discharges and urban and agricultural runoff. They are therefore likely to be an important source of microbiological contamination to shellfisheries within the harbour, although the extent of the impacts of each watercourse will depend both on its discharge rate and the concentrations of *E. coli* it carries.

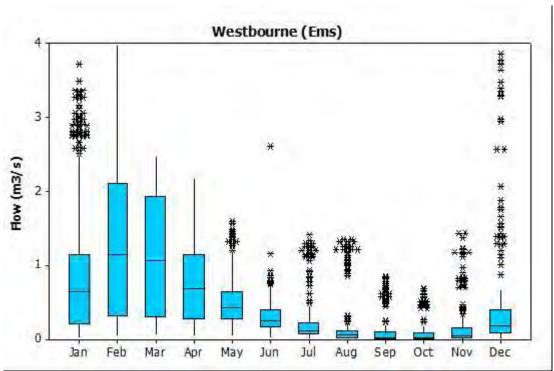
Figure VIII.2: Boxplots of mean daily flow records from the Westbourne gauging station on the Ems river from 2003 – 2013

The Lavant exhibits a higher flow rate on average than the Ems most likely due to its larger catchment size. Base flow rates for both are very low. Boxplots of mean daily flow record by month at Westbourne and Graylingwell gauging stations are presented in Figure VIII.2 and Figure VIII.3. A considerable variation in discharge rates can be seen throughout the year at both. Flows were highest in the colder months at both stations peaking in February in the Ems and January in the Lavant. Water is abstracted from aquifers supplying the River Ems and to a smaller extent from the River Ems itself. Abstractors are required to augment the river with 0.016 m³s⁻¹ when flows of less than 0.032 m³s⁻¹ are recorded at the Westbourne gauging station. However it has been reported that during periods of low flow the augmented flows do not reach Westbourne (Holmes, 2007). During floods, water from the Lavant, downstream of the gauging station may be diverted through a flood relief channel to Pagham Rife to prevent flooding in Chichester (Environment Agency, 2013). Therefore, during major floods, not all of the flows recorded at Graylingwell will continue towards Chichester Harbour.

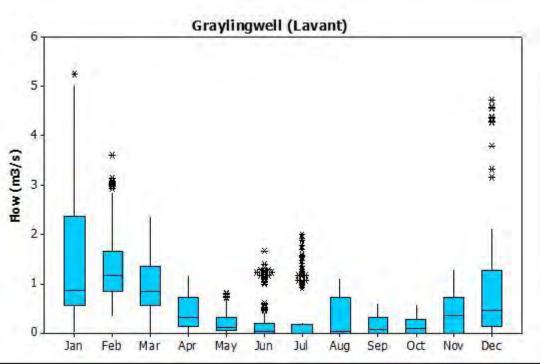
Figure VIII.3: Boxplots of mean daily flow records from the Gralingwell gauging station on the Lavant river from 2003 – 2013

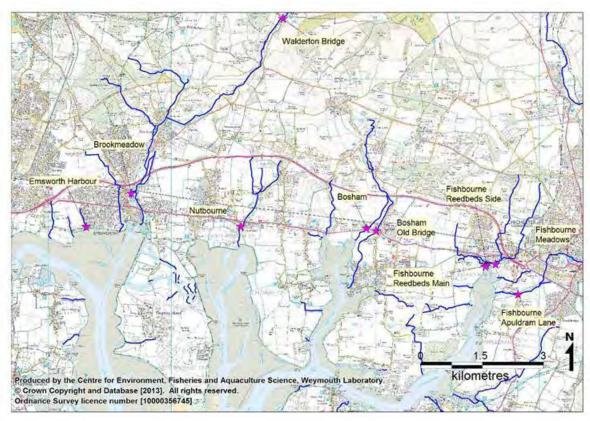
Figure VIII.4: Location of spot gauging stations

Table VIII.2 presents maximum and mean spot flow gauging results at 10 sampling locations within Chichester Harbour, locations of which are illustrated in Figure VIII.4. The highest mean flows are found at Fishbourne Reedbeds Main and Brookmeadow. Surprisingly low flow rates were recorded at the River Lavant (Fishbourne Apuldram Lane).

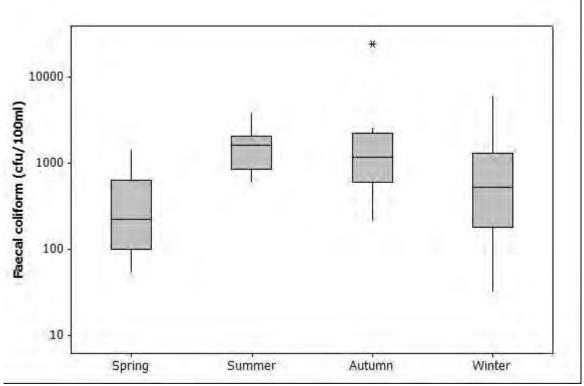
Figure VIII.5: Boxplot of Faecal coliform results from the Lavant stream, December 2010 – April 2013

Figure VIII.5 indicates that there is marked seasonality in levels of faecal coliforms levels in the Lavant. Comparisons of the results between seasons found a significant difference in levels of faecal coliforms (one way ANOVA, p=0.003). Post ANOVA tests (Tukeys comparison) showed that there were significantly higher levels of faecal coliforms in the summer and autumn months than in the spring. This is almost the opposite seasonal pattern to that observed for discharge volumes for this watercourse.

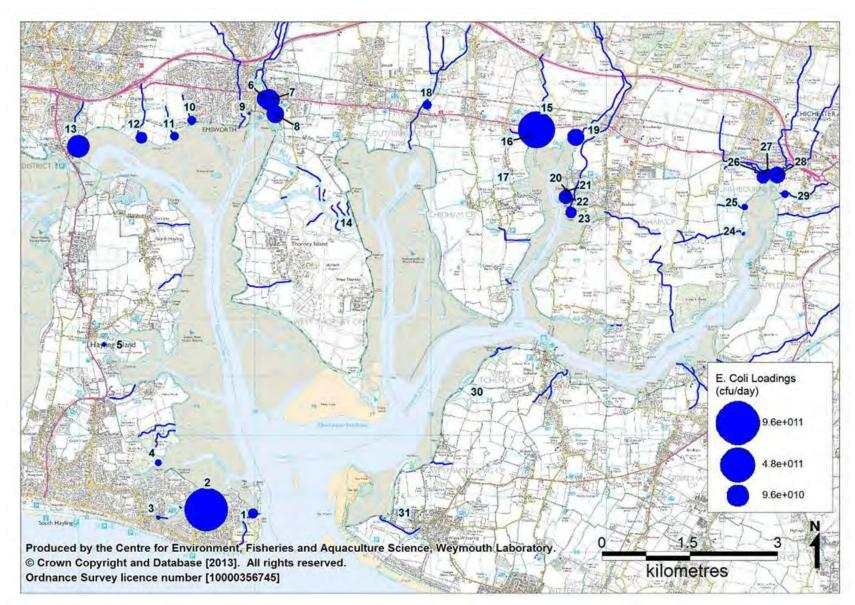
Figure VIII.6: Measured stream loadings from shoreline survey

It was not possible to sample and measure the River Lavant or the Great Deep as their outfalls were covered by the tide at the time, or the stream discharging to Chichester Marina as this was not accessible. Chichester Marina is impounded, and lies behind lock gates which may be opened for access at any state of the tide, and are sometimes left open over high water (Chichester Marina website, 2013).

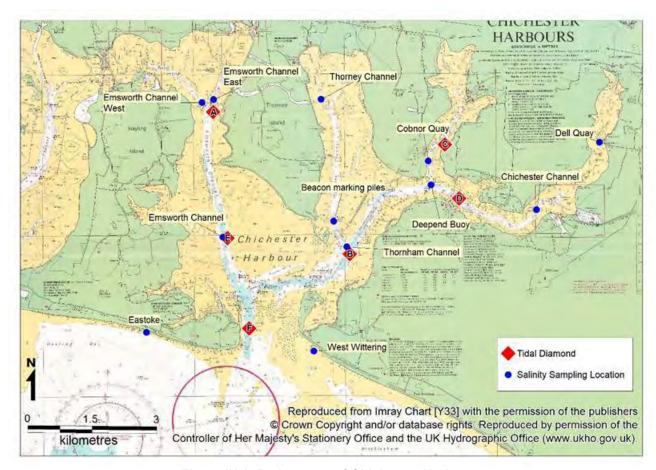
Figure IX.1: Bathymetry of Chichester Harbour

Chichester Harbour is a shallow semi-enclosed tidal inlet with four main channels. It faces south and drains into the eastern Solent. It covers an area of about 29.5km, of which 78% is intertidal (Futurecoast, 2002). Consequently, a large proportion of water will be exchanged on each tide, but the dilution potential will be quite low away from the main channels.

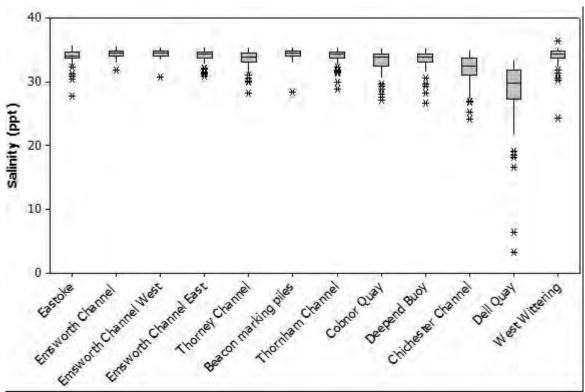
Figure IX.2: Boxplot of salinity readings taken in Chichester Harbour 2003 – 2013

In addition to tidally driven currents, are the effects of freshwater inputs and wind. The flow ratio (freshwater input:tidal exchange) is very low and the system is well mixed (Futurecoast, 2002), so density driven circulation is unlikely to modify tidal circulation. Salinity measurements taken between 2003 and 2013 at twelve points within the harbour indicate average salinities approaching that of full strength seawater throughout (Figure IX.2). Low salinities indicative of more significant freshwater influences were recorded in Dell Quay in the upper Chichester Channel in April/May 2013.

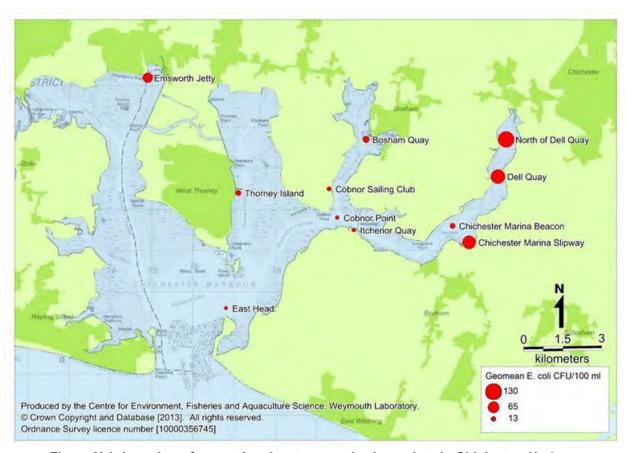
Figure X.1: Location of recreational waters monitoring points in Chichester Harbour

Chichester DC and the Chichester Harbour Conservancy have collected water quality data at 11 sites across the harbour for several years. Figure X.1 shows the locations of the monitoring sites and their geometric mean *E. coli* levels from April 2008 onwards. Summary statistics of results for each site are presented in Table X.1 and Figure X.2 presents box plots of these data.

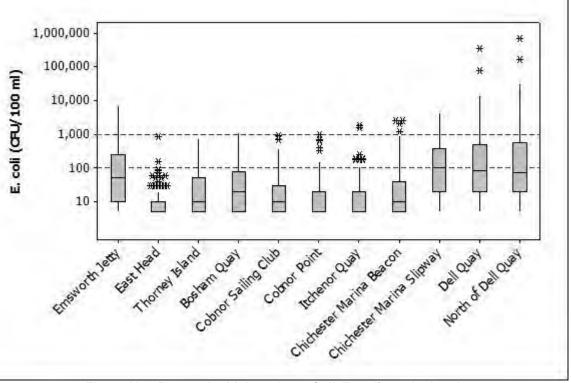
Figure X.2: Box-and-whisker plots of all *E. coli* results by site

All sites had results exceeding 100 E. coli/100 ml and seven of the 11 sites had results exceeding 1,000 E. coli/100 ml. One-way ANOVA testing showed there to be a significant difference in E. coli levels between sites (p <0.001). Table X.2 shows the results of post-ANOVA pairwise Tukey tests. Grey boxes indicate there was no significant difference between sites (p >0.05), and red boxes indicate that the site listed vertically had greater E. coli levels than the site listed horizontally.

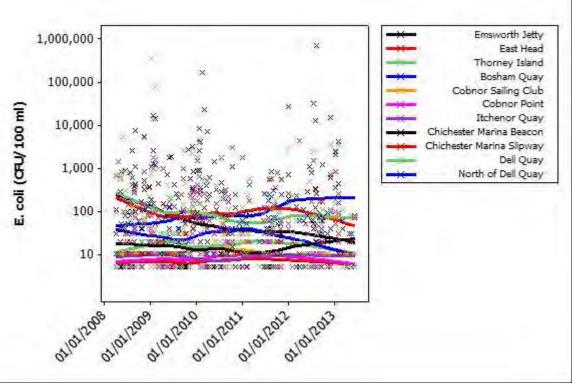
Figure X.3: Scatterplot of *E. coli* results by RMP and date, overlaid with lowess lines

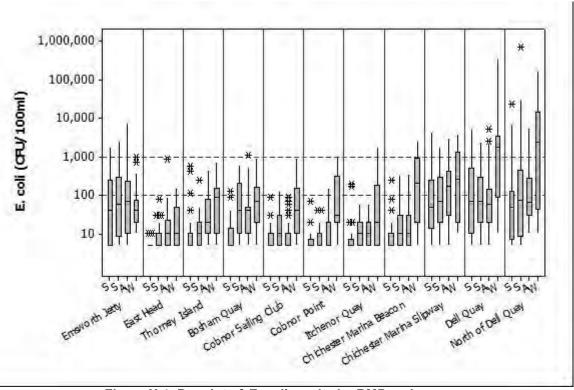
Figure X.4: Boxplot of *E. coli* results by RMP and season

The seasonal patterns of results from April 2008 onwards were investigated by site (Figure X.4). One-way ANOVA tests showed that there were significant differences ( $p \le 0.005$ ) between seasons at all sites except Emsworth Jetty and Chichester Marina Slipway (p = 0.802 and 0.121 respectively). In all cases, there were significantly higher levels of *E. coli* in the winter than in the spring. At East Head, Thorney Island and Bosham Quay, there were higher levels of *E. coli* in the autumn than in spring. At all other sites, there were significantly higher levels of *E. coli* during the winter than during any other season.

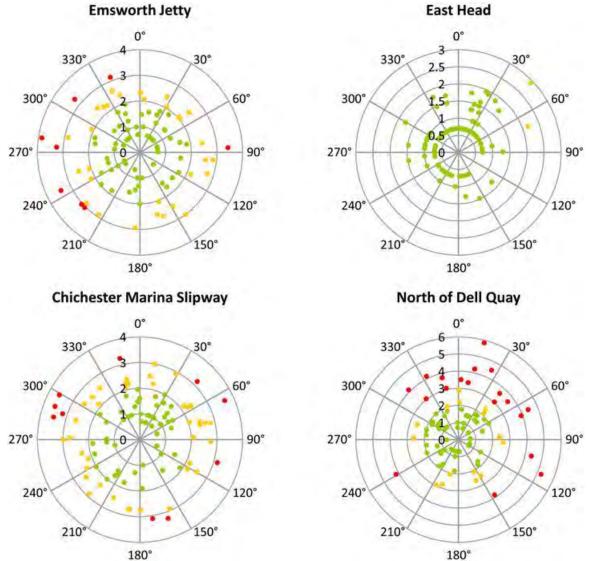
Figure X.5: Polar plots of log10 faecal coliforms against tidal state on the high/low tidal cycle for water quality monitoring points with significant correlations

coliforms/100ml or less are plotted in green, those from 101 to 1,000 are plotted in yellow, and those exceeding 1,000 are plotted in red.

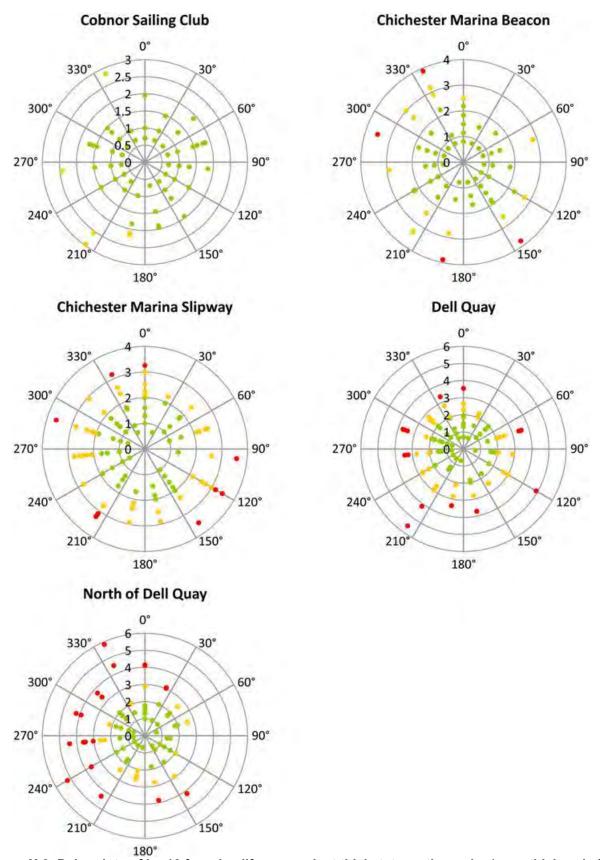
Figure X.6: Polar plots of log10 faecal coliforms against tidal state on the spring/neap tidal cycle for bathing waters monitoring points with significant correlations

Figure X.6 presents polar plots of *E. coli* results against the lunar spring/neap cycle, where a statistically significant correlation was found. Full/new moons occur at 0°, and half moons occur at 180°. The largest (spring) tides occur about 2 days after the full/new moon, or at about 45°, then decrease to the smallest (neap tides) at about 225°, then increase back to spring tides. Results of 100 *E. coli* /100ml or less are plotted in green, those from 101 to 1,000 are plotted in yellow, and those exceeding 1,000 are plotted in red.

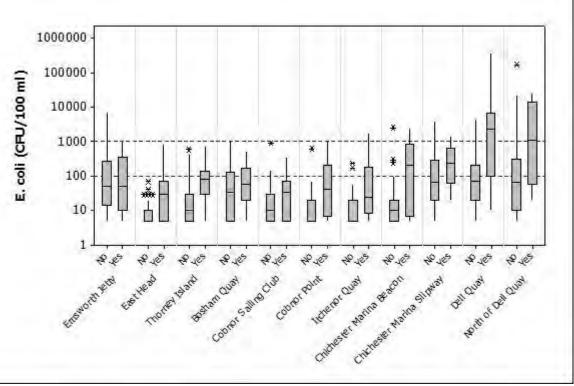
Figure X.7: Boxplots to show the effect spillages from Chichester STW on E. coli levels in water samples within 48 of a spillage event.

To investigate the impact of sewage spills on the level of *E. coli* found in water samples, spill records for the Chichester STW were compared with *E. coli* results. Figure X.7 shows boxplots to compare data from those samples taken when a spill had or had not occurred within 48 hours prior to sampling. Table X.5 shows the results of 2 sample t-tests comparing the level of *E. coli* in water when a spill had or had not occurred within time periods from 24 hours to 72 hours.

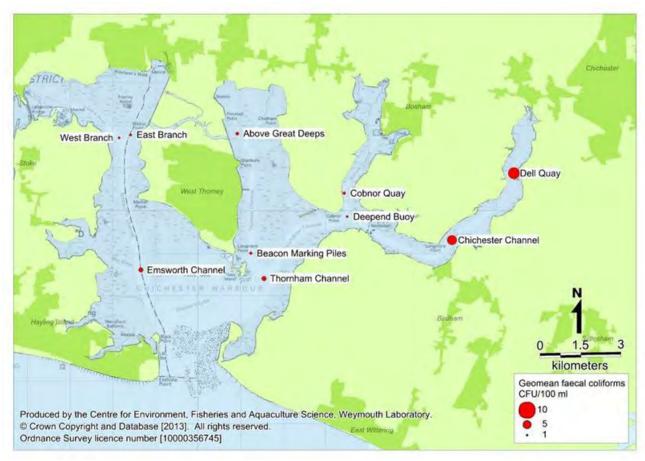
Figure X.8: Location of designated bathing waters monitoring points in Chichester Harbour

There are three shellfish waters sites designated under Directive 2006/113/EC (European Communities, 2006) in Chichester Harbour: Emsworth Channel, Thornham Channel and Chichester Channel. Figure X.8 shows the location of the three Chichester Harbour shellfish water monitoring points as well as seven other sites from which occasional samples have been taken. Table X.6 presents summary statistics for bacteriological monitoring results from the Chichester Harbour shellfish water monitoring points. Only water sampling results are presented here, as flesh results from the shellfish hygiene monitoring programme (Appendix XII) are used to assess compliance with bacteriological standards in shellfish flesh under this programme.

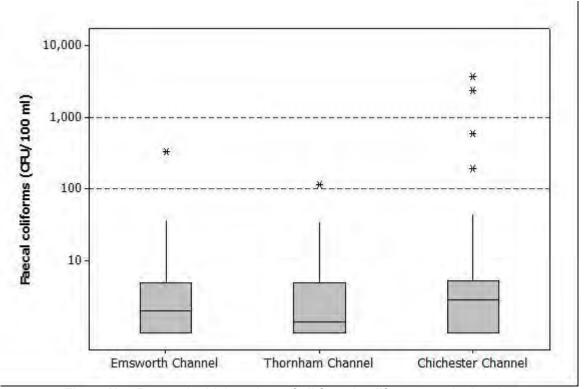
Figure X.9: Box-and-whisker plots of all faecal coliforms results by site

More robust comparisons of sites were carried out on a pair-wise basis by running correlations (Pearson's) between sites that shared sampling dates, and therefore environmental conditions, on at least 20 occasions. These tests revealed significant correlations between all three of the main sites, suggesting that they are influenced by similar sources of contamination.

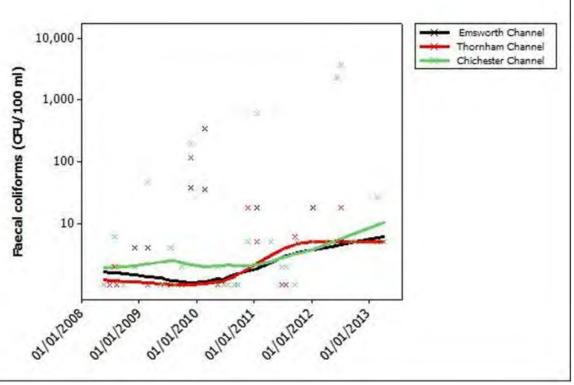
Figure X.10: Scatterplot of faecal coliform results by site and date, overlaid with lowess lines

Figure X.10 shows that faecal coliform levels have increased on average at all three sites during the period examined.

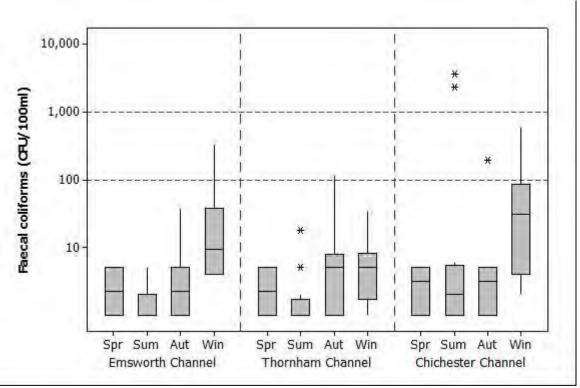
Figure X.11: Boxplot of faecal coliform results by site and season

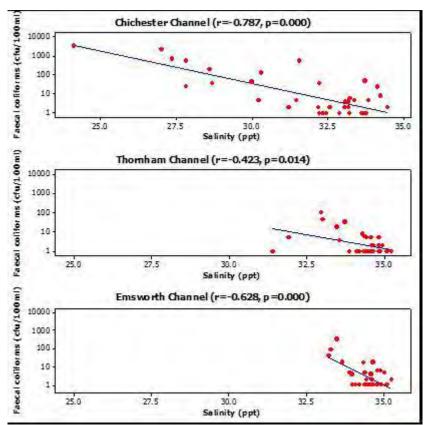
Figure X.12: Scatterplots of salinity against faecal coliforms.

Salinity was recorded on most sampling occasions. Figure X.12 presents scatterplots of salinity against faecal coliforms for the three main sites.

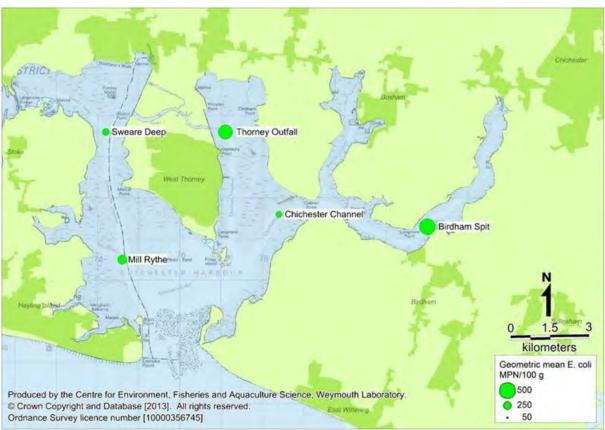
Figure XI.1: Geometric mean *E. coli* (MPN/100g) results of shellfish flesh monitoring from RMPs in Chichester Harbour

The geometric mean results of shellfish flesh monitoring from all RMPs are presented in Figure XI.1. Summary statistics are presented in Table XI.1 and boxplots summarising *E. coli* levels at the RMPs are presented in Figure XI.2.

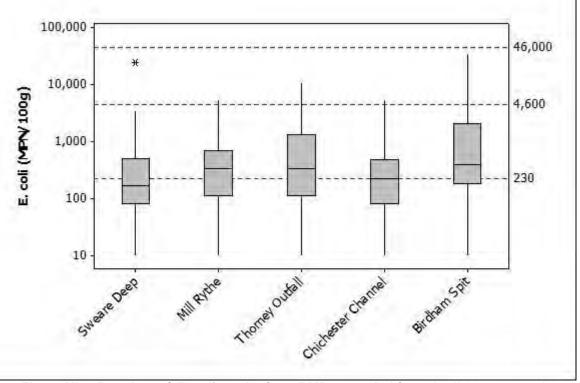
Figure XI.2: Boxplots of E. coli results from RMPs sampled from April 2008 onwards

Comparisons of the sites (One-way ANOVA, p = 0.002) showed that there were significant differences between RMPs. Post ANOVA tests (Tukey) revealed that Birdham Spit had significantly greater levels of *E. coli* contamination than Sweare Deep and Chichester Channel. Additionally, Chichester Channel had significantly lower *E. coli* contamination than Thorney Outfall. All sites had maximum levels above 4,600 cfu/100 g, but none exceeded 46,000. Just over 10% of samples returned results of over 4600 at both Thorney Outfall and Birdham Spit suggesting that results from these RMPs are more likely to align with a C classification. The spread of results from the other three RMPs were consistent with B classifications.

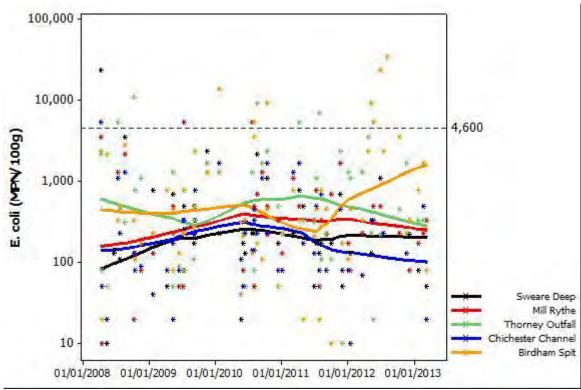
Figure XI.3: Scatterplot of *E. coli* results by RMP and date, overlaid with lowess lines

Figure XI.3 shows some fluctuations over the years, but there is no consistent pattern apparent across the harbour as a whole. However, *E. coli* levels at Birdham Spit appear to have increased on average from mid 2011 to present.

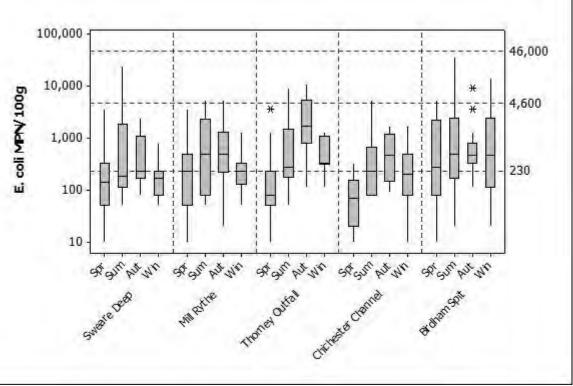
Figure XI.4: Boxplot of E. coli results by RMP and season

One-way ANOVA tests showed that there was no significant seasonal variation at Sweare Deep, Mill Rythe or Birdham Spit (p = 0.064 to 0.627). However there were significant differences in *E. coli* levels between seasons at both Thorney Outfall (p < 0.001) and Chichester Channel (p = 0.001). At both sites, autumn and summer had higher *E. coli* levels than spring. At Chichester Channel, winter *E. coli* levels did not differ significantly from spring levels, but at Thorney outfall spring *E. coli* levels were significantly higher than in winter.

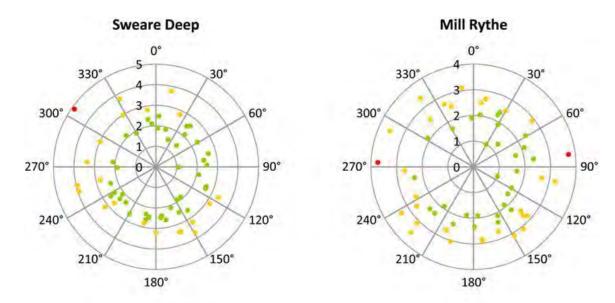
#### **Thorney Outfall**

Figure XI.5 presents polar plots of  $\log_{10} E.$  *coli* results against tidal states on the high/low cycle for the correlations indicating a statistically significant effect. High water at Chichester Harbour is at 0° and low water is at 180°. Results of 230 E. *coli* MPN/100g or less are plotted in green, those from 231 to 4,600 are plotted in yellow, and those exceeding 4,600 are plotted in red.

At Mill Rythe and Sweare Deep *E. coli* levels tended to be higher on average just after low water, possibly suggesting a build-up of contamination on the later stages of the ebb tide. At Thorney Outfall, *E. coli* levels were highest towards the end of the ebb tide, possibly relating to the influence of the Great Deep outfall.

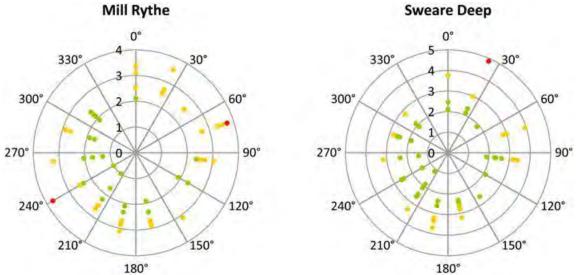
Figure XI.6 presents polar plots of  $\log_{10} E.$  *coli* results against the spring/neap tidal cycle for those RMPs that showed a significant correlation. Full/new moons occur at 0°, and half moons occur at 180°, and the largest (spring) tides occur about 2 days after the full/new moon, or at about 45°, then decrease to the smallest (neap tides) at about 225°, then increase back to spring tides. Results of 230 E. *coli* MPN/100g less are plotted in green, those from 231 to 4,600 are plotted in yellow, and those exceeding 4600 are plotted in red.

Figure XI.6: Polar plots of log<sub>10</sub> *E. coli* results (MPN/100g) against tidal state on the spring/neap tidal cycle for sampling points with significant correlations

At both Mill Rythe and Sweare Deep, higher *E. coli* results tended to occur around the spring tide. This may be because the increased tidal range allowed contamination from distant sources to reach these sites.

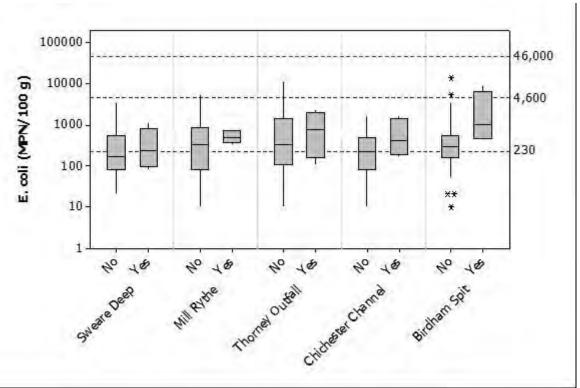
Figure XI.7: Boxplots to show the effect of storm overflow events from Chichester STW on *E. coli* levels in shellfish samples within 48 hours of an event.

To investigate the impact of storm overflow events on the level of *E. coli* found in shellfish flesh, storm spill data for Chichester STW were compared with *E. coli data*. Figure XI.7 shows boxplots to compare hygiene data from those samples taken when a spill had or had not occurred within 48 hours prior to sampling. Table XI.4 shows the results of 2 sample t-tests comparing the level of *E. coli* in flesh when a spill had or had not occurred within time periods from 24 hours to 72 hours.

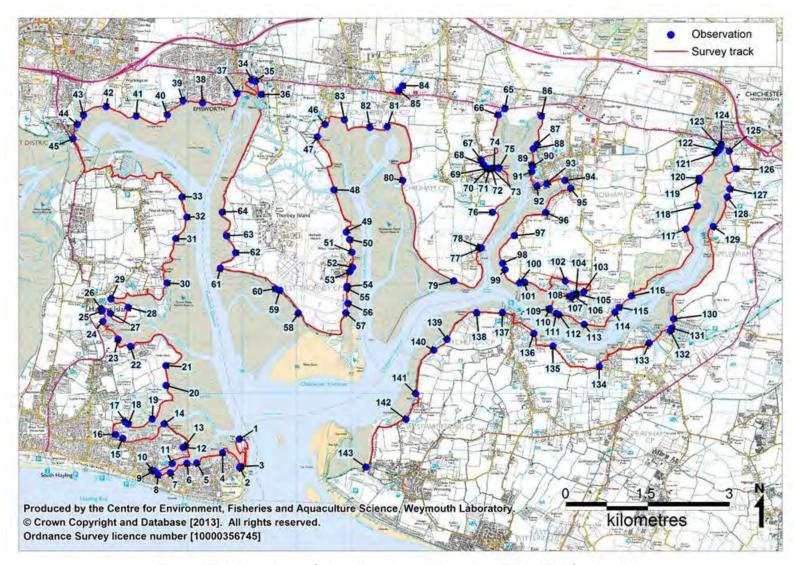
Figure XII.1: Locations of shoreline observations (see Table XII.1 for details)

Seagulls, wading birds and wildfowl were commonly sighted all around the harbour. A high tide roost was seen at the southern tip of Chidham peninsula (observation 79) and a large aggregation of swans was seen on two consecutive days around the Chichester STW outfall (observation 127). Dog walkers and dog excrement were frequently observed along the coastal paths.

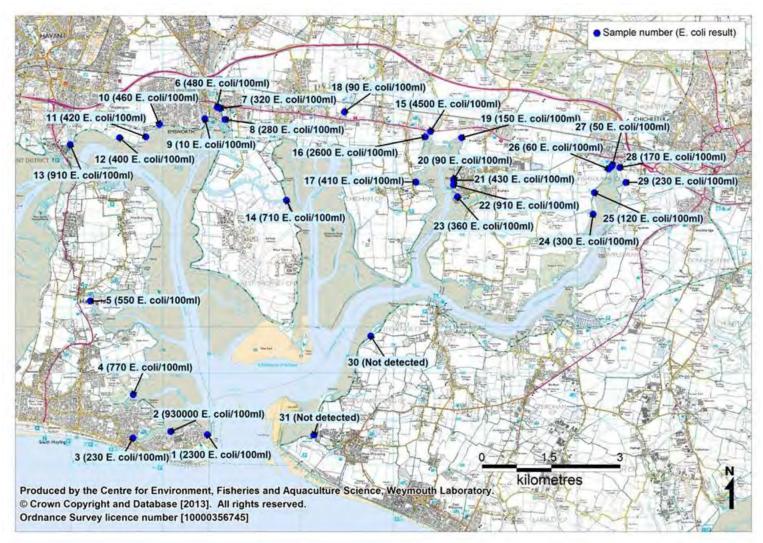
Figure XII.2: Water sample results
