# **CLASSIFICATION OF BIVALVE MOLLUSC PRODUCTION AREAS IN ENGLAND AND WALES**

## **SANITARY SURVEY REPORT**

**Exe Estuary**

**December 2013**

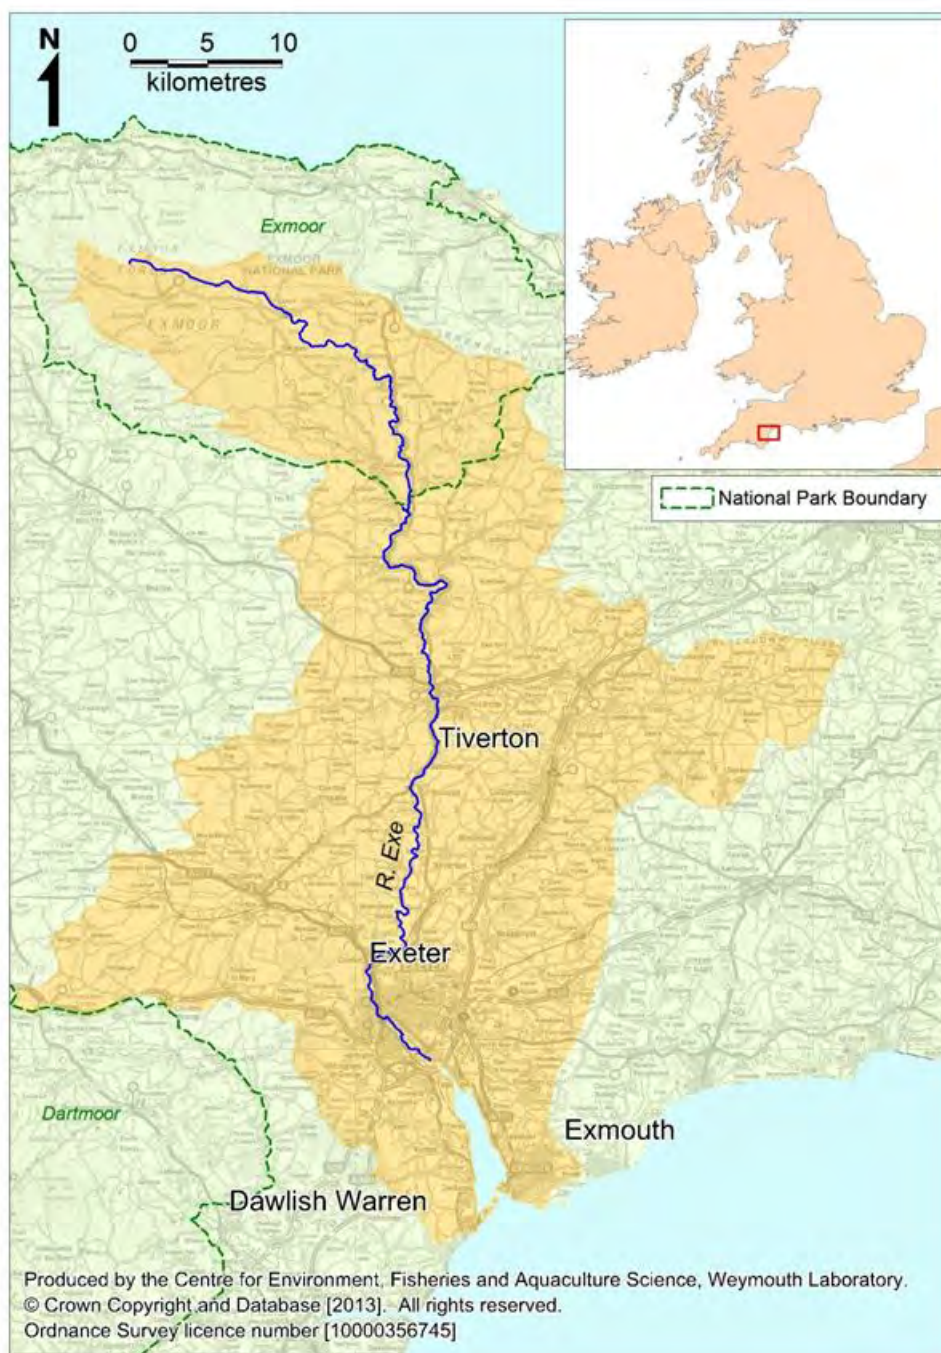
**Figure 1.1 Location of the Exe estuary**

The Exe estuary is situated on the south west coast of England, towards the western end of Lyme Bay (Figure 1.1) in the English Channel. It covers an area of approximately 18 km<sup>2</sup> of which 60% is intertidal (Futurecoast, 2002).

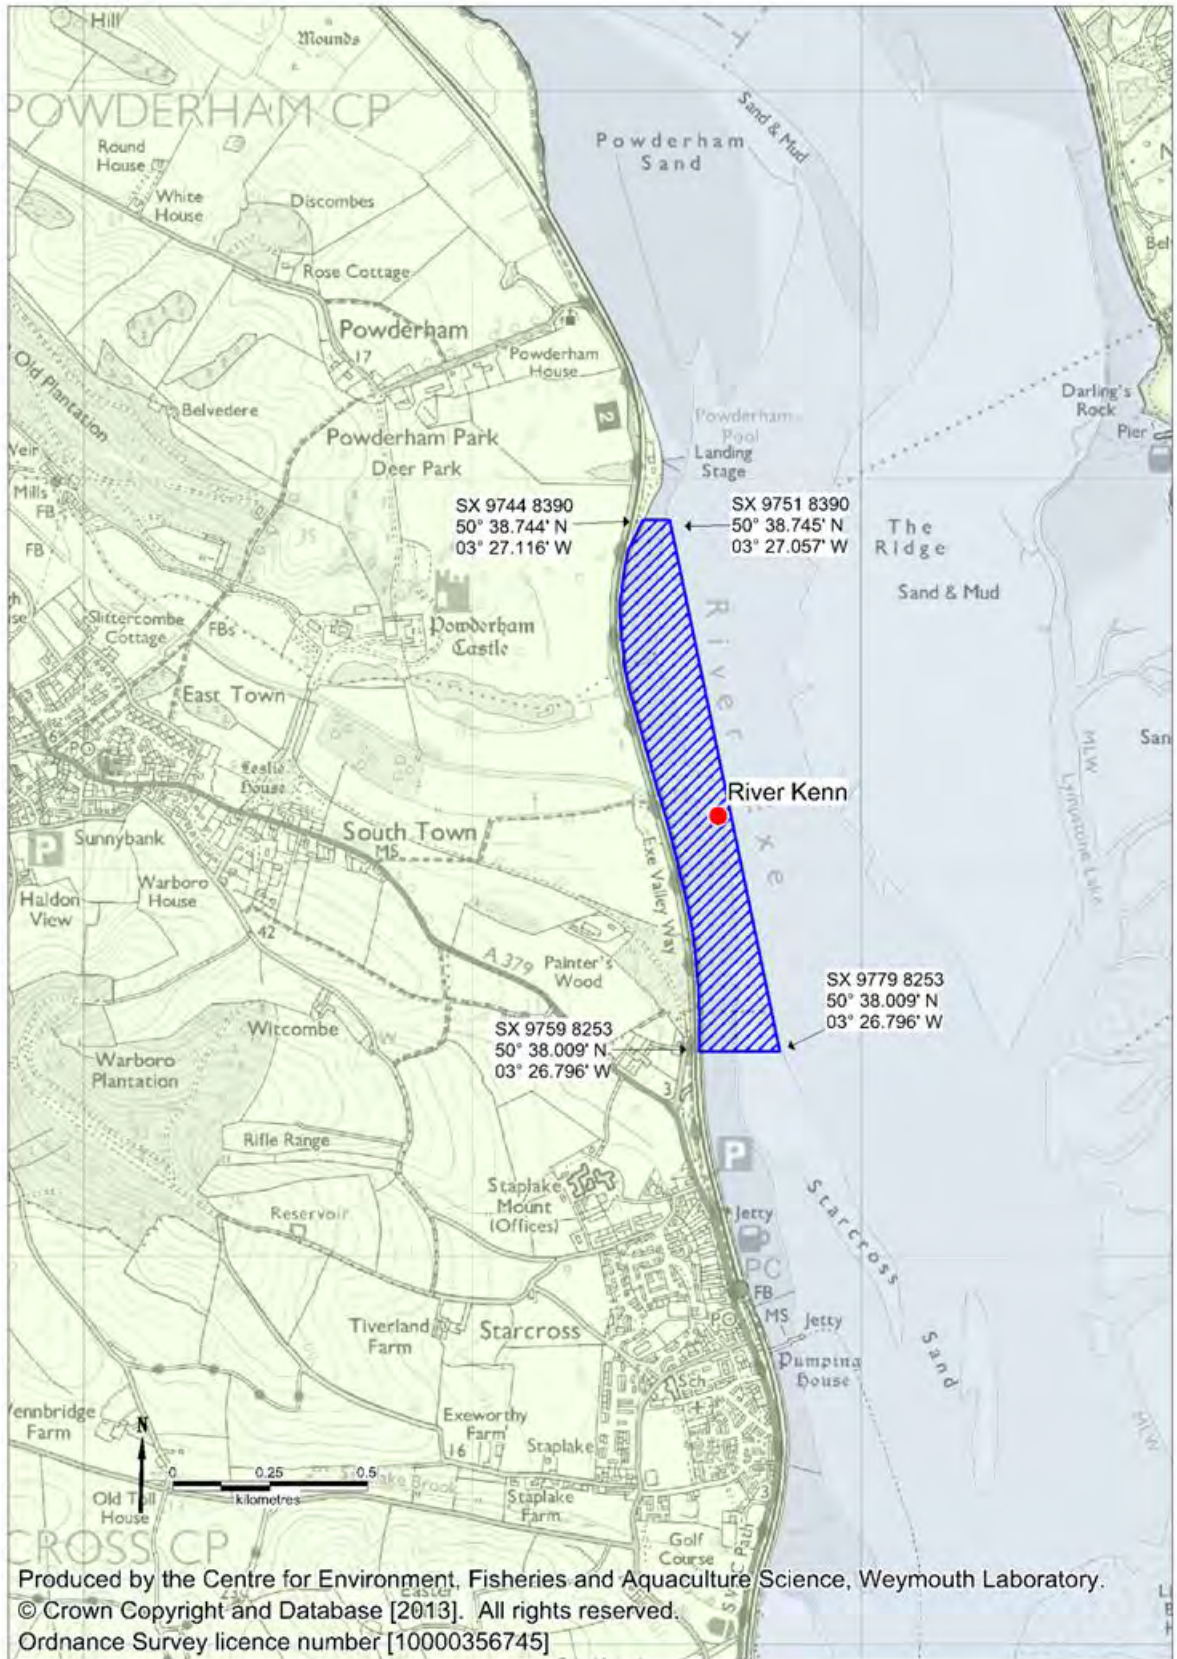
**Figure 3.3: Recommended zoning and monitoring arrangements (native oysters)**

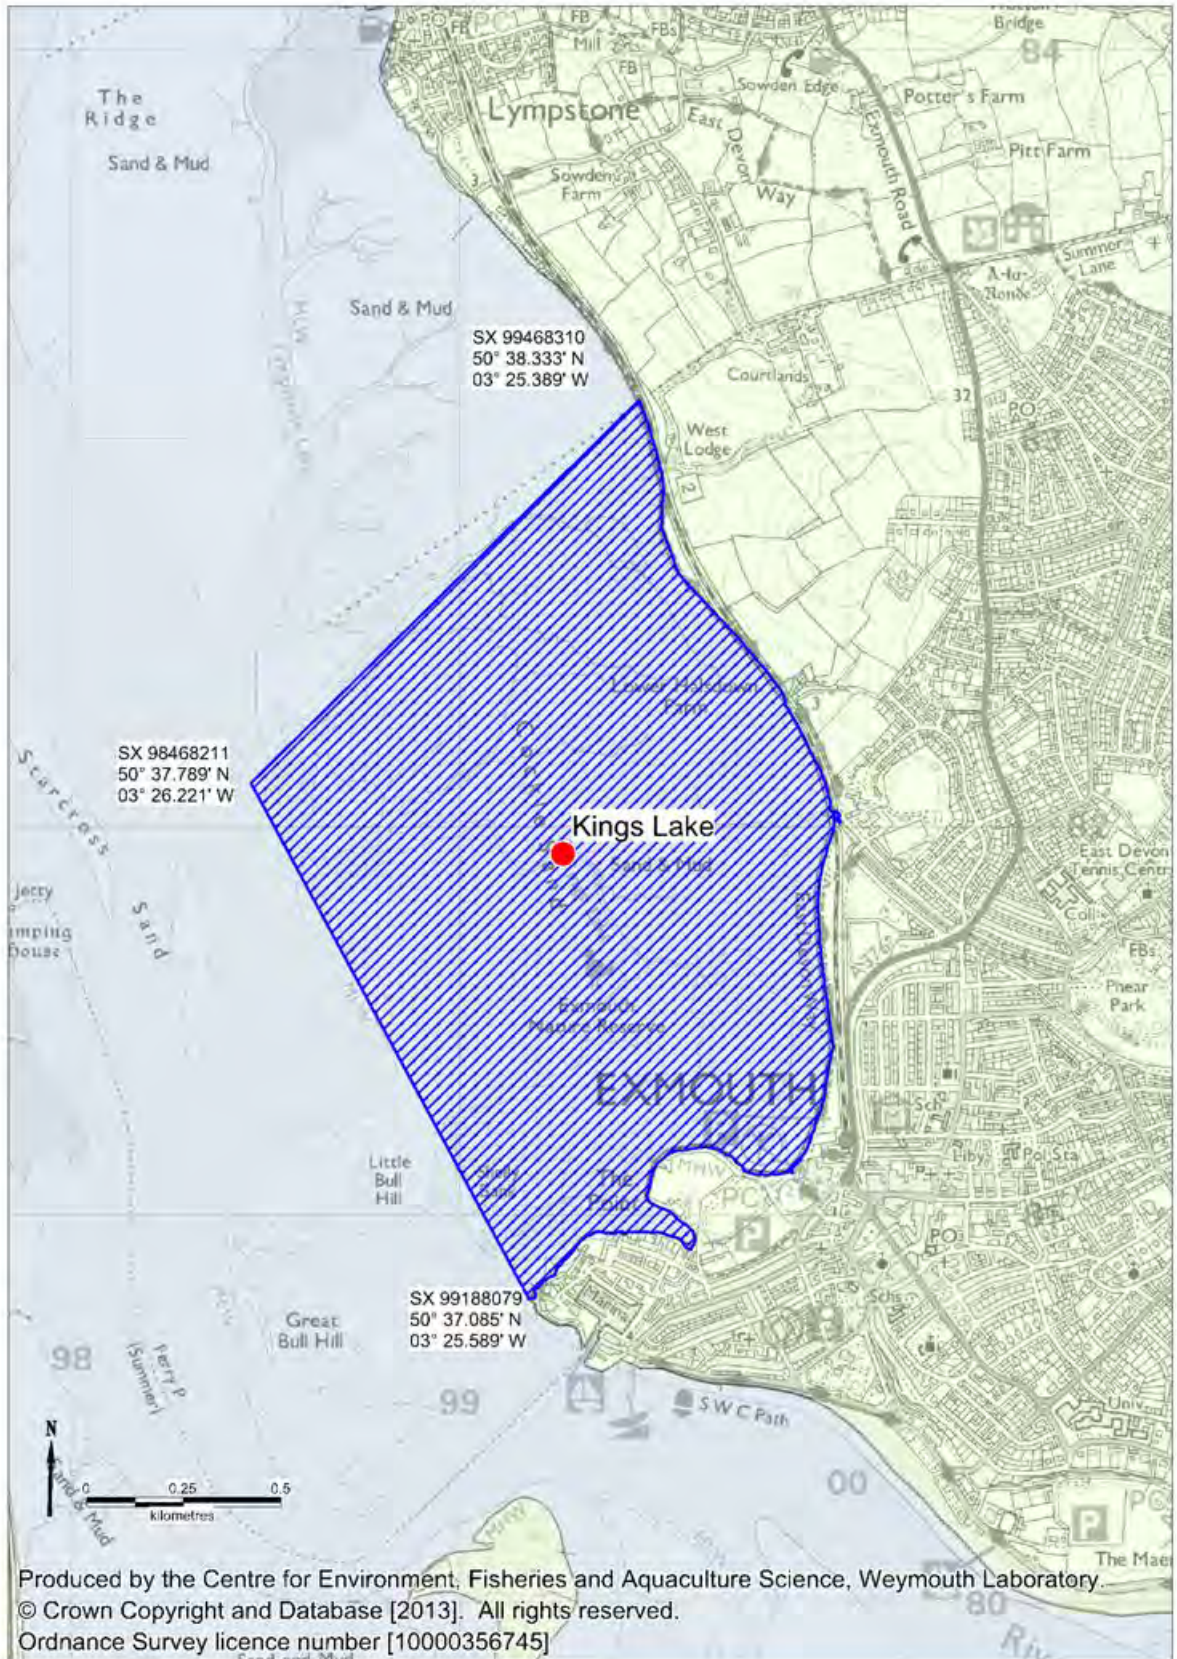
**Figure 3.5: Recommended zoning and monitoring arrangements (cockles)**

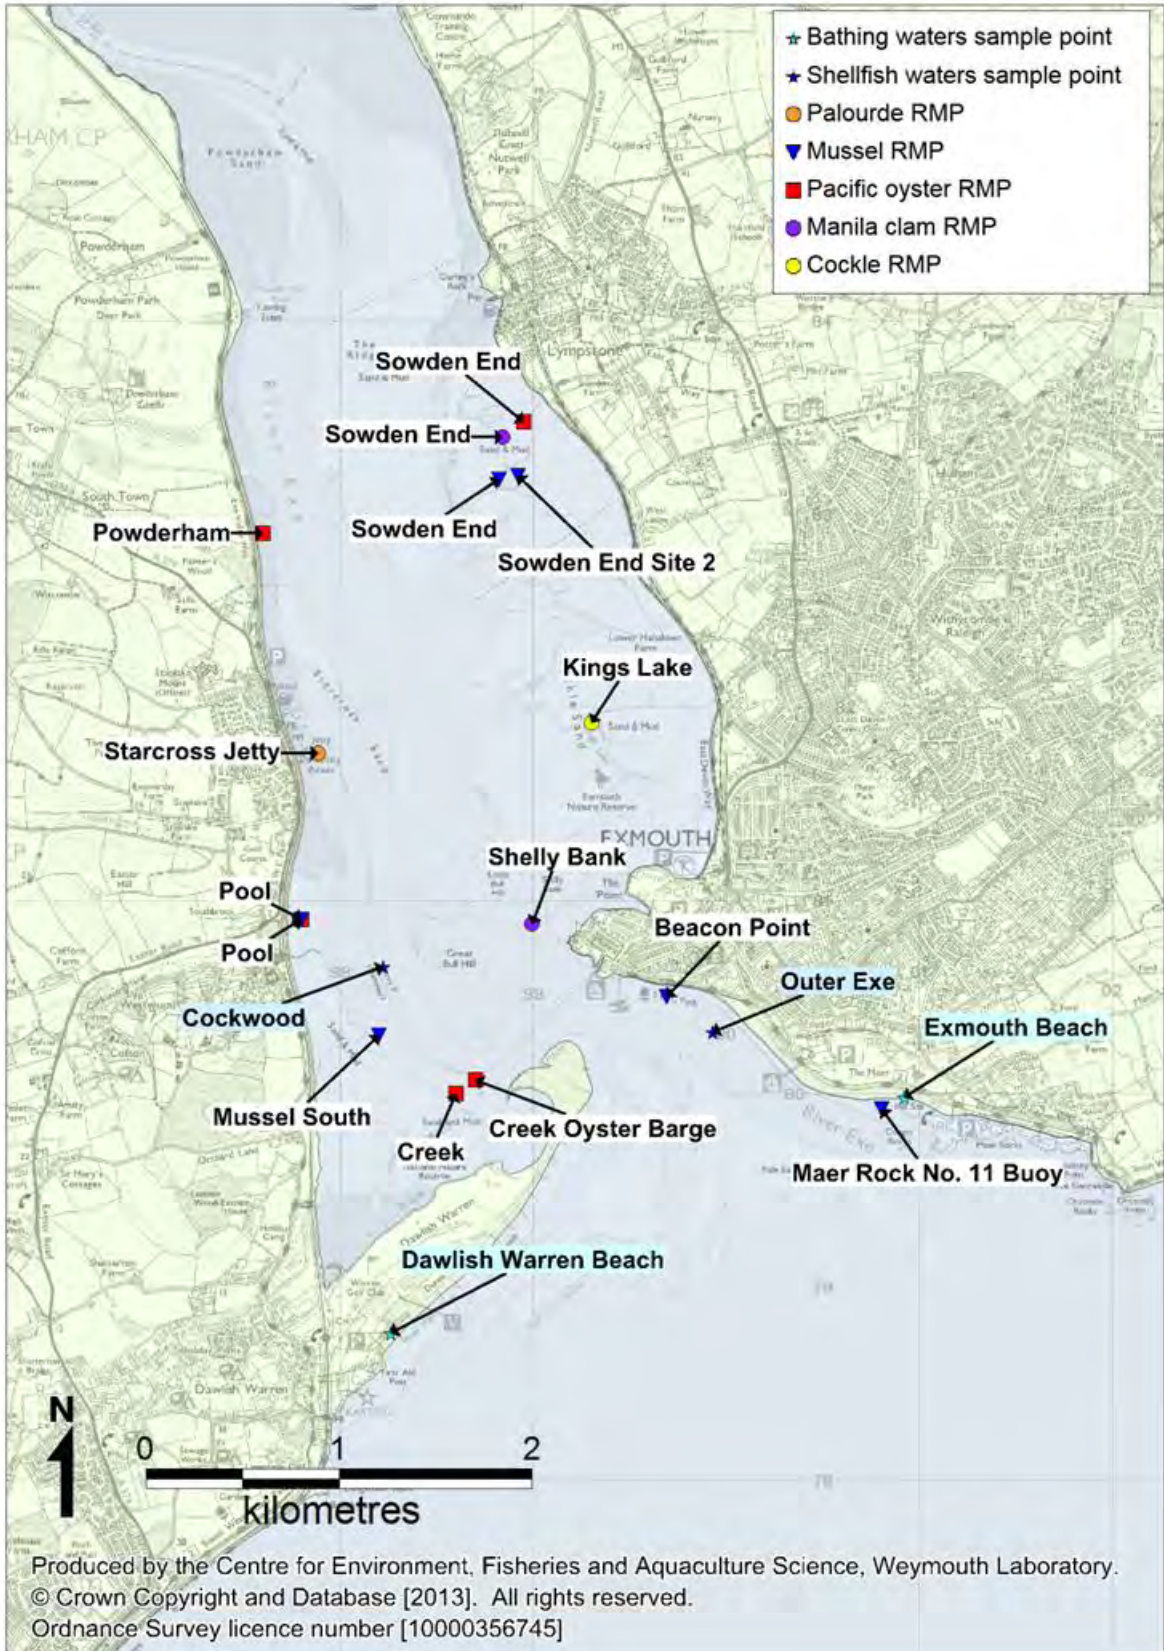
Figure 5.2: Microbiological sampling sites

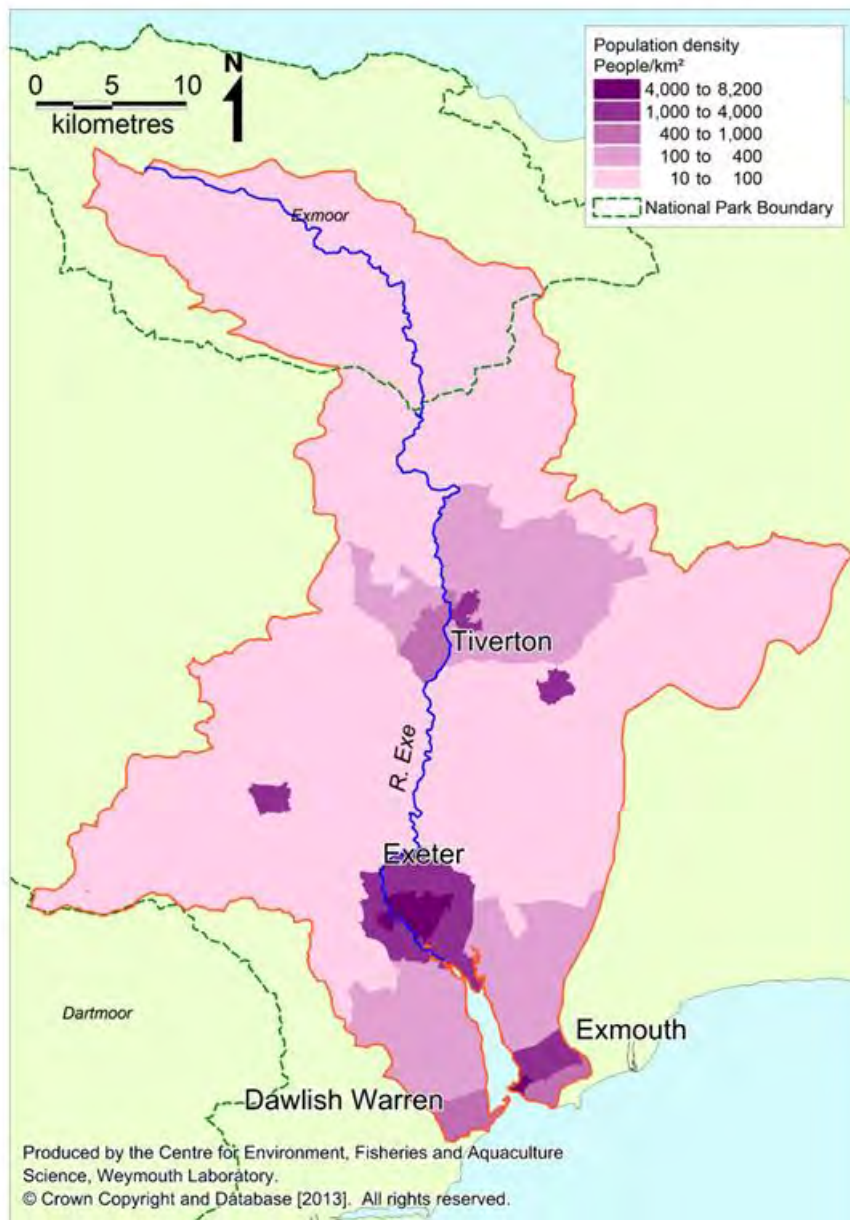
**Figure I.1: Population densities in the Exe catchment area**

Figure I.1 shows the population densities in the census areas that lie fully or partially within the Exe catchment. These data were derived from the 2011 census.

The total population in the catchment is approximately 377,000, and increased by 6.6% between the 2001 and 2011 censuses. Much of the catchment is rural, with the uppermost reaches of the Exe running through the Exmoor national park. Population densities in these areas are low, ranging from 10 to 100 people per km<sup>2</sup>. Exeter, the most populated area, has a total of 118,000 residents, or approximately 31% of the population of the catchment. Other large population centres include Tiverton and Exmouth. All three of these settlements lie on the banks of the River Exe or its

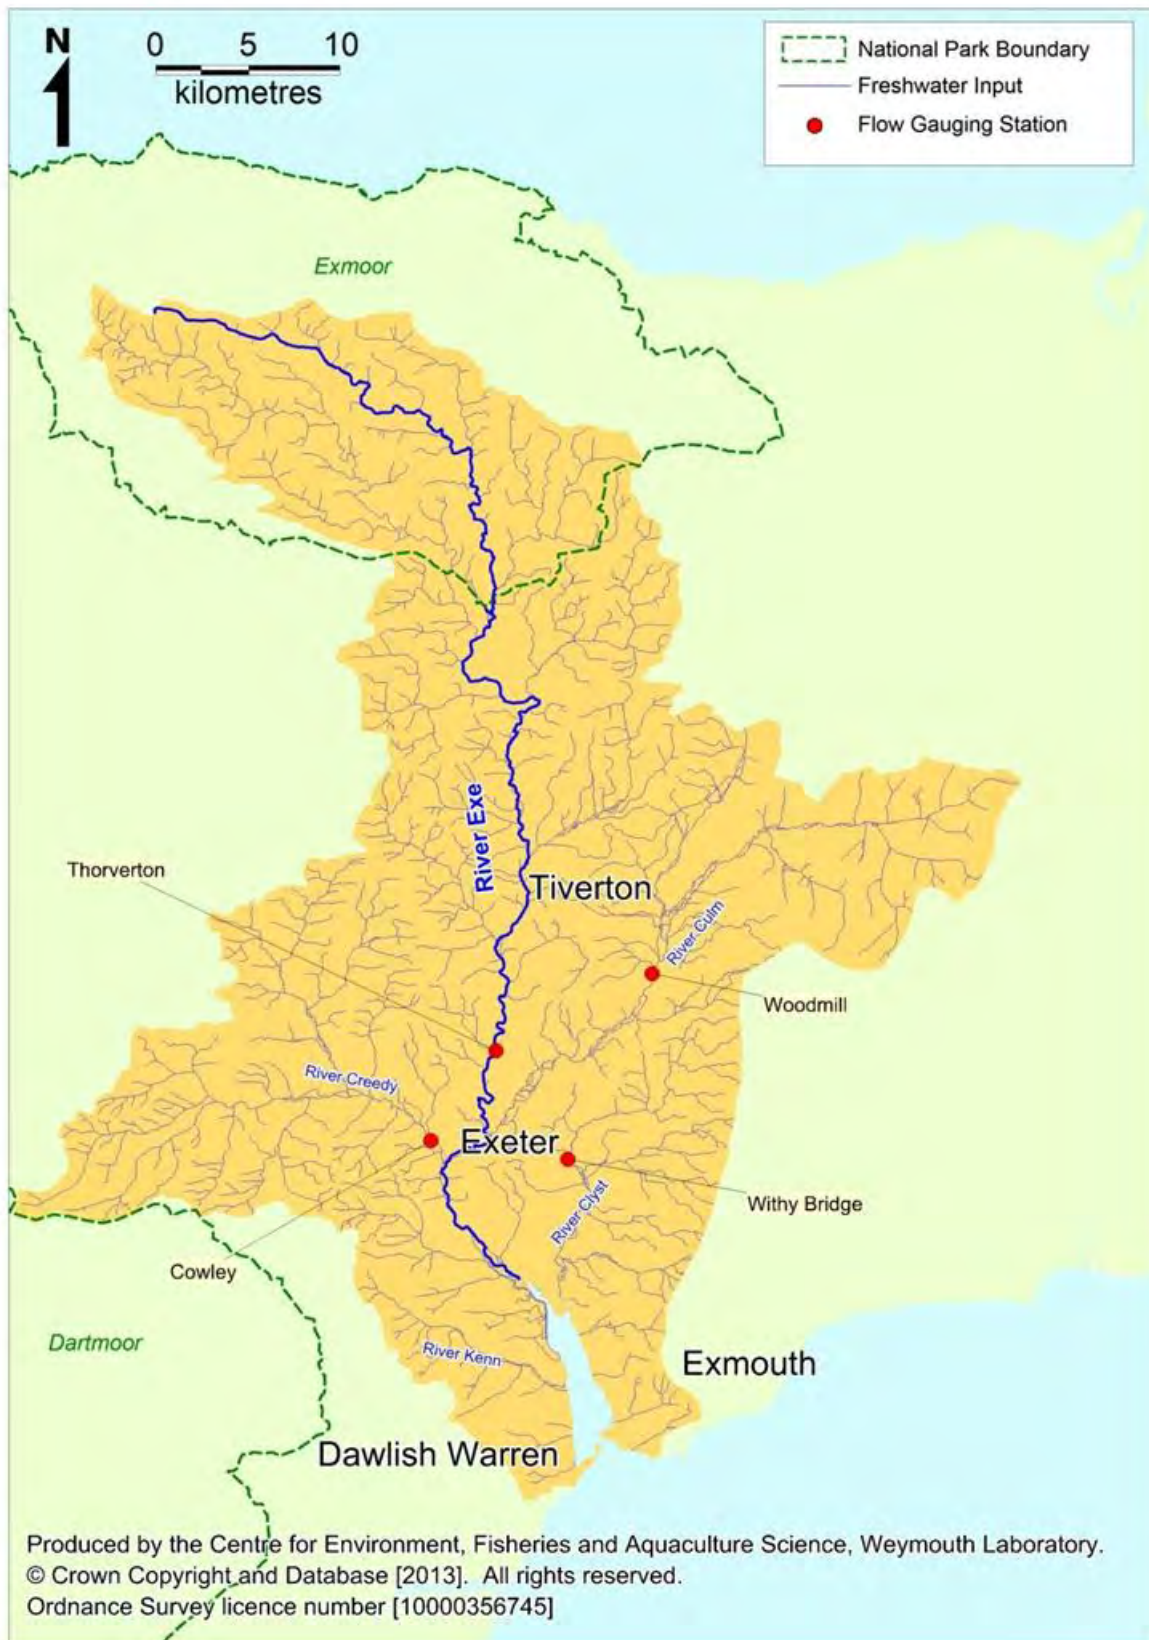
**Figure VIII.1: Freshwater inputs to the Exe estuary**

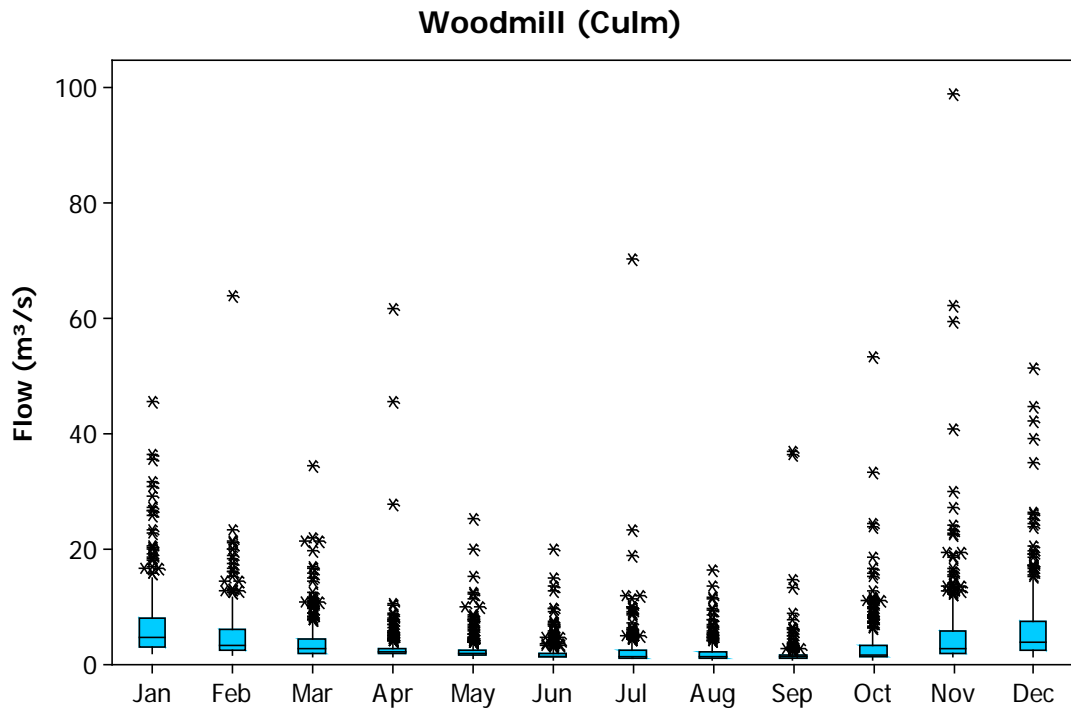
**Figure VIII.3: Boxplots of mean daily flow records from the Woodmill gauging station on the Culm (2003 - 2013)**  
*Data from the Environment Agency*

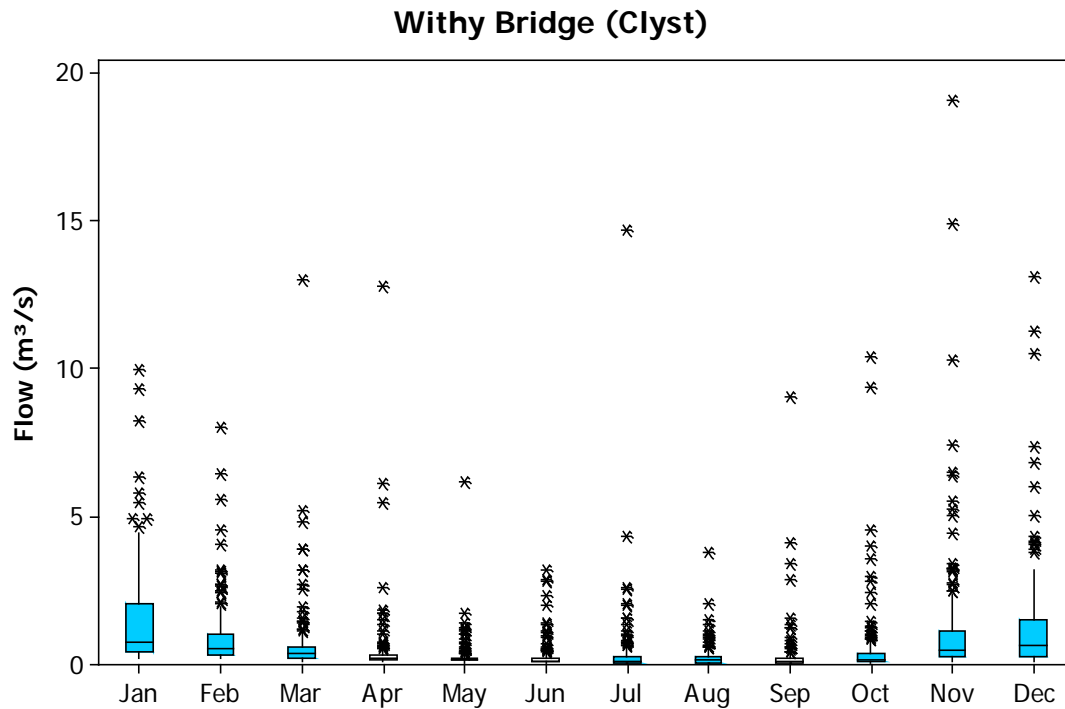
**Figure VIII.5: Boxplots of mean daily flow records from the Withy Bridge gauging station on the Clyst (2008 - 2013)**  
*Data from the Environment Agency*

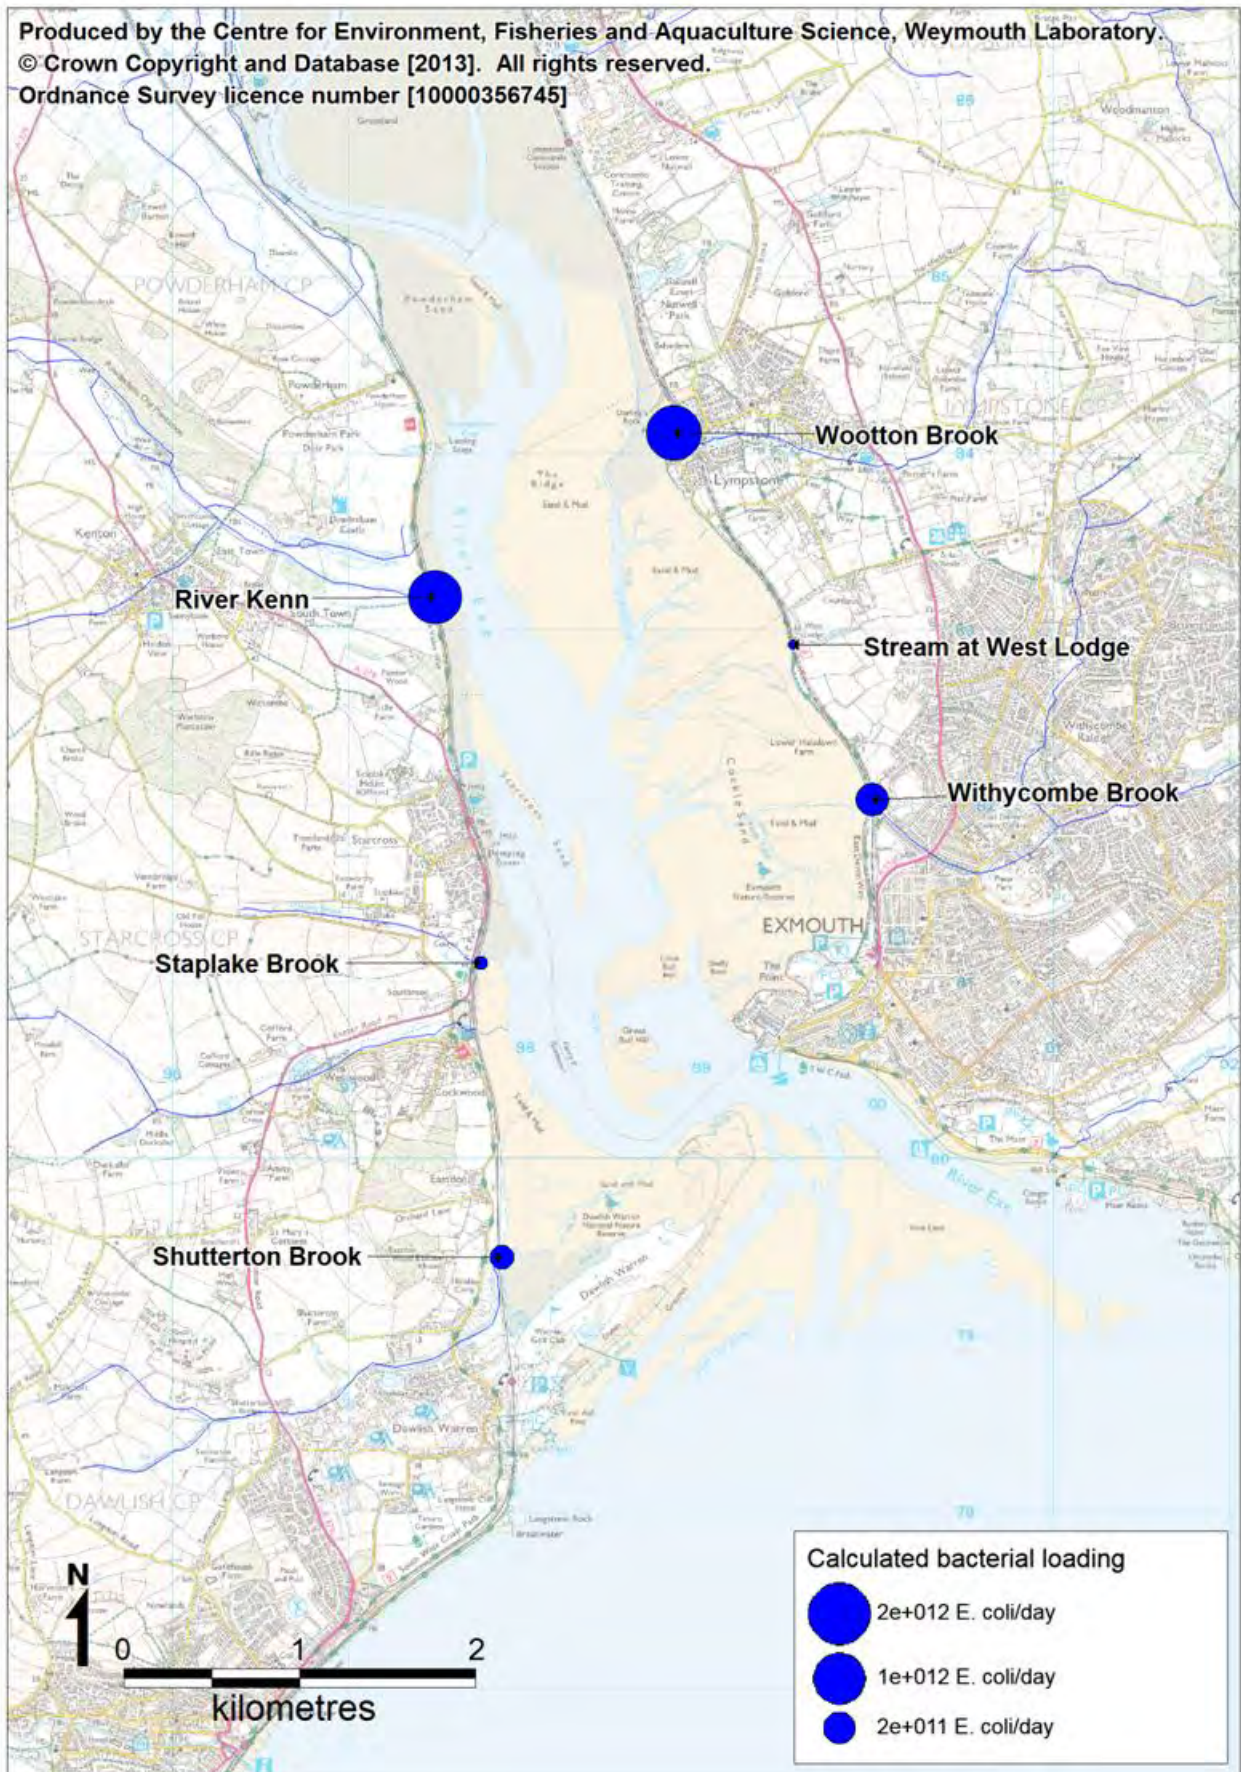
Figure VIII.6: Measured stream loadings from the shoreline survey

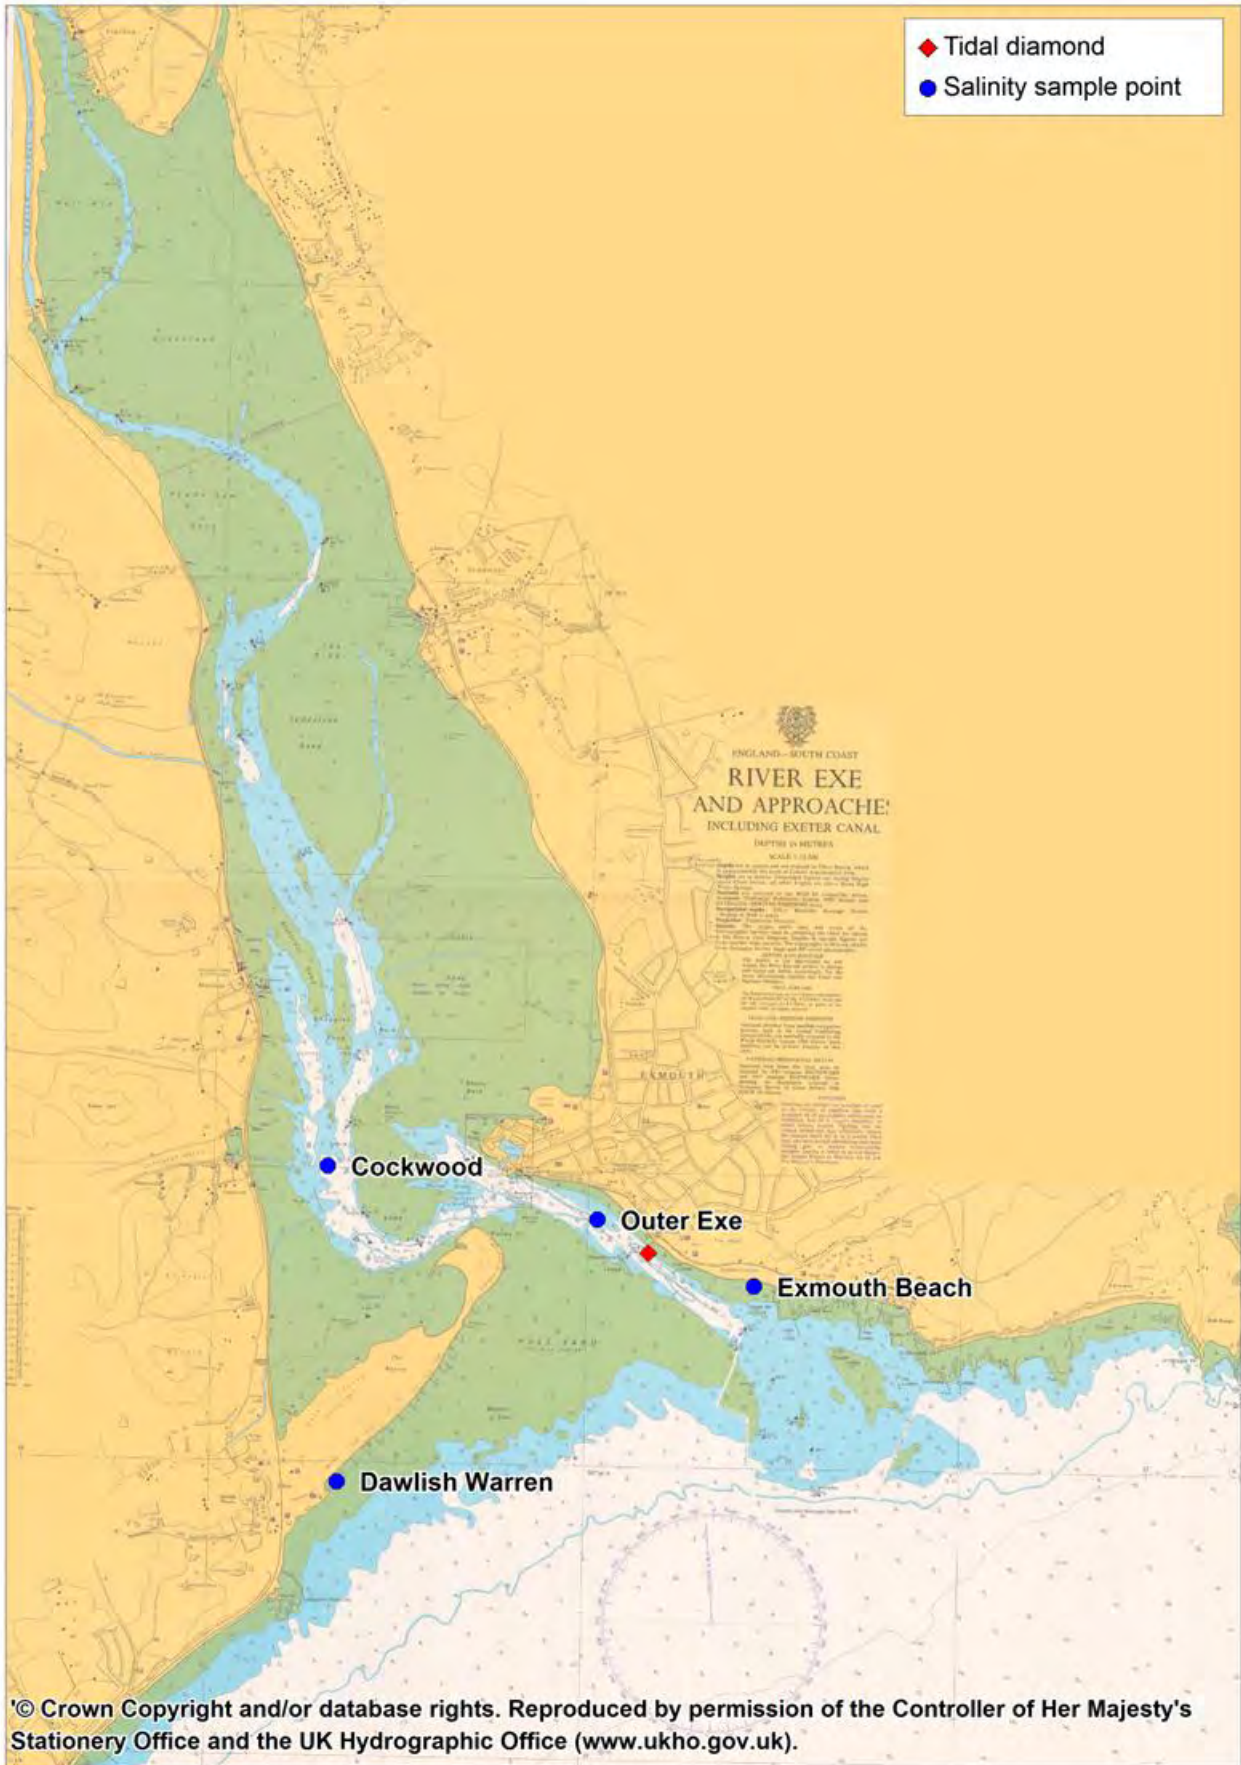
Figure IX.1: Bathymetry of the Exe estuary

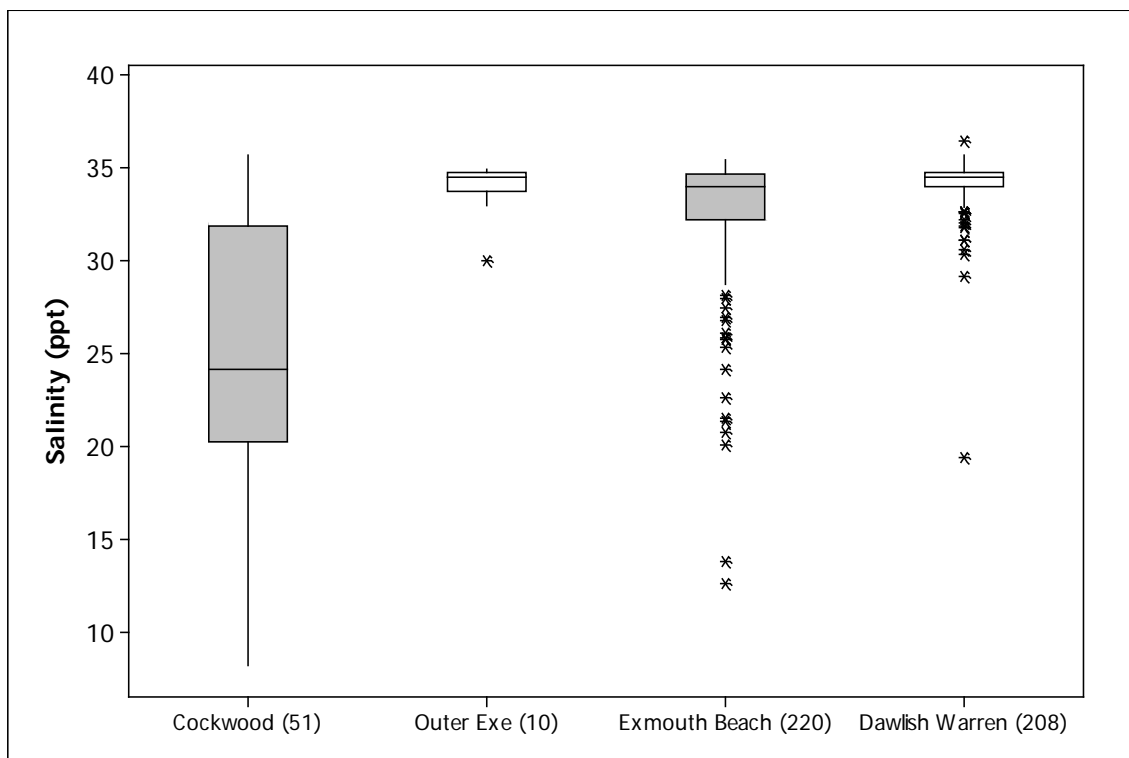
**Figure IX.3: Boxplot of near surface salinity measurements, 2003 to 2013 (number of measurements in brackets)**  
*Data from the Environment Agency*

As land runoff typically contains higher levels of faecal indicator bacteria than seawater, salinity may be used a useful indicator of levels of freshwater borne contamination. An overall gradient of decreasing salinity towards the head is typical within estuaries such as the Exe, and the associated geographic variation in levels of *E. coli* are often key considerations when developing shellfish hygiene sampling plans. Box plots of near surface salinity measurements are presented in Figure IX.3 (sampling locations in Figure IX.1).

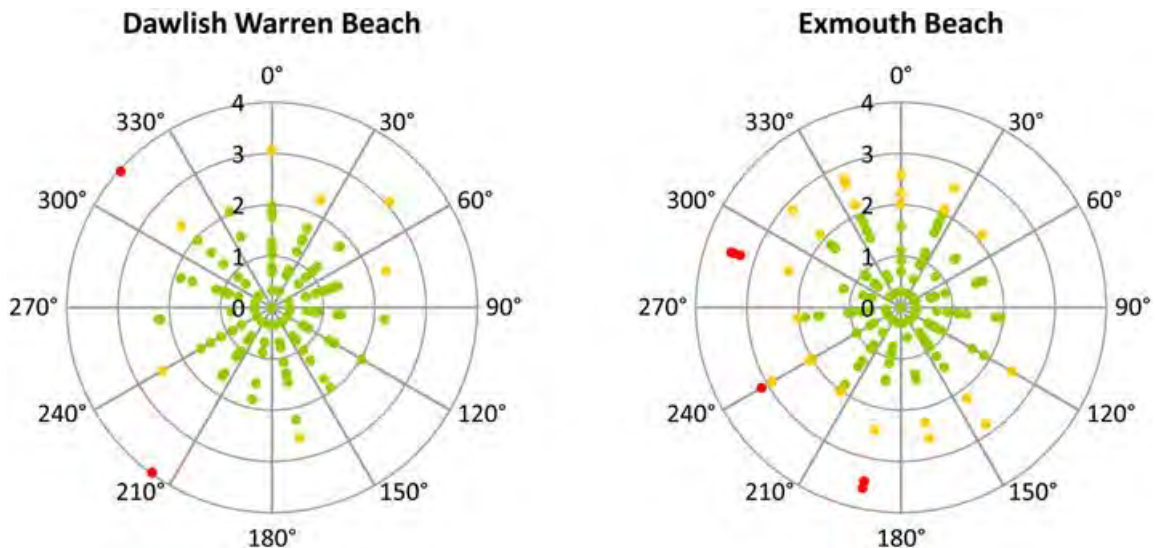
**Figure X.5: Polar plots of log<sub>10</sub> faecal coliforms against tidal state on the spring/neap tidal cycle for bathing waters monitoring points with significant correlations**  
*Data from the Environment Agency*

Figure X.5 presents polar plots of faecal coliform results against the lunar spring/neap cycle, where a statistically significant correlation was found. Full/new moons occur at 0°, and half moons occur at 180°. The largest (spring) tides occur about 2 days after the full/new moon, or at about 45°, then decrease to the smallest (neap tides) at about 225°, then increase back to spring tides. Results of 100 faecal coliforms/100ml or less are plotted in green, those from 101 to 1000 are plotted in yellow, and those exceeding 1000 are plotted in red.

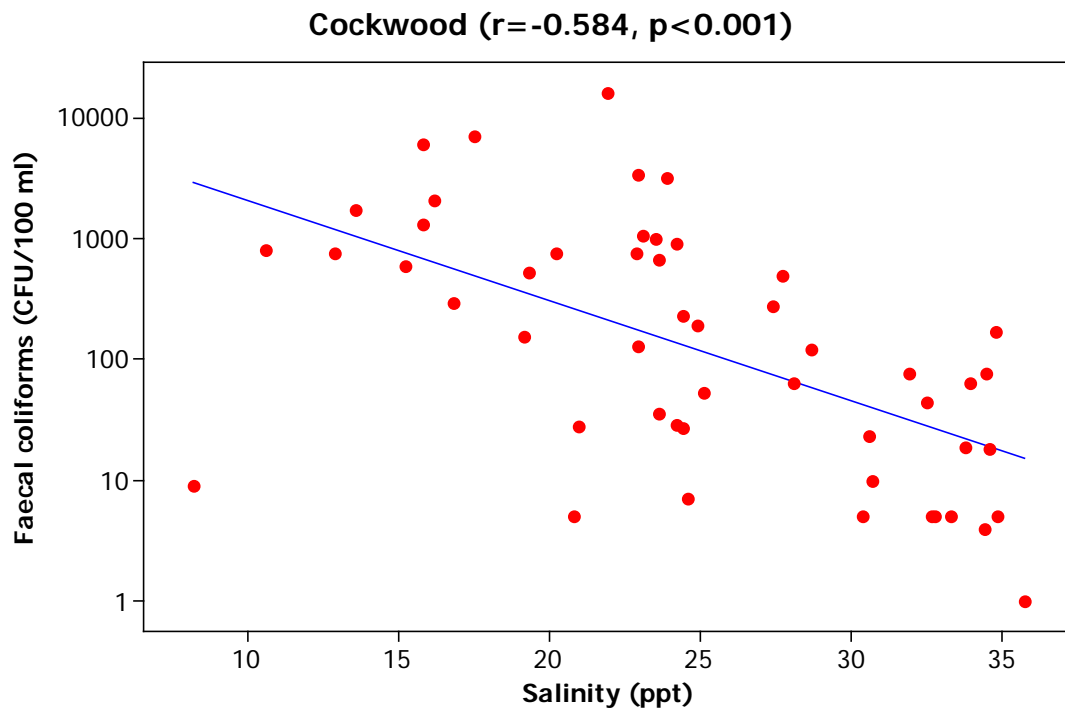
**Figure X.11: Scatterplot of salinity against faecal coliform results**  
*Data from the Environment Agency*

Pearson's correlations were run to determine the effect of salinity on faecal coliforms at Cockwood (too few samples were taken at Outer Exe for reliable comparison). Figure X.11 shows a scatterplot of faecal coliforms against salinity and the results of Pearson's correlations between the two.

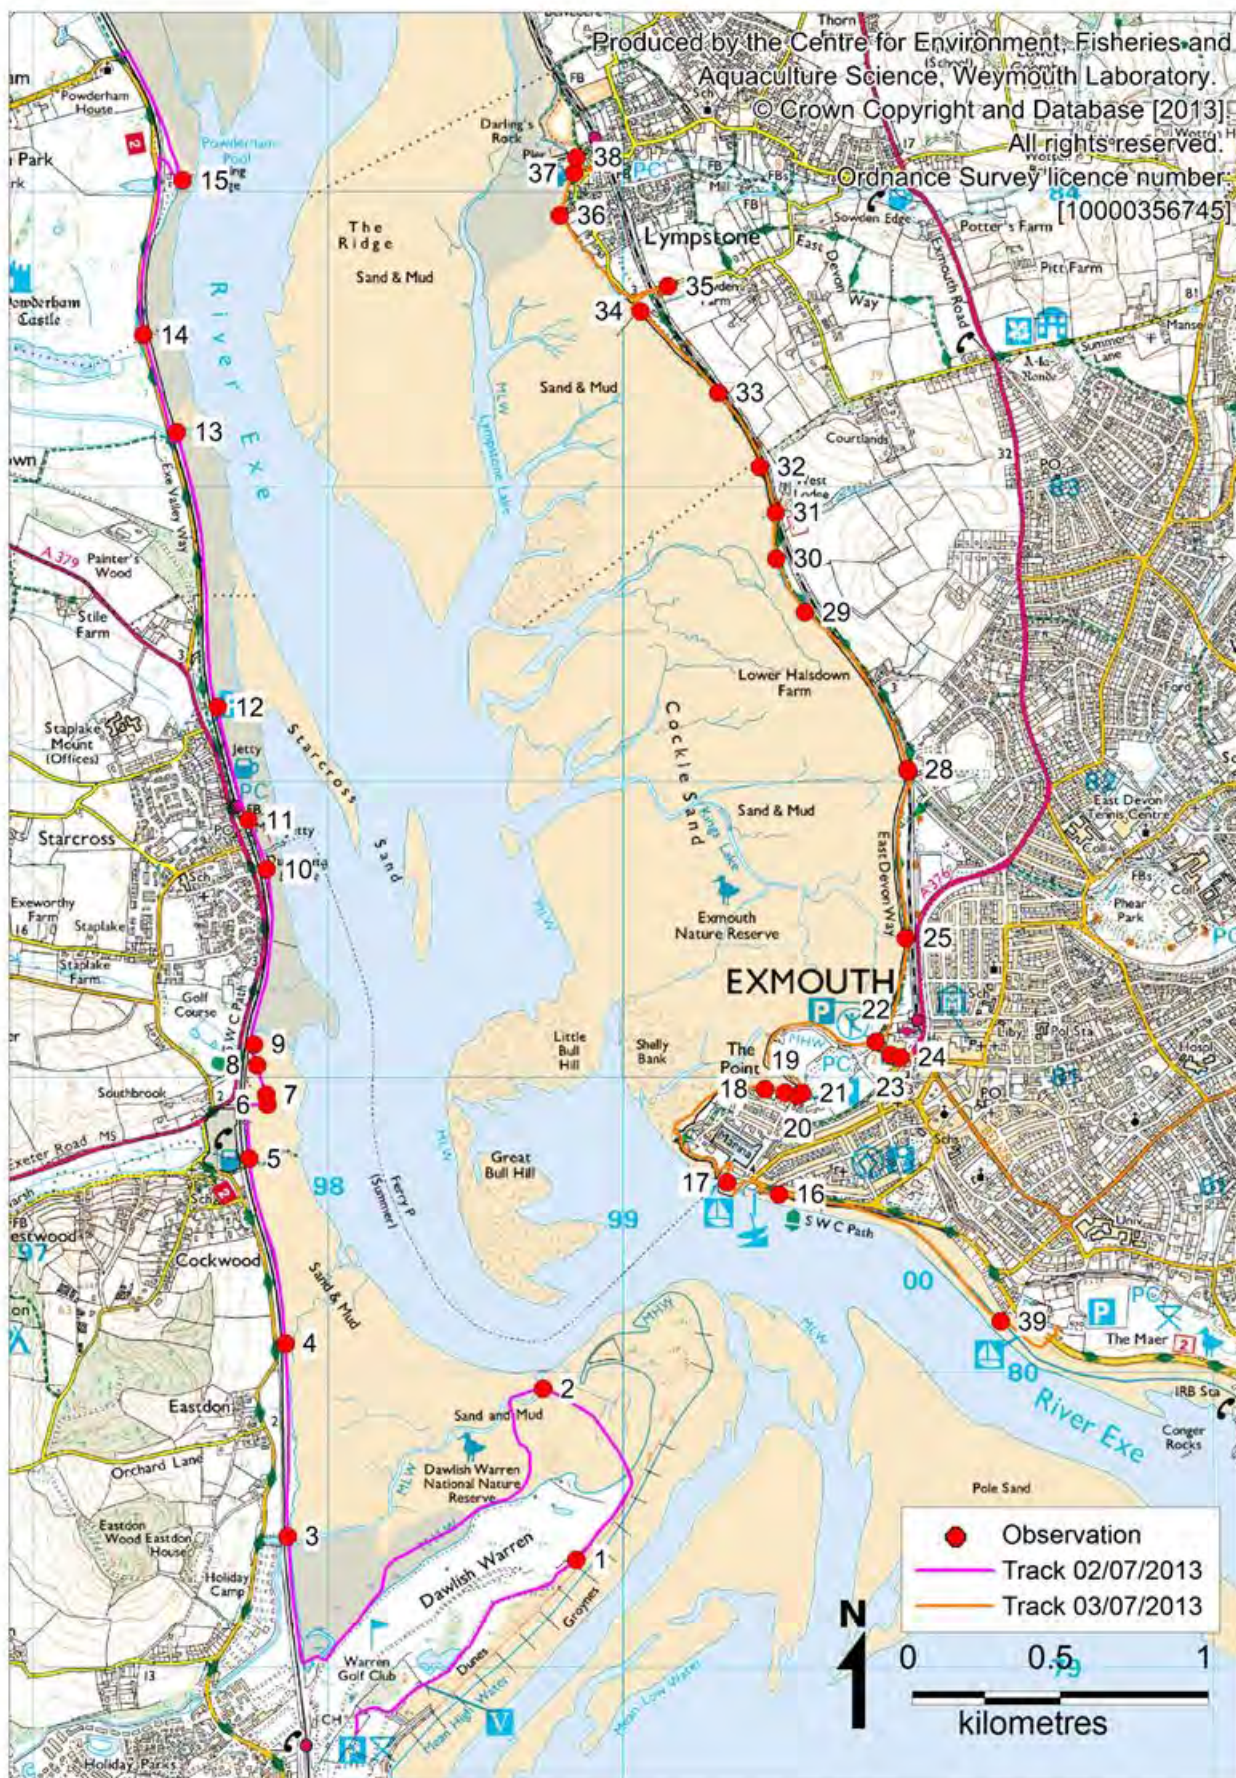
Figure XII.1: Locations of shoreline observations (see Table XII.1 for details)
