CLASSIFICATION OF BIVALVE MOLLUSC PRODUCTION AREAS IN ENGLAND AND WALES

SANITARY SURVEY REPORT

Hayle Harbour

November 2014

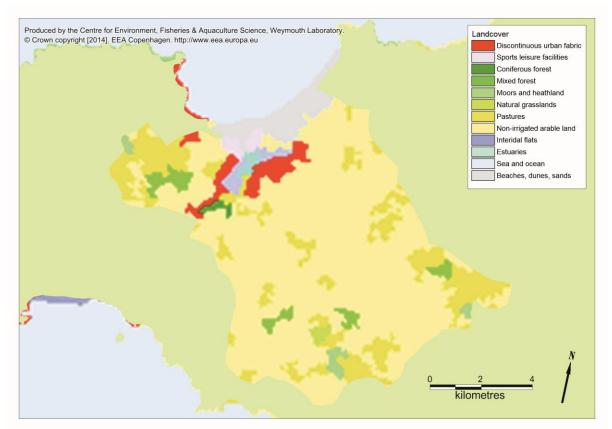
Figure 1.2: Land cover in the Hayle estuary catchment

Land cover in the catchment is mainly arable farmland, with some pockets of pasture and natural areas. The land immediately adjacent to the estuary is largely urbanised, whereas inland areas are sparsely populated. The catchment is drained by two principal watercourses (River Hayle and Angarrack Stream).

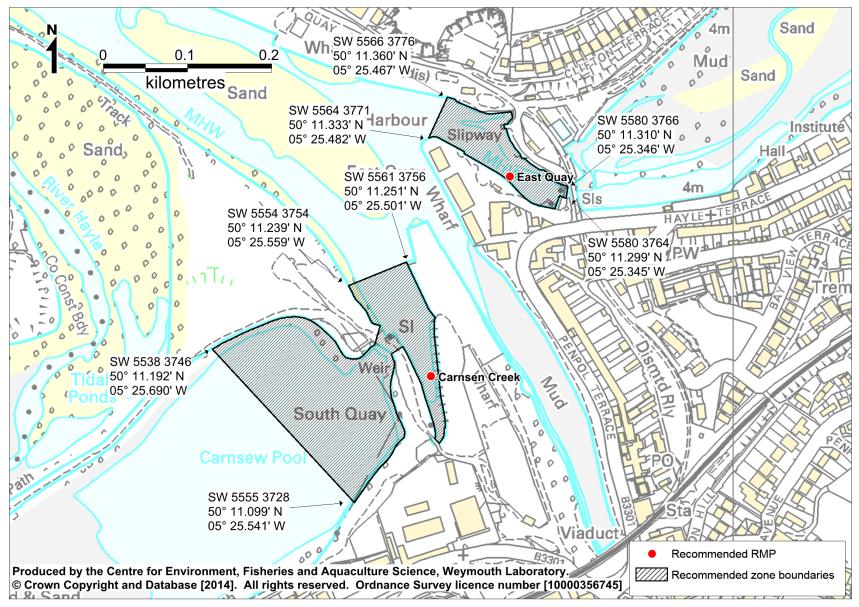
Figure 3.1: Recommended zoning and monitoring arrangements (mussels)

Sources of contamination to Copperhouse Pool are likely to be an influence on this mussel bed. These include the Angarrack Stream, Loggans Mill Leat, Phillack combined sewer overflow (CSO) and overwintering waterbirds. Contamination from Copperhouse Pool will be delivered to the mussel bed during the ebb tide. In the immediate vicinity of the mussel bed there are two point sources, the East Quay pumping station emergency overflow (PSEO) and a contaminated surface water pipe identified during the shoreline survey. These will impact most acutely on the upstream end of the mussel bed on the western side of the channel. There may be some influence from sources to the outer estuary, as well as those to other parts of the inner estuary such as Lelant Water. Contamination from these would be delivered during the flood tide, although it is anticipated that it would be in a more dilute form than contamination from the local sources and from Copperhouse Pool. It is therefore recommended that the RMP is located at the upstream western end of the mussel bed.

There are no confirmed point sources of contamination in the immediate vicinity of the mussel bed in Carnsew Pool and its outlet channel. There may be some influence from sources to the outer estuary, as well as those to other parts of the inner estuary such as Lelant Water and Copperhouse Pool. Contamination from these would be delivered during the flood tide, albeit in a dilute form. Sources of contamination to Carnsew Pool are limited to minor diffuse inputs from birds and possibly dogs. Very limited microbiological monitoring suggested slightly higher levels of contamination in the outlet channel than in the pool. It is therefore recommended that the existing RMP named 'Carnsen Creek' is used to classify the whole of this zone.

Samples should be of mussels of a harvestable size. The sampling method should be hand collection. A tolerance of 10 m applies. The sampling frequency should be monthly throughout the year. Should a more rapid classification be required, then a provisional classification may be awarded once ten samples taken not less than a week apart have been submitted. Samples taken during 2012 should not be counted towards classification as they were taken over two years ago.

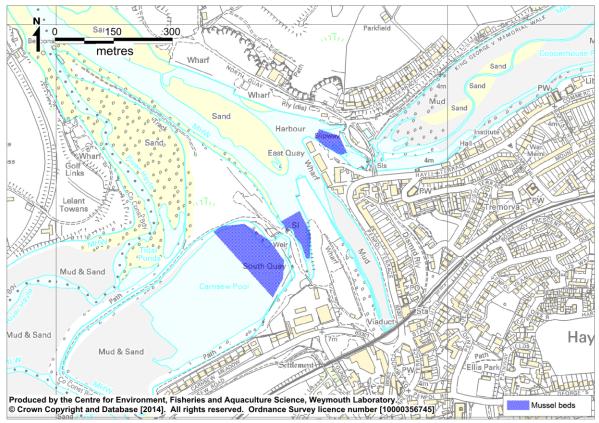
Figure 4.1: Location of mussel beds within Hayle Harbour

An application to harvest naturally occurring stocks of mussels from Hayle Harbour was received in August 2013. They occur in two relatively small areas around the outlets of Carnsew and Copperhouse Pools. These areas provide favourable growing conditions as they are well flushed and oxygenated due to tidal accelerations through the two pool outlets. Much of the stock is of a marketable size, including some very large individuals. Harvest will be via hand, although some stocks are not accessible via this method as they remain submerged at low tide. It is planned that a small number of local fishermen will operate the fishery in a sustainable manner, with input from the IFCA. Local depuration facilities and markets have been identified. In the future, it is possible that mussel culture on suspended ropes may be attempted here. A bulk clearance from the Carnsew outlet tunnels may be required in the near future to facilitate the installation of sluice gates here. This will be undertaken before the end of 2014, and the mussels will be redeposited in Carnsew Pool.

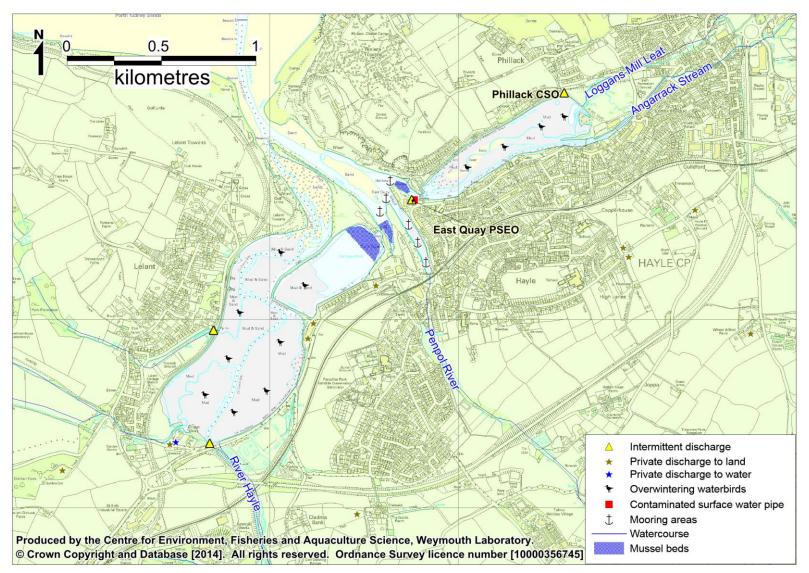
Figure 5.1: Summary of main contaminating influences

Pollution source	Jan	Feb	Mar	Apr	Мау	Jun	Jul	Aug	Sep	Oct	Nov	Dec
Agricultural runoff												
Urban runoff												
Continuous sewage discharges												
Intermittent sewage discharges	?	?	?	?	?	?	?	?	?	?	?	?
Birds												
Boats

Red - high risk; orange - moderate risk; yellow - lower risk; white - little or no risk.

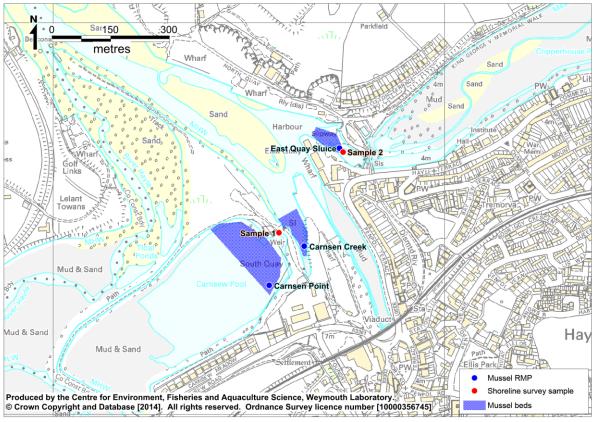
Figure 5.2: Microbiological sampling sites

In 2012, two samples were taken from each of three locations. The geometric mean result was highest at East Quay Sluice (1,455 *E. coli* MPN/100 g), and the highest individual result (9,200 *E. coli* MPN/100 g) was recorded here. Across the other two points the average result was higher at Carnsen Creek (426 *E. coli* MPN/100 g) than at Carnsen Point (185 *E. coli* MPN/100 g). Neither result exceeded 4,600 *E. coli* MPN/100 g at the latter two monitoring points.

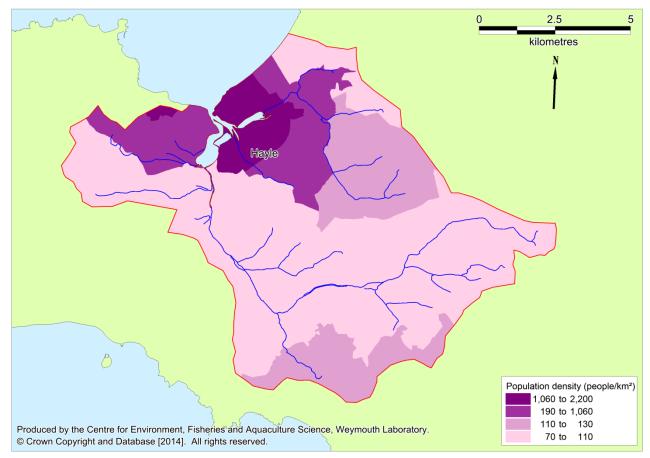
Figure I.1: Human population density in census areas in the Hayle Harbour catchment.

Total resident population within census areas contained within or partially within the catchment area was approximately 28,000 at the time of the last census. The largest settlement in the area is Hayle, which had a population of about 9,400 in the 2011 census. Most of the population is concentrated around the Harbour.

Figure I.1 shows population densities in census output areas within or partially within the Hayle Harbour catchment area, derived from data collected from the 2011 census.

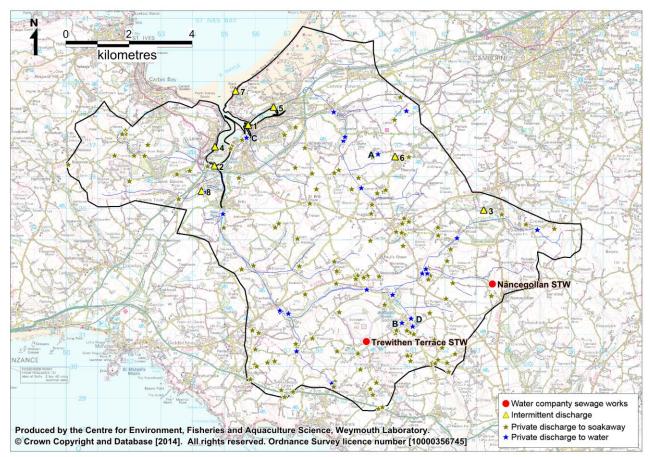
Figure II.1: All permitted sewage discharges to the Hayle Harbour catchment *Contains Environment Agency information* © *Environment Agency and database right*

Details of all consented sewage discharges within the Hayle Harbour hydrological catchment were taken from the most recent update of the Environment Agency national permit database (March 2014). These are mapped in Figure II.1.

The towns of St Ives and Hayle are served by Hayle STW, which discharges secondary treated effluent via a long sea outfall offshore from St Ives Bay. This will be of no impact within Hayle Harbour. There are two small continuous water company sewage works discharging within the catchment, details of which are presented in Table II.1.

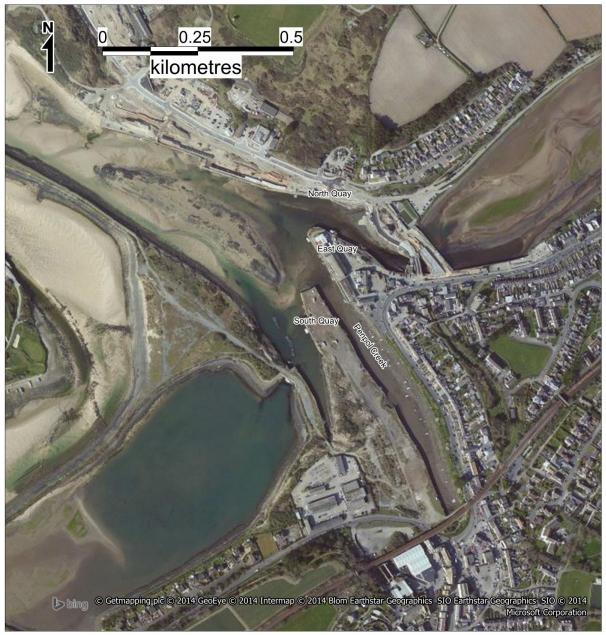
Figure IV.1: Boating activity in Hayle Harbour

The harbour at Hayle is mainly used by small fishing boats, as well as a number of small dinghy type pleasure boats. The area is also used for watersports such as kayaking and jetskiing. It is not generally used by visiting yachts as it can be difficult to navigate and access is restricted to higher states of the tide, although they do occasionally use the harbour.

The harbour accommodates 27 fishing boats, 2 commercial boats and 107 leisure boats. There are also a number of sports clubs which are licensed to use the harbour, including a jet-ski club, canoe club and the local gig club (ING Real Estate, 2011). The fishing boats are generally small, and most are unlikely to have on board toilets. They moor at the North, East and South Quays. Penpol Creek is used for the mooring of small dinghy type pleasure craft, and again most if not all of these are too small to have on board toilets. Vessels used for watersports (kayaks etc) are also too small to make overboard discharges.

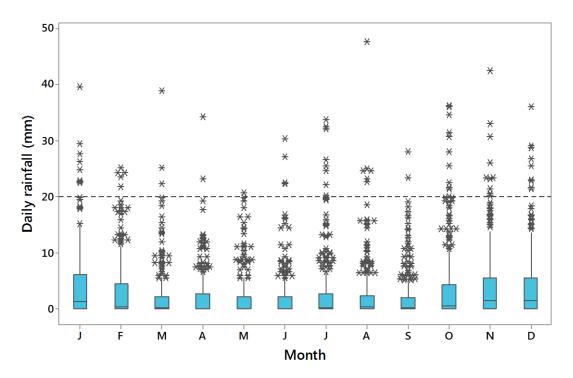
Figure VI.1: Boxplot of daily rainfall totals at St Erth, July 2005 to July 2014. *Contains Environment Agency information* © *Environment Agency and database right*

The St Erth weather station received an average of 1065 mm per year between 2005 and 2014. The autumn and winter months (October to February inclusive) had the highest average rainfall, while May had the lowest average rainfall. Daily totals of over 20 mm were recorded on 2% of days, and in every month of the year. No rainfall was recorded on 41% of days.

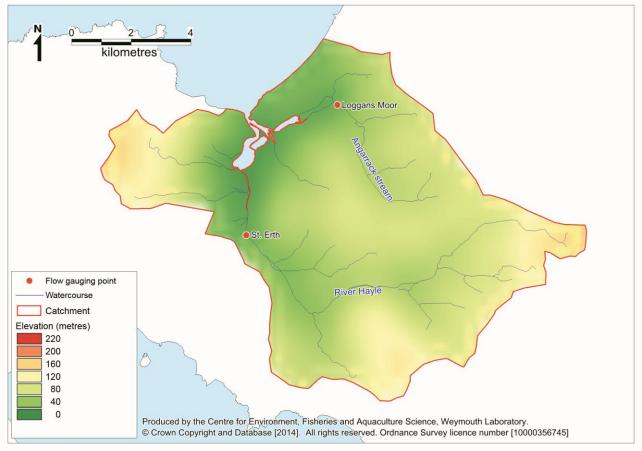
Figure VIII.1: Freshwater inputs to the Hayle estuary

Land within the catchment is mainly used as pasture or for arable crops. There are also some urban areas which are mainly located around the estuary. The maximum elevation is just over 200 m, and the hydrogeology is described as impermeable throughout. However, the St Erth catchment is described as slow responding due to significant groundwater storage, as is consistent with its base flow index² of 0.83 (NERC, 2012).

The hydrological catchment draining to the Hayle estuary, as estimated from topography, covers an area of 96 km². The two main freshwater inputs are the River Hayle and the Angarrack Stream.

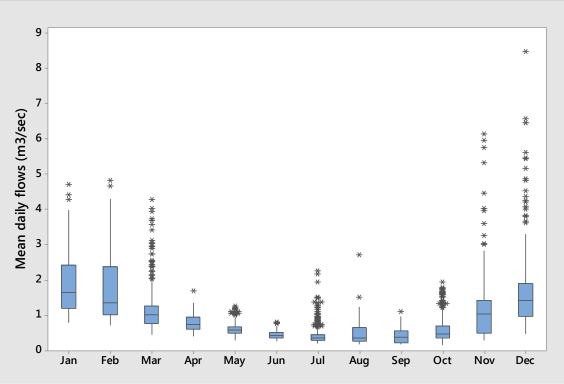
Figure VIII.2: Boxplots of mean daily flows by month for the St Erth gauging station Contains Environment Agency information © Environment Agency and database right

Discharge at St. Erth was lowest on average from May to September and highest on average during December and January, and elevated flow events were rare from April to October. The seasonal pattern and the relatively low range of flows each month is consistent with a significant groundwater component to discharge.

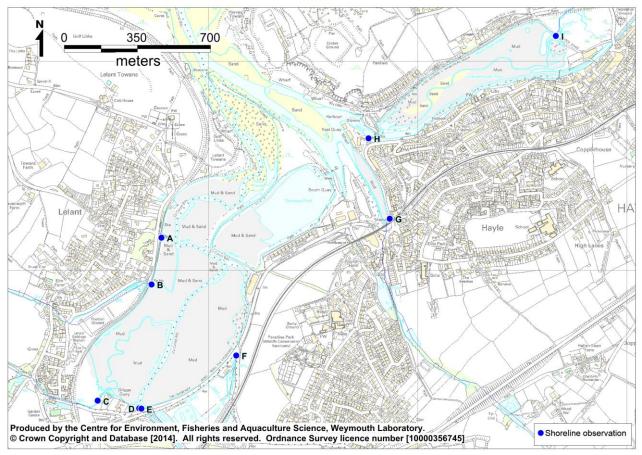
Figure VIII.3: Locations of shoreline stream samples

During the shoreline survey of the perimeter of the estuary, samples and spot flow measurements were made where possible from all flowing freshwater inputs.

Ref	Description	Flow (m³/s)	<i>E. coli</i> concentration (cfu/100 ml)
А	Drainage pipe (flowing)	0.001	19,000
В	Stream (discharging via pipe with flap)	Not measured	2,100
С	Stream (flowing)	Not measured	3,300
D	Drainage pipe (flowing)	Not measured	8,500
Е	River Hayle (flowing)	Not measured	3,100
F	Stream (flowing)	Not measured	5,100
G	Penpol River (flowing)	Not measured	4,500
Н	Drainage pipe (flowing)	Not measured	290,000
1	Loggans Mill Leat (flowing)	Not measured	840

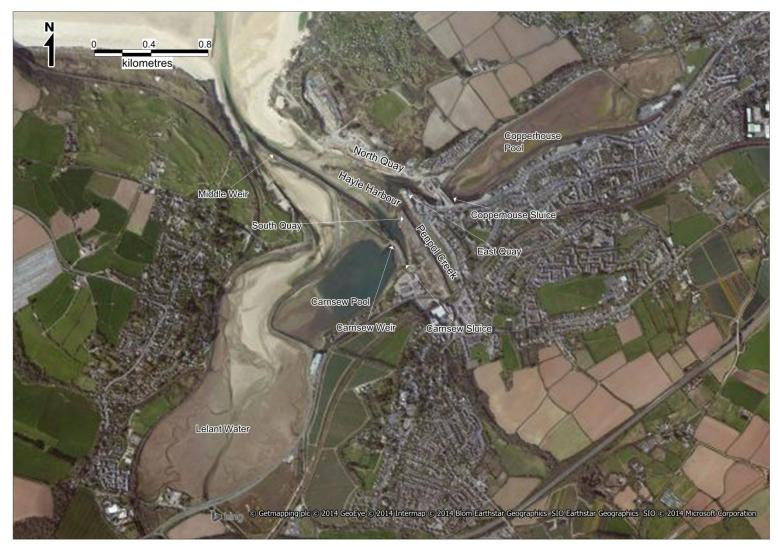
Figure IX.1: Aerial photograph of the Hayle Estuary Bing Maps

Historically, sluice gates at Carnsew and Copperhouse Pools were closed at high tide to hold back water in the two pools, which was subsequently released later during the ebb tide. The effect of this was to flush sediment from the harbour area out into the bay. It is

planned that sluicing will be reinstated following the recent reinstallation of a sluice at Carnsew Pool, to reduce reliance on dredging. Further gates will have to be installed on the Carnsew tunnels. This will result in a significant increase in water flows across the mussel beds, which may scour them from some areas and result in a change in their spatial distribution. Sluicing will be restricted to spring tides from April to August for conservation reasons (Buro Hapold, 2011).

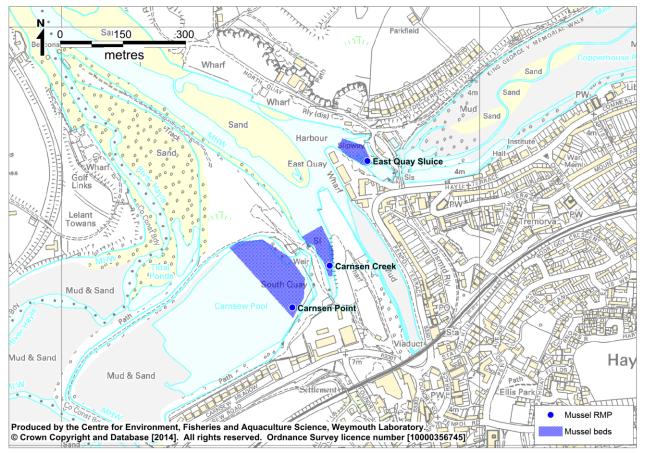
Figure XI.1: Mussel RMPs.

There are three RMPs in Hayle Harbour, all of which are for mussels. Their locations are shown in Figure XI.1, and summary statistics for sampling results are presented in Table XI.1.

Date of first	Date of last	Geometric			% over	% over	% over
Site	Species	No.	sample	sample	mean	Min.	Max.	230	4,600	46,000
Carnsen Point	Mussel	2	16/07/2012	30/07/2012	185.2	70	490	50.0	0.0	0.0
Carnsen Creek	Mussel	2	16/07/2012	30/07/2012	426.3	230	790	100.0	0.0	0.0
East Quay Sluice	Mussel	2	16/07/2012	30/07/2012	1,454.6	230	9,200	100.0	50.0	0.0

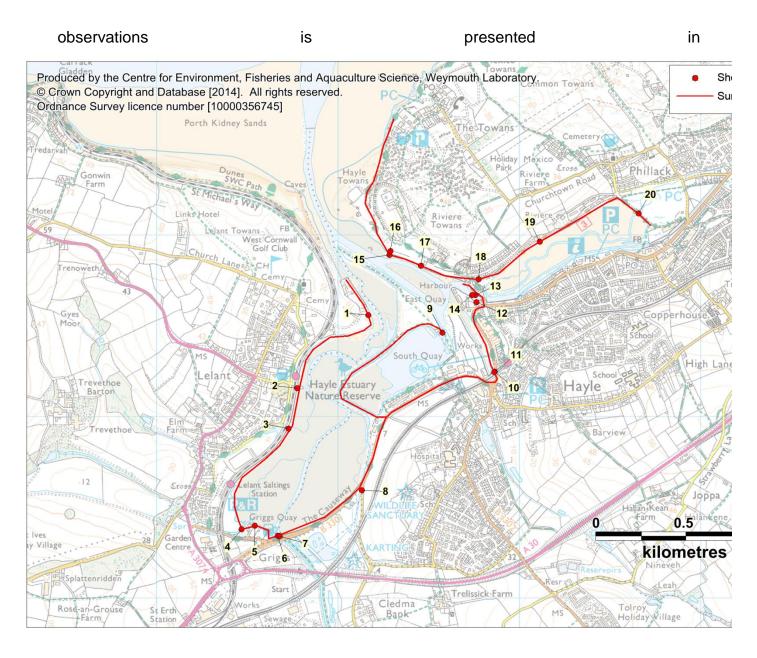
Figure XII.1: Locations of Shoreline Observations (Table XII.3 for details)

Table XII.1 and the locations of these observations are shown in Figure XII.1. The shoreline survey was undertaken over one day by foot.

The outlet of East Quay PSEO was observed (observations 6). At this location there were two pipes. The larger of the two was believed to be the pumping station outfall, and was not flowing at the time. A smaller pipe about 10 m to the east was flowing and gave off a strong sewage smell. A sample taken from this pipe revealed an elevated *E. coli* result of 290,000 cfu/100 ml. A flow reading was not possible as the discharge was too large.

The River Hayle was sampled (observation 7, sample ID H05) on the survey and had an *E. coli* concentration of 3,300 cfu/100 ml. Five smaller streams were also observed (Observation 3, 4, 8, 10 and 20). The streams had *E. coli* concentrations ranging between 840 and 5,100 cfu/100 ml. It was not possible to undertake spot flow gauging on most freshwater inputs for access reasons.

Aggregations of birds (between 30 and 400 individuals) were observed at three locations within the estuary (observations 1, 7 and 19).

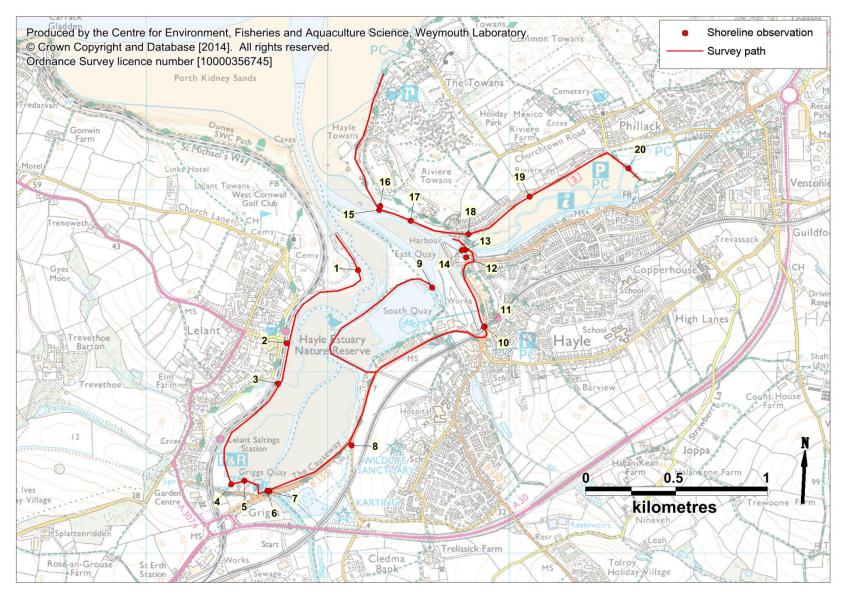
Figure XII.1: Locations of Shoreline Observations (Table XII.3 for details)

I	able XII.	1: Details of Shoreline Observations	
Observation					Photo
no	NGR	Date	Time	Description	
1	SW5516737560	07/10/2014	08:46	~ 30 gulls	
2	SW5477337158	07/10/2014	08:59	Drainage pipe under railway line, flowing H01 (0.01m x 0.11m x 0.62m)	Figure XII.3
3	SW5472536934	07/10/2014	09:08	Stream discharging via large pipe with flap, flowing H02	Figure XII.4
4	SW5446836379	07/10/2014	09:27	Stream flowing H03	
5	SW5454136398	07/10/2014	09:40	Old pipe trickling (disused?)	Figure XII.5
6	SW5466636343	07/10/2014	09:45	Large pipe with grid, possible intermittent, flowing H04	Figure XII.6
7	SW5467636341	07/10/2014	09:49	River Hayle, flowing - H05. ~400 birds on the flats	Figure XII.7
8	SW5513036595	07/10/2014	10:05	Stream, flowing H06	Figure XII.8
9	SW5557537464	07/10/2014	10:49	Mussel sample and water sample H07 from Carsen Pool	Figure XII.9
10	SW5586337248	07/10/2014	11:23	2 x pipes. 1 with flap not flowing & 1 with sluice gate flowing H08	Figure XII.10

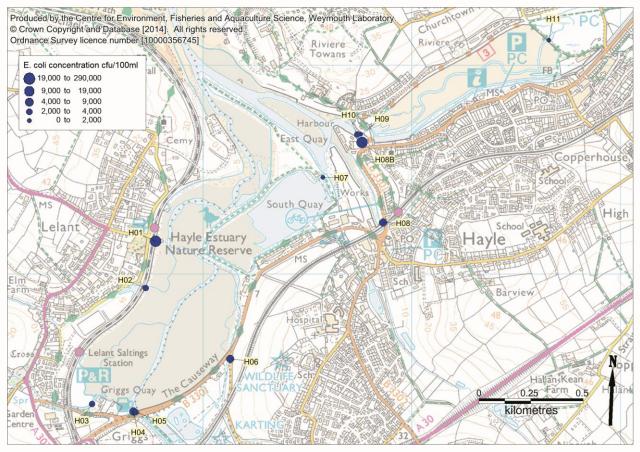
Figure XII.2: Water sample results (Table XII.2 and Table XII.2 for details)

Sample ID	Observation number	Description	Туре	Flow (m³/s)	<i>E. coli</i> conc. (cfu/100 ml)	<i>E. coli</i> loading (cfu/day)
H01	2	Drainage pipe	Freshwater	0.001	19,000	1.2x10 ¹⁰
H02	3	Stream discharging via pipe with flap	Freshwater	-	2,100	-
H03	4	Stream flowing	Freshwater	-	3,300	-
H04	6	Large pipe with grid, flowing	Freshwater	-	8,500	-
H05	7	River Hayle	Freshwater	-	3,100	-
H06	8	Stream, flowing	Freshwater	-	5,100	-
H07	9	Carnsew Pool	Seawater	-	70	-
H08	10	Stream flowing through pipe/sluice	Freshwater	-	4,500	-
H08B	12	Surface water pipe flowing rapidly	Freshwater	-	290,000	-
H09	13	Downstream Copperhouse sluice	Seawater	-	780	-
H10	14	Downstream Copperhouse sluice	Seawater	-	3,900	-
H11	20	Stream flowing	Freshwater	-	840	-
