Helford Estuary Sanitary Survey

Review

March 2014

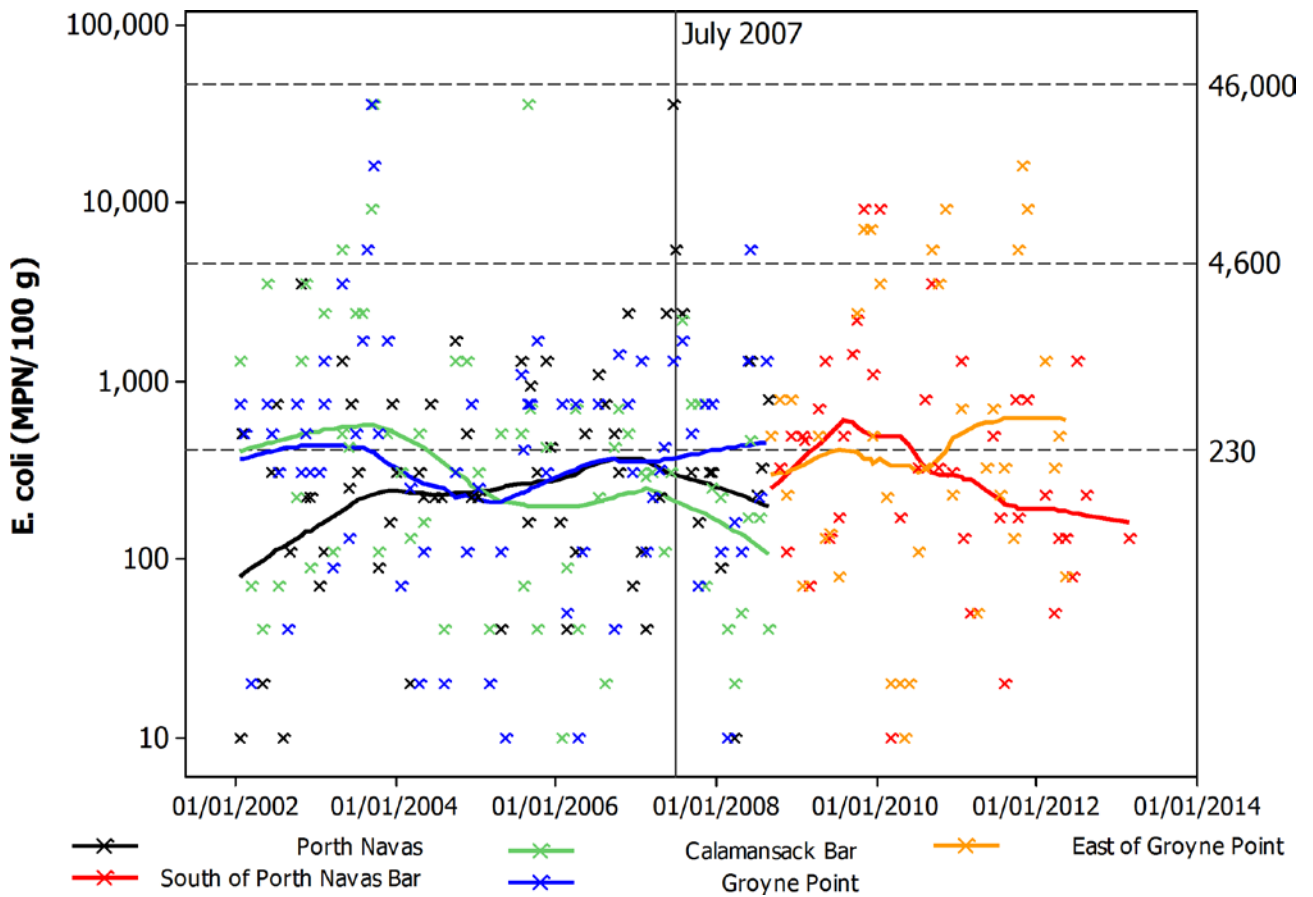
Figure 8.8: Scatterplot of *E. coli* results for native oysters overlaid with loess lines.

E. coli levels have remained largely unchanged in native oysters since 2002.

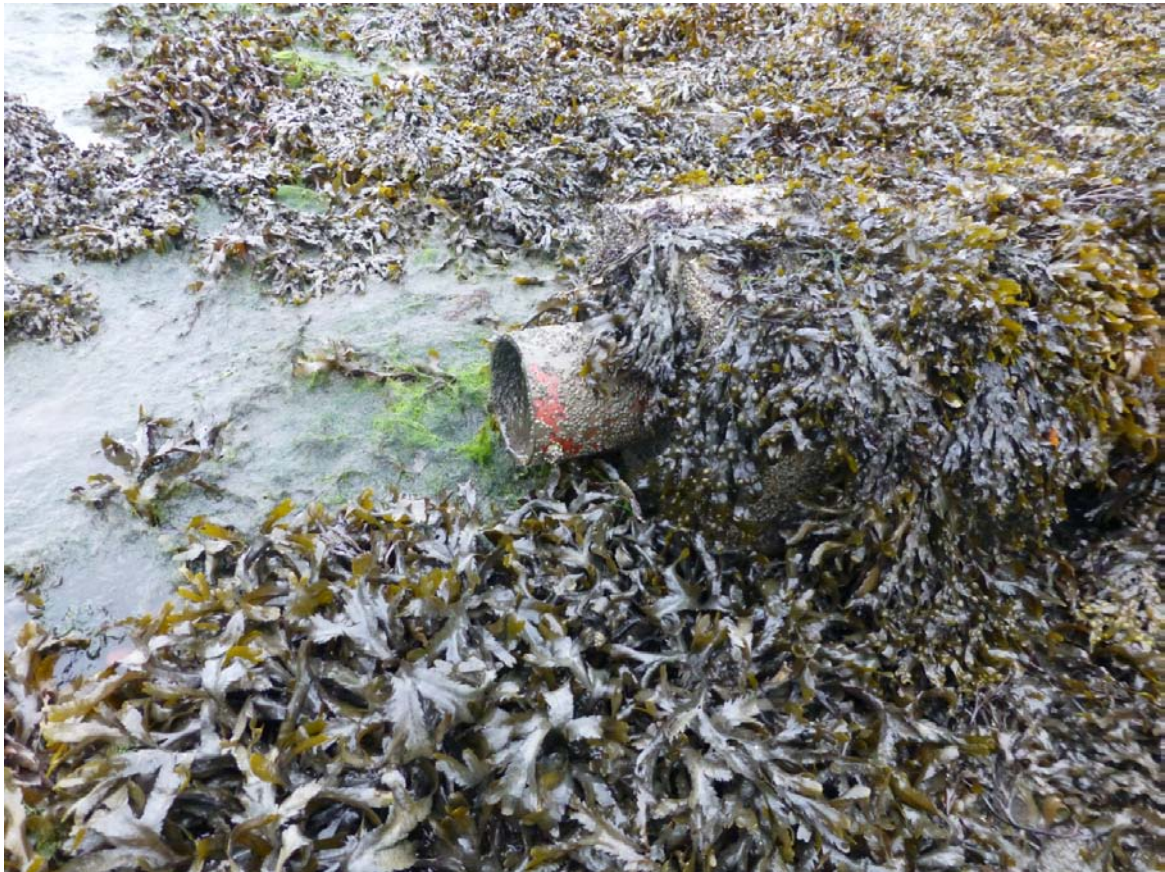
34	SW7720026322	13:08	Stream running across footpath soaking into beach. Too small to sample.	Figure I.27
35	SW7653326465	13:23	Mussels on rocks.	
36	SW7618326187	13:36	Concrete culvert onto beach (40 cm x 40 cm). Lots of gutweed observed at outfall (sample F20).	Figure I.28
37	SW7592326181	13:44	Helford STW outfall pipe exposed but not flowing.	Figure I.29

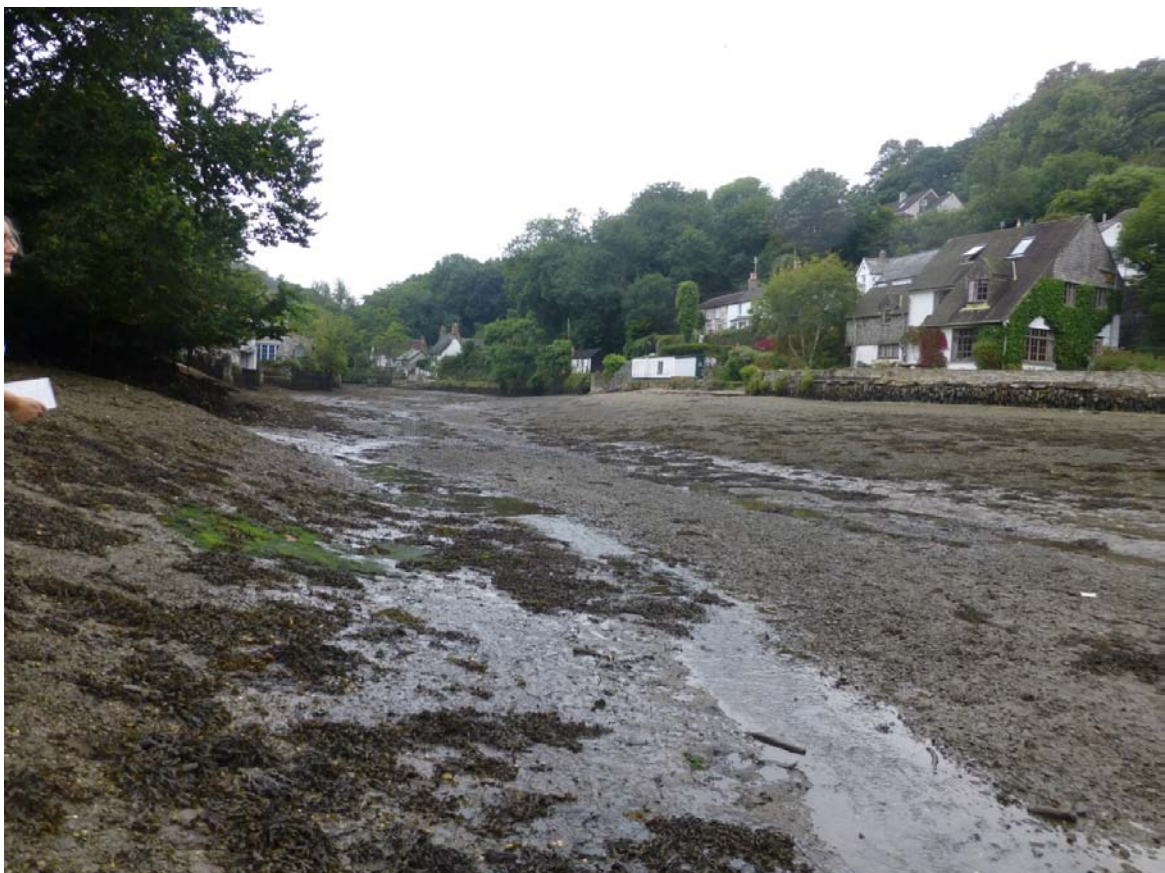
Several small streams were observed flowing into the estuary. Of these streams, Helford Brook (observation 38) returned the highest *E. coli* concentration (1,500 cfu/100 ml) equivalent to a loading of 7.58×10^9 cfu/day.

Observation no.	NGR	Time	Description	Photo
38	SW7585226119	13:50	Stream (sample F22).	Figure I.30
39	SW7585626223	13:55	Iron pipe with missing valve cover (under concrete slipway) and terracotta pipe (10 cm diameter). Neither flowing. Possibly discharge from Shipwright PS.	Figure I.31
40	SW7601226439	14:00	Mussels on rocky shoreline
