Medina Estuary Sanitary Survey

Review

March 2014

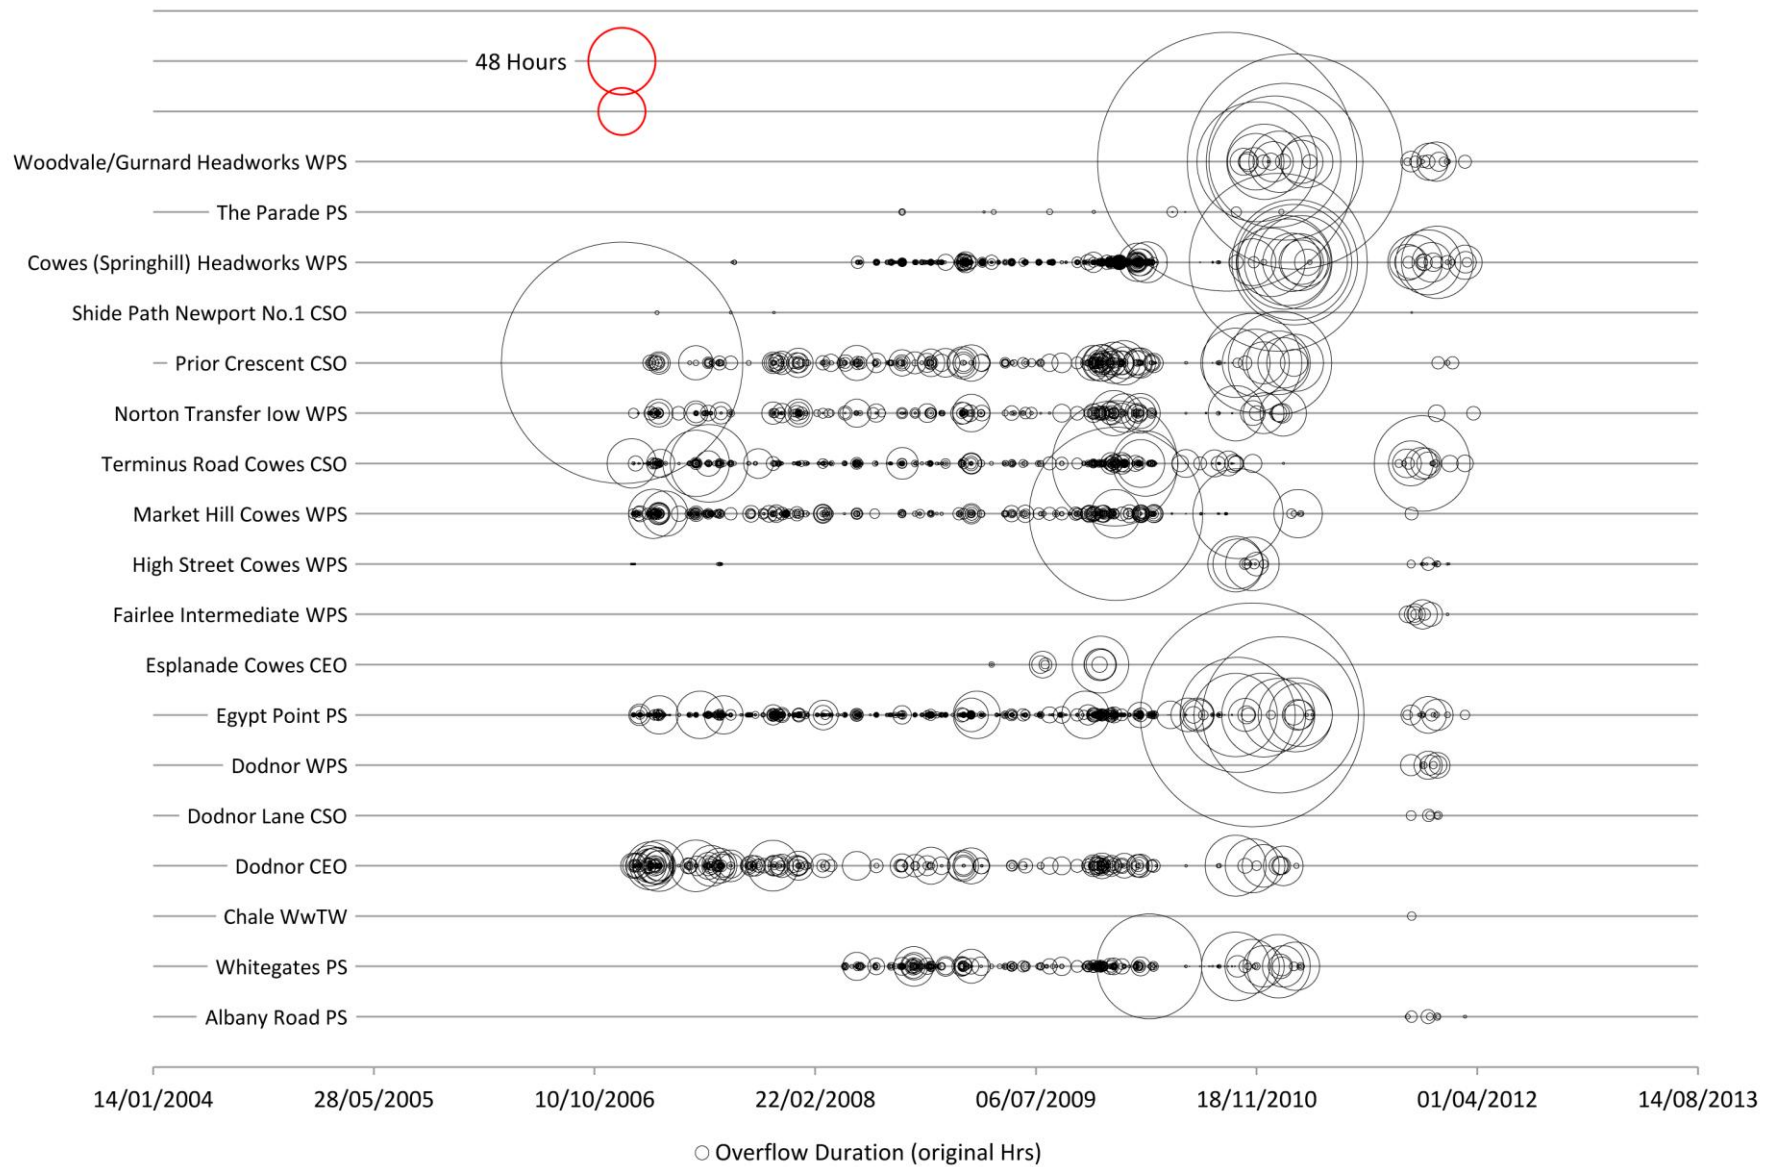
Figure 5.3: Bubble plot of spills from intermittent discharges in the Medina catchment.
 Missing data in 2011, 2012 and 2013 - not available at time of writing

Missing data in 2011, 2012 and 2013 - not available at time of writing
 Spills assessment derived using EA 12/24 hour block counting method
 Figures highlighted are spills ≥ 3% time in the year indicated

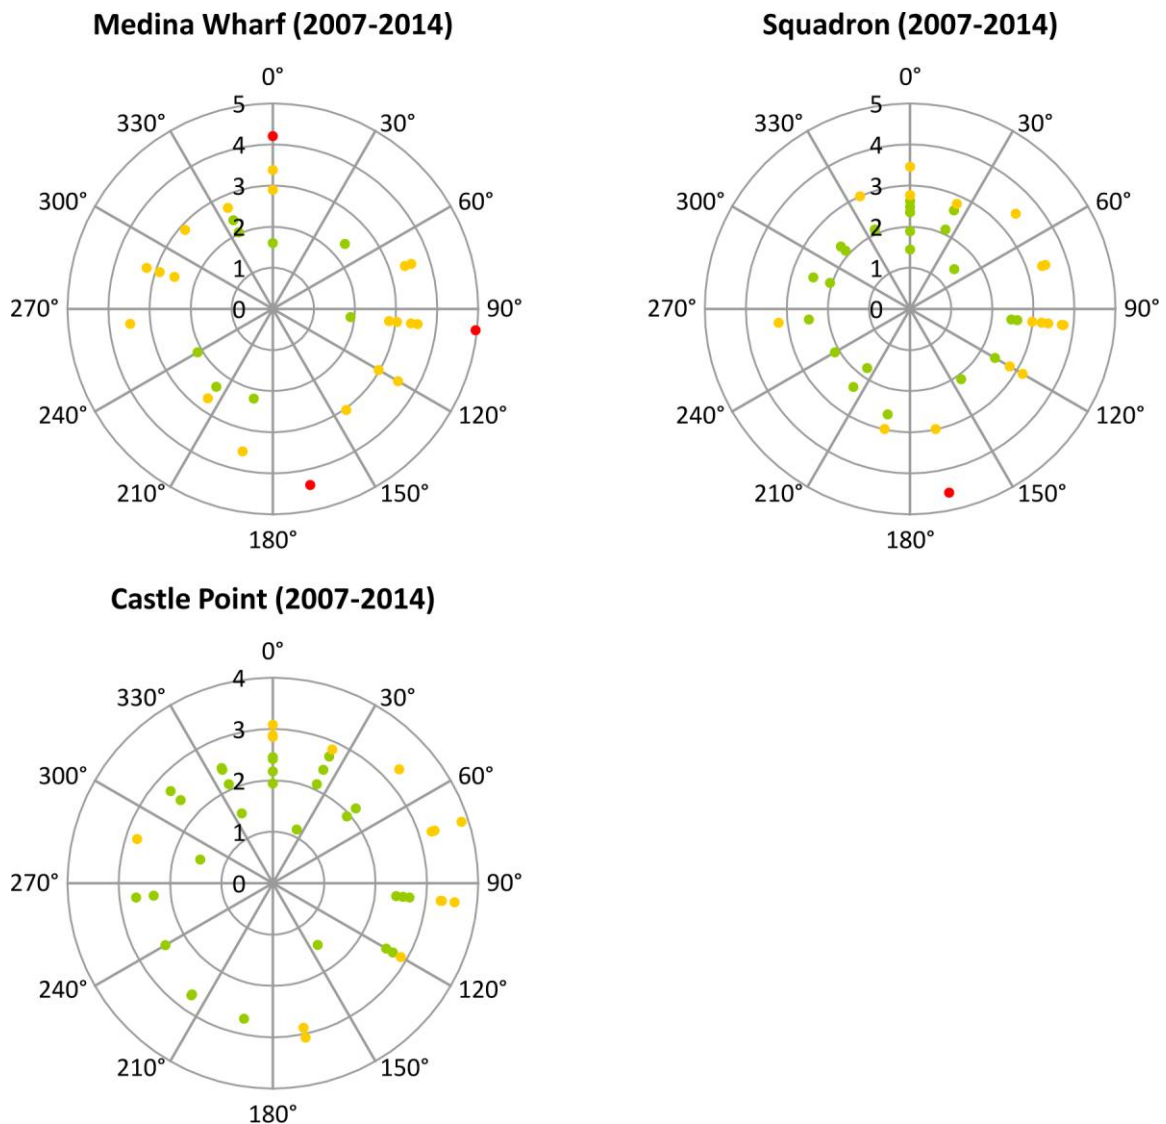
Figure 8.6: Polar plots of log₁₀ *E. coli* results (MPN/100g) at native oyster RMPs against spring/neap tidal state

Figure 8.6 presents polar plots of \log_{10} *E. coli* results against the spring neap tidal cycle for each RMP. Full/new moons occur at 0°, and half moons occur at 180°, and the largest (spring) tides occur about 2 days after the full/new moon, or at about 45°, then decrease to the smallest (neap tides) at about 225°, then increase back to spring tides. Results of 230 *E. coli* MPN/100g or less are plotted in green, those from 231 to 4600 are plotted in yellow, and those exceeding 4600 are plotted in red.

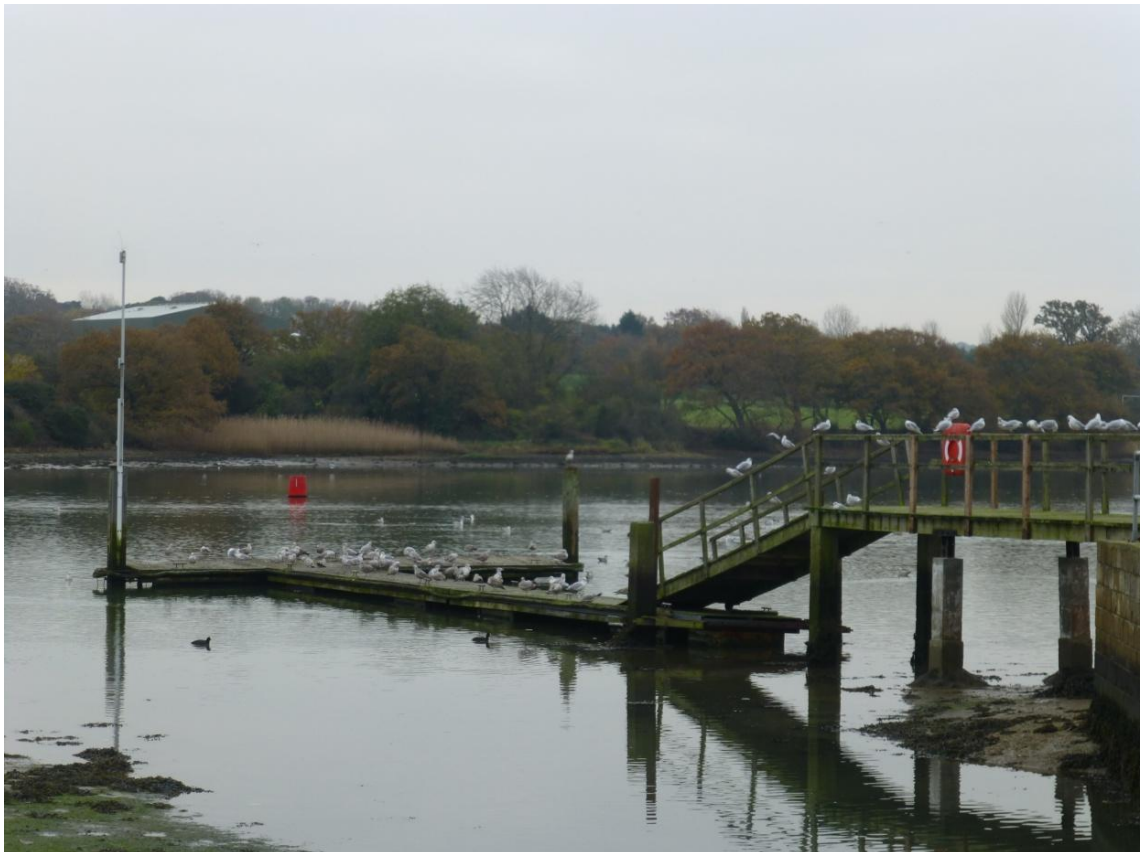
Figure I.19 Observation 49

A range of bird species were observed throughout the survey area (observations 11, 12, 13, 16, 25, 49, 57, 61, 66, 69 & 85) including gulls, geese, ducks and pigeons. Bird aggregations were relatively small ranging from 15 at observation 25 to 60 at observation 49.

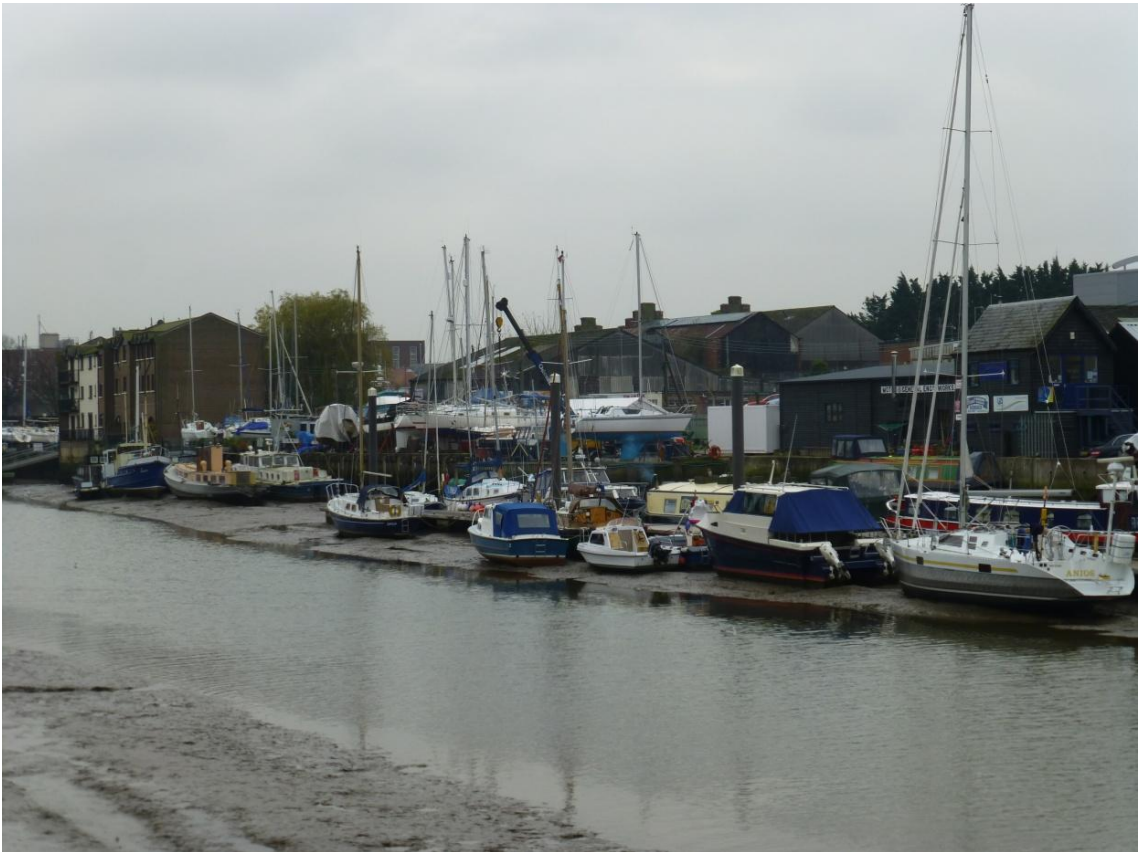
Figure I.22 Observation 58

Around 6 houseboats were observed in the upper reaches of the estuary close to Odessa Boatyard (observation 58) and could be a potential source of sewage pollution to the estuary.

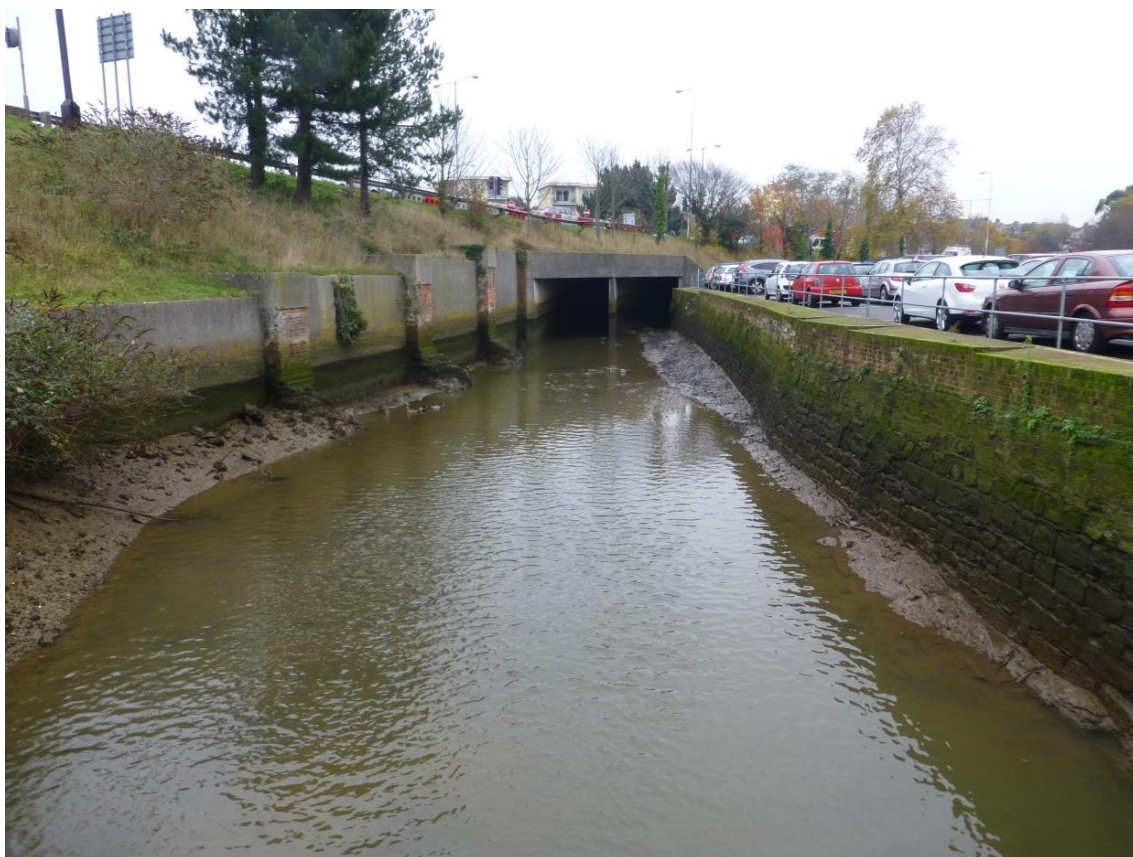
Figure I.25 Observation 62 (MD13)

Two streams were observed in the upper estuary (observation 82 and 87) one of which was flowing at the time of the survey. The River Medina and the Lukely Brook (63 and 62) discharge to the head of the estuary and had low *E. coli* concentrations of 250 cfu/100 ml and 680 cfu/100 ml respectively. They were not accessible for flow measurements but were flowing rapidly at the time of the survey.

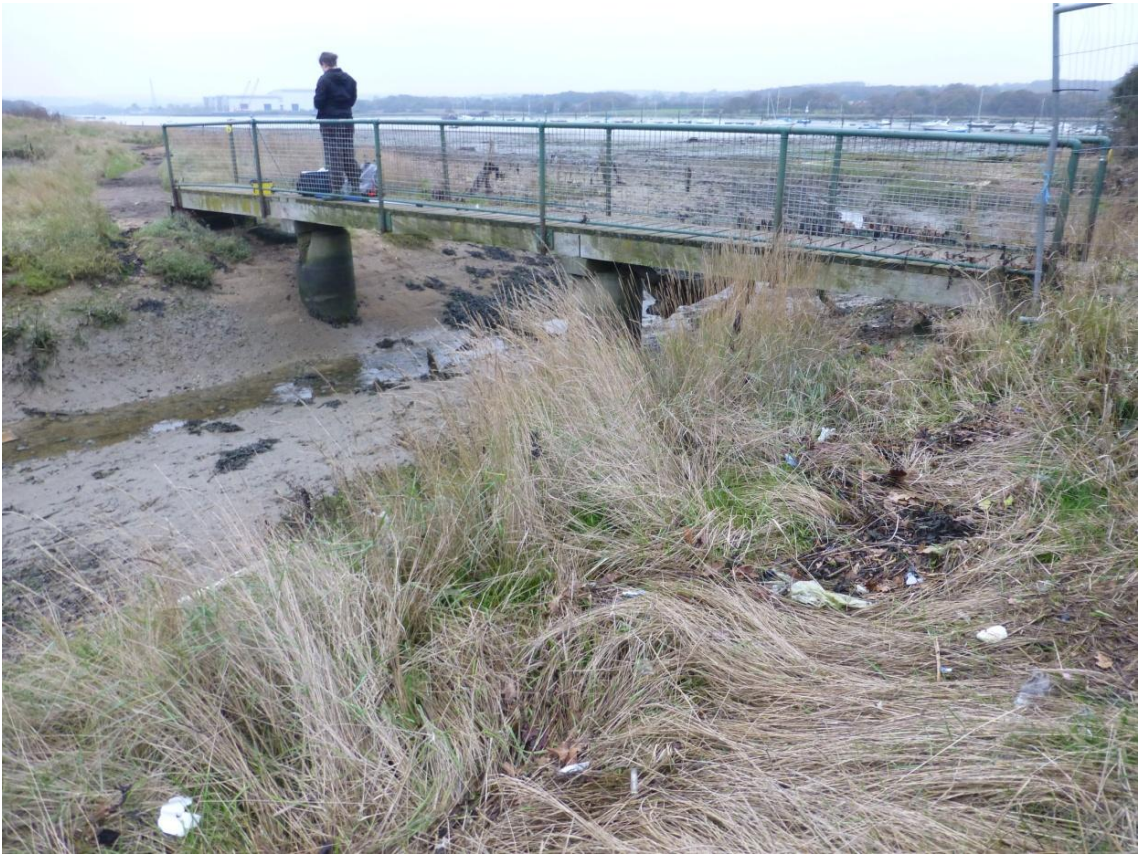
Figure I.34 Observation 87 (MD 22)

87	SZ5113192697	28/11/2013	13:40:49	(MD22) Stream & cotton wool buds	Figure I.34
88	SZ5113392703	28/11/2013	13:47:00	(MD23) Pipe from Medina Leisure Park with Pumping station behind (Package Plant)	Figure I.35

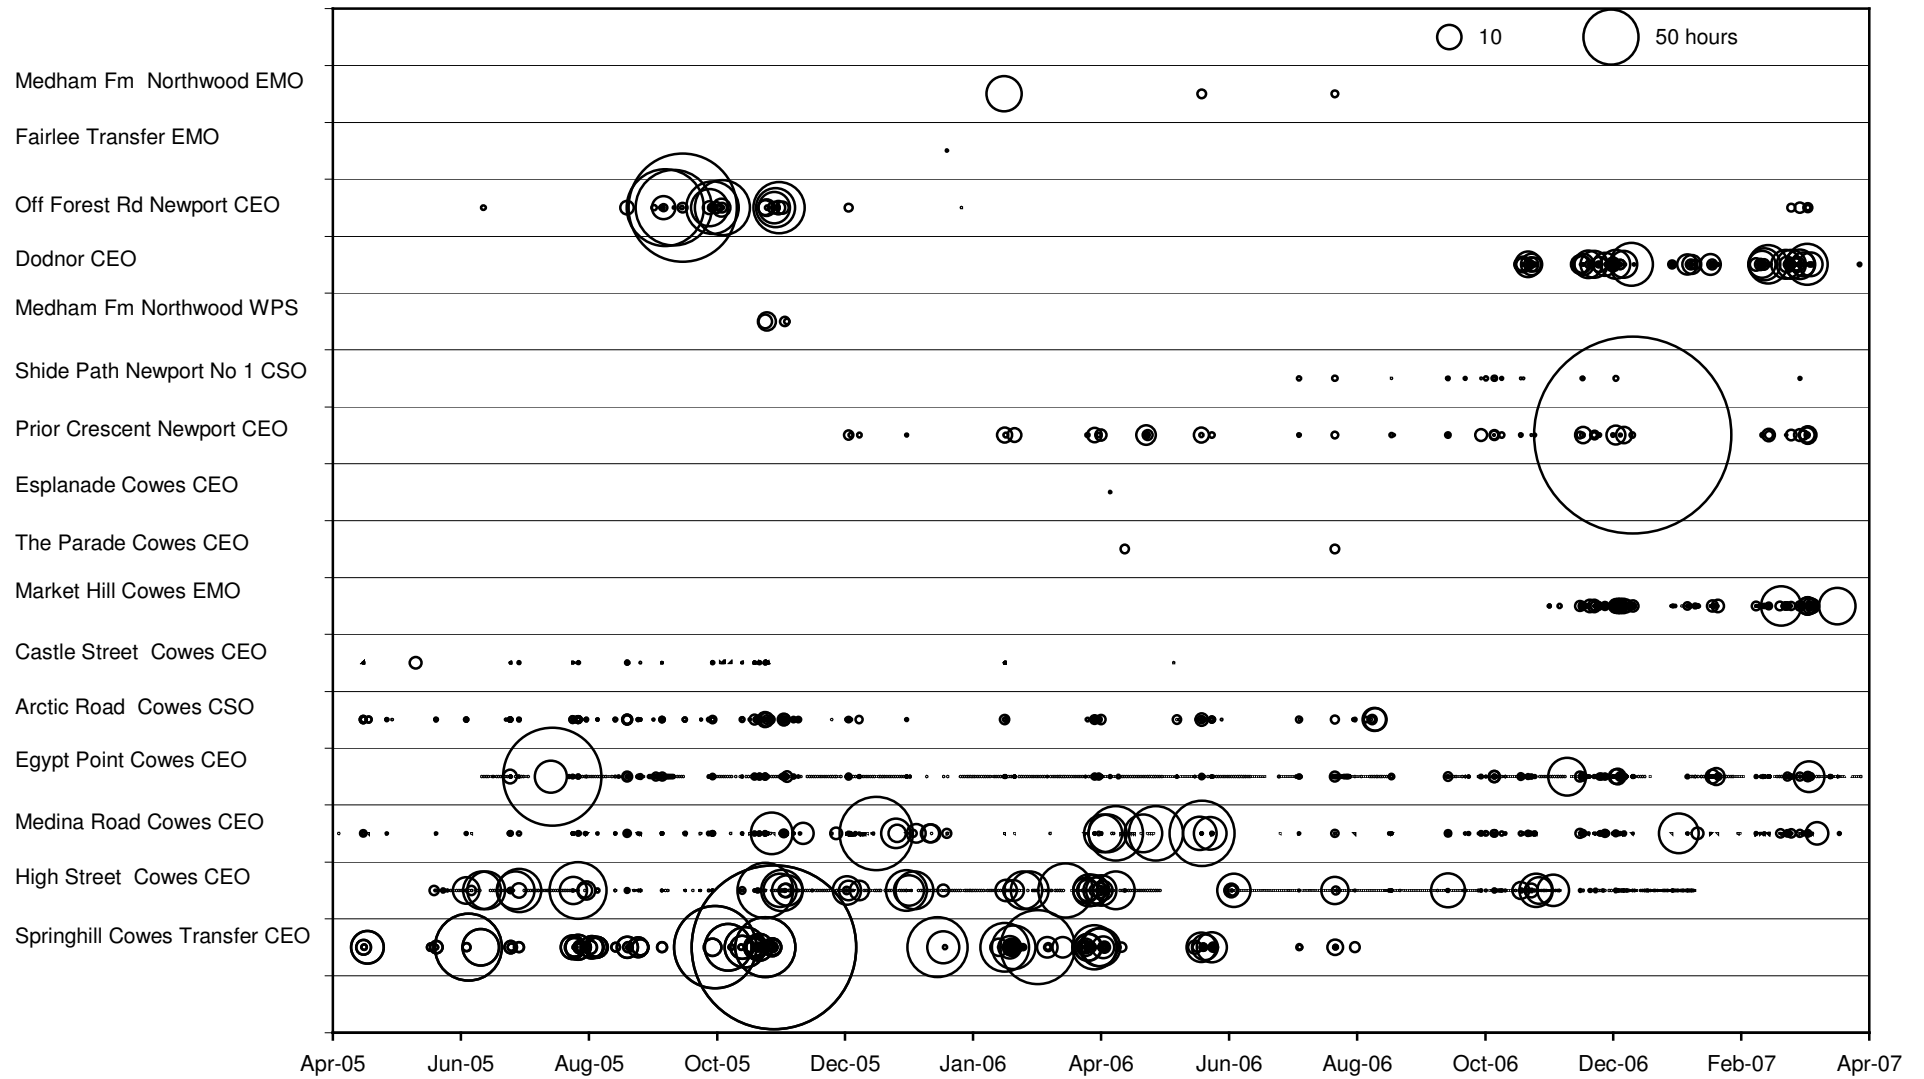
**Figure 4.3: Intermittent discharges to the Medina BMPA, 2005-2007 (Data from Southern Water Services Ltd.)
N.B. Bubble area is proportional to spill duration.**

Intermittent sewage discharges (combined sewer overflows and sewage pumping stations) that discharge to the Medina Estuary and nearby watercourses are listed in Table 4.3. These discharges are mainly located in the urban centres of Cowes and Newport (Figure 4.1) and discharge untreated sewage in the event of a storm or emergency spill. As noted above, a new CSO will be located at Fairlee on completion of the scheme to transfer wastewater flows from the Fairlee catchment to Sandown STW.

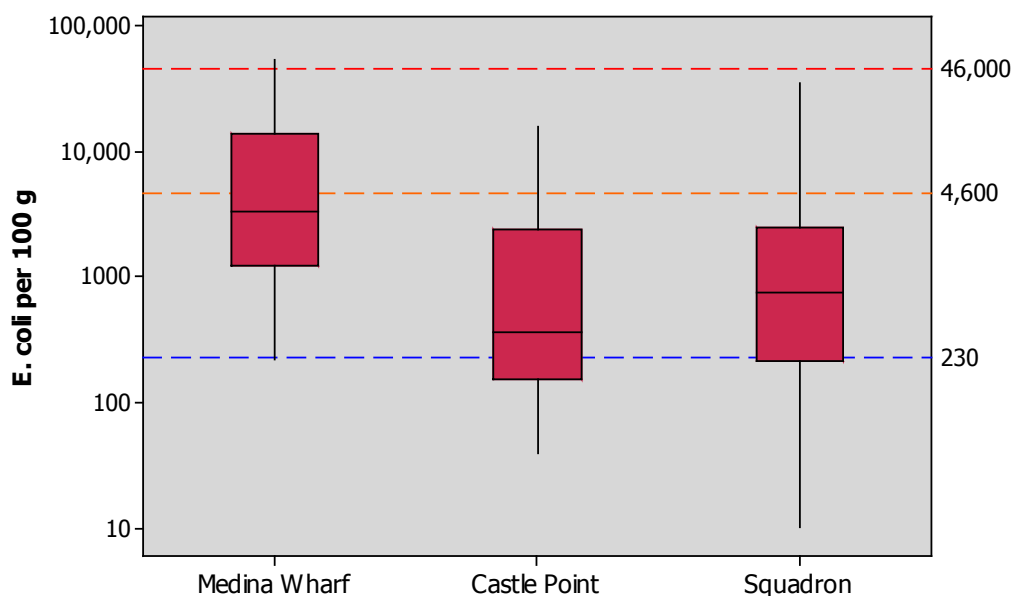
Figure 5.5: *E. coli* results for native oysters from shellfish hygiene monitoring sites in the Medina BMPA, April 2004 to November 2007

Existing shellfish hygiene monitoring points in the Medina BMPA are located at Medina Wharf, within the estuary, and at Squadron and Castle Point, outside of the estuary (Figure 5.1). *E. coli* results for native oysters from these sites for the period 2004 to 2007 are summarised in Figure 5.5 and Table 5.3¹. Levels of bacterial contamination in native oysters are higher within the estuary than outside of the estuary reflecting the differences in levels of contamination in sea water noted above.

Correlation coefficients between rainfall and river flow and *E. coli* levels in shellfish at hygiene monitoring points in the Medina BMPA are given in Table 5.5. *E. coli* levels are significantly correlated with rainfall, the strongest correlations being observed with rainfall in the 24 hours prior to sampling. No significant correlation was evident between *E. coli* level and flow in the River Medina.

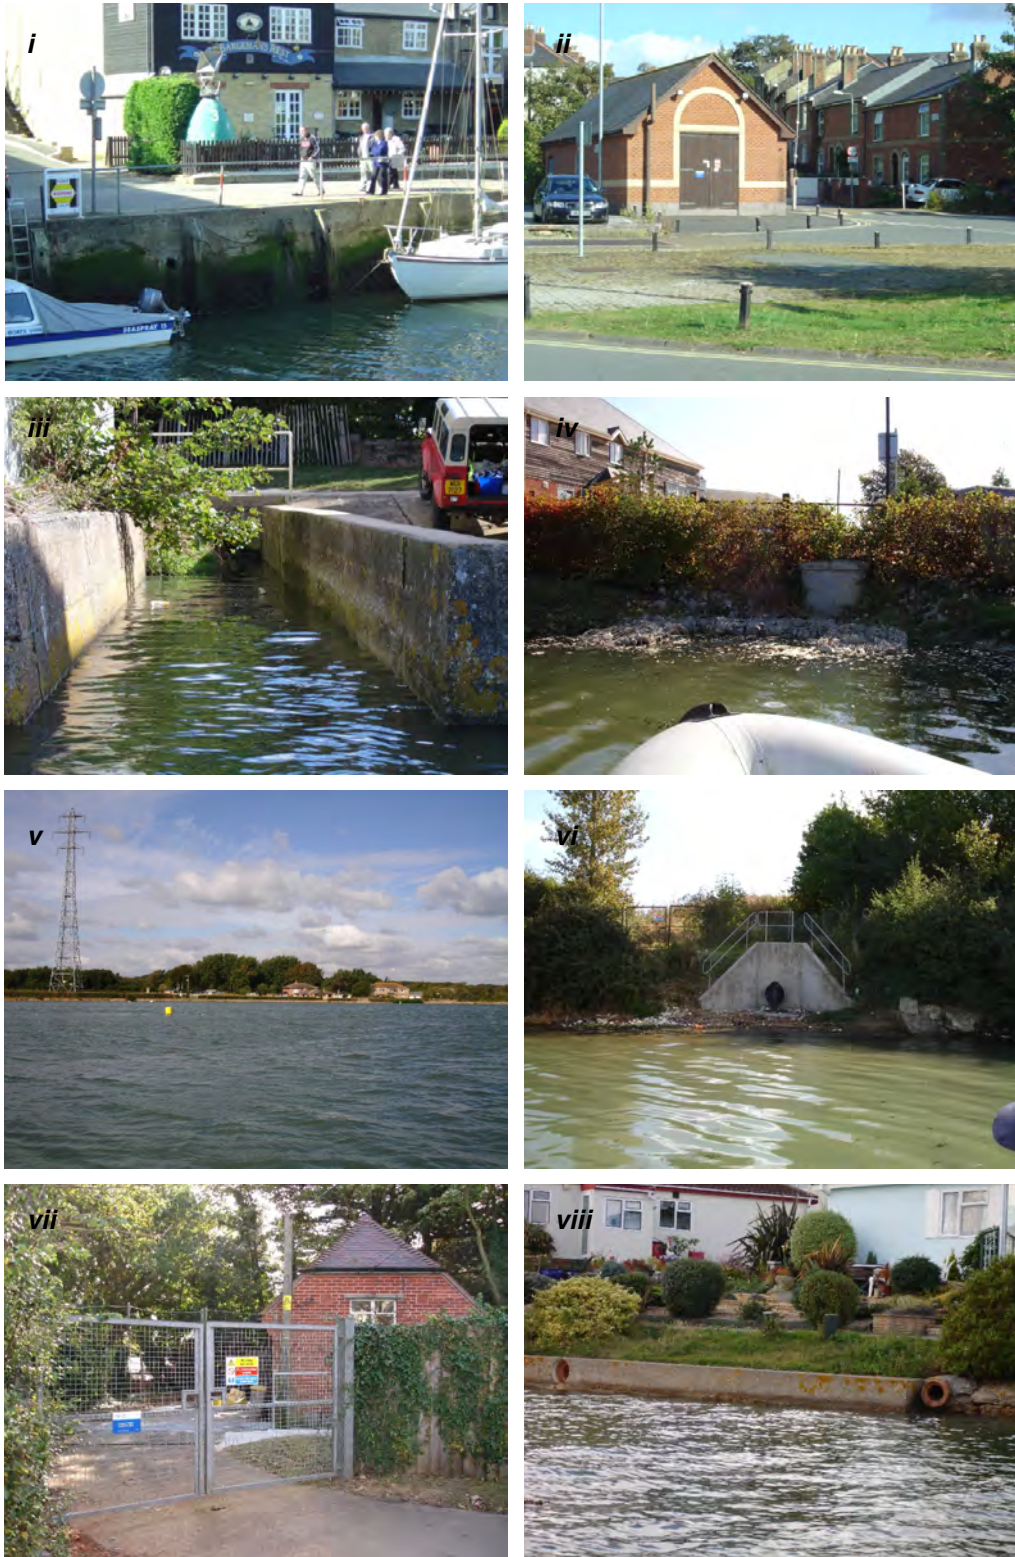
Figure A3: Photos of: i) discharge at Bargemans Rest public house, ii) Newport Quay sewage pumping station, iii) culverted stream at Seaclose Quay, iv) outfall from Newport sewage pumping station outfall at high water, v) Fairlee STW outfall buoy, vi) Fairlee transfer outfall, vii) Dodnor sewage pumping station, viii) Dodnor cottages.

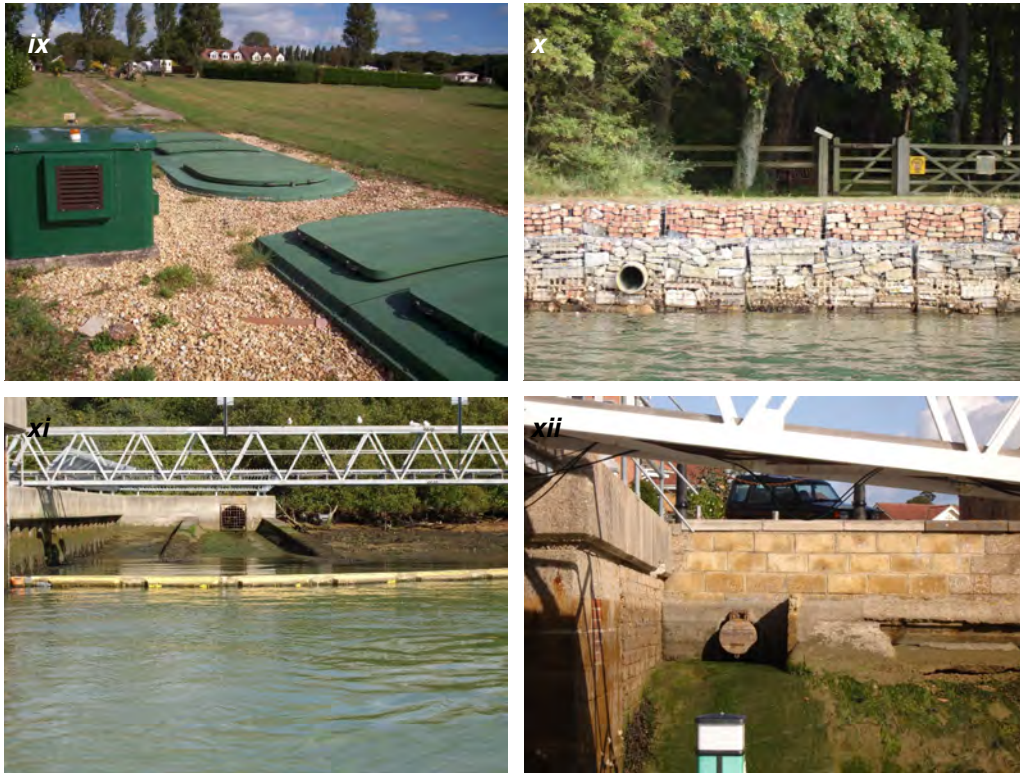
Figure A3 (continued): ix) Medina Leisure Park STW, x) surface water outfall at Folly Point, xi) outfall with grid near gas tanks, xii) discharge near Shepherds Wharf, Cowes.

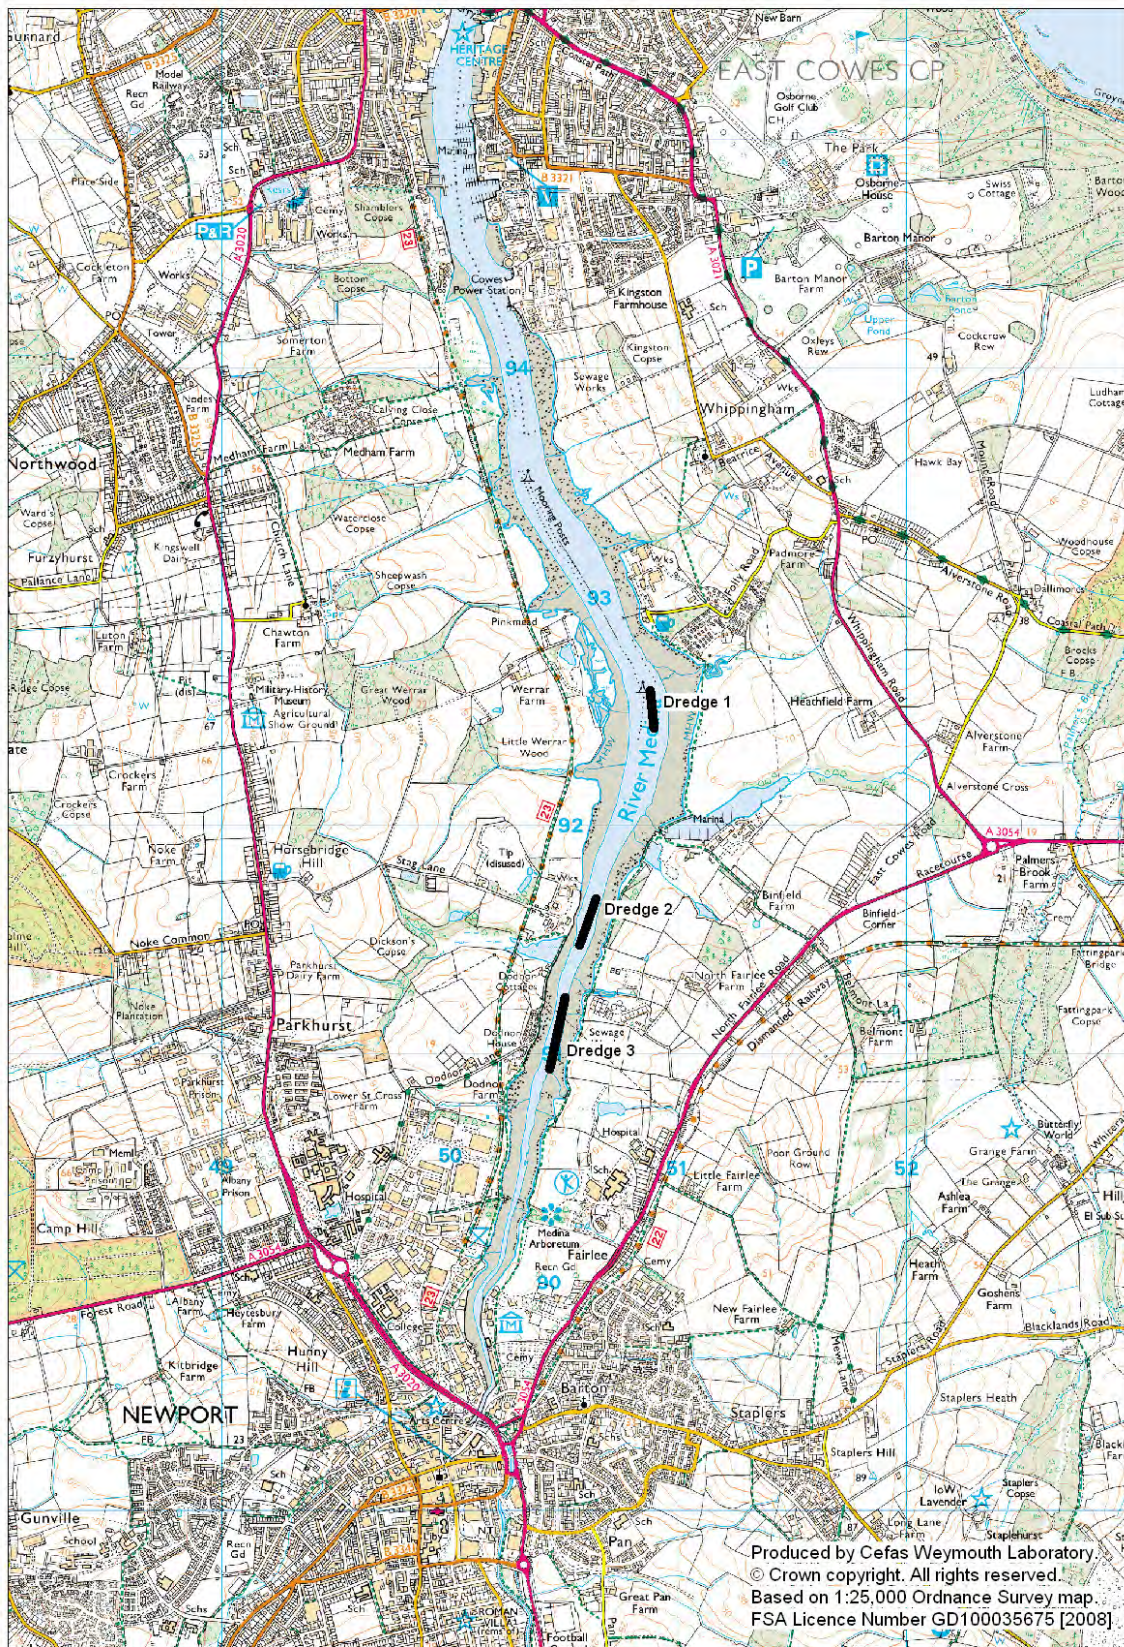
Figure B1: Bacteriological survey dredge locations

- No hard clams (*M. mercenaria*) were found in the upper estuary.
- Cockles (*C. edule*) were present but not in sufficient densities to sample for microbiological analysis.
- Manila clams (*Tapes philippinarum*) were present between the Cement Works and the Medina Valley Centre.

Levels of *E. coli* in Manila clams from near the outfall of Fairlee STW were above prohibited levels (i.e. >46,000 per 100 g).
