## CLASSIFICATION OF BIVALVE MOLLUSC PRODUCTION AREAS IN ENGLAND AND WALES

## SANITARY SURVEY REPORT

**Portsmouth Harbour**

December 2013

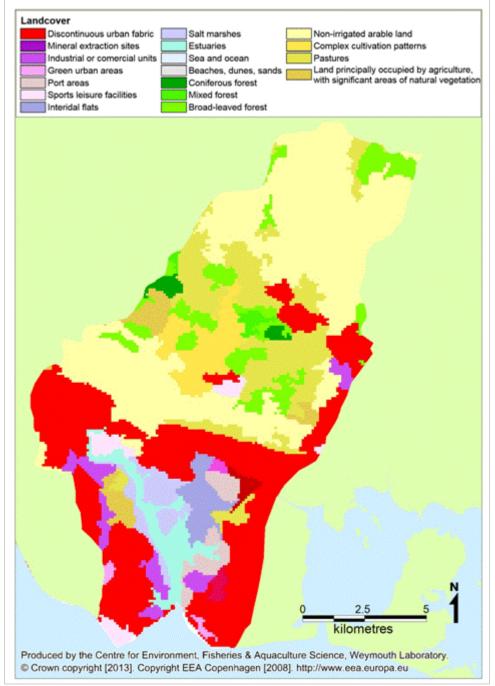
Figure 1.2: Landcover in Portsmouth Harbour catchment area

Figure 1.2 illustrates landcover within Portsmouth Harbour catchment area, which covers approximately 159 km<sup>2</sup>. There is a marked division between the land use in the upper and lower catchments. The lower catchment is highly urbanised containing the towns of Portsmouth, Hayling Island, Portchester and the commercial port areas. The upper catchment is rural in character, consisting of a mixture of arable farmland, woodland, pasture and agriculture. Its' uppermost reaches lie within the South Downs National Park.

The majority of agricultural land within the hydrological catchment of Portsmouth Harbour is arable, although there are some areas of pasture, mainly in its middle to upper reaches (Figure 1.2). Although Figure 1.2 indicates that there are two small pockets of pastures immediately adjacent to the harbour these areas of grassland are used for sports and recreation. Table III.1 presents livestock numbers and densities for the catchment. These data were provided by Defra and are derived from the June 2010 census. Geographic assignment of animal counts in this dataset is based on the allocation of a single point to each farm, whereas in reality an individual farm may span the catchment boundary. Nevertheless, Table III.1 should give a reasonable indication of the numbers and types of livestock within the catchment.

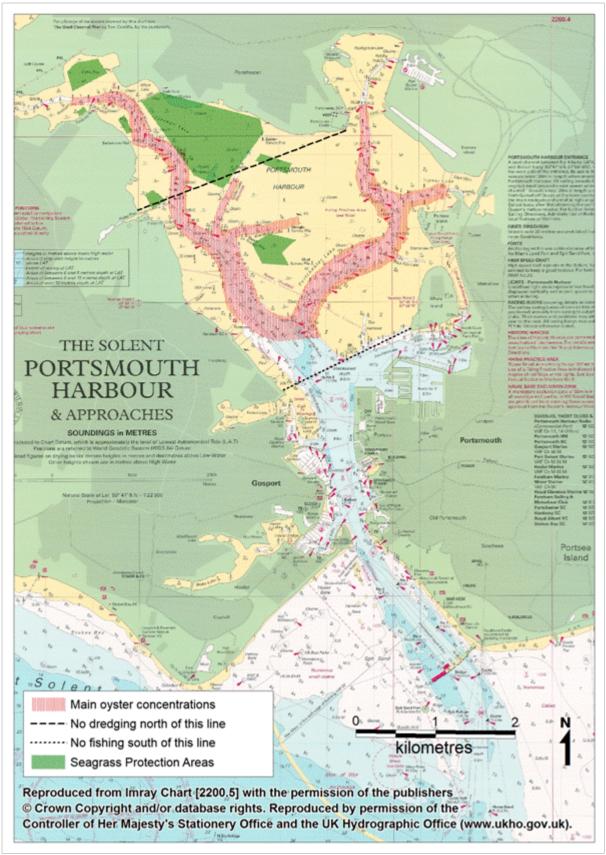
Figure 4.1: Oyster distribution and seagrass areas

The native oyster dredge fishery is supported by a self sustaining natural population of this species (Figure 4.1), which are taken from the main subtidal channels using dredges. Populations of this species in Portsmouth Harbour and the wider Solent area have declined significantly in recent years due to recruitment failures<sup>1</sup>, the causes of which are uncertain (Vause, 2010). The fishery continues nevertheless.

The 'Protection of the Portsmouth Harbour Special Protection Area byelaw 2012' prohibits the use of shellfish dredges in the upper reaches of the western arm of the harbour, north of a line drawn from Portchester Castle to Frater including Fareham Creek i.e. north of the dashed line shown in Figure 4.1 above.

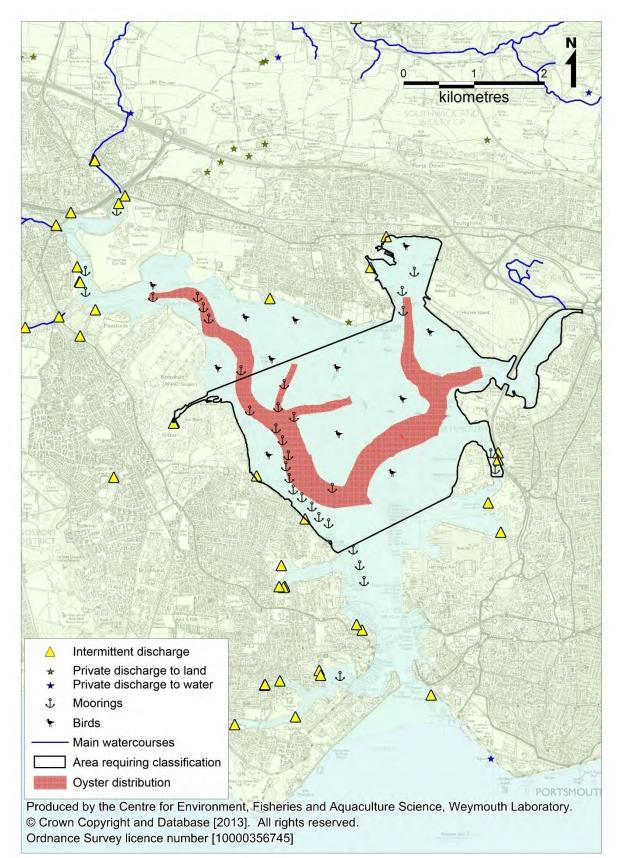
Figure 5.1: Summary of main contaminating influences

In summary, the main single source is the River Wallington, which discharges to the head of the western channel a considerable distance up from the area requiring classification. There are multiple small sources of urban runoff all around the harbour which are likely to be responsible for delivering significant loadings of faecal indicators at times. The intermittent sewage discharges to the harbour, where monitored, only spill infrequently and so their impacts are unlikely to be captured via monthly monitoring. Birds and boats may be a significant source at different times of the year, but may be treated as a diffuse source.

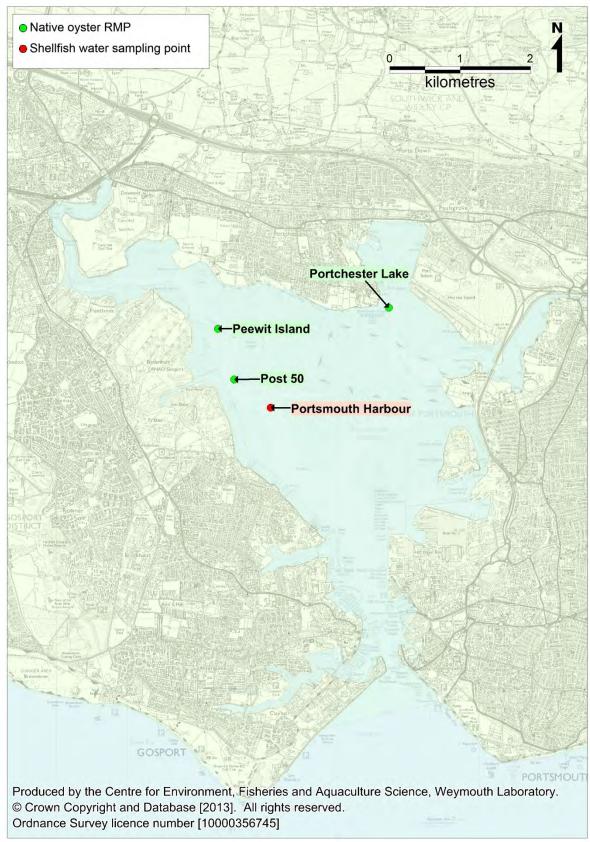
Figure 5.2: Microbiological sampling locations

Portsmouth Harbour has been subject to some microbiological monitoring over recent years, deriving from Environment Agency shellfish waters monitoring and shellfish flesh monitoring for hygiene classification purposes. Figure 5.2 shows the locations of the monitoring points referred to in this assessment. Results of samples taken from 2003 onwards were considered as there have been no major improvements to local sewerage infrastructure since this time.

Only one location (Portsmouth Harbour) was sampled under the shellfish waters monitoring programme, where water samples were taken on a quarterly basis and enumerated for faecal coliforms. The geometric mean result was 15 faecal coliforms/100ml, and the maximum recorded was 577 faecal coliforms/100ml. Since 2002, there was a peak in results in 2007/8, a decline through to 2010, and an increasing trend since then. A strong seasonality was found, with significantly higher results during the winter than during the spring and summer. No influence of tidal state, either across the high/low or the spring/neap tidal cycles was found. A significant influence of rainfall was found. The strongest influence arose one day after the rainfall event, perhaps due to runoff from the bordering urban areas. There was also a weaker more delayed influence which may be due to runoff from the larger River Wallington catchment. Although salinity only ranged from 31 to 35ppt, there was a significant negative correlation with faecal coliform concentrations. This suggests that runoff, although relatively minor in terms of the volumes involved, is a significant contaminating influence.

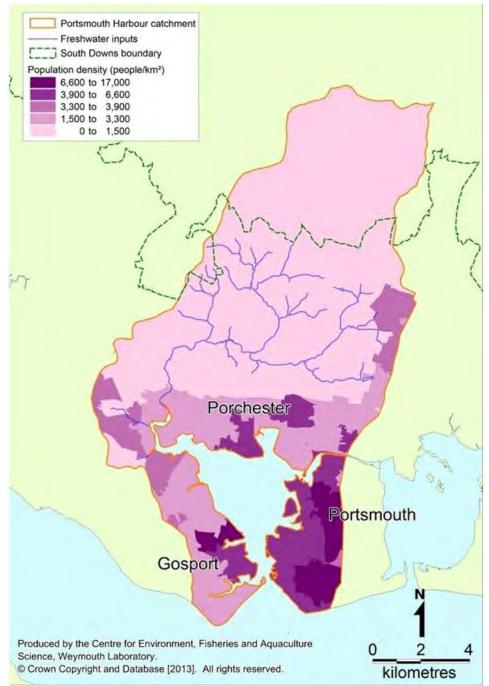
Figure I.1: Human population density in census areas in the Portsmouth Harbour catchment.

Total resident population within the Portsmouth Harbour catchment area was approximately 410,000 at the time of the last census. Figure I.1 indicates that population densities are highest in the areas directly adjacent to the harbour, especially around Portsmouth and Gosport. Much of Portsmouth exceeds 10,000

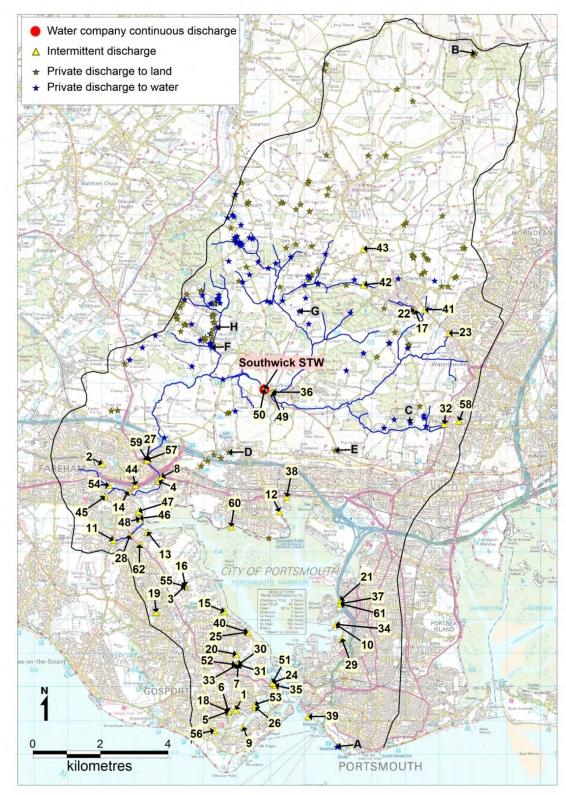
Figure II.1: Sewage discharges to the Portsmouth Harbour catchment

Details of all consented sewage discharges in the Portsmouth Harbour hydrological catchment were taken from the most recent update of the Environment Agency national permit database (March 2013). These are mapped in Figure II.1.

The majority of sewage generated in the Portsmouth Harbour catchment is treated at either the Peel Common STW or Budds Farm STW. Both of these sewage works lie outside of the catchment, Peel Common receives UV disinfection and Budds Farm receives secondary treatment, and discharge via long sea outfalls to the Solent. As such, they should be of no impact on Portsmouth Harbour. There is only one relatively small water company sewage works within the catchment (Table II.1) which serves the village of Southwick. It discharges to the River Wallington about 7km upstream of the tidal limit, and will contribute significantly to the bacterial loading delivered to the harbour by this watercourse.

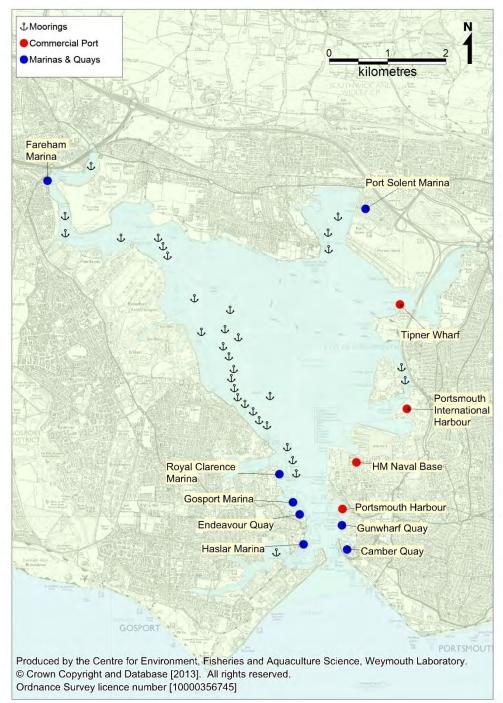
Figure IV.1: Boating activity in Portsmouth Harbour

The discharge of sewage from boats is a potentially significant source of bacterial contamination of shellfisheries in Portsmouth Harbour. It contains a naval base, a commercial port, and several marinas, and so is used by a wide range of craft including military vessels, commercial shipping, a fishing fleet, and recreational boats such as yachts and cabin cruisers. Figure IV.1 presents an overview of boating activity derived from the shoreline survey, satellite images and various internet sources.

Portsmouth International Port is a busy commercial, cruise and ferry port with around 3,000 shipping movements each year (Portsmouth City Council, 2012). The port handles a range of commodities including the importation of fresh fruit, steel, timber and vehicles and the exportation of building material, vehicles and steel. In 2012 the total imports and exports weighed 1.5 million tonnes (Portsmouth City Council, 2012). There are regular car and passenger ferry sailings to France, Spain, the Channel Islands and the Isle of Wight. In addition to this, cruise ships operate from the port, around 38 cruises were run in 2012, transporting passengers across Europe and the Mediterranean. South of the international port is an HM naval base,

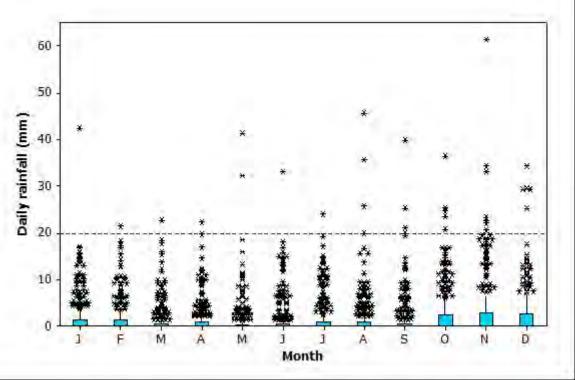
Figure VI.1: Boxplot of daily rainfall totals at Eastney, January 2003 to December 2012. Data from the Environment Agency

The Eastney weather station received an average of 654 mm per year between 2003 and 2012. Figure VI.1 presents a boxplot of daily rainfall records by month at Eastney.

Rainfall records from Eastney, which is representative of conditions in the vicinity of Portsmouth Harbour, indicate relatively low seasonal variation in average rainfall. Rainfall was lowest on average in May and March and highest on average from October to December. Daily totals of over 20mm were recorded on 0.8% of days and 58% of days were dry. High rainfall days (>20mm) occurred in all months, but were slightly more frequent in the second half of the year.

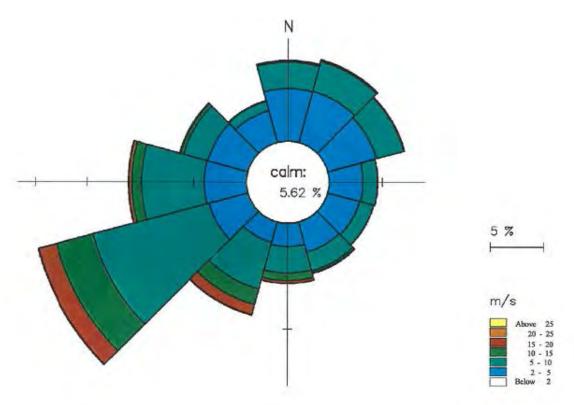
Figure VII.1: Wind Rose for Southampton Water Produced by ABPmer, 2007.

The prevailing wind direction is from the south west and the strongest winds usually blow from this direction (Figure VII.1). A higher frequency of north easterly winds occurs during spring. Coastal locations may receive onshore sea breezes between the late spring and summer months (Met Office, 2012). Portsmouth Harbour is largely enclosed, with a narrow mouth that faces south/south east and therefore receives some shelter from the prevailing winds, although the surrounding land is relatively low lying.

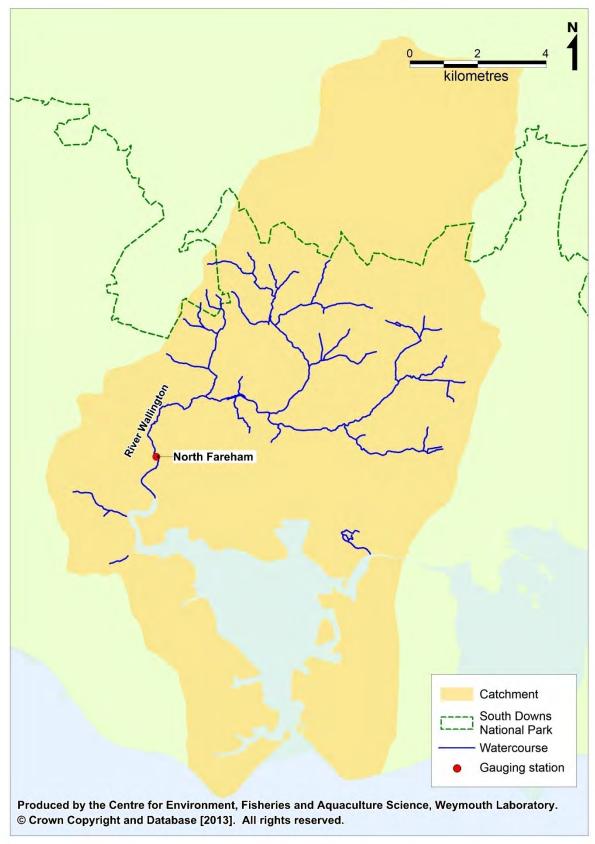
Figure VIII.1: Freshwater inputs into Portsmouth Harbour

Portsmouth Harbour has a hydrological catchment of about 159 km<sup>2</sup>. The main freshwater input is Wallington River which discharges in the north-west corner of the estuary via Fareham Lake (Figure VIII.1). The Wallington River flows predominantly through rural land in its upper reaches, and urbanised land in the lower catchment. Aside from the Wallington, there are only two small watercourses shown on Figure 5.8, both of which discharge to the Fareham Lake.

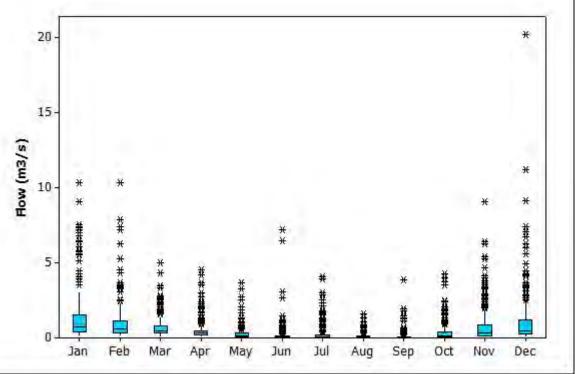
Figure VIII.2: Boxplots of mean daily flow records from North Fareham gauging station on the River Wallington from 2003 - 2013

The Wallington River has low mean flow rates of 0.588 m<sup>3</sup>s<sup>-1</sup>. A boxplot of mean daily flow by month at the North Fareham gauging station is presented in Figure VIII.2.

A strong seasonality in discharge is apparent. Flows were considerably higher on average during the colder months of the year, with peak flow events generally occurring from November to February. During the warmer months, flows were around base flow for much of the time, with sporadic elevated flow events.

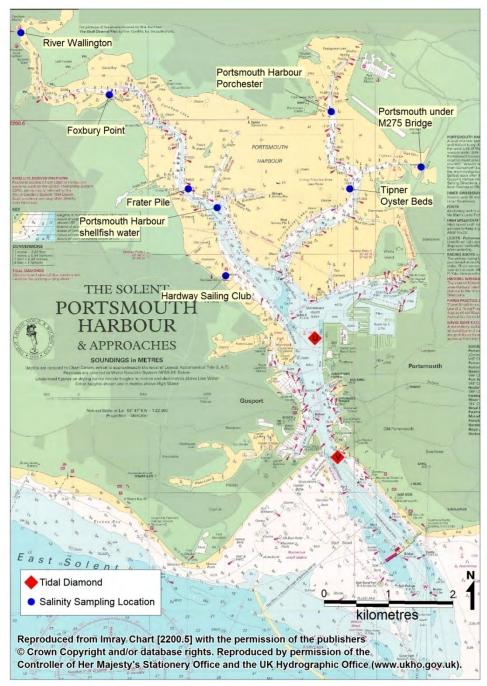
Figure IX.1: Bathymetry of Portsmouth Harbour

Portsmouth Harbour is a partially enclosed tidal inlet which faces south and drains into the eastern Solent. It covers an area of about 16 km<sup>3</sup>, of which 60% is intertidal mudflats and saltmarsh (Futurecoast, 2002). Consequently a large proportion of water will be exchanged on each tide, but the dilution potential will be quite low away from the main channels.

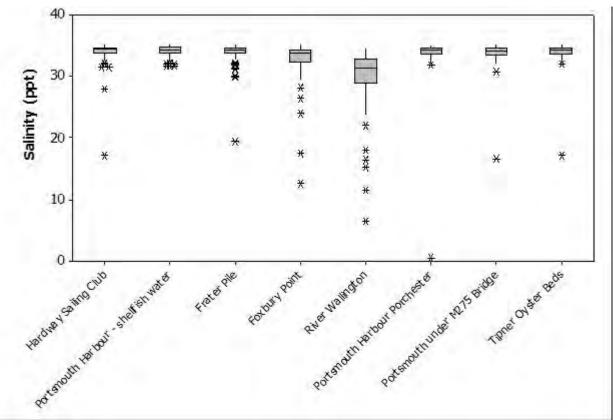
Figure IX.2: Boxplot of salinity readings taken in Portsmouth Harbour 2003 - 2013 Data from the Environment Agency

Superimposed on tidally driven currents are the effects of freshwater inputs and wind. The main freshwater input discharges to the head of the Fareham Creek. The flow ratio (freshwater input:tidal exchange) is very low and the system is well mixed overall, so density effects are unlikely to significantly modify tidal circulation.

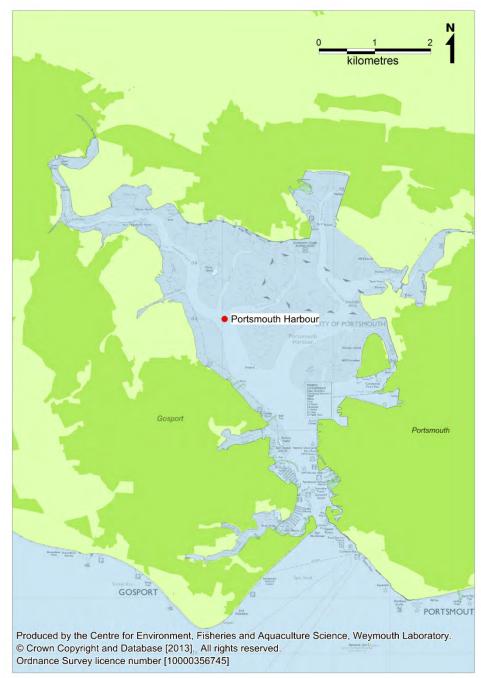
Figure X.1: Location of monitoring point in Portsmouth Harbour Data from the Environment Agency

There is one shellfish waters site designated under Directive 2006/113/EC (European Communities, 2006) in Portsmouth Harbour. Figure X.1 shows the location of this site. Table X.1 presents summary statistics for bacteriological monitoring results and Figure X.2 presents a boxplot of these results.

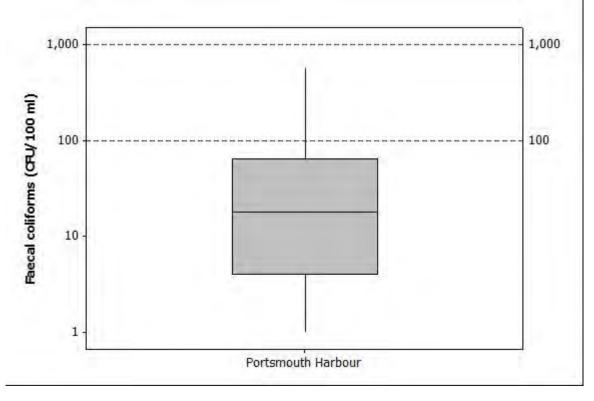
Figure X.2: Box-and-whisker plots of all faecal coliforms results Data from the Environment Agency

Levels of faecal indicator bacteria within Portsmouth Harbour were moderate, with no particularly high results recorded, although they did exceed 100 faecal coliforms/100ml for about 20% of the time.

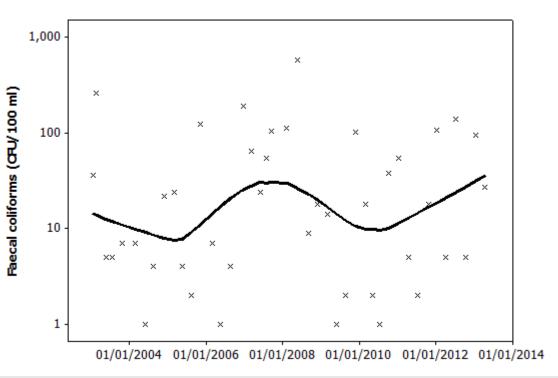
Figure X.3: Scatterplot of faecal coliform results by date, overlaid with lowess lines Data from the Environment Agency

Figure X.3 shows that faecal coliform levels have fluctuated between 2003 and 2013. In 2005, levels were at their lowest, but then increased again until late 2007, when they decreased until 2010. Since 2010 faecal coliform levels have been increasing on average.

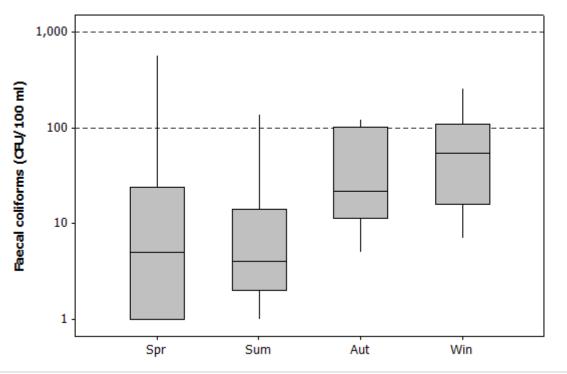
Figure X.4: Boxplot of faecal coliform results by site and season Data from the Environment Agency

Comparisons (One-way ANOVA) of faecal coliform levels revealed that there was a significant difference between seasons (p=0.003). Post ANOVA Tukey tests showed that faecal coliform levels were significantly higher during the winter than during the spring and summer.

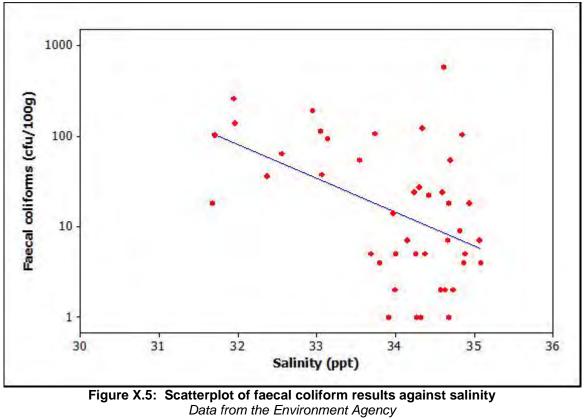
Salinity measurements were taken at the time of bacteriological sampling. Figure X.5 presents a scatterplot showing the relationship between salinity and faecal coliform concentrations.

Although salinity did not vary greatly, fewer low results were recorded when salinity dropped below 34ppt. A significant negative correlation was found between the two parameters (Pearsons correlation, r=-0.479, p=0.001).

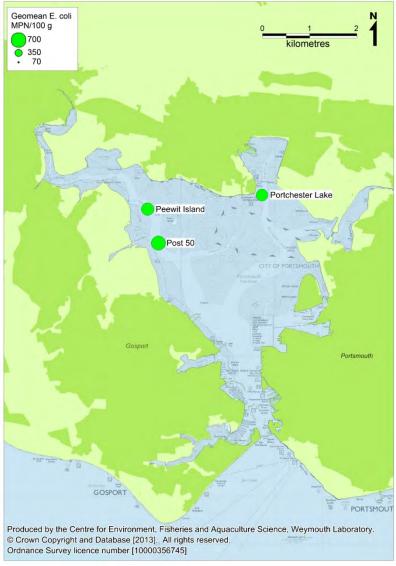
Figure XI.1: Bivalve RMPs active since 2003

There are a total of 3 RMPs in the Portsmouth Harbour that have been sampled between 2003 and 2013. The geometric mean results of shellfish flesh monitoring from all RMPs sampled from 2003 onwards are presented in Figure XI.1. Summary statistics are presented in Table XI.1 and boxplots for sites are show in Figure XI.2.

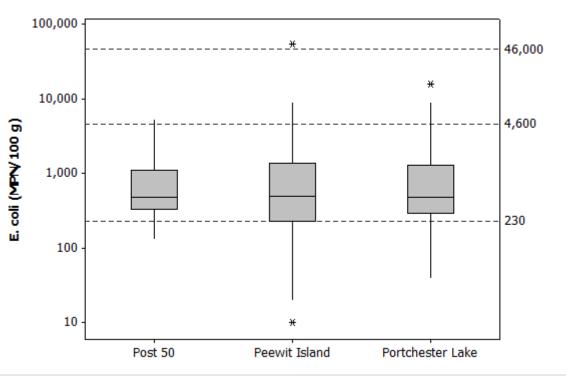
Figure XI.2: Boxplots of *E. coli* results from native oyster RMPs from 2003 onwards.

Peewit Island was only sampled up until April 2011, and Post 50 was only sampled from May 2011, so some caution should be exercised when comparing results from these two sites.

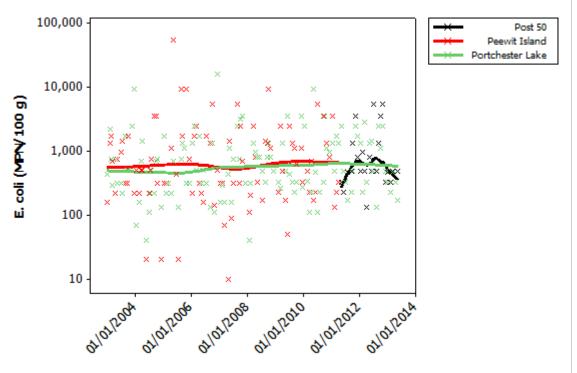
Figure XI.3: Scatterplot of *E. coli* results by sample date, overlaid with lowess lines.

The level of *E. coli* in native oysters has remained stable at Peewit Island and Portchester Lake since 2003.

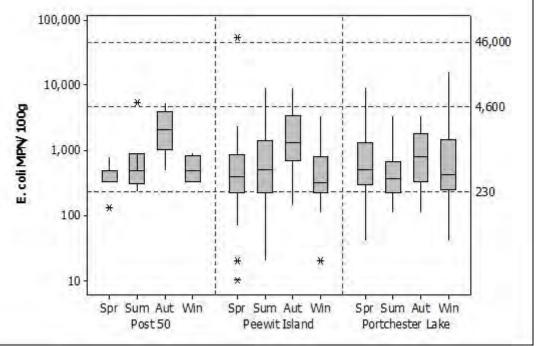
Figure XI.4: Boxplot of E. coli results by RMP and season

One-way ANOVA tests showed that there were significant seasonal variations at Post 50 and Peewit Island (p=0.009 and 0.005 respectively), but not at Portchester Lake (p=0.175). Post ANOVA tests showed that there were significantly higher levels of *E. coli* during the autumn than winter and spring at Post 50 and Peewit Island. This suggests that sources of differing seasonality are influencing the east and west channels.

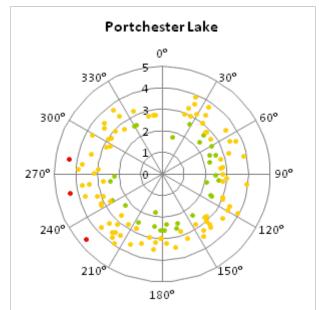
Figure XI.5: Polar plot of log<sub>10</sub> E. coli results (MPN/100g) against high/low tidal state

Figure XI.5 presents a polar plot of  $log_{10}$  *E. coli* results against tidal state on the high/low cycle for Portchester Lake, where a significant correlation was detected. High water at Portsmouth is at 0° and low water is at 180°. Results of 230 *E. coli* MPN/100g or less are plotted in green, those from 231 to 4600 are plotted in yellow, and those exceeding 4600 are plotted in red.

A significant correlation between *E. coli* levels and the state of the tide on the high/low tidal cycle was found at Portchester Lake only, where there appeared to be a weak tendency for higher results during the flood tide. This suggests that sources to the south are of some influence. A correlation between *E. coli* levels and the state of the tide on the spring/neap tidal cycle was found at Pewit Island only. This

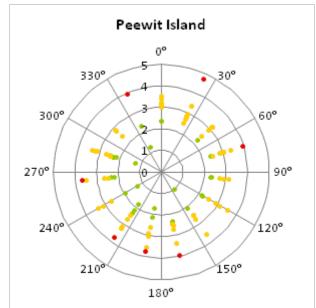
Figure XI.6: Polar plot of log<sub>10</sub> E. coli results (MPN/100g) against spring/neap tidal state

Figure XI.6 presents a polar plot of  $log_{10}$  *E. coli* results against the spring neap tidal cycle for Peewit Island. Full/new moons occur at 0°, and half moons occur at 180°, and the largest (spring) tides occur about 2 days after the full/new moon, or at about 45°, then decrease to the smallest (neap tides) at about 225°, then increase back to spring tides. Results of 230 *E. coli* MPN/100g or less are plotted in green, those from 231 to 4600 are plotted in yellow, and those exceeding 4600 are plotted in red.

correlation was weak, but a tendency for fewer low results during the larger, spring tides could tentatively be seen when the data was plotted. A significant influence of rainfall was found at all three RMPs, although there was some difference in the temporal profile of the responses. Levels of *E. coli* were influenced by rainfall very rapidly at Pewit Island and continued to be affected for several days. Portchester Lake oysters were also affected by rainfall but not as quickly as at Peewit Island. Little influence of rainfall was seen at Post 50 and the response was delayed, but much fewer samples were taken from here.

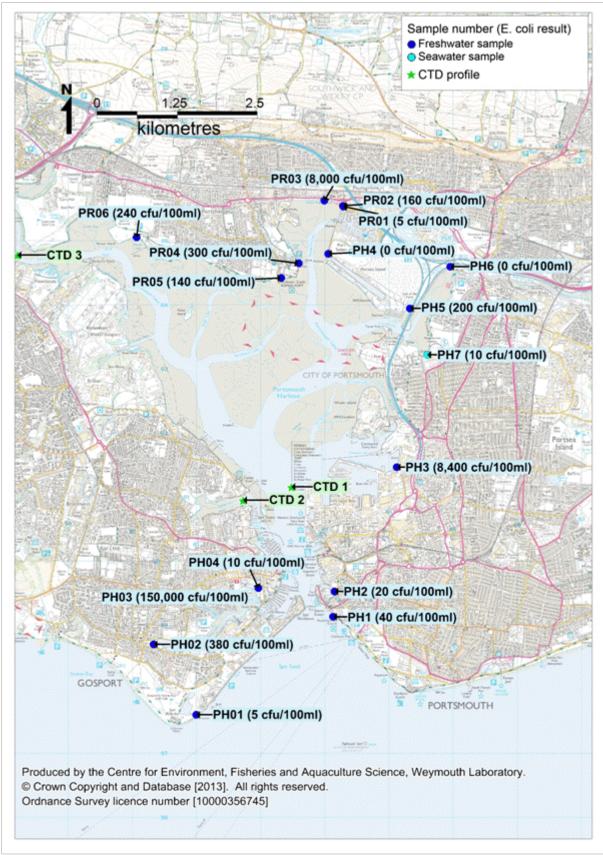
Figure XII.3: Locations of water samples and CTD profiles taken from Portsmouth Harbour

Relatively high concentrations *E. coli* were found in samples taken from CSO's (samples PH3 and PH03) and from a pipe at the head of the Paulsgrove Lake (sample PR03). All of the other freshwater samples were carrying low concentrations of *E. coli*.

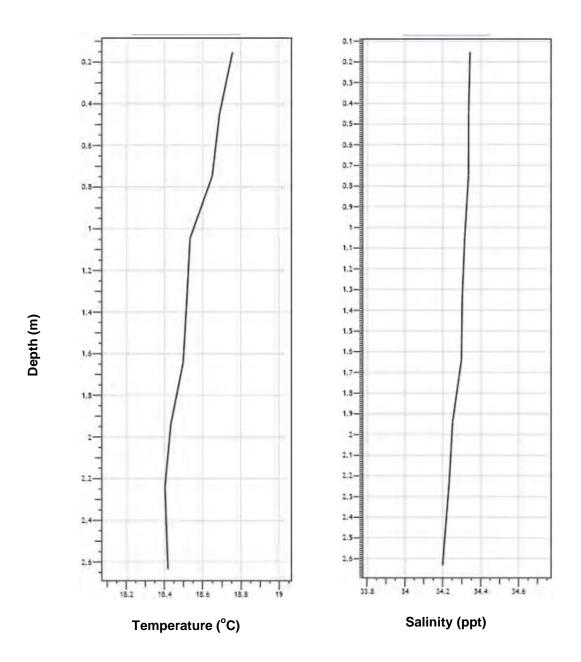
Figure XII.4: Temperature and salinity profiles CTD 1 (observation 32)

There were slight decreases in water temperature lower in the water column, and this was most pronounced at CTD 3 where the temperature dropped from 22.5°C to 20°C in 4 metres. The salinity profile was uniform through the water column at CTD 1 and CTD 2, around 34.2–34.3ppt. At CTD 3, in the upper reaches of Fareham Creek, a slight difference in salinity between the surface waters (33.65ppt) and at 4 metres (34.25ppt) was revealed. Freshwater generally tends to contain higher concentrations of microbiological indicators than seawater, so levels of contamination may have been slightly higher towards the surface in this area. Overall, the three CTD measurements suggest that Portsmouth Harbour is well mixed, with little freshwater influence.
