**CLASSIFICATION OF BIVALVE
MOLLUSC PRODUCTION AREAS IN
ENGLAND AND WALES**

SANITARY SURVEY REPORT

Roach and Crouch

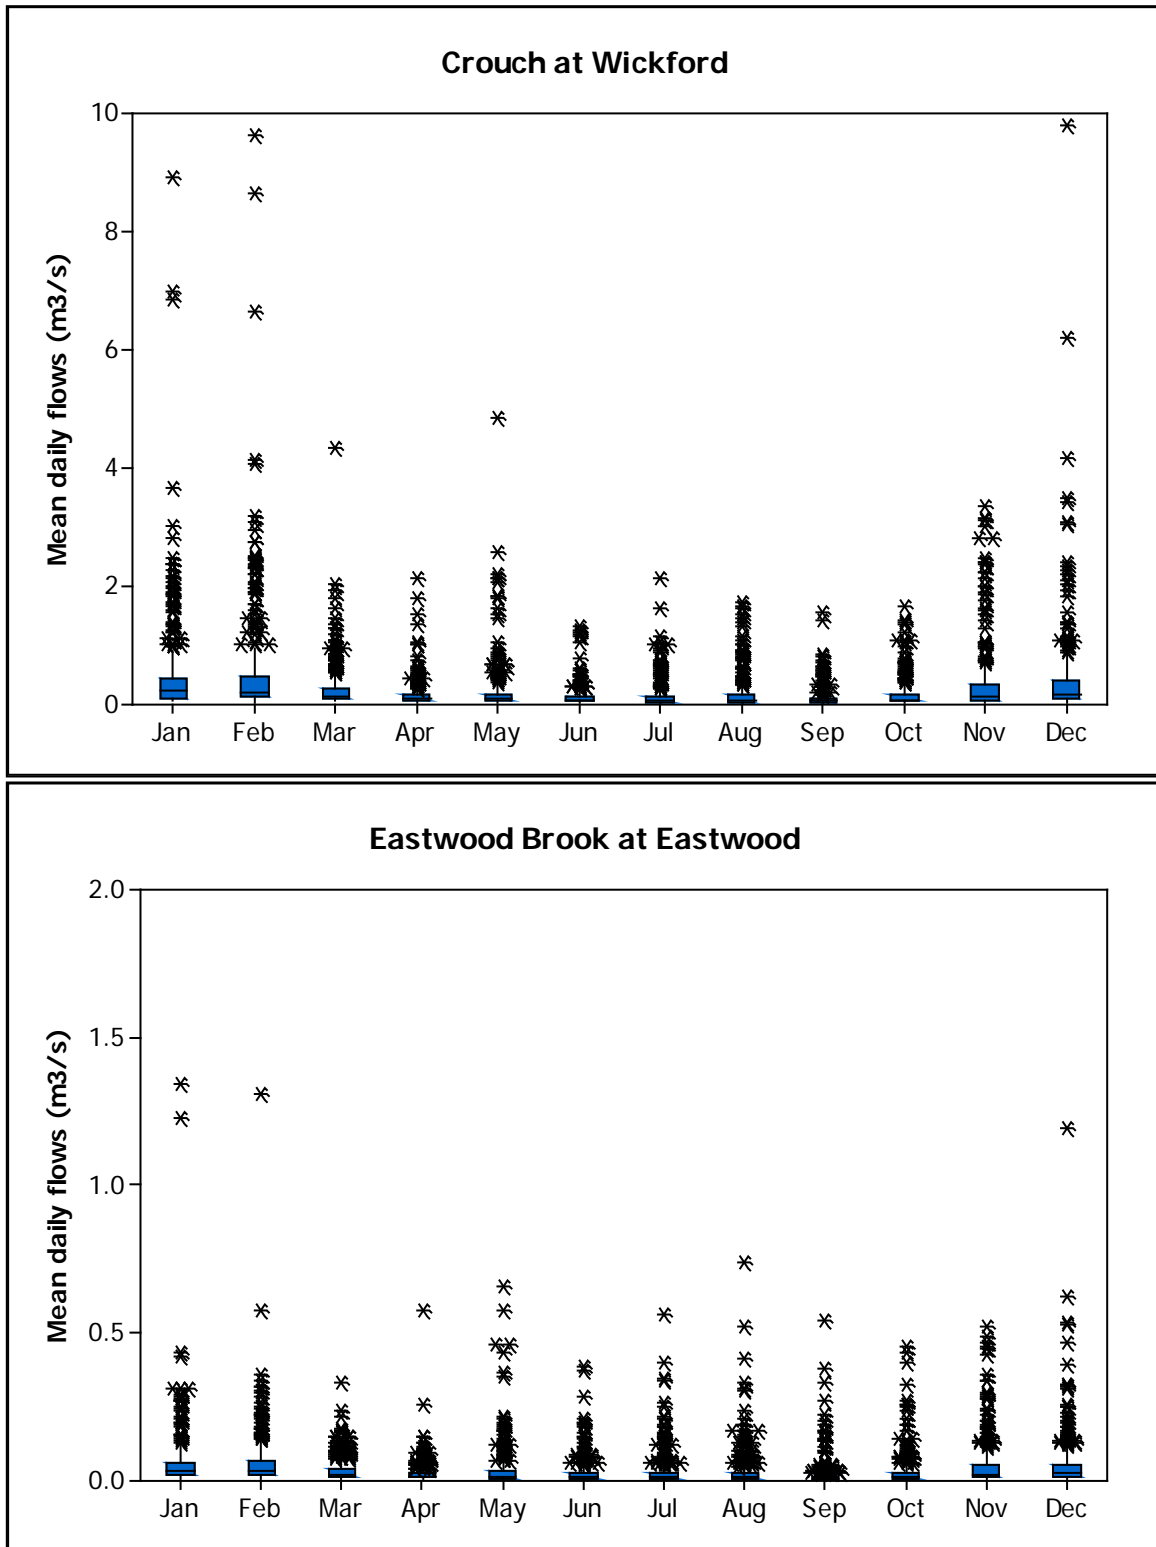
Figure III.2 Boxplot of mean daily flows for the Crouch at Wickford and Eastwood Brook at Eastwood, Jan 2002 to Feb 2012. Data from the Environment Agency.

There are two river gauging stations within the Roach and Crouch catchment area, one on the Crouch and one on the Eastwood Brook. Figure III.2 presents boxplots of mean daily flow records by month.

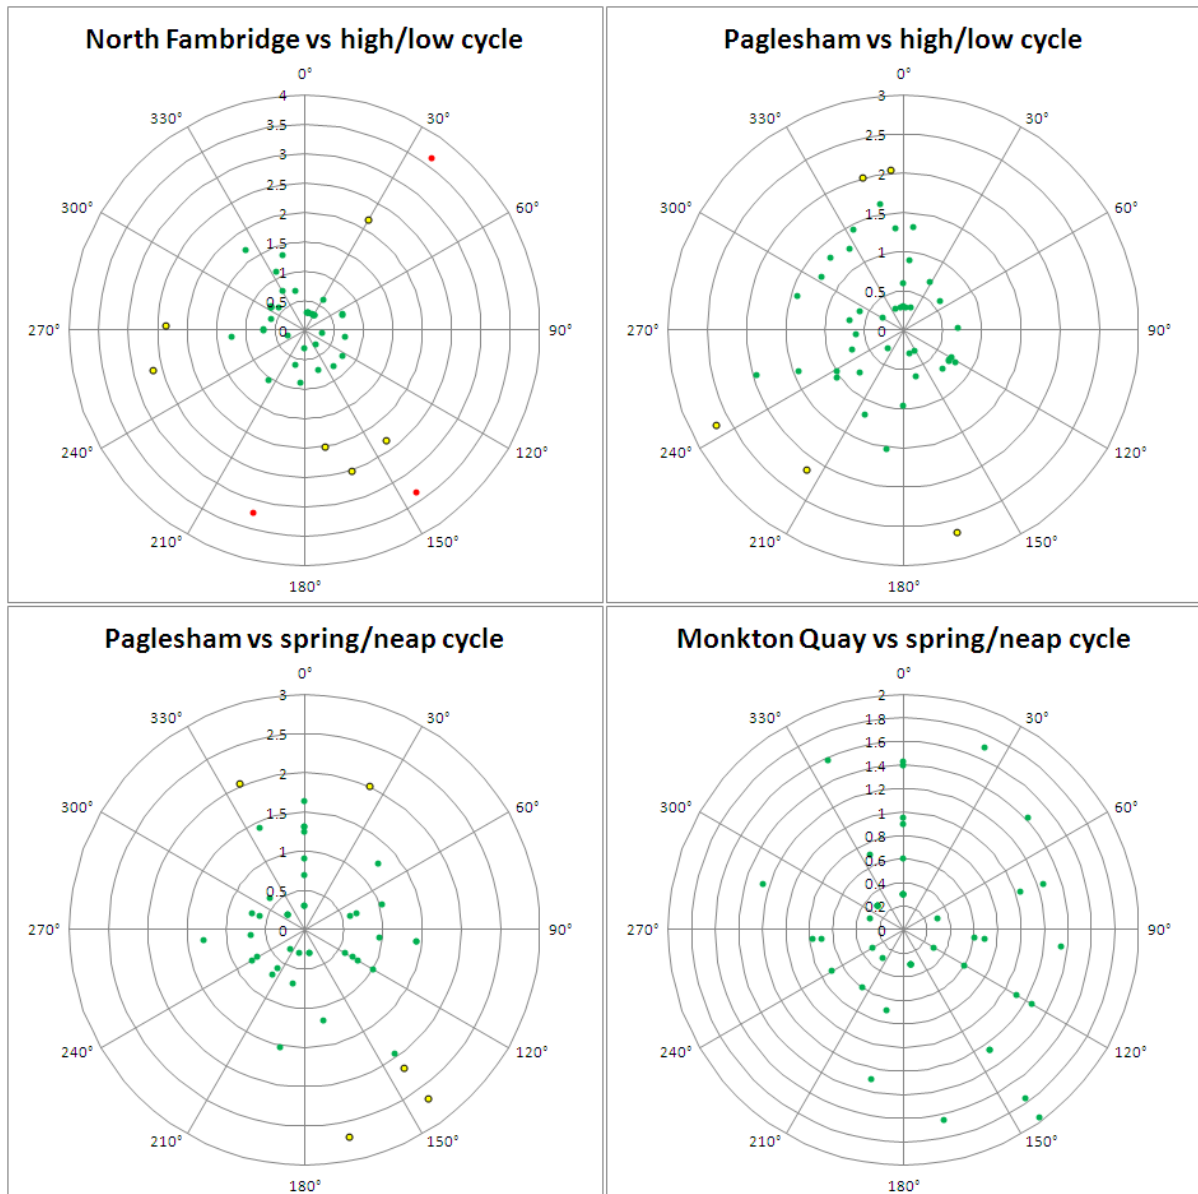
Figure XI.4. Polar plots of \log_{10} faecal coliforms from the main shellfish waters sites against tidal state Data from the Environment Agency

Some relatively weak correlations were found. Figure XI.4 presents a polar plots of \log_{10} faecal coliforms results against tidal states where statistically significant correlations were found. For plots of the high/low cycle high water at Burnham is at 0° and low water is at 180° . For plots of the spring neap tidal cycle full/new moons occur at 0° , and half moons occur at 180° , and the largest (spring) tides occur about 2 days after the full/new moon, or at about 45° , then decrease to the smallest (neap tides) at about 225° , then increase back to spring tides. Results of 100 faecal coliforms/100ml or less are plotted in green, and those from 101 to 1000 are plotted in yellow.

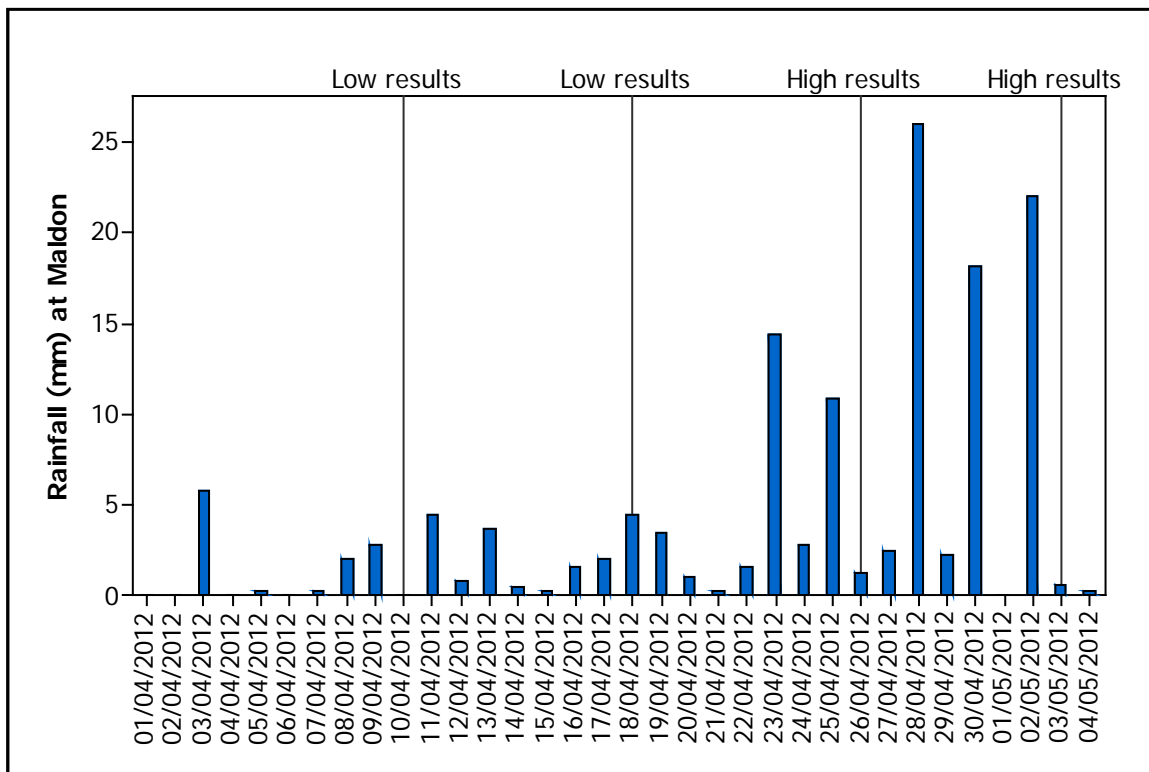
Figure XII.11 Rainfall at Maldon in relation to the high sample results
 Data from the Environment Agency

Although this rainfall event could probably be classed as exceptional, it nevertheless indicates the potential for high levels of contamination within this stretch.

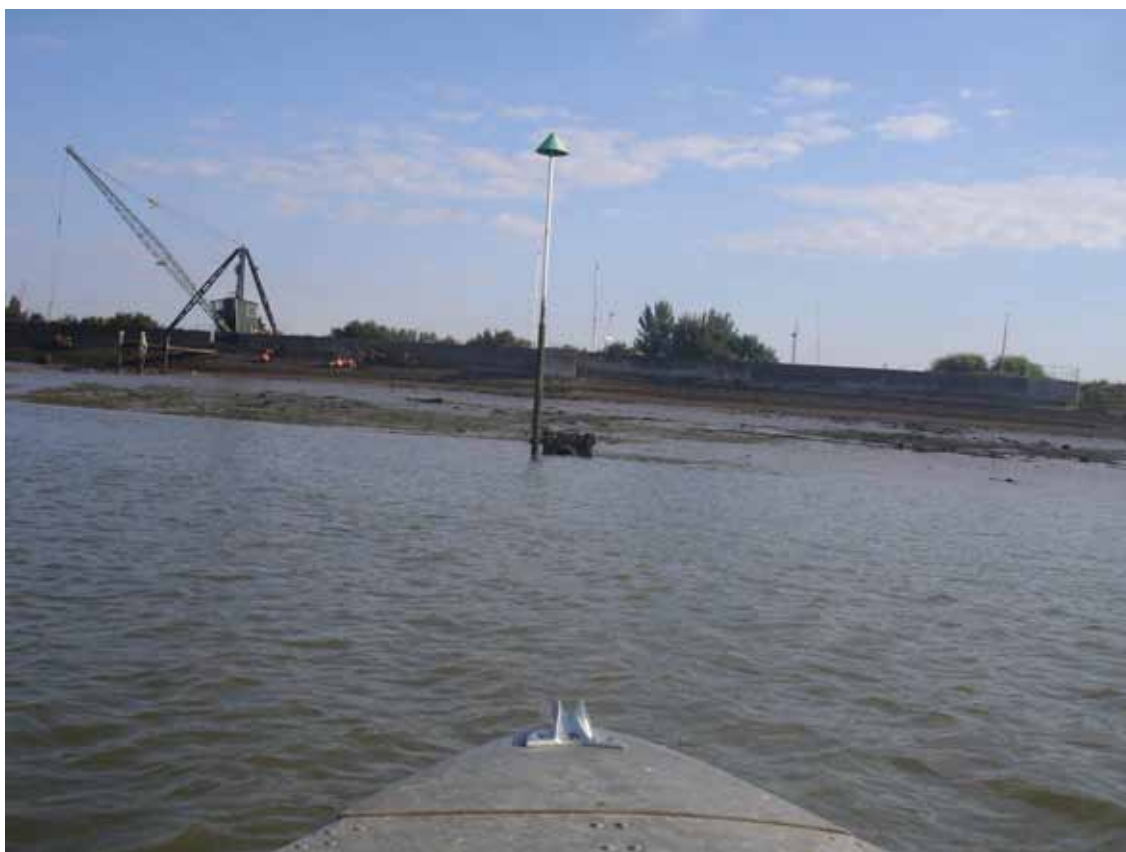
Figure XIII.4 - Burnham-on-Crouch STW outfall

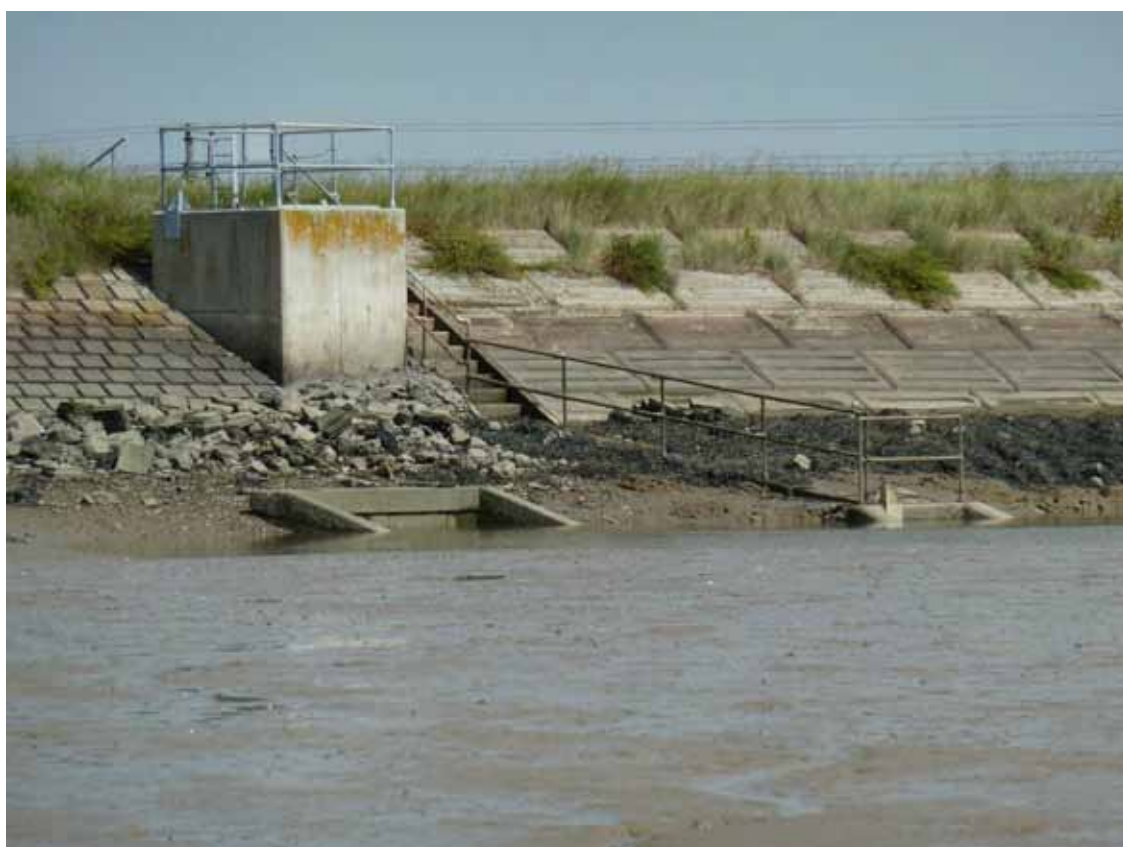
Figure XIII.9 - Rochford STW outfall

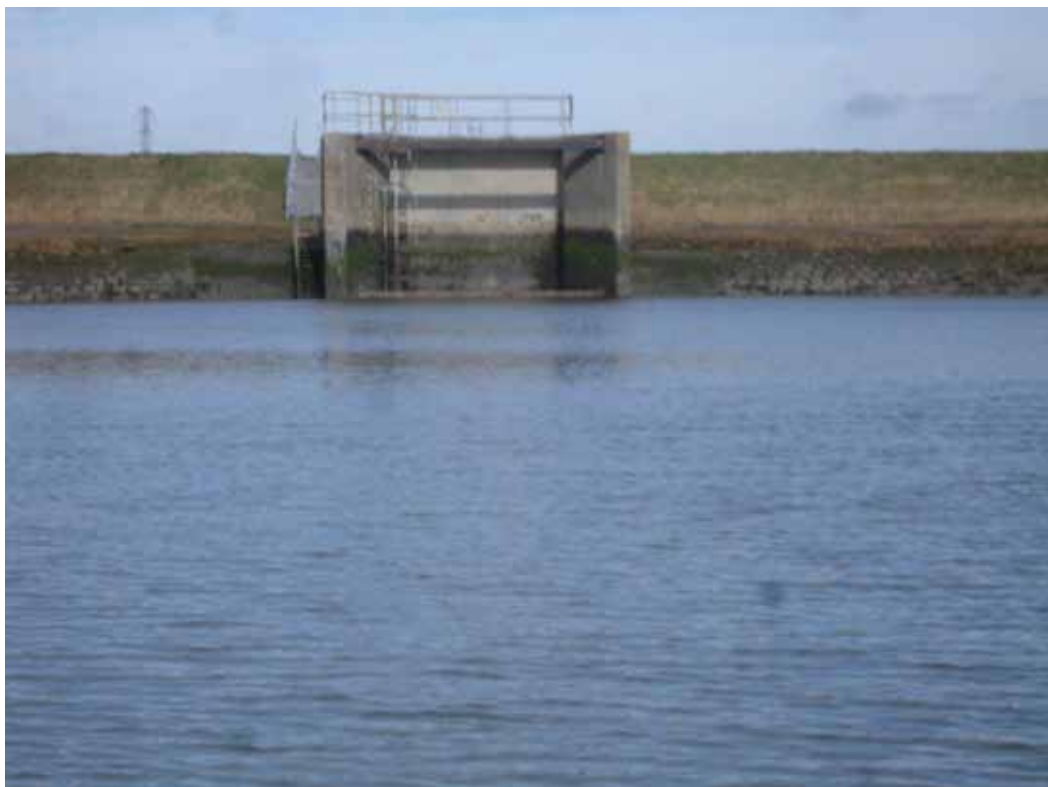
Figure XIV.4 Sluice at head of Clementsgreen Creek

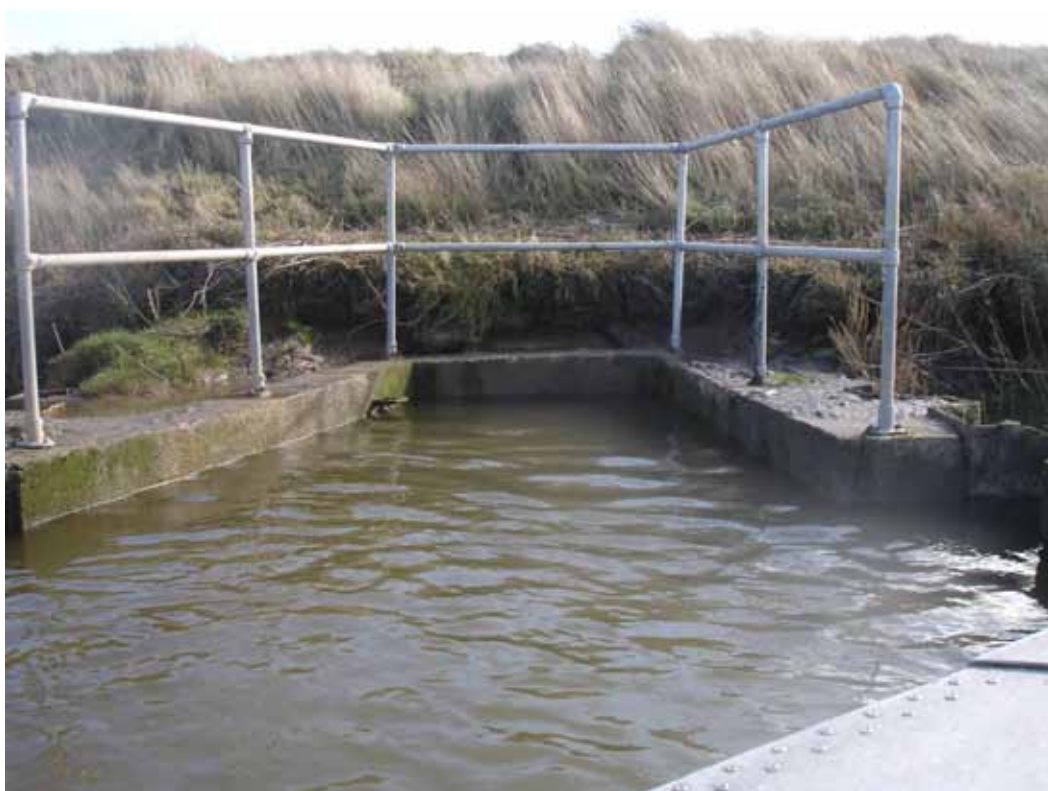
Figure XIV.5 Raleigh West STW outfall

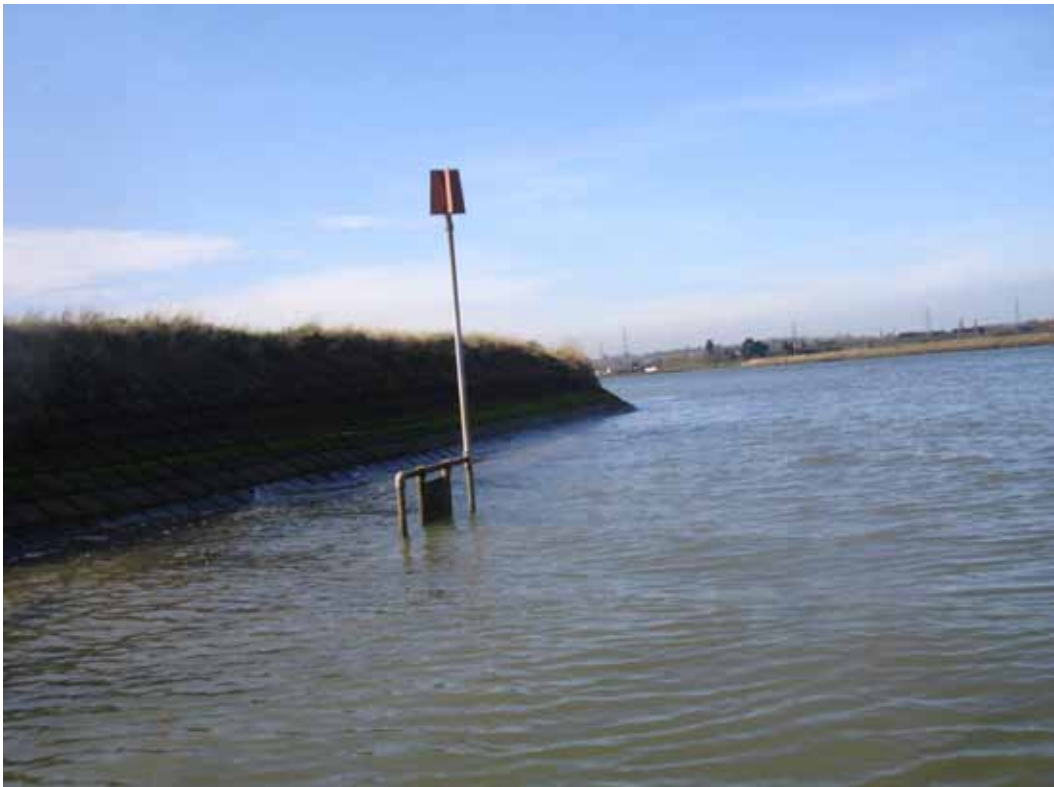
Figure XIV.6 Intermittent sewage outfall marker post

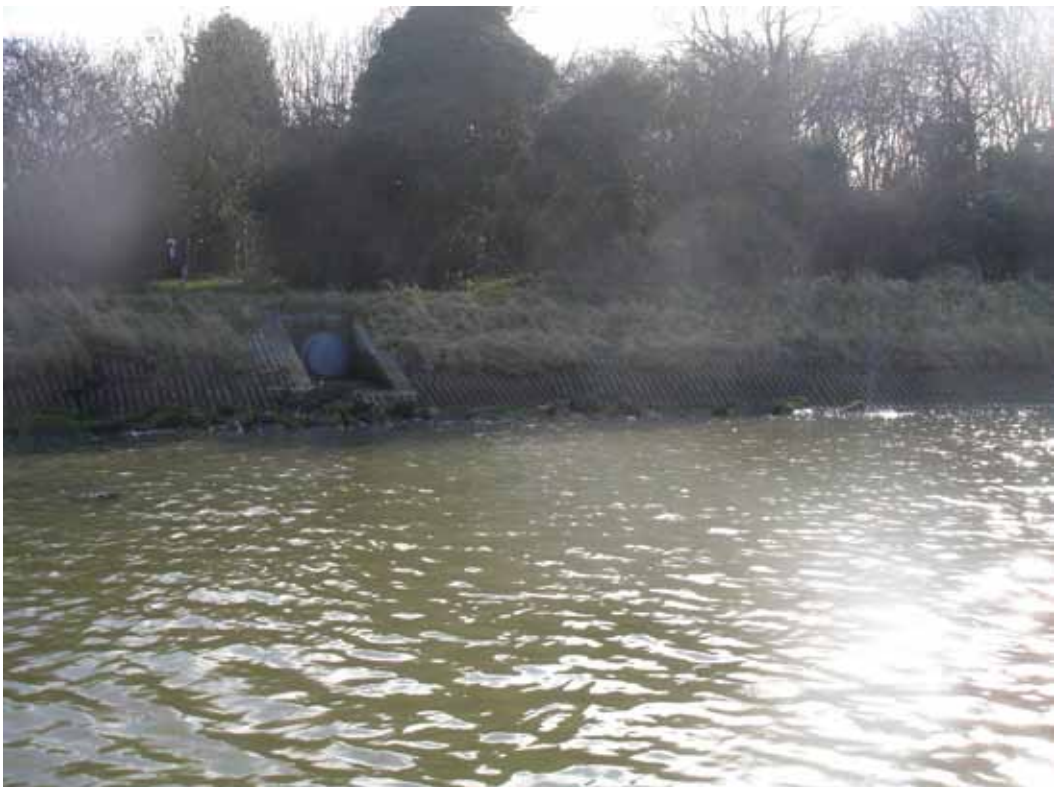
Figure XIV.7 Flap valve, Brandy Hole Reach

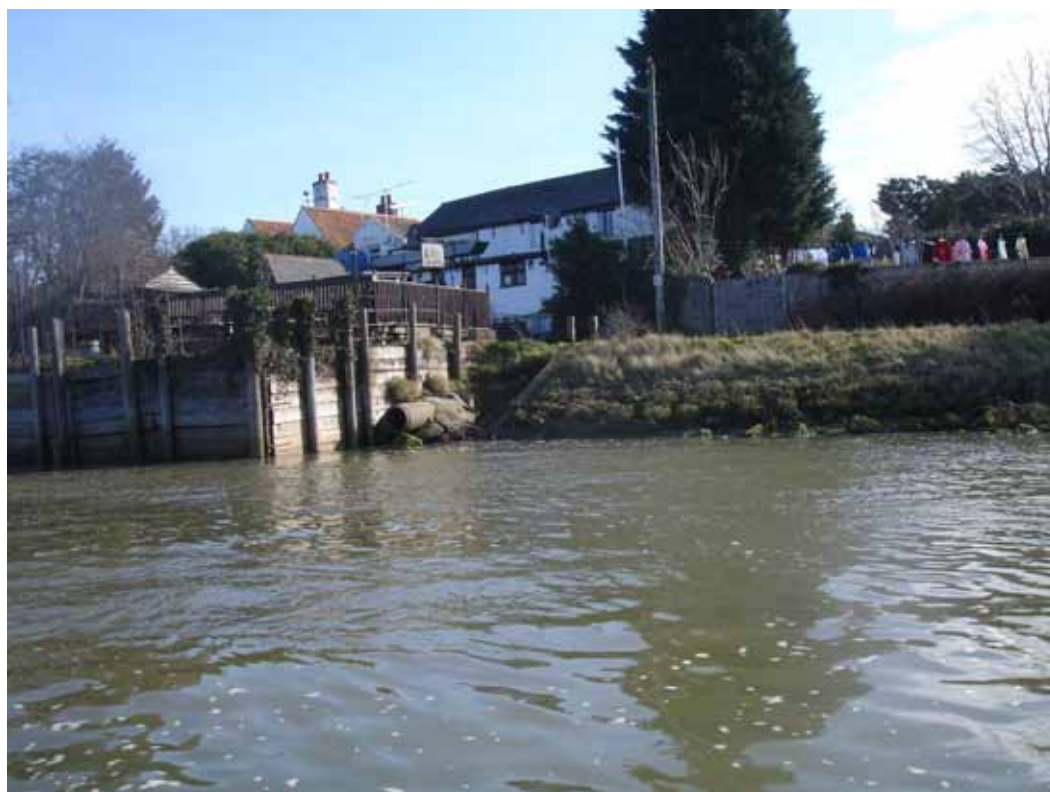
Figure XIV.8 Concrete pipe, Brandy Hole Reach
