## Southampton Water Sanitary Survey

### Review

January 2015

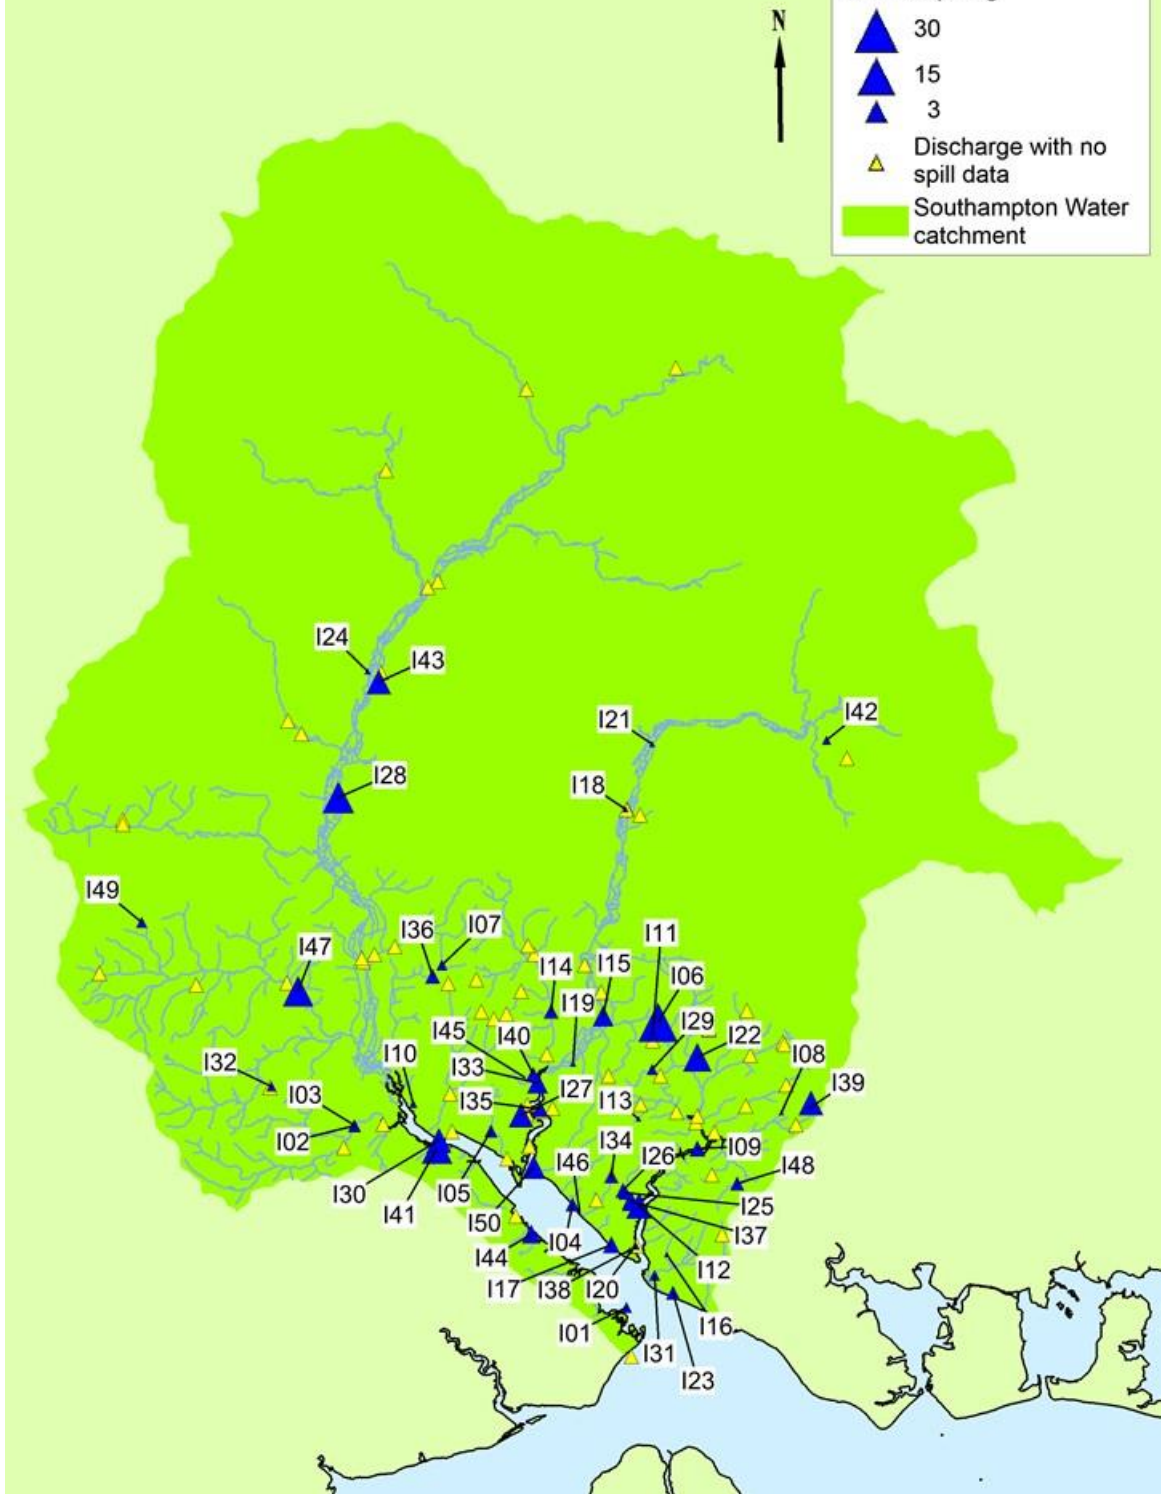
**Figure 5.4: Locations and % time spilling for water company owned intermittent discharges in the Southampton water catchment (details in Table 5.3).**

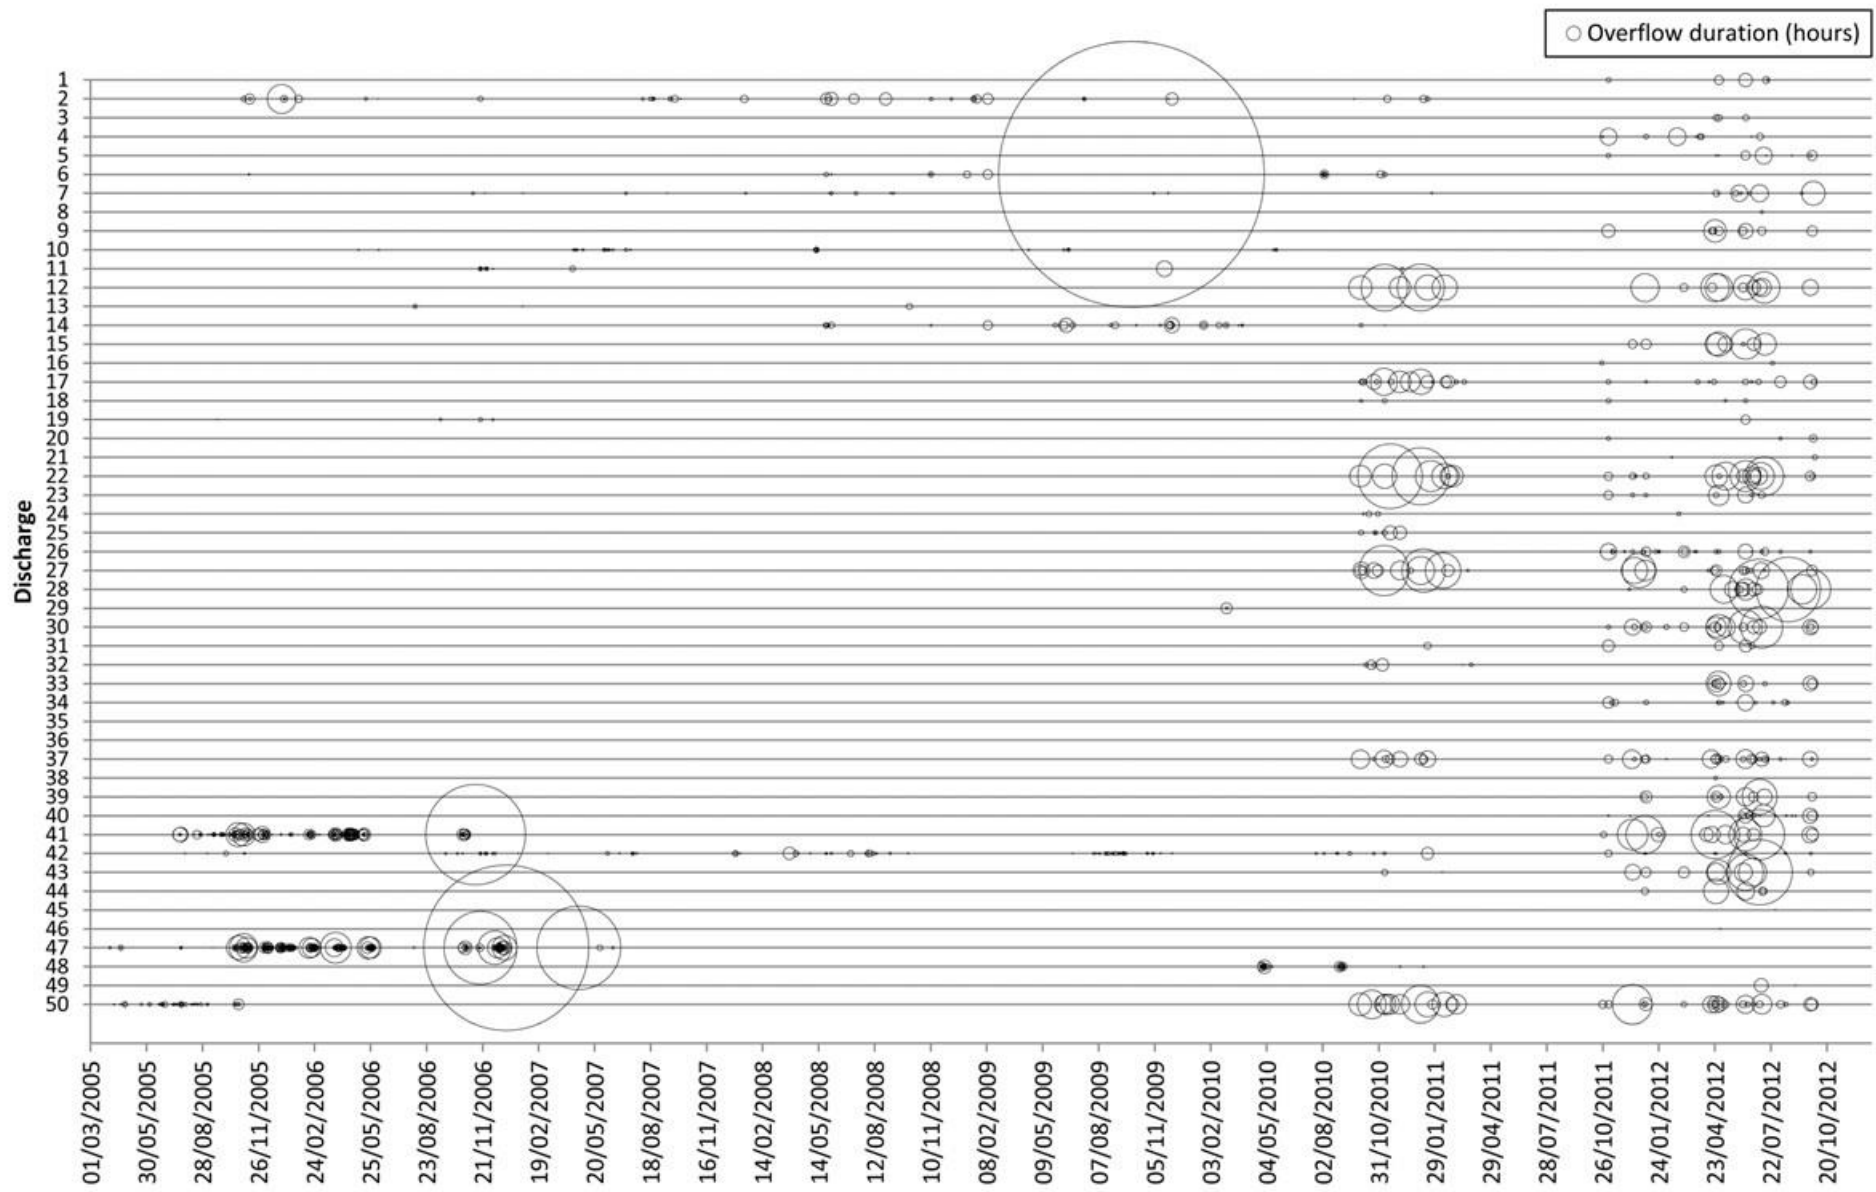
**Figure 5.5: Bubble plot of spills from intermittent discharges in the Southampton Water catchment (details in Table 5.4).**

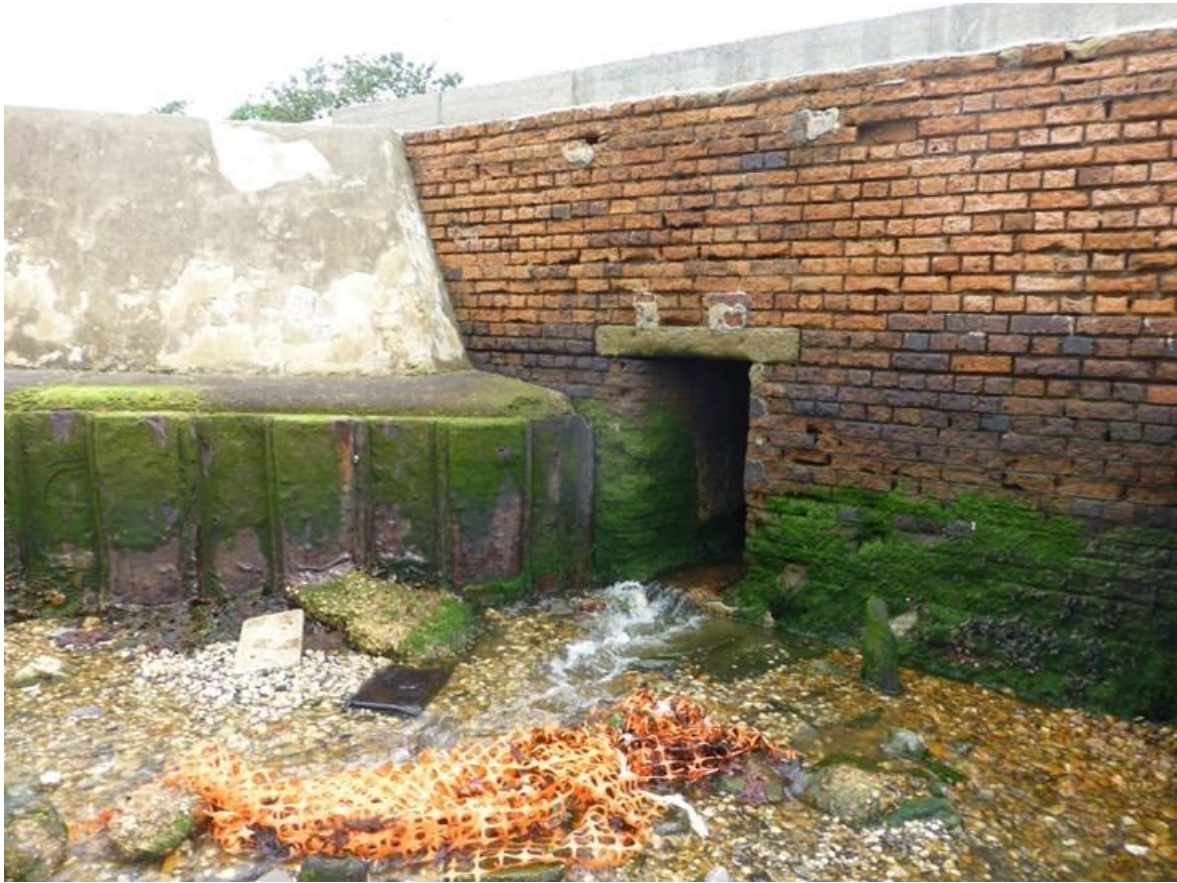
72	SU4538908482	18/06/2014	08:42	Old iron pipe under cliff, 0.15 m diameter. Not flowing.	Figure I.67
73	SU4551808286	18/06/2014	08:48	Old, broken iron pipe, 0.2 m outer diameter, 0.07 m internal diameter. Original pipe extending to sea but broken at beach.	Figure I.68
74	SU4564808089	18/06/2014	08:53	Victoria Road Netley CEO. Pipe encased in concrete, 0.5 m diameter. Not flowing.	Figure I.69
75	SU4563508075	18/06/2014	08:54	Old, broken iron pipe in beach. Mostly buried.	
76	SU4583407915	18/06/2014	09:02	Culvert surrounded by brickwork (0.04 m x 0.4 m x 1.6 m/s) (SE03).	Figure I.70

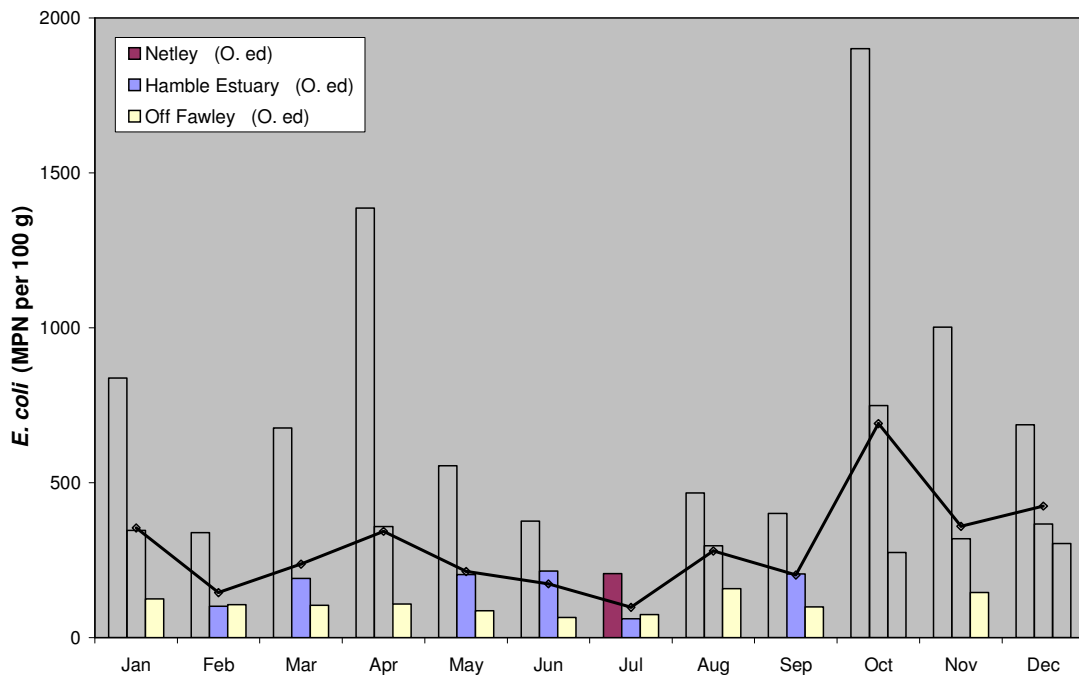
**Figure 6.3:** Variation in geometric mean *E. coli* result by month for native oysters from hygiene monitoring points in Southampton Water, 2004 to 2008. The solid line is the grand (geometric) mean for all three sites combined

Seasonal variation in levels of *E. coli* contamination of oysters from Southampton Water is not particularly marked (Figure 6.3). The highest average (geometric mean) levels of contamination at the Netley and Hamble Estuary monitoring points were recorded in October.

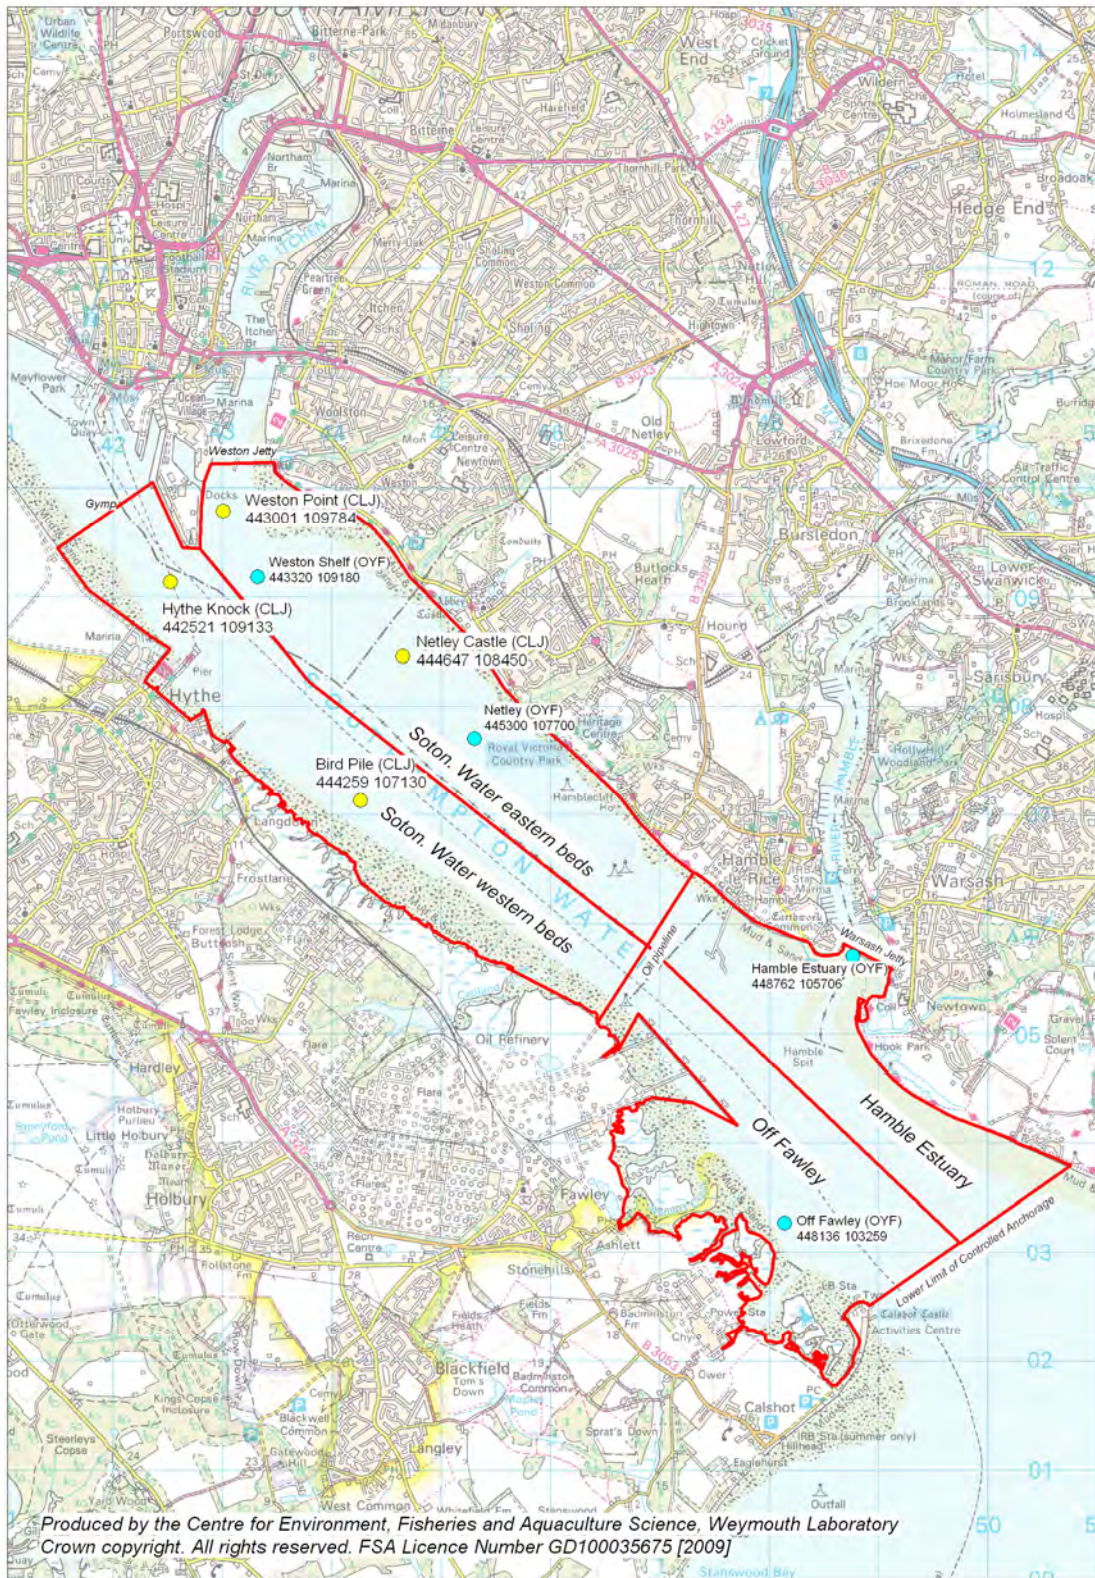
**Figure 1: Classification zones and recommended monitoring points**
