# Scottish Sanitary Survey Project

## Restricted Sanitary Survey Report

Arisaig: Morar Sands

HL 005 204 16

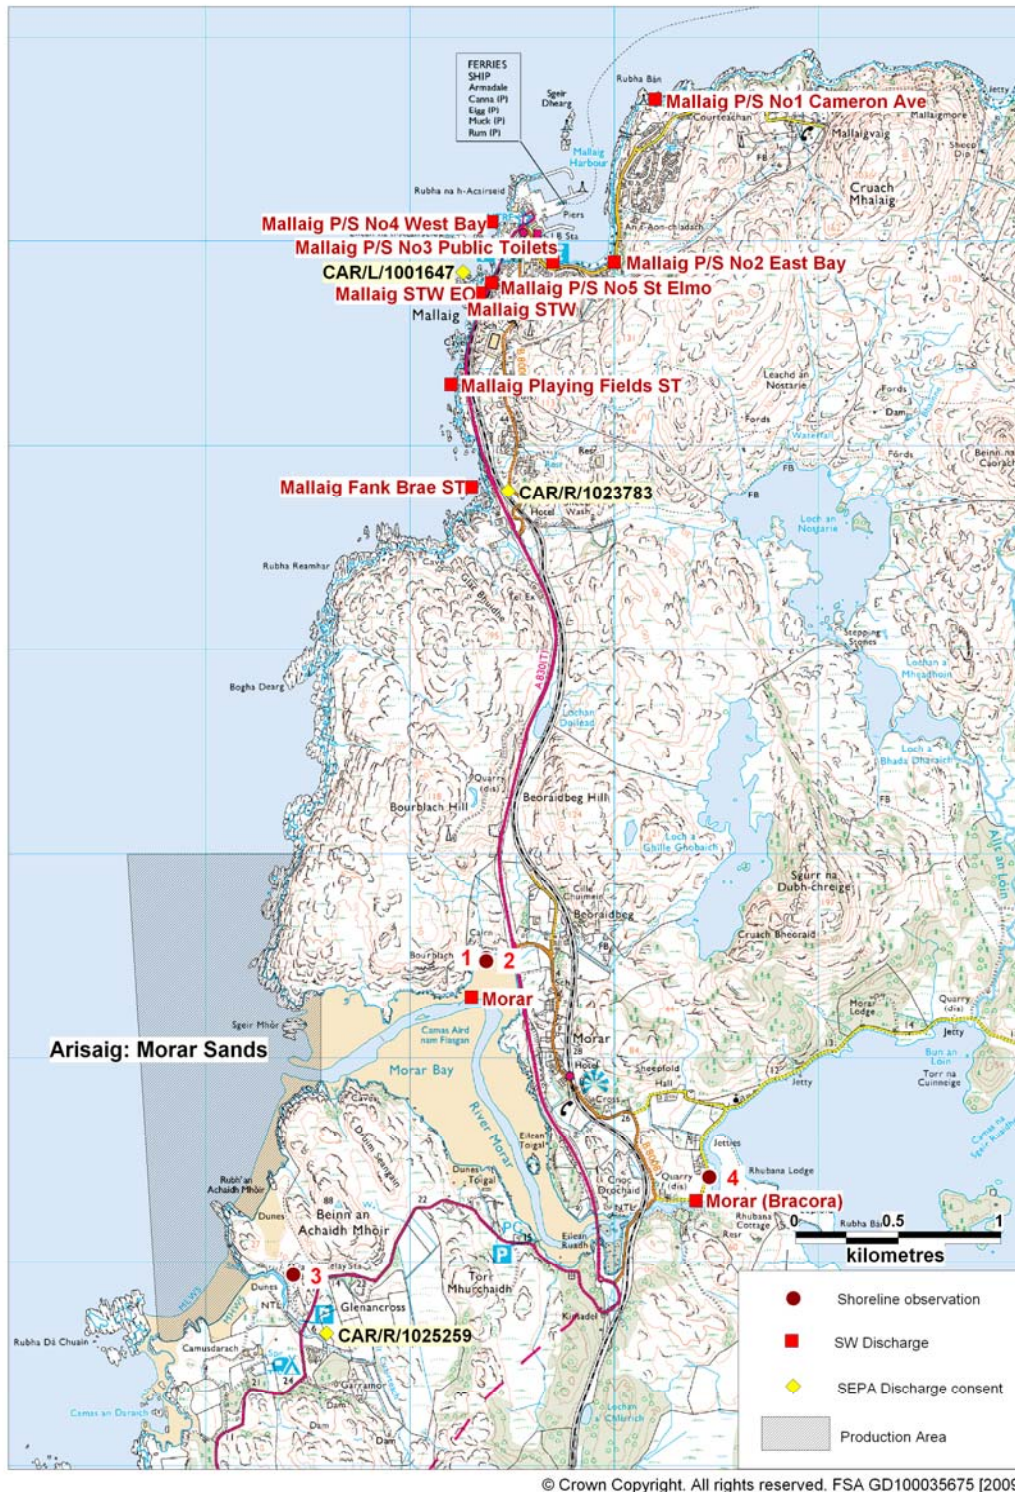
Figure 3.1 Sewage discharges at Arisaig: Morar Sands

Community septic tanks and sewage discharges were identified by Scottish Water for the area surrounding Arisaig: Morar Sands. They are detailed in Table 3.1 and mapped in Figure 3.1.

Septic tanks and outfall pipes were also observed during the shoreline survey and these are listed in Table 3.3. Their locations have been included in the mapped discharges in Figure 3.1. Further details can be found in the shoreline survey report in the appendix.

The input from the Morar and Morar (Bracora) community septic tanks and the potential discharges listed in Table 3.3 would be expected to have a more direct effect on the microbiological quality of the razor clams than would the discharges in the Mallaig area.

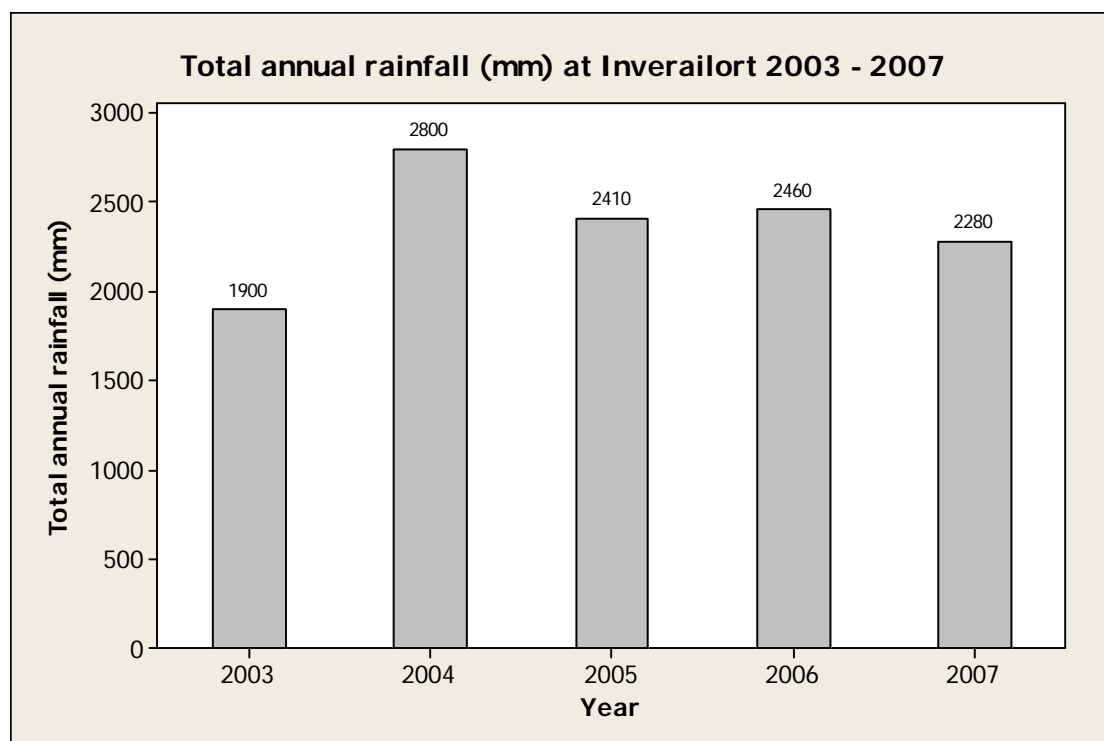
Figure 5.1 Total annual rainfall at Inverailort 2003 – 2007

The total rainfall varied significantly from year to year with 2003 being drier than average and 2004 wetter than average.

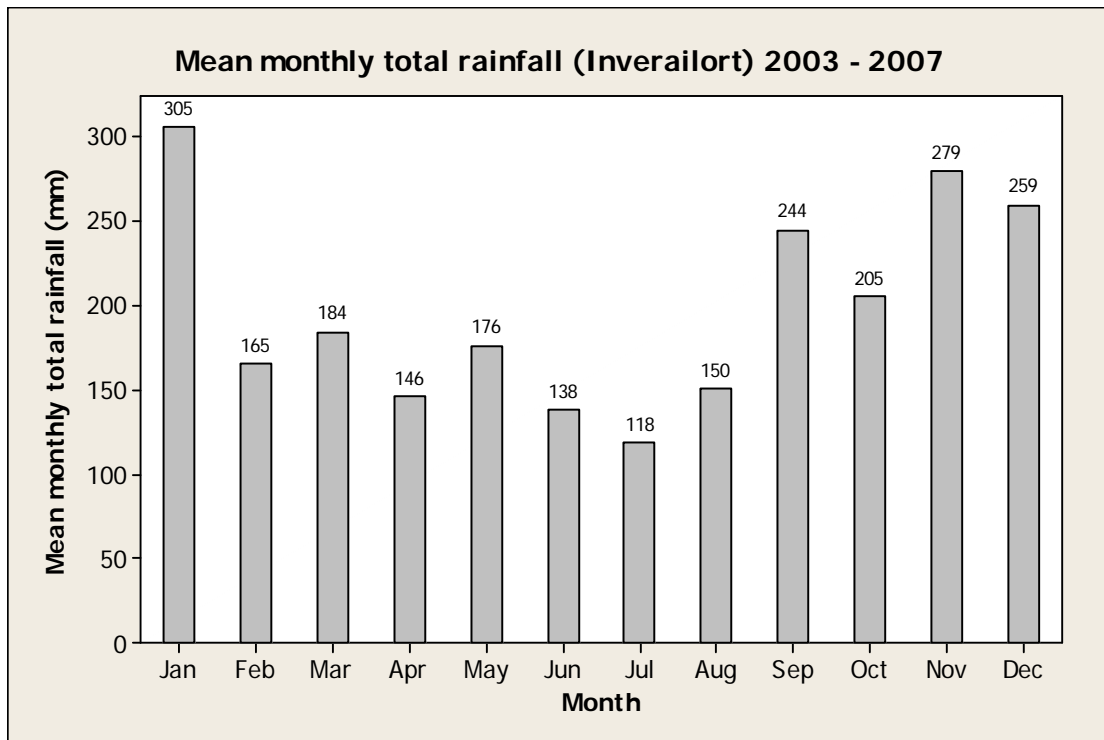
Figure 5.2 Mean total monthly rainfall at Inverailort 2003 – 2007

January was by far the wettest month, though mean rainfall was elevated from September to January, inclusive. There appears to be a seasonal pattern to the rainfall with a relatively dry period occurring from February to August, inclusive with the remainder of the year significantly wetter. Daily rainfall figures could not be calculated for Inverailort during this period as some of the rainfall data is only provided in monthly totals.

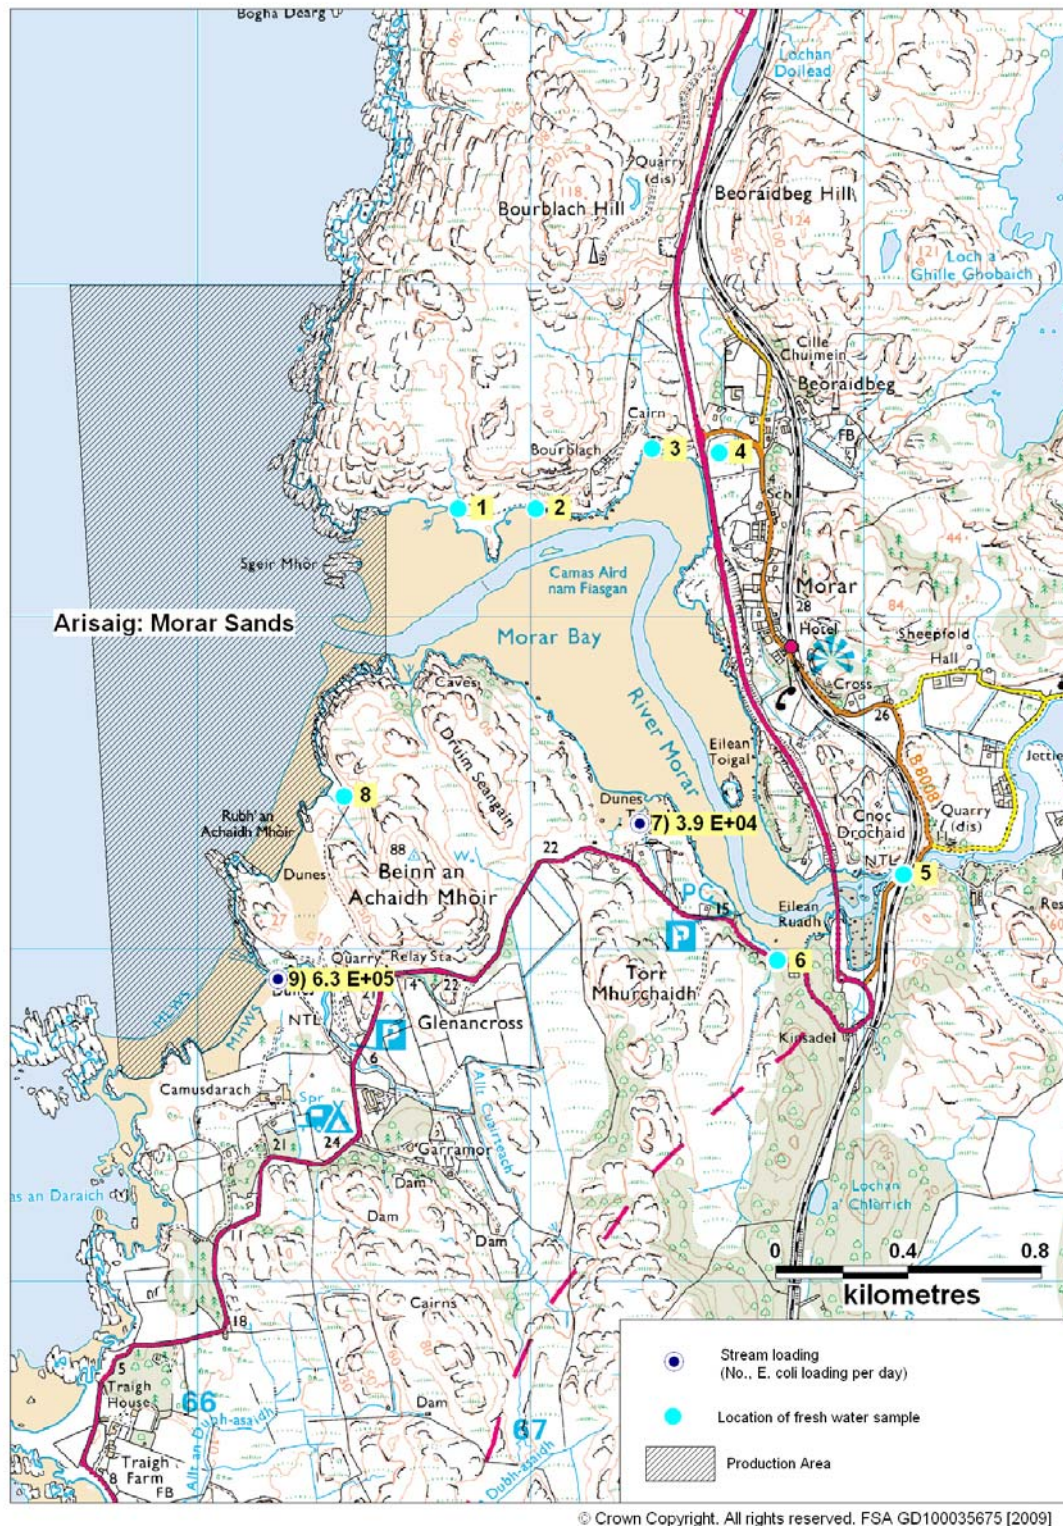
Figure 6.1 Location of stream flows and loadings at Arisaig: Morar Sands

The River Morar goes through Morar Bay and drains into Morar Sands. There are also several other burns discharging into the Arisaig Morar Bay and Morar Sands area, see Figure 6.1. The following rivers, streams and burns were sampled during the shoreline survey. These represented the largest freshwater inputs to Arisaig: Morar Sands.

The streams sampled at the time of the shoreline survey contained between <100 and 3300 cfu *E. coli*/100 ml. Calculated loadings are based on the flows and dimensions observed during the shoreline survey only.

Of the two streams with counts >100 *E. coli* per 100ml, and for which loadings could be calculated, one was located at the south side of Morar Bay and one on the coast south of the bay. Although the *E. coli* concentration of the River Morar was low on the day of sampling the volume of the river means that it is likely to contribute significantly to the *E. coli* loading to the bay.

The two inputs with the highest loadings discharged to the south side of Morar Bay and to the southern end of the production area respectively. The former would be expected to be diluted significantly before reaching the fishery whereas the latter will impact directly in the fishery in the near vicinity.

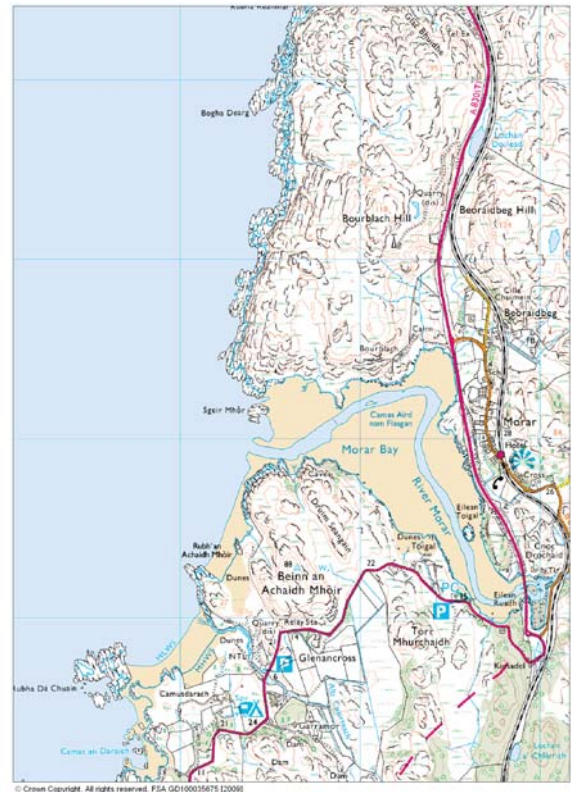
Figure 7.1 Arisaig: Morar Sands Bathymetry  
Figure 7.2 Arisaig: Morar Sands

The bathymetry chart above shows that the mouth of the River Morar and a small band of the coastline is a drying area. After the drying areas the depth then rapidly increases with distance from the coastline from 0 to over 50 m.

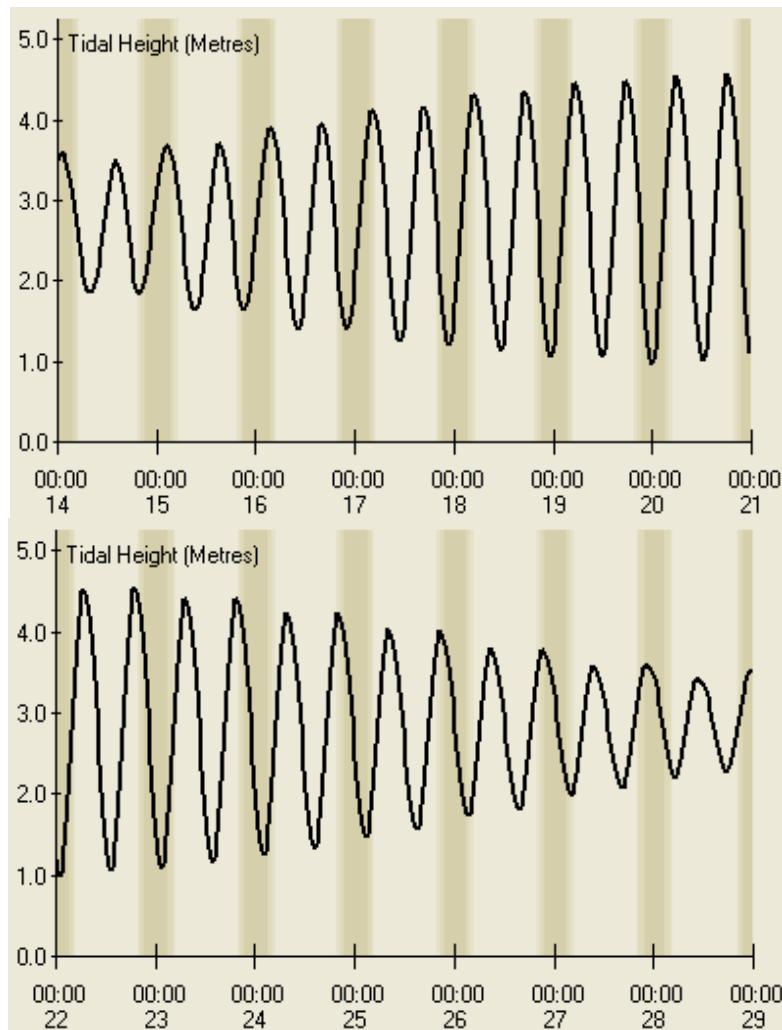
Figure 7.3 Tidal curves for Mallaig

The following is the UKHO summary description for Mallaig:  
The tide type is Semi-Diurnal.

MHWS	5.0 m
MHWN	3.6 m
MLWN	2.1 m
MLWS	0.8 m

Predicted heights are in metres above chart datum. The tidal range at spring tide is therefore approximately 4.2 m and at neap tide 1.5 m.

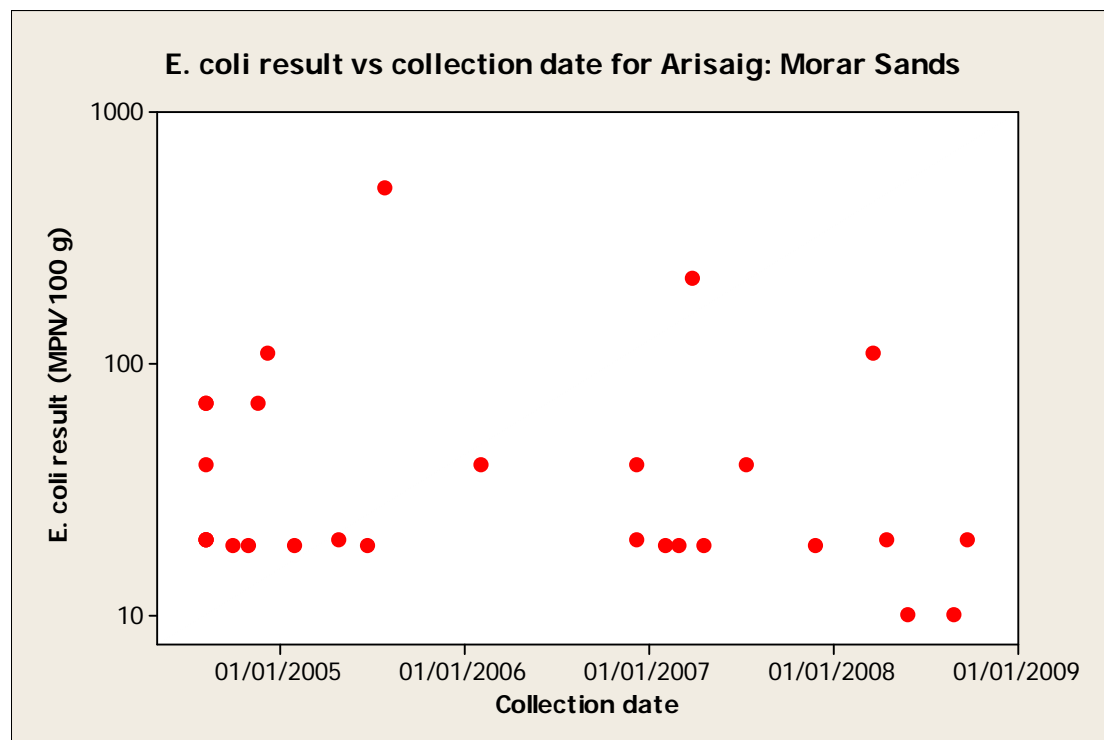
Figure 8.1 Scatterplot of *E. coli* result (MPN/100 g) for razor fish vs collection date on log scale

No overall trends are apparent from Figure 8.1. There is a gap in sampling with only three samples submitted in 2006.

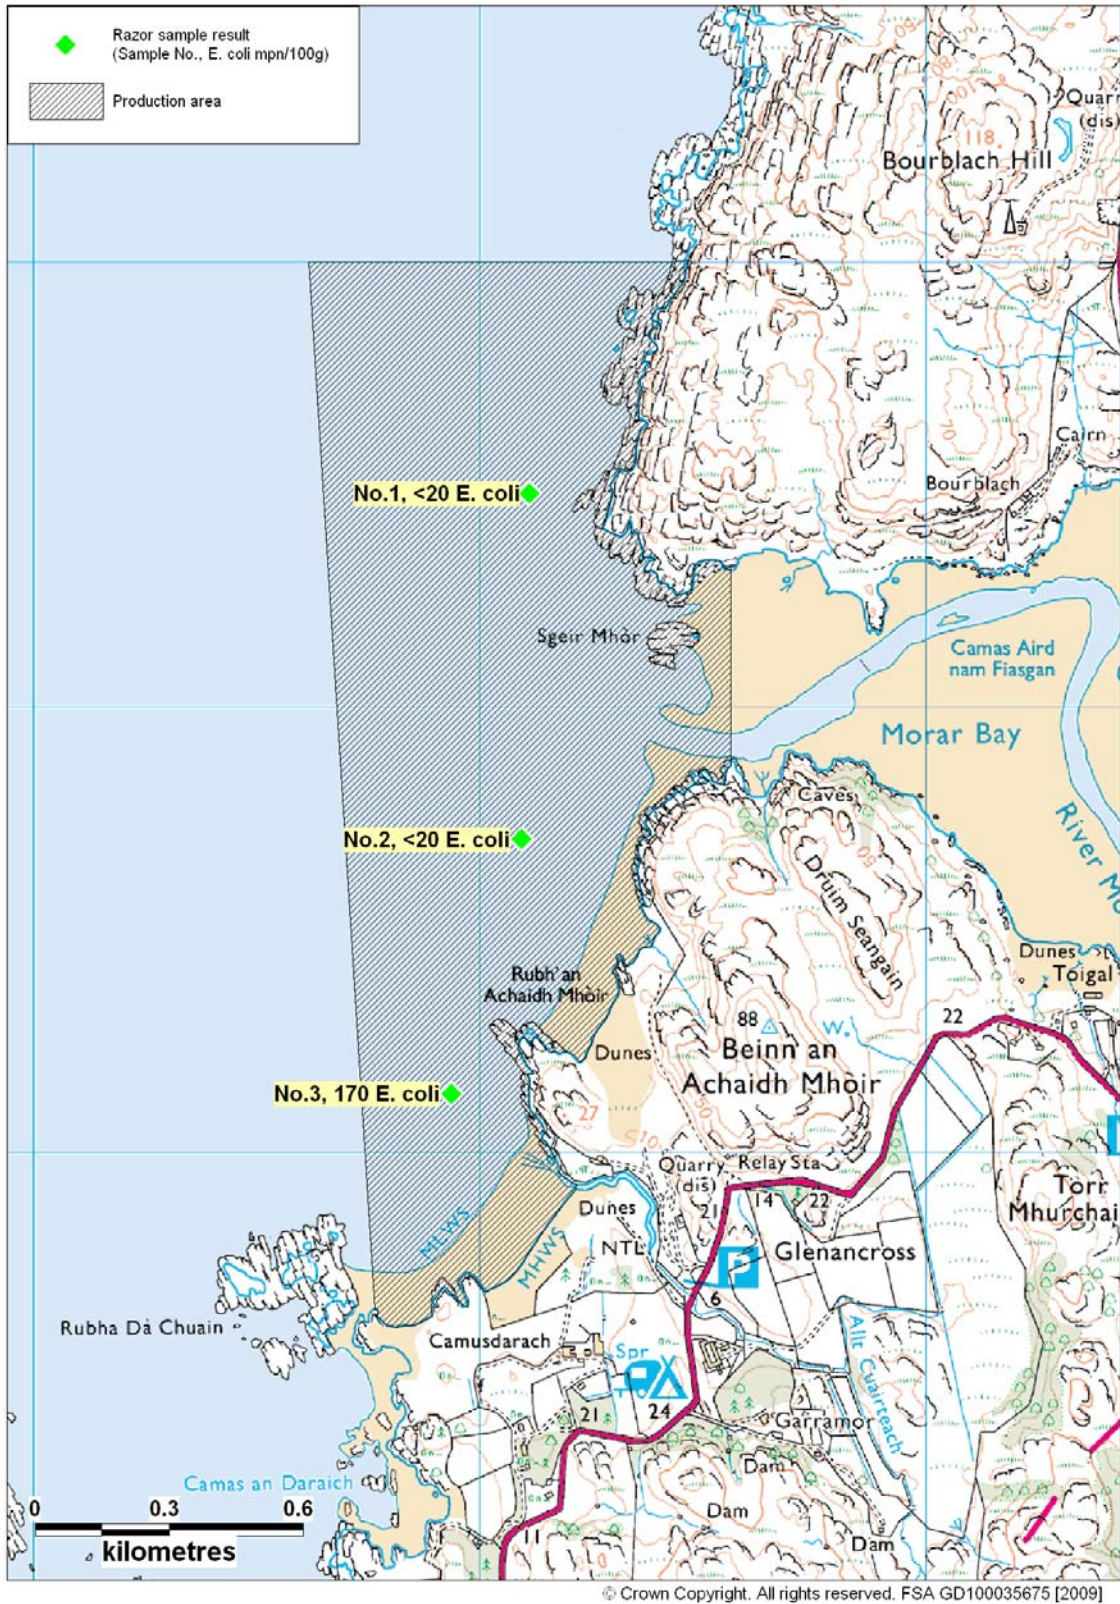
Figure 3. Shellfish sample results

No.	Date	Sample	Grid Ref	Type	E. coli (mpn/100g)
1	10/02/2009	MSSF1	NM66111 93483	Razor clam	<20
2	10/02/2009	MSSF2	NM66094 92708	Razor clam	<20
3	10/02/2009	MSSF3	NM65937 92135	Razor clam	170

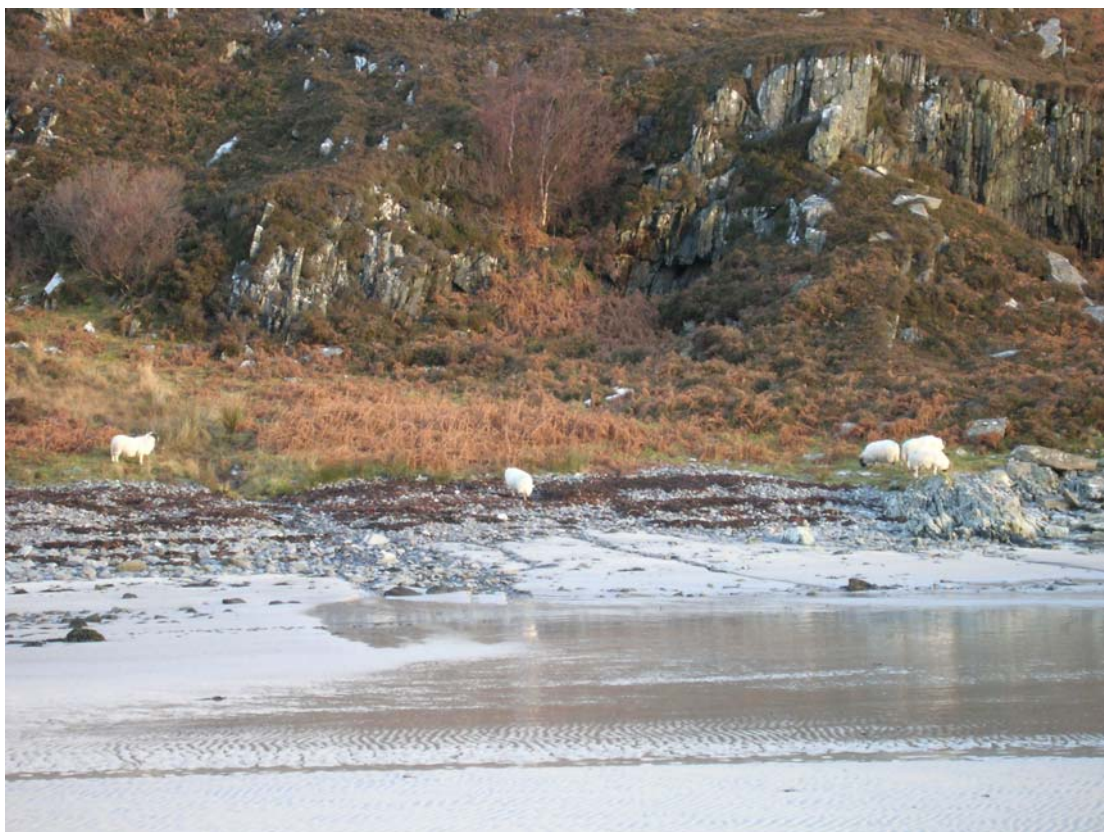
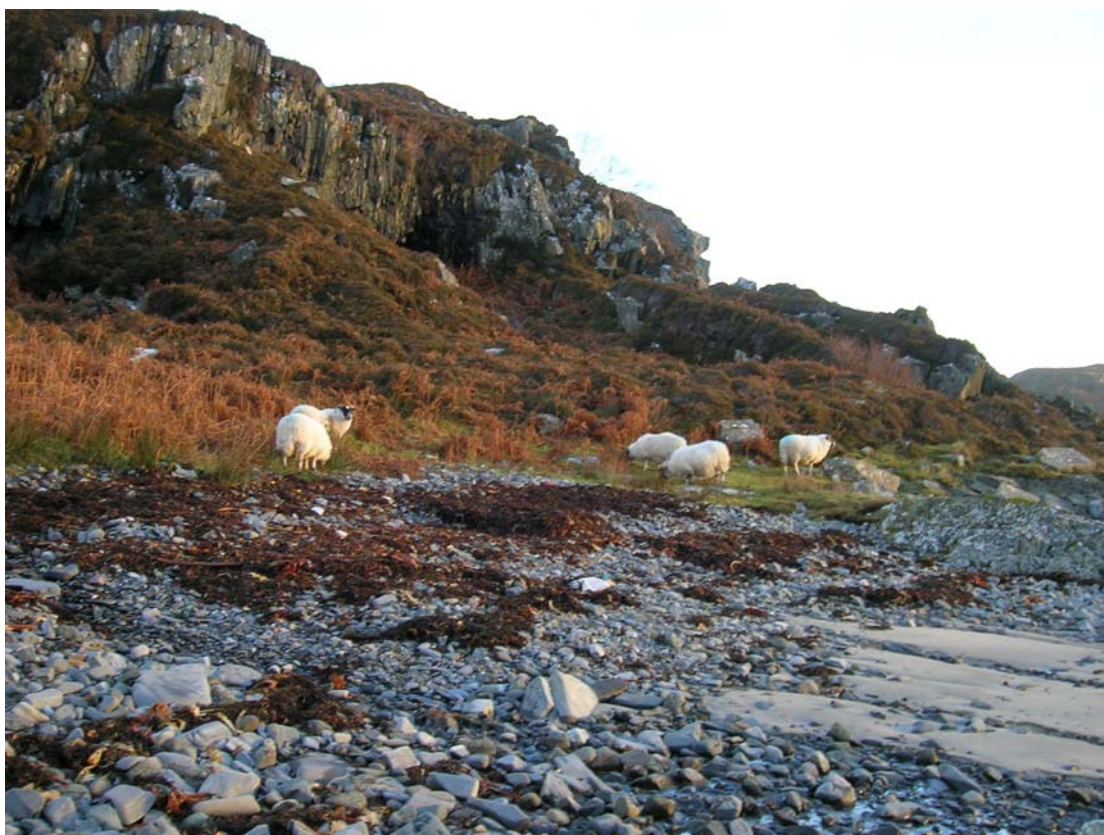
Figure 6. Sheep observed on the shoreline

Figure 7. Sheep observed on the shoreline

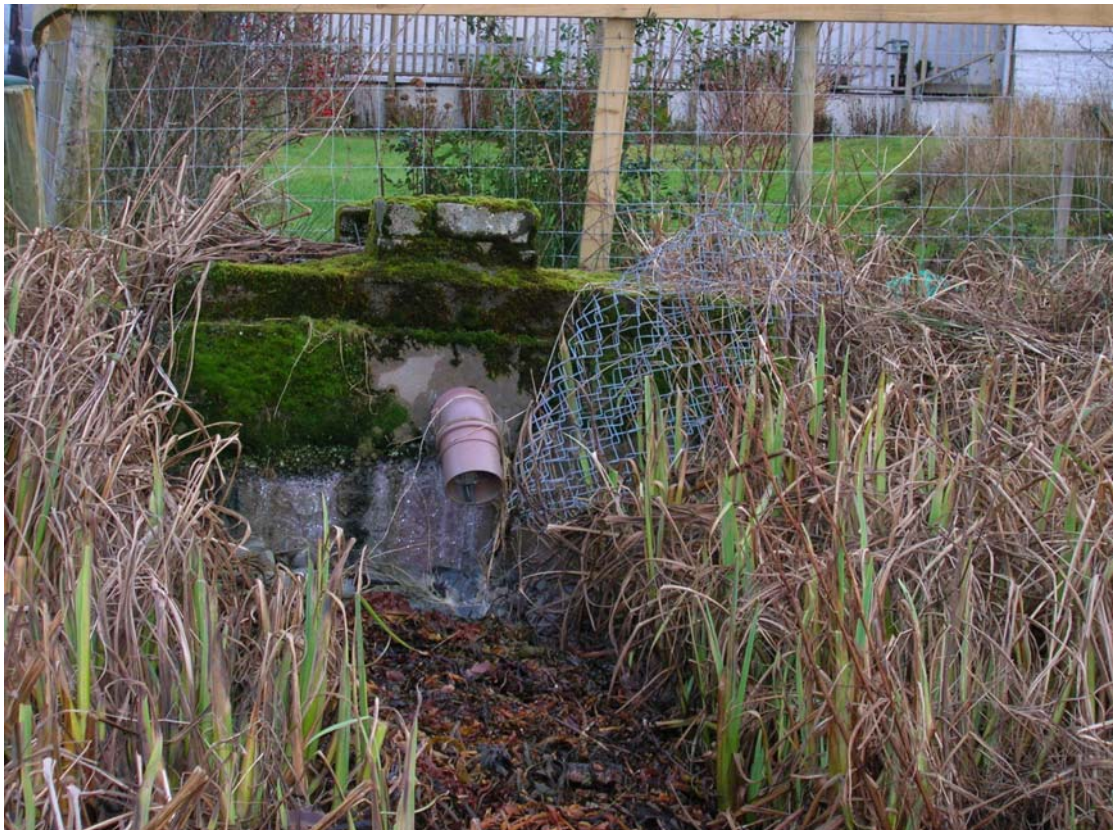
In addition to streams, a fresh water discharge from the Morar septic tank overflow was also sampled and had a high result of >100,000 *E. coli* CFU/100 ml.

Figure 9. Dripping overflow from Morar septic tank

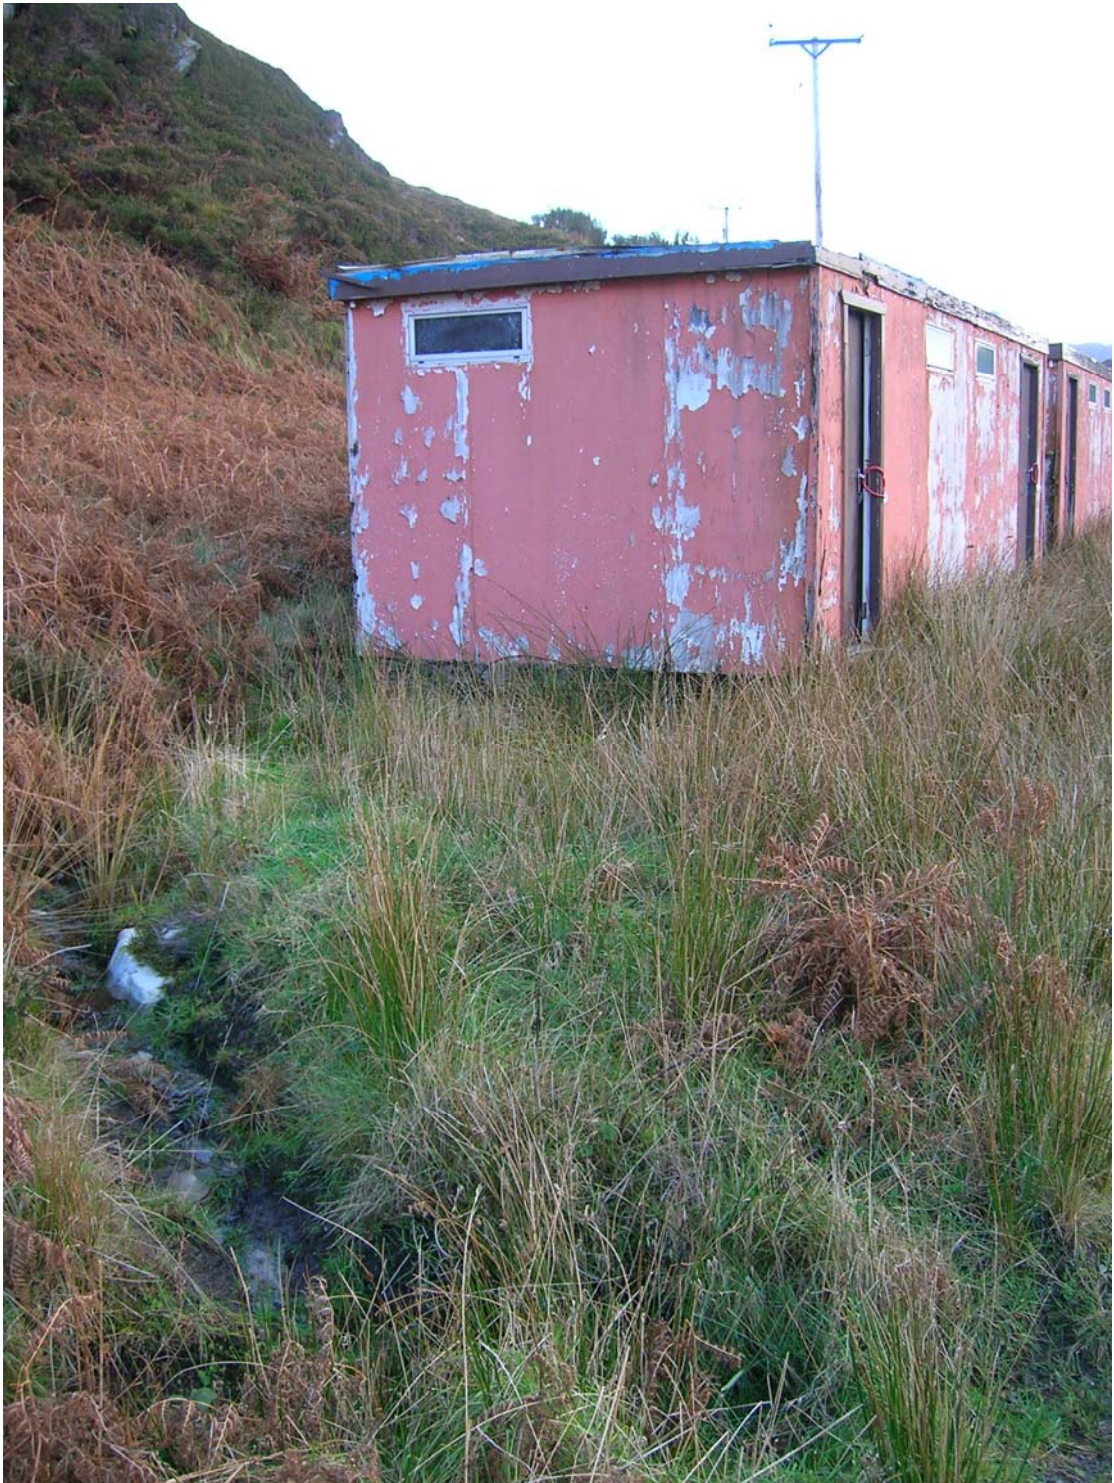
Figure 15. Old campsite toilets

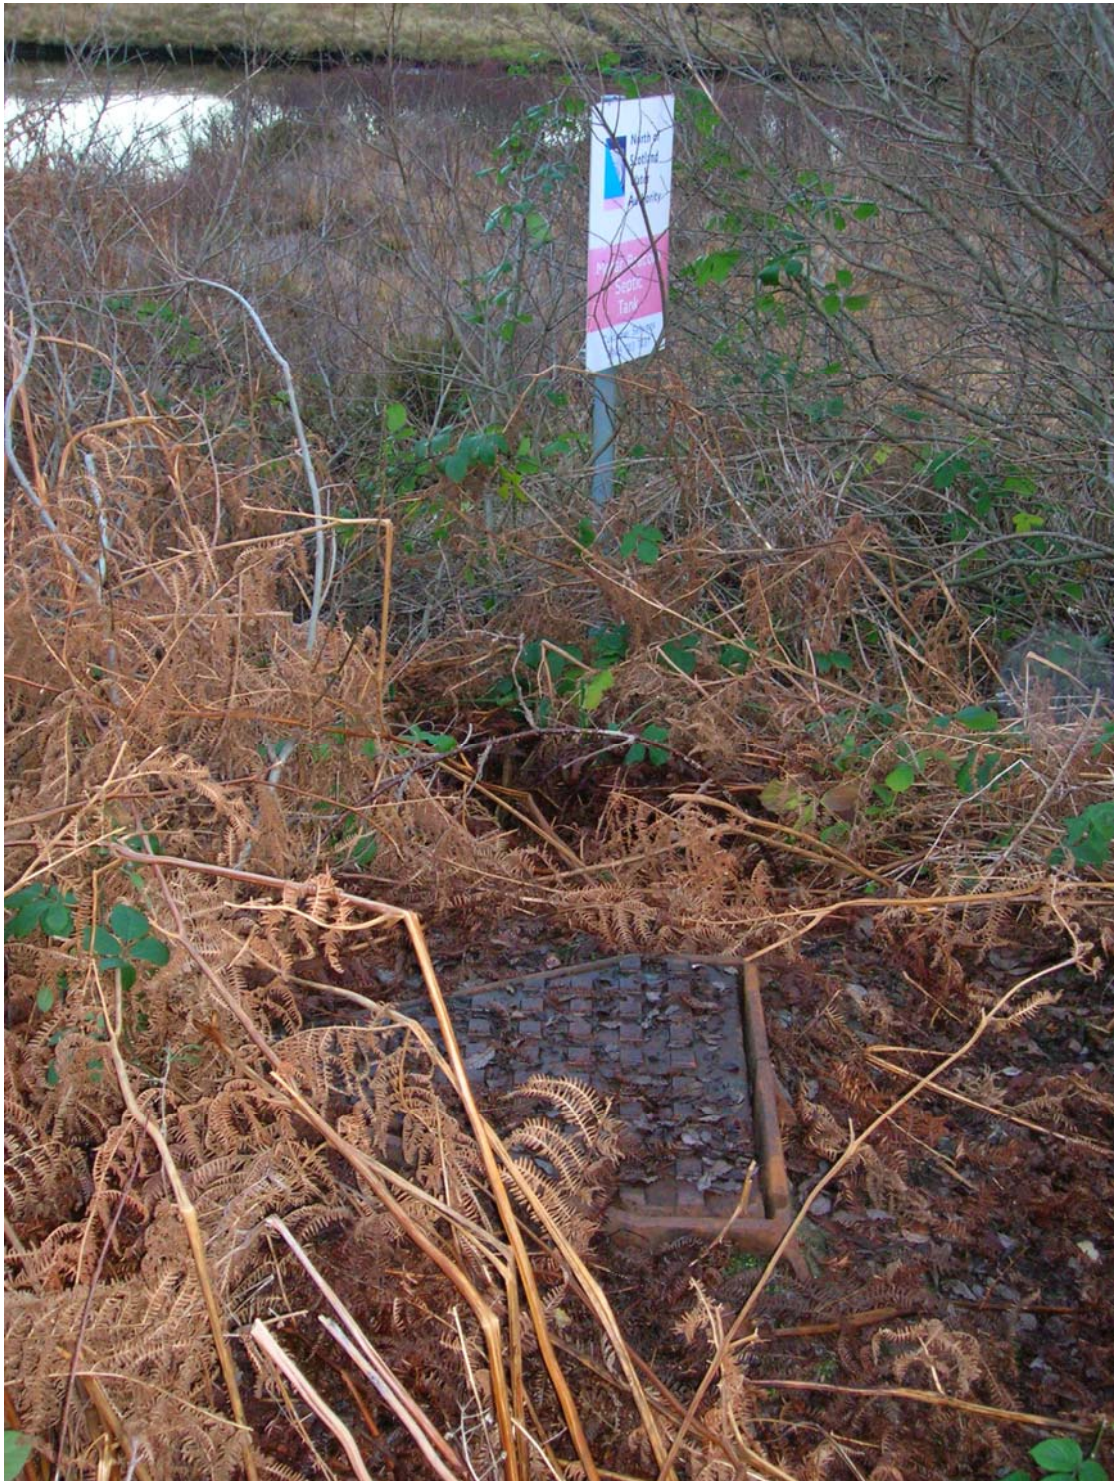
Figure 17. Morar/Bracora septic tank
