# Scottish Sanitary Survey Project

## Restricted Sanitary Survey Report Baleshare UB 492 March 2010

## Baleshare UB 492

### Restricted Sanitary Survey

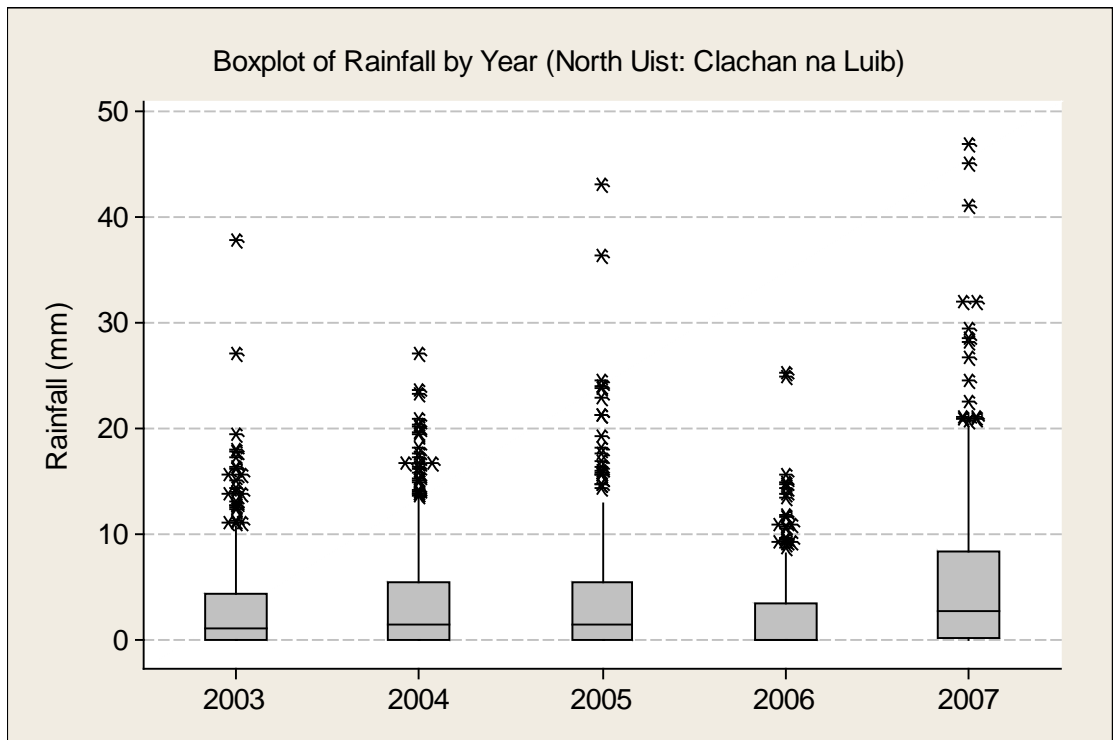
Figure 5.1 Boxplot of daily rainfall at North Uist by year

Figure 5.1 shows that there was significant variation in the median daily rainfall from year to year. Overall, 2006 was a dry year in this area and saw the lowest median rainfall. The highest individual rainfall events occurred in 2005 and 2007.

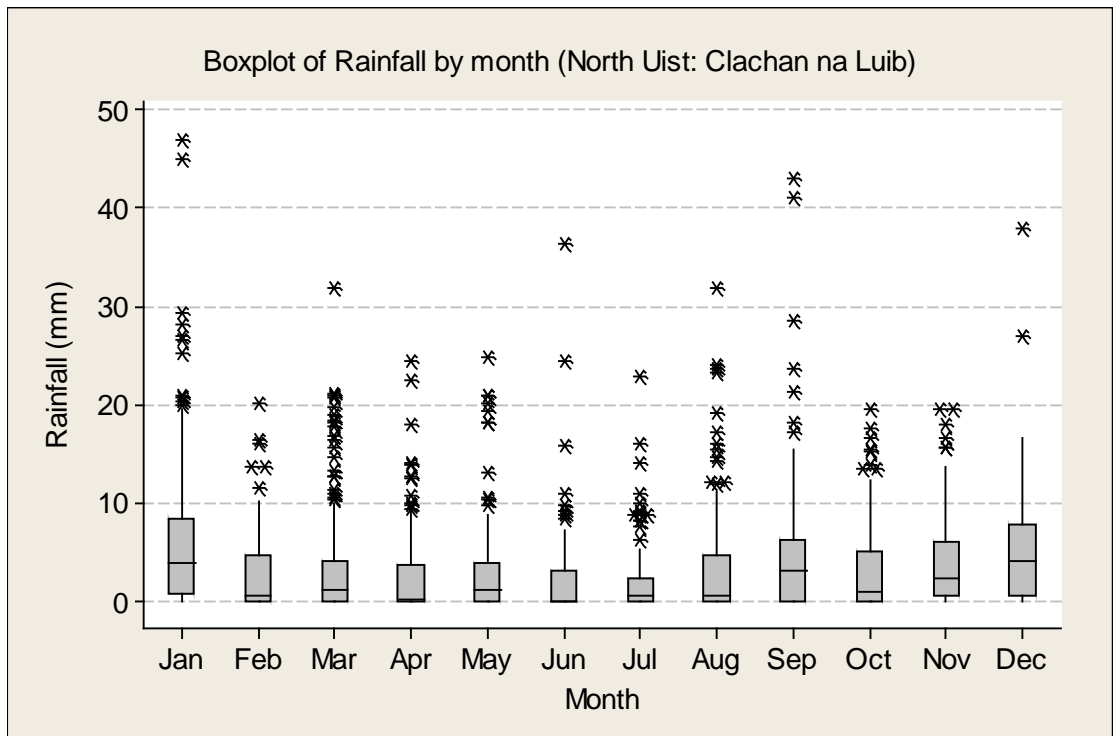
Figure 5.2 Boxplot of daily rainfall values at North Uist by month

The wettest months were December and January, but the high individual rainfall events occurred throughout the year, although not in all individual months. For the period considered here (2003 – 2007), 36% of days for which records were

available experienced no rainfall while 47% of days experienced rainfall of 1mm or less. Although the mean rainfall was 4 mm per day, there were 8 occasions where daily rainfall exceeded 30mm. The highest daily rainfall recorded (47mm) fell in January 2007.

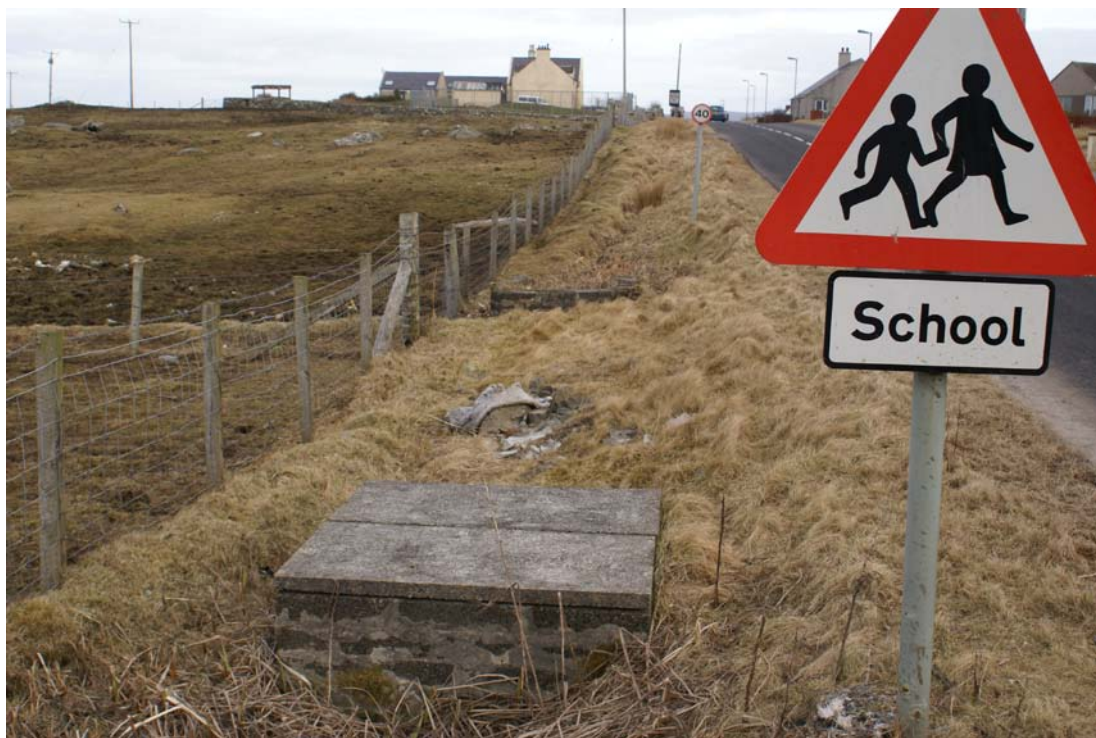
Figure 4. Septic tank at road.

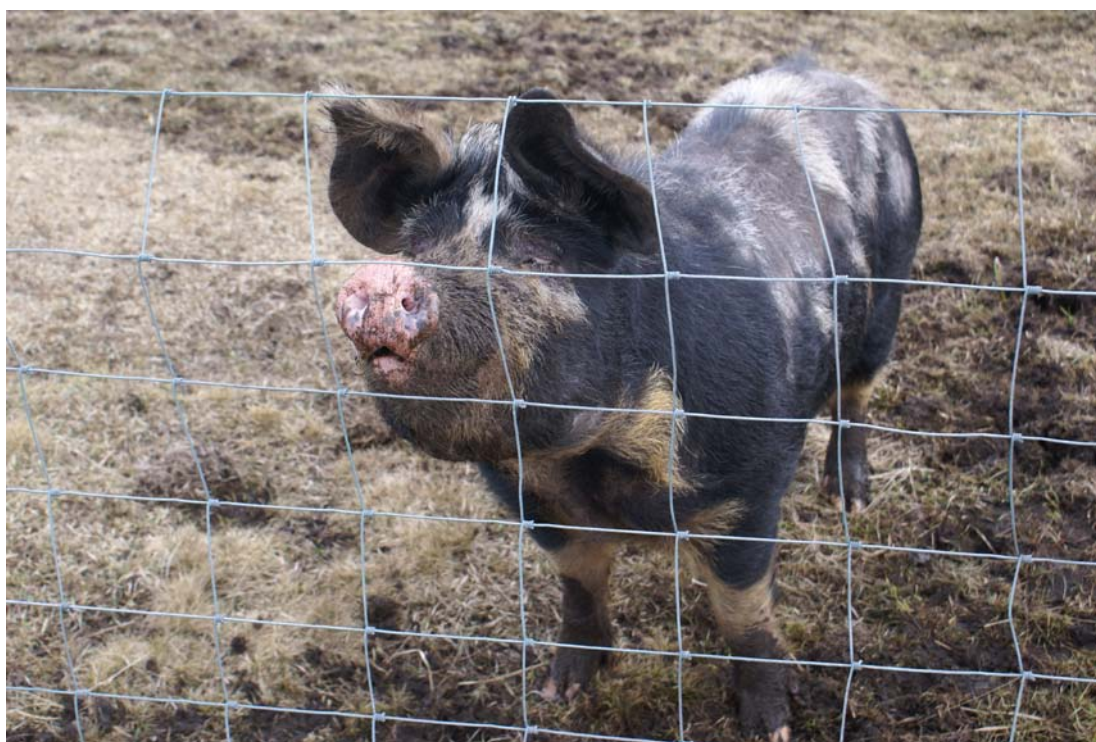
Figure 5. Pig in field close to shoreline

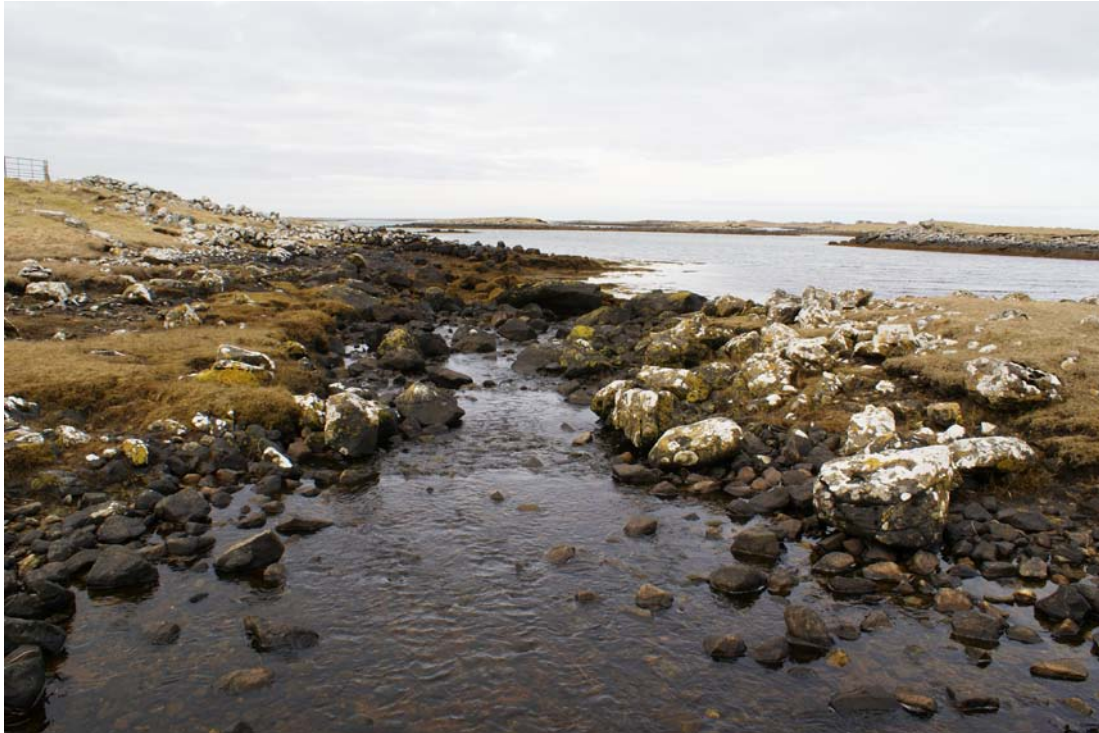
Figure 6. Fresh water field run-off, Fresh water sample BFW2

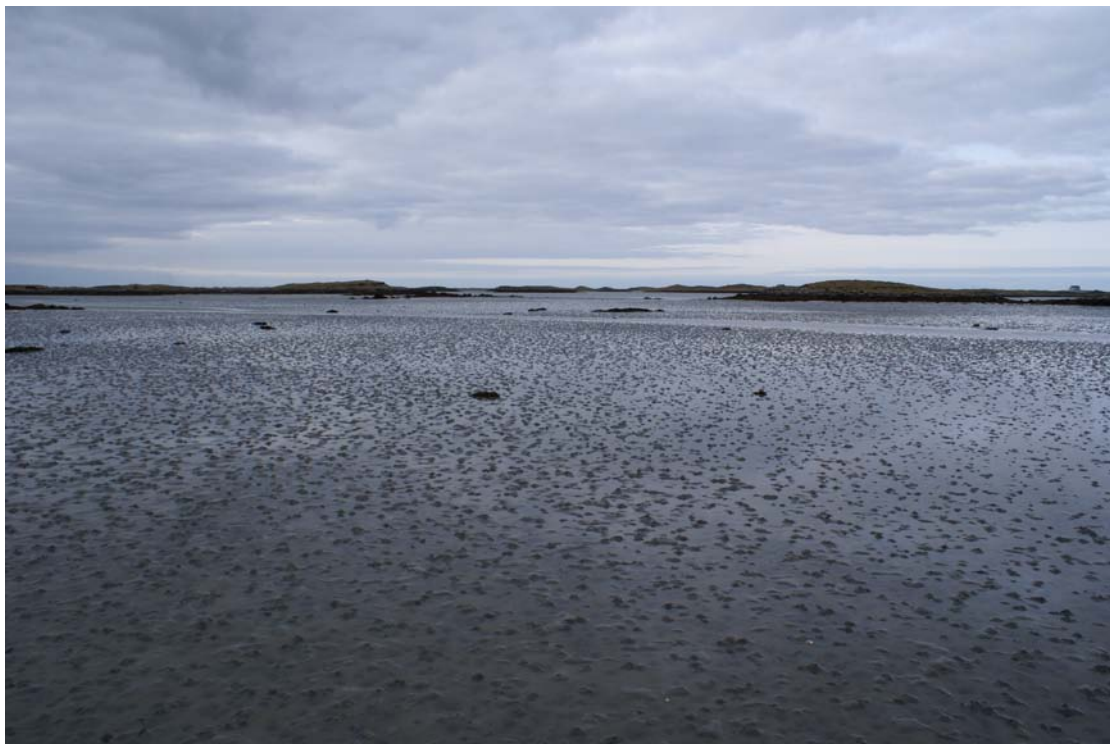
Figure 7. Cockle sample BC1

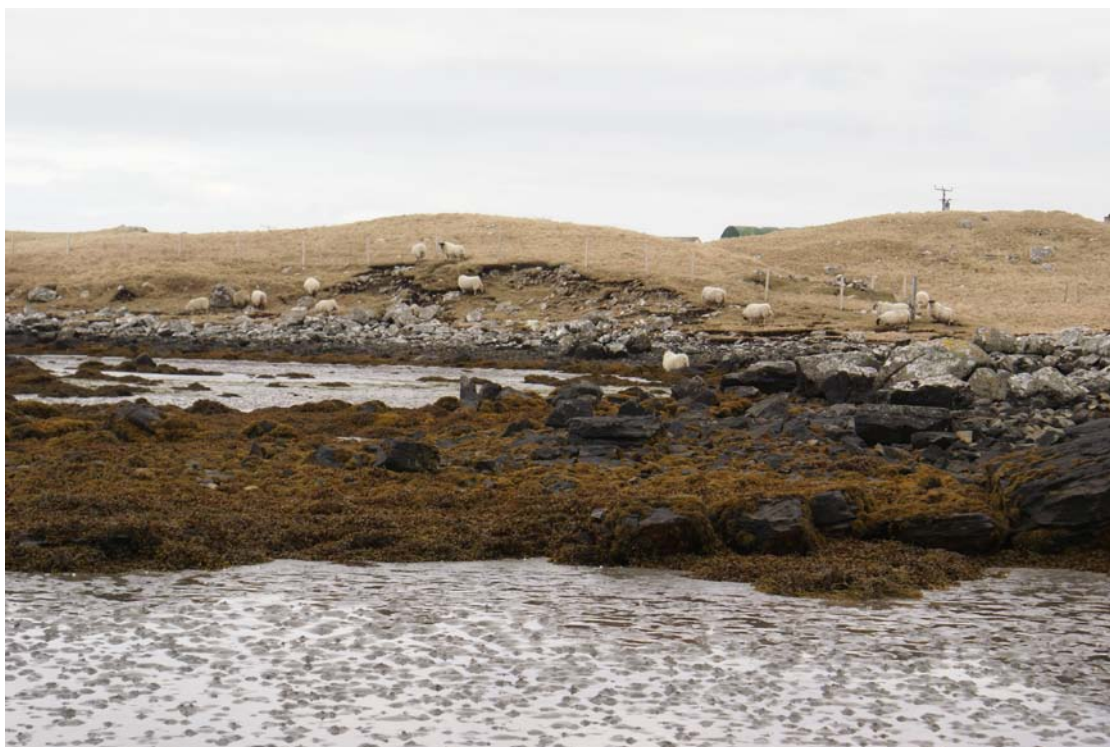
Figure 9. Thirty-one sheep at shoreline

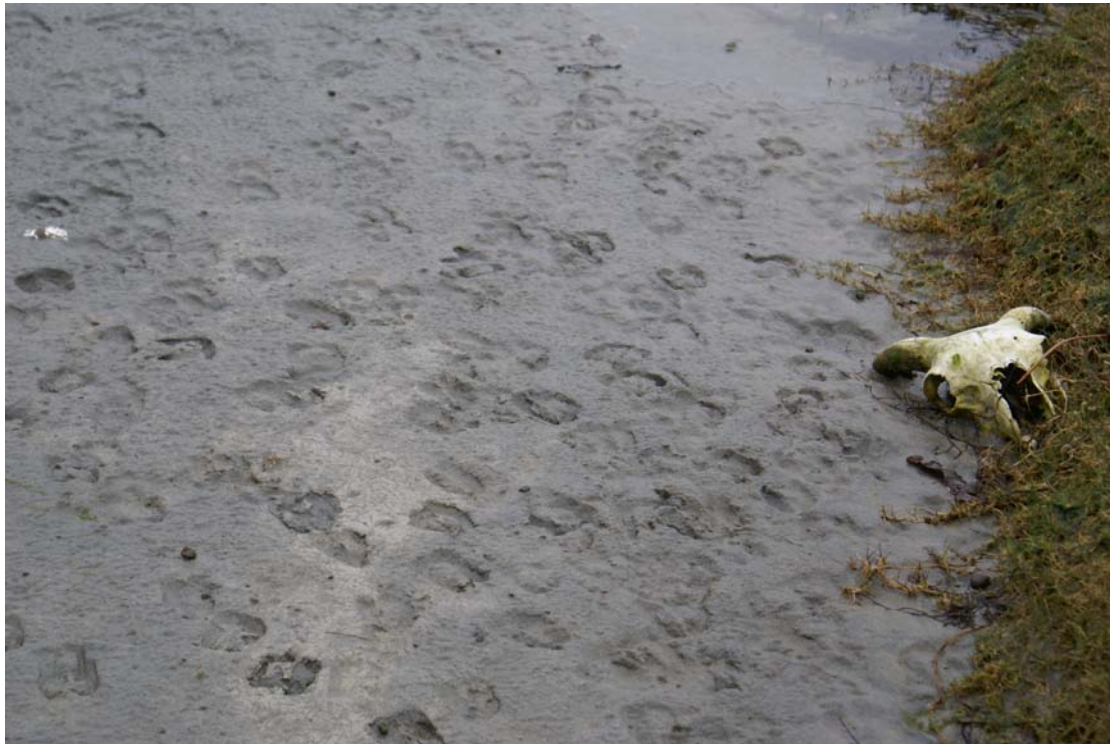
Figure 10. Sheep tracks on shoreline

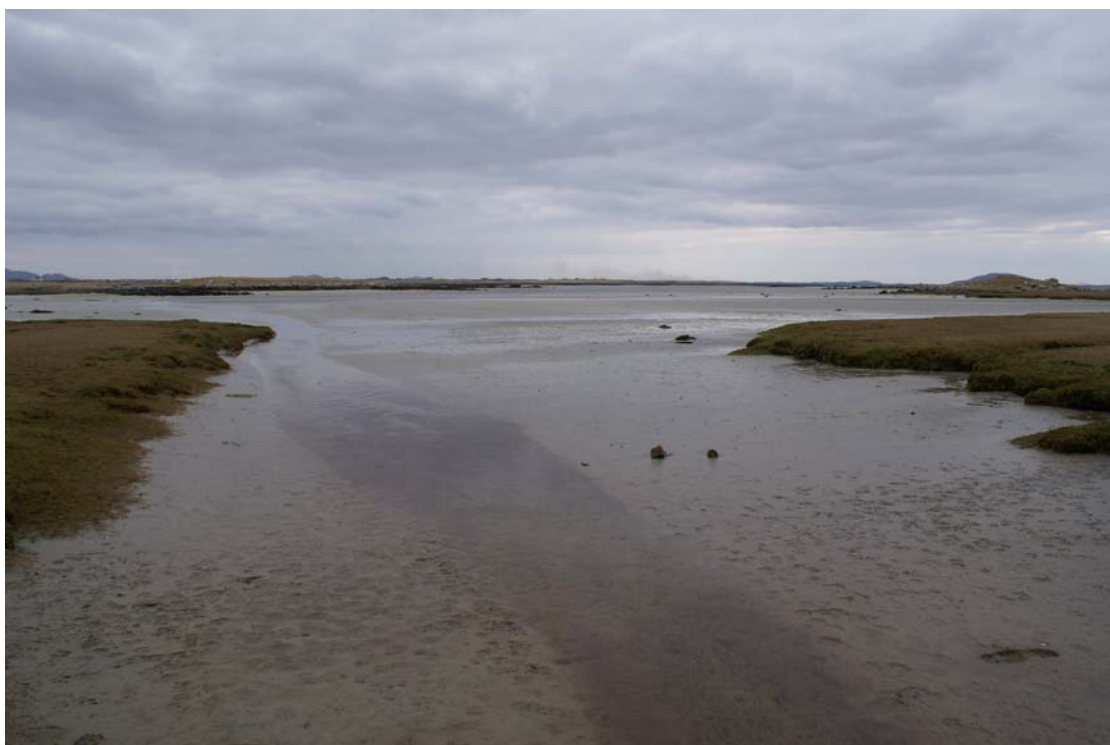
Figure 11. Fresh water input, traced up land. Fresh water sample BFW5
