Scottish Sanitary Survey Report

Sanitary Survey Report Basta Voe Cove SI-232 and SI-324 February 2015

Report Title	Basta Voe Cove Sanitary Survey Report
Project Name	Scottish Sanitary Survey
Client/Customer	Food Standards Agency Scotland
Cefas Project Reference	C63162C
Document Number	C6316C_2014_16
Revision	v0.1
Date	19/02/2015

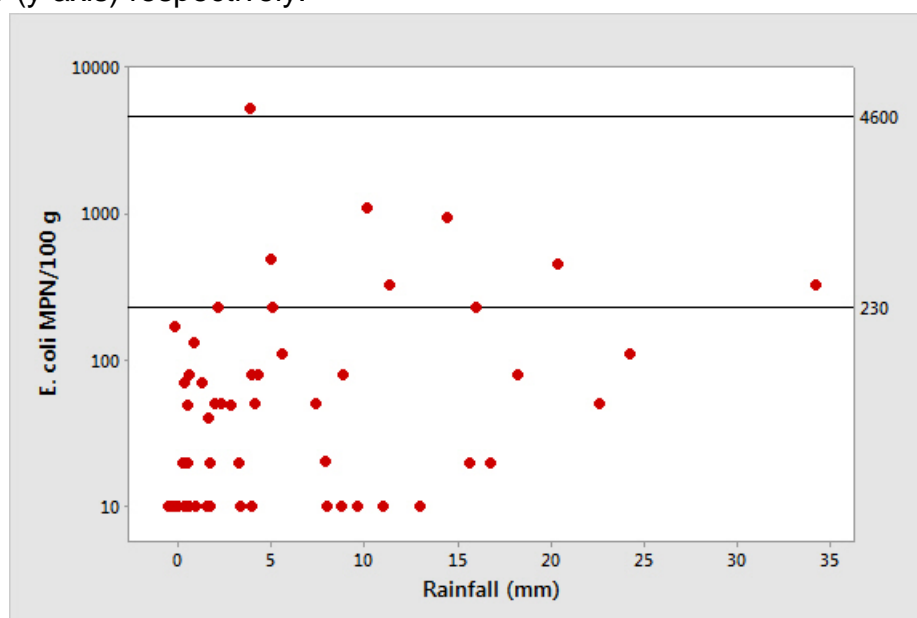
Figure 11.5 Scatterplot of *E. coli* results against rainfall in the previous two days at Basta Voe Cove

A highly significant correlation was found between *E. coli* results and the previous two day rainfall (Spearman's rank correlation $r = 0.385$, $p = 0.004$). The highest result

Statistically significant correlations were found between results and previous two- and seven-day rainfall. It was noted that results >230 *E. coli* MPN/100 g occurred at rainfall levels >5 mm and >10 mm in the previous two days and seven days respectively.

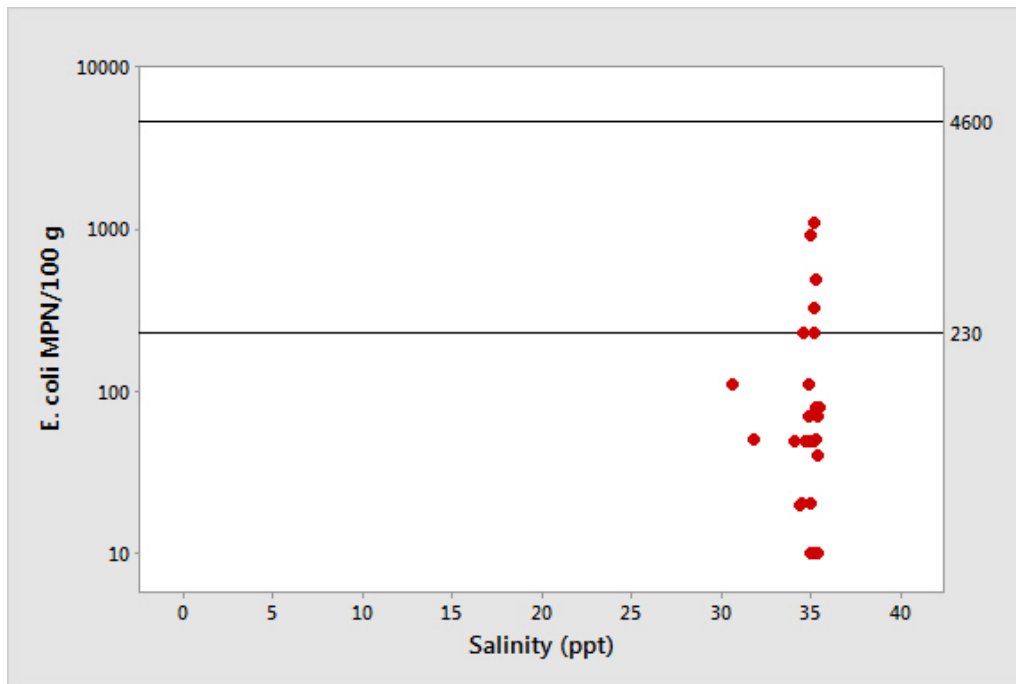
Figure 11.10 Scatterplot of *E. coli* results against salinity at Basta Voe Cove

No statistically significant correlation was found between common mussel *E. coli* results and salinity (Spearman's rank correlation $r = -0.143$, $p = 0.414$).

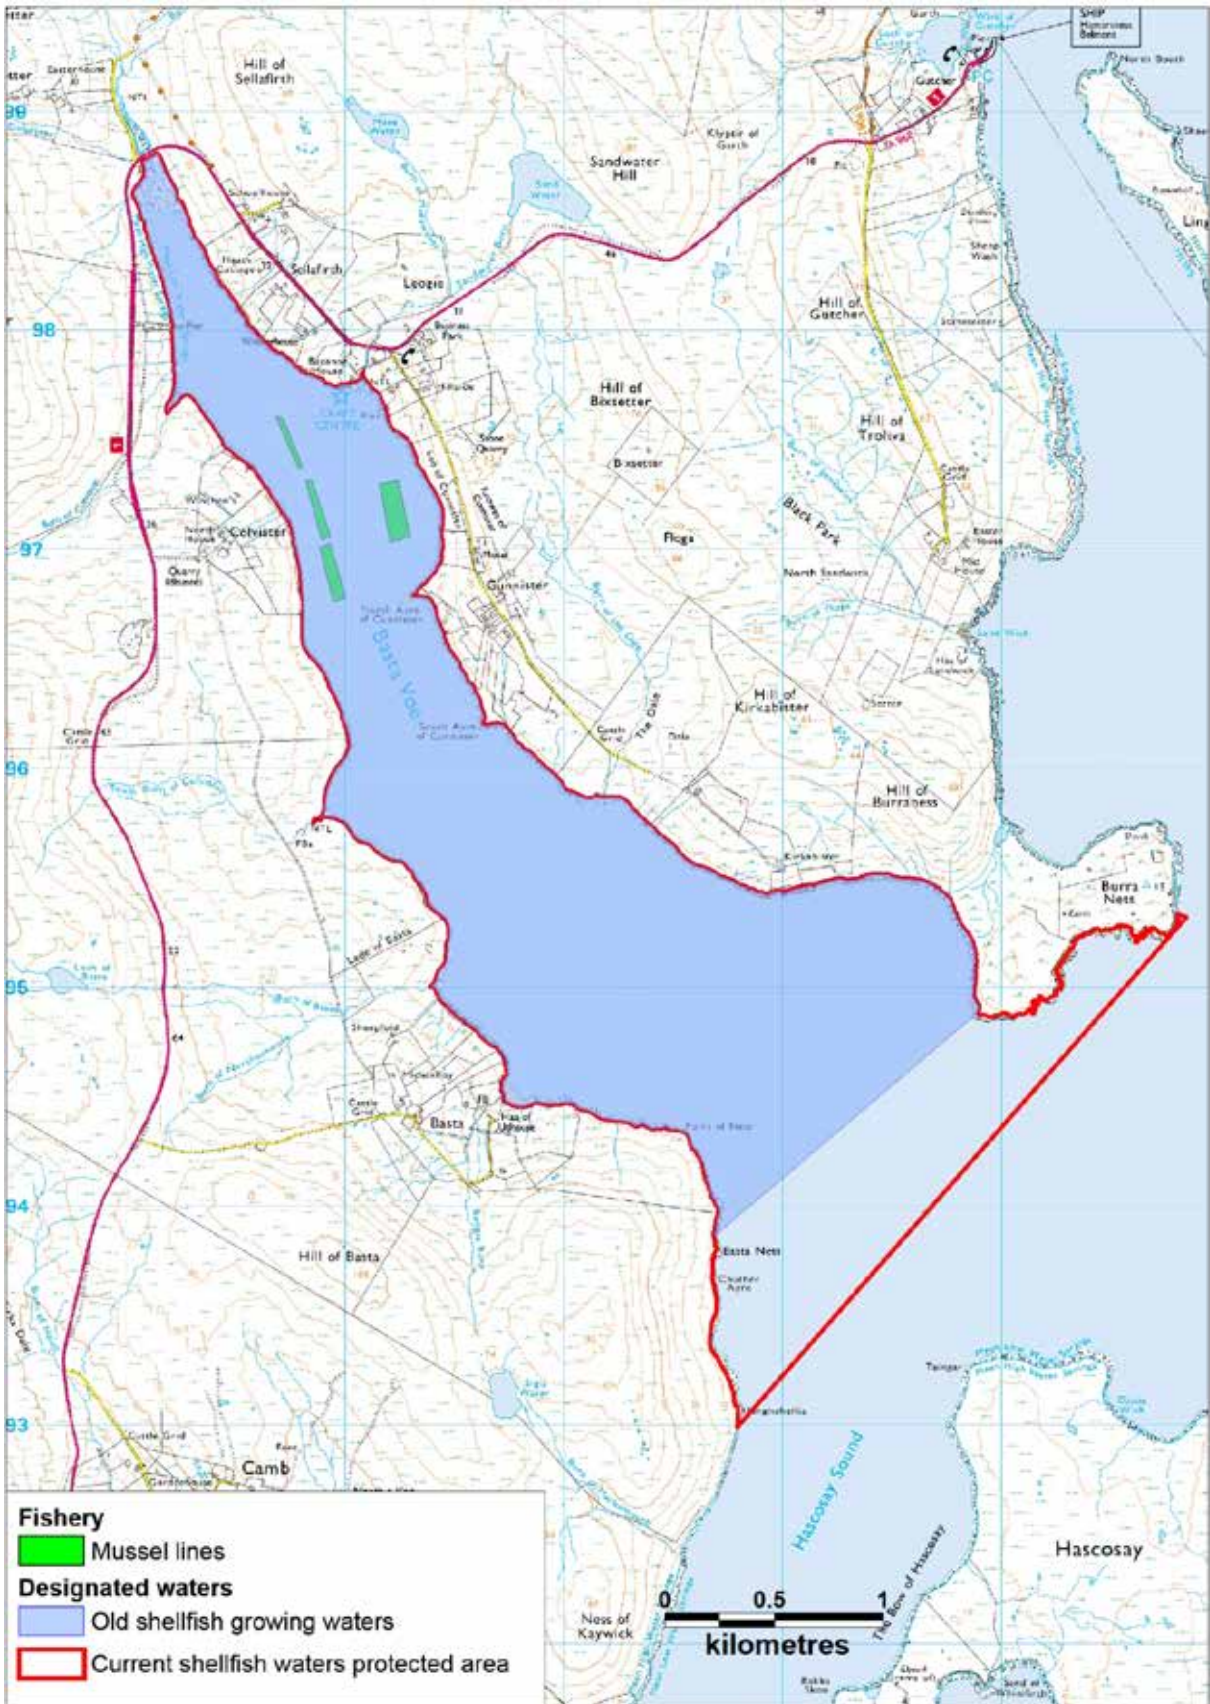
Figure 12.1 Designated shellfish water protected area – Basta Voe

The Shellfish Waters Directive (2006/113/EC) has been repealed (as at 31 December 2013) and equivalent protection for areas previously designated under that Directive is given by The Water Environment (Shellfish Water Protected Areas: Environmental Objectives etc.) (Scotland) Regulations 2013. The Basta Voe, Yell Shellfish Water Protected Area (SWPA) has slightly extended boundaries compared to the previous Basta Voe, Yell Shellfish Growing Water (SGW). The SWPA designation covers matches the production area boundary and includes all of the mussel farms. The designated SWPA for Basta Voe, Yell is shown in Figure 12.1. Since 2007, assessment of the bacteriological status of shellfish waters has been undertaken using the shellfish hygiene *E. coli* data and this data has been reviewed in Section 11.

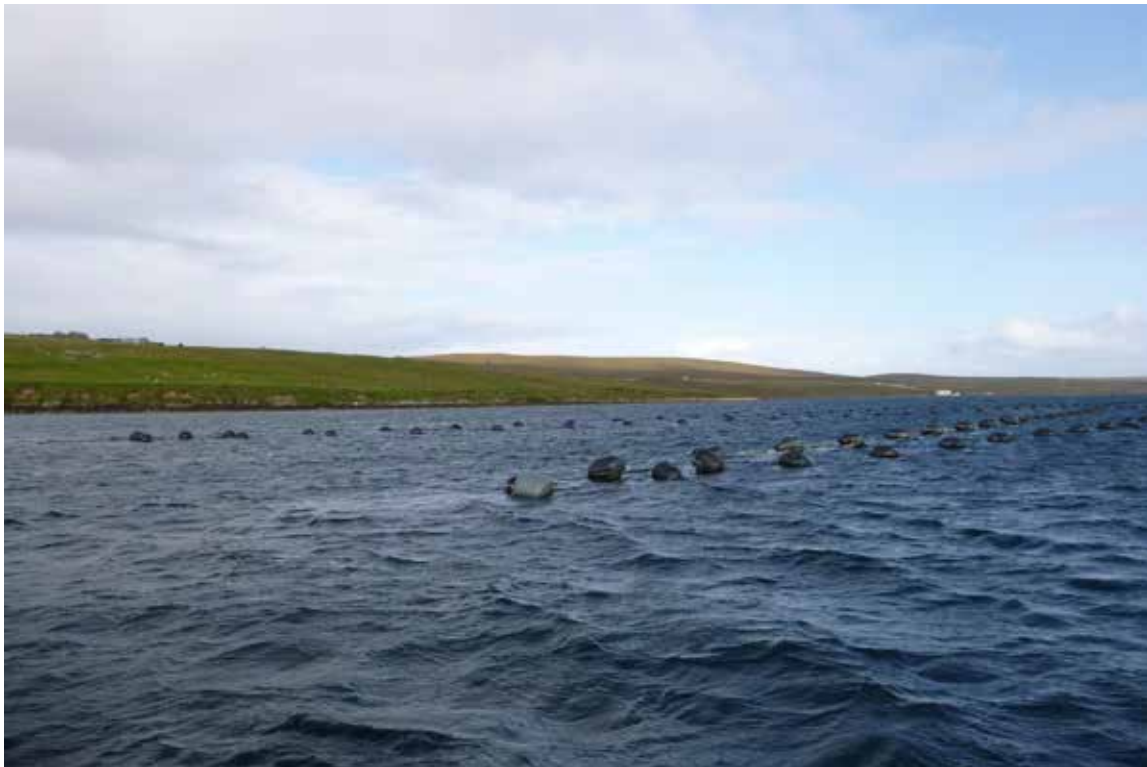
Figure 4 – Mussel lines at the Inner Site 1 Thomason fishery, middle group, looking north-west

The Inner Site 1 Thomason fishery (known to the harvester as Colvister) consisted of three groups of mussel lines running parallel to the eastern shoreline (Figures 4 and 5). The southernmost group had five lines present, one of which was a single double-headed longline with the remaining four lines arranged as quad-headed longlines (i.e. a pair of double-headed lines to a single mooring at either end). The middle group consisted of four lines arranged as quad-headed longlines and the

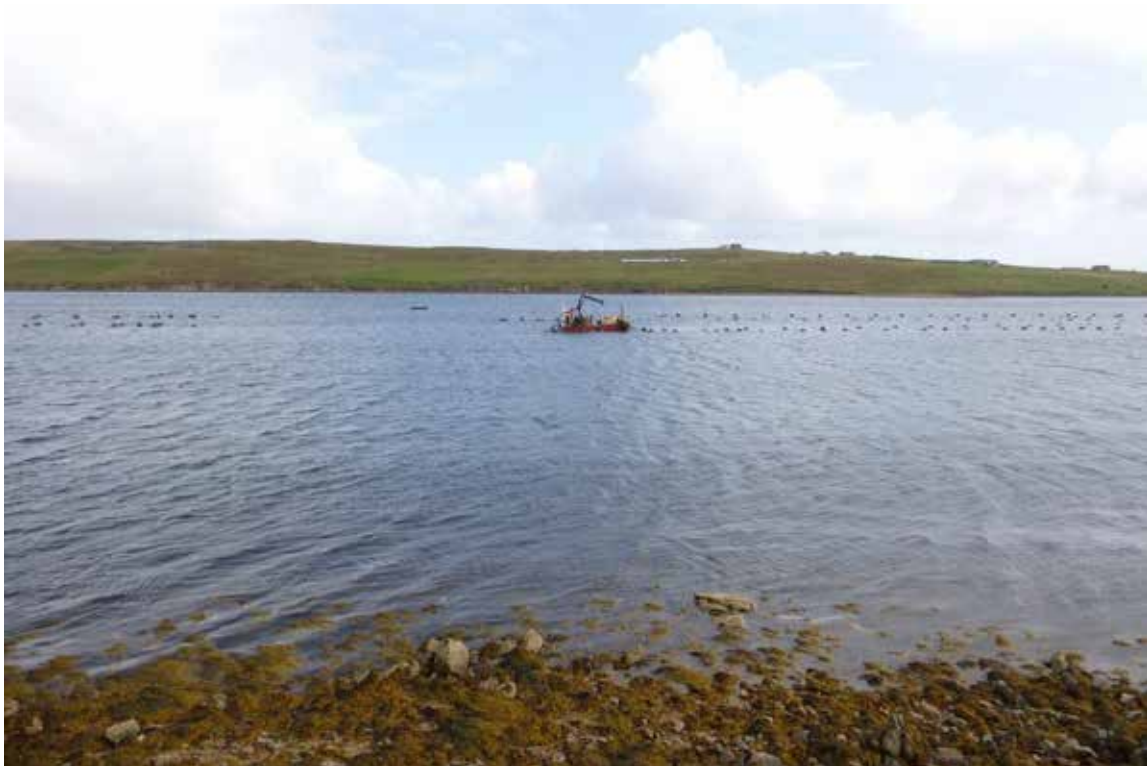
Figure 5 – Mussel lines at the Inner Site 1 Thomason fishery, southern group, looking east

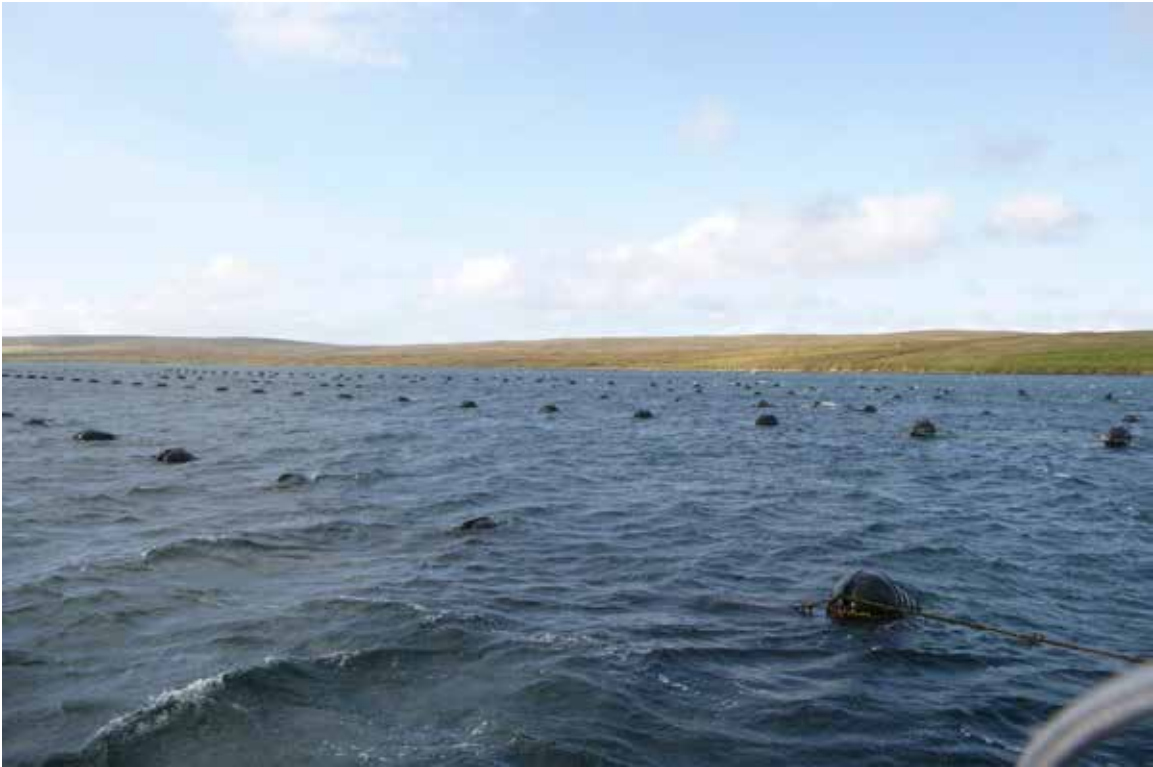
Figure 6 – Mussel lines at the Inner Site 2 Nisbet fishery looking south-west

The Inner Site 2 Nisbet fishery is located on the opposite side of the voe and consisted of a single group of nine double-headed long lines aligned with the shore (Figures 6 and 7). This site is licenced for three 220 metre quad-headed longlines. All lines on both fisheries were with 8 metre droppers.

3	19/08/2014 07:55	HU 52240 97315	452240	1197315	Figure 6		NE corner of the Inner Site 2 Nisbet fishery. Photo looking SW across fishery.
4	19/08/2014 07:58	HU 52294 97058	452294	1197058		BVC-SW02	SE corner of the Inner Site 2 Nisbet fishery. Seawater sample collected.
5	19/08/2014 07:59	HU 52205 97033	452205	1197033			SW corner of the Inner Site 2 Nisbet fishery (approximate, close pass not possible)

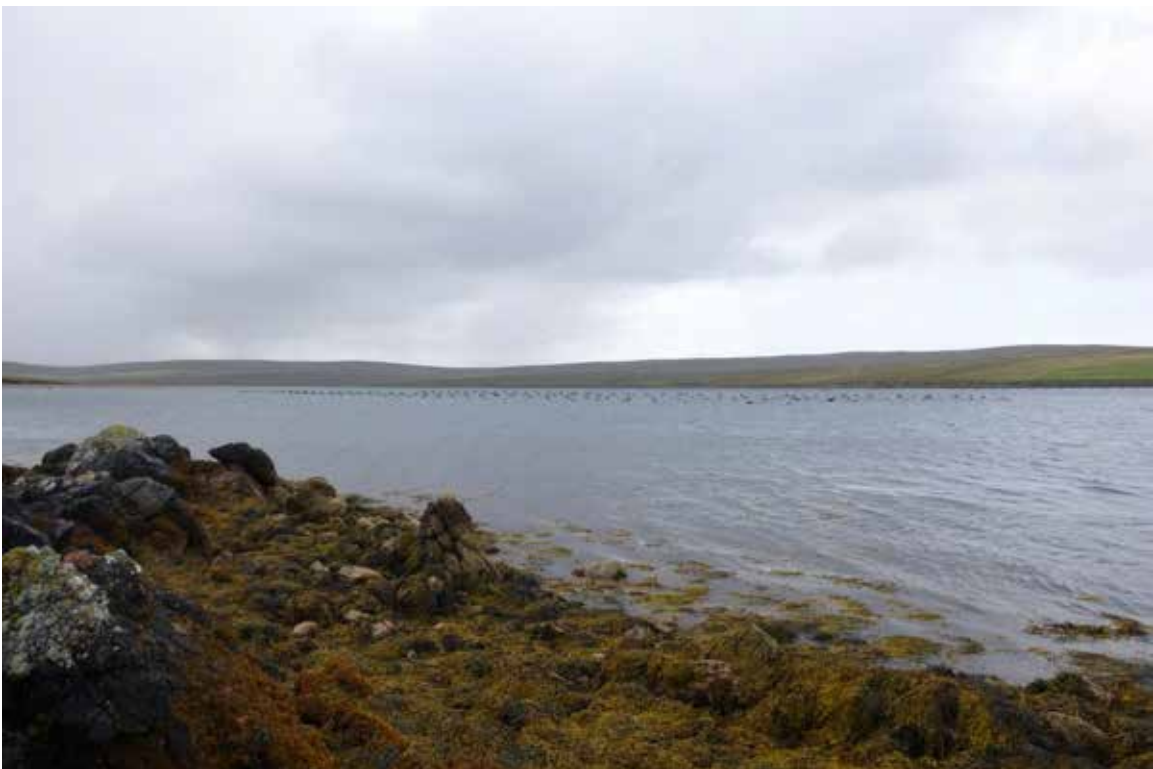
Figure 7 – Mussel lines at the Inner Site 2 Nisbet fishery looking west

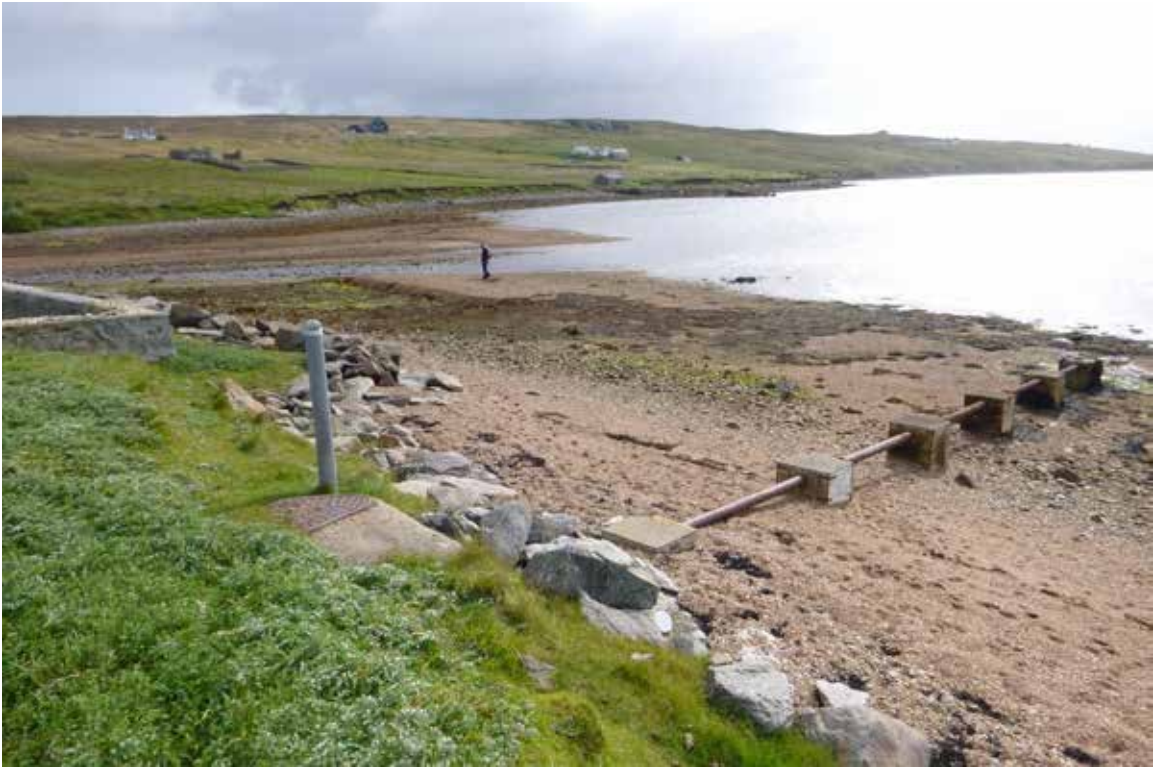
Observations 1 and 2 relate to a septic tank and outfall pipe. A slight grey discharge was noted from the end of the outfall pipe. No sample was taken. This outfall plots close to, and probably represents, CAR/R/1046278 which has a PE of 5.

Figure 8 – Concrete septic tank and outfall associated with property close to shore. Sandwater Burn beyond.

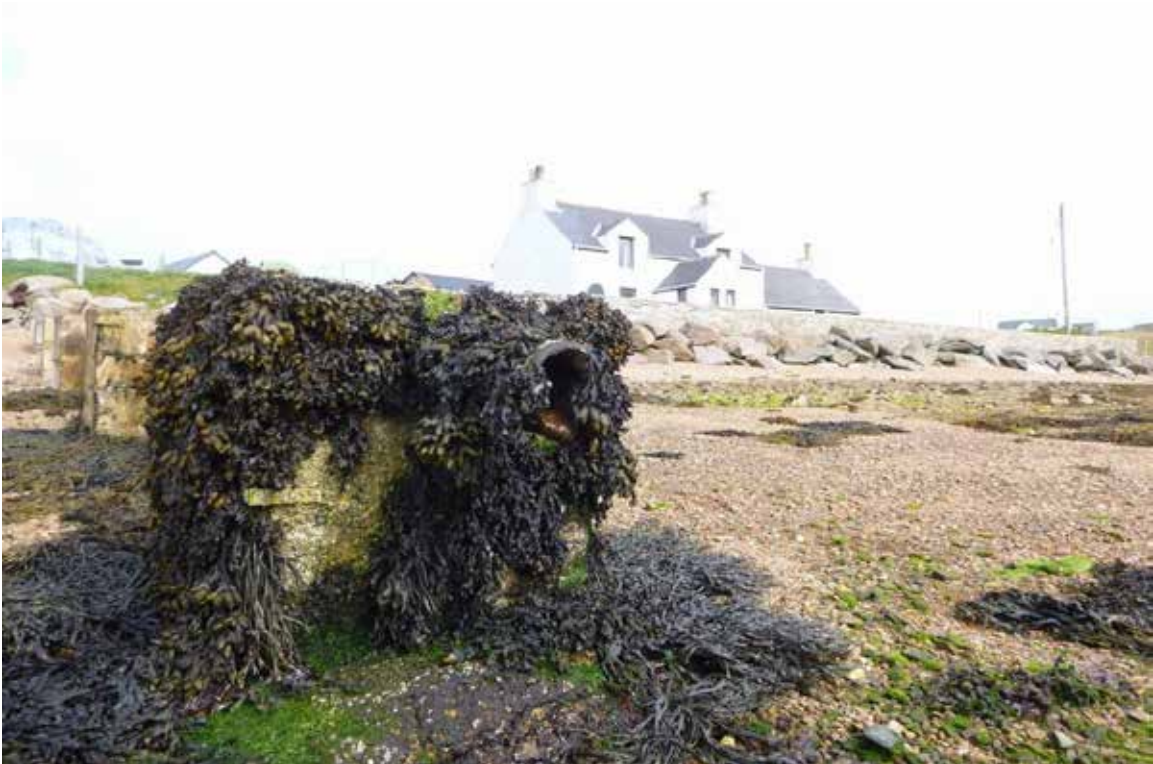
Figure 9 – The outfall associated with the septic tank illustrated in Figure 8.

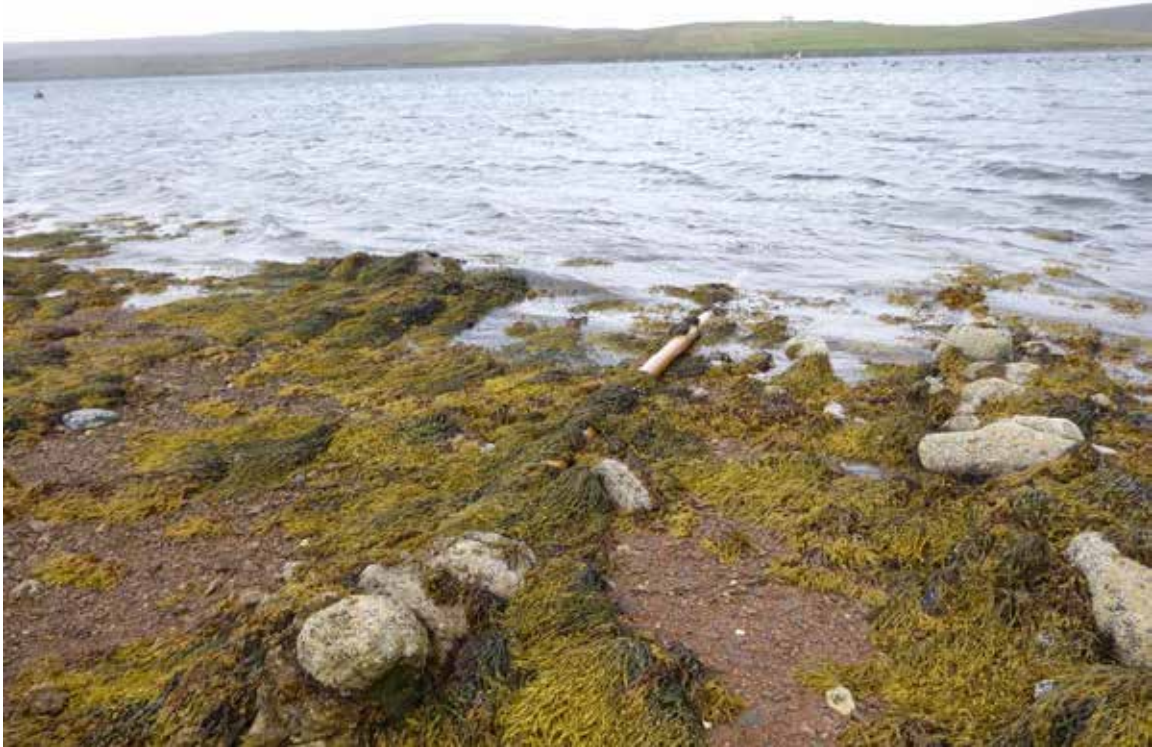
Figure 10 – Discharge pipe to sea associated with the septic tank of the disused North Isles Motel.

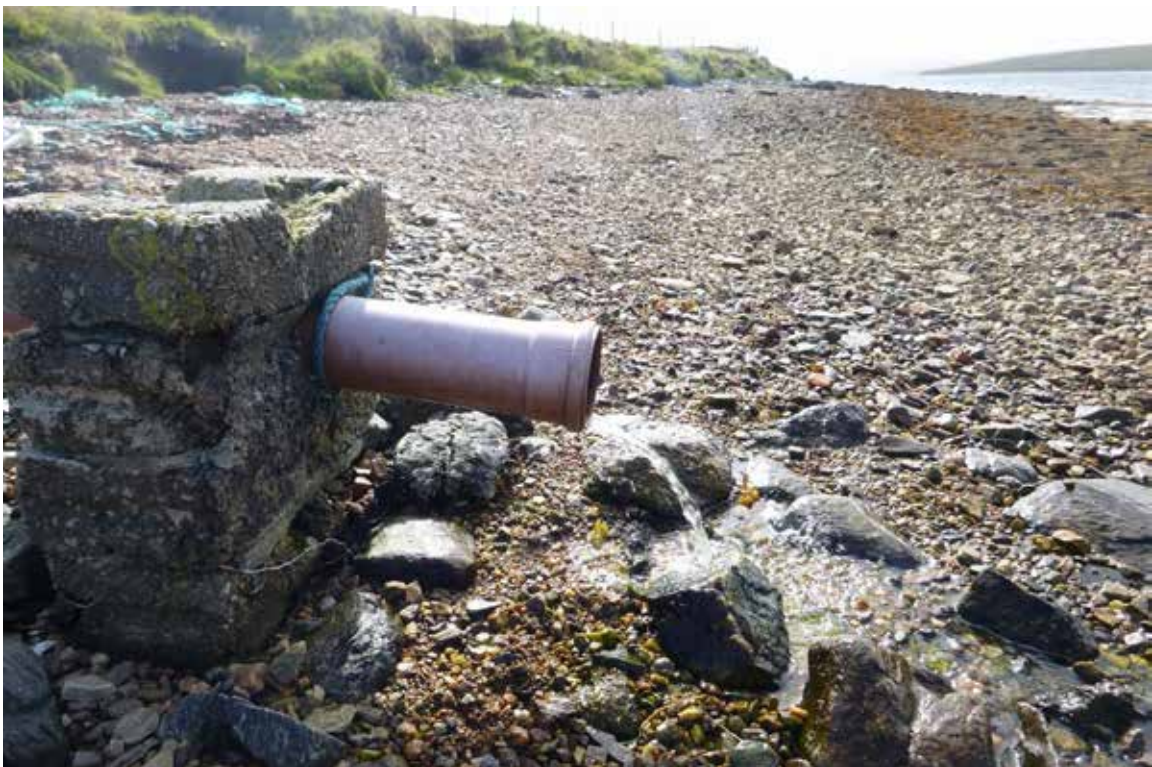
Figure 11 – Pipe with clear discharge. No source identified, potentially field drainage.

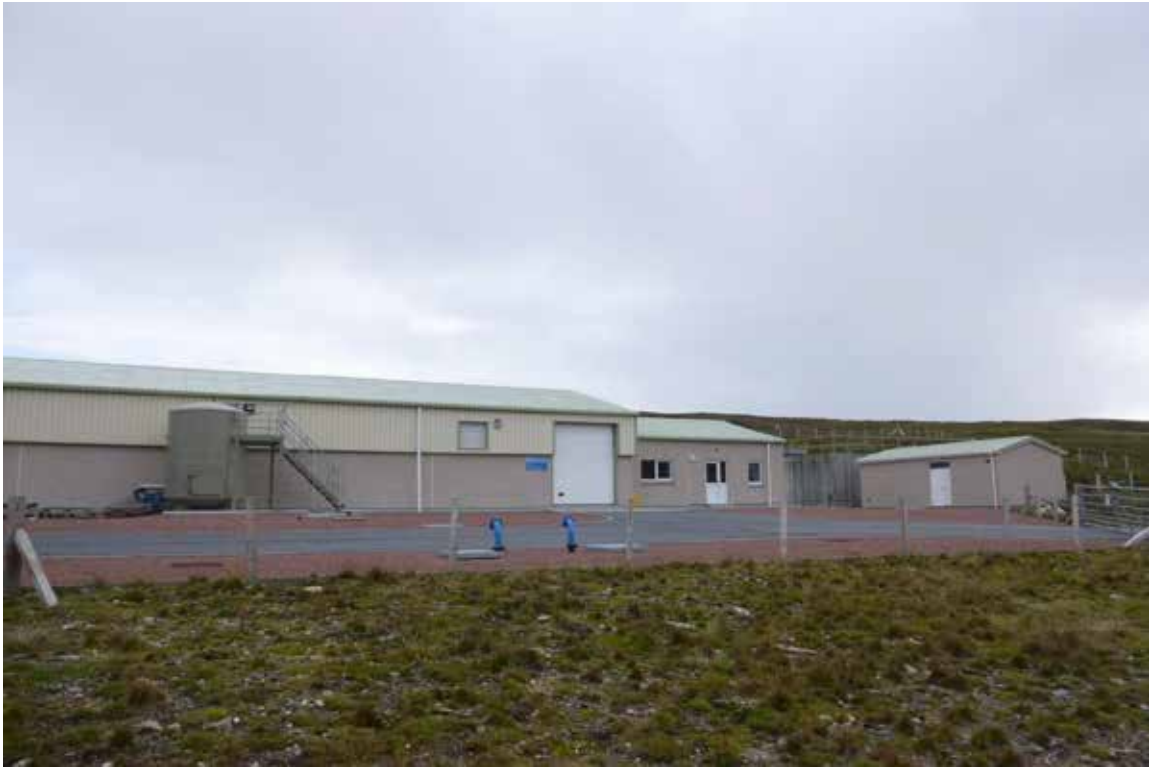
Figure 12 – Yell Water Treatment Works

The Yell Water Treatment Works is located at the head of Basta Voe (Figure 12). A sampling point was located next to a drainage ditch which led to a tributary of the Burn of Gossawater although an outfall from the plant was visible in the area.

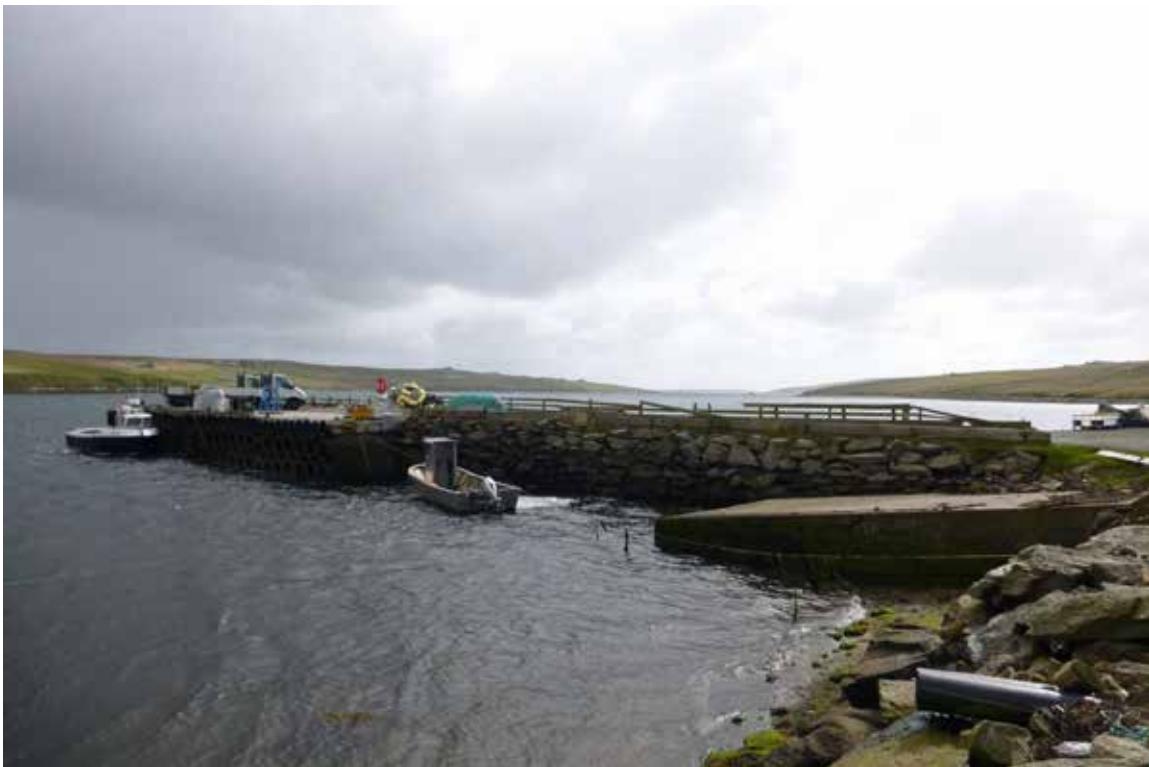
Figure 13 – Shore base and pier operated by C & A Thomason and Thompson Brothers Salmon Ltd. Two discharge pipes to the rock armouring.

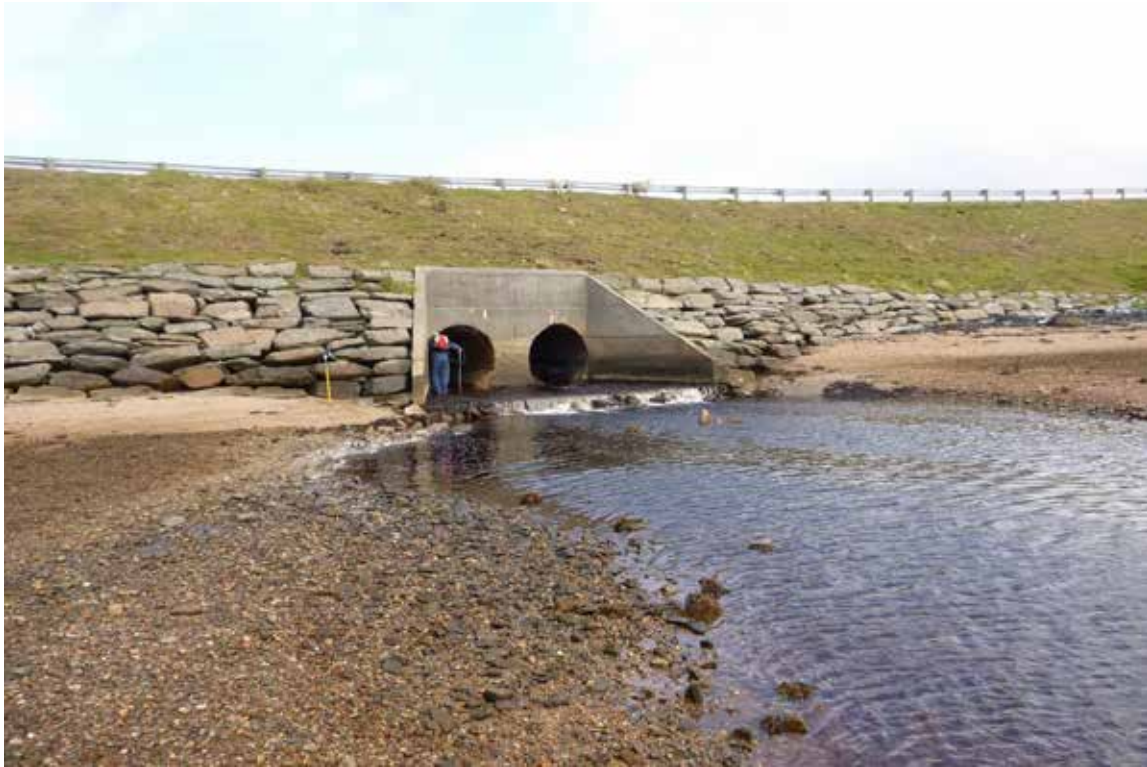
Figure 14 – Culvert for the Burn of Gossawater under the A968 road at the head of Basta Voe.

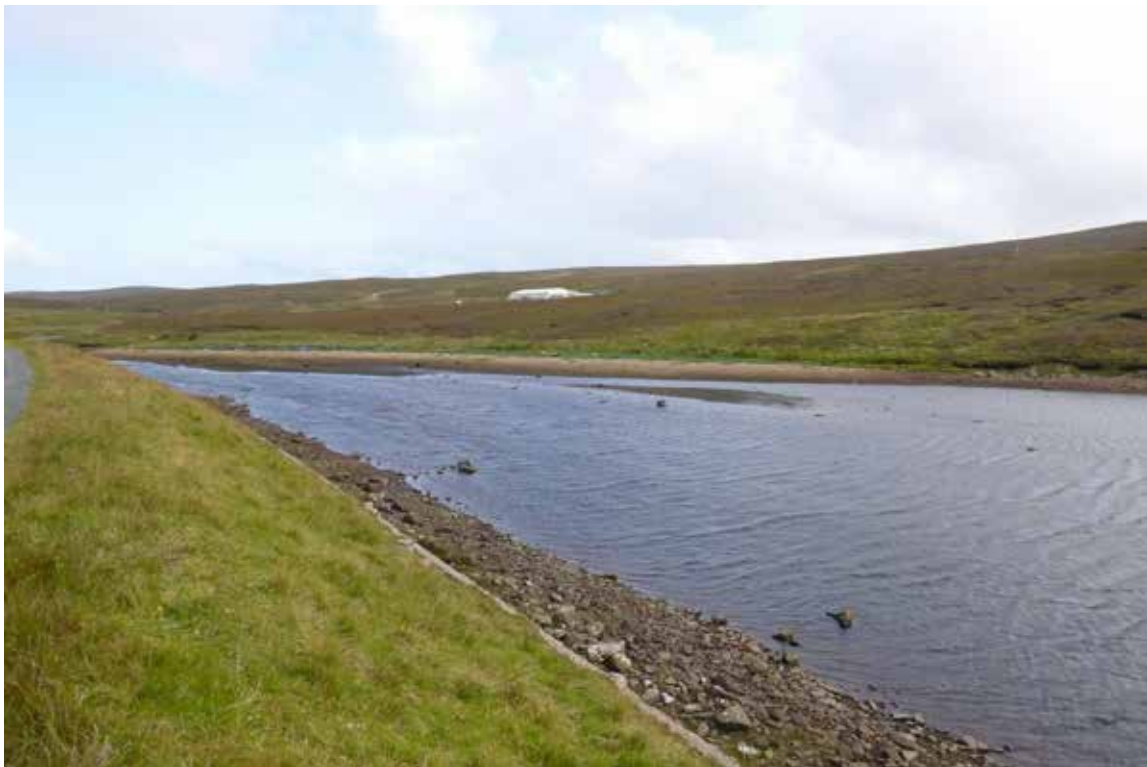
Figure 15 – Pool at the Burn of Gossawater inshore from the culvert.

The four watercourses sampled were found to have *E.coli* levels between 160-350 cfu/100 ml. The lowest levels were present at the South Burn of Colvister and the highest levels were present at Sandwater Burn. The Burn of Gossawater at the head of Basta Voe was the largest watercourse encountered and this passed beneath the A986 road via two culverts (Figure 14). A pool was present on the landward side of this and strandline debris on the grass surrounding the pool indicated that this was subject to tidal influence (Figure 15).
