Scottish Sanitary Survey Programme

Sanitary Survey Report Bay of Backaskail OI 453 January 2012

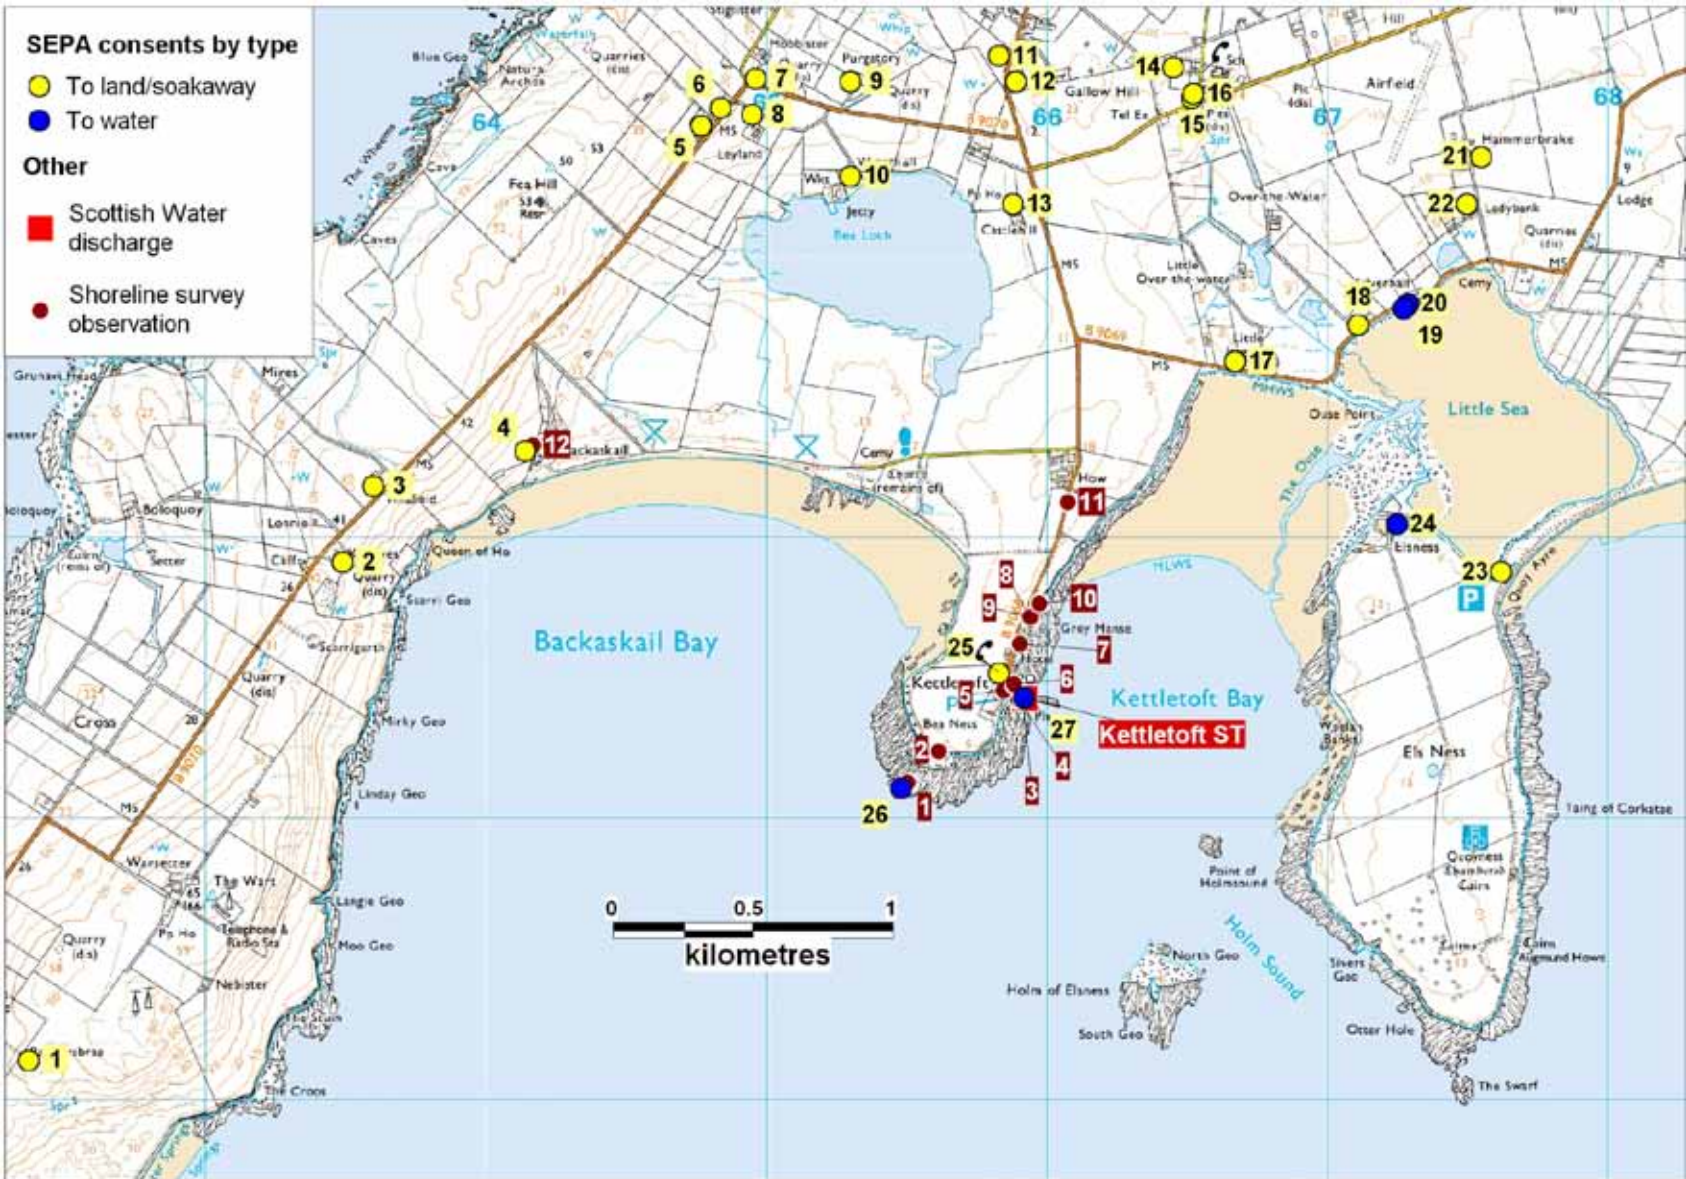
Figure 4.1 Map of discharges for Backaskail Bay

The only direct discharge to Backaskail Bay is from the Scottish Water septic tank, which discharges off the end of Bea Ness. The discharge consent identifies that the maximum consented flow is 19m³ per day, and that an emergency overflow discharges adjacent to Kettletoft pier. It is likely that the pipe observed along the jetty (Table 4.3, No. 10) is the emergency overflow pipe. No evidence of recent flow from this pipe was seen during the shoreline survey. As this should only flow in emergency, it is not expected to affect the bacteriological water quality in the area on a regular basis.

The sewage pumping station at Kettletoft was observed during the survey, and though evidence of the outfall pipe was observed, the pipe itself was not seen. A seawater sample taken from the location suggested moderate faecal contamination.

A number of discharge pipes were observed along the shore of Kettletoft, some of which were active. These appeared to relate to caravans interspersed among the homes along the shore. Other outfall pipes appeared to be out of use and may relate either to homes that were only occupied seasonally or that had been connected to the Scottish Water tank at Kettletoft, making the older discharge pipes redundant.

Observation 11 relates to the septic tank for How Farm. No discharge pipe was found on the shore side of the tank, therefore it is presumed to drain to soakaway. Although SEPA identified a consented discharge to Little Sea at the farm on the north end of Els Ness, no septic tank or evident discharge was found during the shoreline survey.

Discharges along Kettletoft Bay, and any further discharges along Els Ness or Little Sea would be most likely to affect water quality within Kettletoft Bay itself. Discharge from the Scottish Water septic tank at Kettletoft could potentially affect water in both bays, depending on local hydrodynamics. There were no direct discharges to the head of Backaskail Bay.

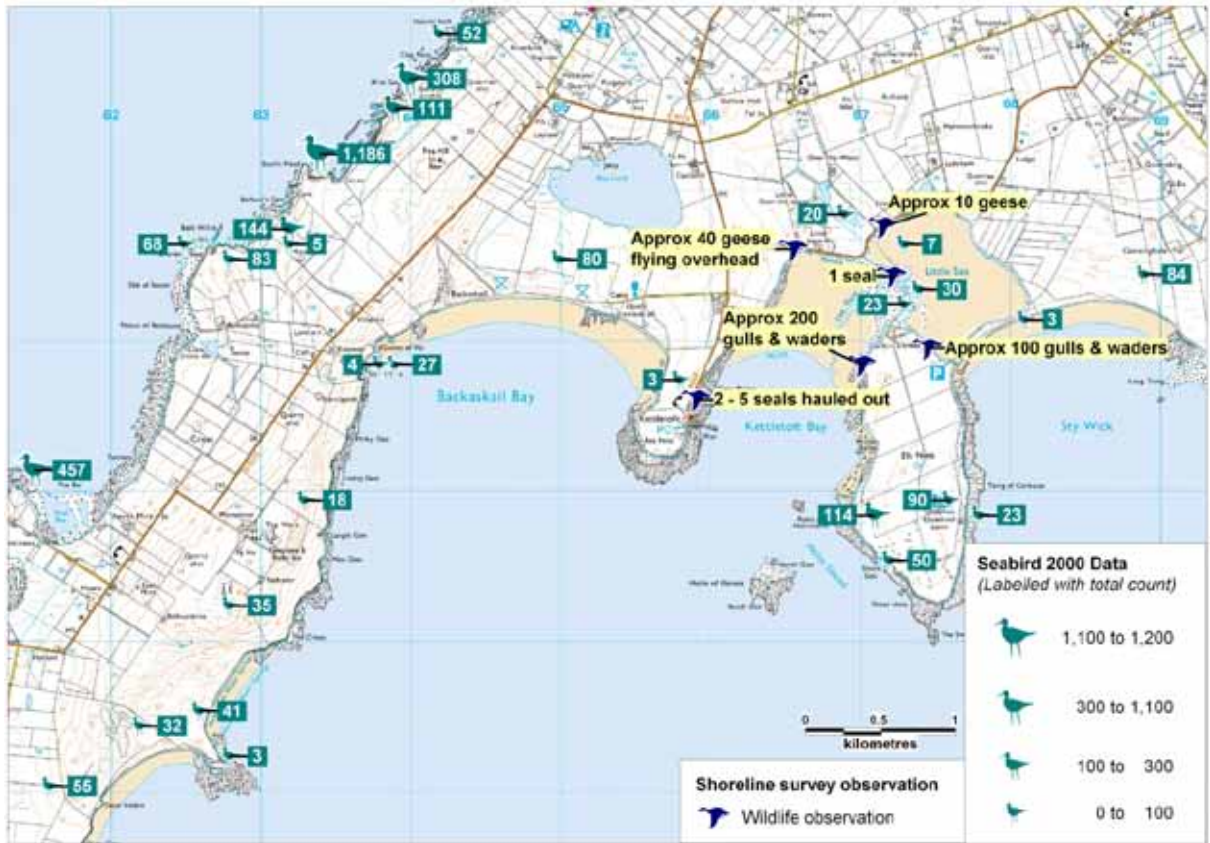
Figure 8.1 Map of seabird distributions at Backaskail Bay

Overall, the risk of faecal contamination to the waters around the fishery is mainly from seabirds breeding on Els Ness and along the west shore of Backaskail Bay during summer, geese and ducks using Bea Loch in autumn, and from wading birds and seals in Kettletoft Bay. The extent of

contamination from birds is likely to be affected by their seasonal presence but there is likely to be some contribution from these animals throughout the year. Highest impact is likely to be at the outlet of Bea Loch, along the northeast shore of Backaskail Bay, and within the Little Sea. Contamination from seals may be highest where they routinely haul out, and this was observed along the shore at Kettletoft.

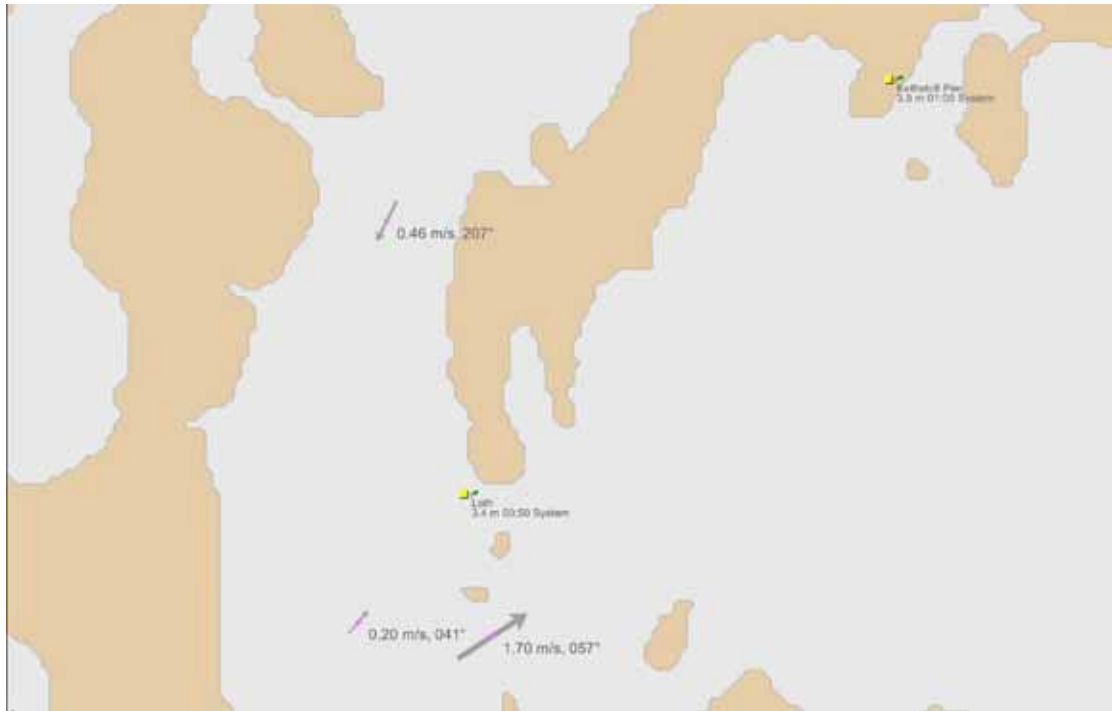
Figure 14.3 Spring flood tide off Sanday

Tidal stream information was available for a number of stations south and west of the south-west tip of Sanday. The location of these stations and the tidal stream arrows at peak spring flood and neap tide are shown in Figures 14.3 and 14.4. The tidal diamond for SN027R, located in Spurness Sound between Sanday and Stronsay, is shown in Table 14.1. The Clyde Cruising Club guide indicates that although tidal streams are strong in Spurness Sound, as indicated by the figures and the tidal diamond, they are weak in

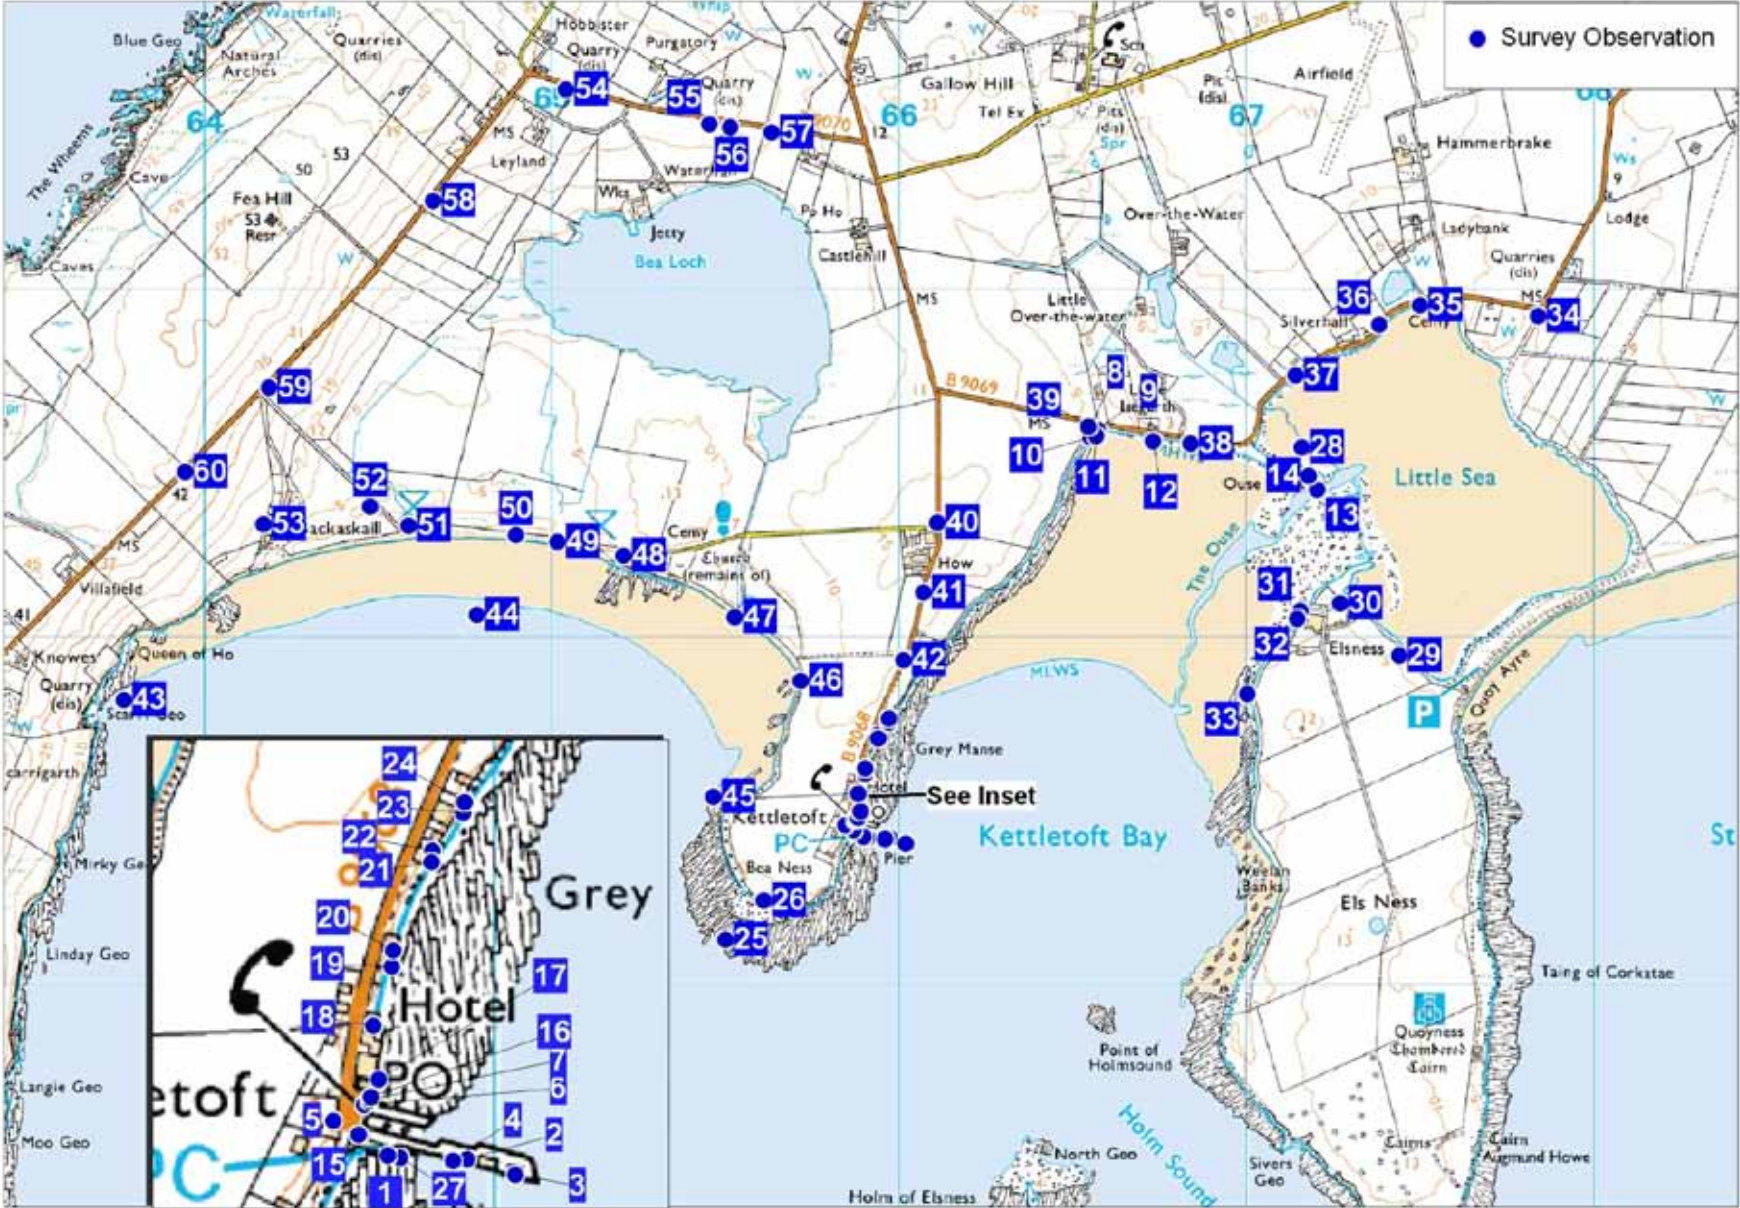
Figure 1. Map of Shoreline Observations

Five seals were observed hauled out on the shore at Kettletoft, and a further seal was observed off Ouse Point. Approximately 300 gulls and wading birds were observed on the intertidal mud off the north shore of Els Ness. A flock of 40 geese were observed flying overhead at the north end of Kettletoft Bay.

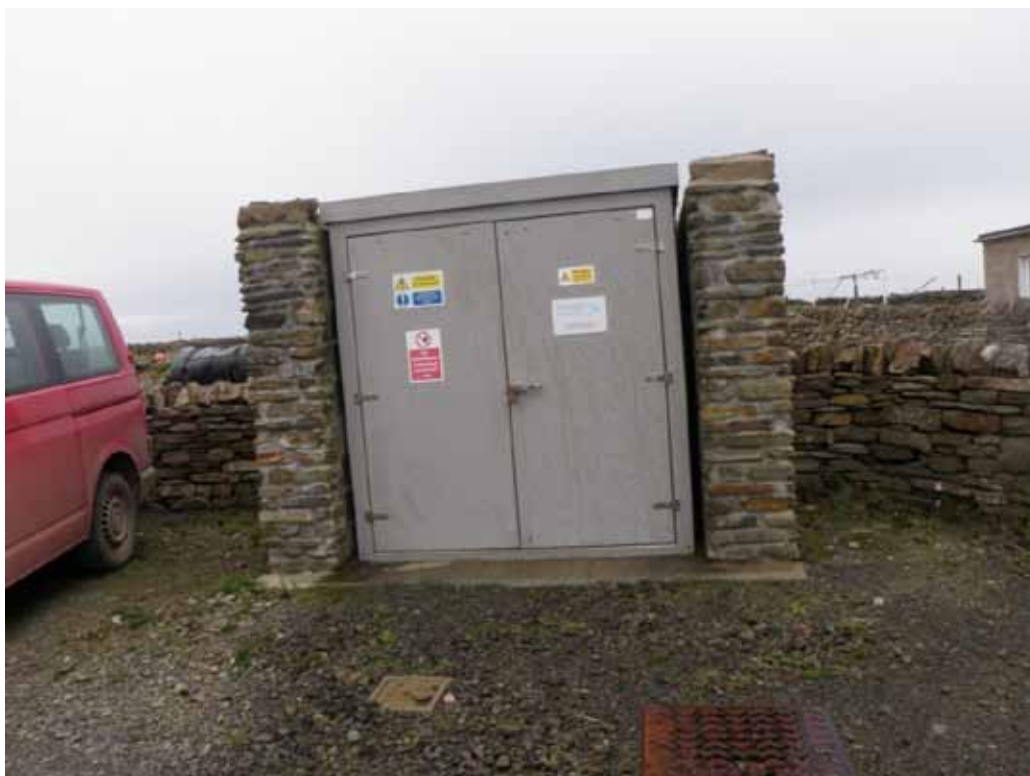
Figure 4. Scottish Water ST and pumping station

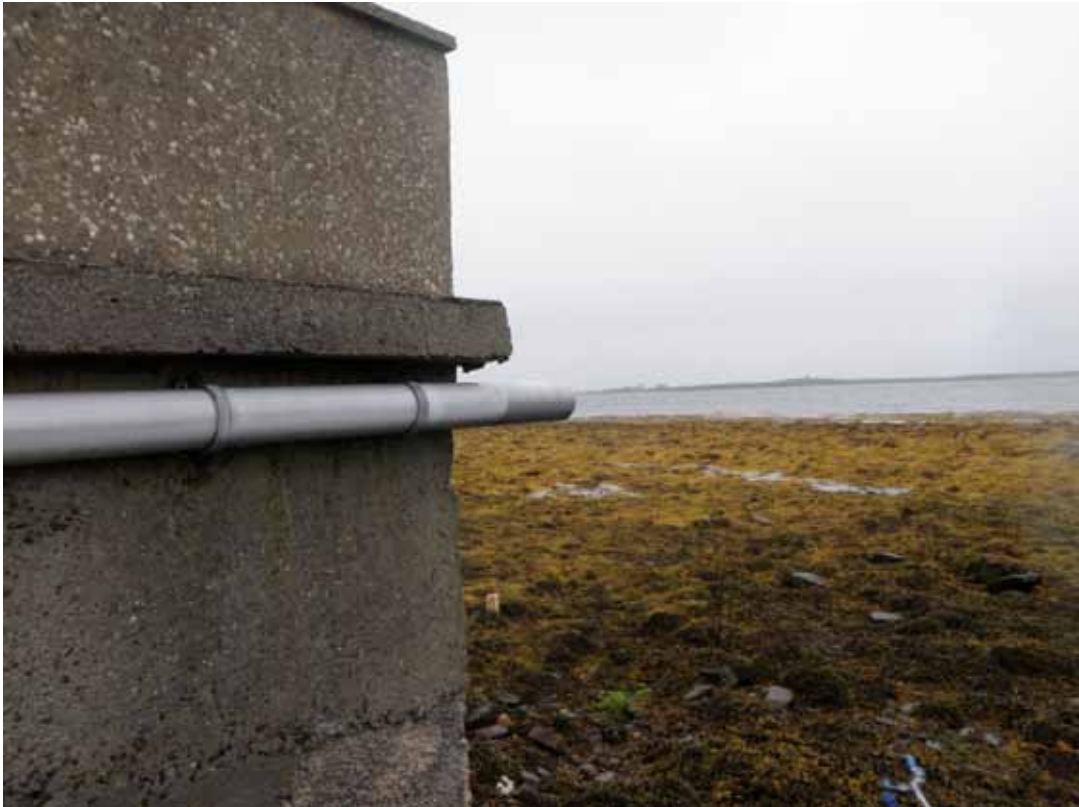
Figure 5. New drainage pipe along seawall at Kettletoft.

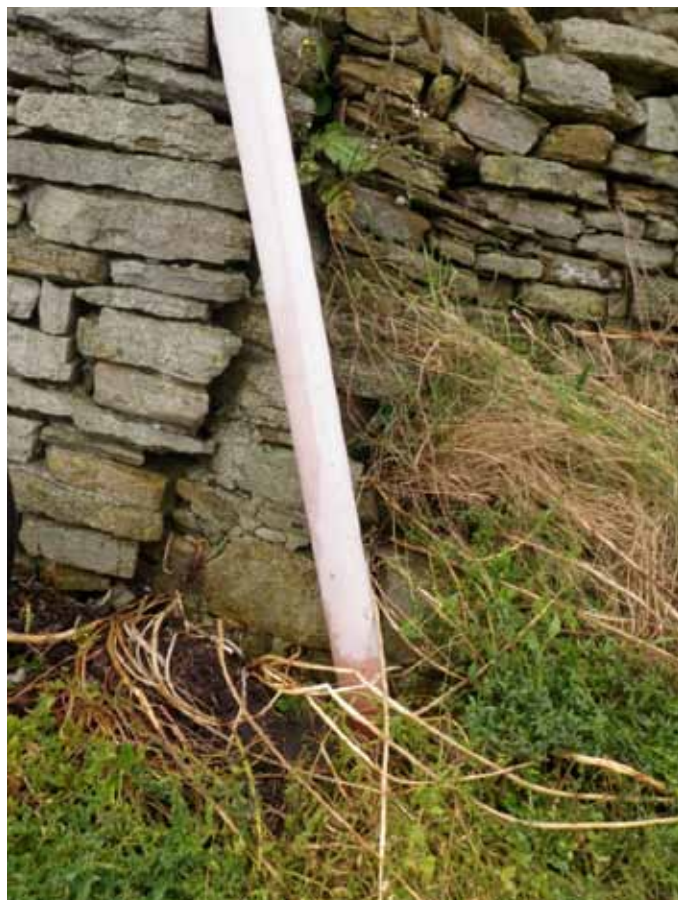
Figure 6. Plastic pipe to ground at upper shore

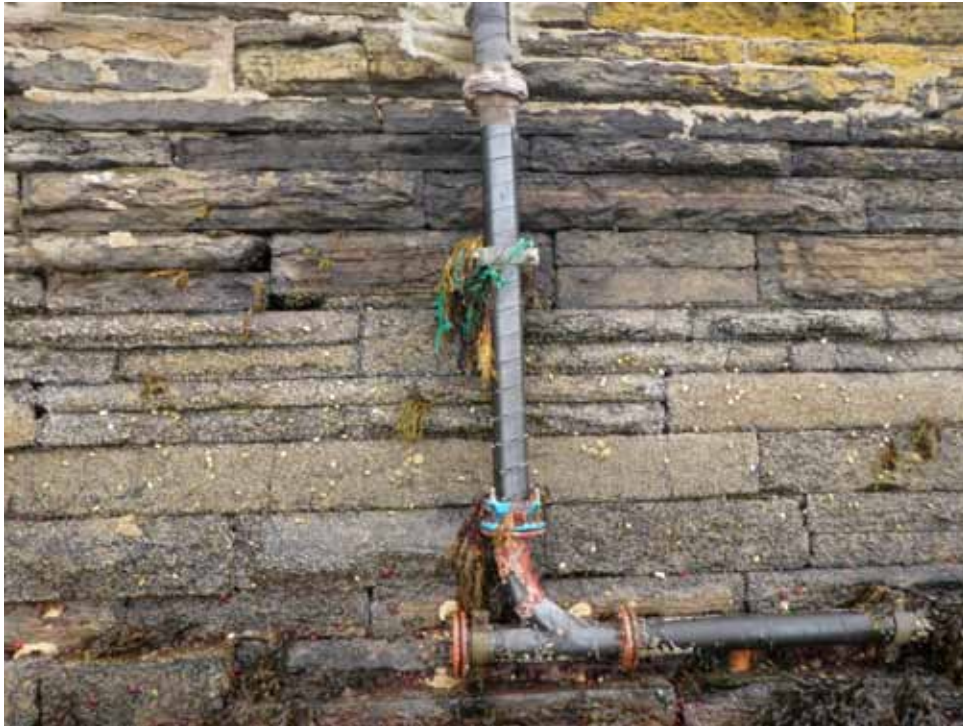
Figure 7. Pipe behind facilities at Kettletoft pier

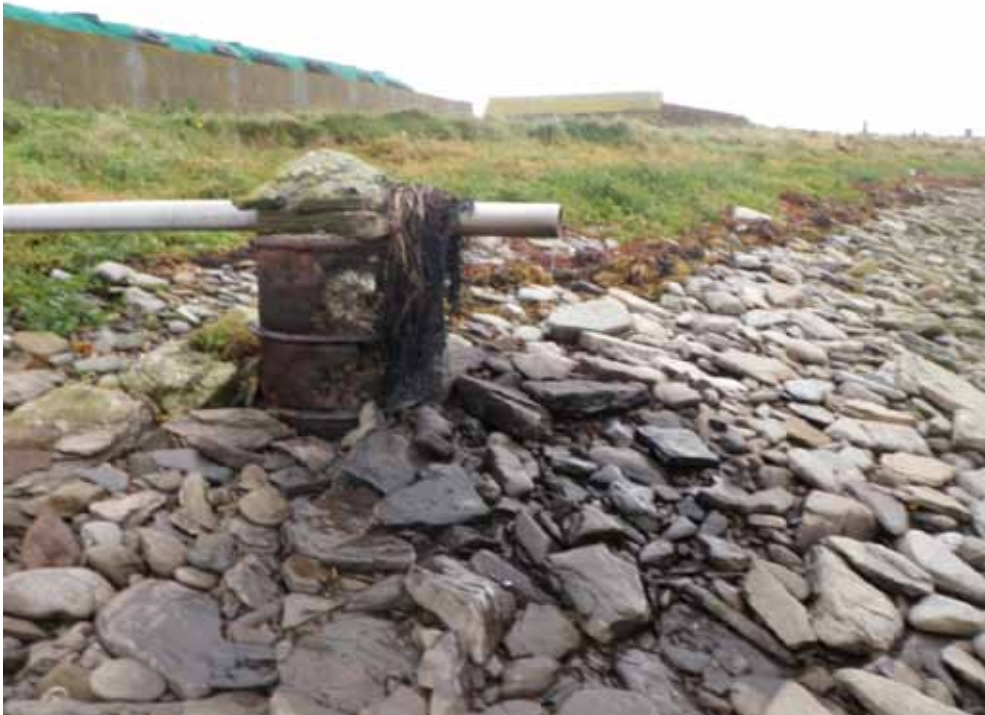
Figure 9. Silage effluent pipe at Elsness

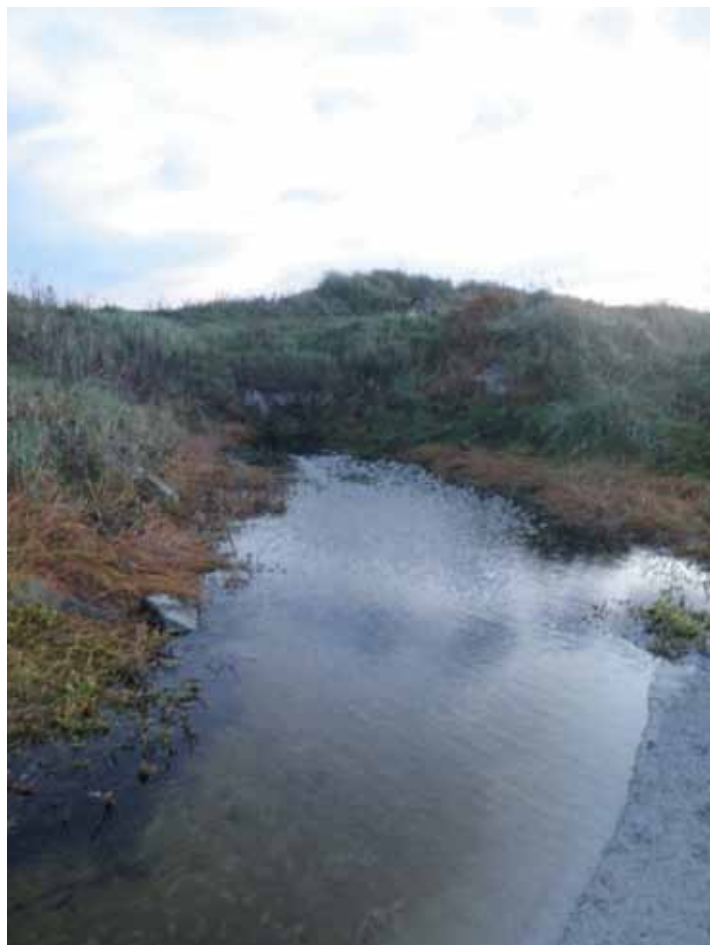
Figure 10. Water puddled next to sand berm

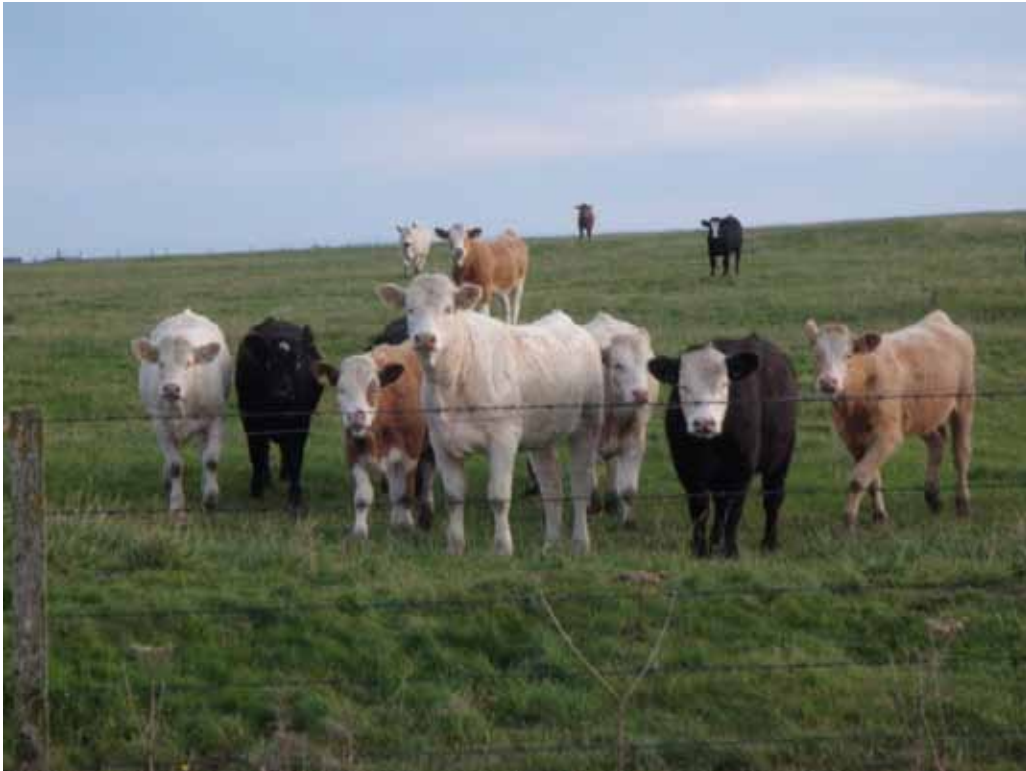
Figure 11. Calves near cemetery car park above Backaskail Bay

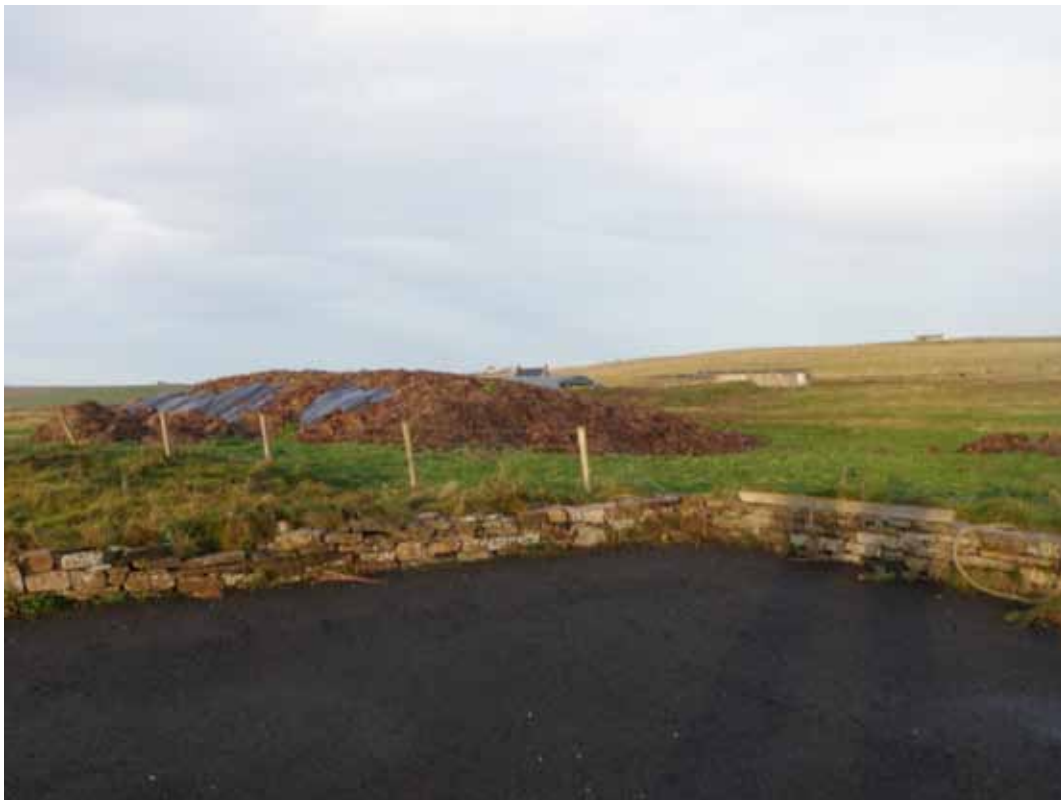
Figure 12. Silage at Backaskail car park
