Scottish Sanitary Survey Project

Sanitary Survey Report
Busta Voe Lee North
SI 327
January 2008

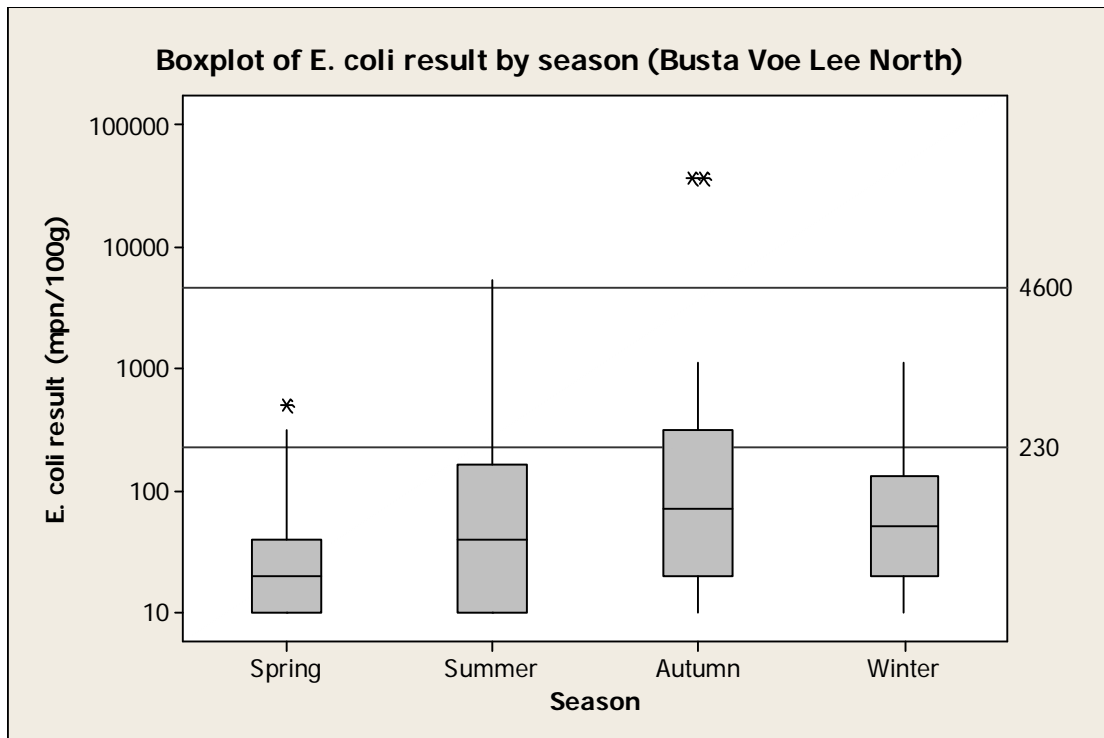
Figure 11.6 Boxplot of shellfish *E.coli* result by season

A seasonal effect was observed, with lowest results in the spring compared to all other seasons. The seasonal effect is statistically significant (One-way ANOVA, $p=0.000$, Appendix). This was confirmed using post ANOVA tests as found in the Appendix.

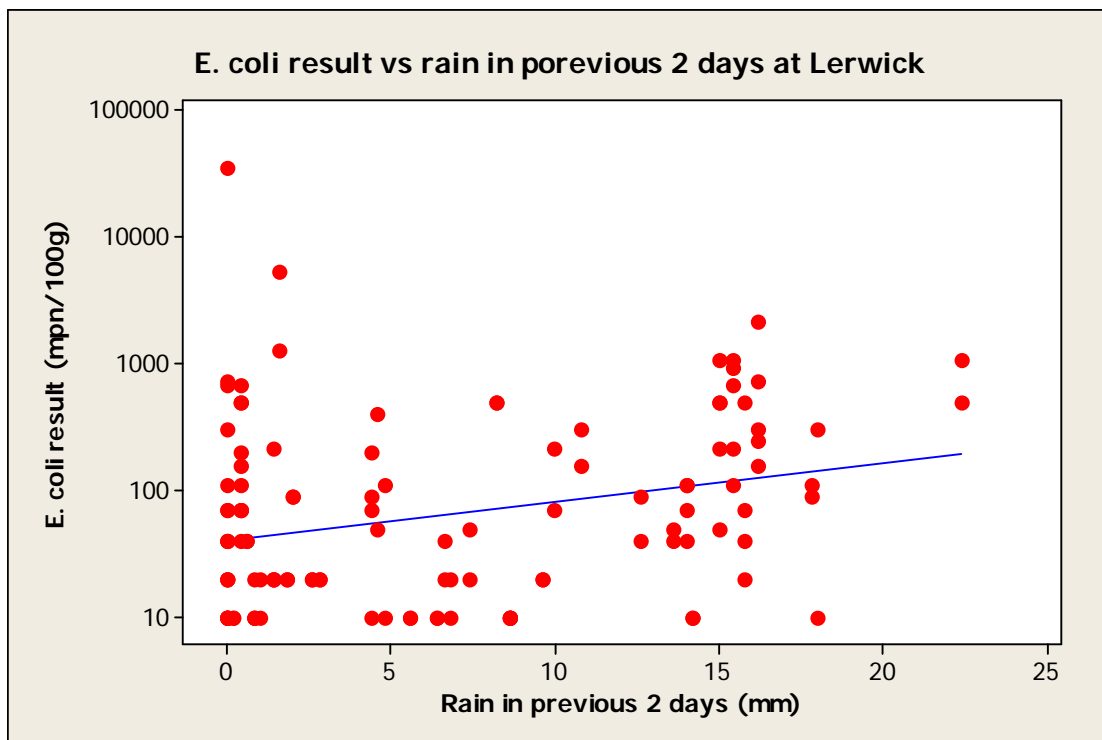
Figure 11.7 Scatterplot of shellfish *E. coli* result against rainfall in previous 2 days

The coefficient of determination indicates that there is a very weak positive relationship between the *E. coli* result and the rainfall in the previous two days (Adjusted R-sq=6.7%, p=0.003, Appendix).

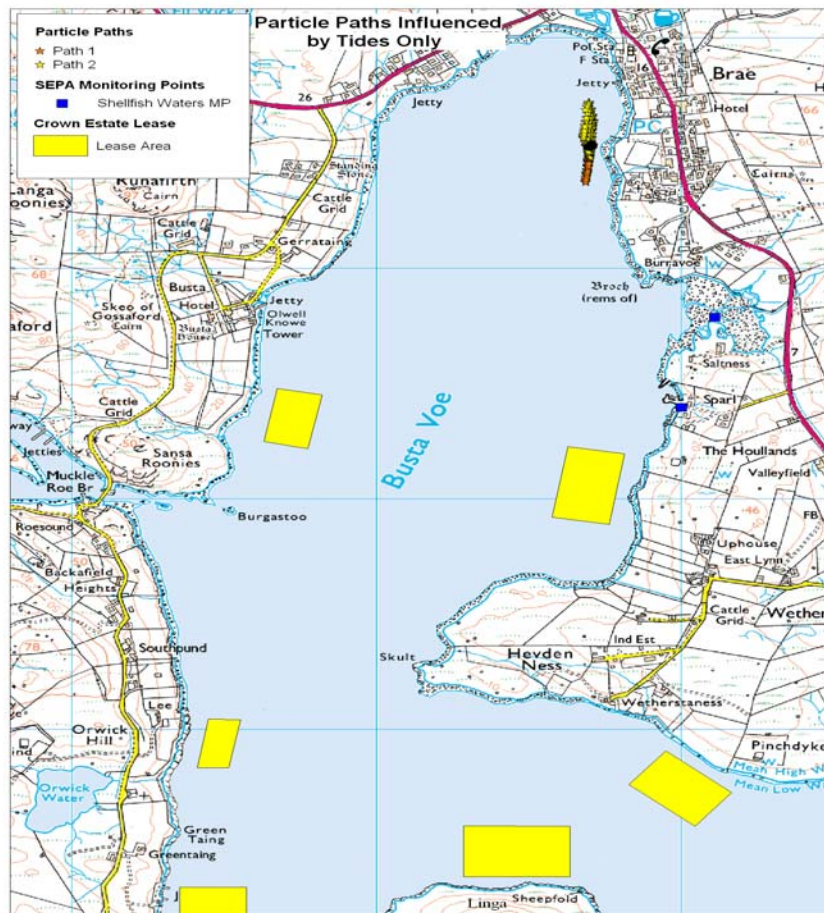
Modelled tidal currents were found to be very weak in Busta Voe, with speeds generally much less than 10 cms^{-1} . Stronger tidal currents were associated with narrow constrictions and sills such as that between Linga and Hevden Ness. Even here peak tidal current speeds were generally less than 15 cms^{-1} . The tidal residual flow was predicted to be very weak and generally of the order of a few millimetres per second. Consequently tidal currents lead to very small transport distances (figure 12.3). Imposing even a modest wind was found to have a large the effect on water movement and particle paths as discussed below.

Figure 13.3: Particle paths for tide only. The black circle shows the start location. Two paths are shown representing particles released on flood and ebb tides. (about 6.2 hours apart).

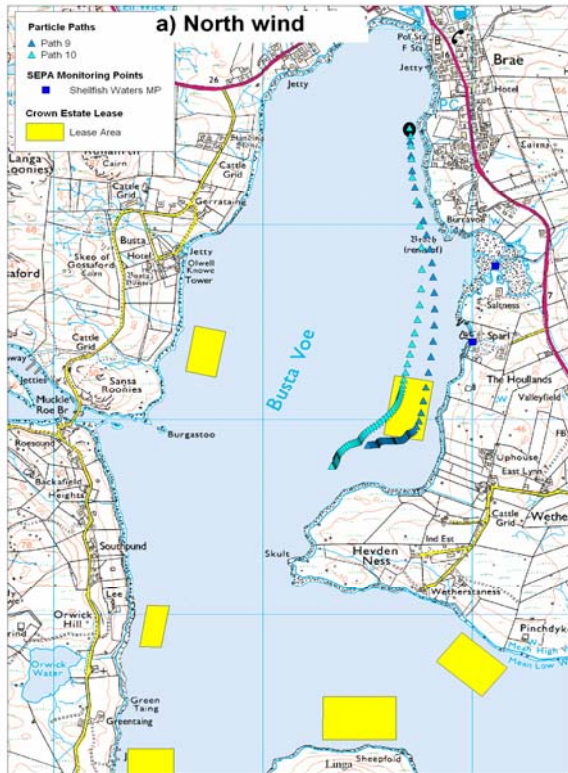
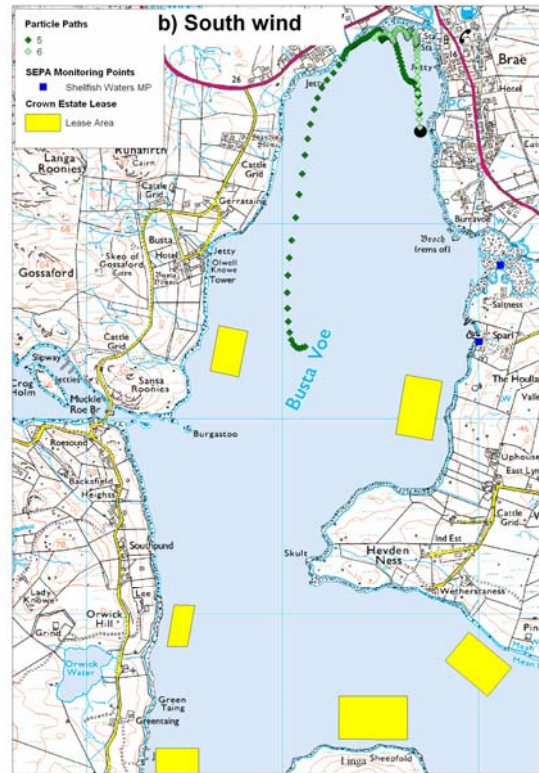
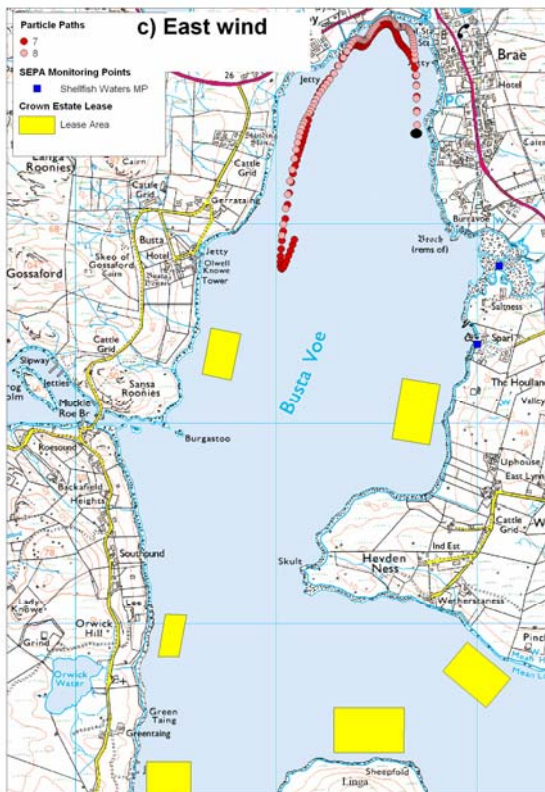
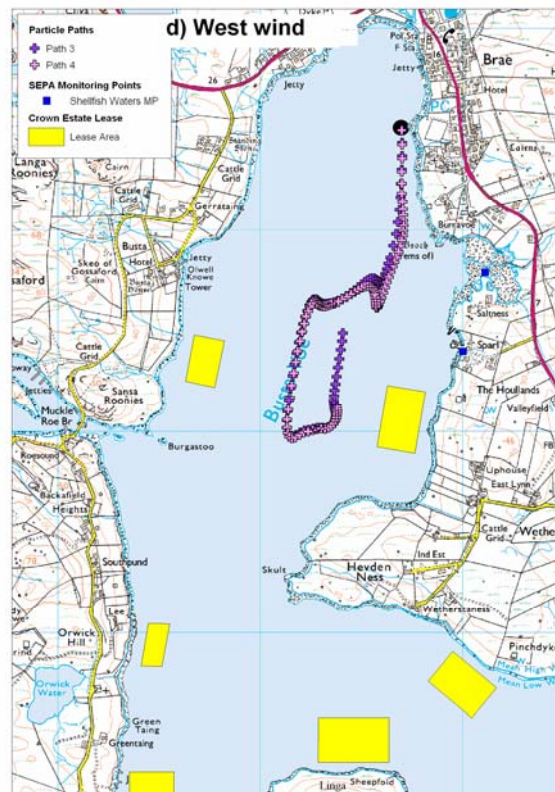
In general tidal flows appear to be weak, and wind generated currents have a major influence. The prevailing south-westerly wind direction seems likely to act to confine inputs from sources near Brae to the north eastern corner of the Voe and generally away from leased areas. However contamination is likely to impact production areas under some wind conditions, with northerly winds most likely to cause this. On average, winds with a significant northerly component occur for about 20% of the time.

Figure 13.4: Particle paths for tide with superimposed wind driven flows for south, north, east and west winds. The black circle shows the start location. For each wind condition, two paths are shown representing particles released on flood and ebb tides. (about 6.2 hours apart).

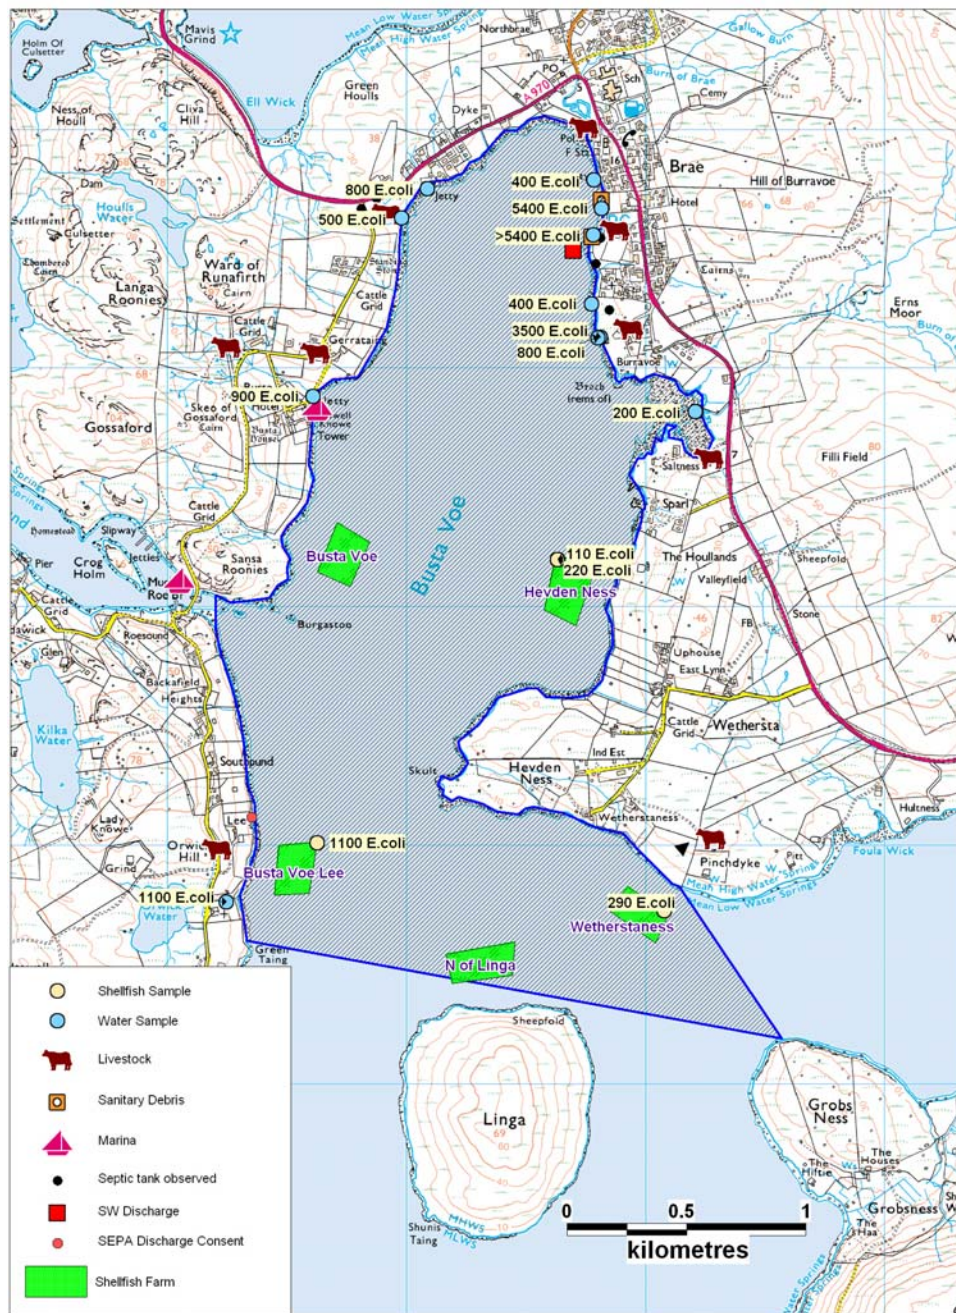
Figure 15.1 Significant findings from shoreline survey

Wildlife were observed, including a seal and an assortment of seabirds. Greylag geese were seen in a field near the shore. The harvester reported that an otter was resident in the area, though this was not directly observed on the day. Overall, no significant concentrations of wildlife were seen in the voe. The cormorants observed resting on the mussel floats constituted the most significant potential source of faecal bacteria from wildlife. The most significant noted observations are mapped in Figure 15.1 below.

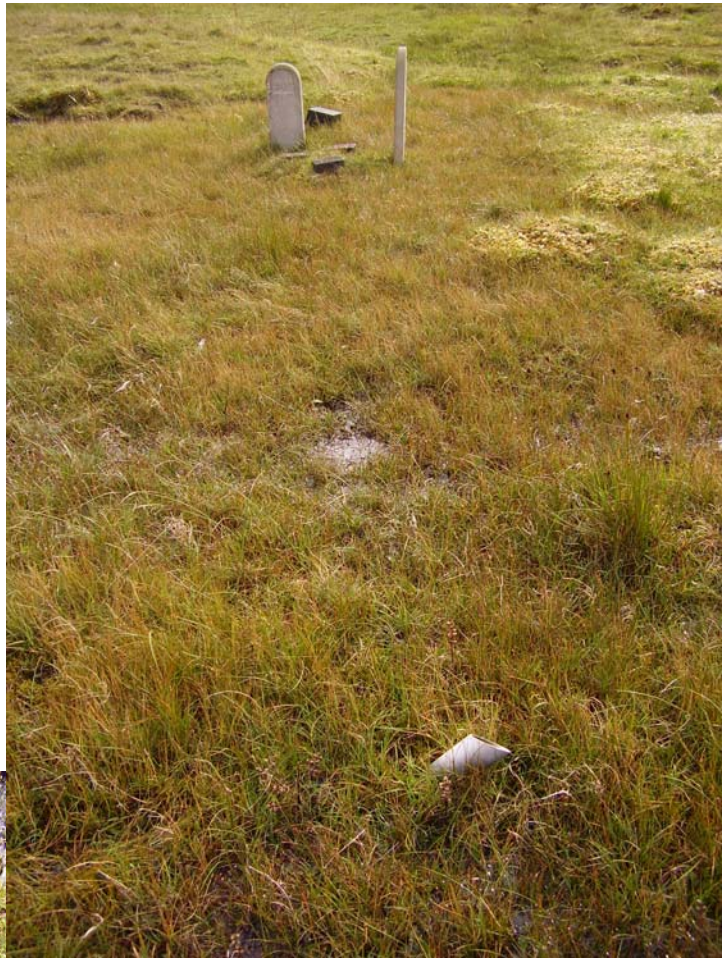
Figure 8. Busta050901.
Plastic pipe and inspection
covers.

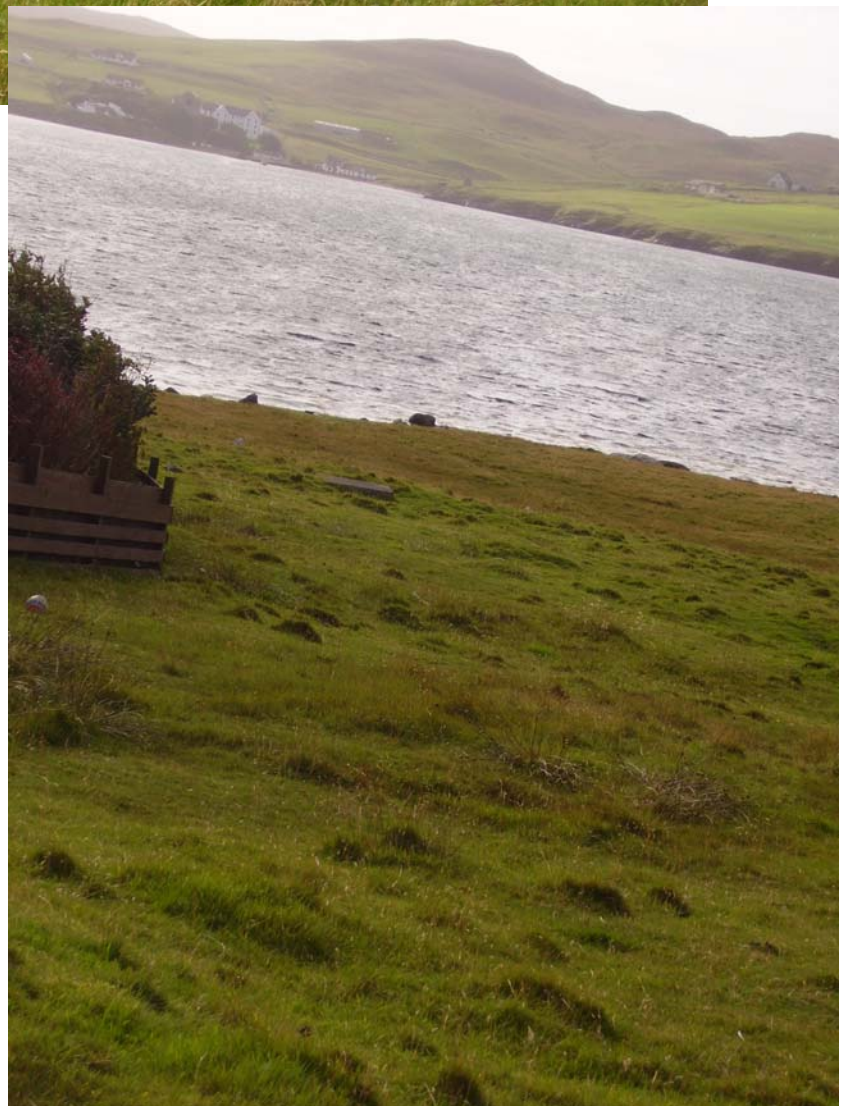
Figure 13. Busta050910. Septic tank cover.

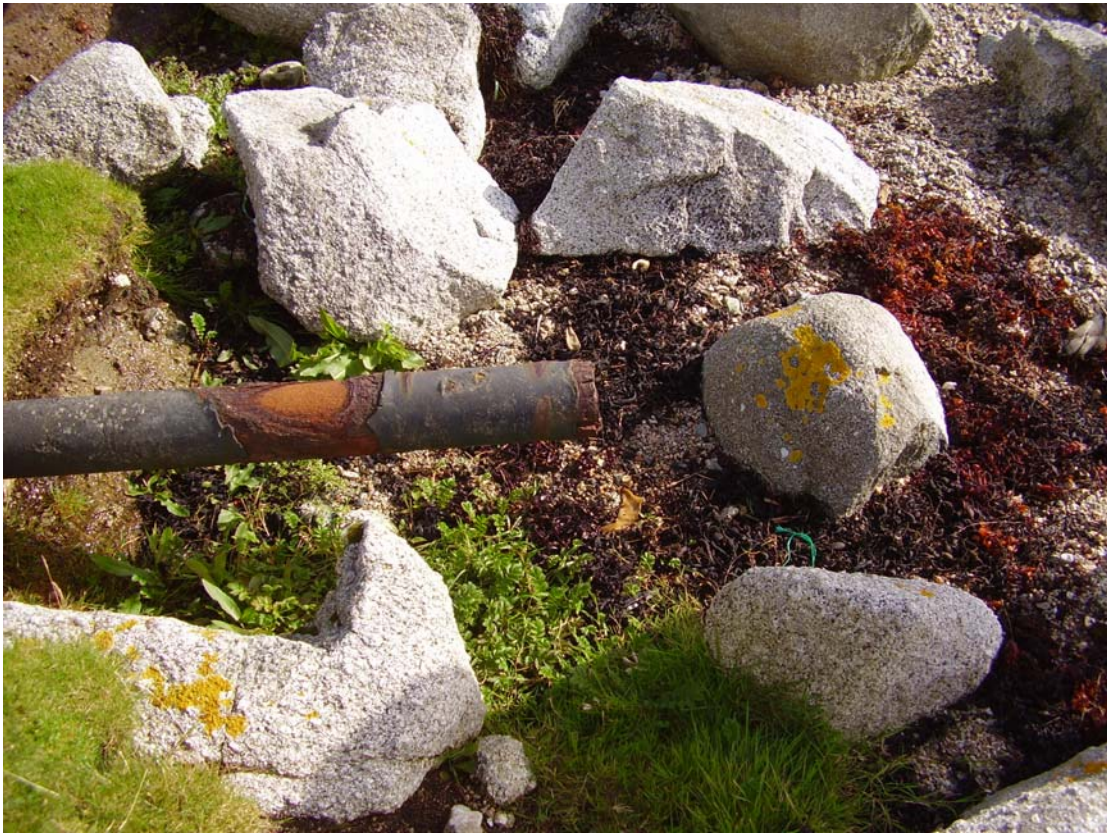
Figure 14. Busta050912. Discharge pipe.

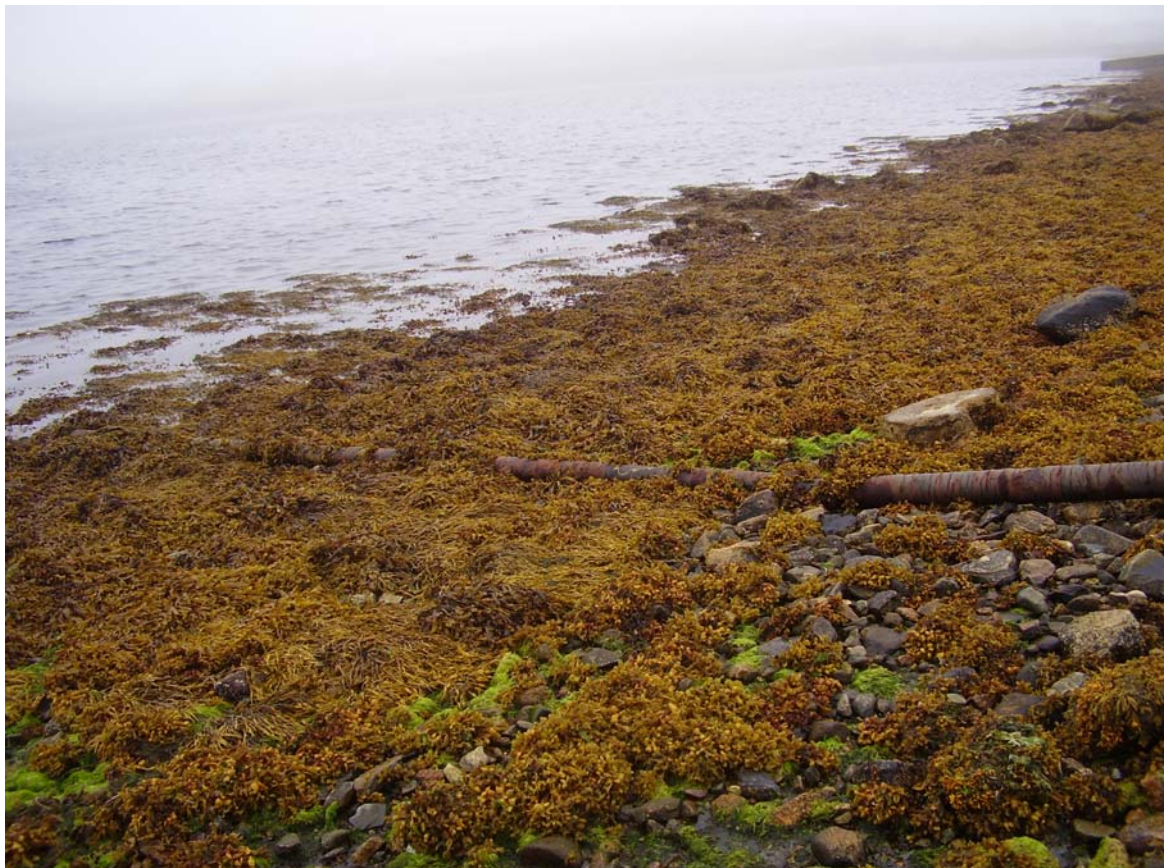
Figure 23. Busta060910. Broken pipe on shore.

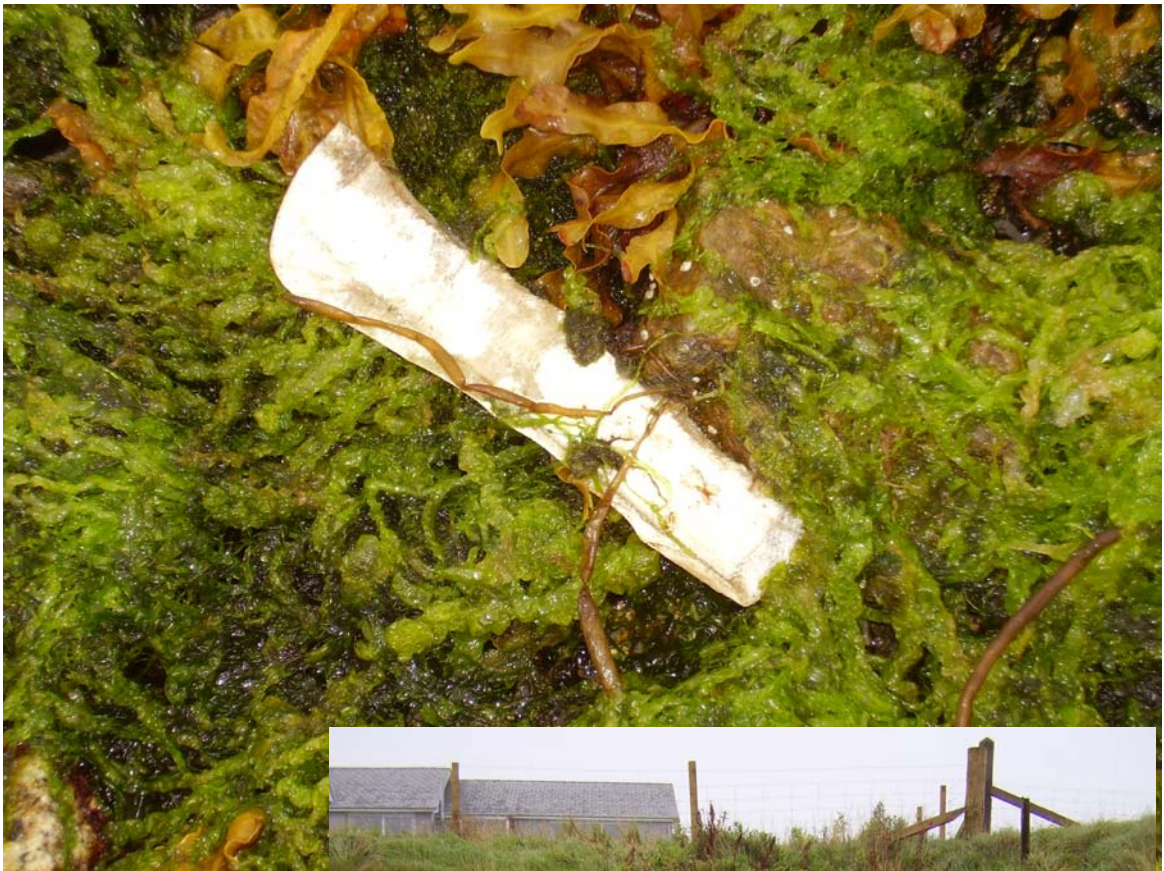
Figure 24. Busta060911. Sanitary debris.

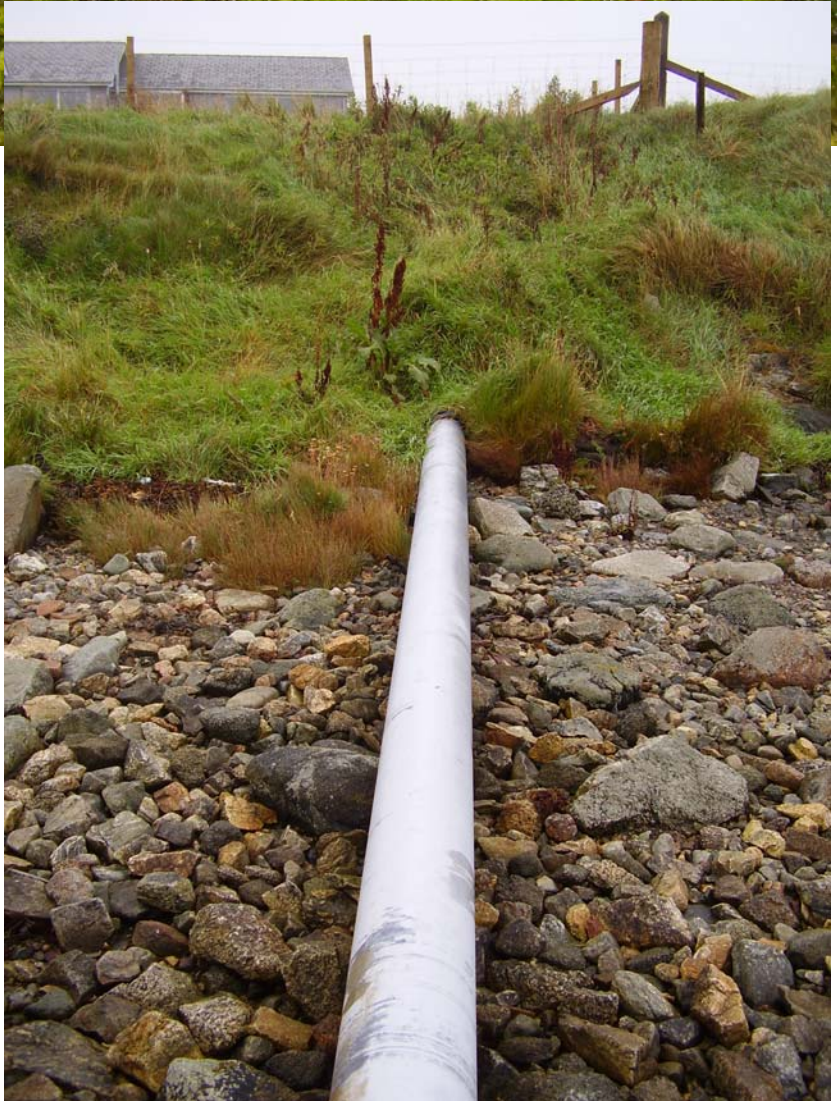
Figure 25. Busta060914. Large pipe, dripping.

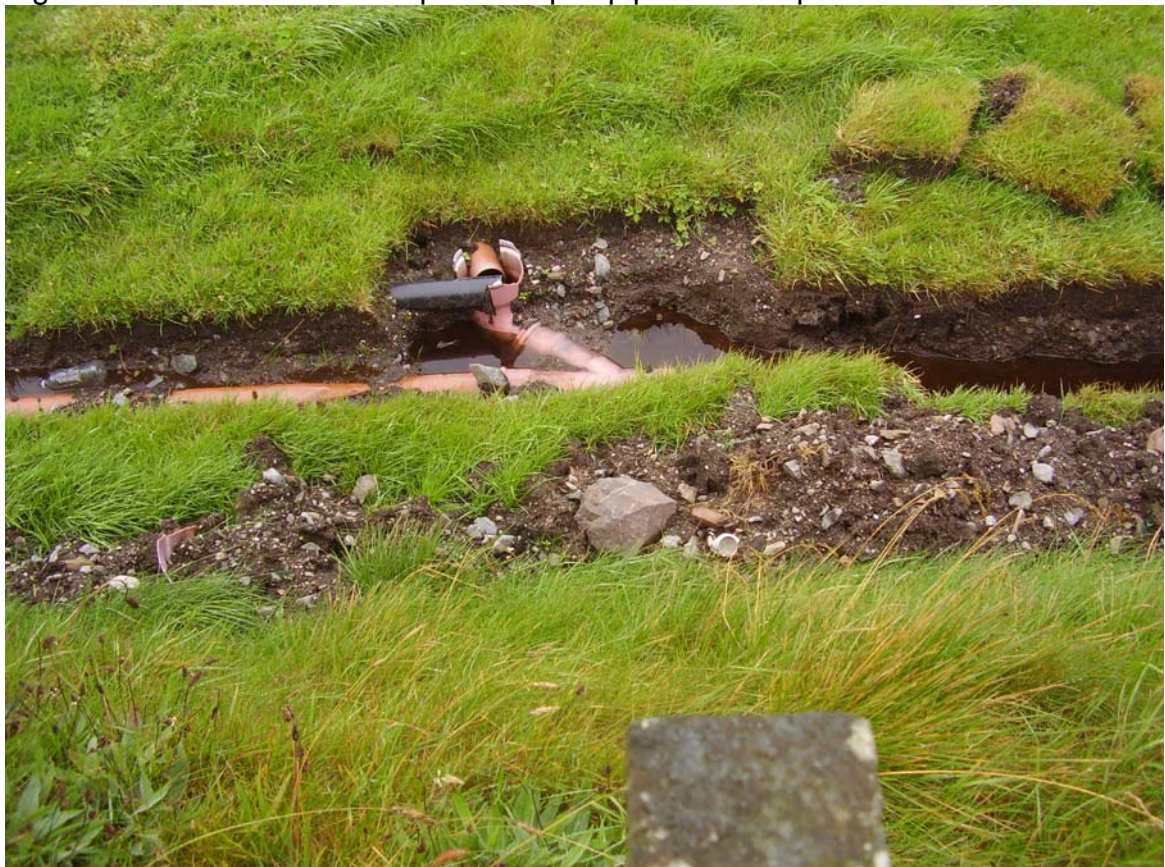
Figure 29. Busta060921. Exposed septic pipe under repair.
