Scottish Sanitary Survey Project

Restricted Sanitary Survey Report

Castle Stalker

AB 492

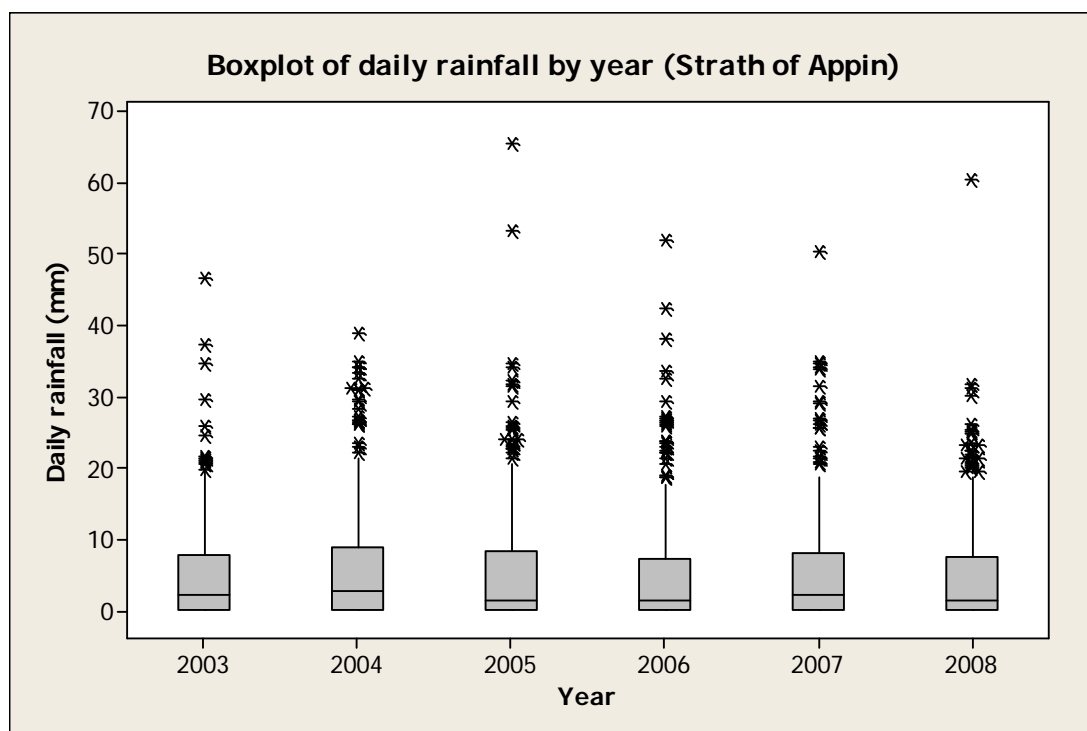
Figure 5.1 Boxplot of daily rainfall at Strath of Appin by year

Due to the missing data it is not appropriate to present total rainfall at Strath of Appin by year or month. Instead, Figures 5.1 and 5.2 summarise the pattern of rainfall recorded at Strath of Appin. The box and whisker plots present the distribution of individual daily rainfall values (observations) by year (Figure 5.1) or by month (Figure 5.2). The grey box represents the middle 50% of the observations, with the median at the midline. The whiskers extend to the largest or smallest observations up to 1.5 times the box height above or below the box. Individual observations falling outside the box and whiskers are represented by the symbol *.

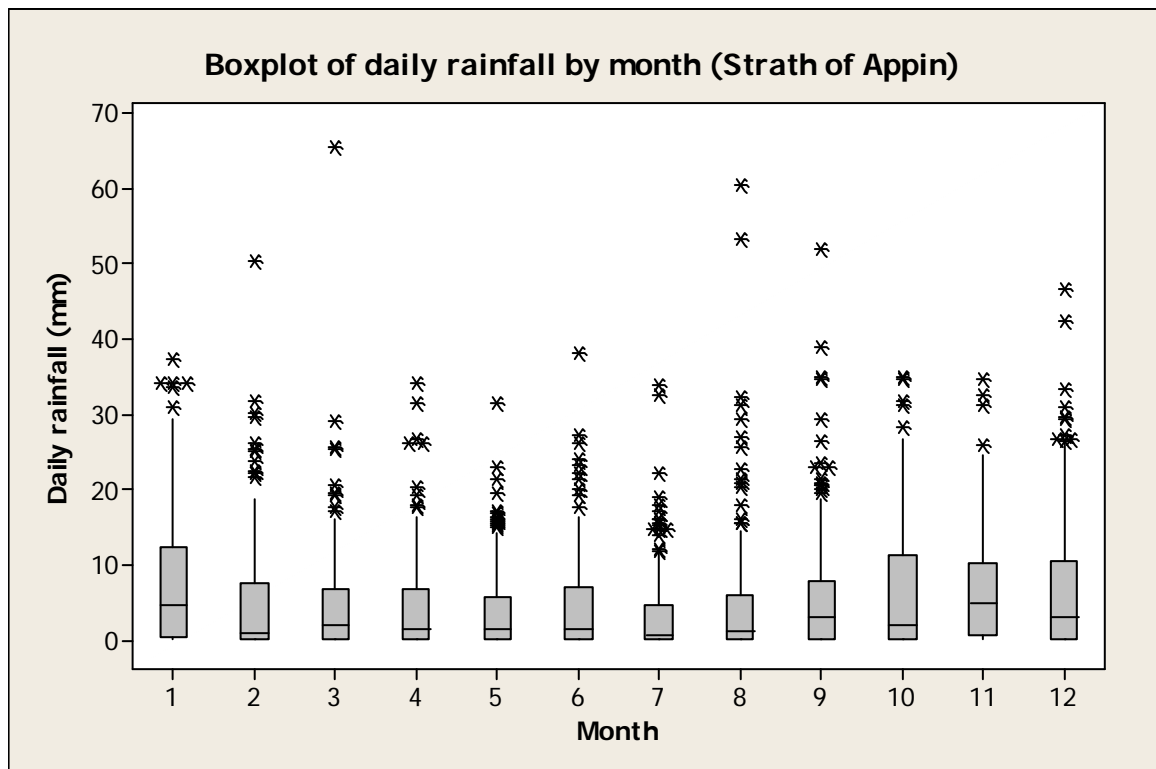
Figure 5.2 Boxplot of daily rainfall values at Strath of Appin by month

The wettest months were September to January inclusive. For the period considered here (2003 – 2006), 30% of days for which records were available experienced no rainfall while 43% of days experienced rainfall of 1mm or less.

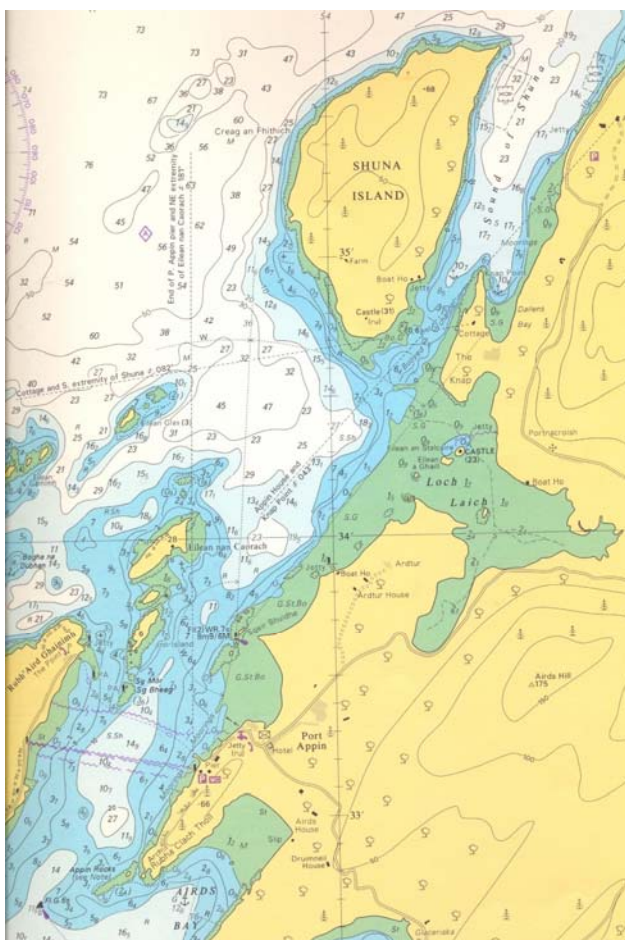
Figure 8.1 Castle Stalker Admiralty chart

The UKHO Admiralty chart above (Figure 8.1) shows that the whole of Loch Laich and some of the water either side of it is a drying area.

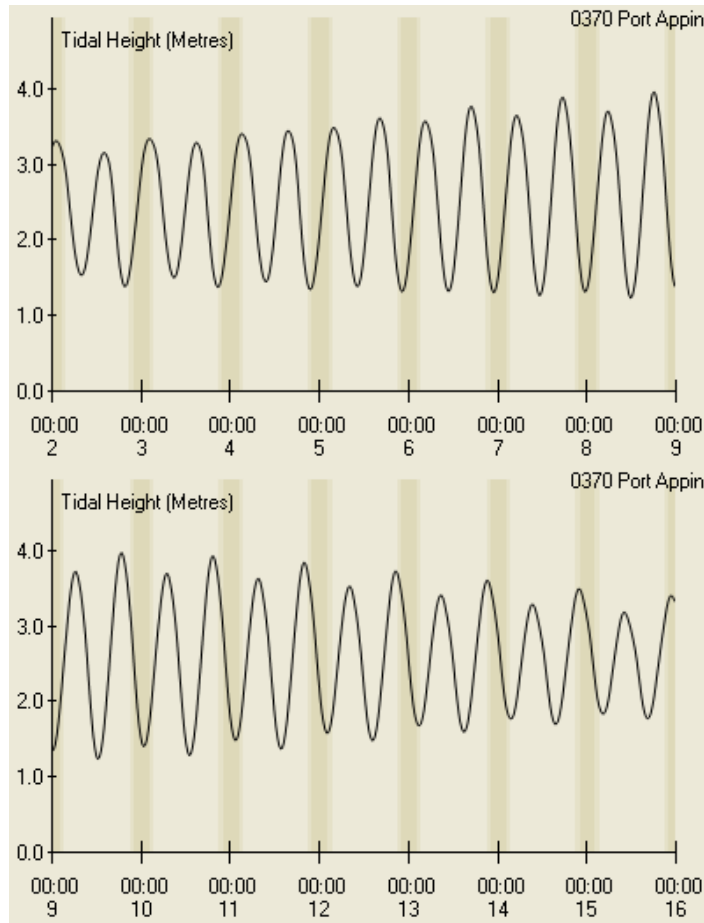
Figure 8.3 Tidal curves for Port Appin

The following is the UKHO summary description for Port Appin:
The tide type is Semi-Diurnal.

MHWS	4.2 m
MHWN	3.1 m
MLWN	1.9 m
MLWS	0.8 m

Predicted heights are in metres above chart datum. The tidal range at spring tide is therefore approximately 3.4 m and at neap tide 1.2 m.

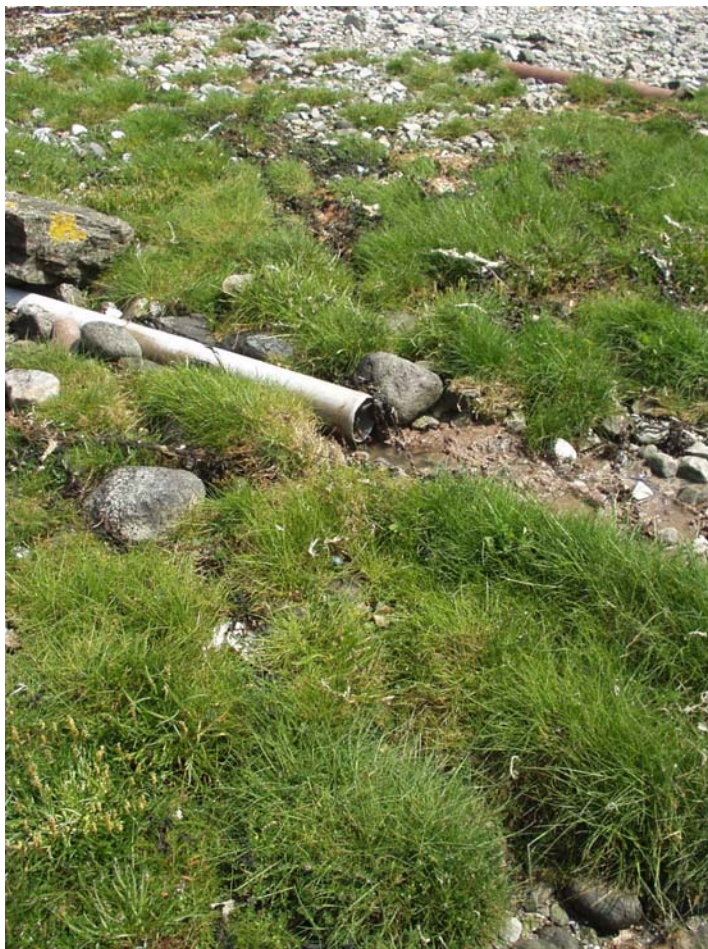
Figure 4. Outfall pipe

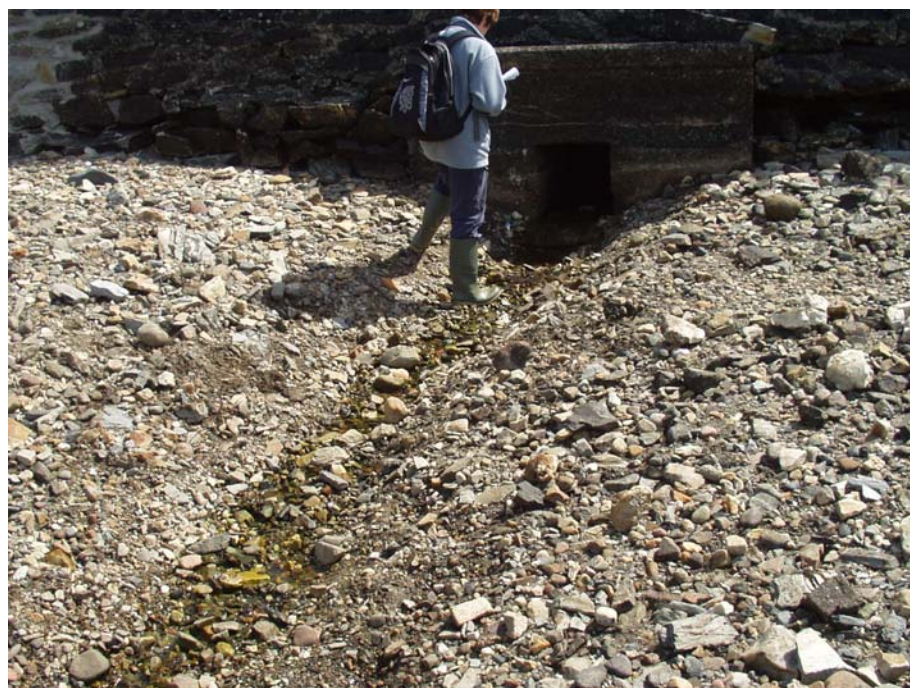
Figure 5. Small stream, water sample 4

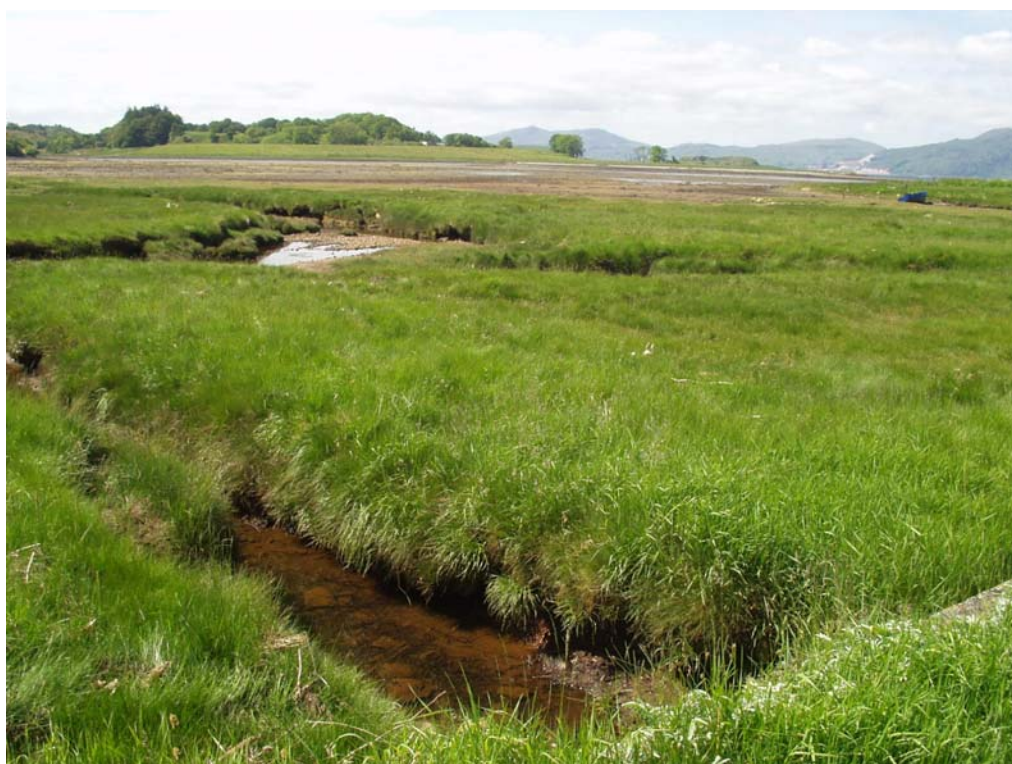
Figure 7. Small stream, water sample 9

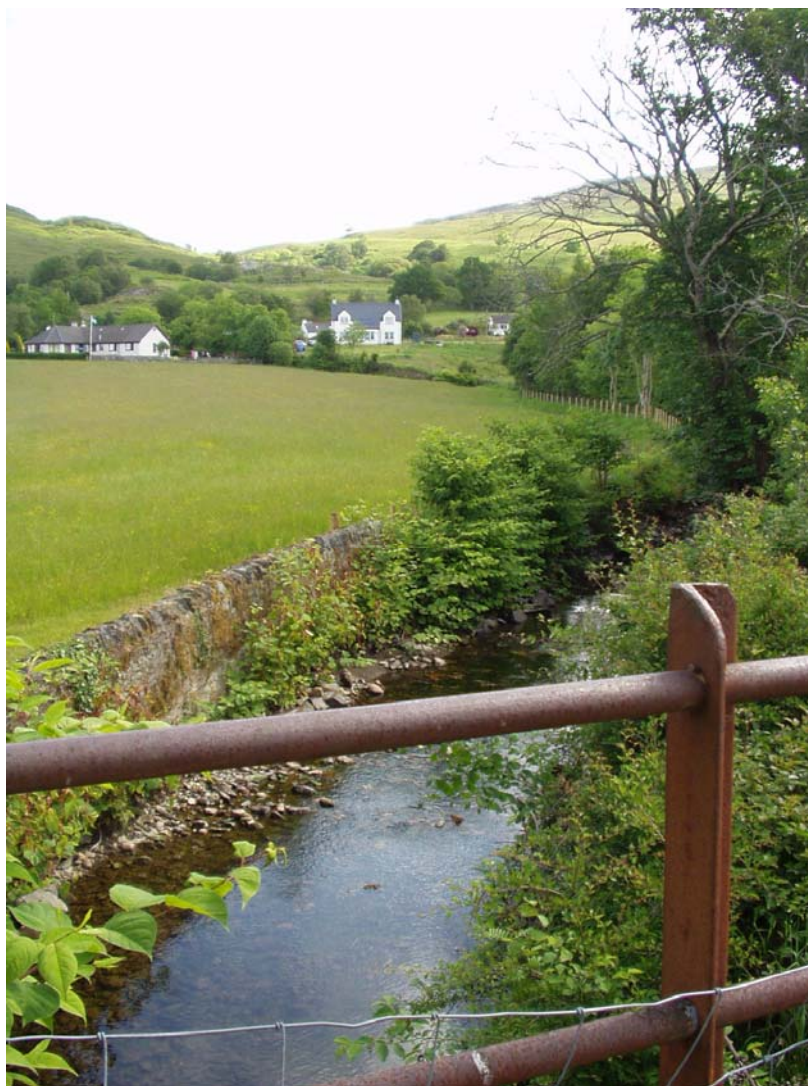
Figure 8. Burn, water sample 10

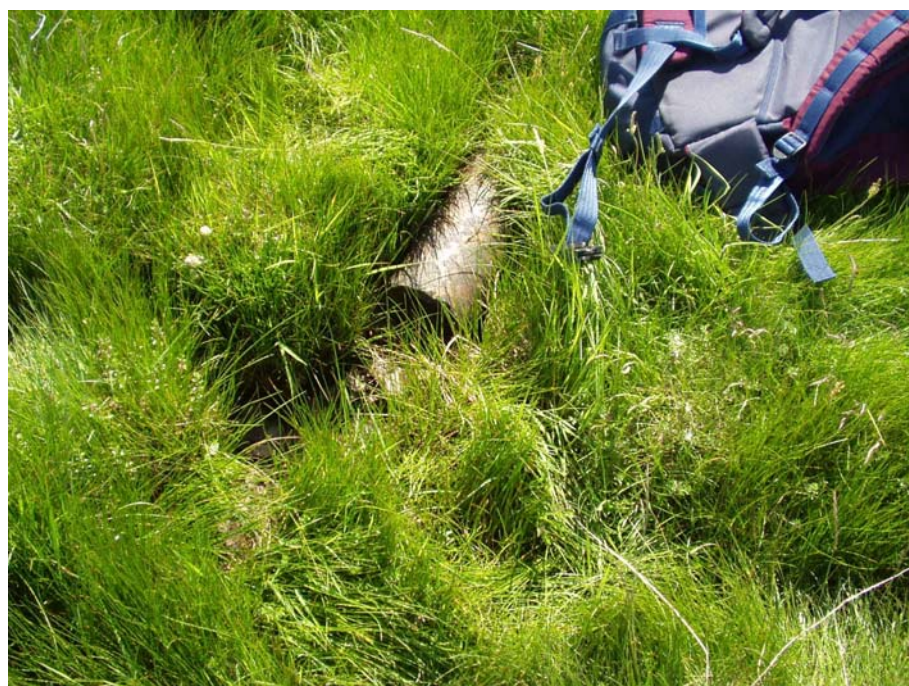
Figure 9. 6" clay pipe below house

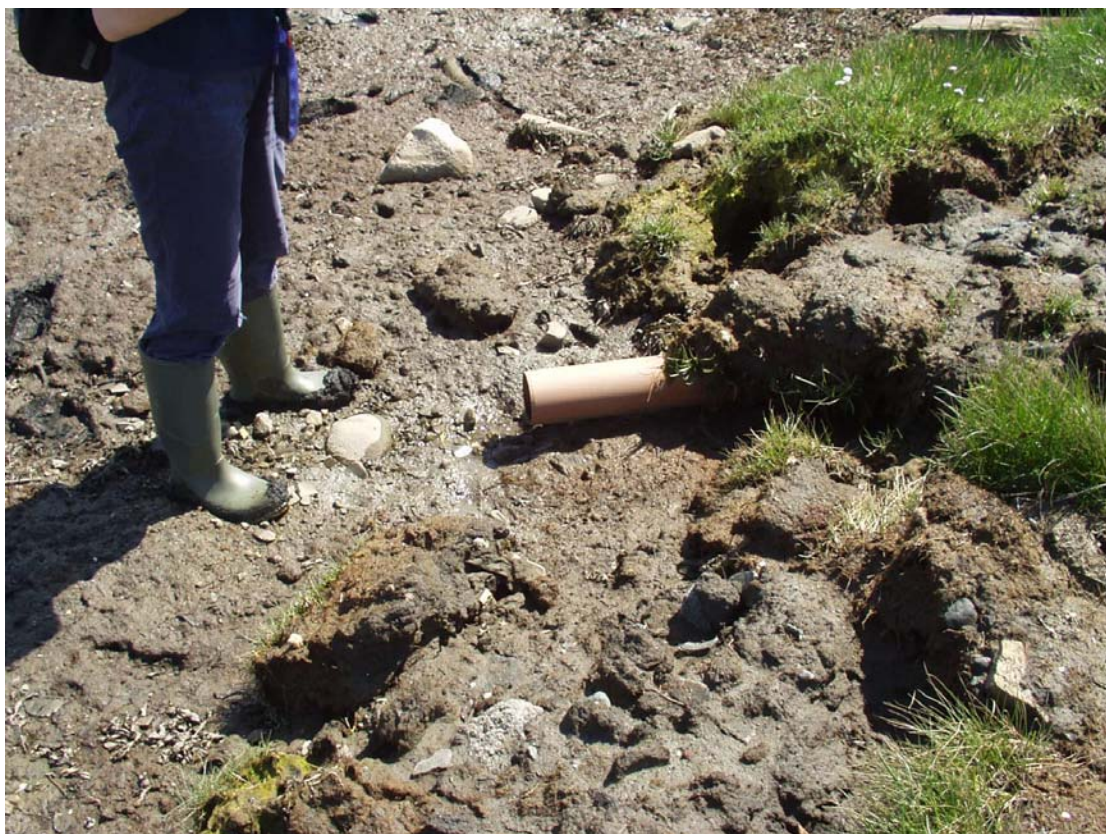
Figure 10. 4" plastic pipe down to shore, dripping, no smell

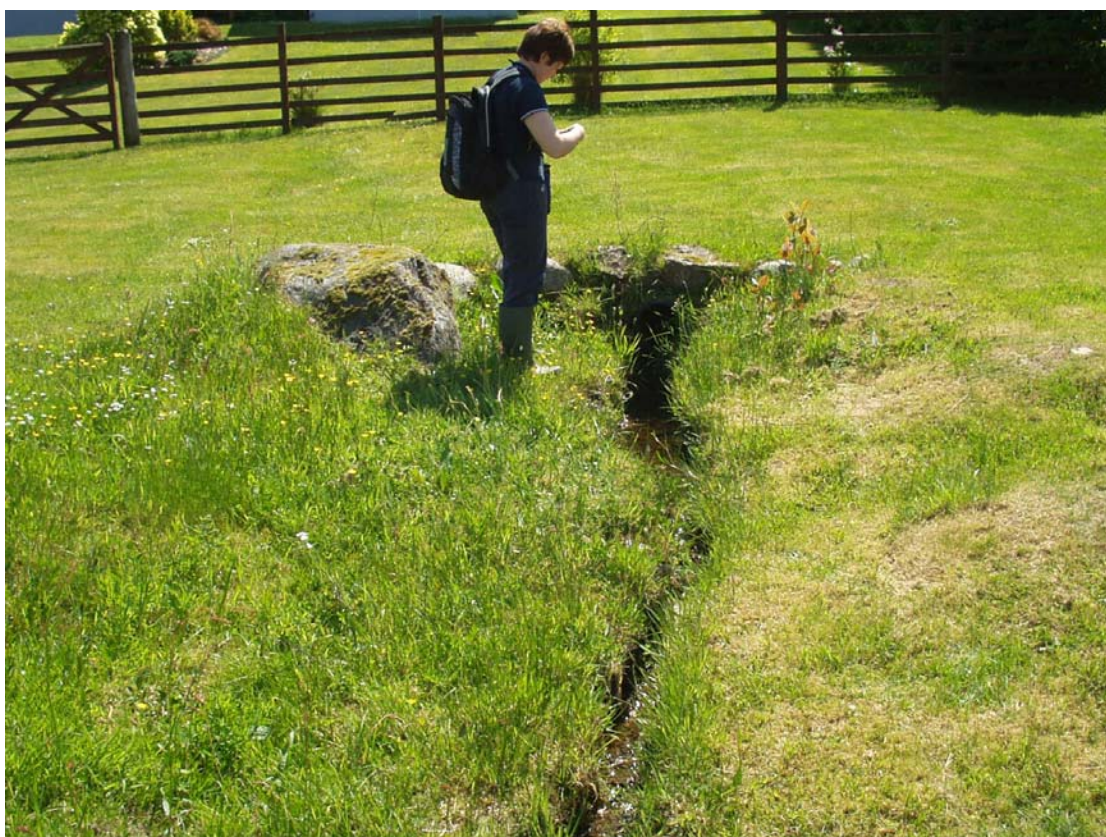
Figure 11. Small stream, water sample 13

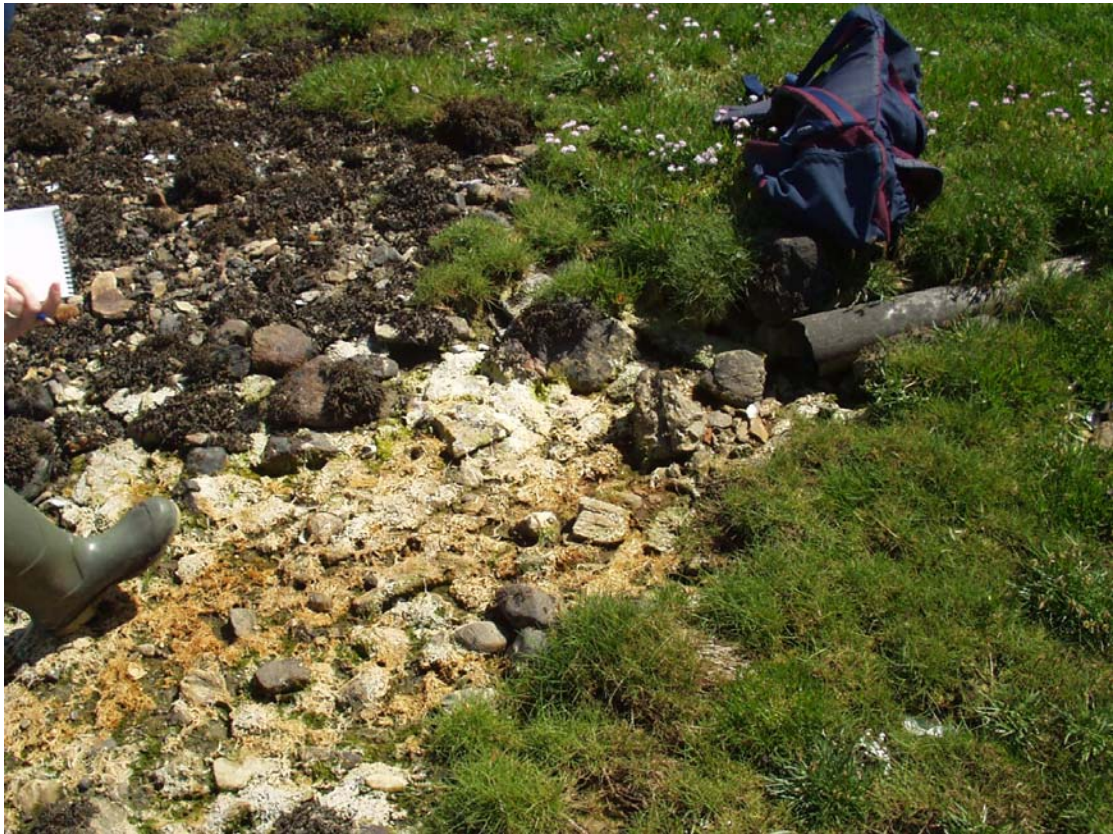
Figure 12. 6" cast iron pipe, not flowing

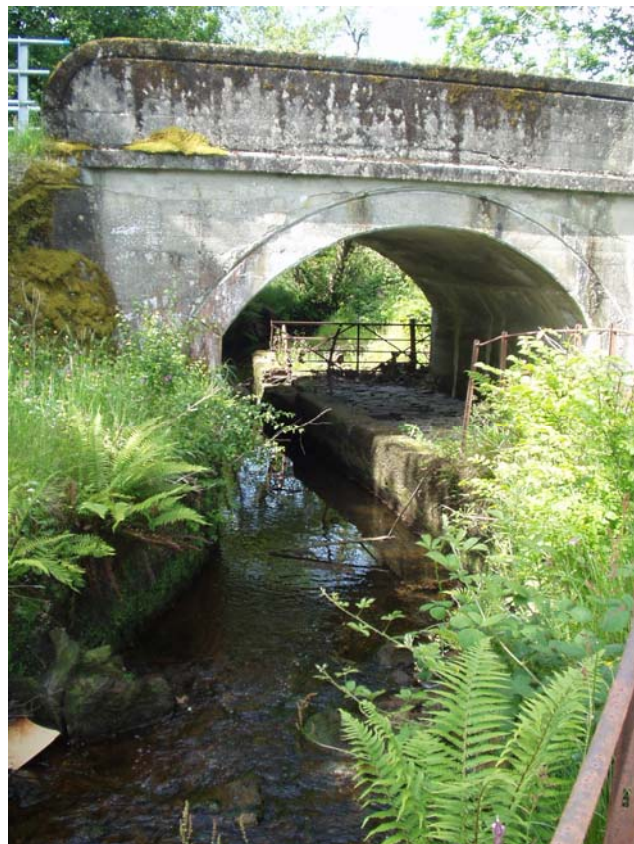
Figure 13. Burn, water sample 17
