Scottish Sanitary Survey Report

Sanitary Survey Report Dunstaffnage Cockles AB-696 May 2015

Report Title	Dunstaffnage Cockles
Project Name	Scottish Sanitary Survey
Client/Customer	Food Standards Agency Scotland
Cefas Project Reference	C6316A
Document Number	C6316A_2014_27
Revision	V1.0
Date	27/05/2015

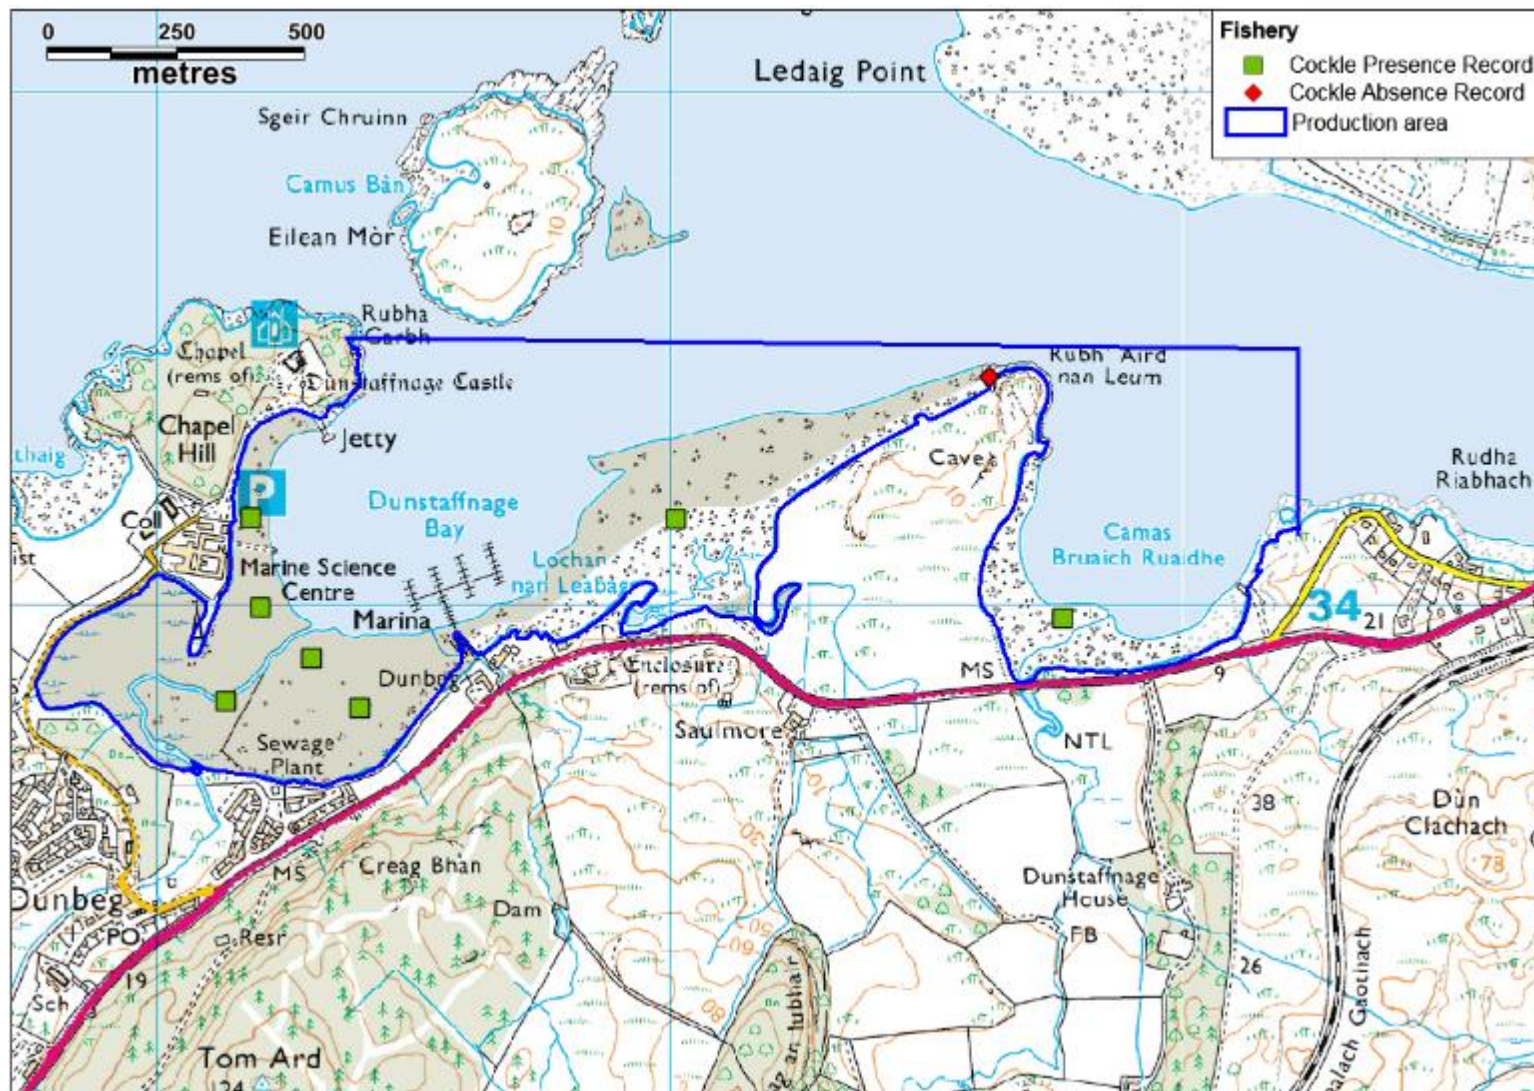
Figure 2.1 Dunstaffnage Cockle Fishery

During the shoreline survey, cockles were found at a number of intertidal locations within the production area but not at NM 8962 3445 where the substrate was identified to be stony and rocky. Historical surveys conducted in the bay and listed in the National Biodiversity Network (NBN) Gateway (<https://data.nbn.org.uk/imt>) reported the presence of cockles in the bay (Scottish Natural Heritage, 2011). Cockle presence locations from the NBN gateway and the shoreline survey are shown in Figure 2.

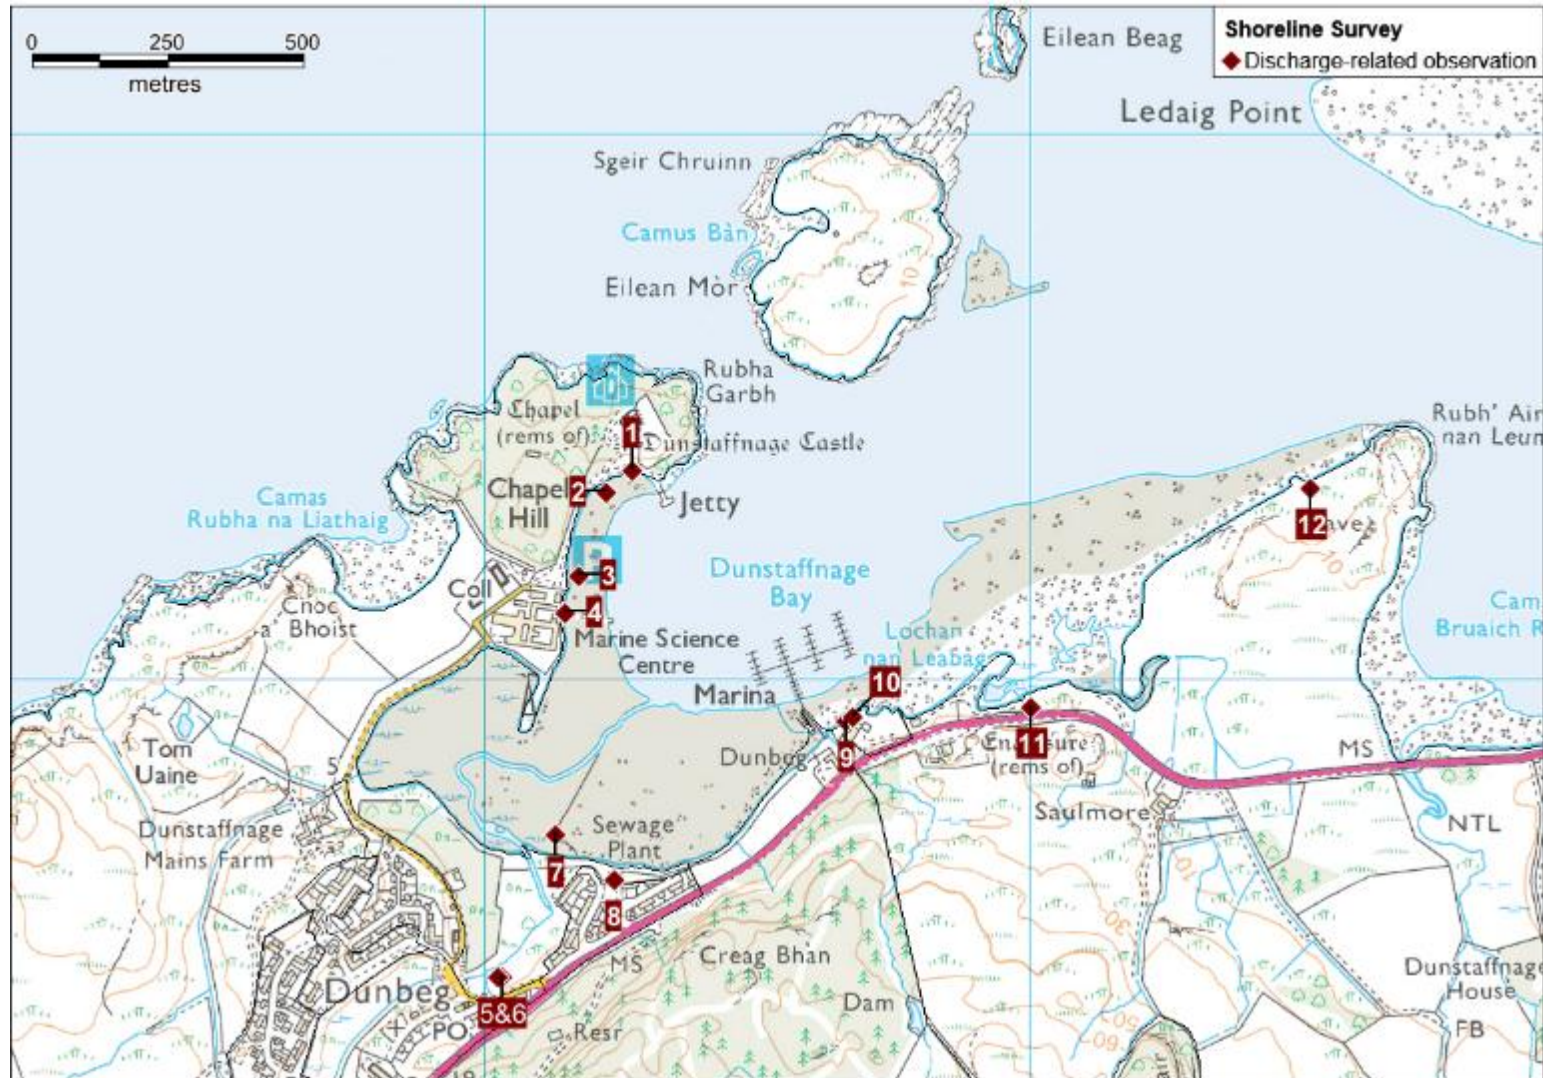
Figure 4.2 Map of discharge-related shoreline survey observations in the vicinity of Dunstaffnage Bay

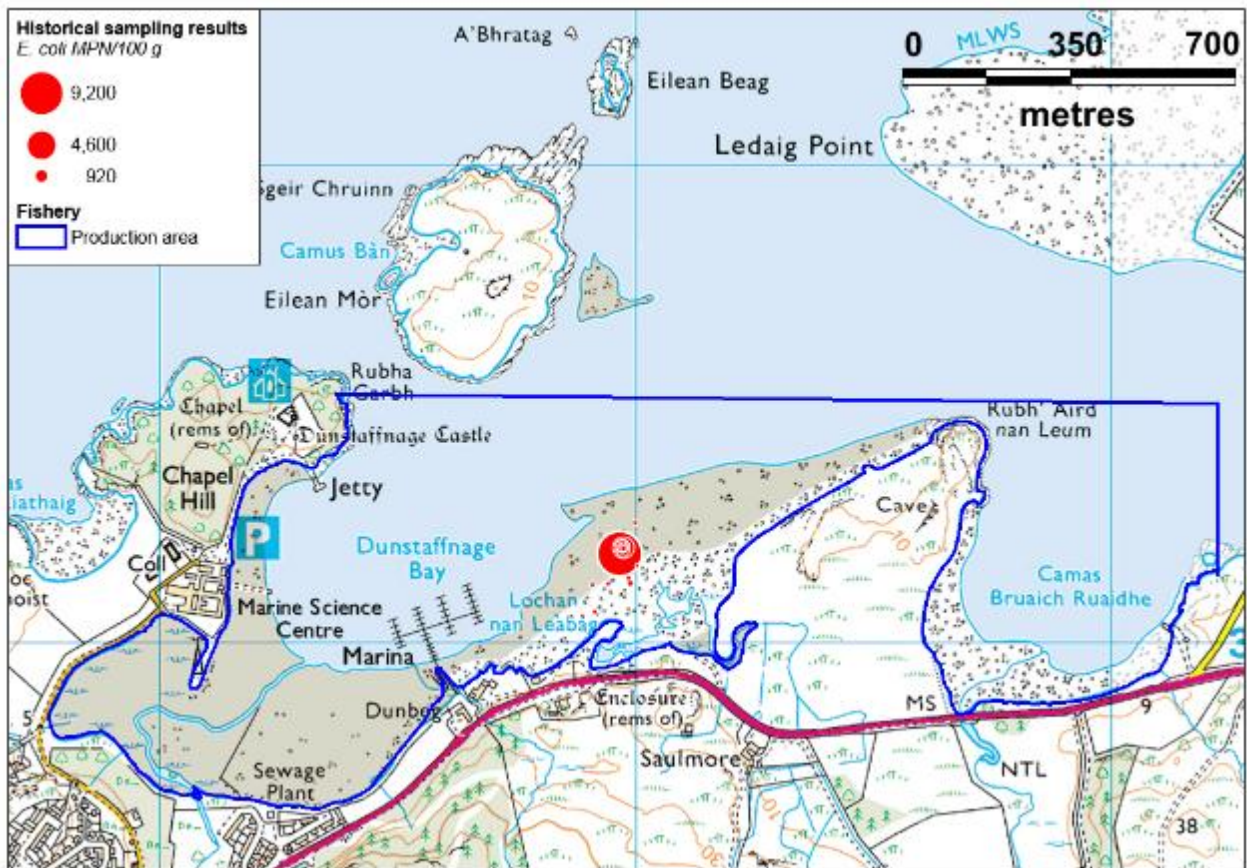
Figure 11.1 Map of reported sampling locations for common cockles at Dunstaffnage Bay

The reported sampling locations for all samples assigned to Dunstaffnage Cockles are shown on the map thematically in Figure 11.1. The symbols sizes are graduated proportional to the magnitude of the *E. coli* results.

All 17 samples were reported to have been taken on the intertidal area to the east of Dunstaffnage Marina.

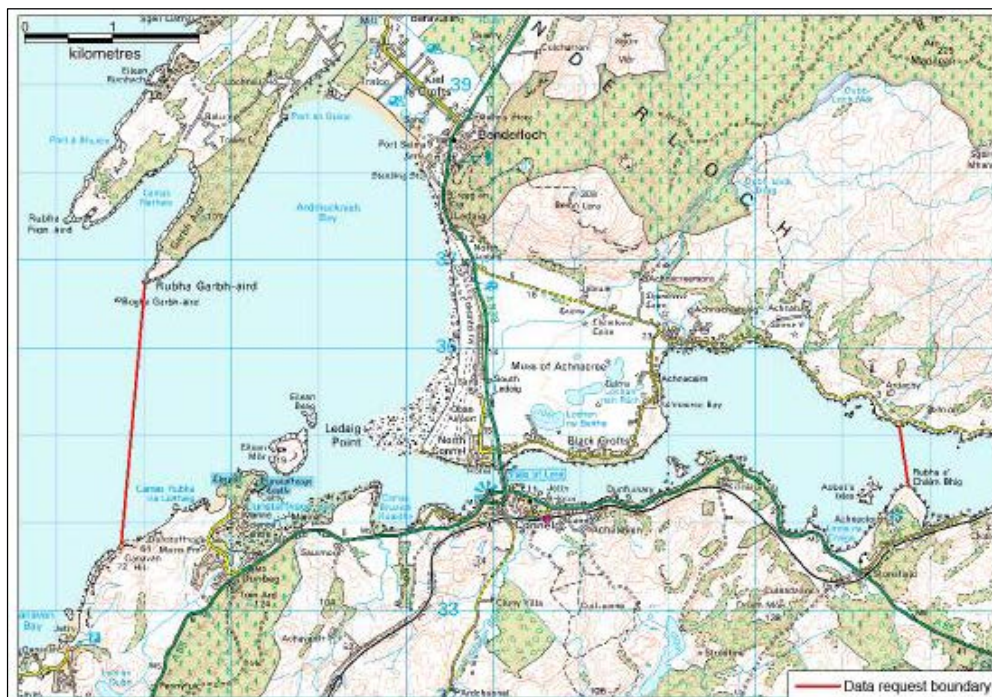
Figure 13.1 Extent of the Dunstaffnage Bay hydrographic study area

Dunstaffnage Bay is situated in Argyll and Bute on the west coast of Scotland, approximately 4 km to the northeast of Oban. The assessment area is comprised of Ardmucknish and Dunstaffnage Bays in the west and the western end of Loch Etive in the east (Figure 13.1). These components are separated by a narrow channel characterised by a tidal race at the Falls of Lora. This channel is approximately 180 m in width at its narrowest point.

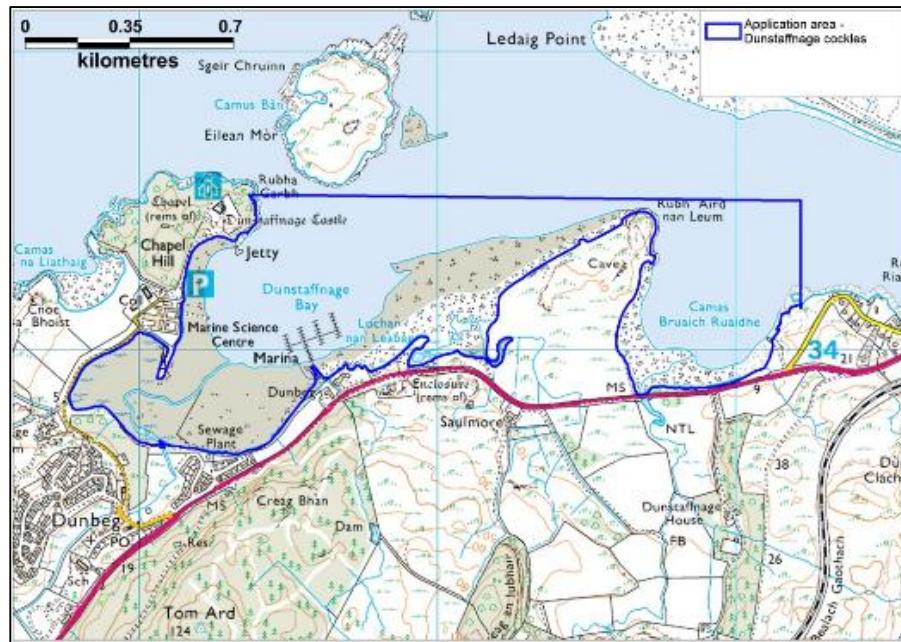
Figure 13.2 Dunstaffnage Bay application area for cockles

Dunstaffnage Bay itself is approximately 0.8 km² in area, and approximately half of this area is exposed at low tide. A map of Dunstaffnage Bay can be found in Figure 13.2.

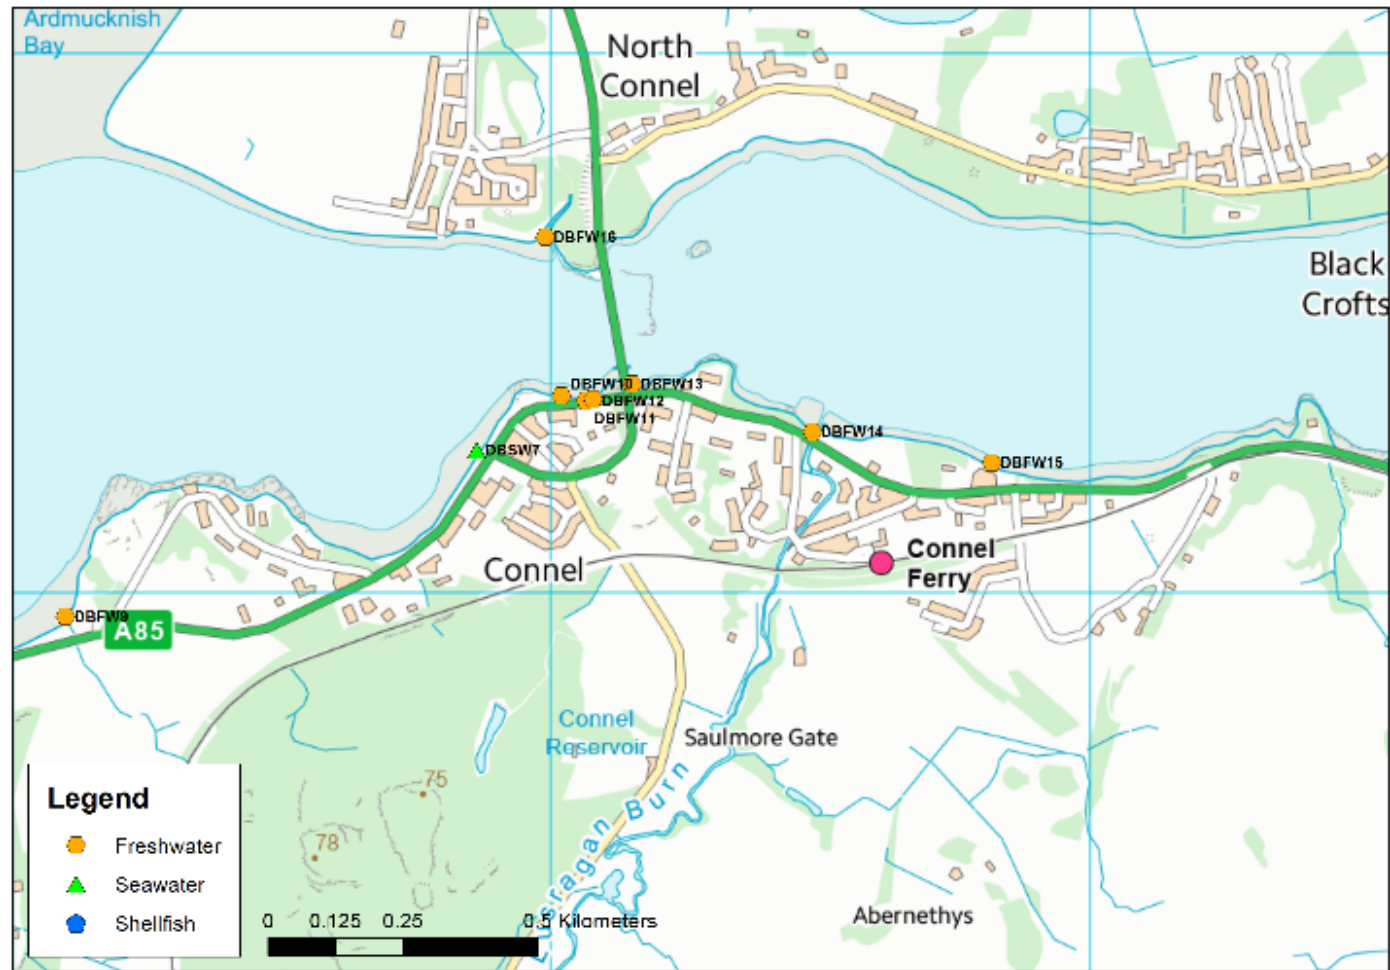
Figure 4. Dunstaffnage Bay samples_east

Specific observations made during the survey are mapped in Figures 1-4 and listed in Table 1. Water and shellfish samples were collected at the locations marked on Figures 3 and 4. Bacteriology results are given in Tables 2 and 3.

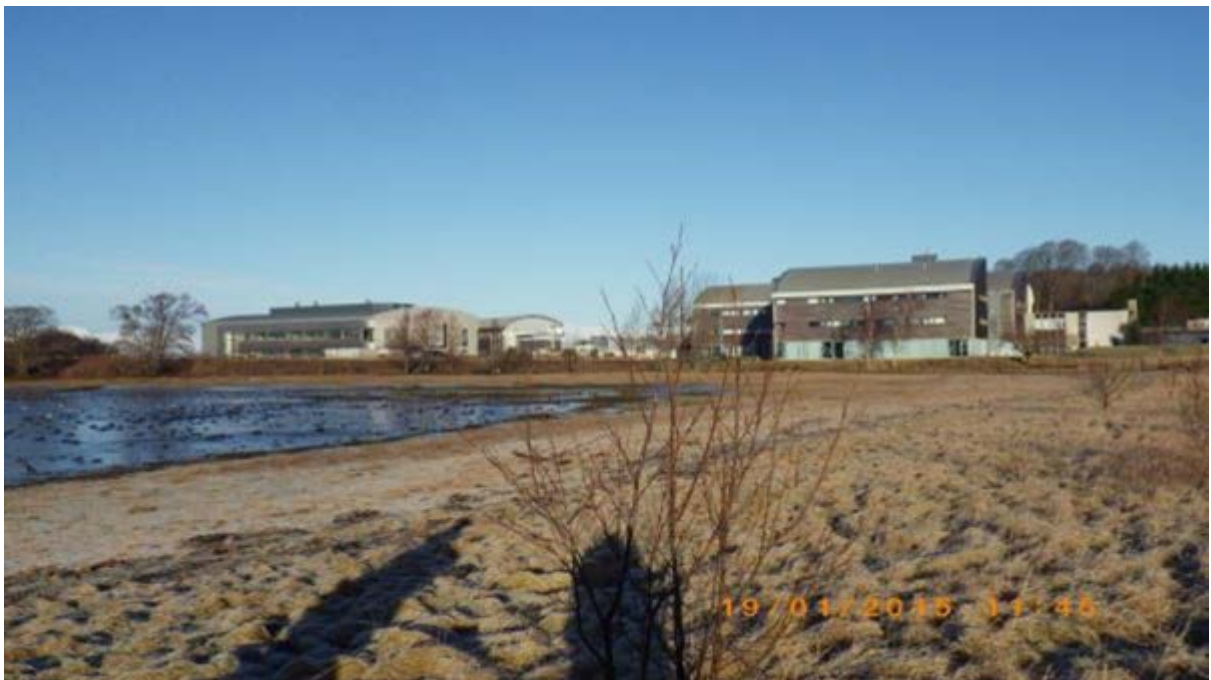
Figure 6. Scottish Marine Institute complex (Malin House, The European Marine Science Park building on the left). Waypoint 9.

The survey area has a variety of land uses. To the west and south of Dunstaffnage Bay there is a mixture of farmland, woodland and business use (Scottish Marine Institute, Fig. 6), turning to a mixture of residential and forest/rough ground at Dunbeg. Dunstaffnage Marina and Poppies Garden Centre to the southeast of the bay then gives way to a mix of rough ground and farmland until Connel village starts at the western mouth of Loch Etive. The presence of a few broken clay pigeons in the vicinity of waypoints 46 and 47 indicates possible use of this area for target shooting. Normally clays would be launched out to sea and there would be no evidence onshore. From here the survey route consists of residential properties on both the north and south side of the loch, with those on the north side set back from the lochside by farmland and sloping crofting ground. A small airport is present in North Connel (Oban Airport) to the west of the bridge, on flat land bordering the shoreline.

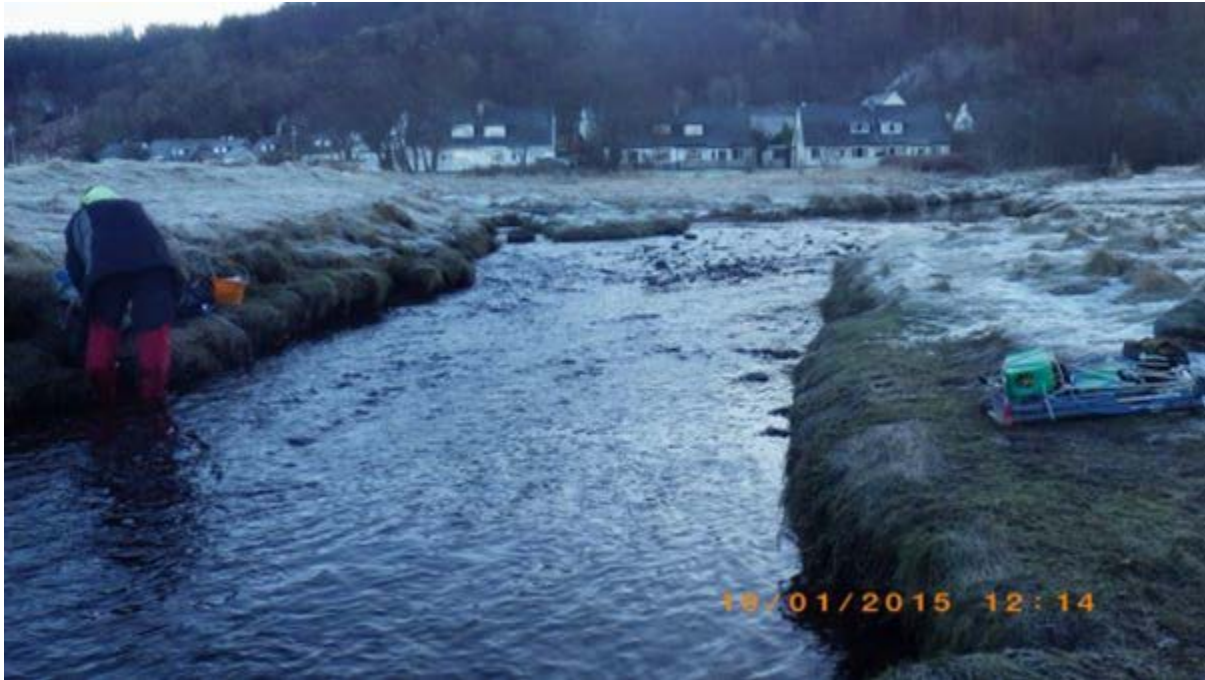
Figure 7. Unnamed watercourse passing through Dunbeg village. Waypoint 14.

The largest watercourse on the survey route was the Lusragan Burn, running into Loch Etive through Connel (Fig. 18, WP81/82). Other larger streams include the unnamed stream running through Dunbeg (Fig. 7, WP14) and the stream running into the bay of Camas Bruaich Ruaidhe, Fig. 12, WP54-55 passing Dunstaffnage House further inland. Other small streams were noted on the survey route, and these are noted in the shoreline observations in Table 1.

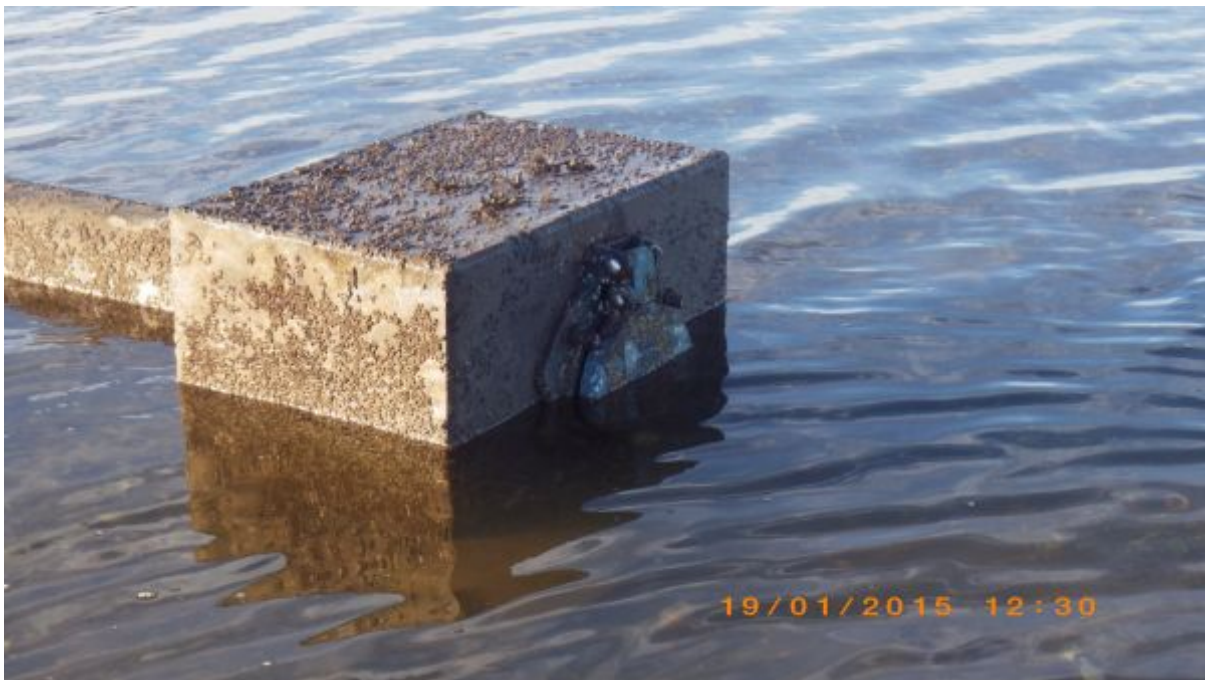
Figure 8. Dunbeg combined waste water overflow pipe end. Waypoint 16.

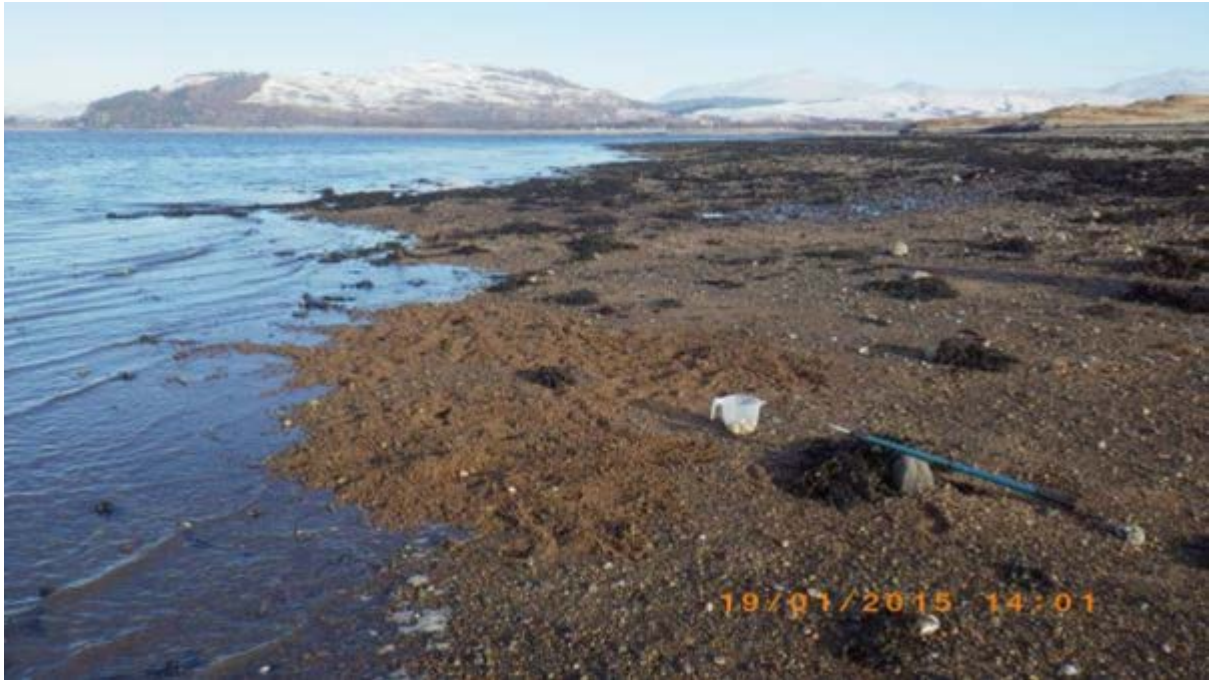
Figure 9. Site of shellfish sample DBSF4 off Poppies Garden Centre. WP34.

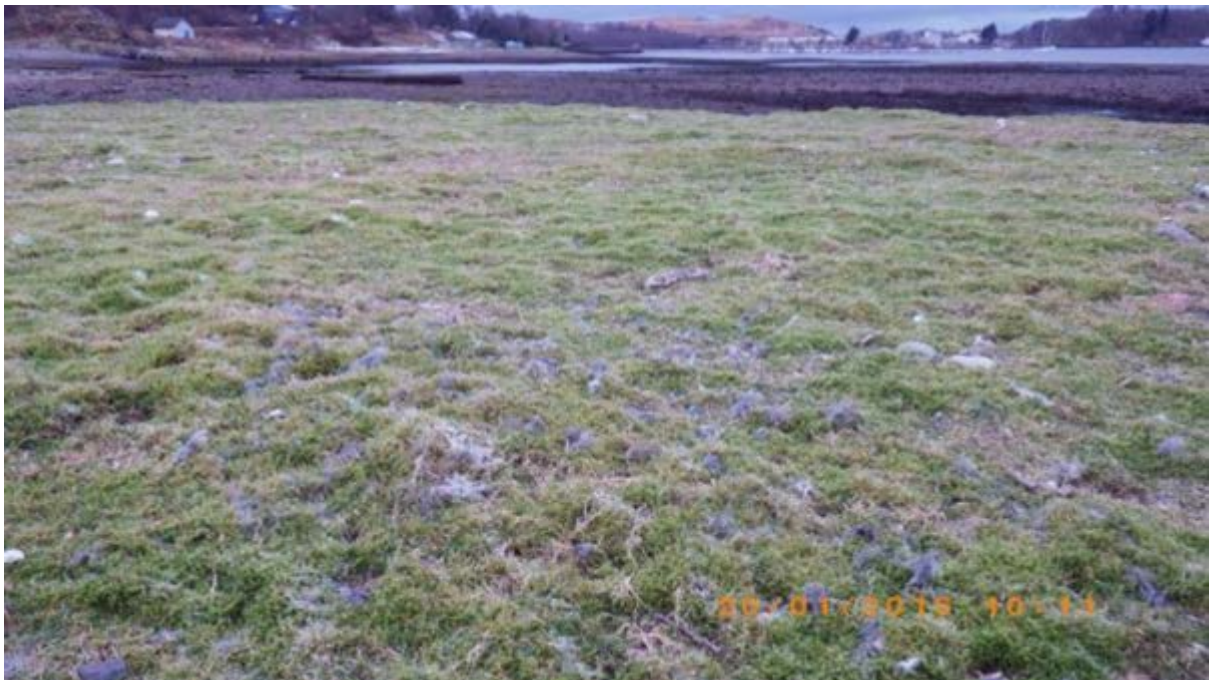
Figure 10. Rabbit fur from raptor kill on grass north east of Poppies Garden Centre (left of centre in the distance). Waypoint 45.

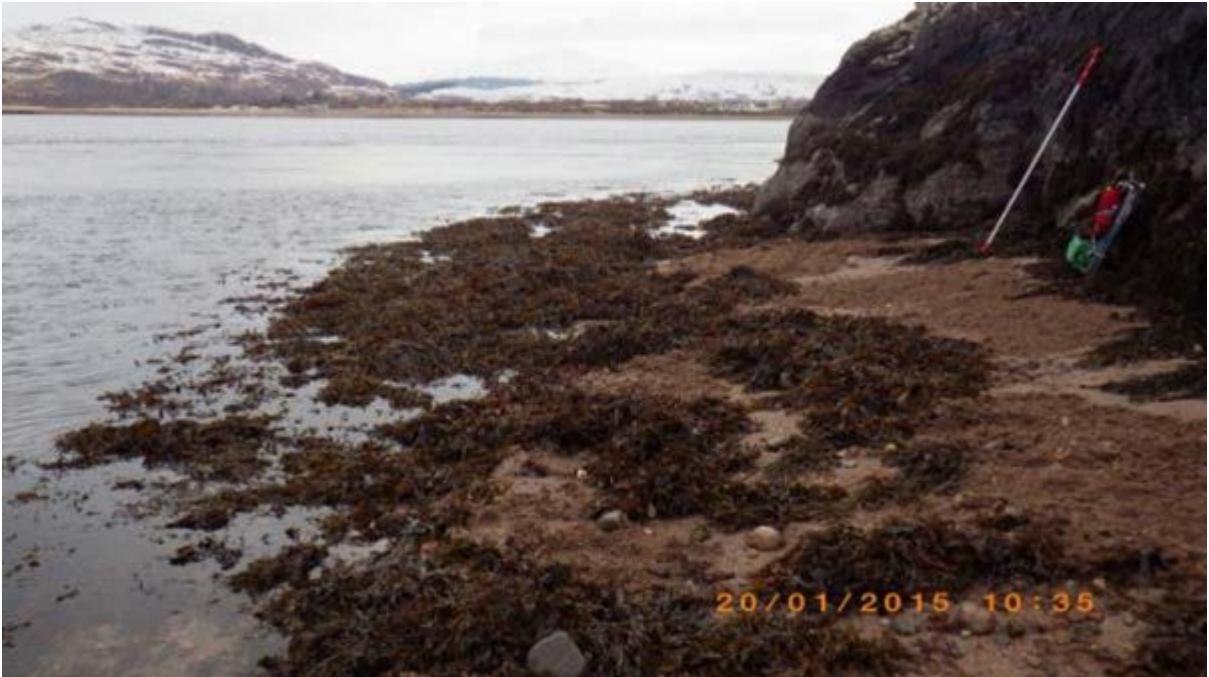
Figure 11. Site of seawater sample DBSW5 and unsuccessful attempt at cockle sample. Waypoint 48.

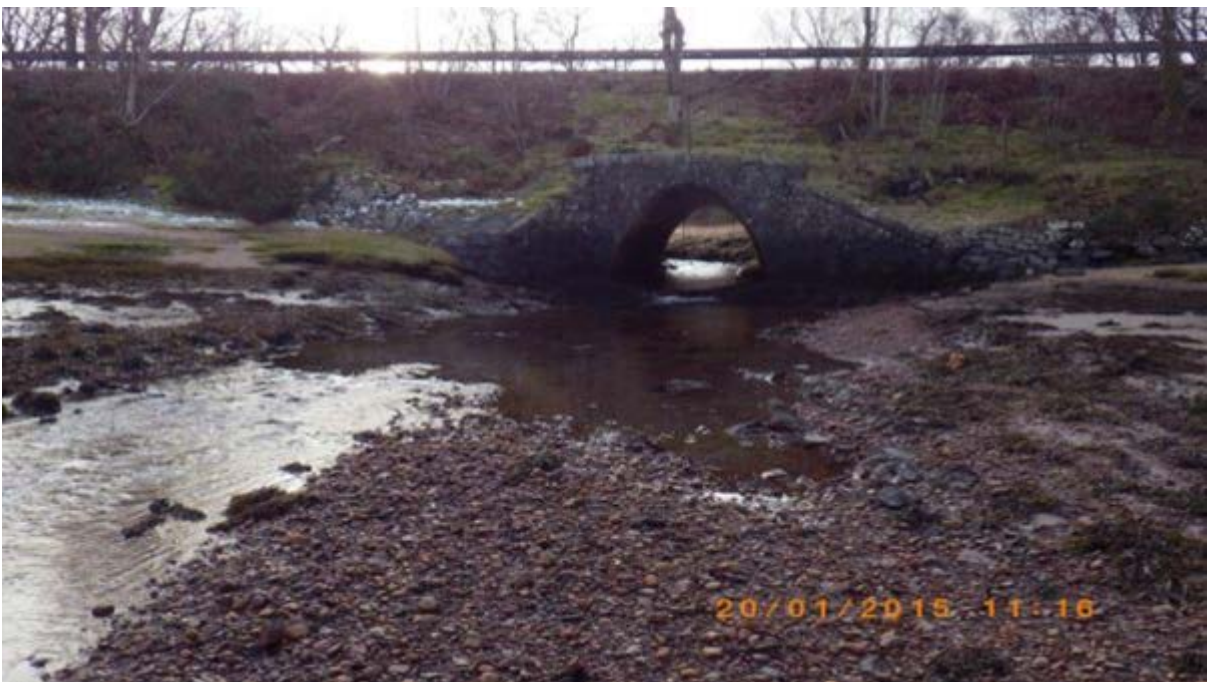
Figure 12. Unnamed stream running into Camas Bruaich Ruaidhe (site of freshwater sample DBFW8). Waypoint 50.

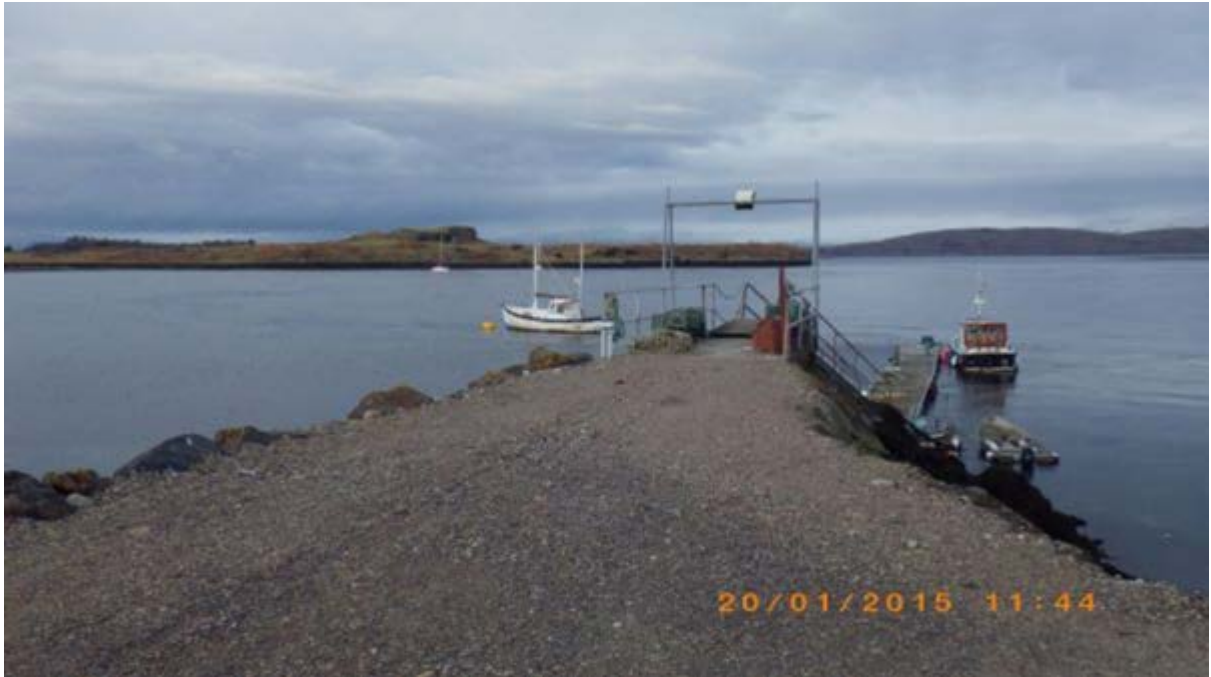
Figure 13. Pontoon, site of local authority mussel sample source. Waypoint 56.

The shoreline survey identified that the local authority currently take weekly *Mytilus edulus* samples from NM 90120 34039 (within Camas Bruaich Ruaidhe). It is assumed that those samples are taken for biotoxin testing as the samples reported on the FSAS database as having been tested for *E. coli* are identified as cockles taken from the eastern side of Dunstaffnage Bay (see Section 11).

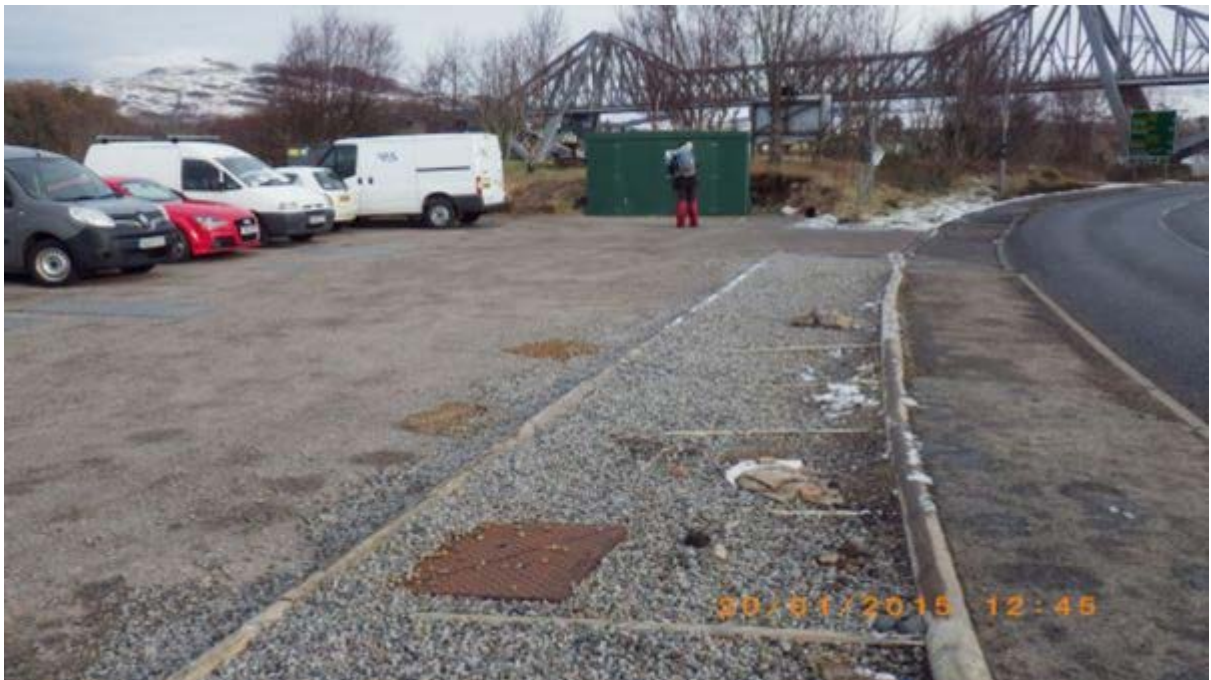
Figure 14. Scottish Water WWPS at south west side of Connel Bridge. Waypoint 68.

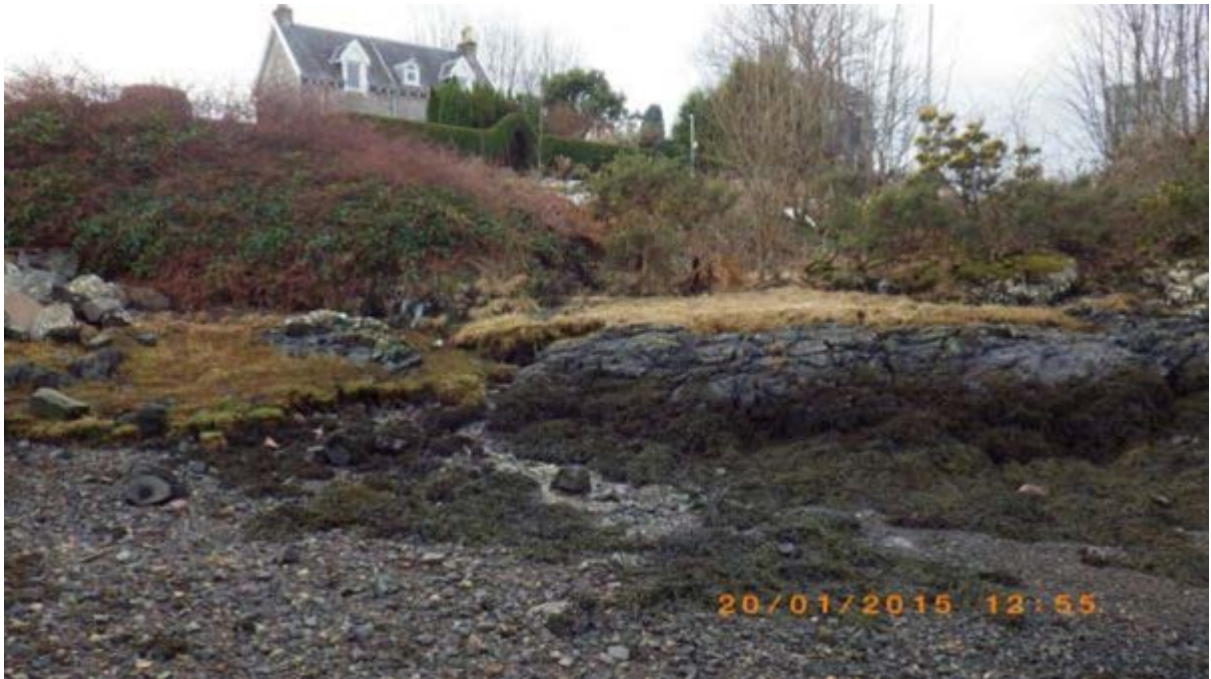
Figure 15. Site of unplanned freshwater sample DBFW10, Connel village.

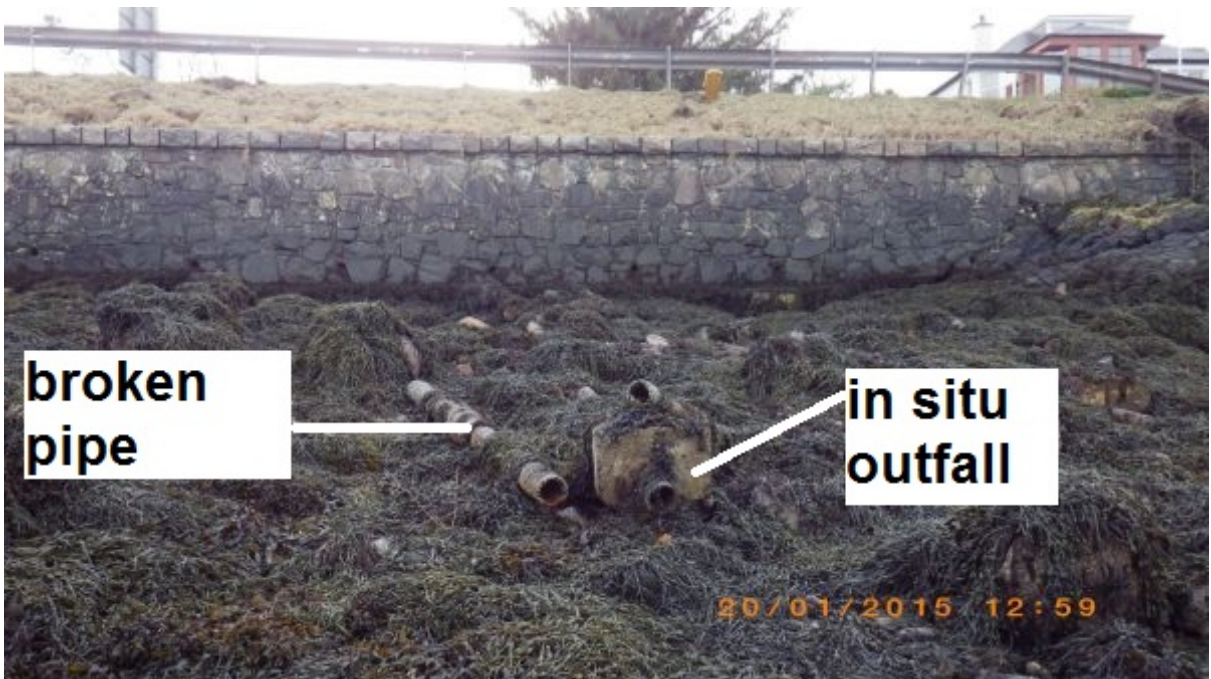
Figure 16. Site of unplanned freshwater sample DBFW11, Connel village.

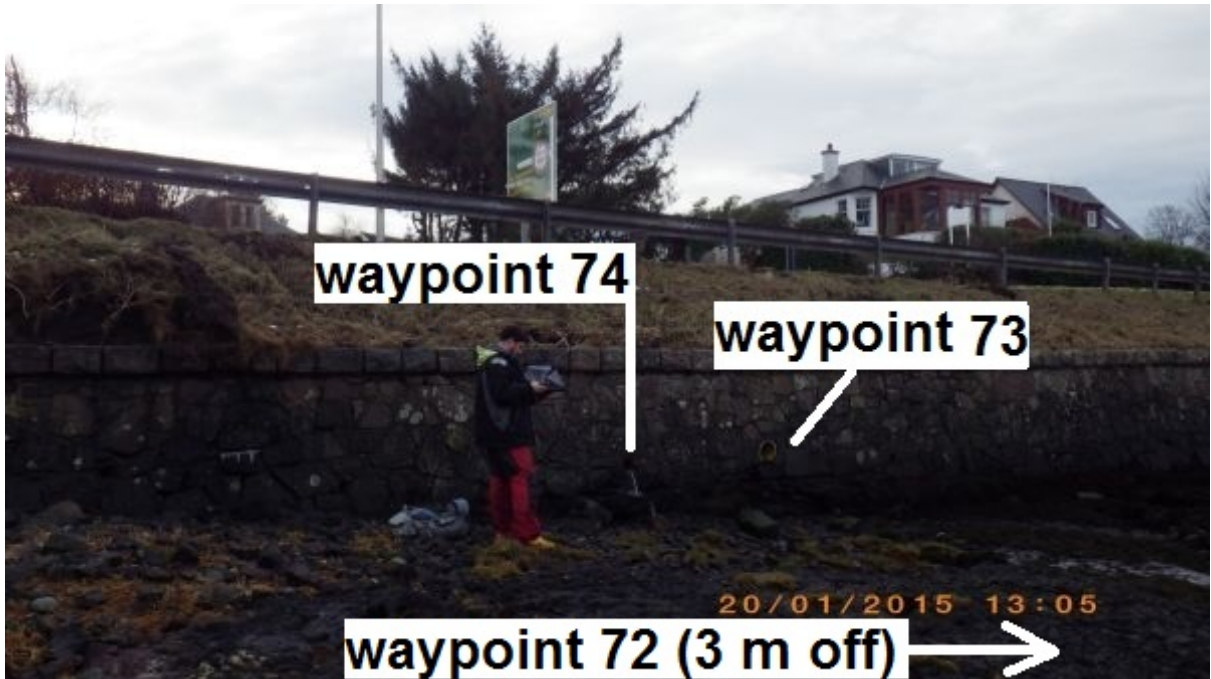
Figure 17. Site of unplanned freshwater samples DBFW11 and 12, Connel village, southwest side of Connel Bridge. Waypoints 73 and 74.

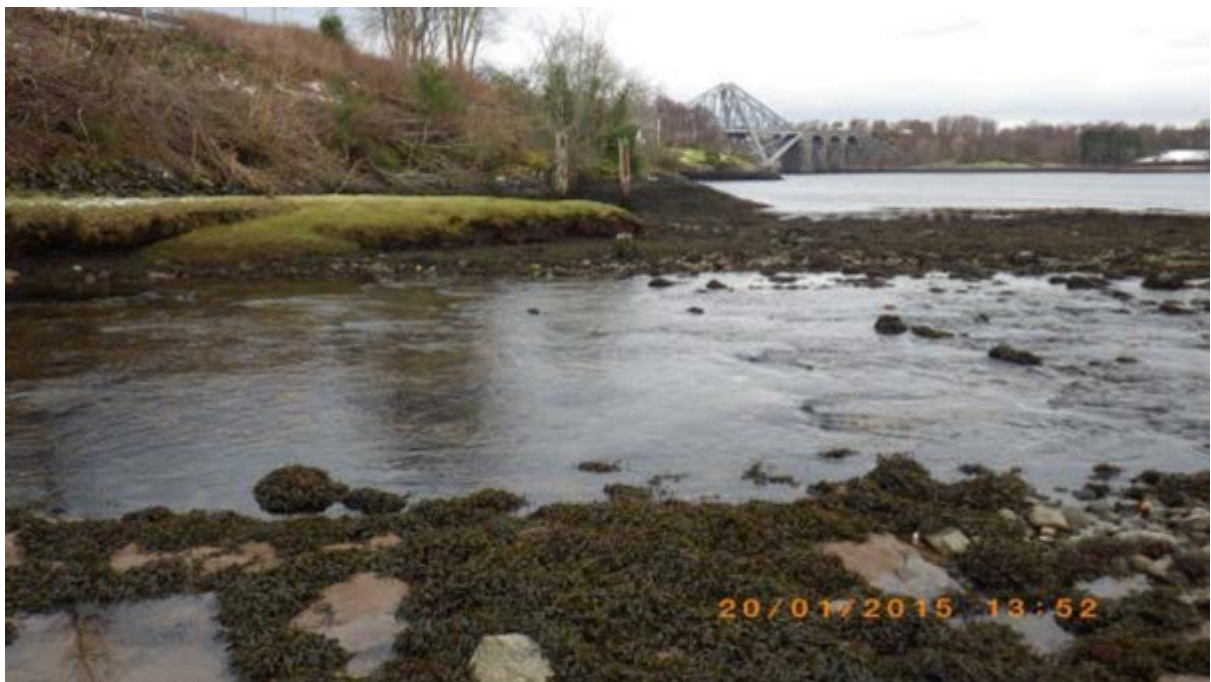
The average flow for Lusragan Burn has previously been stated to be 0.99 m³/s (Magill, *et al.*, 2008): this equates to approximately 85,500 m³/d. The flow measured

Figure 18. Lusragan Burn, Connel village, site of planned freshwater sample DBFW14. Waypoints 81 and 82.

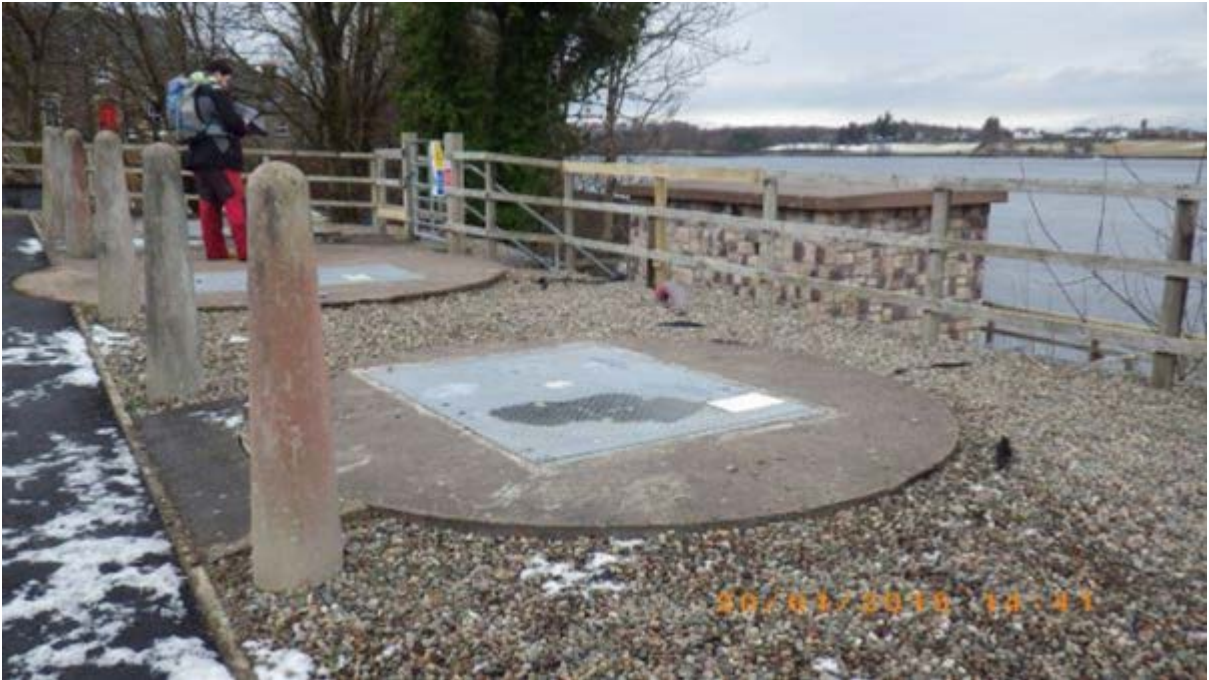
33	NM 91864 34230			Discharge pipe of 20 cm diameter with end below LWS. Pipe situated below Scottish Water pumping station.
34	NM 91893 34200	Fig. 18		Scottish Water waste water pumping station with three sets of manholes. Control kiosk on shore side. Pipe at WP 87 immediately below.
35	NM 92007 34217			Small watercourse running under road from woods and fields south side of A85. Small plastic drainage pipe adjacent with no flow.
36	NM 92287 34295			Discharge pipe with no flow or discharge evidence. Pipe broken on mid shore.
37	NM 92381 34277			Manhole covers in garden of cottage (former boathouse converted to holiday dwelling).

Figure 19. Scottish Water WWPS, Connel village, east of the south end of Connel Bridge. Waypoint 95.

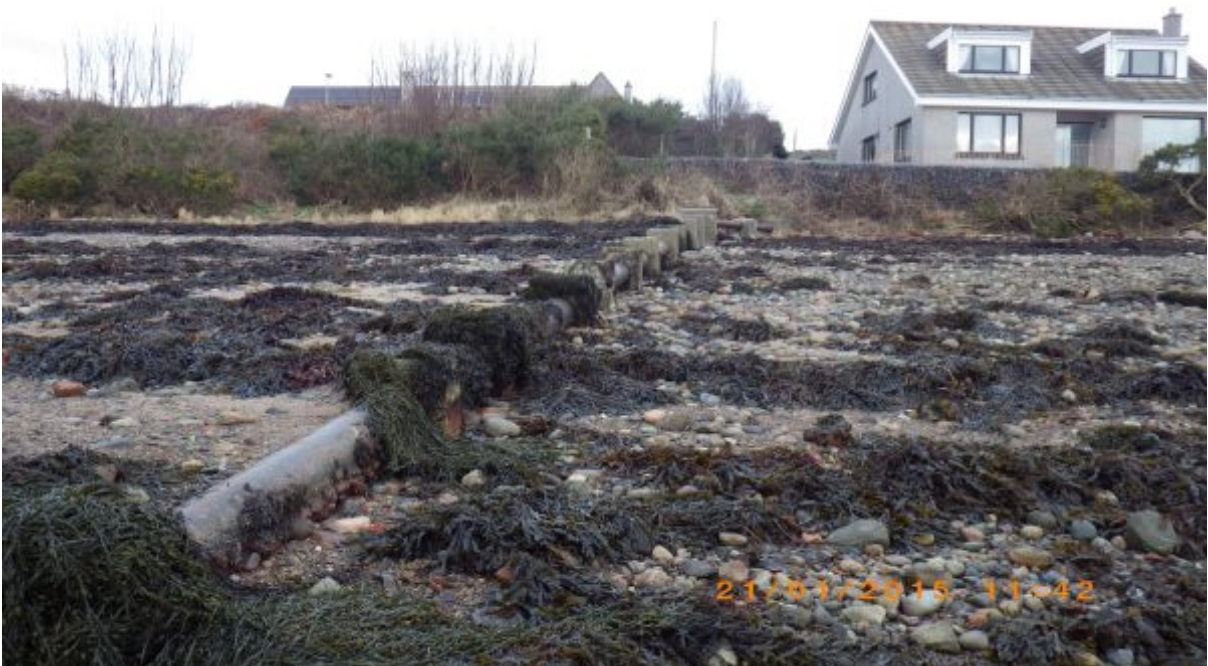
Figure 20. Outfall pipe, North Connel, with end at subtidal level. Watpoint 116.

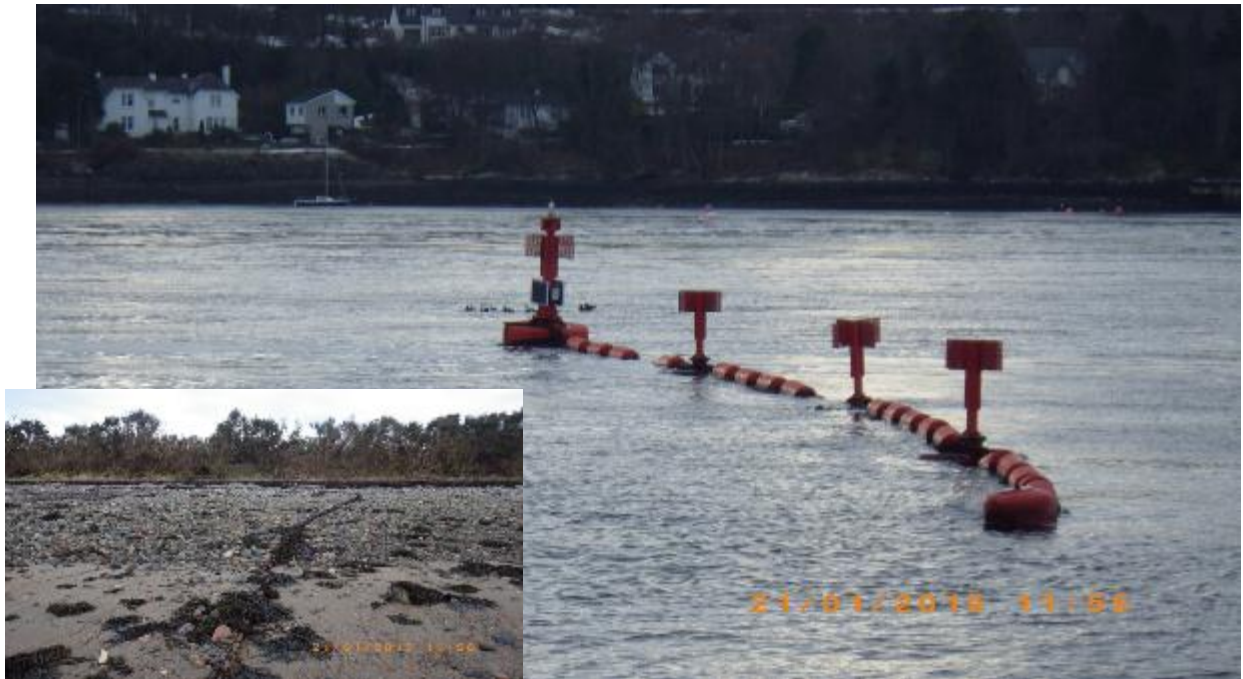
Figure 21. Buoy array at end of Oban Airport. Heavy chain and concrete anchoring block on shore (inset image). Waypoint 120.

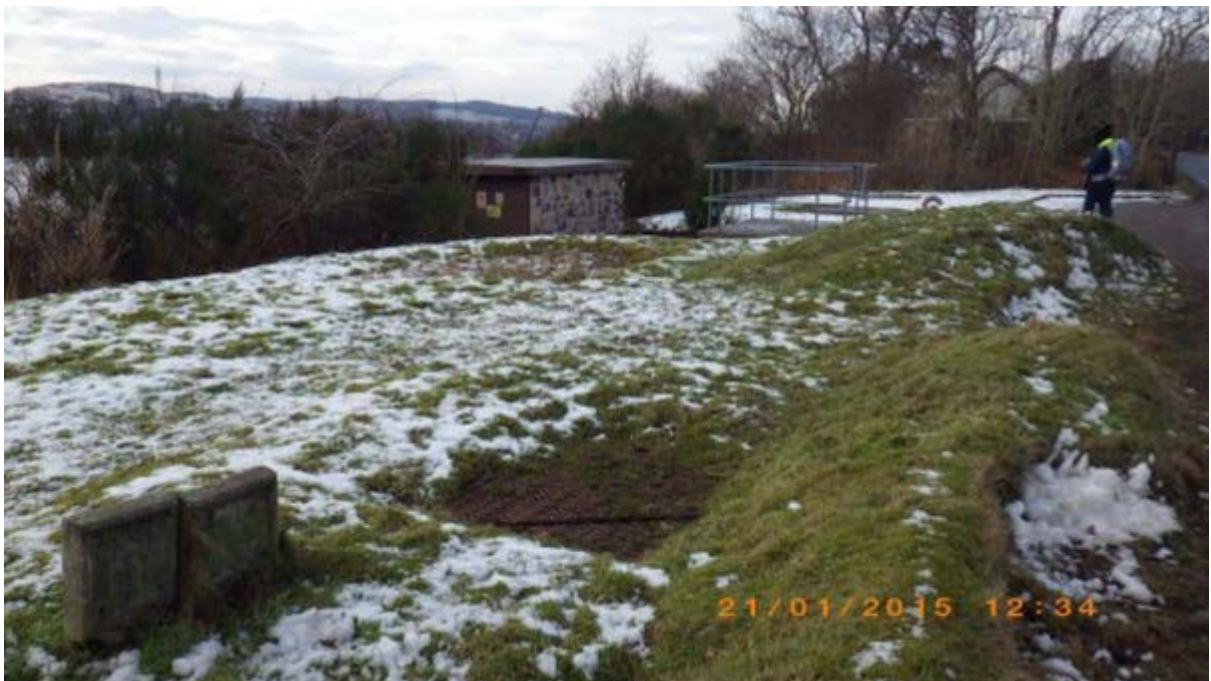
Figure 22. Scottish Water WWPS, North Connel, east of the Connel Bridge. Waypoint 127.
