Scottish Sanitary Survey Report

Sanitary Survey Report
East Burwick
SI-583-1060-08
October 2014

Report Title	East Burwick Sanitary Survey Report
Project Name	Scottish Sanitary Survey Programme
Client/Customer	Food Standards Agency in Scotland
Cefas Project Reference	C6316C
Document Number	C6316C_2014_7
Revision	V1.0
Date	27/10/2014

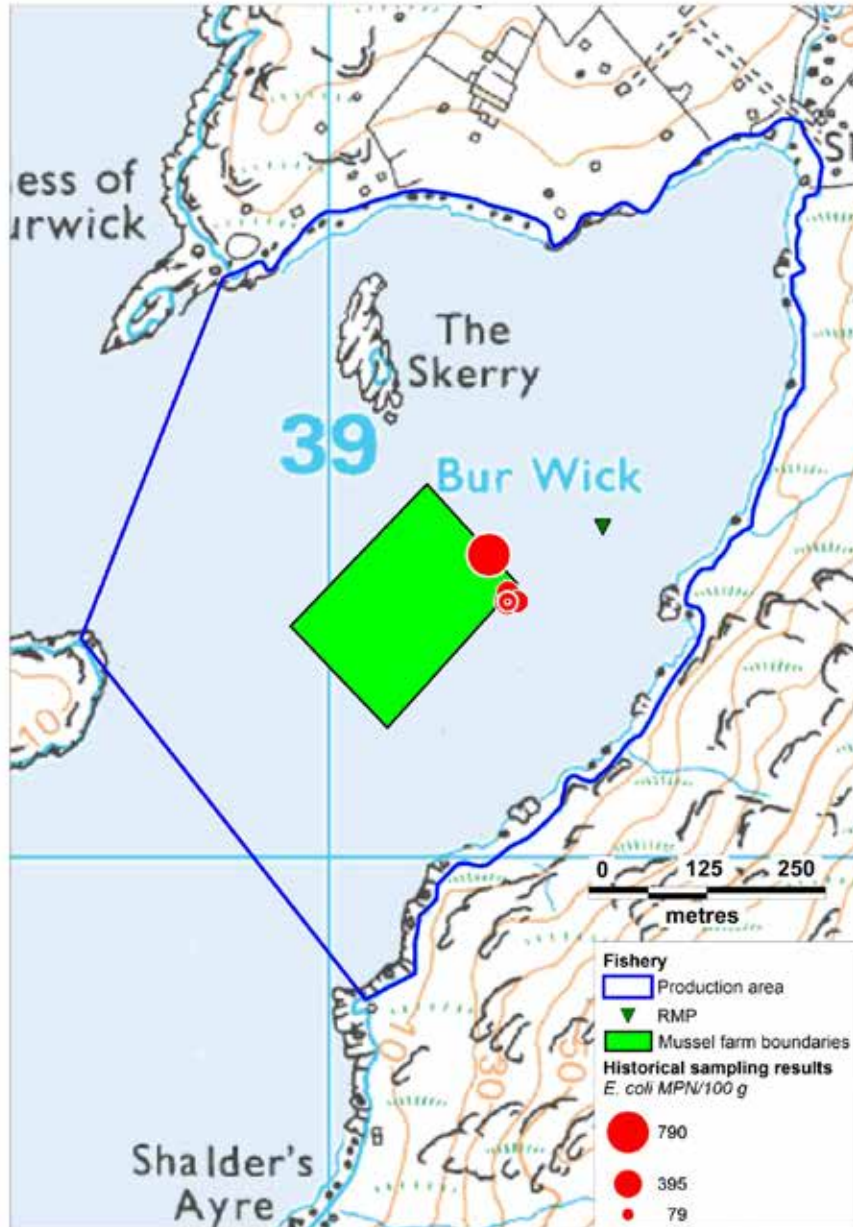
Figure 12.1 Map of reported sampling locations for common mussels at East Burwick

The nine East Burwick sample results were all taken from the northeast corner of the mussel farm. The highest result was associated with a sample taken slightly to the north and west of the other sampling locations.

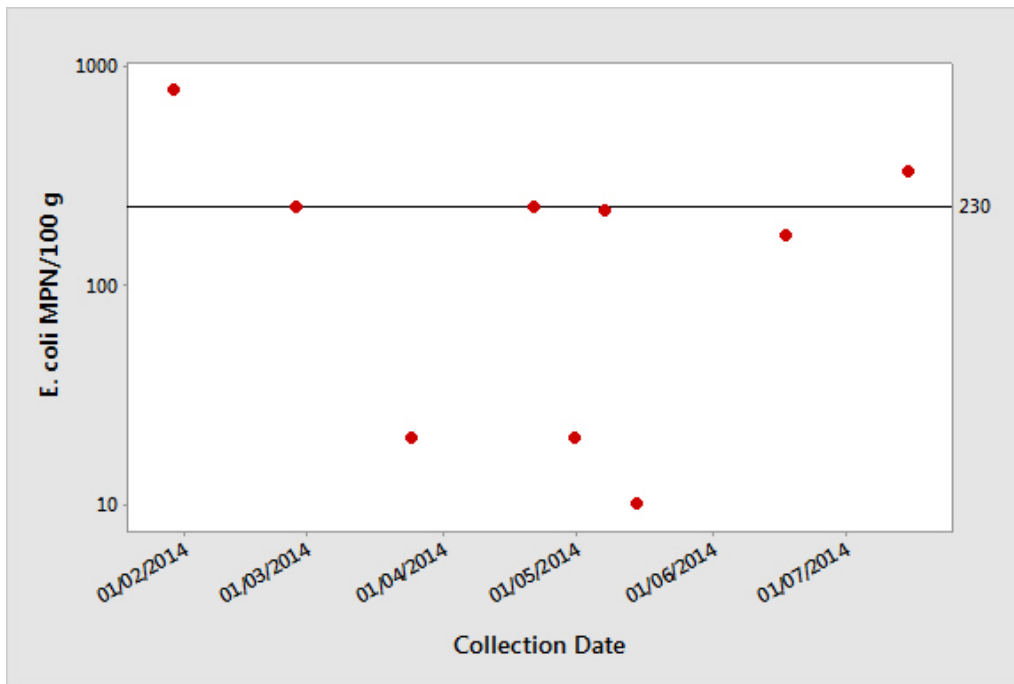
Figure 12.2 Scatterplot of *E. coli* results by collection date at East Burwick, fitted with a lowess line

The highest result was from a sample taken in January 2014.

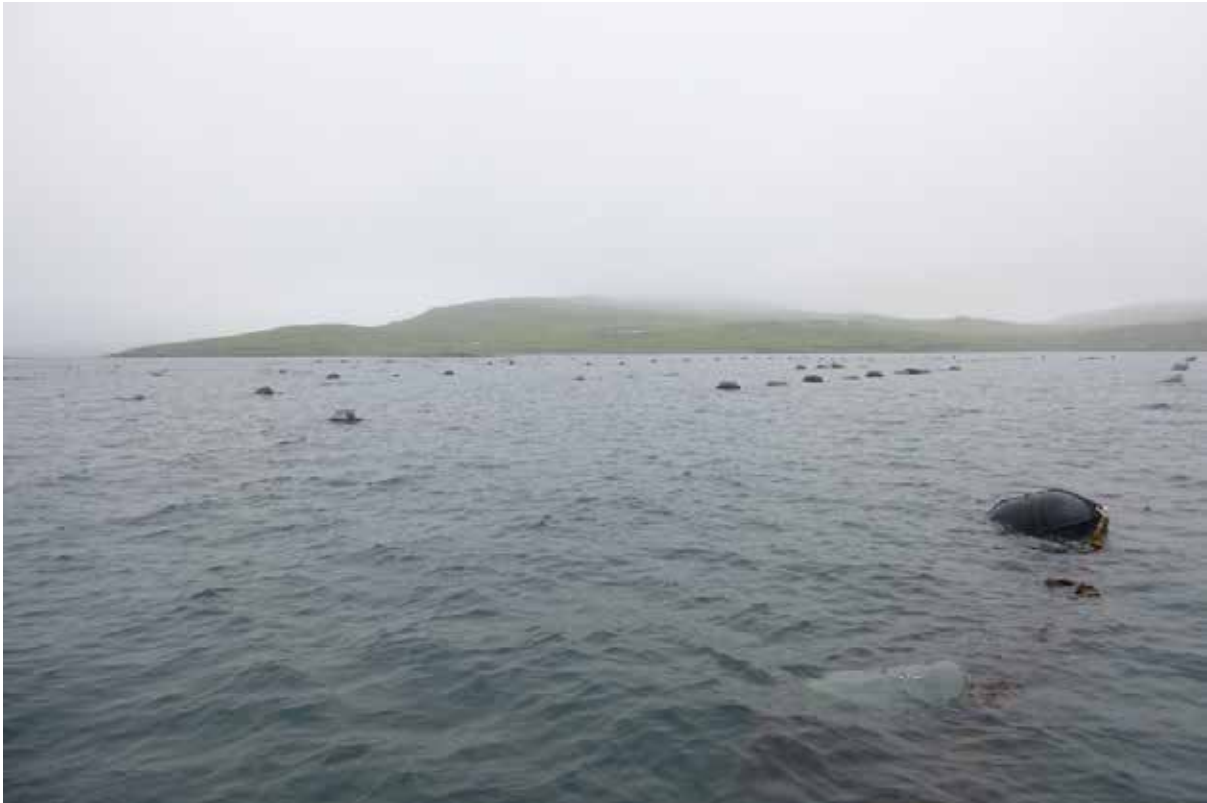
Figure 4 – Mussel lines at the East Burwick fishery looking North.

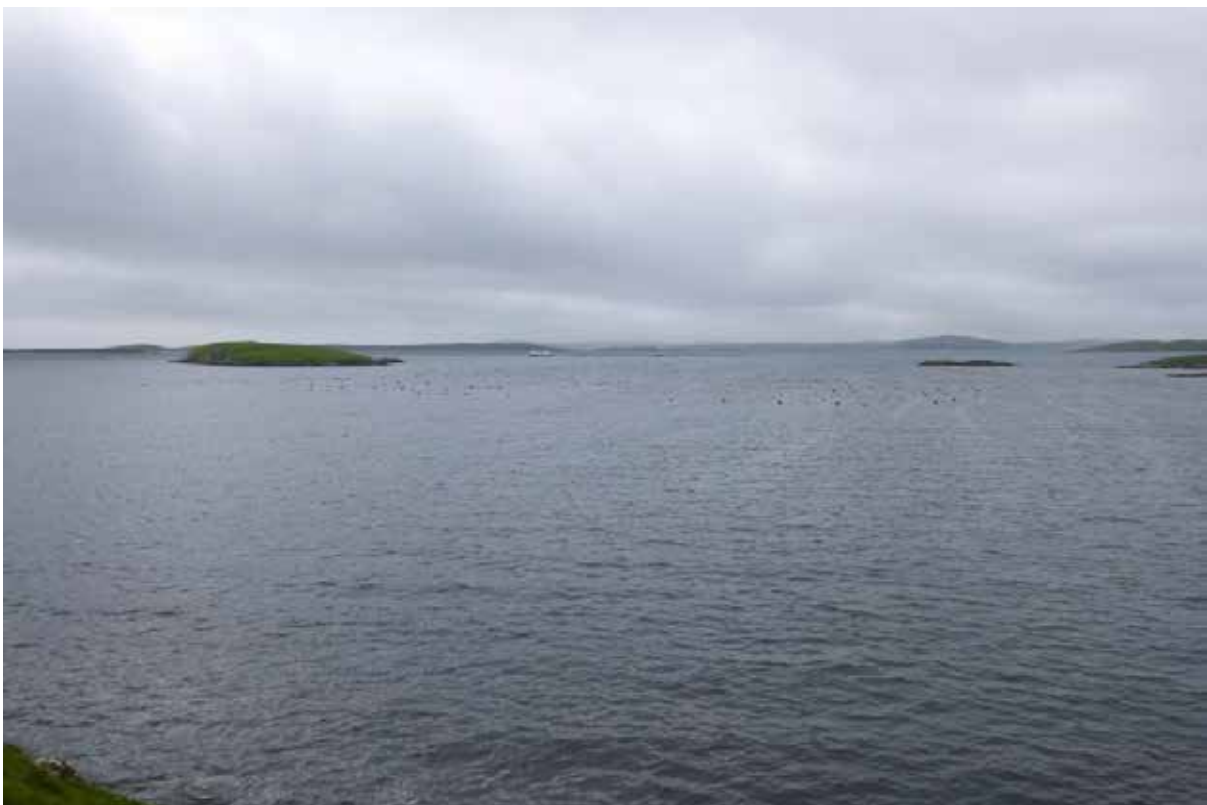
Figure 5 – East Burwick fishery from the southern shore of the production area looking west.

24	17/06/2014 13:37	HU 39382 40194	439382	1140194	Figure 5		East Burwick fishery. Very steep escarpments.
25	17/06/2014 13:39	HU 39397 40258	439397	1140258			Lowland area, small stony beach. Lots of rubbish washed up, nettles present. 20 sheep observed on the hill. 3 oystercatchers and one gull in flight. Boggy area above beach, bog cotton present.

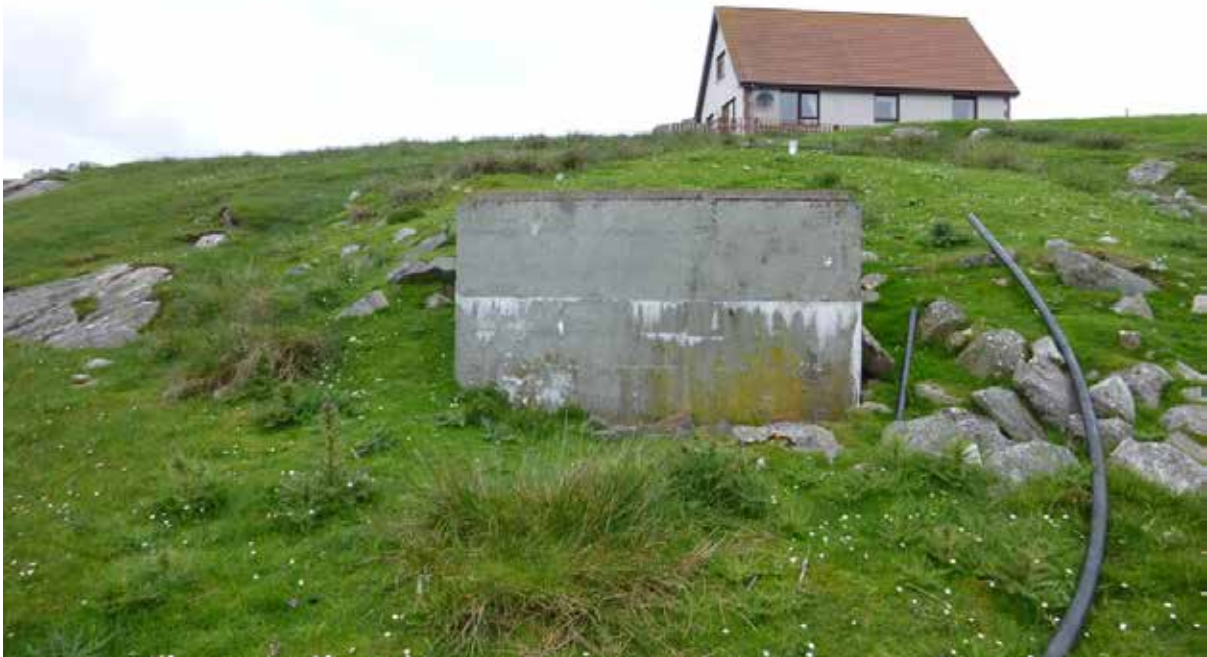
Figure 6 – Septic tank associated with a house at Burwick

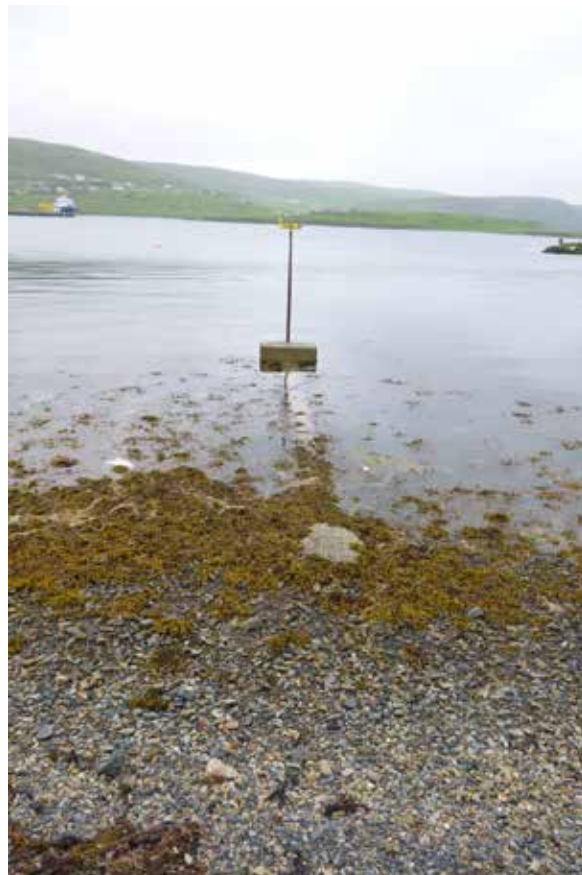
Figure 7 – Pipe associated with the West Shore Sewage Pumping Station

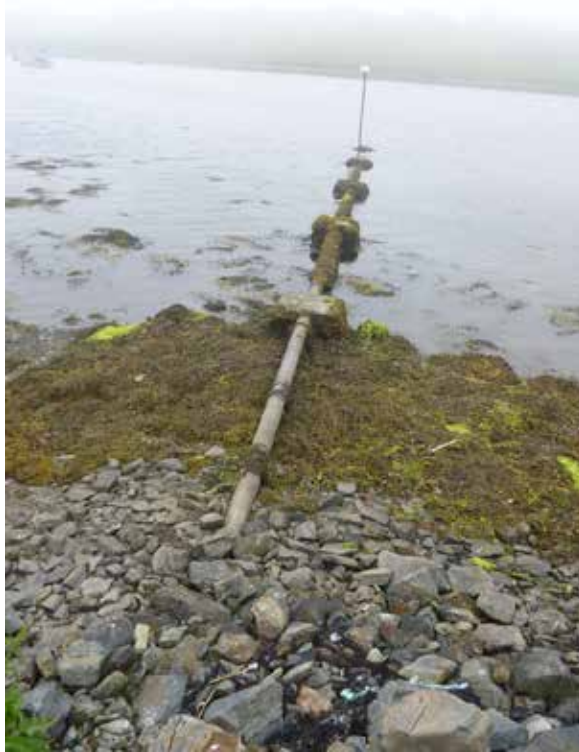
Figure 8 – Pipe associated with the Blydoit Sewage Pumping Station

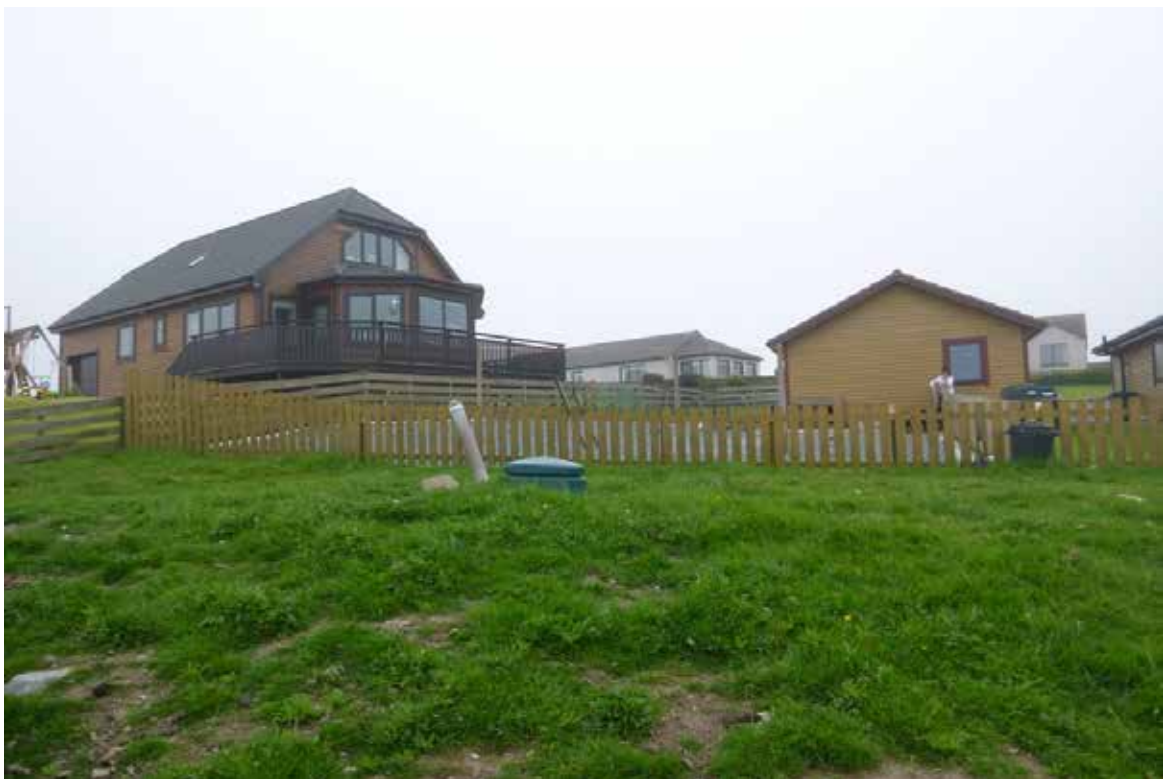
Figure 9 – Septic tank associated with houses at Scarfataing

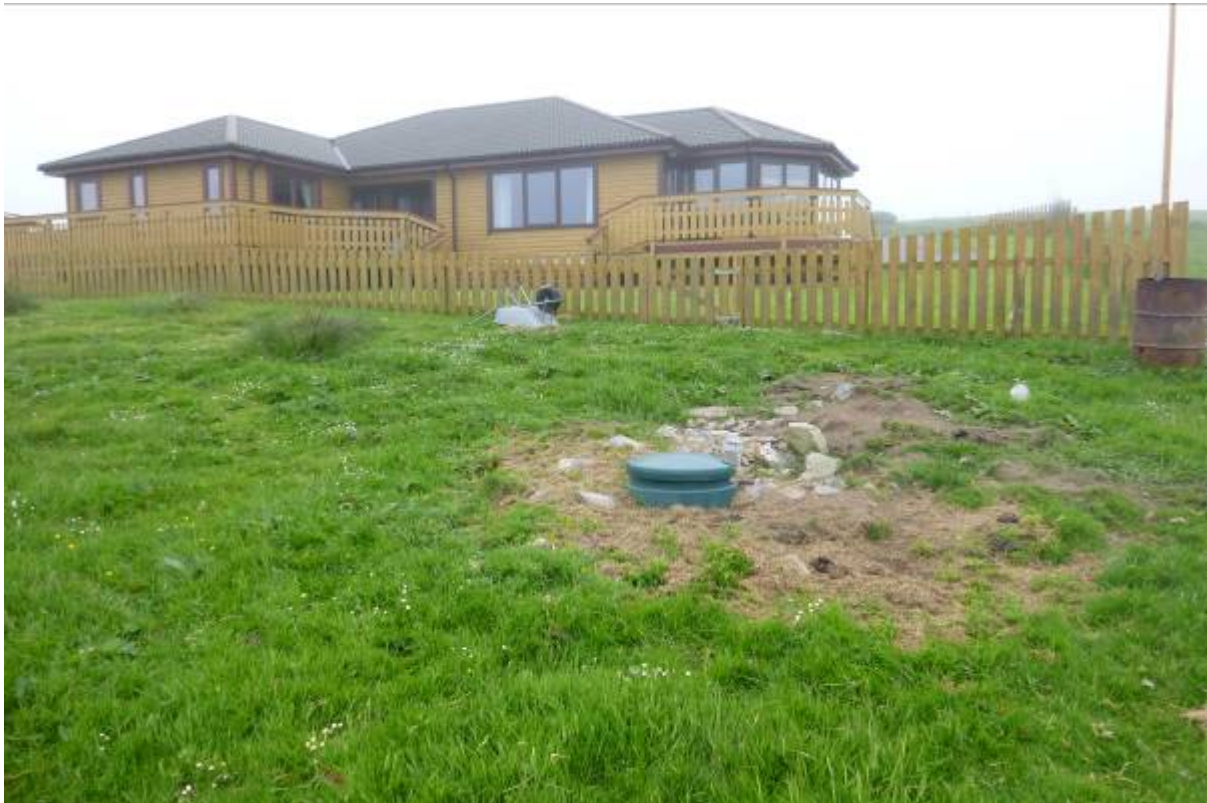
Figure 10 – A second septic tank associated with houses at Scarfataing

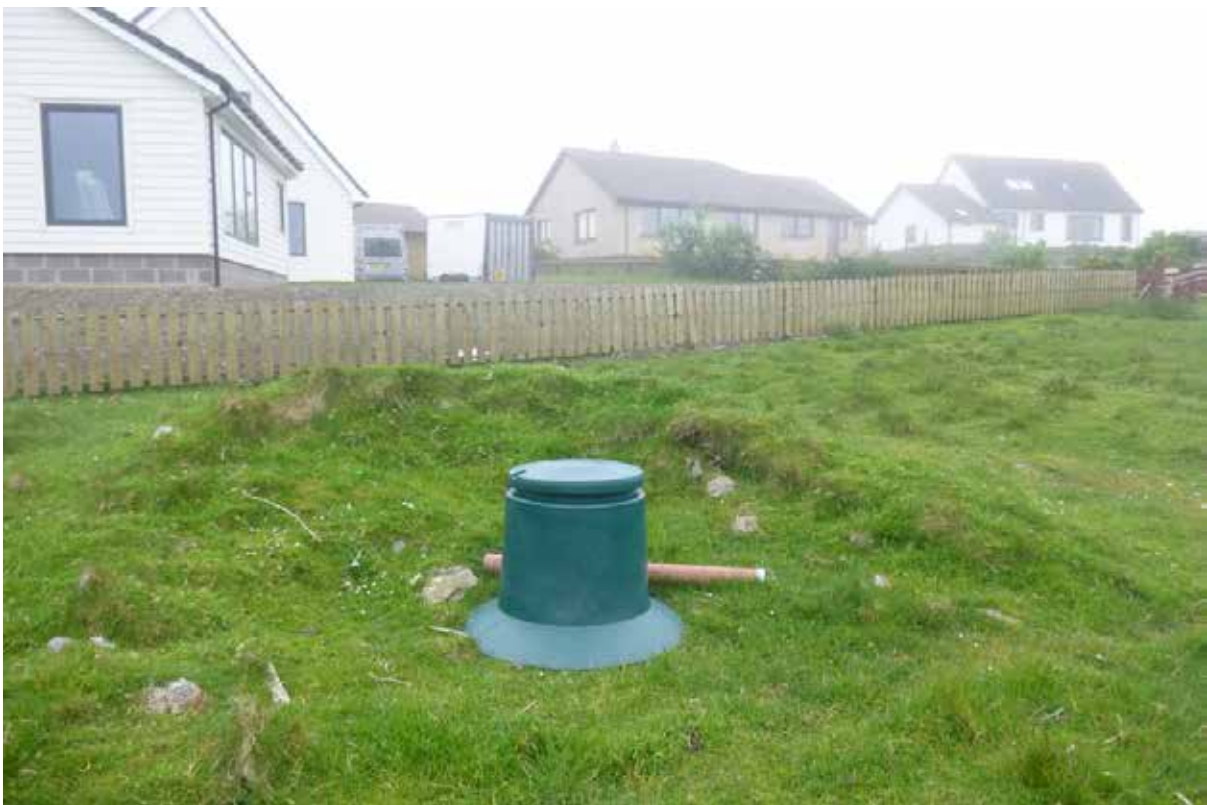
Figure 11 – Septic tank associated with a new house near Scarfataing.

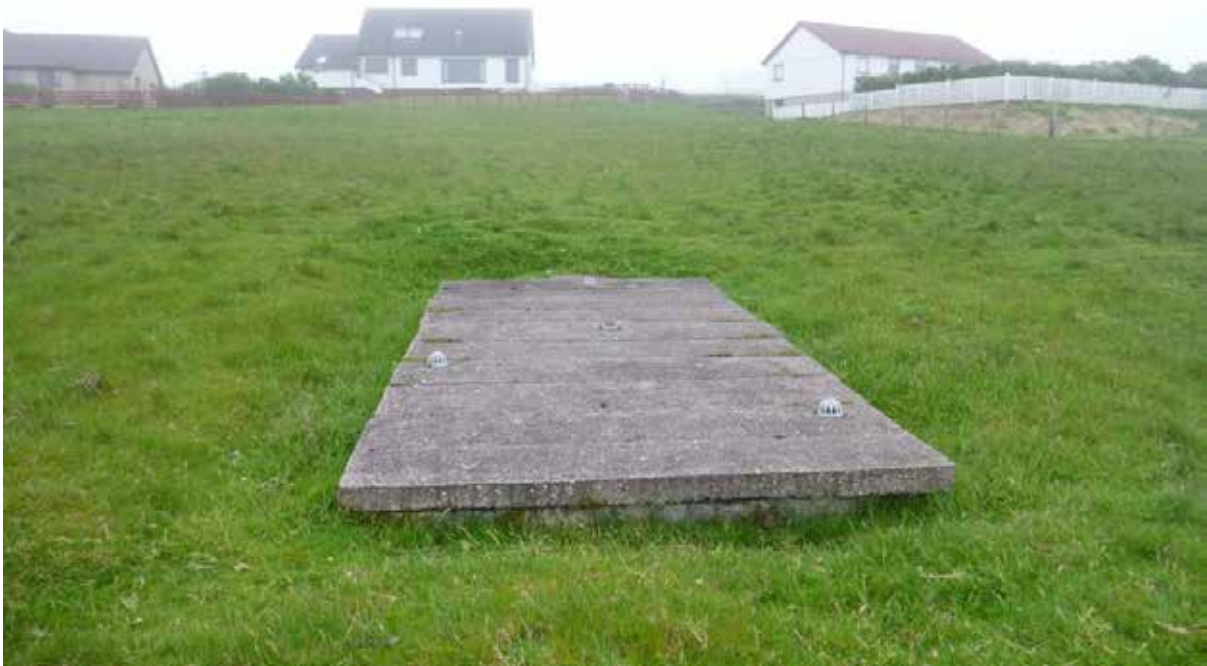
Figure 12 – Concrete septic tank below a group of houses near Cauldhame.

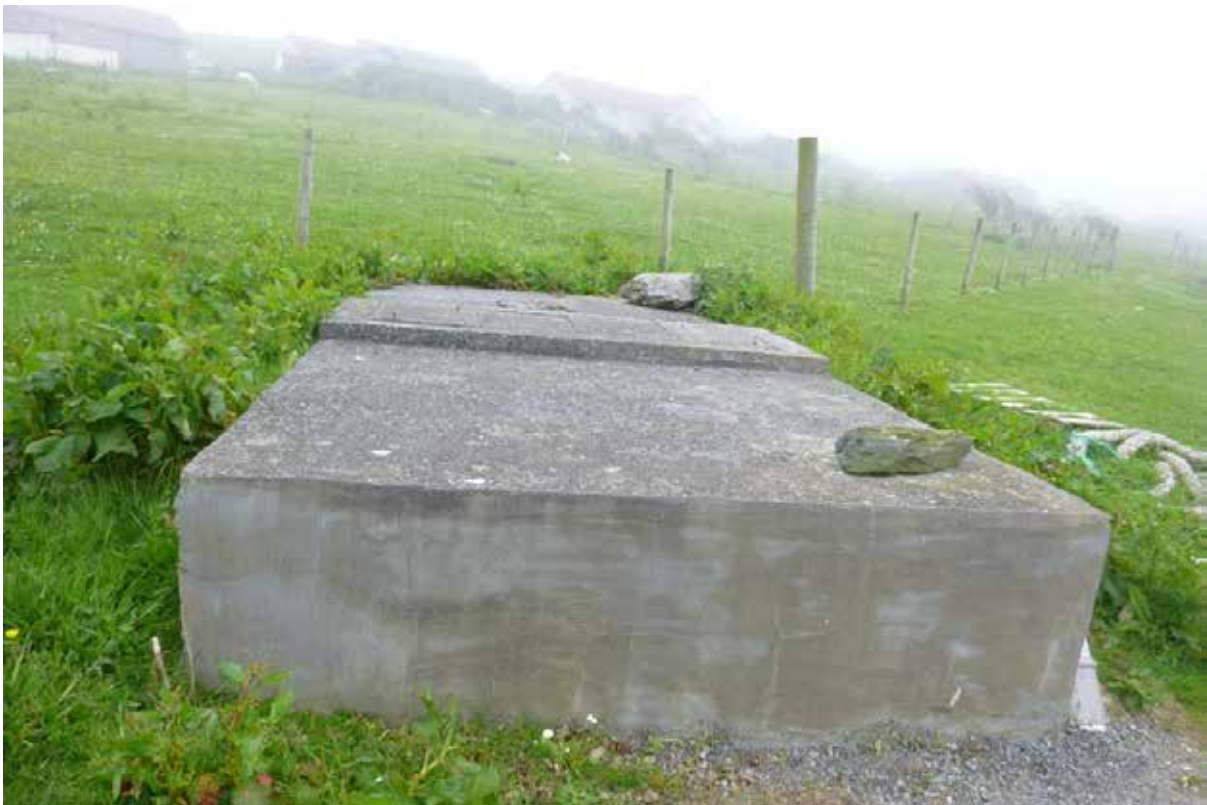
Figure 13 – Concrete septic at Cauldhame.

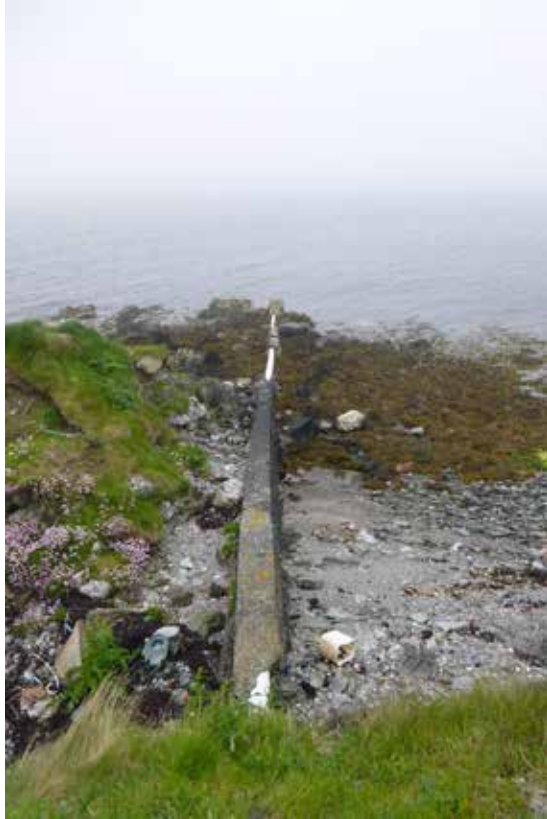
Figure 14 – Discharge pipe from septic tank in Figure 13. Seawater sample obtained from shore.

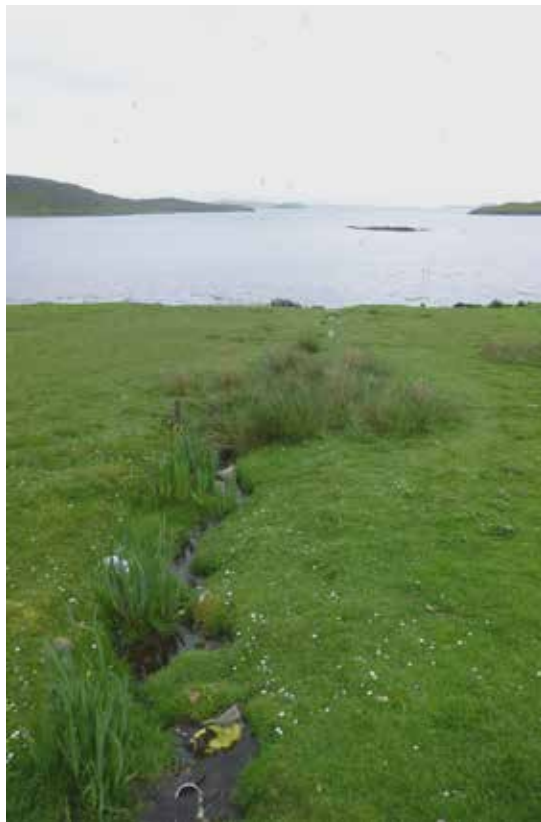
No.	Date/Time (UT)	NGR	Easting	Northing	Associated Photograph	Associated Sample	Description
17	17/06/2014 12:22	HU 39171 40741	439171	1140741	Figure 15	EB-FW02	Spring leading to the beach. Water iris present. Large stagnant pool up the hill where the spring originates. Freshwater sample collected. Flow rate measured, time taken to fill 350ml jug - 3.7s/4.1s/3.9s.
18	17/06/2014 12:24	HU 39122 40719	439122	1140719			Old boat at the shore. Lowland stony beach area. Flat grassland areas above the beach increasing to hills. Old disused house and outbuildings up the hill. Sixty sheep above the beach no fences so they have access to the shore.
19	17/06/2014 12:33	HU 39060 40714	439060	1140714			Old disused hut and boat. Four eider ducks in the water. East Burwick fishery, small workboat taking a look around the site. Trailer at the shore. Two house ruins.
20	17/06/2014 12:39	HU 38941 40615	438941	1140615	Figure 17		Small pier. Sea urchin carcasses and shells, possibly feeding area for birds. Two creels present at the pier. Eleven sheep observed above the shore.

Figure 15 – Additional freshwater sample obtained from a watercourse on the northern shore of the East Burwick production area.

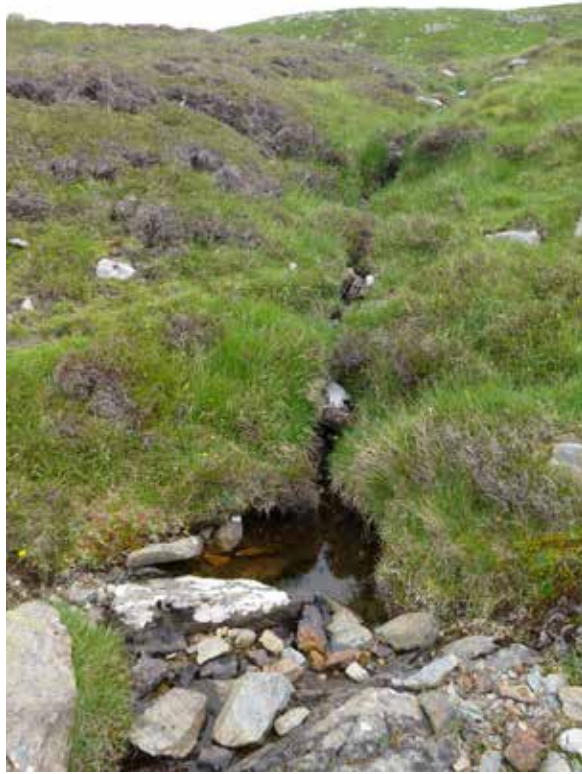
No.	Date/Time (UT)	NGR	Easting	Northing	Associated Photograph	Associated Sample	Description
26	17/06/2014 13:48	HU 39508 40495	439508	1140495	Figure 16	EB-FW05	Small watercourse leading to the shore through rocks. No flow small stagnant pools. One gull and one oystercatcher in flight. Freshwater sample obtained, unable to measure flow rate.
27	17/06/2014 13:57	HU 39499 40772	439499	1140772			Lowland stony beach area at head of voe. Three oystercatchers on the beach. End of the survey walk.
28	17/06/2014 14:40	HU 40363 39146	440363	1139146	Figure 18		Shoreline walk - Scalloway pier to NAFC Marine Centre. Scalloway Harbour. Three Scottish Sea Farms workboats, one NAFC workboat and two other workboats present. Nine boats out of the water on the pier. Nine houses observed near the shore to the north of the harbour.
29	17/06/2014 14:47	HU 40359 39350	440359	1139350			Public toilets at the shore. Scalloway's main street with two shops, a care centre, hairdressers, an engineering business, chemist, hotel and public house, bank and gym.

Figure 16 – Small watercourse sampled north of the East Burwick fishery.

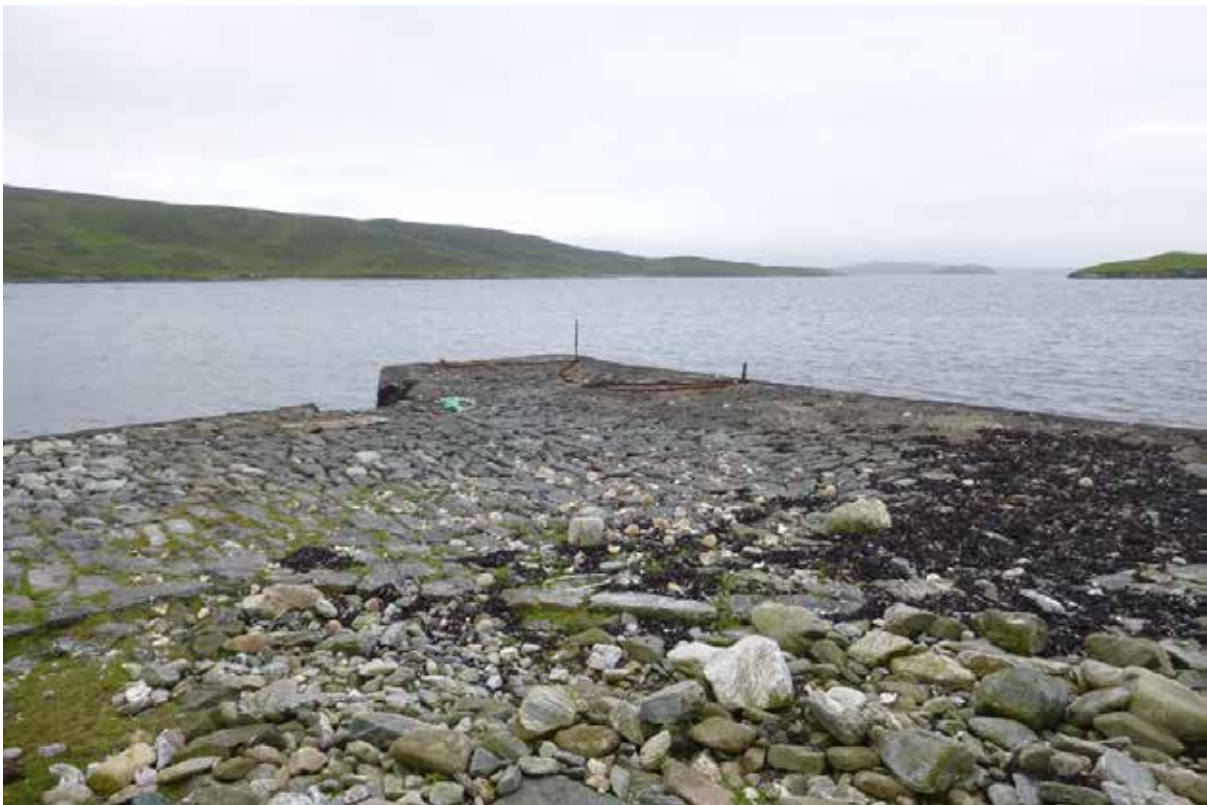
Figure 17 – Small stone pier at the Ness of Burwick

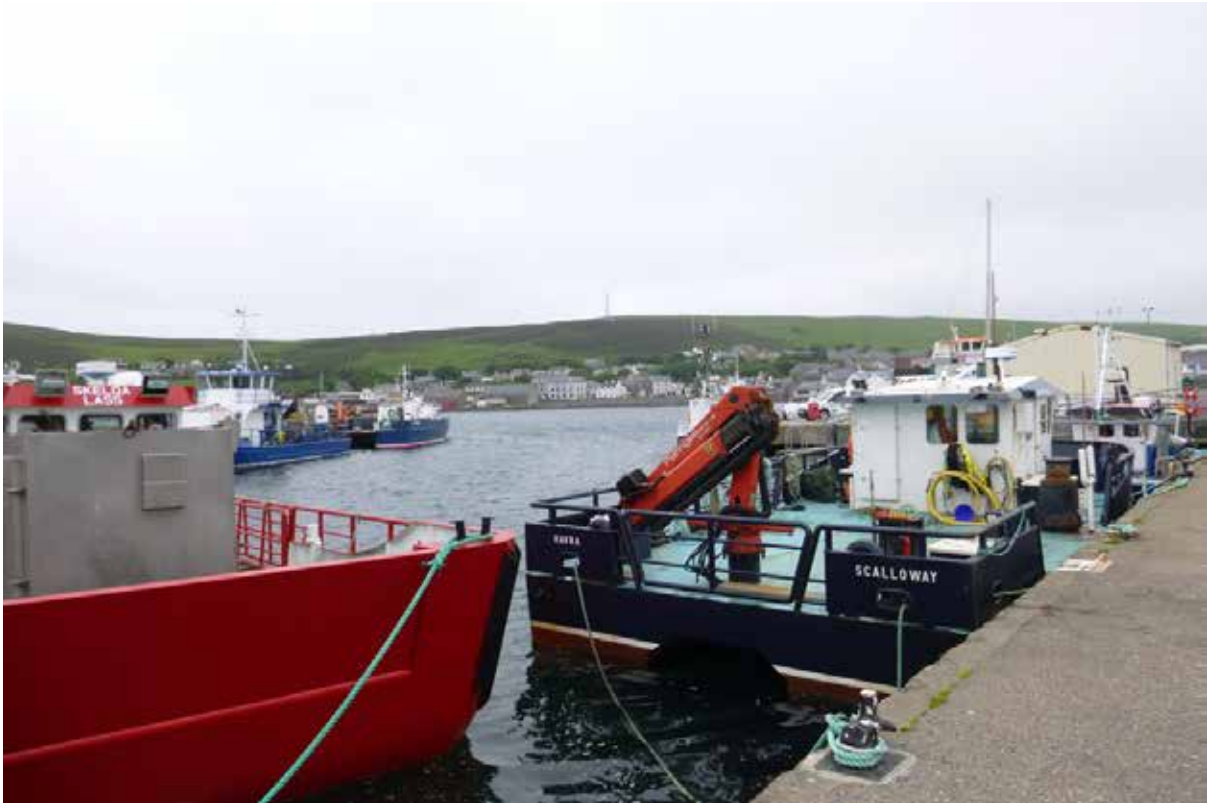
Figure 18 – Workboats berthed at Blacksness Pier

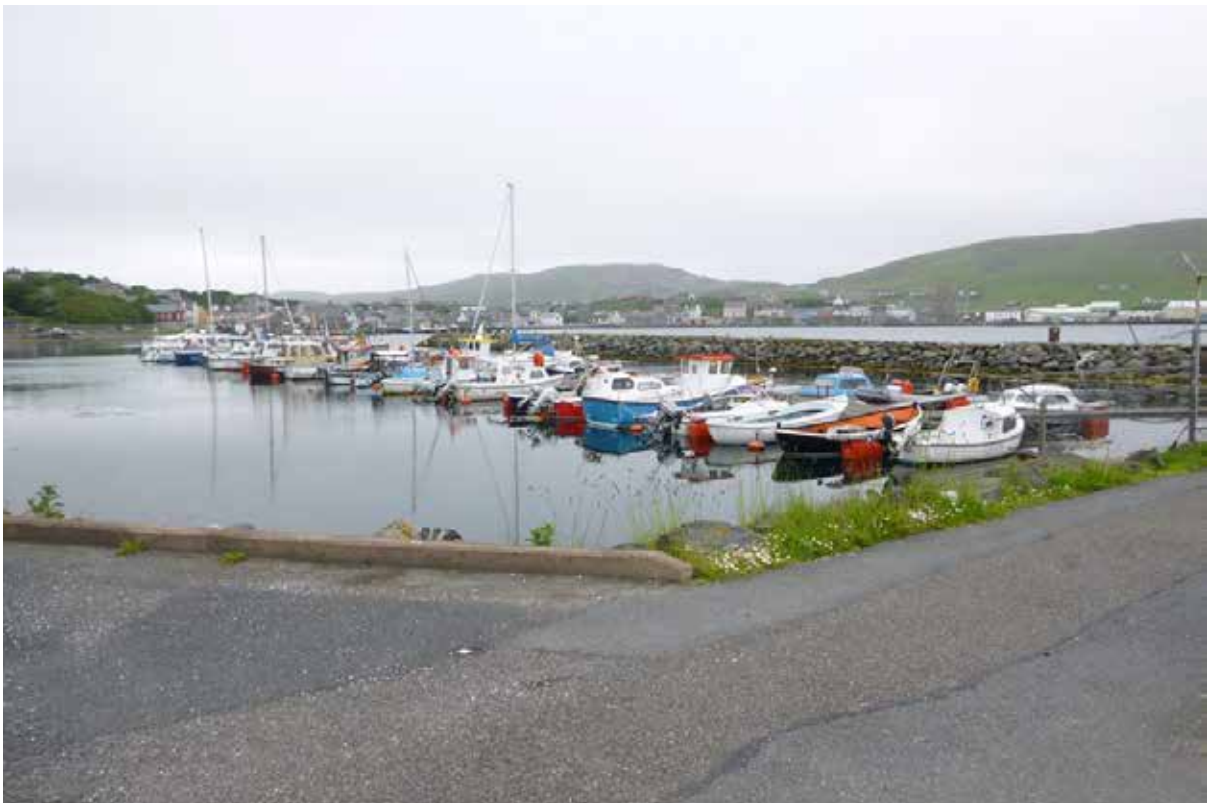
No.	Date/Time (UT)	NGR	Easting	Northing	Associated Photograph	Associated Sample	Description
33	17/06/2014 15:03	HU 39794 39084	439794	1139084	Figure 19		Port Arthur marina (58 berths). 39 boats present in the marina at the time of the survey, 11 boats observed on the shore or on trailers.
34	17/06/2014 15:04	HU 39789 39010	439789	1139010			Scalloway Boating Club. Three boats on shore. Pontoon with two yachts and one small motorboat present.
35	17/06/2014 15:06	HU 39790 38997	439790	1138997			Pipe with a small clear water discharge, no smell, to the south of the boating club. Most likely land drainage. Algae present inside the pipe.
36	17/06/2014 15:07	HU 39796 38988	439796	1138988			Large blue pipe entering the water at the north end of the NAFC Marine Centre building (not in use). Concrete tank at the top of the rocky shore where pipe originates. Three gulls in flight.
37	17/06/2014 15:16	HU 39674 38847	439674	1138847			NAFC Marine Centre, John Goodlad Centre, Hatchery and storage areas behind the John Goodlad Centre. Scottish Sea Farms large workboat and a yacht heading in towards Scalloway harbour.

Figure 19 – Port Arthur marina

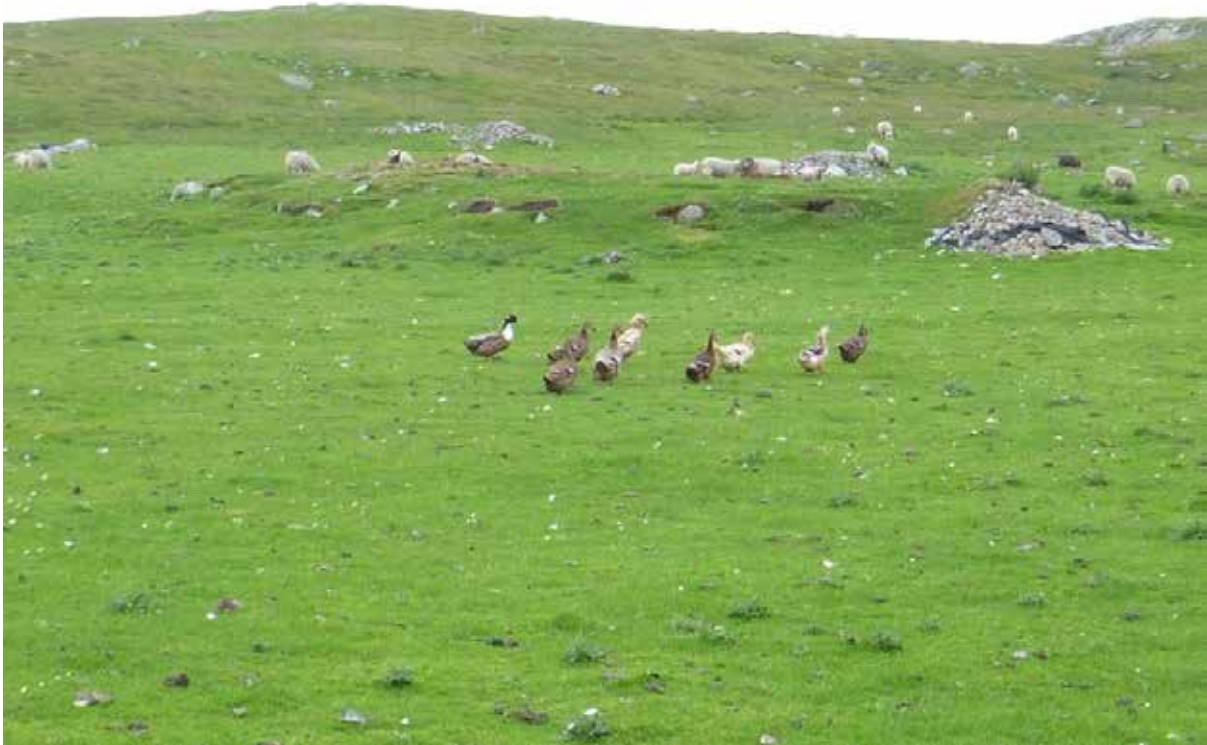
Figure 20 – Domestic animals in a field above the shore at Burwick
