Scottish Sanitary Survey Report

Sanitary Survey Report
East Loch Tarbert
UB-259
June 2015

Report Title	East Loch Tarbert Sanitary Survey Report
Project Name	Scottish Sanitary Survey
Client/Customer	Food Standards Agency Scotland
Cefas Project Reference	C6316A
Document Number	C6316A_2014_9
Revision	1.1
Date	11/06/2015

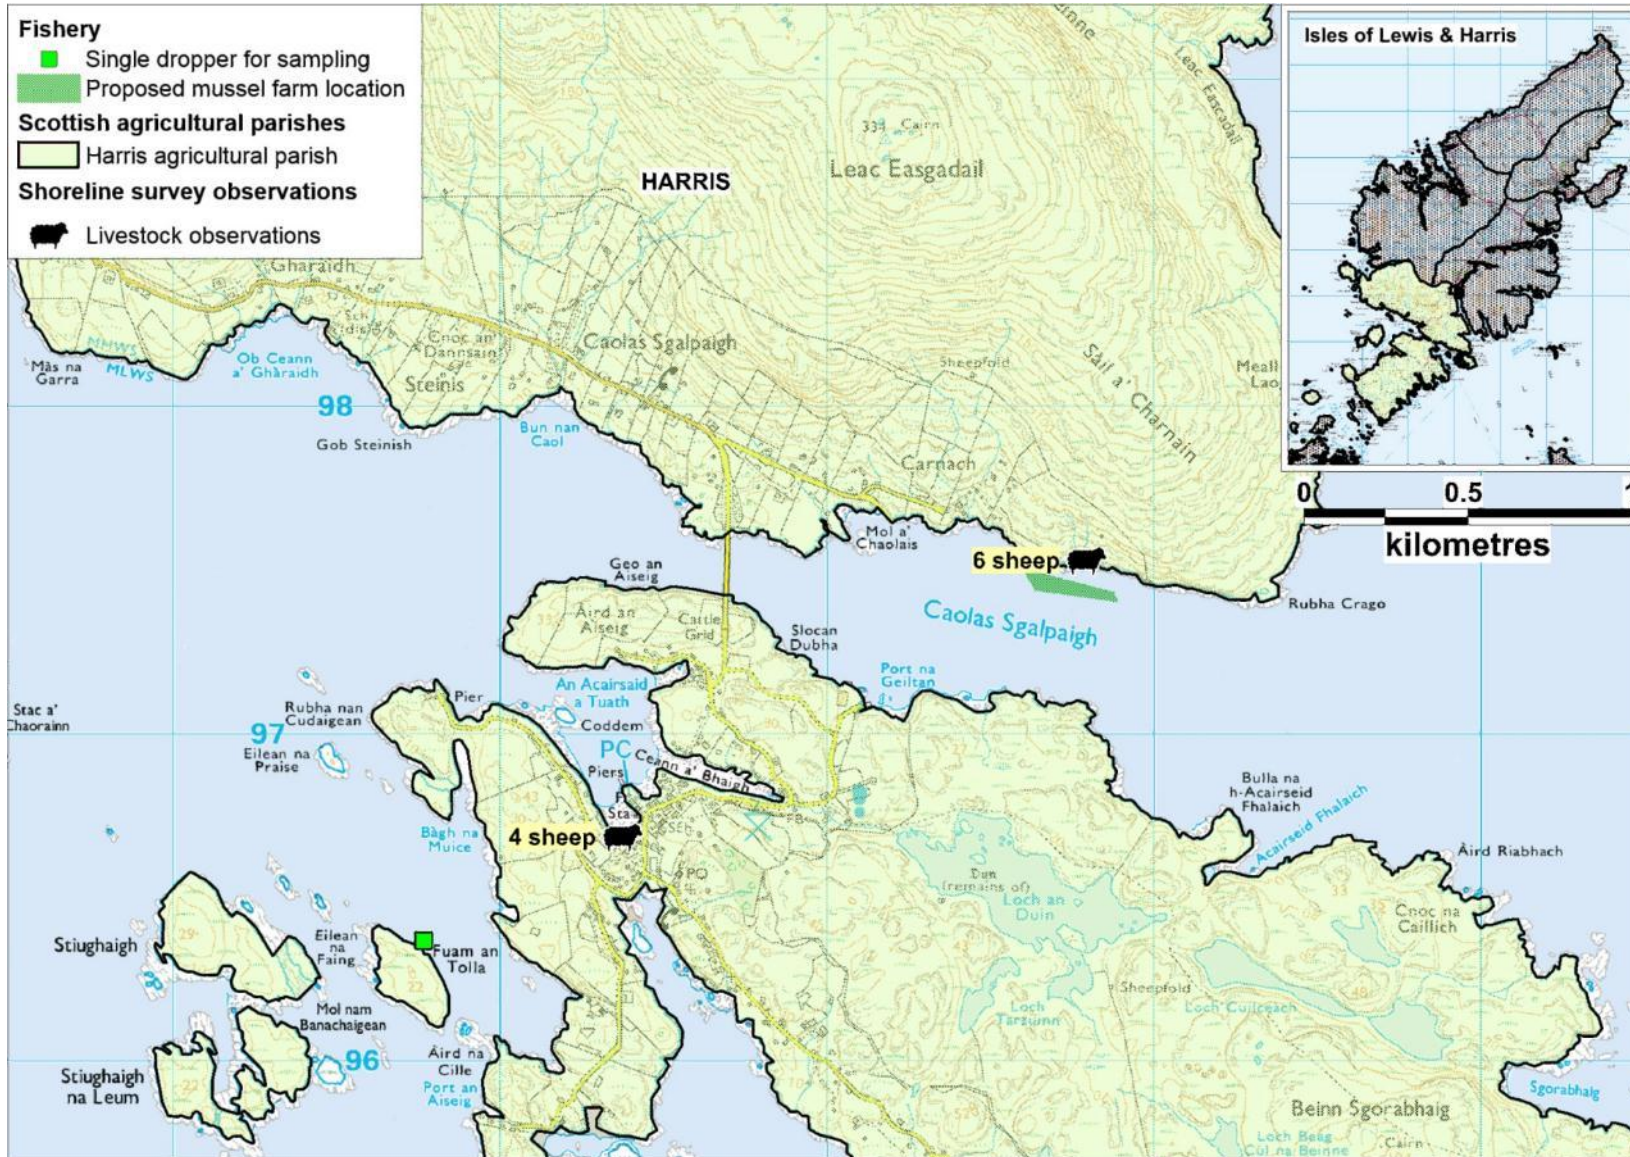
Figure 5.1 Livestock observations at East Loch Tarbert

Numbers of sheep are expected to be approximately double during the spring and summer months when lambs are present. Any contributions of faecal contamination from livestock are expected to be low, with livestock grazing on the improved pasture on the Harris coastline adjacent to the proposed shellfish farm location potentially affecting any mussel lines closest to the shoreline.

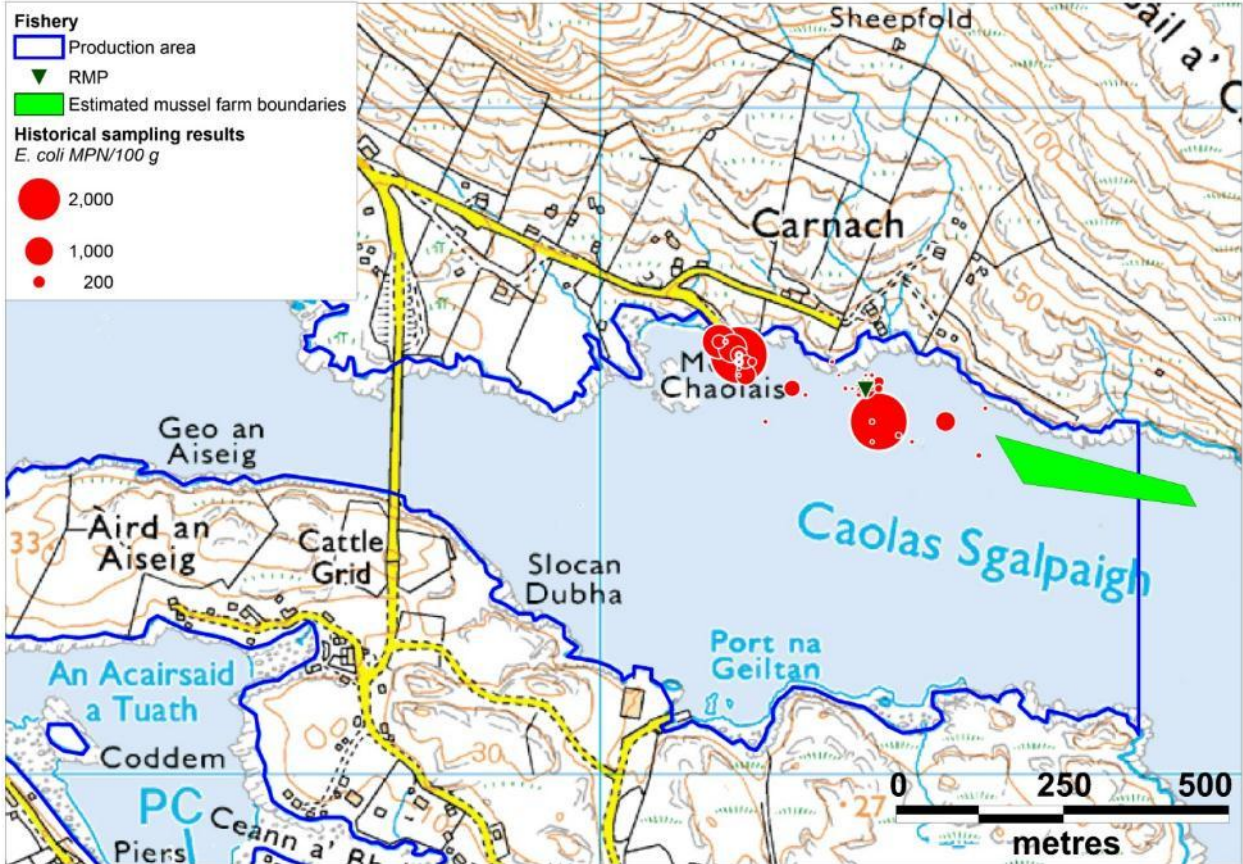
Figure 11.1 Map of reported sampling locations for common mussels at East Loch Tarbert

The geographical locations of all sample results assigned to East Loch Tarbert are mapped thematically in Figure 11.1.

Site	No. of samples	Minimum	Maximum	GM	90%
East	26	<20	>18000	31	490
West	33	<20	5400	48	760

An un-paired t-test was carried out to determine whether there was a statistically significant difference in sample results between the two sampling sites. No statistically significant difference was found (t-test, $t = -0.95$, $DF = 52$, $p = 0.346$).

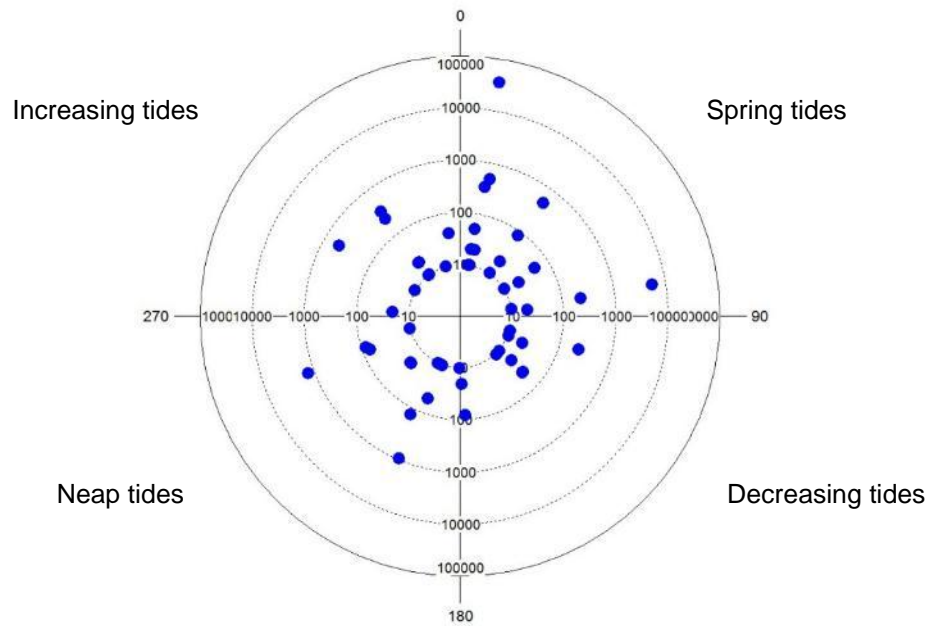
Figure 11.7 Polar plot of *E. coli* results on the spring/neap tidal cycle at East Loch Tarbert

No statistically significant correlation was found between \log_{10} *E. coli* results and the spring/neap tidal cycle (circular-linear correlation $r = 0.152$, $p = 0.275$).

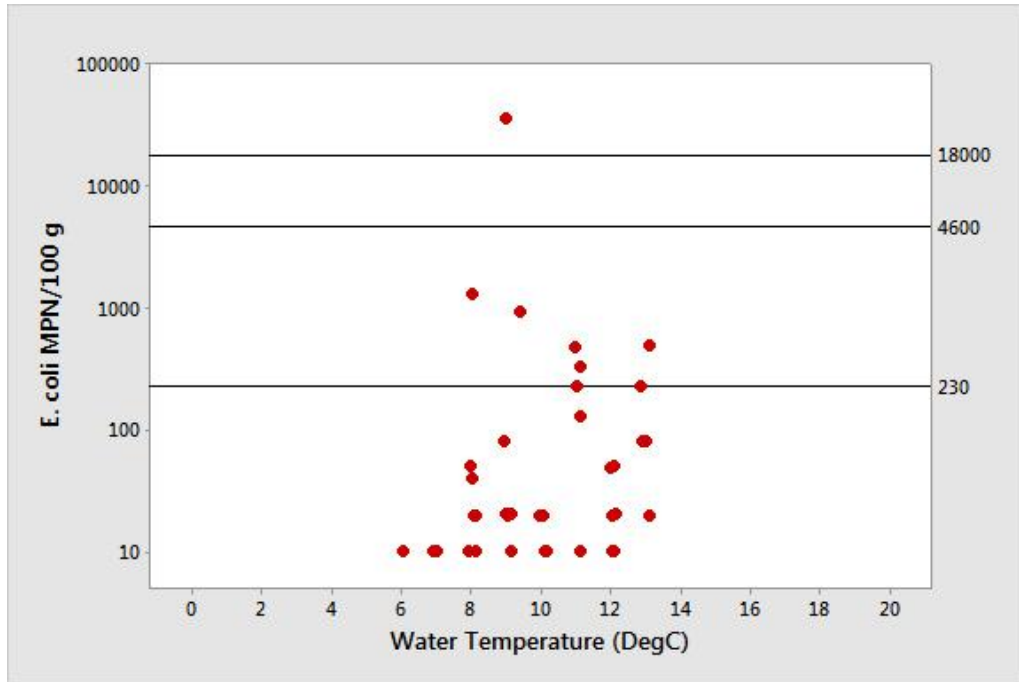
Figure 11.9 Scatterplot of *E. coli* results against water temperature at East Loch Tarbert

A statistically significant correlation was found between *E. coli* results and water temperature (Spearman’s rank correlation $r = 0.365$, $p = 0.019$). There is no clear pattern in the graph but results >230 *E. coli* MPN/100 g correlated with water temperatures of between 8 and 13°C.

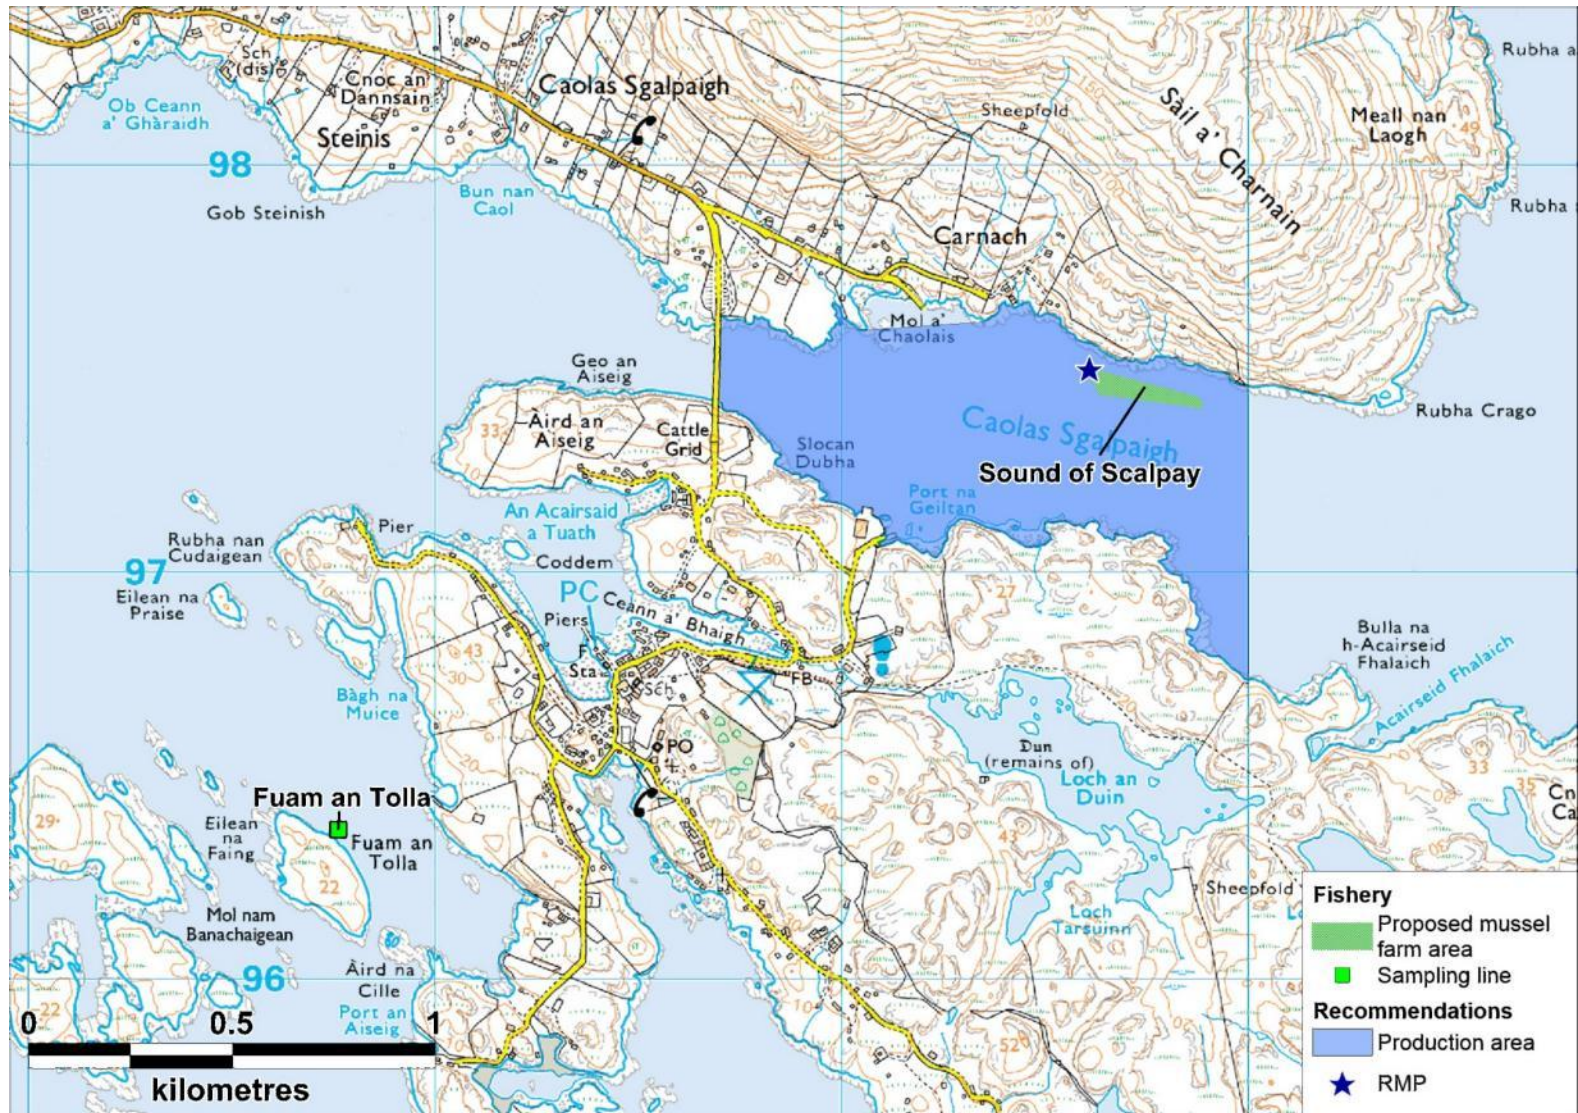
Figure 18.1 Map of recommendations at East Loch Tarbert

Once sampling has commenced, a monthly monitoring frequency is recommended.

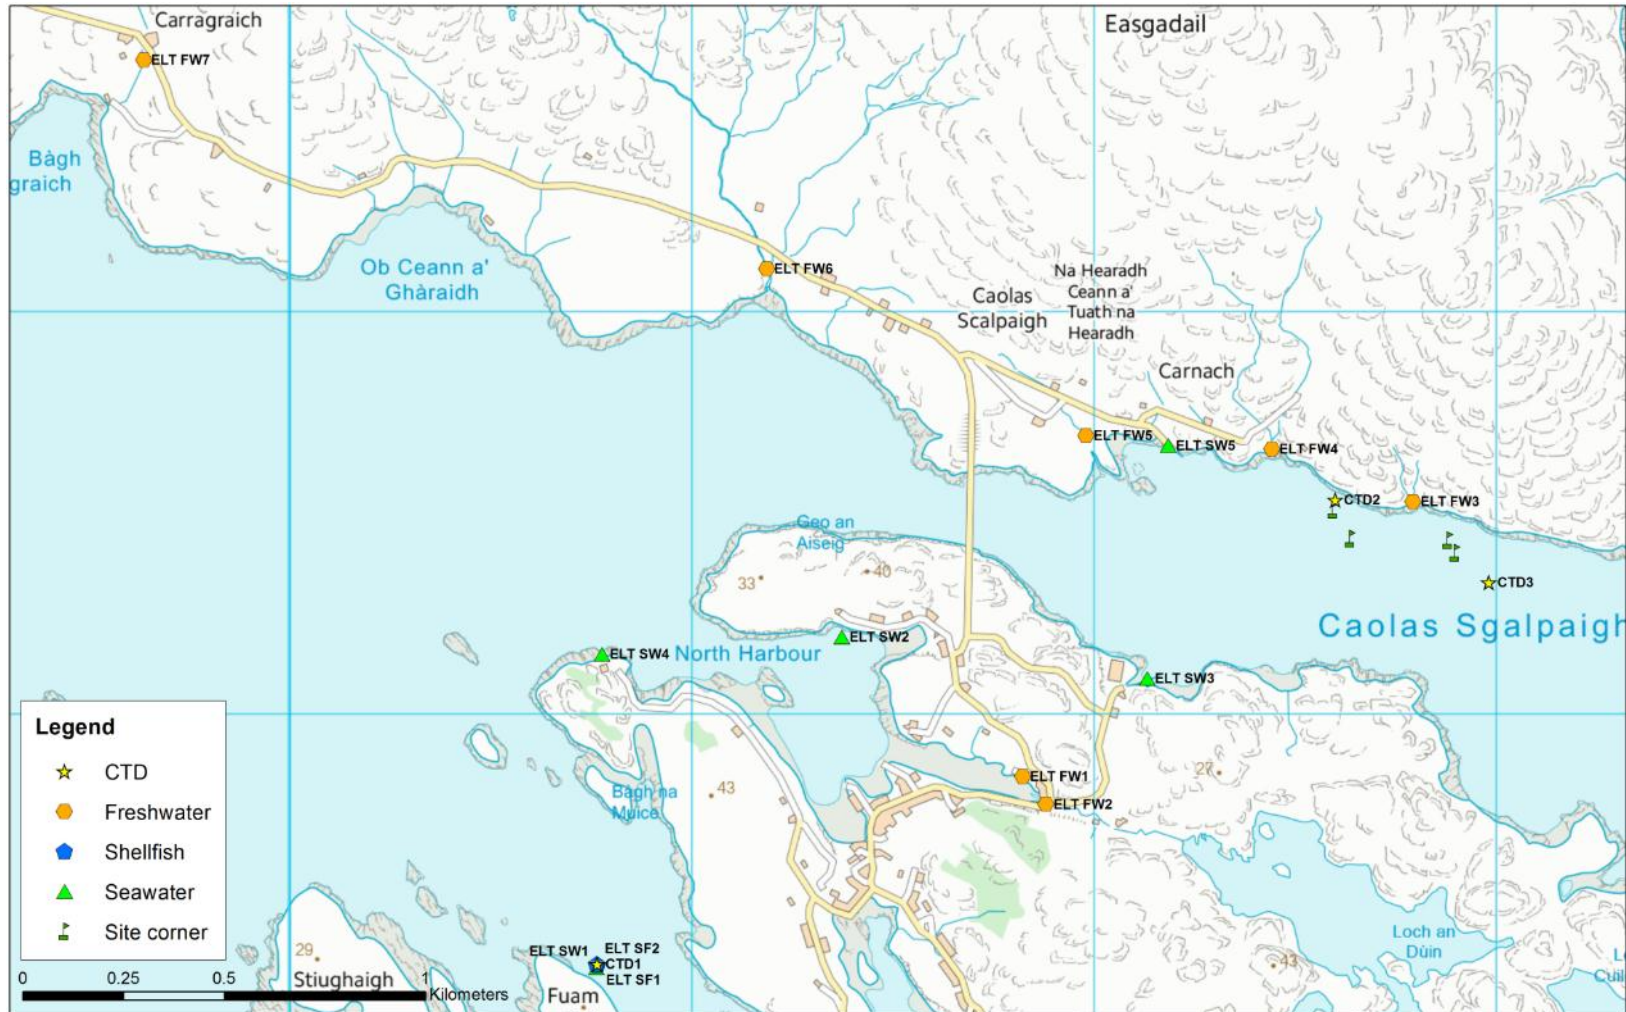
Figure 2. East Loch Tarbert, Harris, samples

Seawater and freshwater samples were collected at the sites marked in Figure 2.

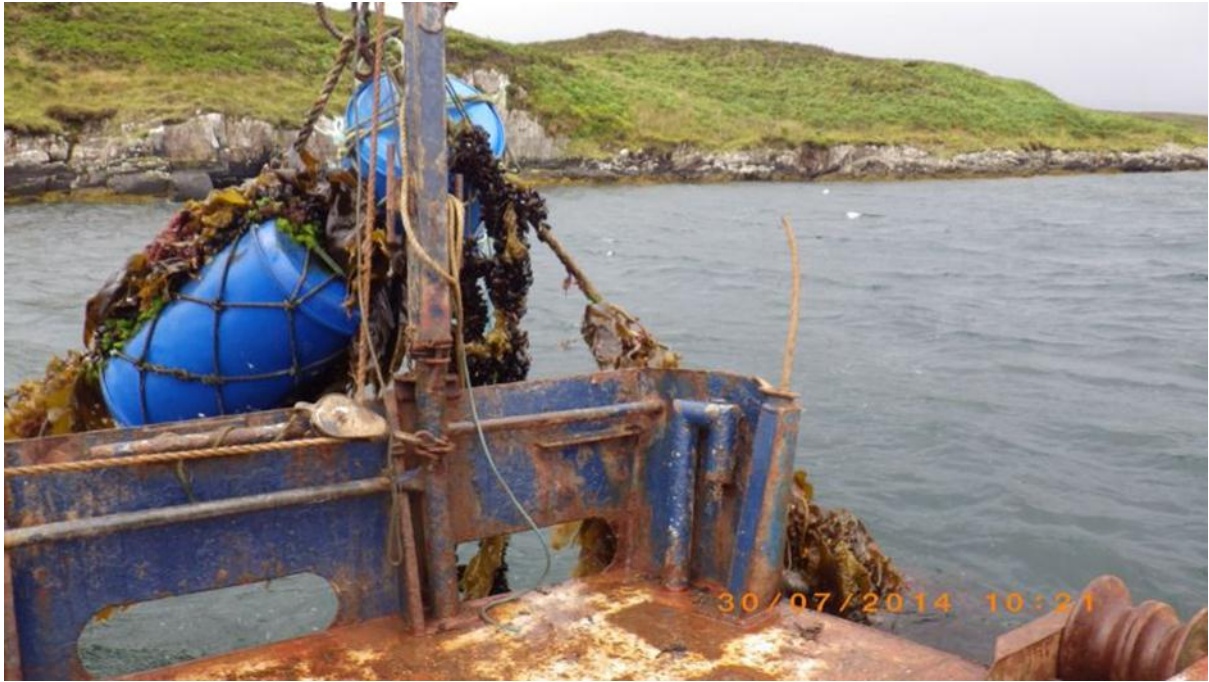
The harvester had also been testing a site he applied for on the west side of Scalpay to the east of the island of Fuam an Tolla, but this was proving to be too exposed and mussels were slipping off the lines. One mooring with a single dropper was on this site in order to provide samples for regular testing by the sampling officer and the team also acquired the shellfish samples from this location (Figs. 3&4).

Figure 3. Site of harvesters' single mussel line E of Fuam an Tolla, Scalpay. Waypoint 1. Site of sample ELTSW1.

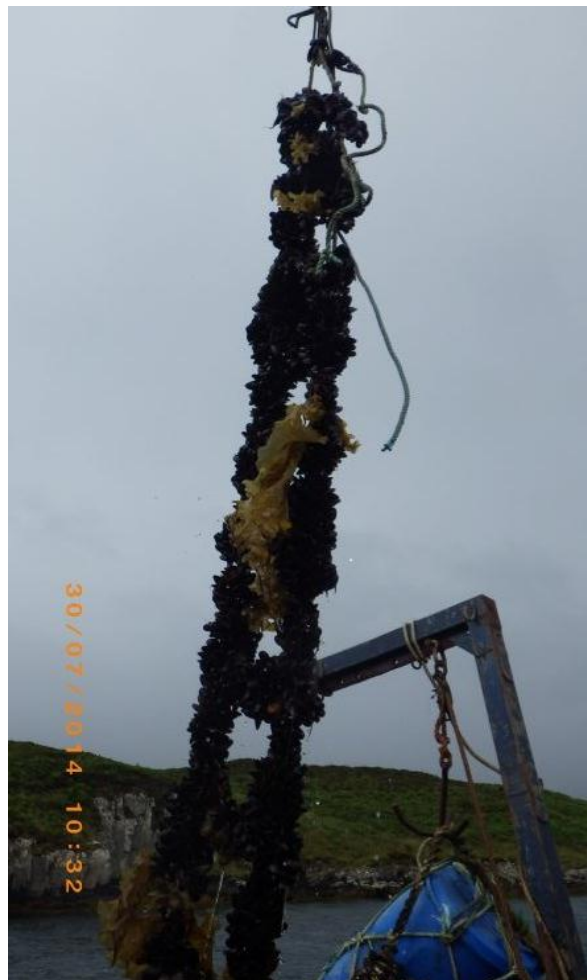
Figure 4. Planned mussel sample (ELTSF2) from only available dropper. Waypoint 3.

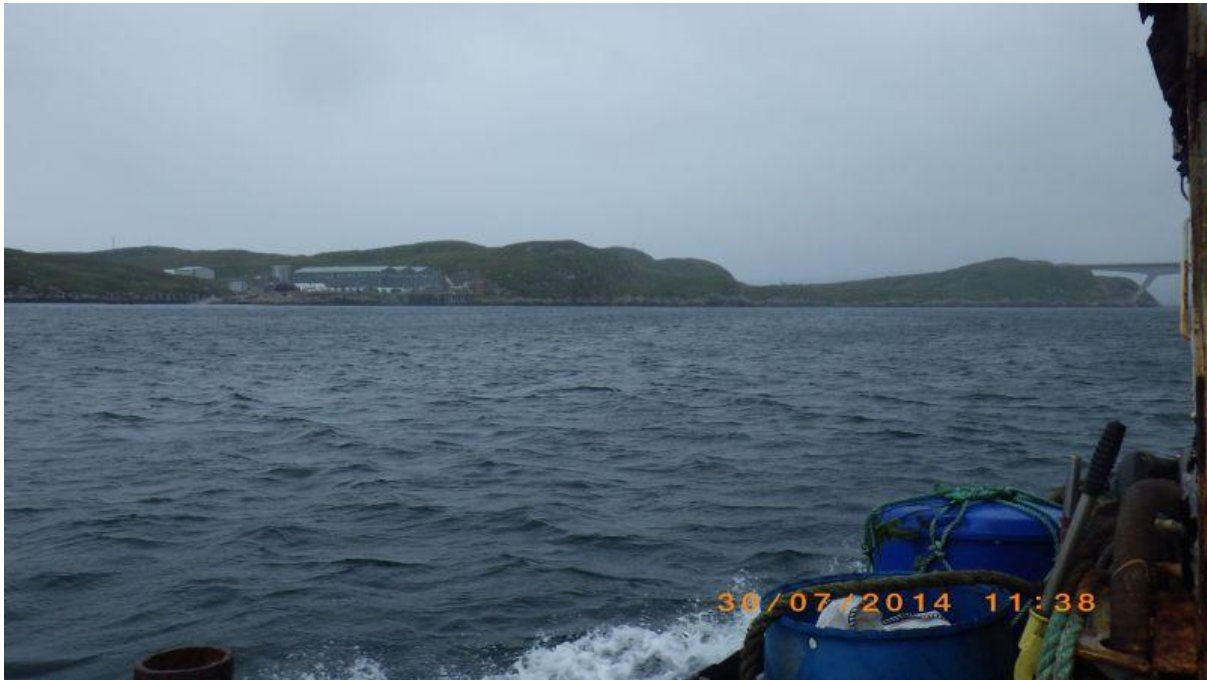
Figure 5. SW corner of planned/desired array, Caolas Sgalpaigh (Sound of Scalpay). Net Services Shetland Ltd situated directly south and Scalpay Bridge visible on the right. Waypoint 8.

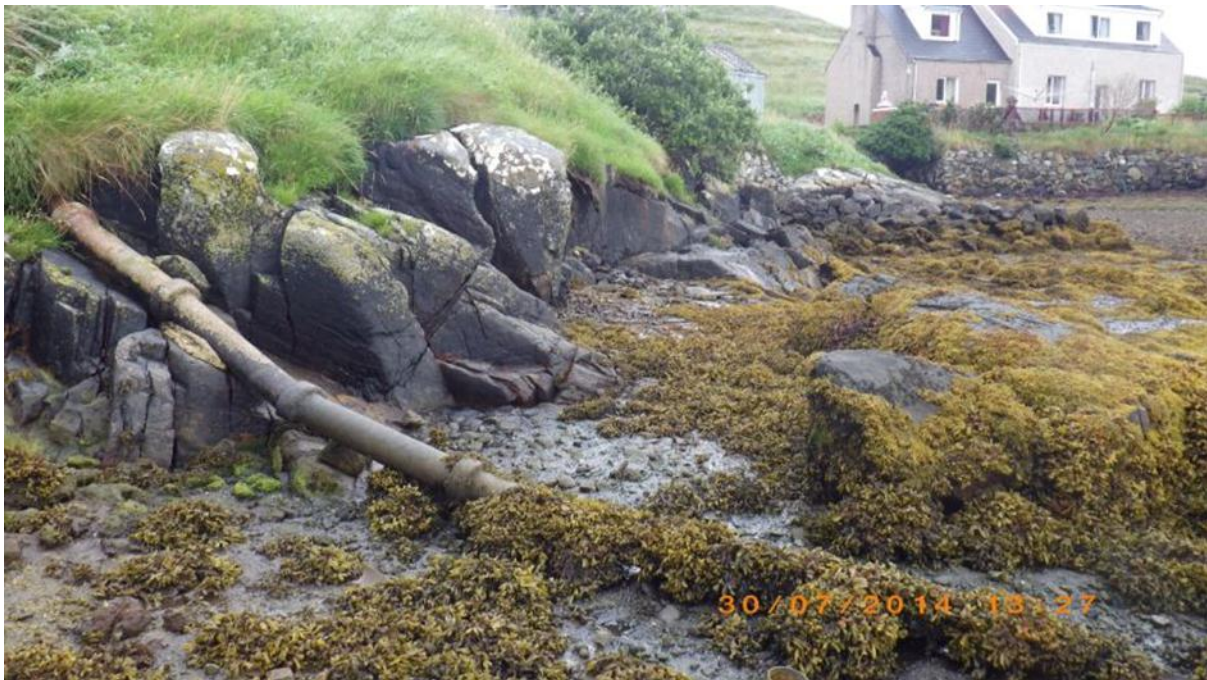
Figure 6. Broken and disused outfall pipe Ceann a Bhaigh, Scalpay. Waypoint 21.

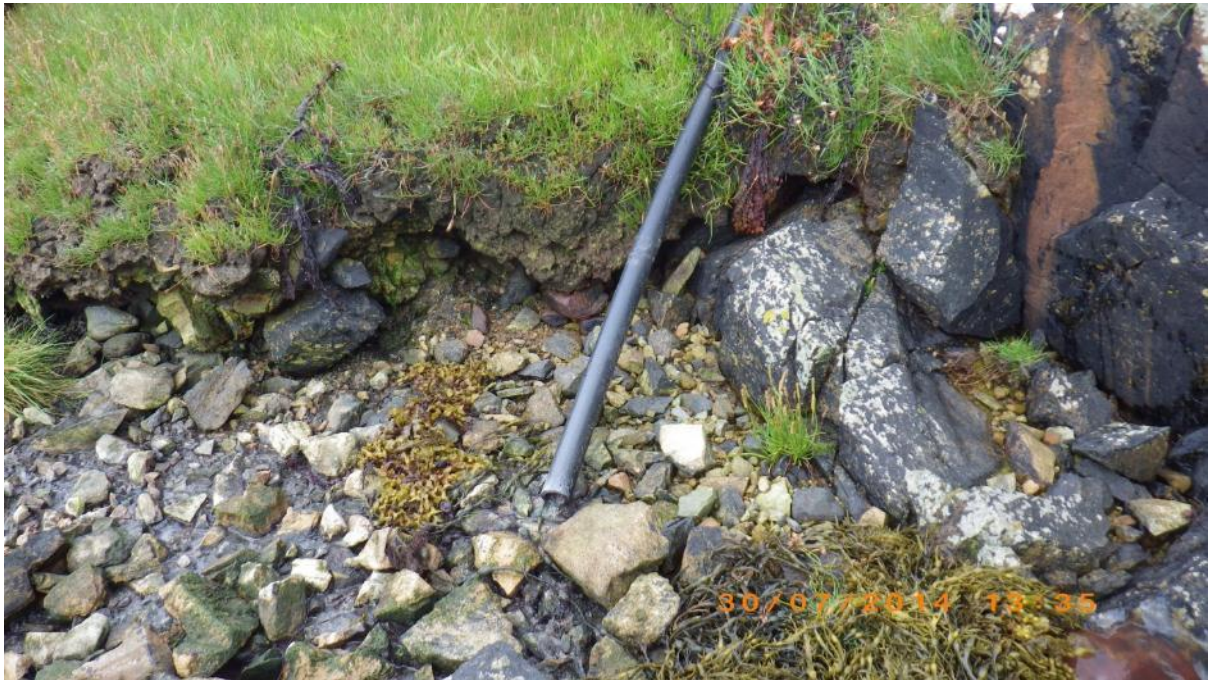
Figure 7. Unplanned freshwater sample (ELTFW1), contaminated.
Waypoint 24.

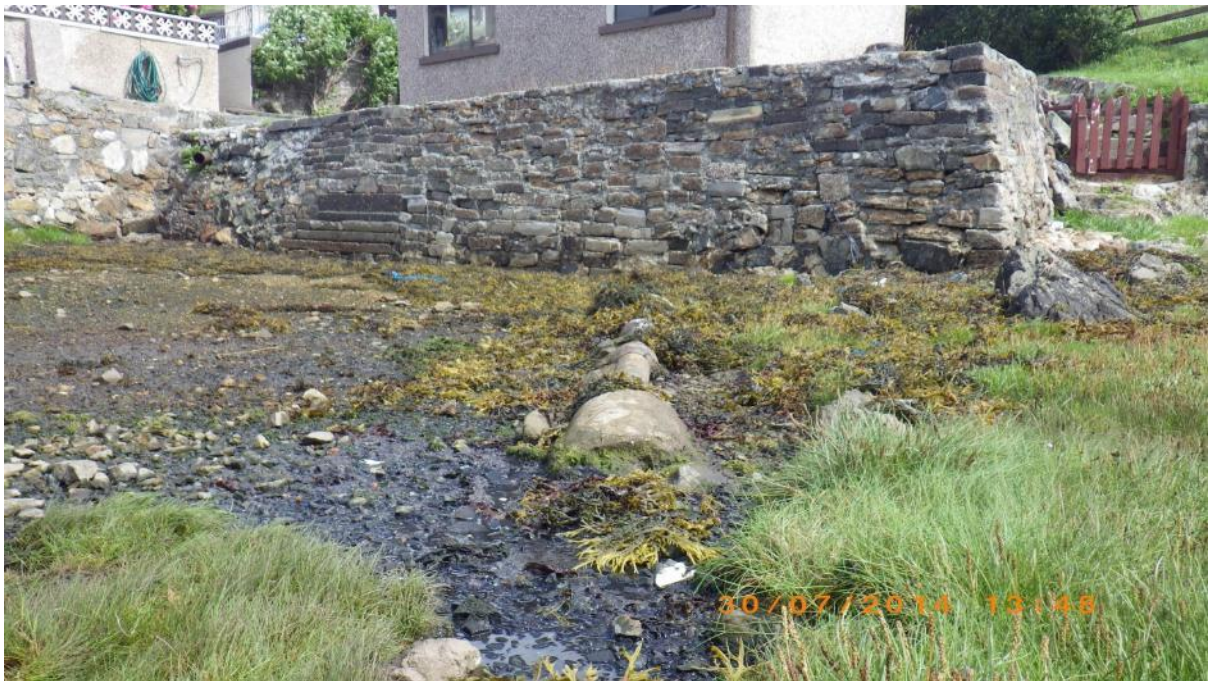
Observation 10 appears to relate to a consented discharge to sea (CAR/R/1068152), but the location at which the pipe was found is approximately 23 m east of the location identified in the consent.

Figure 8. Stagnant but active ceramic outfall pipe.
Waypoint 27.

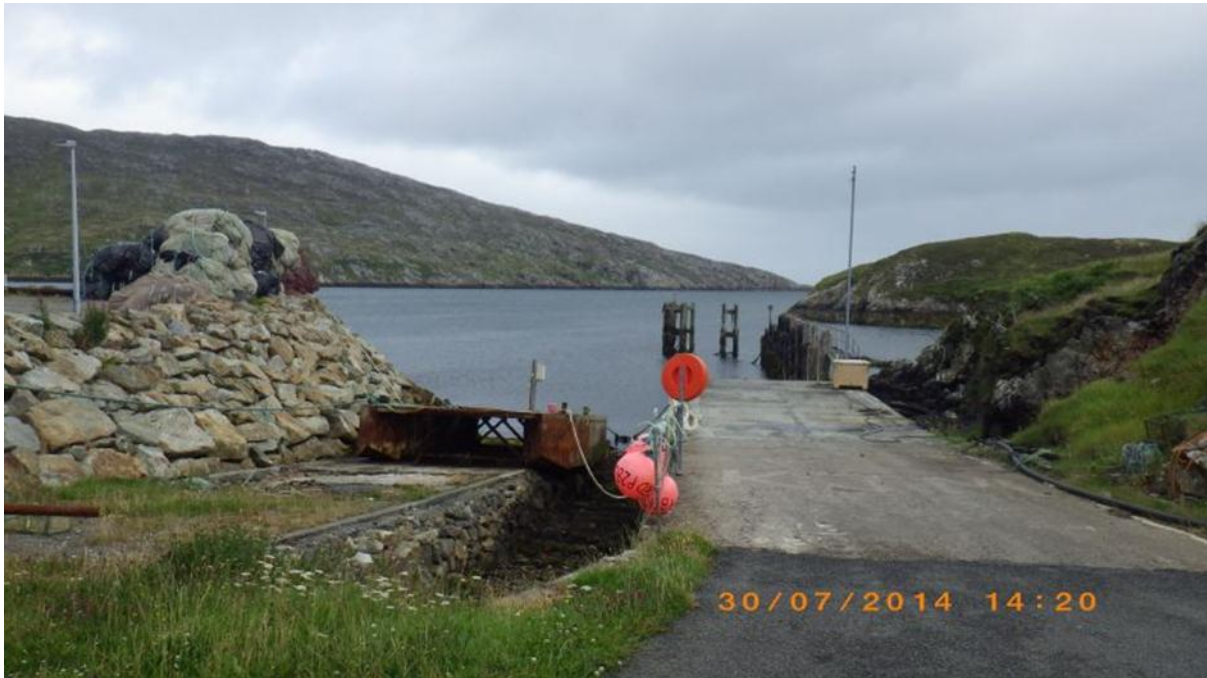
The team observed only two industrial premises and both were on Scalpay, servicing the salmon farm industry. One is a former shellfish processing factory on the north shore of Scalpay by the old Scalpay ferry slipway and is currently used for washing salmon farm nets (nets can be seen in Fig.9). The second is situated at a slipway on the road end at the west of Scalpay with an associated pontoon for mooring workboats. Scottish Water has a significant facility in the form of a large metal shed at Carragraich the function of which was not clear.

Figure 9. Location of planned seawater sample (ELTSW3) taken from Port na Geiltan slipway, directly opposite the harvesters preferred site. Nets awaiting washing stacked on the left. Waypoint 30.

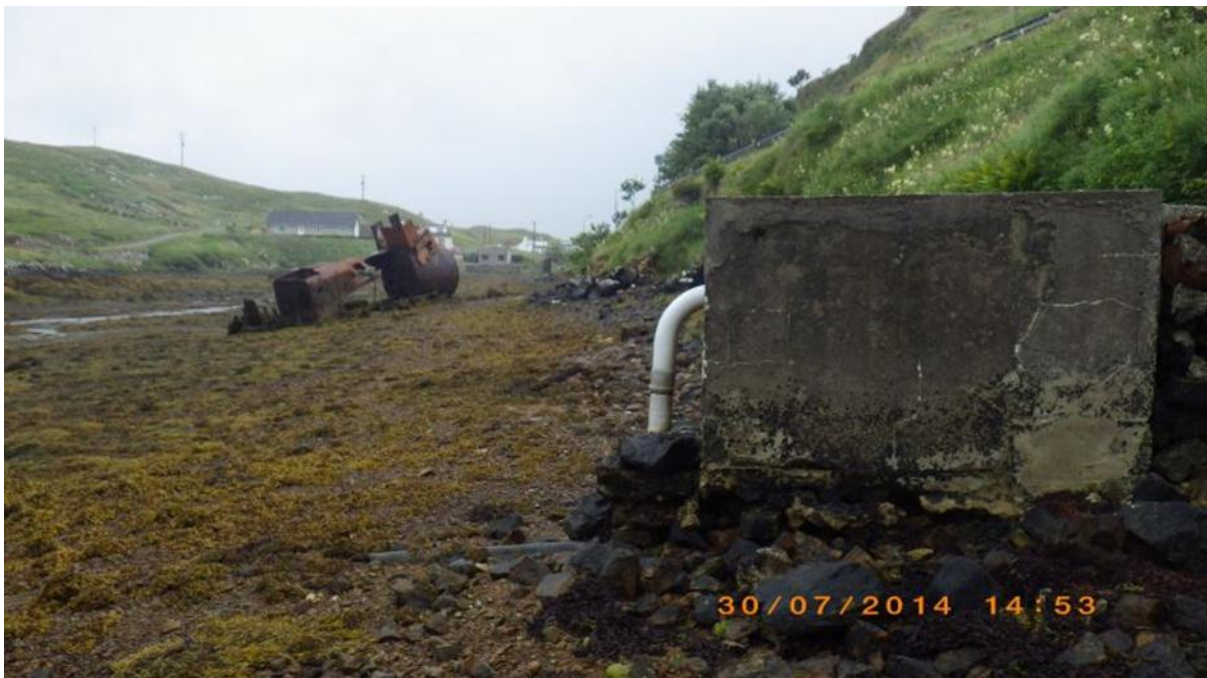
Fig. 10. Disused septic tank with broken outfall pipe south side of Ceann a Bhaigh. Large rusting marine metal fragments onshore in the background looking east. Waypoint 35.

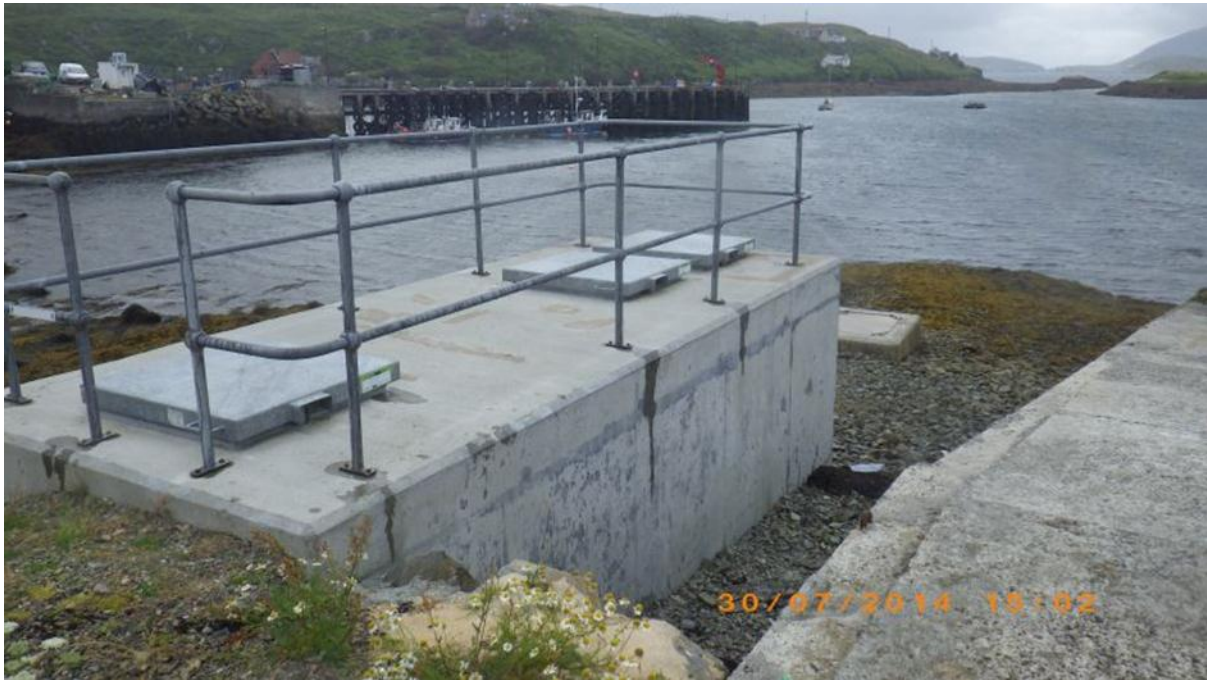
Fig. 11 Scottish Water communal septic tank Scalpay harbour north. Waypoint 38.

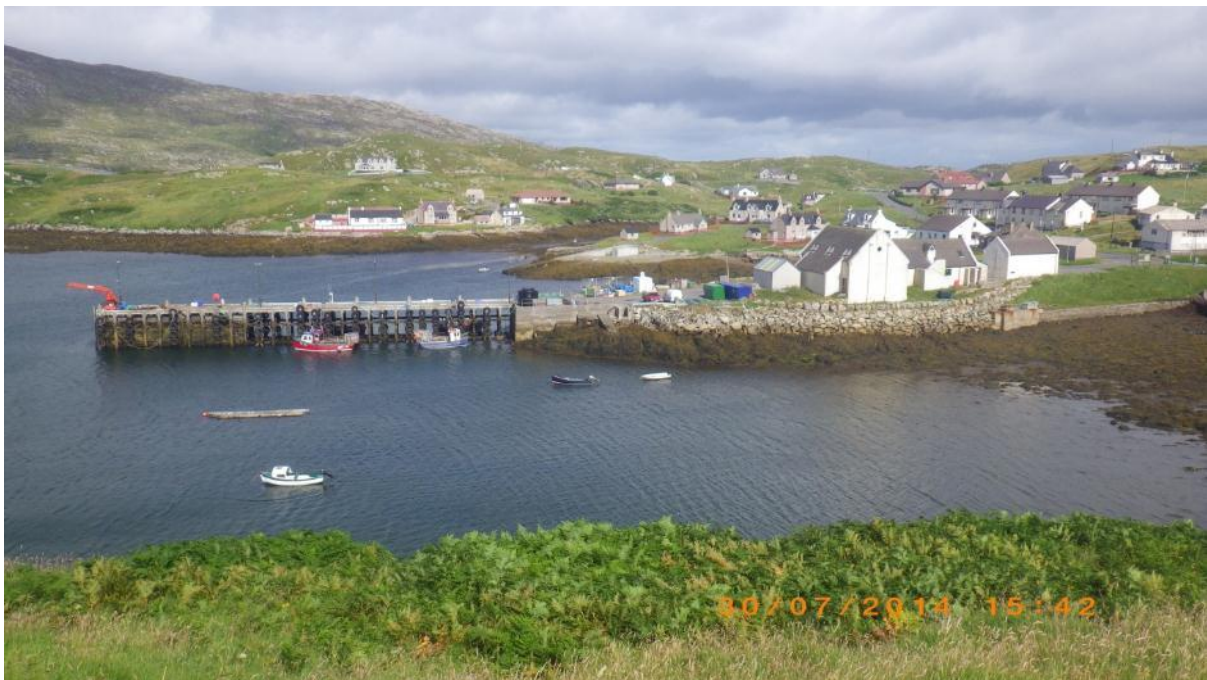
On the island of Scalpay there is a concentration of housing around the harbour area covered by the designated shore walk (Fig. 12). Elsewhere on Scalpay dwellings tend to be well separated. The team observed commercial premises at each of two road ends on Scalpay (waypoints 30 and 33) and in the harbour area near the school, where there is a community café and gift shop run as a charity (waypoint 40). The team did not visit the café but did observe a septic tank below the premises but were unable to confirm if it was disconnected or currently in use as the outfall pipe was buried.

Figure 12. Overview of Scalpay harbour area looking north with the two harbours, either side of the pier. Cenn a' Bhaigh middle distance, partially hidden. Waypoint 45.

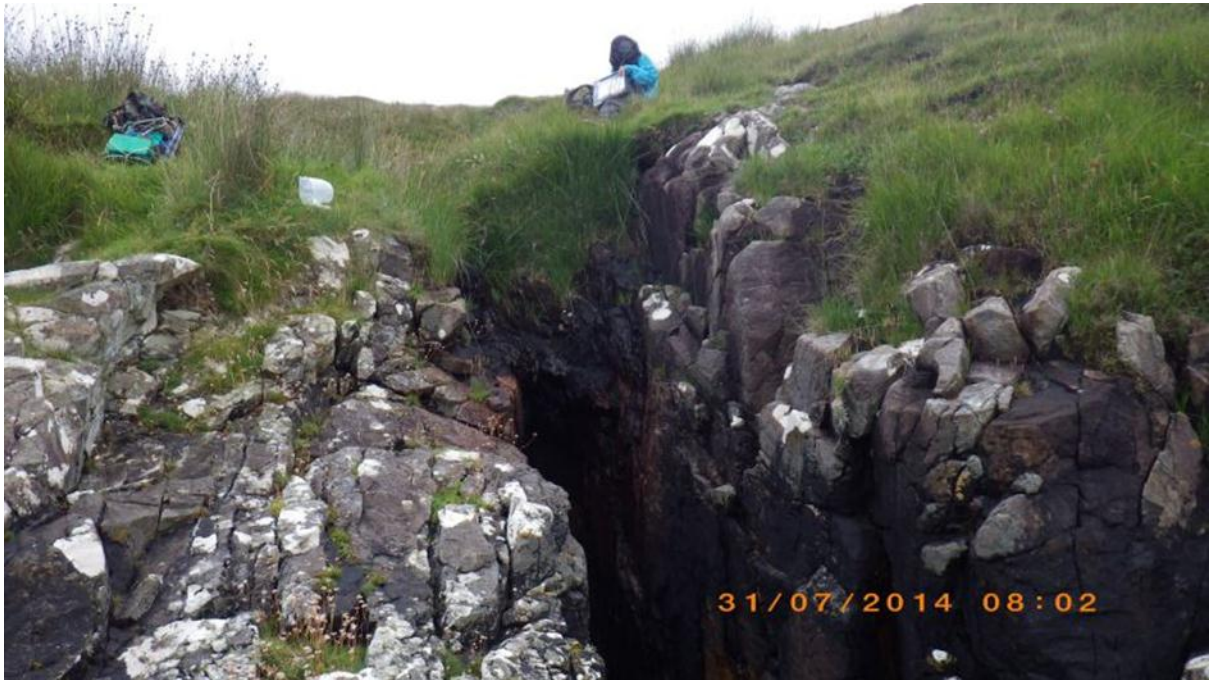
East of Scalpay Bridge, at the extreme of the shore survey section, one hare and one otter were seen by the team. The otter was swimming in the sea some distance from the shore and a suspected otter spraint was observed beside the watercourse sampled (Fig. 13, waypoint 50).

Figure 13. Planned freshwater sample (ELTFW3). Low flow ending in drips above steep gully. Waypoint 50.

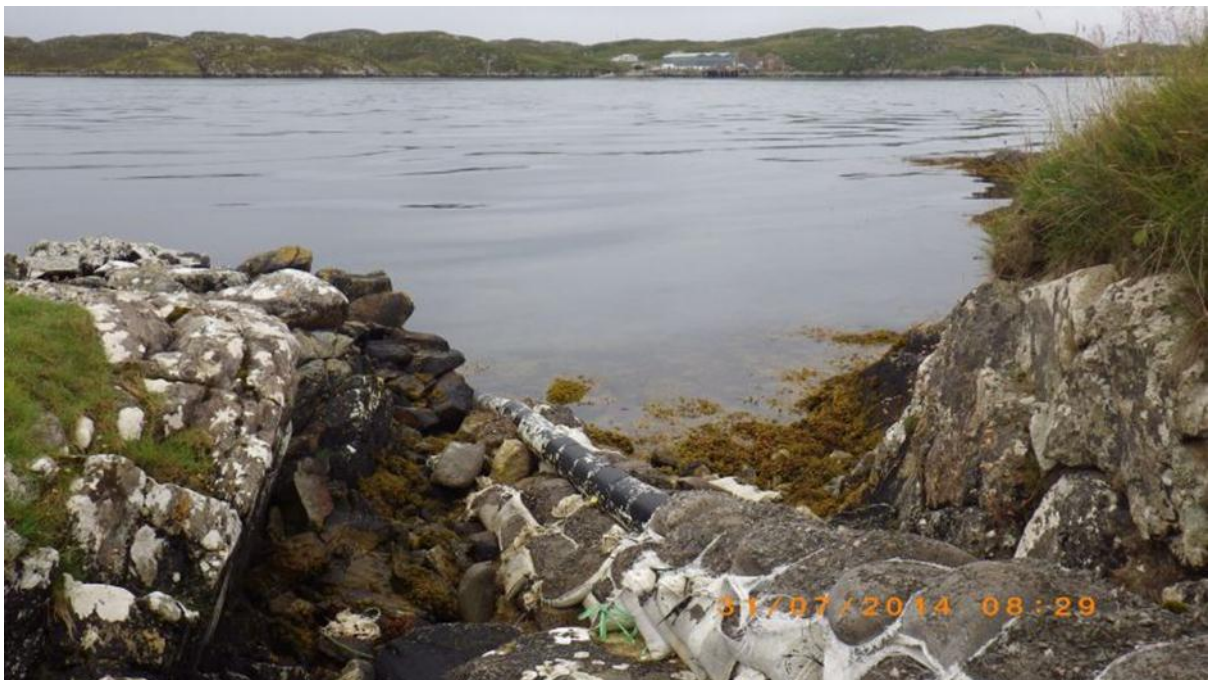
Fig. 14 Outfall pipe of 150 mm black plastic secured by bags of cement aggregate. Pipe end underwater. Waypoint 51.

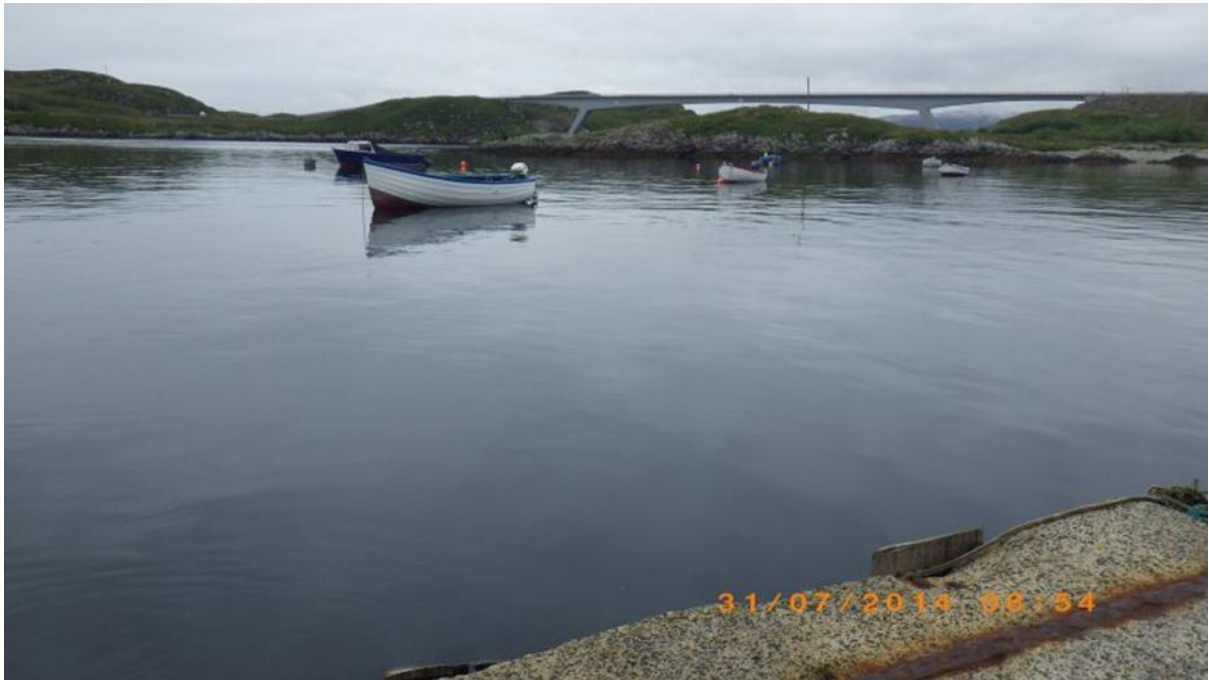
Only a few small leisure boats (less than about 6 m in length) were observed on the north side of Scalpay Sound. Five open leisure boats and a sixth with a cuddy were moored beside the old Scalpay ferry slipway (Fig. 15). A property opposite the mussel array site at Carnach had some small boats onshore and one boat was tied at the high shore at a small harbour near Mol a Chaolais (waypoint 59, NG 21979 97693).

Figure 15. Planned seawater sample (ELTSW5). Former Scalpay ferry slipway, Harris, looking SW towards Scalpay Bridge. Waypoint 57.

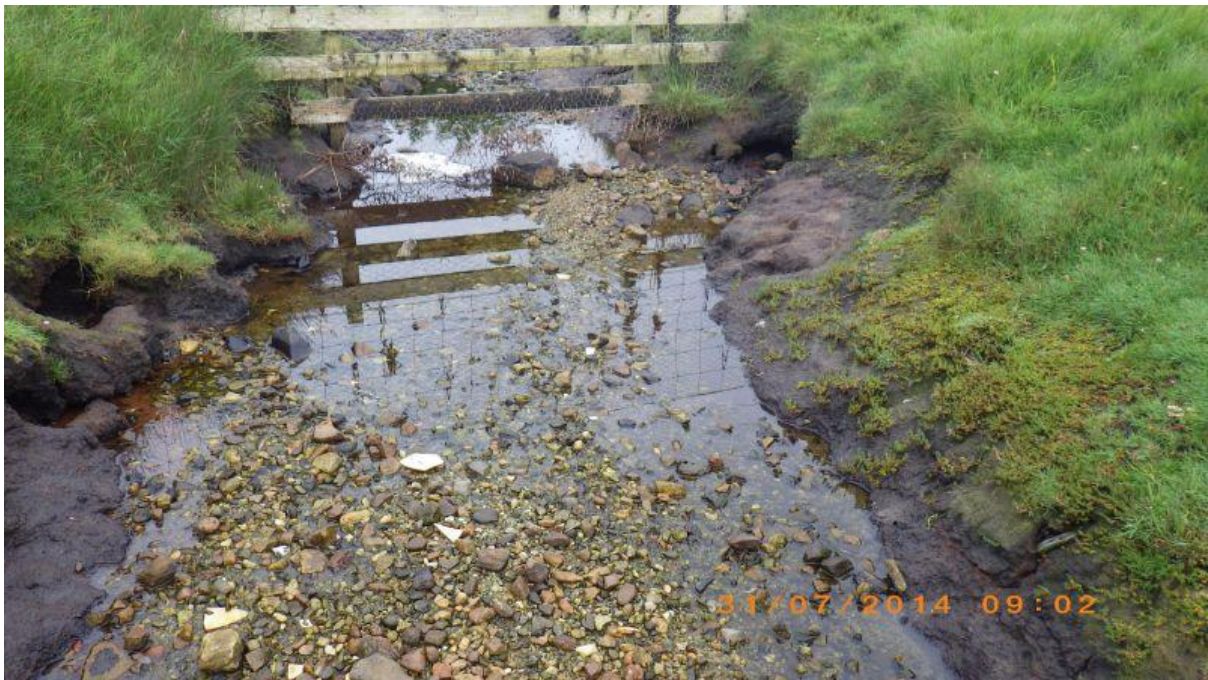
Figure 16. Planned freshwater sample (ELTFW5). Waypoint 59.

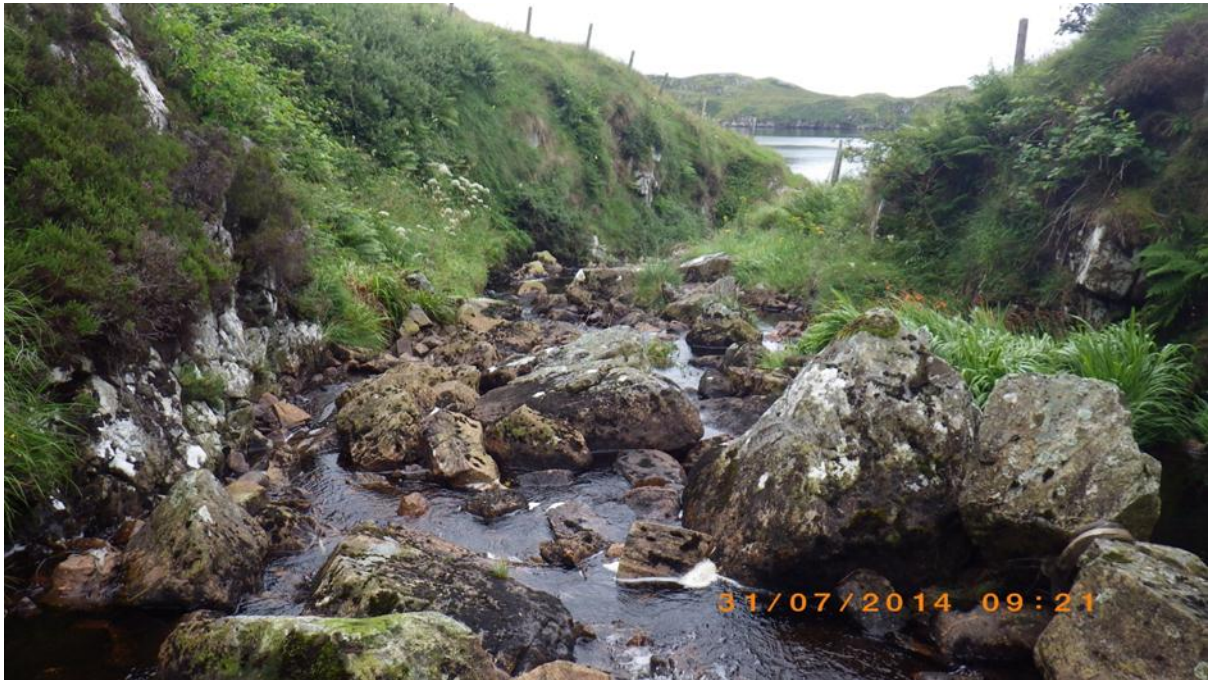
Figure 17. Planned freshwater sample (ELTFW6). Waypoint 61.

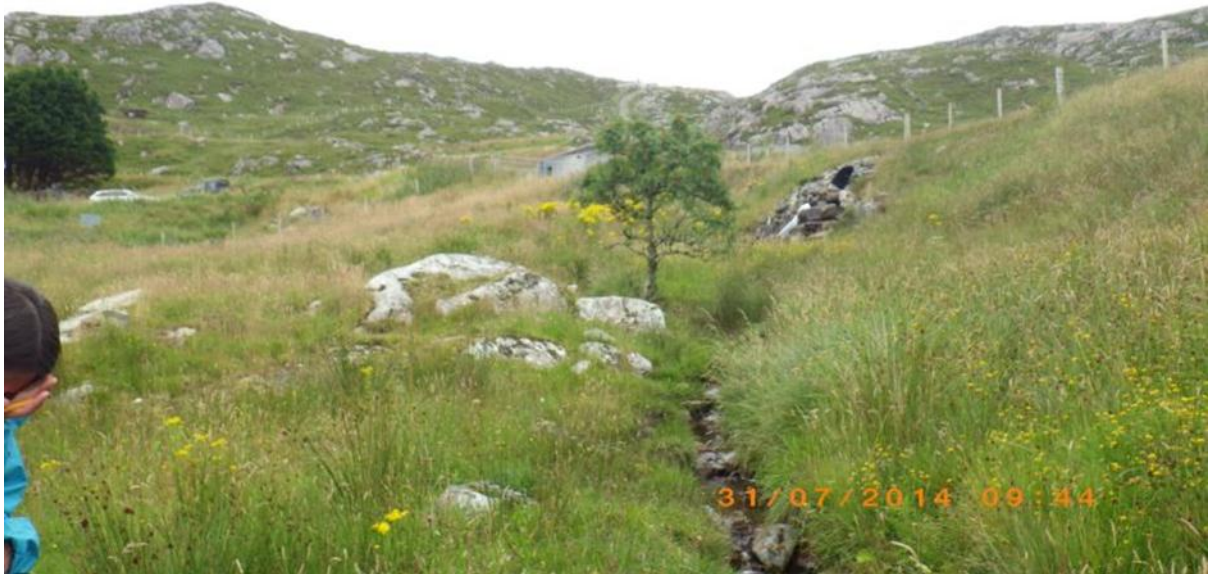
Figure 18. Unplanned freshwater sample (ELTFW6). Waypoint 63.

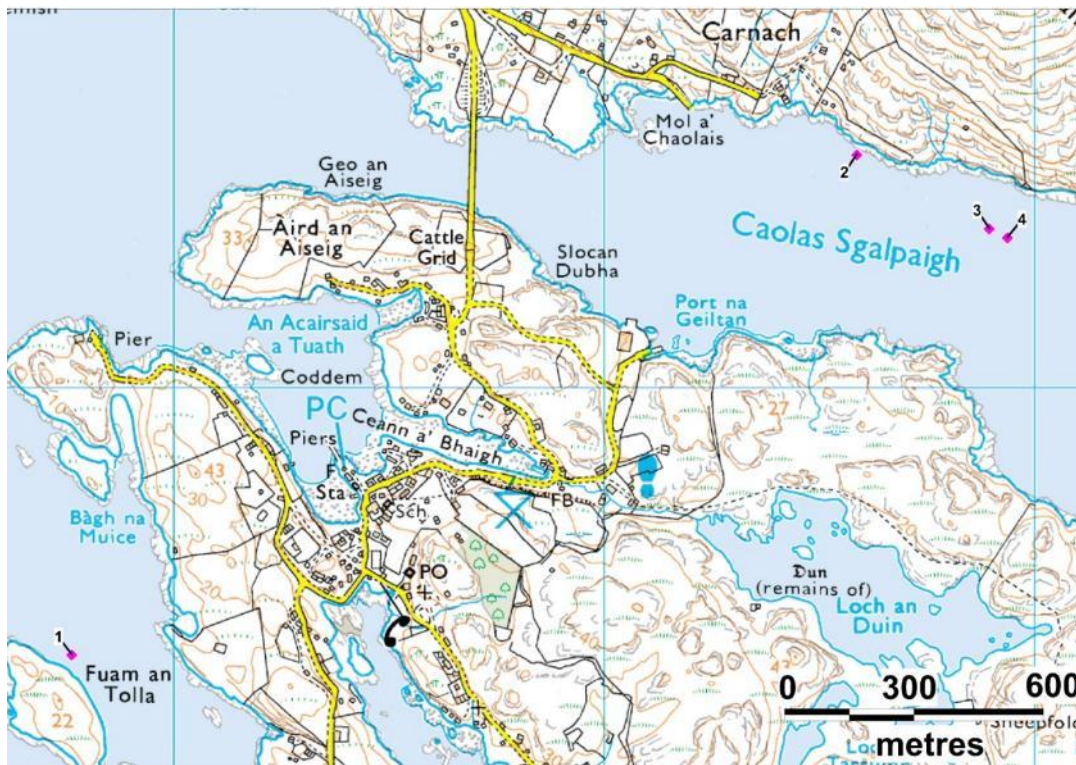
Figure A7.1 Location of CTD cast

CTD profiles were taken at two locations in the normal production area from the harvester's boat. The absence of the mussel array at the time of the team visit meant it was not possible to moor the boat and there was some boat drift while the casts were being taken. A CTD cast was taken at the site of the single point dropper east of Fuam an Tolla. The gathered data will be sent to client as a separate document. A "Castaway" S/N 10G100653 instrument was used to collect the data.

Data obtained during the shoreline survey. The locations of the casts are shown in Figure A7.1.
