**Sanitary Survey Report
Inner Loch Torridon
RC-090
May 2014**

Report Title	Inner Loch Torridon Sanitary Survey
Project Name	Scottish Sanitary Survey
Client/Customer	Food Standards Agency Scotland
Cefas Project Reference	C5792C
Document Number	C5792C_2013_18
Revision	V1.0
Date	28/05/2014

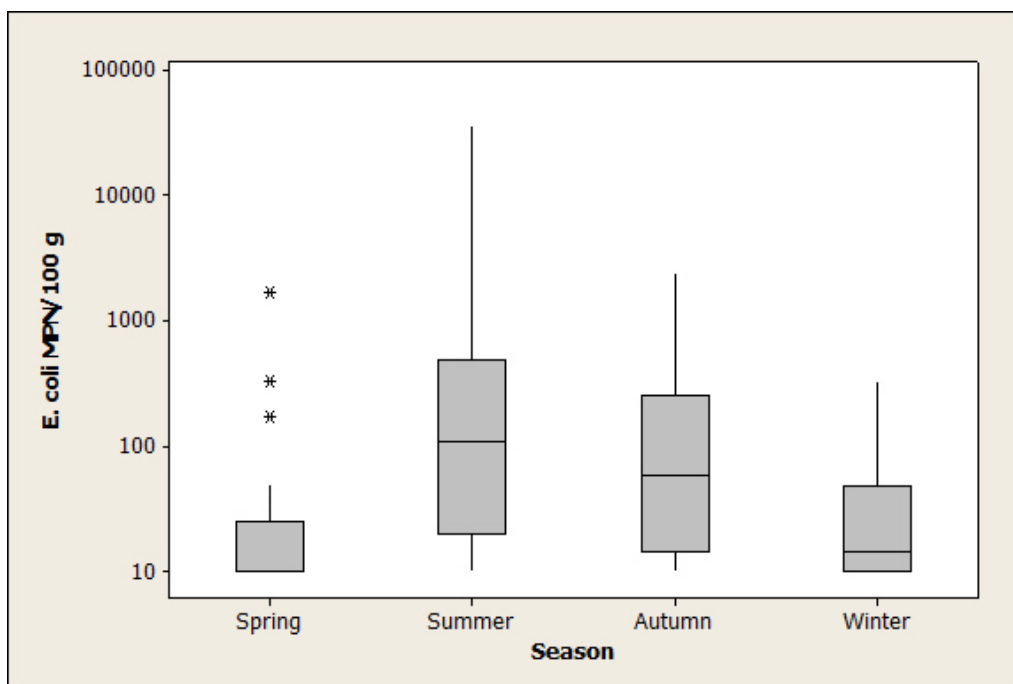
For statistical evaluation, seasons were split into spring (March-May), summer (June-August), autumn (September-November) and winter (December-February). A boxplot of *E. coli* results by season for Inner Loch is presented in Figure 11.4.

Figure 11.4 Boxplot of *E. coli* results by season at Inner Loch Torridon

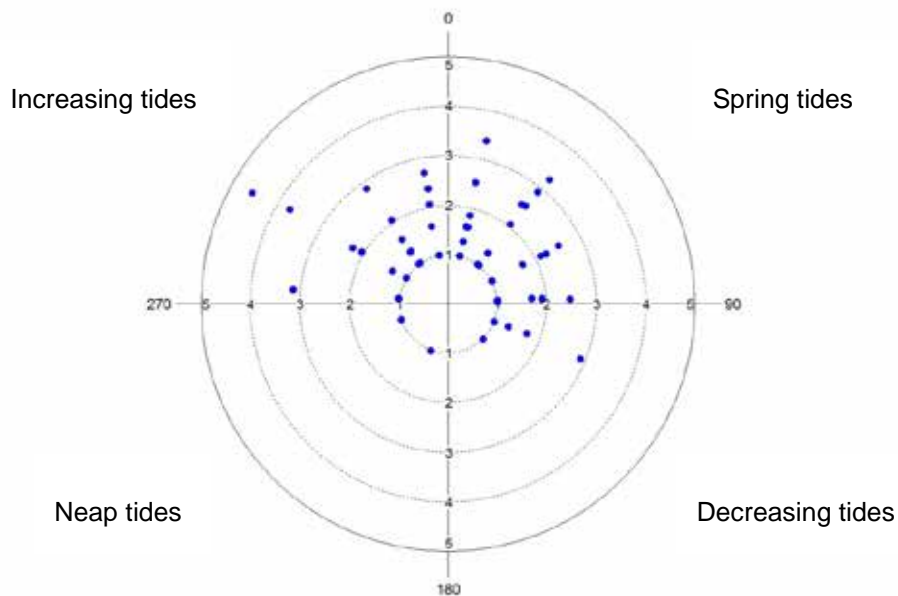
Figure 11.7 Polar plots of \log_{10} *E. coli* results on the spring/neap tidal cycle at Inner Loch Torridon

No significant correlation was found between \log_{10} *E. coli* results and the spring/neap tidal cycle (circular-linear correlation $r = 0.208$, $p = 0.058$), with the majority of results taken on increasing and spring tidal states.

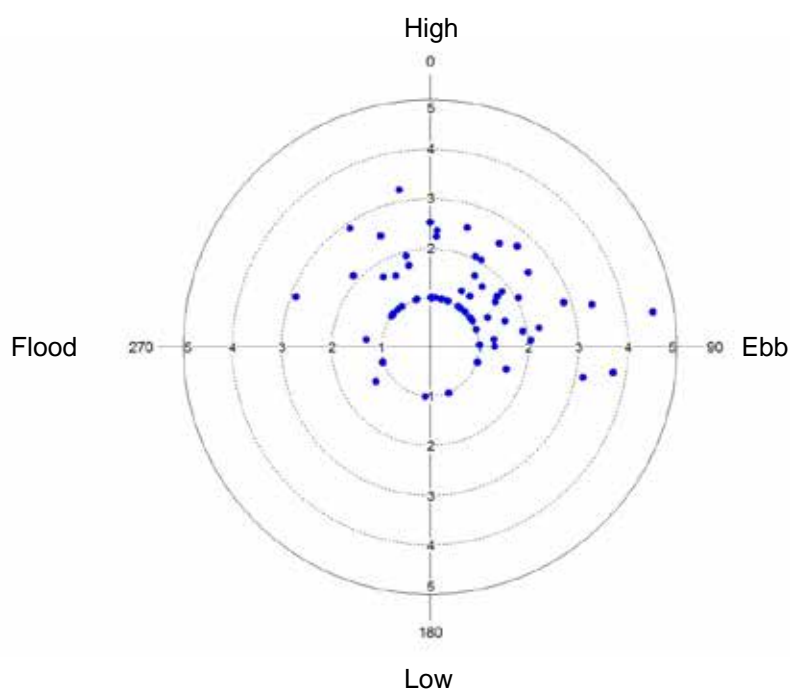
Figure 11.8 Polar plots of \log_{10} *E. coli* results on the high/low tidal cycle at Inner Loch Torridon

No significant correlation was found between \log_{10} *E. coli* results and the high/low tidal cycle (circular-linear correlation $r = 0.189$, $p = 0.095$). Most samples were taken around high tide, and very few samples were taken at low tide.

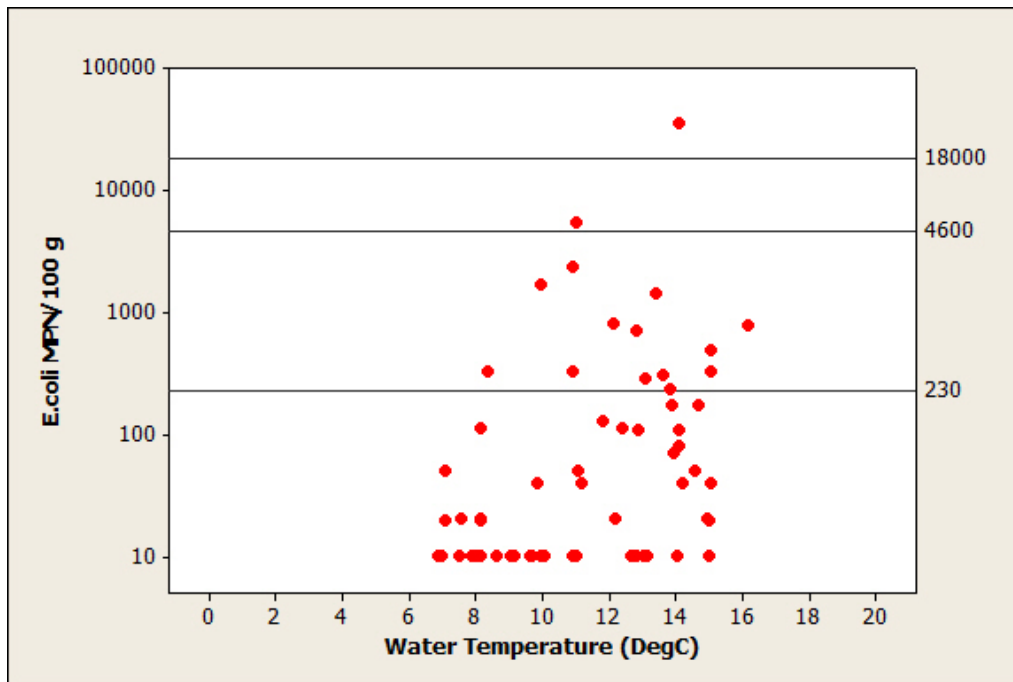
Figure 11.9 Scatterplot of *E. coli* results against water temperature at Inner Loch Torridon

A significant correlation was found between *E. coli* results and water temperature (Spearman’s rank correlation $r = 0.434$, $p = 0.000$). The highest results occurred at temperatures greater than 10°C, however low results occurred across all recorded water temperatures.

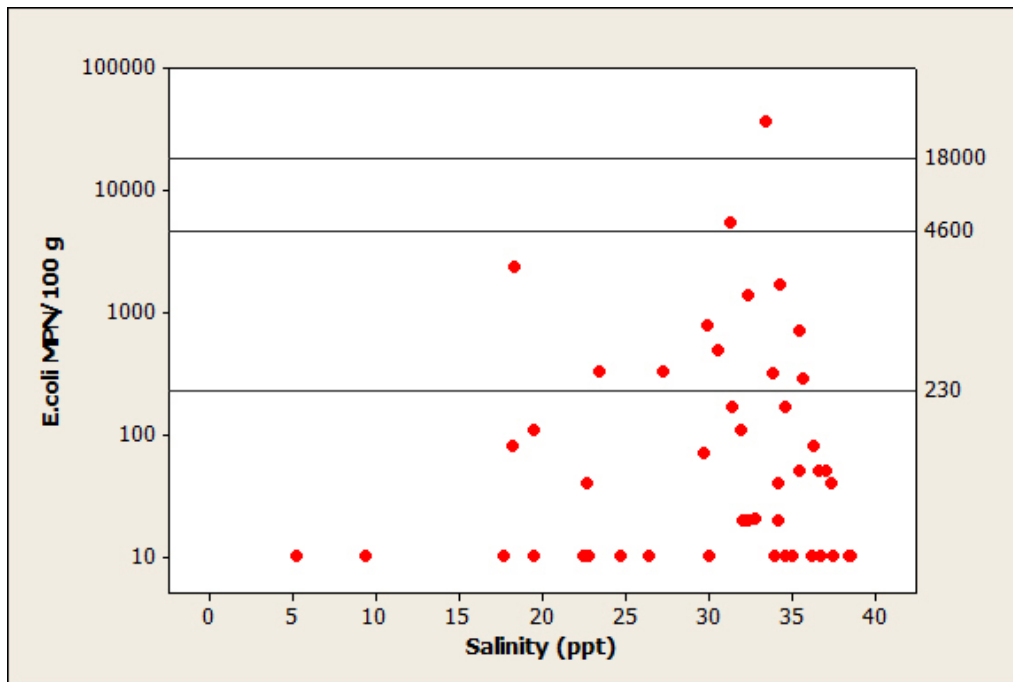
Figure 11.10 Scatterplot of *E. coli* results against salinity at Inner Loch Torridon

No significant correlation was found between common mussel *E. coli* results and salinity (Spearman's rank correlation $r = -0.043$, $p = 0.772$).

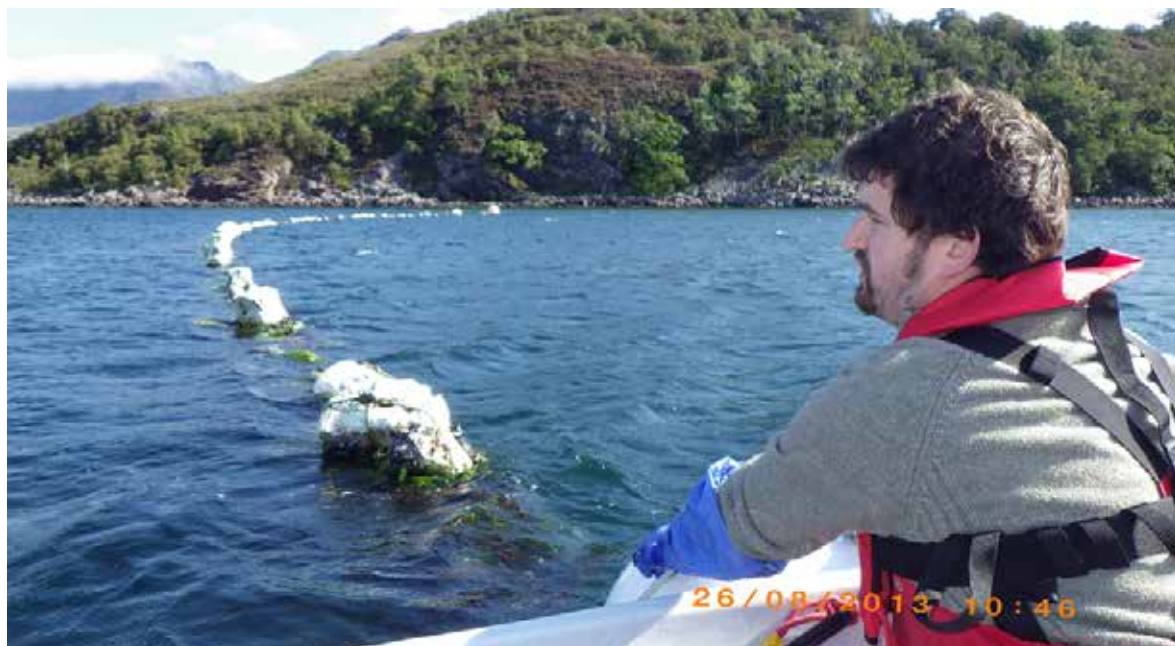
Figure 3: Ob Gorm Beag mussel sample (LTSF1) from middle of N (outermost) line. Waypoint 8.

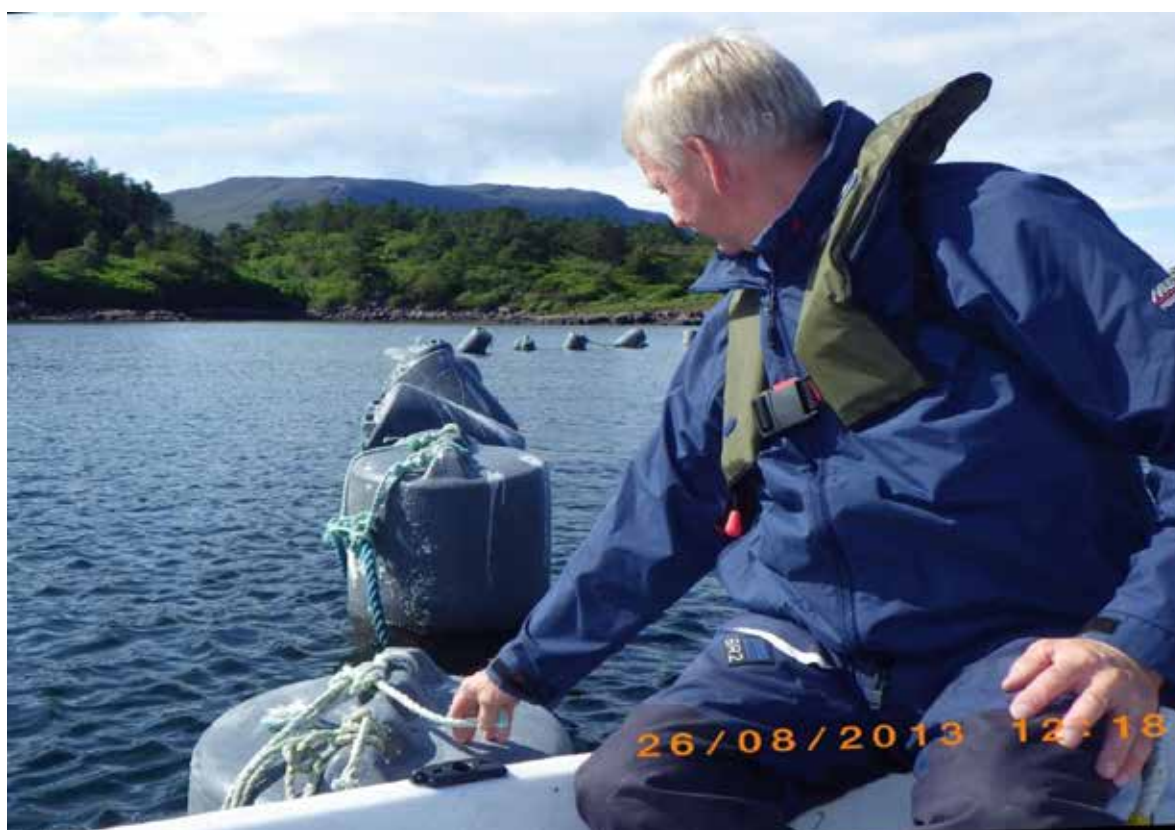
Figure 4: Dubh Aird, SE corner of mussel lines at LTSW5 sample site showing plastic floats. Waypoint 29.

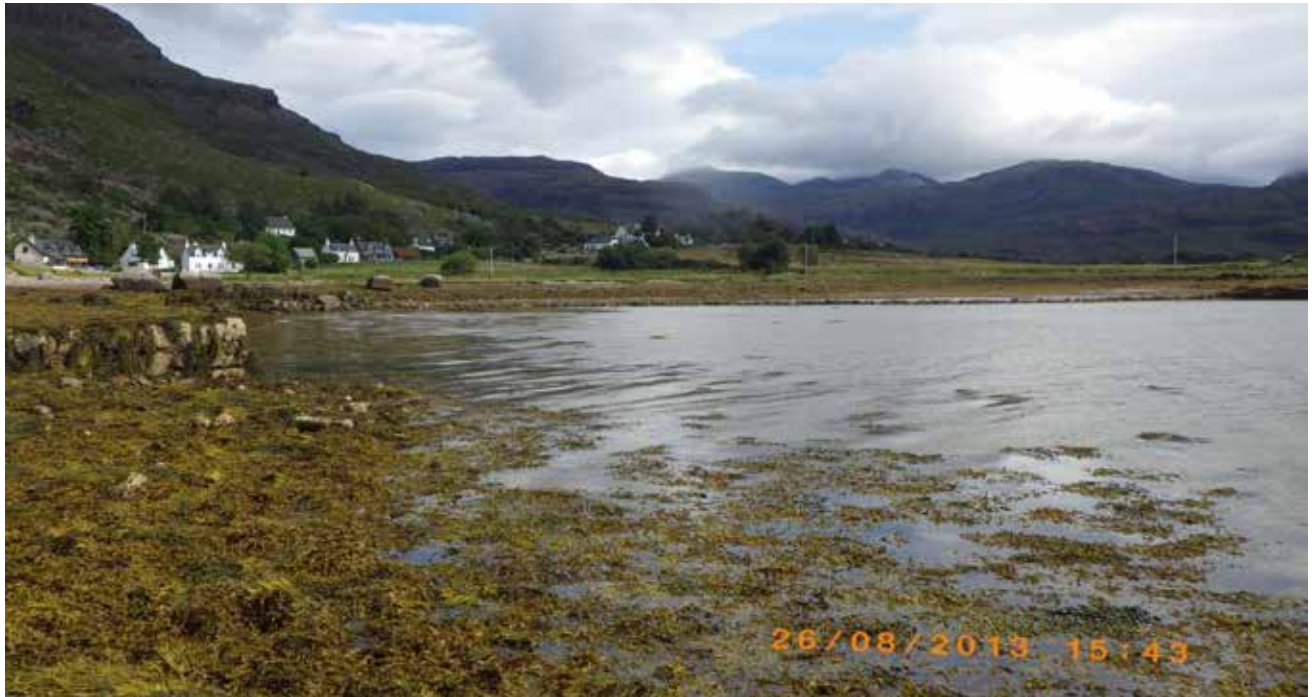
Figure 5: Western end of the village of Torrison, with public jetty visible on the middle left. Waypoint 36. Site of seawater sample LTSW6.

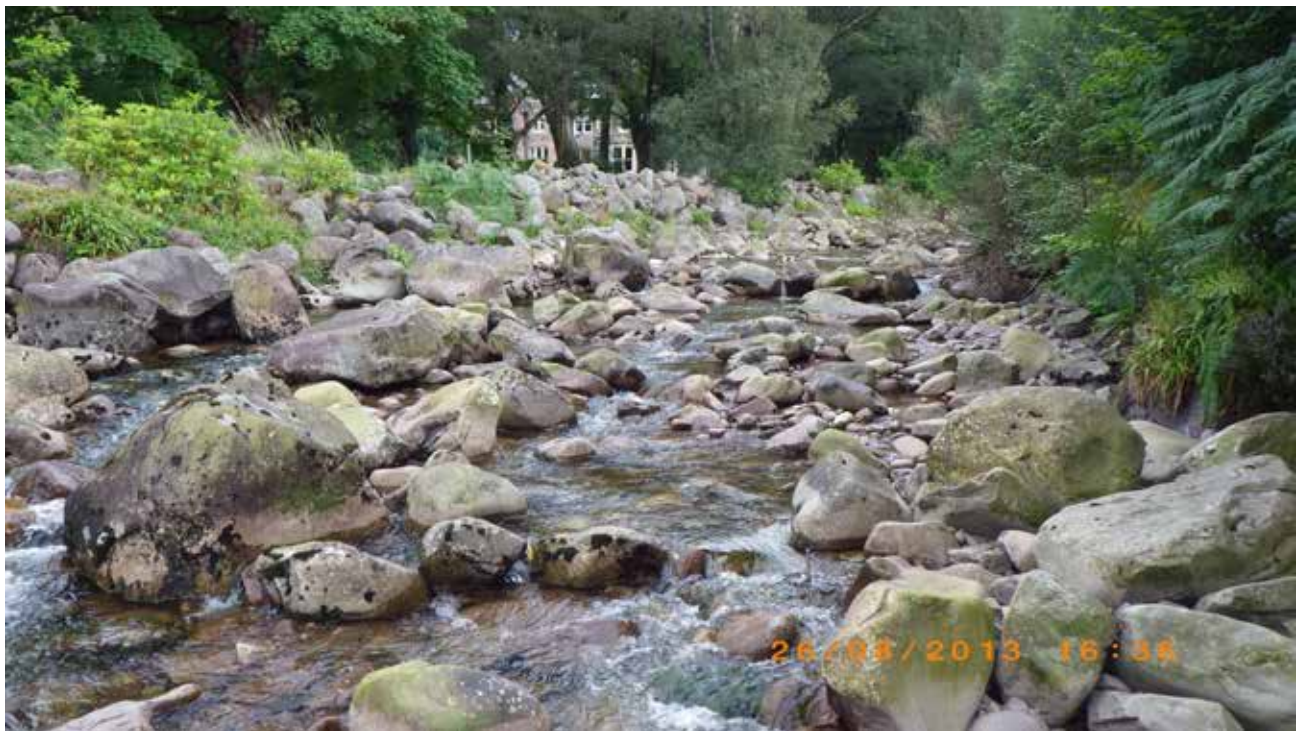
No.	Date	NGR	Associated Photograph (Appendix 5)	Description
1	27/08/2013	NG 8636 5514	Fig. 12	Septic tanks cover at lone house on the peninsula. Tank appears to soakaway into marshy ground - no discharge pipe observed.
2	27/08/2013	NG 8881 5433	Fig. 6	Two manholes present in hotel grounds, on path to river
3	27/08/2013	NG 8885 5428	-	Possible location of septic tank - 3x metal manhole covers below hotel in field.

Figure 6: Allt Coire Roill river, looking upstream with Torrison Hotel behind. Waypoint 40.

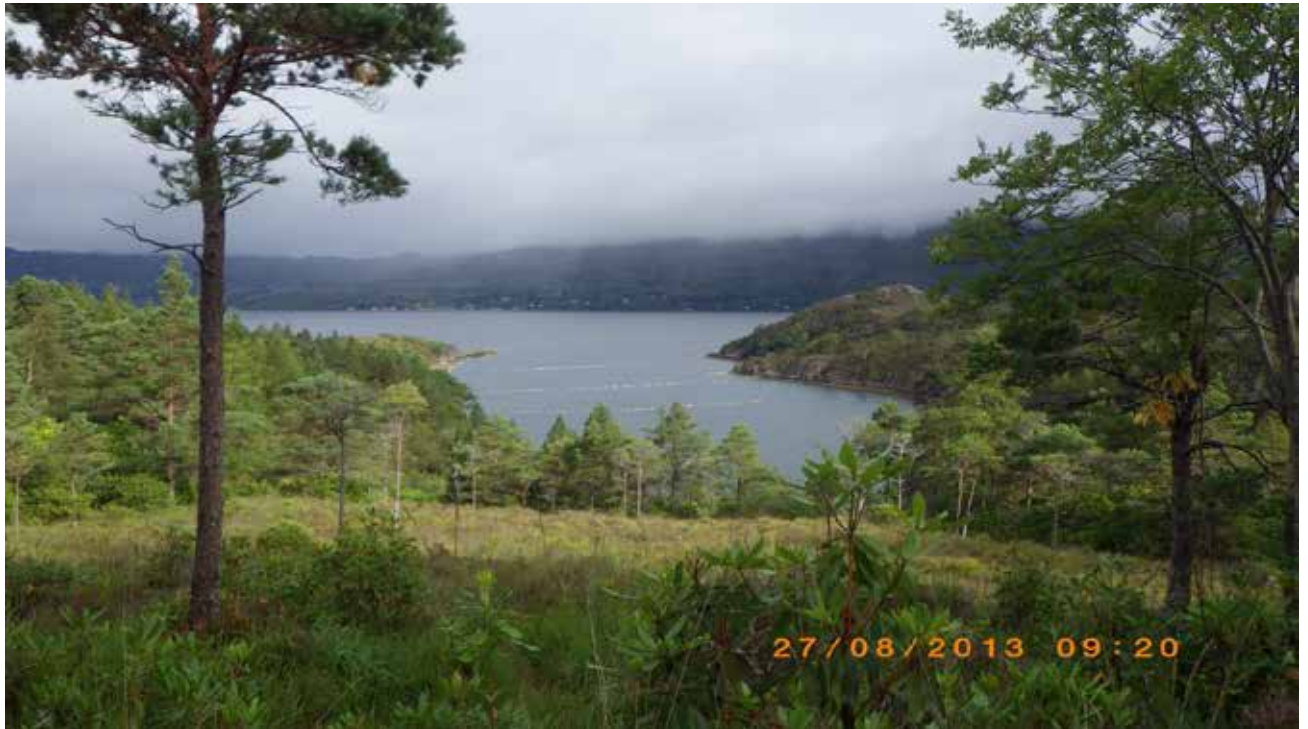
Figure 7: Ob Gorm Beag overview from South (photo taken while walking to the start of survey, day 2). Waypoint 42.

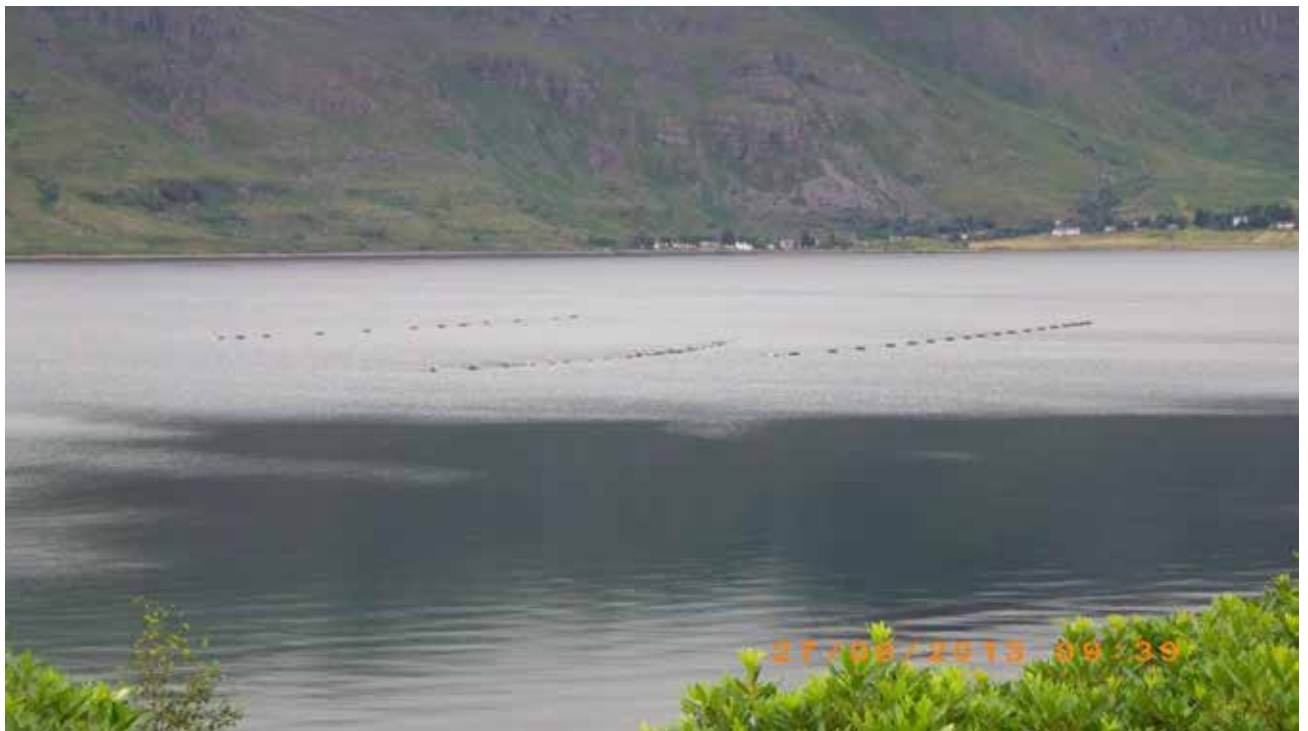
Figure 8: Dubh Aird site, viewed from the West on the 2nd day of survey. The W end of Torridon village is in the background on the far shore. Waypoint 43.

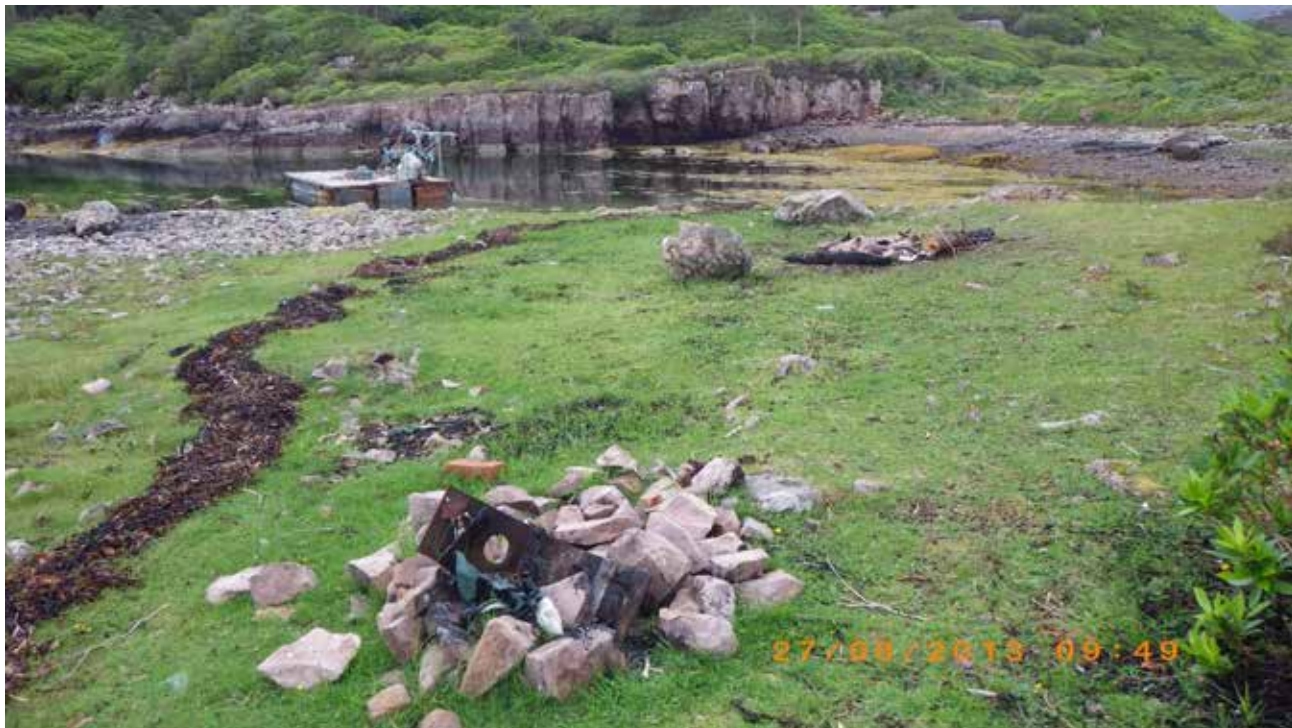
Figure 9: Abandoned campsite and fire hearth on shore to the West of Dubh Aird site. Waypoint 45.

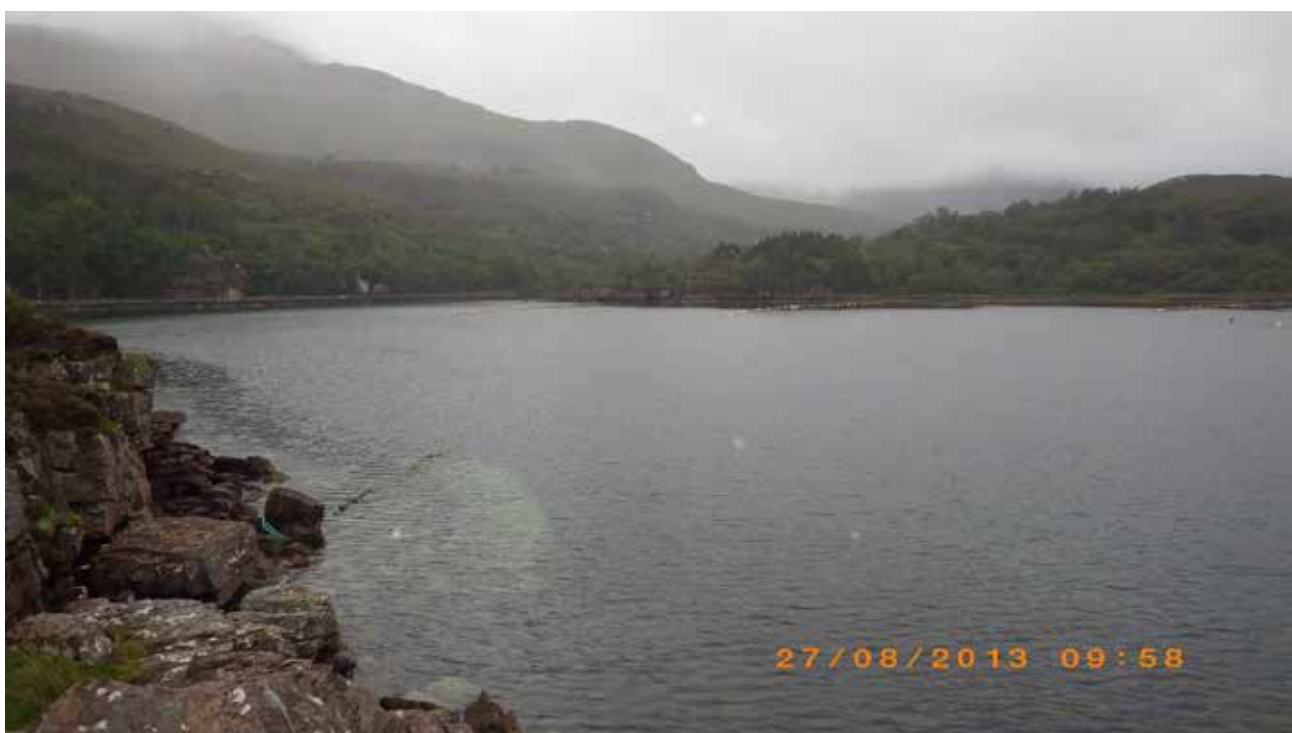
Figure 10: Ob Gorm Mor site, taken on day 2 of the survey, looking west. Waypoint 46.

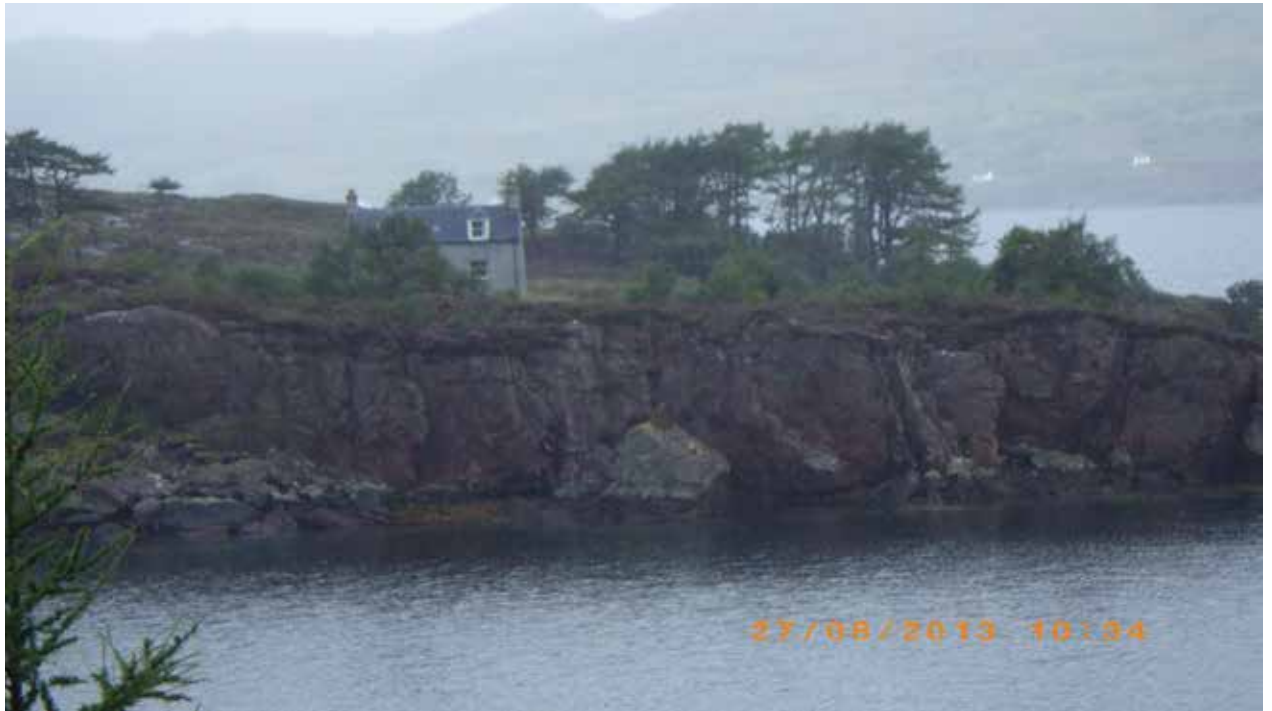
Figure 11: Sole house on Aird Mhor peninsula with typical shoreline below. Waypoint 50.

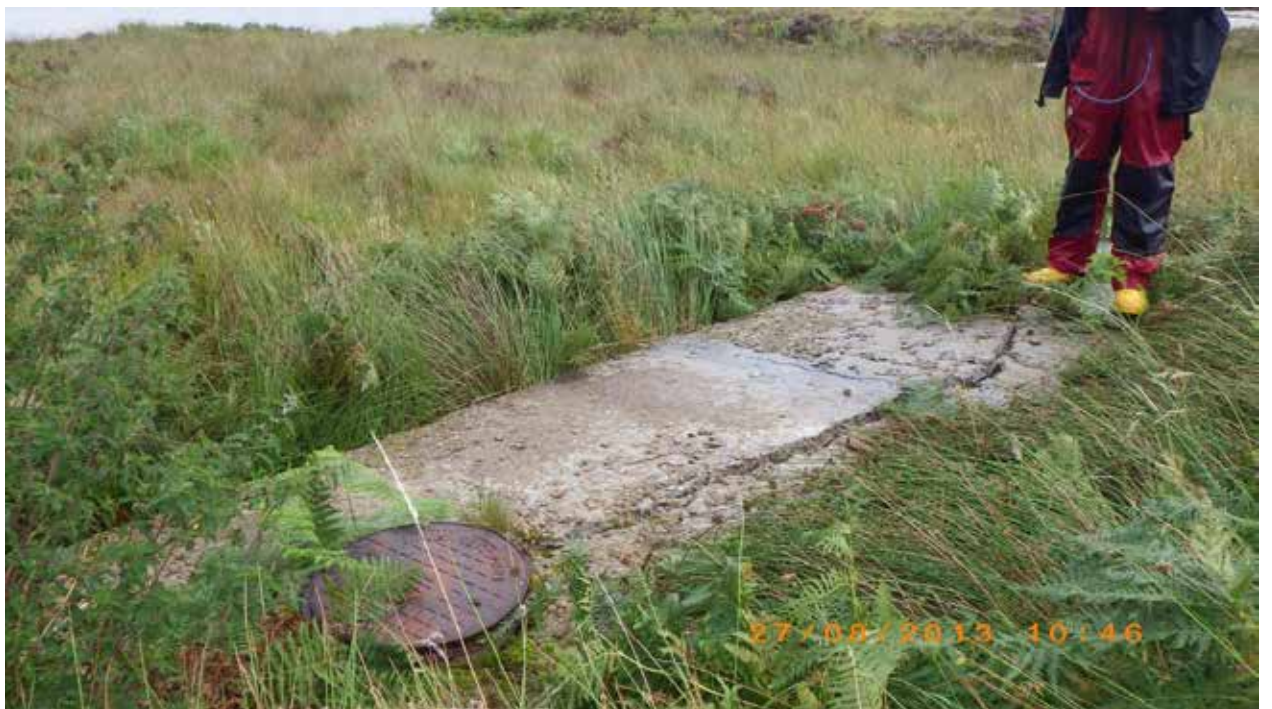
Observation 1 relates to a septic tank associated with a single dwelling observed approximately 400 m to the northwest of the Ob Gorm Mor mussel farm. The tank lies within 50 m of the shoreline, and near marshy ground where the soakaway was presumed to be located. Any overland flow from this soakaway would have the potential to contaminate water nearby and may affect the north end of the Ob Gorm Mor site.

Figure 12: Septic tank for house on Aird Mhor peninsula with longitudinal crack through concrete. Waypoint 51.

One septic tank, discharging to soakaway, was observed during the shoreline survey at the head of Aird Mhor peninsular adjacent to Ob Gorm Mor: this is less than 400 m from the mussel farm but only serves one dwelling. It is located within the extent of the shellfish farm lease and so the mussel farm could, in principle, expand or move closer to that discharge.

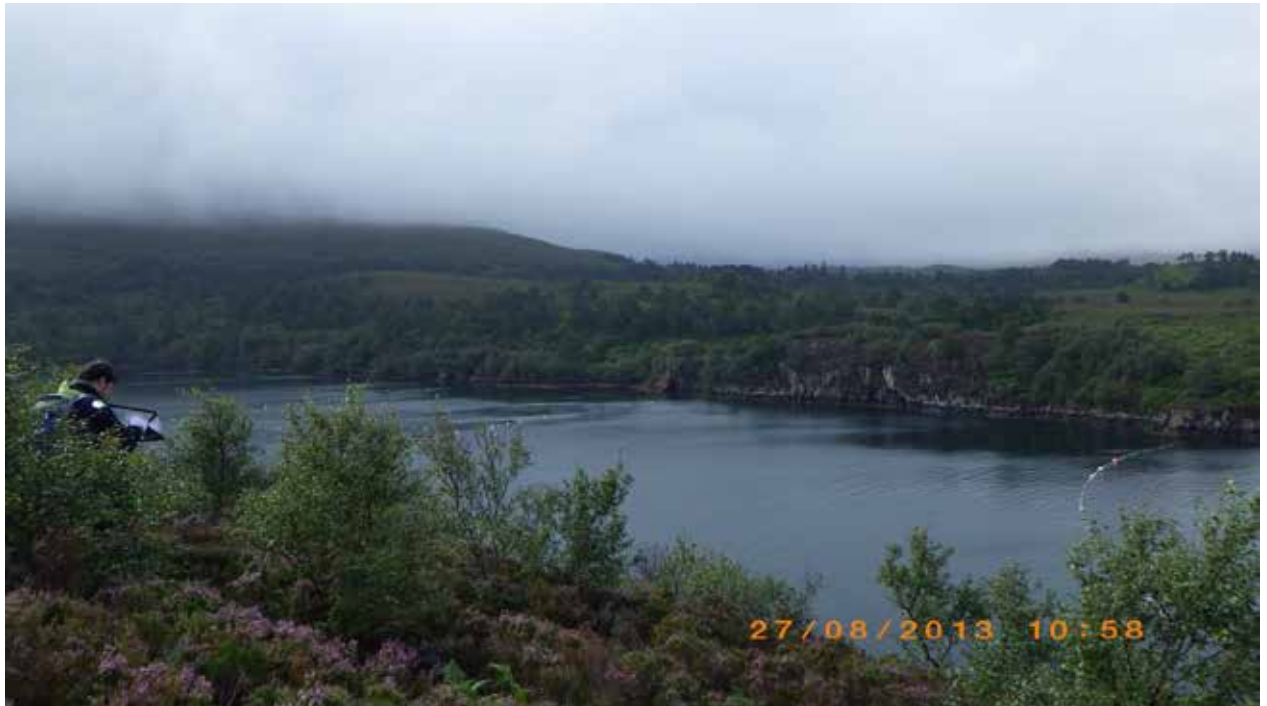
Figure 13: Overview of Ob Gorm Beag from the Aird Mhor peninsula, showing the difficult shoreline and access along the loch, with mussel lines present. Waypoint 52.

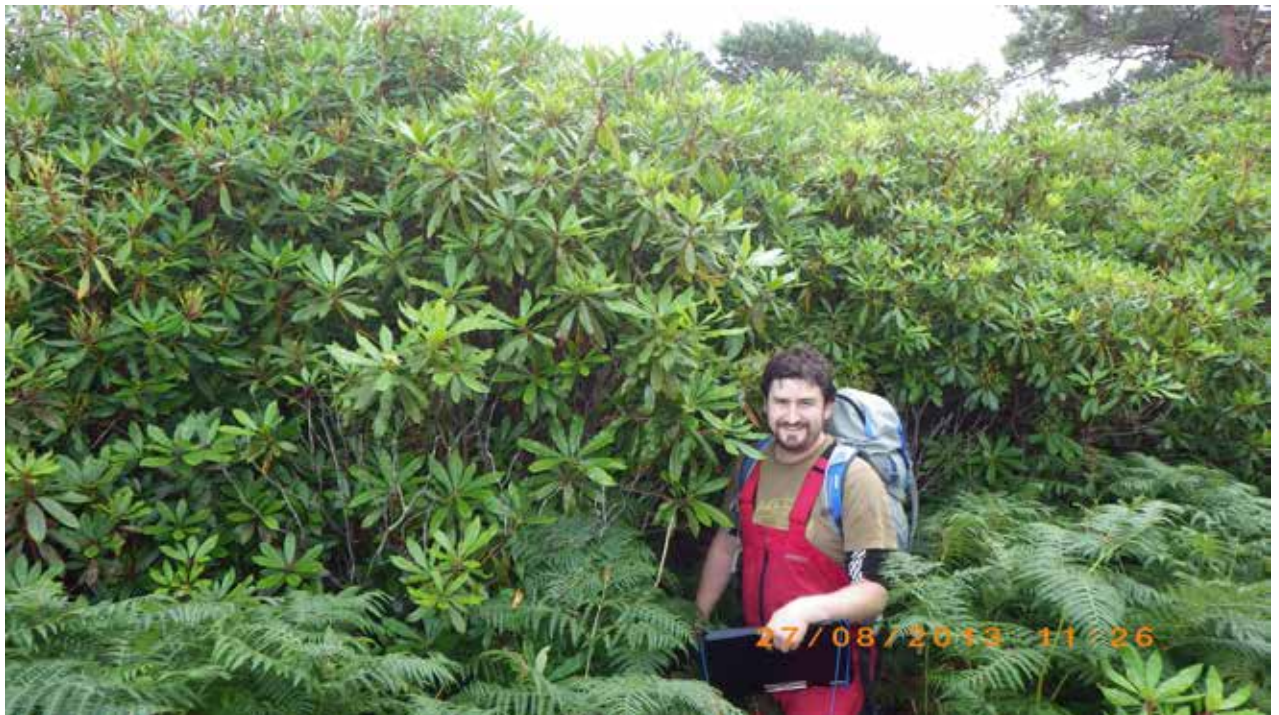
Figure 14: Typical *Rhododendrum ponticum* foliage in the area between the track and shoreline, limiting access. Waypoint 55.

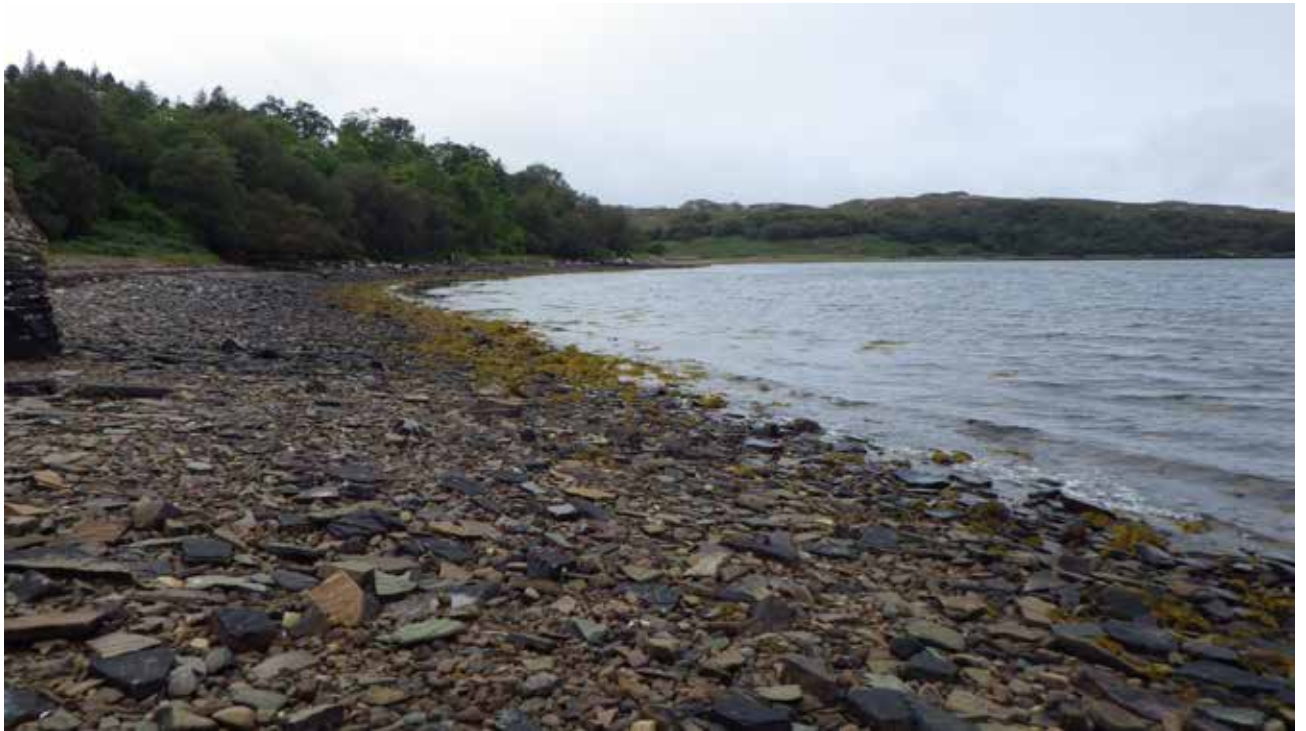
Figure 15: Shoreline in Corran Badan Mhugaidh, looking west. Waypoint 60.

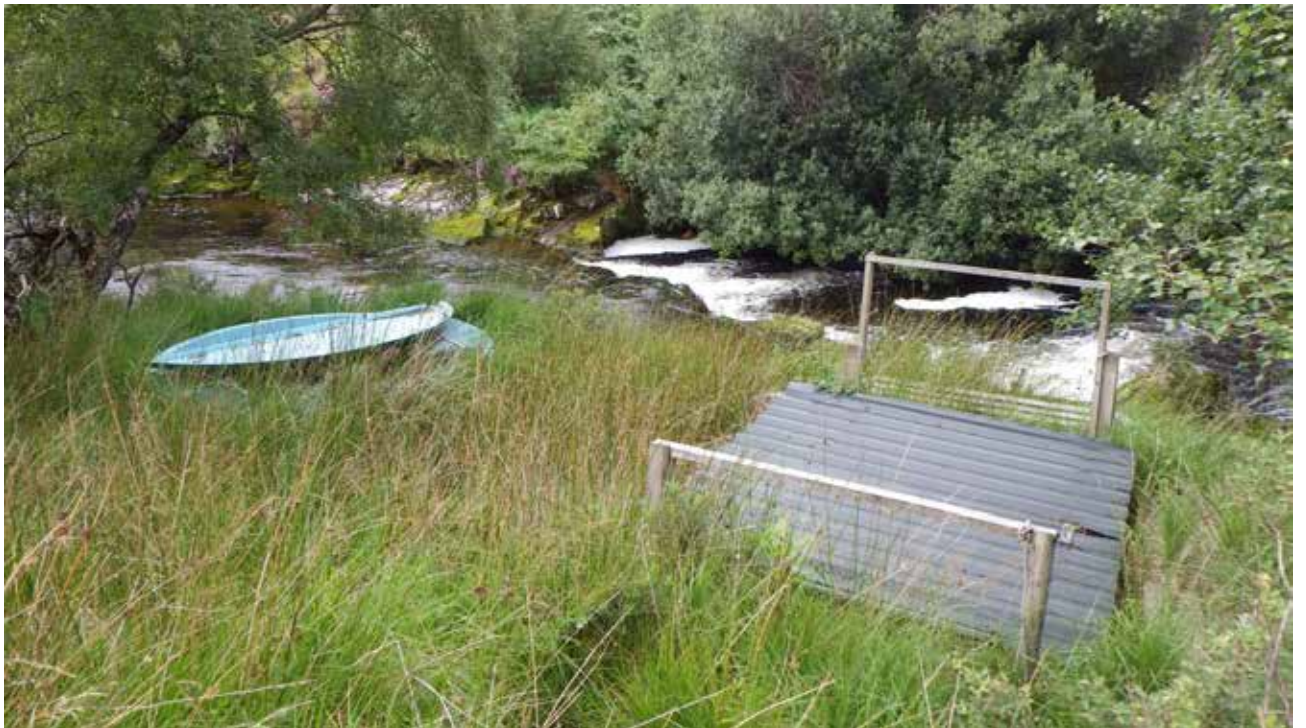
Figure 16: Two tanks recessed into riverbank next to River Balgy. Waypoint 62.

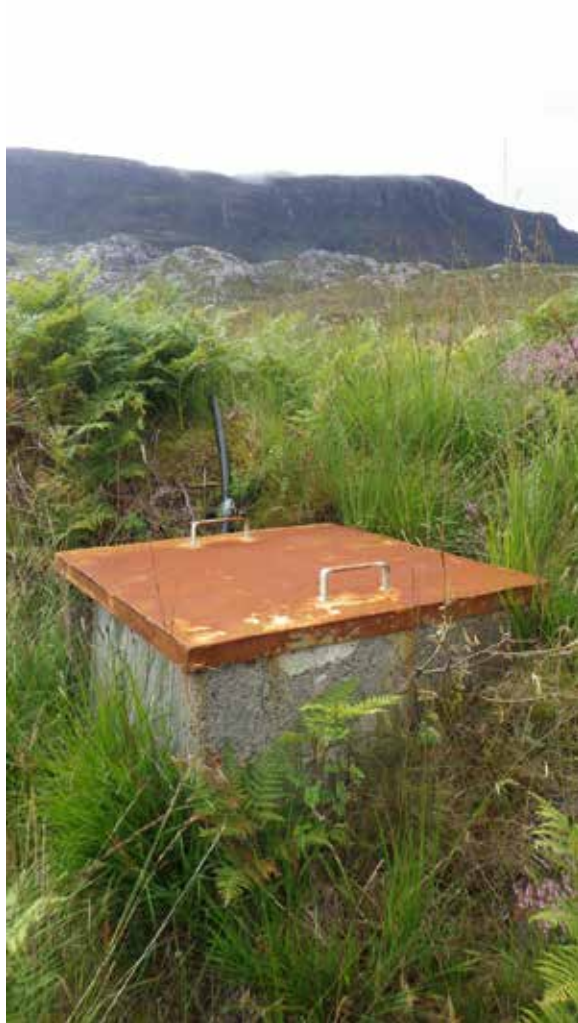
Figure 17: Concrete box with pipe entering, noted on west bank of River Balgy. Waypoint 65

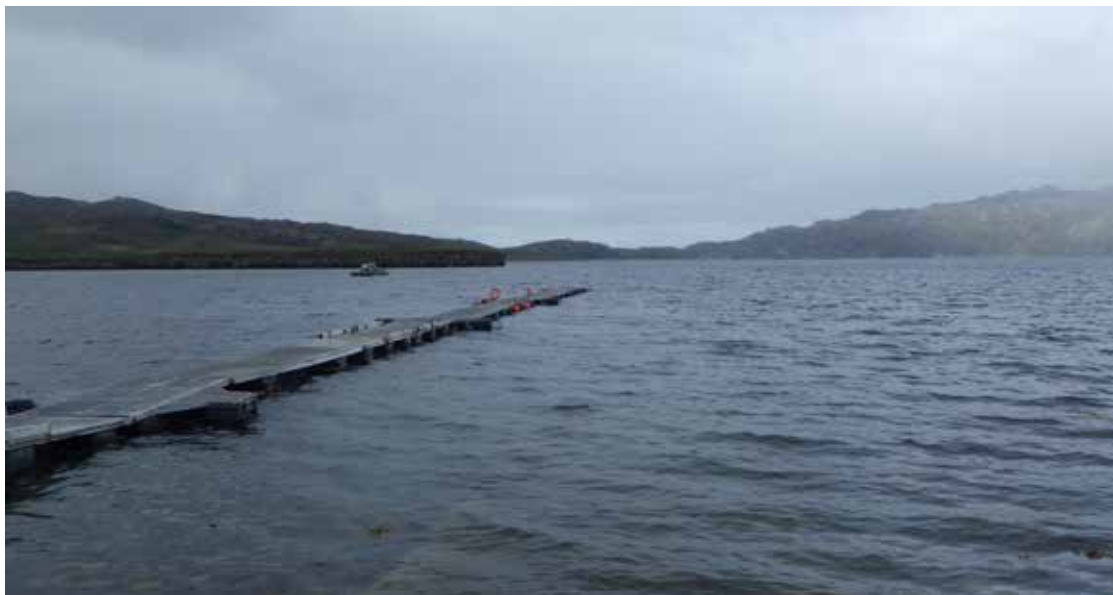
Figure 18: Inner Loch Torridon Marine Harvest shore base, with pontoon and moorings visible. Waypoint 67.

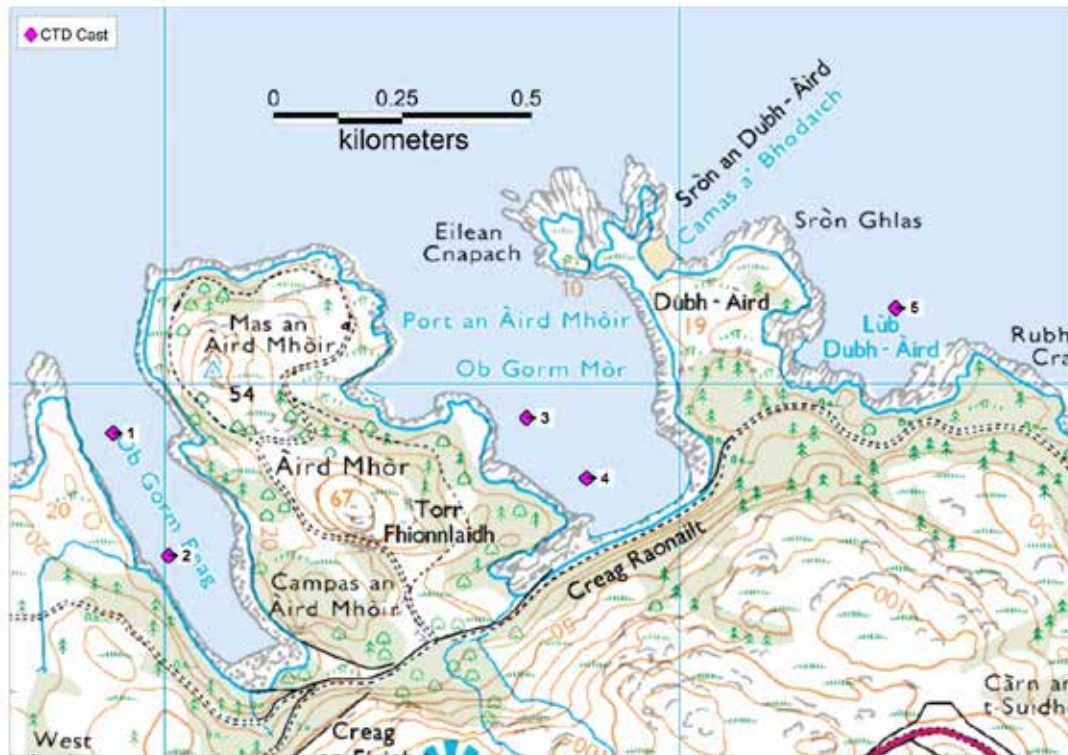
**Figure A7.1 Location of CTD cast
CAST 1**

Data obtained during the shoreline survey. The locations of the casts are shown in Figure A7.1.
