Scottish Sanitary Survey Review

Sanitary Survey Review
Islay: Loch Gruinart Craigens
AB 094
September 2012

Islay: Loch Gruinart Craigens

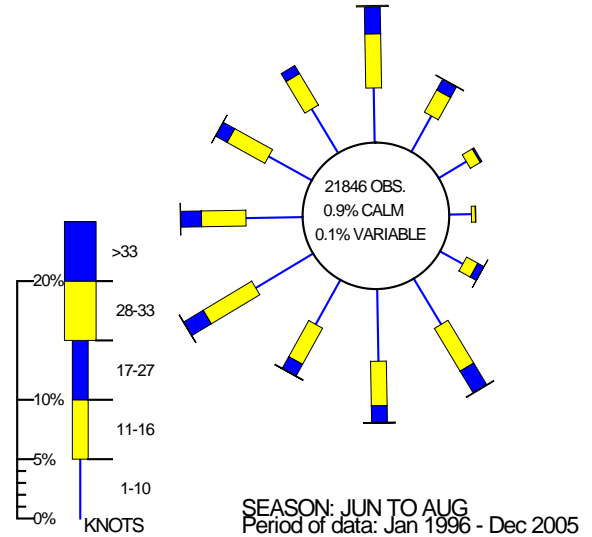
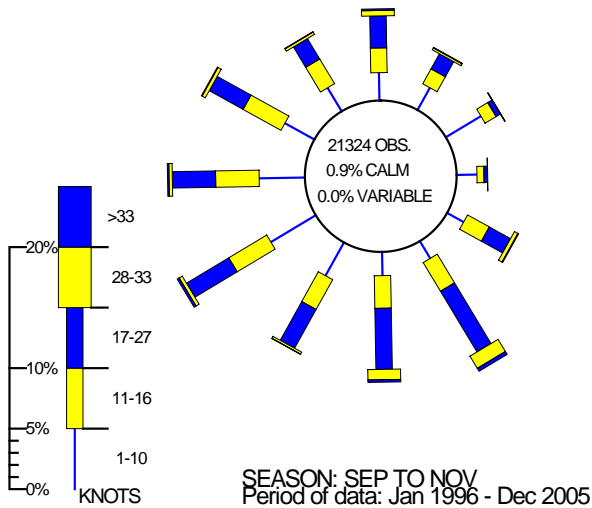
Figure 7.5 Seasonal wind roses for Tiree (1996-2006)

Prevailing winds throughout all four seasons and across the two survey periods appears to be south and west, with the highest winds recorded in autumn and winter. Slight variations are evident between survey periods and seasons.

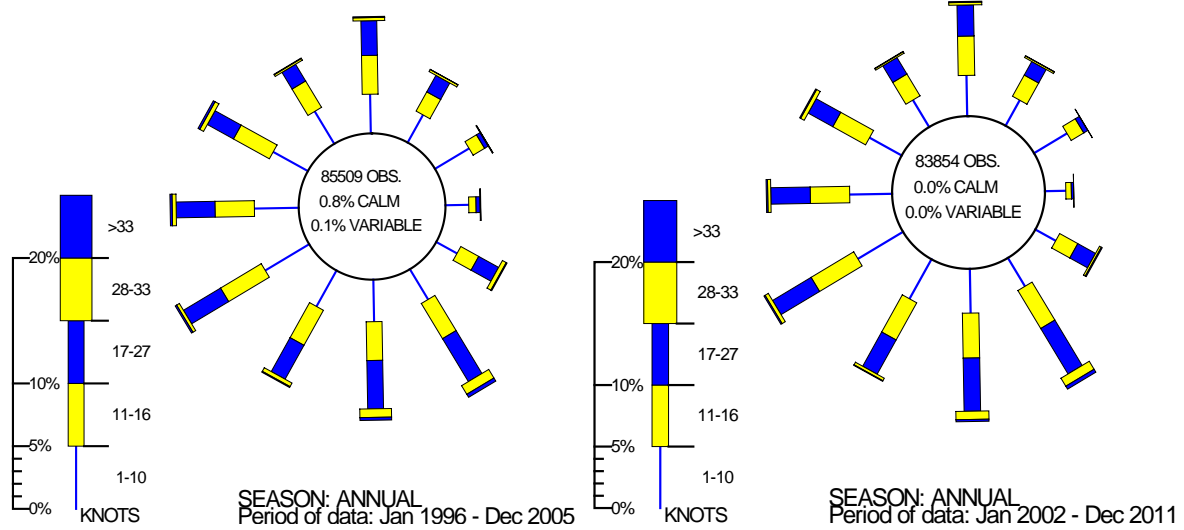
Figure 7.7 Annual wind roses for Tiree 1996-2005 and 2007-2011

The prevailing annual wind direction at Tiree between 1996-2006 and 2002-2011 is the same, with high winds coming from the south and west. Between survey periods, there appears to be a slight increase in the 2007-2011 dataset with recorded wind speeds of >33 knots in the SW. Overall, due to the topography of Loch Gruinart, it is believed that tidally driven circulation will be a more important factor to consider when looking into particulate dispersal, than wind driven circulation. However, strong winds and a high spring tide will increase the tide height, flushing out accumulated faecal matter from above the high water mark into the Loch.

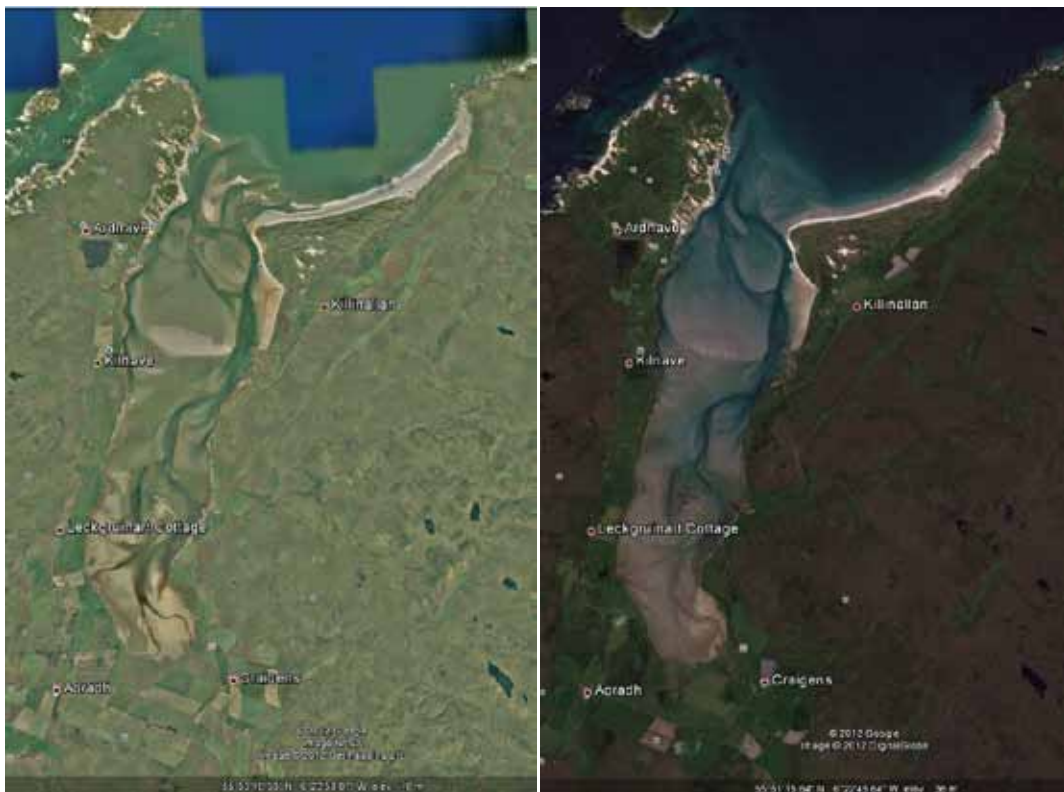
Figure 9.1 Google Earth Images of Loch Gruinart Craigen's. Image courtesy of Image © 2012 Getmapping plc, DigitalGlobe, GeoEye. Data SIO, NOAA, U.S. Navy, NGA, GEBCO.

Hydrography at Loch Gruinart remains largely unchanged since the 2007 Report. Recent satellite imagery (© Google Earth 2012) shows how the sand bars at the entrance of the Loch have moved since 2008 in Figure 9.1 where the image on the left is from 2008 and on the right 2010. Shifts in sand bars are a normal and regular phenomenon. It is unclear whether the shifts will have significantly changed the tidal flushing within Loch Gruinart. It should also be noted that the time of year may also be significant in shaping the extent of the sand bars, with images taken at 23/09/2008 and 23/07/2011 respectively. Tidal state may also play a role in the sand bars that are evident in these images.

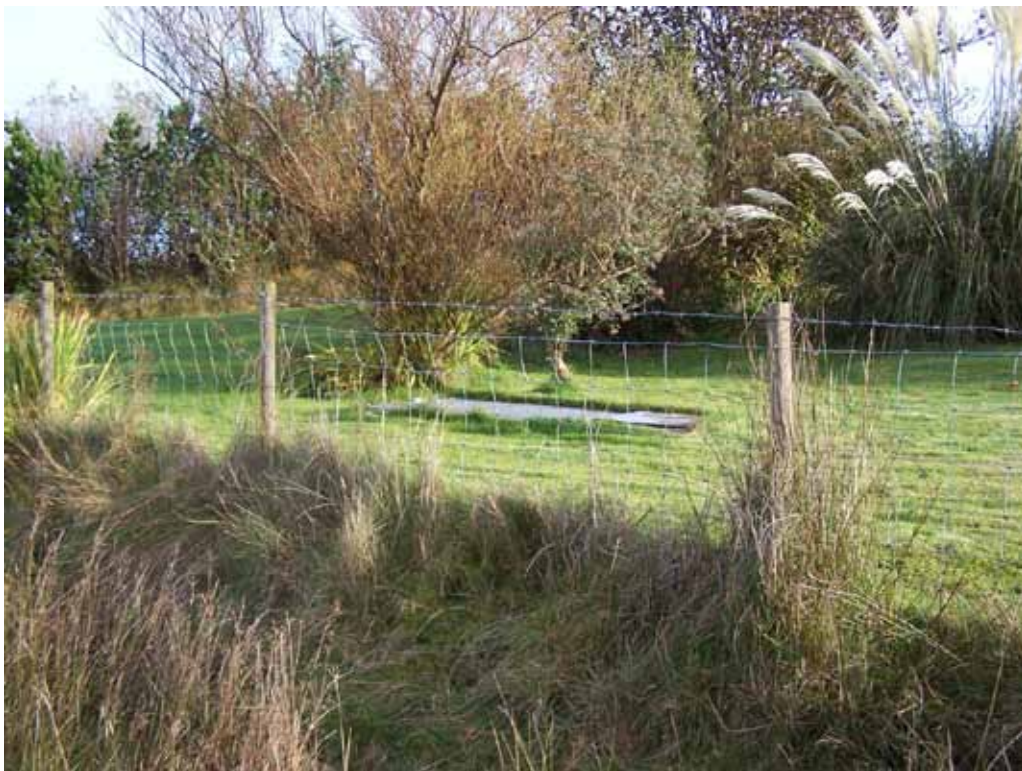
An additional discharge was observed during the shoreline survey, at a house near the shore at NR 29526 67650. Despite the OS map showing this site to be a well, its location (close to watercourse Allt a Ghil) and shape meant it was suggested as a septic tank. The location of this discharge is shown in Figure 3.2 highlighted in red as Discharge 3.

Figure 2 Septic tank not shown on original survey plan.

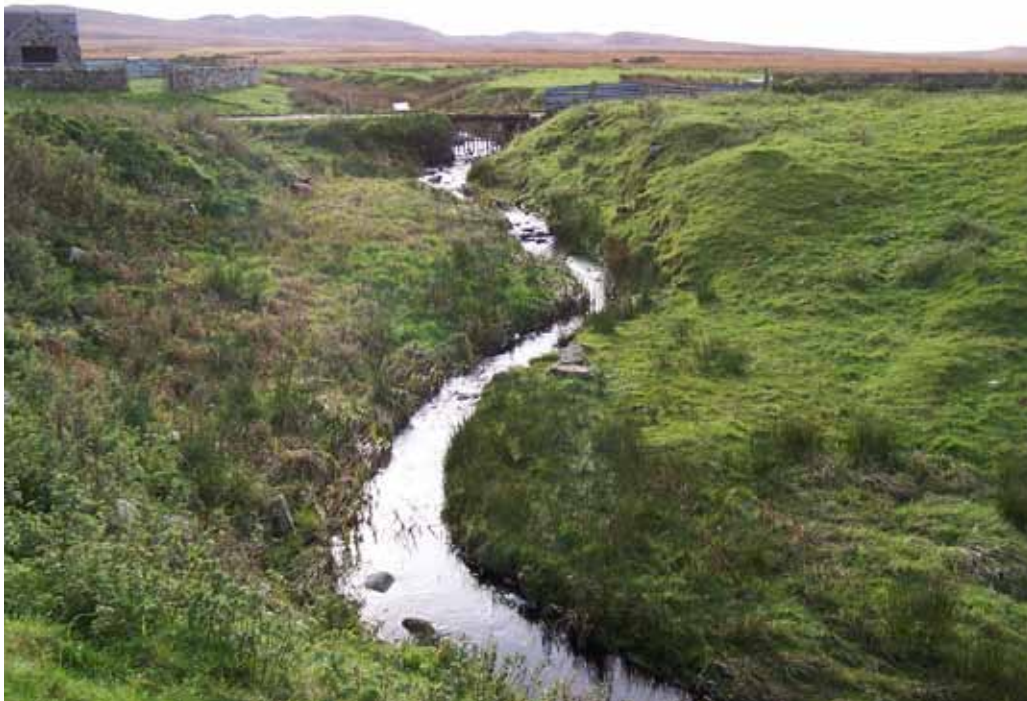
Figure 3 Stream running past farm.

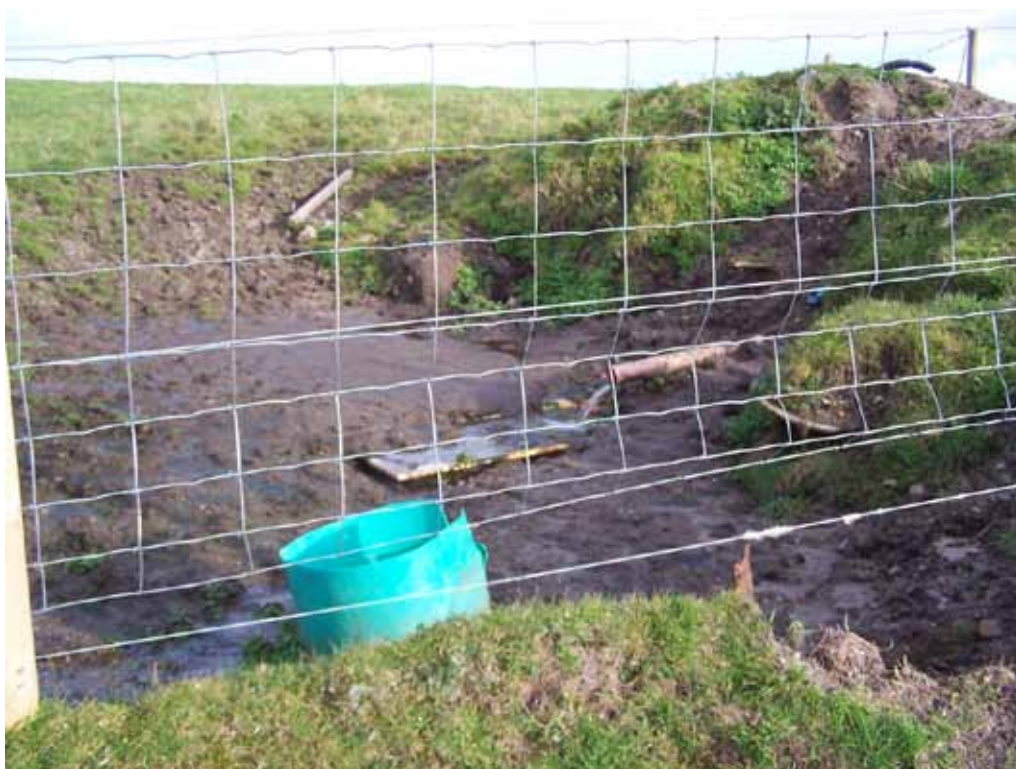
Figure 4 Run-off from land pipe.

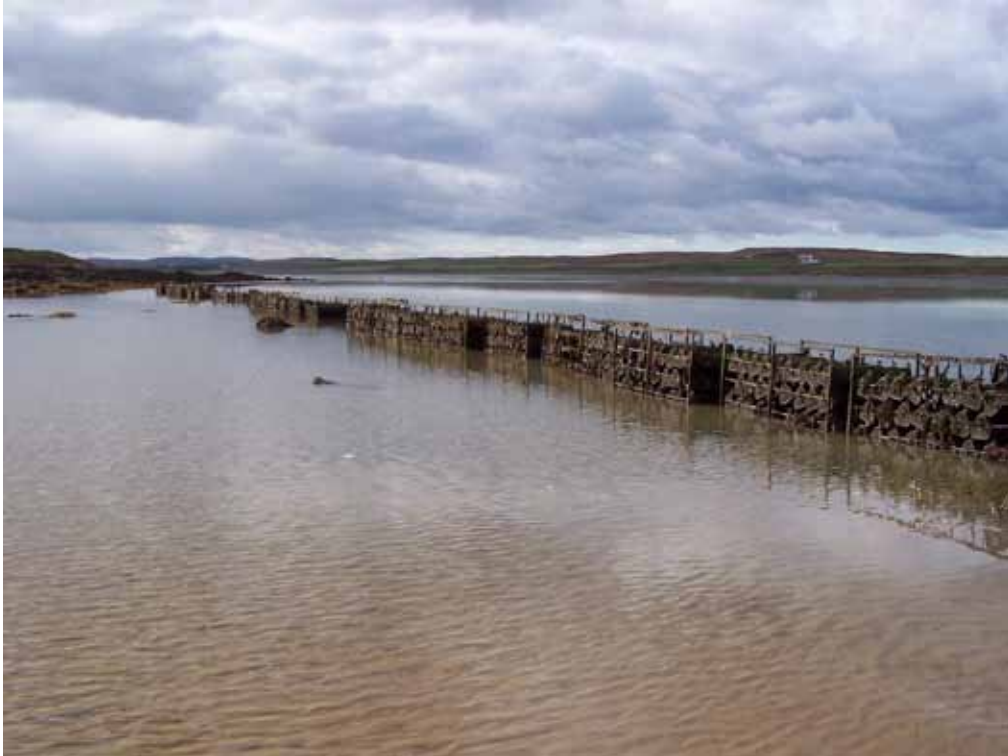
Figure 5 Pacific oysters growing in stacked triangular baskets on trestles. Water and oyster sample ISSF1/ISW4.

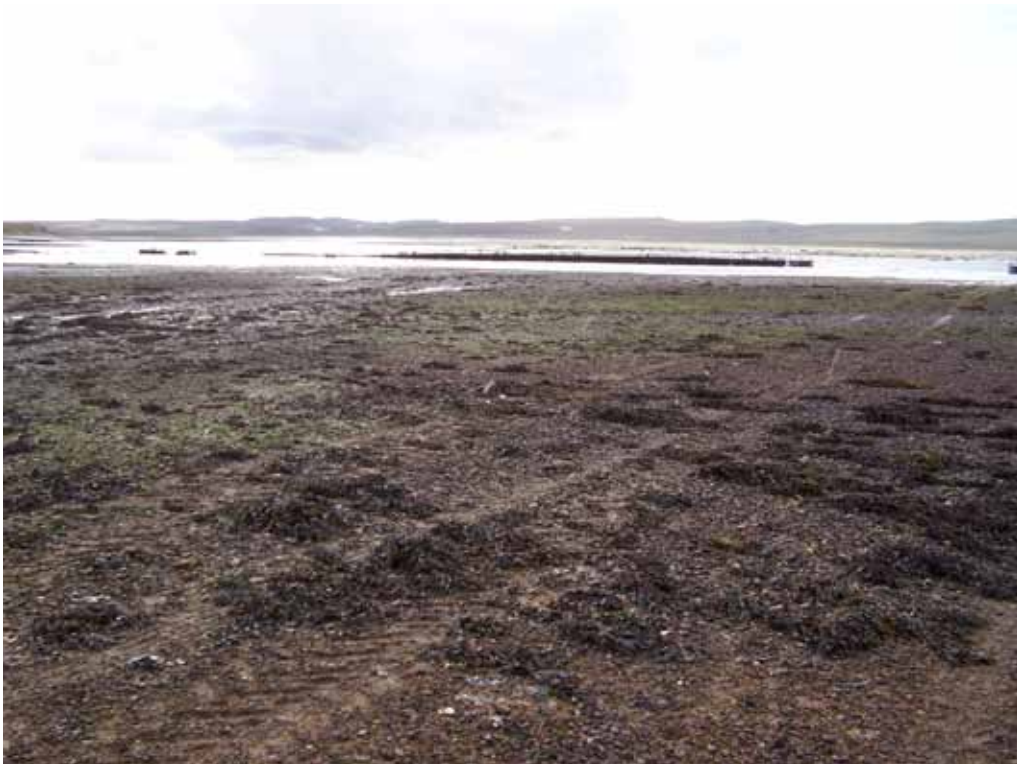
Figure 6 View from top of shore showing track marks and extent of oyster trestles.

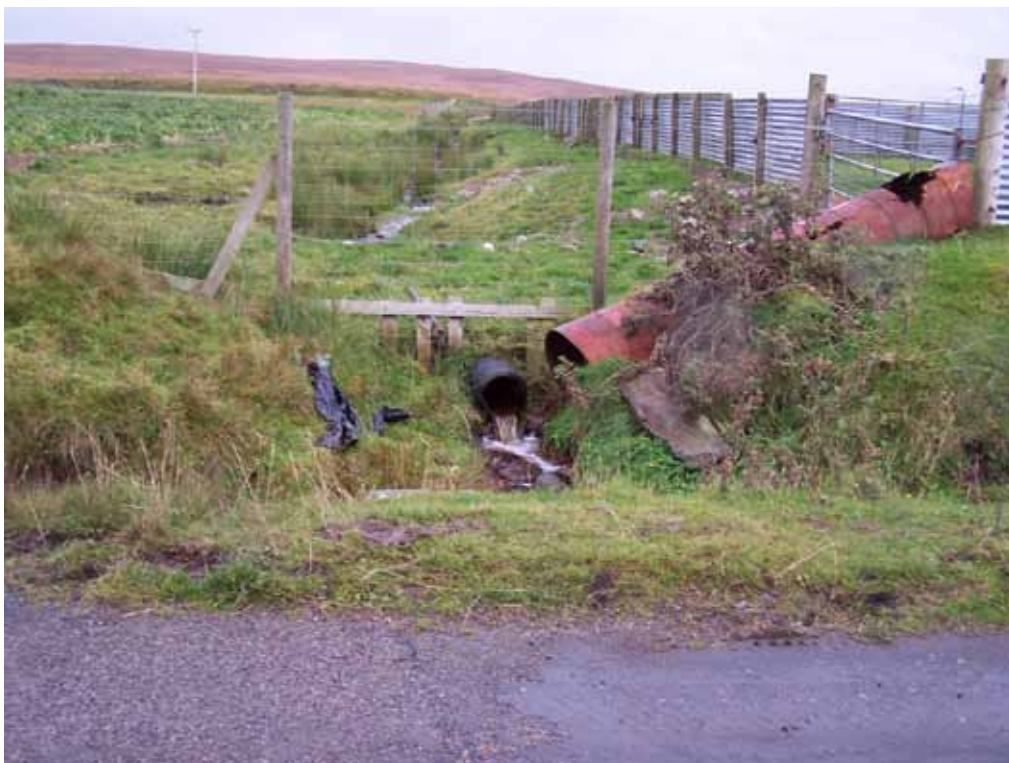
The wetted flow was estimated for the two pipes found at NR 29480 69198, where the diameter of the pipes was used to calculate the circumference before estimations of wetted flow were estimated from photographs given in Appendix 1 in Figures 7 and 8.

Figure 7 Stream running through metal pipe.

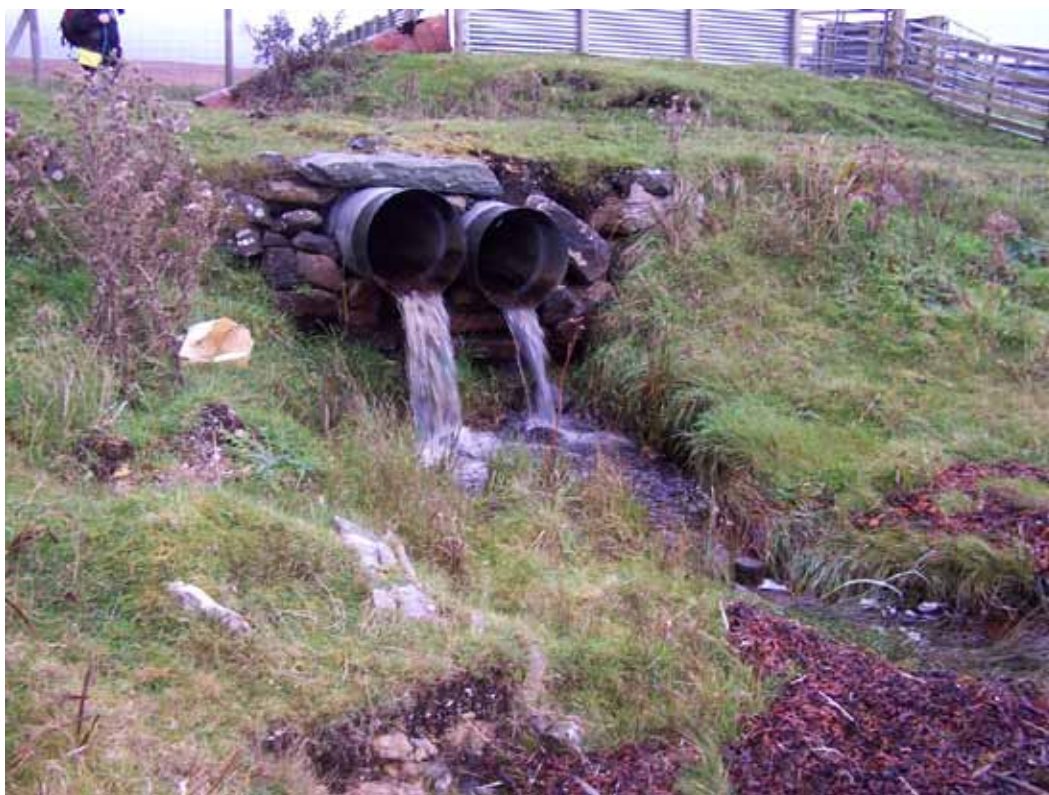
Figure 8 Same stream as above channelled into two metal pipes. Water sample ISW9.

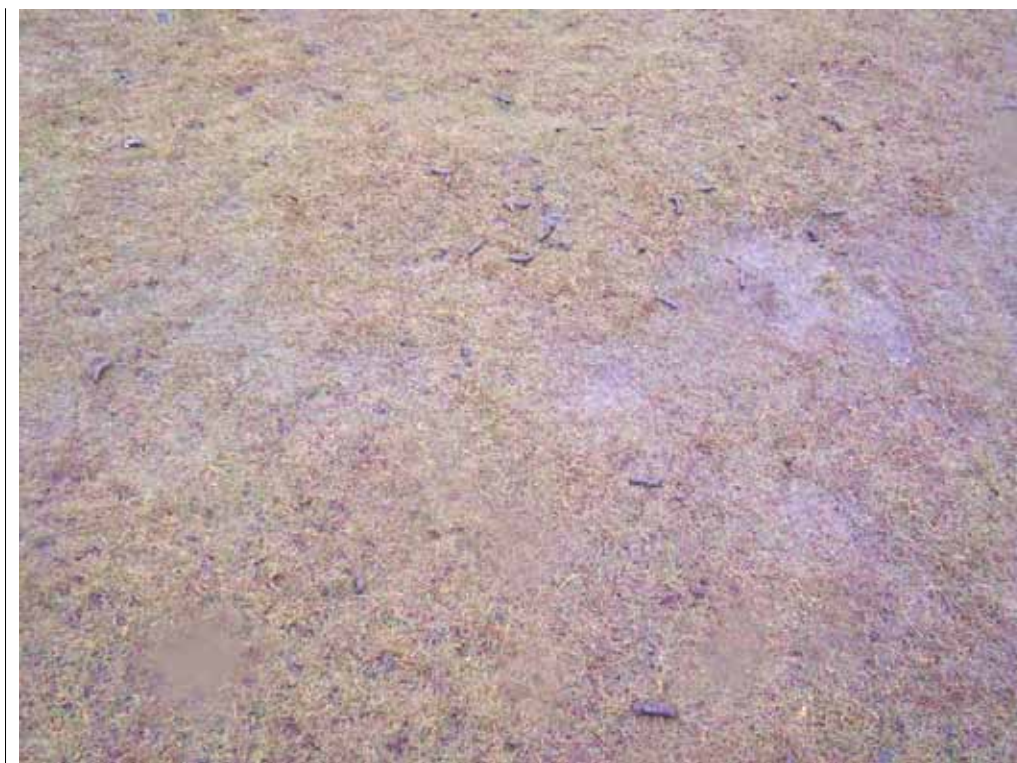
Figure 9 Goose droppings.

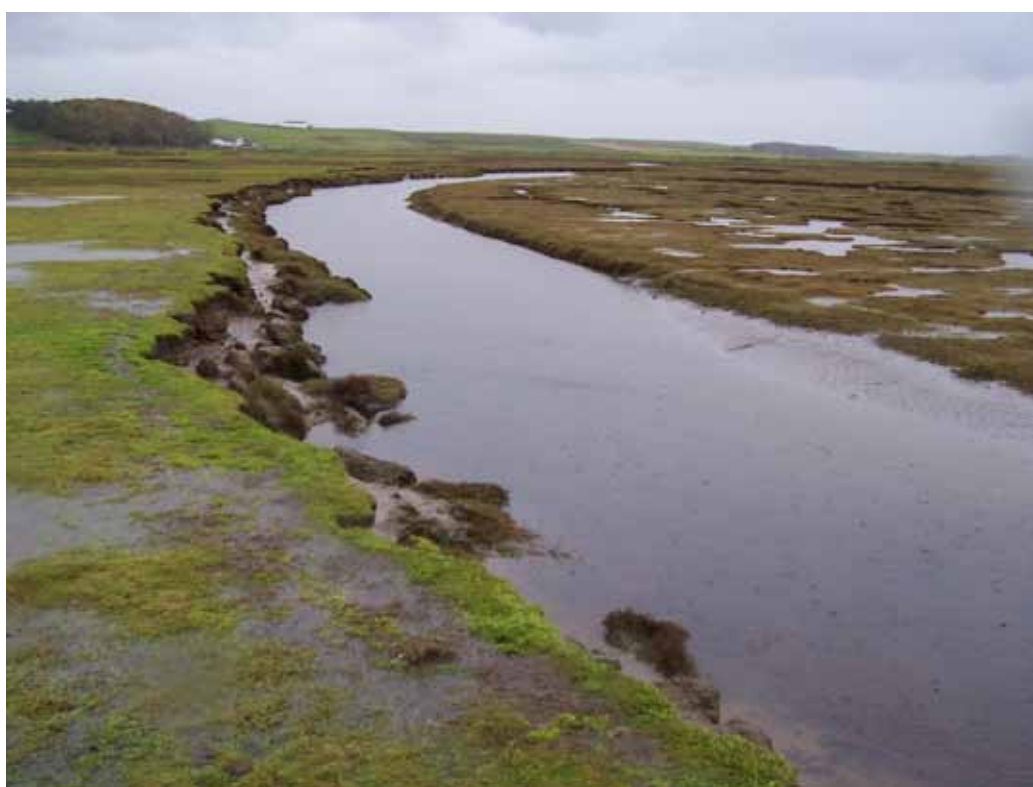
Figure 10 River and water-logged rough grassland. Water sample ISW10.

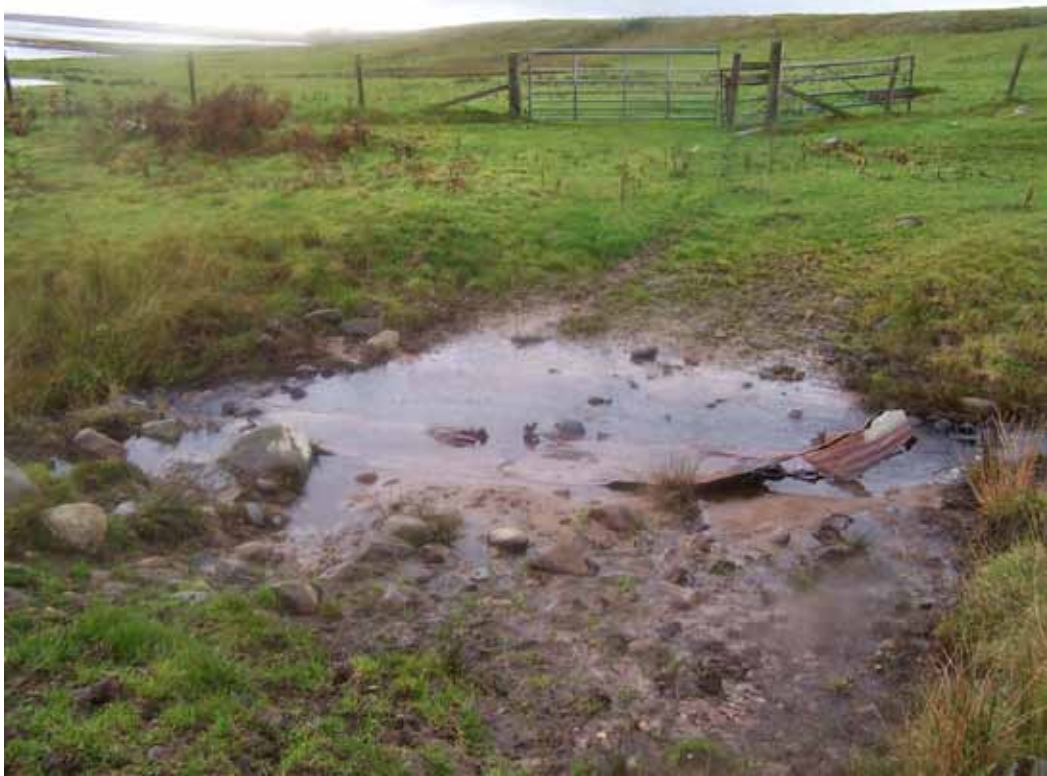
37	17/10/12	12:46:45	NR 28329 70308	128329	670308			Evidence of sheep drinking water from here, droppings present and poaching of ground. Approx. 20 sheep in field.
38	17/10/12	12:49:01	NR 28371 70281	128371	670281	Figure 11	ISW12	Stream flowing downhill through field heading out to loch. Width 53cm; depth 9.5 cm; flow 0.503 m/s; s.d. 0.012. Large piece of rusty corrugated iron in stream. Further downstream large plastic container. 16 cows in adjacent field.
39	17/10/12	13:03:58	NR 28308 70033	128308	670033			Fields around the shoreline are fenced but evidence of both cows and sheep being on the shore with the presence of droppings.
410	17/10/12	13:20:23	NR 28110 69386	128110	669386		ISW13	Small stream flows through rough grassland to loch. Water flow slow. Width 60cm; depth 19cm; flow 0.017m/s; s.d. 0.005.
41	17/10/12	13:38:50	NR 28095	128095	669289		ISW14	Small stream flows through rough grassland to loch. Width 70cm; depth 8.5 cm; flow 0.155m/s; s.d. 0.007. This stream is

Figure 11 Stream with rusty corrugated metal sheeting. Water sample ISW12.

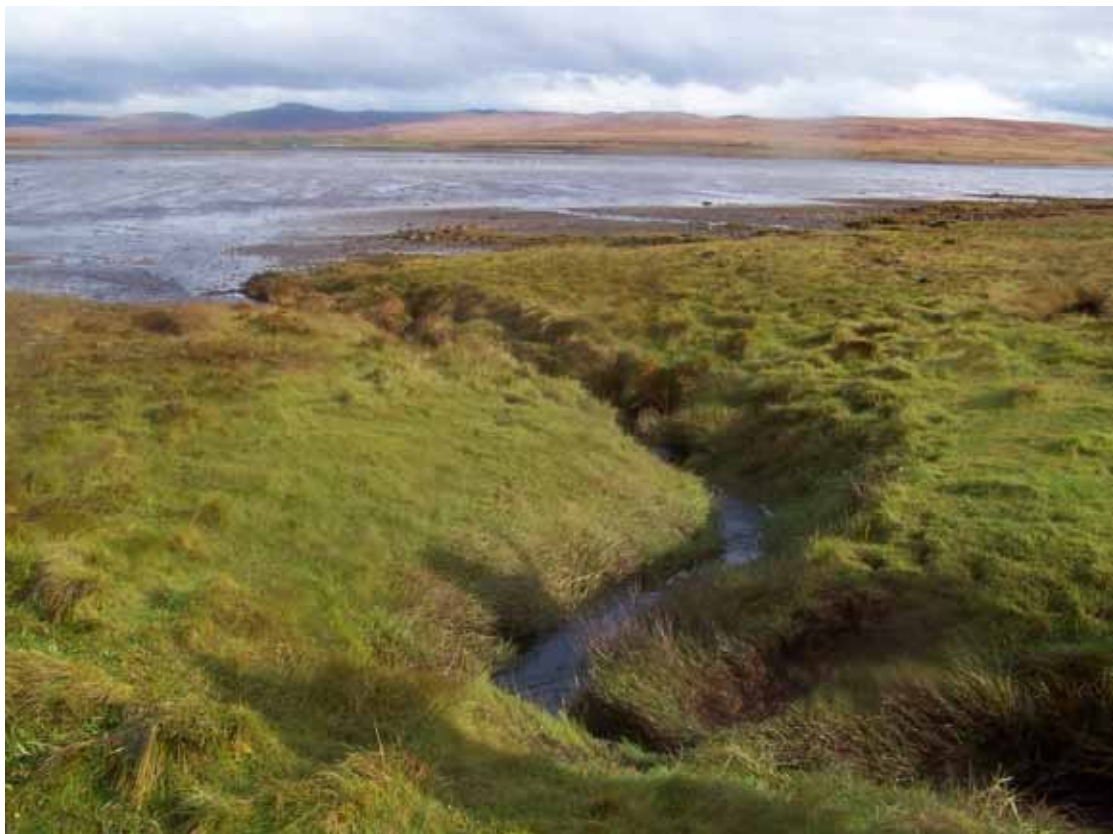
Figure 12 Small stream flowing through rough grassland to loch. Water sample ISW15. Geese can be seen in distance on mudflats.
