Scottish Sanitary Survey Project

Restricted Sanitary Survey Report Machrie Bay AB 510 November 2009

Shoreline Survey Report

Machrie Bay AB 510

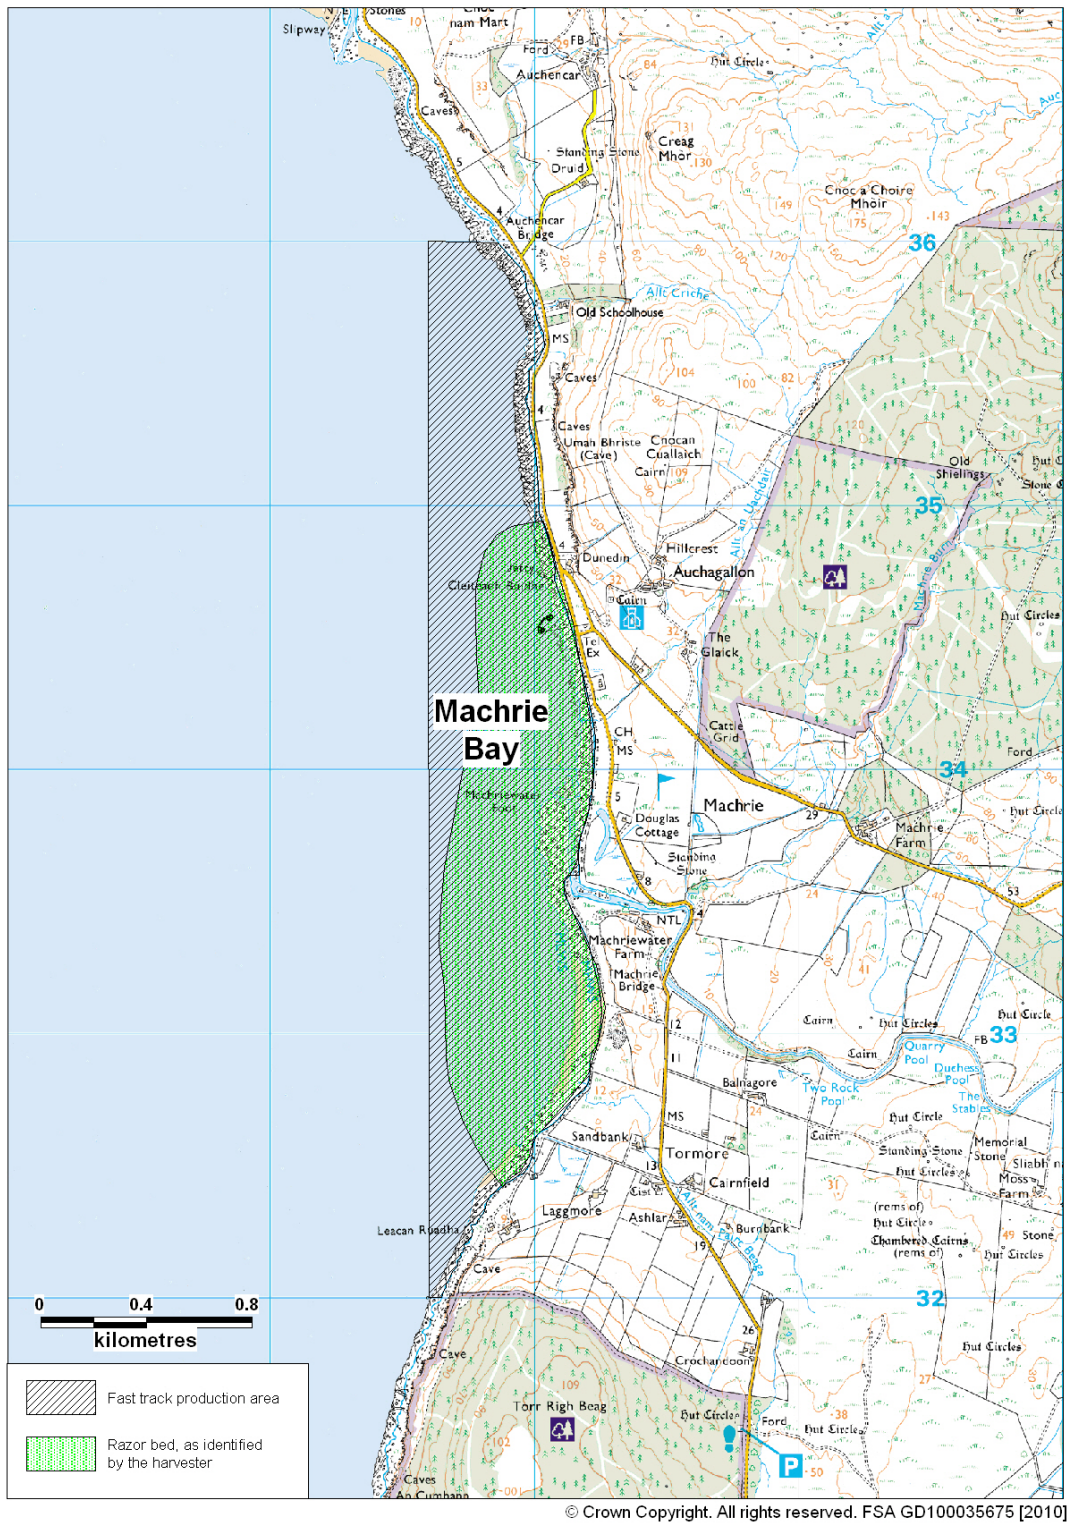
Figure 2.1 Machrie Bay fishery

From information given by the harvester in support of the classification applications, the razor clam bed lies within the fast track production area boundaries, over the area identified in Figure 2.1. Harvesting of razor clams is planned to take place throughout the year. The razor clams will be hand dived.

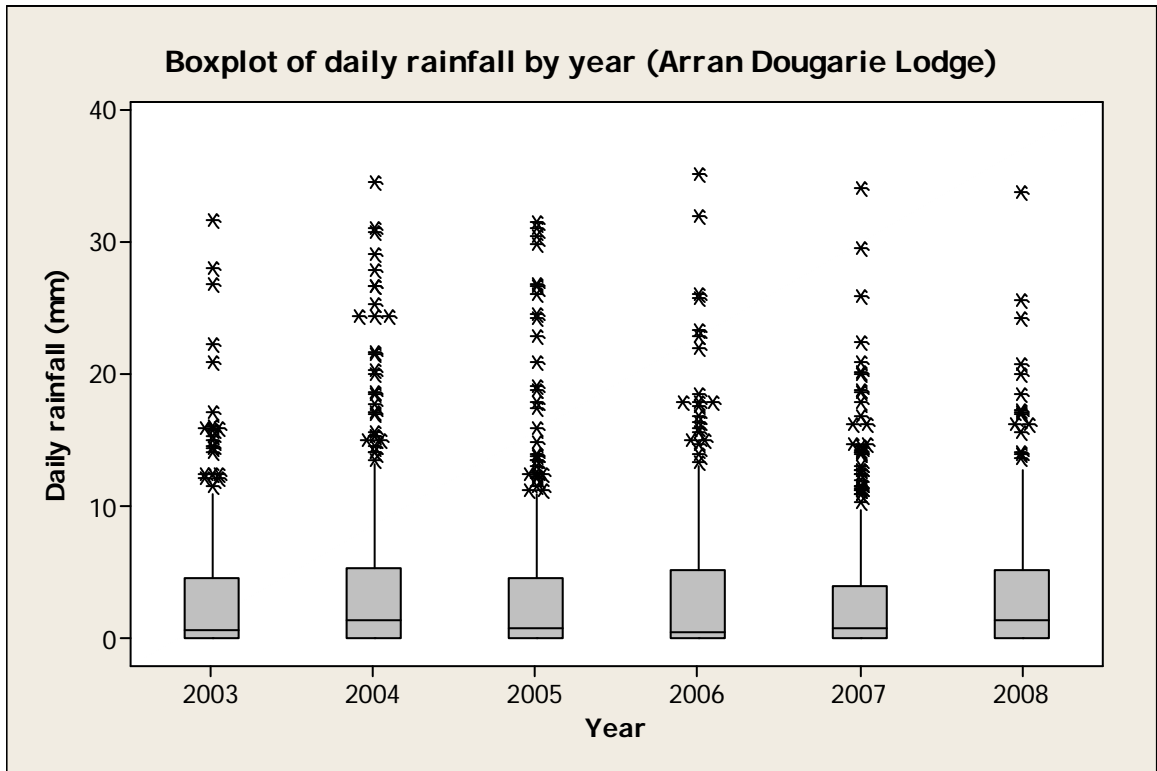
Figure 5.1 Boxplot of daily rainfall at Arran Dougarie Lodge by year

Due to the missing data it is not appropriate to present total rainfall at Arran Dougarie Lodge by year or month. Instead, Figures 5.1 and 5.2 summarise the pattern of rainfall recorded at Arran Dougarie Lodge. The box and whisker plots present the distribution of individual daily rainfall values (observations) by year (Figure 5.1) or by month (Figure 5.2). The grey box represents the middle 50% of the observations, with the median represented by the line. The whiskers extend to the largest or smallest observations up to 1.5 times the box height above or below the box. Individual observations falling outside the box and whiskers are represented by the symbol *.

The median daily rainfall in 2004 and 2008 was somewhat higher than in the other years. Other than this, the general pattern was similar over the years 2003 to 2008 inclusive.

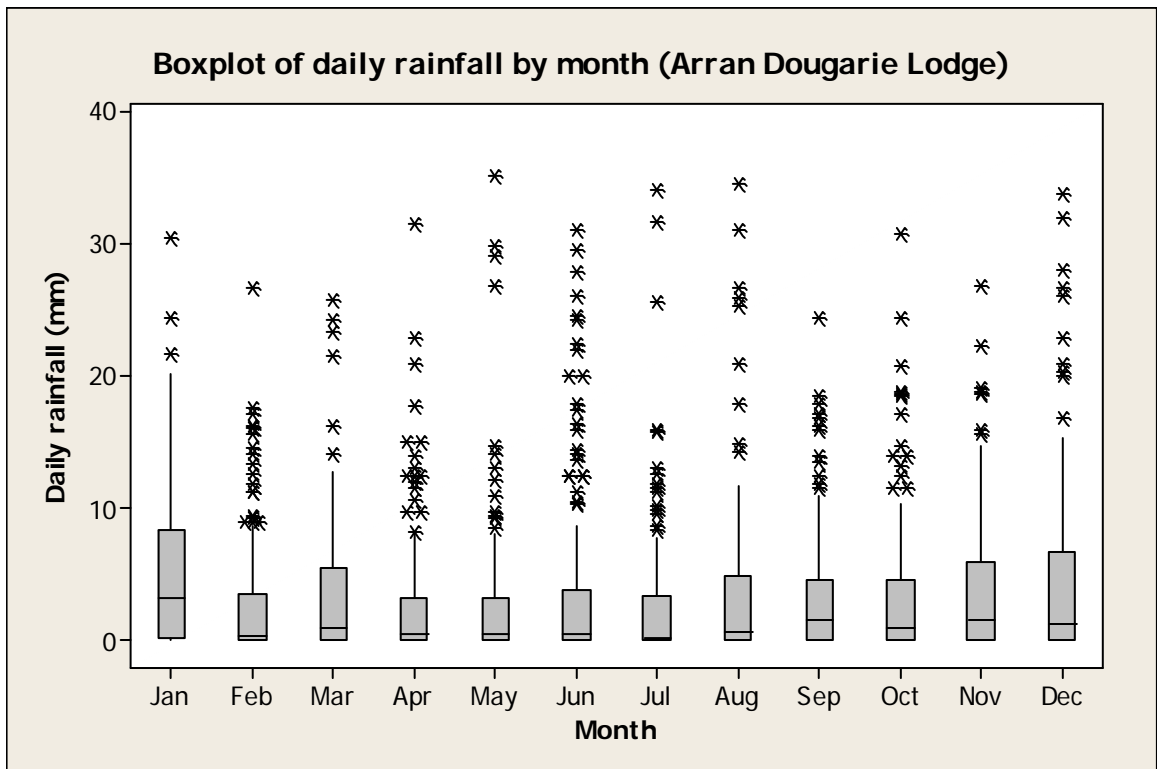
Figure 5.2 Boxplot of daily rainfall values at Arran Dougarie Lodge by month

The wettest months were December and January. For the period considered here (2003 – 2008), 35% of days for which records were available experienced no rainfall while 52% of days experienced rainfall of 1mm or less. Though median rainfall was less than 10 mm per day, the maximum recorded daily rainfall was greater than 30 mm and such events were seen in most months. The highest daily rainfall recorded here fell in May, one of the driest months.

Rainfall patterns at Arran Dougarie Lodge (the nearest rainfall station) show that seasonal variation in rainfall levels occurs and the wettest months were December and January. An increase in rainfall may be expected to wash a flush of bacteria from the surrounding land into the production area. The impact of rainfall events is likely to be most acute nearest where the streams enter the bay.

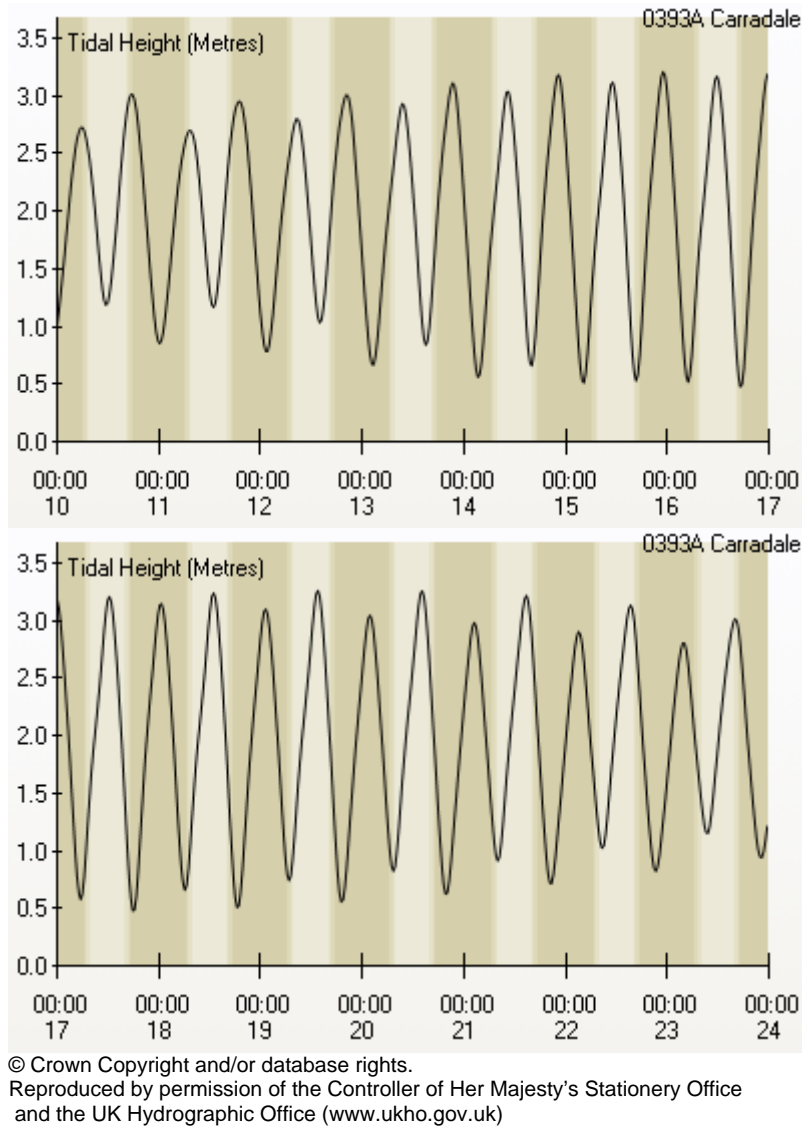
Figure 8.3 Tidal curves for Carradale

The two tidal curves below are for the port of Carradale, the nearest secondary port– they have been output from UKHO TotalTide. The first is for seven days beginning 00.00 GMT on 10th November 2009. The second is for seven days beginning 00.00 GMT on 24th November 2009. Together they show the predicted tidal heights over high/low water for a full neap/spring tidal cycle.

The tide type is Semi-Diurnal.

MHWS	3.1 m
MHWN	2.6 m
MLWN	1.1 m
MLWS	0.4 m

Predicted heights are in metres above chart datum. The tidal range at spring tide is therefore approximately 2.7 m and at neap tide 1.5 m.

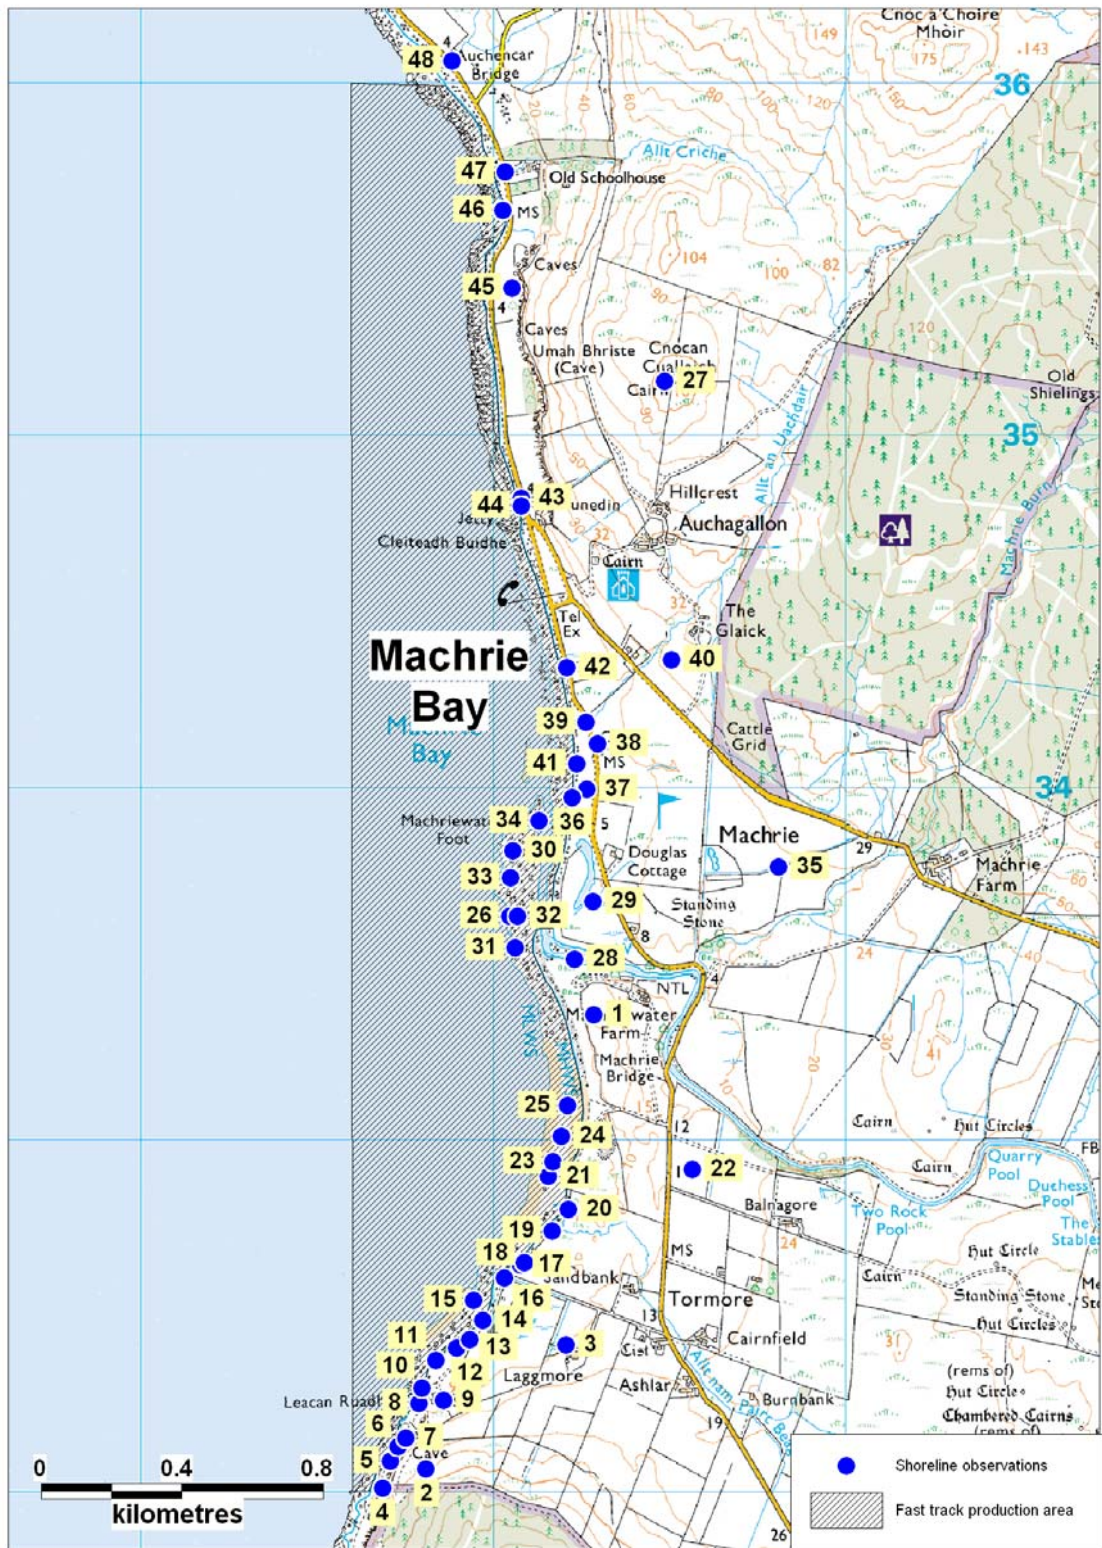
Figure 1. Shoreline Observations

The area surveyed has several scattered dwellings around the bay. There is a golf course with a club house near Douglas Cottage, north of Machrie Water. The golf club house had septic tanks and several inspection covers and outfall pipes. Additional septic tanks and three possible outfall pipes were observed near houses near Laggmore.

There are cattle and sheep scattered along most of the coastline of Machrie Bay, although the majority of livestock tends to be concentrated in three main areas. There were large flocks of sheep (approx 140 in total) north and south of Auchagallon. Close to Machrie Water approx 72 sheep and 12 cattle were observed. Further south near Laggmore approx 90 sheep in total were also observed.

During the shoreline survey approximately 70 sea birds were observed on the rocks at low tide close to the mouth of the Machrie Water.

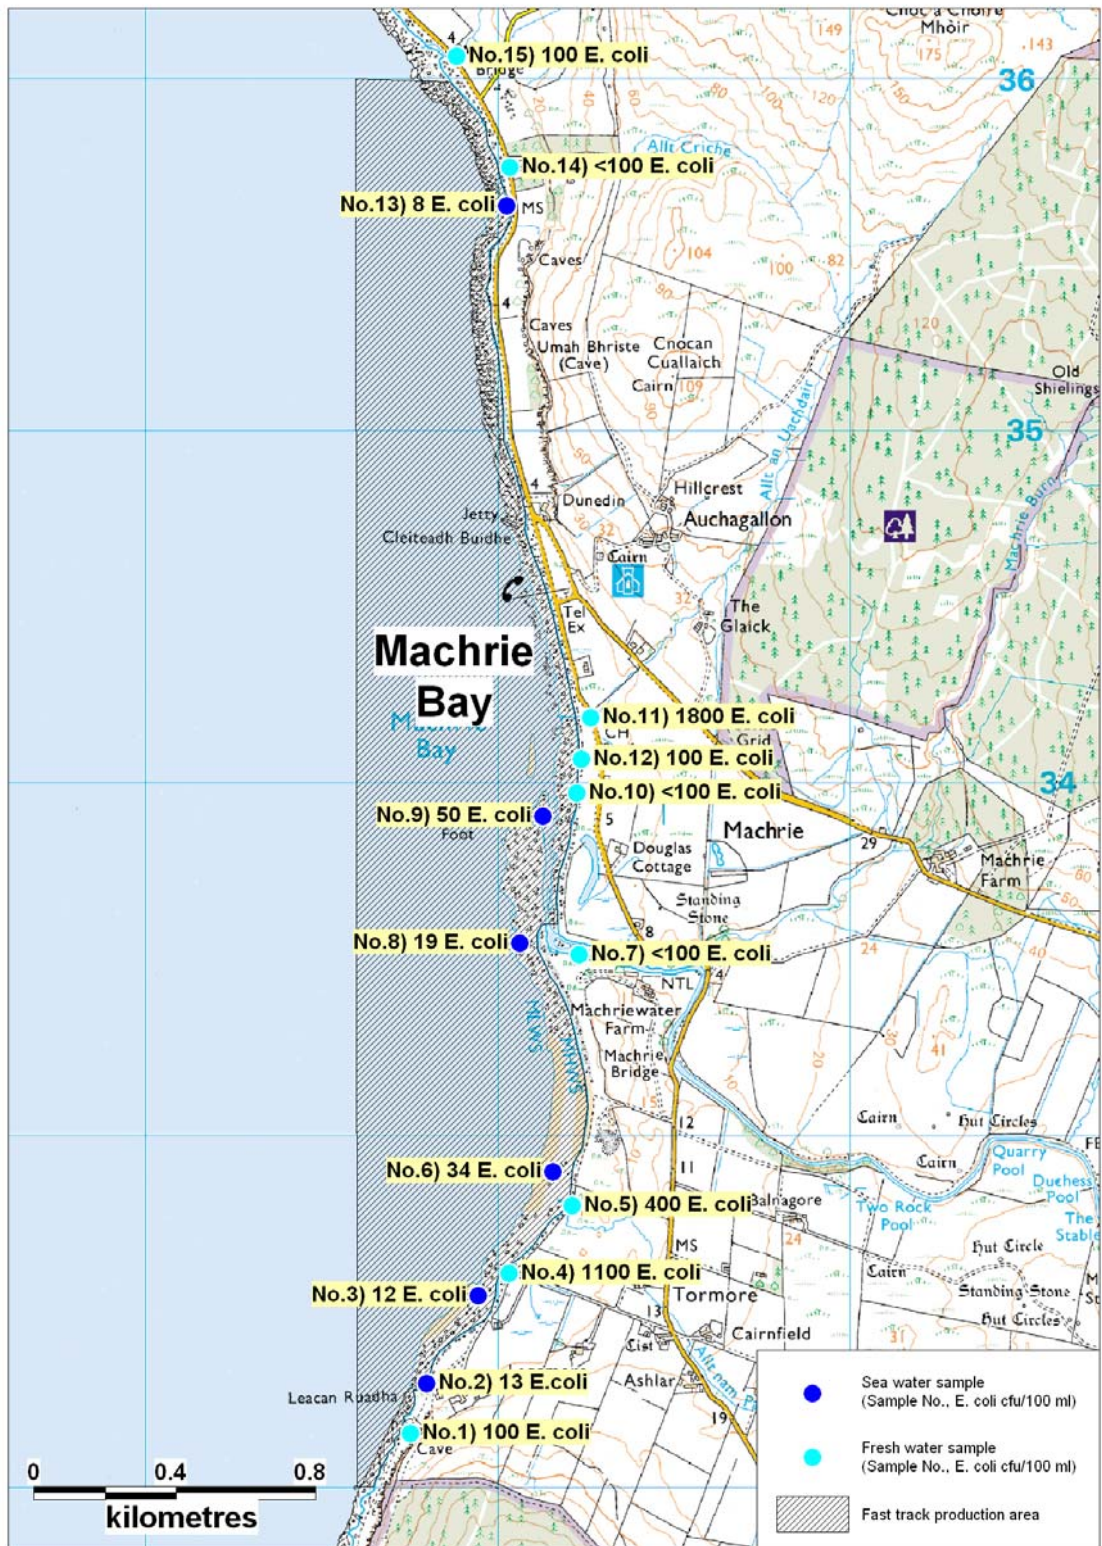
Figure 2. Water sample results

Samples were also tested for salinity by the laboratory using a salinity meter under more controlled conditions. These results are shown in Table 2, given in units of grams salt per litre of water. This is the same as ppt.

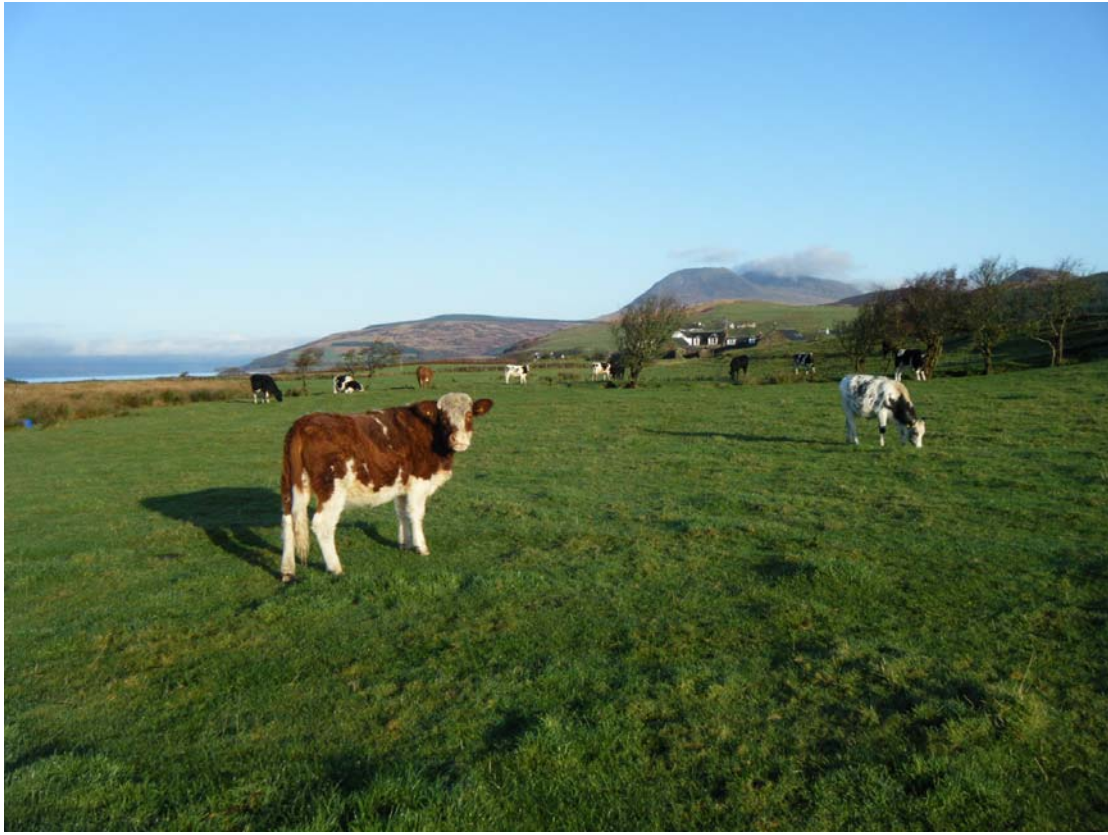
Figure 4. Cattle in field just south of Machrie Water

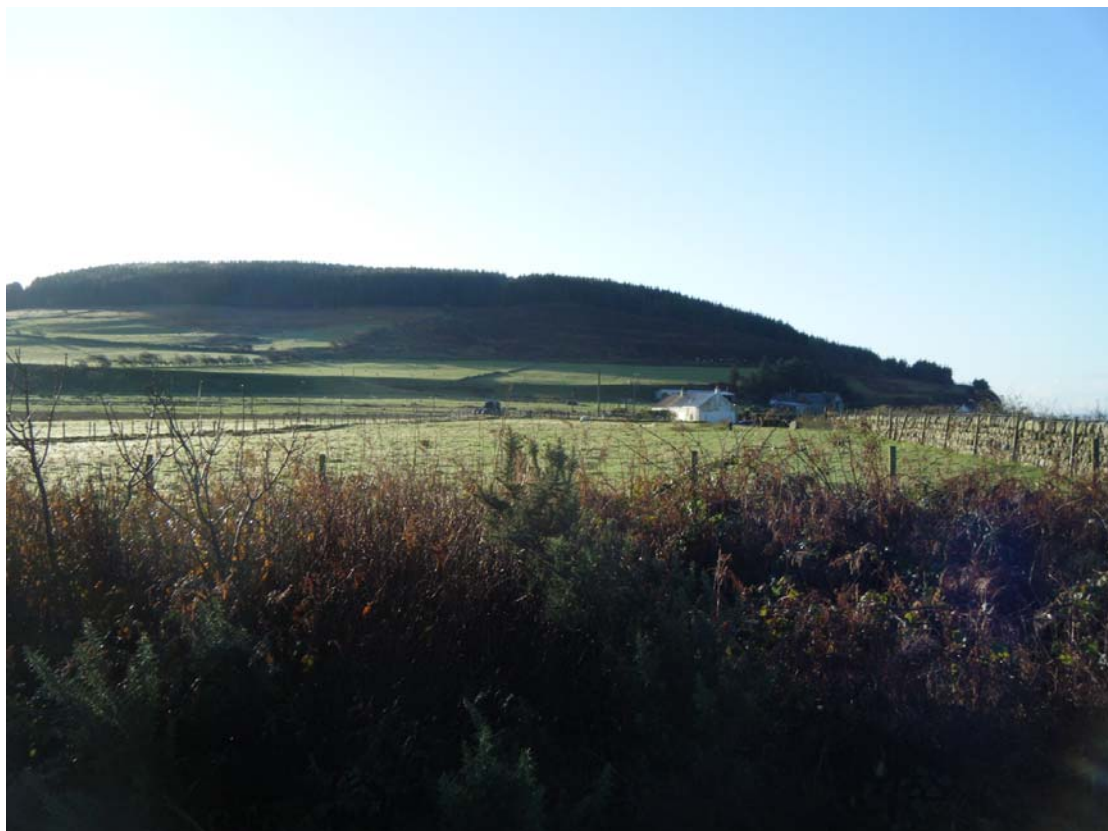
Figure 5. Sheep in fields around Laggmore

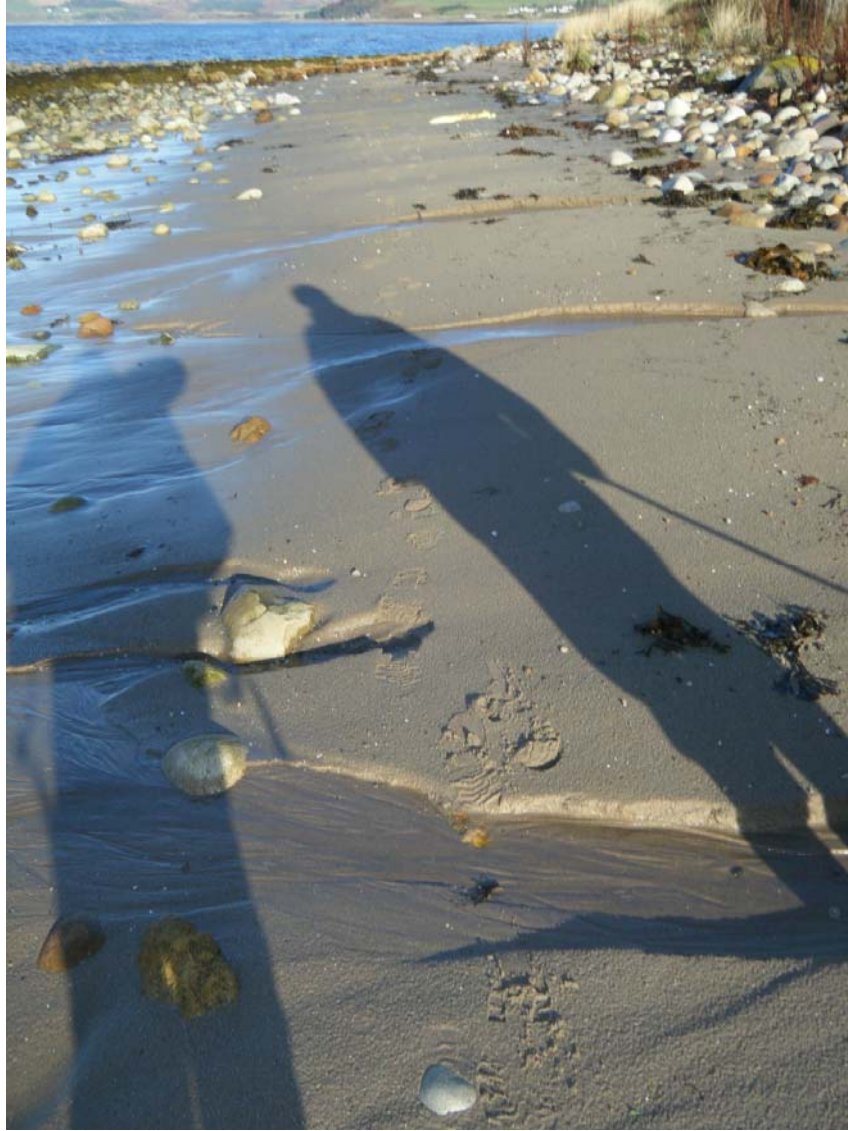
Figure 9. Flows through rocks on beach

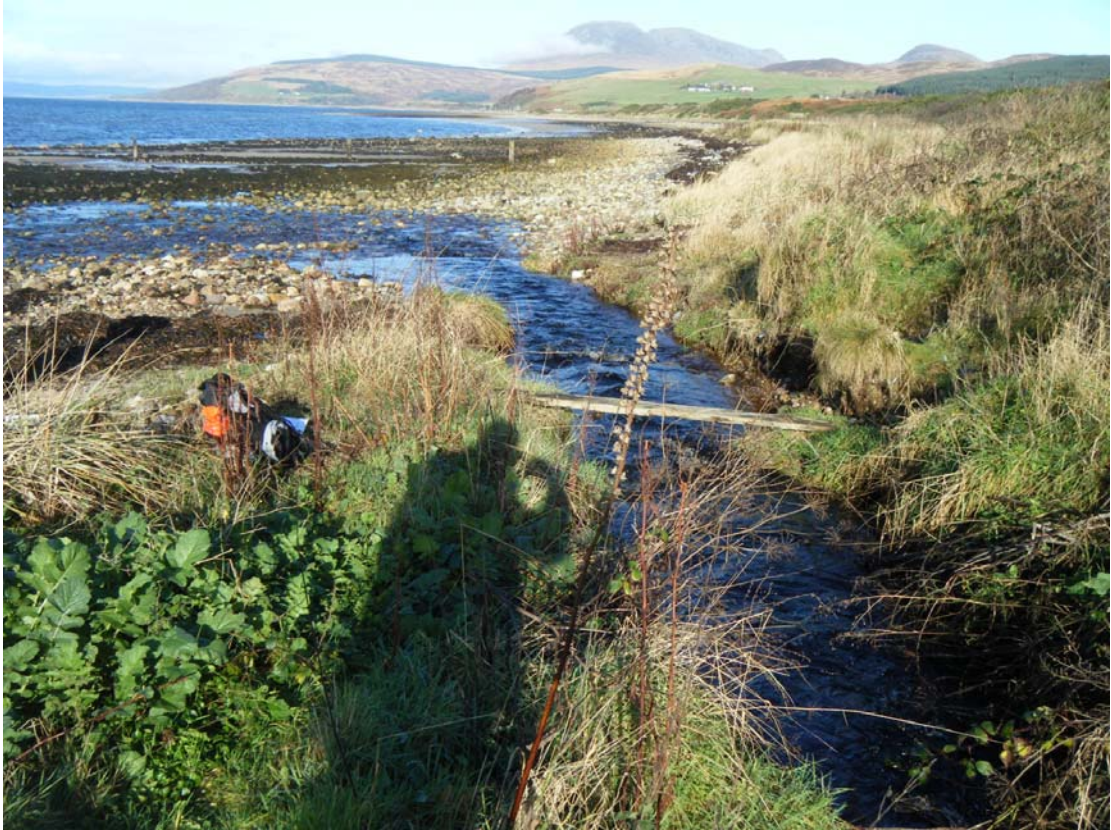
Figure 10. Allt nam Pairc Beaga water sample 5

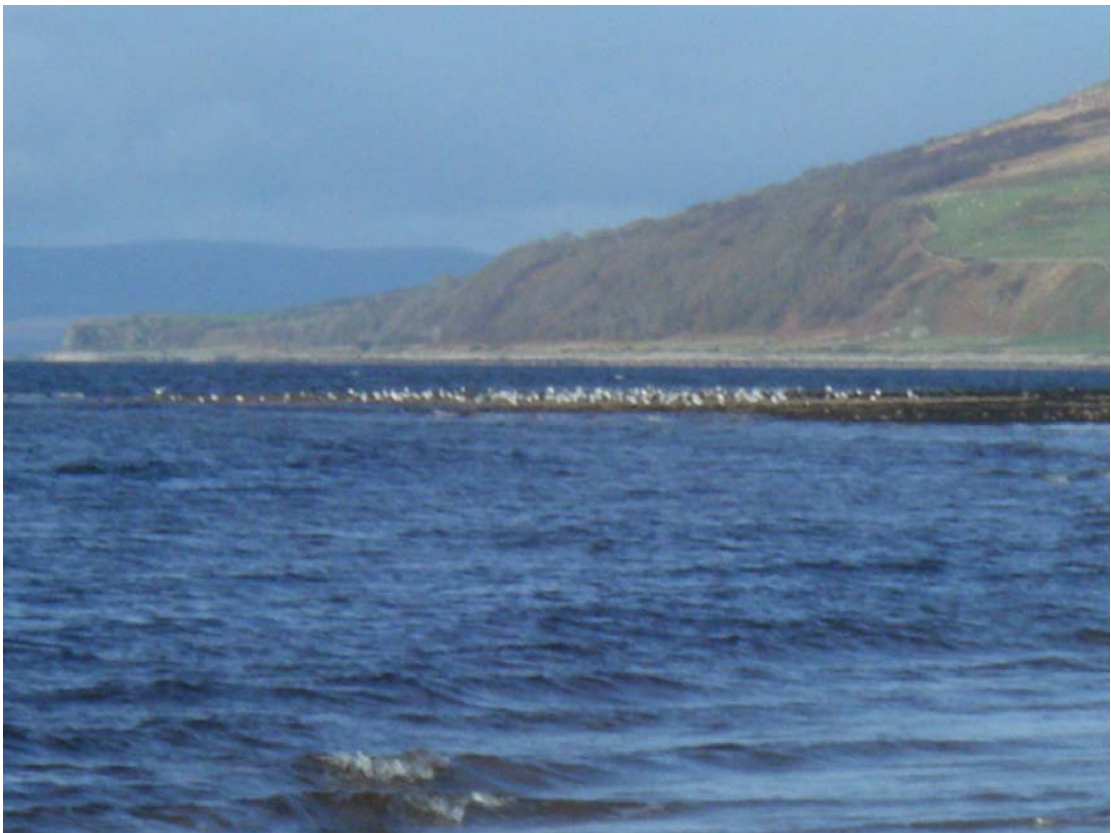
Figure 11. Seabirds on rocks north side of Machrie Water

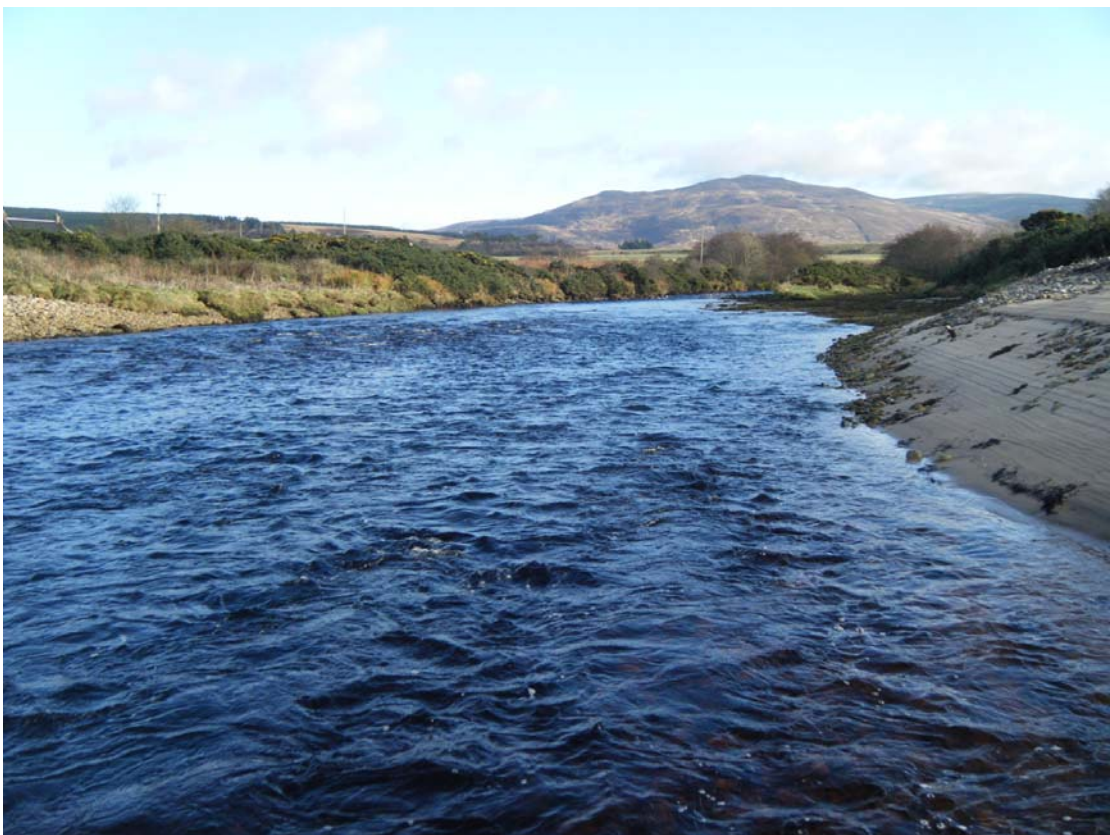
Figure 13. Machrie River

No.	Date	Time	NGR	East	North	Associated photograph	Description
21	10/11/2009	12:07	NR 89158 32898	189158	632898		Water sample 6 (seawater) Salinity 26 ppt.
22	10/11/2009	12:07	NR 89566 32916	189566	632916		5 cattle in field behind sampling site for water sample 6 (seawater)
23	10/11/2009	12:10	NR 89172 32939	189172	632939		Salinity just north of water sample 6 (seawater) site is still low - 26ppt.
24	10/11/2009	12:11	NR 89195 33010	189195	633010		Sandbar at low tide holding the fresh water in near the shore
25	10/11/2009	12:21	NR 89213 33098	189213	633098		Scenic photographs looking north.
26	10/11/2009	12:21	NR 89048 33637	189048	633637	Figure 11	Approx. 70 sea birds on rocks on the north side of Machrie water at low tide
27	10/11/2009	12:28	NR 89489 35155	189489	635155	Figure 12	House and approx. 100 sheep on hills on the Northern part of site at Hill Cnocan Cullaich
28	10/11/2009	12:41	NR 89232 33513	189232	633513	Figure 13	Machrie water, too deep and too wide to measure and take a flow reading. Water sample 7 (fresh water).

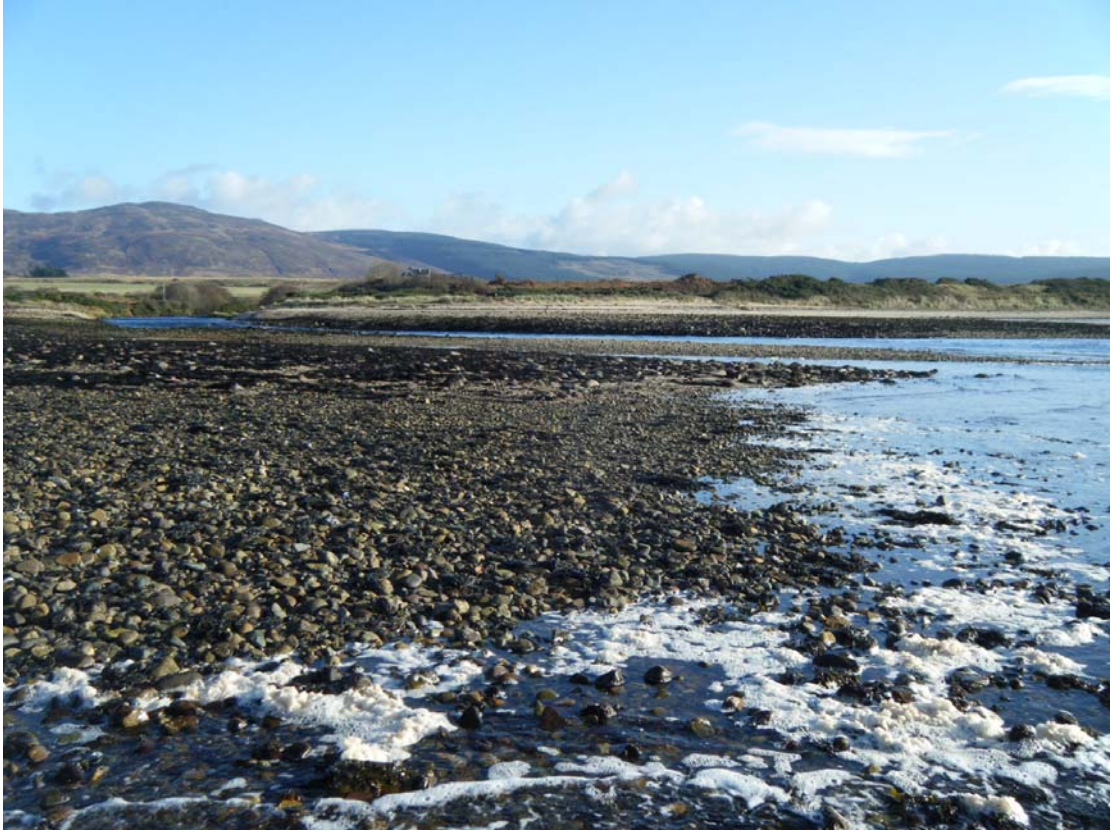
Figure 14. Seawater sample 8 taken at mouth of Machrie Water

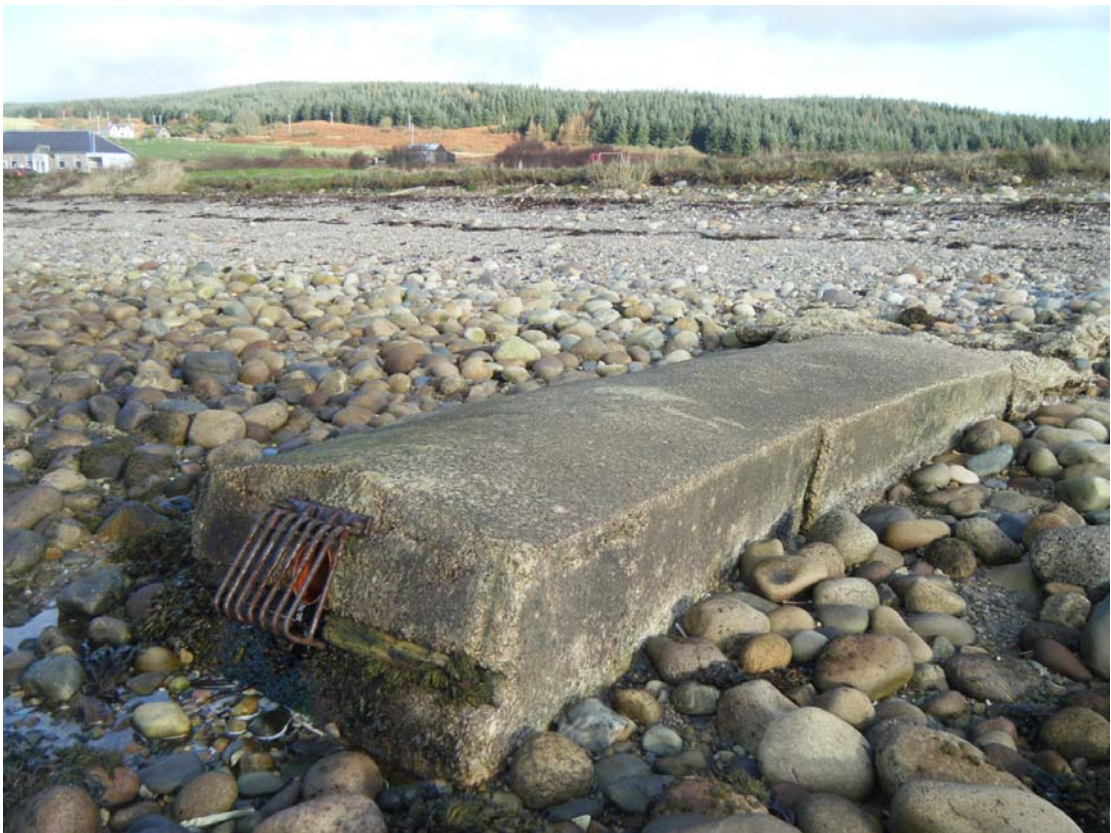
Figure 15. Concrete drainage pipe leading onto beach, possibly from golf course

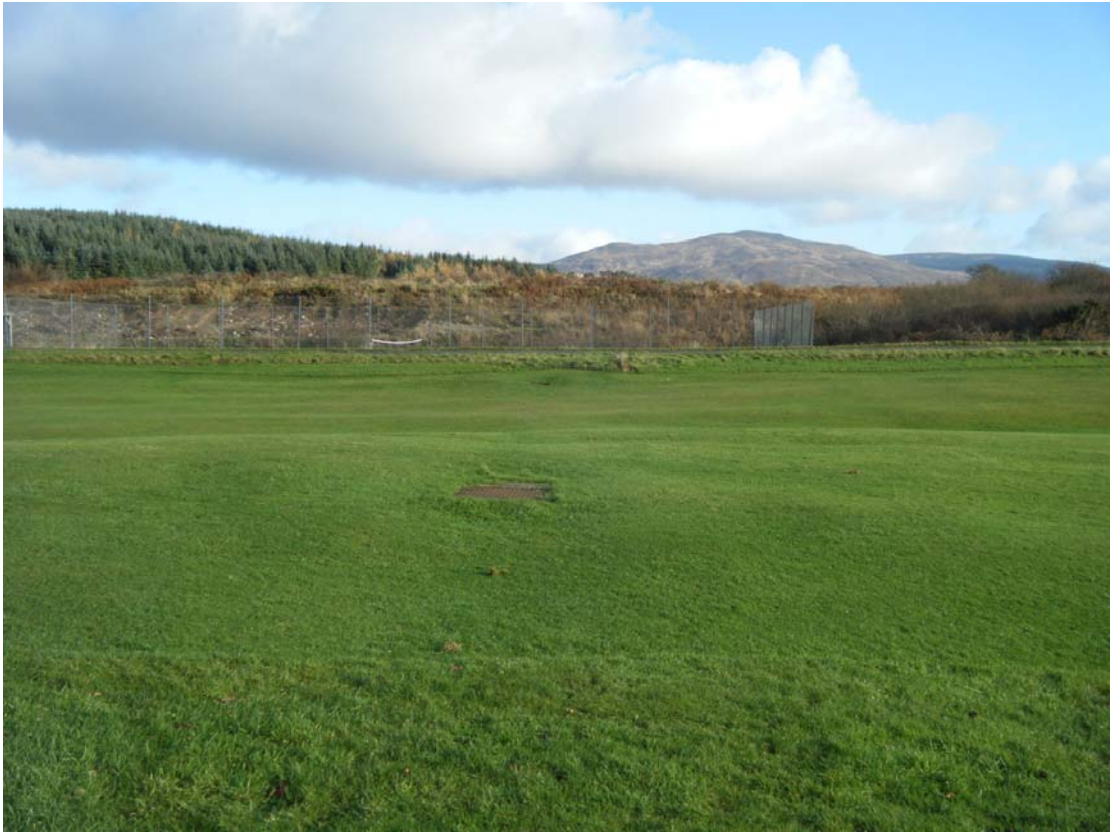
Figure 16. Two inspection covers on golf course

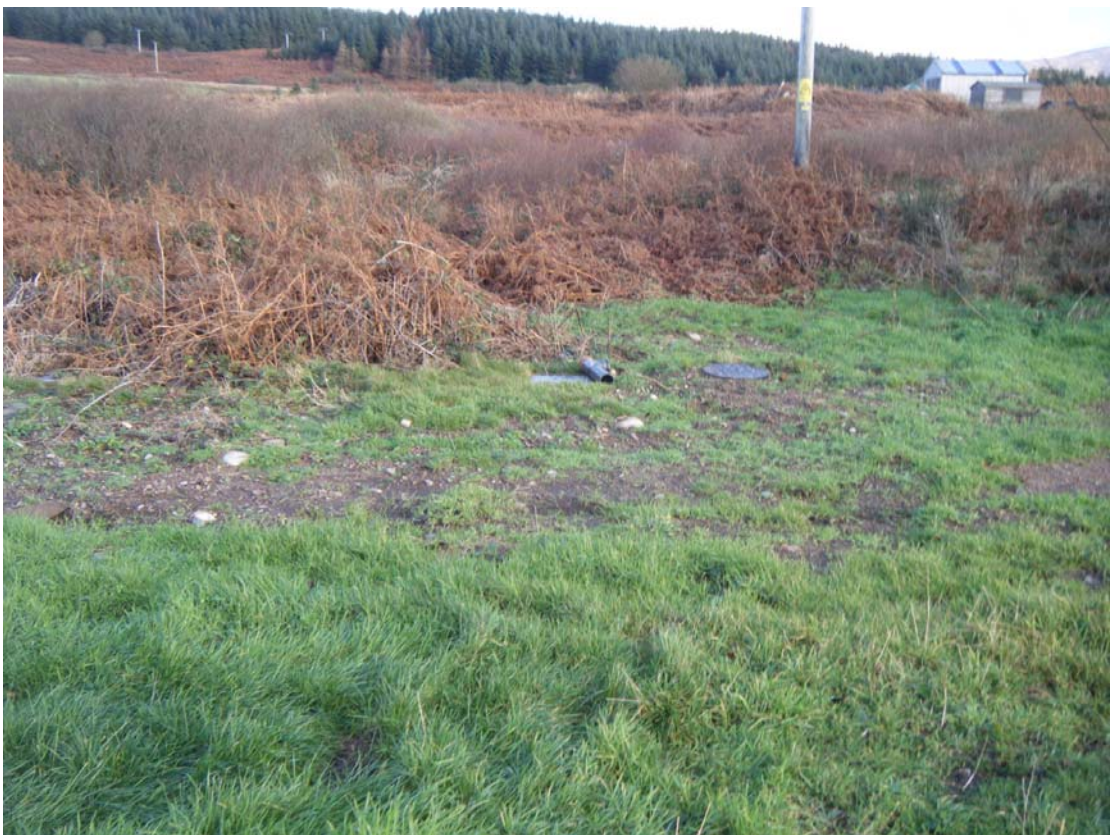
Figure 17. Septic tank for golf course clubhouse

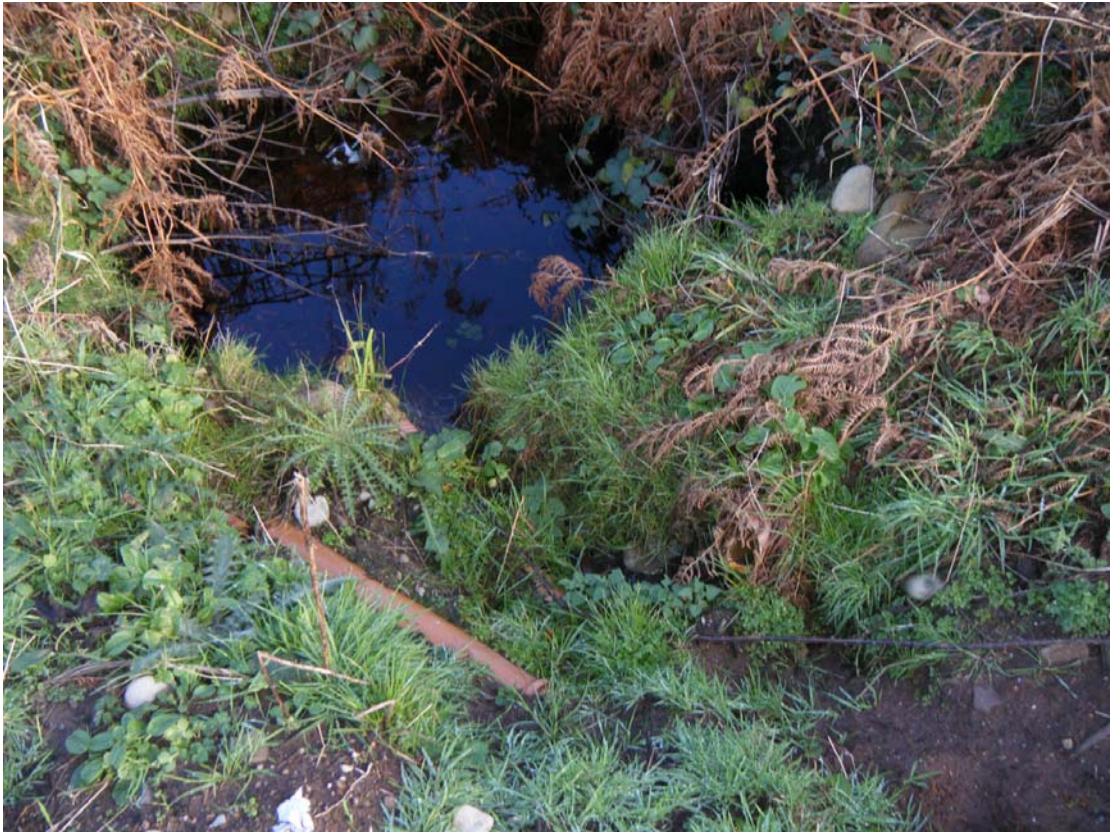
Figure 18. Septic tank outfall for clubhouse leading into small stream

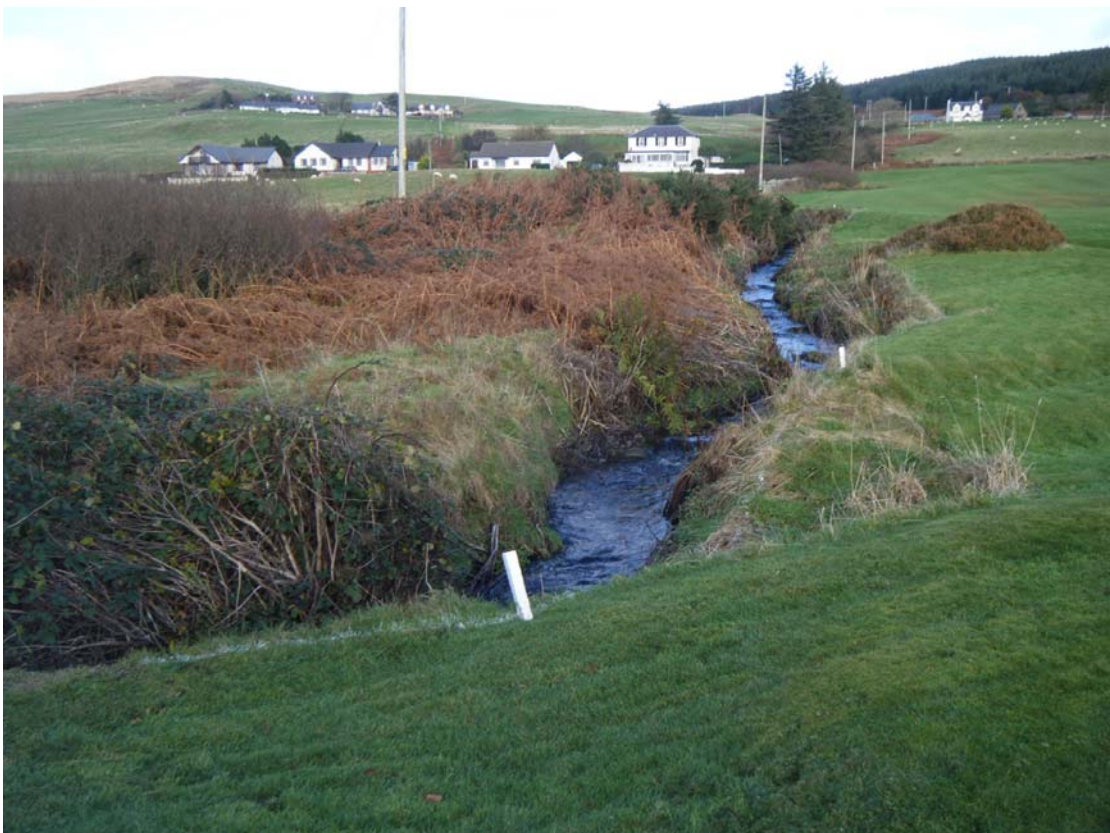
No.	Date	Time	NGR	East	North	Associated photograph	Description
39	10/11/2009	13:57	NR 89265 34188	189265	634188	Figure 19	Allt an Uachdair water, water sample 11 (fresh water) W 0.55, D 0.10, F 2.066. Estimated 11 houses in catchment area of Allt an Uachdair burn in background up hill.
40	10/11/2009	13:57	NR 89508 34364	189508	634364		Approx. 40 sheep in field behind the houses
41	10/11/2009	14:06	NR 89239 34070	189239	634070	Figures 20 & 21	Probably a drainage pipe for the golf course, but slight possibility that it is the septic tank discharge for the clubhouse, water sample 12 (fresh water) taken. Picture of shoreline looking north Ullt an Uachdair in foreground.
42	10/11/2009	14:14	NR 89210 34343	189210	634343		Pond on other side of road to beach, no flow to beach
43	10/11/2009	14:24	NR 89082 34824	189082	634824	Figure 22	32 cm diameter pipe under road from a small stream, W 0.13, D 0.01, F 1.586

Figure 19. Allt an Uachdair water sample 11

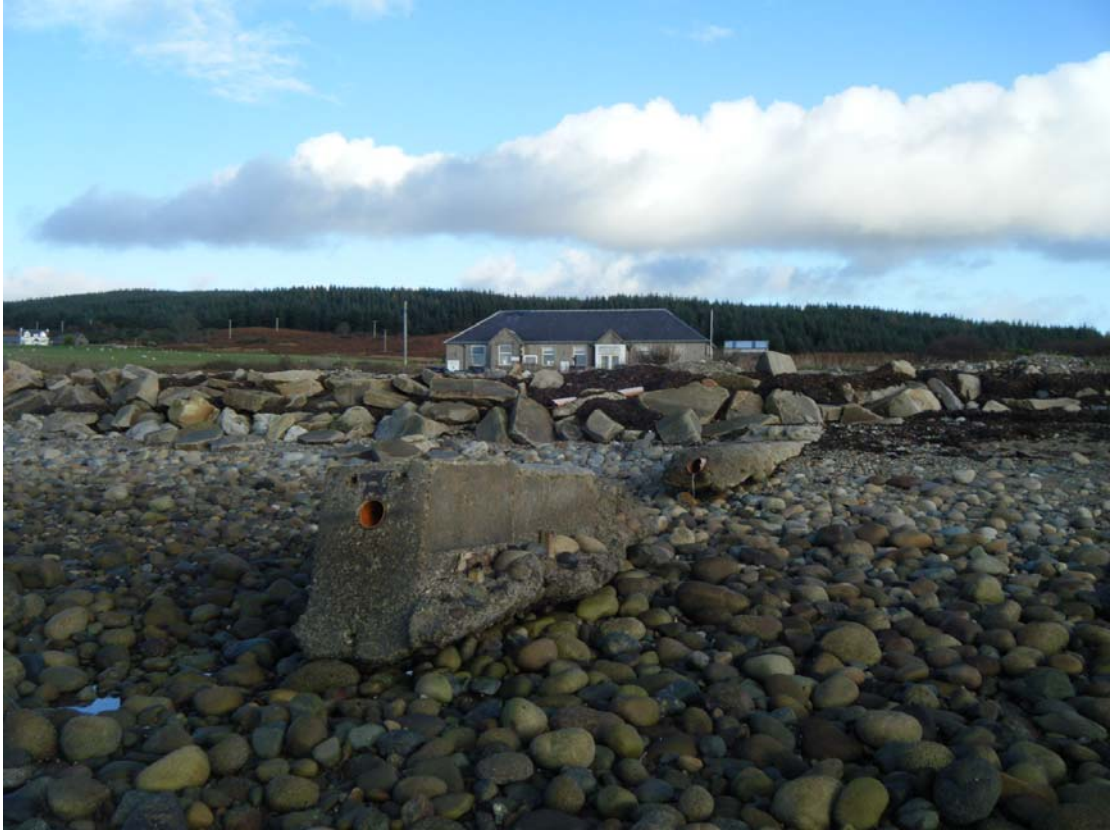
Figure 20. Concrete pipe, might be drainage for golf course

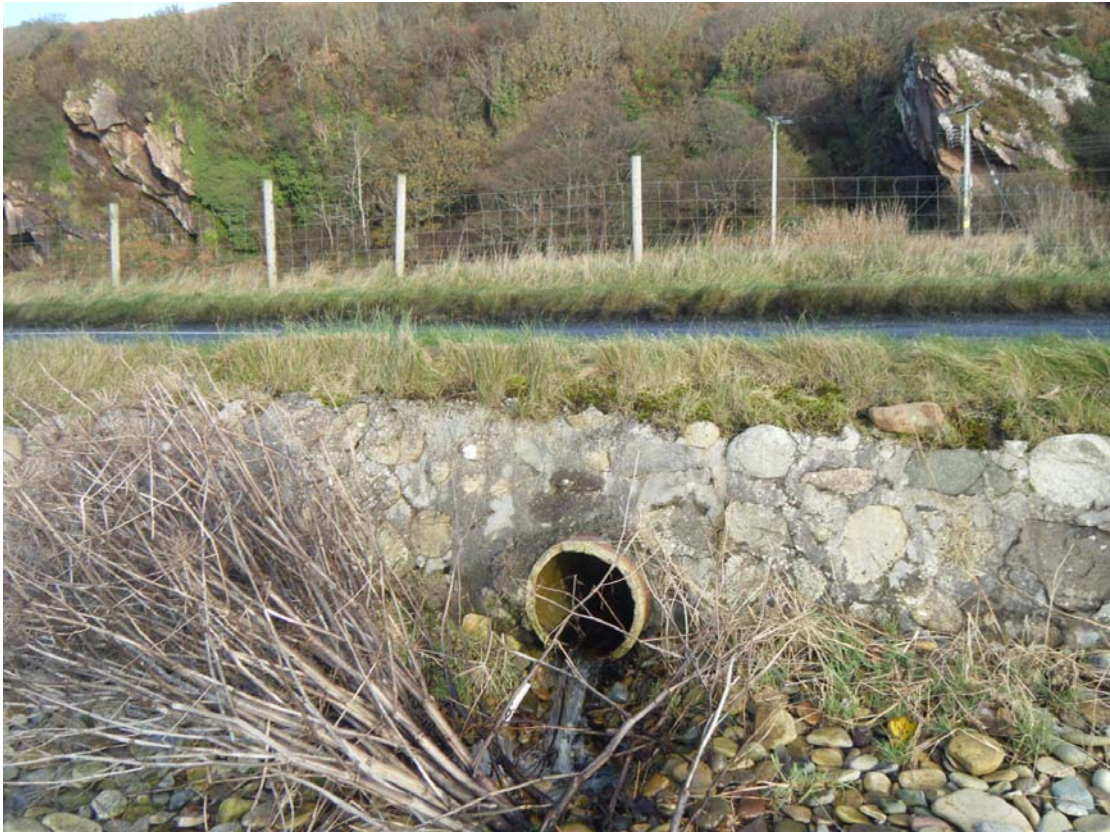
Figure 22. 32cm diameter pipe
