Scottish Sanitary Survey Project

Restricted Sanitary Survey Report Machrie Bay AB 510 November 2009

Shoreline Survey Report

Machrie Bay AB 510

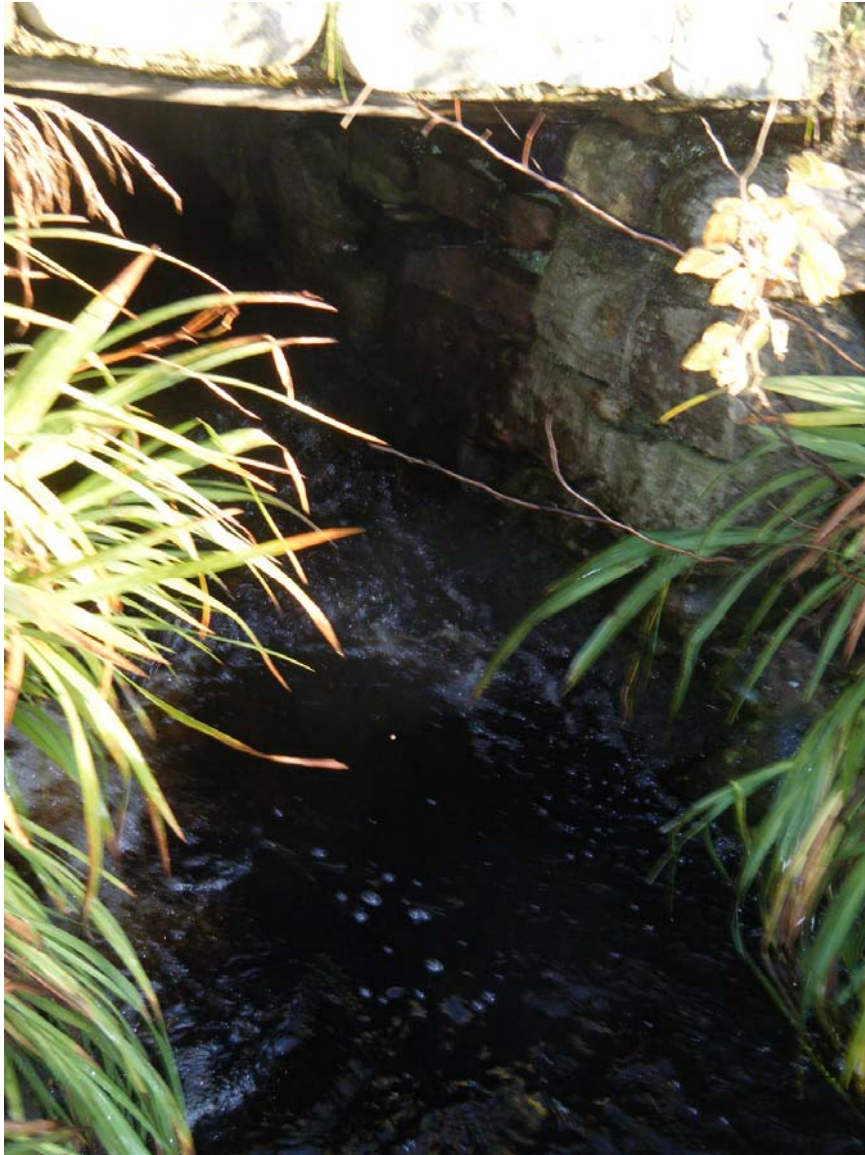
Figure 23. Culverted stream at school house water sample 14

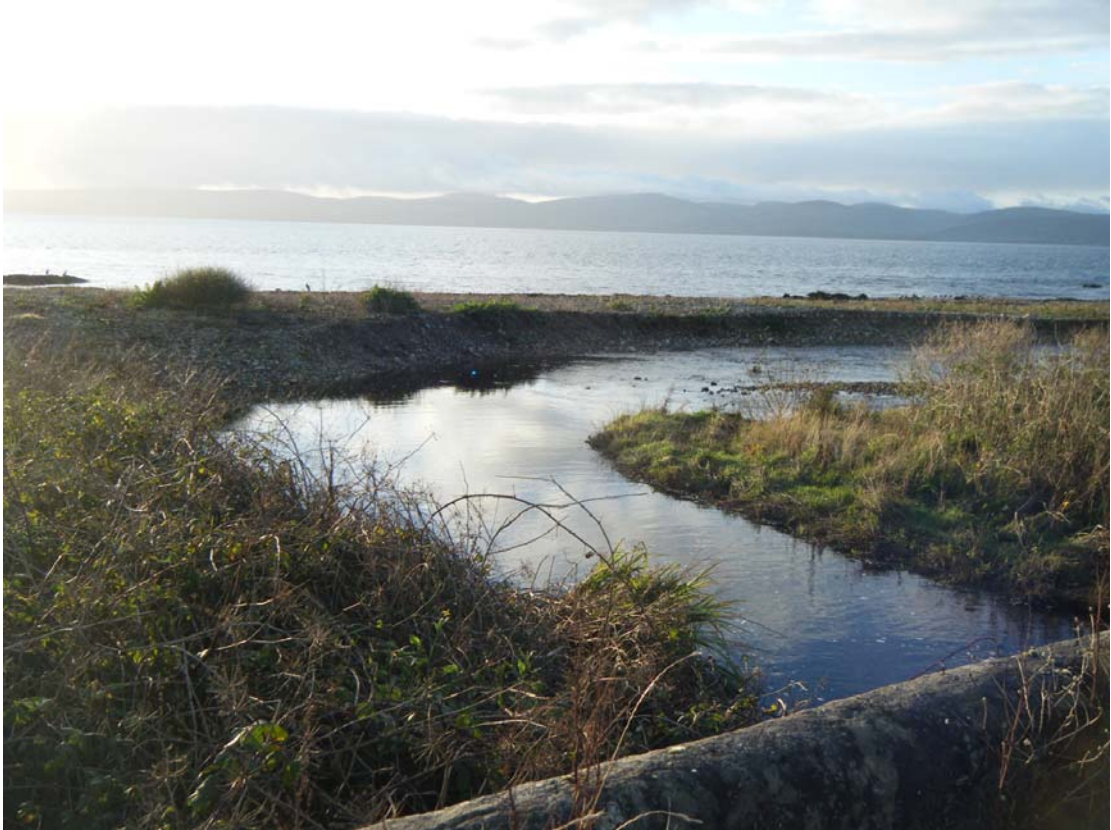
Figure 24. Auchencar Bridge

44	10/11/2009	14:30	NR 89082 34802	189082	634802		20cm diameter under road to beach at Dunedin House, W 0.2, D 0.1, F 0.11
45	10/11/2009	14:30	NR 89056 35421	189056	635421		Approx. 40 sheep in field other side of road
46	10/11/2009	14:49	NR 89028 35641	189028	635641		Water sample 13 (seawater)
47	10/11/2009	14:59	NR 89036 35750	189036	635750	Figure 23	Culverted stream at Old Schoolhouse, water sample 14 (fresh water) W 0.01, D 0.03, F 1.271
48	10/11/2009	15:11	NR 88885 36065	188885	636065	Figure 24	Auchencar Bridge, approx. 15 sheep in field next to bridge. Water sample 15 (fresh water) W 2.5, D 0.22, F 0.504
