Scottish Sanitary Survey Project

Sanitary Survey Report
Isle of Gigha
AB 541
January 2011

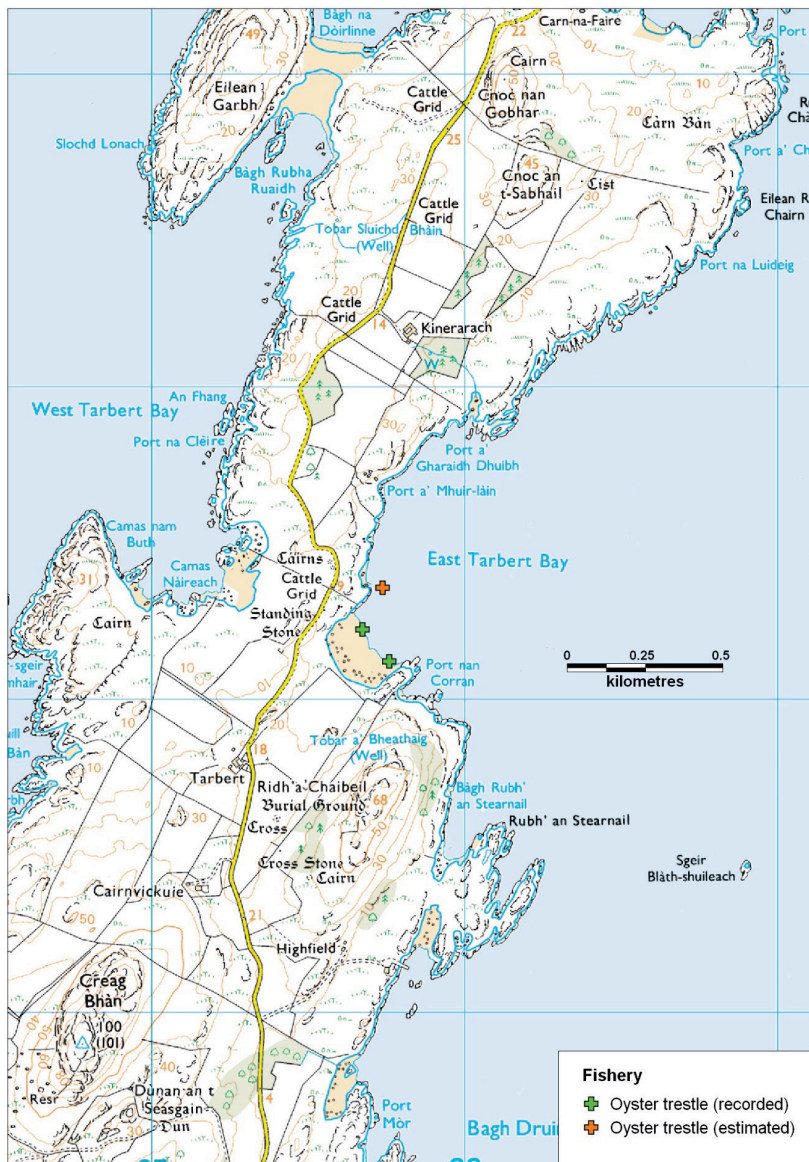
Figure 2.1 Isle of Gigha fishery

The site does not fall within a presently classified production area and does not have an associated Crown Estate (CE) lease. The locations of the oyster trestles are shown in Figure 2.1. In addition to the trestles in place at the time of the shoreline survey, the harvester put down a further 2 areas of trestles during the winter of 2010/11. These are situated on either side of the existing trestles on the east side of the bay, one set to the east and one set to the west. The NGR of the newly added trestles to the west is NR 65744 52103. The tide has not yet been suitable to measure the NGR of the other set of trestles. These can be measured fully during better spring/summer tides.

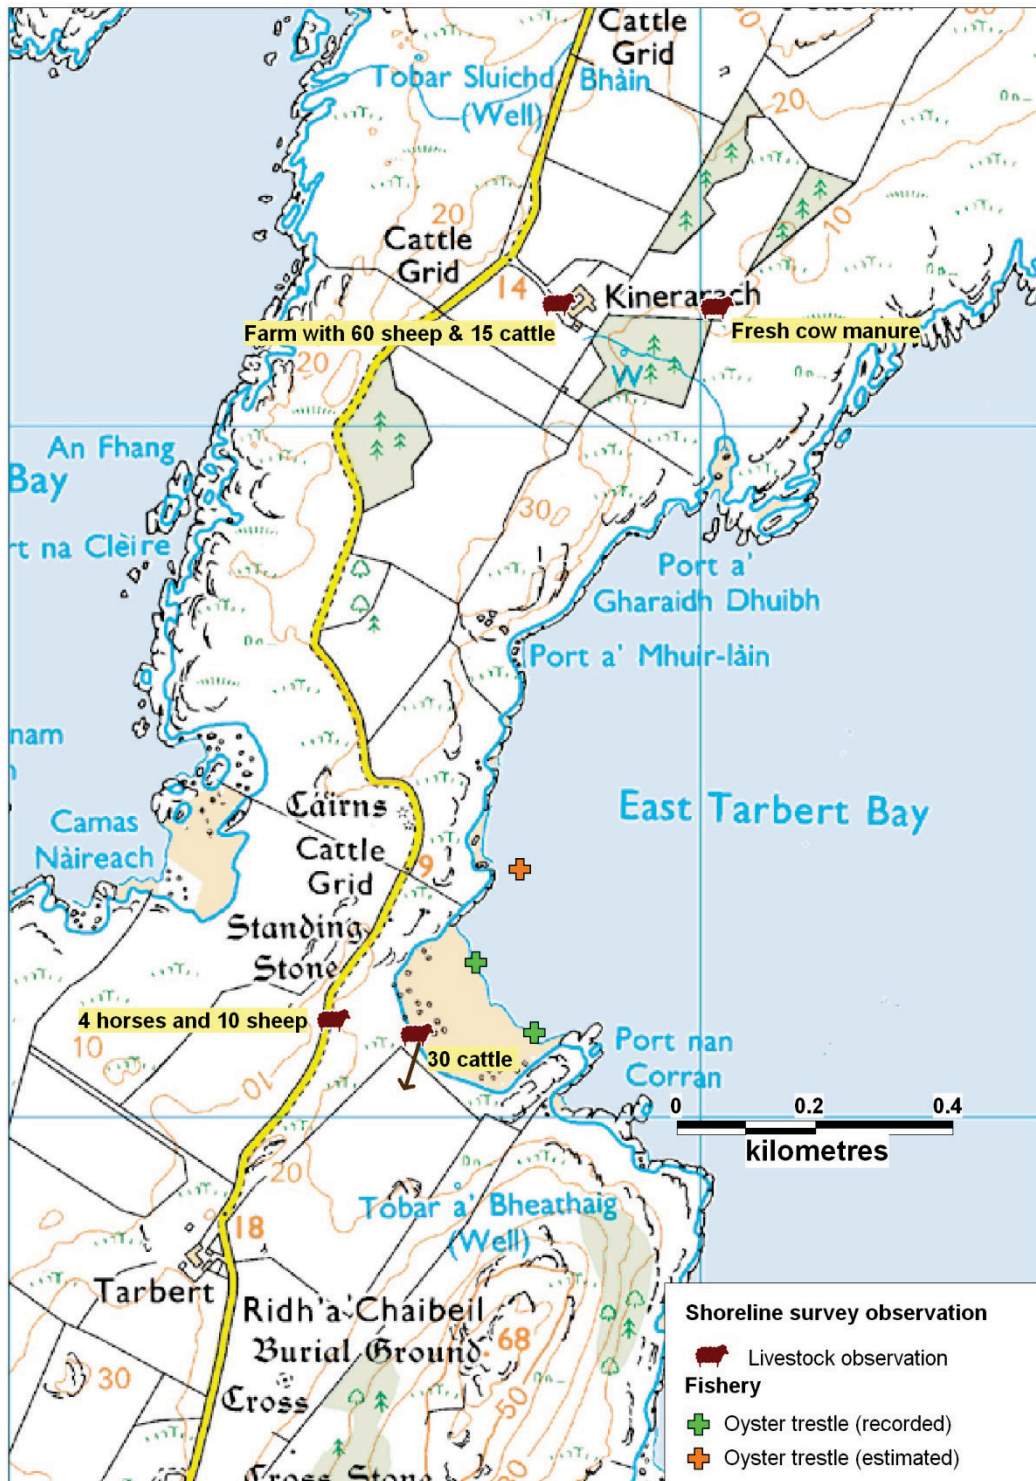
Figure 7.1 Livestock observations at East Tarbert Bay

During the shoreline survey approximately 30 cattle were observed in a field near the southern end of East Tarbert Bay. Another 4 horses and 10 sheep were observed in an adjacent field. At the northern end of East Tarbert Bay, a large amount of fresh cow manure was observed in a field next to the woodland and a farm with approximately 60 sheep and 15 cattle were seen at Kinerarach.

The area around much of the bay is likely to be used for grazing, with 75 animals noted to the north and 44 to the southwest of the oyster trestles. Watercourses draining land where animals are grazed is likely to carry faecal material from these areas to the bay. Impacts will be highest near where the watercourses enter the bay.

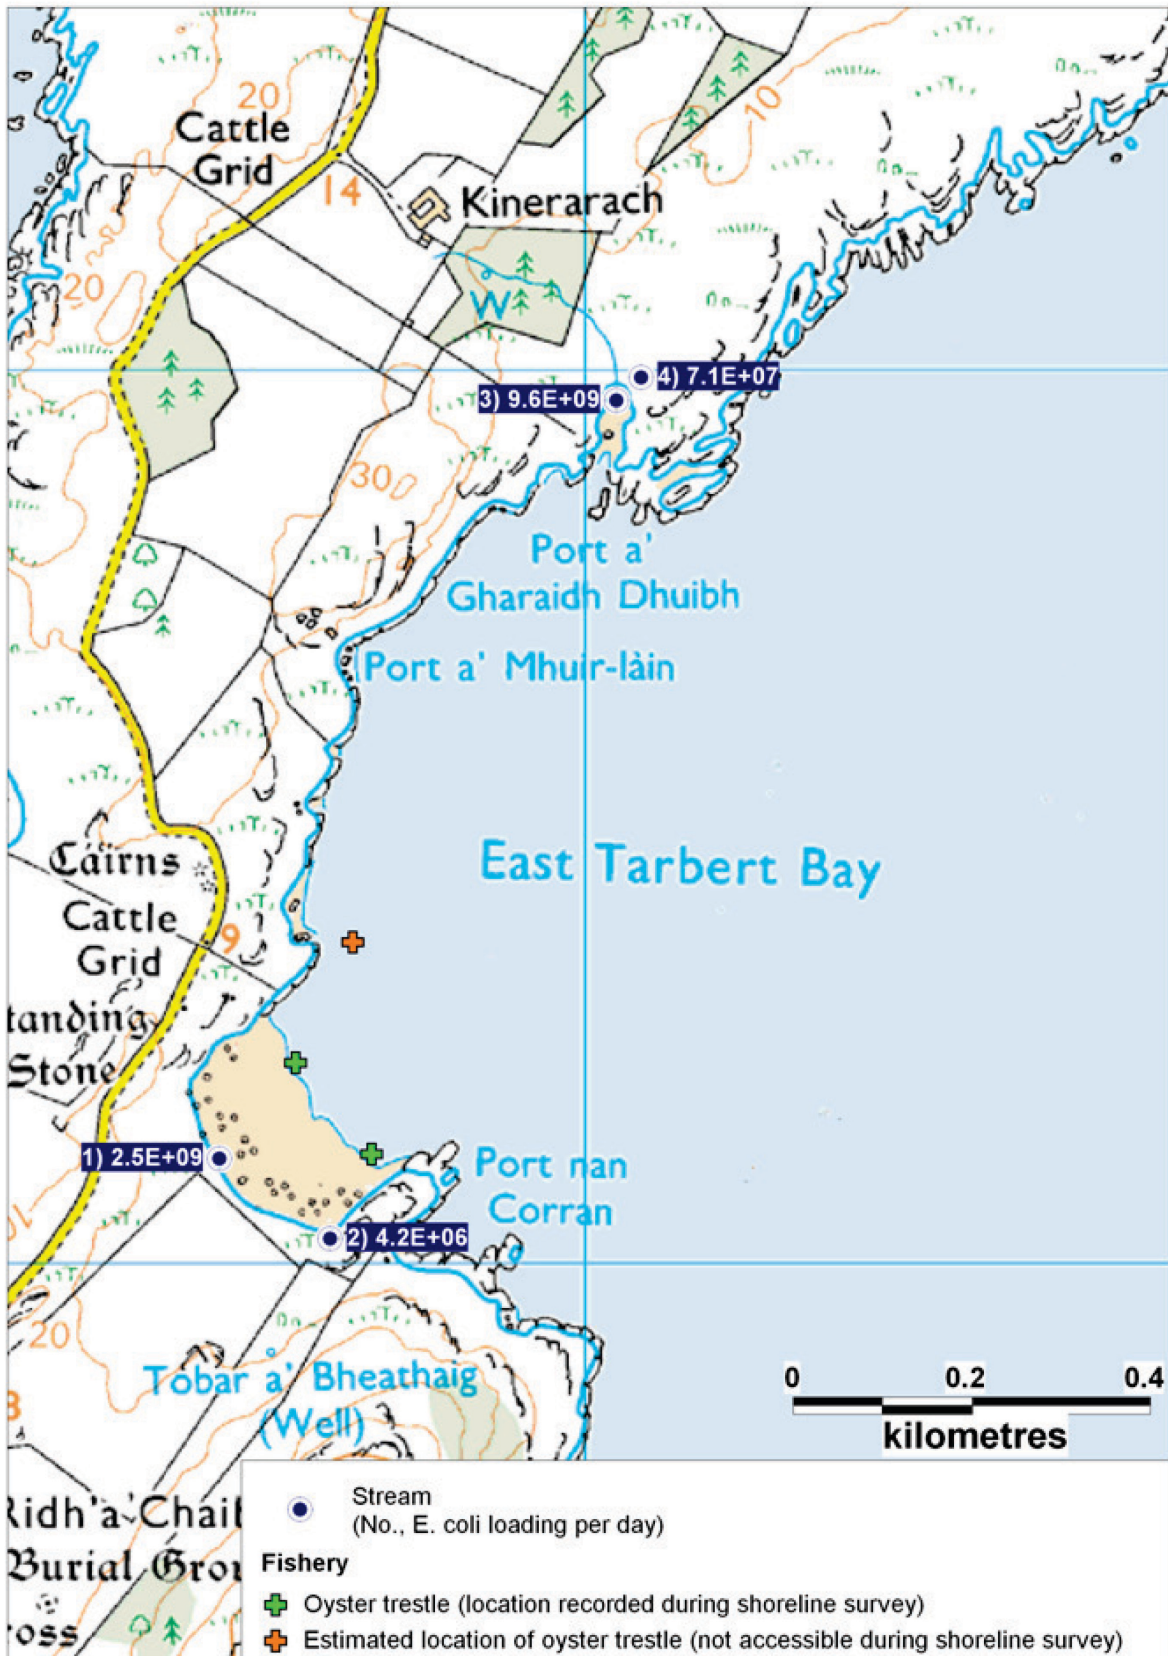
Figure 13.1 Map of river/stream loadings at Isle of Gigha

The calculated loadings for two of the four streams (numbers 1 and 3) were moderately high while the loadings for the other two were low. Streams 1 and 2 would impact directly on the oyster trestles, predominantly on the two located within the small embayment at the southern end of East Tarbert Bay. Given that stream 1 had the higher loading, there is the potential for the trestle at the centre of that embayment to be affected to a greater extent.

Loadings from all of these watercourses would be expected to increase at least tenfold following heavy rain.

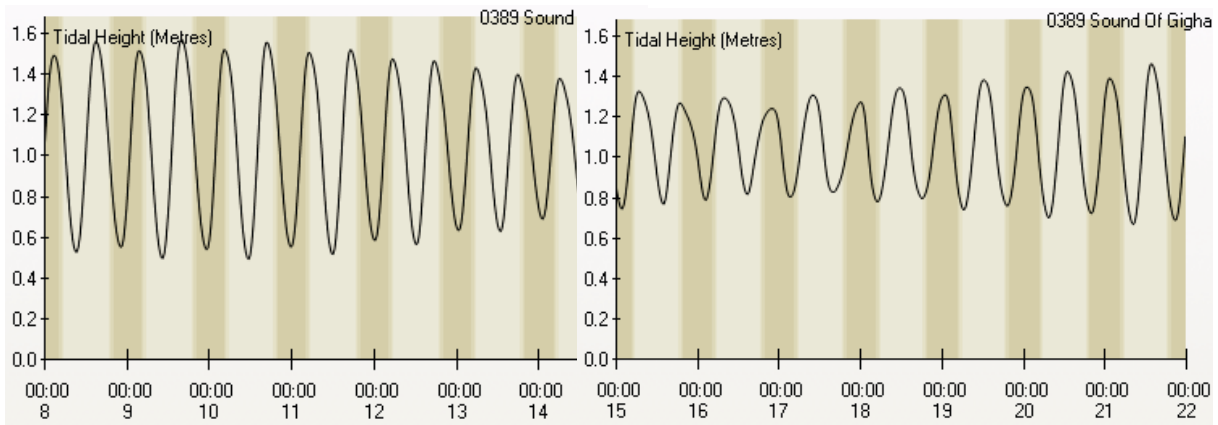
Figure 14.3 Tidal curves for Sound of Gigha

The two tidal curves below are for Sound of Gigha, approximately 3 km south of the oyster farm. The tidal curves have been output from UKHO TotalTide. The first is for seven days beginning 00.00 BST on 08/09/10 and the second is for seven days beginning 00.00 BST on 15/09/10. Together they show the predicted tidal heights

over high/low water for a full neap/spring tidal cycle, including the dates of the shoreline survey.

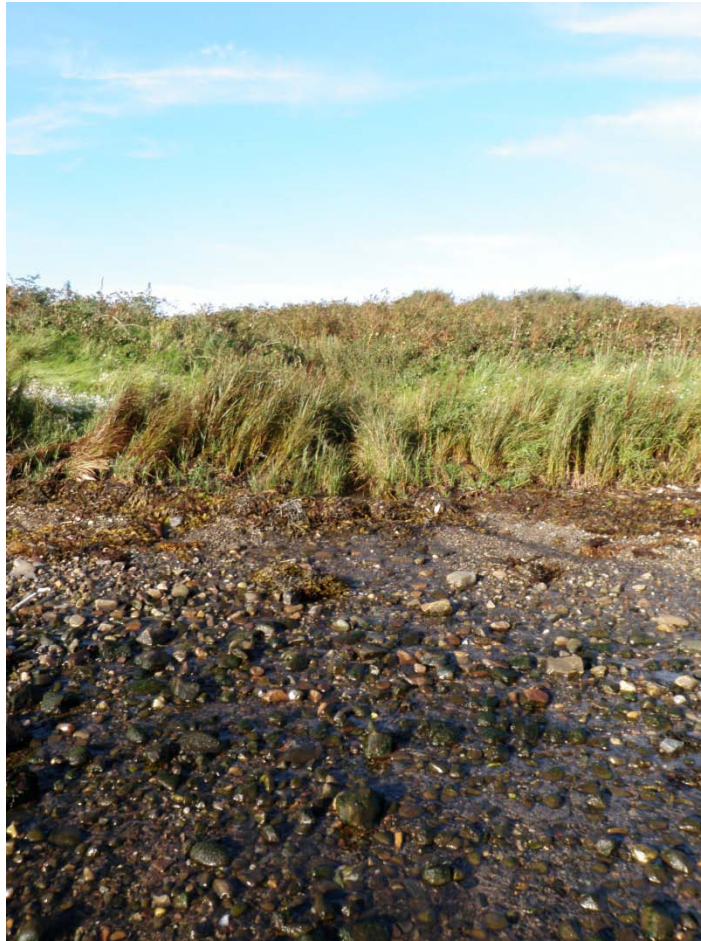
Figure 4. Stream and location of fresh water sample 1 (GIGHA FW1)

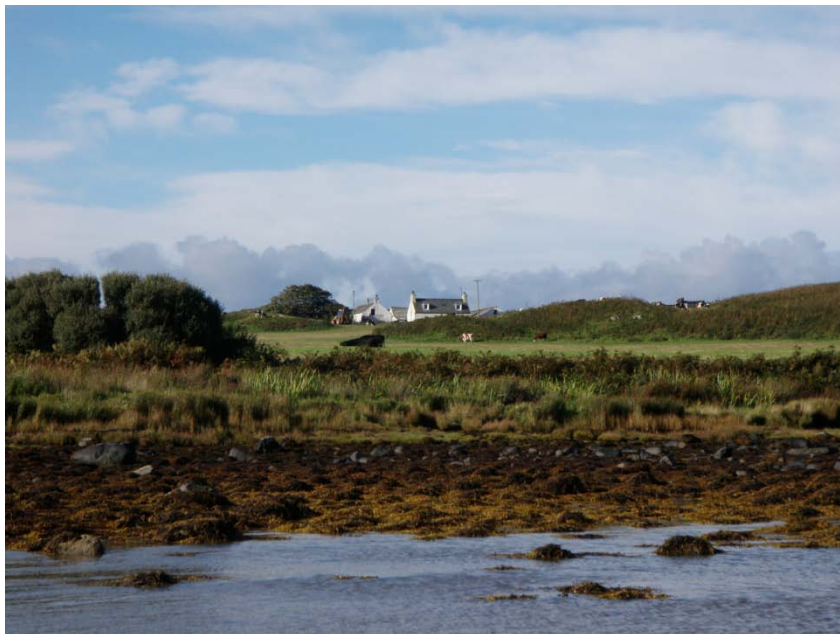
Figure 5. Approximately 30 cattle in field behind shoreline, fenced in. Also three houses in background.

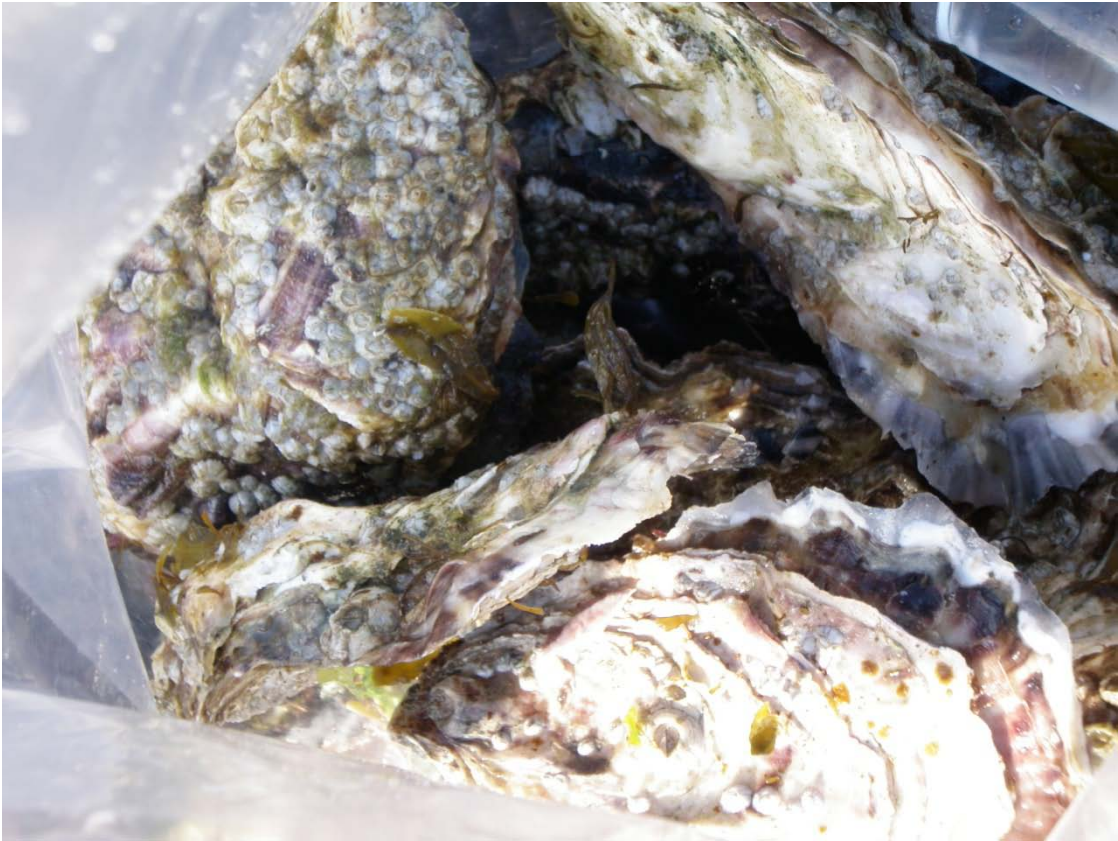
Figure 8. Oyster sample 1 (GIGHA OYSTER1)

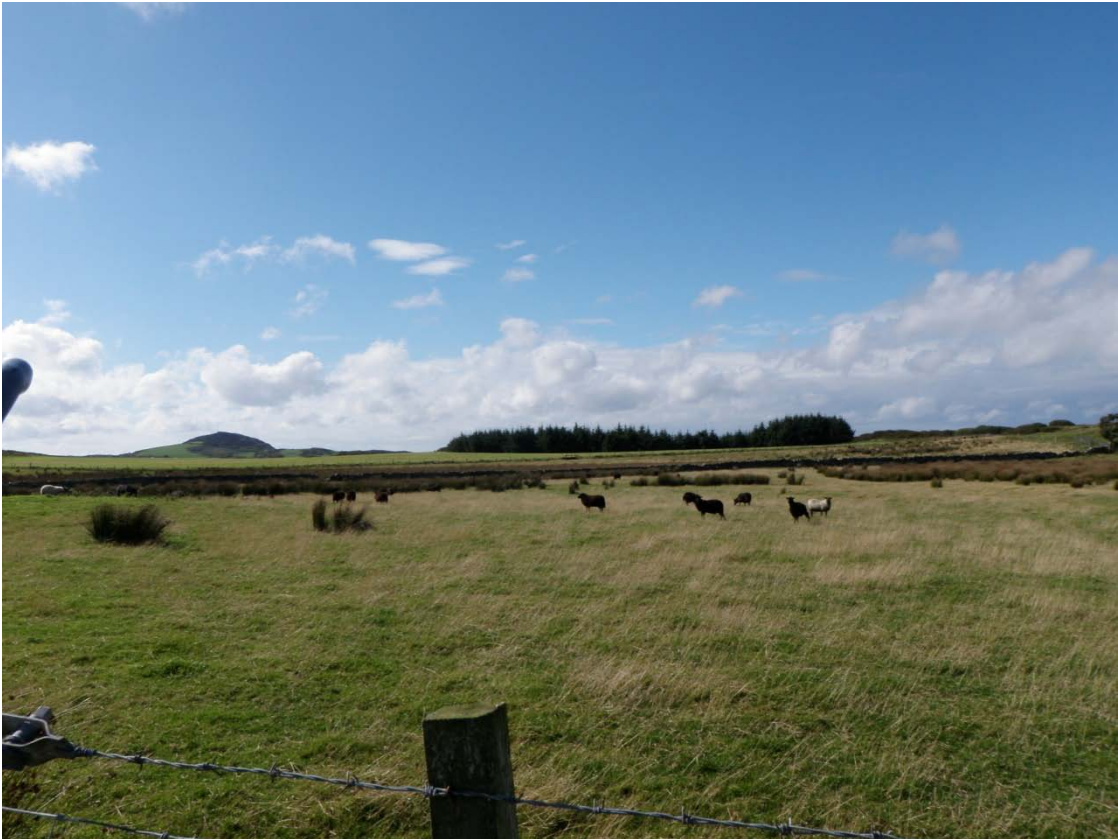
Figure 15. Approximately 60 sheep in field adjacent to farm

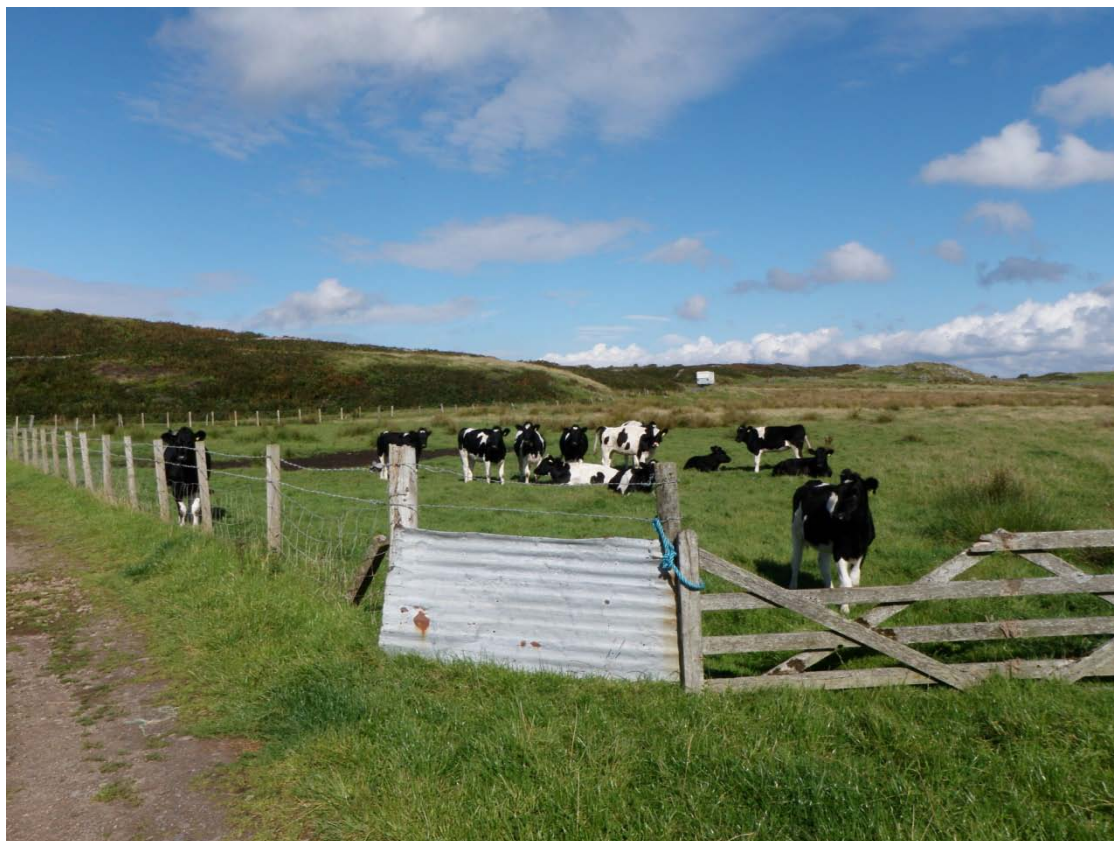
Figure 16. Approximately 15 cattle in field adjacent to farm
