Scottish Sanitary Survey Report

**Sanitary Survey Report
Kerrera Cockles
AB-697-1513, -1514 & -1515
May 2015**

Report Title	Kerrera Cockles
Project Name	Scottish Sanitary Survey
Client/Customer	Food Standards Agency Scotland
Cefas Project Reference	C6316A
Document Number	C6316A_2014_27
Revision	V1.0
Date	22/05/2015

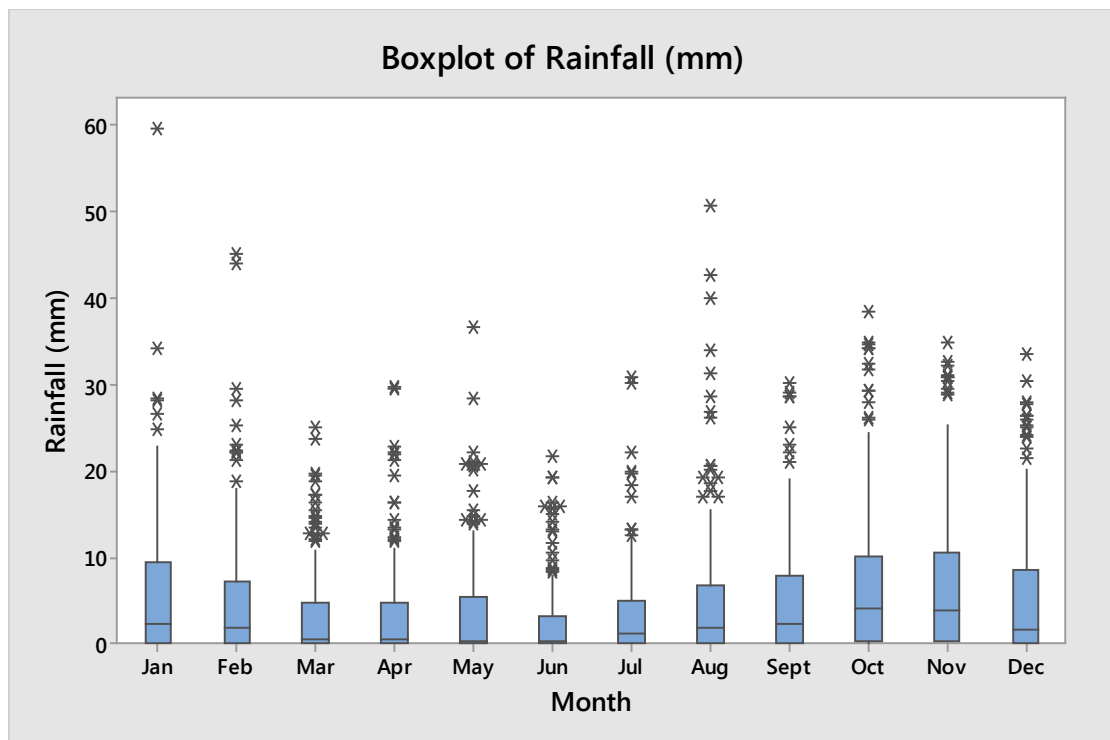
Figure 9.2 Box plot of daily rainfall values by month at Lismore; Frackersaig Farm (2008 – 2013)

Monthly rainfall totals over the period 2008-2013 were higher during the autumn and winter. Rainfall generally increased from August peaking in October (1348 mm). Weather was driest in June (429 mm). Rainfall values exceeding 30 mm/d were seen in all months except March, April and June.

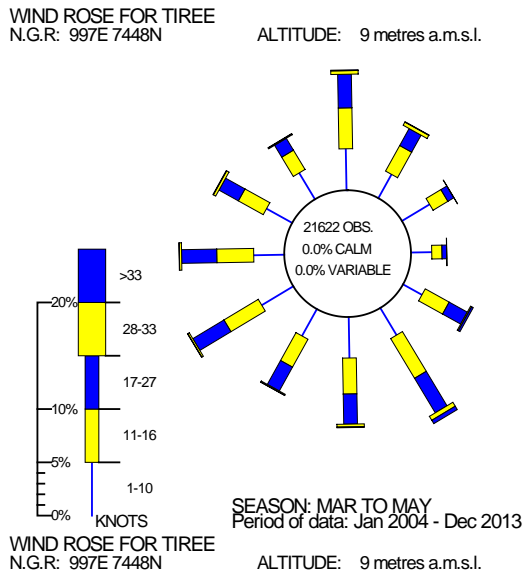
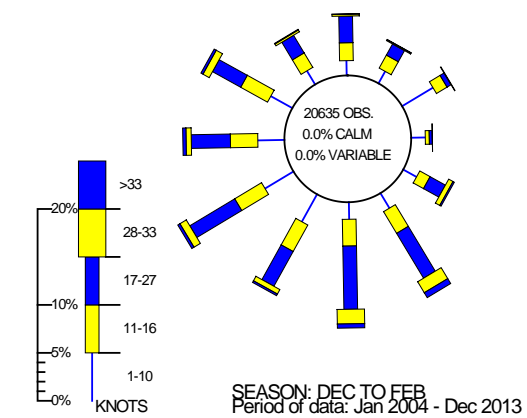
Figure 9.3 Seasonal wind roses for Tiree

Overall, the winds were predominantly from between south-southeast and west. The strongest wind tended to be from the south. Seasonally, the strongest winds occurred during the autumn and winter. A greater proportion of northerly winds were seen in the spring and summer than in autumn and winter.

Wind is an important factor in the spread of contamination as it has the ability to drive surface water at about (3%) of the wind speed (Brown, 1991) so a gale force wind (34 knots or 17.2 m/s) would drive a surface water current of about 1 knot or 0.5 m/s. Therefore strong winds can significantly alter the pattern of surface currents. Strong winds also have the potential to affect tide height depending on wind direction and local hydrodynamics of the site. A strong wind combined with a spring tide may result in higher than usual tides, which will carry any accumulated faecal matter at and above the normal high water mark into the production area.

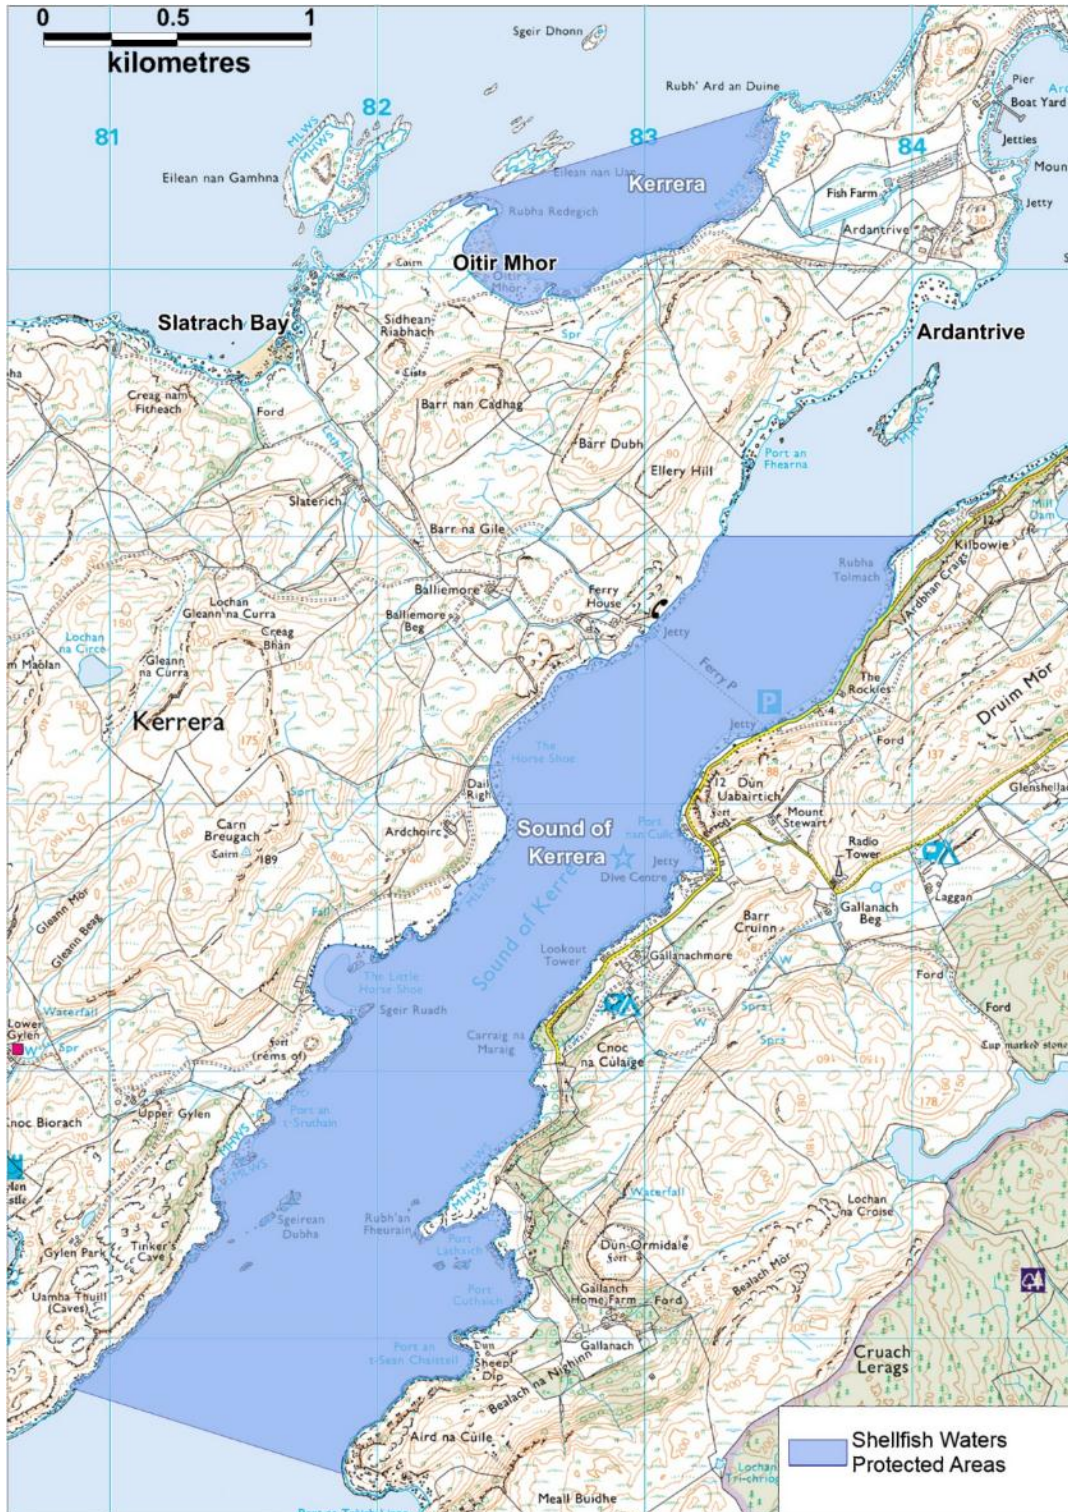
Figure 12.1 Designated shellfish water protected area – Kerrera and Sound of Kerrera

The designated SWPA for Kerrera and the Sound of Kerrera are shown in Figure 12.1. Since 2007, assessment of the bacteriological status of shellfish waters has been undertaken using the shellfish hygiene *E. coli* data and this data has been reviewed in Section 11.

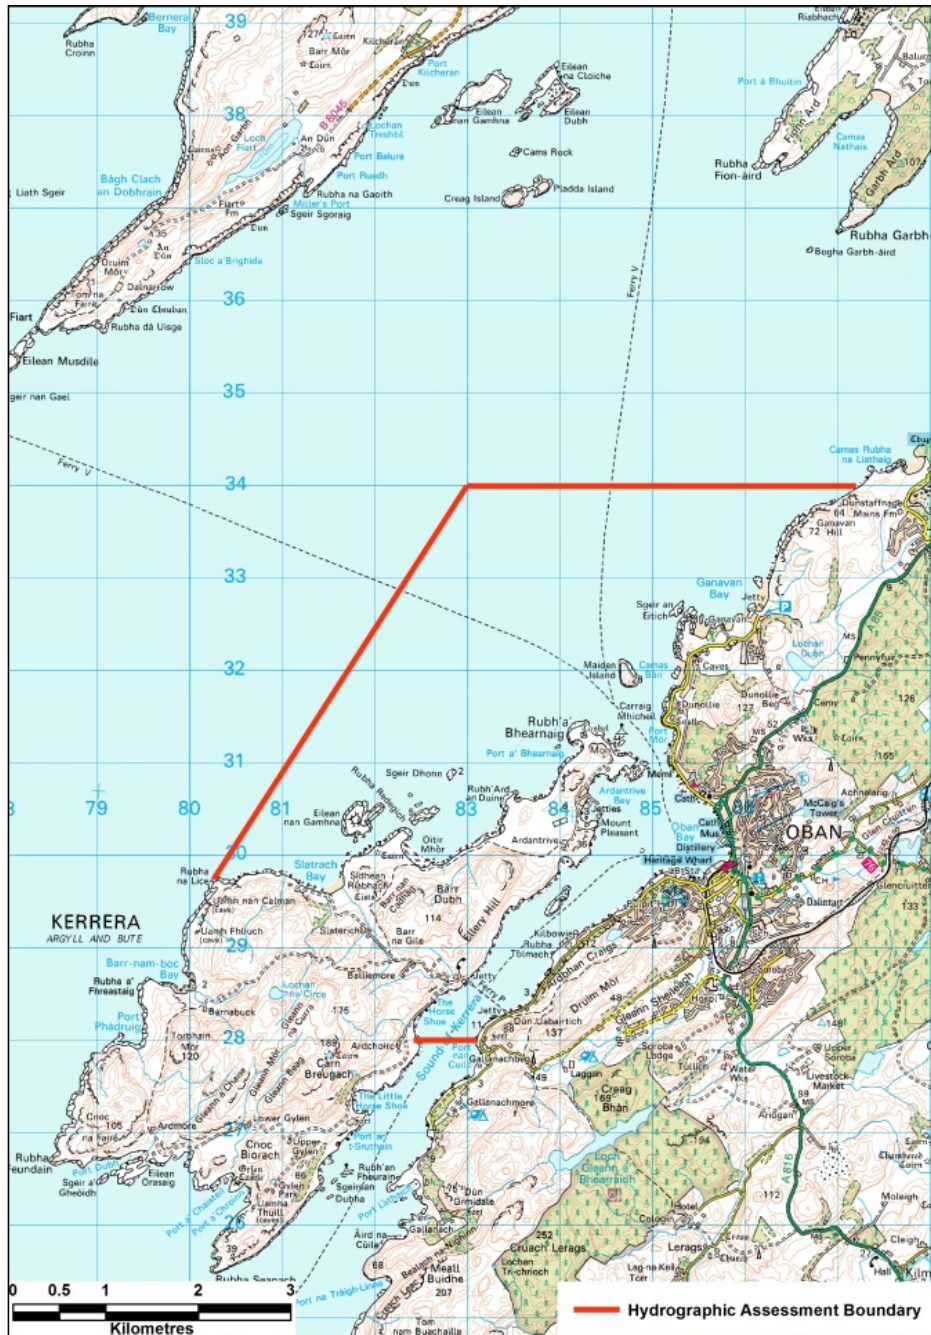
Figure 13.1 Extent of the Isle of Kerrera hydrographic study area

The assessment area encompasses the northern part of the Sound of Kerrera, Oban Bay, and adjacent waters in the Firth of Lorn extending from Rubha na Lice, on the Isle of Kerrera, northwards to Camas Rubha na Liathaig. The assessment area extends 3-4 km offshore in to the Firth of Lorn from the Isle of Kerrera and the mainland. At its widest, the Sound of Kerrera is approximately 2 km in width, while Oban Bay is approximately 1.5 km² in area.

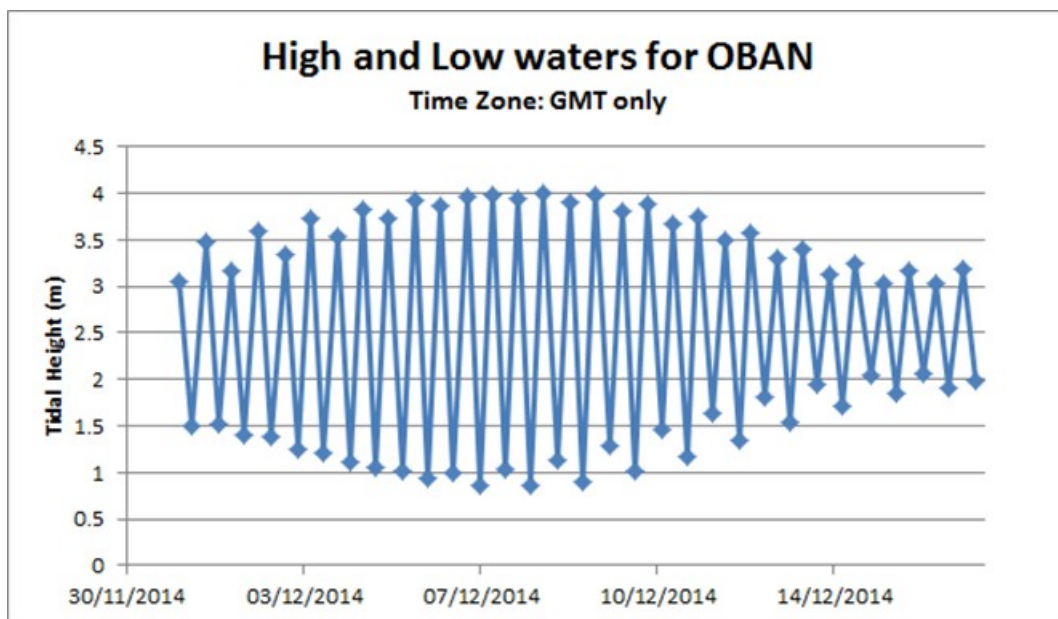
Figure 13.3 Two week tidal curve for Oban.

Standard tidal data for Oban, centred around the survey date of 8th December 2014, are shown in Figure 13.3. Tidal predictions for Oban indicate that in this region the tidal characteristics are semi-diurnal, with a well-developed spring-neap cycle.

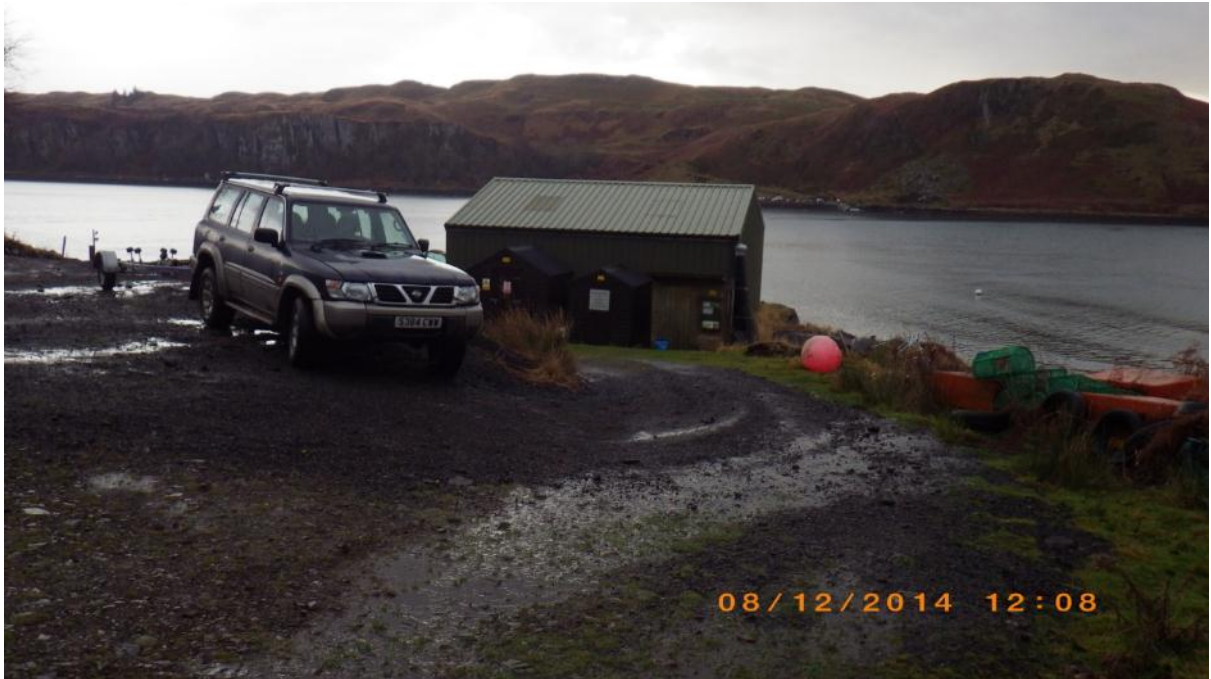
No.	Date	NGR	Associated Photograph (Appendix 5)	Associated Sample	Description
1	08/12/2014	NM 82939 28653	Fig 3		Ferry landing. One compost toilet next to shore.
2	08/12/2014	NM 83018 28665			Long metal pipe with several joins leading out to sea.
3	08/12/2014	NM 84033 29913	Fig 4/Fig 5		One metal pipe, no flow.
4	08/12/2014	NM 84347 30408	Fig 8		20 cm diameter ceramic pipe with Mount Pleasant House on shore behind. No flow.
5	08/12/2014	NM 84213 29122	Fig 10	KCFW6	Raw sewage leaking from manhole cover on ground, no flow able to be measured.

Fig 3. Ferry landing with compost toilet next to shore. Associated with waypoint 5.

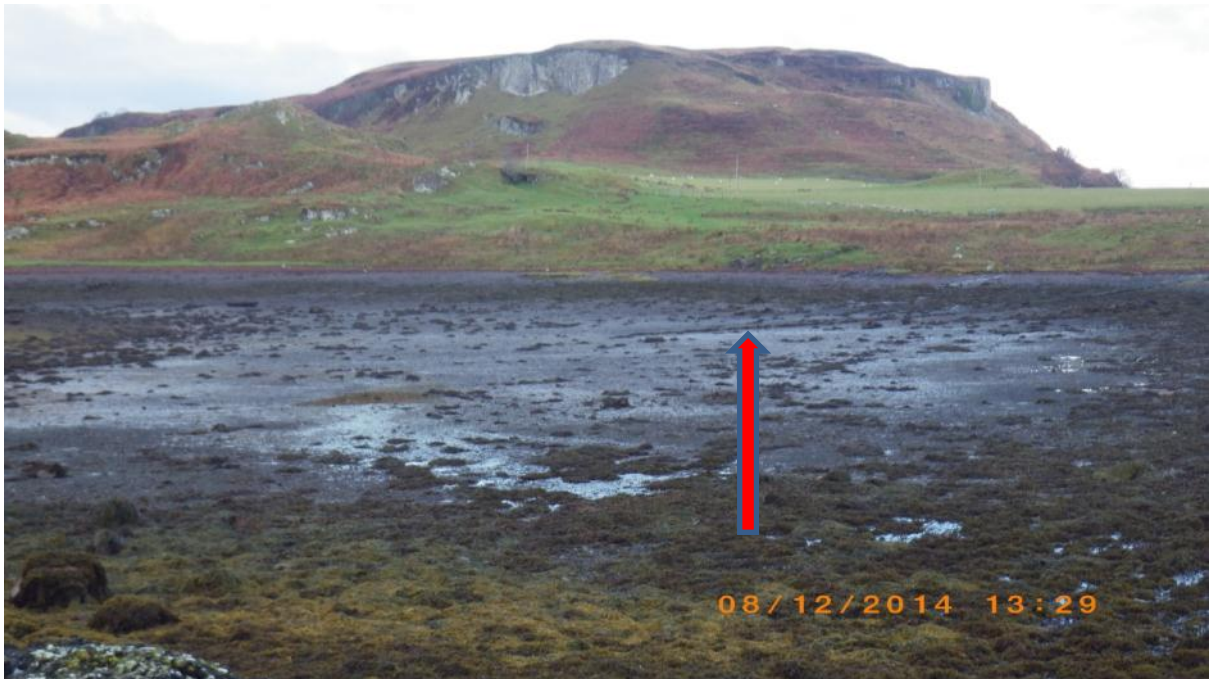
Fig 4. Bay where cockle samples were obtained associated with waypoints 14-16. Red arrow shows pipe on shore, no flow observed.

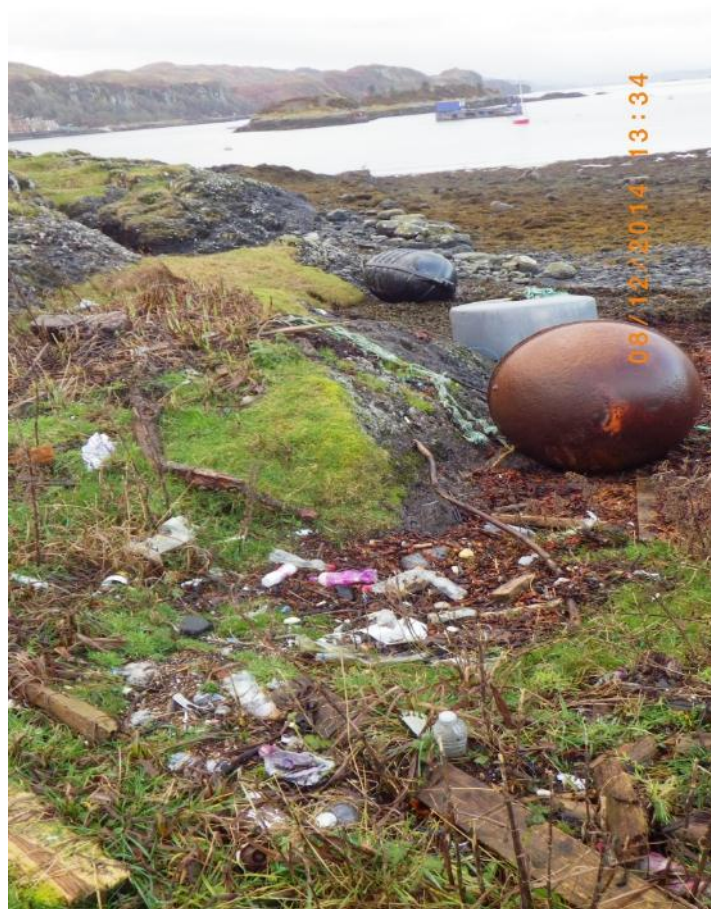
Fig 5. Debris on shore associated with waypoint 16.

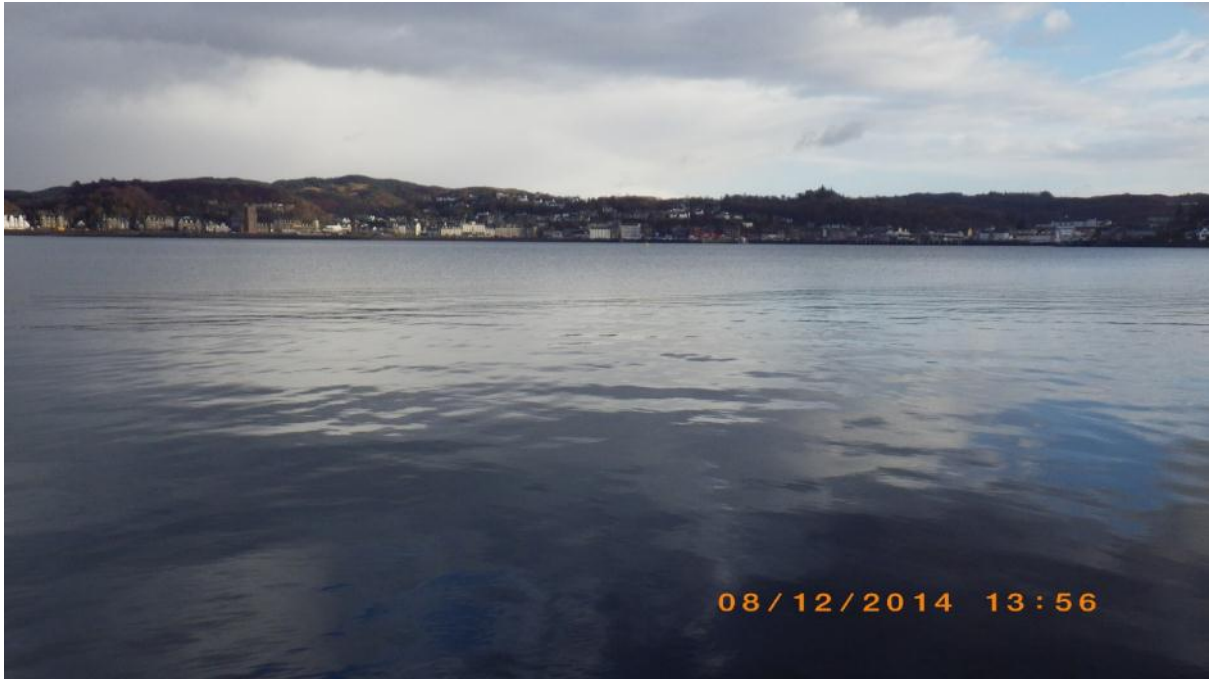
Fig 6. View across the water from waypoint 18 looking towards the town of Oban.
Associated with seawater sample KCSW2.

18	08/12/2014	12:54	NM 84401 30260	184402	730260	Fig 6	KCSW2	Seawater sample from jetty.
19	08/12/2014	13:15	NM 84293 30382	184293	730382	Fig 7		Mount Pleasant and Ardandrive Bay Marina. Seventeen boats moored out of water and twenty three boats in the water.
20	08/12/2014	13:17	NM 84347 30408	184348	730408	Fig 8		20 cm diameter ceramic pipe with Mount Pleasant House on shore behind. No flow.
21	08/12/2014	14:19	NM 85092 29771	185093	729772	Fig 9	KCFW4	Unplanned freshwater sample from pipe.
22	08/12/2014	14:23	NM 85091 29772	185091	729773			Associated with waypoint 21. PVC pipe diameter - 11 cm; Water width - 4 cm; Depth - 2 cm; Flow estimated using bucket, flow 250ml/s.
23	08/12/2014	14:36	NM 84965 29668	184966	729668			Broken disused metal pipe leading into sea.
24	08/12/2014	14:38	NM 84974 29657	184974	729657		KCFW5	Planned freshwater sample from unnamed watercourse.

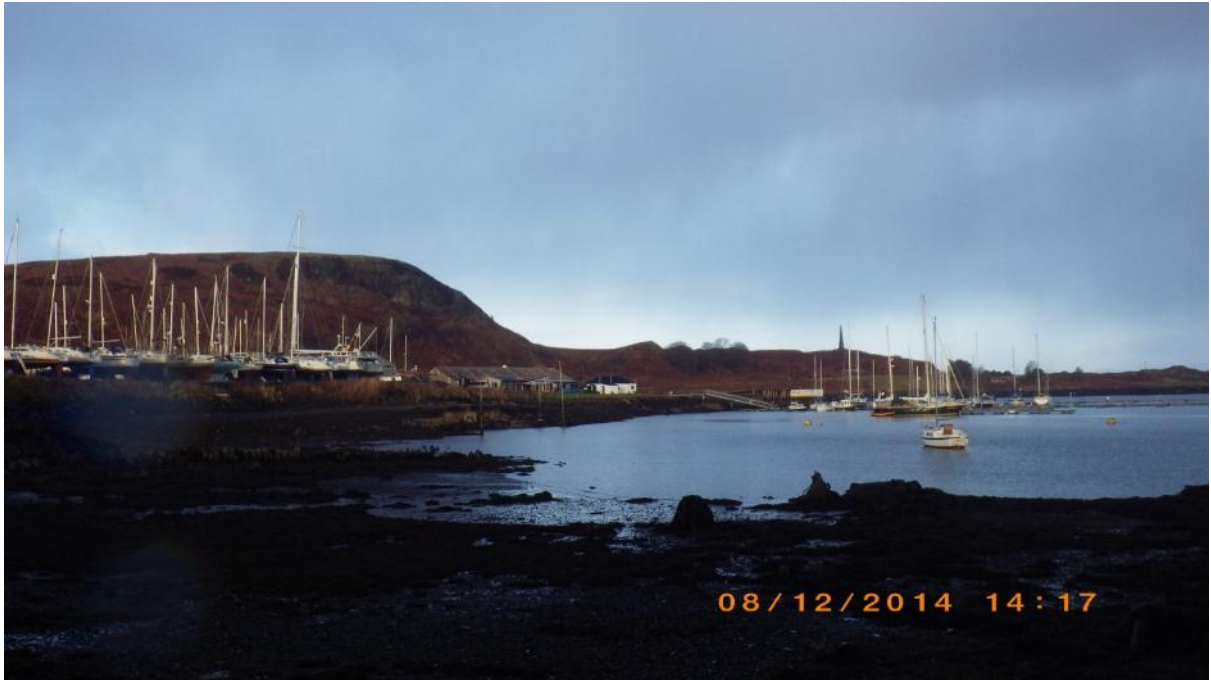
Fig 7. Marina at Ardantive Bay associated with waypoint 19.

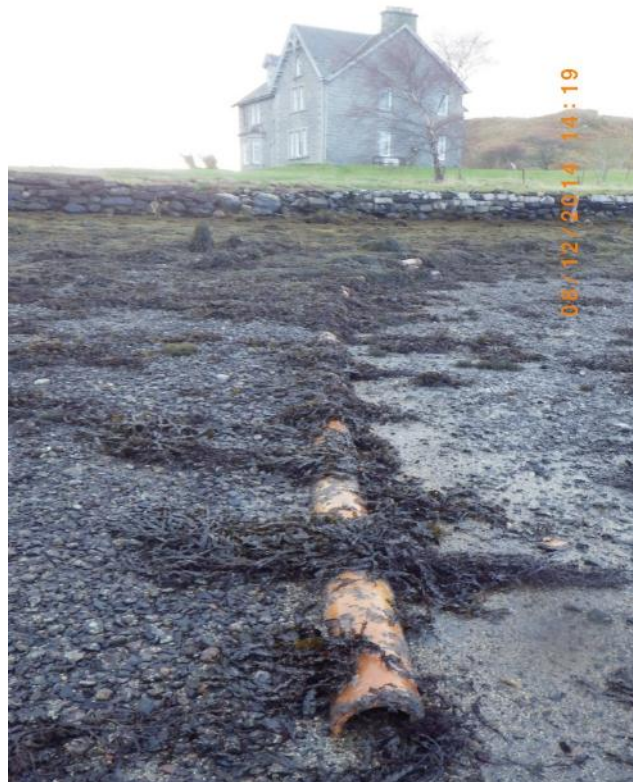
Fig 8. House at Mount Pleasant with pipe onto shore, no flow was observed, associated with waypoint 20.

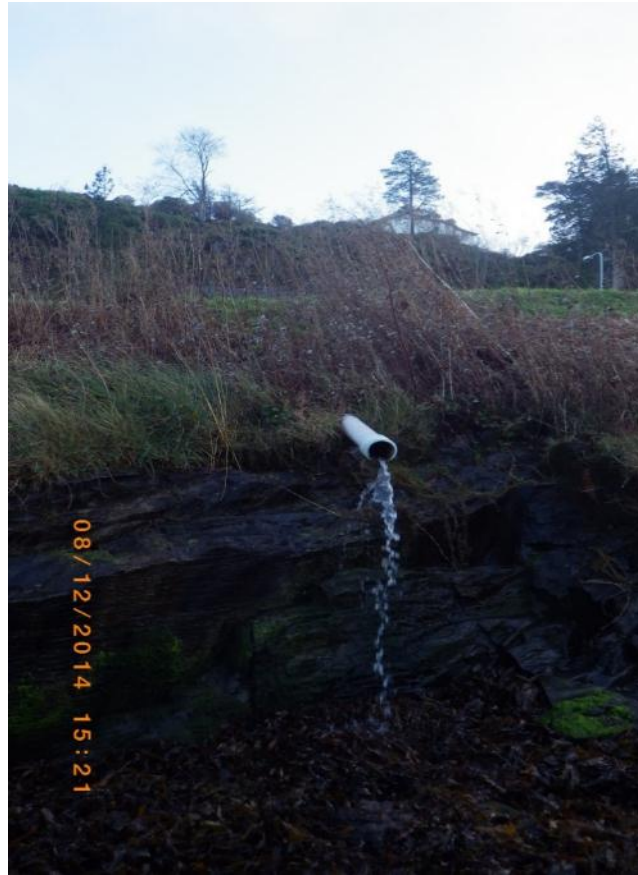
Fig 9. Pipe discharging water onto shore, unplanned freshwater sample KCFW4 taken, associated with waypoint 21.

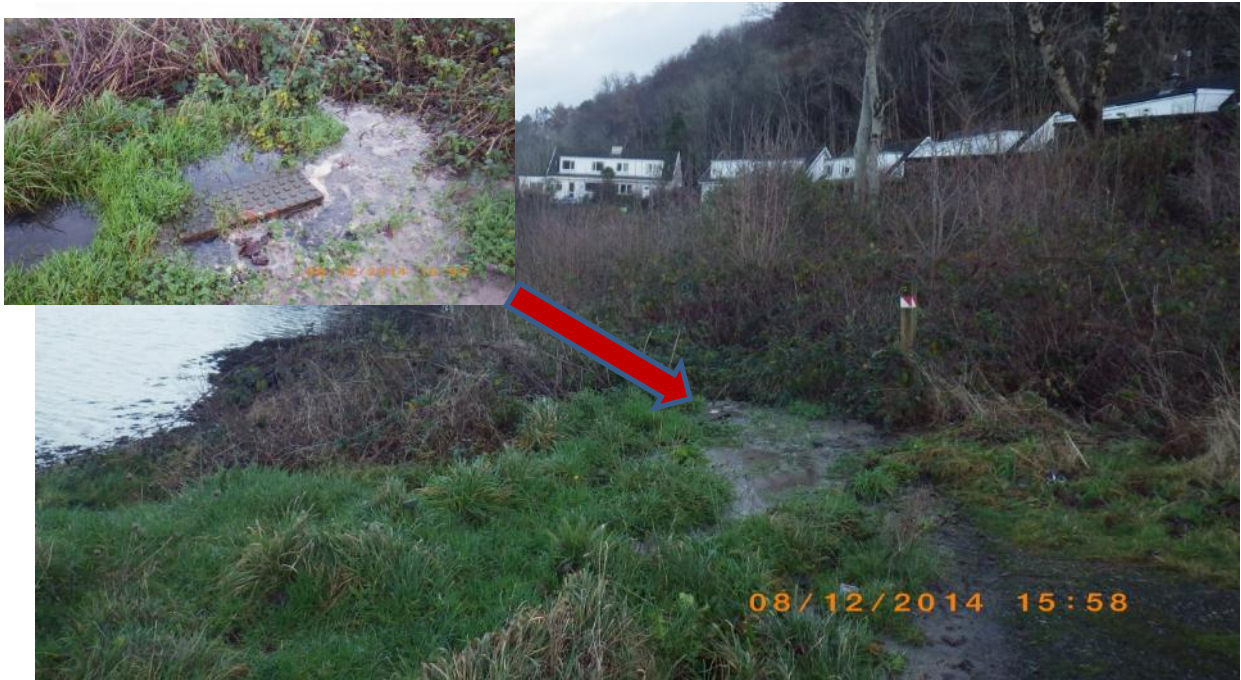
Fig 10. Houses at Dungallan Terrace with overflowing manhole. Insert shows raw sewage around manhole cover. Associated with waypoint 28 and location of contaminated freshwater sample KCFW6.

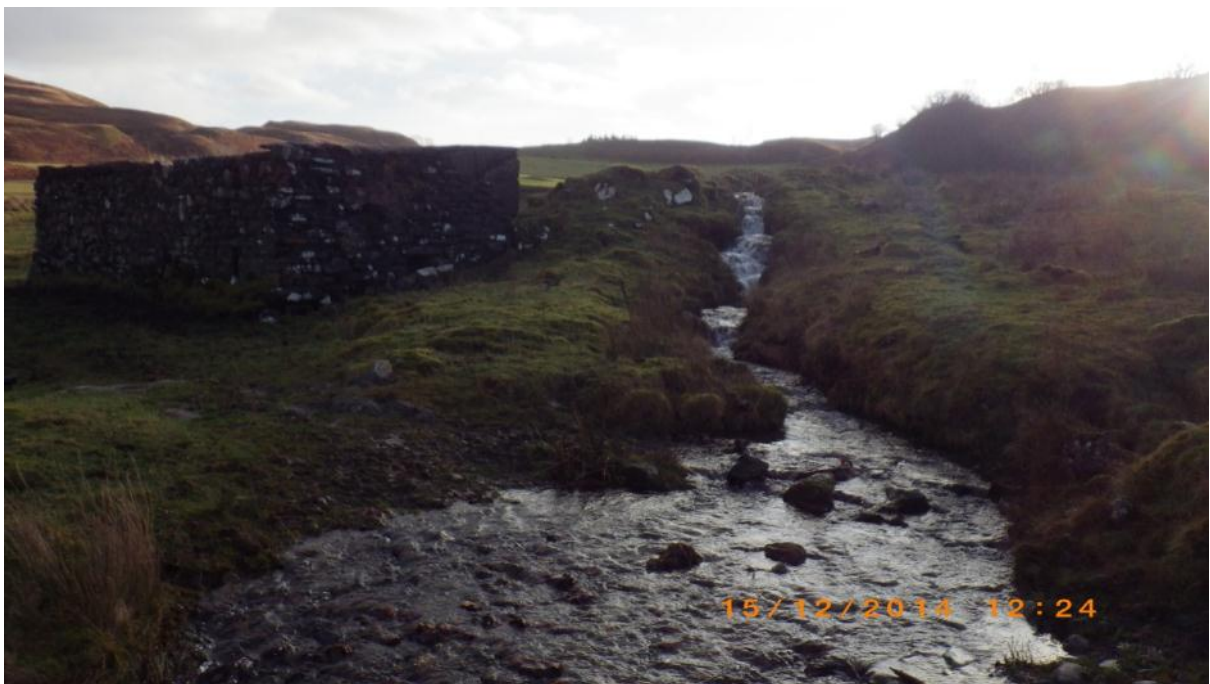
Fig 11. Unplanned freshwater sample taken from watercourse. Associated with waypoint 29 and location of freshwater sample KCFW7.

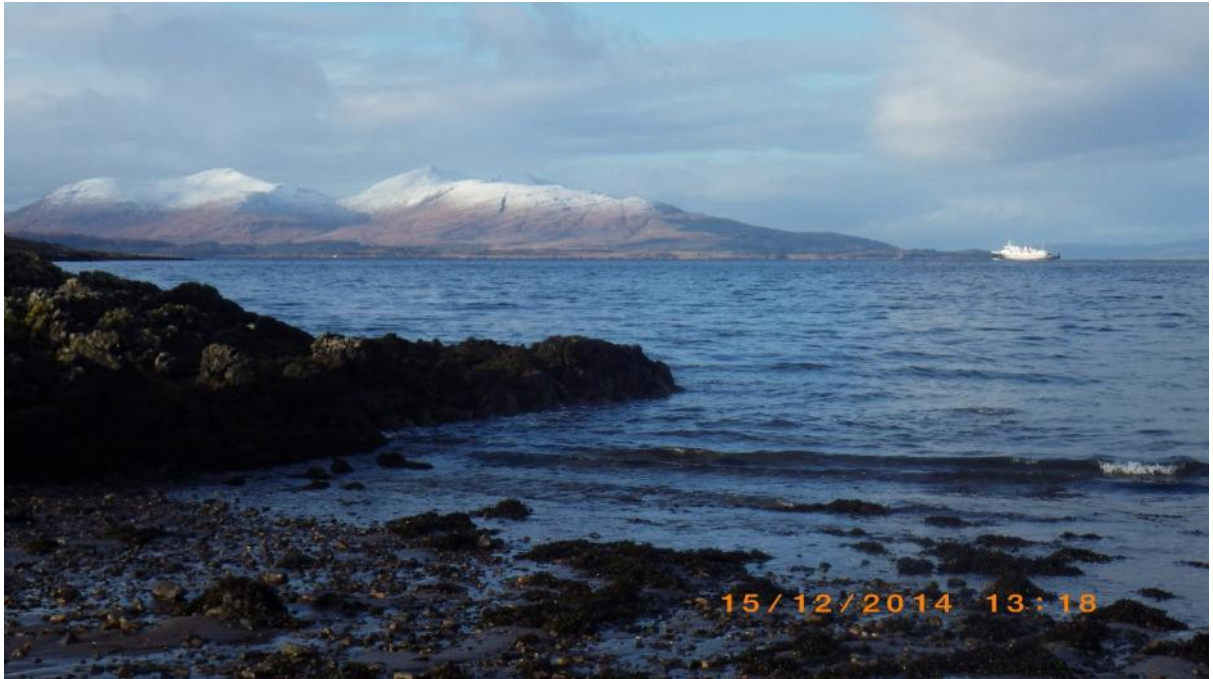
Fig 12. Calmac ferry route passing northeast of survey area. Associated with waypoint 35.

No.	Date	Time	NGR	East	North	Associated photograph	Associated sample	Description
34	15/12/2014	12:13	NM 81642 29639	181643	729639		KCSF2	Cockle sample taken from Slatrach Bay. Very difficult to find any cockles. Not much evidence of cockle shells either.
35	15/12/2014	12:15	NM 81643 29640	181643	729640	Fig 12		Calmac ferry passing by.
36	15/12/2014	12:18	NM 81653 29644	181654	729644		KCSW3	Seawater sample from Slatrach Bay.
37	15/12/2014	12:20	NM 81660 29646	181661	729647		KCFW9	Planned freshwater sample from watercourse named Leth Allt.
38	15/12/2014	12:20	NM 81661 29647	181661	729647			Associated with waypoint 37. Watercourse width - 2 m 70 cm; Depth - 16 cm; flow - 0.516 m/s; SD - 0.013.
39	15/12/2014	12:34	NM 81715 29784	181715	729785			Very small burn less than 1 m in width so not sampled.
40	15/12/2014	13:03	NM 82341 30133	182342	730133		KCFW10	Planned freshwater sample from small unnamed watercourse.

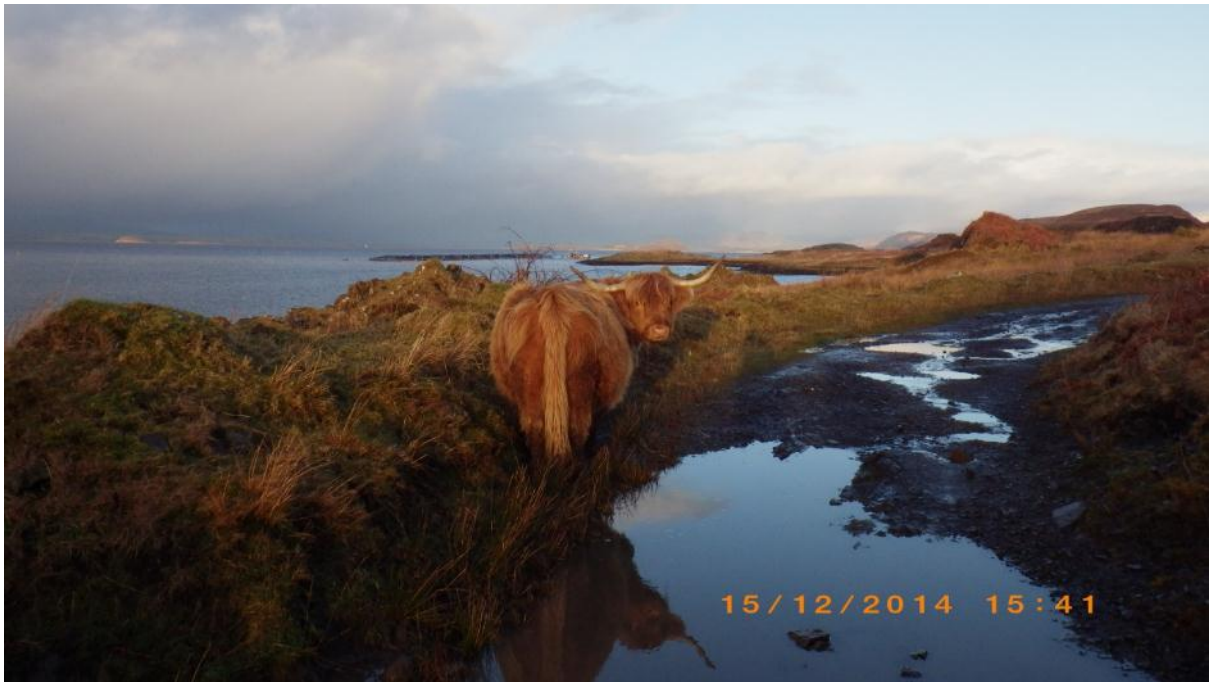
Fig 13. Highland cow grazing close to shore. Associated with waypoint 49.

There were two sheep seen at waypoint 7, and a further nine sheep and one wild goat were observed at waypoint 9. In the fields surrounding Ardantive farmhouse, one cow and more than fifty sheep were counted. On the north shore of the island, close to waypoint 30, one horse, three cows and approximately eighty sheep were observed scattered across the hillside. There were fourteen cows next to the shore at waypoint 41 and two highland cows at waypoint 49 (Fig 13).
