# Scottish Sanitary Survey Report

**Sanitary Survey Report  
Kilfinichen Bay  
AB-695  
June 2015**

<b>Report Title</b>	Kilfinichen Bay Sanitary Survey Report
<b>Project Name</b>	Scottish Sanitary Survey
<b>Client/Customer</b>	Food Standards Agency Scotland
<b>Cefas Project Reference</b>	C6316A
<b>Document Number</b>	C6316A_2014_15
<b>Revision</b>	1.1
<b>Date</b>	11/06/2015

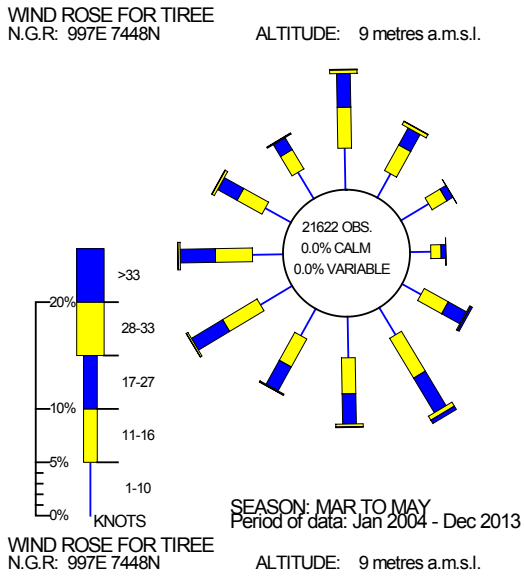
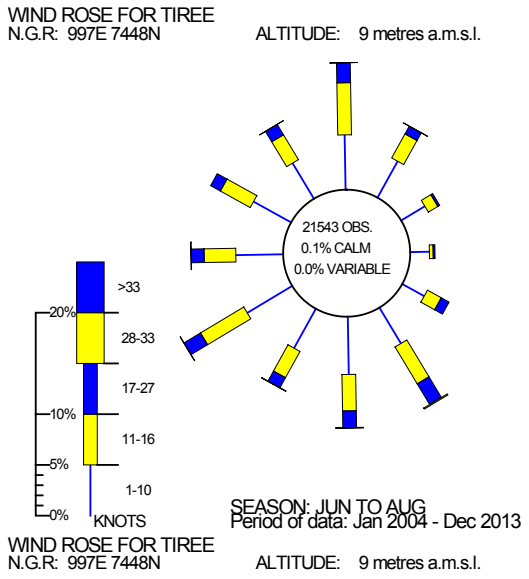
**Figure 9.3 Seasonal wind roses for Tiree**

Wind data was collected from Tiree and summarised in seasonal wind roses in Figure 9.3 and annually in Figure 9.4.

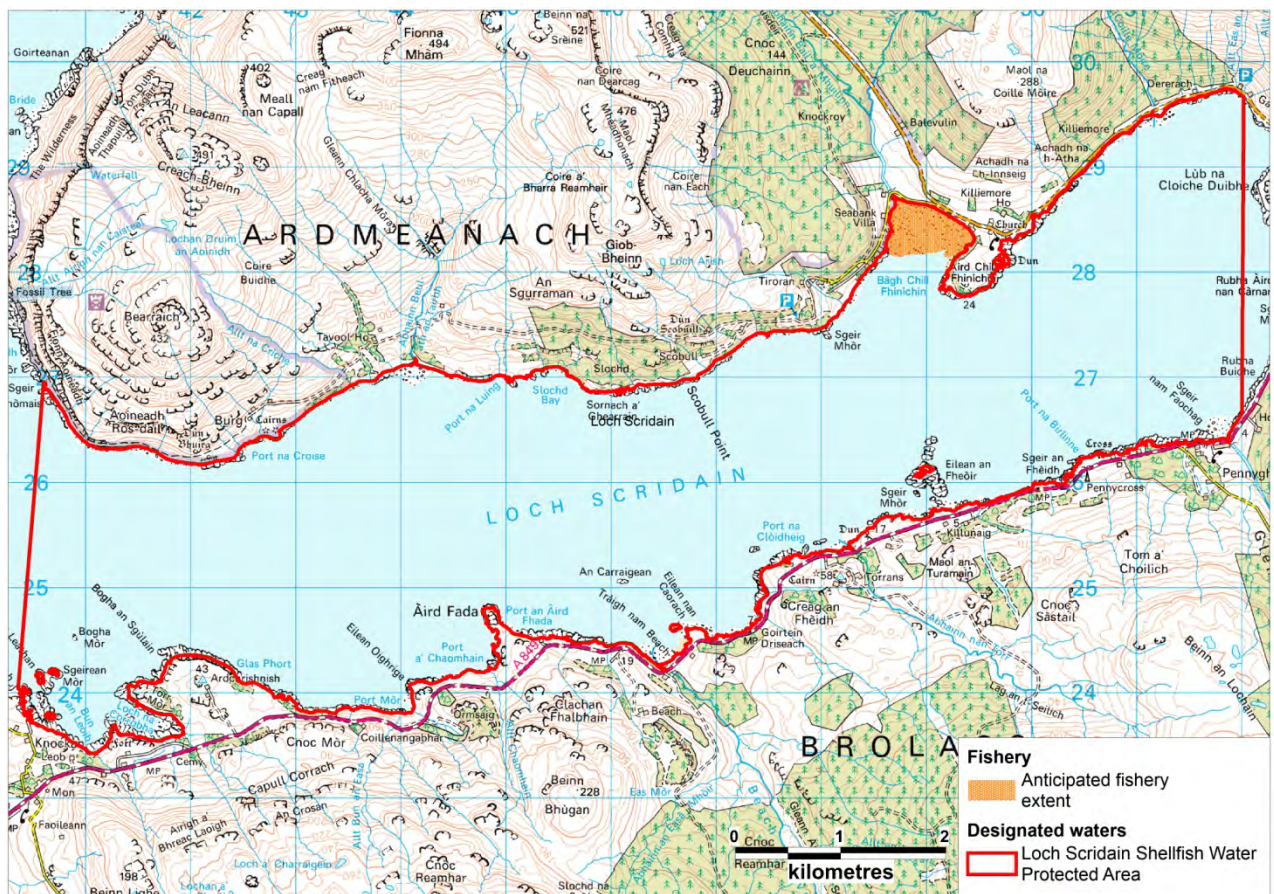
**Figure 12.1 Designated shellfish water protected area – Kilfinichen Bay**

The Shellfish Waters Directive (2006/113/EC) has been repealed (as at 31 December 2013) and equivalent protection for areas previously designated under that Directive is given by The Water Environment (Shellfish Water Protected Areas: Environmental Objectives etc.) (Scotland) Regulations 2013. Kilfinichen Bay cockle bed is within the boundaries of the Loch Scridain Shellfish Water Protected Area (SWPA). The SWPA designation covers 30 km<sup>2</sup> including the majority of Loch Scridain and Kilfinichen Bay production area and shellfish bed. The designated SWPA for Loch Scridain is shown in Figure 12.1. Since 2007, assessment of the bacteriological status of shellfish waters has been undertaken using the shellfish hygiene *E. coli* data and this data has been reviewed in Section 11.

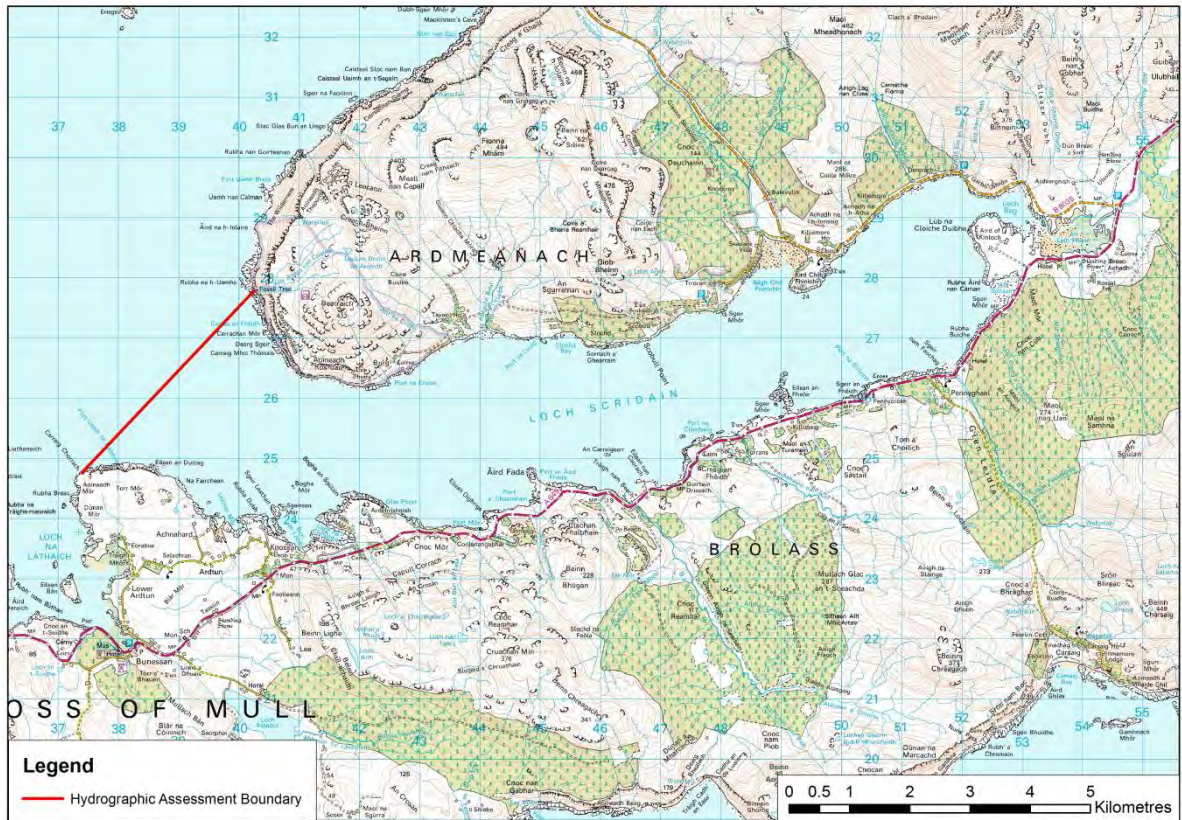
**Figure 13.1** Extent of the hydrographic study area

Kilfinichen Bay is an inlet located on the northern shore of the sea loch of Loch Scridain on the west coast of the Isle of Mull, Argyll and Bute. Kilfinichen Bay is bordered on its eastern side by the headland of Aird Kilfinichen, with the area known as Ardmeanach lying to the west. The extent of the hydrographic survey assessment area encompasses the entirety of Loch Scridain, within the red line in Figure 13.1 demarcating the western edge of the area, between the headlands of Carraig Chorrach and Rubha na h-Uamha.

Loch Scridain is open to the sea at its western end, with Loch Beg and the inlet An Leth Fhonn found at the head. Numerous small streams and burns flow into Loch Scridain, including Abhainn Bail a' Mhuilinn, which enters the loch through Kilfinichen Bay. The landscape surrounding Loch Scridain includes low hills and areas of woodland.

The total length of the assessment area is 19.3 km, with a maximum width of 4 km. Kilfinichen Bay lies roughly 6 km west of the head of Loch Scridain, and is approximately 1 km wide at its maximum point.

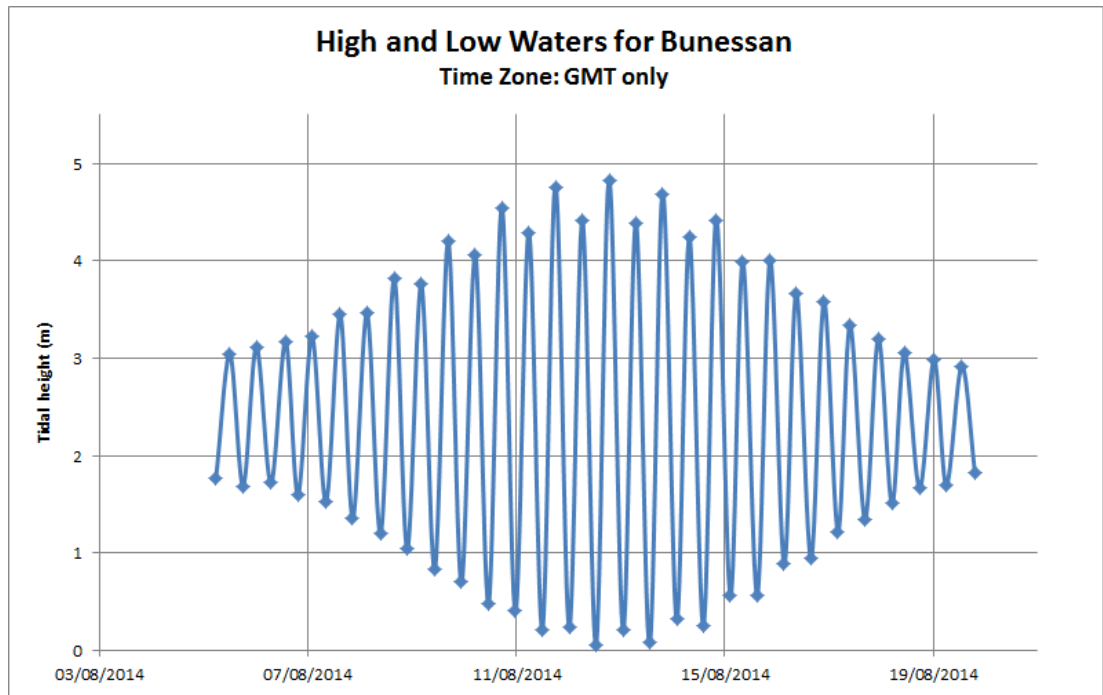
**Figure 13.3 Two week tidal curve for Bunessan.**

Standard tidal data for Bunessan, centred around the survey date of 12<sup>th</sup> August 2014, are shown in Figure 13.3. Tidal predictions for Bunessan indicate that in this region the tidal characteristics are semi-diurnal, with a well-developed spring-neap cycle.

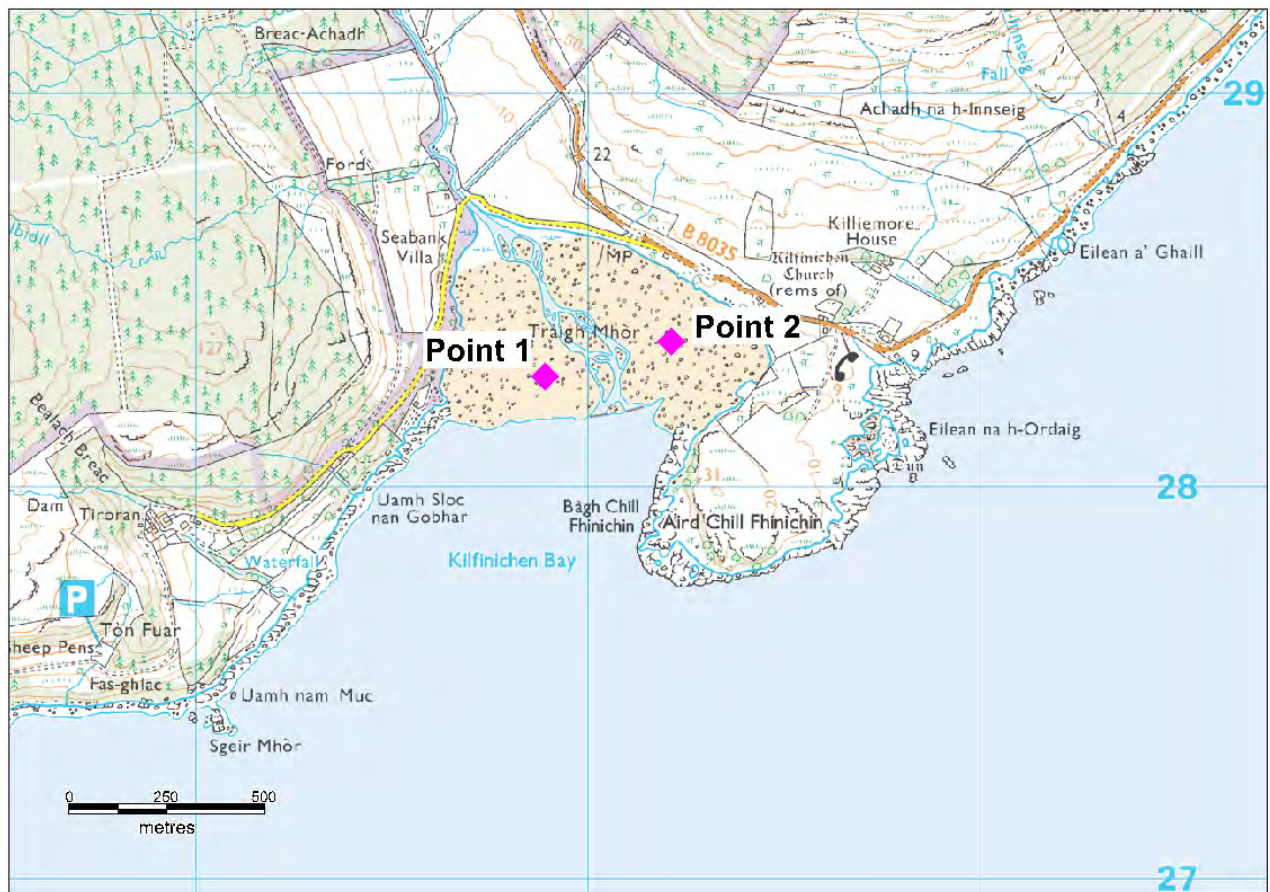
**Figure 15.1 Bacteriological survey sampling locations**

A bacteriological survey was undertaken at Kilfinichen Bay to help inform the assessment of spatial impacts from potential sources of contamination in the area. Sampling was undertaken by hand-raking on two occasions at two locations that had been sampled during the shoreline survey. The locations are shown in the map in Figure 15.1. The results, together with the geometric mean and maximum values for these at each site, are given in Table 15.1.

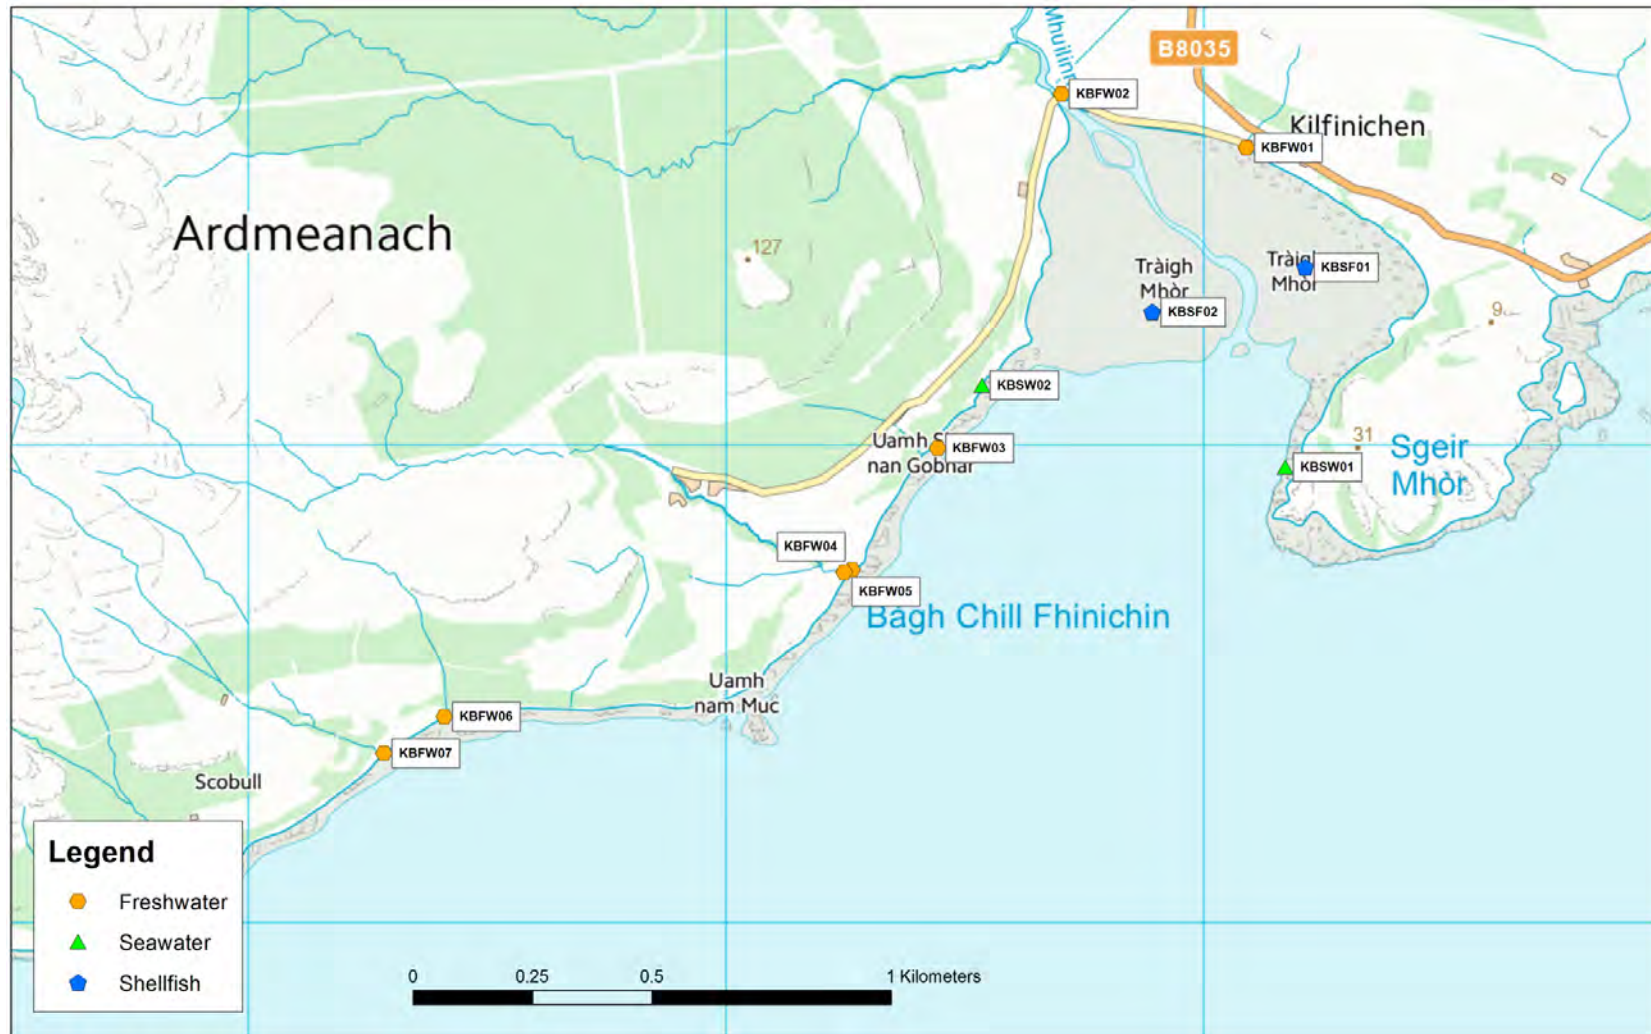
**Figure 2. Kilfinichen Bay sample locations**

Seawater and freshwater samples were collected from the locations marked in Figure 2. A total of seven freshwater and two seawater samples were collected. Both the seawater samples were from the planned locations on the east and west side of Kilfinichen Bay. All the planned freshwater samples were also collected, with one additional sample (KBFW04) taken from an outflow pipe at WP 26.

Two shellfish samples of common cockles (*Cerastoderma edule*) were taken from Kilfinichen Bay, one sample from the eastern side and one from the western side (see Figure 2).

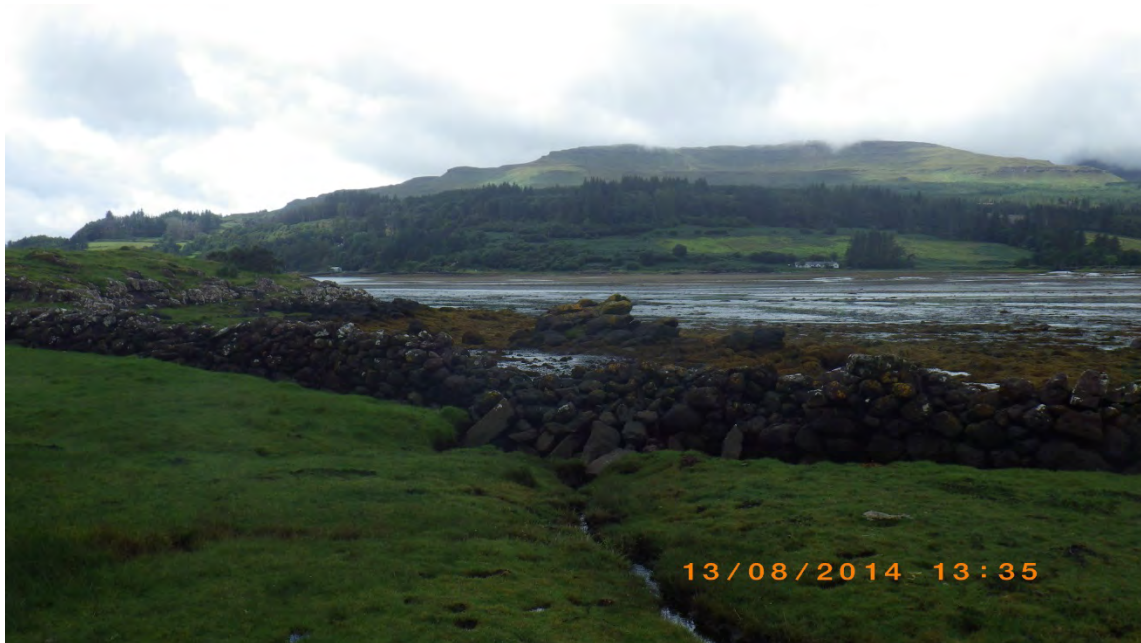
**Figure 3:** Kilfinichen Bay, looking to the South and West. Photo taken from WP 5

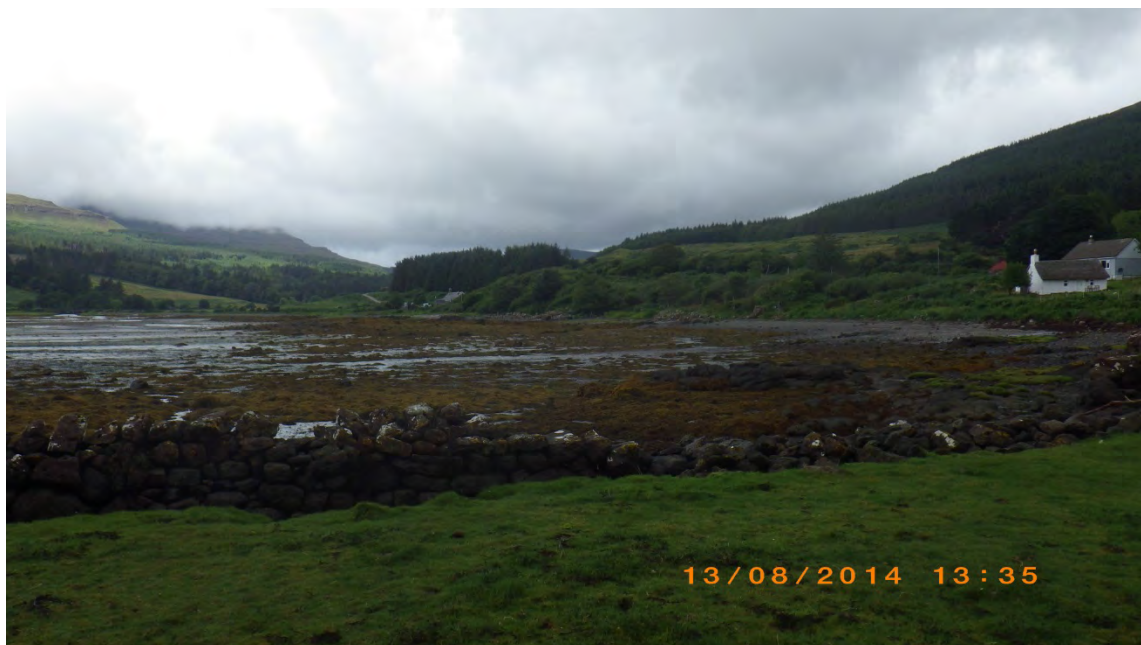
**Figure 4:** Kilfinichen Bay, looking to the North and East, also taken from WP 5

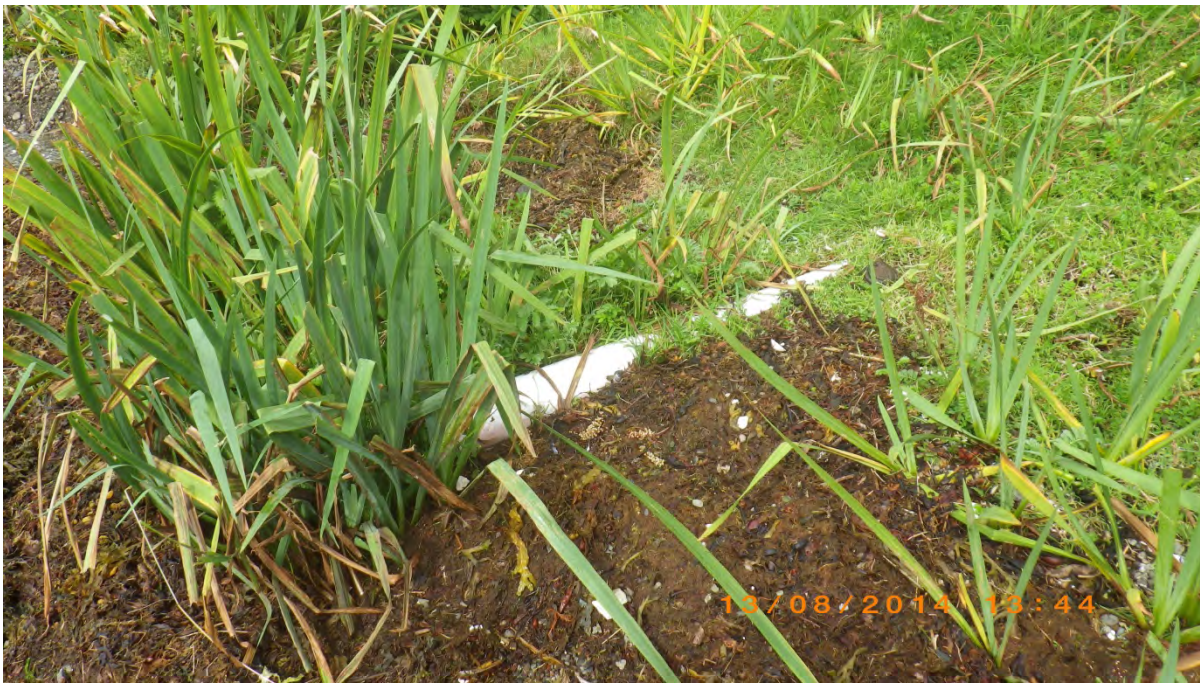
**Figure 5:** PVC pipe running to shoreline below house on shoreline. End obscured by reeds, but no discharge. WP 7

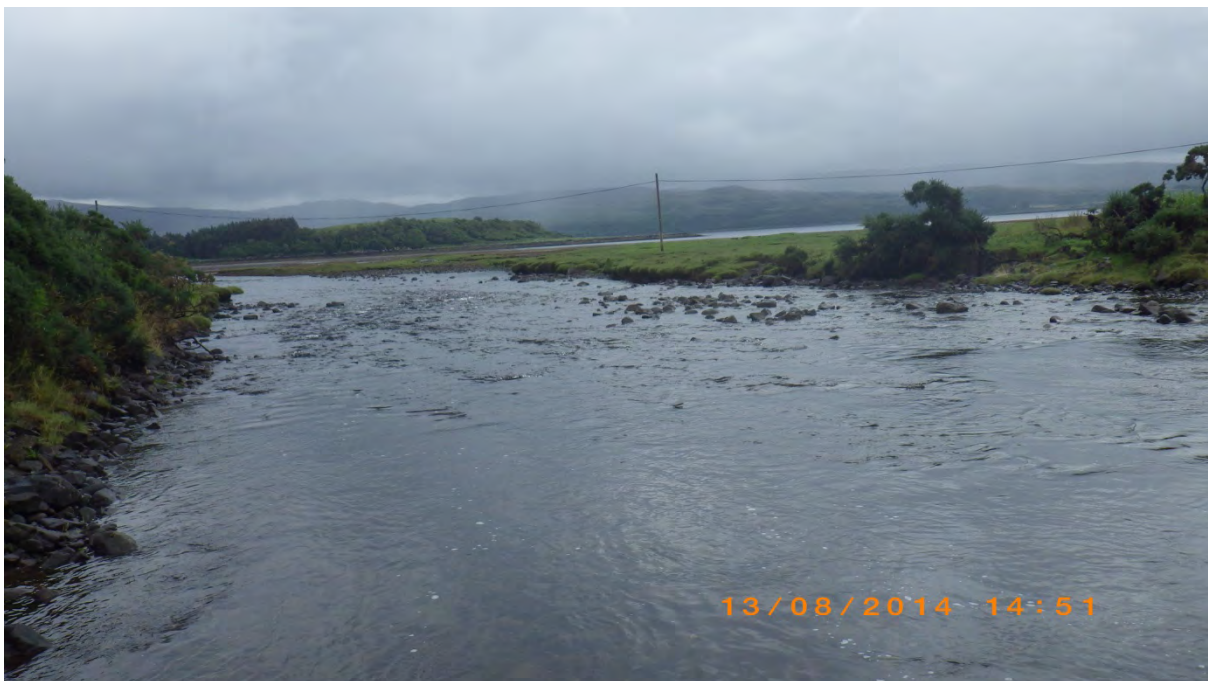
**Figure 6:** Abhainn Bail a Mhuilinn River, running into Kilfinichen Bay. Photo taken from road running over bridge, site of WP 13 & 14

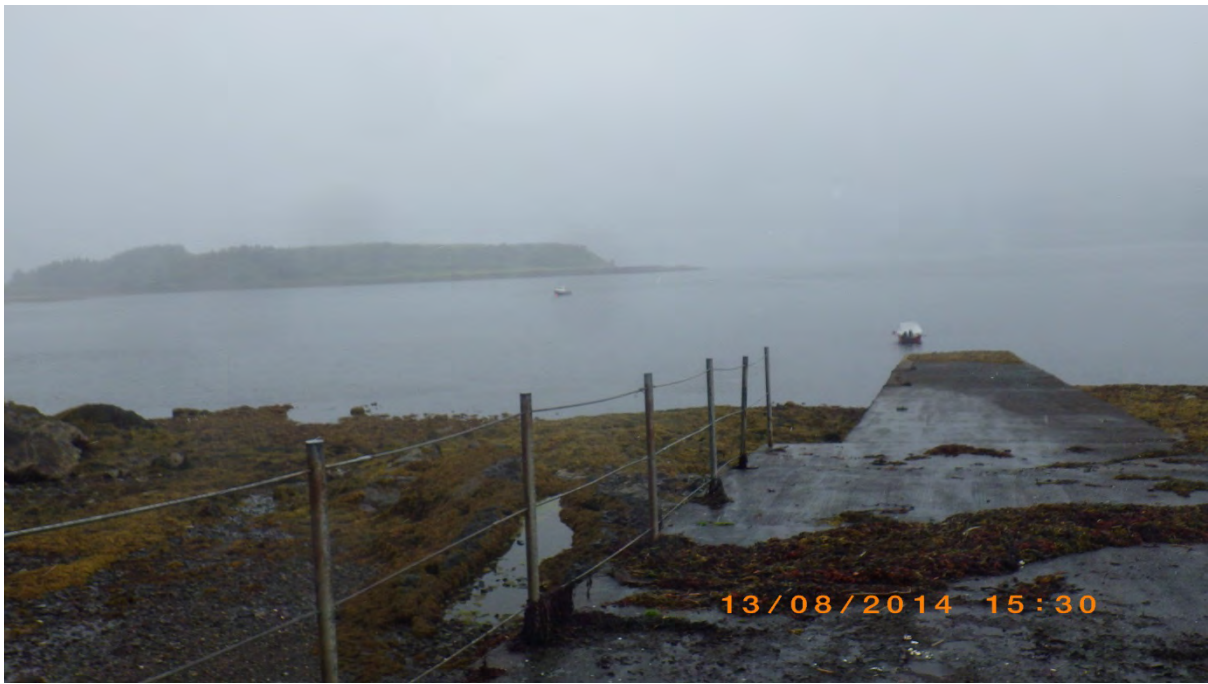
**Figure 7:** Pier and slipway (out of shot to left) at Uam nan Gobhar. Moorings with boats offshore (WP 21)

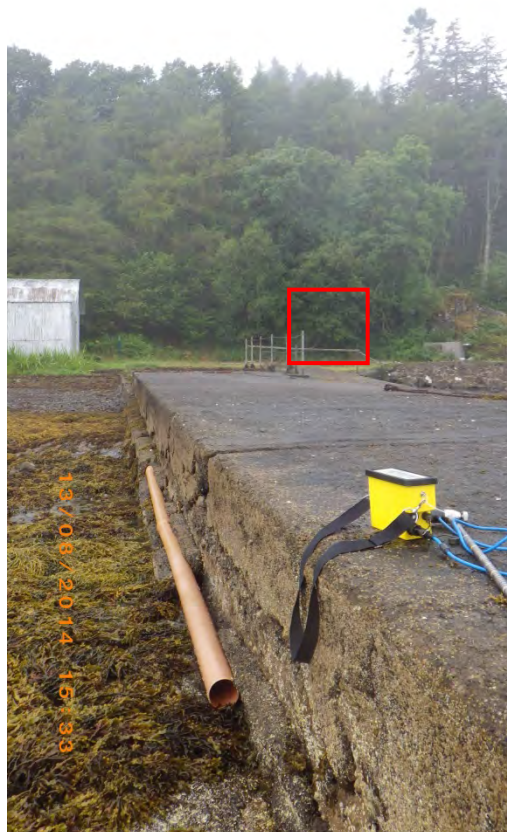
Observation 2 relates to a fibreglass septic tank with the outfall pipe observed alongside a concrete pier. No discharge was observed. This septic tank relates to CAR/R/1100348, which plots next to a small pier on the map.

**Figure 8:** PVC discharge pipe on side of pier, with fibre glass tank present on upper shoreline (centre right within red box). WP 22

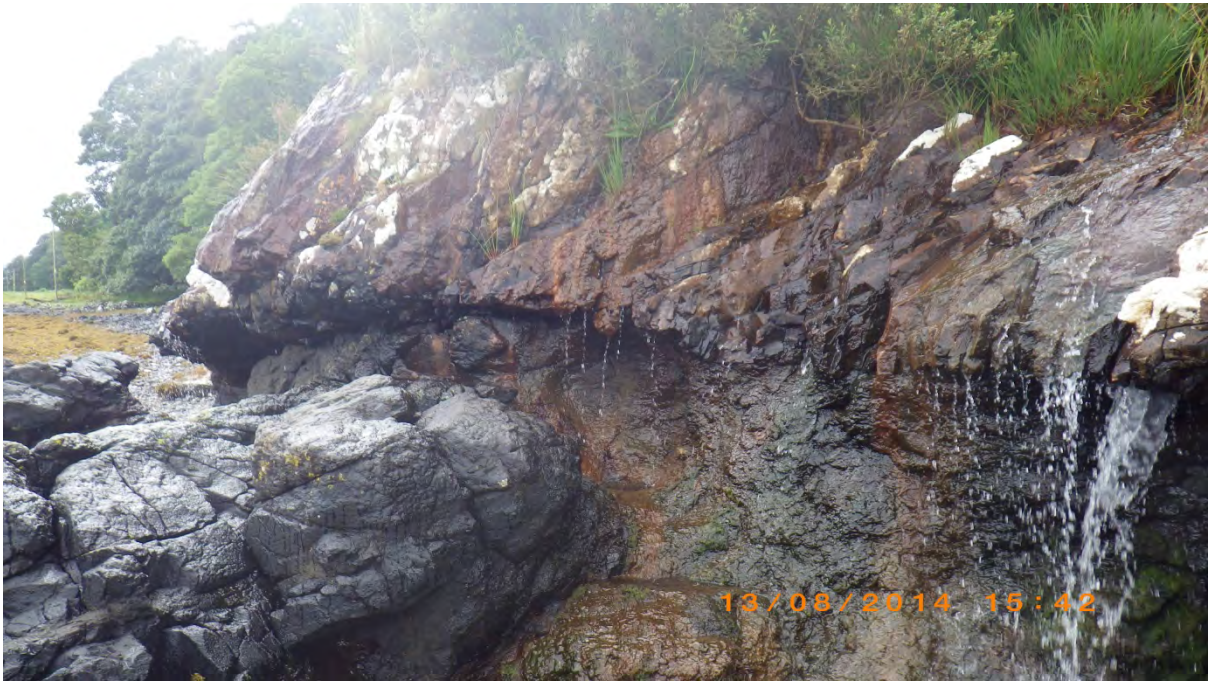
**Figure 9:** Stream encountered with dispersed flow over rocks and onto shore (WP 23 & 24)

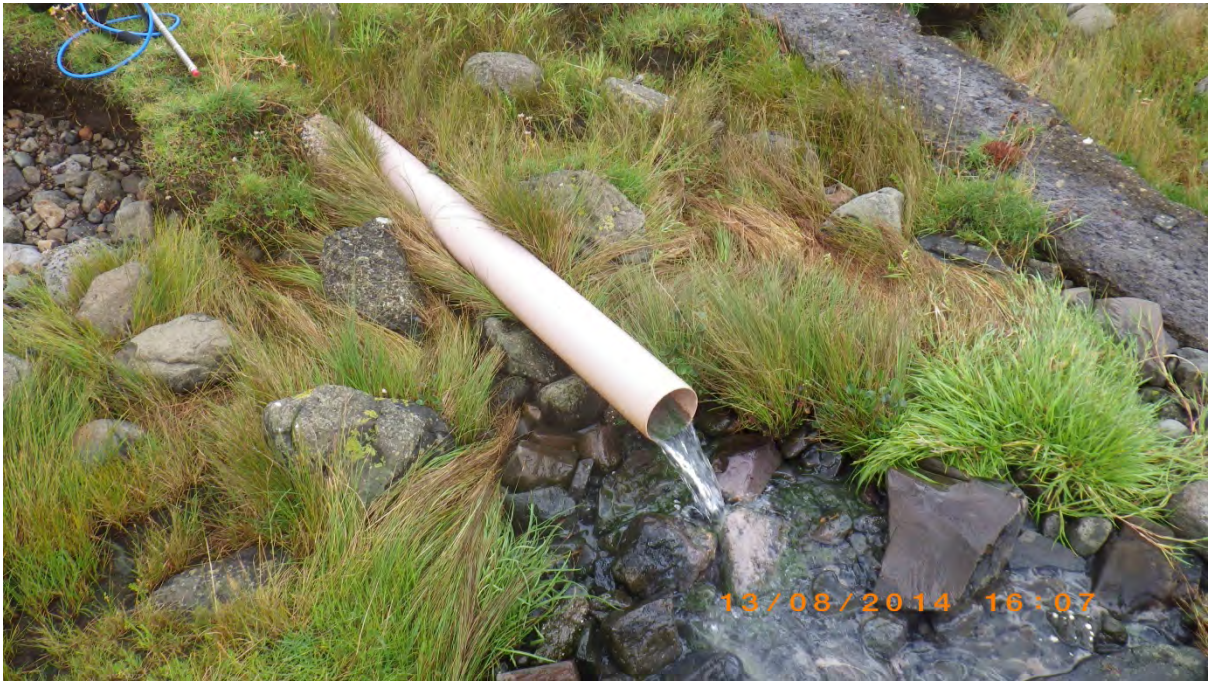
There is a small population on land adjacent to Kilfinichen Bay and a hotel was noted at Tiroran. Two STs with pipes were observed, but access difficulties prevented the surveyors from determining whether they were flowing. A seawater sample taken close to the end of one of the STs returned a moderately contaminated seawater result of 38 *E. coli* cfu/100 ml. A third pipe with no visible ST was noted within the bay itself, though the end was similarly not visible. A discharging sewage pipe was noted to the southwest of the bay and a freshwater sample taken from the flow returned exceedingly very high result of 10,000,000 *E. coli* cfu/100 ml, indicating marked sewage contamination.

**Figure 10:** Pipe present below hotel at Tiroran, with active discharge (WP 26)

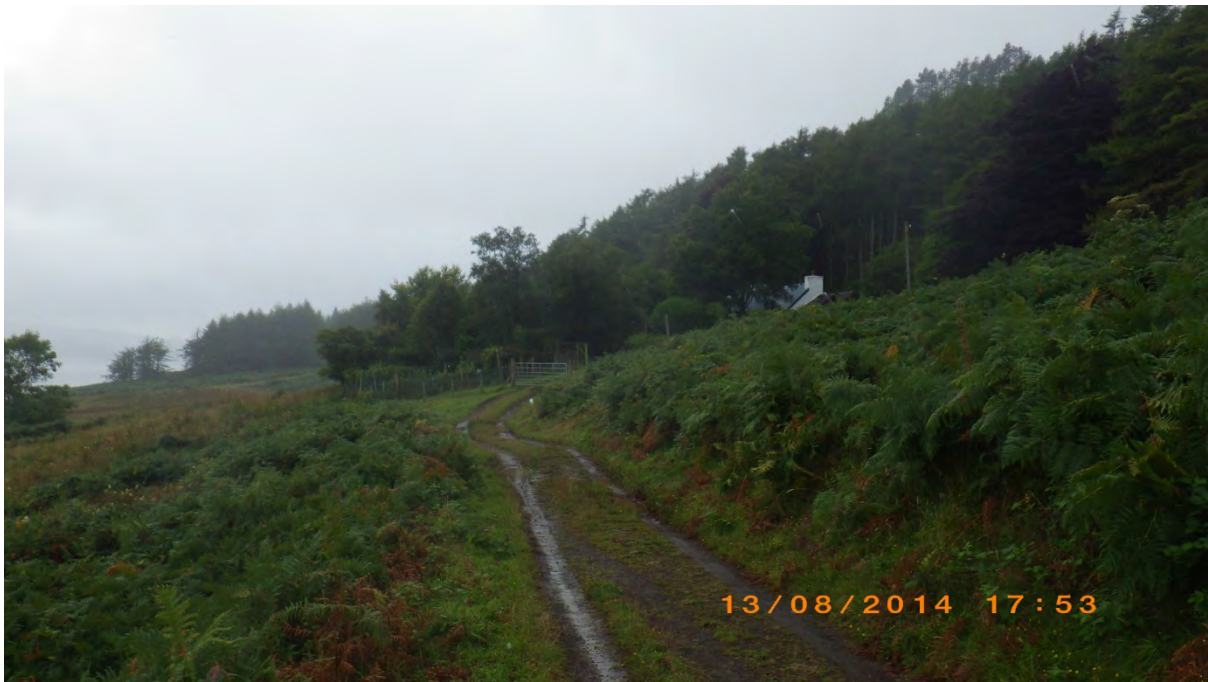
**Figure 11:** House at Scobull. No visible signs of septic tank or discharge (WP 33)

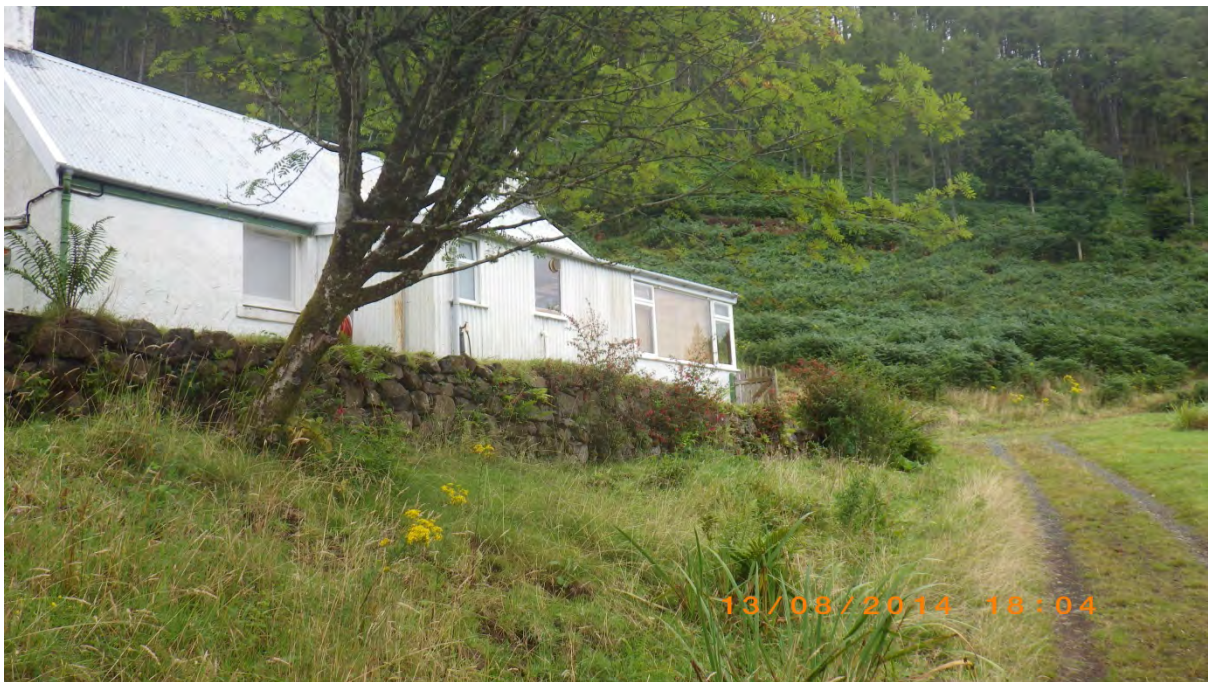
**Figure 12:** House at Co-Leathadan, where there were no visible signs of septic tank or discharge (WP 34)
