# Scottish Sanitary Survey Report

Loch Bay

SL-117-275-04

April 2014

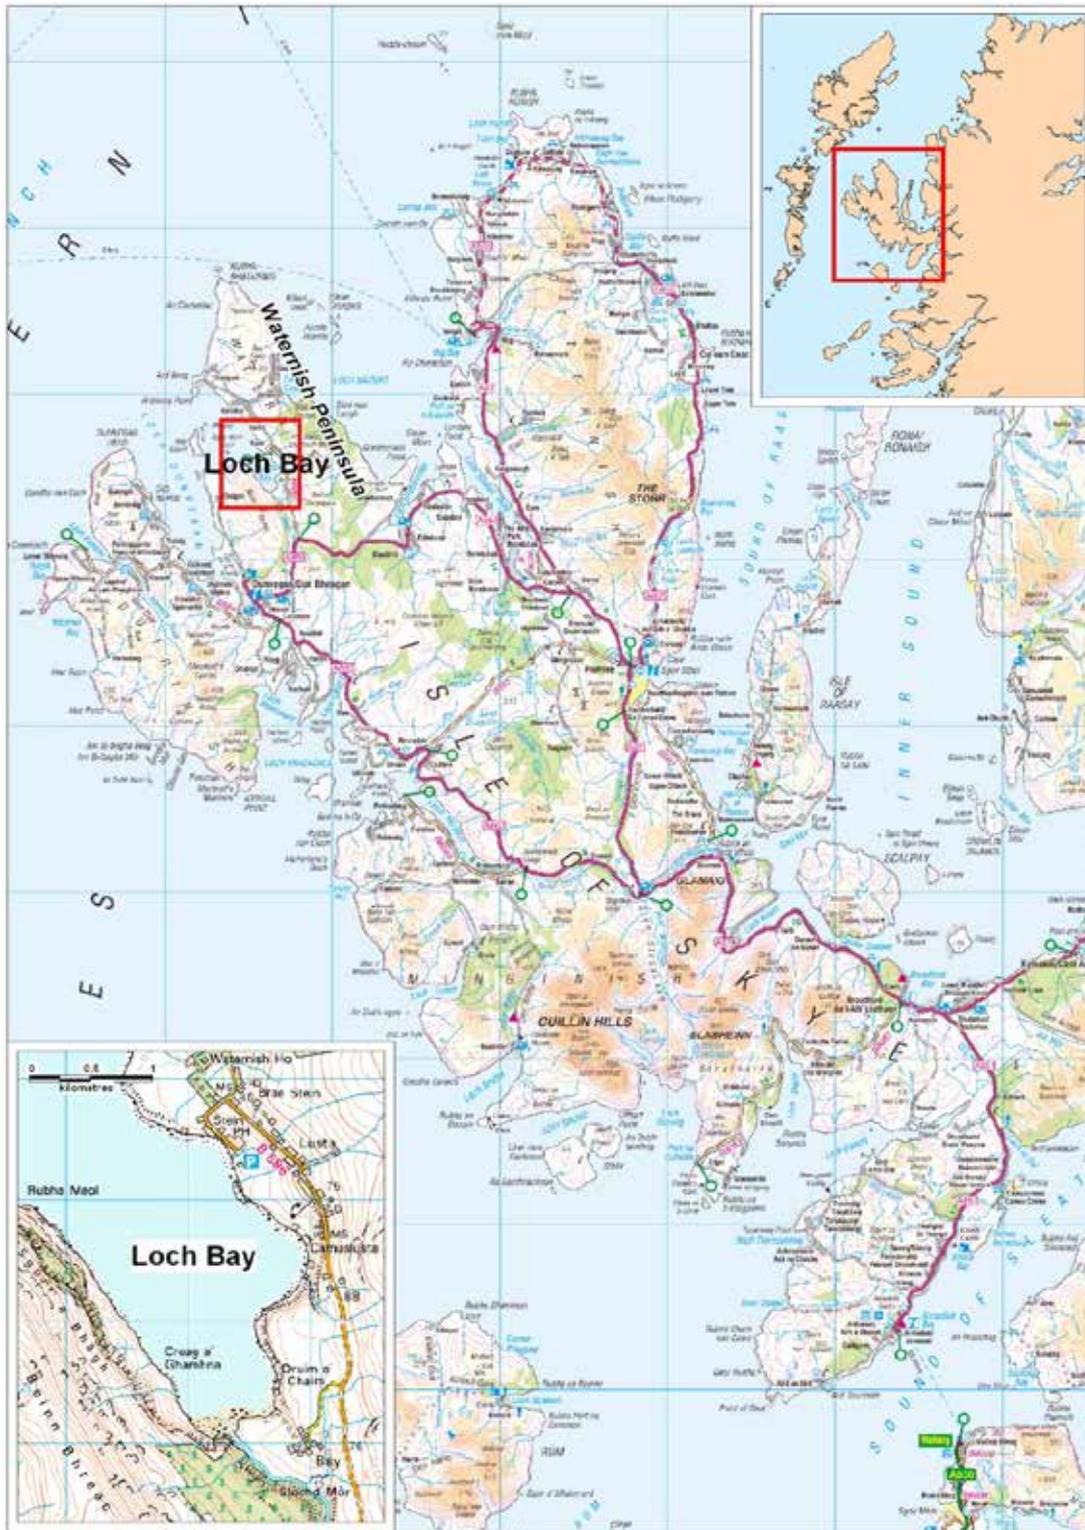
**Figure 1.1 Location of Loch Bay**

Loch Bay lies west of the Waternish peninsula, northern Isle of Skye, off the west coast of Scotland. The location of the area is shown in Figure 1.1. The Loch opens to the NW into outer Loch Dunvegan and the Little Minch. It is part of the Skye and Lochalsh area of the Highland Council.

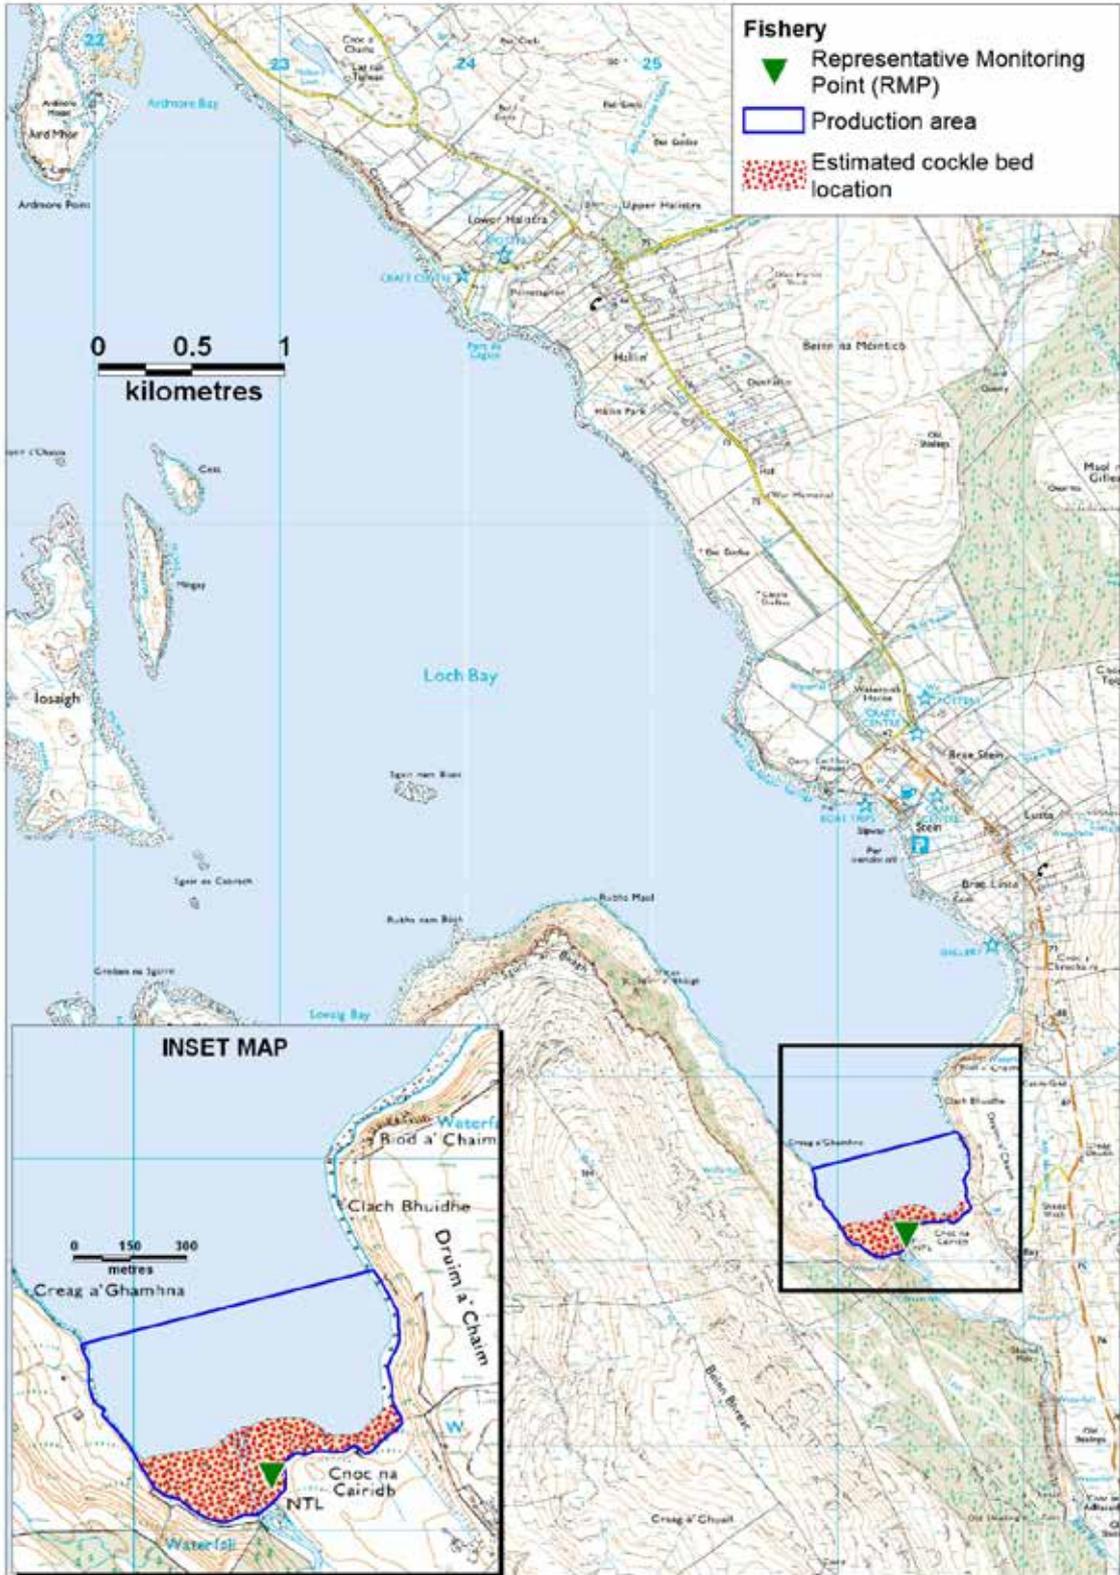
The production area is located in the SE corner of the loch, at the mouth of the Bay River. No information was found on the precise extent of the cockle bed. It is anticipated that cockles would be present (and harvested) throughout the intertidal sands within the production area. However, no information was found on cockle densities in the area. Locations of the cockle bed, production area and RMP are shown in Figure 2.1.

Few cockles were found during the shoreline survey, and these were small in size. Cockle numbers were reported to be lower toward the west side of the sands and highest numbers seen to the east of the Bay River, where the RMP is located.

**Figure 2.1 Loch Bay Area Fishery**

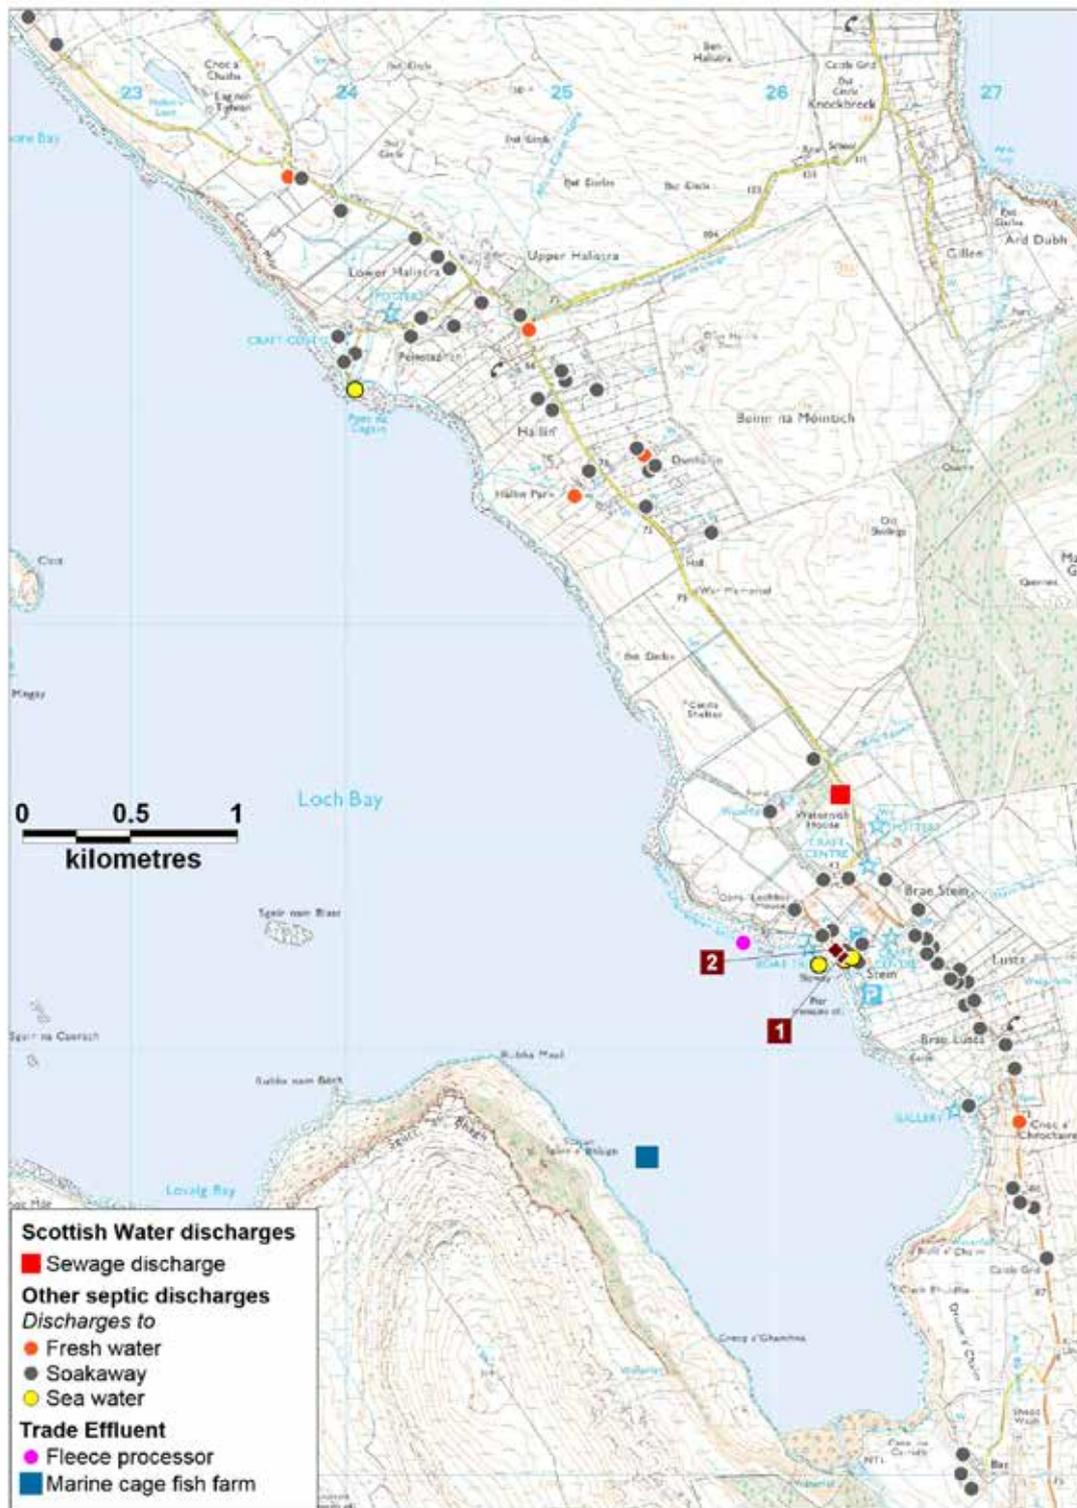
Three consented discharges were identified to Loch Bay at Stein and two to watercourses between Stein and the production area. The only discharge observed during the shoreline survey was recorded at Stein.

**Figure 4.1 Map of discharges for Loch Bay**

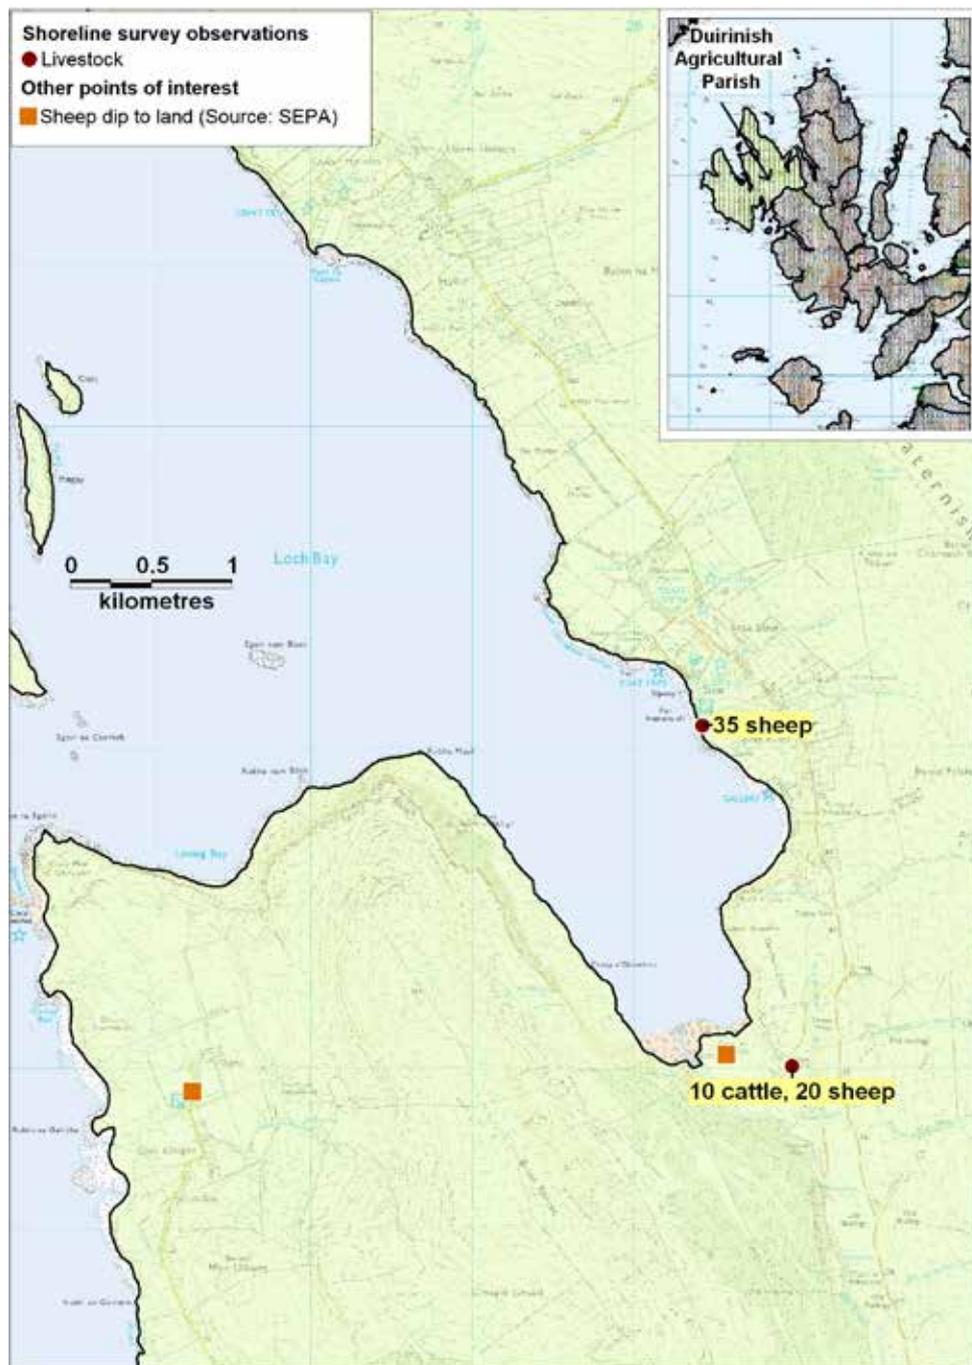
During the shoreline survey 10 cattle and 20 sheep in total were observed in the fields south of the fishery. On the eastern shoreline approximately 35 sheep were observed in fields inland from the survey route. The Ordnance Survey map identifies a cattle shelter on the eastern shoreline; however it was not confirmed during the shoreline survey whether this was still in use. Two sheep dips were located by SEPA in the area; the closest is located inland south of the production area, close to where the livestock were observed during the shoreline survey.

**Figure 5.1 Livestock observations at Loch Bay**

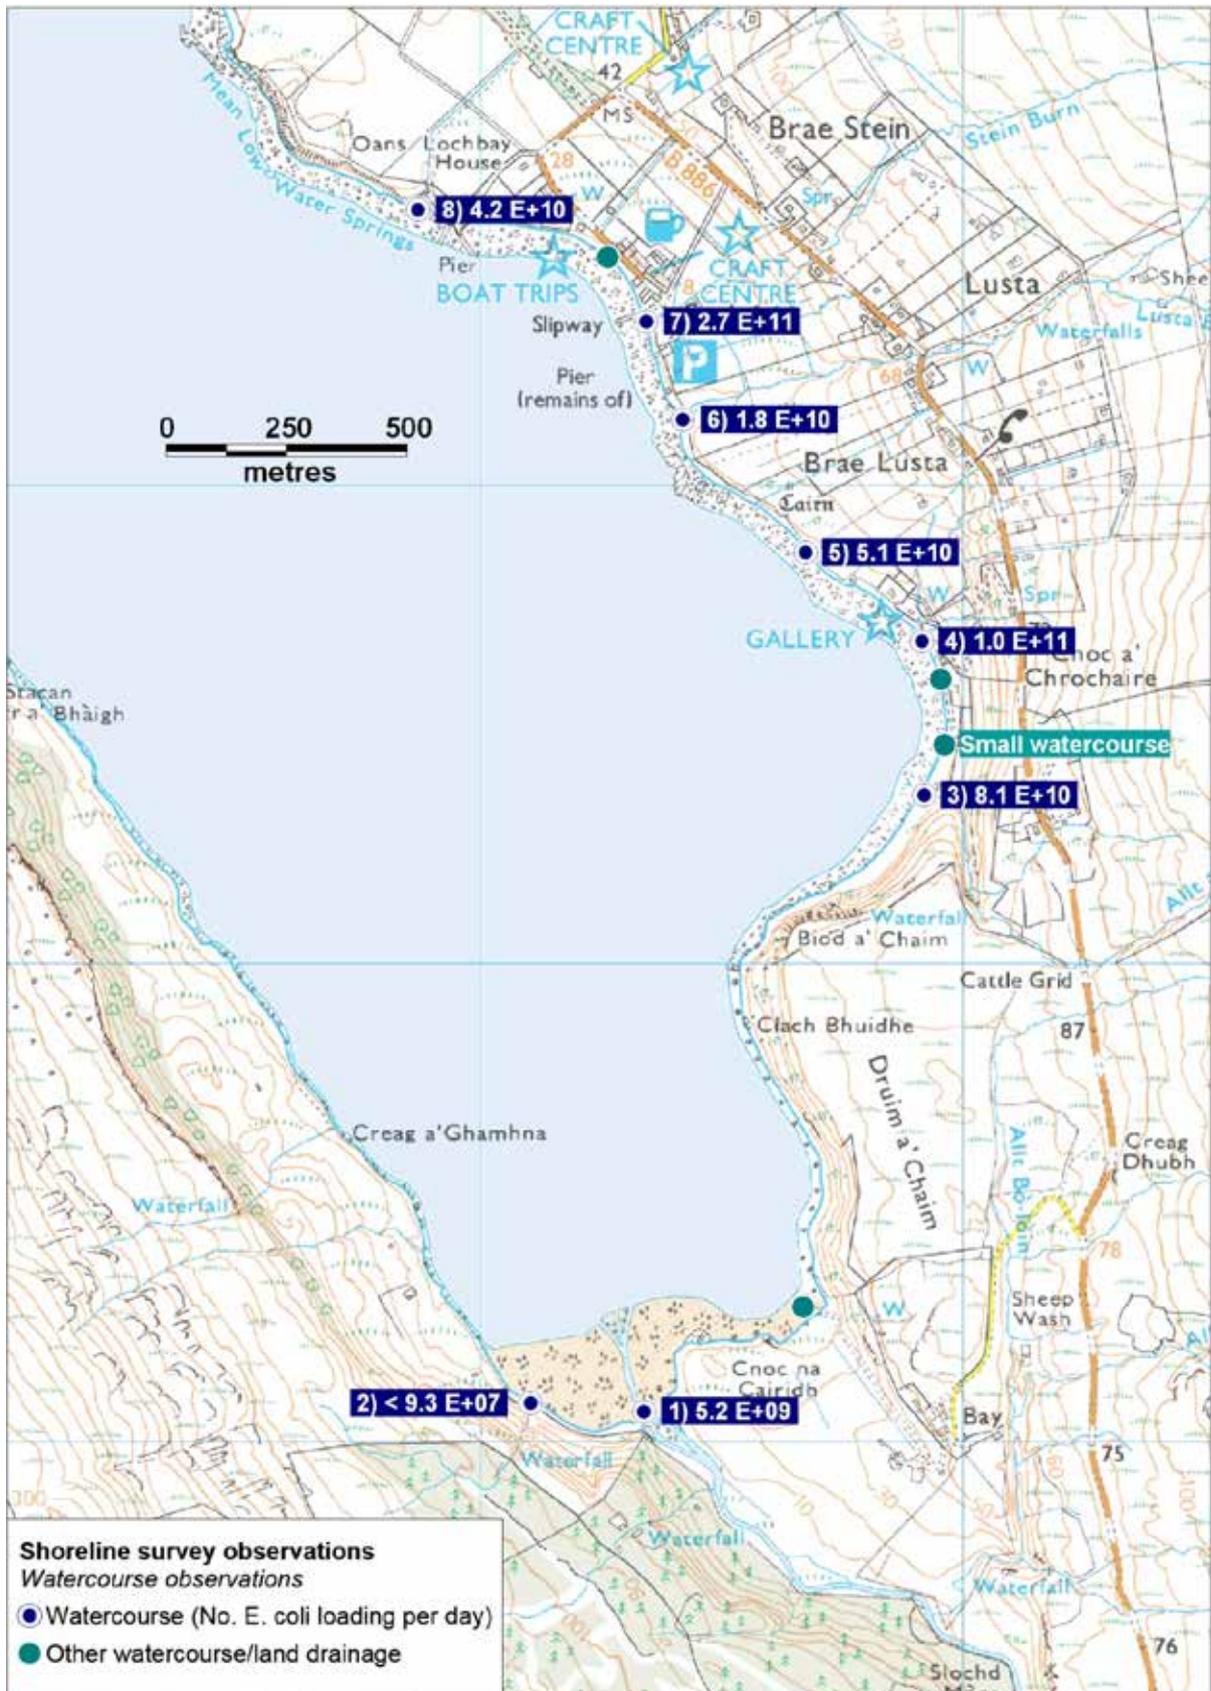
centre of the cockle bed and had an moderate estimated loading. An unnamed watercourse flows across the west end of the cockle bed and had an estimated loading two orders of magnitude lower than that of the Bay River. The Bay River drains a significantly larger catchment area that includes improved pasture area, which may explain the higher loading. The area of land drainage noted on shoreline adjacent to the eastern extent of the shellfish bed may represent a significant contamination source when flowing, as it drains an area that includes the houses identified at Bay and therefore could potentially carry diffuse contamination from human sources under very wet conditions.

Watercourses that flowed through the crofted areas around Stein were found to have the moderately to high loadings, with the highest loadings recorded from Stein Burn (2 km north of the cockle bed) and a small, unnamed watercourse adjacent to houses approximately 1.5km NE of the cockle bed.

The locations and loadings of measured watercourses as well as noted areas of land drainage are shown in Figure 8.1.

**Figure 8.1 Map of watercourse loadings at Loch Bay.**

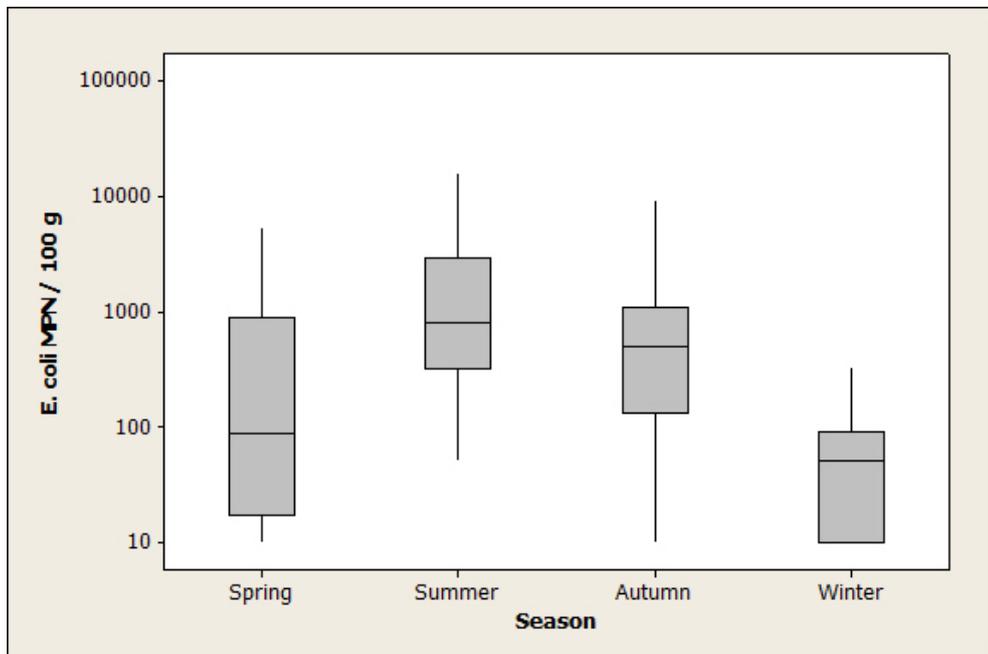
**Figure 11.4 Boxplot of *E. coli* results by season at Loch Bay**

A very highly statistically significant difference was found between *E. coli* results by season (one-way ANOVA,  $p = 0.001$ , Appendix 4). Using Tukey's method, results in

summer were found to be significantly higher than in spring and winter, and results in autumn were also found to be significantly higher than those in winter.

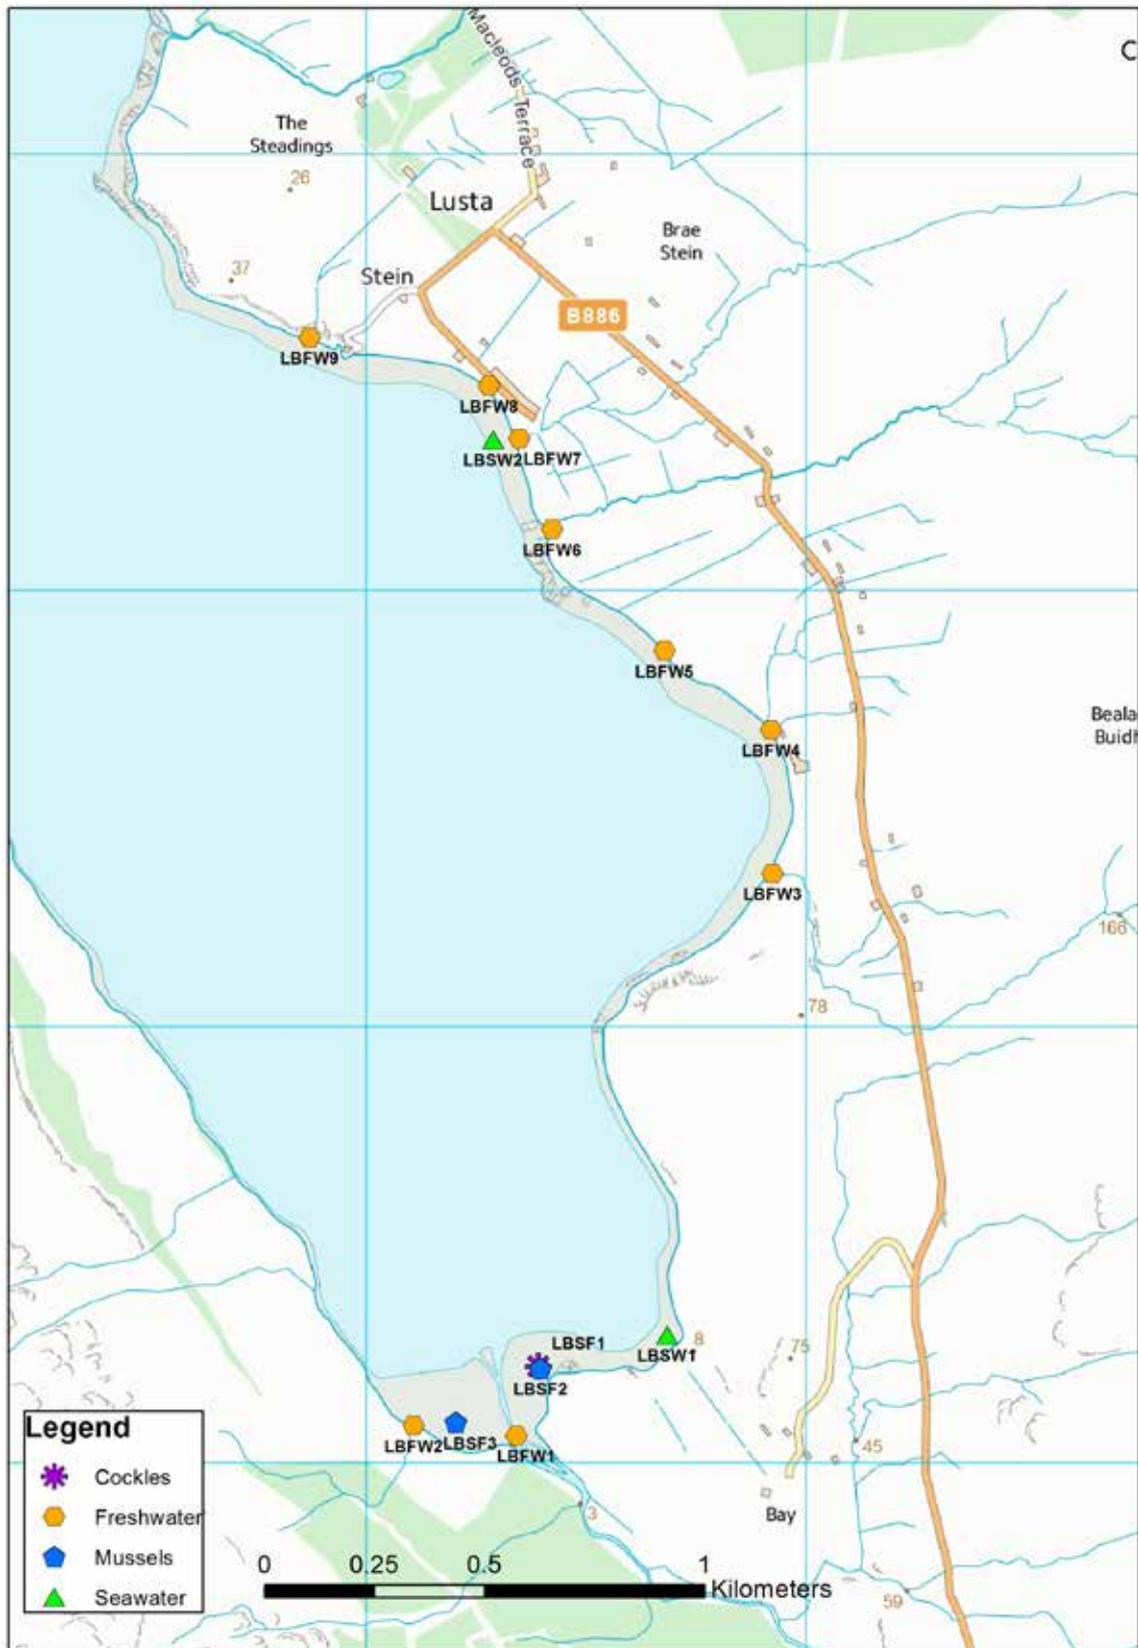
**Figure 2. Loch Bay samples**

Water and shellfish samples were collected at sites marked on the Loch Bay map shown in Figure 2.

One cockle sample was collected by the survey team from the shore at the head of Loch Bay during low tide. As stated in the observation table above, cockles were extremely sparse and the majority of cockles that were found were predominantly small. Therefore it was only possible to take one cockle sample instead of the planned three. Due to the scarcity of cockles, two common mussel samples were also collected. These were taken from rocks on the shore at the east and west side of the head of Loch Bay as illustrated in Figure 2.

No.	Date	Sample	Grid Ref	Type	E. coli (MPN/100g)
1	21/10/2013	LBSF1	NG 26390 54221	Cockles	<20
2	21/10/2013	LBSF2	NG 26395 54216	Mussels	<20
3	21/10/2013	LBSF3	NG 26203 54092	Mussels	50

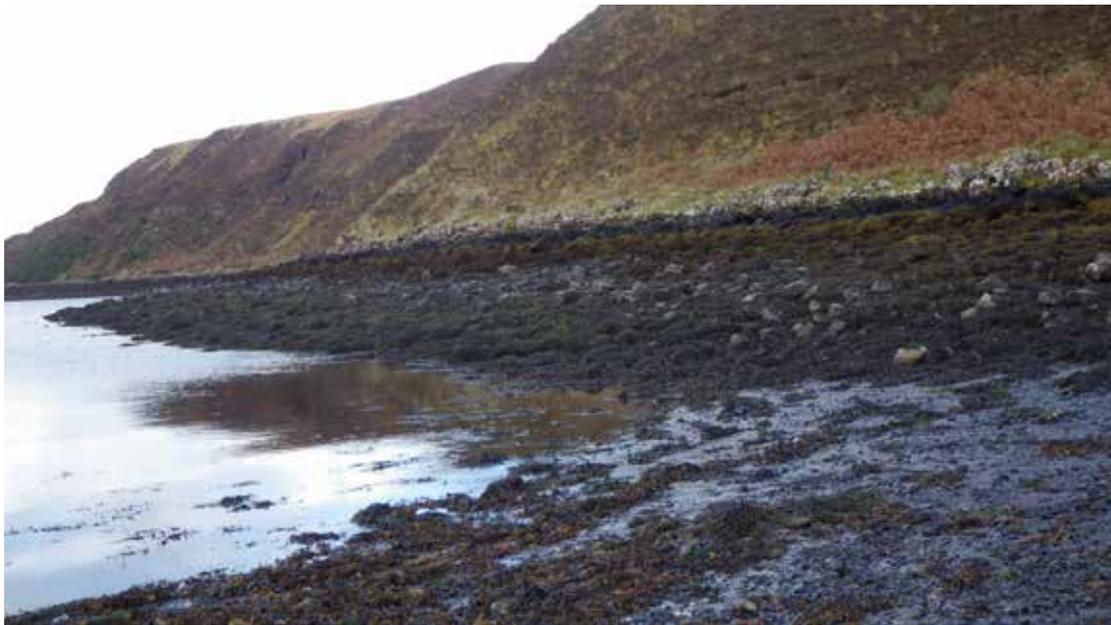
Figure 3. Seawater sample LBSW1 from the head of Loch Bay on the east shore. Associated with waypoint 2.

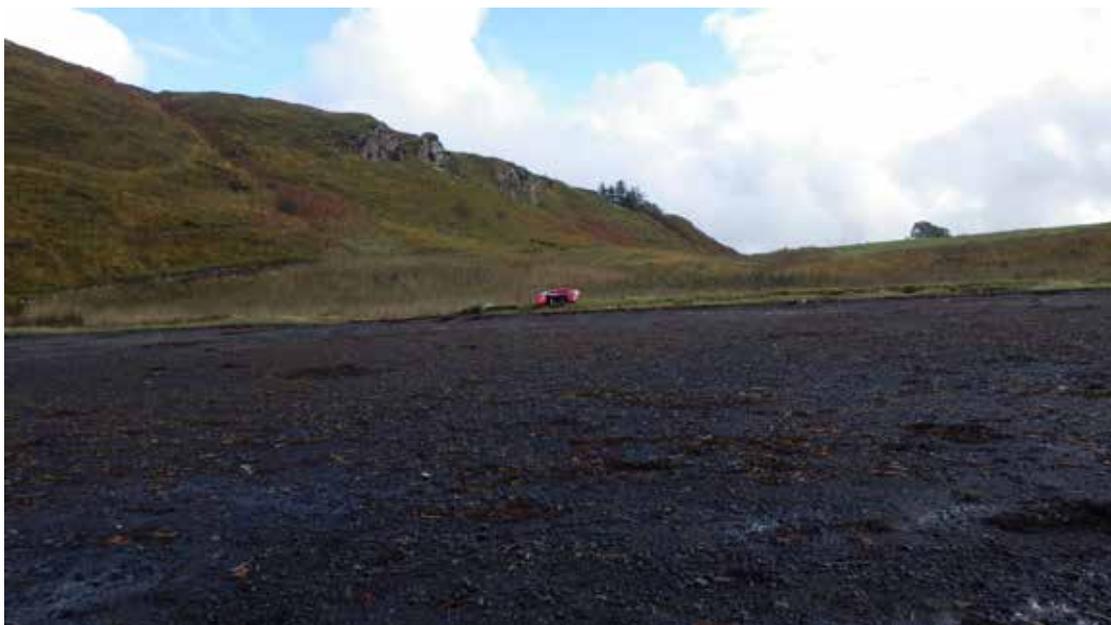
Figure 4. Inflatable RIB on upper shore. Associated with waypoint 4.

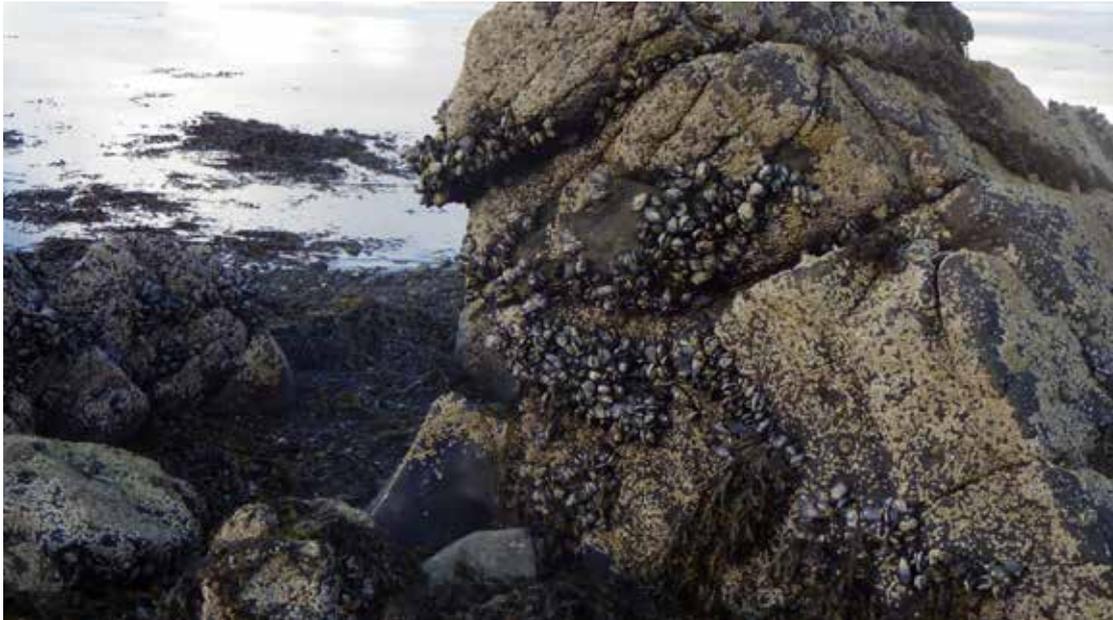
Figure 5. Extra shellfish sample LBSF2 taken from shore mussels as cockles were very small and sparse. Associated with waypoint 6.

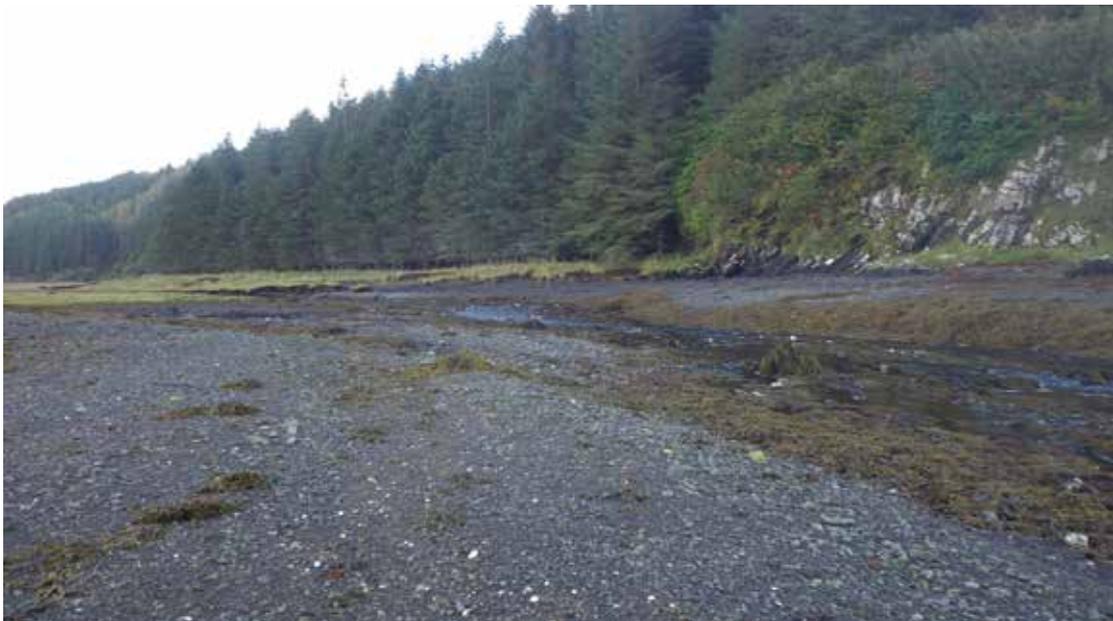
7	21/10/2013	16:22	NG 26348 54076	126348	854077	Figure 6		Attempted search for cockles at mouth of river. None found. Four seagulls on shore. Three cows on grassland above shore.
8	21/10/2013	16:24	NG 26360 54088	126361	854088			Attempted search for cockles. None found.
9	21/10/2013	16:27	NG 26341 54062	126341	854063		LBFW1	Planned freshwater sample from Bay River at head of Loch Bay. Sample associated with waypoint 10.
10	21/10/2013	16:31	NG 26340 54064	126340	854065			Watercourse Width - 4.23 m. East shore measurements: Depth - 21 cm; Flow - 0.291 m/s; SD - 0.010. West shore measurements: Depth - 25 cm; Flow - 0.120 m/s; SD - 0.008.
11	21/10/2013	16:43	NG 26318 54140	126318	854140	Figure 7		Site of attempted cockles search (20 mins). No cockles found.
12	21/10/2013	16:46	NG 26346 54073	126346	854073			Site of attempted cockles search. No cockles found.
13	21/10/2013	17:01	NG 26203 54092	126204	854092		LBSF3	Mussel sample taken in absence of cockle samples on west shore of Loch Bay.

Figure 6. Site of attempted search for cockles at mouth of river. Associated with waypoint 7.

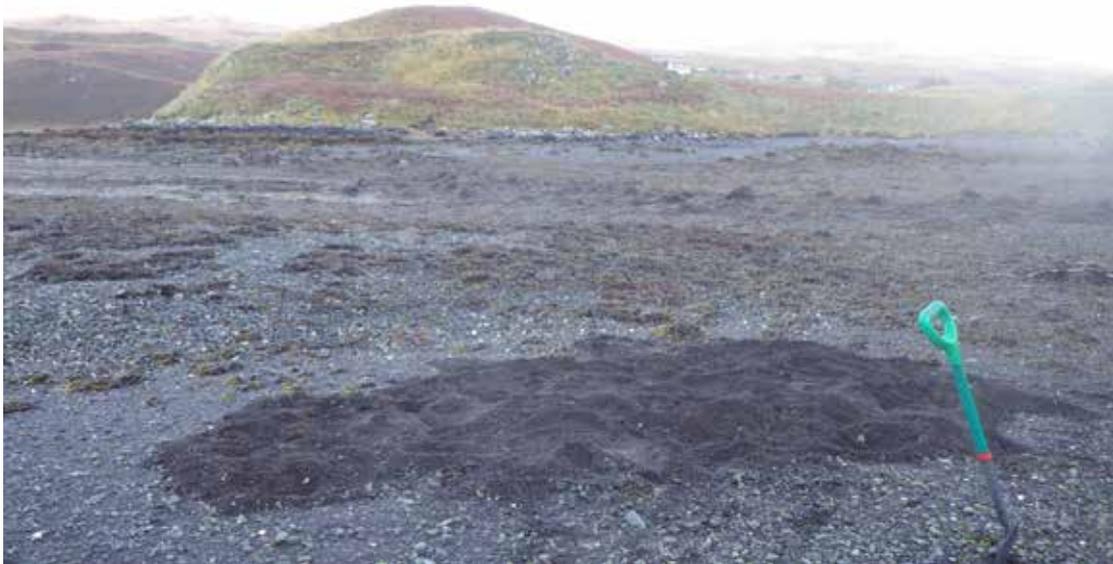
Figure 7. Site of attempted search for cockles. Associated with waypoint 11.

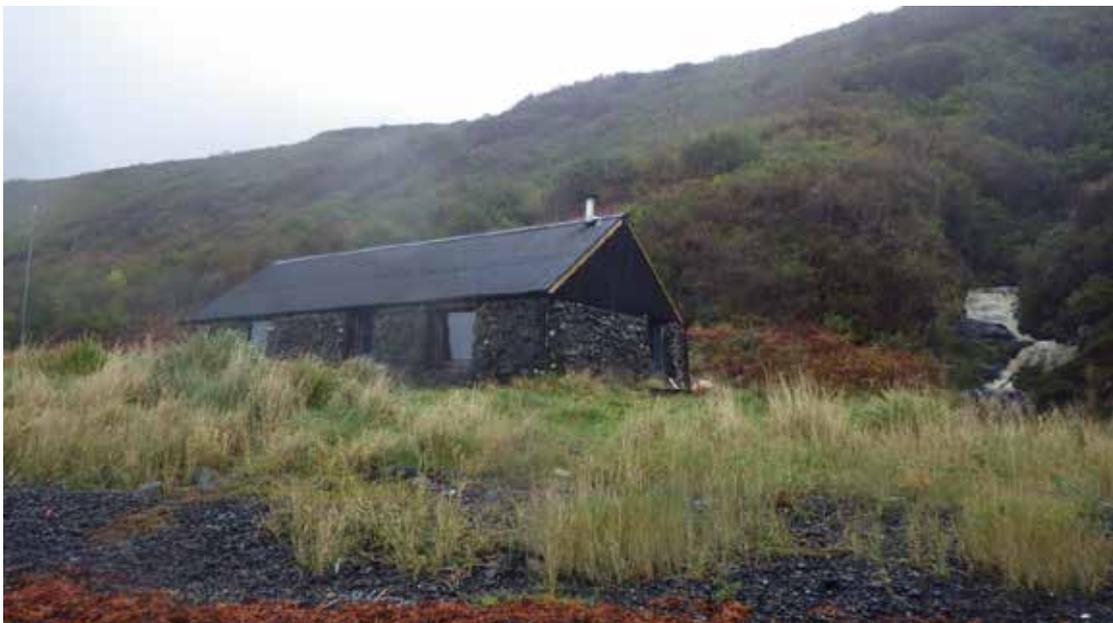
Figure 8. Planned freshwater sample LBFW3 taken from river (Allt a' Chaim) running next to house. Associated with waypoint 17.

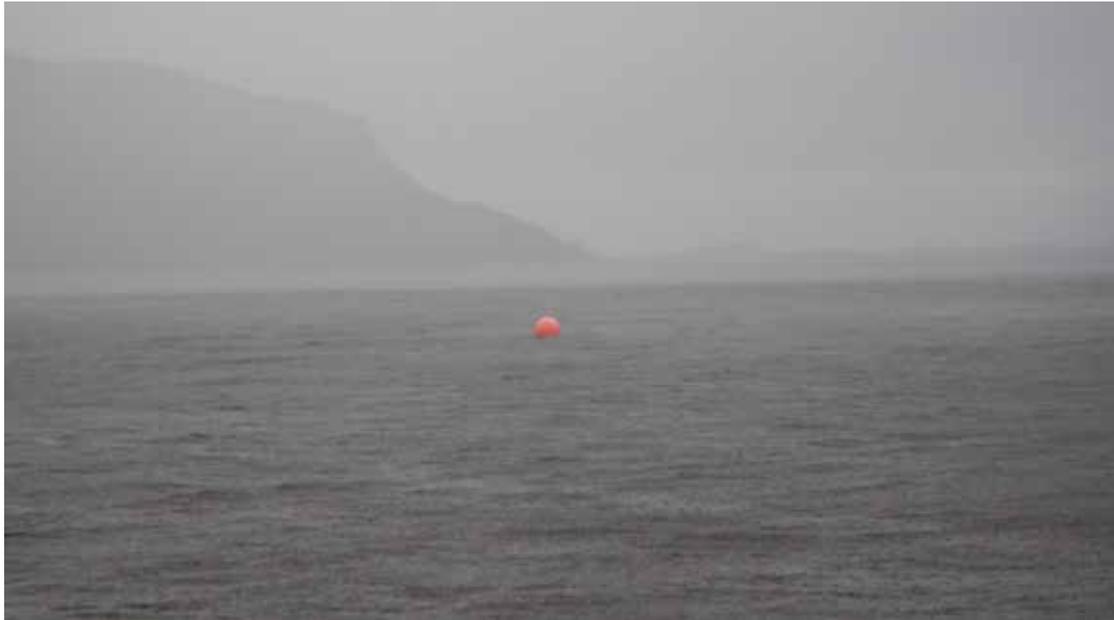
19	22/10/2013	11:02	NG 26936 55404	126936	855404	Figure 9		Boat above shore and one mooring in bay.
20	22/10/2013	11:07	NG 26963 55461	126963	855461			Stream running down from hillside, not sampled as hillside clear of housing and livestock and the property next to watercourse had no pipe running into it.
21	22/10/2013	11:11	NG 26956 55598	126956	855598			Very shallow ground drainage running from hillside, not sampled.
22	22/10/2013	11:14	NG 26920 55679	126921	855680	Figure 10	LBFW4	Planned freshwater sample from unnamed burn. Sample associated with waypoint 23.
23	22/10/2013	11:14	NG 26917 55676	126918	855677			Burn measurements: Width - 80 cm; Depth - 12 cm; Flow - 1.307 m/s; SD - 0.025. Houses adjacent to burn, no pipes visible on foreshore. No birds or wildlife.
24	22/10/2013	11:27	NG 26678 55861	126678	855861		LBFW5	Planned freshwater sample from small unnamed burn running off hillside. Sample associated with waypoint 25.

Figure 9. One mooring in bay. Associated with waypoint 19.

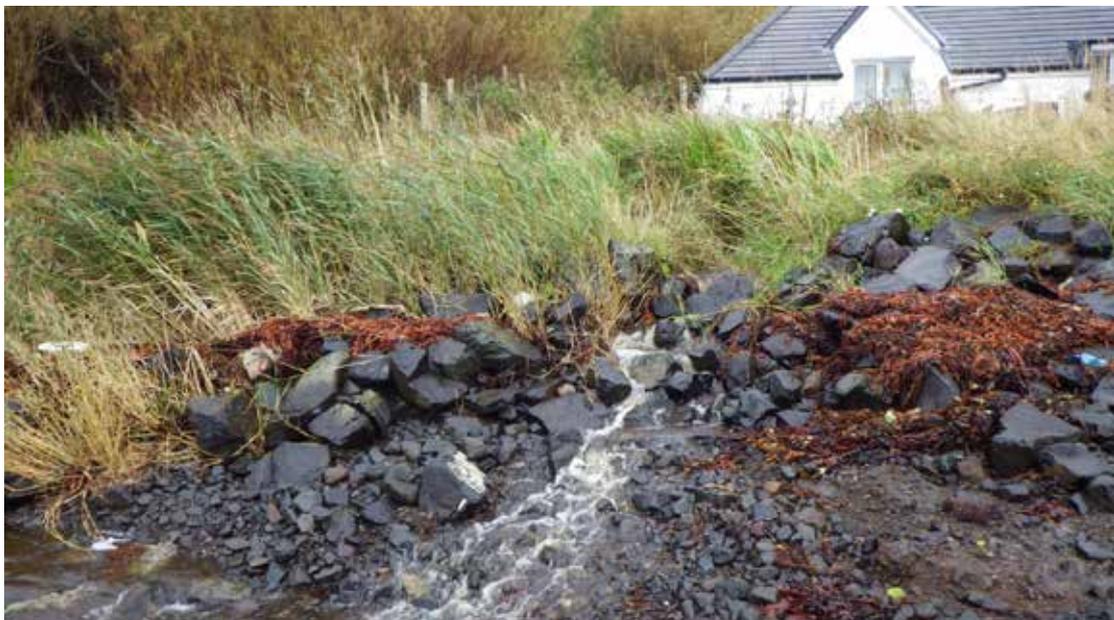
Figure 10. Planned freshwater sample LBFW 4 from unnamed burn. Associated with waypoint 22.

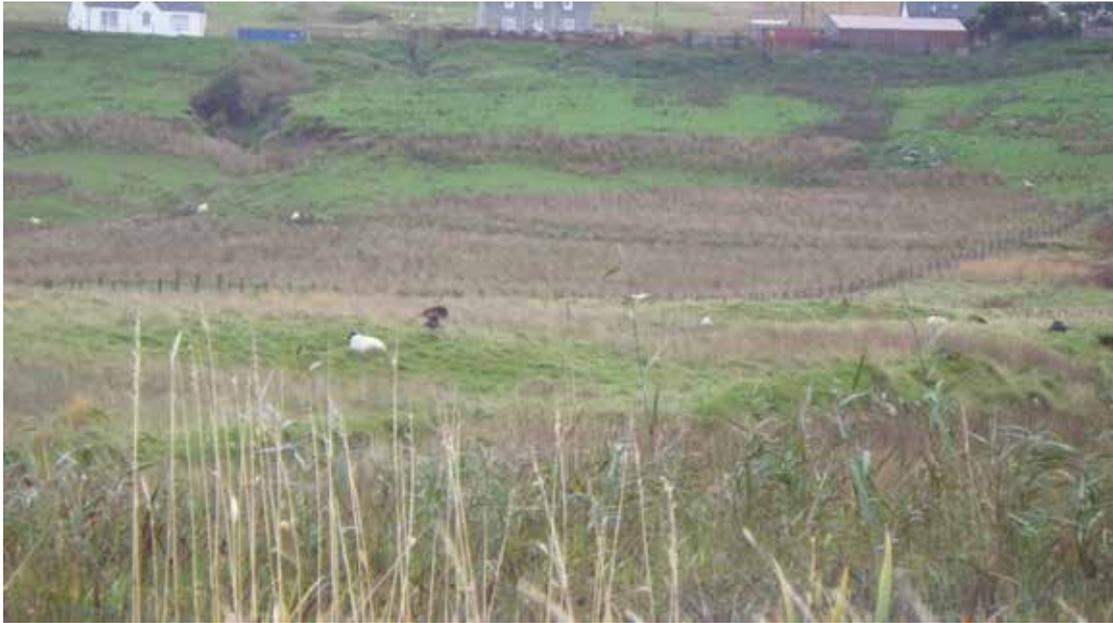
Figure 11. Approximately thirty five sheep in field immediately above Lusta Burn. Associated with waypoint 27.

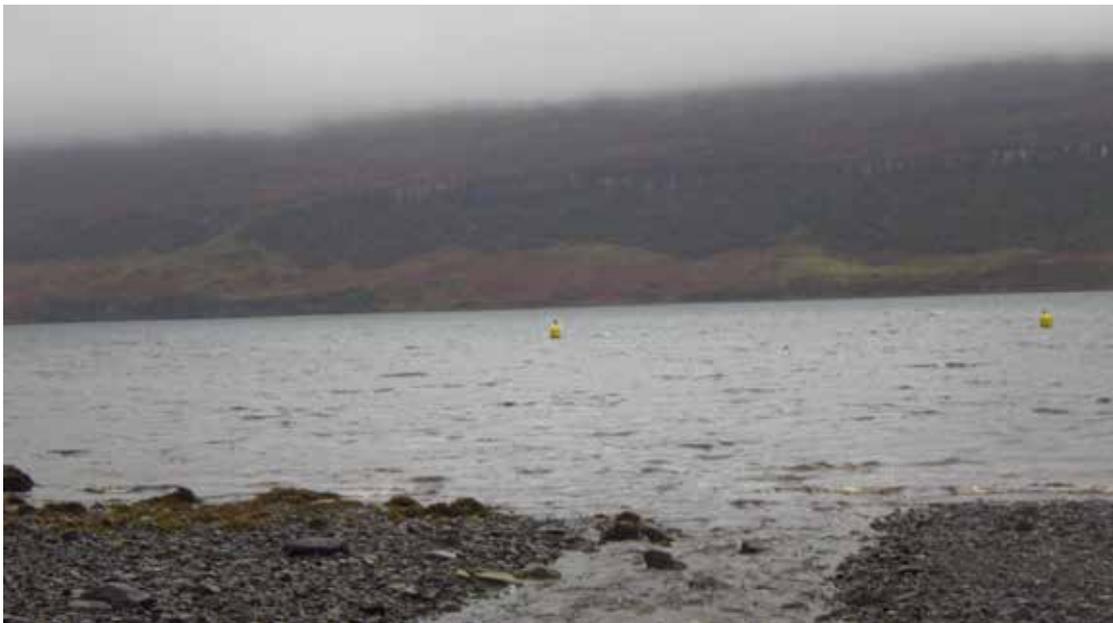
Figure 12. Unplanned freshwater sample LBFW7 from Stein Burn. Associated with waypoint 28.

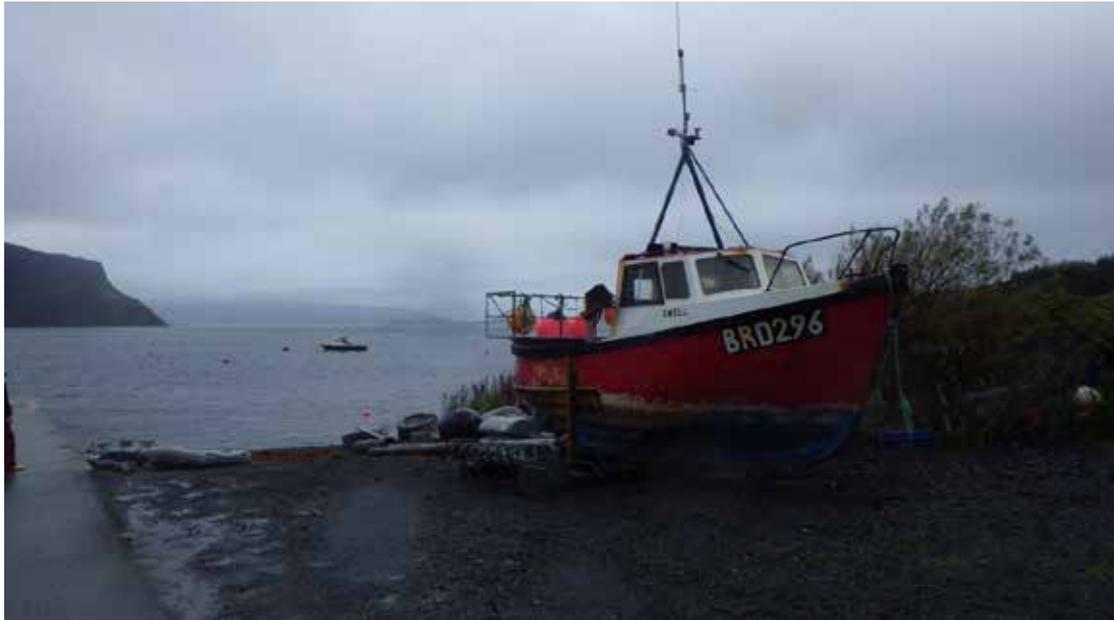
Figure 13. Eleven moorings in bay, access to slipway, one pleasure craft moored, twelve smaller vessels on shore. Associated with waypoint 31.

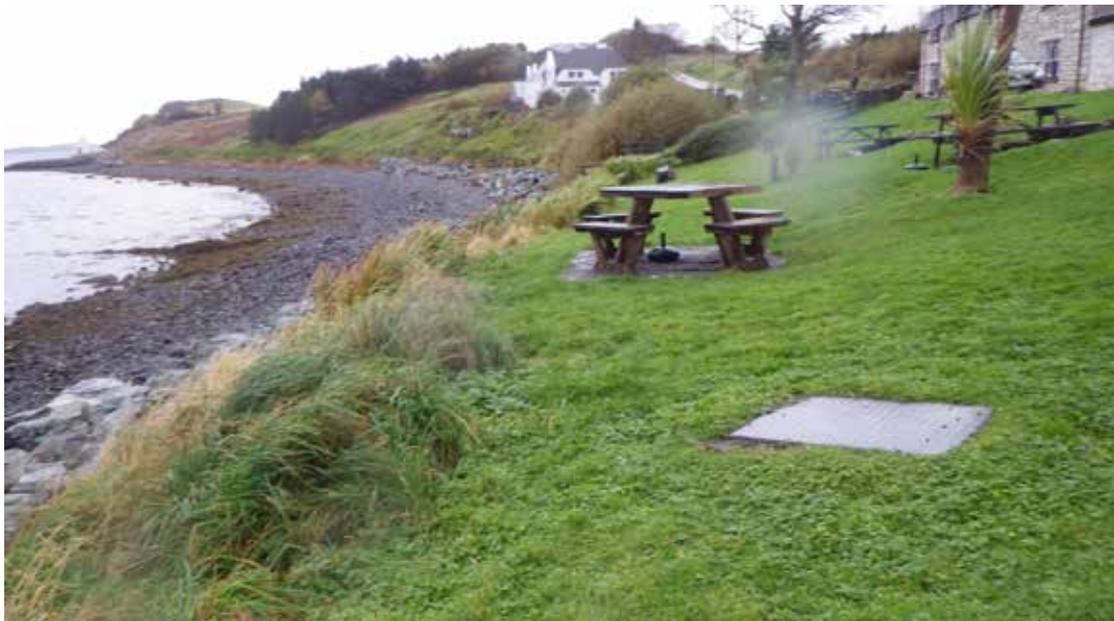
Observation 1 reports a manhole cover above the shore at Stein. No discharge was noted but several consents plot in the vicinity and this probably serves as an inspection point for one of them.

Figure 14. Manhole cover above shore, below Stein Inn. No discharges onto shore below. Associated with waypoint 32.

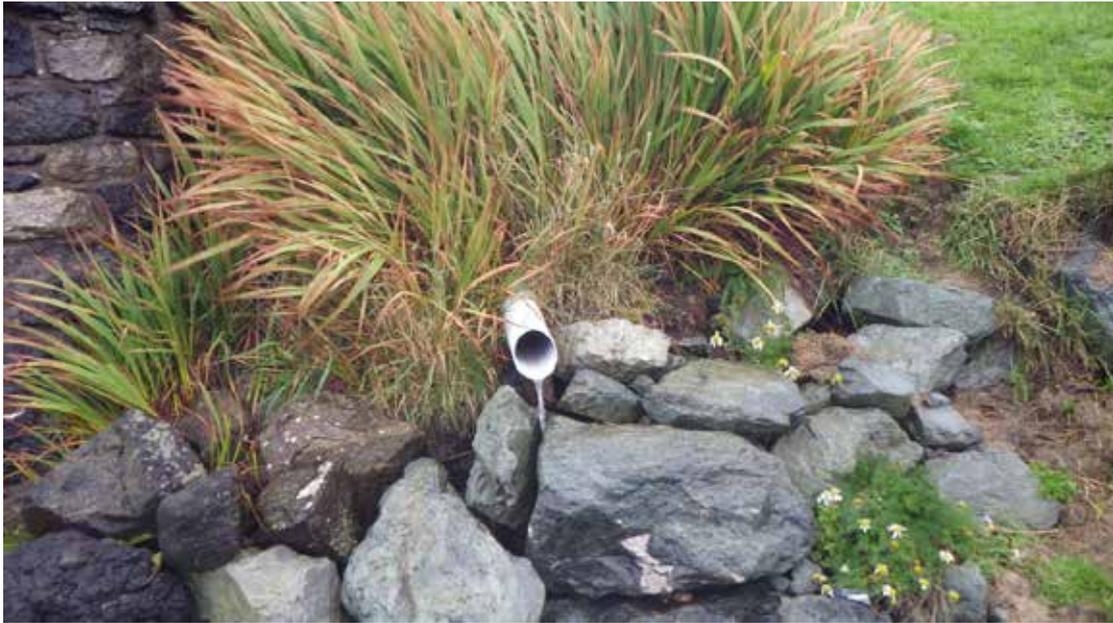
No.	Date	Associated Photograph (Appendix 5)	<i>E. coli</i> (cfu/100ml)	Description
1	22/10/2013	Fig14	-	Manhole cover above shore, below Stein Inn. No observed discharges onto shore below.
2	22/10/2013	Fig15	5000	Sample taken from 10cm UPVC pipe draining onto foreshore (contaminated).

Figure 15. Unplanned freshwater sample LBFW 8 taken from 10cm UPVC pipe draining onto foreshore (contaminated). Associated with waypoint 33.

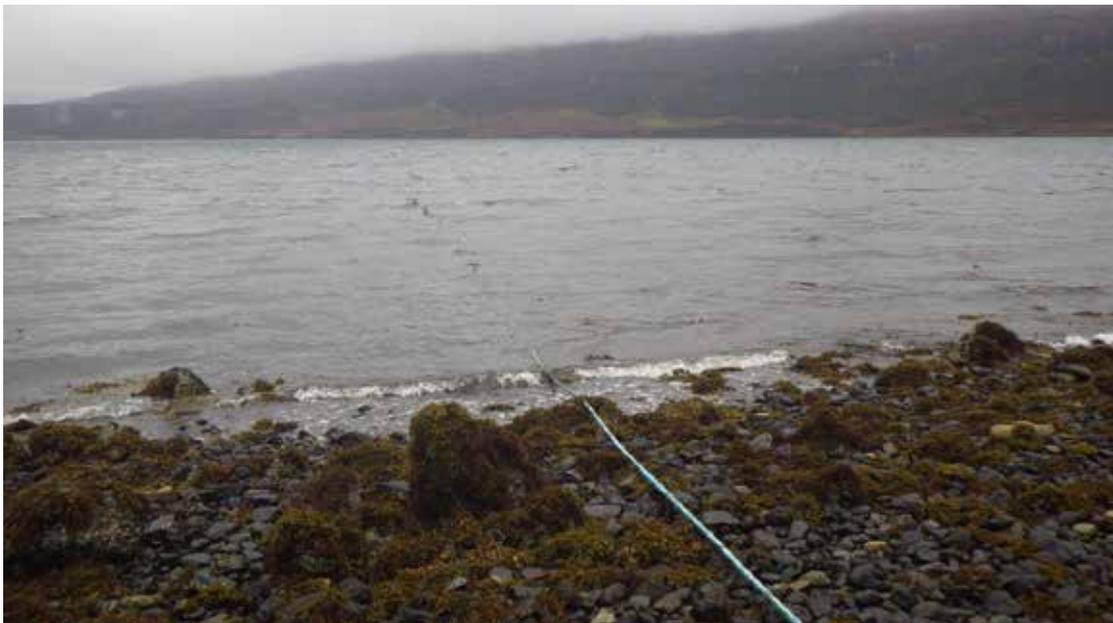
Figure 16. Three centimetre diameter blue plastic pipe running from above shore into water. Associated with waypoint 35.
