# Scottish Sanitary Survey Report

Loch Bay

SL-117-275-04

April 2014

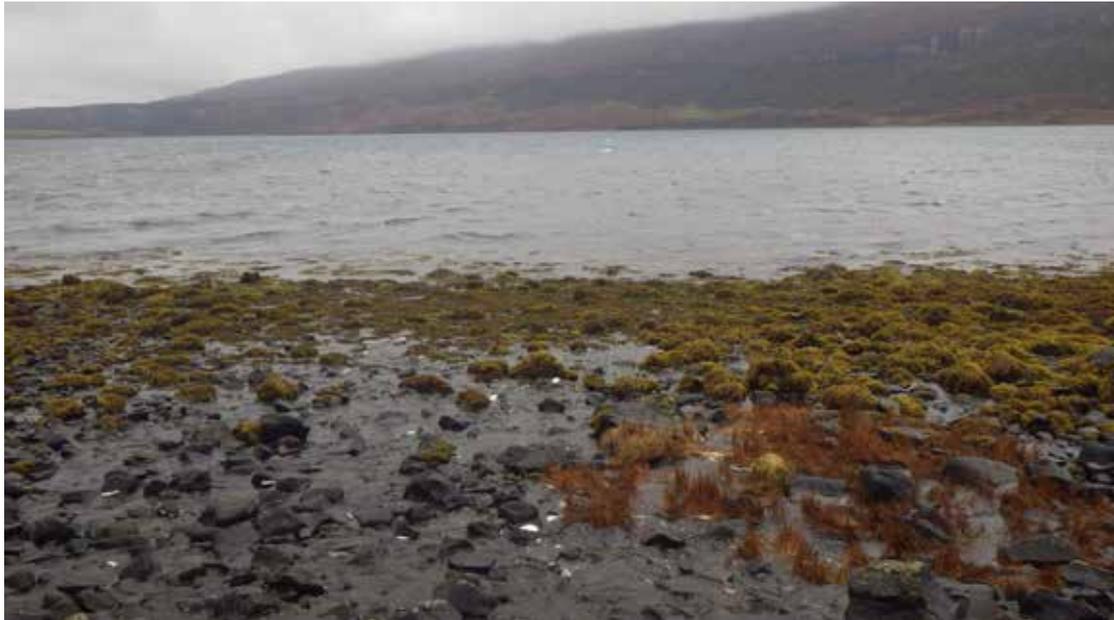
Figure 17. Planned freshwater sample LBFW9 from unnamed burn. Associated with waypoint 36.
