Scottish Sanitary Survey Report

Sanitary Survey Report Loch Beag HL-118 June 2015

Report Title	Loch Beag
Project Name	Scottish Sanitary Survey
Client/Customer	Food Standards Agency Scotland
Cefas Project Reference	C6316A
Document Number	C6316A_2014_8
Revision	V1.1
Date	10/06/2015

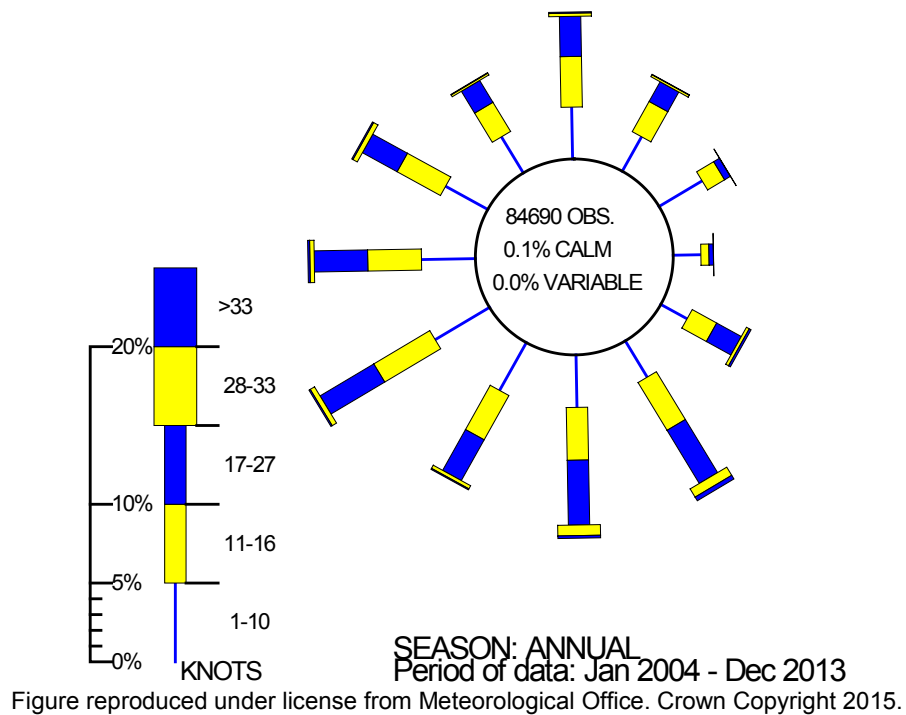
Figure 9.4 Annual wind rose for Tiree

Wind is an important factor in the spread of contamination as it has the ability to drive surface water at about (3%) of the wind speed (Brown, 1991) so a gale force wind (34 knots or 17.2 m/s) would drive a surface water current of about 1 knot or 0.5 m/s. Therefore strong winds can significantly alter the pattern of surface currents. Strong winds also have the potential to affect tide height depending on wind direction and local hydrodynamics of the site. A strong wind combined with a spring tide may result in higher than usual tides, which will carry any accumulated faecal matter at and above the normal high water mark into the production area.

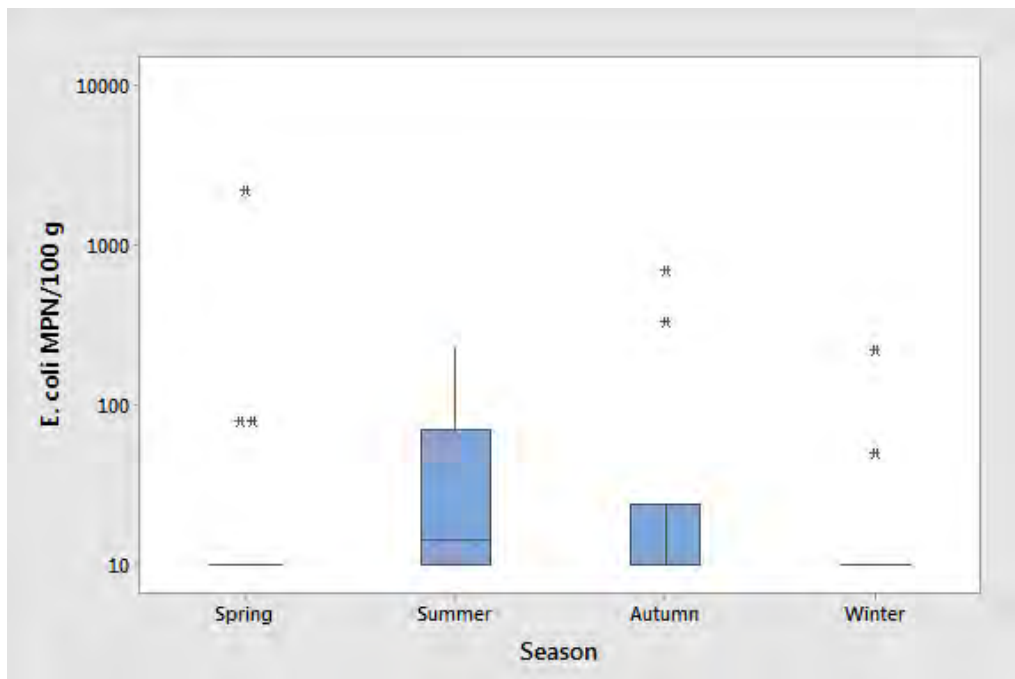
Figure 13.4 Boxplot of *E. coli* results by season at Loch Beag

For statistical evaluation, seasons were split into spring (March-May), summer (June-August), autumn (September-November) and winter (December-February). A boxplot of *E. coli* results by season for Loch Beag is presented in Figure 13.4.

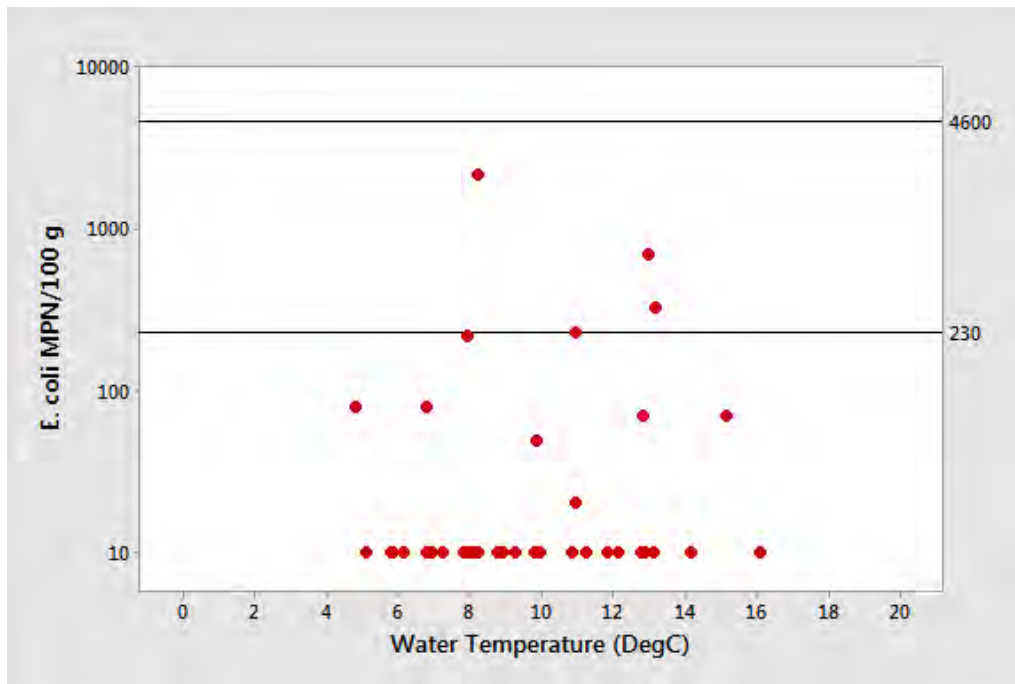
Figure 13.9 Scatterplot of *E. coli* results against water temperature at Loch Beag

Water temperature can affect survival time of bacteria in seawater (Burkhardt, et al., 2000). It can also affect the feeding and elimination rates in shellfish and therefore may be an important predictor of *E. coli* levels in shellfish flesh. Water temperature is obviously closely related to season. Any correlation between temperatures and *E. coli* levels in shellfish flesh may therefore not be directly attributable to temperature, but to the other factors e.g. seasonal differences in livestock grazing patterns. A scatterplot of *E. coli* results against water temperature for Loch Beag is shown in Figures 13.9. Water temperature was recorded for 42 out of the 49 Loch Beag samples. Jittering of symbols was applied at 0.02 (x-axis) and 0.001 (y-axis) respectively.

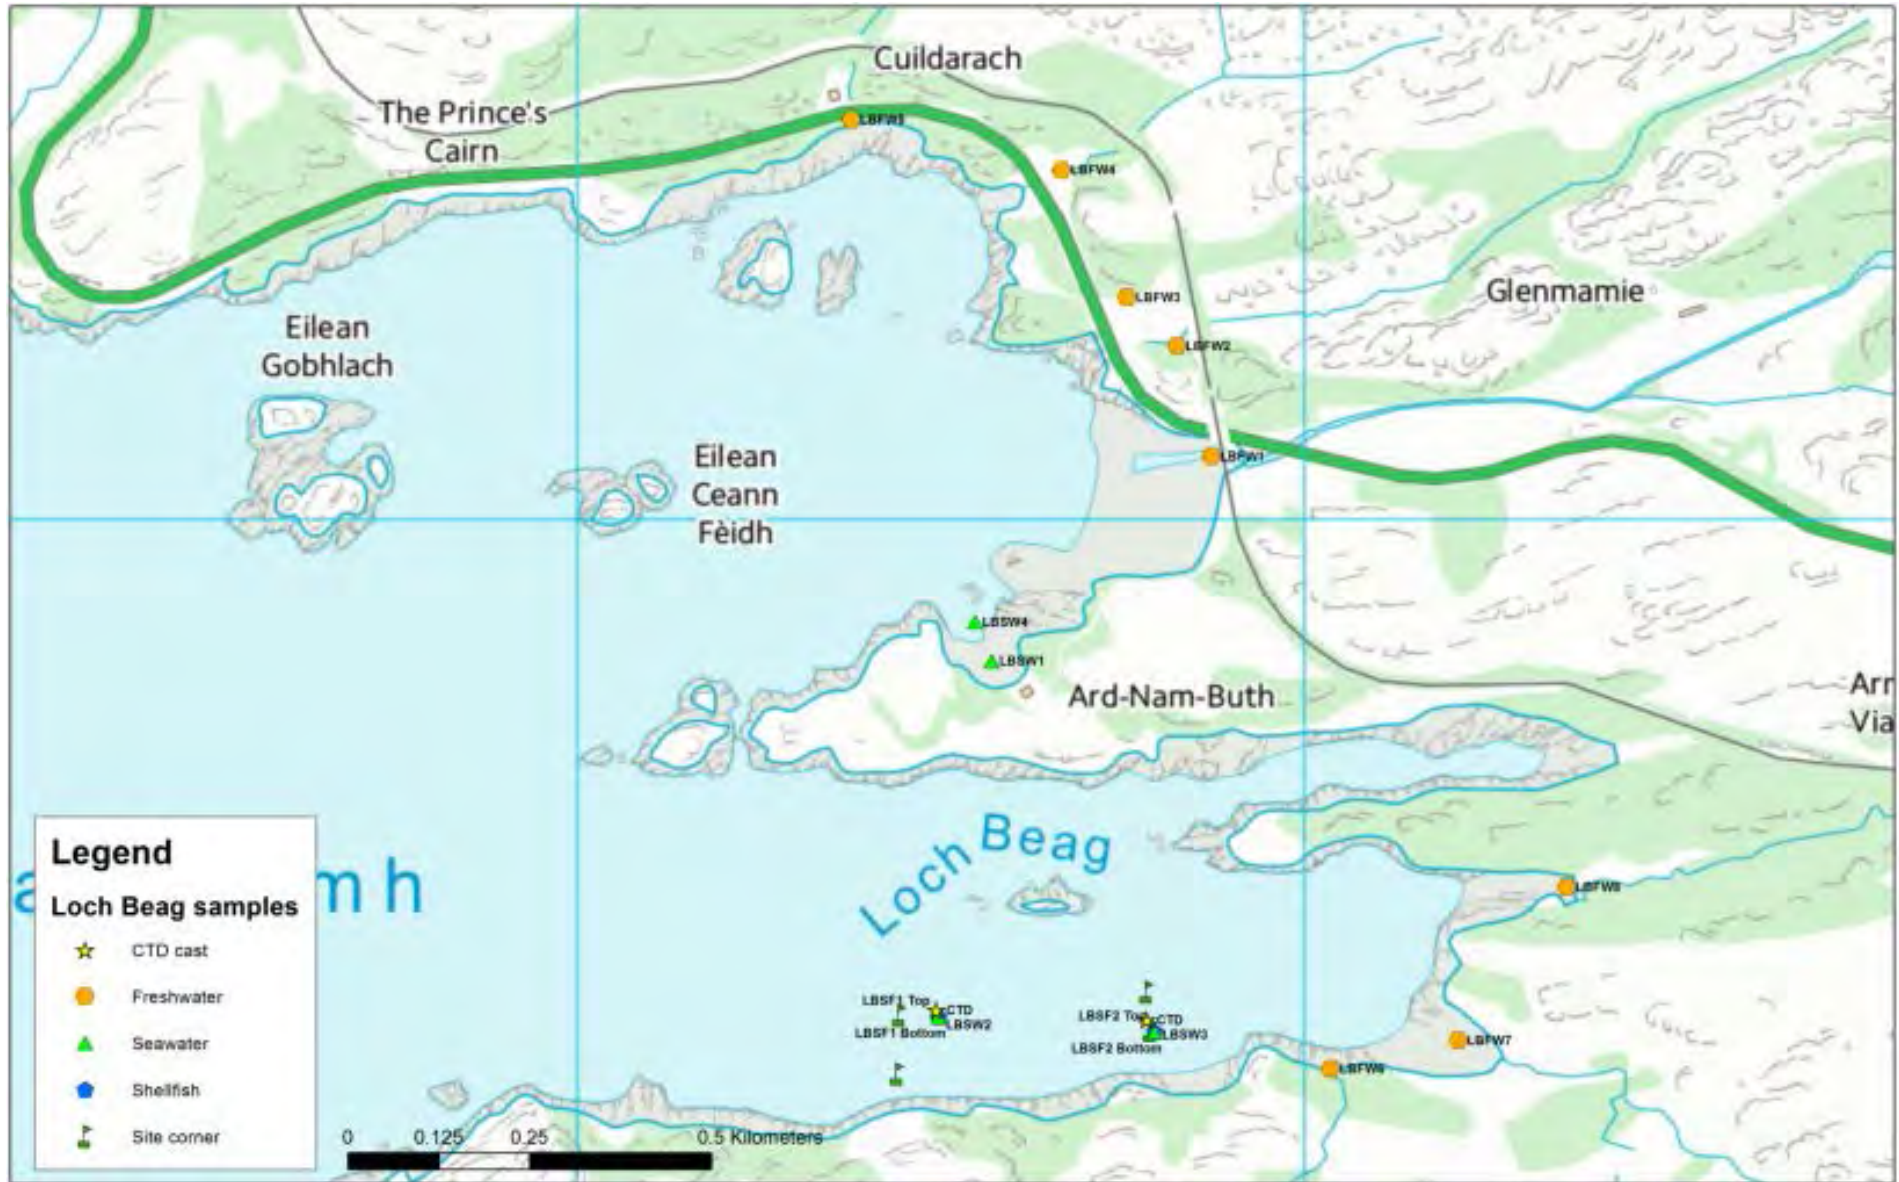
Figure 2. Loch Beag samples.

There are two mussel lines in total, each approximately 300 m long with 8 m droppers. Mussel samples were collected from both the top and the bottom of the droppers, as requested, at the locations marked in Figure 2.

Seawater and freshwater samples were collected at the sites marked in Figure 2. An extra freshwater sample was taken at waypoint 9 due to its proximity to a static caravan.

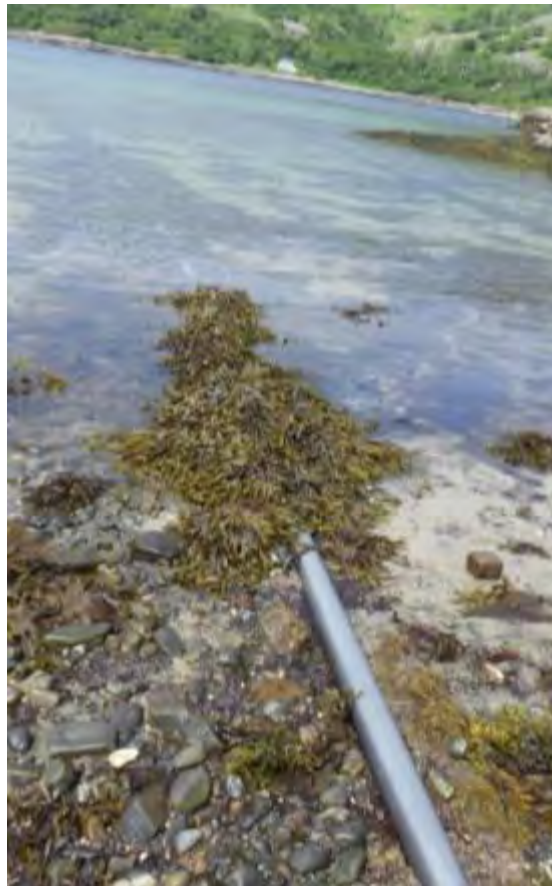
Figure 3. Pipe running into sea from house behind. Associated with waypoints 2 and 3. Site of seawater sample LBSW1.

The shoreline survey report observed several dwellings. All of these are assumed to discharge sewage effluent to some degree, given the lack of community sewage treatment, however evidence of sewage infrastructure was reported at only one, on the north shore of the Àird-nam-bùth peninsula. A seawater sample taken from near the end of this discharge pipe indicates a low level of contamination.

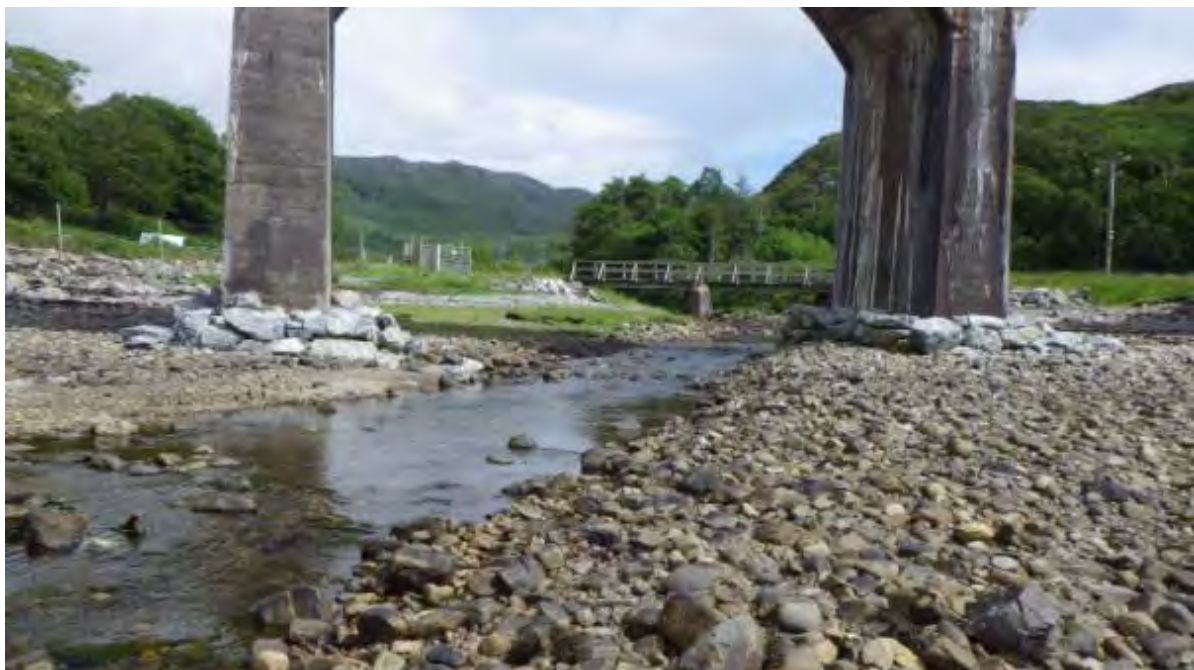
Figure 4. Large watercourse (Allt a' Mhàma) running under viaduct. Associated with waypoints 5 and 6. Site of freshwater sample LBFW1.

Allt a' Mhàma (watercourse No. 1) had a moderate estimated *E. coli* loading while the others either had low loadings or the loading could not be determined due to the *E. coli* result being less than the lower limit of detection. However, this watercourse, plus watercourses 2 to 4, are located north of the Àird-nam-bùth peninsula and are not likely to have a significant impact at the site of the present fishery. Watercourses No. 5 to 7 lie within 600 m of the eastern end of the mussel farm. The *E. coli* loading of all of the watercourses would be expected increase after heavy rainfall and, under those conditions, watercourses 5 to 7 could impact on the water quality at the eastern end of the mussel farm.

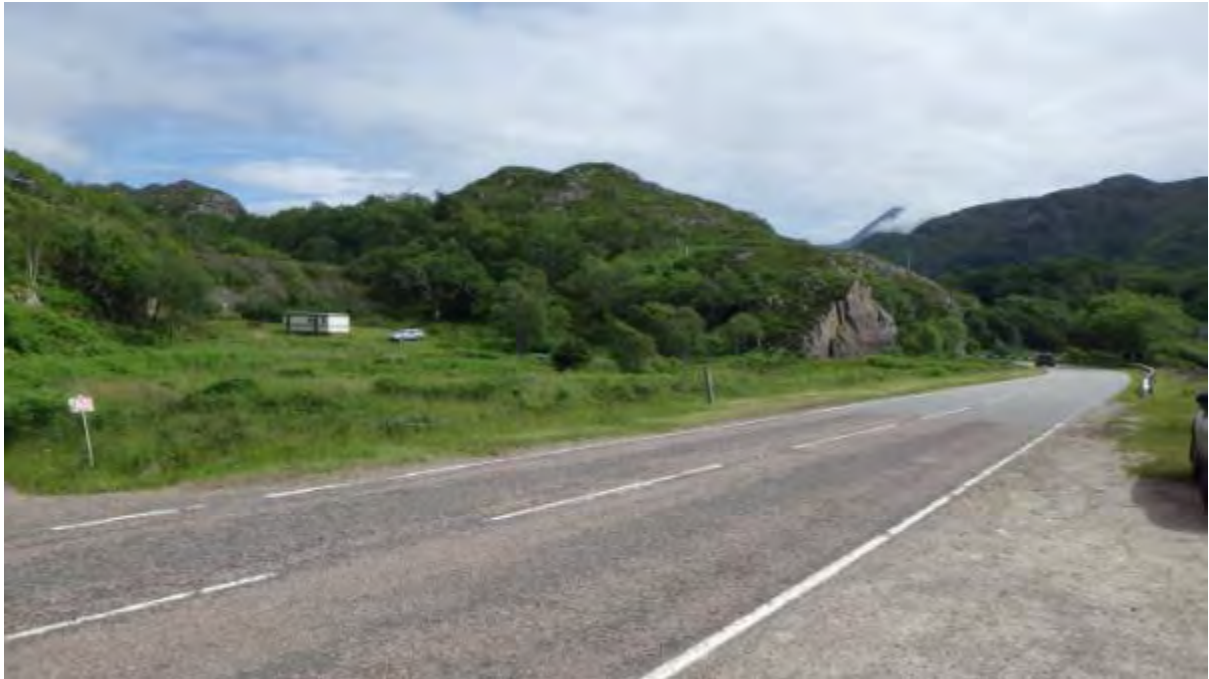
Figure 5. Static caravan next to Glac Ruadh Burn. Associated with waypoint 8.

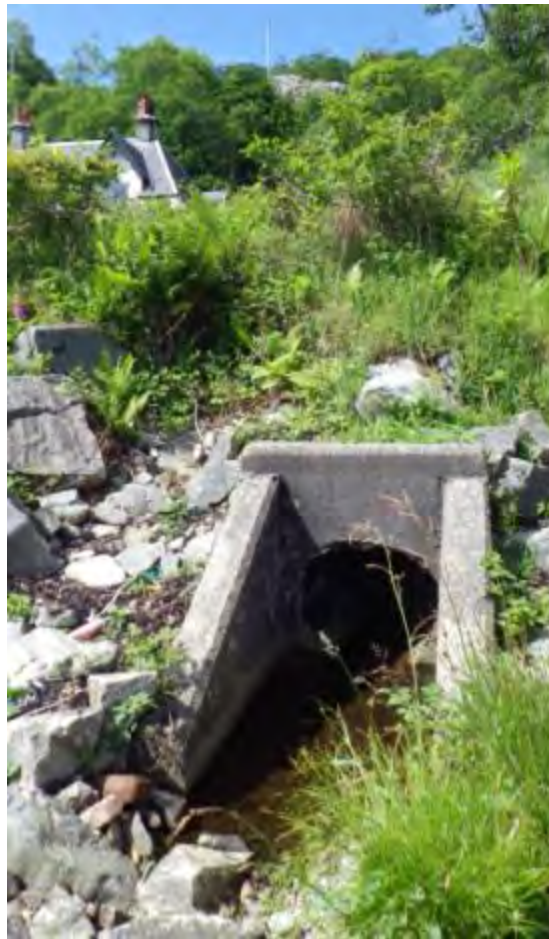
Figure 6. Culvert below house at Cuilidarrach. Associated with waypoints 13 and 14. Site of freshwater sample LBFW5.

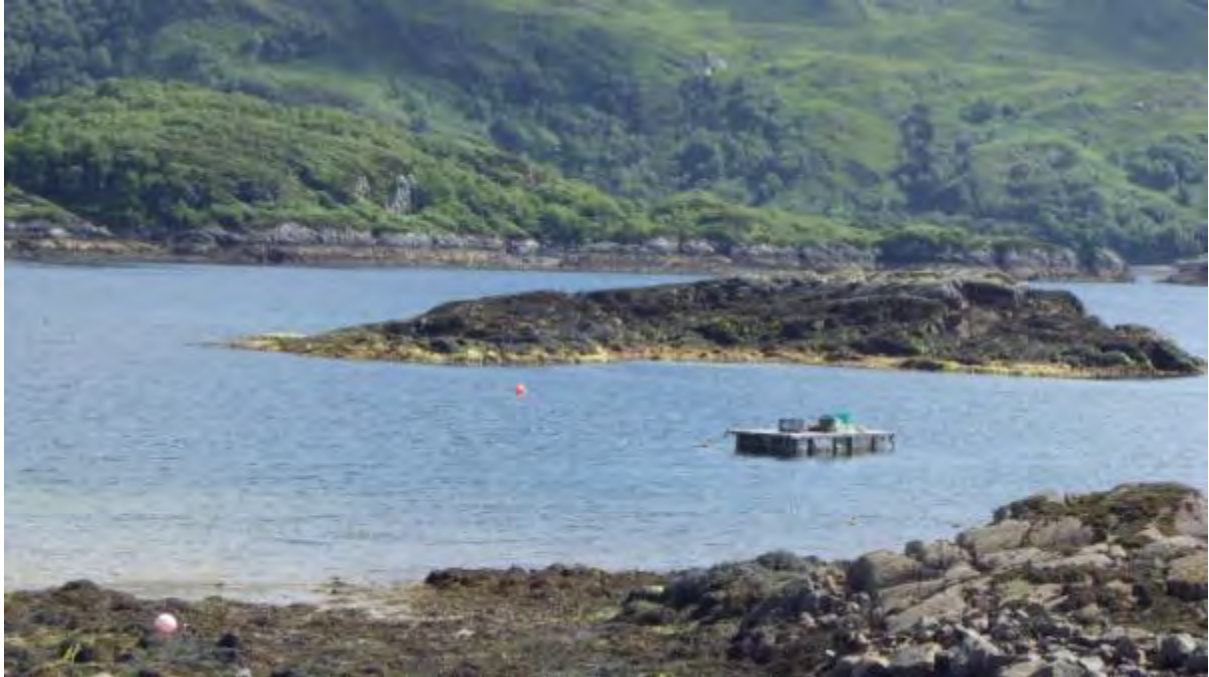
Figure 7. Three buoys and a small storage platform on water in front of house. Associated with waypoint 14.

No.	NGR	Associated Photograph (Appendix 5)	Sample <i>E. coli</i> Value (<i>E. coli</i> cfu/100 ml)	Description
D1	NM 72378 84548	Figure 7	270	Three buoys and a small storage platform on water in front of house.
D2	NM 72821 84242	Figure 5	10	One static caravan with one occupant on grassland next to burn.
D3	NM 73358 83498	Figure 9	<10	Small watercourse (Arnabol Burn) running down glen past wooden chalet onto shore.

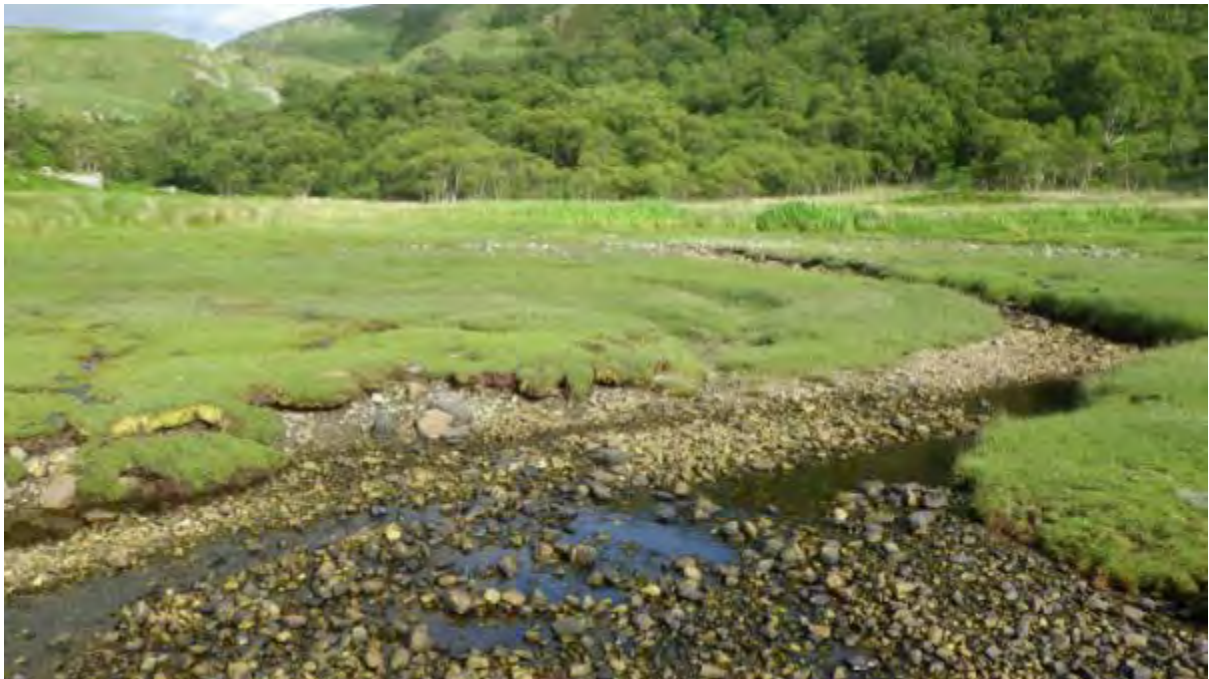
Figure 8. Small river (Allt Camas an Raoigh) running onto shore. Associated with waypoints 17 and 18. Site of freshwater sample LBFW7.

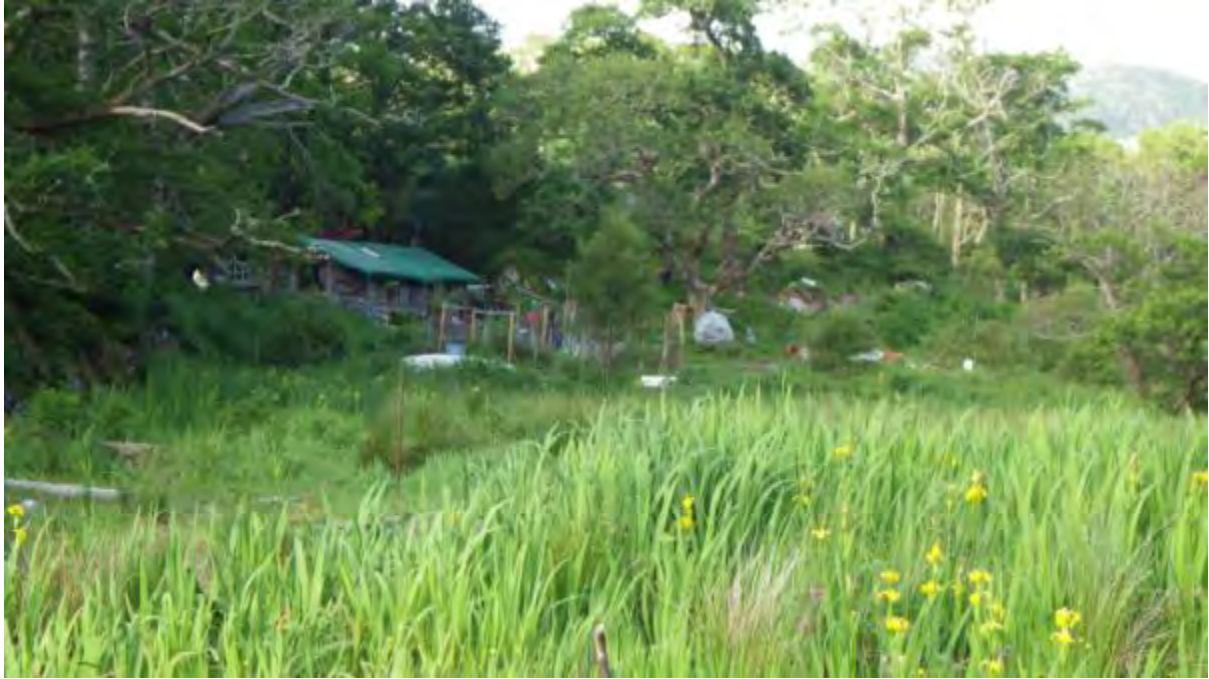
Figure 9. Wooden chalet on shore next to the Arnabol Burn. Associated with waypoint 22.
