Sanitary Survey Review

Loch Creran

AB 129, 130, 131, 312 and 313

April 2013

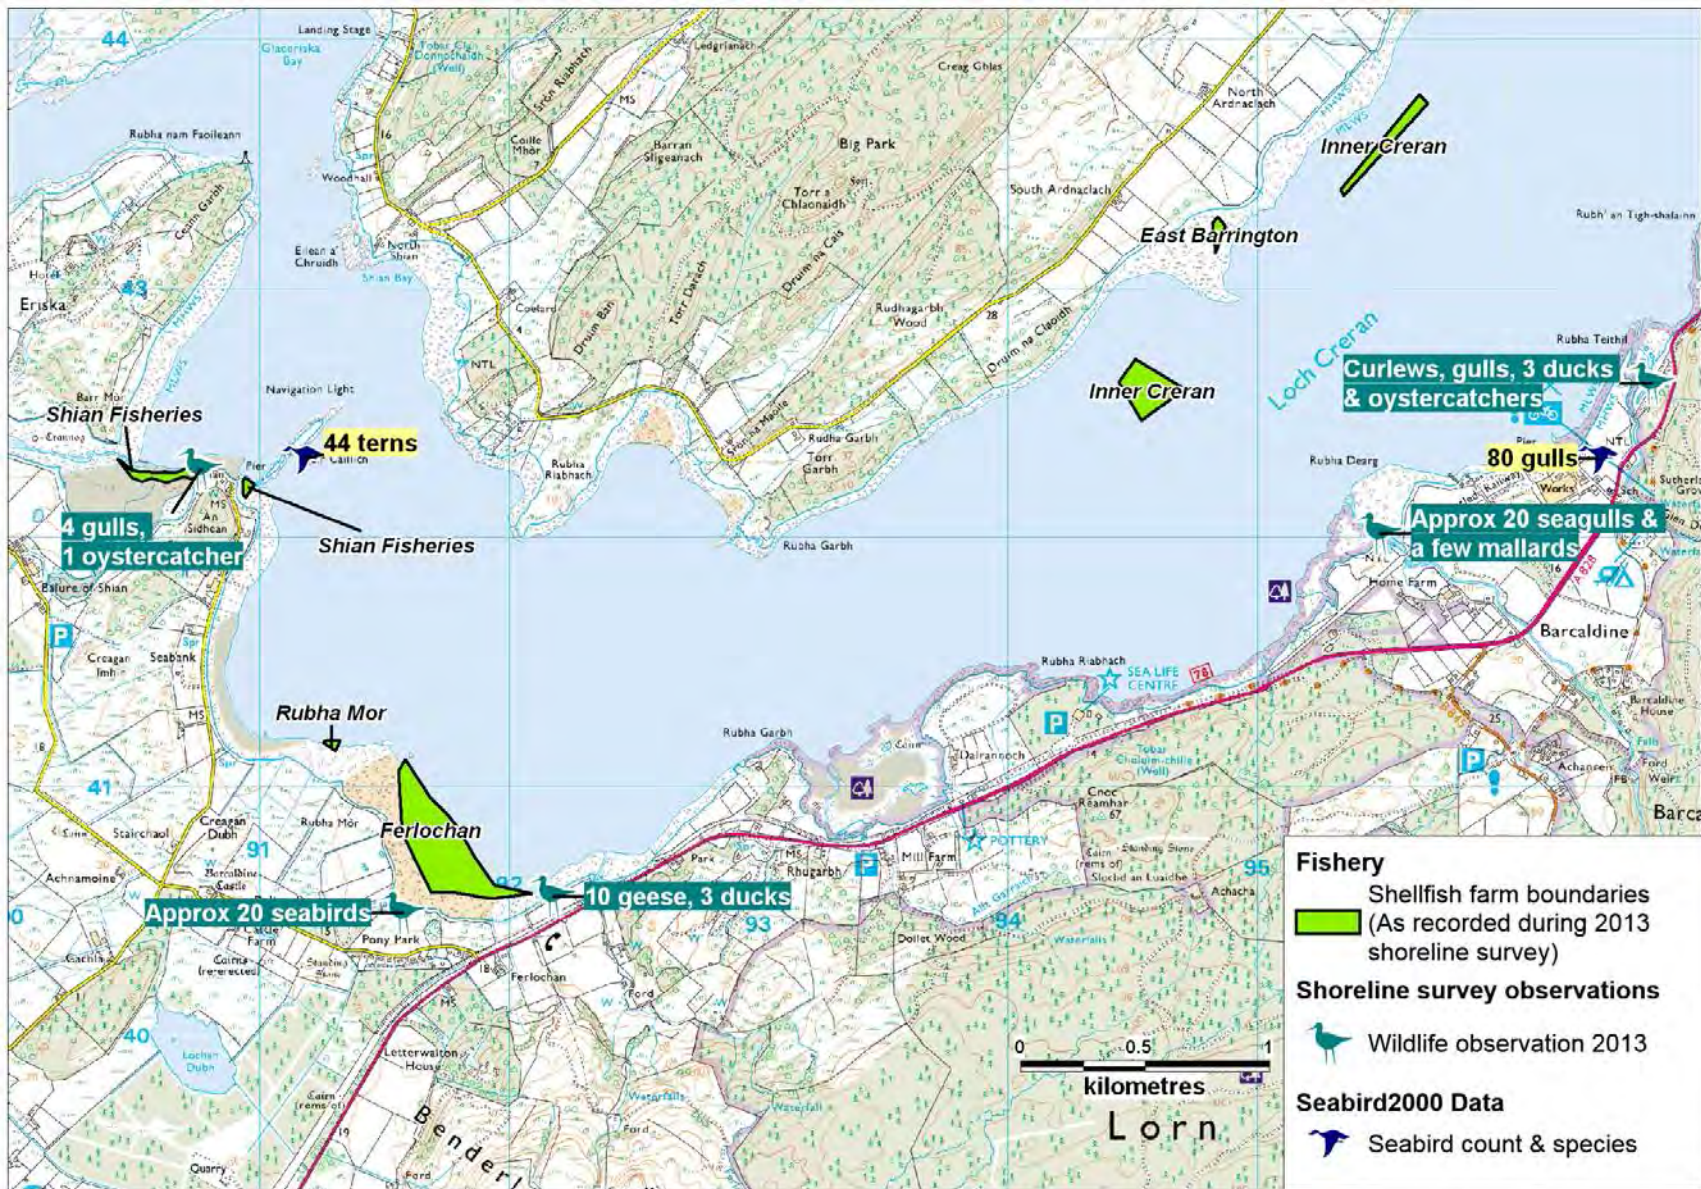
Figure 5.1 Map of wildlife around Loch Creran, including observations made during the recent shoreline survey

During the recent shoreline survey, birds were the most common wildlife observed, with unidentified seabirds, gulls, oystercatchers, curlews, ducks and geese all recorded on the southern shoreline. Geese and seabirds were seen close to the fishery at Rubha Mor, whilst a small number of gulls and one oystercatcher were also observed close to the Shian oyster fishery. Small numbers of birds were also observed on the shoreline adjacent to the fisheries in Upper Loch Creran.

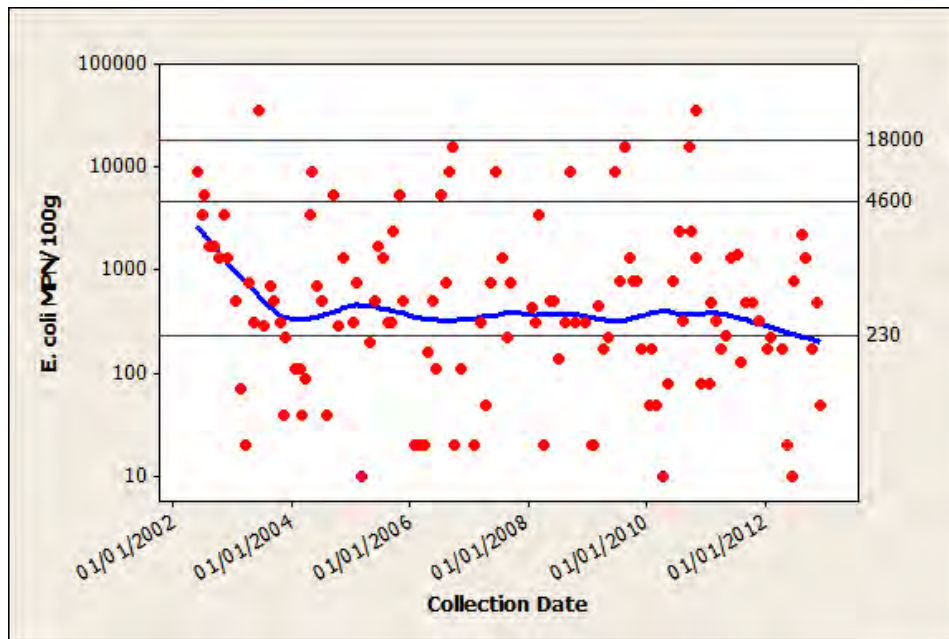
Figure 9.4 Scatterplot of East Barrington Pacific oyster *E. coli* results by date (2002-2012), with a lowess line

The general trend has been for the extent of contamination to be stable across the years 2001-2012 although there was an initial drop in the lowess line after 2002: the results of samples taken in 2002 were all >1000 *E. coli* MPN/100 g. Two samples were >18000 *E. coli* MPN/100 g and were taken in 2003 and 2010 respectively.

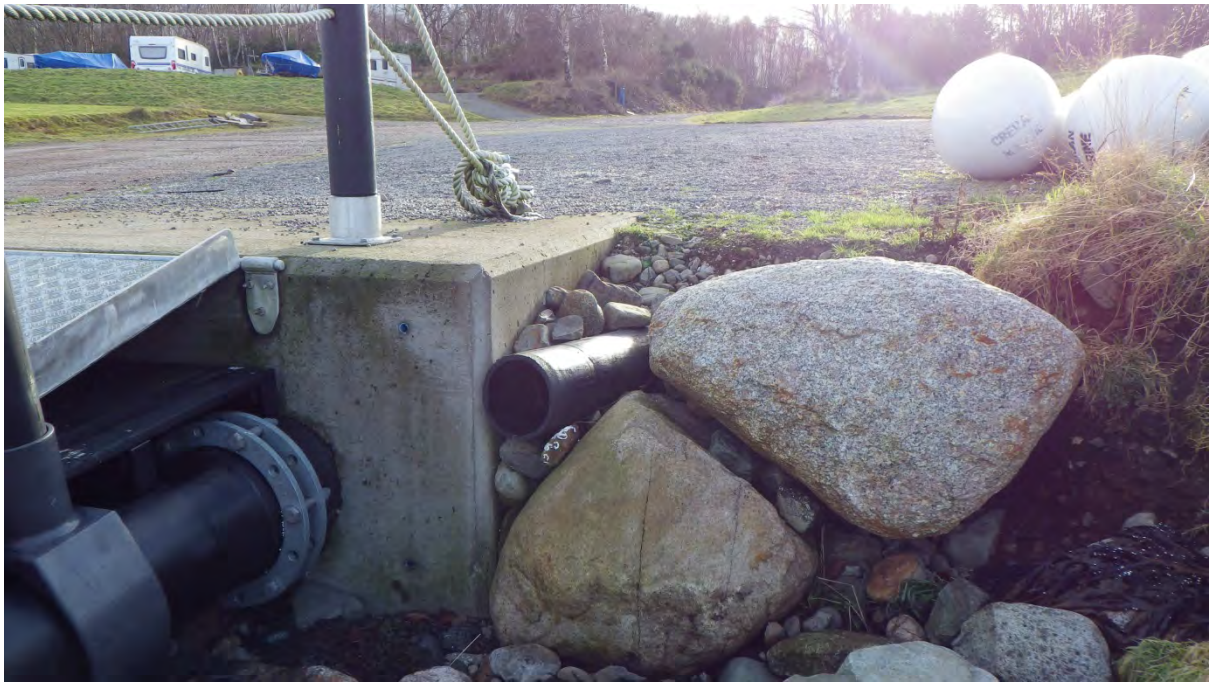
Figure 9. Plastic pipe with no discharge at pontoon by caravan park. Waypoint 5.

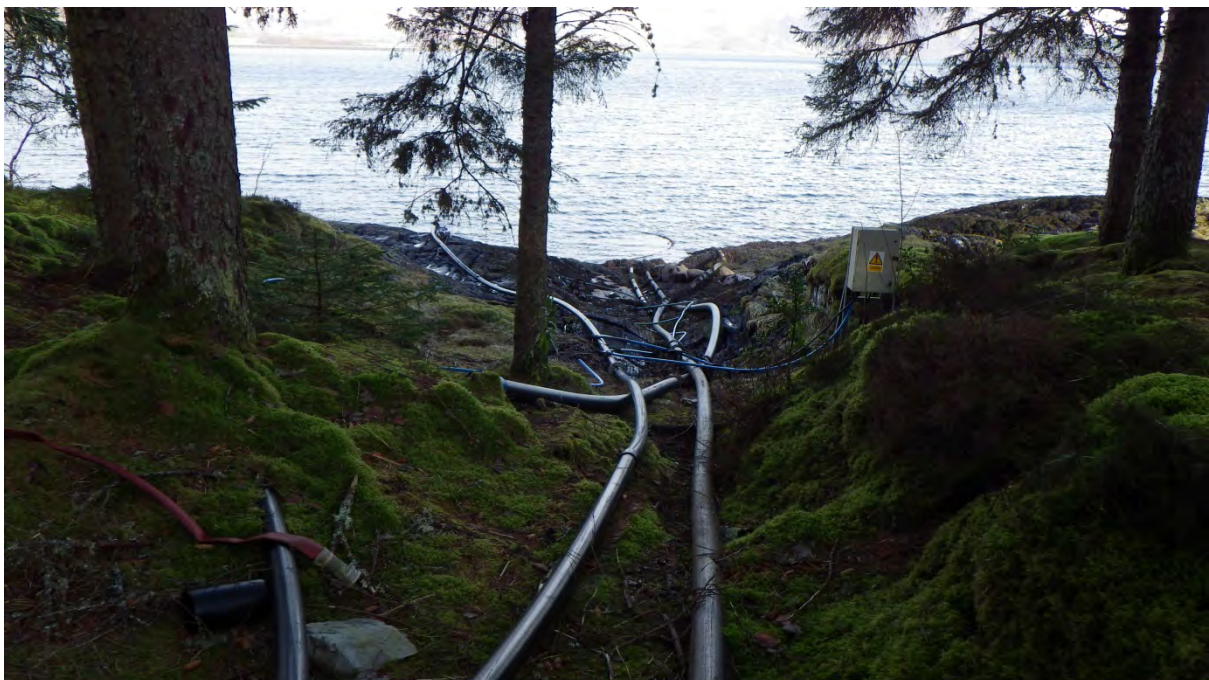
Figure 12. Pipes run up and down on shore next to SLC with pump attached near water. Waypoint 10.

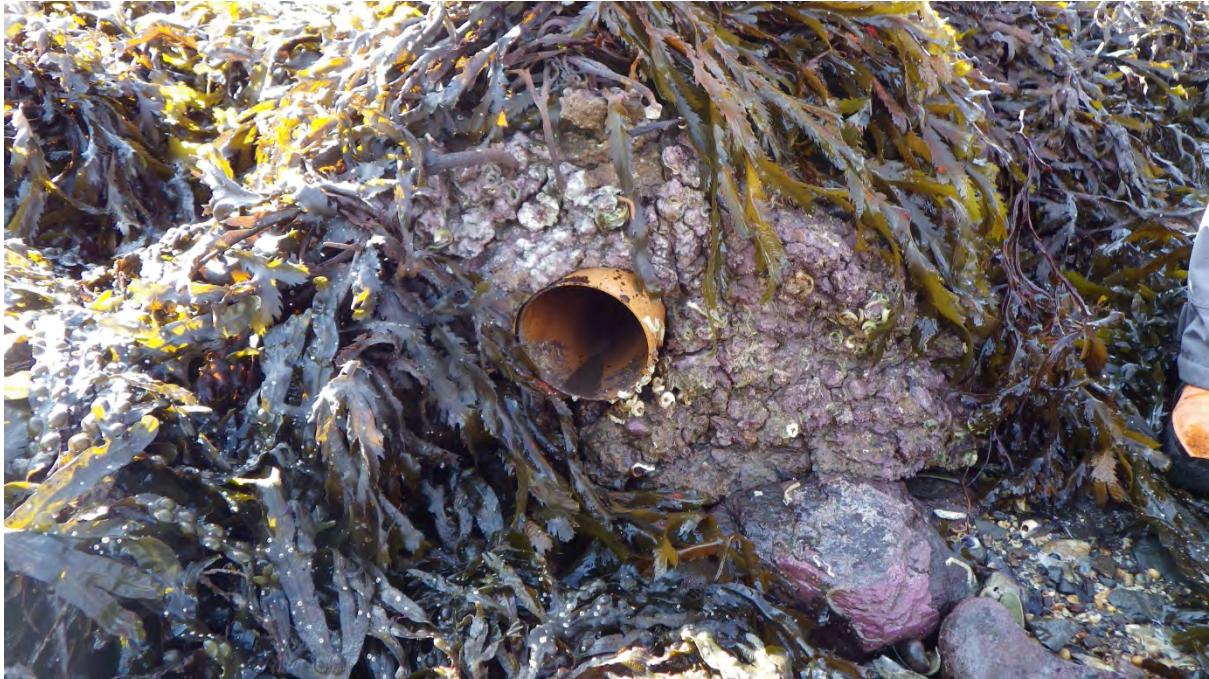
Figure 13. Sewage pipe running from house on shore into sea. Waypoint 12.

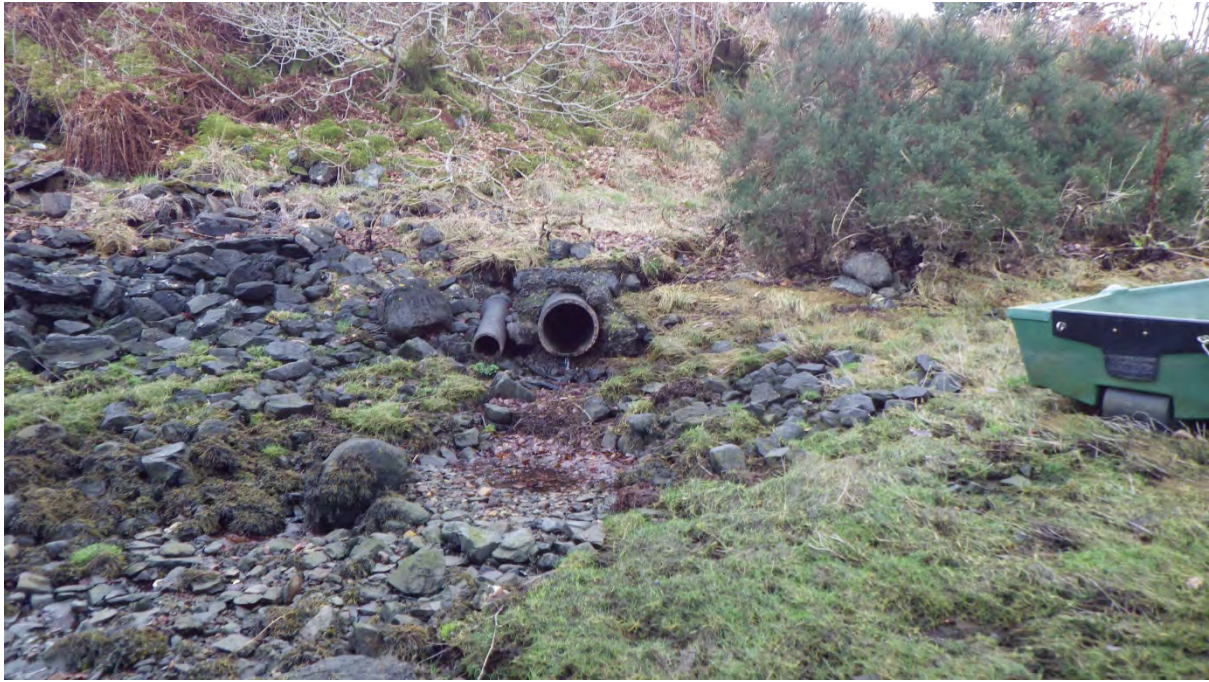
Figure 15. Clay pipes on shore next to house. Waypoint 20.

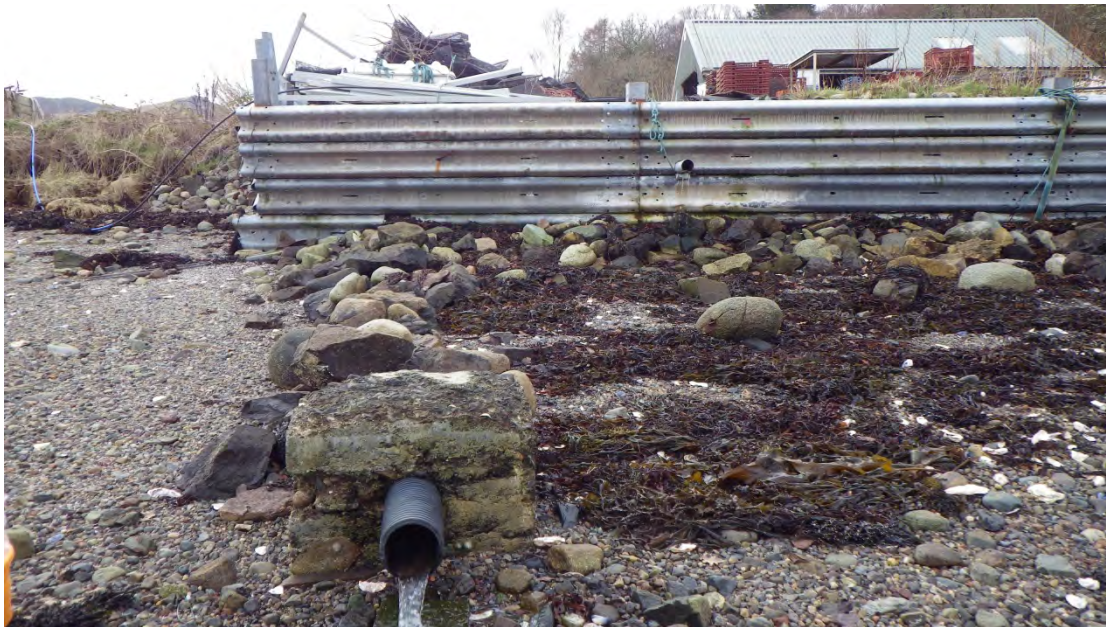
Figure 16. Oyster processing yard with outflows. Waypoint 22.

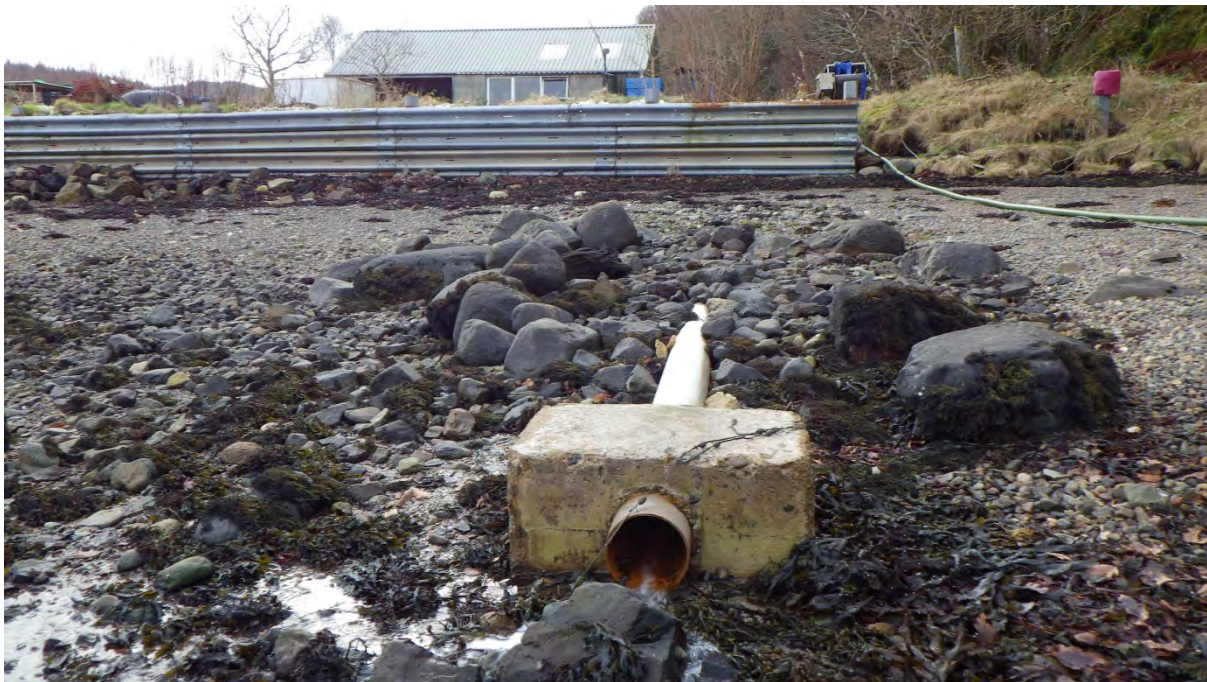
Figure 18. Second large outflow from processing farm. Waypoint 23.

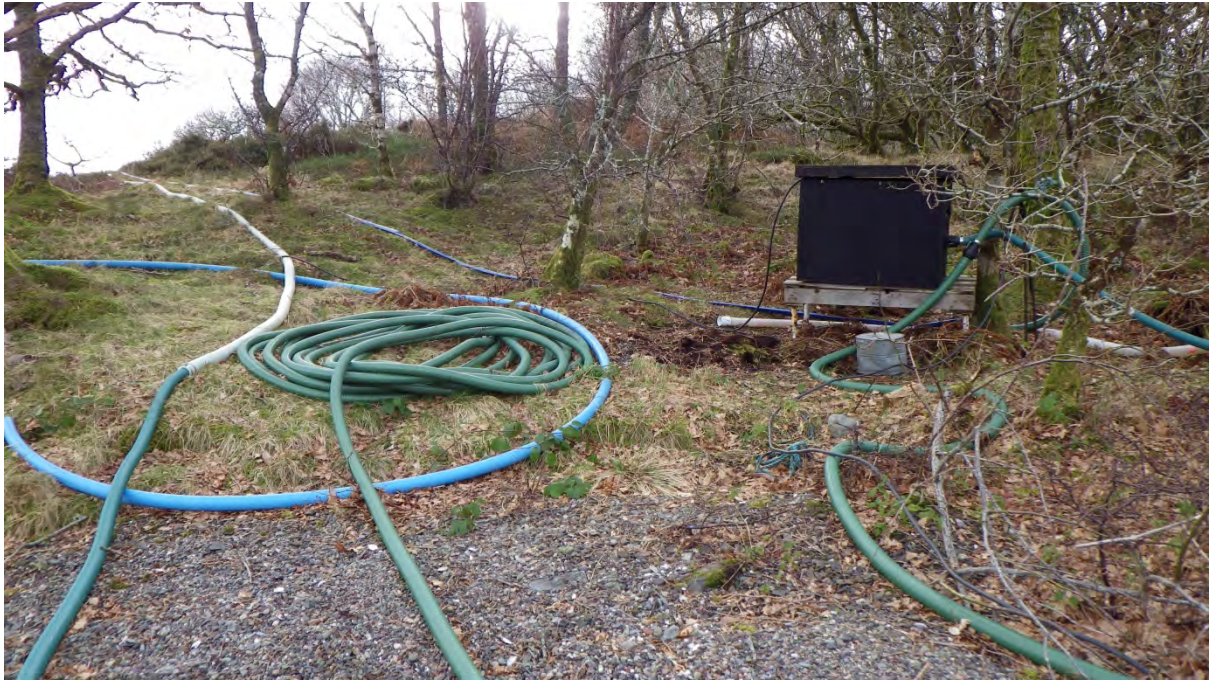
Figure19. Pipework running to and from processing yard. Waypoint 23.

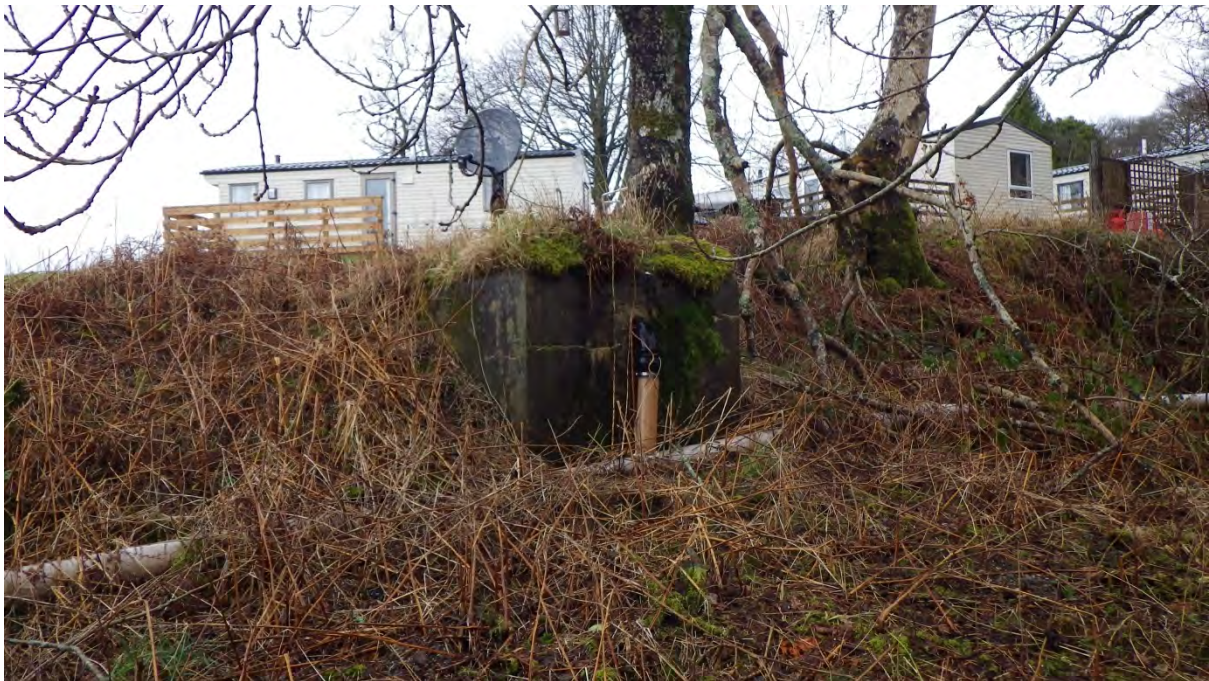
Figure 26. Discharge pipe at caravan site. Waypoint 71.

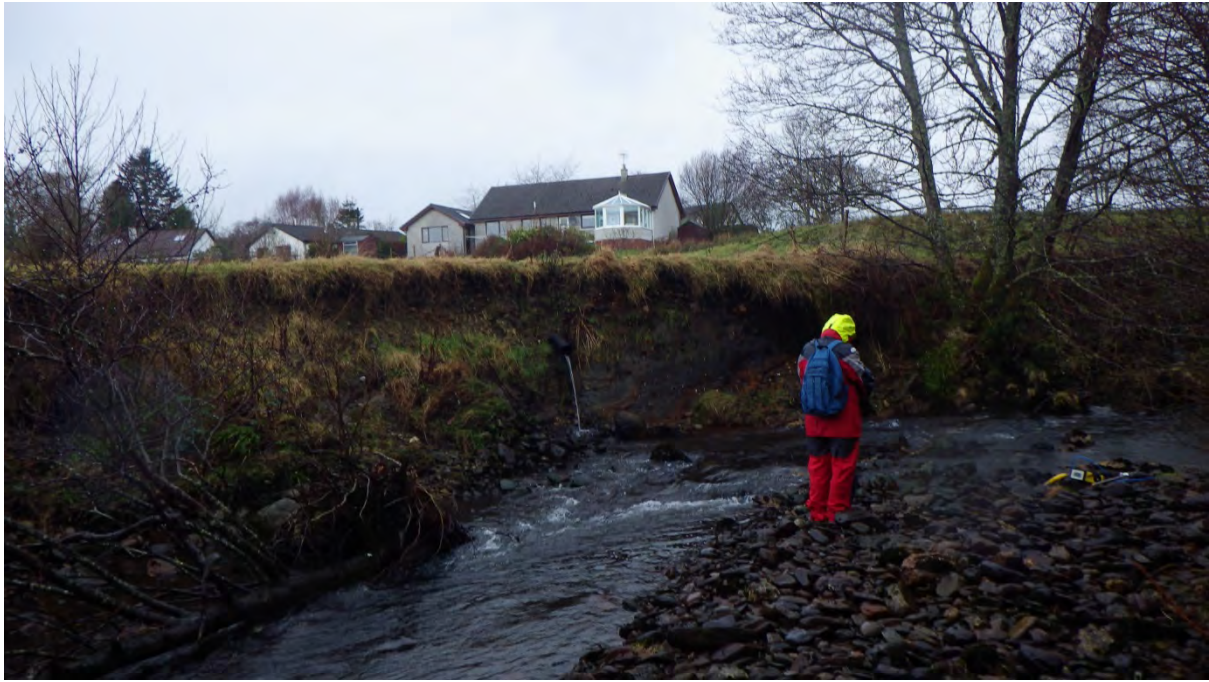
Figure 27. Plastic corrugated pipe possibly land drain with smell. Waypoint 74A.

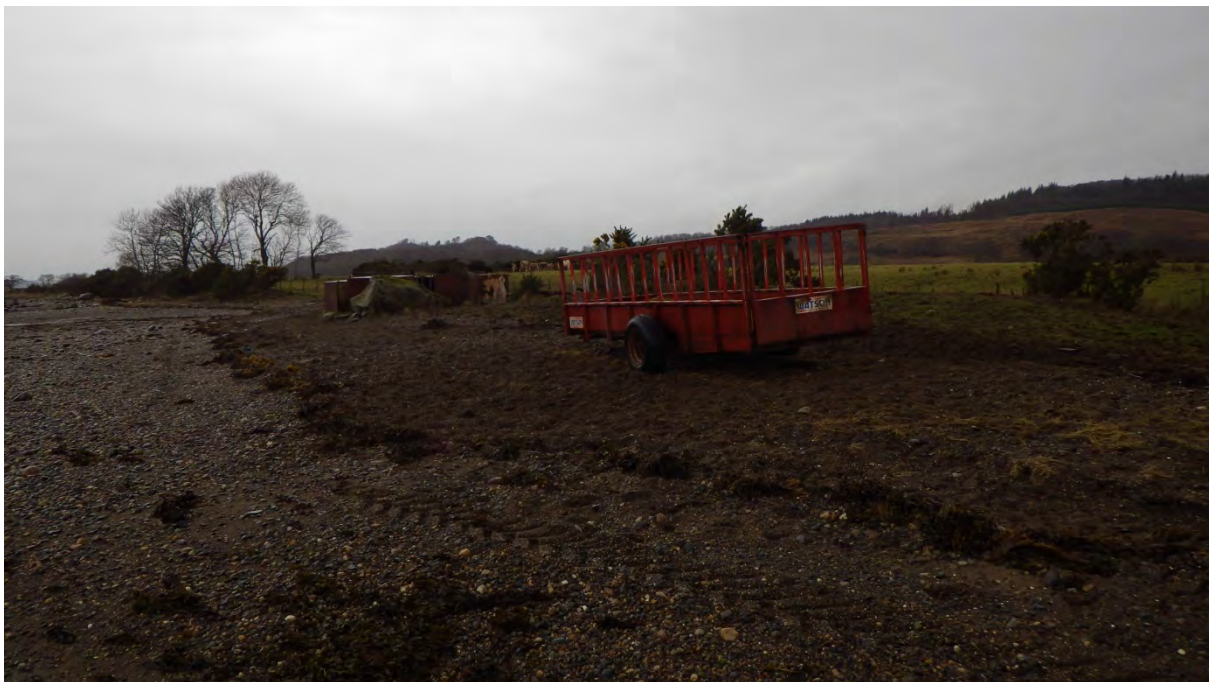
Figure 28. Feeder and cows on shore with faecal matter. Waypoint 77.

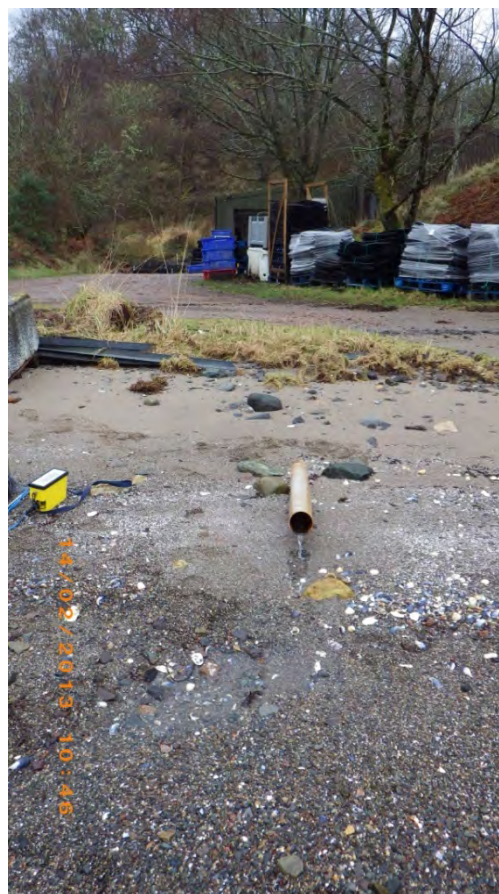
Figure 30. PVC pipe running onto shore from oyster shed. Waypoint 95.

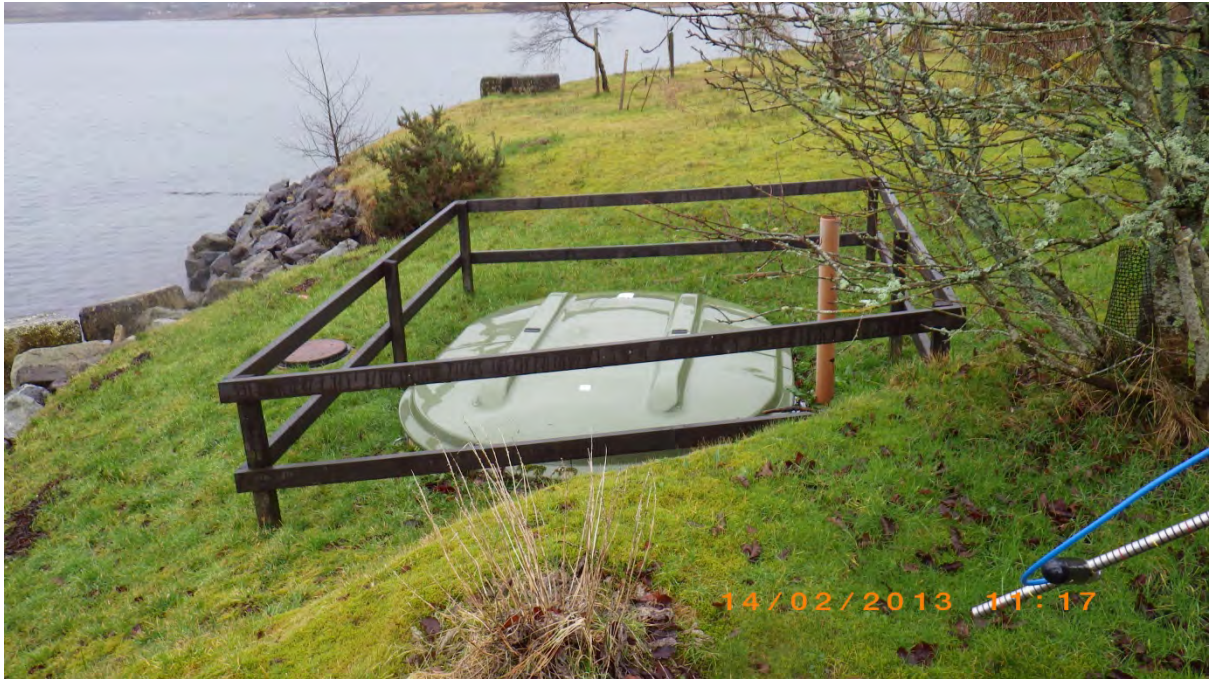
Figure 31. Septic tank outside Scottish Sea Farms. Waypoint 98.
