Sanitary Survey Report Loch Eriboll HS 139 July 2013

Report Title	Loch Eriboll Sanitary Survey Report
Project Name	Scottish Sanitary Survey
Client/Customer	Food Standards Agency Scotland
Cefas Project Reference	C5792C
Document Number	C5792C_2013_3
Revision	Final V1.0
Date	18/10/2013

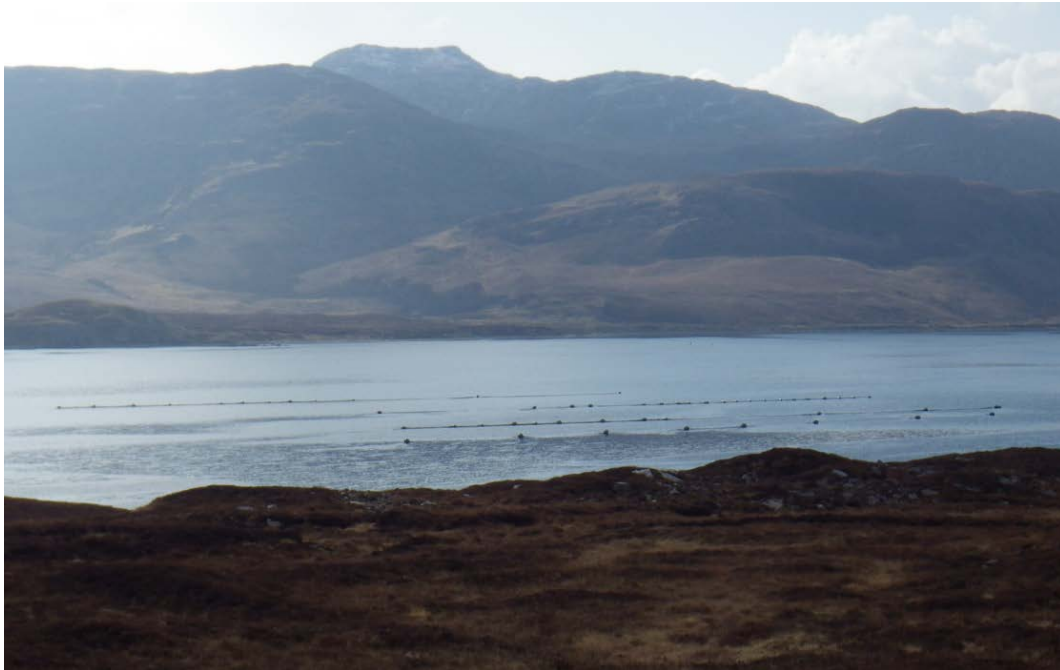
Figure 2.1 Mussel farm at Laid, Loch Eriboll

Due to problems with the harvester's boat, it was not possible for the shoreline survey team to access the mussel farms directly and therefore the locations were observed from shore. Photographs taken of the lines showed they were maintained and some lines appeared to be heavy, suggesting growth on them (Figure 2.1 and 2.2). The shoreline survey report identified that in addition to the two farms mapped, other areas of derelict lines were seen to the NW of Eilean Choraidh and southwest of the mussel farm at Laid. Although the specific locations were not recorded, the estimated locations were determined from photographs taken during the survey. No mussel lines were seen along the east side of Eilean Choraidh, where there are two shellfish leases.

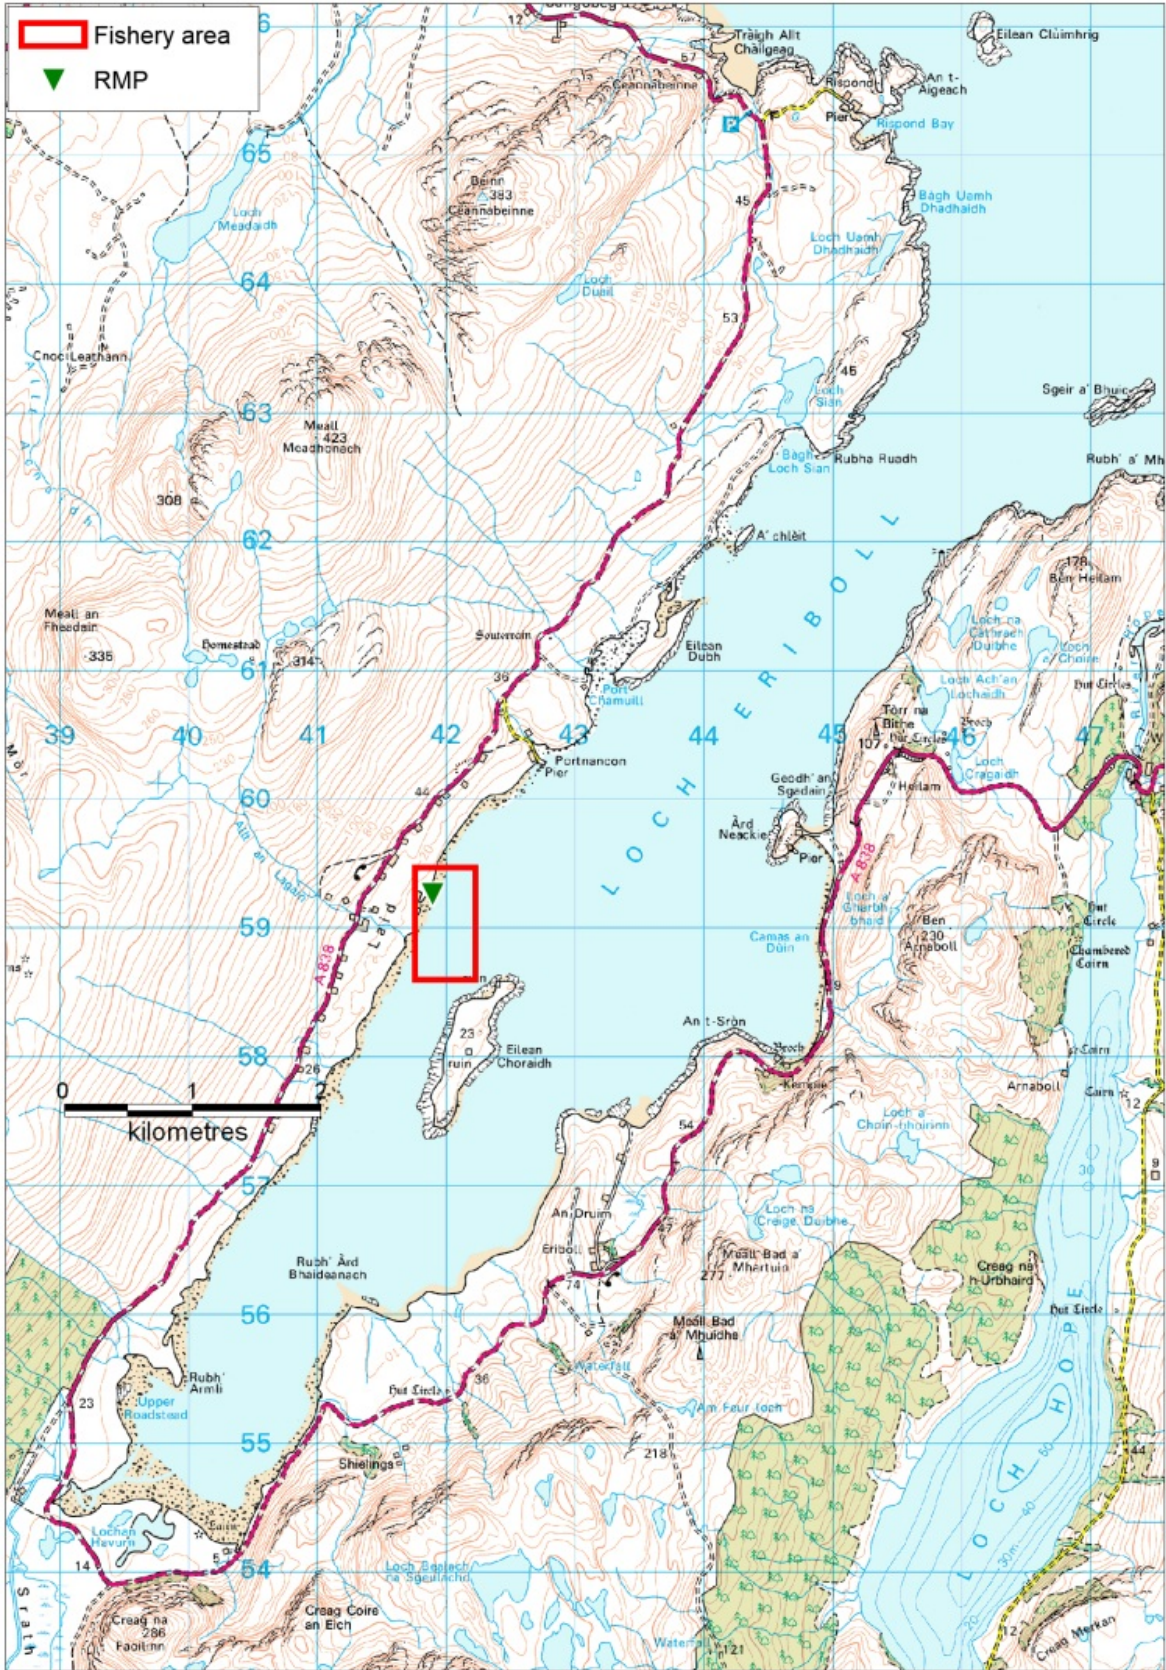
Figure 13.1 Extent of hydrographic study area

Loch Eriboll is a deep sea loch situated on the NW tip of Scotland and lies to the east of Cape Wrath. It is unique from other Scottish large deep sea lochs in that it is the only loch exposed to the north. The Kyle of Durness and the Kyle of Tongue which both flank Loch Eriboll have a sand and mud composition and are not true sea lochs. It has a north-east facing aspect and the area contains five crofting townships which are all small in size. Heilam is the first settlement at the mouth of the loch in the northeast and opposite is Portnancon on the NW. Laid is south of this on the mid-west and is the largest settlement around the loch. On the mid-east is Eriboll and Polla lies on the south at the head of the loch. At the north of the loch lies Eilean Hoan with another larger island situated in the south of the loch, Eilean Choraiddh. There are a number of small islets throughout the area. The study area is shown in Figure 13.1

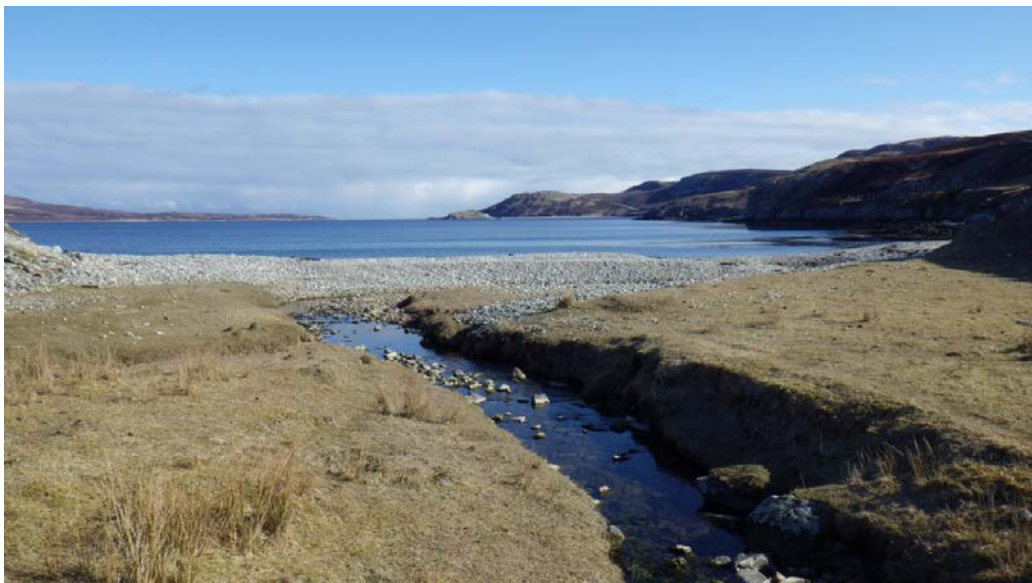
Figure 6: Beach and stream below Eriboll Farm. Location of waypoints 5 and 6 and associated samples. Ard Neackie peninsula is visible in centre distance of photo.

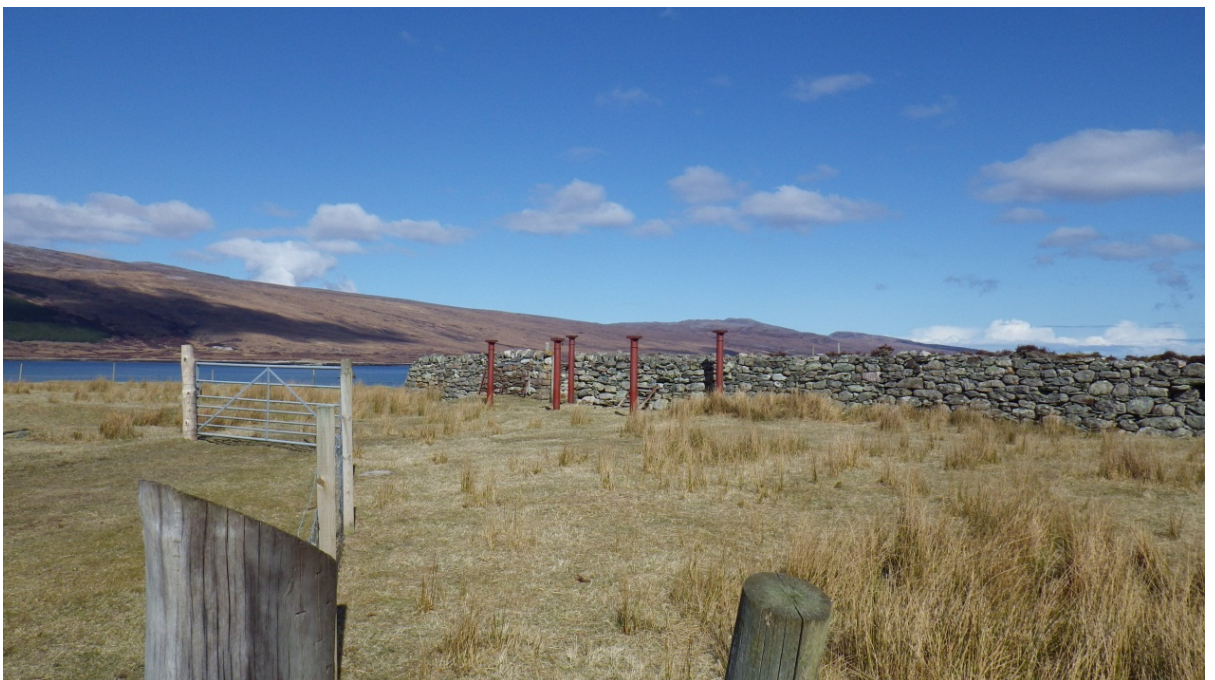
Much of the land around Loch Eriboll is used for rough grazing and sheep were observed grazing on the hills on both sides of the loch. A sheep fold on the southern shore of the loch was observed to have been in recent use, although no animals were present at the time of the survey. An unspecified number of cattle were

Figure 8: Sheep fold at waypoint 23.

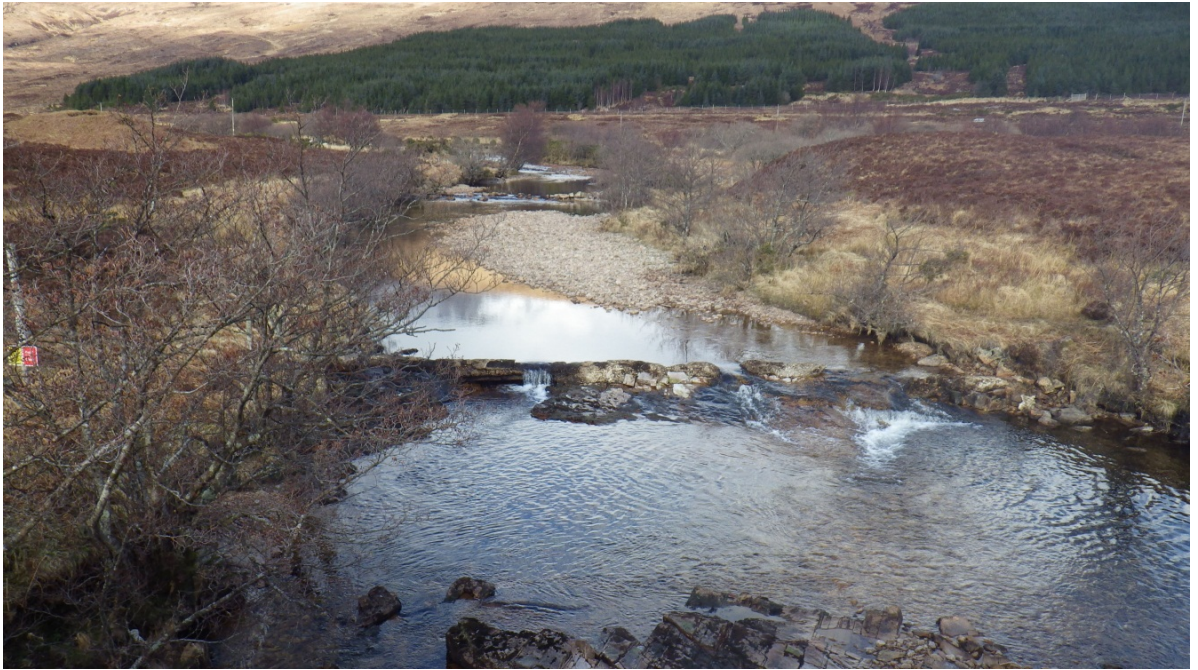
Figure 9: Waypoints 29 and 30. Un-named River flowing under A838 road overbridge. The largest watercourse on survey.

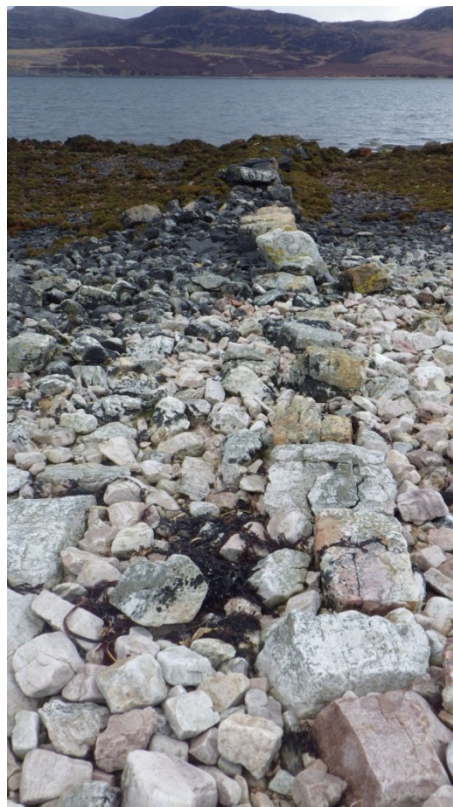
Figure 10: Stone run on shore, initially mistaken for cover for a discharge pipe, but actually shoreline boundary walls for crofts above (waypoint 44).

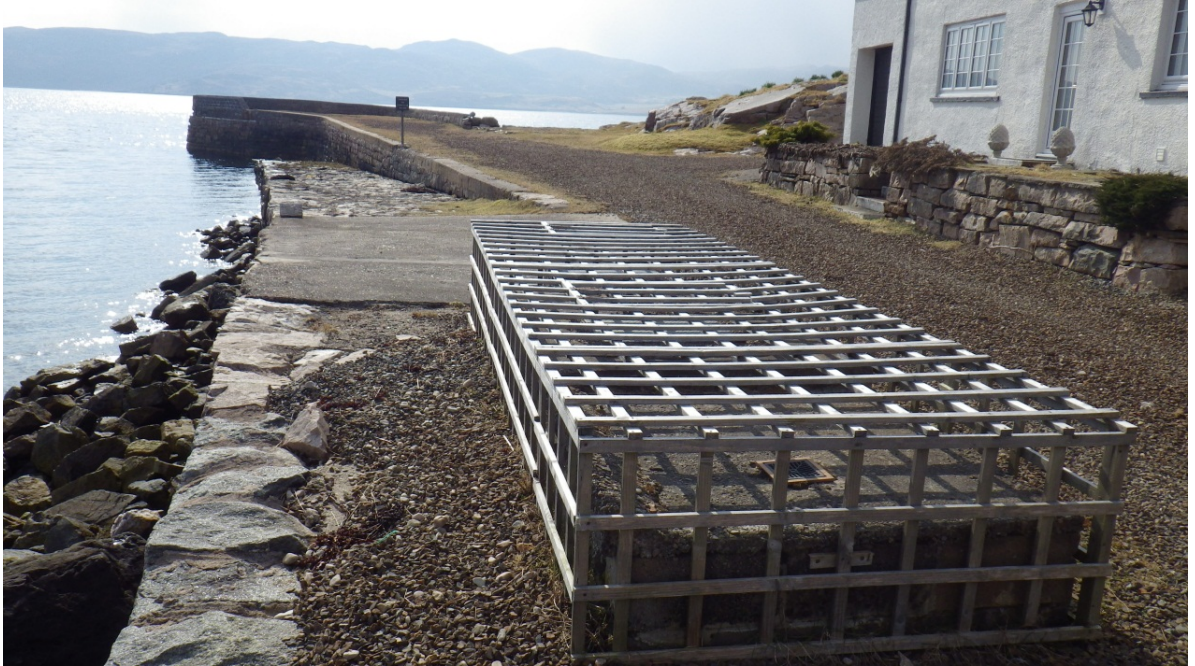
The only sewage-related infrastructure observed during the shoreline survey was a group of septic tanks, partially sunk into concrete and covered by a wooden frame at Portnancon Pier. This is shown in Figure 4.1. This appears to relate to the B&B at Portnancon (No. 2, Table 4.1), which has a PE of 11. No outfall was noted. The dwellings are recorded as holiday cottages so use is likely to be seasonal. This tank lies 1.4 km northeast of the oyster trestles and 3.7 km northeast of the Laid mussel site.

Figure 13: Holiday homes and Pier at Portnancon, with septic tanks enclosed in wooden cage (waypoint 61).

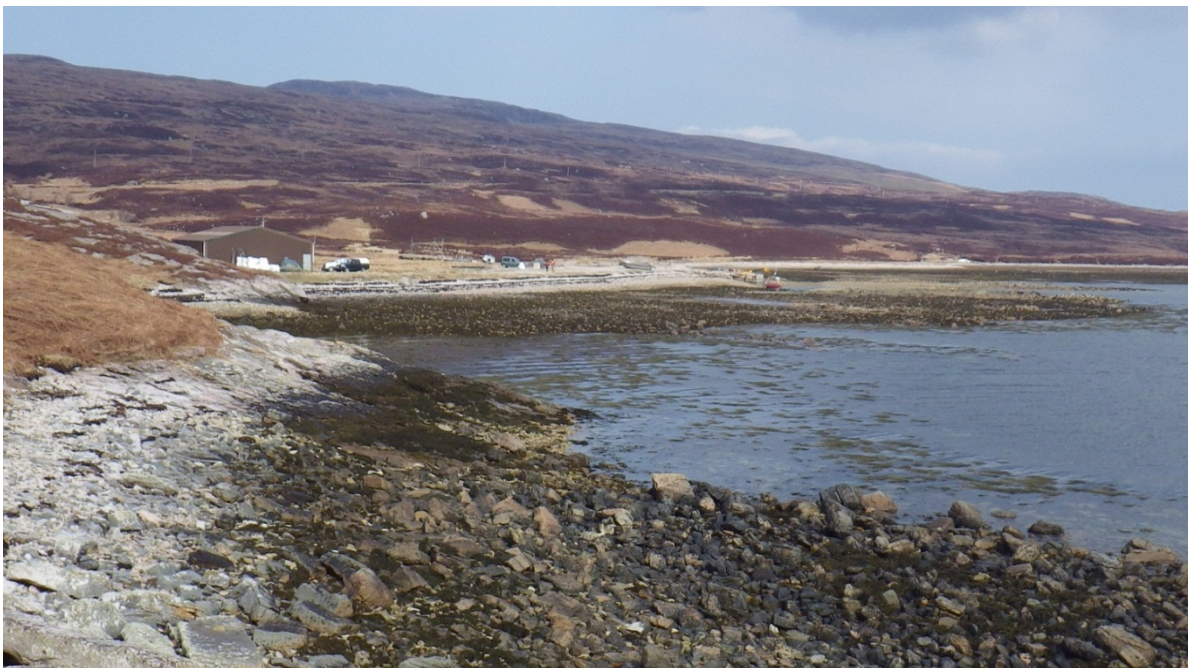
Figure 14: Fish farm base at Port Chamuill, taken from the south (waypoint 65).

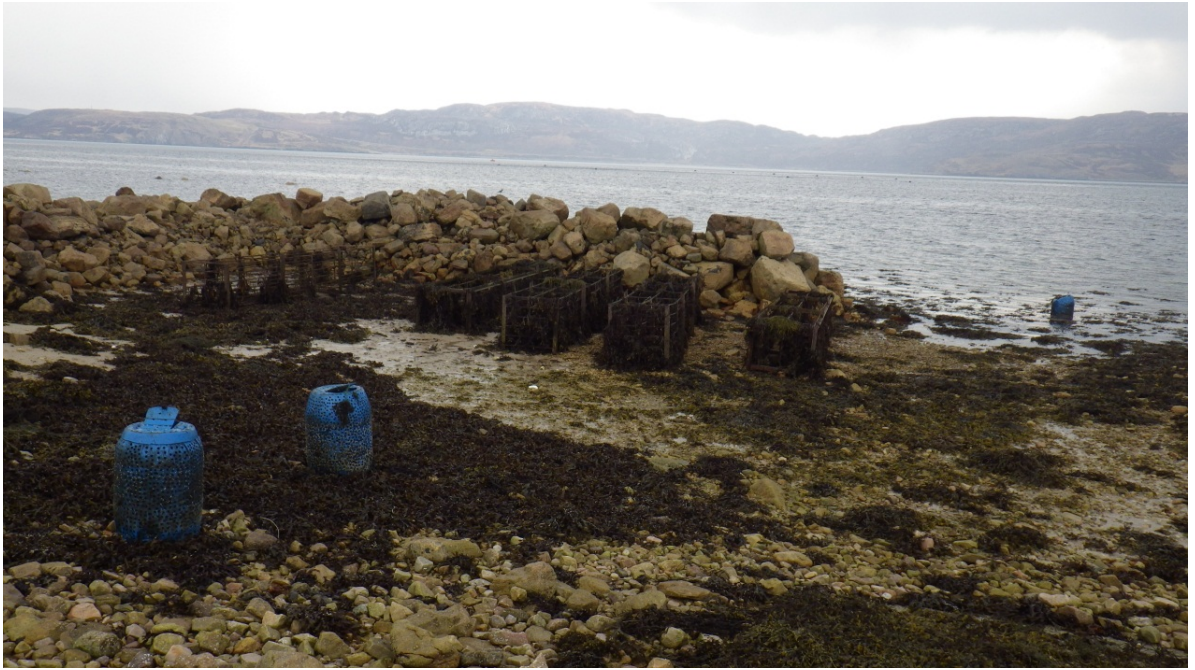
An area of 11 trestles was found in the vicinity of the RMP location. Two bags containing live Pacific oysters were present at the time of survey. Mussels were also sampled from bags on these trestles.

Figure 15: Oyster trestles at the RMP (waypoint 69). Site is largely empty and abandoned.

It is recommended that the RMP for mussels be retained at the trestle location due to its proximity to identified sources of contamination and its accessibility for sampling. However, it is recommended that the RMP be moved to the southern end of the trestles, nearer the watercourse sources to the south.
