Scottish Sanitary Survey Project

Sanitary Survey Report
Loch Fyne: Otter Ferry
AB 151
February 2011

Report Distribution – Loch Fyne: Otter Ferry

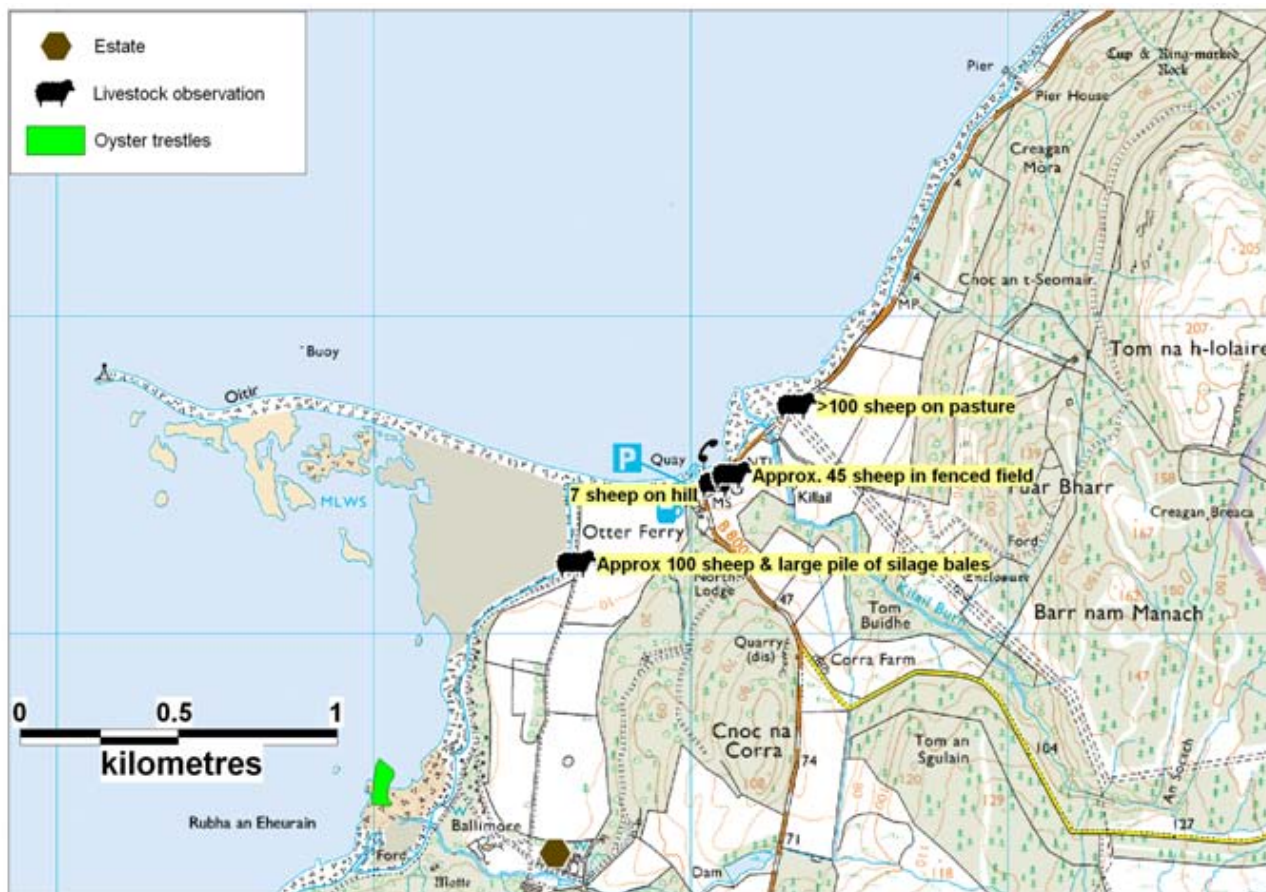
The spatial distribution of animals observed and noted during the shoreline survey is illustrated in Figure 7.1. The harvester reported that roughly 1000 sheep were kept on the estate and that these were grazed on fields around the area and brought into barns during the winter. Bedding from the barns is scraped up and spread on the fields after the sheep are put back out in spring. A small number of cattle are also kept (<10) further uphill from the estate, though these were not directly observed.

The estate farm buildings are located adjacent to a stream and any runoff from hardstanding areas would be carried to the fishery via the burn, making it a potential route for contamination from livestock barns when animals are kept on site.

A strip of woodland separates the pasture areas nearest the oyster farm from the shoreline, providing a buffer against direct runoff from faecal matter applied to the pasture areas. North of this, the pasture lies inland of the road although there is a wider area of mud and this is further from the fishery. North of the oitir, or sandspit, at Otter Ferry pasture lines both sides of the Kilail Burn and this is likely to carry runoff contaminated with sheep manure to Loch Fyne.

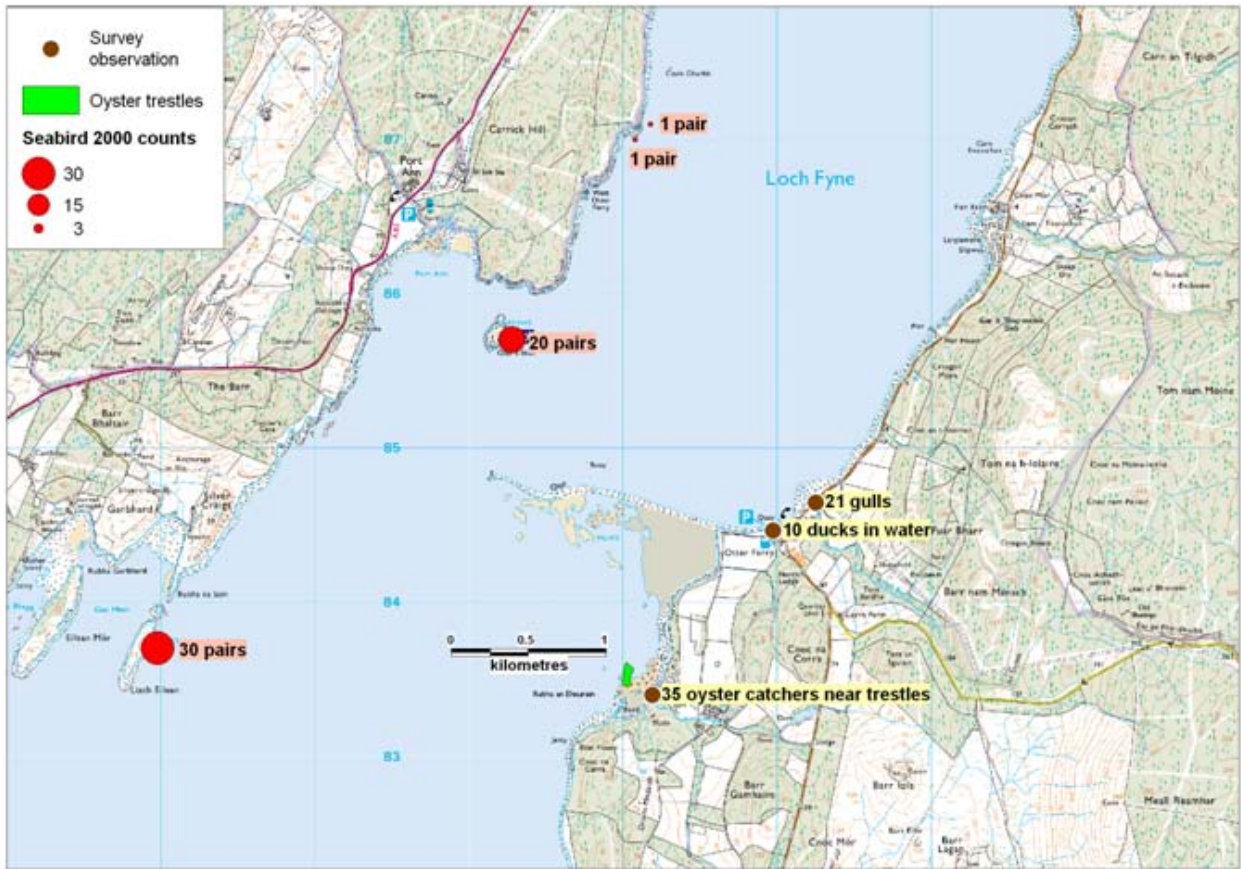
Figure 8.1 Map of wildlife observations at Otter Ferry

Species potentially impacting on water quality at Otter Ferry include eider ducks, wading birds, deer, and seals. However, the impacts of these on the fishery will be unpredictable. There will be some seasonal variation in the numbers and types of animals, particularly birds, present in the vicinity of the oyster farm. Seabirds and nesting wading birds are likely to be present on or

near their nests during the summer months. Eider ducks may be present in very large numbers in summer.

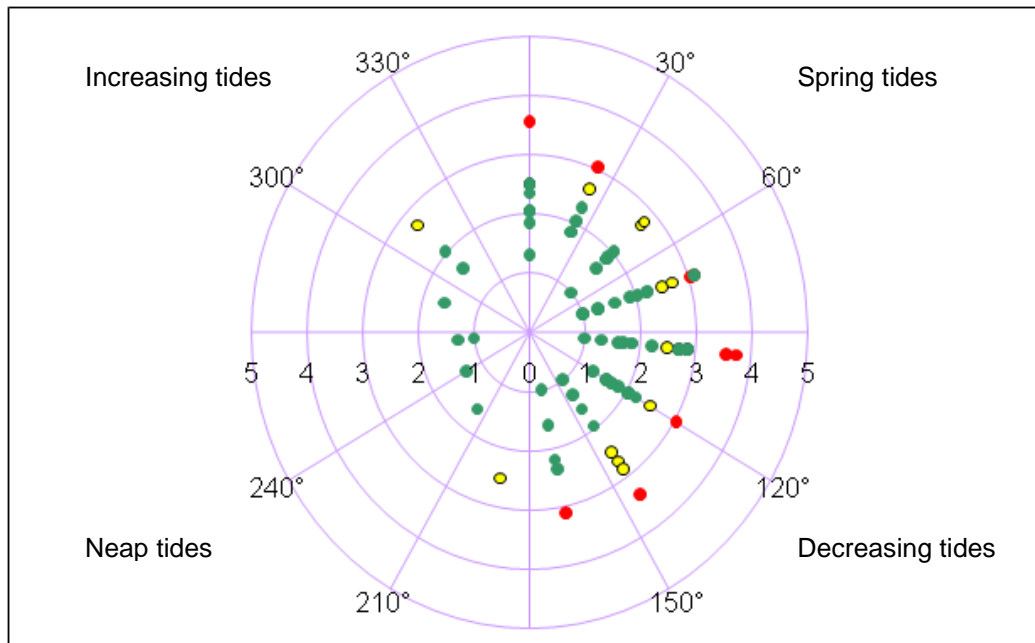
Figure 11.8 Polar plot of \log_{10} *E. coli* results on the spring/neap tidal cycle

No statistically significant correlation was found between *E. coli* results and the spring/neap cycle (circular-linear correlation, $r=0.168$, $p=0.092$, Appendix 6). Sampling was heavily targeted towards spring tides.

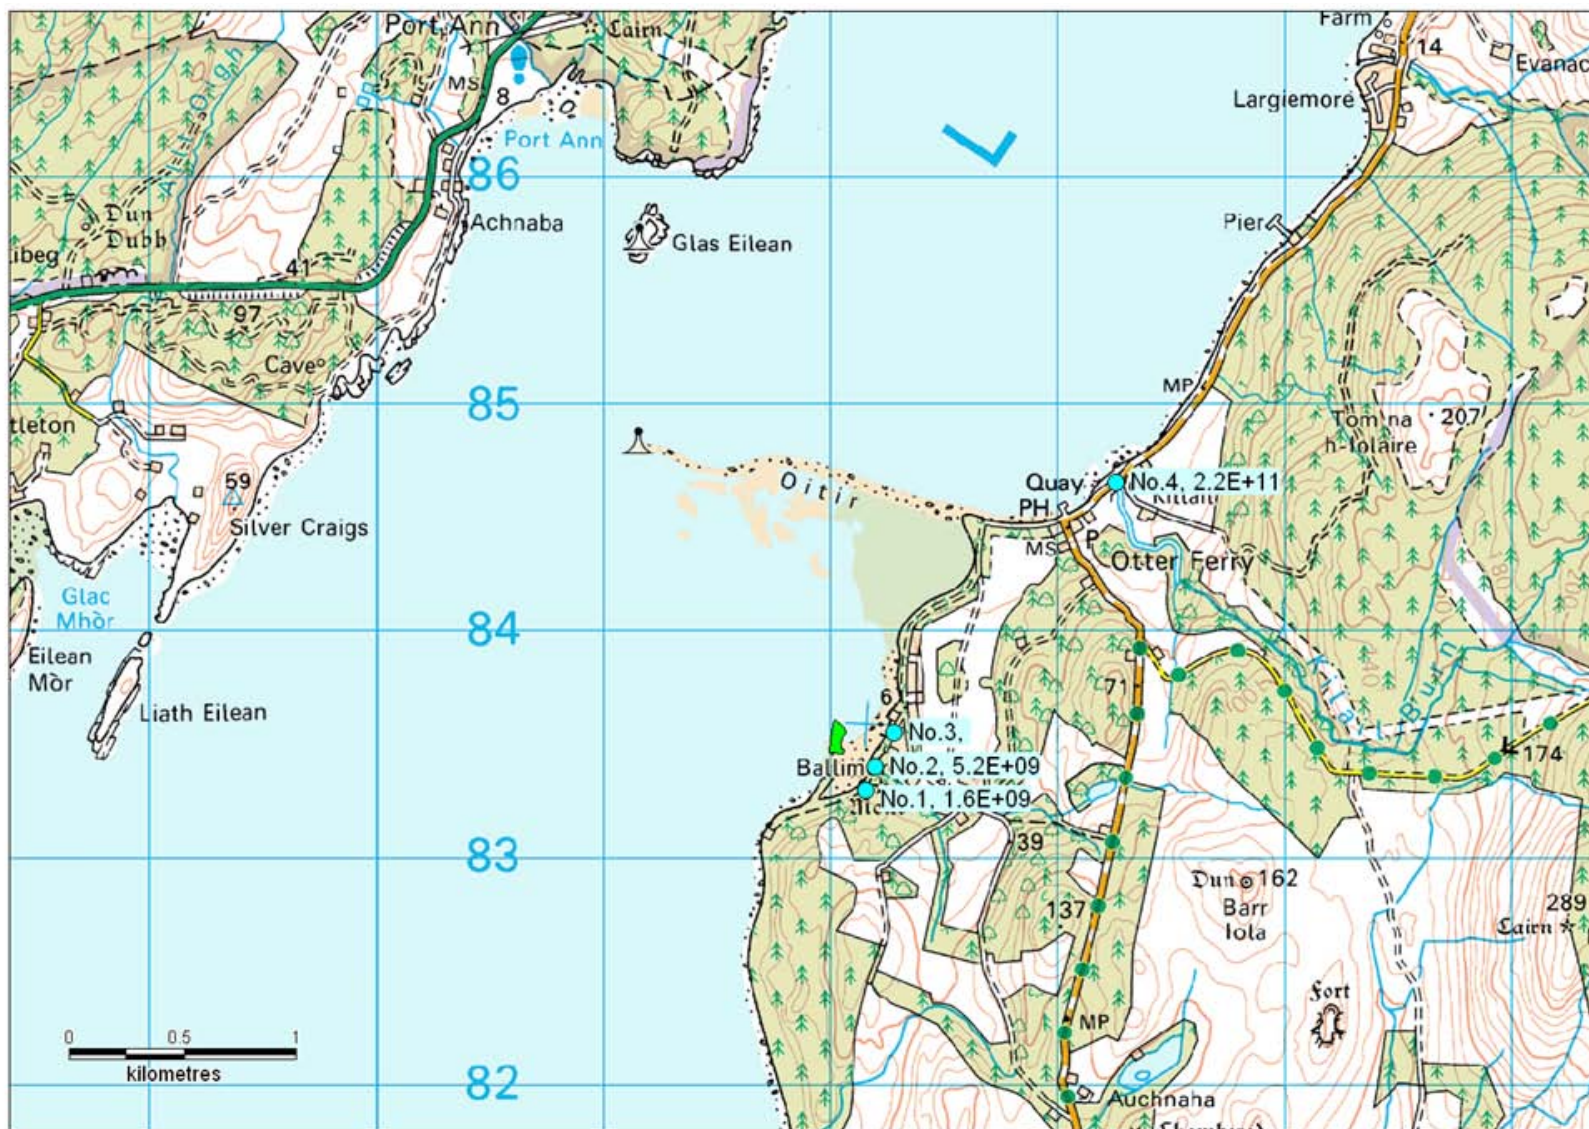
The burns and streams listed in Table 13.1 were measured and sampled during the shoreline survey. The locations are shown on the map presented in Figure 13.1. These watercourses were deemed to represent the potentially most significant freshwater inputs into the survey area in the immediate vicinity of the Loch Fyne: Otter Ferry shellfishery. There were rain showers on the day of the survey and it had also rained on the preceding day.

The microbiological loadings from the watercourses would be expected to be lower after periods of dry weather.

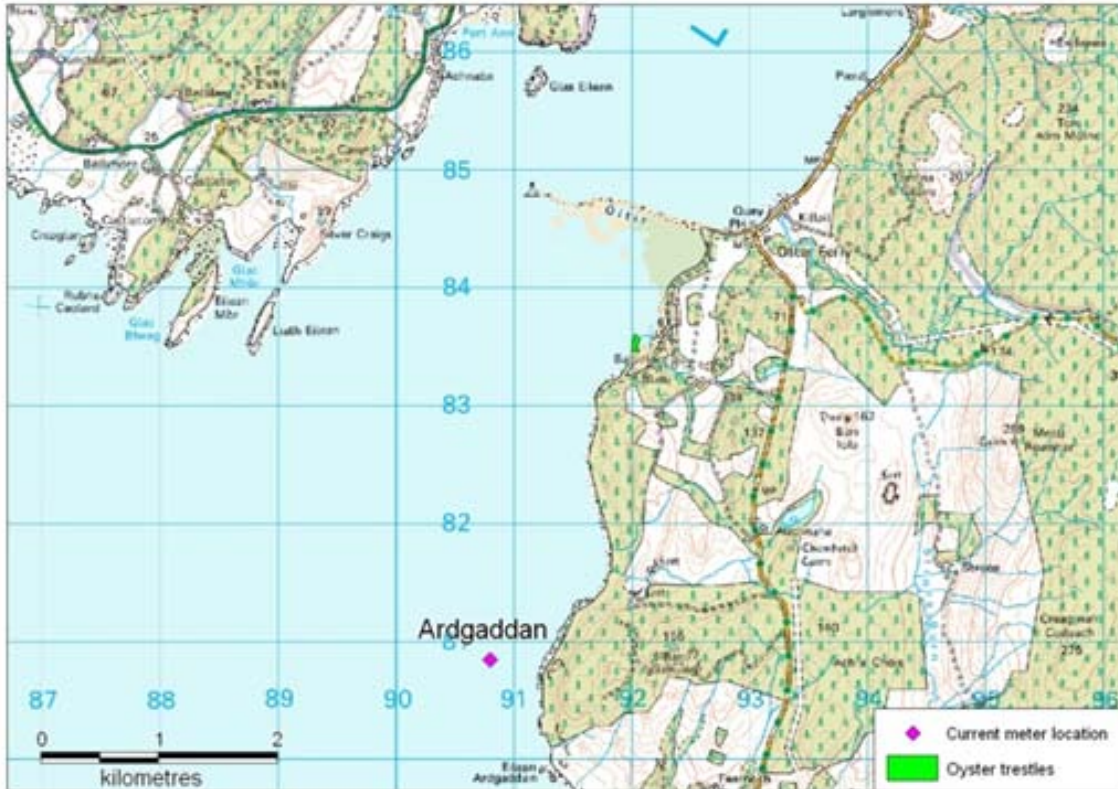
At the maximum spring tide speed of 0.57 m/s given for the tidal station, the maximum distance travelled by contaminants over a flood or ebb tide would be more than 8 km, ignoring dilution and dispersion. The distance would be less on neap tides.

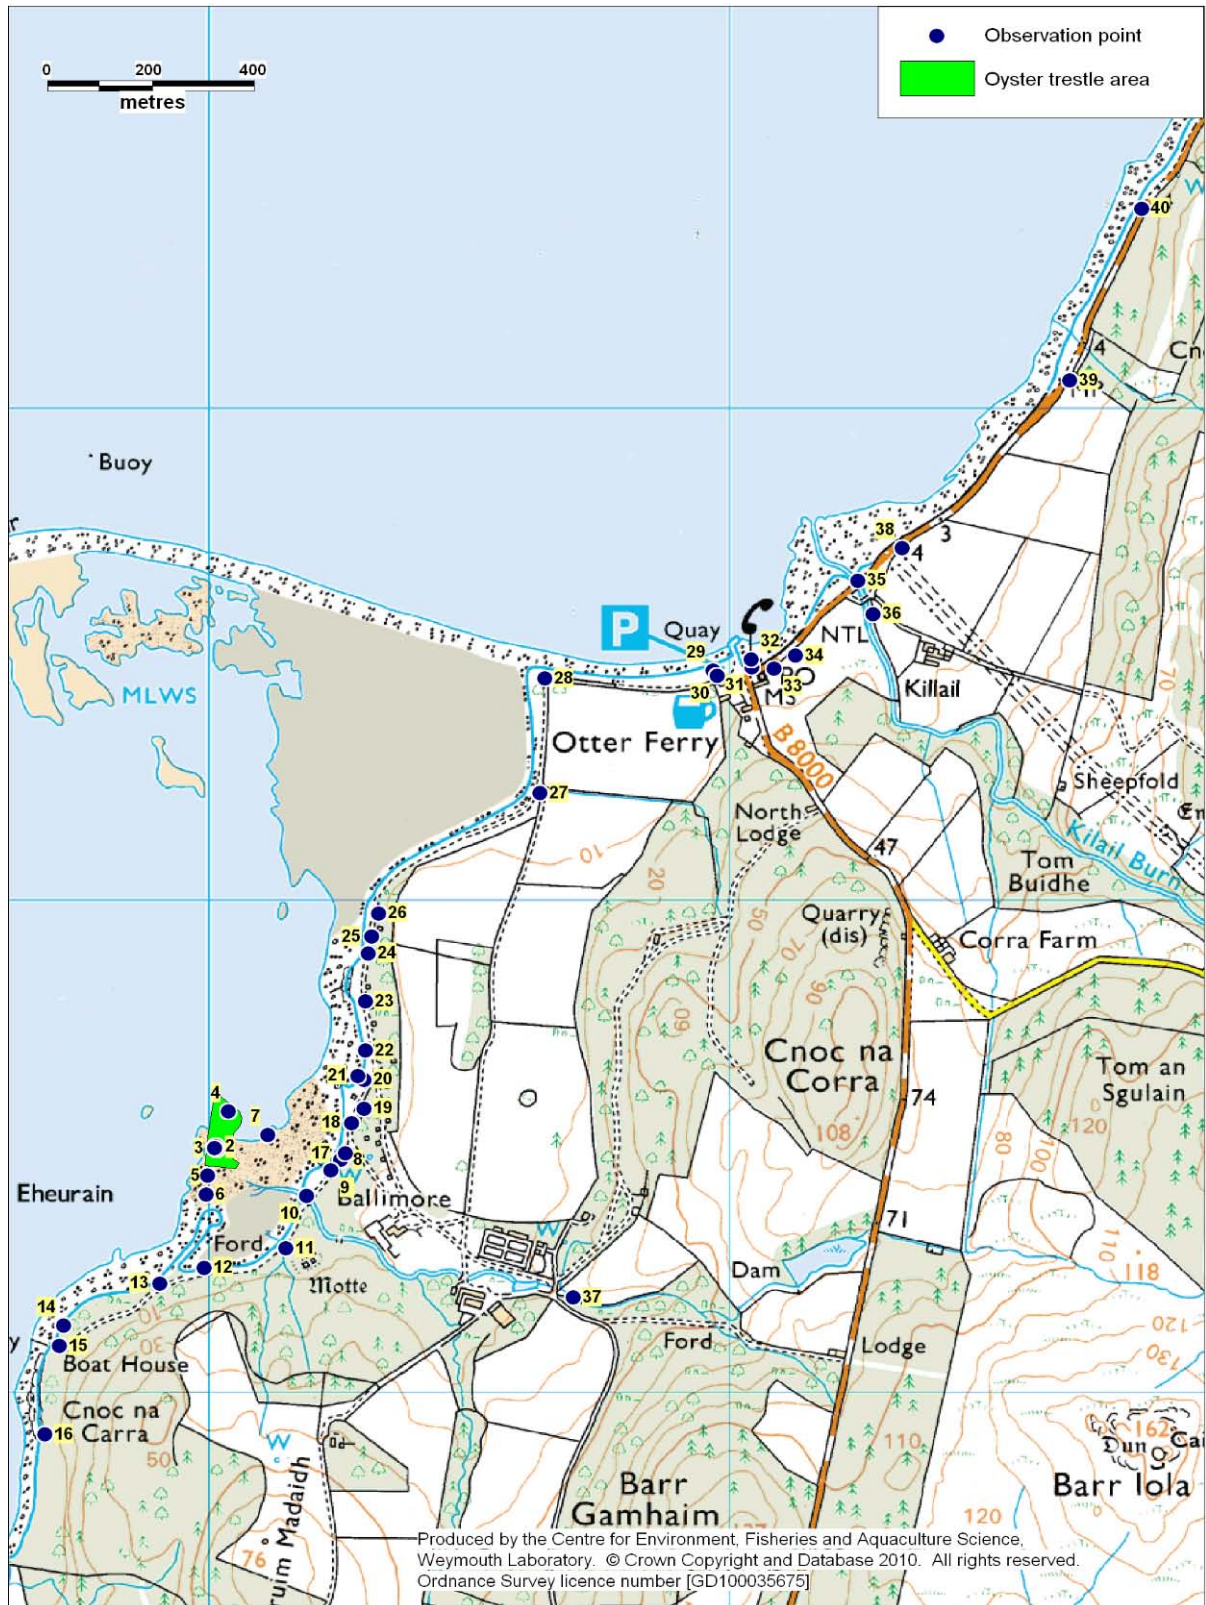
Figure 1. Map of shoreline survey observations

No.	Date	Time (GMT)	NGR	East	North	Associated photograph	Description
1	11/08/2010	06:28:44	NR 92018 83495	192018	683495		Stream crossing shoreline
2	11/08/2010	06:31:10	NR 92016 83501	192016	683501	Figure 4	Sample LFOF10-001, oyster sample plus norovirus sample
3	11/08/2010	06:40:43	NR 92014 83497	192014	683497		Water sample (22 ppt) LFOF10-003
4	11/08/2010	06:46:43	NR 92040 83572	192040	683572		LFOF10-002, oyster sample
5	11/08/2010	06:52:58	NR 92000 83441	192000	683441		Stream crossing shoreline
6	11/08/2010	06:54:05	NR 91998 83402	191998	683402		RMP
7	11/08/2010	07:02:48	NR 92117 83523	192117	683523		Stream crossing shoreline
8	11/08/2010	07:56:37	NR 92256 83473	192256	683473	Figure 5	Pipe exiting wall, water seeping down wall, insufficient flow for sample
9	11/08/2010	08:00:01	NR 92237 83452	192237	683452	Figure 6	Pipe, 15cm diameter, flowing 100ml=10sec. Water sample LFOF10-004, foul discharge from estate house

10	11/08/2010	08:07:07	NR 92191 83400	192191	683400		Stream, 0.18mx2.5m, flow 2m=24sec. Sample taken at trestles (see 3 above). 35 oyster catchers near trestles
11	11/08/2010	08:15:39	NR 92151 83293	192151	683293		Small stream, 0.05mx.5m flow 1m=5sec. Sample LFOF10-005
12	11/08/2010	08:25:03	NR 91994 83254	191994	683254	Figure 7	Small stream, flow too shallow to measure or sample accurately
13	11/08/2010	08:30:20	NR 91909 83222	191909	683222		Outfall pipe - no evidence of recent use, nothing apparent on shore above pipe
14	11/08/2010	08:37:18	NR 91724 83136	191724	683136		Fox dropping on shore
15	11/08/2010	08:38:37	NR 91716 83095	191716	683095		Boat house
16	11/08/2010	08:45:44	NR 91688 82915	191688	682915		Southern extent of shoreline walk
17	11/08/2010	09:06:00	NR 92265 83486	192265	683486		2 yachts observed passing light at end of Otter Spit
18	11/08/2010	09:09:59	NR 92277 83548	192277	683548		Stream seeping across rocks and foreshore. Water sample LF10-006

27	11/08/2010	09:56:42	NR 92640 84218	192640	684218		Dry stream bed, field with roughly 100 sheep and large pile of silage bales
28	11/08/2010	10:05:50	NR 92649 84451	192649	684451		Old boathouse at Otter Spit, corner of pasture (no sheep on at the time)
29	11/08/2010	10:12:39	NR 92973 84468	192973	684468	Figure 12	10 ducks floating near end of pontoon, 3 boats on mooring (6 photographed earlier in day)

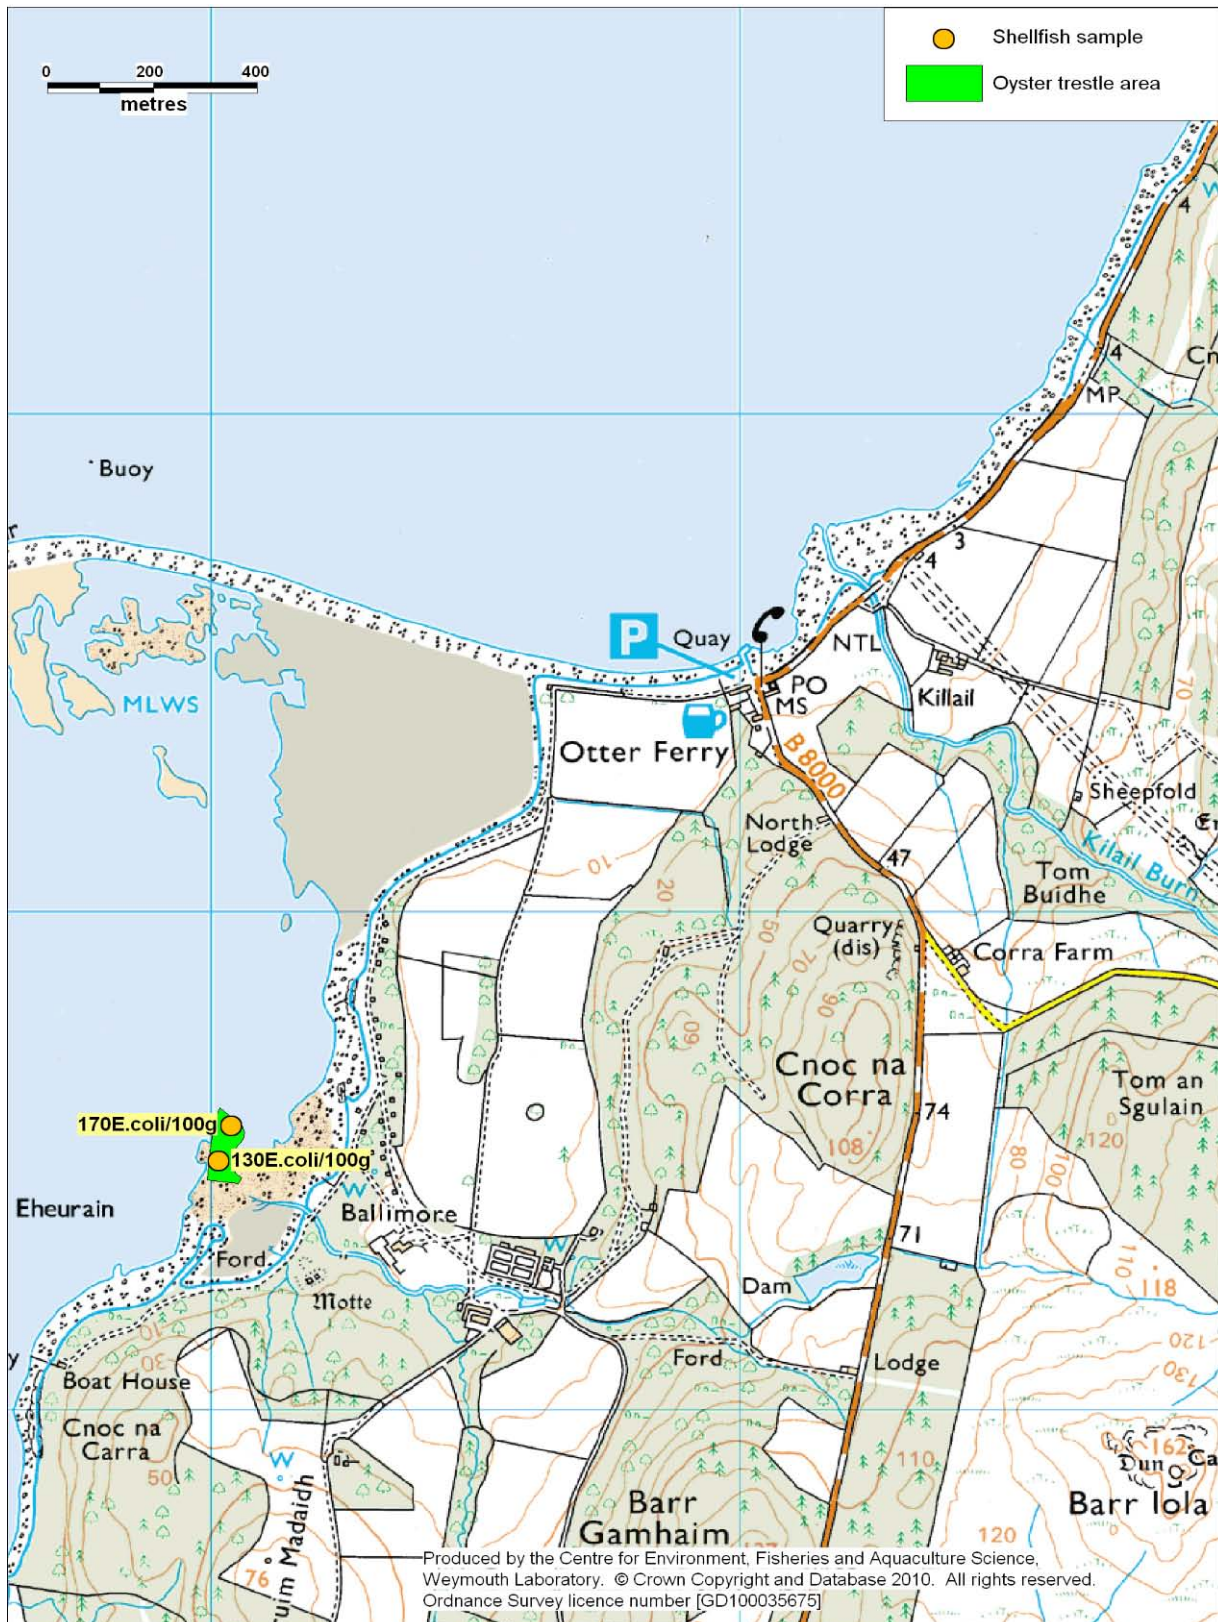
Figure 3. Shellfish sample results map

No.	Date	Sample	Grid Ref	Type	E. coli (MPN/100 g)
1	11/08/2010	LFOF10-001	NR 92016 83501	Pacific oyster	130
2	11/08/2010	LFOF10-002	NR 92040 83572	Pacific oyster	170

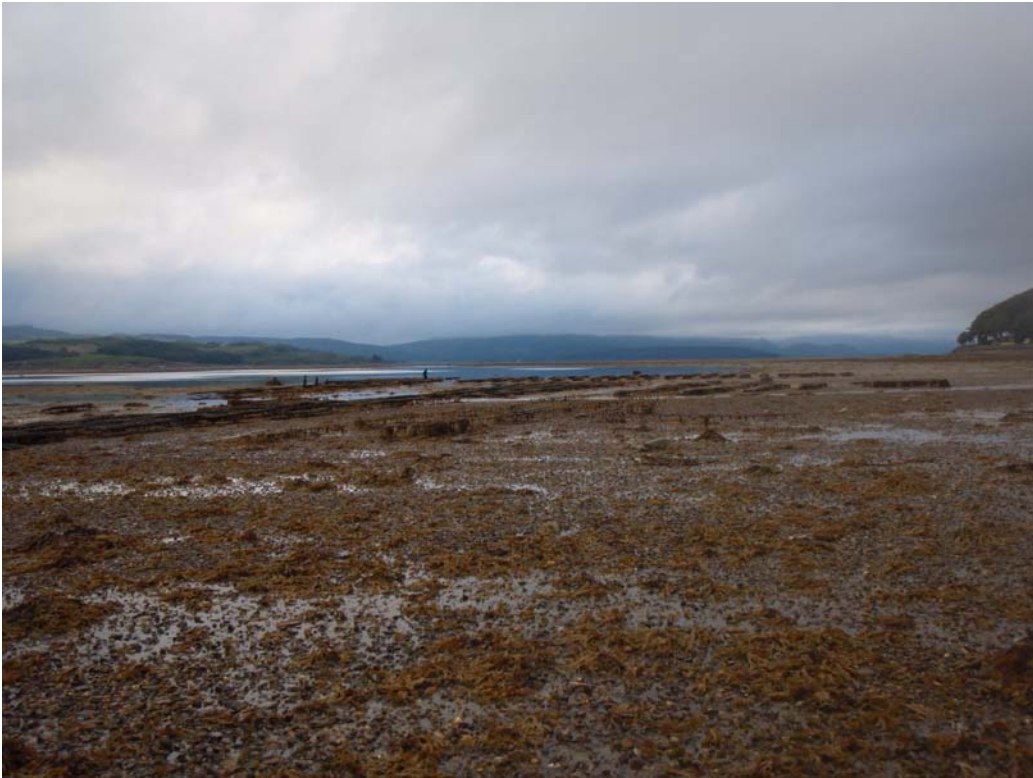
Figure 4. Oyster farm at Otter Ferry

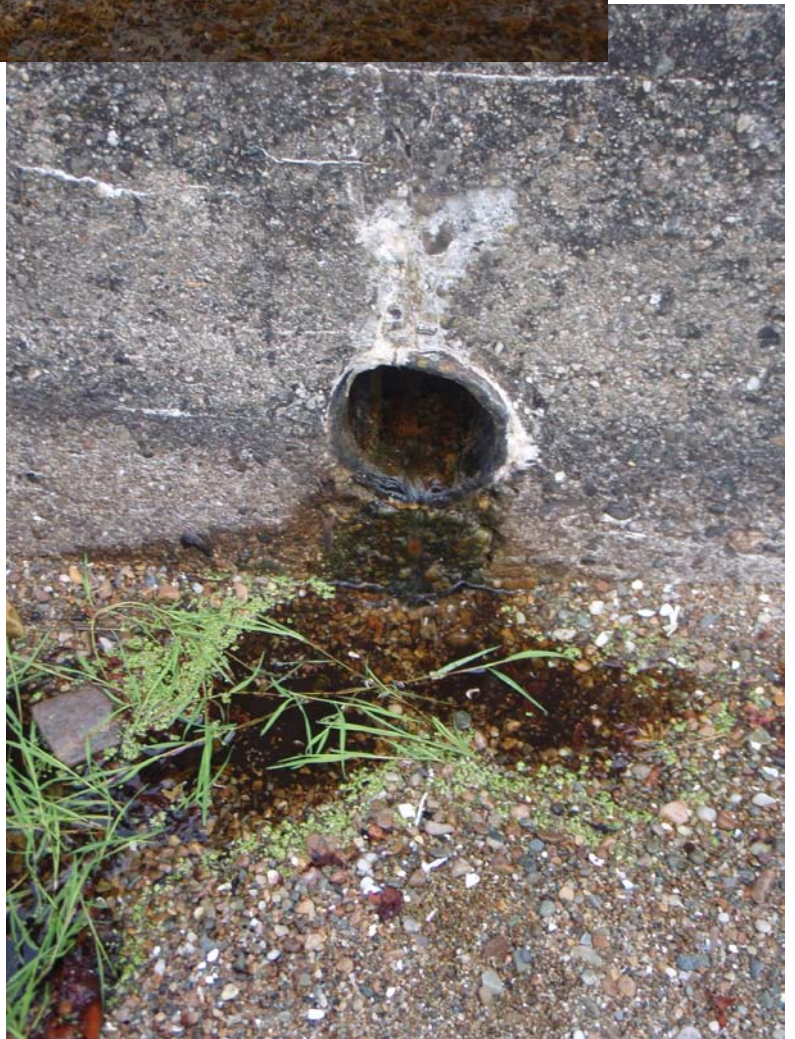
Figure 5. Drainage pipe in seawall

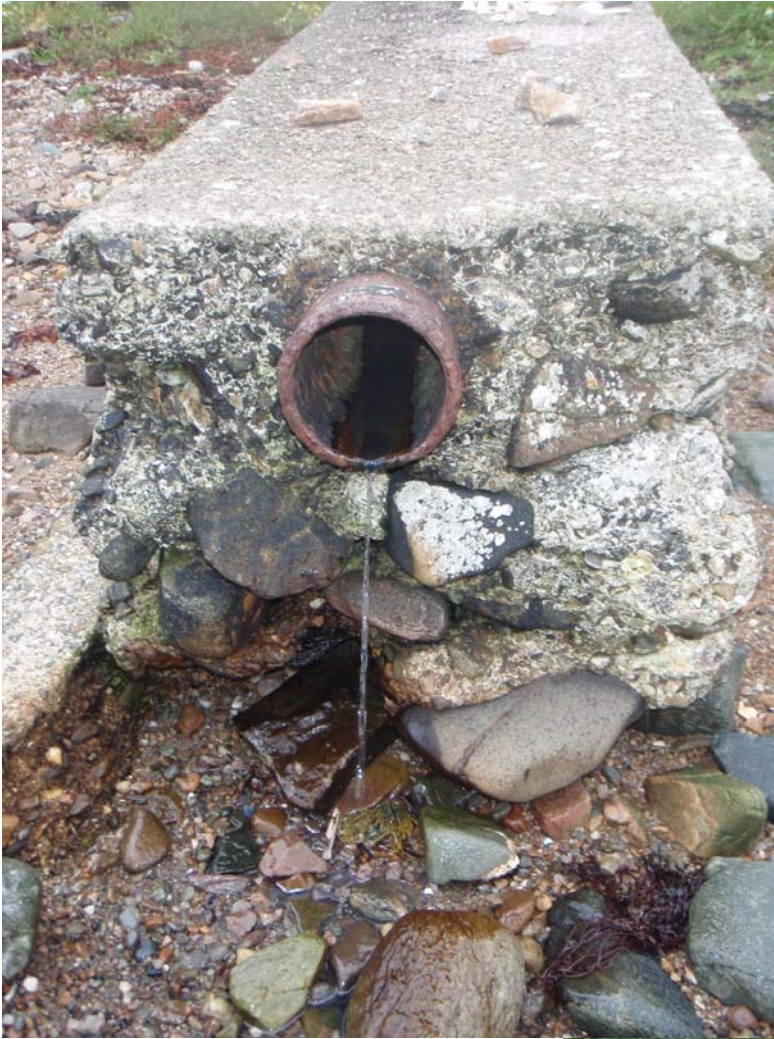
Figure 6. Discharge pipe

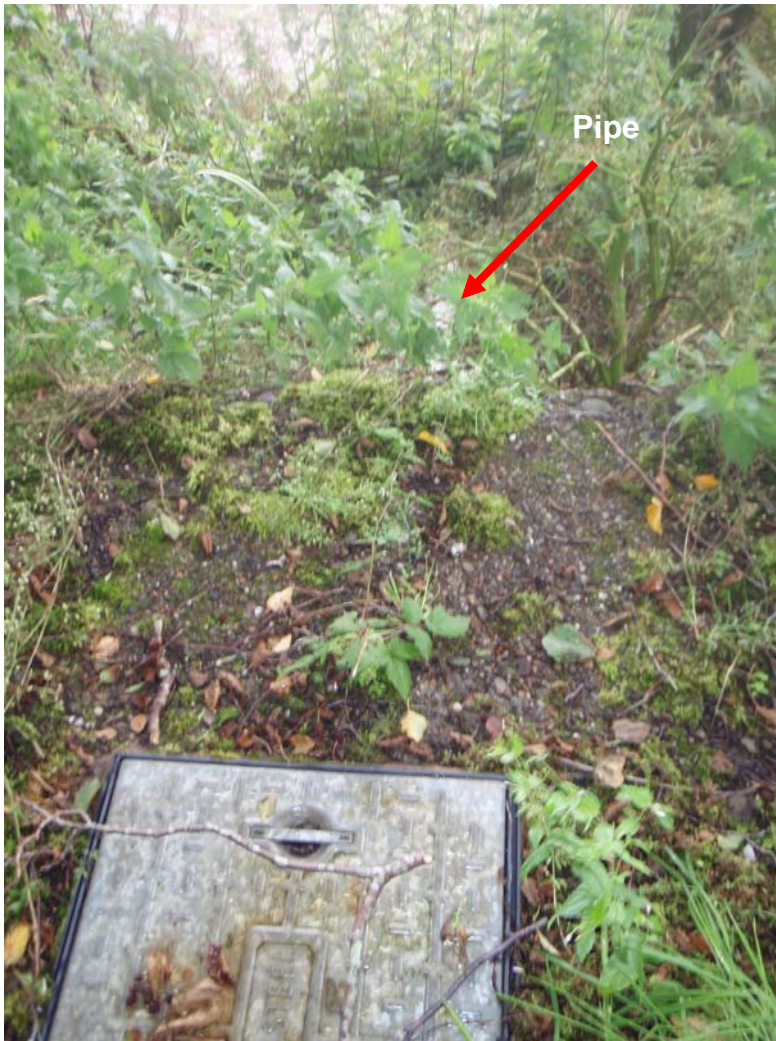
Figure 8. Septic tank with outlet pipe

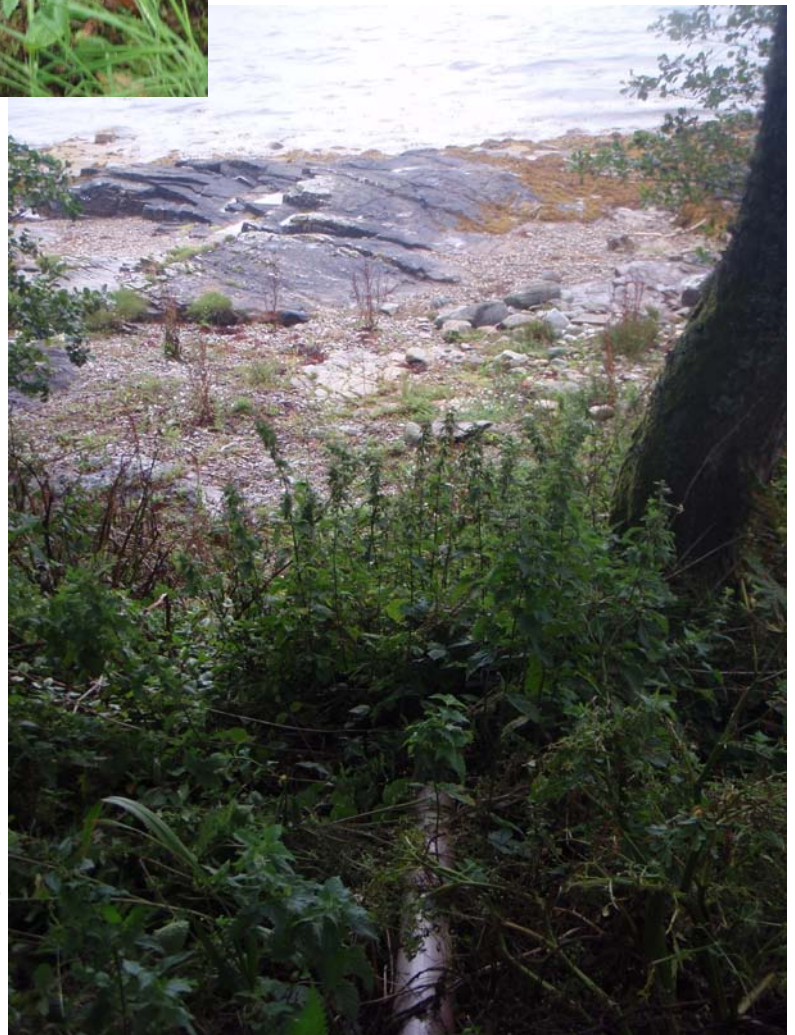
Figure 9. Discharge pipe for tank above

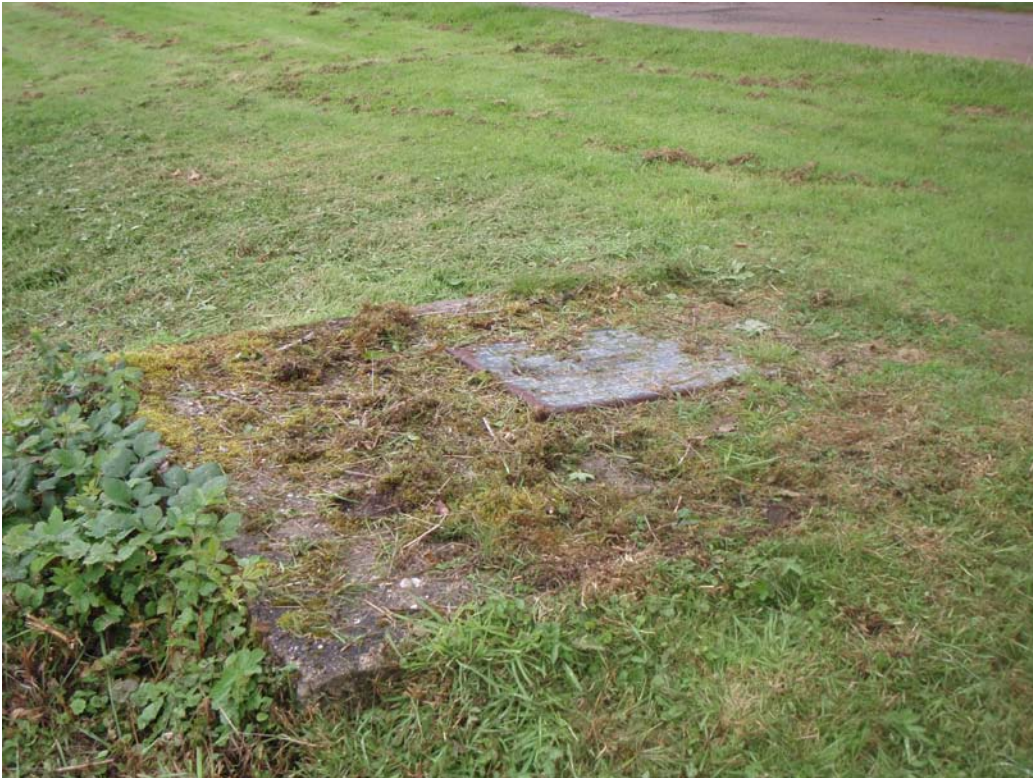
Figure 10. Septic tank 2

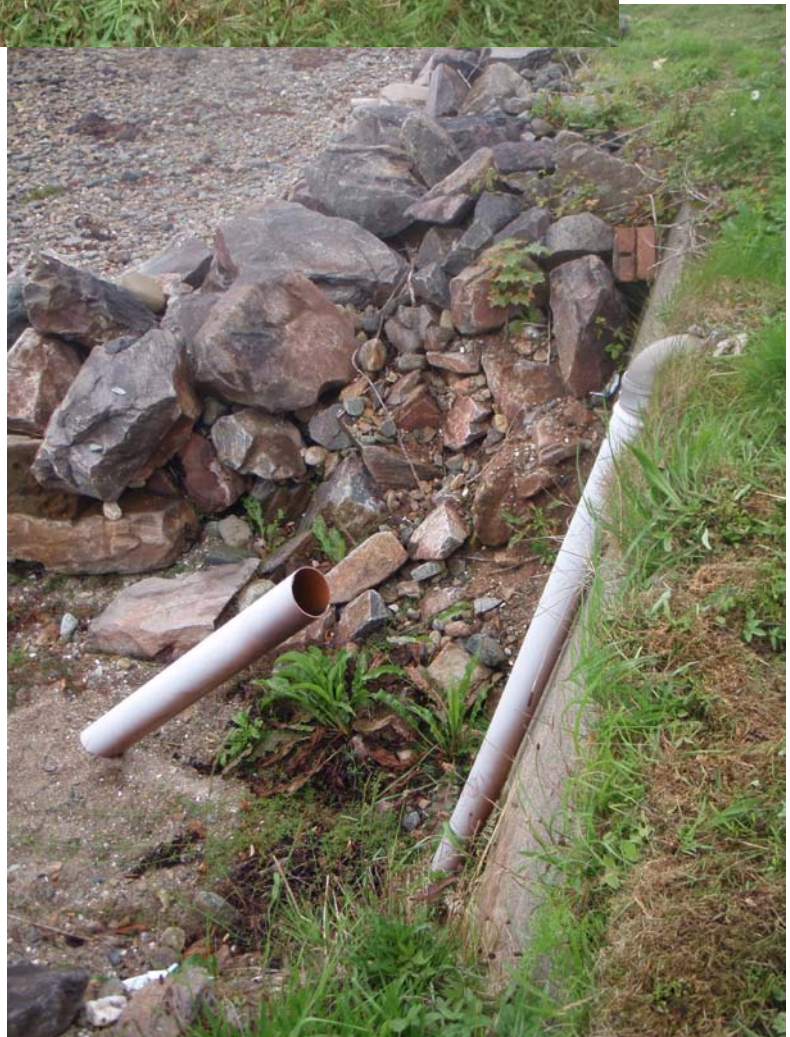
Figure 11. Discharge pipe for tank 2

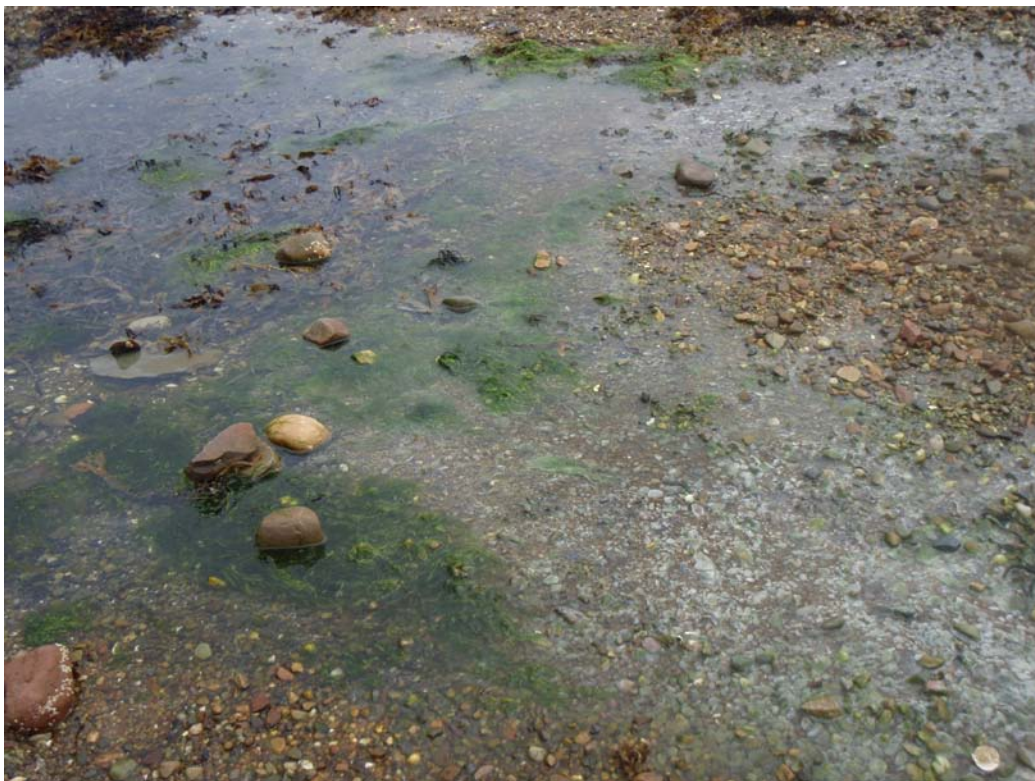
Figure 13. Sewage fungus in discharge at shoreline
