# Scottish Sanitary Survey Review

**Loch Fyne: Stonefield and Loch Fyne: Stonefield  
Oysters**

**AB-154-043-15 and AB-435-840-13**

**April 2015**

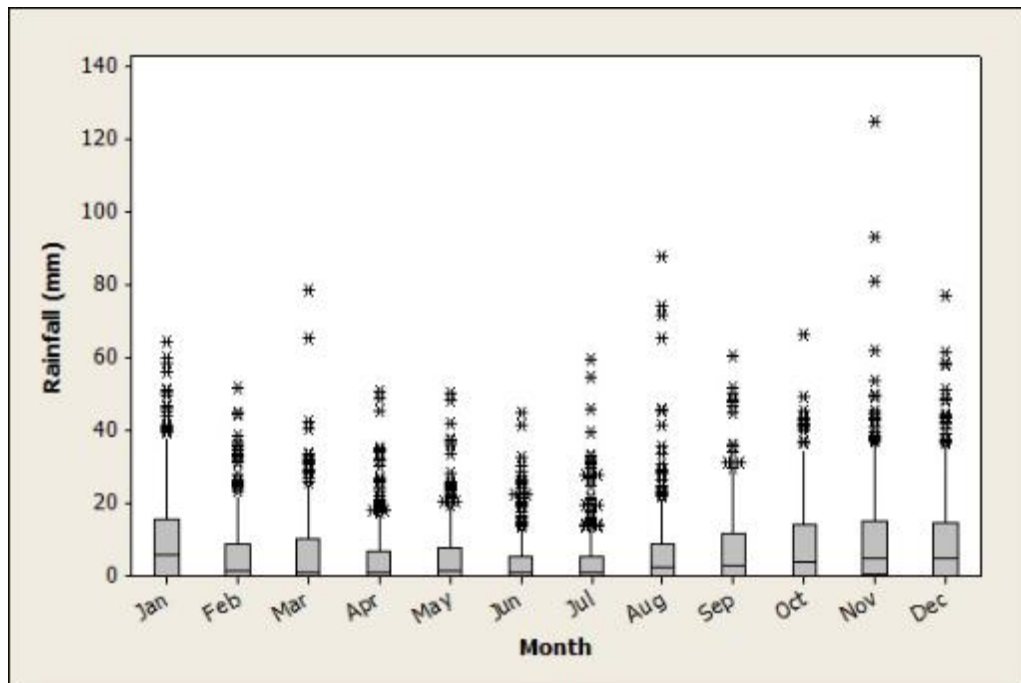
**Figure 6.2 Boxplot of daily rainfall at Benmore Younger Botanical Gardens by month (2003-2013)**

Overall, daily rainfall values were highest from October to January, and lowest from April to July. Extreme rainfall events exceeding 40 mm per day occurred in all months in the dataset, and therefore runoff associated with high rainfall can occur at any time of year.

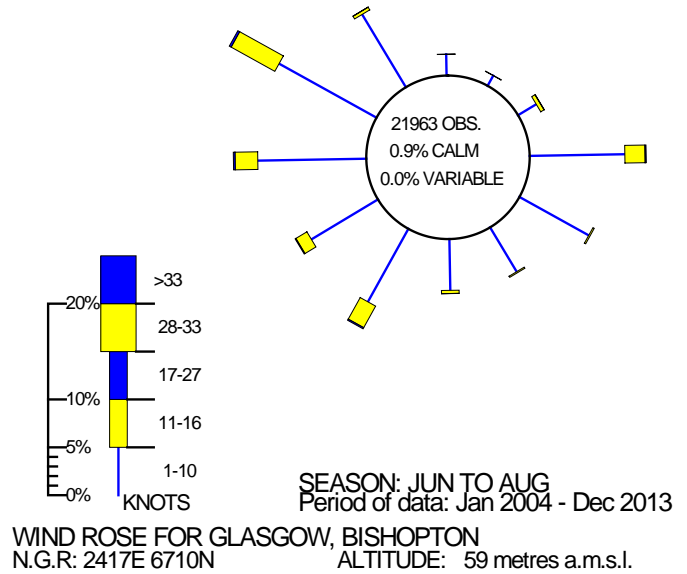
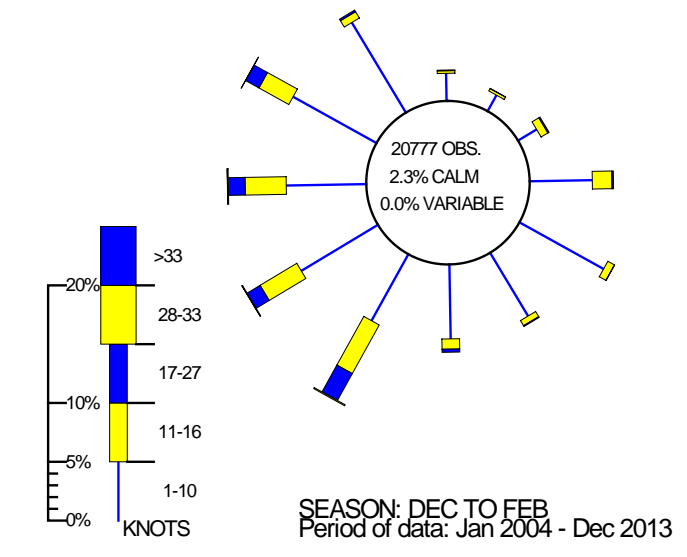
**Figure 6.3 Seasonal wind roses for Glasgow: Bishopton (2004-2013)**

Prevailing winds are from the west throughout most of the year. However, winds blow from the east a significant proportion of the time, particularly from March to May. Wind strength is weakest from all directions from June to August.

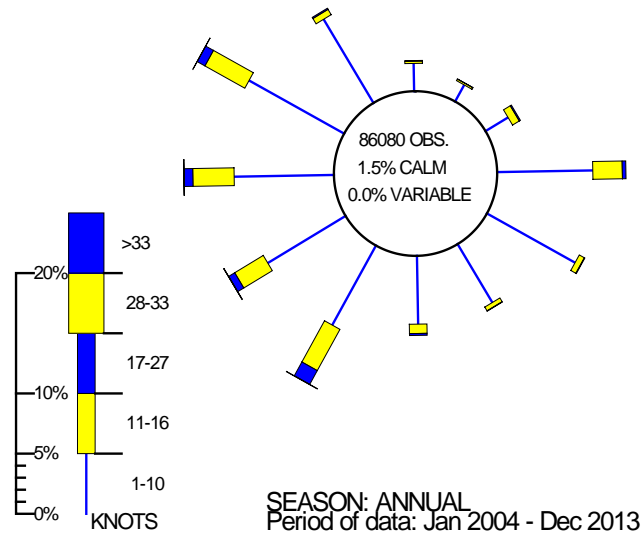
Figure reproduced under license from Meteorological Office. Crown Copyright 2015  
**Figure 6.4 Annual wind rose for Glasgow: Bishopton (2004-2013)**

Overall, winds tend to blow broadly from a westerly direction at Glasgow Bishopton, with easterly winds occurring a proportion of the time. Whilst Glasgow Bishopton is located on the west coast of mainland Scotland, Loch Fyne: Stonefield is in a part of the loch that runs north-south, with a large stretch of land on the western side (Kintyre headland), which is expected to limit the impact that westerly winds will have on particle transport at the shellfish farm.

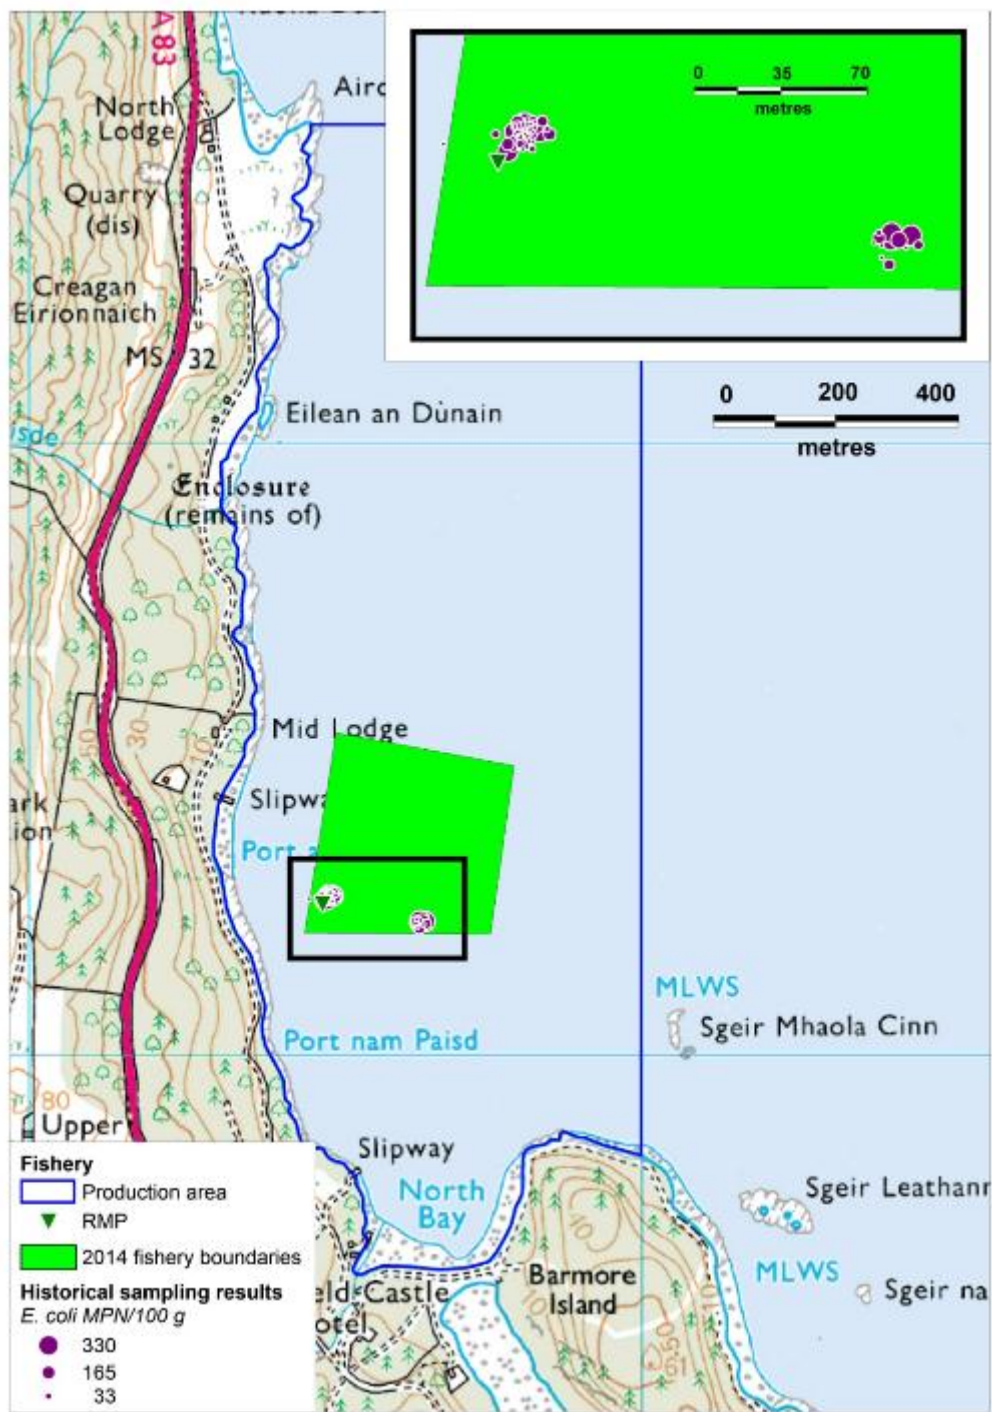
**Figure 7.2 Sample results and locations from Loch Fyne: Stonefield Oysters**

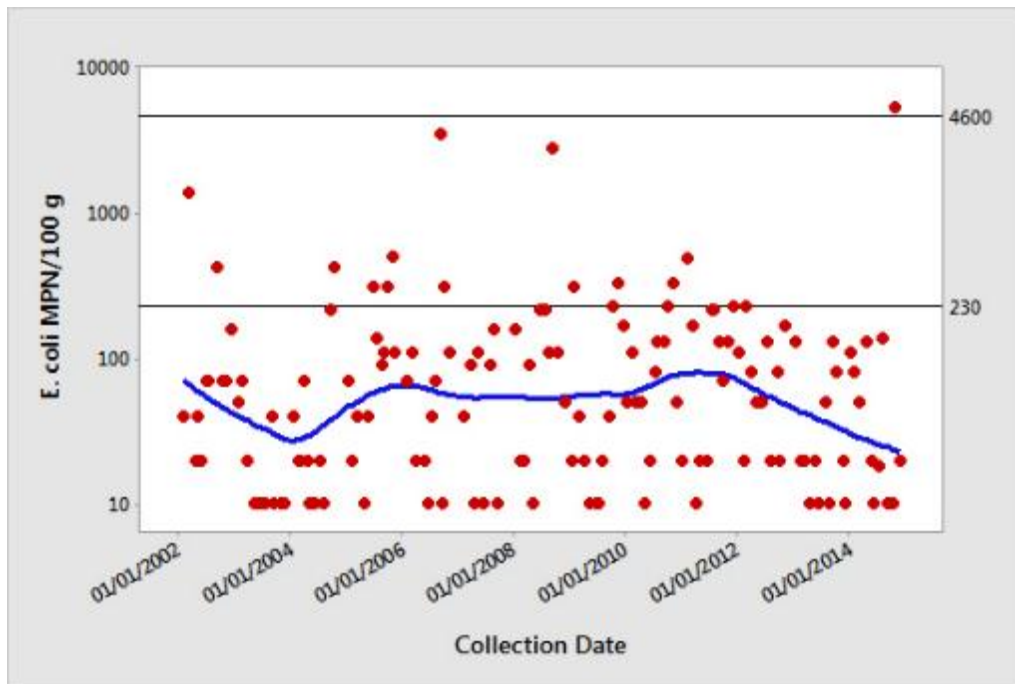
**Figure 7.3 Scatterplot of Loch Fyne: Stonefield *E. coli* results by date (2002-2014)**

No marked change in the general level of *E. coli* results in the queen scallops was evident over the date range shown.

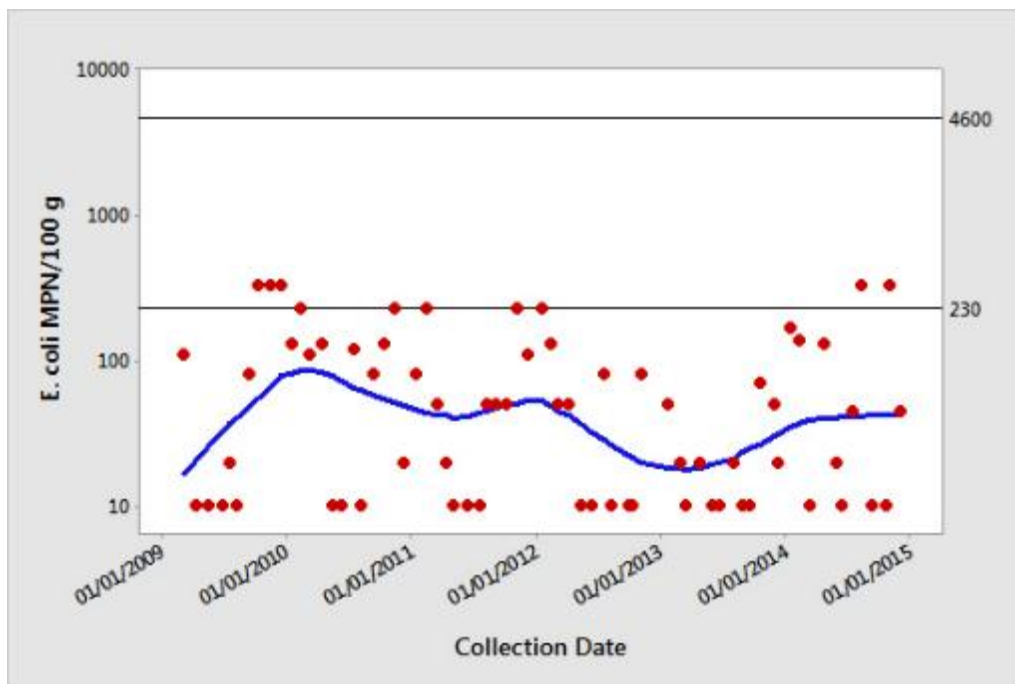
**Figure 7.4 Scatterplot of Loch Fyne: Stonefield Oysters *E. coli* results by date (2009-2014)**

There is no evidence of a marked change in the level of *E. coli* results in the Pacific oysters since 2009.

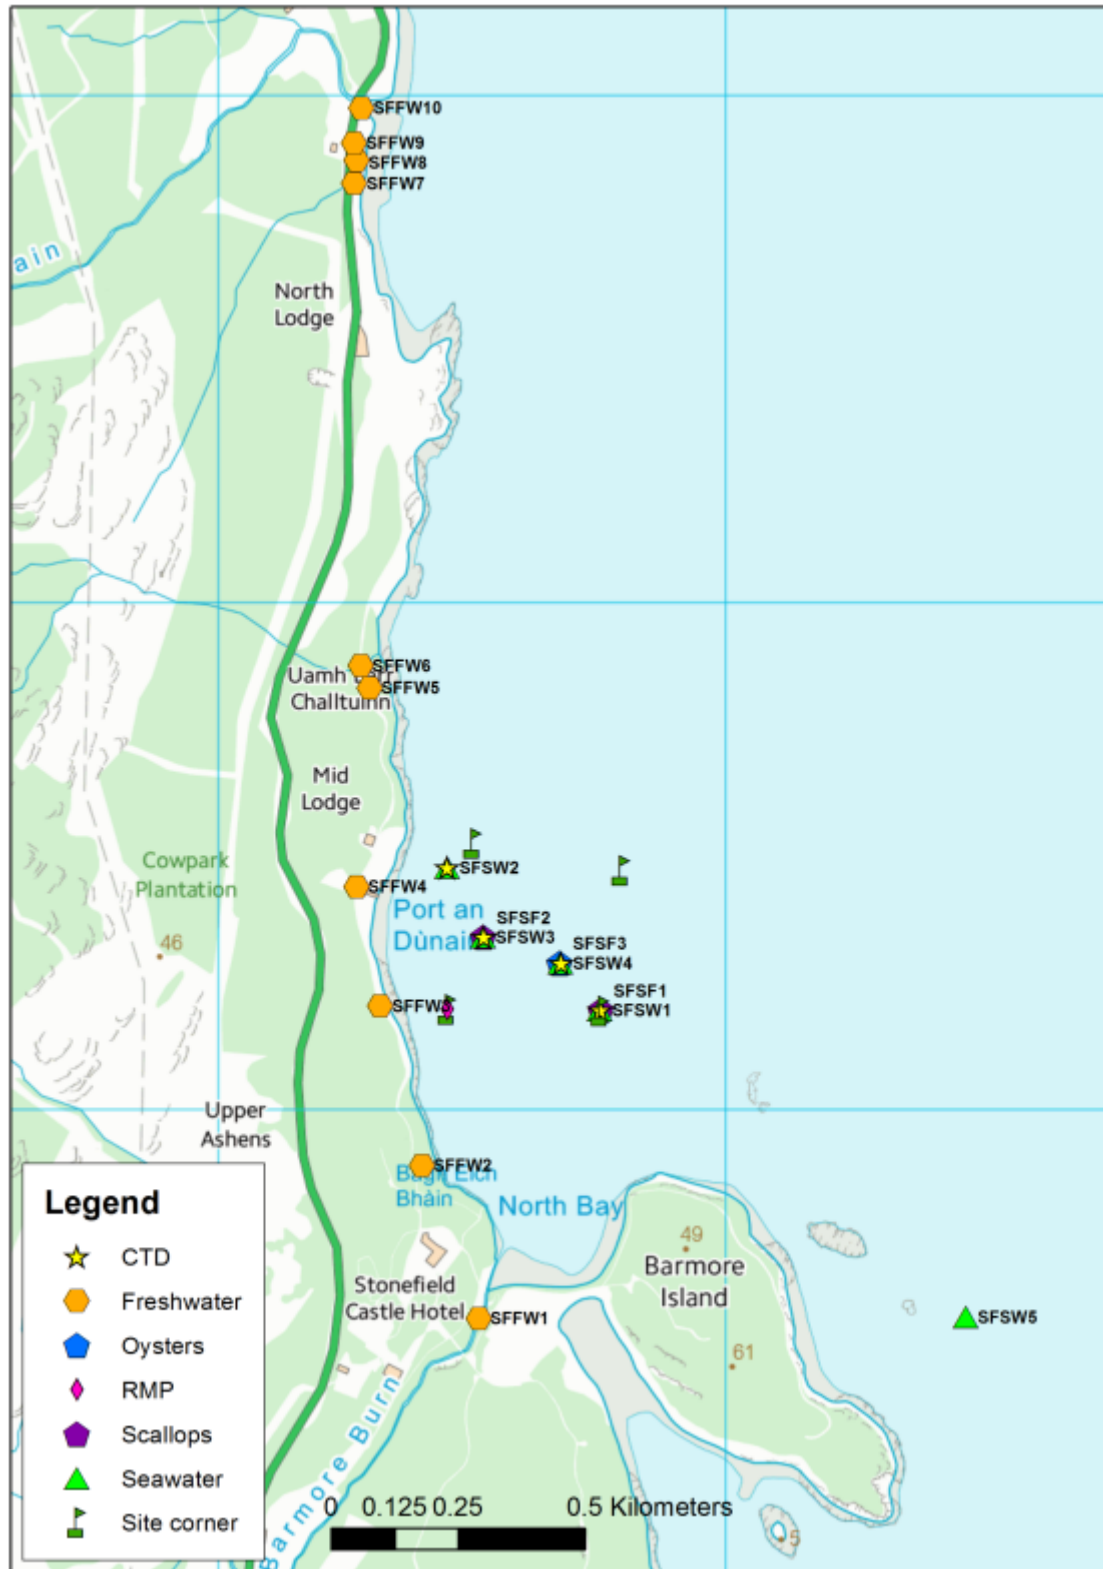
Figure 2. Loch Fyne: Stonefield samples north.

Specific observations made during the survey are mapped in Figures 1 and 2 and listed in Table 1. Water and shellfish samples were collected at the locations marked on Figures 3 and 4. Bacteriology results are given in Tables 2 and 3. Photographs are presented in Figures 5 – 22.

Four CTD profiles were taken at locations detailed in Figures 2 and 4. The gathered data will be sent to Cefas as agreed previously on a separate Excel sheet.

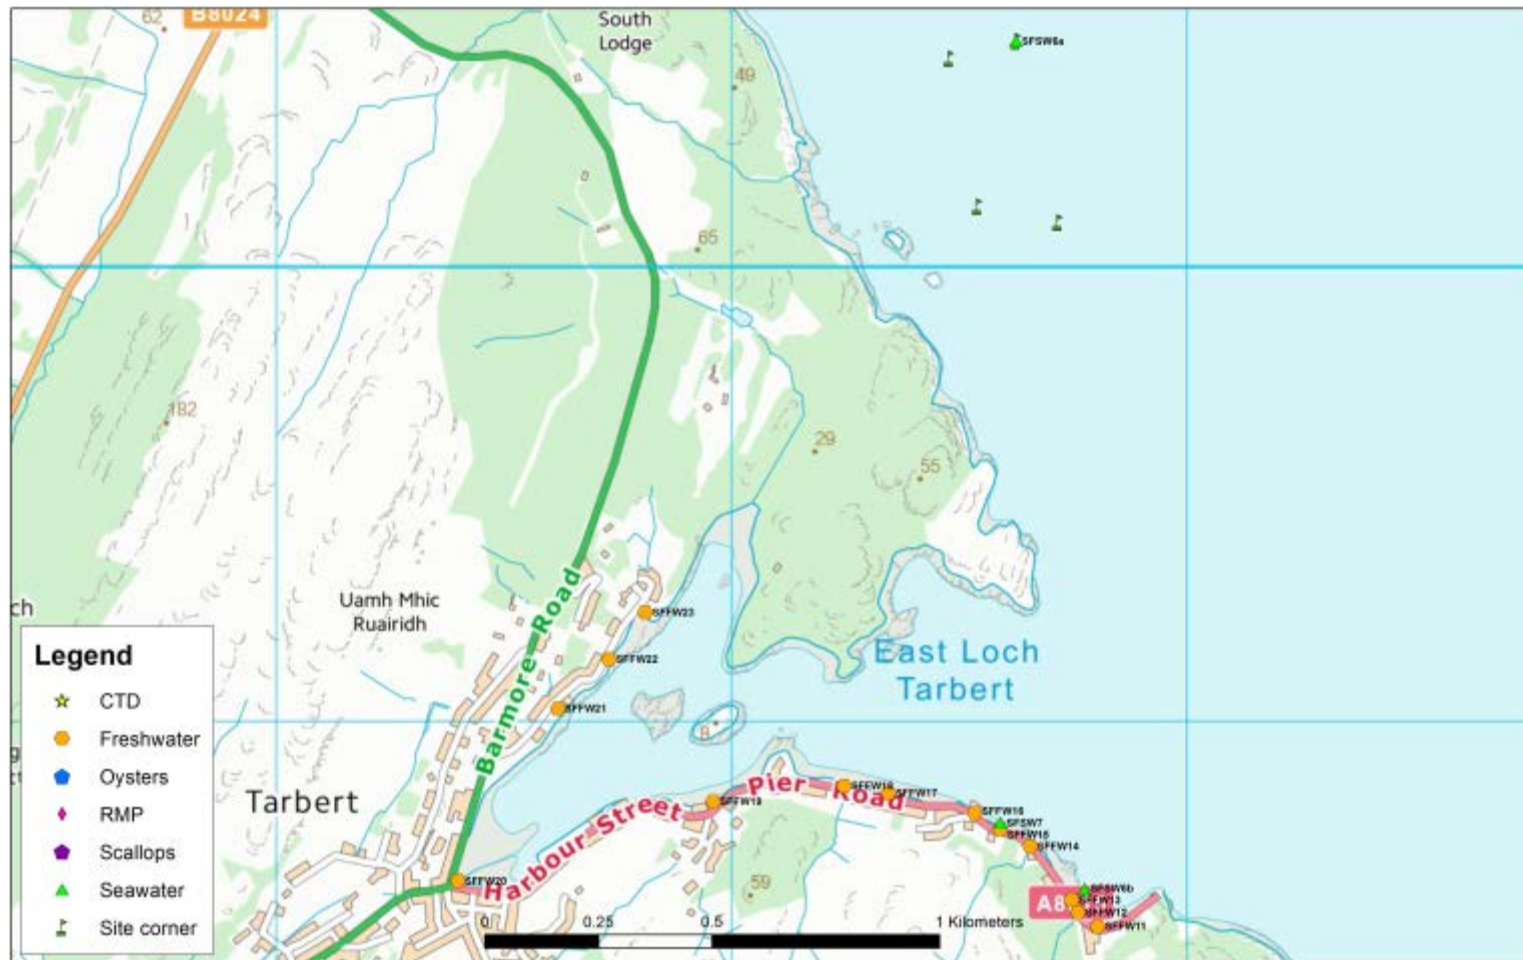
Figure 4. Loch Fyne: Stonefield samples south.

There were no mature shellfish available to sample at the most southerly site, south of Barmore Island but the location and extent of this site was recorded, as requested (Figures 3 & 4 and waypoints 25-29).

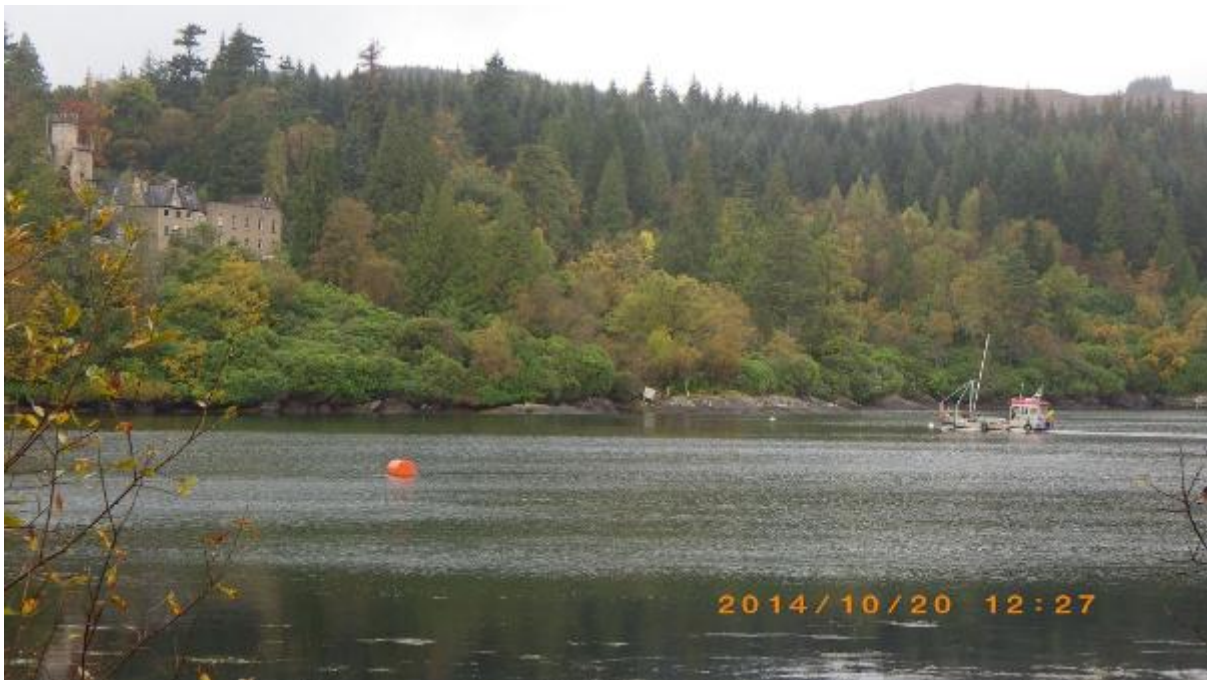
No.	Date	Time	NGR	East	North	Associated photograph	Associated sample	Description
1	20/10/2014	12:24	NR 86822 71833	186823	671834	Fig 5		Start of shore walk at Barmore Island. Stonefield Castle Hotel and two houses on opposite (mainland) shore. One passing working boat close to shore (harvester's boat).
2	20/10/2014	12:32	NR 86668 71625	186668	671625			Shore Cottage on mainland shore south of Barmore Island causeway. One heron in water.
3	20/10/2014	12:35	NR 86555 71624	186556	671625			Harvester shore base consisting of shed with piles of lantern nets stored outside.
4	20/10/2014	12:52	NR 86513 71588	186513	671589	Fig 6	SFFW1	Planned freshwater sample from Barmore Burn.
5	20/10/2014	12:52	NR 86514 71591	186515	671591			Associated with waypoint 4. Stream split into three flows by large rocks: Width 1 = 1.95 m, depth 1a = 16 cm (@ 0.25 m from rock), flow 1a 0.617 m/sec SD 0.017; depth 1b = 19 cm (@ 0.95 m from rock), flow 1b 0.741 m/sec SD 0.008. Width 2 = 0.9 m, depth = 25 cm, flow 0.588 m/sec SD 0.020. Width 3 = 1.15 m, depth 15 cm, flow 1.039 m/sec SD 0.019. Shore walk paused for boat work and shellfish sampling.

Figure 5. Associated with waypoint 1. Harvester's boat passing close to shore.

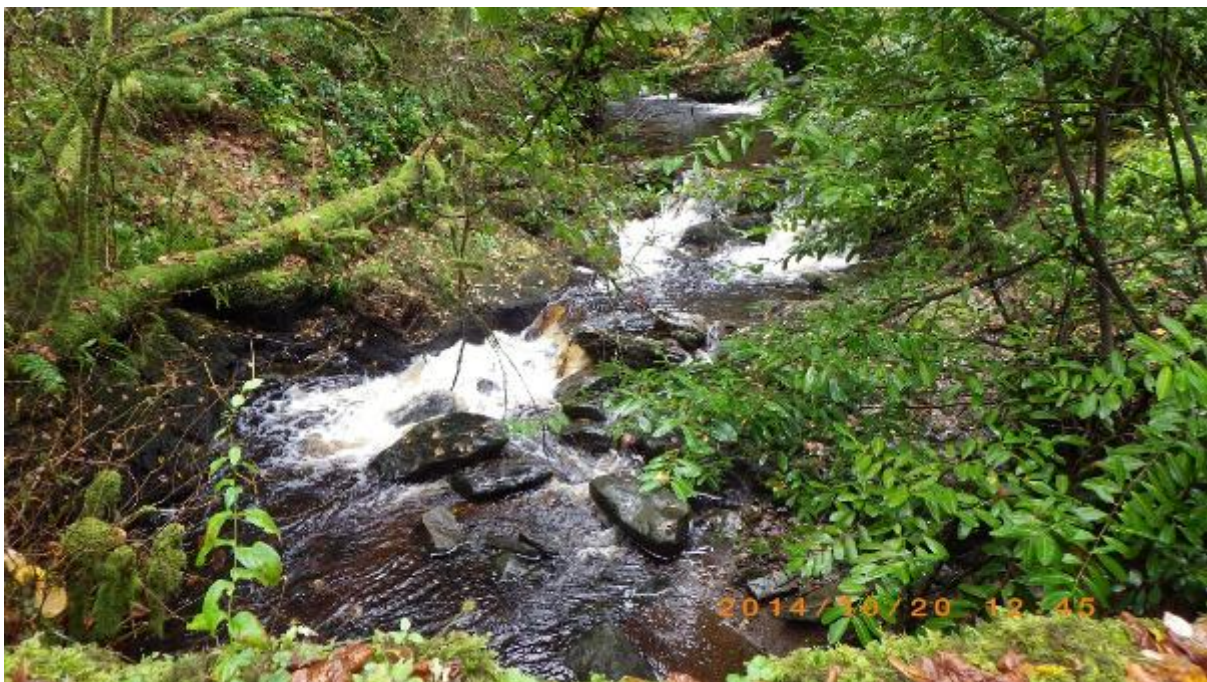
Figure 6. Associated with waypoint 4. Site of freshwater sample SFFW1 from Barmore Burn.

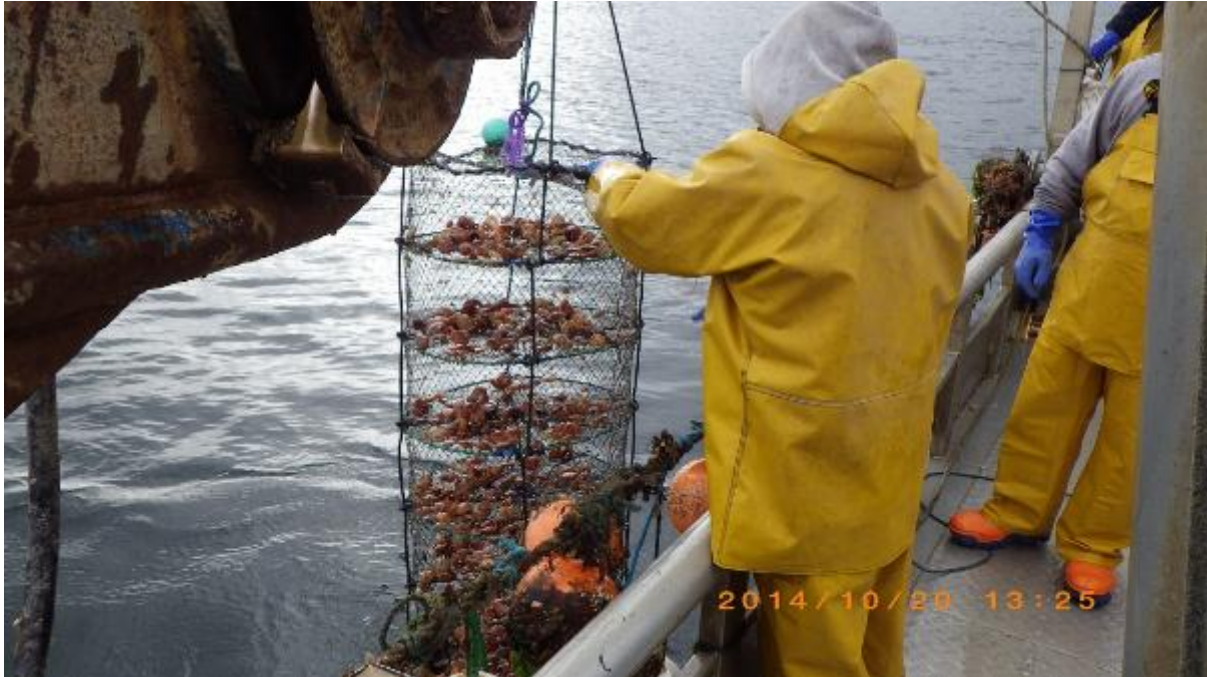
6	20/10/2014	13:25	NR 86753 72196	186754	672197	Fig 7	SFSF1	Planned shellfish sample of Queen scallops.
7	20/10/2014	13:26	NR 86752 72196	186752	672196		SFSW1	Planned seawater sample.
8	20/10/2014	13:26	NR 86752 72196	186752	672197		CTD	Planned CTD cast sample.
9	20/10/2014	13:32	NR 86752 72195	186753	672195			SE corner of farm array.
10	20/10/2014	13:36	NR 86793 72472	186793	672472			NE corner of farm array of nine lines between 8 and 10 m deep. Harvesting conducted all year and when stock are large enough.
11	20/10/2014	13:39	NR 86501 72526	186502	672526			NW corner of farm array. No shellfish available for sampling at this location.

Figure 7. Associated with waypoint 6. Location of Queen scallop sample SFSF1.

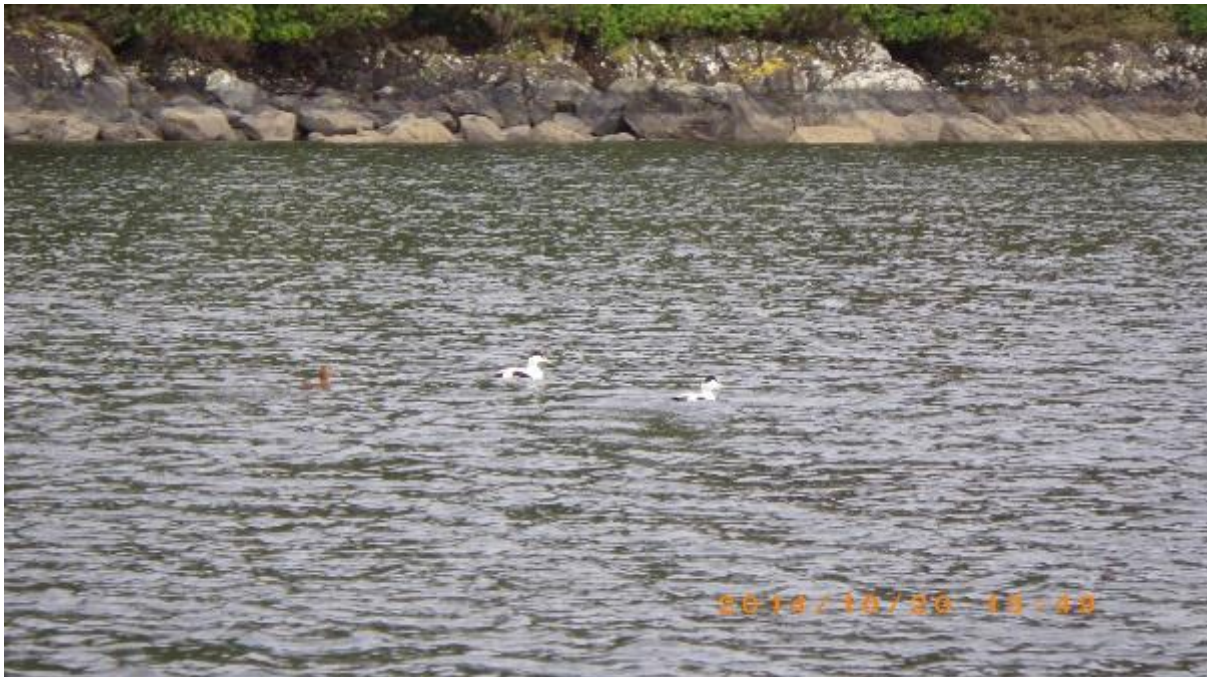
Figure 8. Associated with waypoint 15. Two eider drakes and one eider duck.

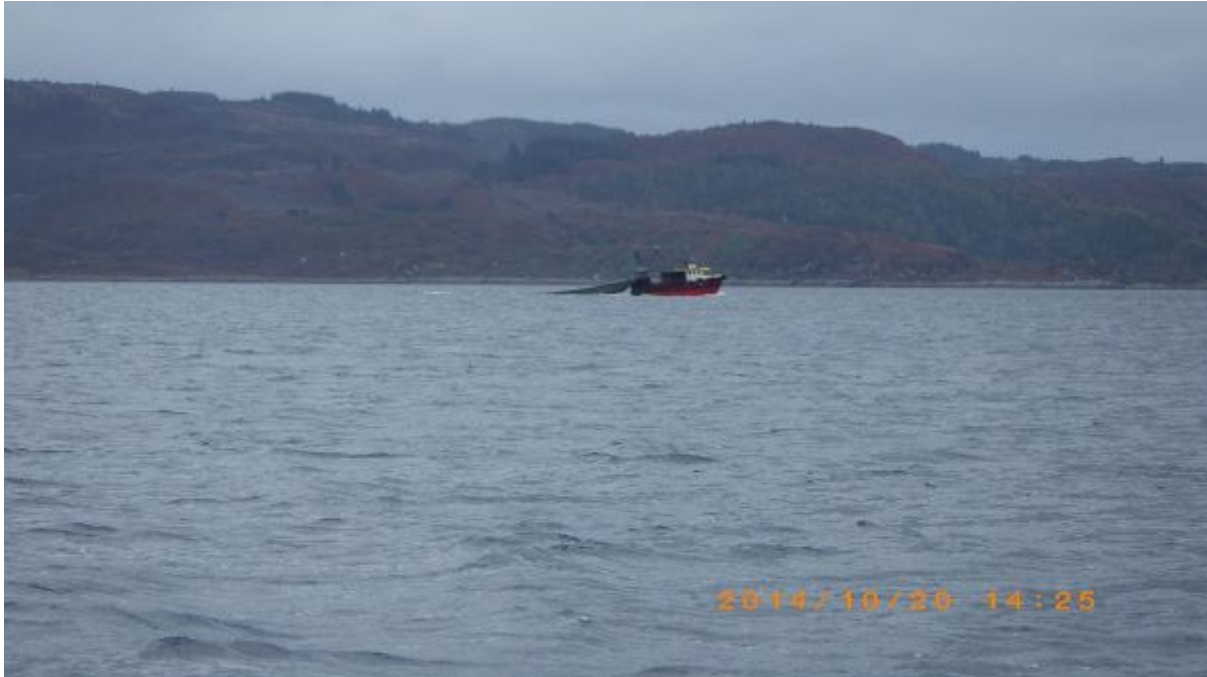
Figure 9. Associated with waypoint 24. Location of planned seawater SFSW5.

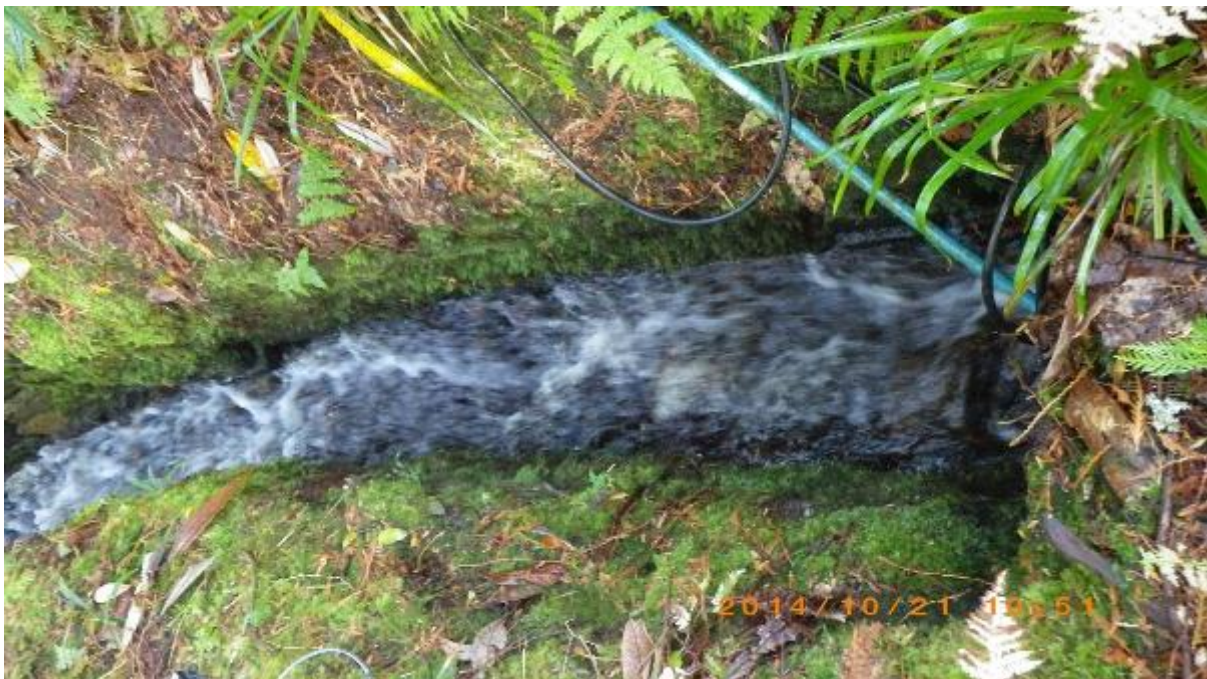
Figure 10. Associated with waypoints 41 and 42. Location of unplanned freshwater sample SFFW4 from an unnamed watercourse running in open, rectangular masonry culvert.

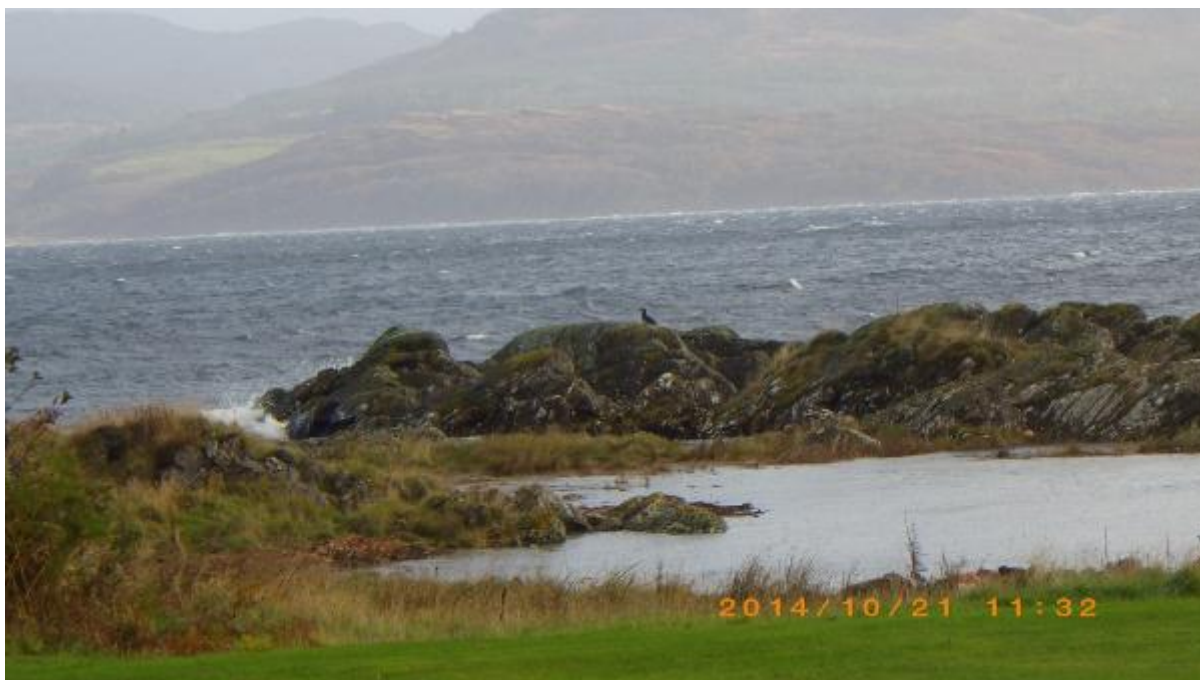
Figure 11. Associated with waypoint 52. One shag perched on rocks by sea.

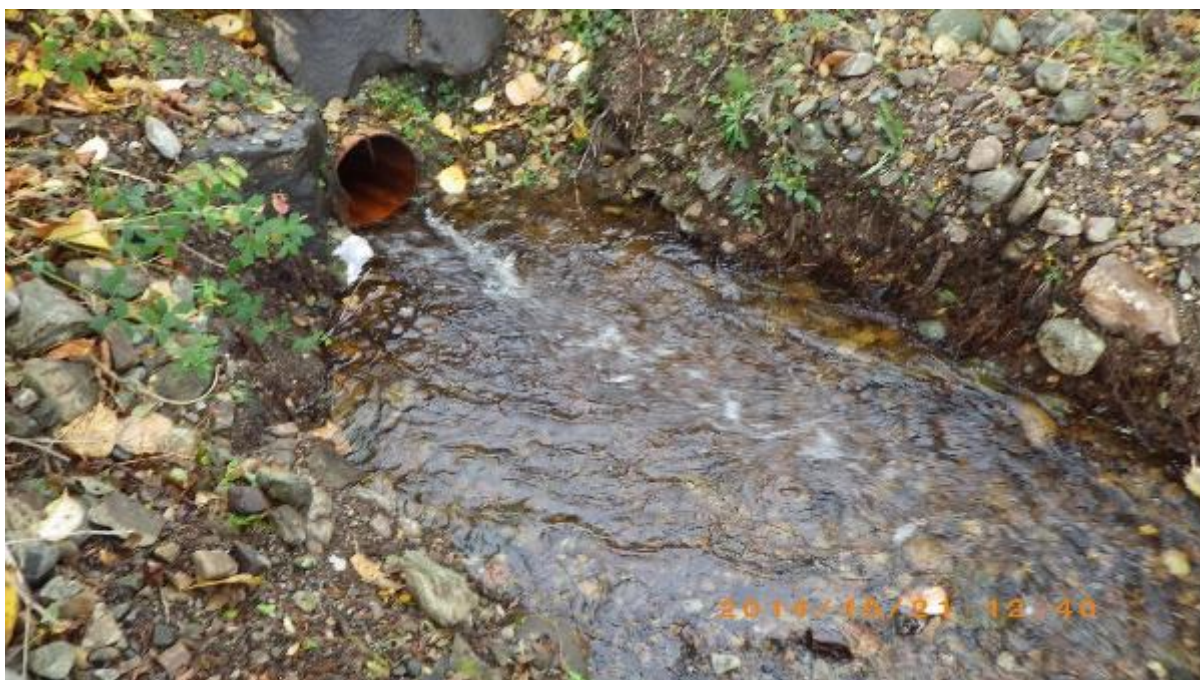
No.	Date	Time	NGR	East	North	Associated photograph	Associated sample	Description
56	21/10/2014	12:37	NR 86268 73827	186268	673827	Fig 12	SFFW7	Planned freshwater sample from unnamed watercourse.
57	21/10/2014	12:37	NR 86268 73827	186268	673827	Fig 12		Associated with waypoint 56. Width - 0.39 m (internal diameter of piped watercourse), flow width - 31 cm, depth - 8 cm, flow - 1.816 m/sec, SD - 0.064.
58	21/10/2014	12:45	NR 86273 73872	186273	673873	Fig 13	SFFW8	Unplanned freshwater sample from soil pipe.
59	21/10/2014	12:45	NR 86272 73873	186273	673873	Fig 13		Associated with waypoint 58. Brown plastic 100 mm diameter soil pipe with outlet under water. Leak at joint sampled.
60	21/10/2014	12:53	NR 86268 73906	186268	673907		SFFW9	Unplanned freshwater sample from pipe.
61	21/10/2014	12:53	NR 86268 73906	186268	673907			Associated with waypoint 60. Possible field drain with dwelling house nearby on the mainland side (west) of the A83. Diameter - 0.45 m, flow width - 37 cm, depth - 10 cm, flow - 0.273 m/sec, SD - 0.063.

Figure 12. Associated with waypoints 56 and 57. Location of planned freshwater sample SFFW7 from an unnamed watercourse.

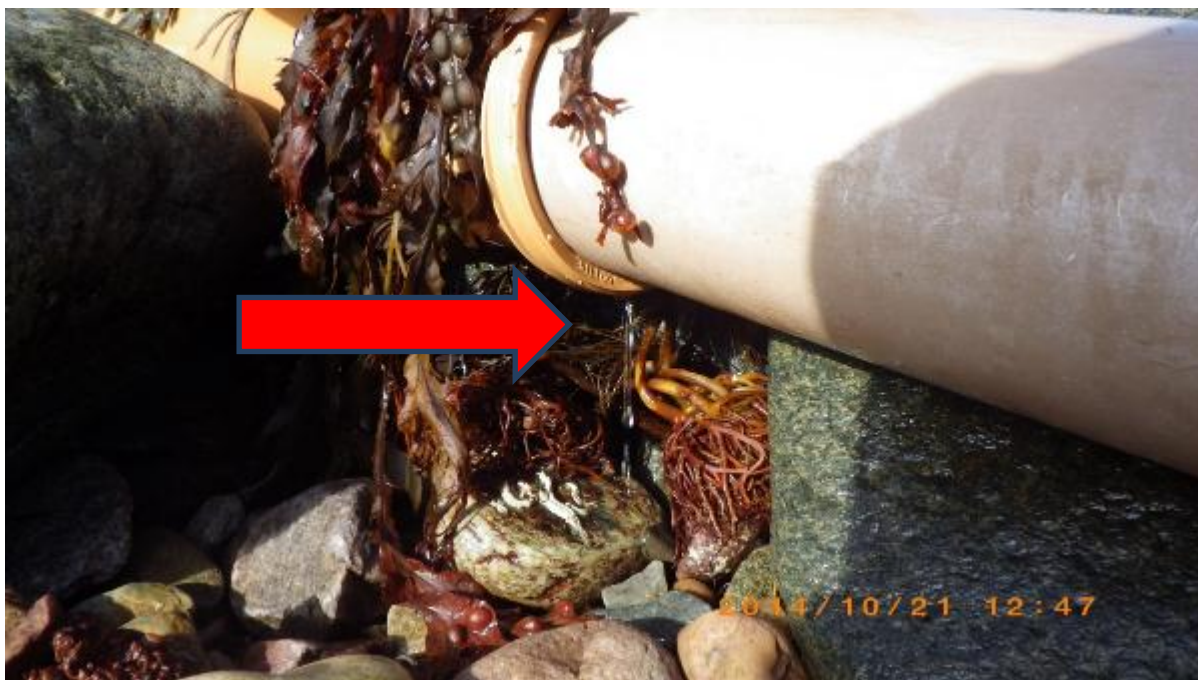
No	NGR	Description
1	NR 8628 7399	ST and outfall on north bank of river, 5 m upstream from the bridge
2	NR 8627 7387	Brown plastic 100 mm diameter soil pipe with outlet under water. Leak at joint sampled (SFFW8) returned a result of 900000 <i>E. coli</i> cfu/100 ml
3	NR 8631 7355	North Lodge dwelling house mainland side of the roadway with septic tank on lawn seaward of the roadway
4	NR 8631 7249	3x metal drain covers on lawn in front of building construction site
5	NR 8642 7177	Large concrete septic tank about 30 m from the hotel. Approximate size 2.4 x 4.8 m and with three manhole covers
6	NR 8681 6924	Large unnamed watercourse heavily flowing with pipe next to it. Houses behind and Scottish Water structures above
7	NR 8673 6914	Septic tank and iron outflow pipe. Pipe diameter - 10 cm; flow - 30 ml / 1 sec. Freshwater sample (SFFW22) result <1000 <i>E. coli</i> cfu/100 ml
8	NR 8668 6909	Metal manhole cover on road

Figure 13. Associated with waypoints 58 and 59. Location of unplanned freshwater sample SFFW8 from leak in pipe.

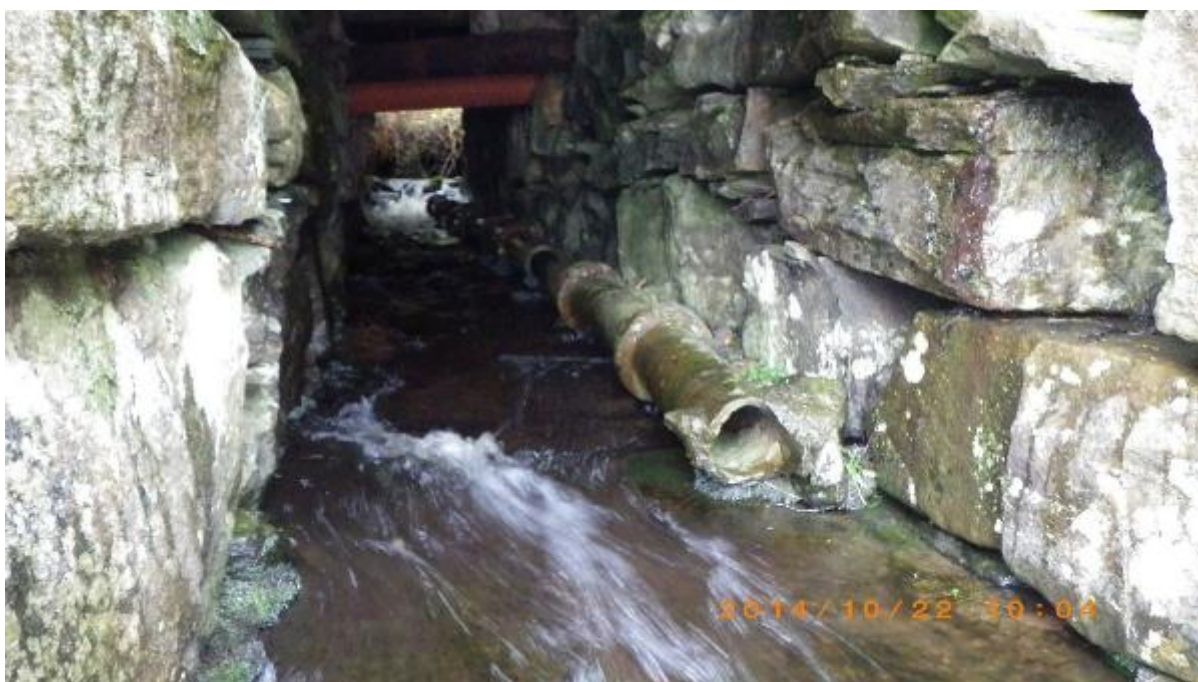
Figure 14. Associated with waypoints 67 and 68. Location of unplanned freshwater sample SFFW11 from culvert.

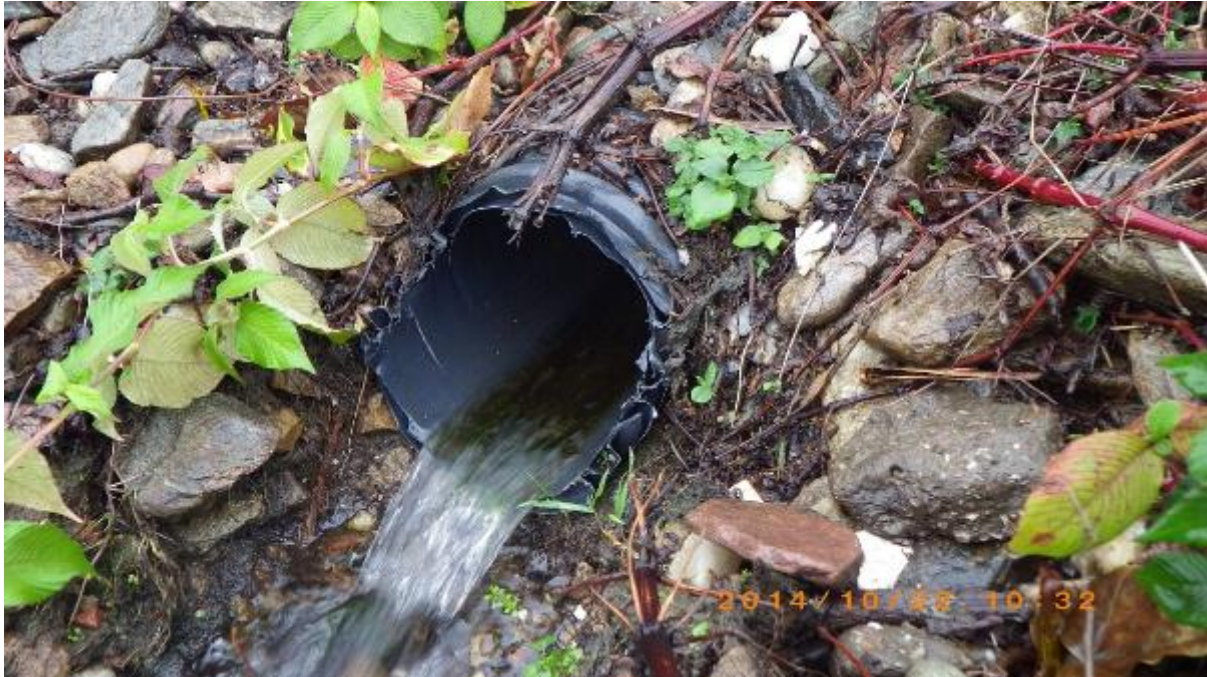
Figure 15. Associated with waypoints 72, 73 and 74. Location of unplanned freshwater sample SFFW13 from pipe.

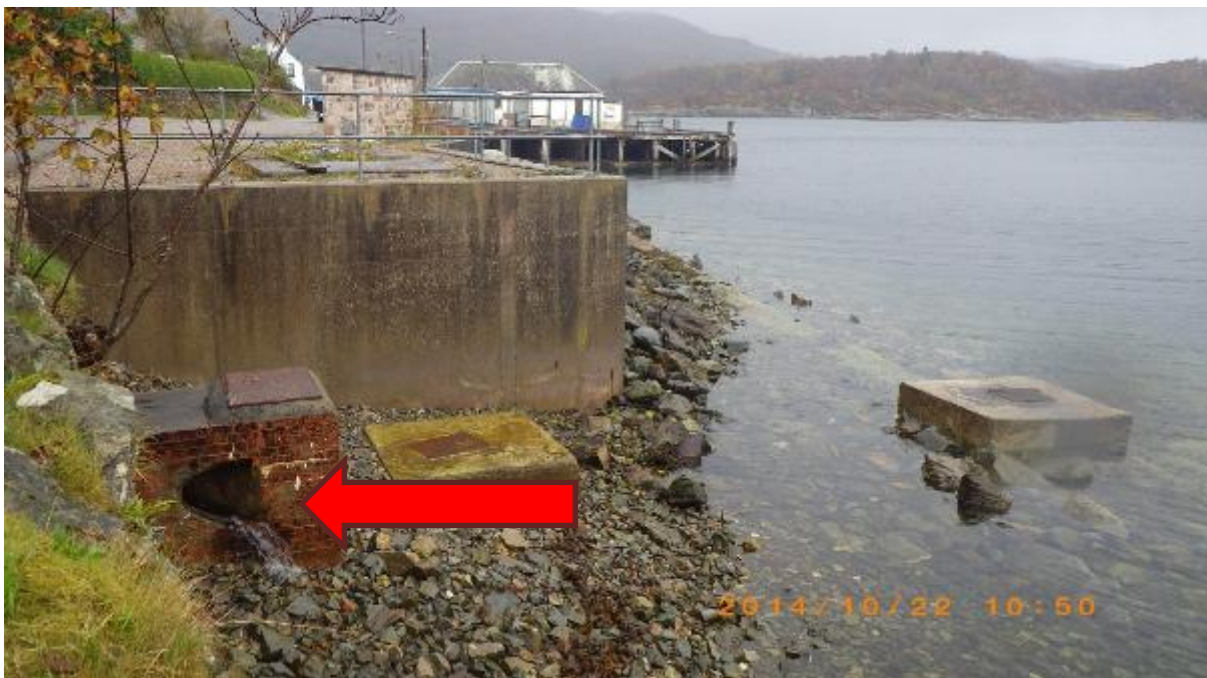
9	NR 8659 6897	Toilet and shower block with laundry facilities next to harbour office
10	NR 8661 6872	Toilet block mainland roadside
11	NR 8685 6882	Metal manhole cover on road
12	NR 8735 6884	Plastic pipe 150 mm diameter, water width - 8 cm, depth - 1 cm, flow approximately - 1.8 L/min (measured by sample bottle 30 ml in 1 sec). Freshwater sample (SFFW17) result <1000 <i>E. coli</i> cfu/100 ml
13	NR 8753 6880	Ceramic pipe next to possible shellfish depuration site on pier beside road. Pipe diameter - 150 mm, water width - 8 cm, depth - 1 cm, flow - 0.098 m/sec, SD - 0.400. Loose pipe and leaking water underneath pier but inaccessible to sample. Freshwater sample (SFFW16) result 80 <i>E. coli</i> cfu/100 ml
14	NR 8759 6878	Scottish water pumping station. Seawater sample (SFSW7) result 34 <i>E. coli</i> cfu/100 ml
15	NR 8759 6876	Broken pipe emerging from old brickwork block on shore about 3 m east of Scottish Water pumping station close to pier. Pipe internal diameter 48 cm, water flow width - 14 cm, depth - 2, flow - 1.096 m/sec, SD - 0.167. Sample (SFFW15) result 20 <i>E. coli</i> cfu/100 ml

Figure 16. Associated with waypoints 81 and 82. Location of unplanned freshwater sample SFFW15 from pipe.

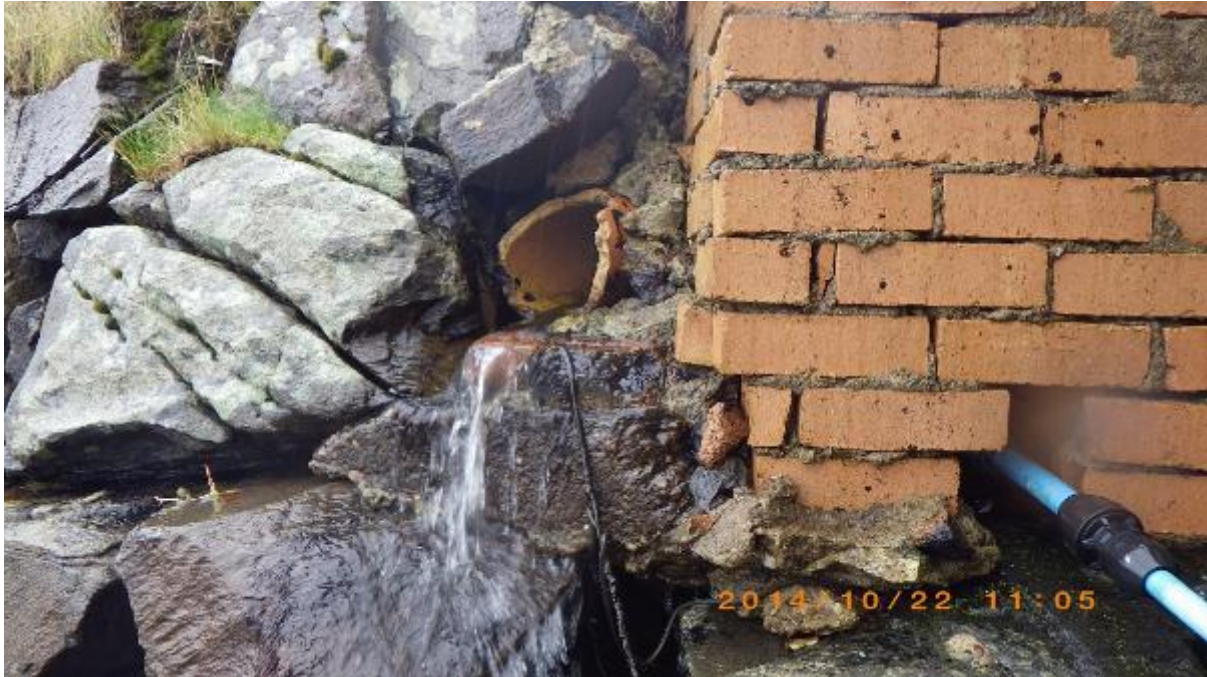
Figure 17. Associated with waypoints 84 and 85. Location of unplanned freshwater sample SFFW16 from broken pipe.

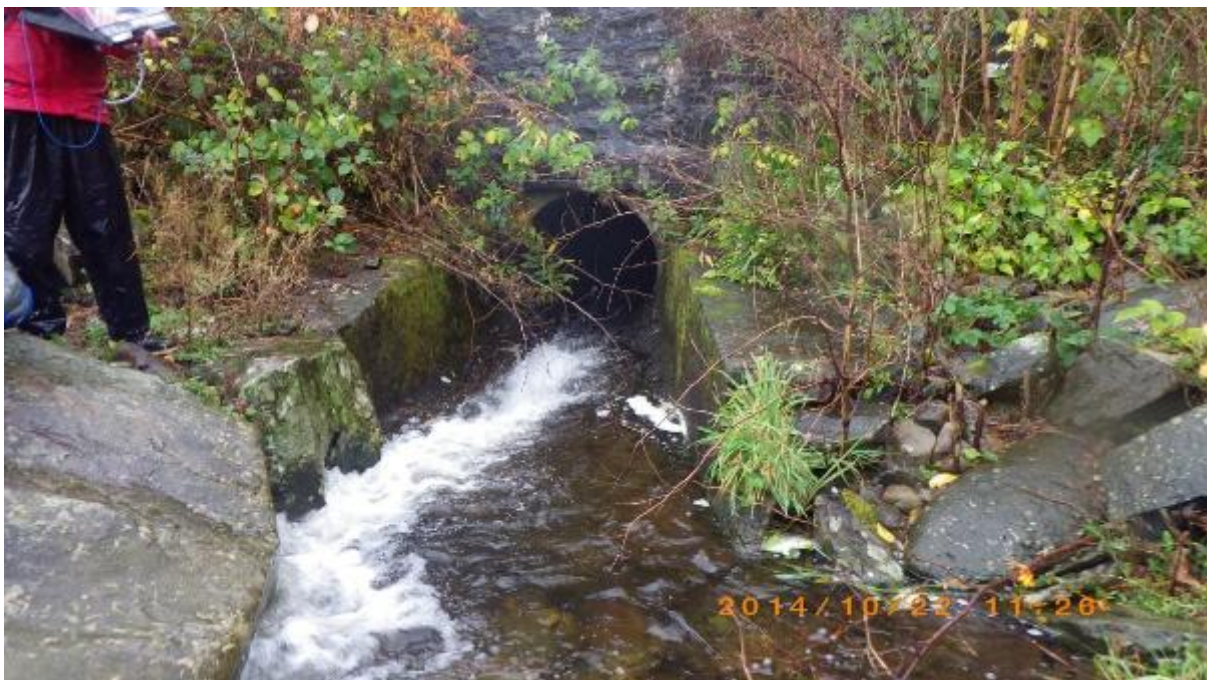
Figure 18. Associated with waypoints 89 and 90. Location of unplanned freshwater sample SFFW18 from under road pipe.

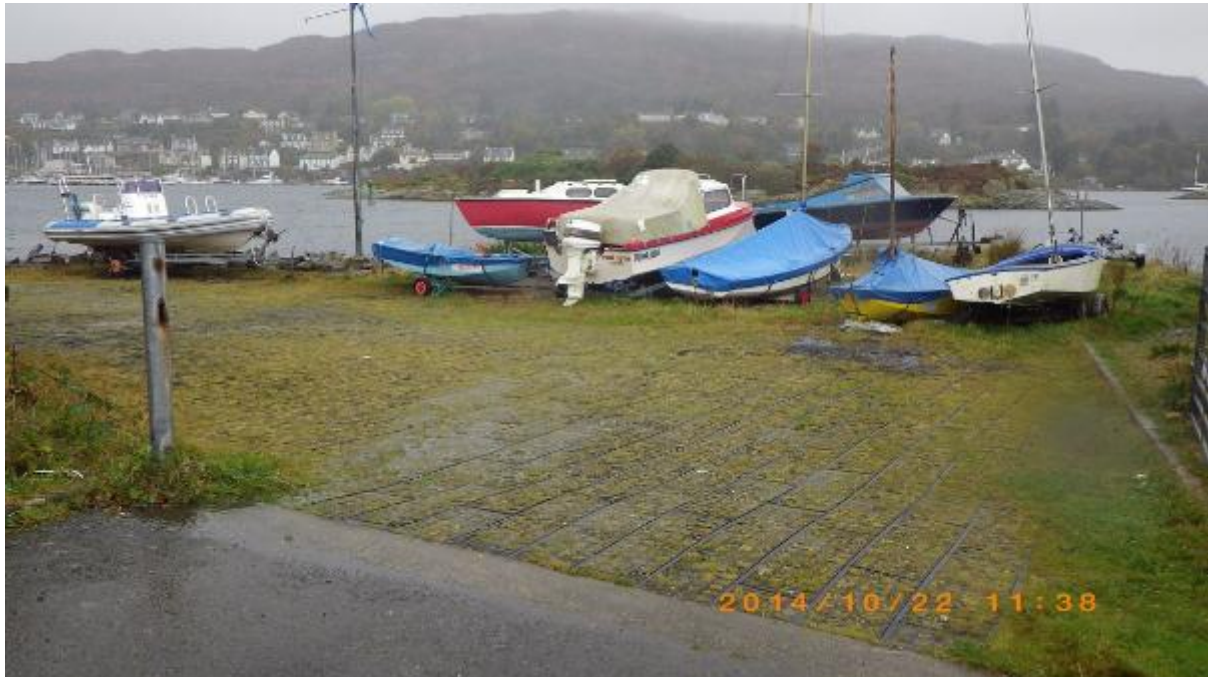
Figure 19. Associated with waypoint 91. Sailing club premises with 9 leisure craft on hard standing and 14 kayaks plus dinghies.
