# Scottish Sanitary Survey Review

**Loch Fyne: Stonefield and Loch Fyne: Stonefield  
Oysters**

**AB-154-043-15 and AB-435-840-13**

**April 2015**

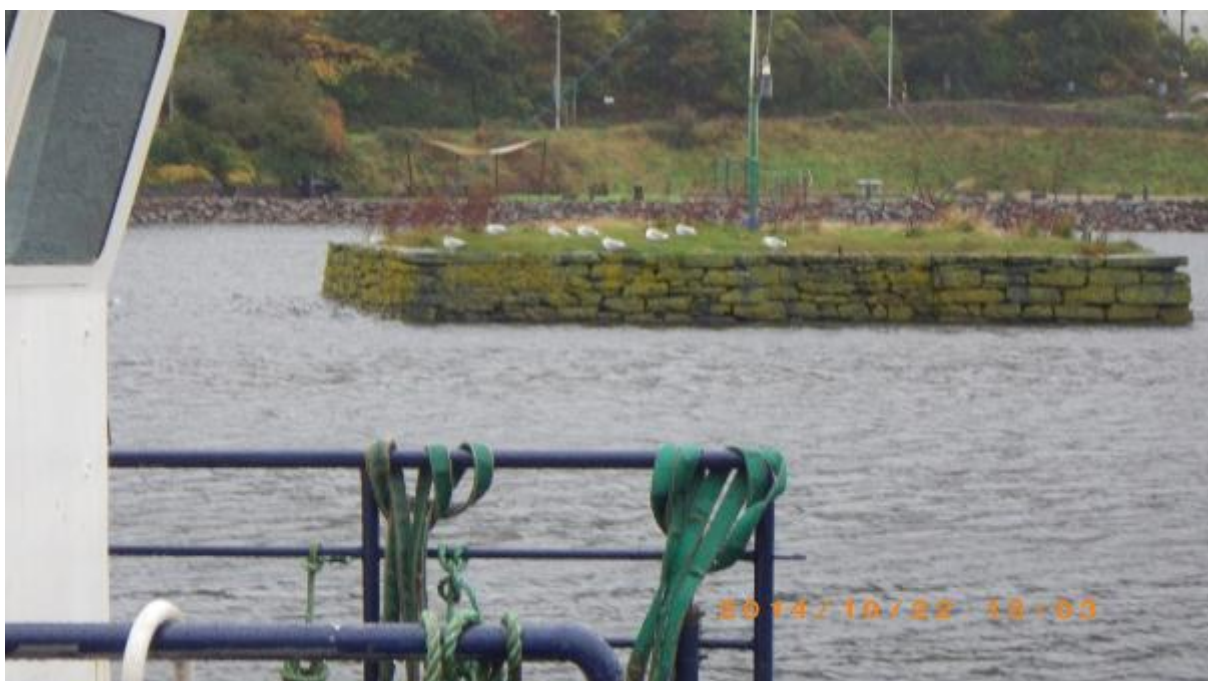
Figure 20. Associated with waypoint 98. Eight seagulls on artificial island.

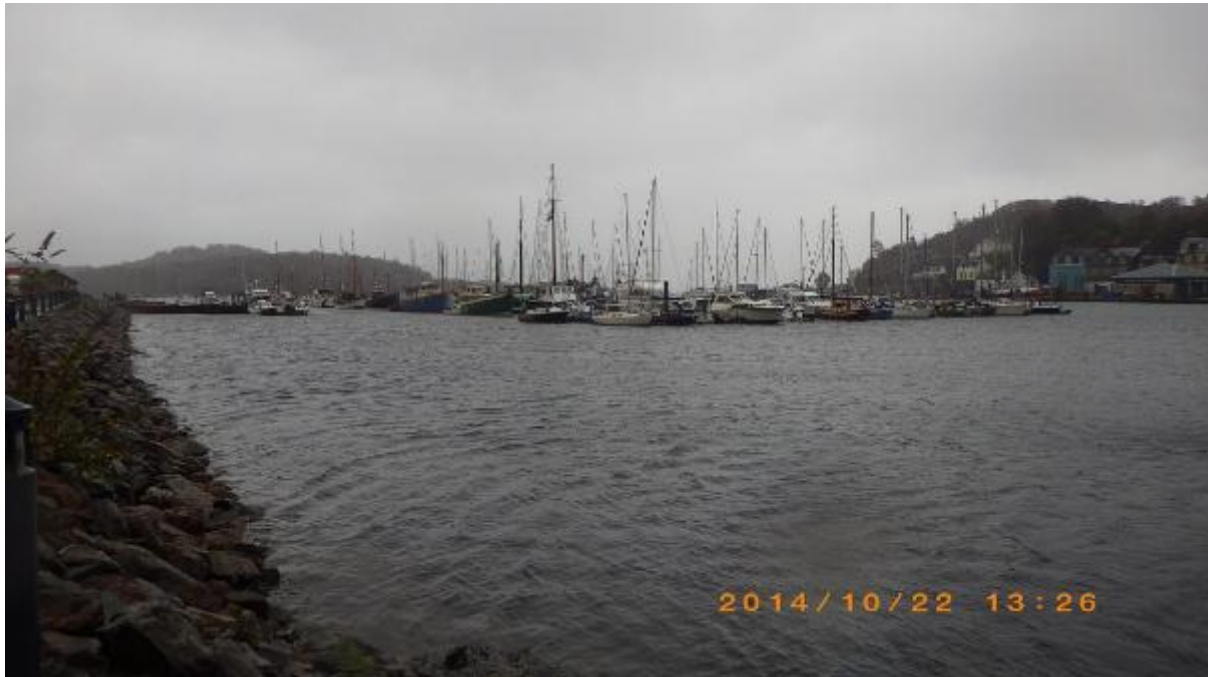
Figure 21. Associated with waypoint 103. Pier and Pontoon by Tarbert Yacht Chandlery.

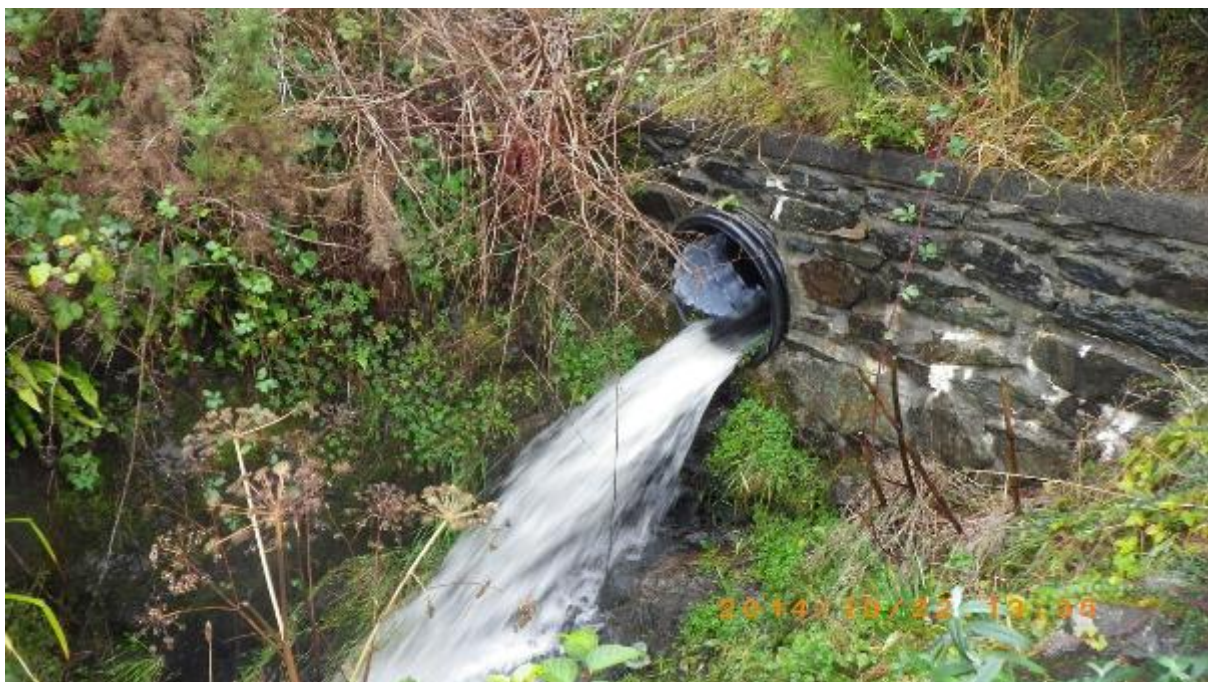
Figure 22. Associated with waypoints 105 and 106. Location of unplanned freshwater sample SFFW21 from large unnamed watercourse directed under road through black plastic pipe.

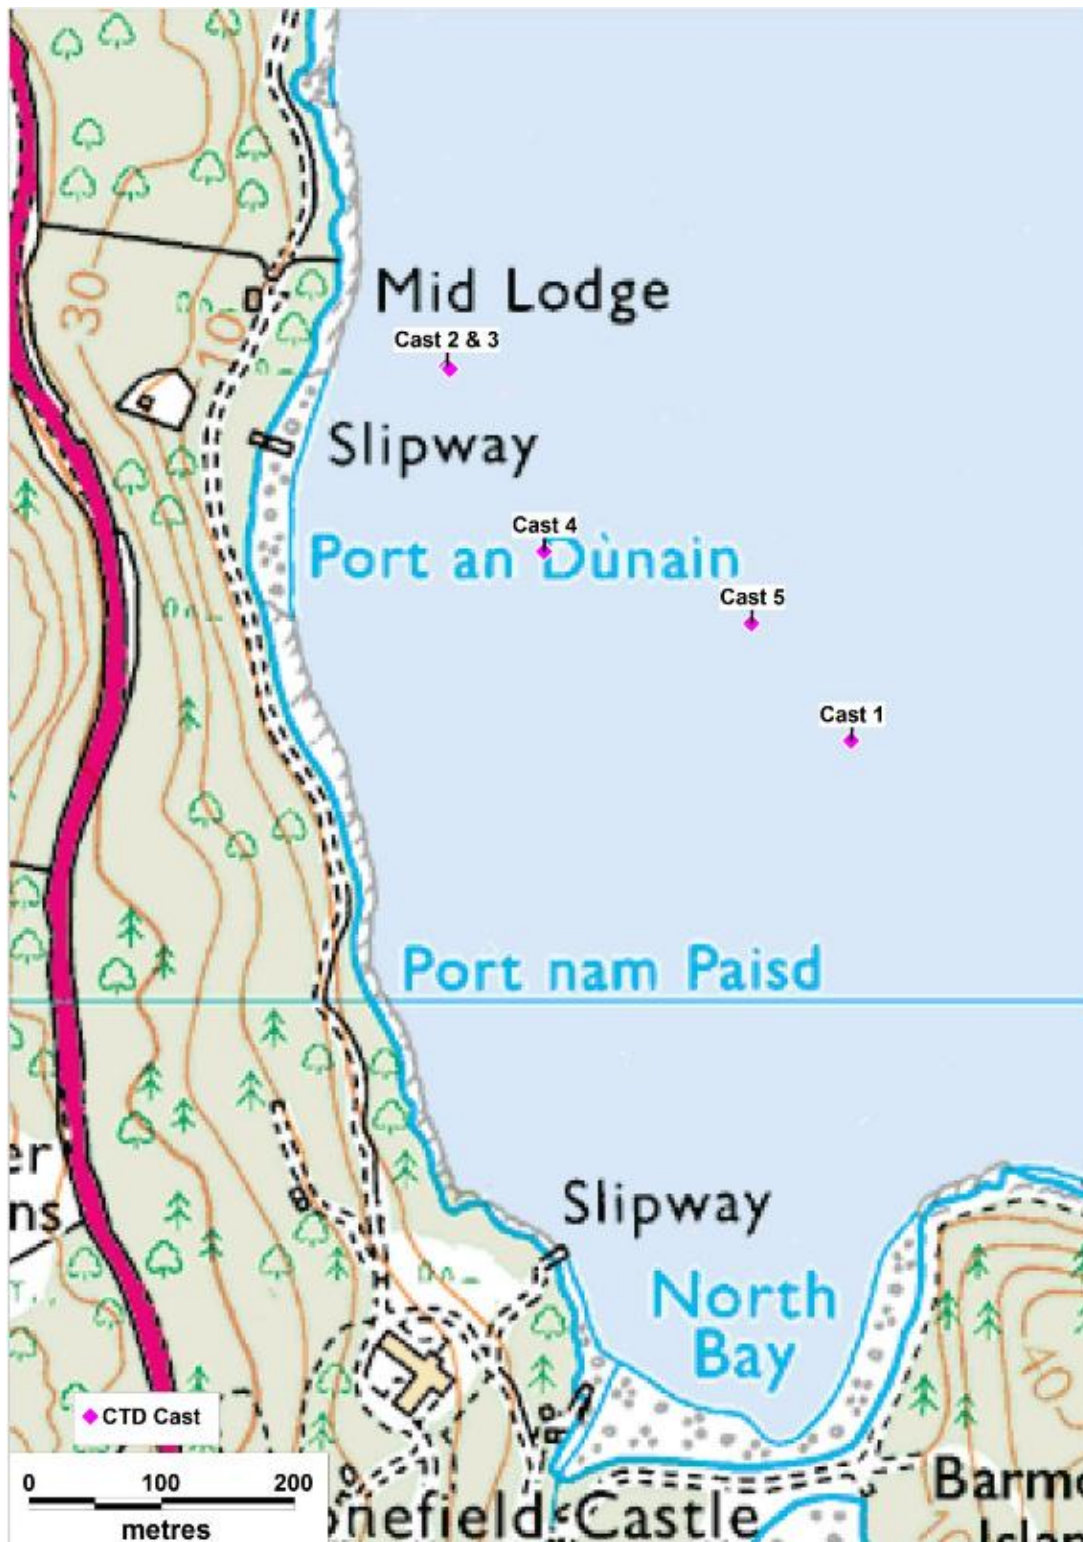
**Figure A Location of CTD cast**

Data obtained during the shoreline survey. The locations of the casts are shown in Figure A.
