Scottish Sanitary Survey Review

**Loch Fyne: Stonefield and Loch Fyne: Stonefield
Oysters**

AB-154-043-15 and AB-435-840-13

April 2015

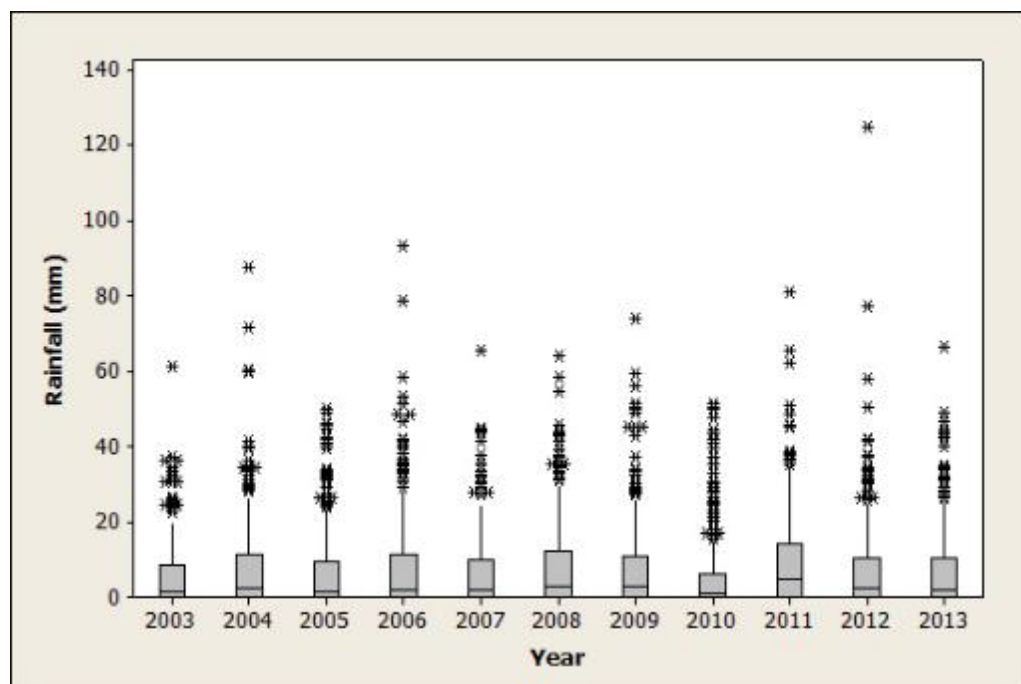
Figure 6.1 Boxplot of daily rainfall at Benmore Younger Botanical Gardens by year (2003-2013)

The majority of observations were below 10 mm per day. Extreme rainfall events of greater than 40 mm per day occurred in all years. The largest single rainfall event exceeded 120 mm and occurred in 2012. The driest year was 2010 (1952 mm) and the wettest year was 2011 (3340 mm). This is despite the missing data from 57 days in 2012, and had the data been complete a greater difference would have been seen.
