# **Scottish Sanitary Survey Project**

Sanitary Survey Report Loch Harport Inner SL 159 March 2011

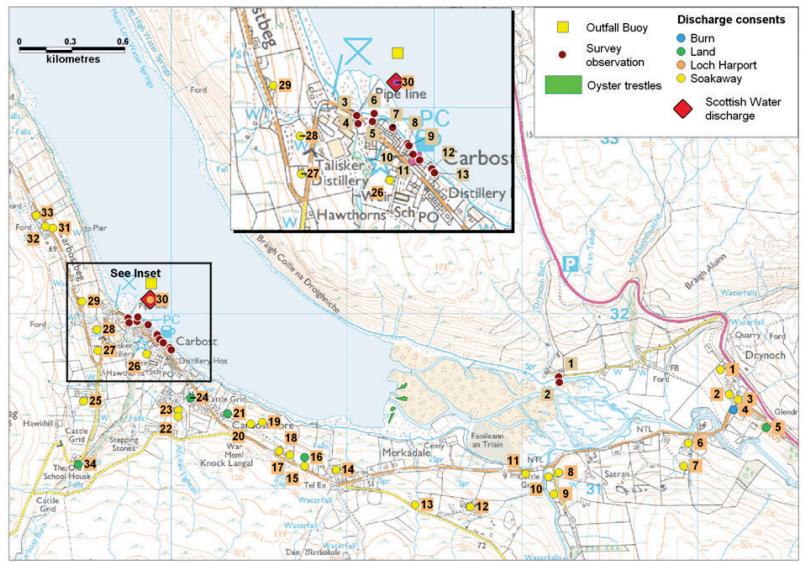
Produced by Cefas Weymouth Laboratory. © Crown Copyright and Database 2011. All rights reserved. Ordnance Survey licence number [GD100035675] Figure 4.1 Map of discharges for Loch Harport Inner

The Carbost septic tank was observed during the survey, and evidence of a discharge from the distillery was also seen. The boil that was observed was not at the location of the Carbost discharge and was presumed to be related to the distillery discharge. The location of the buoy marking the end of the distillery discharge was determined by using recording bearings from the shoreline. A number of other pipes were present but not flowing and some of

All of the sewage discharges identified in the tables are shown mapped in Figure 4.1 along with the location of the fishery.

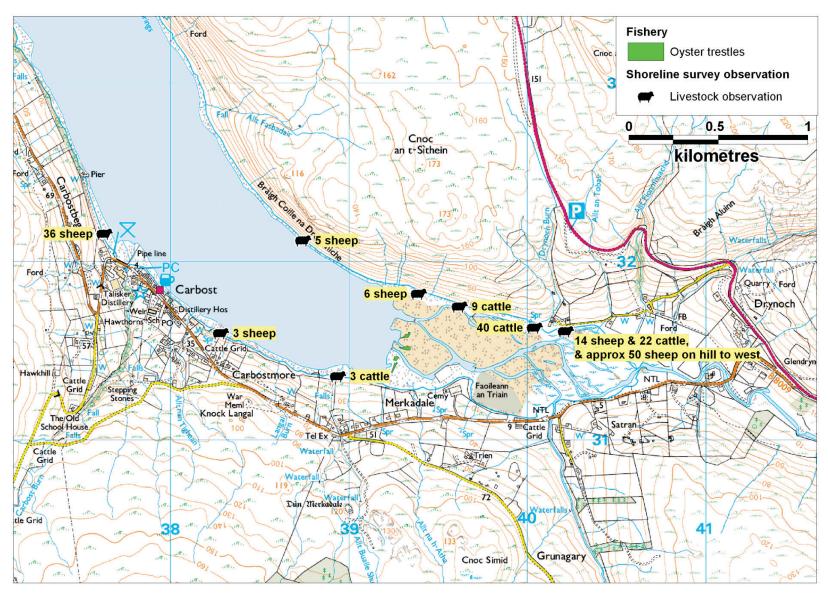
Reproduced by permission of Ordnance Survey on behalf of HMSO. © Crown Copyright and Database 2011. All rights reserved. Ordnance Survey licence number [GD100035675] Figure 7.1 Livestock observations at Loch Harport

Cattle and sheep were observed along much of the land around the head of the loch. Although the majority of animals observed were contained behind fences, local information obtained by the surveyor indicated that sheep were present on the intertidal area at the head of the loch through much of the winter. At the time of survey, sheep were observed at the north side of the intertidal area at the head of the loch.

Therefore, it is likely that livestock faeces impact water quality at the head of the loch and the impact may be higher in winter, when sheep are allowed onto the shore to graze.

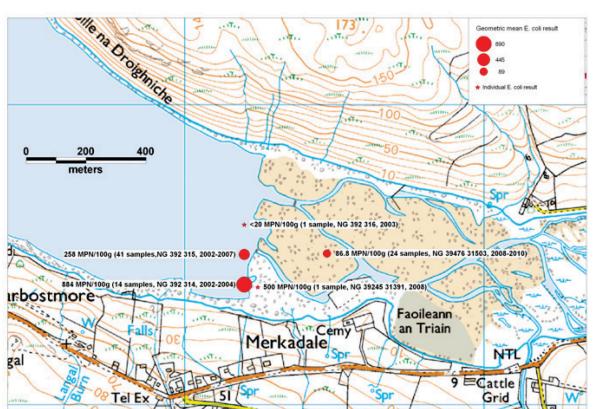
Within the Loch Harport: Inner production area, five locations were sampled, three of which were sampled on multiple occasions. Figure 11.1 presents a map of these results.

Figure 11.1 gives the impression of higher results at locations closest to the south shore. A comparison of results from the three locations sampled on multiple occasions reveals a significant difference (One-way ANOVA, p=0.002). A post ANOVA test (Tukeys comparison, Appendix 6) revealed that results from NG 392 314 were significantly higher than those from NG 39476 31503. It must be noted that these locations were sampled on different occasions and hence under differing environmental conditions, so the differences may be attributable to temporal rather than spatial variations.

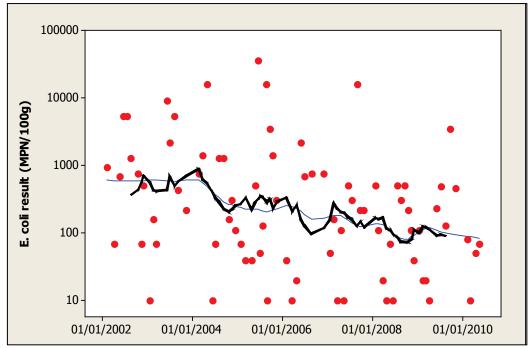
Figure 11.2 Scatterplot of *E. coli* results by date with rolling geometric mean (thick line) and loess line (thin line).

In terms of overall temporal trends, a gradual but quite marked improvement in levels of contamination was seen between 2002 and 2010. The frequency of higher results decreased from the start of 2007 onwards, suggesting there may have been a significant reduction of inputs around this time. It is however possible that this change may have been a consequence of the changes in sampling location. A significant seasonal pattern was found, with results for the summer were significantly higher than those for the winter and spring, and results for the autumn were significantly higher than those for the spring. All class C results arose between May and August, and a strong positive correlation was found between *E. coli* results and water temperature was also found.

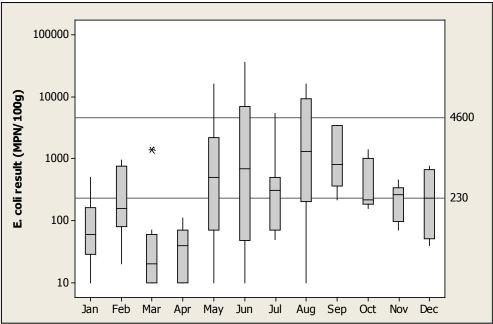
Figure 11.3 Boxplot of E. coli results with loess lines by month

Season dictates not only weather patterns and water temperature, but livestock numbers and movements, presence of wild animals and patterns of human occupation. All of these can affect levels of microbial contamination, and cause seasonal patterns in results. Figure 11.3 presents a boxplot of *E. coli* result by month.

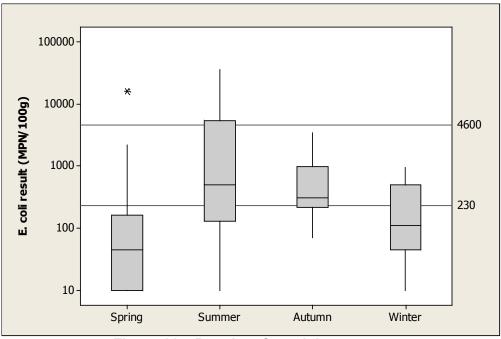
Figure 11.4 Boxplot of result by season

A significant seasonal difference was found (One-way ANOVA, p=0.001, Appendix 6). A post ANOVA test (Tukeys comparison, Appendix 6) indicated that results for

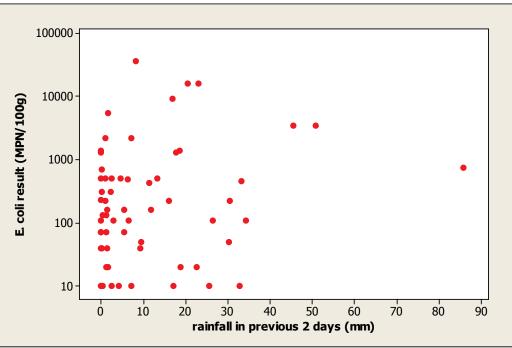
Figure 11.5 Scatterplot of result against rainfall in previous 2 days

No significant correlation was found between 2 day rainfall and *E. coli* results (Spearman's rank correlation=0.118, p>0.10, Appendix 6).

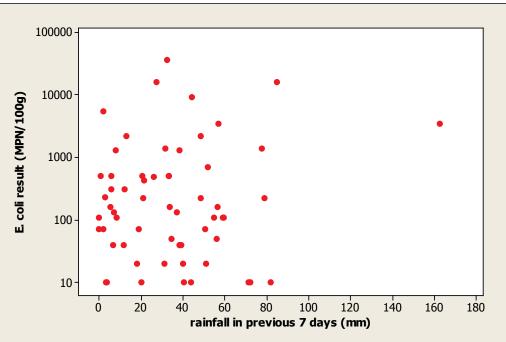
Figure 11.6 Scatterplot of result against rainfall in previous 7 days

No significant correlation was found between *E. coli* result and rainfall in the previous 7 days (Spearman's rank correlation= 0.009, p>0.25, Appendix 6).

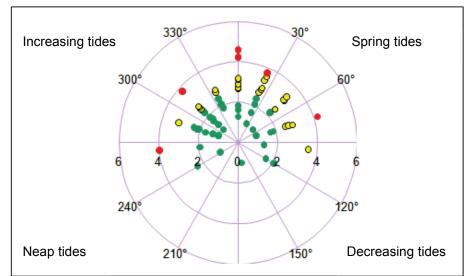
Figure 11.7 Polar plot of log<sub>10</sub> E. coli results on the spring/neap tidal cycle

A significant correlation was found between *E. coli* results and the spring/neap cycle (circular-linear correlation, r=0.286, p=0.002, Appendix 6) with a higher proportion of elevated results occurring around spring tides. However, in general, sampling was targeted towards increasing and spring tides and this may have limited the detection of effects on other tidal states.

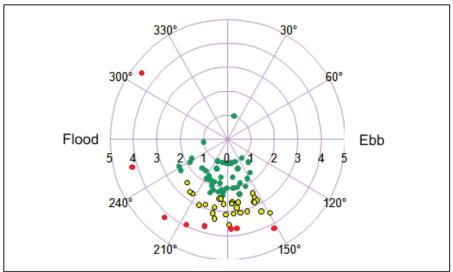
Figure 11.8 Polar plot of log<sub>10</sub> *E. coli* results on the high/low tidal cycle

No significant correlation was found between *E. coli* results and the high/low tidal cycle (circular-linear correlation, r=0.047, p=0.843, Appendix 6). Sampling was targeted towards low water.

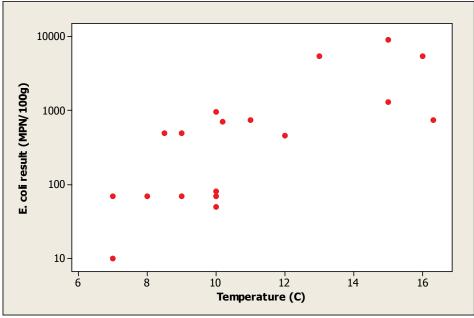
Figure 11.9 Scatterplot of *E. coli* result by water temperature

A positive correlation was found between *E. coli* result and water temperature (Spearman's rank correlation=0.772, p<0.0005, Appendix 6). This apparent effect may be coincidental with other seasonal factors.

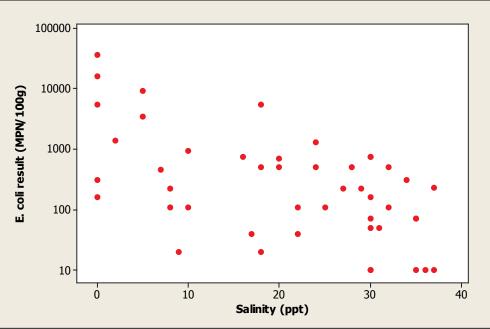
Figure 11.10 Scatterplot of E. coli result by salinity

Salinity will give a direct measure of freshwater influence, and hence freshwater borne contamination at the site. Figure 11.10 presents a scatter plot of *E. coli* result against salinity. A significant negative correlation was found between *E. coli* results and salinity (Spearman's rank correlation=-0.522, p<0.0005, Appendix 6).

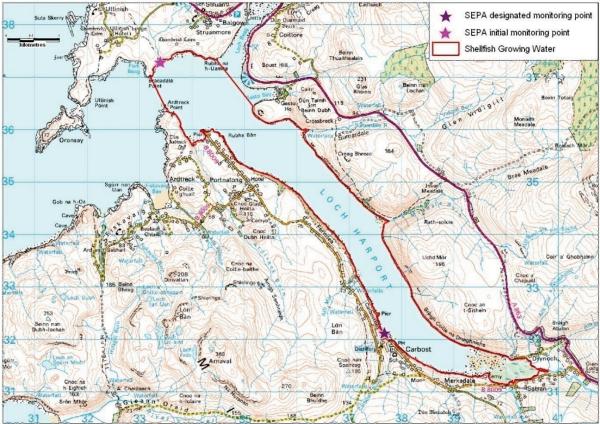
Reproduced by permission of Ordnance Survey on behalf of HMSO. © Crown Copyright and Database 2011. All rights reserved. Ordnance Survey licence number [GD100035675] Figure 12.1 SEPA designated growing water and monitoring points

Loch Harport was designated as a Shellfish Growing Water in 2002. The designated area is described as: "An area bounded by lines drawn between NG 332 370 (Bracadale Point) and NG 335 364 (Ardtreck Point) and between NG 334 374 (Rubha na h-Uamha) and NG 352 364 and extending to MLWS.". The associated sampling point is given by SEPA as: NG 37680 32133. The extent of the designation, and location of the sampling point, are shown in Figure 12.1.

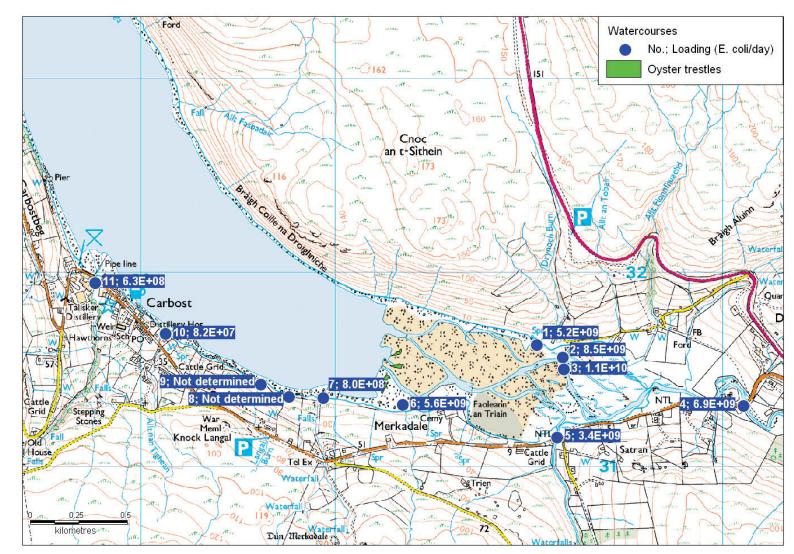
Produced by Cefas Weymouth Laboratory. © Crown Copyright and Database 2011. All rights reserved. Ordnance Survey licence number [GD100035675] Figure 13.1 Map of stream loadings at Loch Harport

No	Grid Reference	Description	Width (m)	Depth (m)	Flow (m/s)	Flow in m³/day	<i>E.coli</i> (cfu/ 100ml)	Loading ( <i>E.coli</i> per day)
1	NG 4004 3163	Drynoch Burn	1.3	0.1	0.022	247	2100	5.2 x 10 <sup>9</sup>
2	NG 4018 3157	Stream	1.5	0.09	0.303	3530	240	8.5 x 10 <sup>9</sup>
3	NG 4018 3151	River	6.9	0.173 <sup>1</sup>	0.169 <sup>1</sup>	17500	60	1.1 x 10 <sup>10</sup>
4	NG 4111 3132	River Drynoch	2.8	0.165 <sup>2</sup>	0.341 <sup>2</sup>	13800	50	6.9 x 10 <sup>9</sup>
5	NG 4015 3115	Vikisgill Burn	4.5	0.13 <sup>1</sup>	0.12 <sup>1</sup>	5640	60	3.4 x 10 <sup>9</sup>
6	NG 3935 3132	Allt na h-Atha	0.6	0.04	0.118	245	2300	5.6 x 10 <sup>9</sup>
7	NG 3894 3136	Allt Buaile Shuaine	0.3	0.21	0.184	1000	80	8.0 x 10 <sup>8</sup>
8	NG 3876 3136	Small stream	Ν	ot measure	d <sup>3</sup>	-	10	Not determined
9	NG 3862 3143	Langal Burn	Not measured <sup>3</sup>			-	20	Not determined
10	NG 3813 3169	Allt nan Tighean	0.32	0.09	0.055	137	60	8.2 x 10 <sup>7</sup>

11	NG 3776 3195	Carbost Burn	0.43	0.07	0.202	525	120	6.3 x 10 <sup>8</sup>

Calculated loadings were low to moderate. Despite the low *E. coli* concentrations in the watercourses at the head of the loch, the loadings were moderate due to the relatively large flows. These watercourses, including the River Drynoch, will impact on the water quality at the oyster trestles over the course of the ebb tide until the seawater is below the level of the oysters. Two streams (6 and 7 in Table 13.1) were close to the oyster farm and would be expected to contribute to contamination at the trestles despite having low loadings: stream 6 drained across the foreshore directly towards the trestles. Loadings from all of the watercourses would be expected to be significantly higher following moderate to heavy rainfall. A number of small watercourses were marked on the OS map on both sides of the loch but not recorded during the shoreline survey: these were not flowing at the time of the survey but would be expected to run after rainfall and to be a conduit for land run-off.

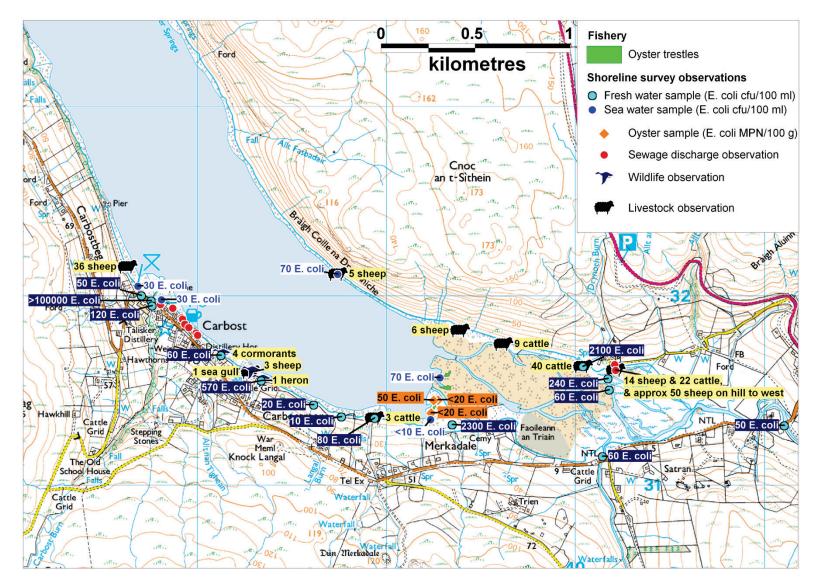
Produced by Cefas Weymouth Laboratory. © Crown Copyright and Database 2011. All rights reserved. Ordnance Survey licence number [GD100035675] Figure 15.1 Summary of shoreline survey findings for Loch Harport Inner

Sheep and cattle were recorded at a number of locations around the loch. These were mostly fenced off from the shoreline but sheep were observed on the shore on the north side of the head of the loch and local information identified that grazing across the drying area took place during much of the winter.

Figure 15.1 shows a map summarizing the findings from the shoreline survey.

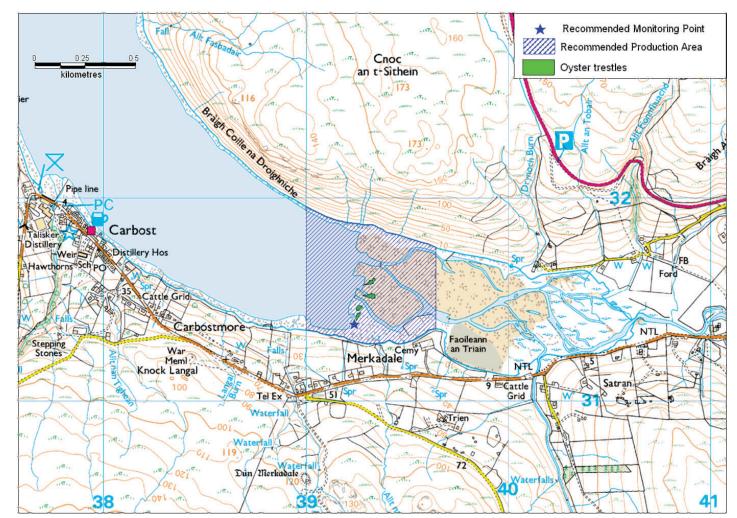
Produced by Cefas Weymouth Laboratory. © Crown Copyright and Database 2011. All rights reserved. Ordnance Survey licence number [GD100035675] Figure 17.1 Map of recommendations at Loch Harport Inner

Given the seasonal variability, the recommended frequency for ongoing monitoring is monthly.

A summary of the recommendations is shown in Figure 17.1.

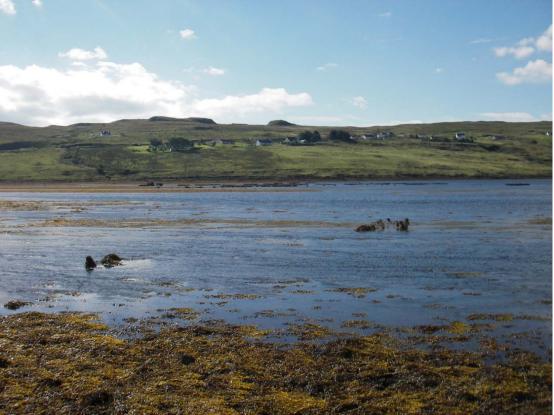
Figure 4. View from northern shore looking towards the oyster trestles

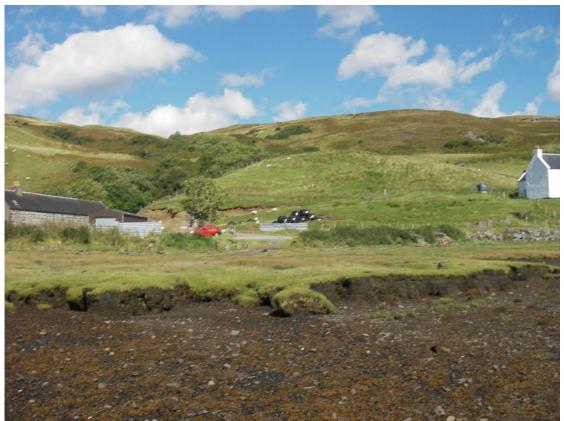
Figure 5. Farmed area on the northern side at the head of the loch

9	08/09/2010	12:00	NG 40042 31629	140042	831629	Figure5	LH/FW/01	Small stream: width 1.3 m, depth 0.1 m, flow 0.022 m/s; approx 40 sheep behind fence about 20 m from foreshore; fertile green land and farmyard buildings	
10	08/09/2010	12:29	NG 40210 31640	140210	831640			Septic tank (seeping?) by ?holiday cottage	
11	08/09/2010	12:30	NG 40215 31609	140215	831609	Figure 6		Broken pipe from septic tank - not flowing; 9 sheep on shore; approx 5 sheep and 7 cows above; 15 cows in distance to east; approx 50 sheep on hill to west	
12	08/09/2010	12:38	NG 40175 31565	140175	831565		LH/FW/02	Stream: width 1.5 m, depth 0.09 m, flow 0.303 m/s	
13	08/09/2010	12:45	NG 40181 31505	140181	831505	Figure 7	LH/FW/03	River: width 6.9 m; depth 0.18 m flow 0.065 m/s; depth 0.18 m flow 0.278 m/s; depth 0.16 m flow 0.165 m/s	
14	08/09/2010	13:00	NG 40428 31621	140428	831621			Dwelling above shoreline; no septic tank visible

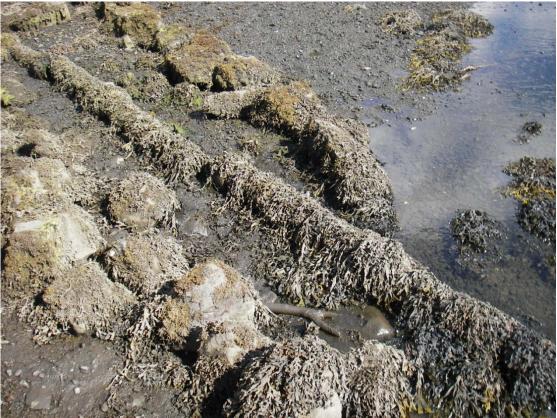
Figure 6. Broken septic tank outlet pipe

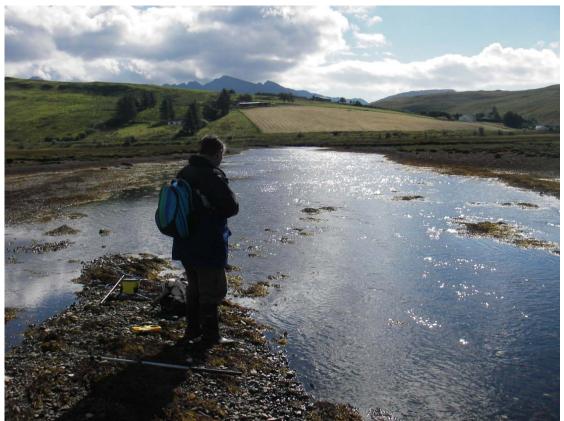
Figure 7 River at the intertidal area

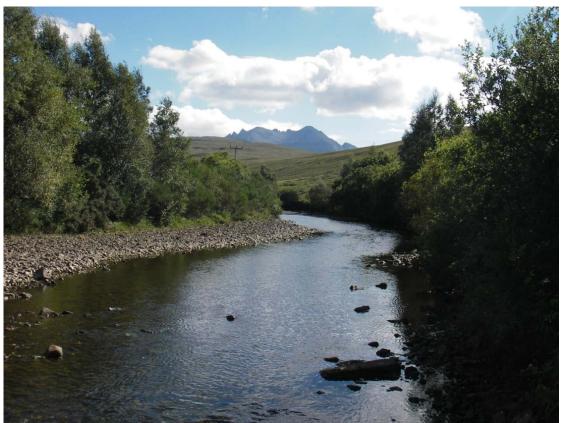
Figure 8. River Drynoch looking upstream from road bridge

No.	Date	Time (BST)	Position	Easting	Northing	Associated photograph	Associated sample	Description	
16	08/09/2010	13:06	NG 40242 31635	140242	831635			Land drain; not flowing	
17	08/09/2010	13:22	NG 41107 31317	141107	831317	Figure 8	LH/FW/04	River Drynoch; width 2.8 m; depth 0.18 m flow 0.400 m/s; depth 0.15 m flow 0.281 m/s	
18	09/09/2010	09:25	NG 40142 31122	140142	831122			River by road bridge	
19	09/09/2010	09:31	NG 40145 31154	140145	831154	Figure 9	LH/FW/05	Vikisgill Burn downstream from bridge; width 4.5 m; depth 0.09 m flow 0.170 m/s; depth 0.17 m flow 0.092 m/s; depth 0.13 m flow 0.097 m/s	
20	09/09/2010	09:53	NG 37632 32155	137632	832155			Slipway; trees and fern above shore; 36 sheep behind fence; 7 small boats and dinghies; 86° to outfall buoy	
21	09/09/2010	09:59	NG 37639 32131	137639	832131			Land seepage with bright green algae	
22	09/09/2010	10:01	NG 37656 32109	137656	832109			? Stream running from under sea defence: no sign of stream by road

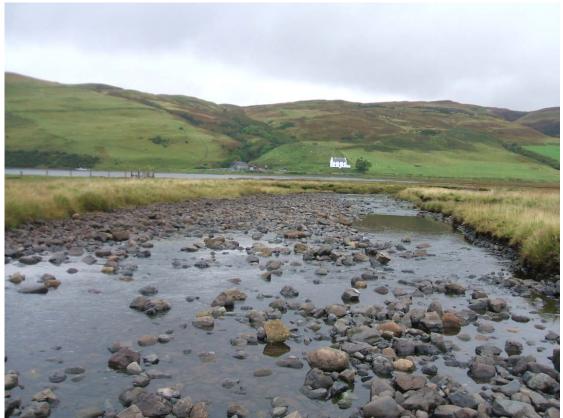
Figure 9. Vikisgill Burn

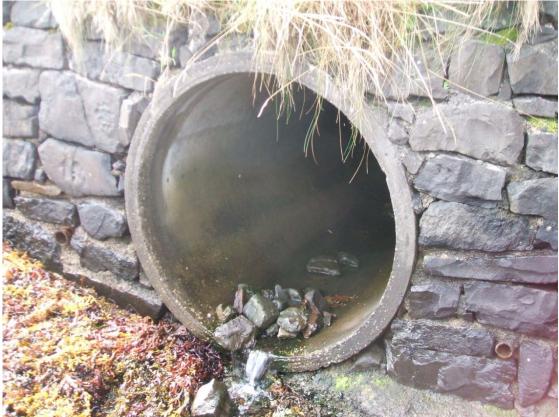
Figure 10. Culvert under road

23	09/09/2010	10:07	NG 37687 32054	137687	832054		LH/SW/02	Seawater sample opposite outfall marker buoy	
24	09/09/2010	10:12	NG 37705 32003	137705	832003	Figure 10	LH/FW/06	Under road culvert: flow 1.7I/2sec	
25	09/09/2010	10:19	NG 37757 31976	137757	831976	Figure 11	LH/FW/07	Possible flow from septic tank; 10" pipe with liquid flowing round it; several surface water pipes (not flowing) between points 24 and 25	
26	09/09/2010	10:27	NG 37762 31950	137762	831950	Figure 12	LH/FW/08	Stream by distillery; width 0.43 m; depth 0.07 m; flow 0.202 m/s; several pipes (not flowing) protruding from distillery wall	
27	09/09/2010	10:33	NG 37807 31957	137807	831957	Figures 13, 14		Scottish Water Septic Tank; 20° to outfall buoy	
28	09/09/2010	10:37	NG 37812 31982	137812	831982	Figure 15	LH/SW/03	Approximate area of "boil" seen 08/09/10; not present at this time	
29	09/09/2010	10:43	NG 37871 31938	137871	831938			21 cm outflow pipe; slight trickle only; not sampled; one yacht offshore

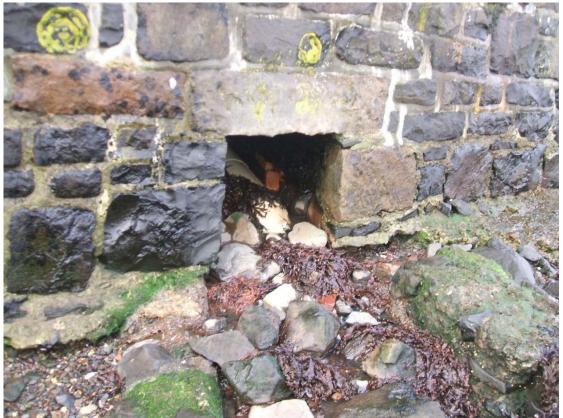
Figure 11. Probable septic tank outlet

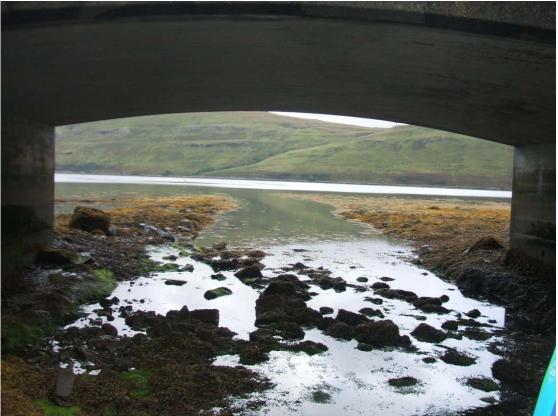
Figure 12. Stream by Tallisker distillery

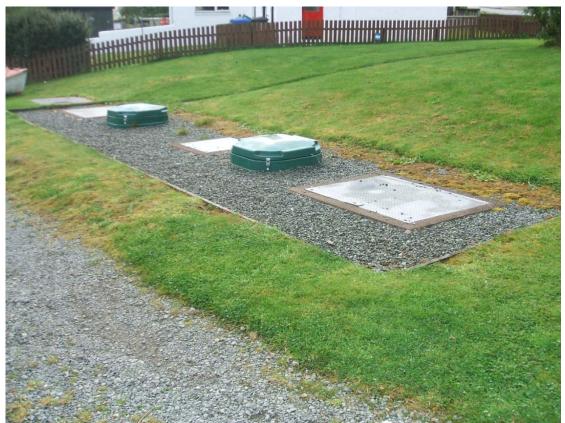
Figure 13. Scottish Water Community Septic Tank at Carbost

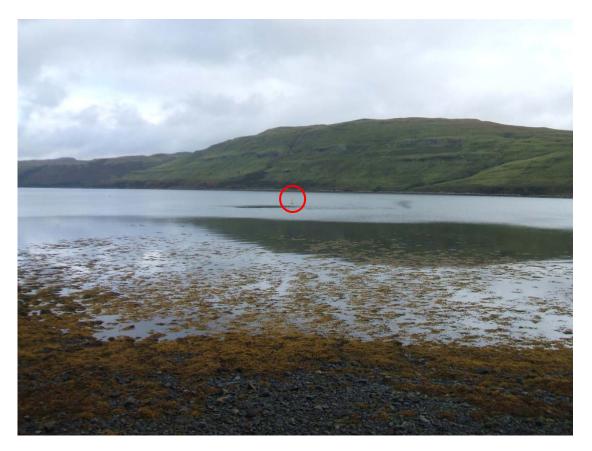
Figure 14. Distillery discharge marker buoy

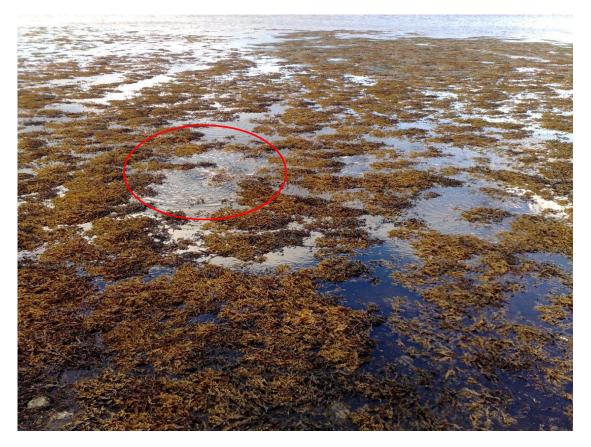
Figure 15. Location of "boil" seen offshore of community septic tank

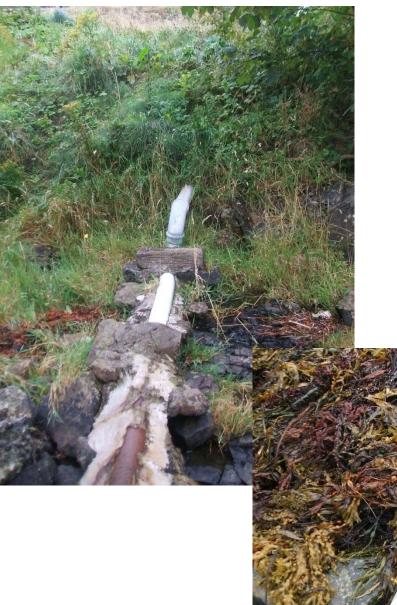
Figure 16. Probable septic tank outlet

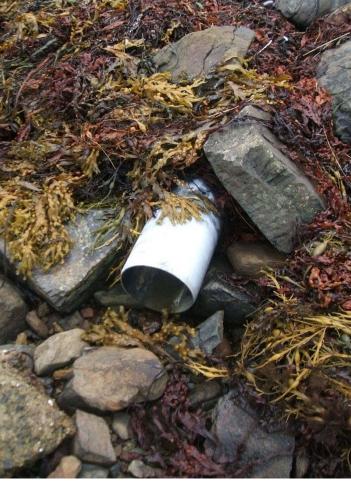
Figure 17. Probable septic tank outlet

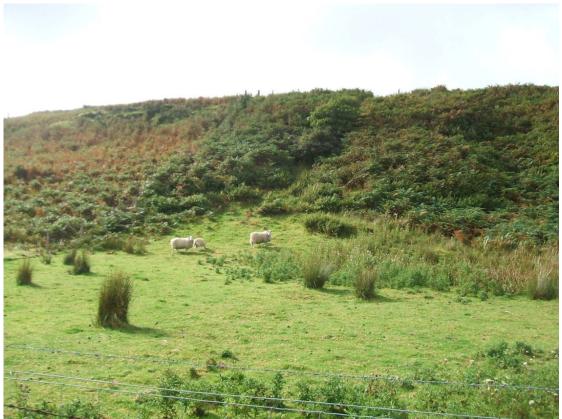
Figure 18. One of a series of crofts on the southern shore

No.	Date	Time (BST)	Position	Easting	Northing	Associated photograph	Associated sample	Description	
31	09/09/2010	10:47	NG 37923 31880	137923	831880			11 cm outflow pipe; no flow	
32	09/09/2010	10:49	NG 37935 31853	137935	831853			24 cm clay outflow pipe below bunkhouses; no flow	
33	09/09/2010	10:51	NG 37957 31835	137957	831835			8" metal outflow pipe; end went under water	
34	09/09/2010	10:54	NG 37995 31807	137995	831807	Figure 16		14 cm plastic pipe joining metal outflow pipe; end went under water	
35	09/09/2010	10:57	NG 38003 31795	138003	831795	Figure 17		15 cm plastic outflow pipe; not flowing	
36	09/09/2010	11:06	NG 38127 31687	138127	831687		LH/FW/09	Small stream; width 0.32 m; depth 0.09 cm; flow 0.055 m/s; tress/bracken above foreshore	
37	09/09/2010	11:07	NG 38129 31689	138129	831689			1 yacht offshore; 4 cormorants on mooring	
38	09/09/2010	11:17	NG 38284 31598	138284	831598	Figure 18		Heavily ferned croftland; 3 sheep fenced off from shore (but gate in fence); seagull nearby

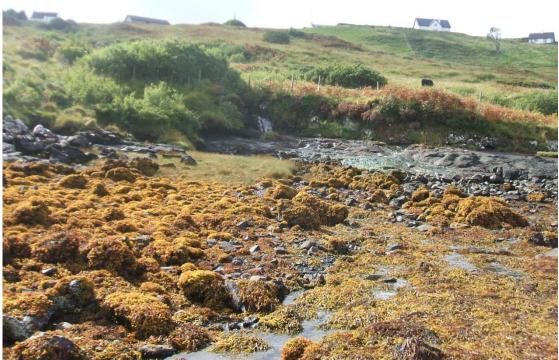
Figure 19. Small stream from croftland south-west of oyster trestles

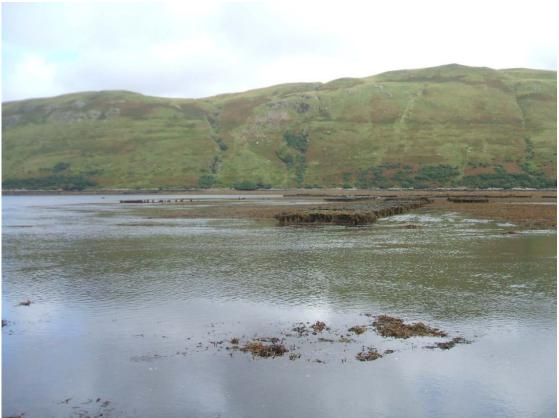
Figure 20. Oyster trestles viewed from the southern shore

The fishery at Loch Harport Inner has been established for many years and consists of several blocks of trestles in 3 main areas in the intertidal area towards the head of the loch (Figure 20). One is located relatively high up the foreshore and can be accessed at tide heights under which the other blocks are still submerged. The other two areas are located further towards the centre of the loch.
