# Scottish Sanitary Survey

## Sanitary Survey Review

Loch Inchard

December 2013

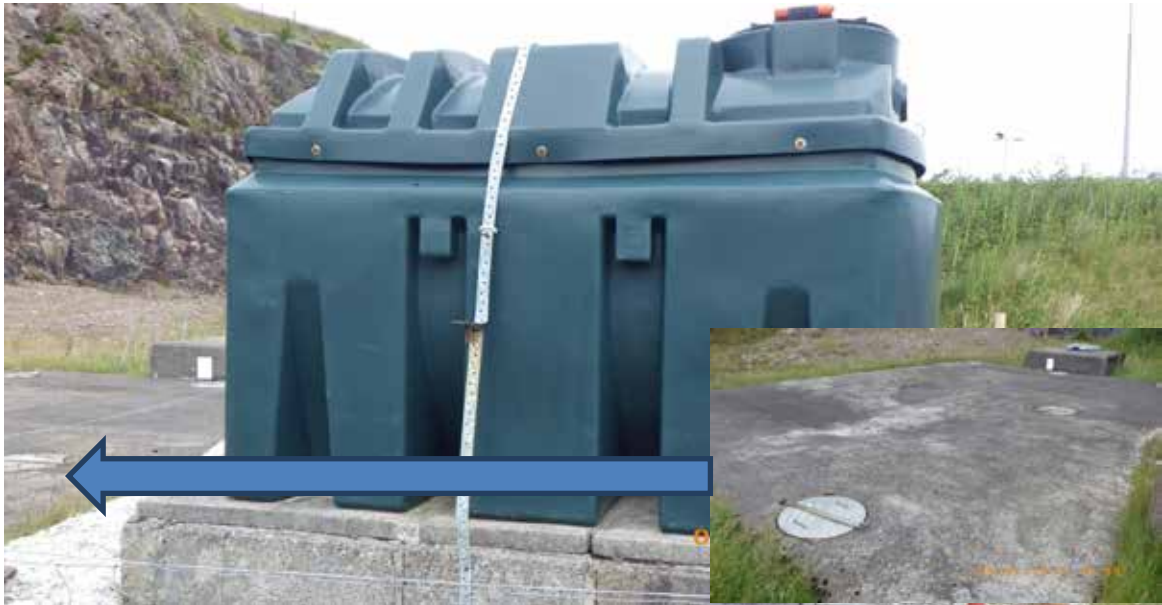
Figure 5. Container and manhole covered area at location marked on map as Kinlochbervie septic tank. Waypoint 25.

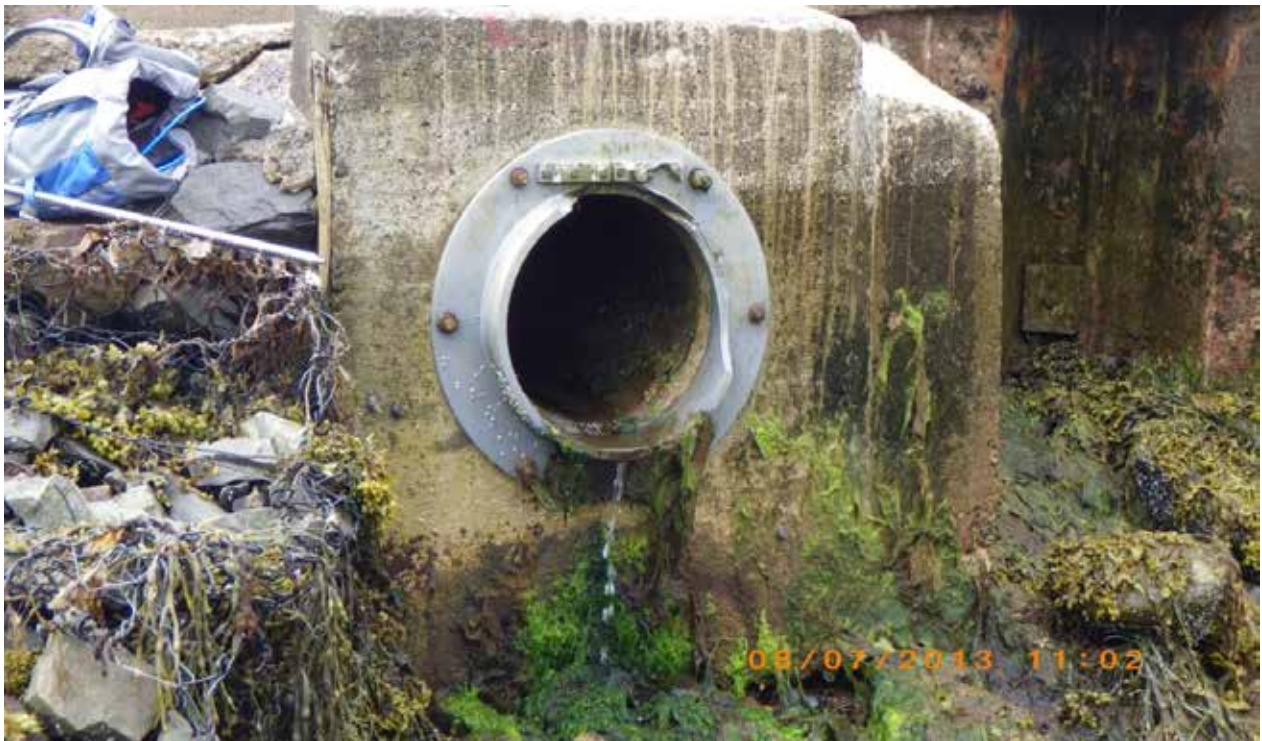
Figure 6. Sewage outfall pipe, location of water sample LIFW1. Waypoints 28 & 29.

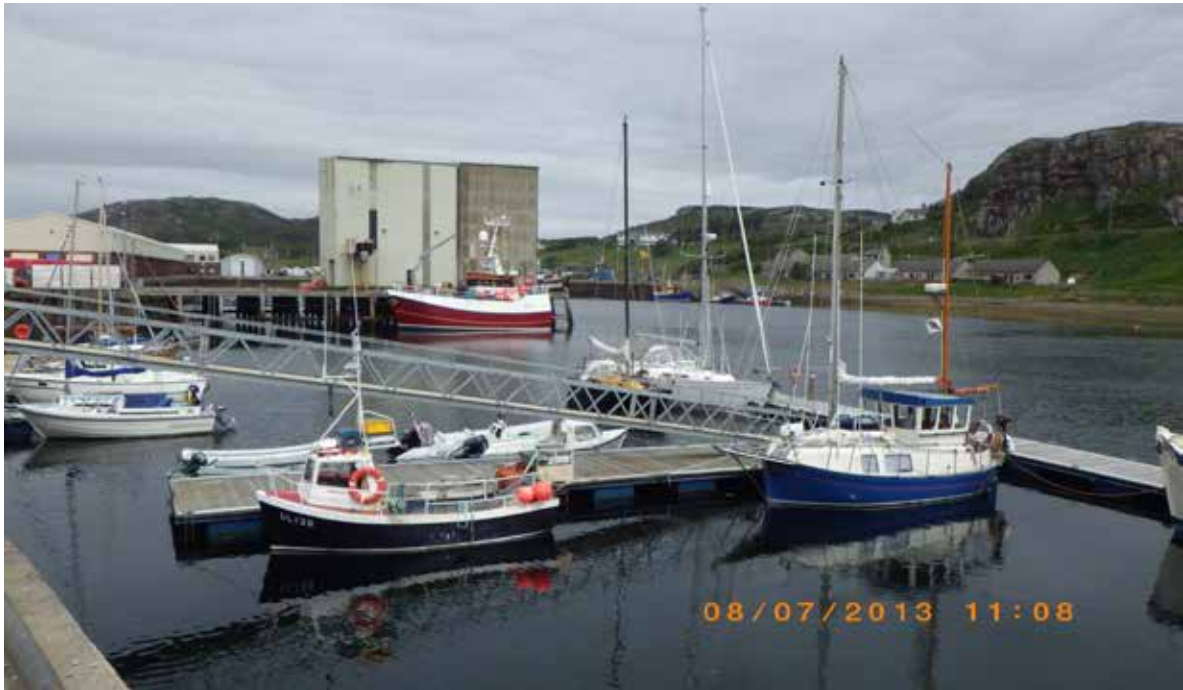
Figure 7. Boats moored at pier. Waypoint 30.

| No. | Date | Time | NGR | East | North | Associated photograph | Associated sample | Description |
|---|---|---|---|---|---|---|---|--|
| 30 | 08/07/2013 | 11:07 | NC 22168 55974 | 222169 | 955974 | Figure 7 | | On western side of pier, 13 boats of varying use and size moored (a mix of fishing and pleasure). No outflow pipes visible around this area. |

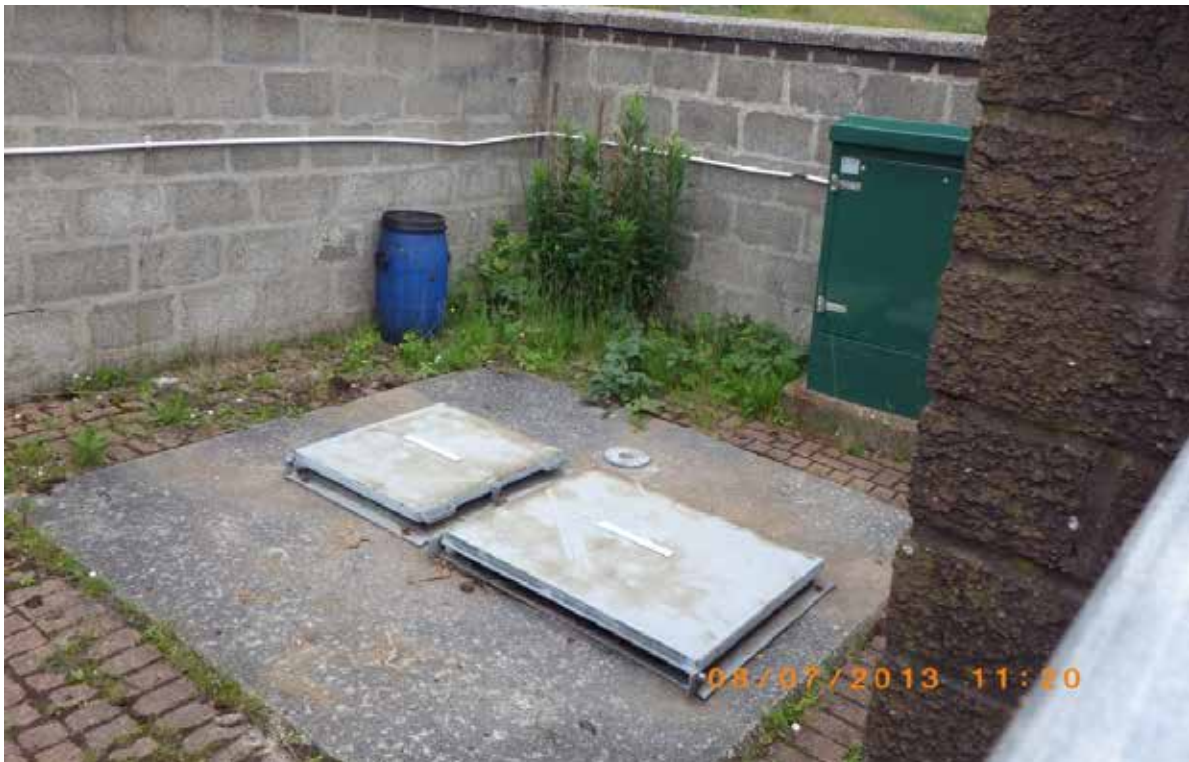
Figure 8. Septic tank storage area. Waypoint 32.

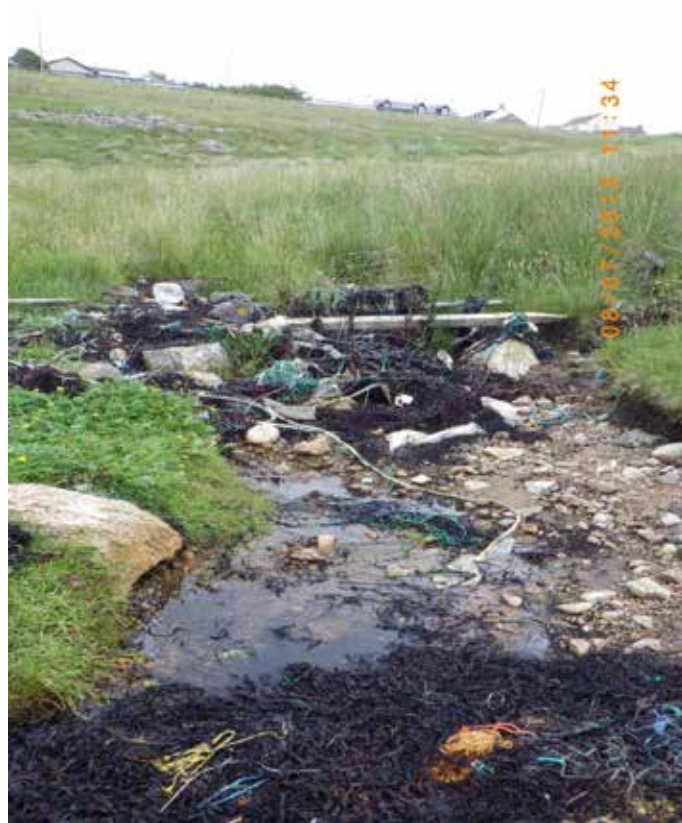
Figure 9. Planned water sample LIFW2. Waypoints 35 & 36.

| No. | Date | Time | NGR | East | North | Associated photograph | Associated sample | Description |
|---|---|---|---|---|---|---|---|---|
| 36 | 08/07/2013 | 11:34 | NC 22330 56085 | 222331 | 956086 | Figure 9 | | Watercourse filled with seaweed and debris. Small flow entering stagnant pool on shore. White oily substance in pool. Depth 1cm. Width 0.5m 5ml/second approximate flow calculated using graduated sample container and wrist watch. Flow rate estimated due to sampling point being unsuitable for flow meter use. |

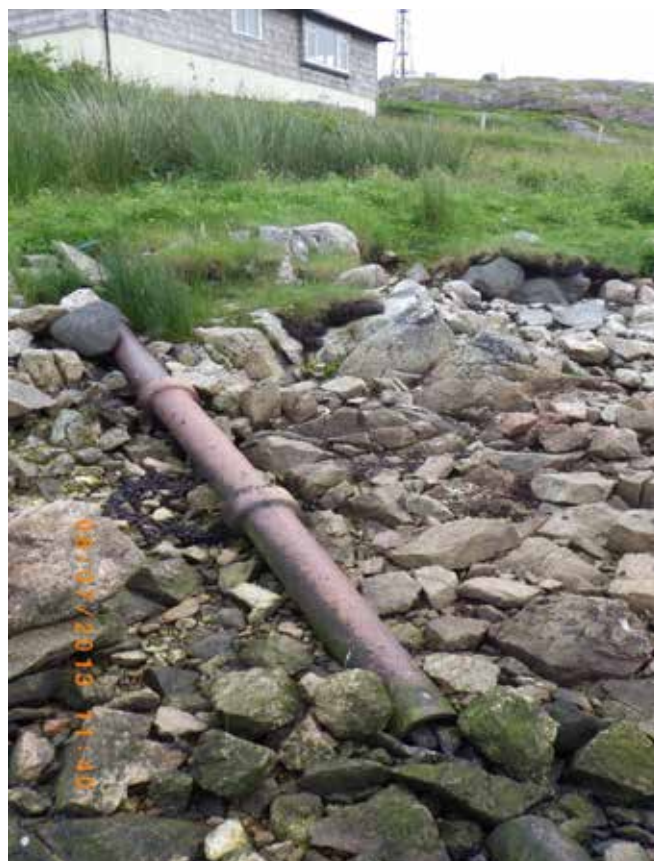
Figure 10. Pipe running to shore below house. Waypoint 37.

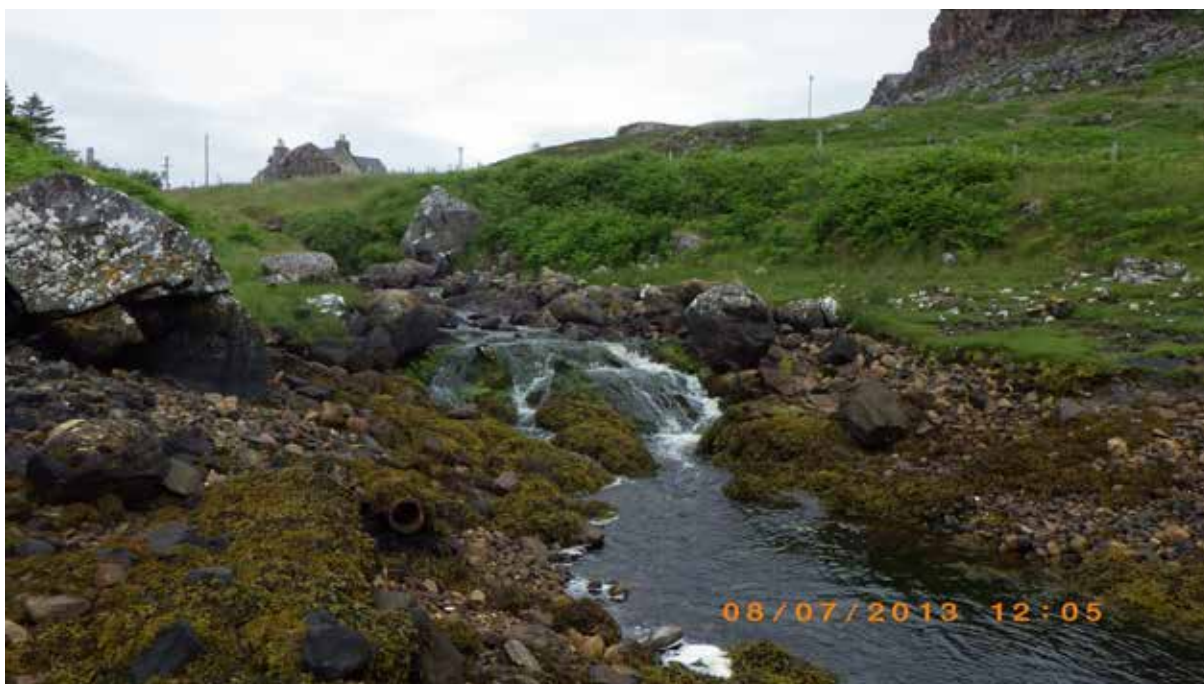
Figure 11. Planned water sample LIFW3. Waypoints 40 & 41.

| No. | Date | Time | NGR | East | North | Associated photograph | Associated sample | Description |
|---|---|---|---|---|---|---|---|---|
| 41 | 08/07/2013 | 12:06 | NC 22911 55848 | 222912 | 955848 | Figure 11 | | Fast running watercourse with broken pipe lying beside it. 2.5m width. Depth 32cm. Flow rate 0.260 m/sec, SD 0.017 |

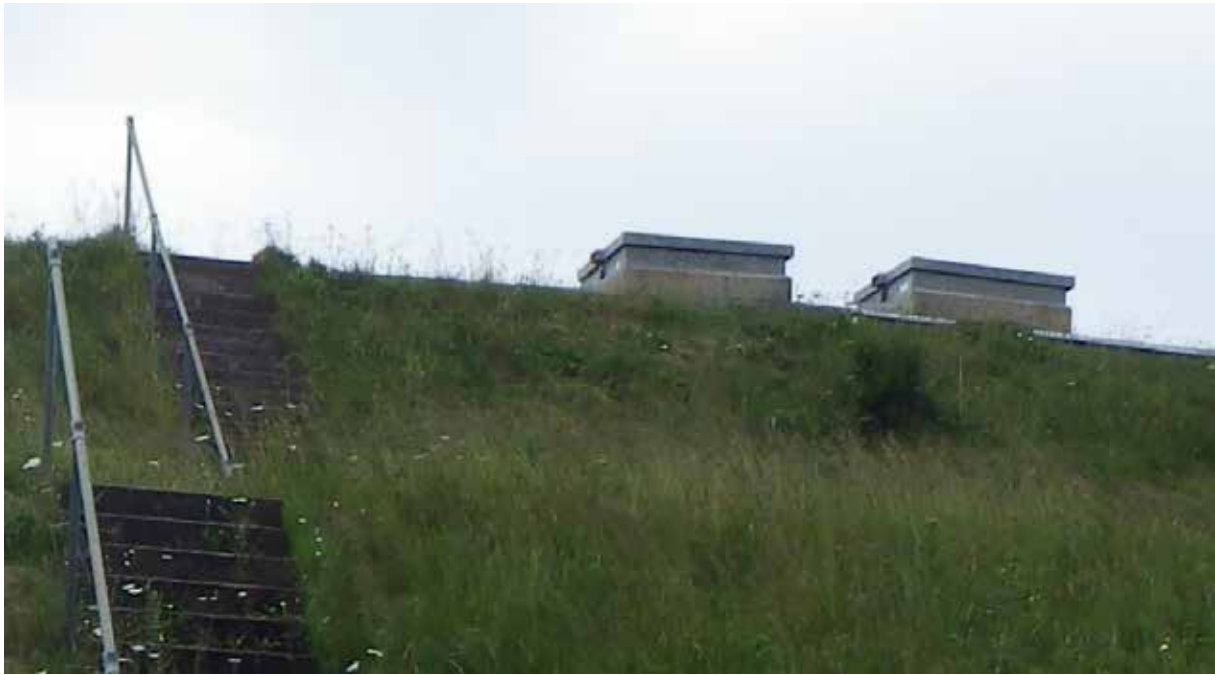
Figure 12. Septic tanks. Waypoint 42.

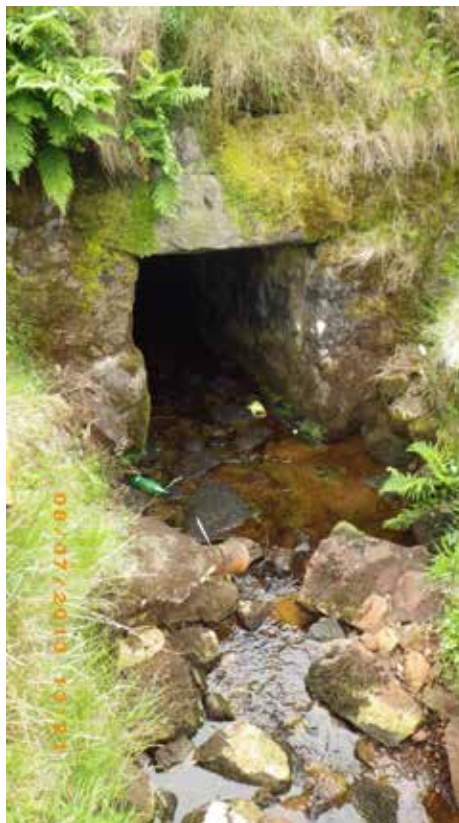
Figure 13. Planned water sample LIFW4. Waypoints 43 & 44.

| No. | Date | Time | NGR | East | North | Associated photograph | Associated sample | Description |
|---|---|---|---|---|---|---|---|---|
| 44 | 08/07/2013 | 13:15 | NC 24198 55723 | 224198 | 955724 | Figure 13 | | Width 0.5m. Depth 15cm. Flow 0.086m/sec, SD 0.012. Pipe flowing into watercourse prior to running under the road. Smell coming from watercourse, possibly sewage. |

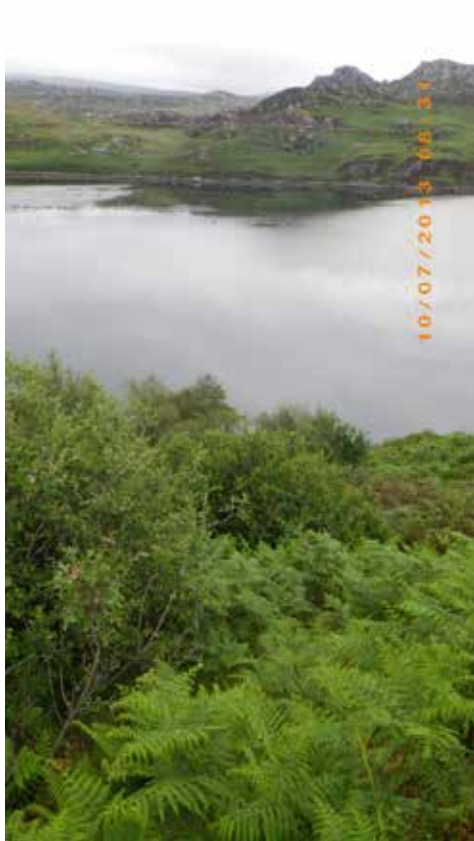
Figure 14. No access to shore. Waypoint 48.

| No. | Date | Time | NGR | East | North | Associated photograph | Associated sample | Description |
|---|---|---|---|---|---|---|---|---|
| 48 | 10/07/2013 | 8:31 | NC 24683 53049 | 224684 | 953050 | Figure 14 | | Watercourse running down hill and sampled higher up hill near road due to inaccessibility to the shore (steep hill, overgrown ferns). No houses around or below the sampling point. Width 1m. Depth 17cm. Flow 0.228m/sec, SD0.013. |

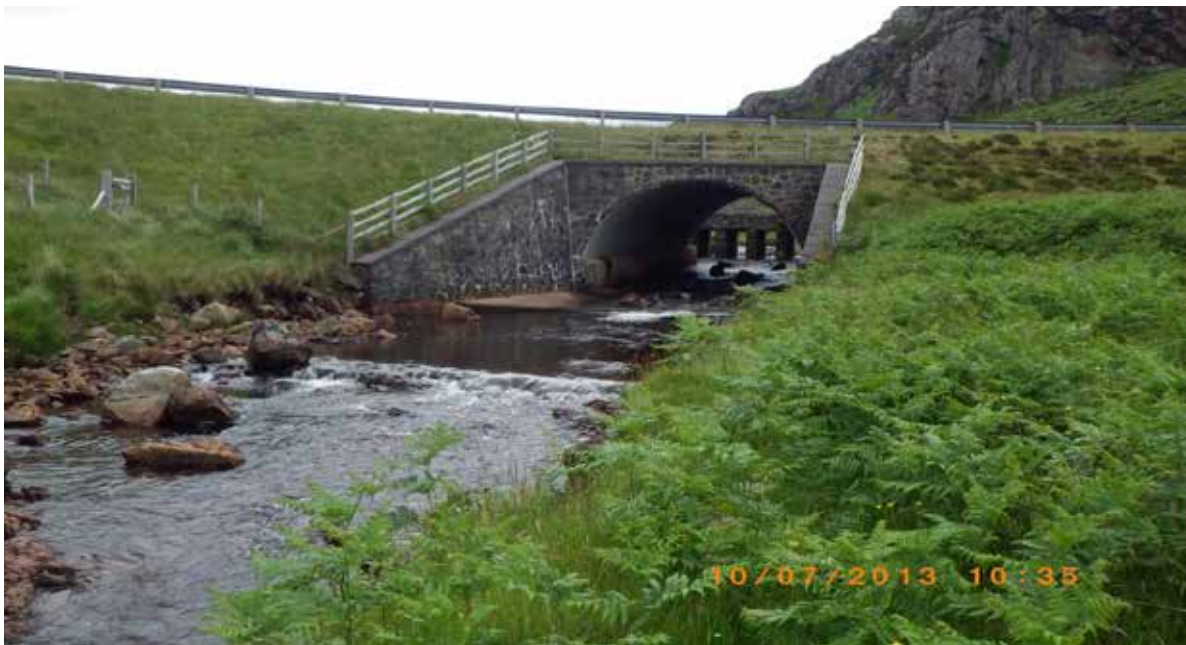
Figure 15. Planned water sample LI2FW5. Waypoint 60 & 61.

| No. | Date | Time | NGR | East | North | Associated photograph | Associated sample | Description |
|---|---|---|---|---|---|---|---|--|
| 61 | 10/07/2013 | 10:36 | NC 25571 54120 | 225572 | 954121 | Figure 15 | | Fast-running wide river flowing under the road directly into the loch. Width 10m. Depth 1 34cm. Flow 1 0.767. SD0.074. Depth 2 38cm. Flow 2 0.469m/sec. SD0.076. |

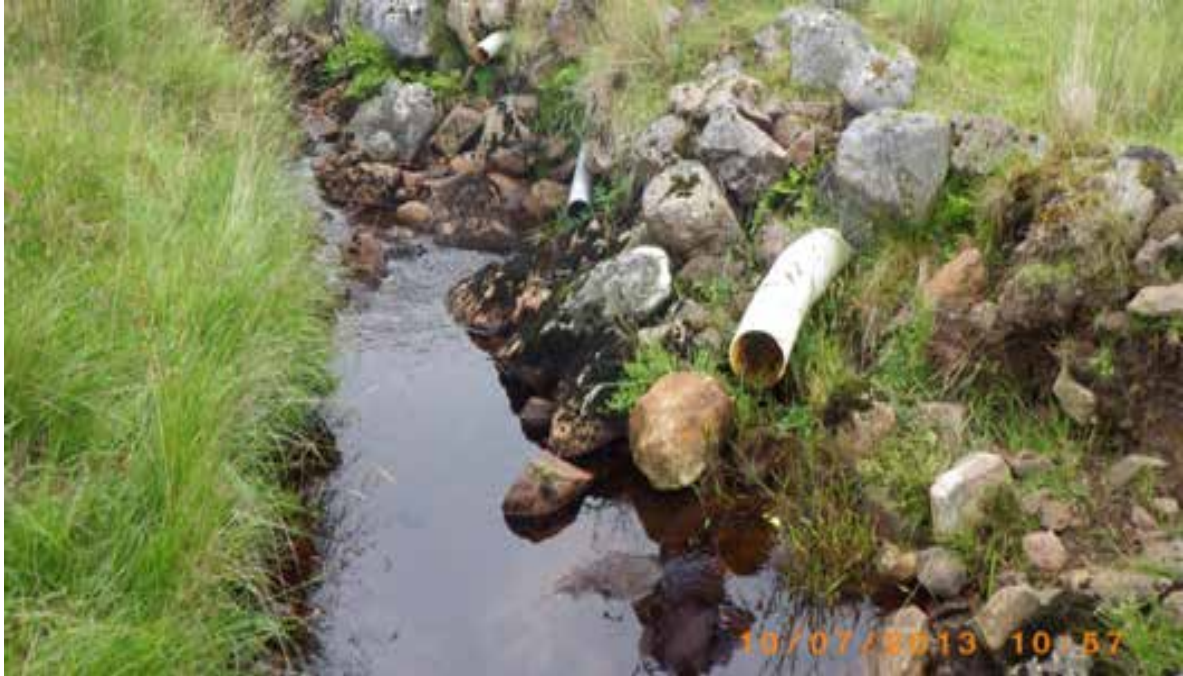
Figure 16. Pipes running into watercourse, Sample LI2FW6. Waypoint 65 & 66.

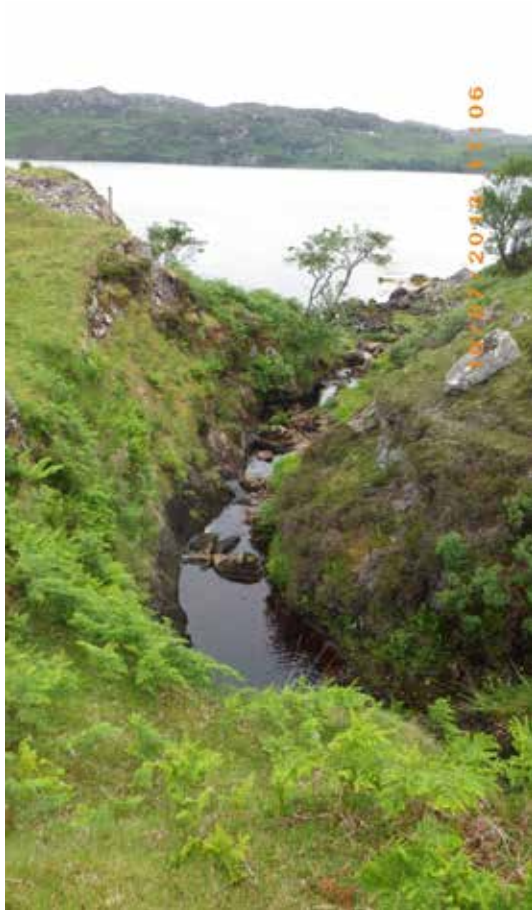
Figure 17. Steep bank beside water course. Waypoint 67.

| No. | Date | Time | NGR | East | North | Associated photograph | Associated sample | Description |
|---|---|---|---|---|---|---|---|---|
| 67 | 10/07/2013 | 11:07 | NC 25338 54210 | 225338 | 954211 | Figure 17 | | Steep banks leading down to loch resulting in no sample being taken at this watercourse. |

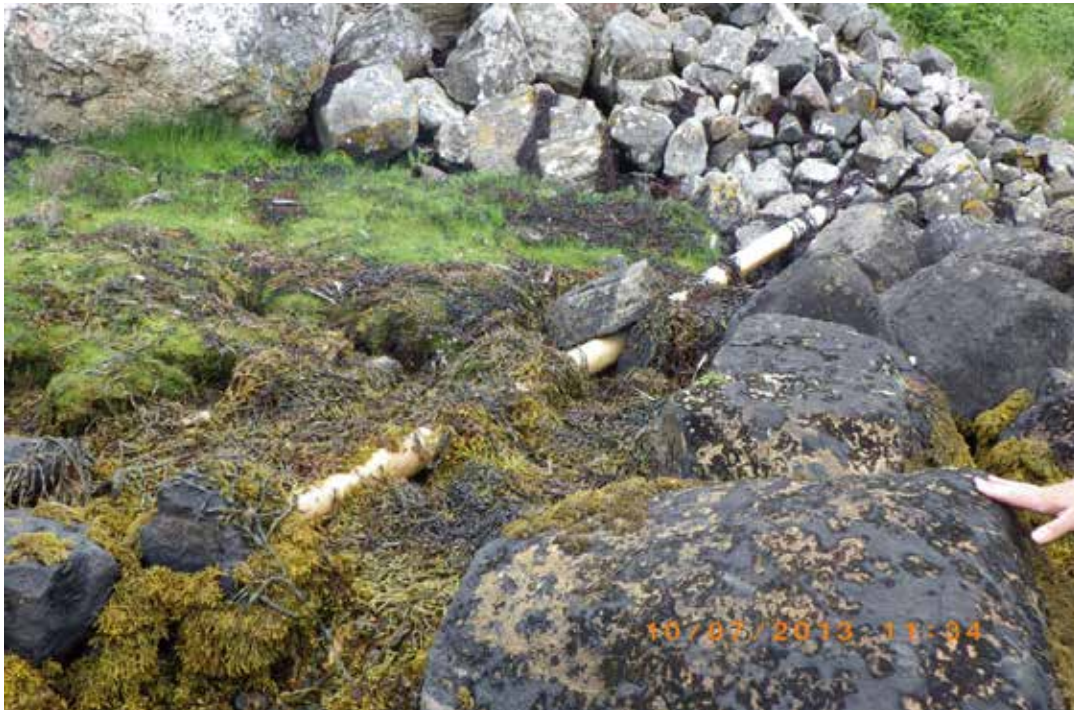
Figure 18. Pipe running to shore from house, Unplanned Seawater Sample LI2SW1. Waypoint 70 & 71.

A seawater sample was also taken adjacent to a dry pipe coming from a house east of Rhiconich. A high result of 1700 *E. coli* cfu/ 100 ml indicates significant faecal contamination in the vicinity of the pipe. This pipe corresponds to the location given for Inchard House in the 2011 Loch Inchard Shellfish Growing Water Report (SEPA, 2011). That report also identified three ST outfalls adjacent to the Rhiconich shoreline: these were referred to as Rhiconich Hotel, Rhiconich Police House & Public toilet block and Sutherland District Council.

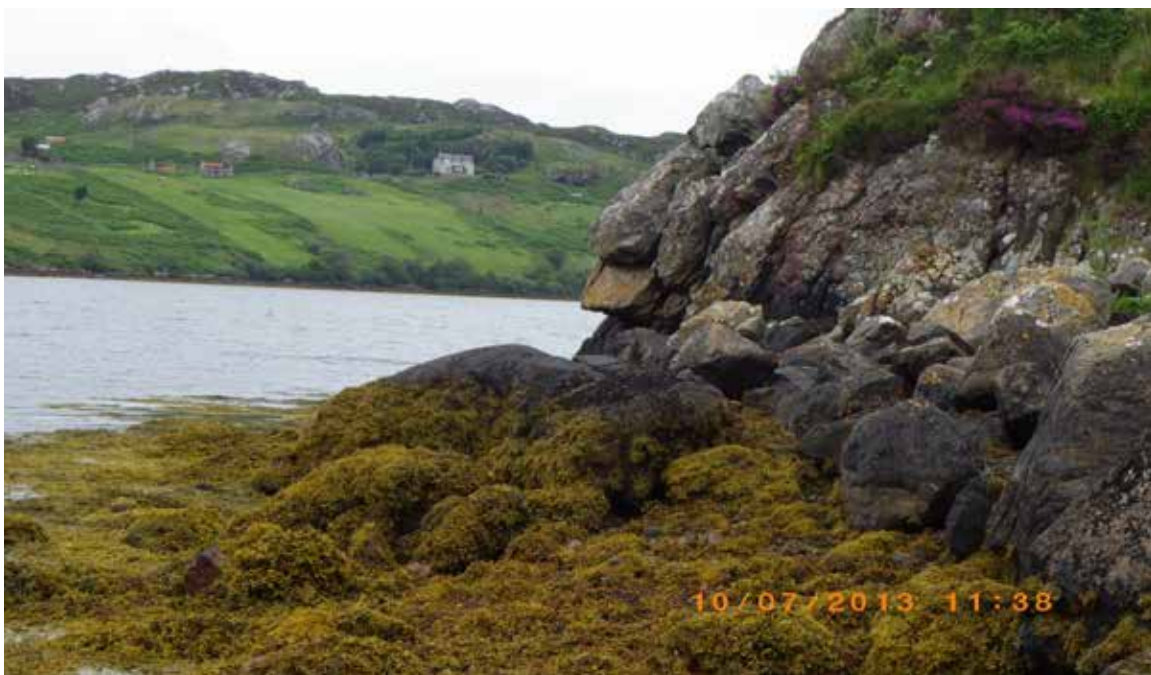
Figure 19. Rocky steep shore. Waypoint 71.

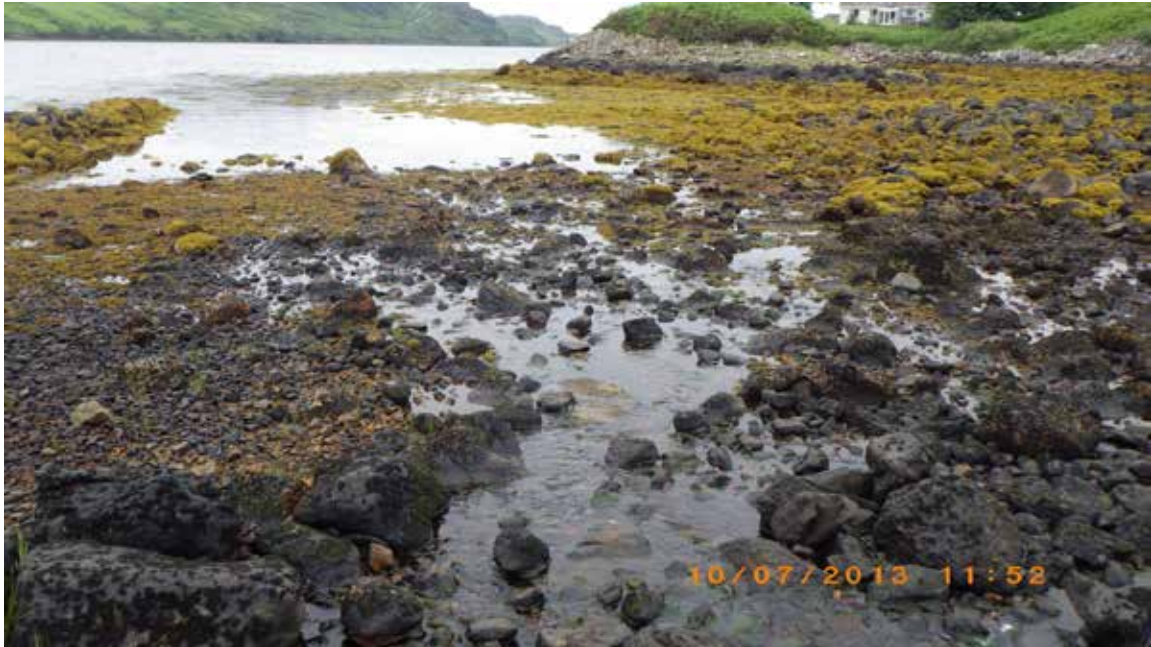
Figure 20. Wide shallow sampling point LI2FW8. Waypoint 76.
