# Scottish Sanitary Survey Report

## Sanitary Survey Report Loch Kishorn RC 329 March 2013

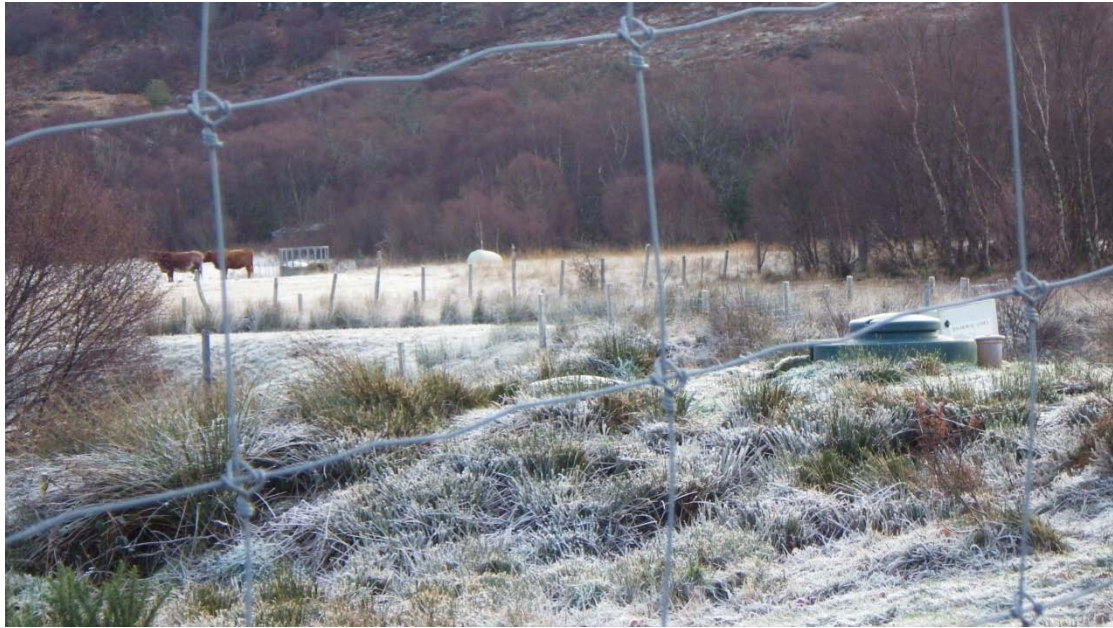
Figure 6: Septic tank in field with 2 cows in adjacent field (Waypoint 2)

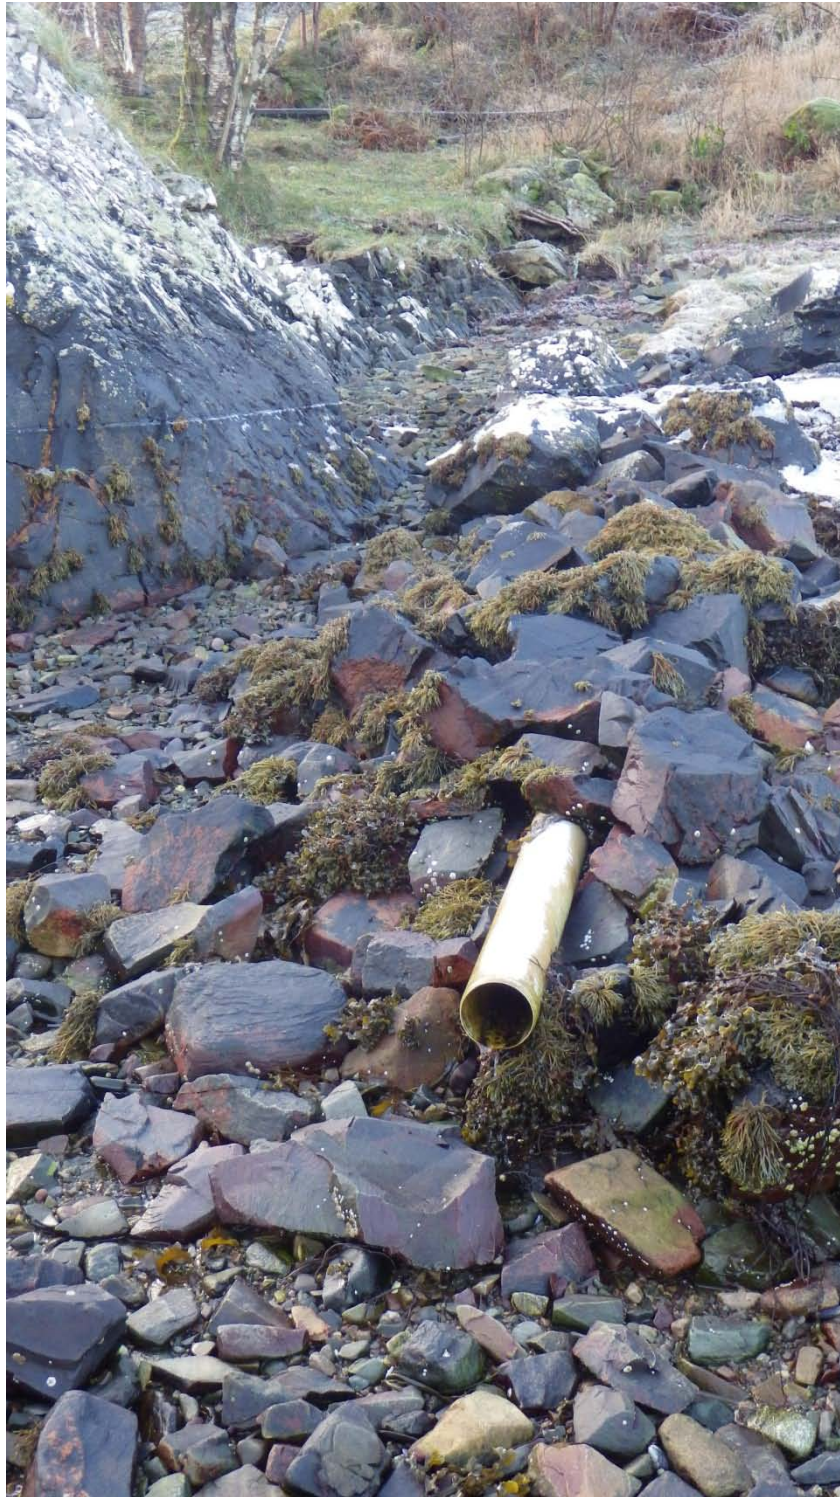
Figure 7: Plastic pipe discharging on to shore (Waypoint 5)

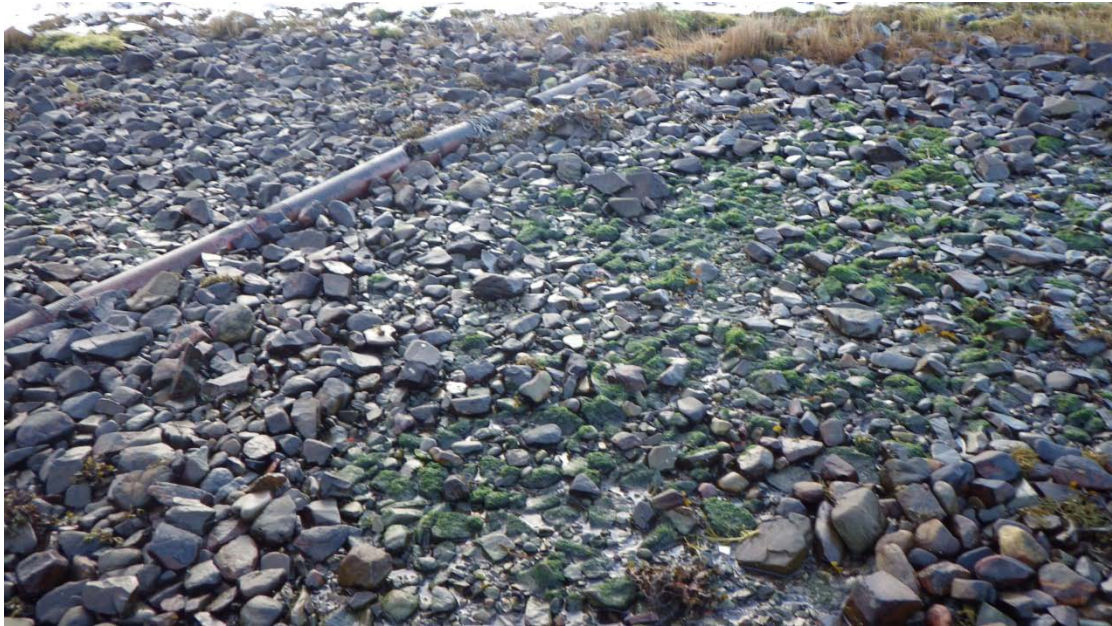
Figure 8: Broken clay pipe and green algae (*Ulva* sp.) on shore (Waypoint 6)

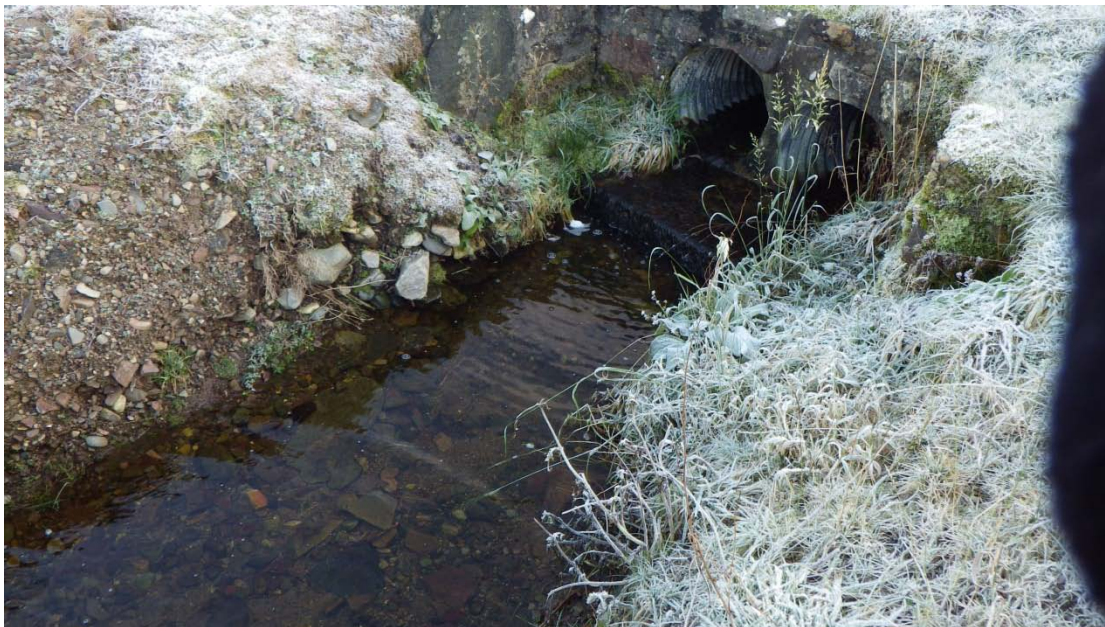
Figure 9: Culvert running under road (Waypoint 8)

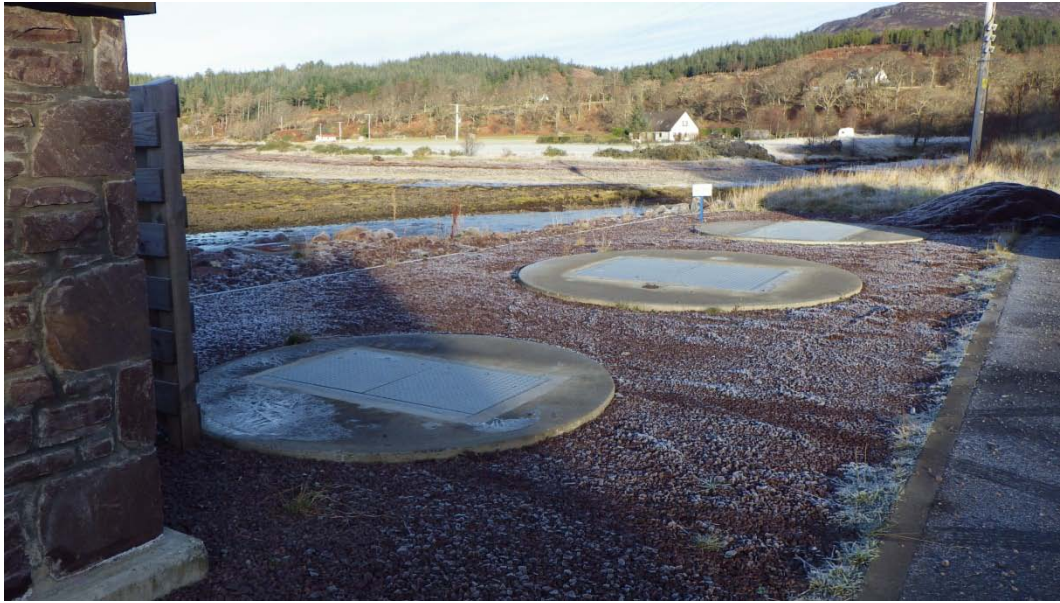
Figure 10: Kishorn Achintraid CSO (Waypoint 11)

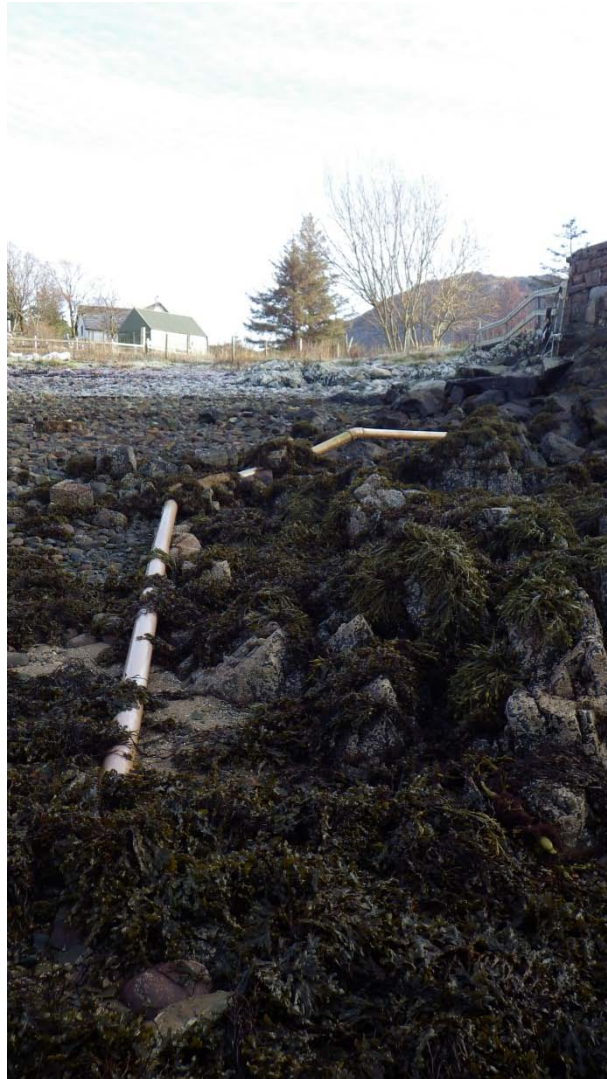
Figure 11: Plastic outflow pipe not on original map with no obvious discharge (Waypoint 15)

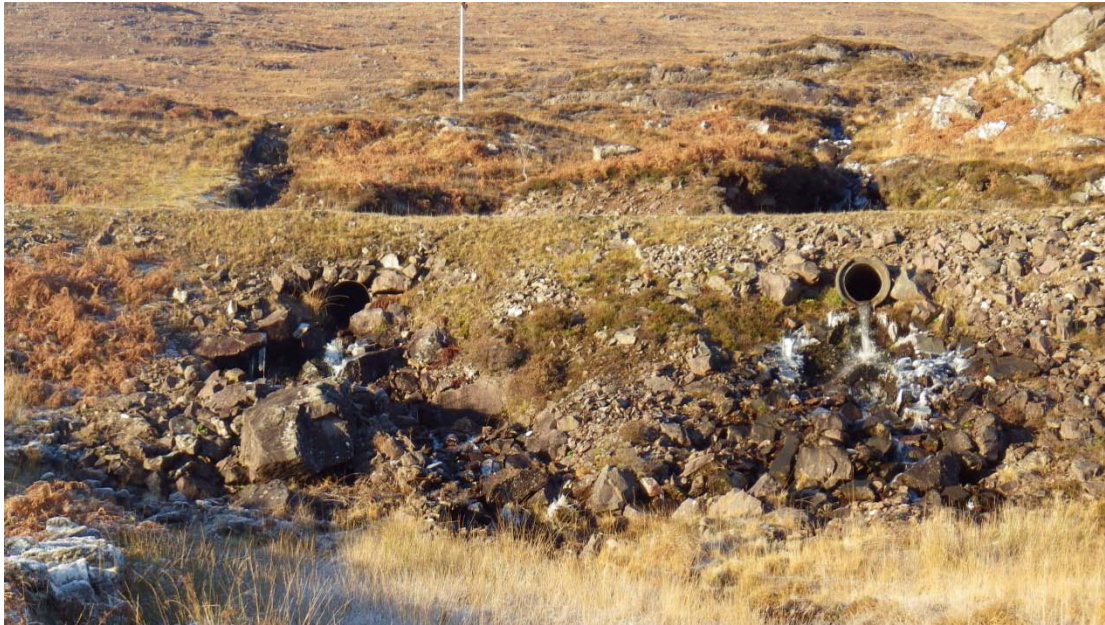
Figure 22: Two concrete pipes running under road and discharging on to shore (Waypoint 31)

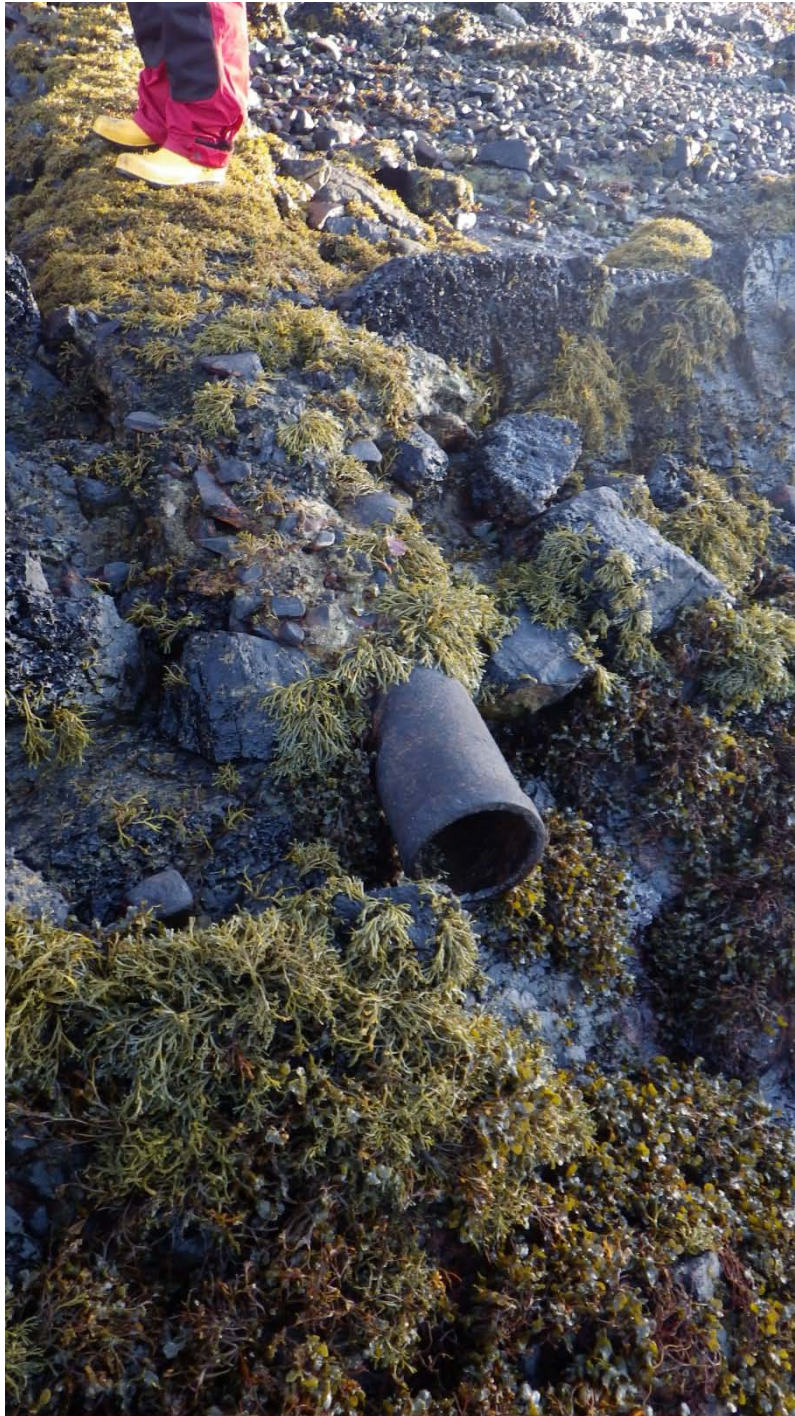
Figure 26: Cast iron pipe on shore with no evident outflow (Waypoint 38)

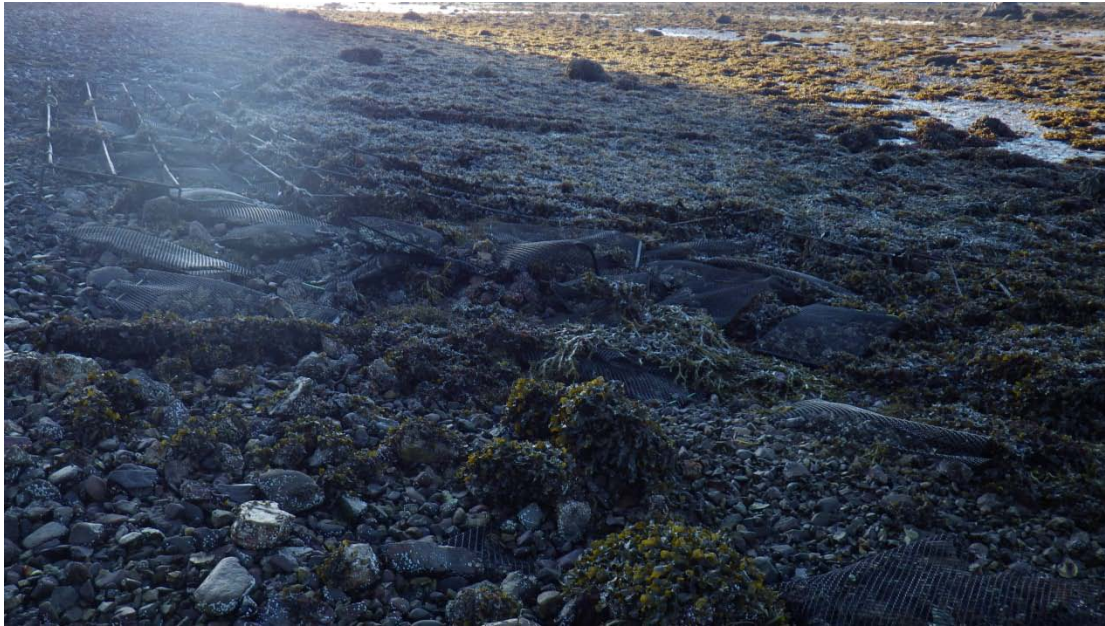
Figure 27: Old overgrown oyster trestles (Waypoint 38)

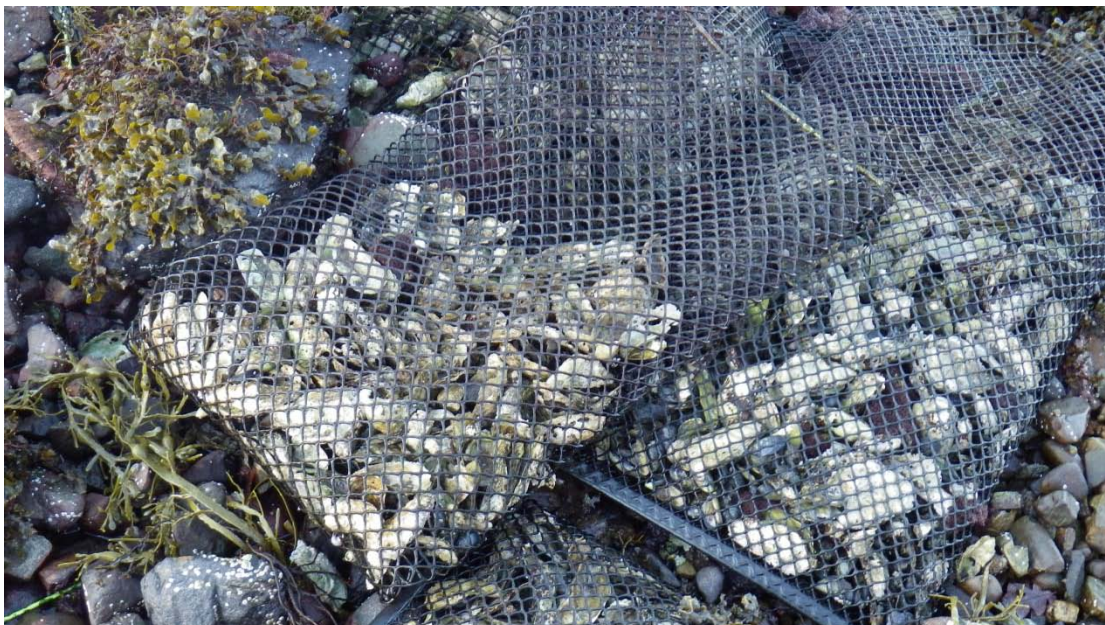
Figure 28: Old abandoned oyster bags containing empty shells (Waypoint 38)

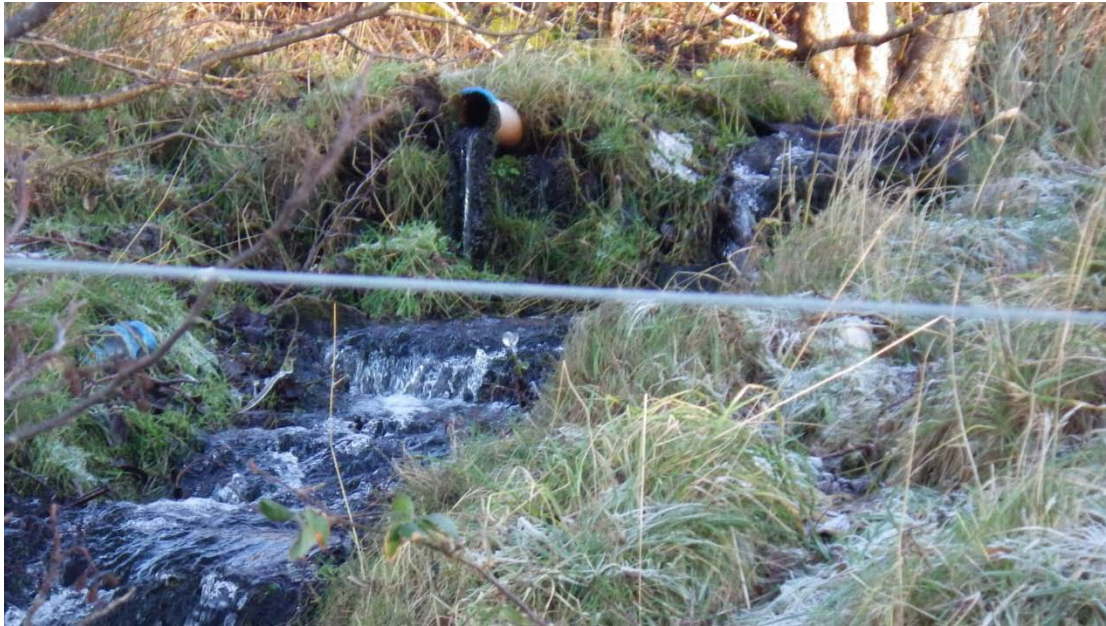
Figure 30: Plastic outfall pipe visible behind fence discharging into stream. (Waypoint 40)

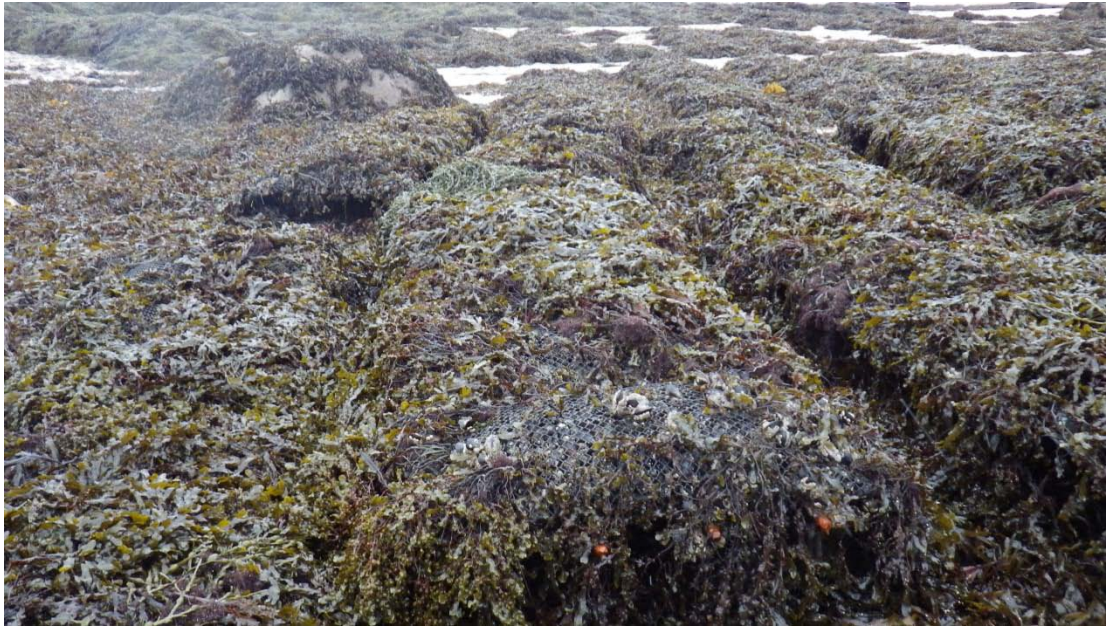
Figure 32: Overgrown oyster bags at oyster fishery (Waypoint 45)

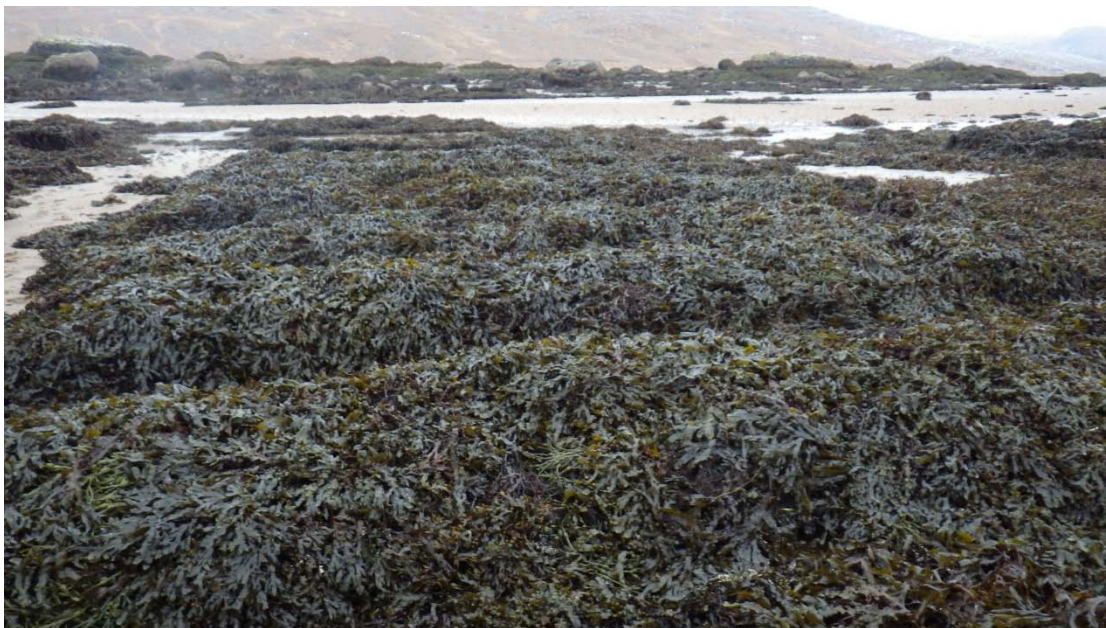
Figure 33: Overgrown oyster trestles at oyster fishery (Waypoint 45)
