Scottish Sanitary Survey Programme

Sanitary Survey Report

Production Area: Loch Leven: Lower

SIN: HL 170 222 08

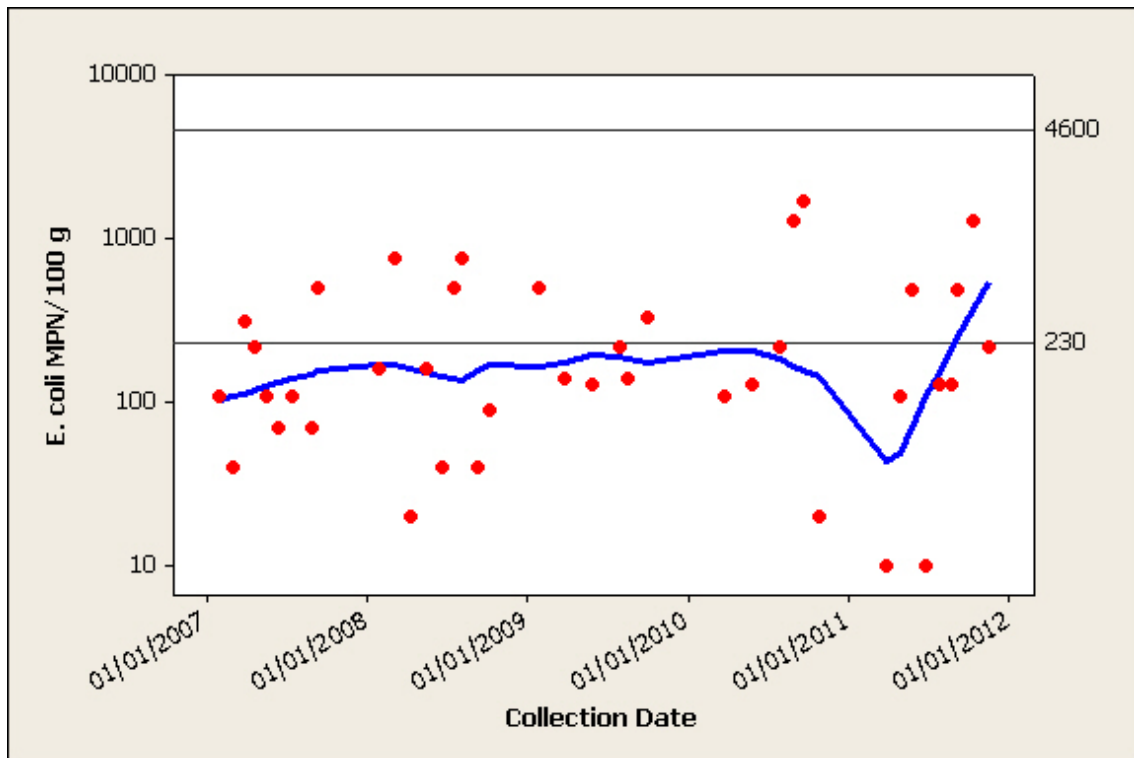
Figure 11.2 Scatterplot of *E. coli* results by date with loess line

The dip in the trend line in early 2011 was associated with the only two <20 *E. coli* MPN/100 g results seen at the site over the period under review. The subsequent sharp rise in the trend line may simply be due to the results returning to their usual level. However, over the period since January 2007, there does appear to have been a slight general increase in the microbiological contamination of the mussels at the site. During the review period, results greater than 1000 *E. coli* MPN/100 g have only been seen since August 2010. However, it should be noted that several results greater than 1000 *E. coli* MPN/100 g were seen in monitoring at this site prior to 2007 and the trend shown in Figure 11.2 should not be taken out of that context.

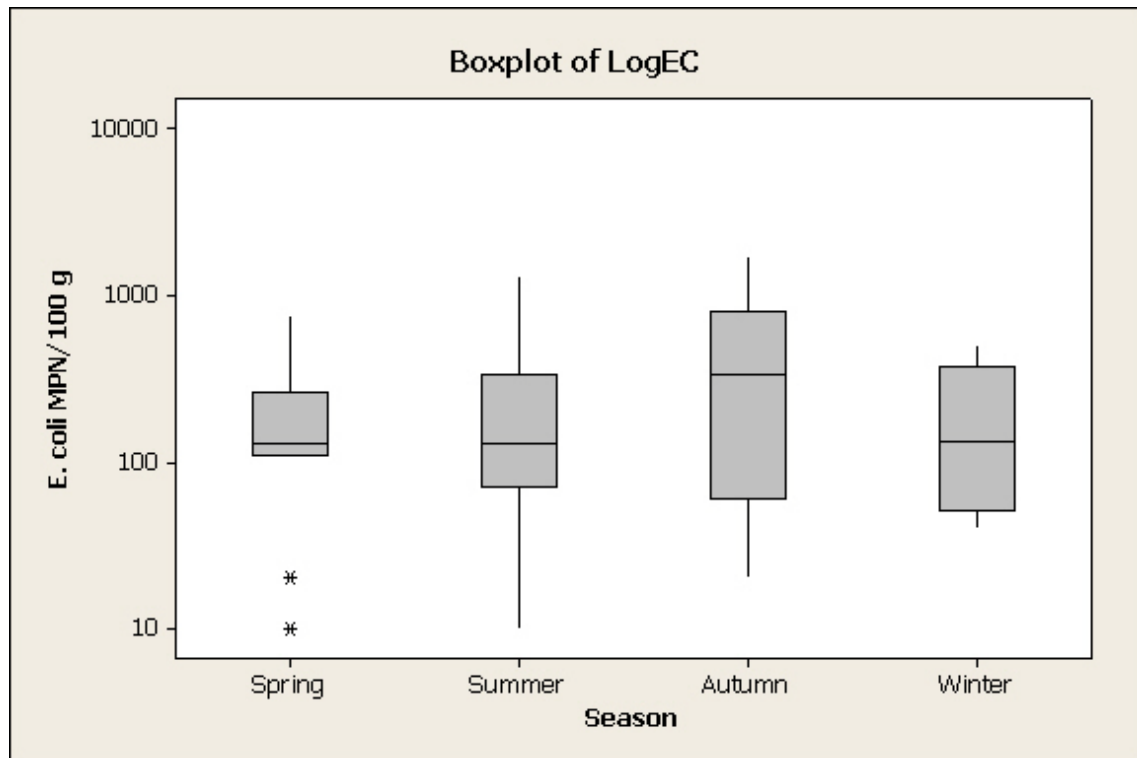
Figure 11.4 Boxplot of result by season

No significant difference was found between results by season (One-way ANOVA, $p=0.694$, Appendix 4). However, care needs to be taken in placing too much emphasis in the outcome of this analysis due to the uneven distribution of sampling occasions by month.

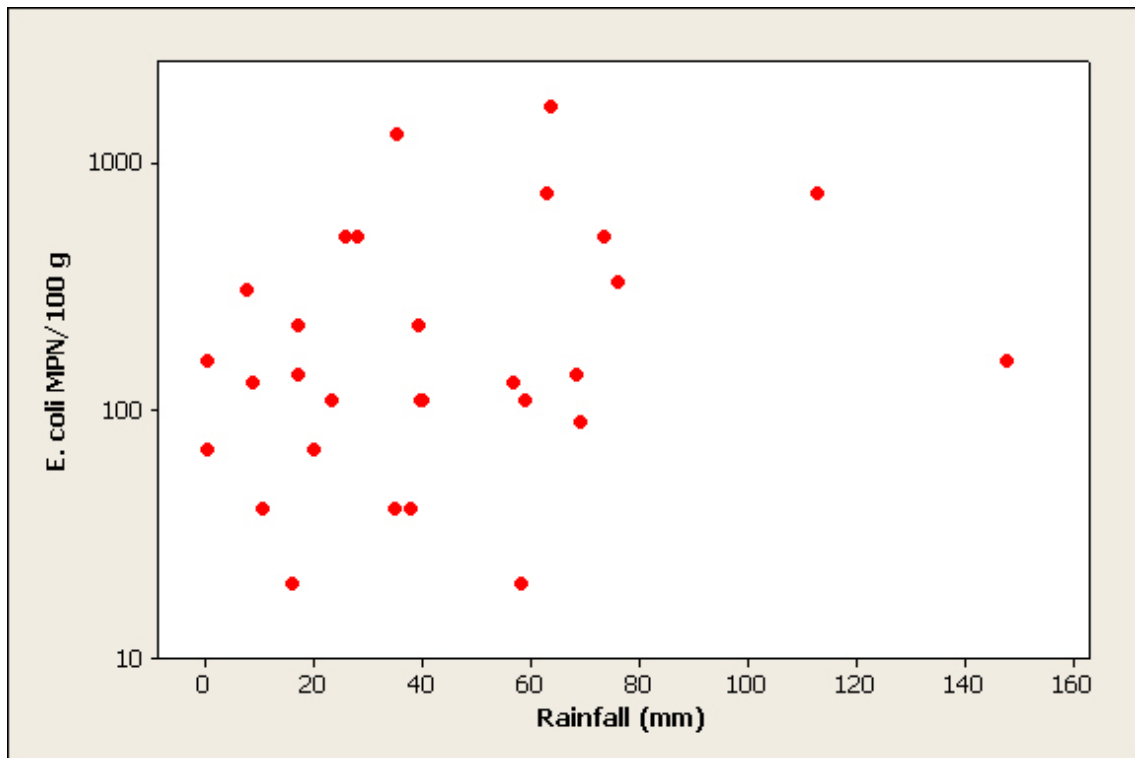
Figure 11.6 Scatterplot of result against rainfall in previous 7 days

No significant correlation was found between *E. coli* result and rainfall in the previous 7 days (Spearman's rank correlation= 0.303, $p=0.110$).

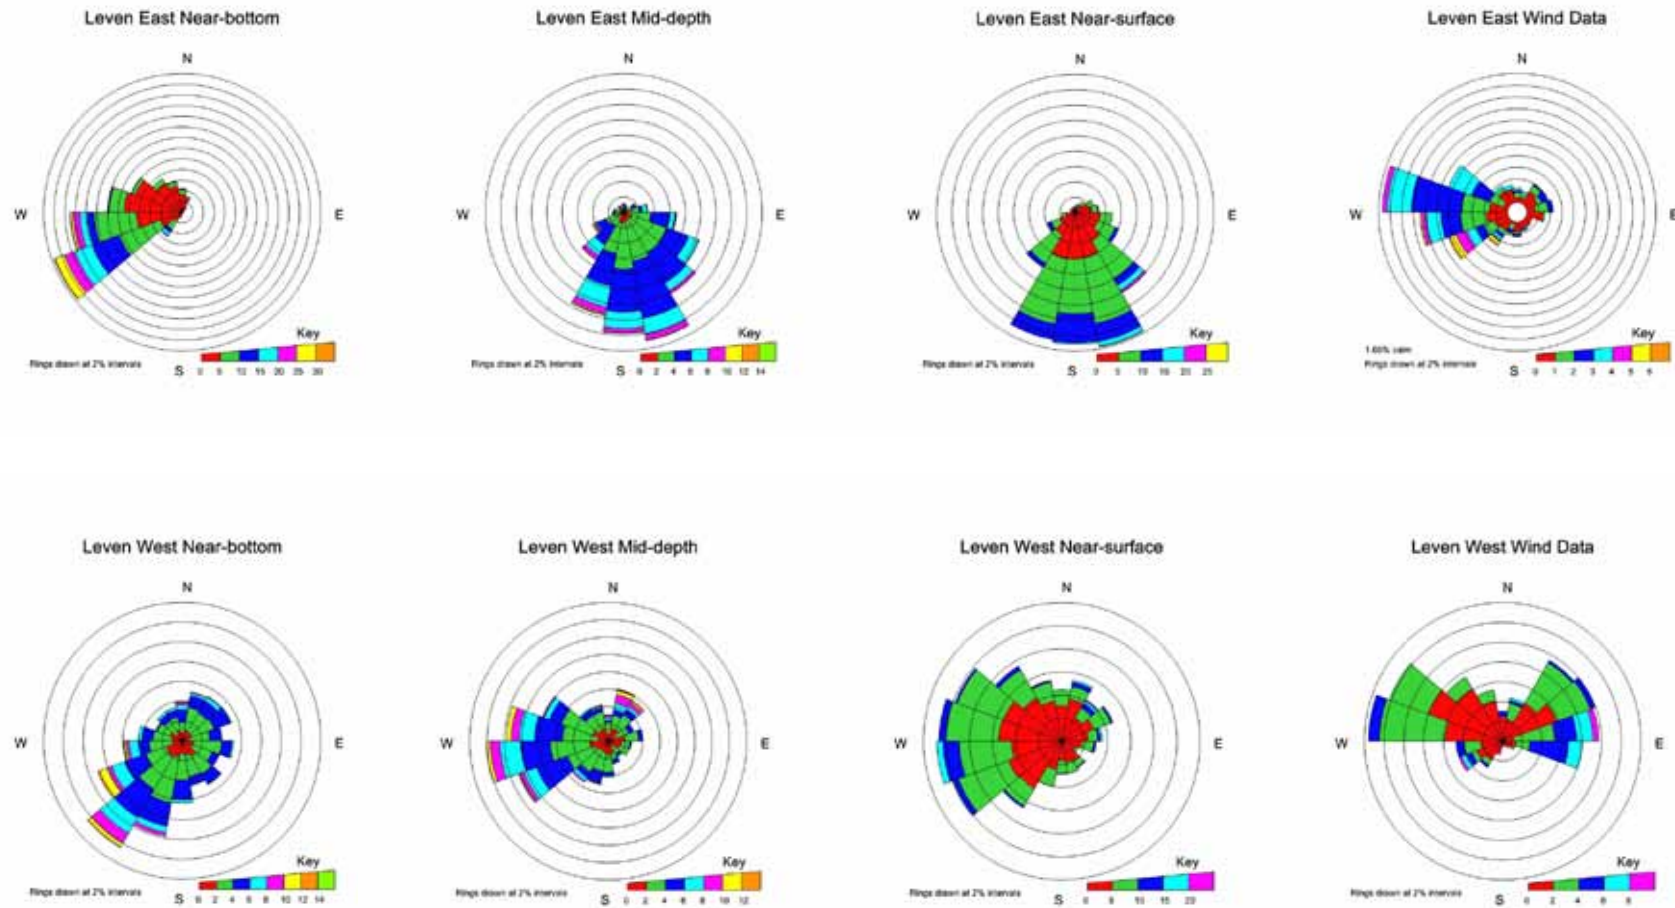
The mid-depth and near-surface measurements made during the current meter studies are most relevant to the depths of the droppers on the mussel rafts. At a maximum speed of 26 cm/s, contamination would be maximum distance of 3.7 km over a tidal cycle, ignoring any effects of dilution and dispersion. In general, currents, and therefore transport distances, would be expected to be less than this. Given the faster currents through the narrows to the west, contamination from sources within Ballachulish Bay could easily reach the mussel farm within a tidal cycle. To the east, contamination from sources as far as Glencoe could also reach the farm on a spring tide.

Currents measured in cm/s. Wind measured in m/s. As per convention, currents are plotted against the direction towards which they are travelling while winds are plotted against the direction from which they are travelling. The length of each segment in a plot relates to the proportion of observations lying in that direction. The speed relates to the colour key beneath each plot. The proportion that each colour takes up in an individual segment relates to the proportion of observations in that direction having speed in that range. Directions are in degrees true.

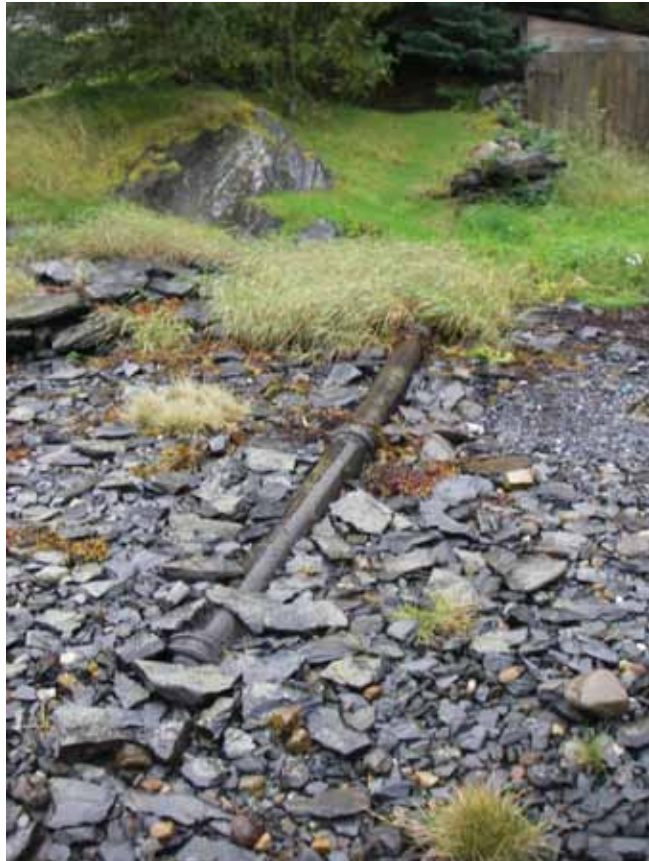
Figure 5. Pipe running from property

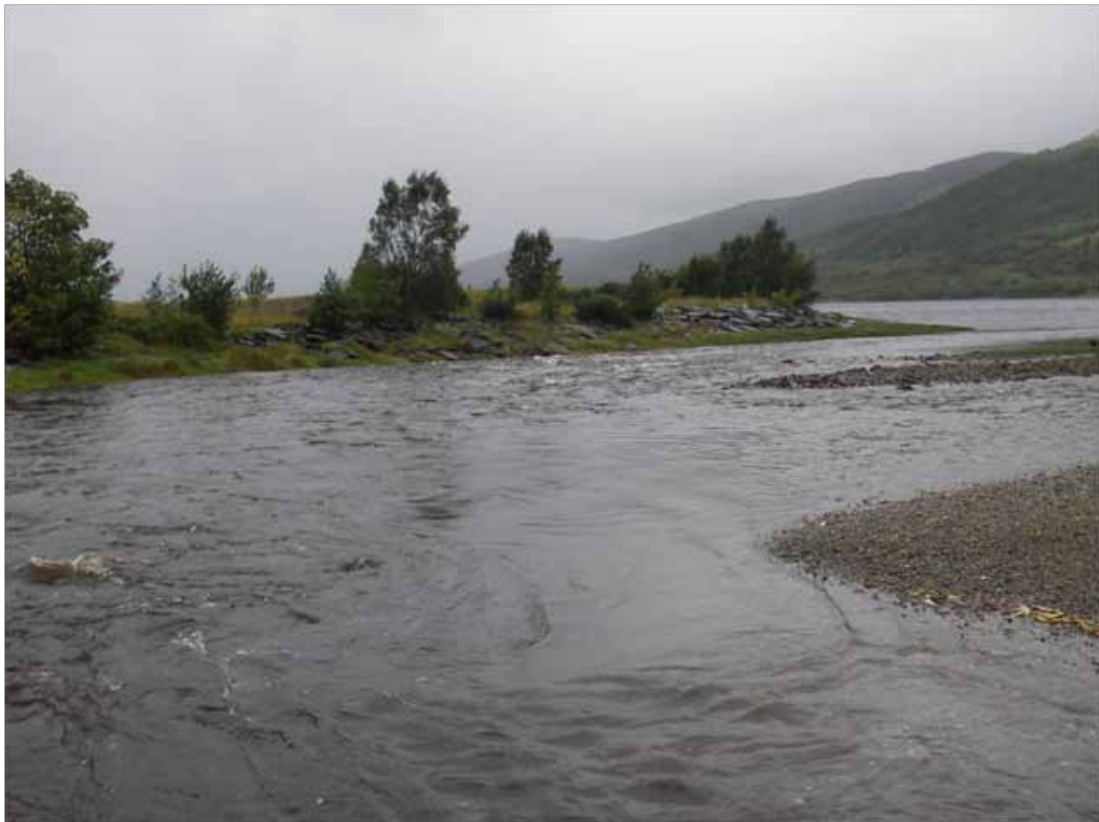
Figure 6. Laroch River

9	06/09/11	10:44:37	NN 07576 58398	207576	758398			Small inlet by house. Green algae on shore.
10	06/09/11	10:50:06	NN 07790 58467	207790	758467			23 gulls and 6 ducks by river mouth.
11	06/09/11	10:55:58	NN 07846 58395	207846	758395	Figure 6	LLW06	East side of river - 1st reading; width by GPS; depth 40 cm; flow 0.961 m/s
12	06/09/11	10:56:38	NN 07847 58392	207847	758392			East side of river- 2nd reading
13	06/09/11	11:05:25	NN 07836 58389	207836	758389			West side of river - 1st reading
14	06/09/11	11:05:31	NN 07837 58389	207837	758389			West side of river - 2nd reading
15	06/09/11	11:12:15	NN 07929 58637	207929	758637			Five small boats offshore
16	06/09/11	11:22:53	NN 08196 58637	208196	758637			Pier by Isles of Glencoe Hotel; 2 yachts; 5 open boats; 1 disused fishing boat; disused fishermen's huts
17	06/09/11	11:33:19	NN 07999 58850	207999	758850		LLW07	Seawater sample
18	06/09/11	11:39:53	NN 08157 58833	208157	758833			Salmon farm on other side of loch; island just offshore - no animals seen

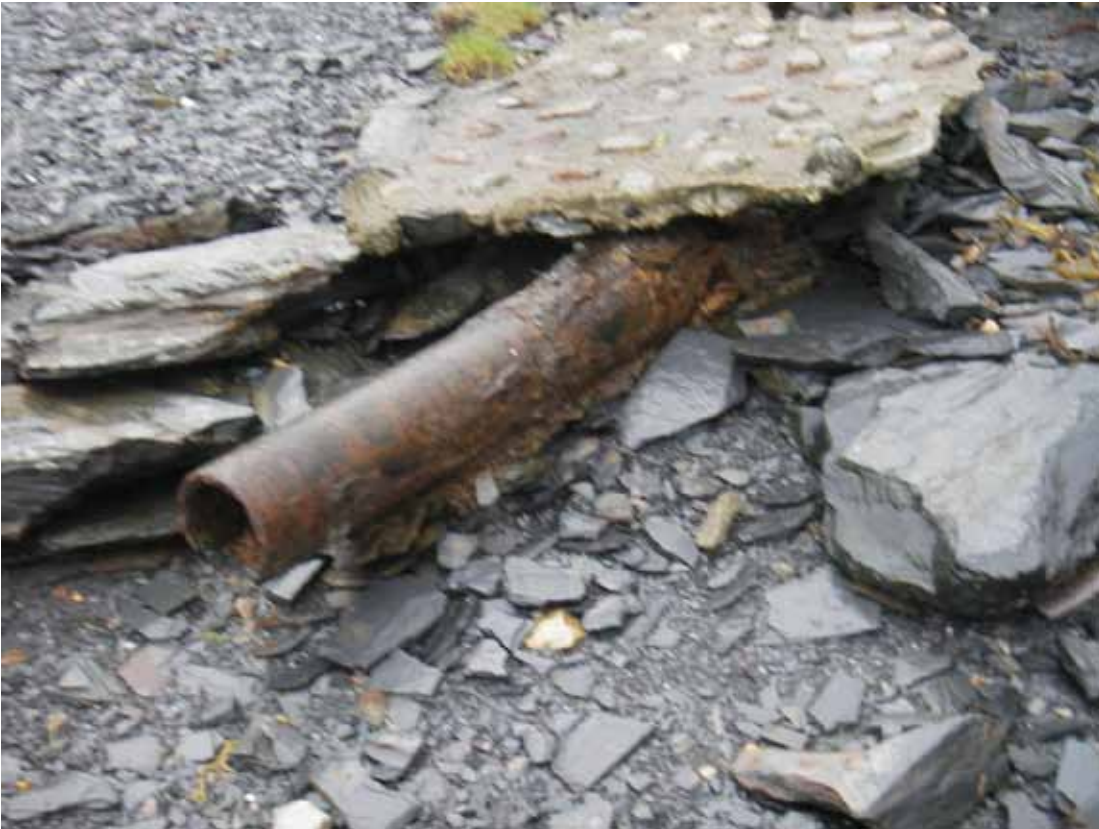
Figure 7. Possibly disused pipe by hotel

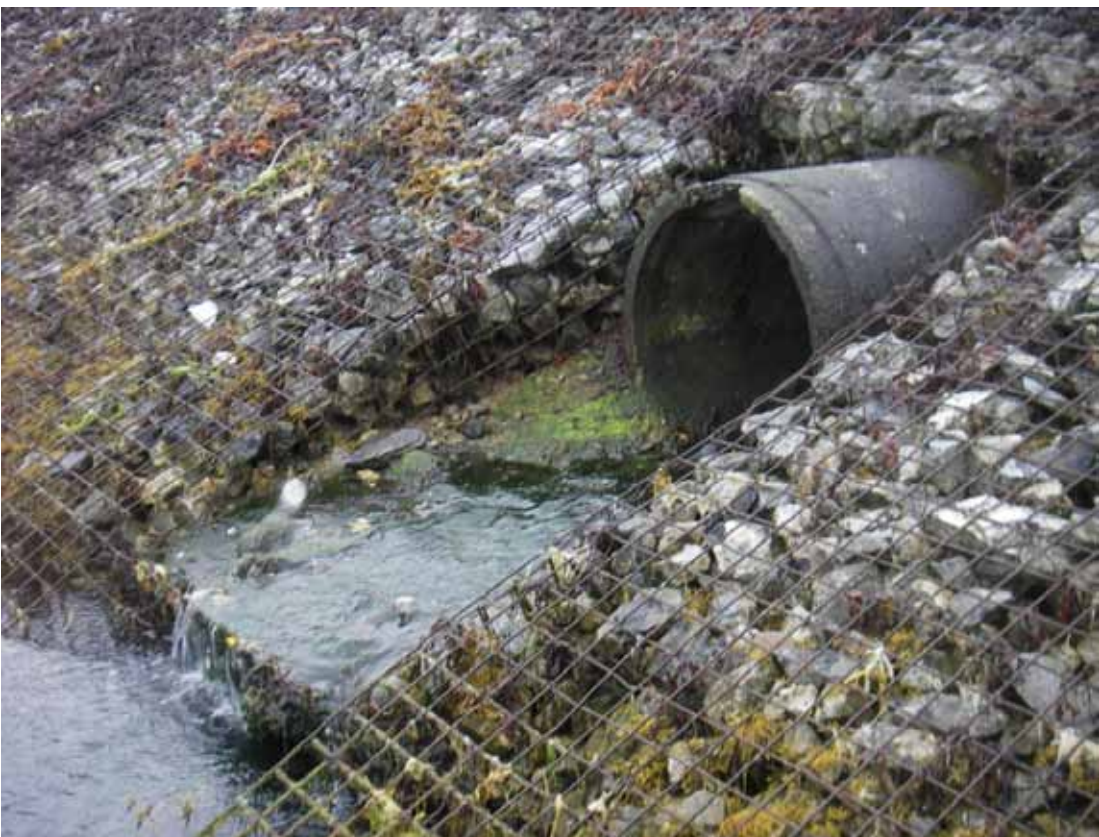
Figure 8. Stream running through concrete pipe

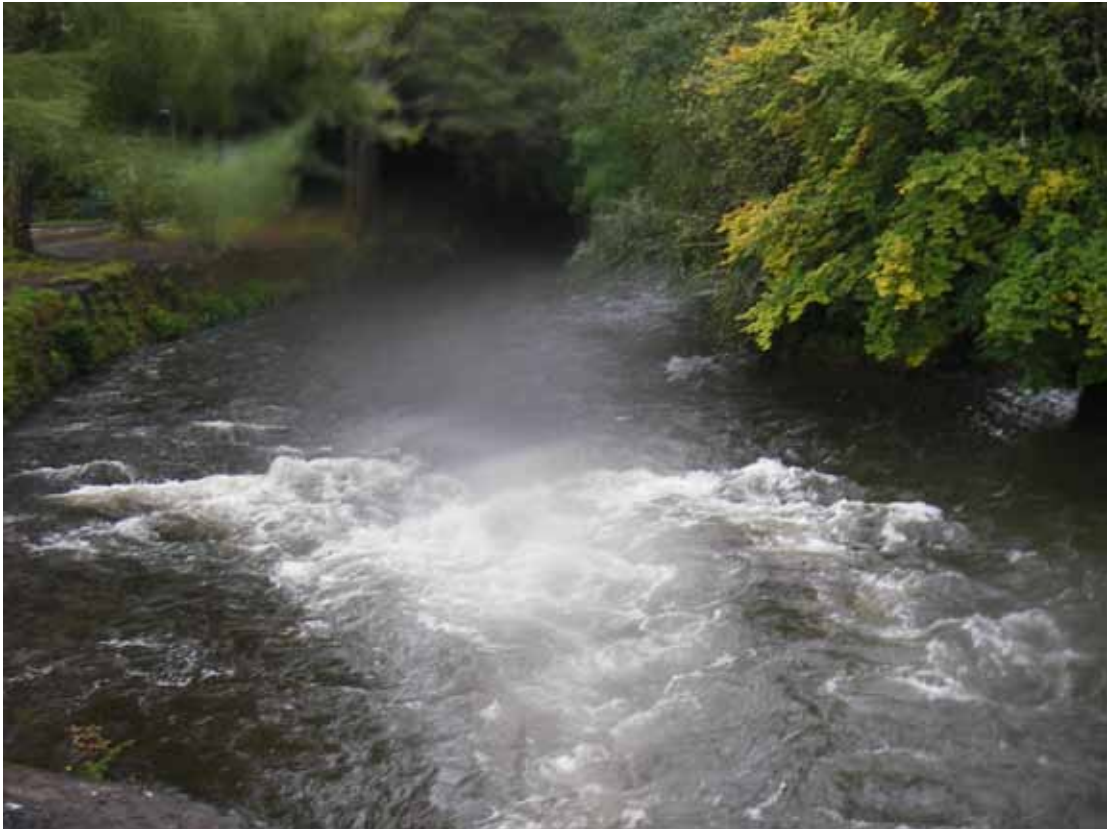
Figure 9. River Coe at road bridge

No.	Date	Time	NGR	Easting	Northing	Photograph	Sample	Observation
25	06/09/11	12:31:44	NN 10388 58935	210388	758935	Figure 9	LLW09	East side of Coe River - 1st reading; Width from GPS; depth 70 cm; flow 1.362 m/s
26	06/09/11	12:31:53	NN 10389 58936	210389	758936			East side of Coe River - 2nd reading; Outlet pipe on side of bank - trickle flowing
27	06/09/11	12:46:57	NN 09771 58810	209771	758810	Figure 10		Glencoe Waste Water Pumping Station
28	06/09/11	12:50:28	NN 09681 58799	209681	758799	Figure 11	LLW10	Two long outfall pipes; one looks newer than the other; seawater sample partway out along pipes
29	07/09/11	08:46:55	NN 07910 59827	207910	759827			Start of survey section; above fish farm
30	07/09/11	08:56:33	NN 07770 59764	207770	759764		LLW11	Burn; width 3 m; depth 4 cm; flow 1.234 m/s; water sample
31	07/09/11	09:08:12	NN 07753 59675	207753	759675		LLW12	Small stream; width 1m; depth 7 cm; flow 0.056 m/s; some flow bypassing measured width; two photos of fish farm

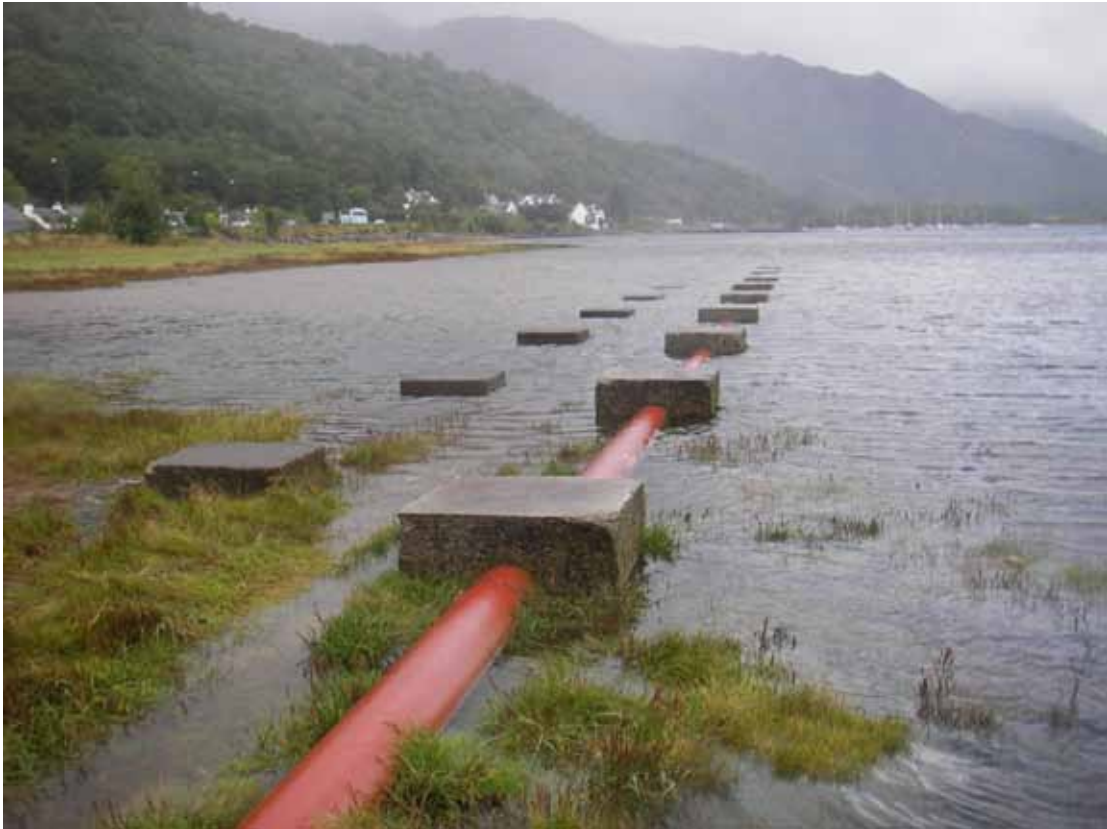
Figure 11. Pipes running out from Glencoe WWPS

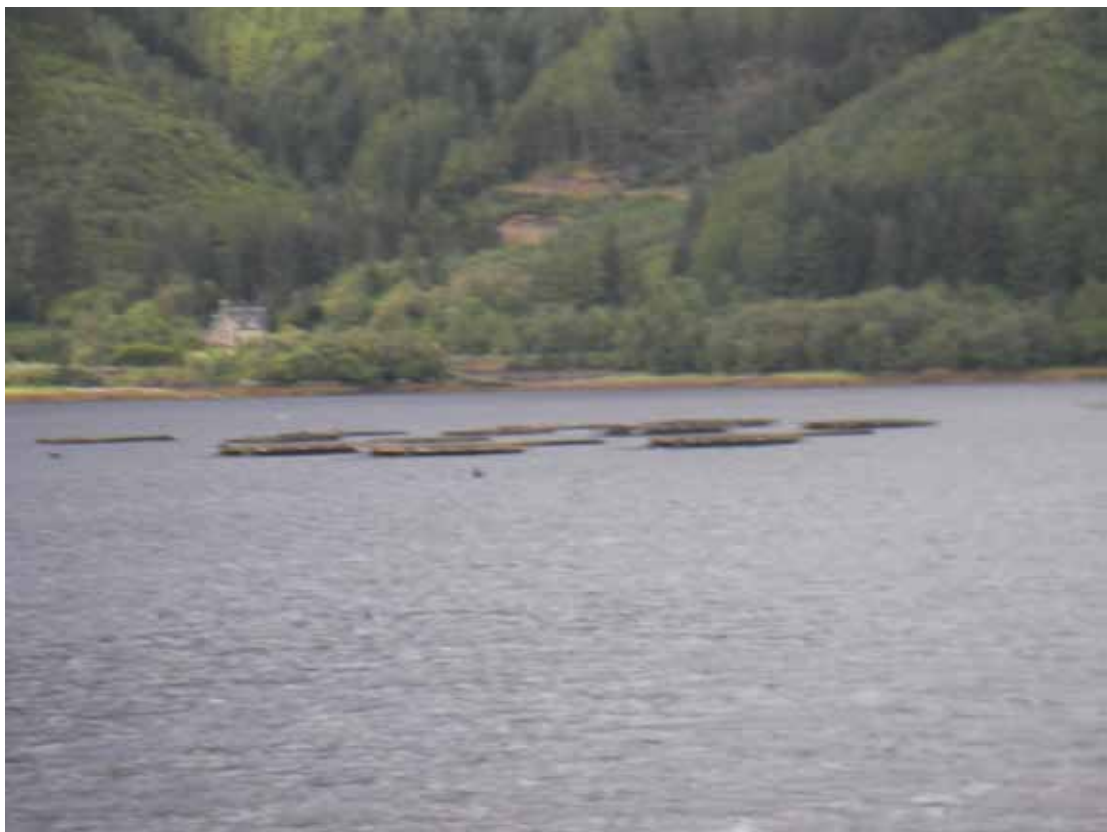
Figure 12. Mussel rafts

32	07/09/11	09:24:12	NN 07520 59508	207520	759508		LLW13	Very small stream; width 40 cm; depth 3 cm; flow 0.200 m/s
33	07/09/11	09:33:16	NN 07442 59435	207442	759435	Figure 12		Top of hill overlooking mussel farm
34	07/09/11	09:36:24	NN 07377 59426	207377	759426		LLW14	Seawater sample; land run-off nearby; lots of broken mussel shell on rocks
35	07/09/11	09:45:32	NN 07332 59517	207332	759517		LLW15	Small stream; width 20 cm; depth 2 cm; flow 0.111 m/s; also land seepage nearby
36	07/09/11	09:53:52	NN 07244 59590	207244	759590			Very small stream - too small to measure or sample; lots of broken mussel shell on beach
37	07/09/11	10:05:45	NN 06964 59592	206964	759592			Very small stream - too small to measure or sample
38	07/09/11	10:07:13	NN 06953 59585	206953	759585			Very small stream - too small to measure or sample
39	07/09/11	10:26:58	NN 06403 59279	206403	759279		LLW16	Headland is grazed; no sheep at time but moderate amount of droppings; approx 40 Canada geese; seawater sample

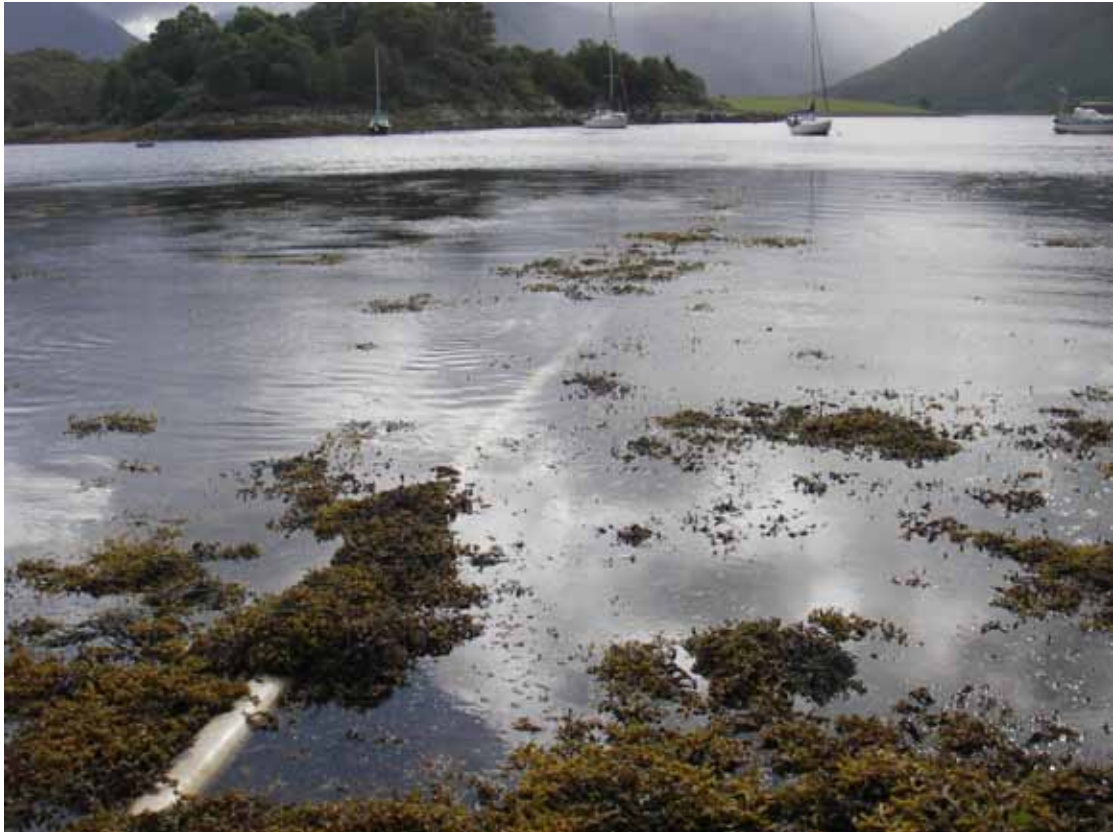
Figure 13. Pipe running out into bay from property
