Scottish Sanitary Survey Project

Sanitary Survey Report Loch Riddon AB 183 February 2010

Shoreline Survey Report

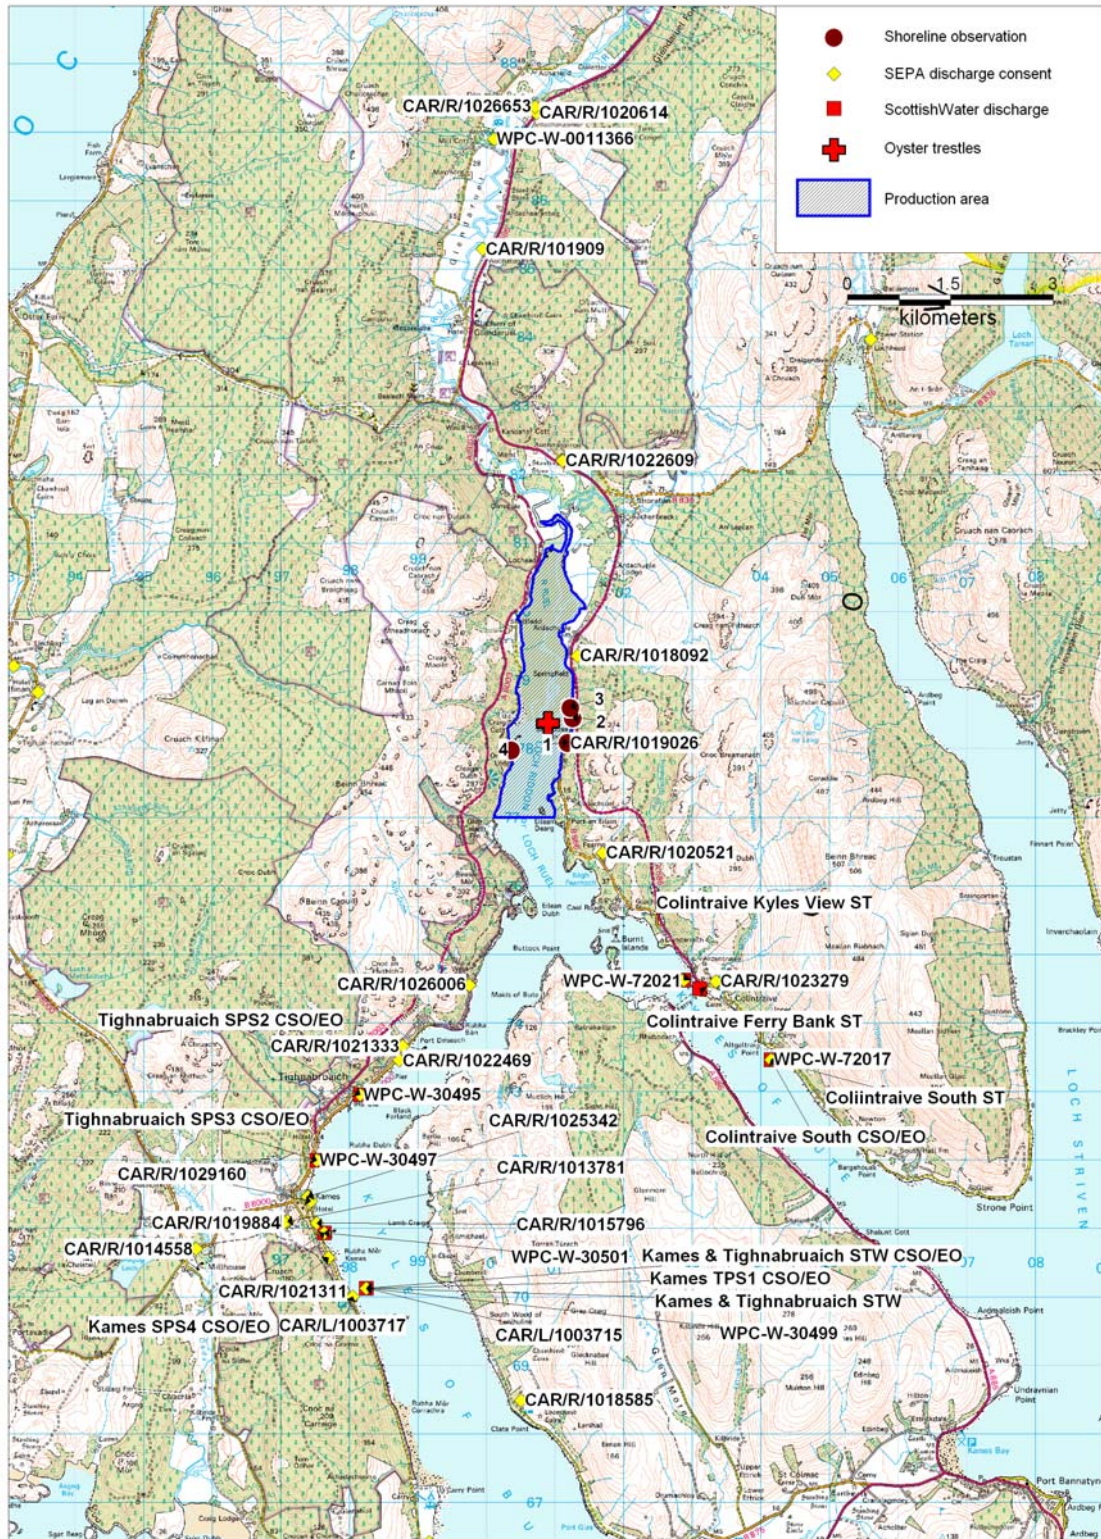
Figure 4.1 Sewage discharges at Loch Riddon

A total of four small private discharges direct to the production area were noted during the shoreline survey (observations 1-4 in Table 4.3). Of these, three were to the east shore, within 0.4 km of the trestles, and one was to the west shore 0.6 km from the trestles. Consent number CAR/R/1019026 applies to observation 1. Assuming a population equivalent of 5 for each discharge, the total population equivalent discharging direct to the production area is 20.

In summary, though sewage inputs direct to Loch Riddon appear to be relatively minor, and are likely to be greater during the summer, evidence of human faecal contamination to the oysters was present throughout the year. It is possible that

contamination from Colintraive and Tighnabruaich and Kames may impact on the fishery, but they are a considerable distance away. The most significant sources of human sewage relative to the oyster fishery are those on the east shore, those to the River Ruel and its tributaries, and yachts anchored in the vicinity of the oyster farm. The detection of norovirus in oyster samples from Loch Riddon indicates that human faecal contamination is present throughout the year.
