Scottish Sanitary Survey Programme

Sanitary Survey Report

Production Area: Loch Roag: Miavaig

March 2012

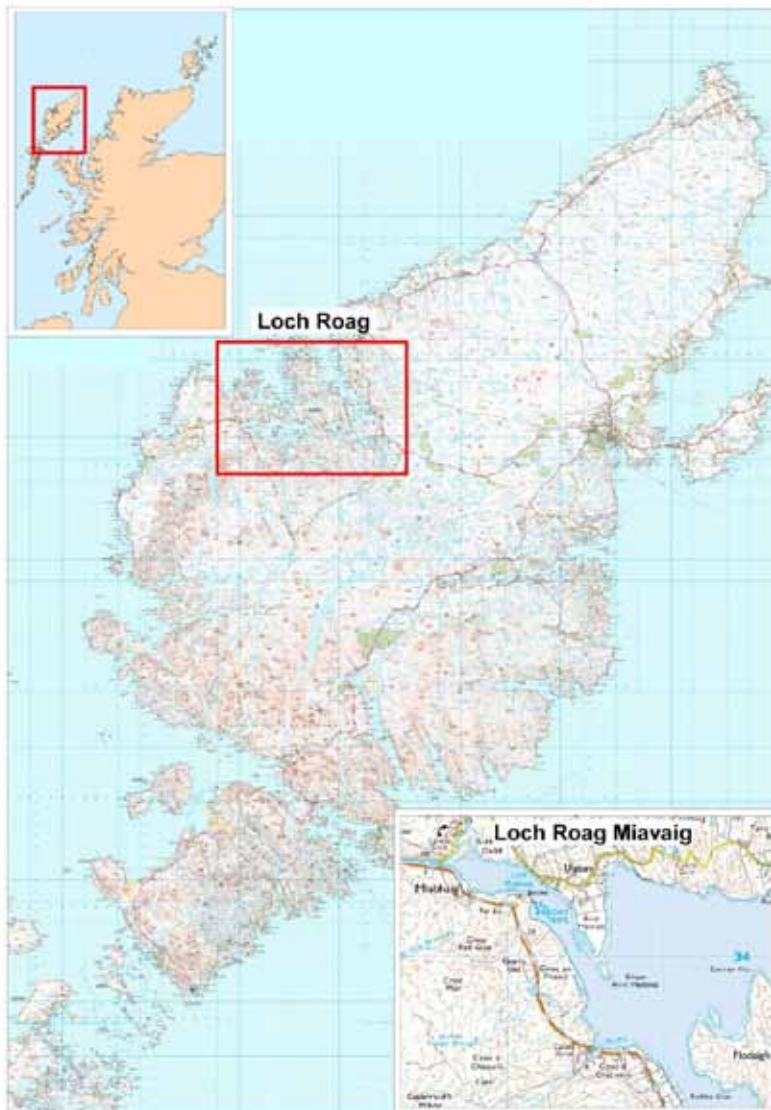
Figure 1.1 Location of Loch Roag Miavaig

Loch Roag is a remote complex of lochs and small islands on the western coast of the Isle of Lewis. Its shores are sparsely populated and the loch supports a significant number of shellfish and salmon farms. It is 7 km long and has a maximum depth of 40 m, though at the production area examined for this report it is 0 - 18 metres in depth. Miavaig is located in the western end of the loch.

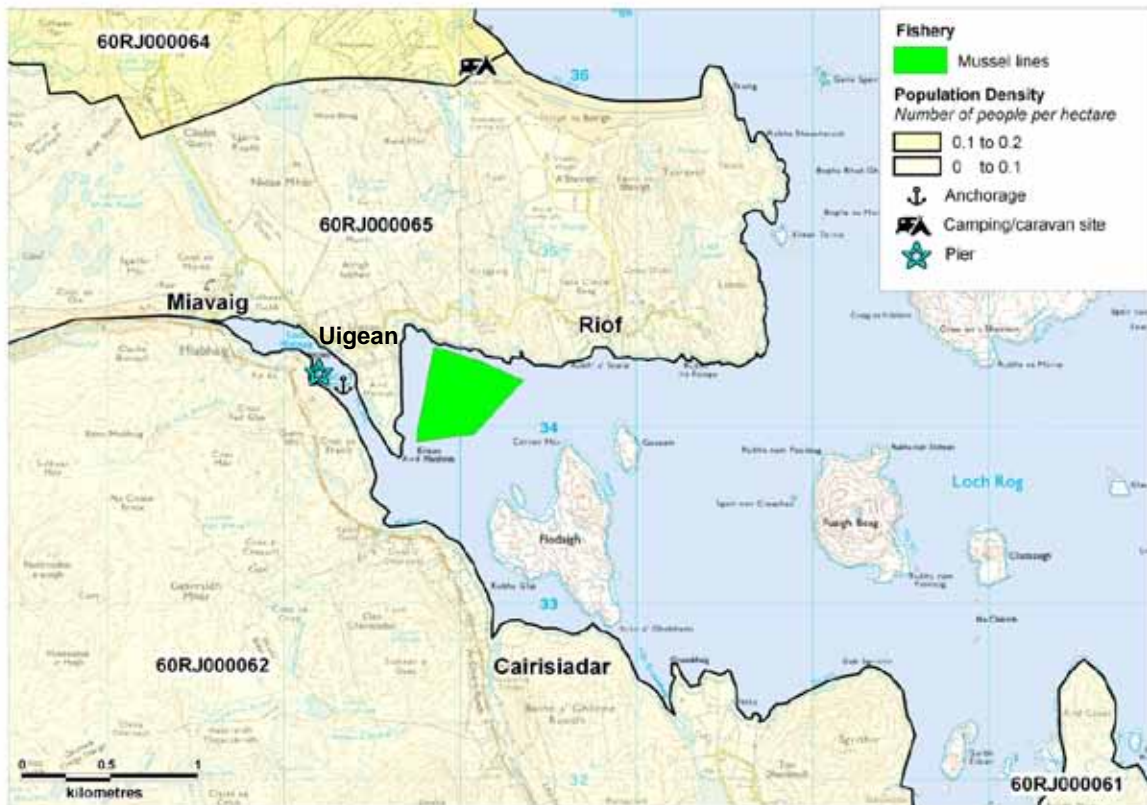
Figure 3.1 Population map of Loch Roag: Miavaig

Information on the human population of the area around Loch Roag: Miavaig was obtained from the General Register Office for Scotland. Data was provided for the 2001 census by output area. The population density for the output areas nearest the fishery is shown thematically mapped in Figure 3.1.

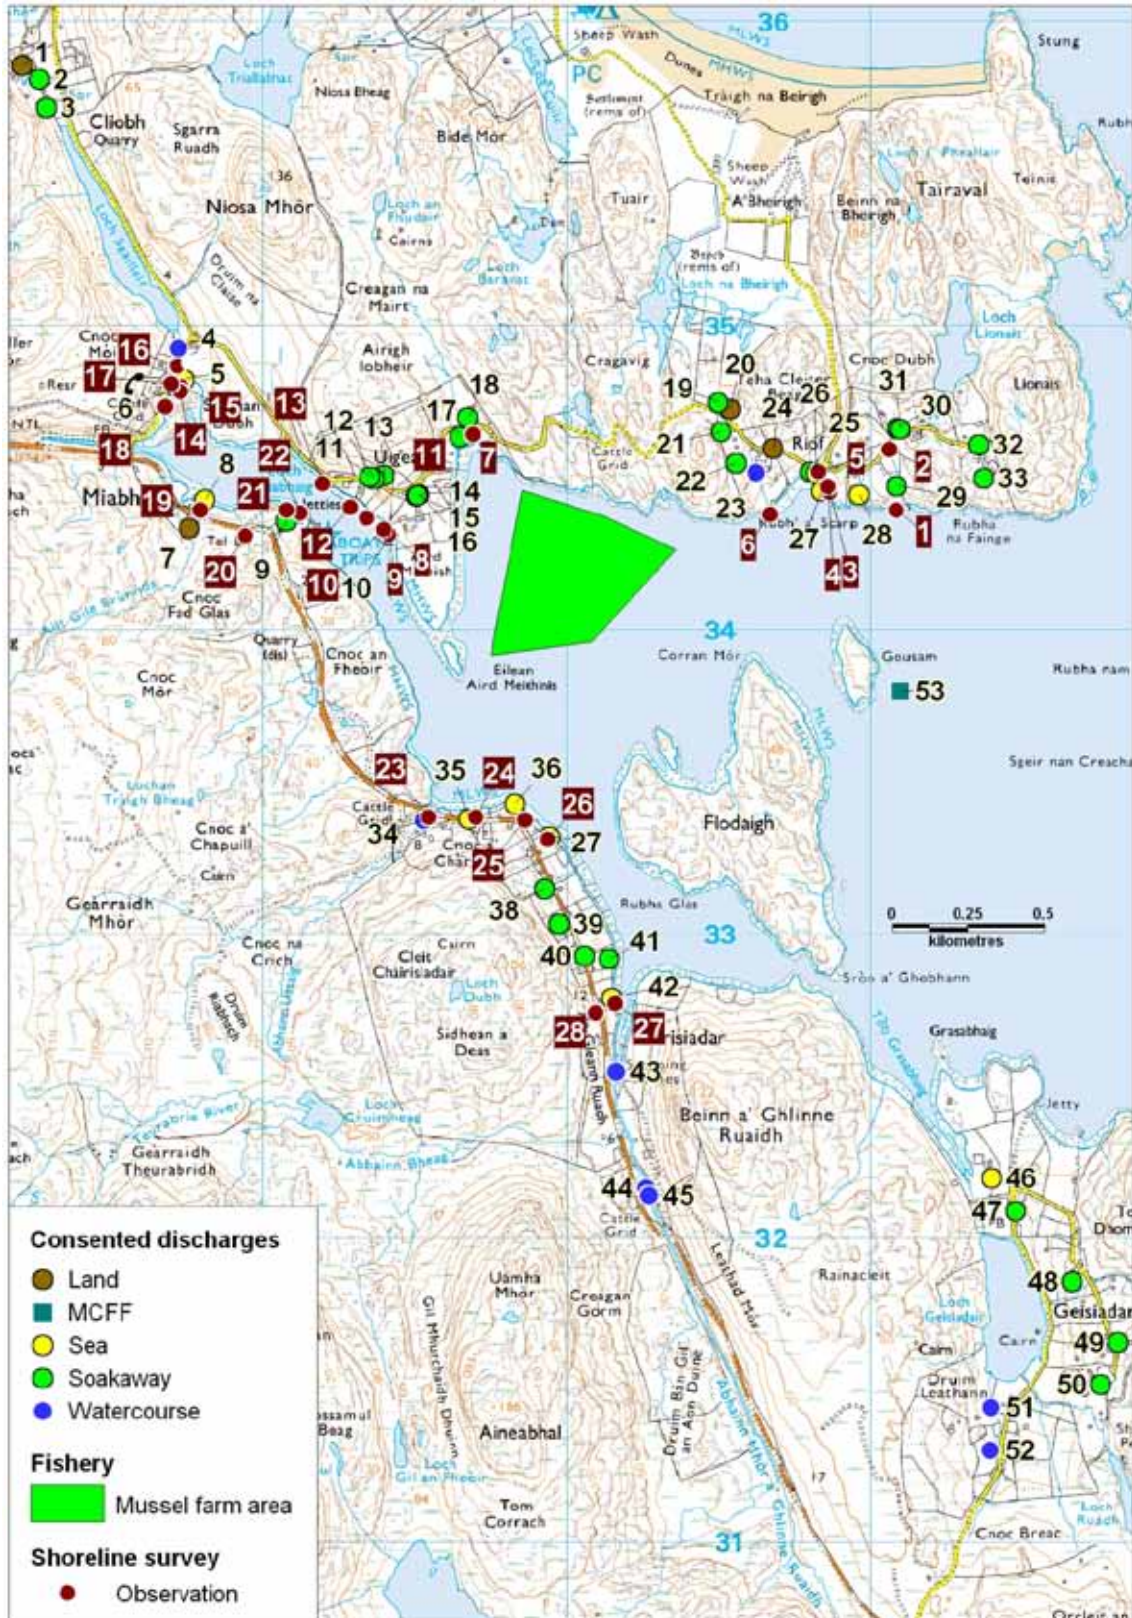
The observed septic tanks and outfalls in most cases appeared to correspond to consents provided by SEPA, as can be seen in Figure 4.1. In some cases, there appeared to be discharge pipes to shore adjacent to where septic tanks were identified as being on soakaway systems. The largest concentration of observed septic tanks was found around Loch Miabhaig, followed by Riof, and along the road north of Cairisiadar. Most of the tanks appear to be on soakaway systems. If appropriately sited and maintained in good working order, these should not materially impact water quality at the fishery. However, due to their proximity to the shore any overland flow resulting from failure of the soakaway field would be likely to impact the waters immediately adjacent. The septic tank from the church at the head of Loch Miabhaig (Table 4.1, No. 6 and Table 4.2, No. 15) is likely to discharge a significantly higher volume when the church is in use and will constitute a significant source to the head of the loch. None of the provided consents appeared to relate to the facilities at Miavaig Pier, and no discharge was observed from these buildings. However, toilets at the Marine Harvest base and tour boat base are likely to discharge somewhere in the area. A seawater sample taken at the slip way contained 63 *E. coli* cfu/100 ml, which is indicative of moderate faecal contamination. The source(s) of this contamination were not clear but may have included any discharge from the shore base, boats or other sources in the vicinity.

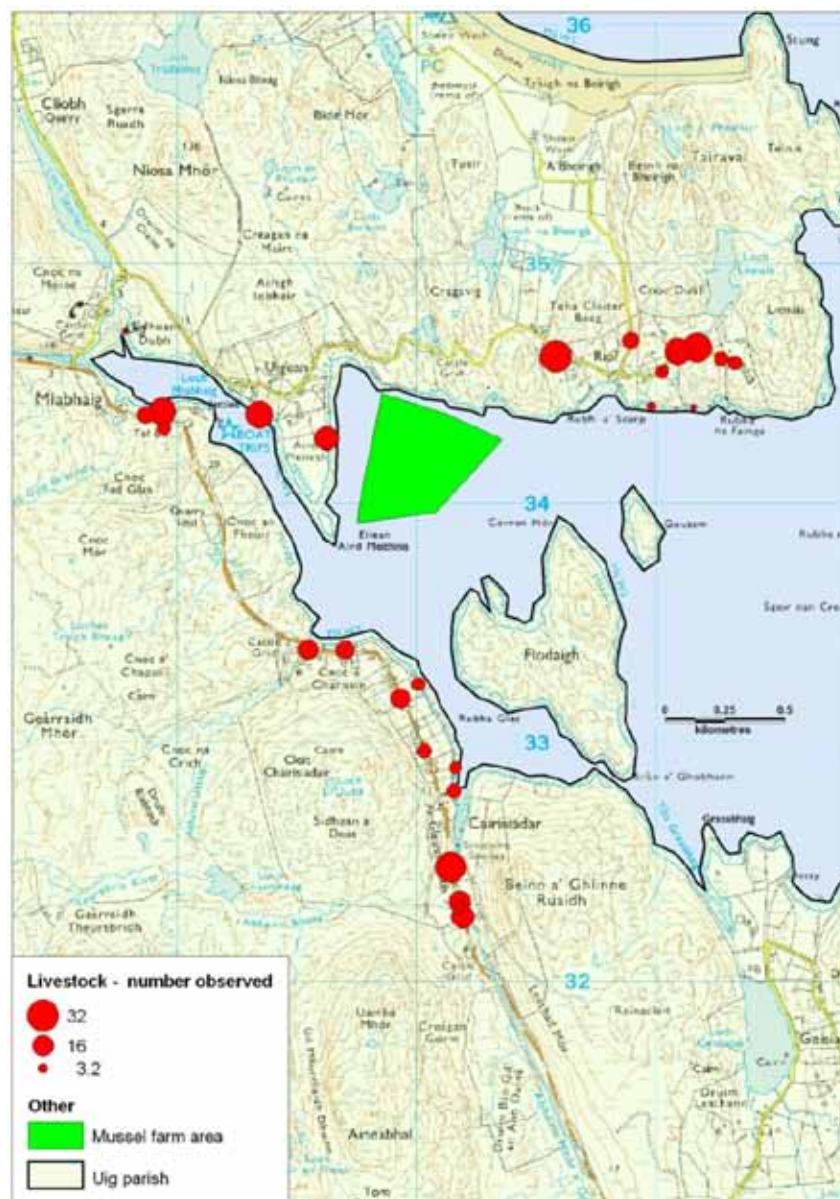
Figure 7.1 Livestock observations at Loch Rog: Miavaig

mussel farm and evidence of recent livestock presence (hoof prints and dung or droppings) was observed to the north of the mussel lines. This area was closest of the observations to the mussel farm. Further livestock were recorded around Miavaig and along the B8011 between Miavaig and Cairisiadar.

During periods of heavy rain, runoff from land at these locations is likely to wash faecal material from the hillsides into the loch and any impact on the fishery is most likely to affect the lines nearest the shore. Livestock numbers are likely to be highest in summer, when lambs are present, and drop again in autumn when they are sent to market. Animals will tend to be kept on or near to croft areas and so distributions may not vary markedly from those observed during the survey.

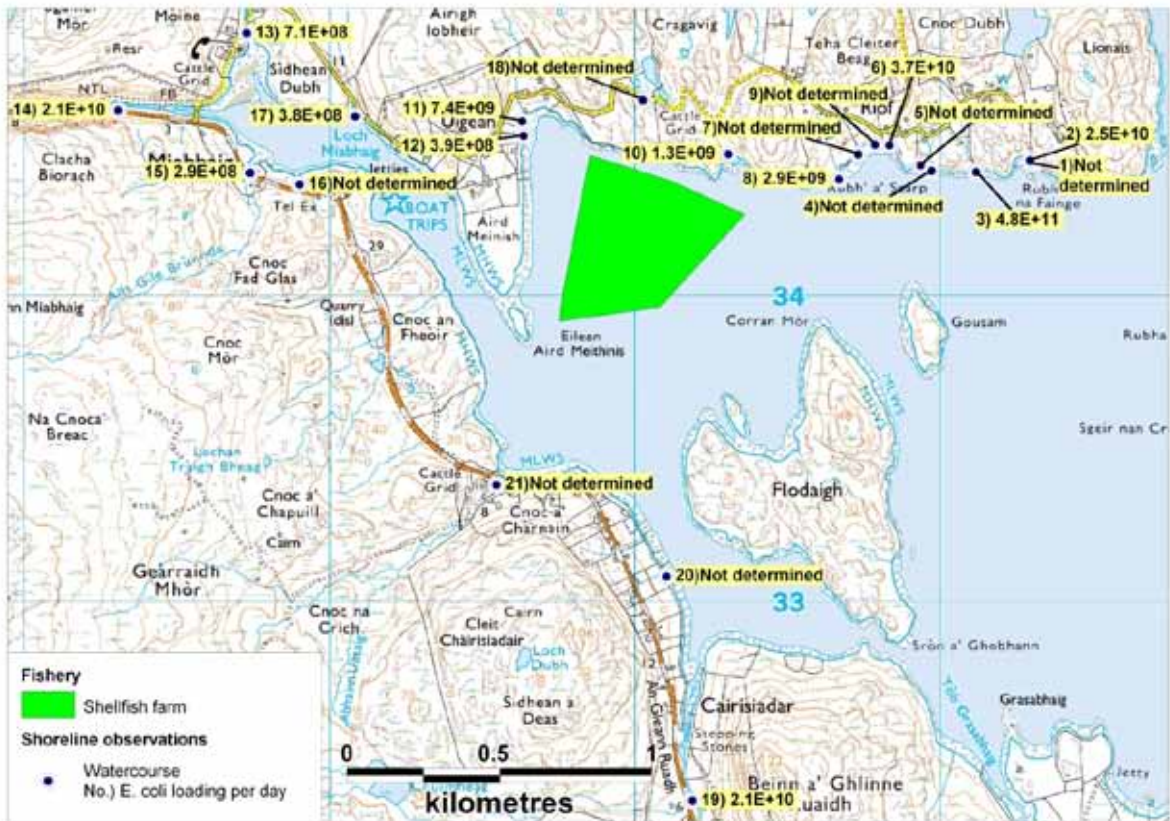
Figure 13.1 Map of river/stream loadings at Loch Roag: Miavaig

The watercourses listed in Table 13.1 and mapped in Figure 13.1 were measured and sampled during the shoreline survey. Heavy rain occurred prior to, and during, the first two days of the survey.

In general, the estimated loadings for the sampled and measured watercourses were moderate and, under similar rainfall conditions, would be expected to impact on the water quality in the area. The two streams located near Uigean have the potential to directly impact on the microbiological quality of the mussels at the north-western corner of the lines. The watercourses on the outer northern shore (including the Reef area) will potentially impact on the northern part of the lines while those located within Loch Miabhaig will

generally add to the contamination levels within the outer area during an ebb tide and may specifically impact on the south-western corner of the lines.

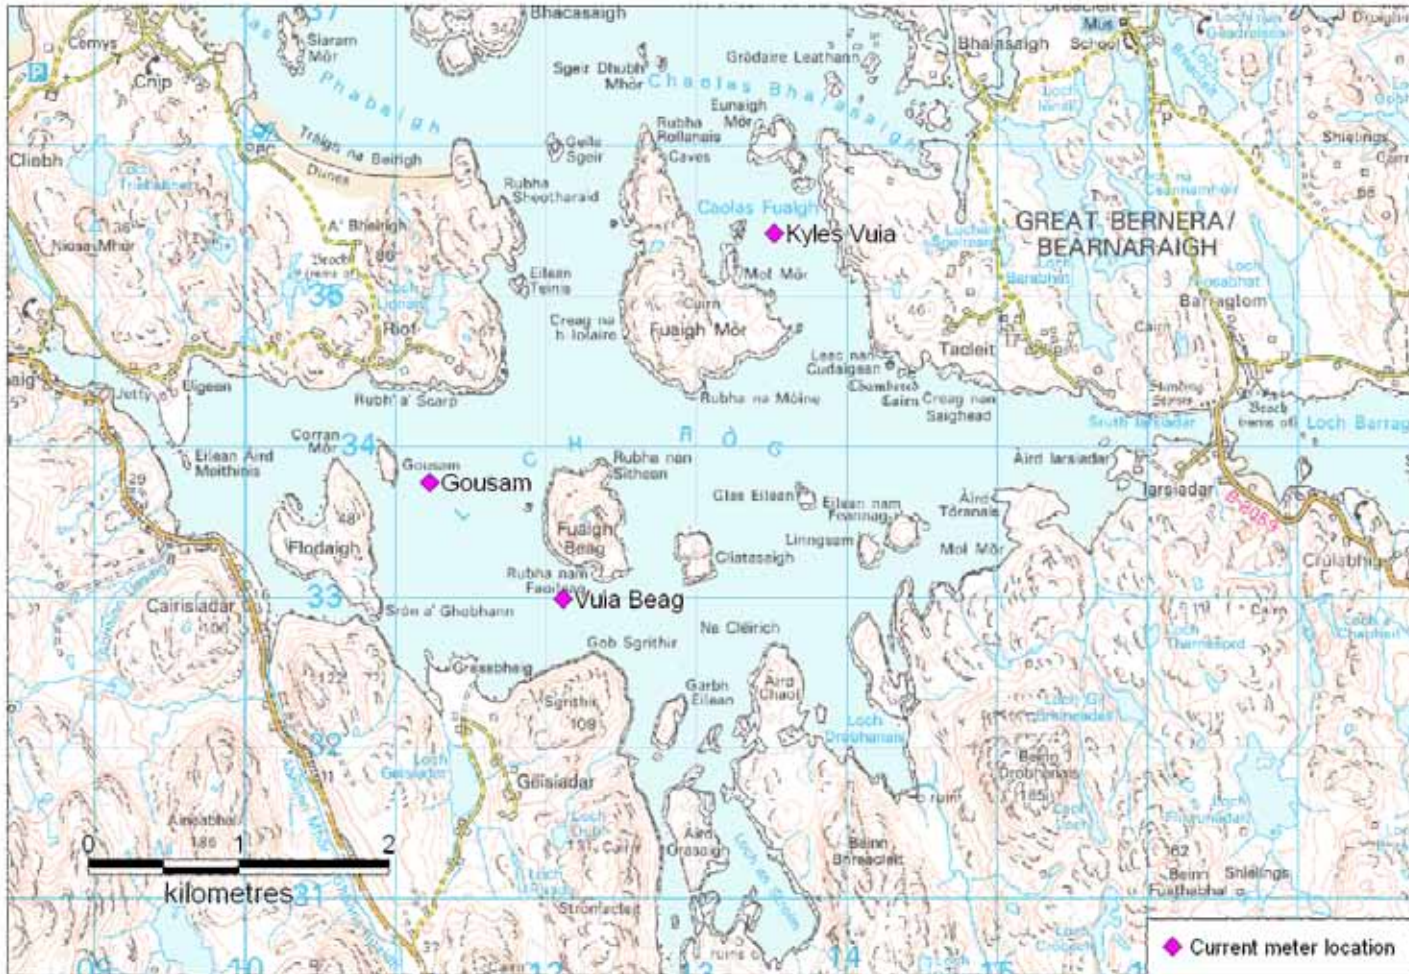
Figure 14.3 Current meter locations

SEPA provided current meter study data for three locations within Loch Roag. The locations are shown in Figure 14.3. The survey periods were as given in Table 14.1. Unfortunately, none of the locations were in close vicinity to the mussel farm. However, the data will inform the general assessment of current movements within Loch Roag.

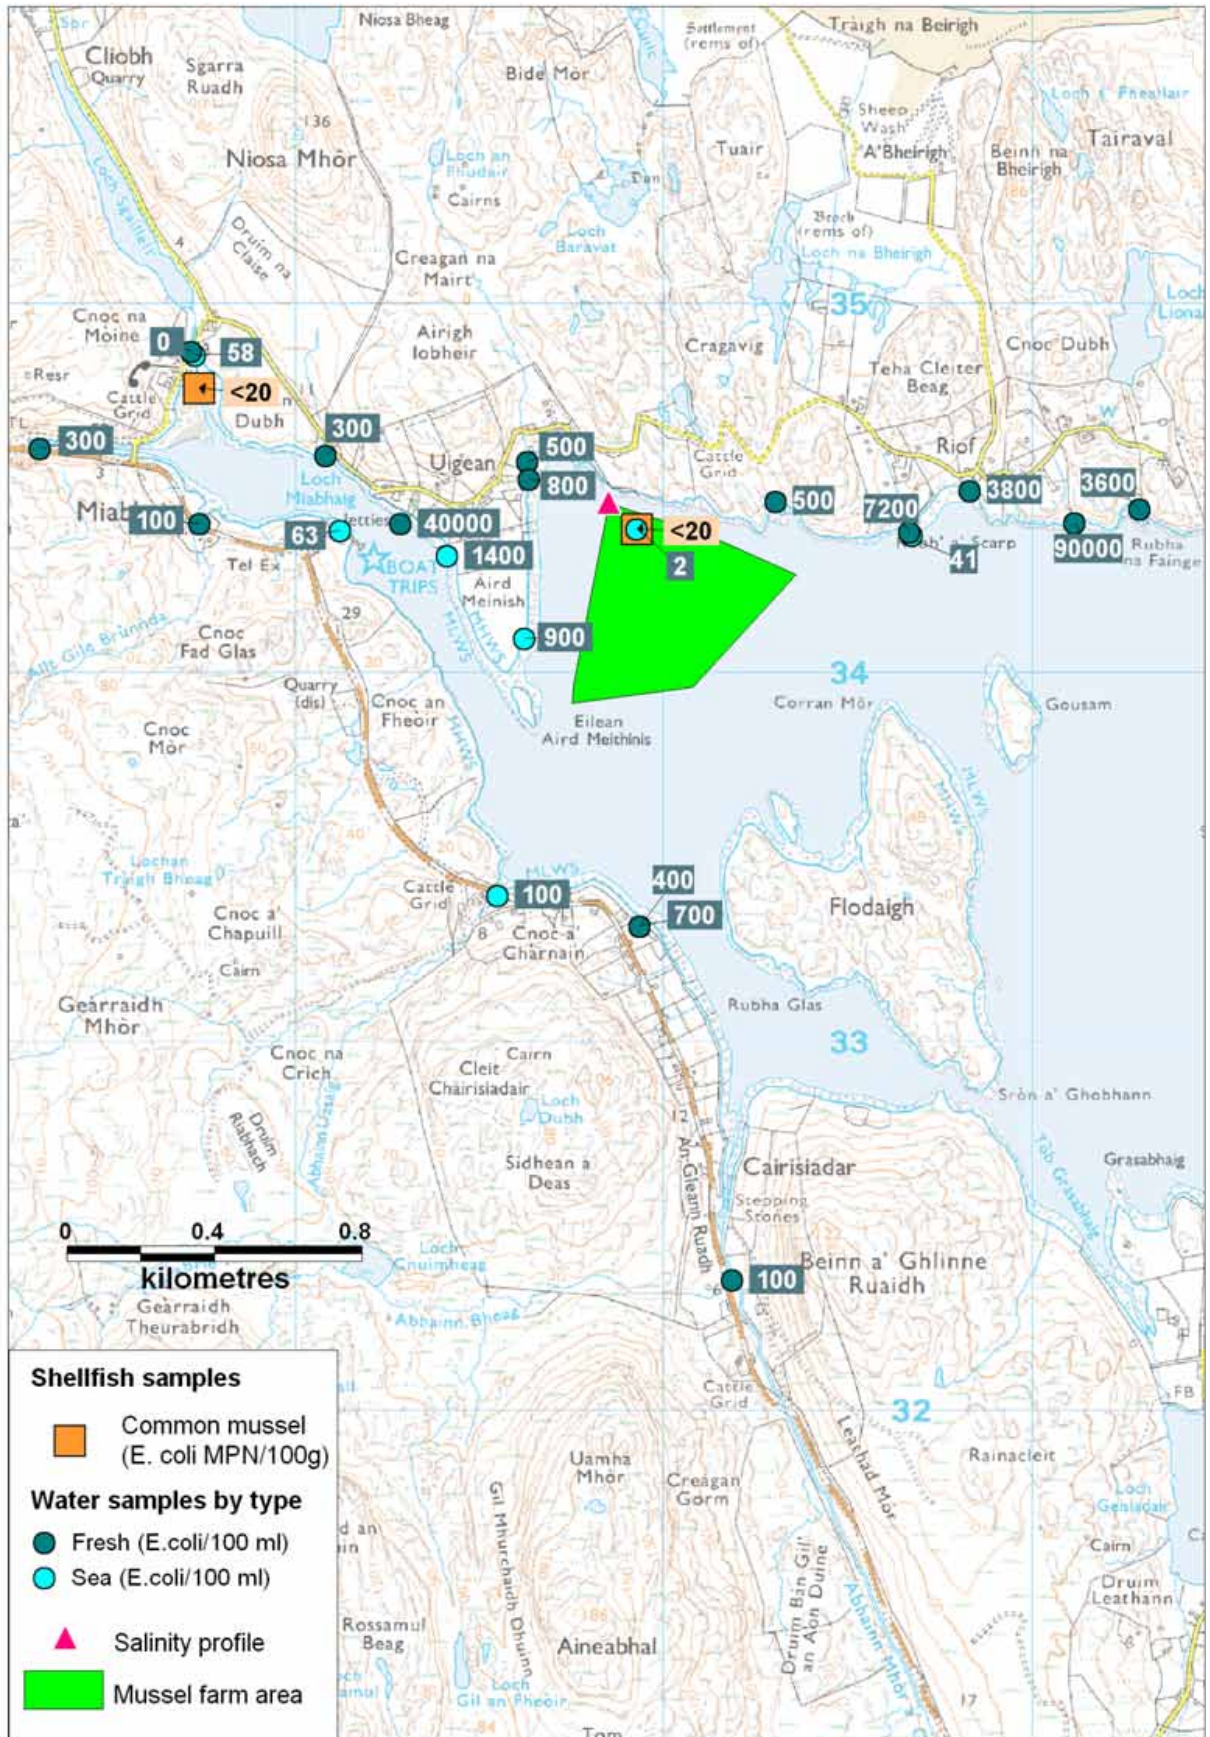
Figure 3. Sample results

Water and shellfish sampling locations are shown mapped in Figure 3.

Contamination levels in freshwater ranged from 100 to 90000, with all samples containing >1000 E. coli/100 ml coming from sources along the north shore. Seawater samples were generally less contaminated, though the most contaminated seawater samples were also taken from within Loch Miavaig or along the northern shore of the fishery.

Shellfish samples taken during the survey contained no to very low concentrations of *E. coli*.

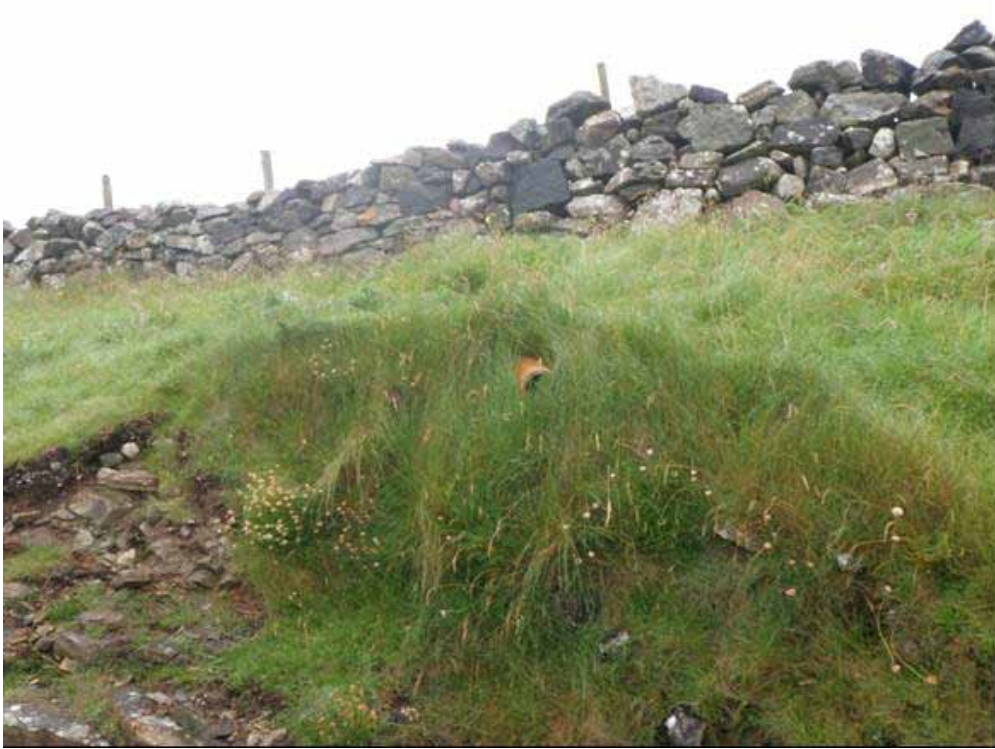
Figure 4. Dry end of discharge pipe

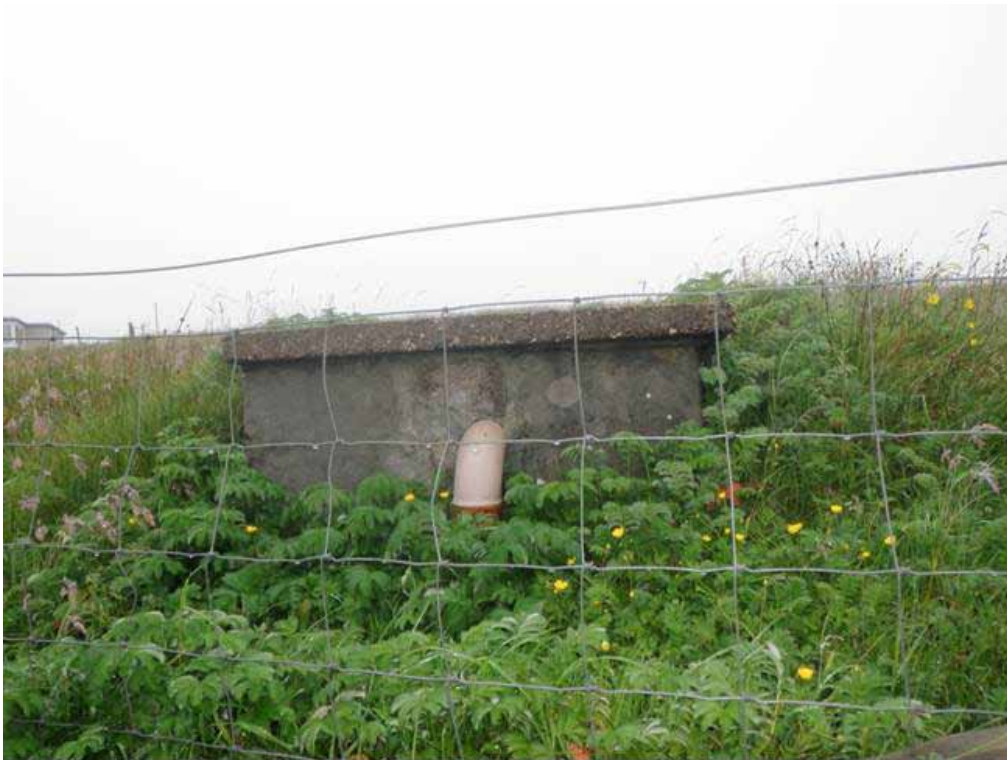
Figure 5. Septic tank above shoreline

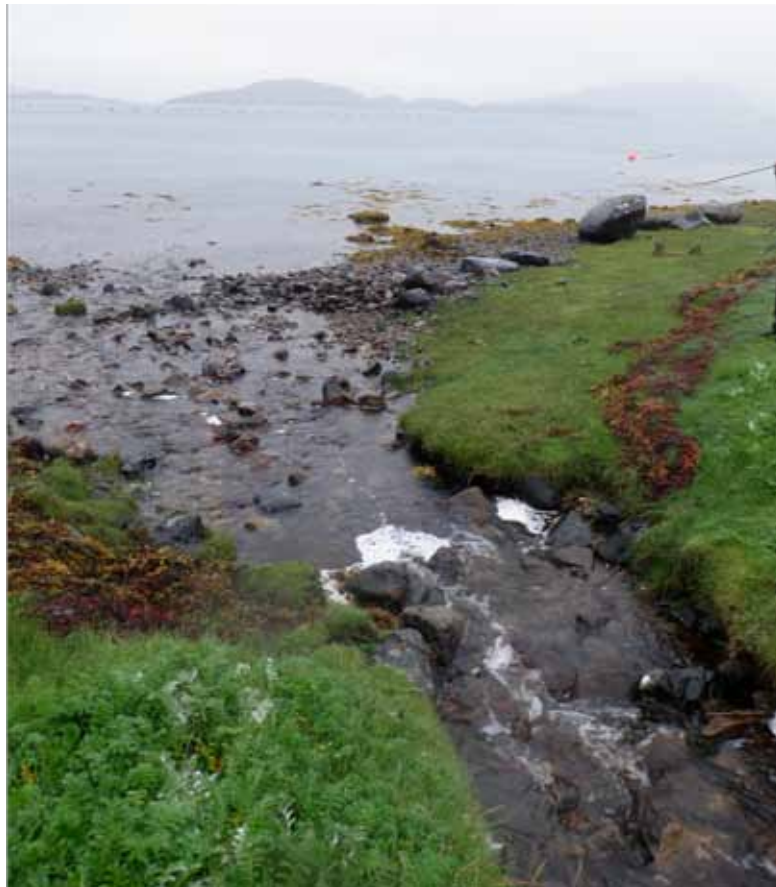
Figure 7. Stream on west side of Uigean

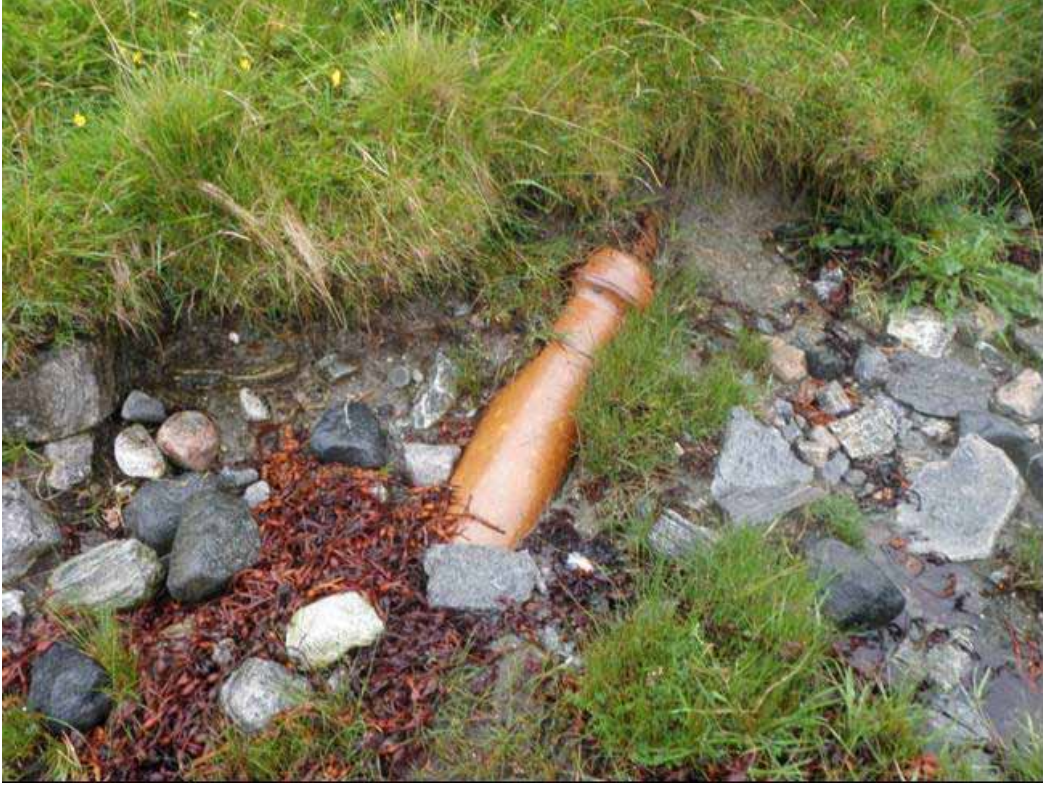
Figure 8. Ceramic septic pipe

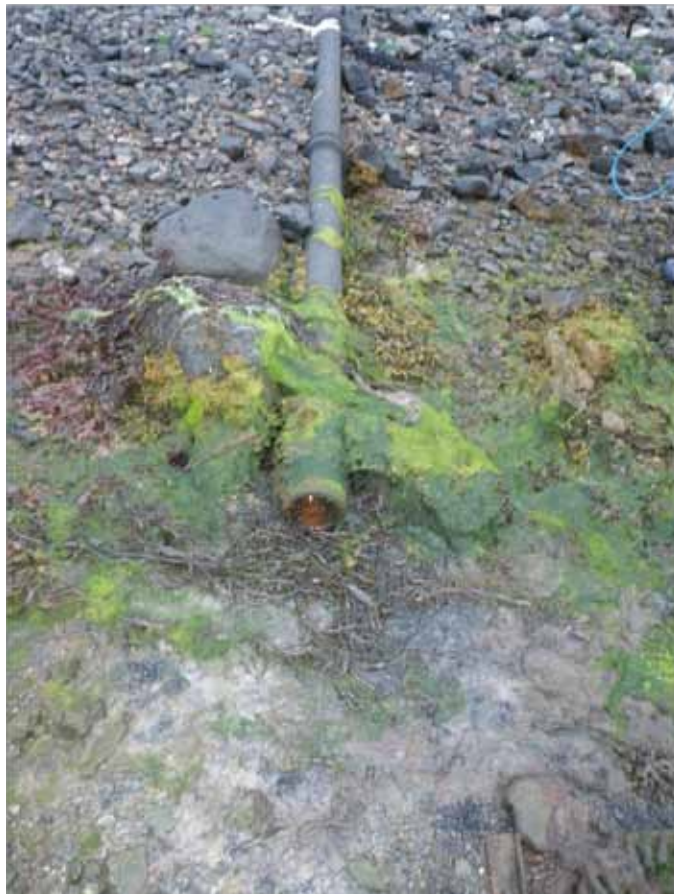
Figure 9. Septic discharge from church at Loch Miavaig

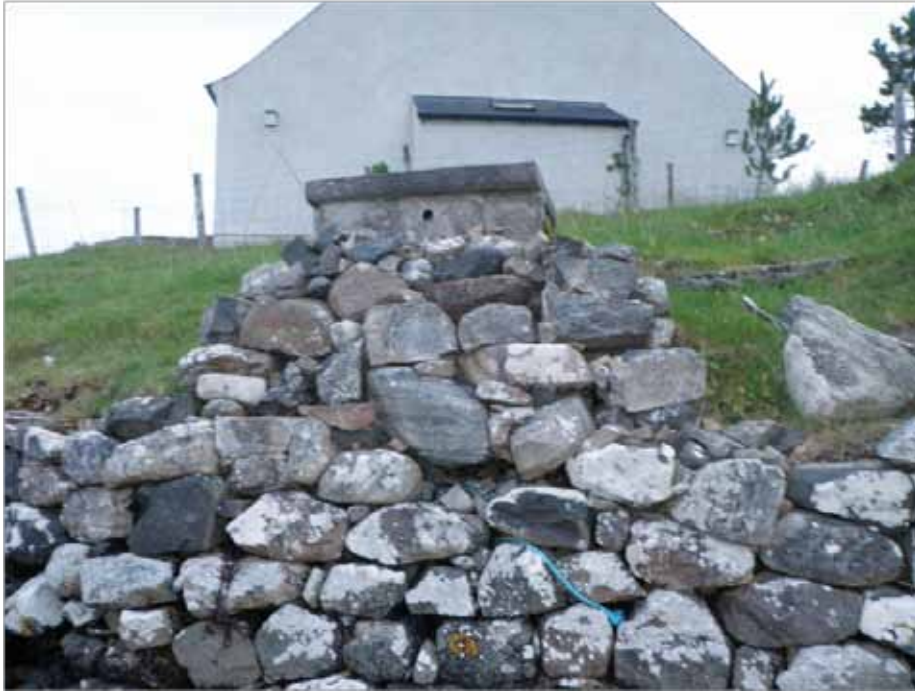
Figure 10. Septic tank with dry overflow above shoreline

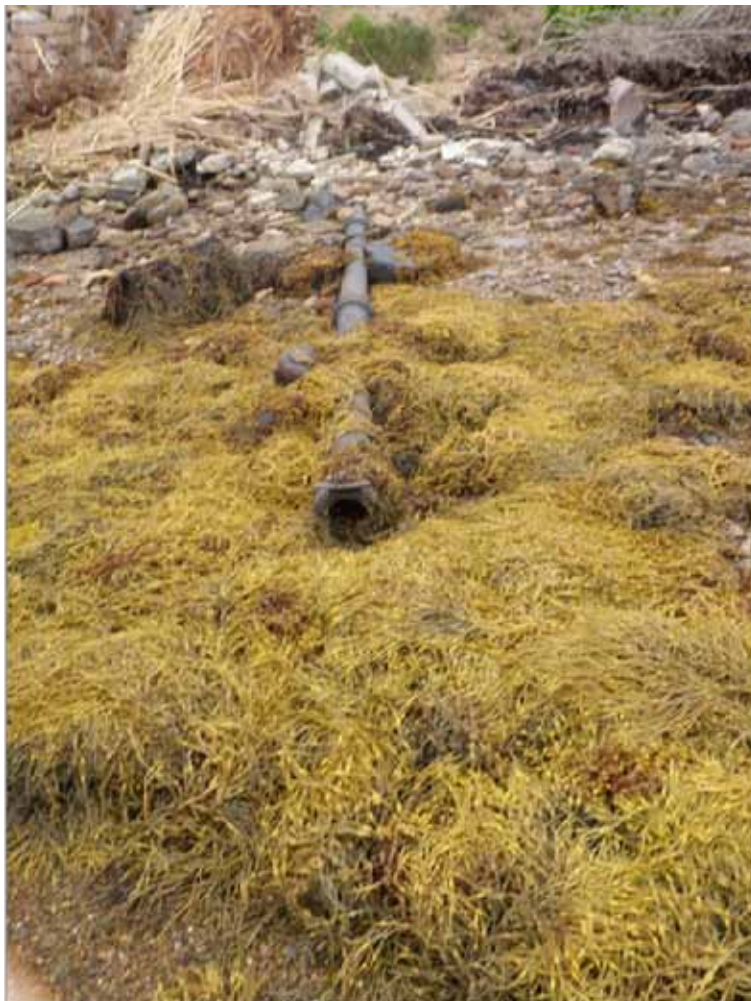
Figure 11. Iron discharge pipe below house

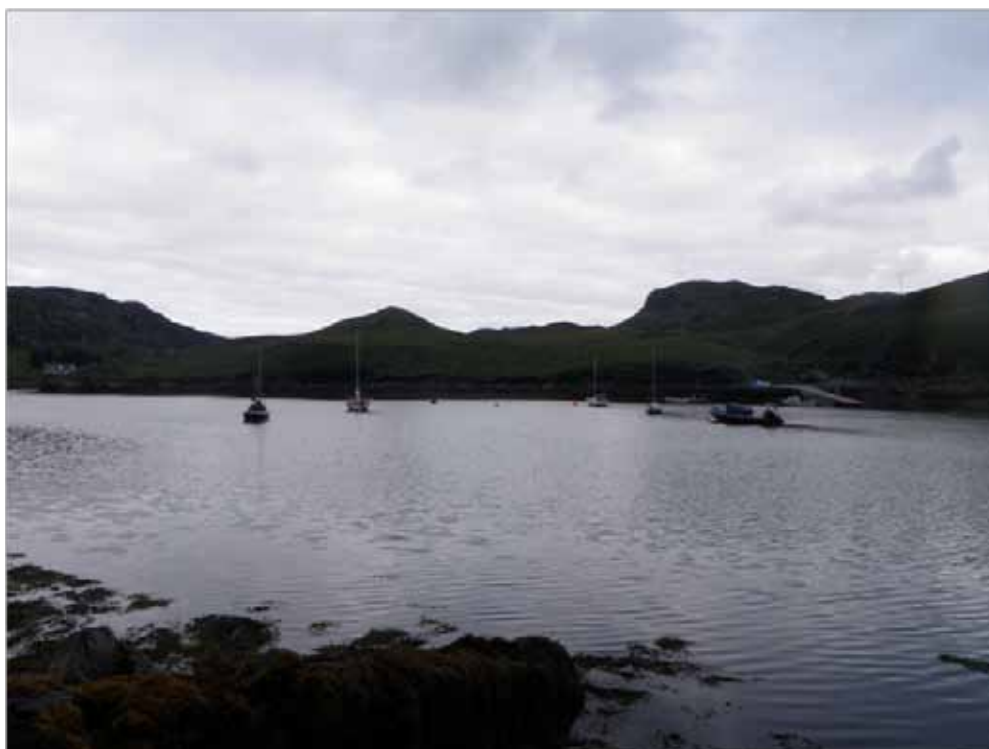
Figure 12. Boats on moorings

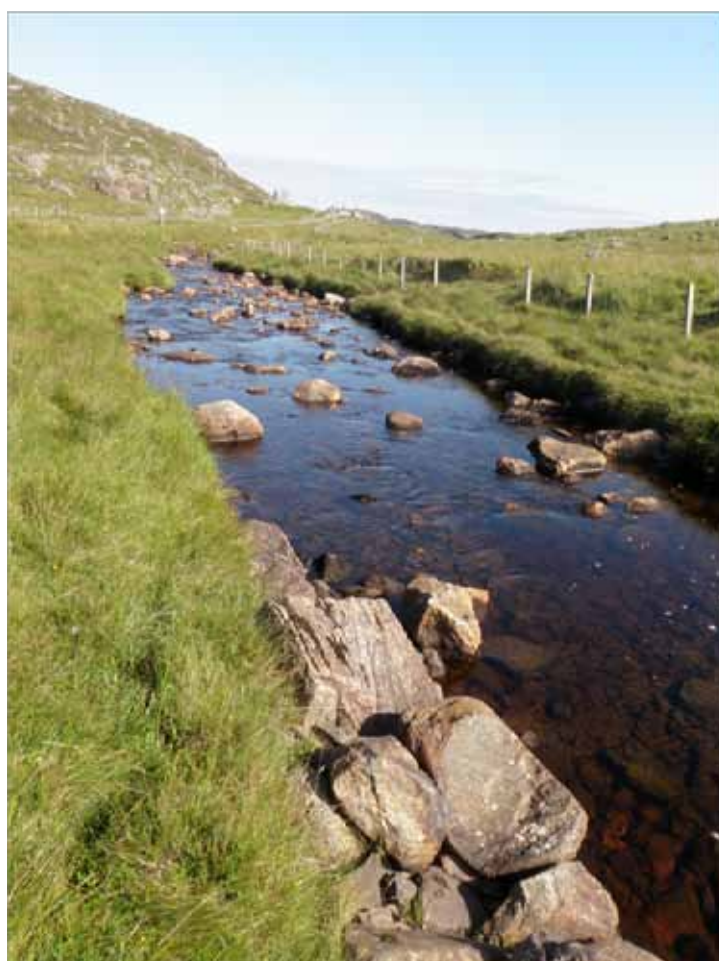
Figure 13. Abhainn Mhor a' Ghlinne Ruaidh

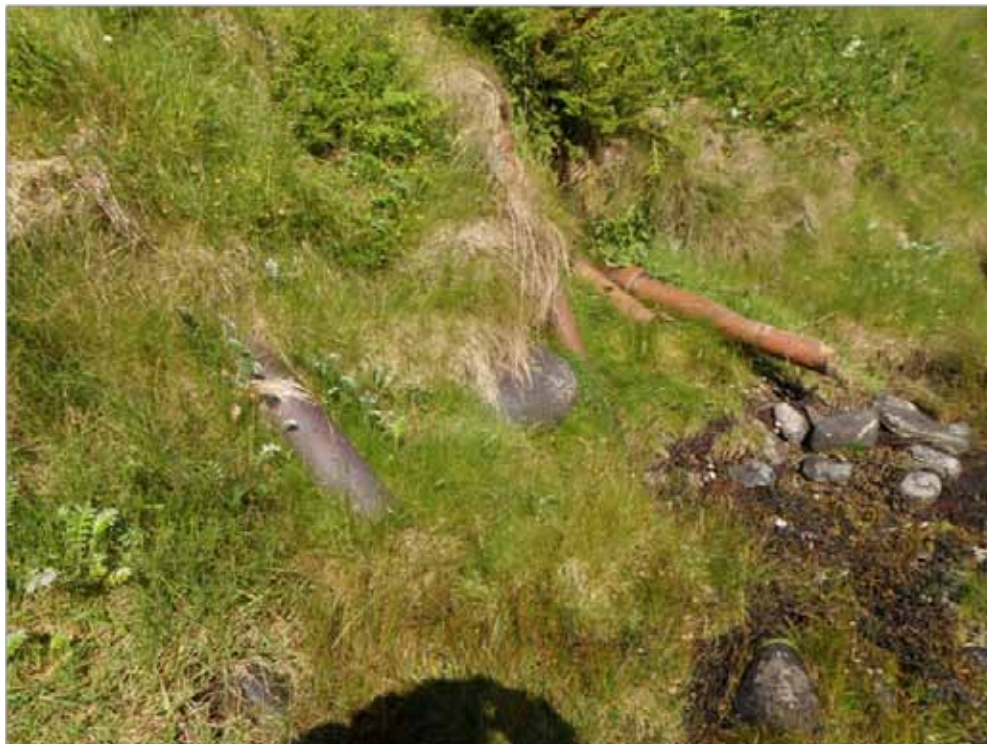
Figure 14. Four discharge pipes

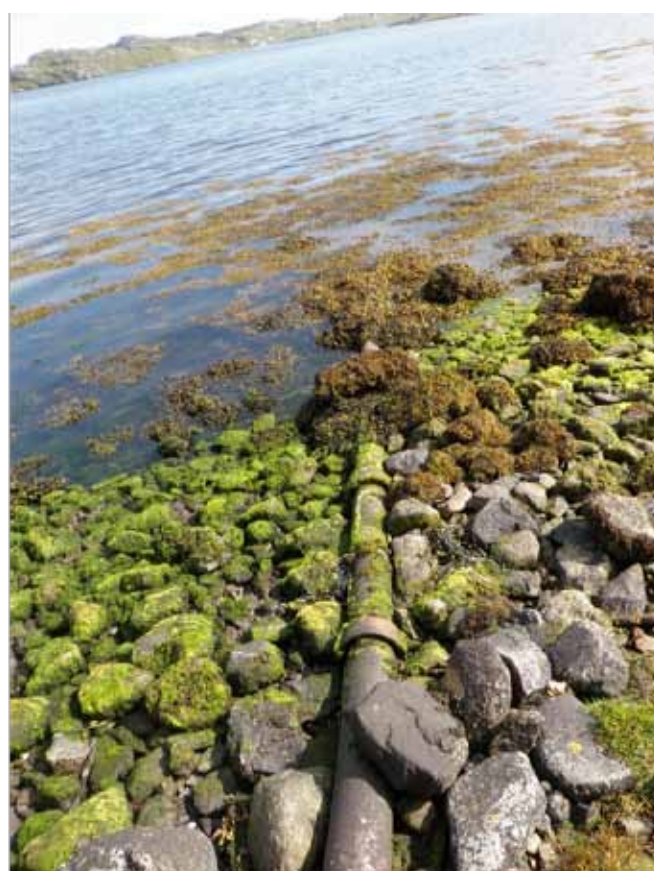
Figure 15. Cast iron discharge pipe

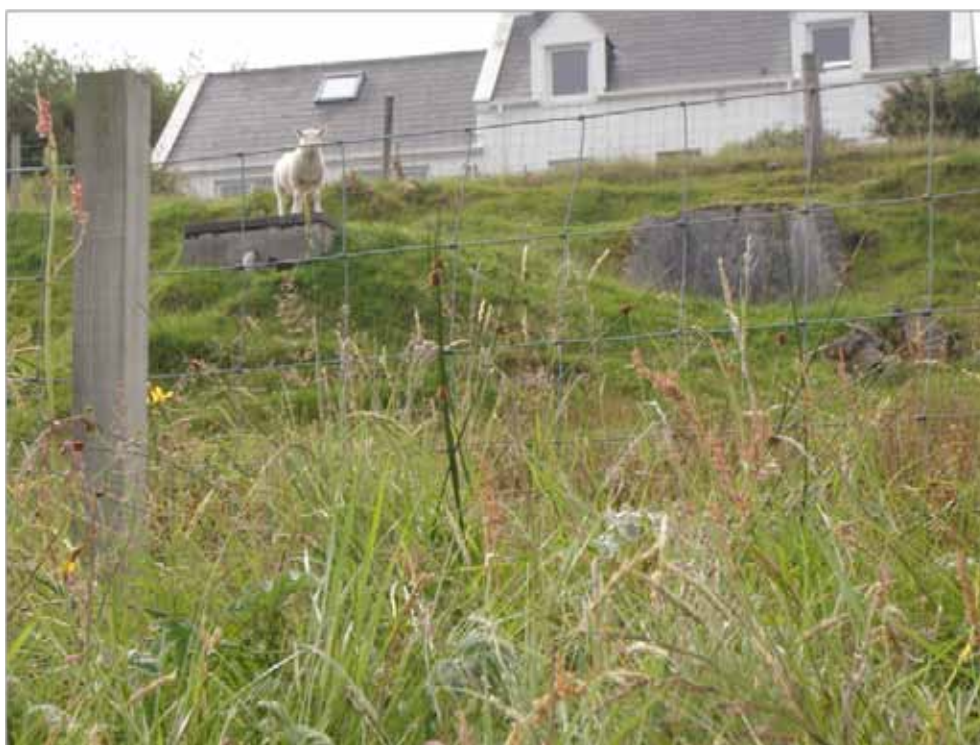
Figure 16. Septic tank and sheep above shore

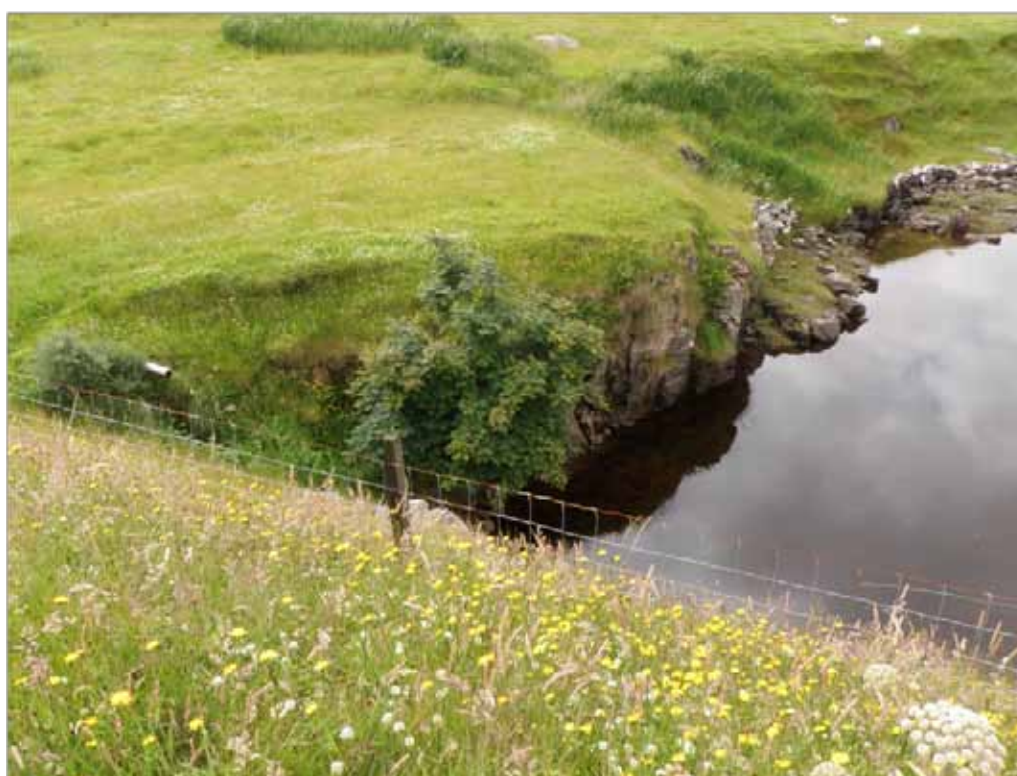
Figure 17. Discharge pipe to ponded end of Abhainn Uasaig
