Scottish Sanitary Survey Review

**Loch Scridain East and Loch Scridain:Killiemore
AB-314, AB-663, AB-664, AB-665 and AB-666
October 2014**

Report Title	Loch Scridain East and Loch Scridain Killiemore Sanitary Survey Review
Project Name	Scottish Sanitary Survey
Client/Customer	Food Standards Agency Scotland
Cefas Project Reference	C6316B
Document Number	C6316B_2014_14
Revision	V1.0
Date	15/12/2014

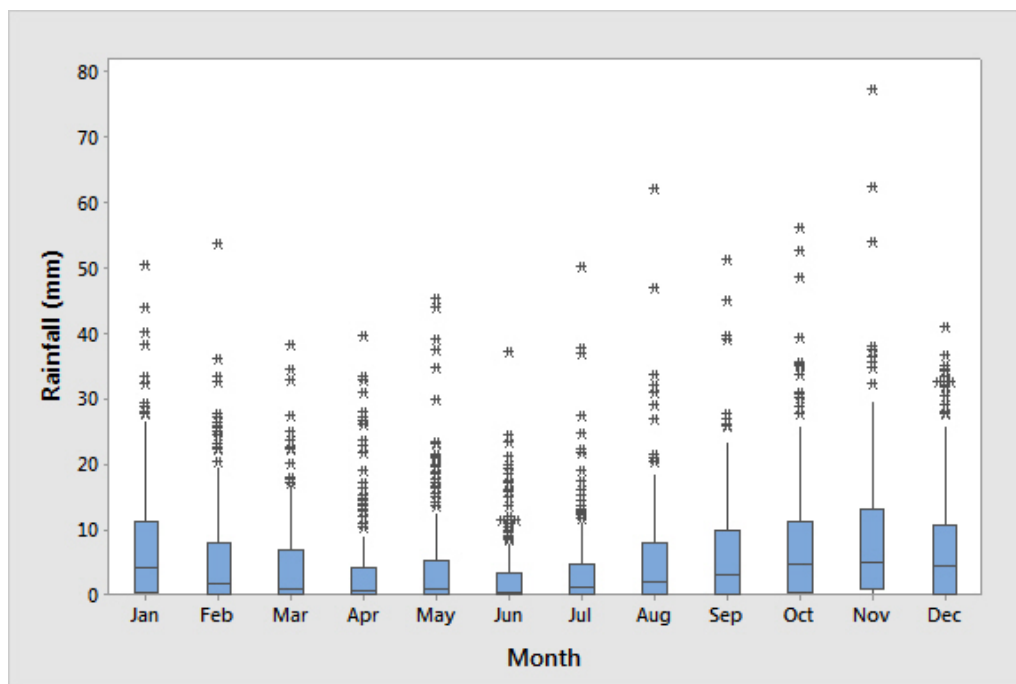
Figure 6.2 Boxplot of daily rainfall at Mull: Gruline by month (2007-2013)

The 2008 report concluded that the wettest months were between September and January, with rainfall events of >50 mm in January and August. In the 2007-2014 period, rainfall events >50 mm occurred in January and February and in months between August and November. Rainfall events >60 mm occurred in August and November, with the latter month also having a rainfall event of >70 mm. Driest months were noted as July in the 2008 report and June in the 2008-2013 dataset.

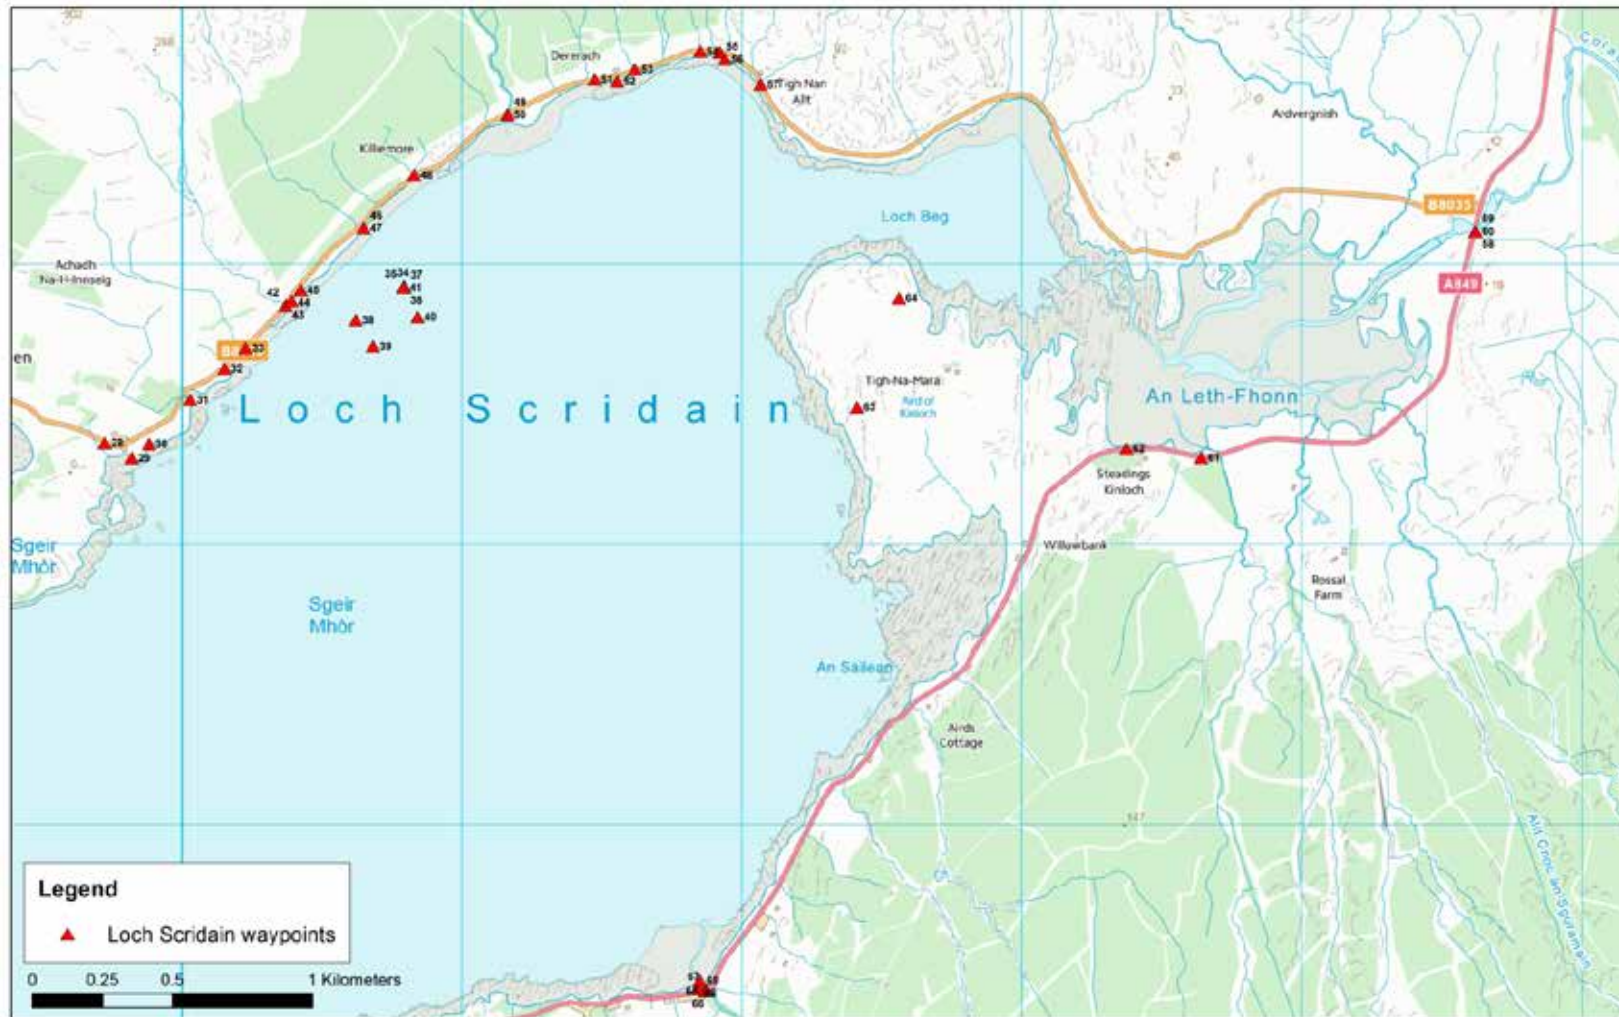
Figure 2. Loch Scridain Waypoints, eastern half of survey area

The specific observations made at each WP can be found in Table 1, with each of the WP locations displayed in Figures 1 and 2.

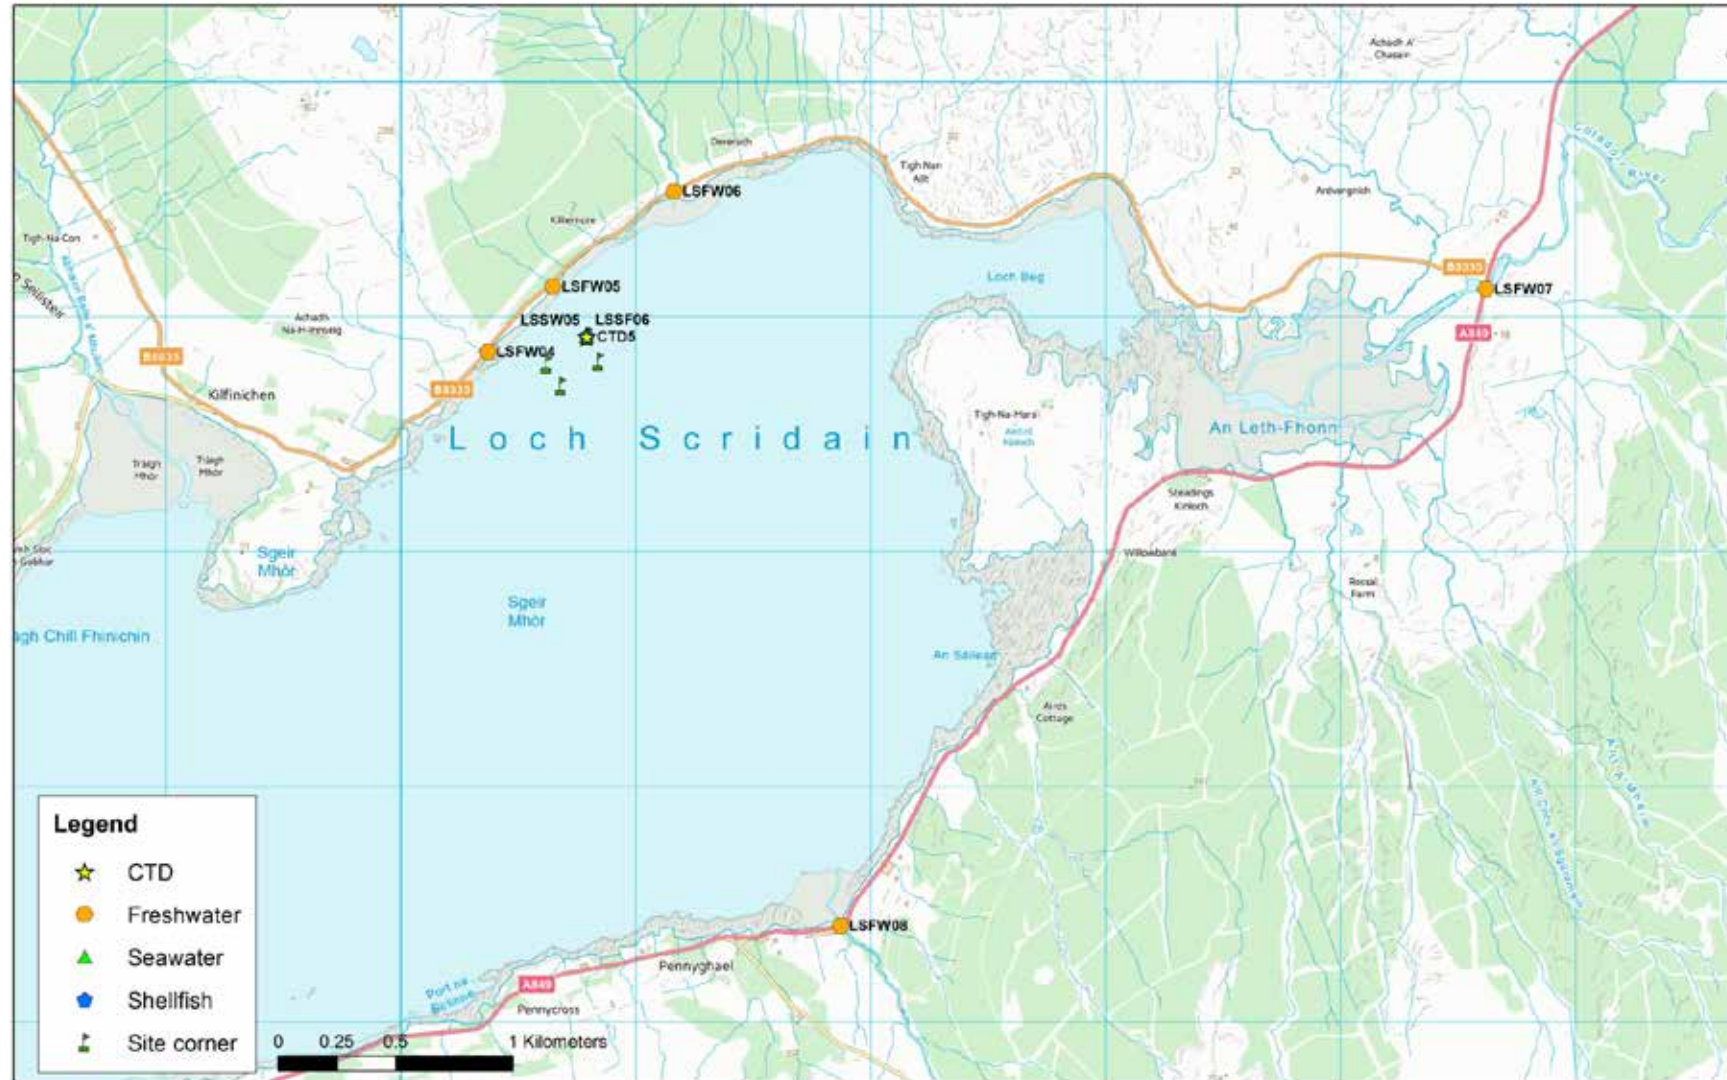
Figure 4. Loch Scridain sample positions, eastern half of survey area

Seawater and freshwater samples were collected at the sites marked in Figures 3 and 4. A total of five seawater samples and eleven freshwater samples were collected from around the survey area. These samples represented all of the planned water samples, excluding a freshwater sample from an outlet of the Coladoir River to Loch Beg, as the water course could not be found.

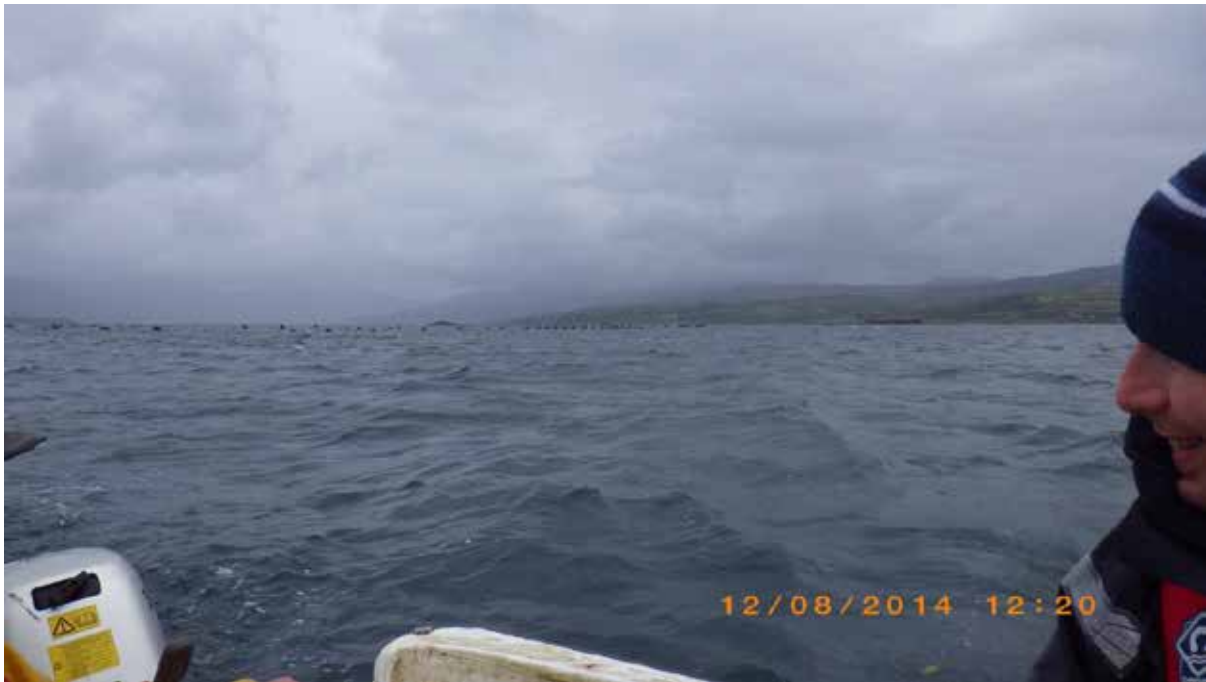
Figure 5: Western section of Aird Fada mussel lines. Photo looking east, and taken slightly to the west of WP 6.

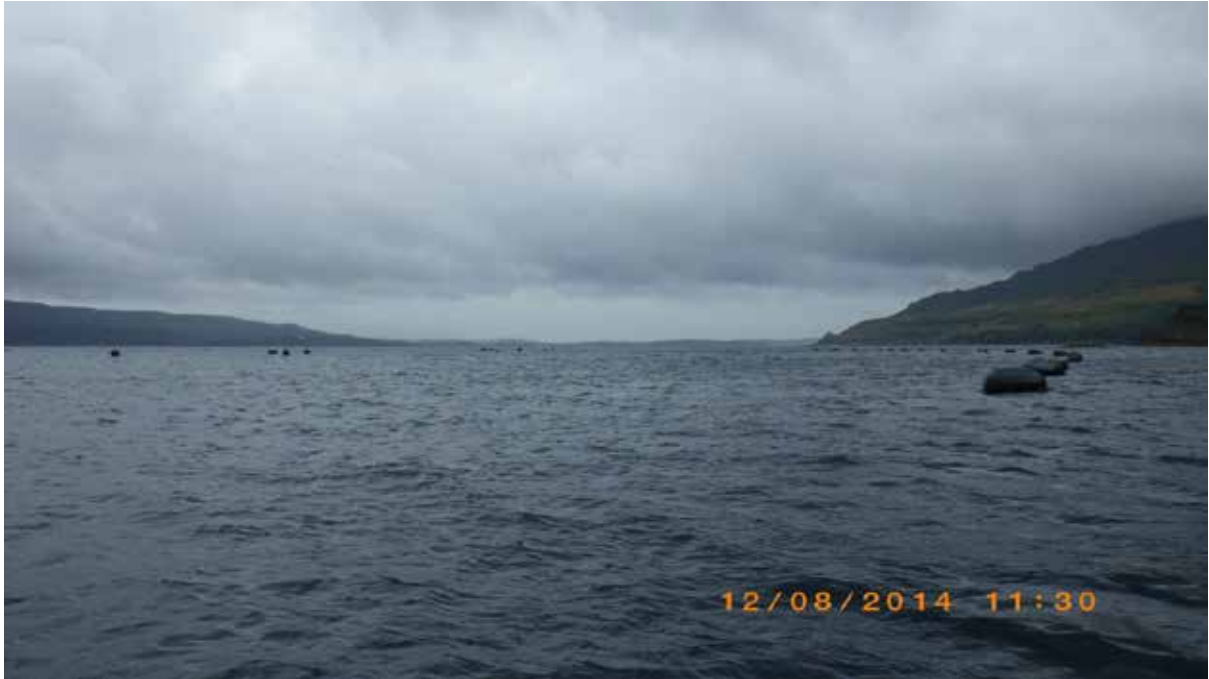
Figure 6: Slochd Bay mussel lines, looking west. Photo taken from WP 21.

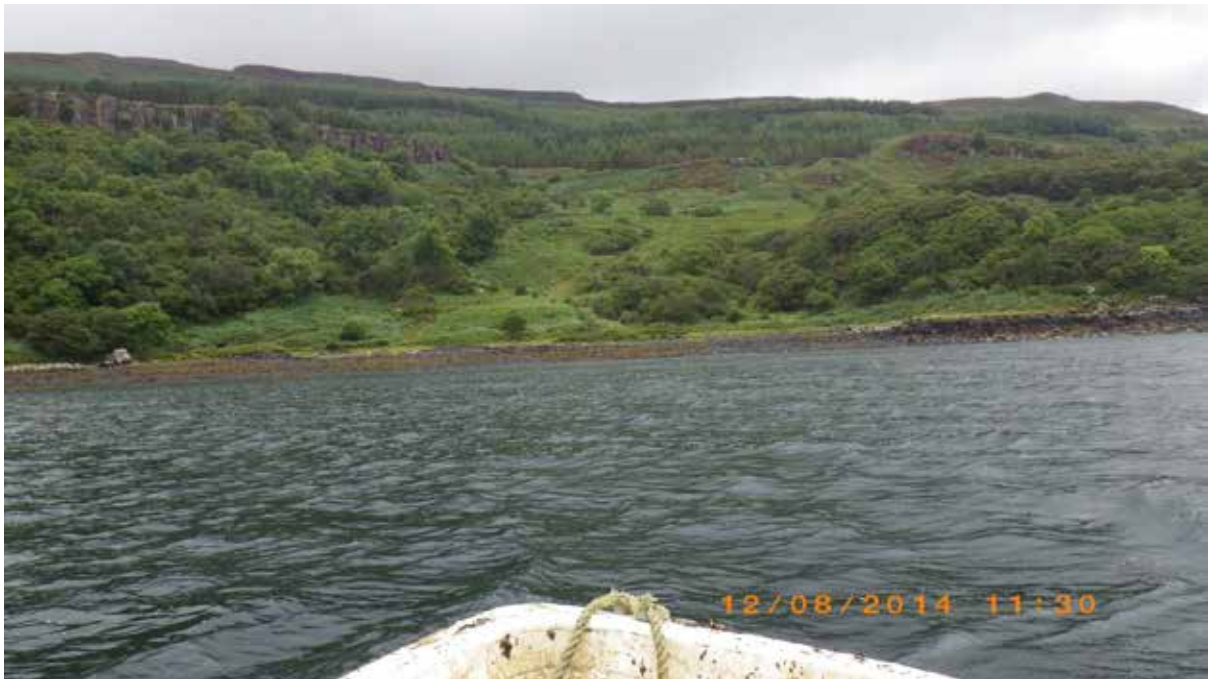
Figure 7: Photo of Slochd Bay, taken from WP 21. The boat was used to gain access to the shore at this location, as access via land was difficult.

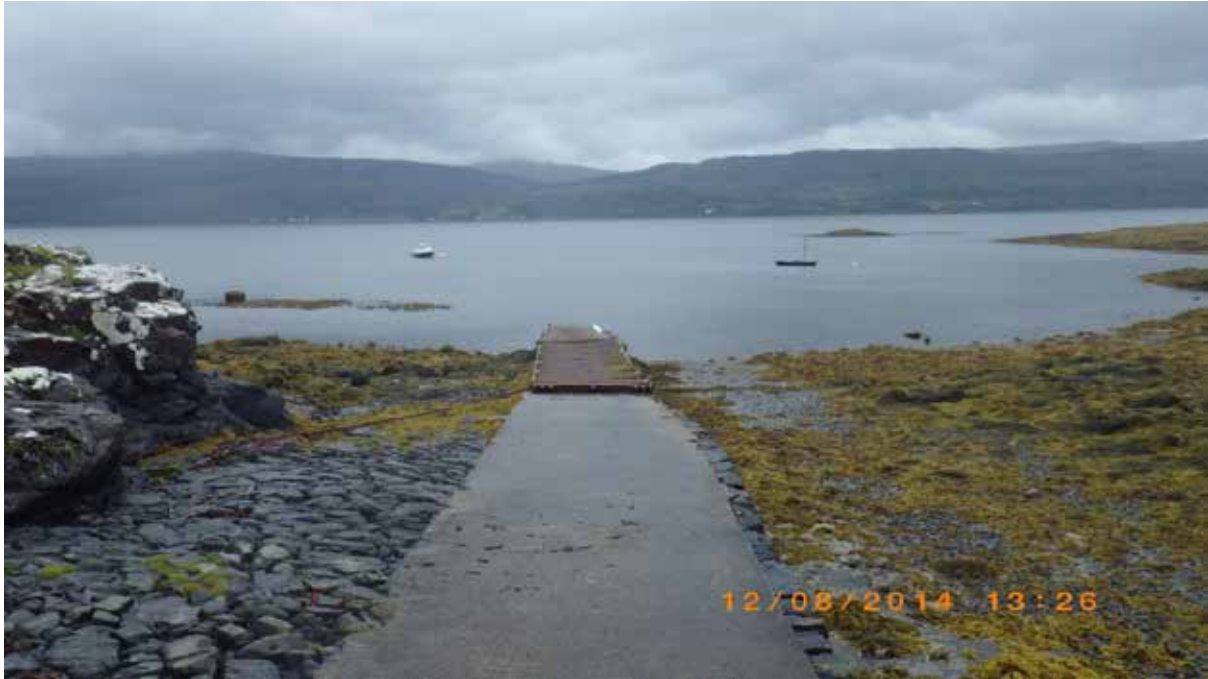
WP No.	Date	Time	NGR	East	North	Associated photograph	Associated sample	Description
28	12/08/2014	13:23	NM 49724 28361	149724	728361			Start of survey section around Killiemore.
29	12/08/2014	13:24	NM 49821 28307	149821	728308	Fig. 8		Small stone pier with pontoon, small wooden shed present above shoreline. Two moorings in bay, both with small pleasure craft.
30	12/08/2014	13:27	NM 49882 28357	149883	728358			Small stream running from forested uninhabited area. Not sampled – no habitation or livestock present .
31	12/08/2014	13:34	NM 50030 28516	150030	728517	Fig. 9		Small stream running from forested uninhabited area. Not sampled – no habitation or livestock present. One grey heron spotted on mid-shore.
32	12/08/2014	13:38	NM 50152 28627	150152	728627			Small stream running from forested uninhabited area. Not sampled. Seventeen sheep visible on far hill behind shoreline.
33	12/08/2014	13:42	NM 50227 28699	150228	728700			Small stream running from forested uninhabited area. Not sampled – no habitation/ livestock present.

Figure 8: Pier below Killiemore House, WP 29.

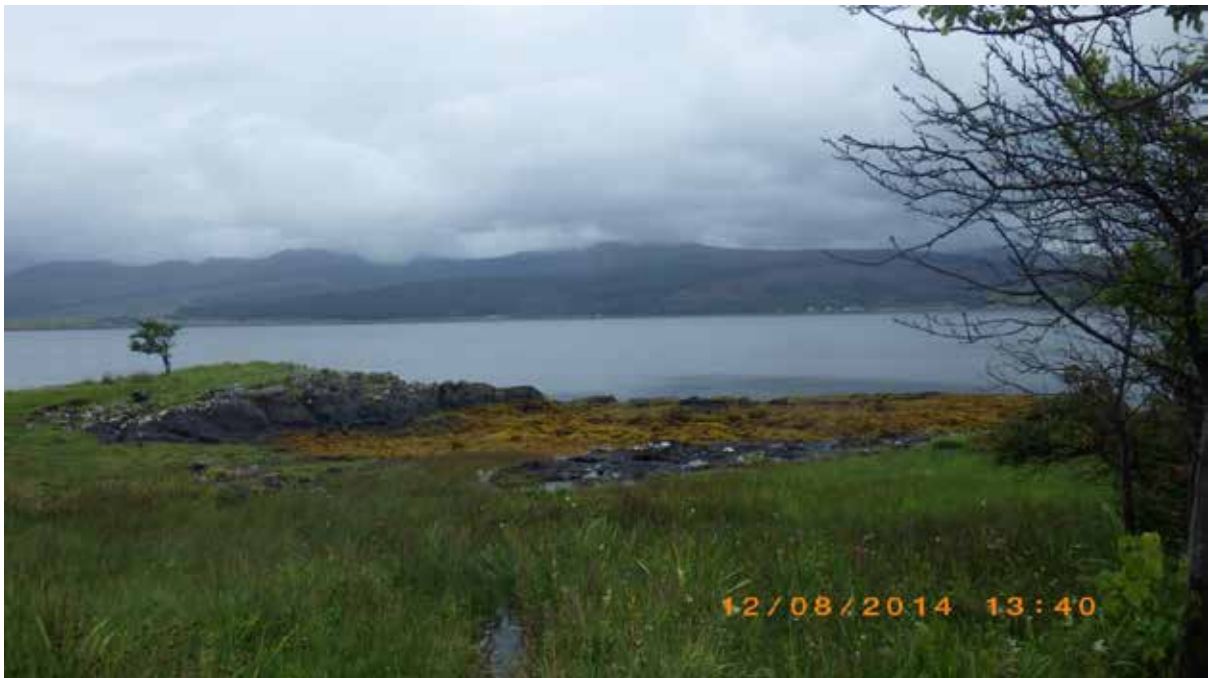
Figure 9: Small, un-sampled stream and shoreline on northern shore, looking S to southern shore of Loch Scridain. Taken from WP 31.

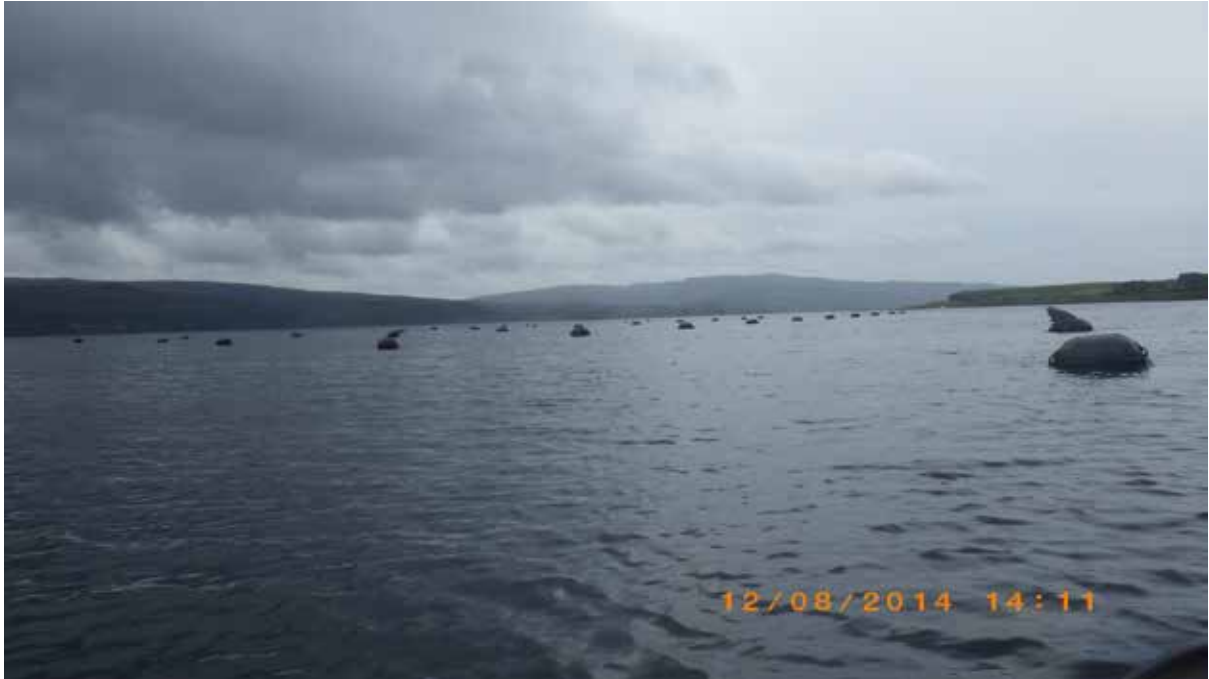
- Killimore comprised of 5x200 m long lines. The lines had been seeded with spat in the last year and the droppers were mainly coiled at the surface. Most mussels present were juveniles.

Figure 10: Killiemore mussel lines, looking west. Taken from WP 34.

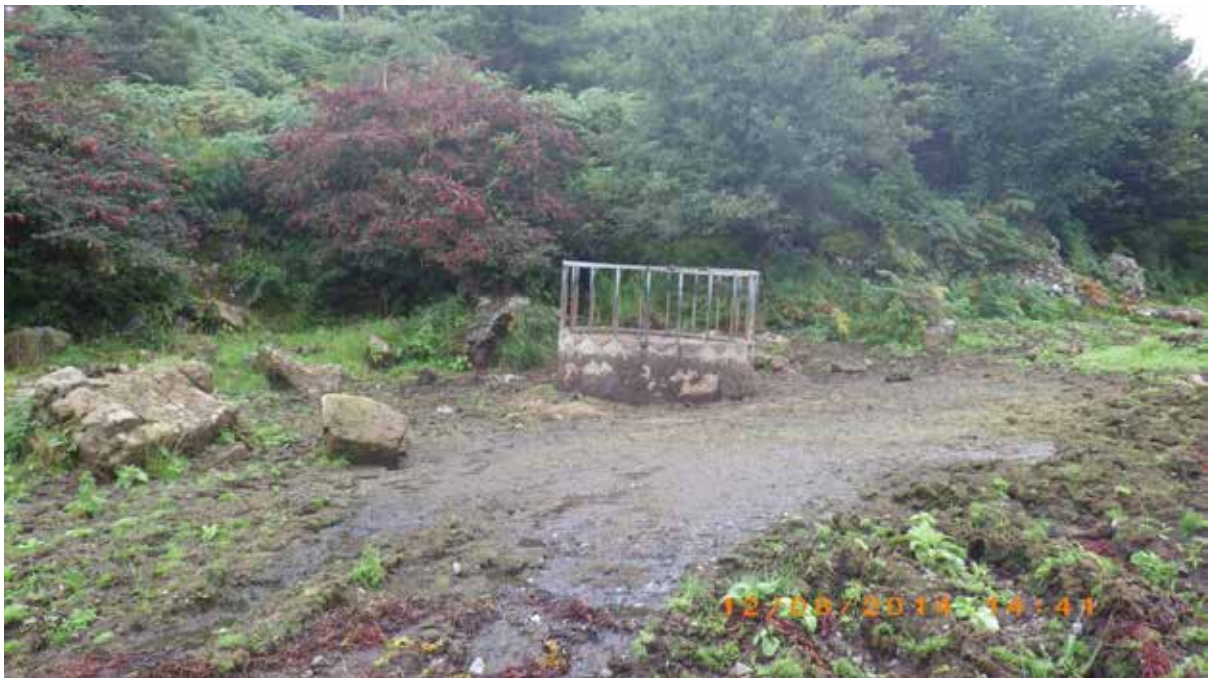
Figure 11: Site of feeding troughs on shoreline at Killiemore (WP 45).

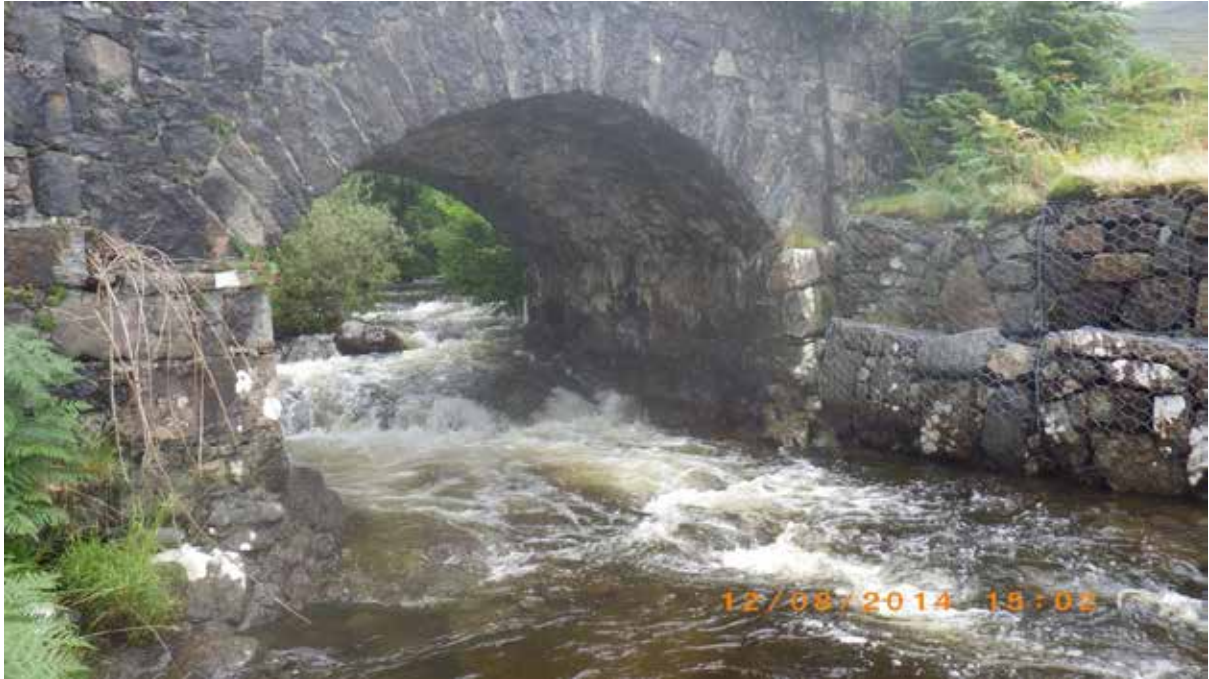
Figure 12: Allt na Coille Moire River in spate, sampled as LSFW06 (WP 49)

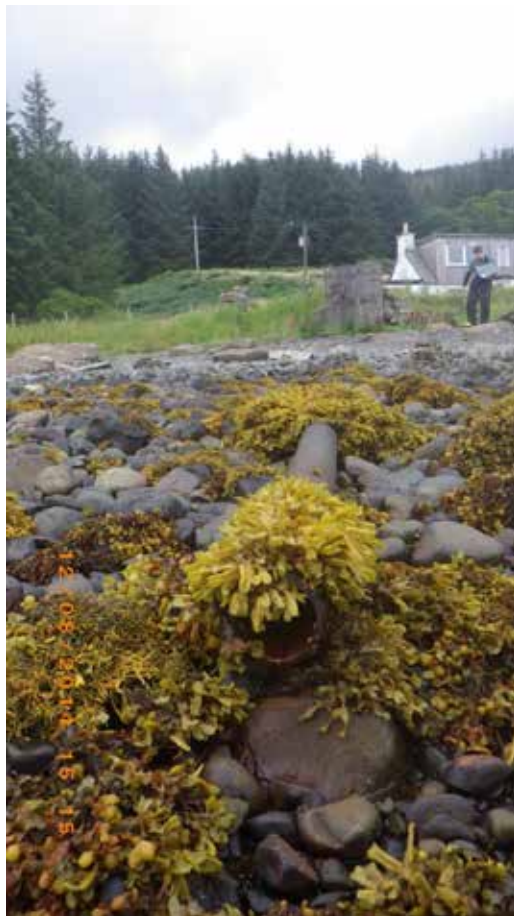
Figure 13: Discharge pipe below property near Killiemore, no flow present (WP 52).

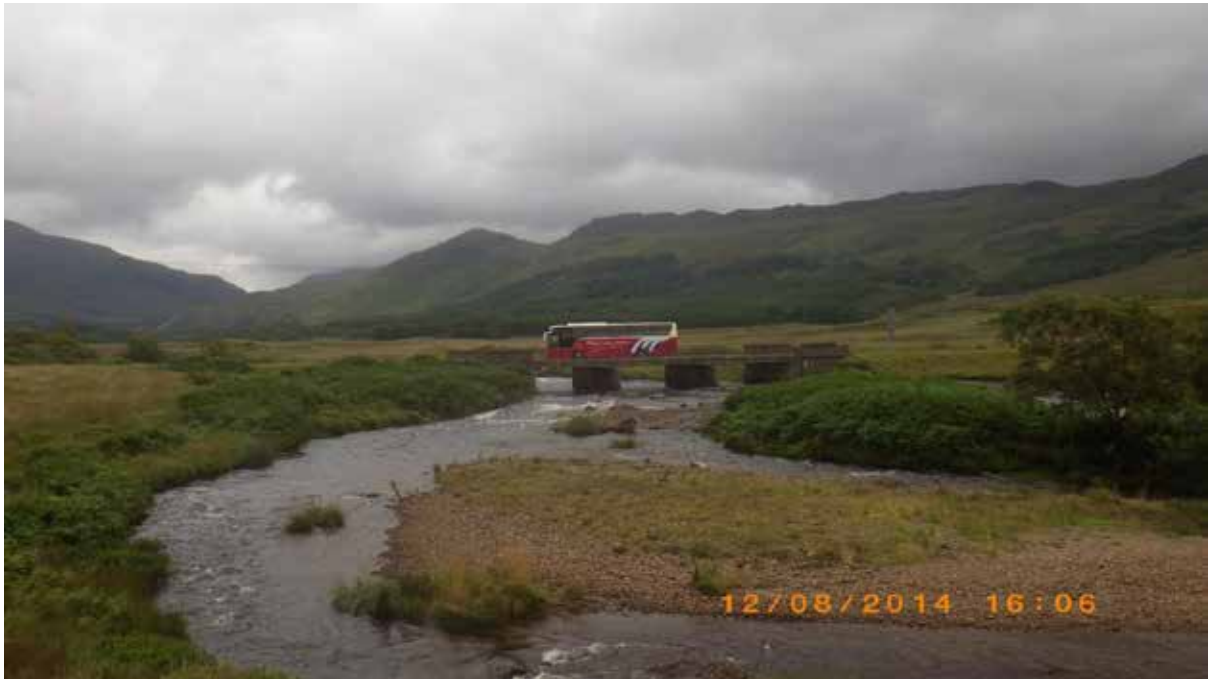
58	12/08/2014	15:48	NM 54620 29117	154620	729118	Fig. 14	LSFW07	Planned freshwater sample – Coladoir River, at A849 road bridge, slightly to south of junction with B8035.
59	12/08/2014	15:48	NM 54620 29117	154620	729118			Observations associated with WP58. Wide river, flow assessed at road bridge. Split into three sections from N to S. Width section A): 6.2m. Depth1: 7cm; Flow1: 0.430 m/s; 0.028 SD; Depth2: 8 cm; Flow2: 0.499 m/s; 0.021 SD; Depth3: 1m 50cm; Flow3: 0.525 m/s; 0.041 SD. Width section B): 8.4m; Flow estimated using floating stick method. 20 s to cover 6m 60cm = 0.33 m/s; Width section C): 7m; Depth: 1m 25cm; Flow: 0.553 m/s; 0.054 SD.
60	12/08/2014	15:48	NM 54619 29116	154620	729117			Photos of river and area around bridge associated with WP58 & 59; seven sheep observed in fields next to river.

Figure 14: Modern road bridge carrying A849 road over the Coladoir River. Site of LSF07 (WP 58).

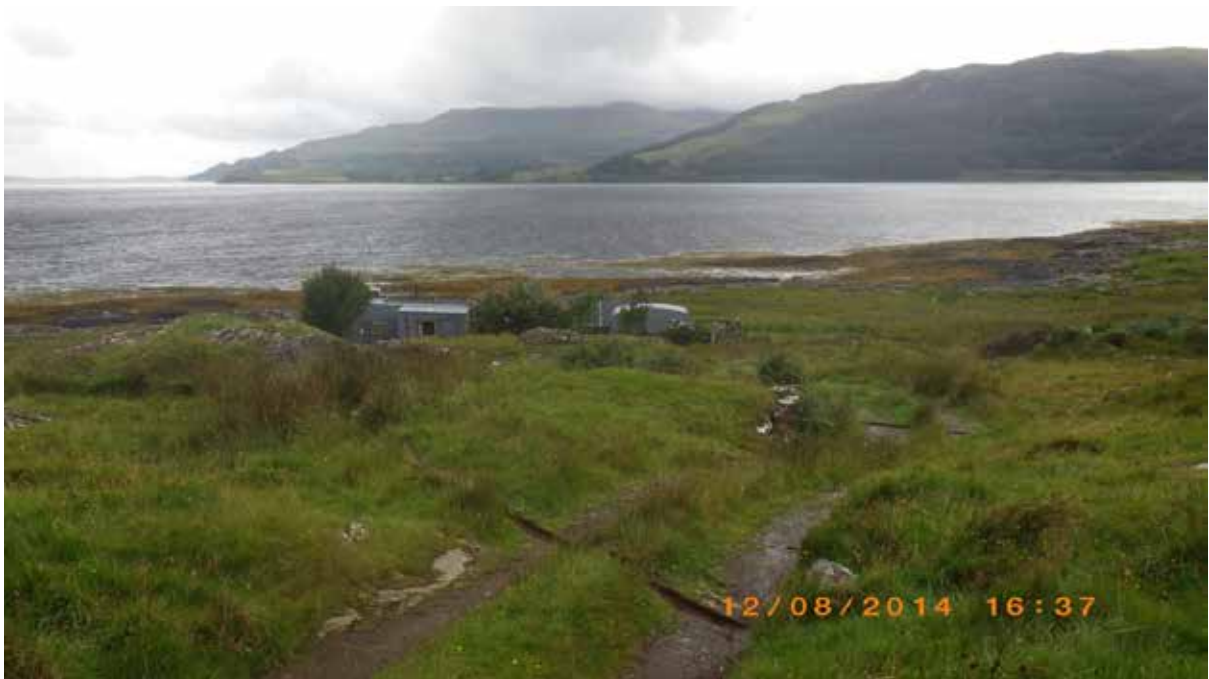
Figure 15: Two small houses and caravan above shoreline, western side of Aird of Kinloch. Grassland area with grazing sheep present to the right of image (WP 63).

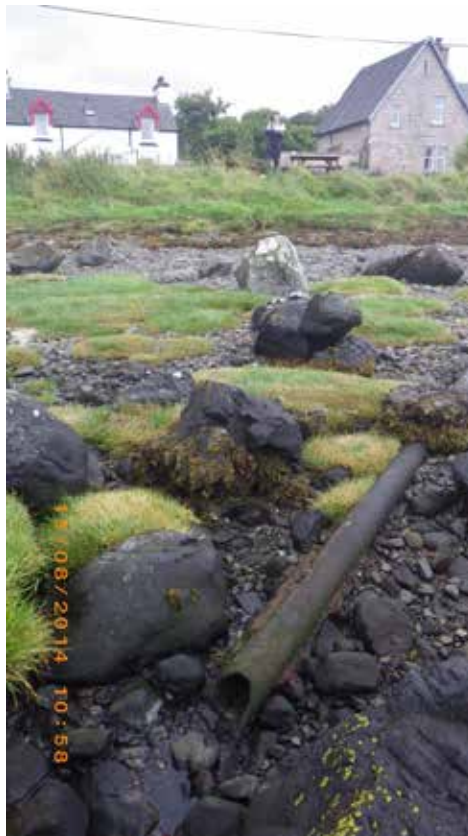
Figure 16: Discharge pipe on foreshore at Pennyghael (WP 69). Building on the right hand side of photo is Pennyghael Village Hall.

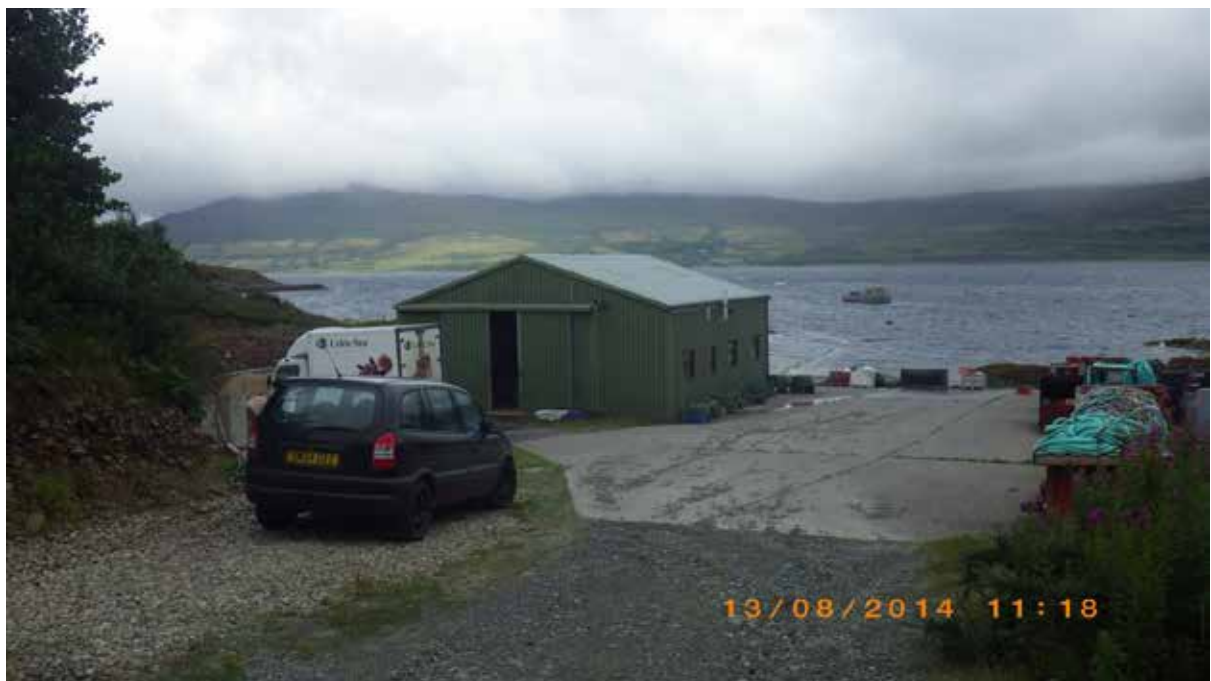
Figure 17: Celtic Sea shore base at Aird Fada, with Aird Fada mussel long lines visible in background (WP 70).

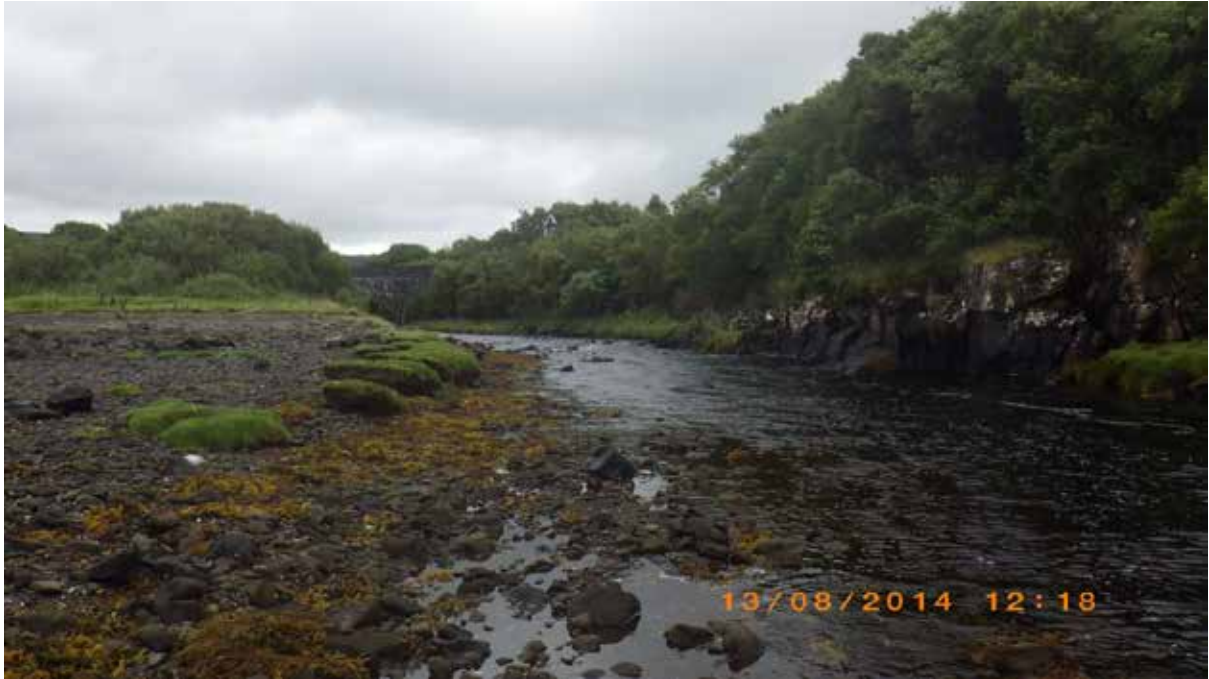
WP No.	Date	Time	NGR	East	North	Associated photograph	Associated sample	Description
73	13/08/2014	11:31	NM 45656 24460	145657	724460			Small stream running to shore from bracken covered hillside. No habitation visible. Not sampled.
74	13/08/2014	11:41	NM 45993 24433	145994	724434		LSFW10	Planned freshwater sample – unnamed watercourse, Port nam Beach.
75	13/08/2014	11:41	NM 45994 24433	145995	724434			Observations associated with WP74 - Width: 1m 5cm; Depth: 16cm; Flow: 0.143 m/s; 0.031 SD.
76	13/08/2014	11:46	NM 46071 24472	146071	724473			Impossible to follow shoreline further on foot due to large impassable rocks and state of tide. Continued by foot along road to next sample point and observed shoreline from distance - trees running to waterline, no human habitation or activity seen.
77	13/08/2014	12:09	NM 46456 24291	146456	724291	Fig. 18	LSFW11	Planned freshwater sample – Beach River, Traigh nam Beach.

Figure 18: Beach River, with A849 road bridge partially visible. Site of LSF11 sample (WP 77).

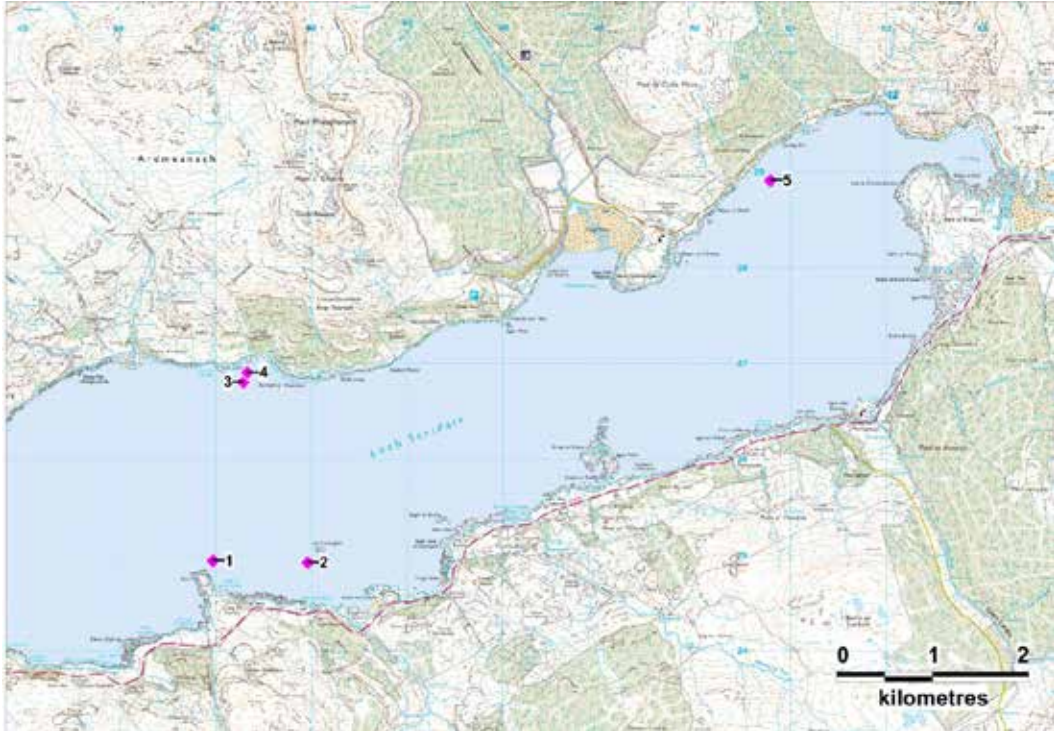
**Figure A6.1 Location of CTD cast
CAST 1**

Data obtained during the shoreline survey. The locations of the casts are shown in Figure A6.1.
