# Scottish Sanitary Survey Report

**Sanitary Survey Report**  
**Loch Slapin**  
**SL-194-290-08**  
**September 2014**

<b>Report Title</b>	Loch Slapin
<b>Project Name</b>	Scottish Sanitary Survey
<b>Client/Customer</b>	Food Standards Agency Scotland
<b>Cefas Project Reference</b>	C6316A
<b>Document Number</b>	C6316A_2014_03
<b>Revision</b>	V1.0
<b>Date</b>	12/09/2014

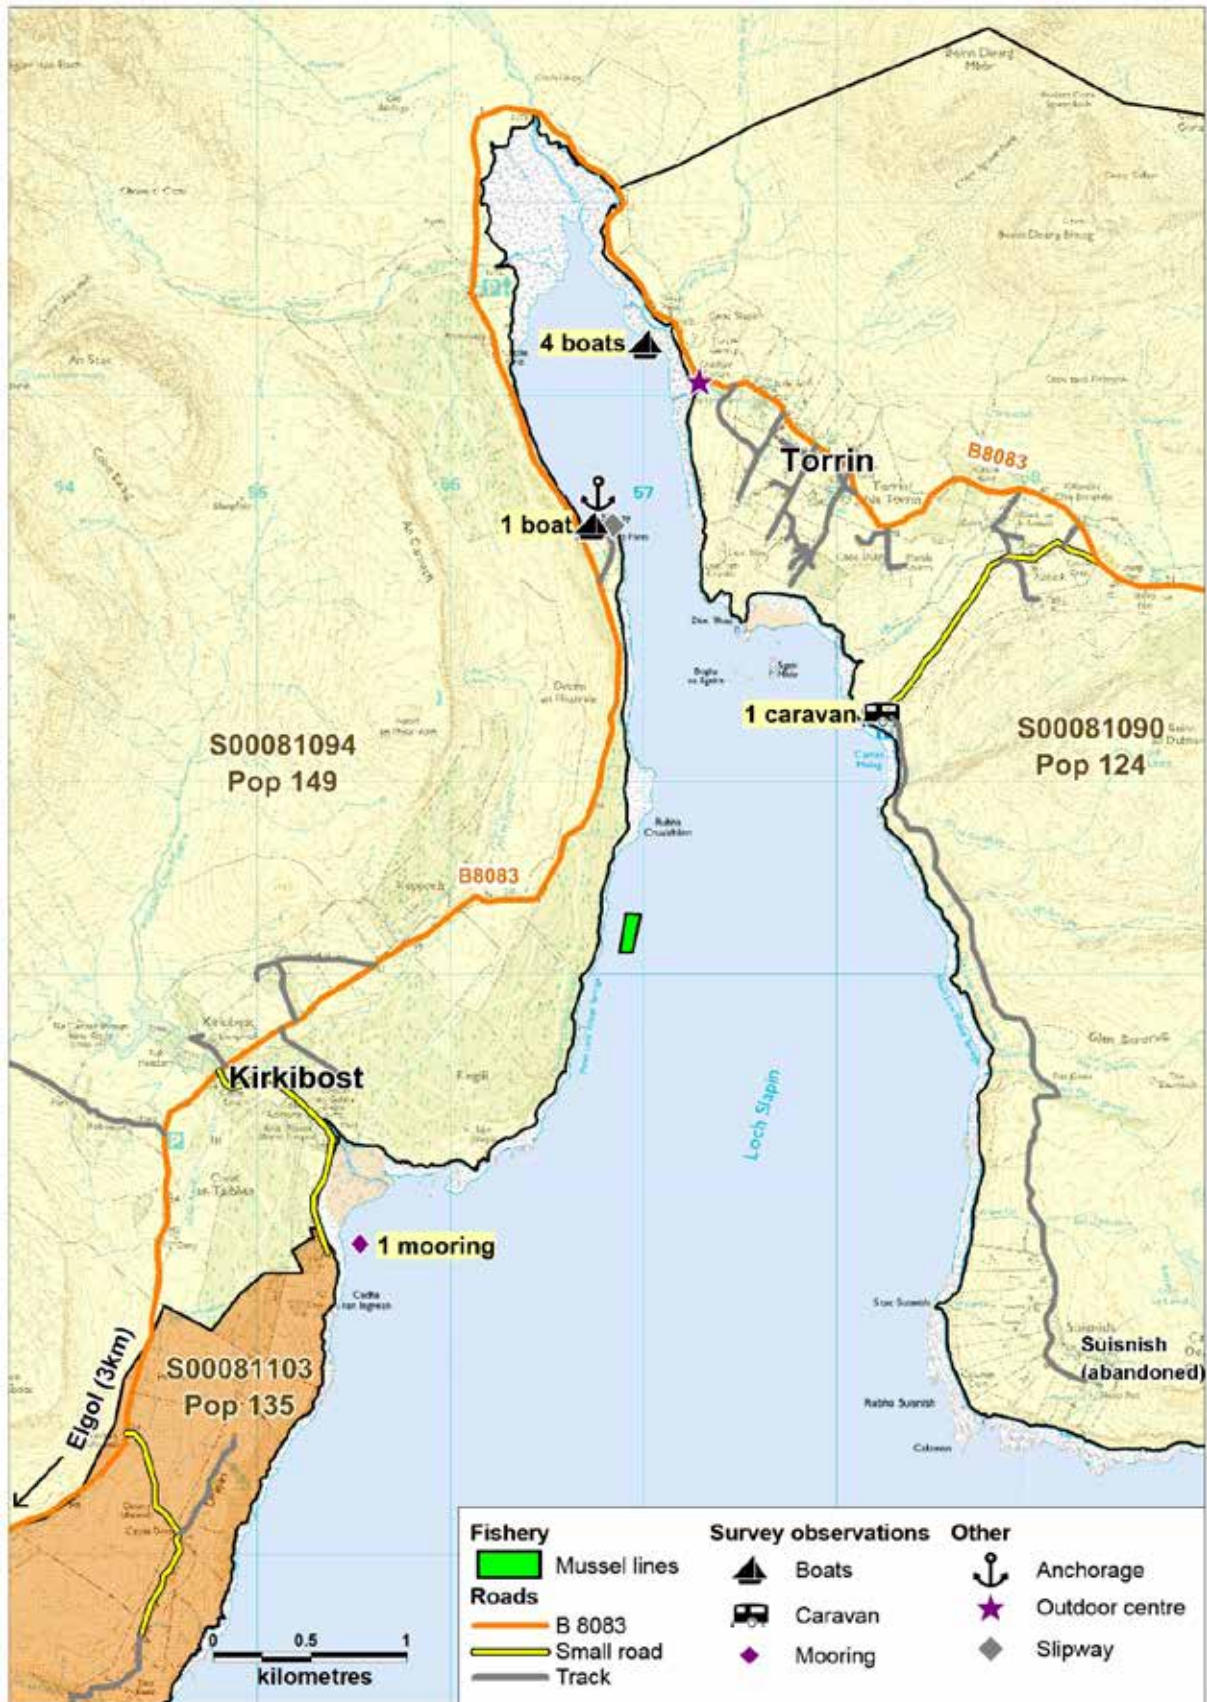
**Figure 3.1 Population map for the area in the vicinity of Loch Slapin**

Information was obtained from the General Register Office for Scotland on the population within the vicinity of Loch Slapin production area. The last census was undertaken in 2011. The recorded population per census output area is shown in Table 3.1. The census output areas surrounding Loch Slapin are shown thematically mapped by the 2011 population densities in Figure 3.1. Overall, the population density is low (< 3 people per km<sup>2</sup>) along the majority of the shoreline surrounding the loch. The majority of the population in census output area S00081103, which has the highest density, is located on the opposite side of the Strathaird peninsula to Loch Slapin.

Torrin is the principal centre of population around the loch. As it contains a relatively large amount of holiday accommodation, any faecal contamination arising from that community is likely to have a sizeable seasonal variation. The area in general is used by climbers and hill walkers attempting the Cuillin range, and therefore the tourist season may be expected to extend beyond the traditional summer holiday months.

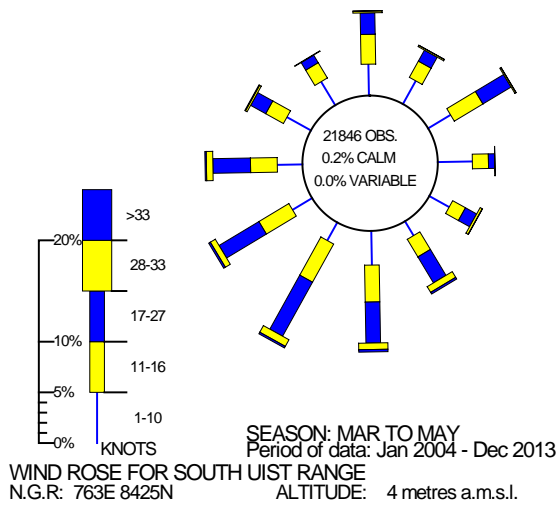
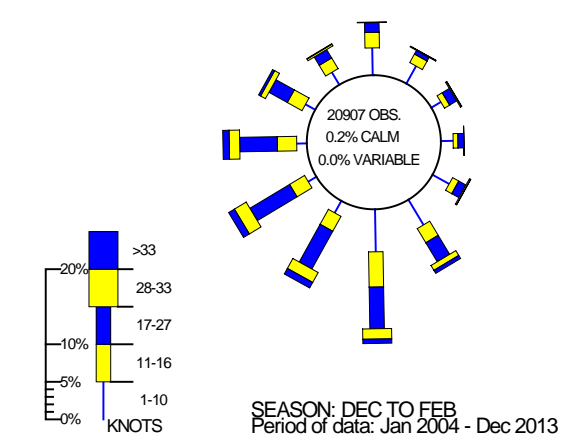
Figure reproduced under license from Meteorological Office. Crown Copyright 2012.  
**Figure 9.3 Seasonal wind roses for South Uist: Range**

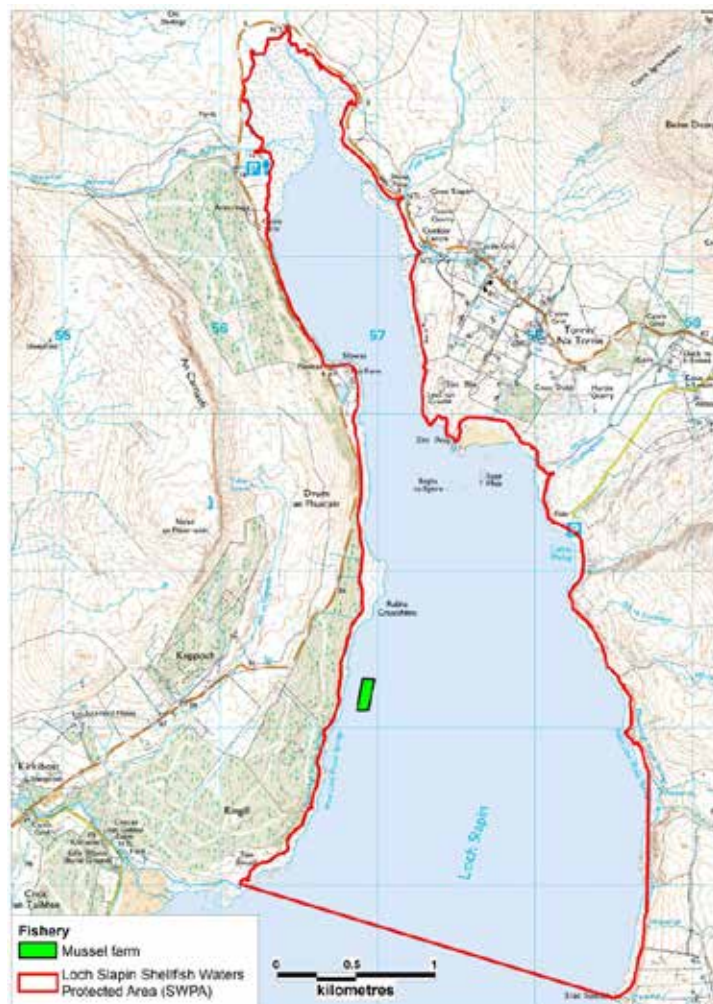
**Figure 12.1 Designated shellfish water protected area – Loch Slapin**

The Shellfish Waters Directive (2006/113/EC) has been repealed (as at 31 December 2013) and equivalent protection for areas previously designated under that Directive is given by The Water Environment (Shellfish Water Protected Areas: Environmental Objectives etc.) (Scotland) Regulations 2013. The Loch Slapin Shellfish Water Protected Area (SWPA) has the same boundaries as the previous Loch Slapin Shellfish Growing Water (SGW). The SWPA designation covers the majority of the loch. The designated SWPA for Loch Slapin is shown in Figure 12.1. Since 2007, assessment of the bacteriological status of shellfish waters has been undertaken using the shellfish hygiene *E. coli* data and this data has been reviewed in Section 11.

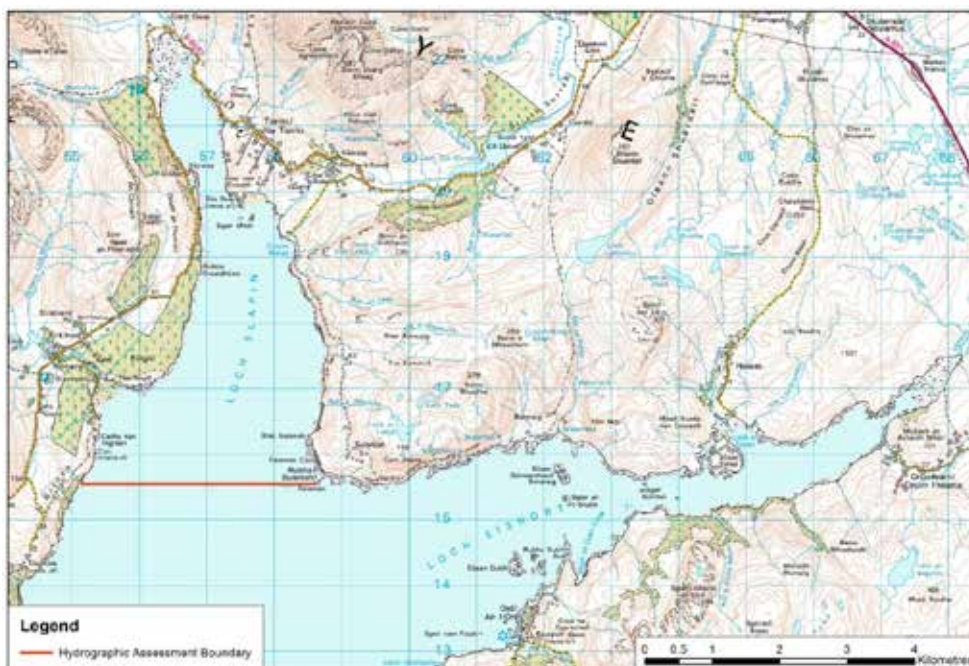
**Figure 13.1 Extent of the hydrographic study area**

The assessment area encompasses Loch Slapin, to the north of Rubha Suisnish (southern boundary). It is shown in Figure 13.1 with the assessment area demarcated by the red line. The total length of Loch Slapin is 6.9 km. Loch Slapin is approximately 3 km in width at its southern end, narrowing to 0.5 km at Leac nan Craobh before widening to approximately 1 km at its northern end.

Figure 13.2 shows the bathymetry of Loch Slapin. One sill is found in the loch, extending from Leac nan Craobh, 500 m south of the slipway at Faoilean (see Figure 13.1). The sill is 500 m in width at high water, and has a mean depth of 3 m and a maximum depth of 7 m (Edwards & Sharples, 1986). The basin to the north of this sill has a maximum depth of 17 m. To the south of the sill, bathymetry deepens toward the mouth of the loch, where depths of approximately 35 m are reached at the assessment area boundary.

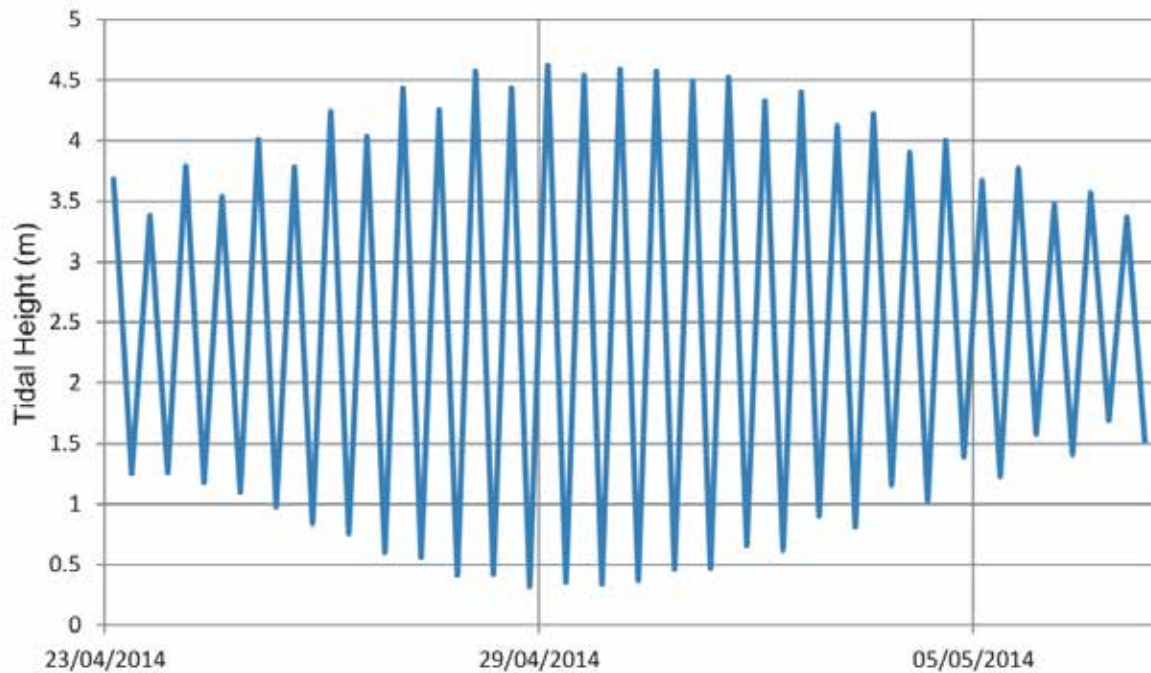
**Figure 13.4 – Two week tidal curve for Bay of Laig, Inner Hebrides.**

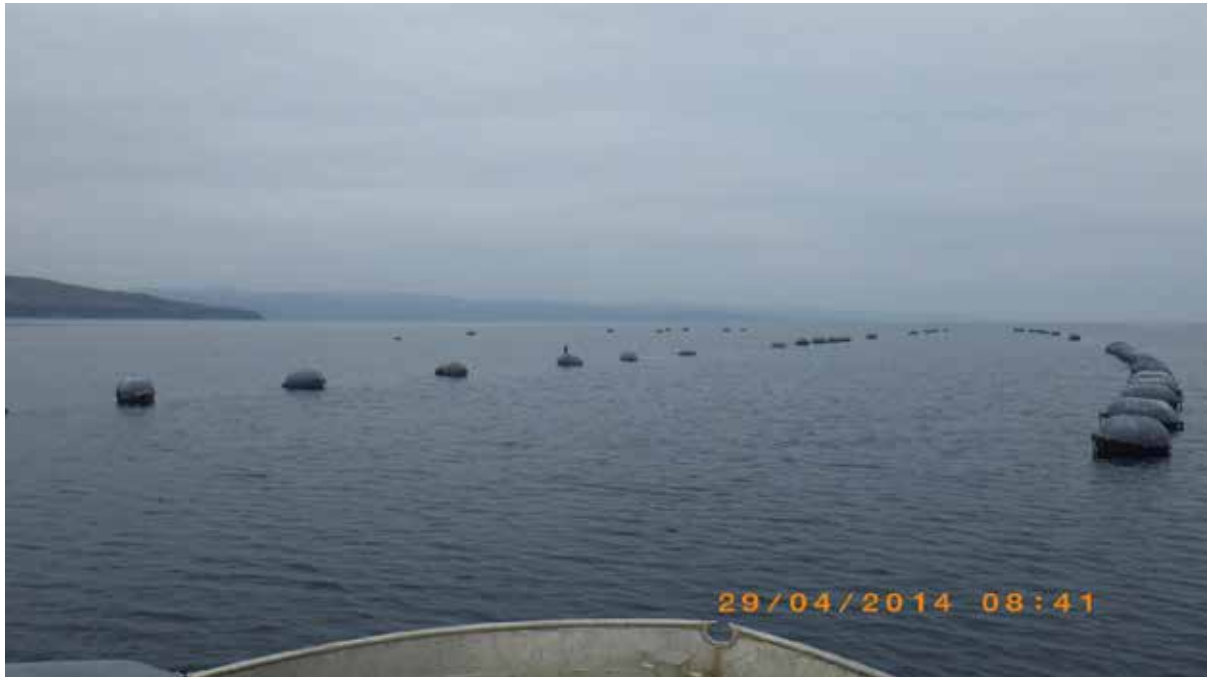
**Figure 3. NW corner of mussel lines at Loch Slapin. Associated with waypoint 1.**

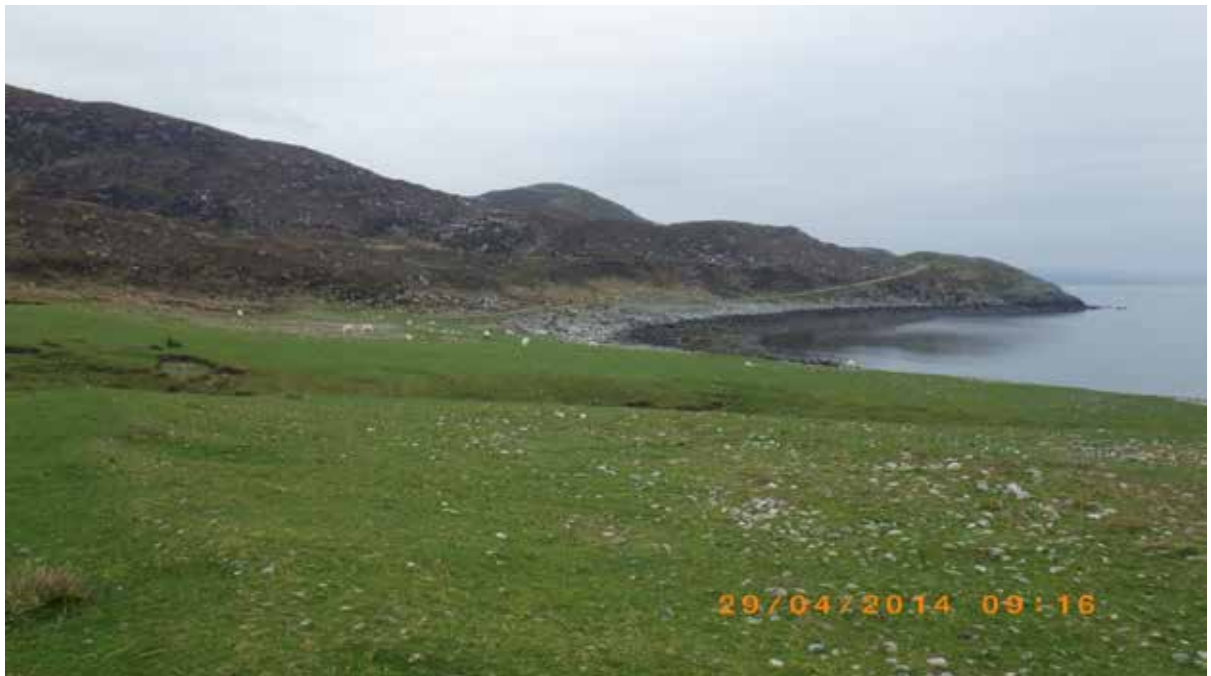
**Figure 4. Start of shoreline walk at Pole on NE shore of Loch Slapin. Eighteen sheep on shore, eleven adults and seven lambs. Associated with waypoint 12.**

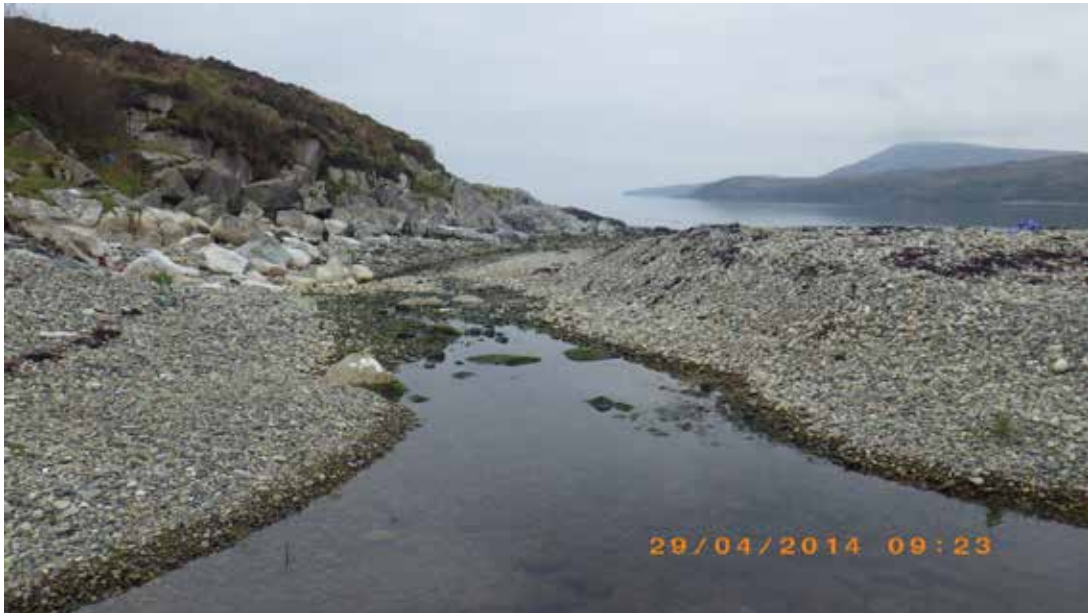
**Figure 5. Planned freshwater sample. River running to shore with quarry behind. Associated with waypoints 14 and 15. Site of LSFW1.**

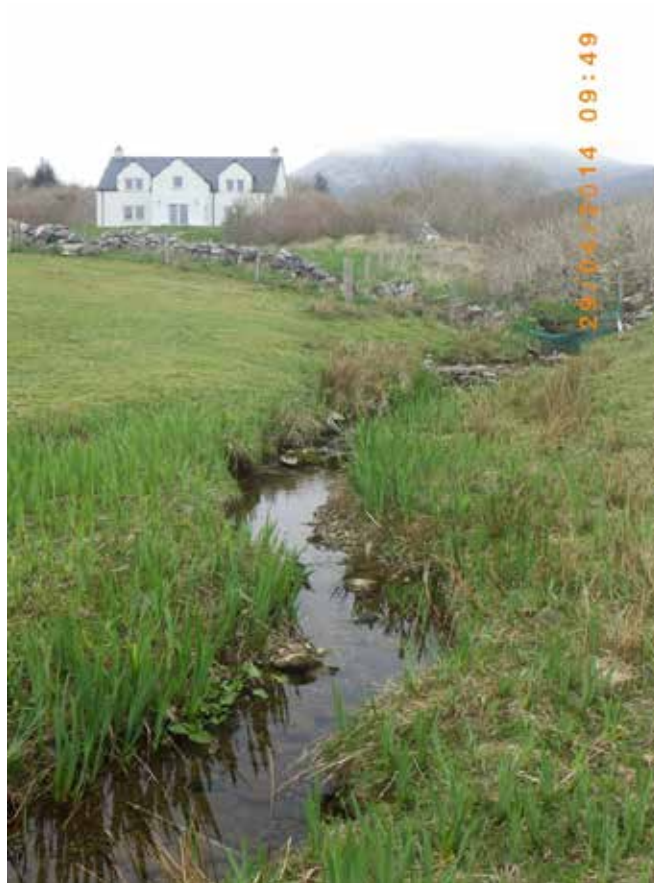
**Figure 6. Planned freshwater sample. River running onto shore with house behind. Associated with waypoints 16 and 17. Site of LSFW2.**

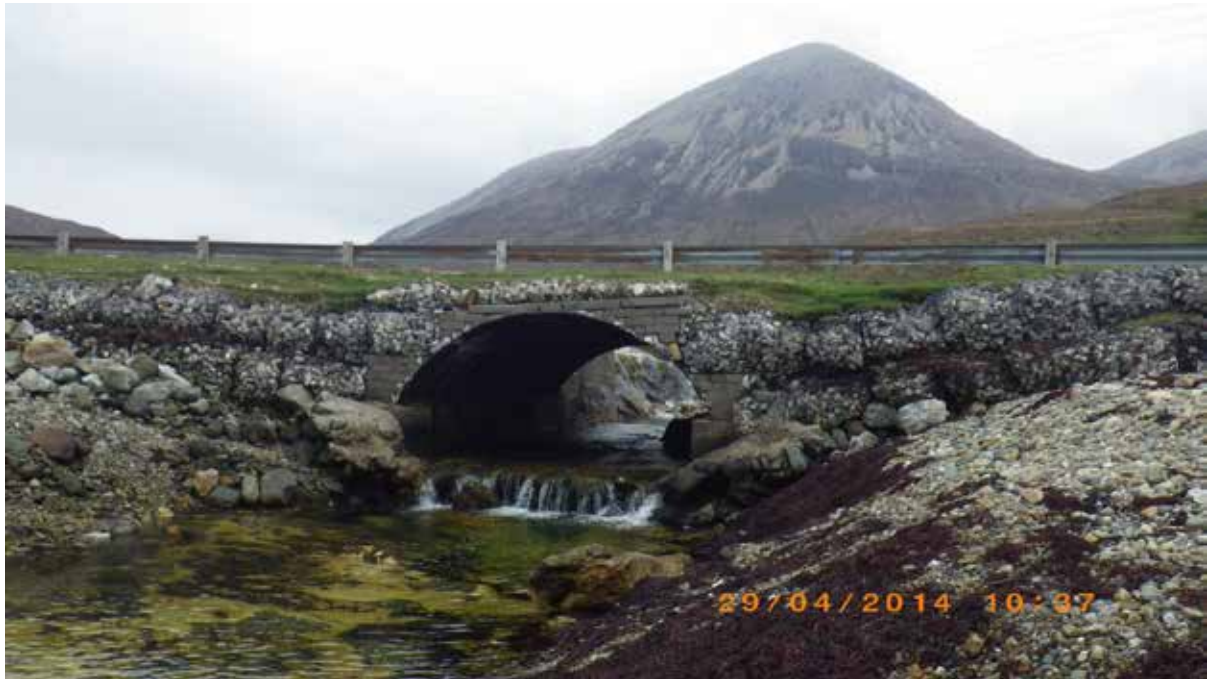
**Figure 7. Planned freshwater sample. Large watercourse running under road onto shore. Associated with waypoints 24 and 25. Site of LSFW4.**

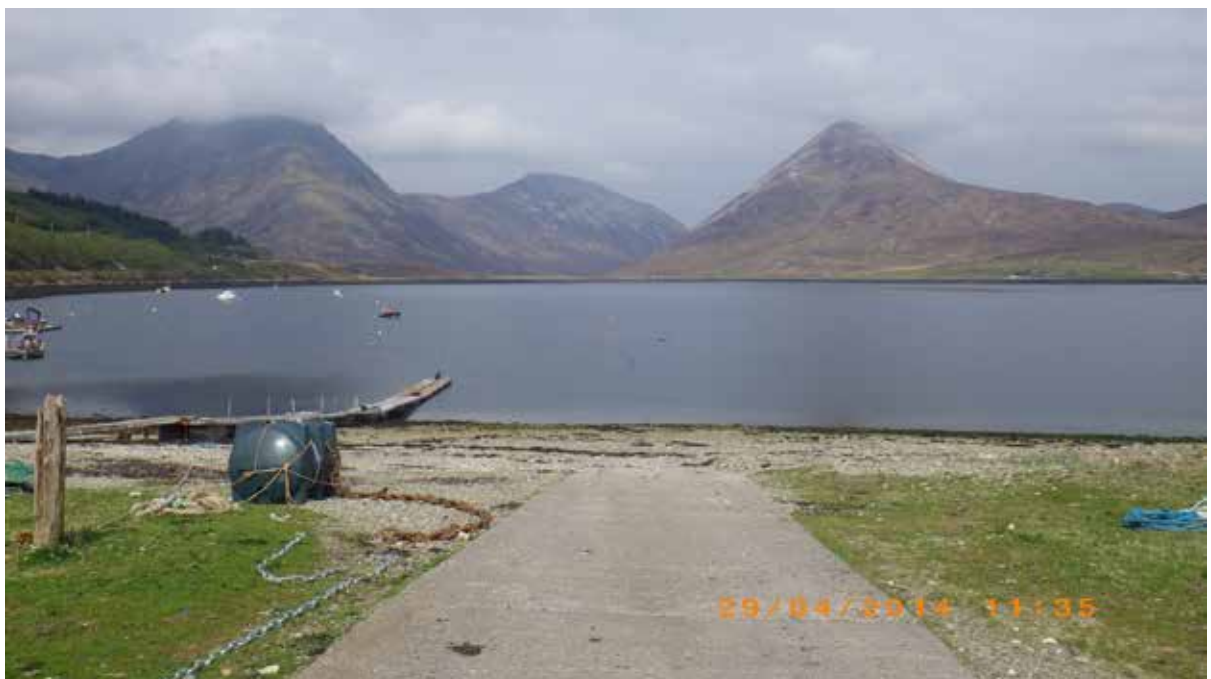
**Figure 8. Planned seawater sample from slipway. Associated with waypoint 27. Site of LSSW3.**

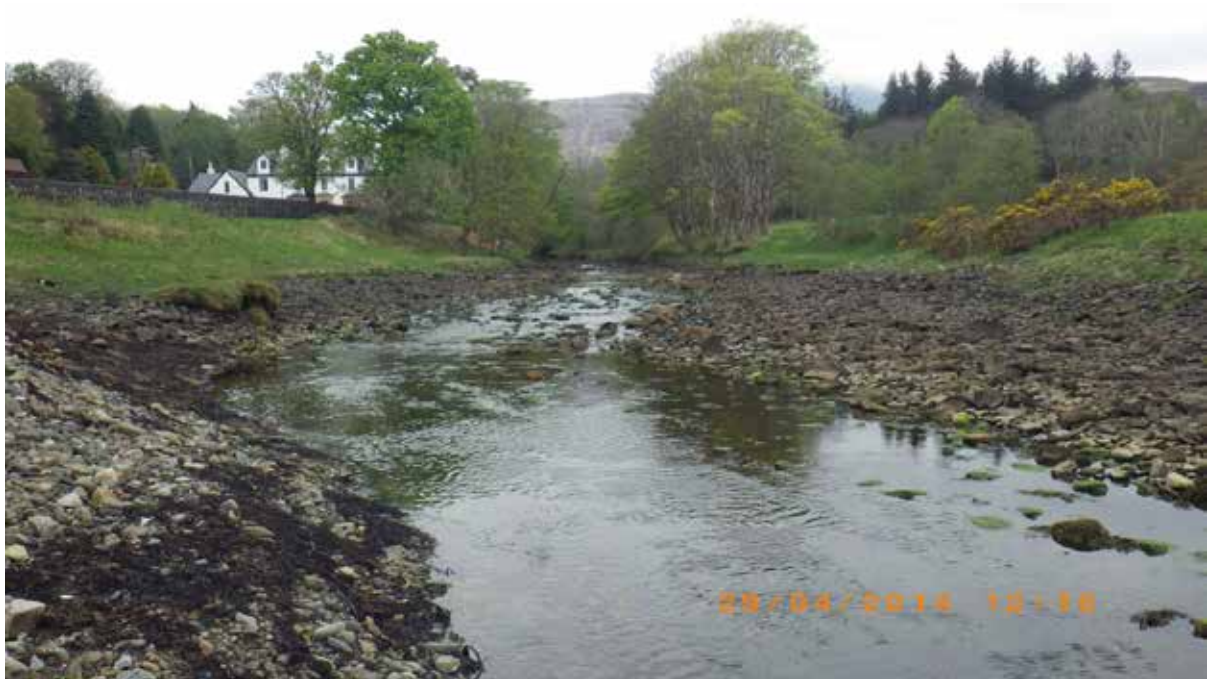
**Figure 9. Planned freshwater sample. Large watercourse running onto shore. Houses behind. Very bad smell. Associated with waypoints 30 and 31. Site of LSFW5.**

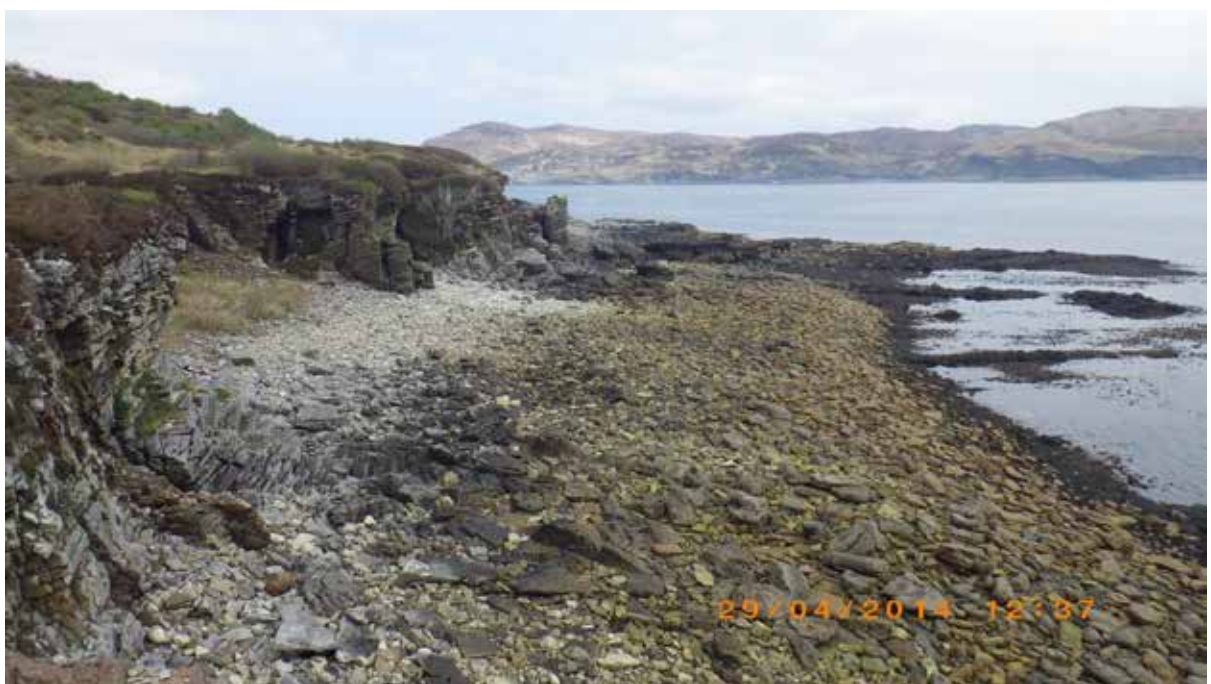
**Figure 10. Cliffs next to shoreline. Associated with waypoint 62.**

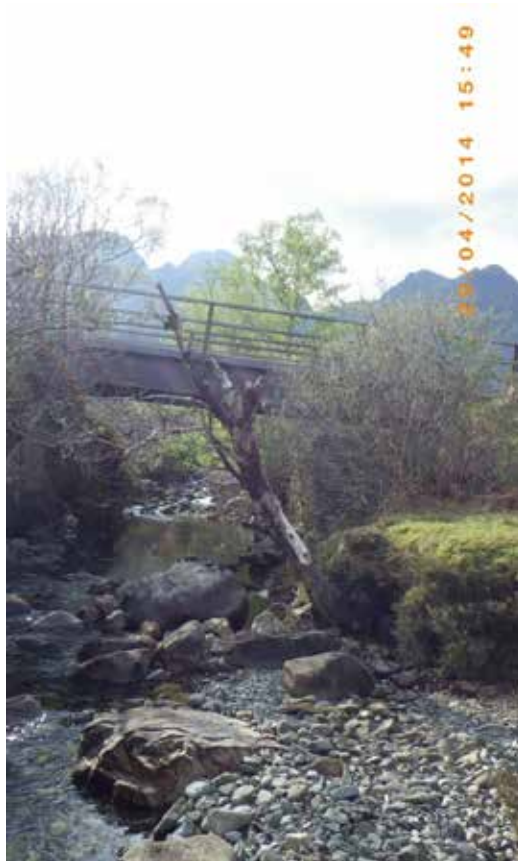
**Figure 11. Planned freshwater sample. River running under road onto shore next to car park. Associated with waypoints 36 and 37. Site of LSFW6.**

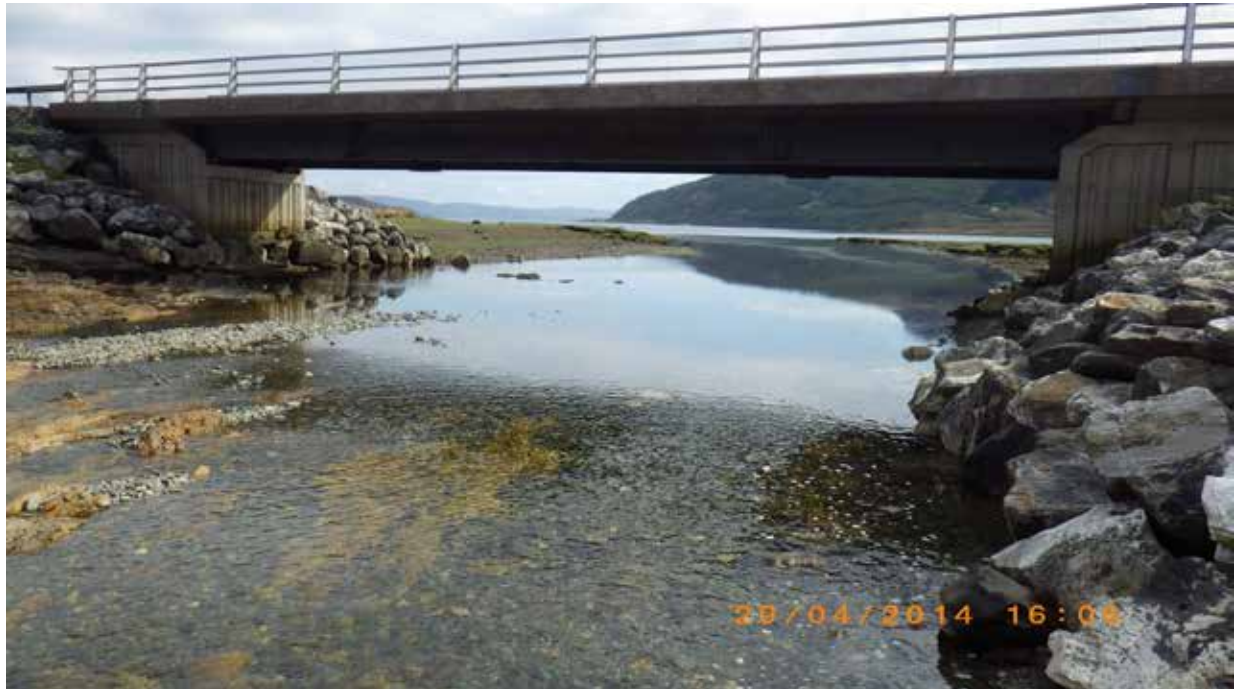
**Figure 12. Planned freshwater sample. River at head of Loch Slapin. Associated with waypoints 39 and 40. Site of LSFW7.**

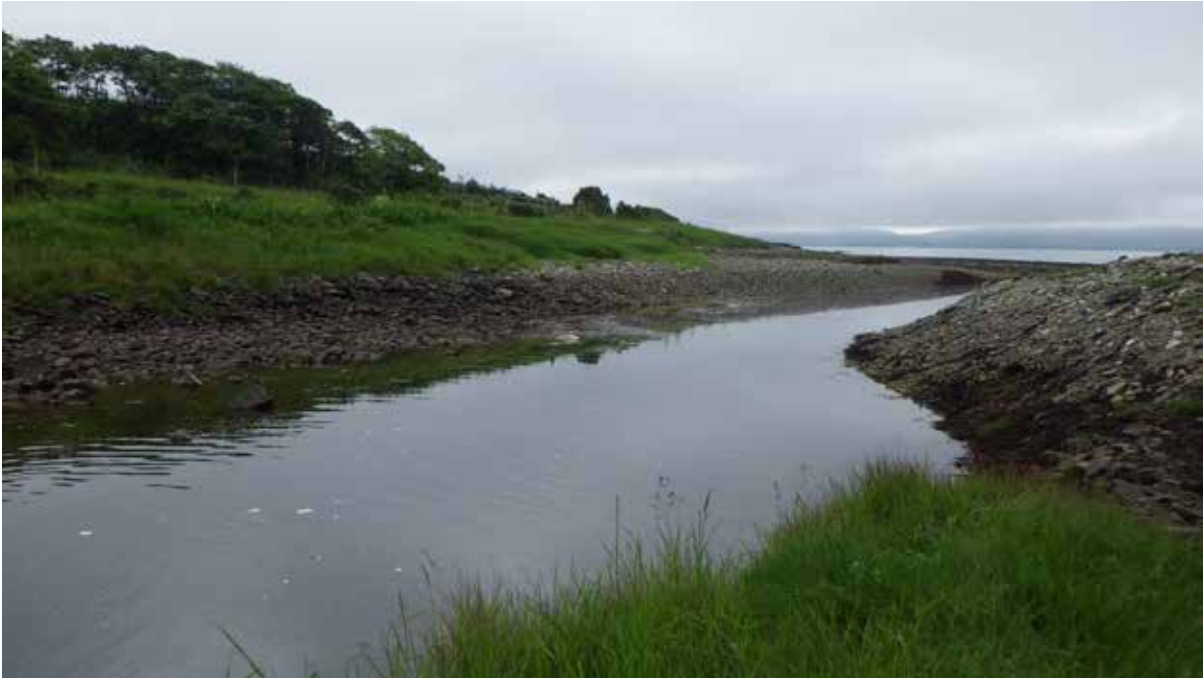
**Figure 3. Watercourse running onto shore next to house at Kilmarie. Associated with waypoints 1 & 2. Location of freshwater sample LSFW1.**

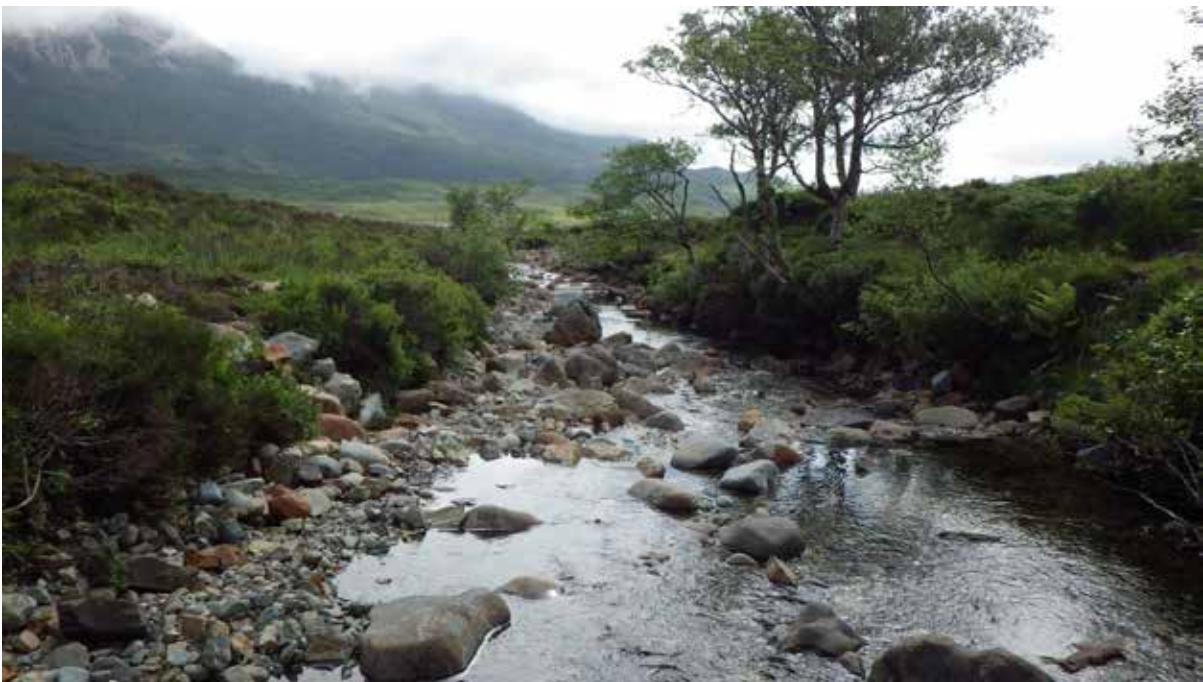
**Figure 4. Watercourse running under road onto shore by car park. Associated with waypoints 4 & 5. Location of freshwater sample LSFW2.**

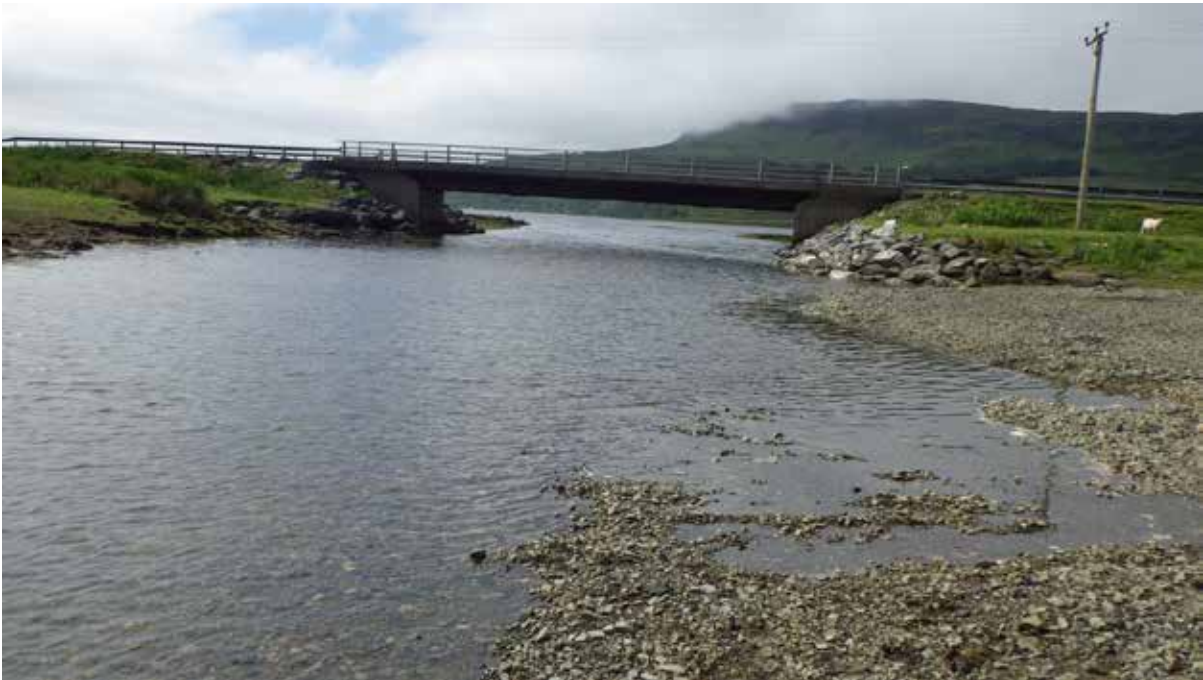
**Figure 5. Large watercourse at head of Loch Slapin. Associated with waypoints 6 & 7. Location of freshwater sample LSFW3.**

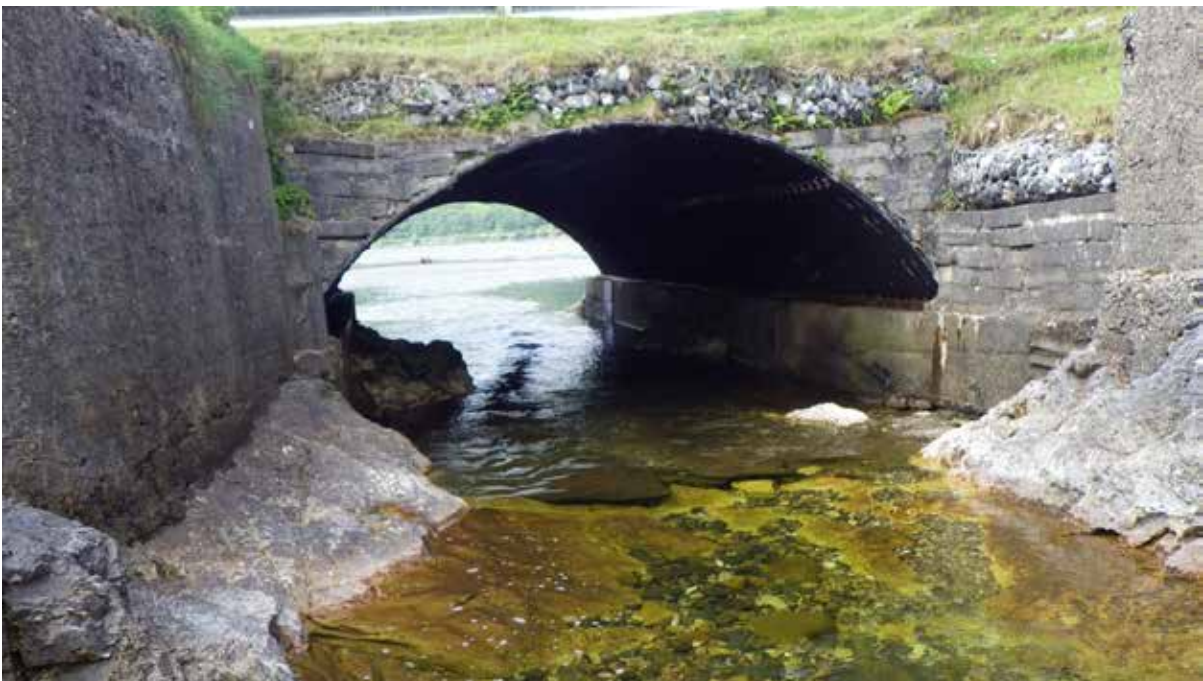
**Figure 6. Watercourse running under road onto shore next to sheep pen. Associated with waypoints 8 & 9. Location of freshwater sample LSFW4.**

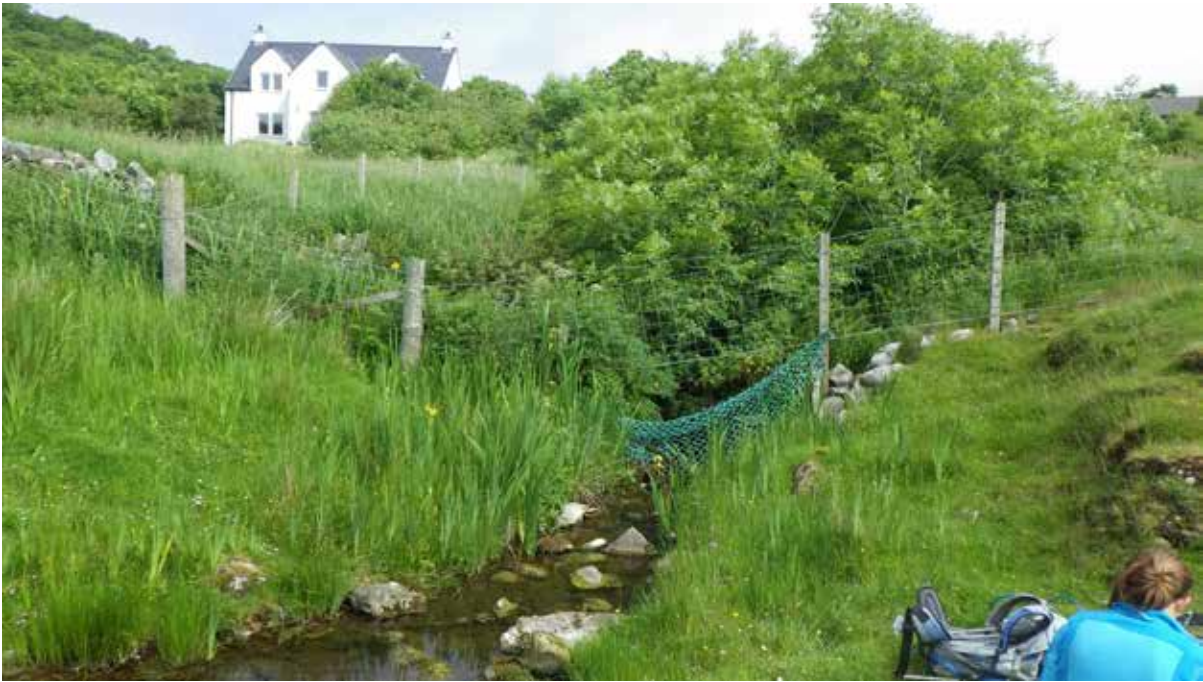
**Figure 7. Unnamed watercourse running onto shore below house. Associated with waypoints 12 & 13. Location of freshwater sample LSF7.**

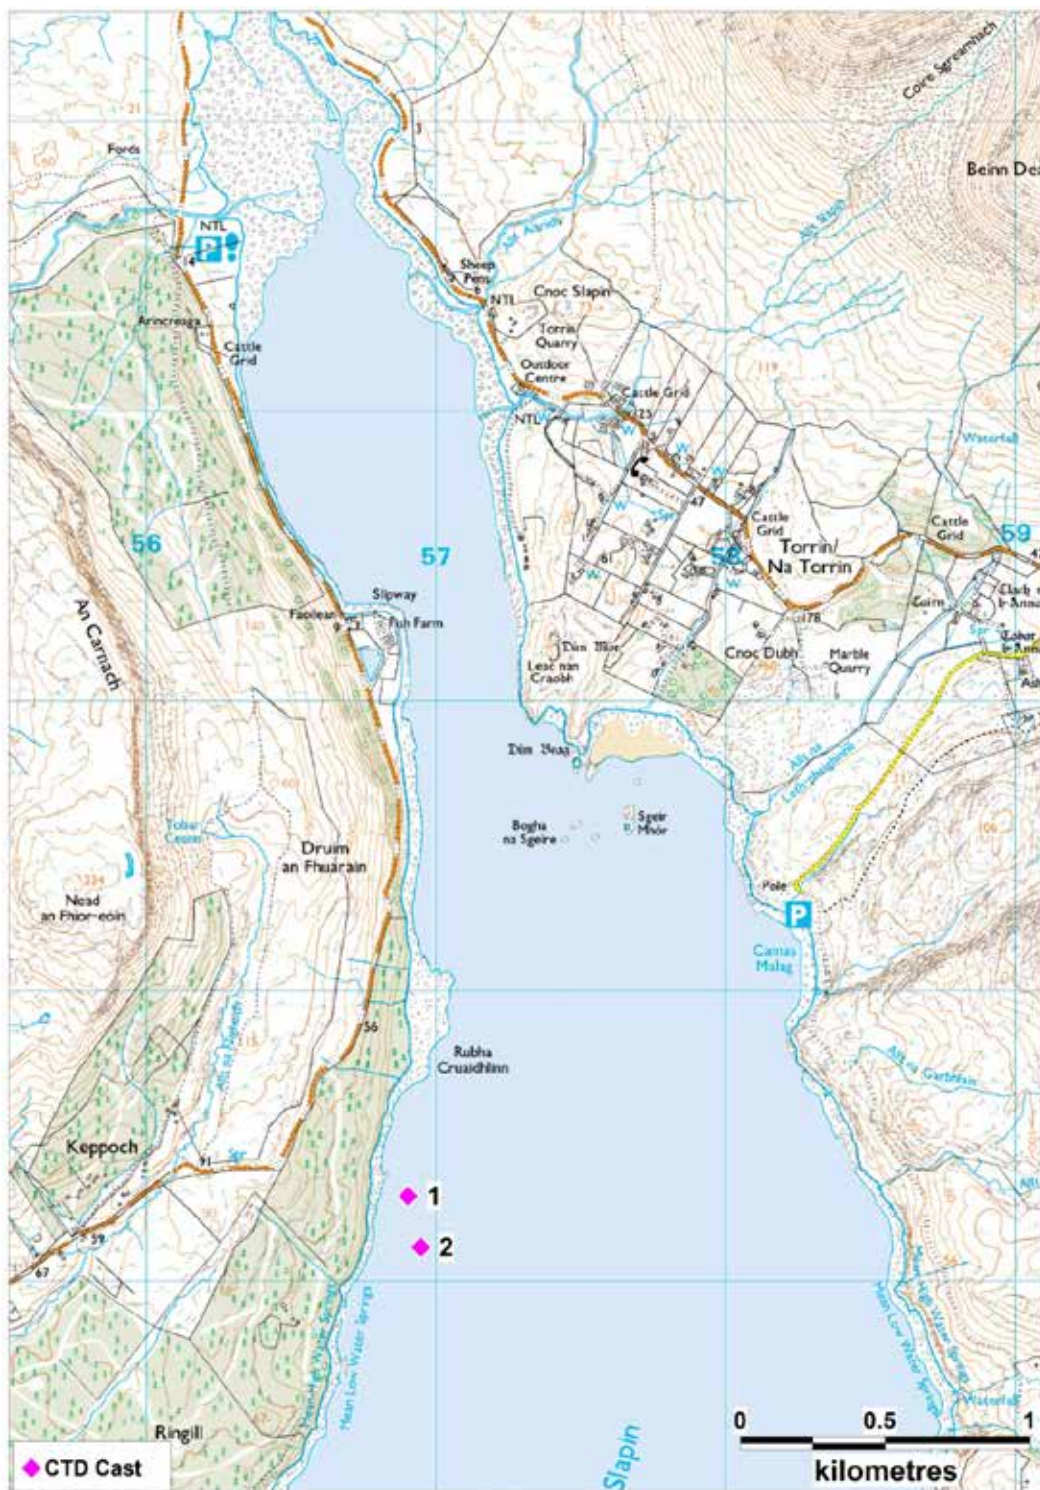
**Figure A8.1 Location of CTD casts**

Two CTD profiles were taken, one at the NE end of the site and the second at the SW side of the site. The gathered data will be sent to Cefas as agreed previously on a separate Excel sheet.

Data obtained during the shoreline survey. The locations of the casts are shown in Figure A8.1.
