Sanitary Survey Report Loch Sligachan SL-195 June 2015

Report Title	Loch Sligachan Sanitary Survey Report
Project Name	Scottish Sanitary Survey
Client/Customer	Food Standards Agency Scotland
Cefas Project Reference	C6316D
Document Number	C6316D_2014_11
Revision	1.1
Date	10/06/2015

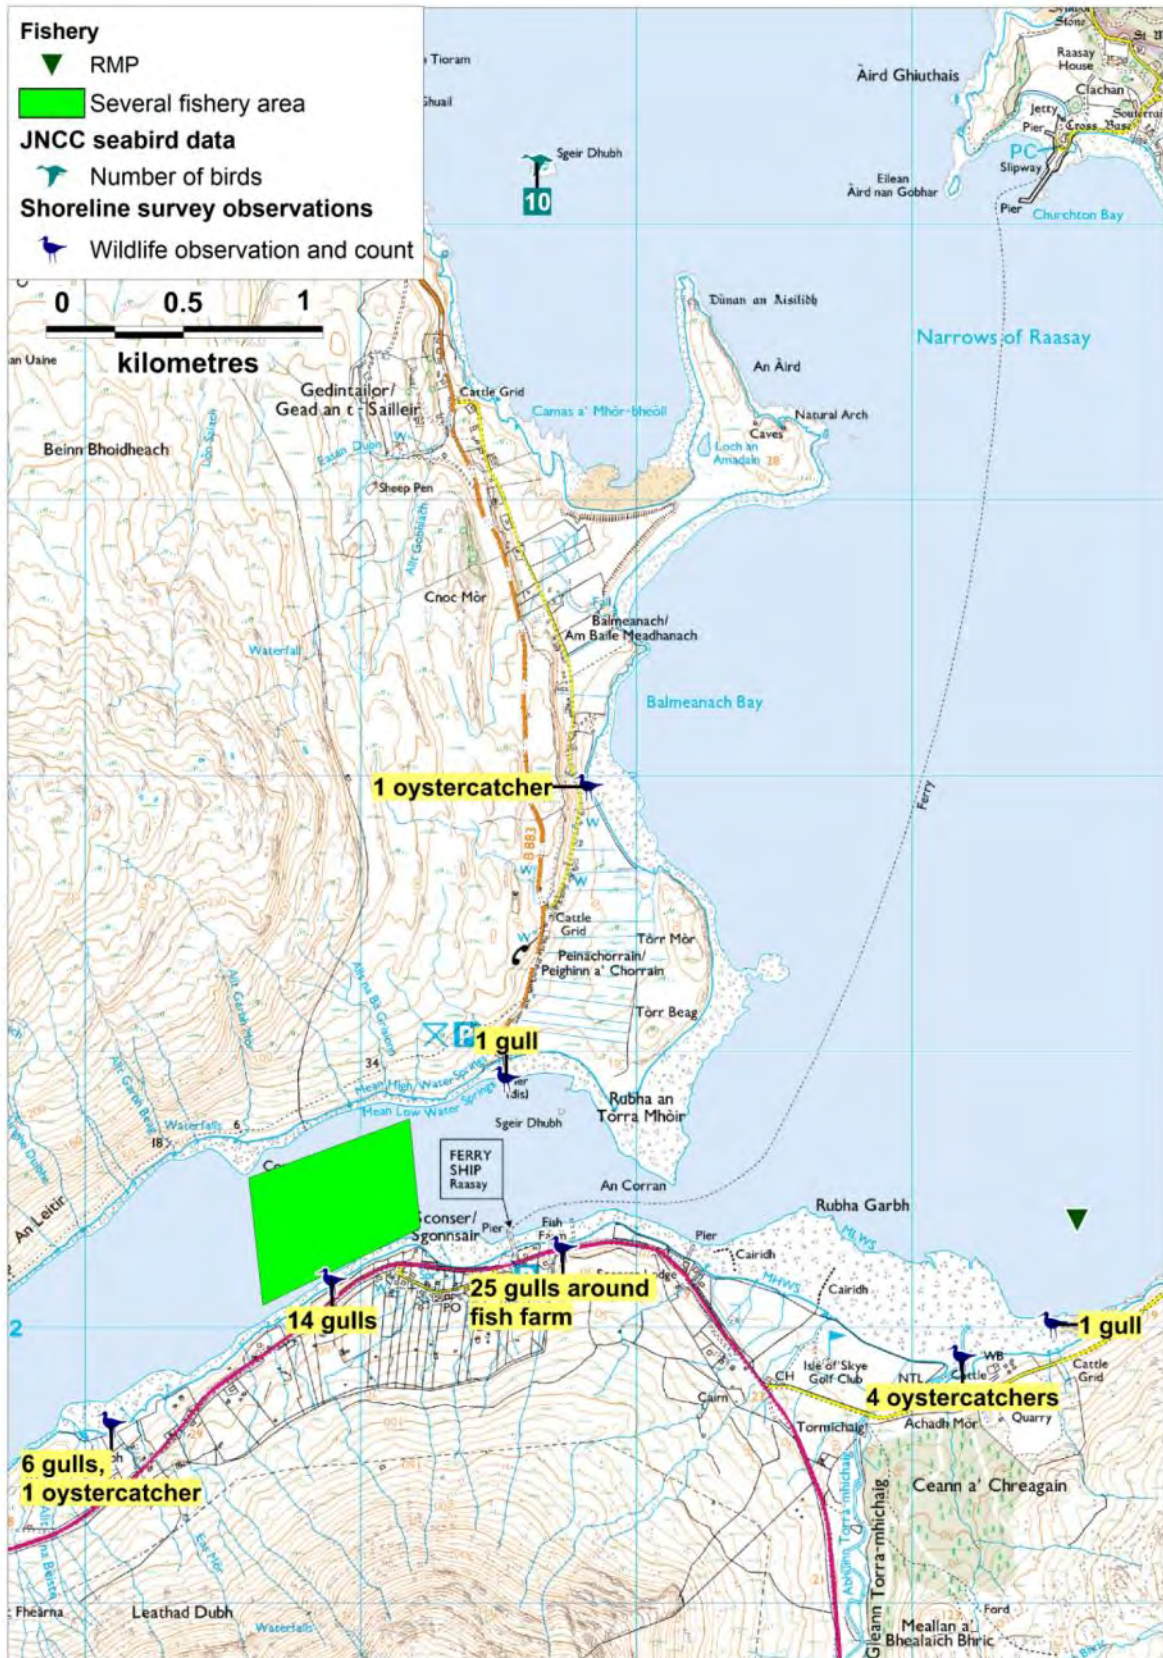
Figure 6.1 Map of wildlife distributions around Loch Sligachan

Wildlife are not expected be significant source of contamination to the Loch Sligachan scallop fisheries, although they will contribute to background levels of contamination throughout the loch. The limited amount of contamination from wildlife will be mainly attributable to seabirds, including gulls and oystercatchers, and any impact will be sporadic in both spatial and temporal terms. Minor input may occur from other species such as seals, otters and deer.

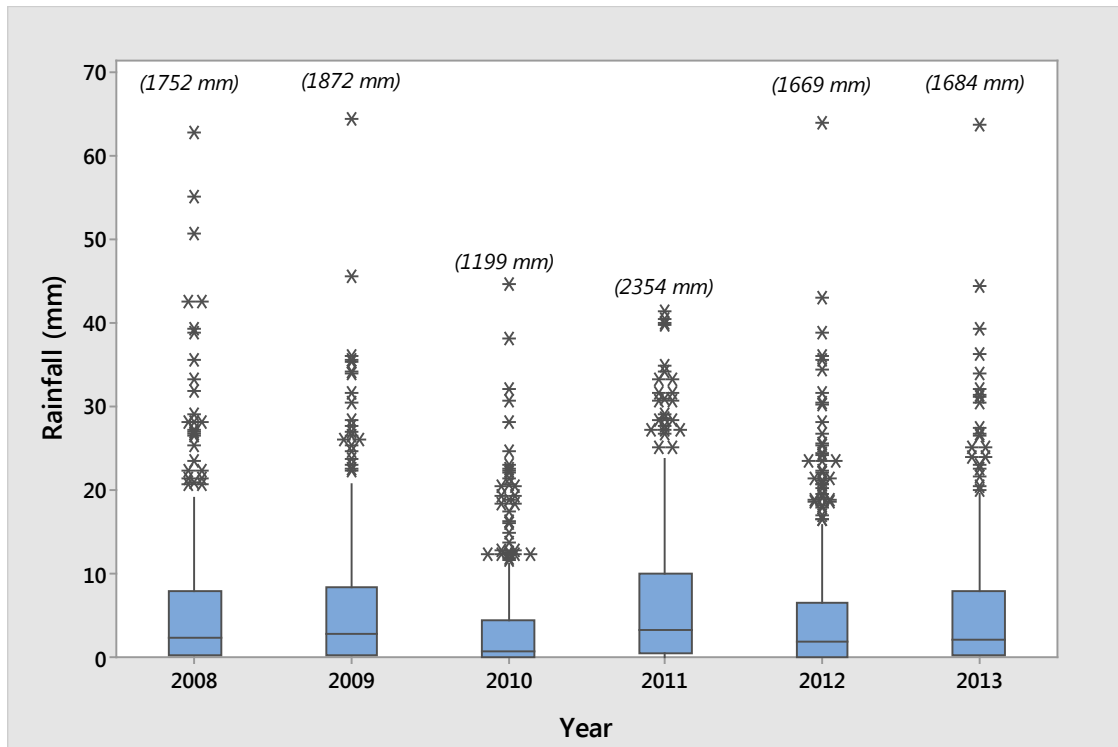
Figure 9.1 Box plot of daily rainfall values by year at Skye: Lusa (2008 – 2013)

Daily rainfall values varied from year to year, with 2010 having the lowest overall daily rainfall and the lowest total rainfall (1199 mm). The wettest year was 2011 (2354 mm). Rainfall values exceeding 40 mm/d occurred in all years, but extreme rainfall values exceeding 60 mm/d occurred in 2008, 2009, 2012 and 2013.

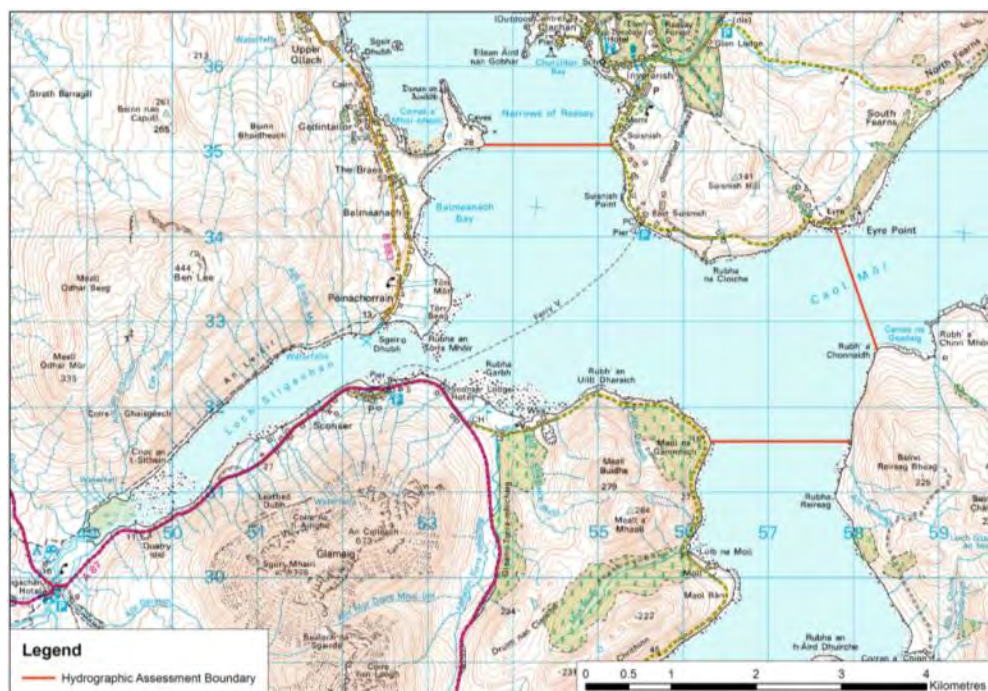
Figure 13.1 Extent of the hydrographic study area

Loch Sligachan lies on the eastern coast of the Isle of Skye, within the Highland region on the west coast of Scotland. The mouth of Loch Sligachan opens to the south of the Isle of Raasay, where the Sound of Raasay meets the Inner Sound. The hydrographic assessment area for Loch Sligachan is illustrated in Figure 13.1, with the red lines demarcating the boundaries of the area. The assessment area covers the entire of Loch Sligachan, and extends beyond the mouth of the loch to the area to the south of Raasay. The northern boundary runs across the Narrows of Raasay, and the eastern boundary from Eyre Point on Raasay to Rubh' a' Chonnaidh on Scalpay. The southern limit extends from Scalpay to Maol na Gainmich on Skye.

The total length of Loch Sligachan is 4.4 km. The loch has a relatively consistent width, being slightly narrower at the head and mouth, and with a maximum width of approximately 700 m towards the eastern end of the loch by Sconser. A spit of sand runs out from the headland at Rubha an Tòrra Mhòir at the mouth of the loch.

Bathymetry is generally gently sloping on either side of the sill and at the head of Loch Sligachan. A substantial gravelly and marshy intertidal area is found at the head of Loch Sligachan (Figure 13.1) and areas of intertidal gravel are also found to the east of the sill on both northern and southern shores at the mouth of the loch.

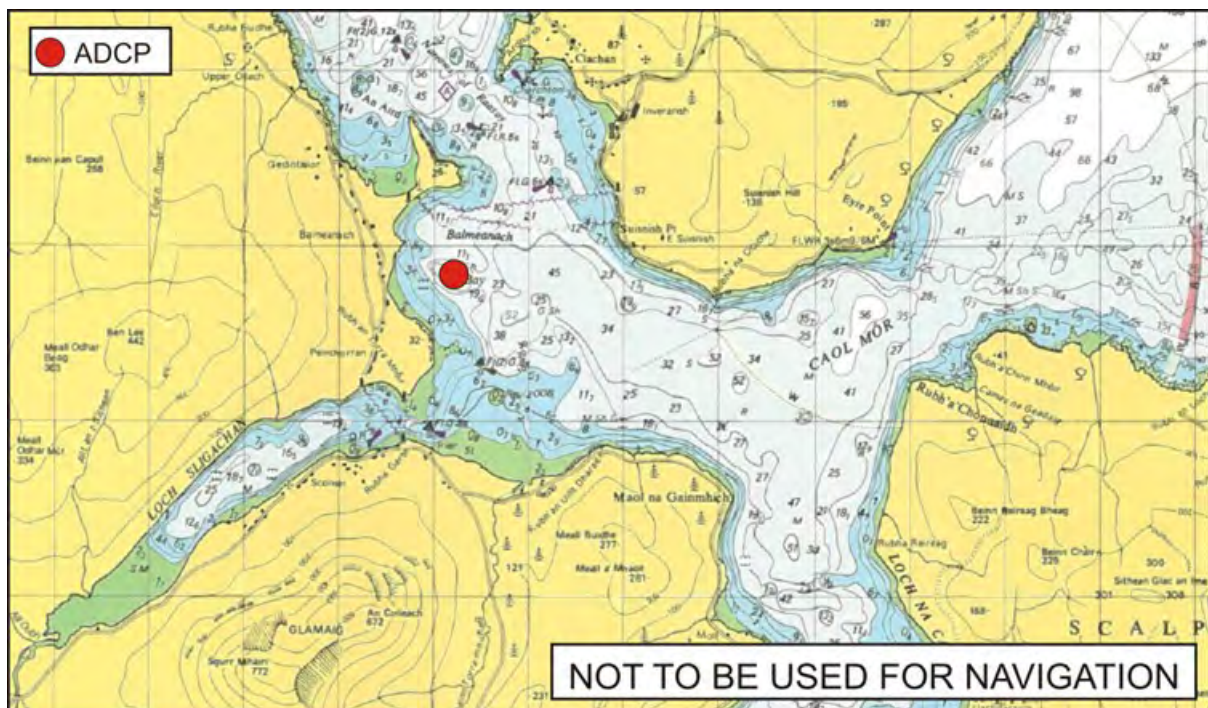
Figure 13.2 shows the bathymetry of the assessment area. Loch Sligachan has one shallow sill at a depth of 4 m at its mouth. The sill is 650 m in length, and stretches from Rubh'an Torra Mhor in the north to Rubha Garbh in the south. To the west of the sill, the basin of Loch Sligachan reaches a maximum depth of 25 m. To the east of the sill, bathymetry slopes gently to approximately 35 m. The maximum depth within the assessment area to the east of the sill is 56 m, to the northwest of Rubh'a Chonnaidh. Depths of greater than 52 m can be found in isolated areas across the assessment area to the east of the sill.

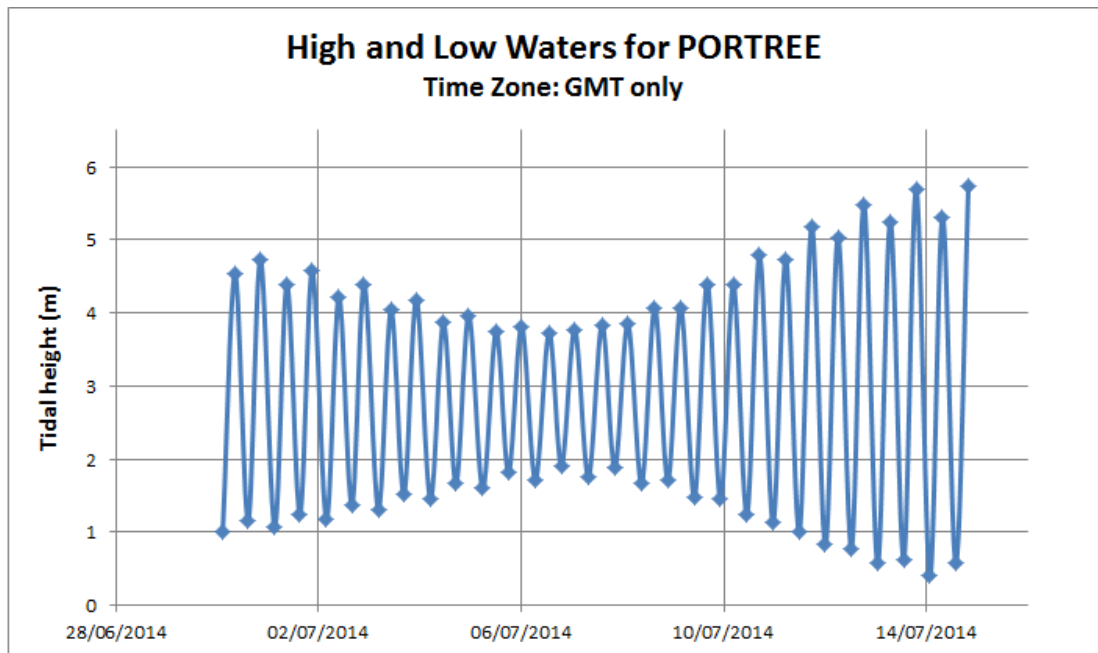
Figure 13.3 Two week tidal curve for Portree. Reproduced from Poltips3 [www.pol.ac.uk/appl/poltips3]

Standard tidal data for Portree, centred around the survey date of 7th July 2014, are shown in Figure 13.3. Tidal predictions for Portree indicate that in this region the tidal characteristics are semi-diurnal, with a well-developed spring-neap cycle.

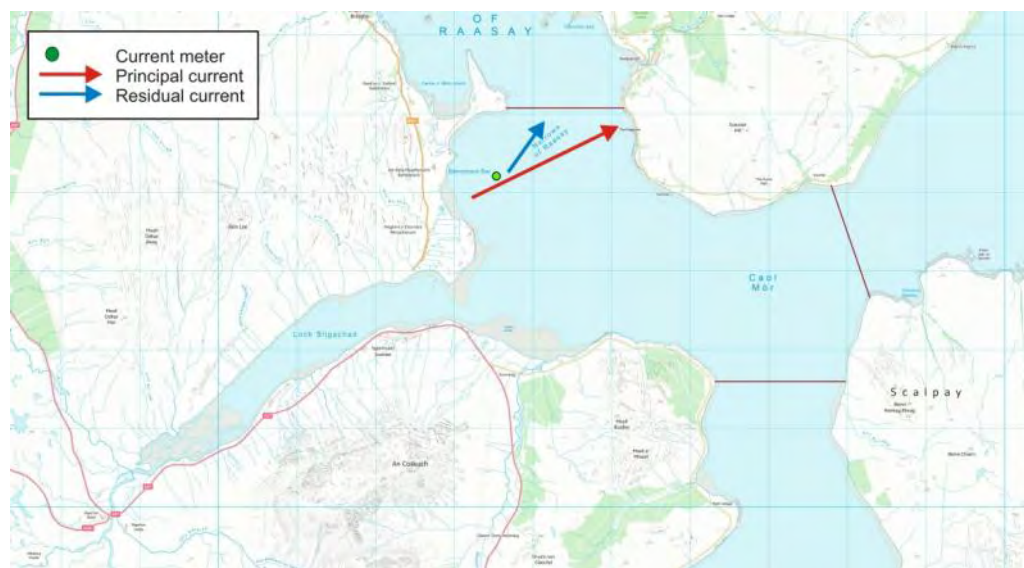
Figure 13.4 Map showing 2000 Loch Sligachan sample site within the assessment area.

Current meter data were available at a single site within the assessment area. Data were obtained from SEPA for a site towards the northern boundary of the assessment area, at Balmeanach Bay. There was no accompanying hydrographic report by the appointed contractor who obtained this dataset. This location is shown in Figure 13.4. The survey spanned 15 days between 21st February 2000 and 9th March 2000; a half-lunar period, the minimum necessary to capture a spring-neap cycle.

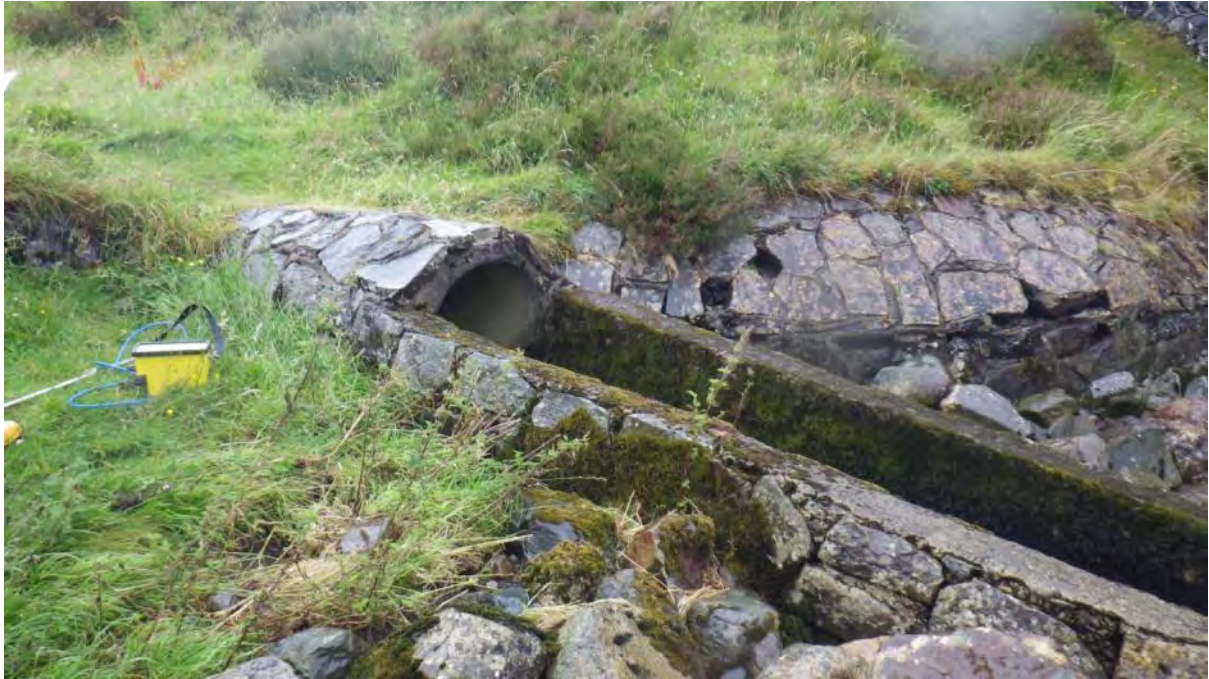
Figure 7. Discharge pipe running under A863 road into river. Site of LSFW1. Associated with Waypoint (WP) 3.

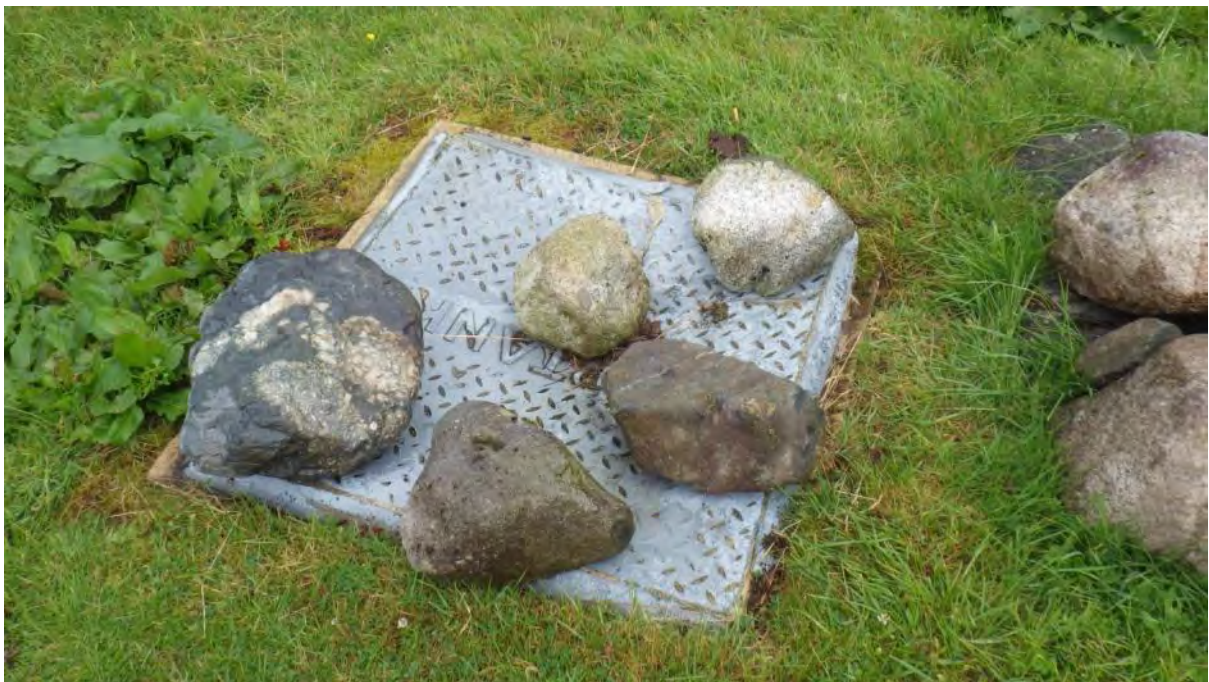
Figure 8. Septic tank on campsite grounds. Associated with WP10.

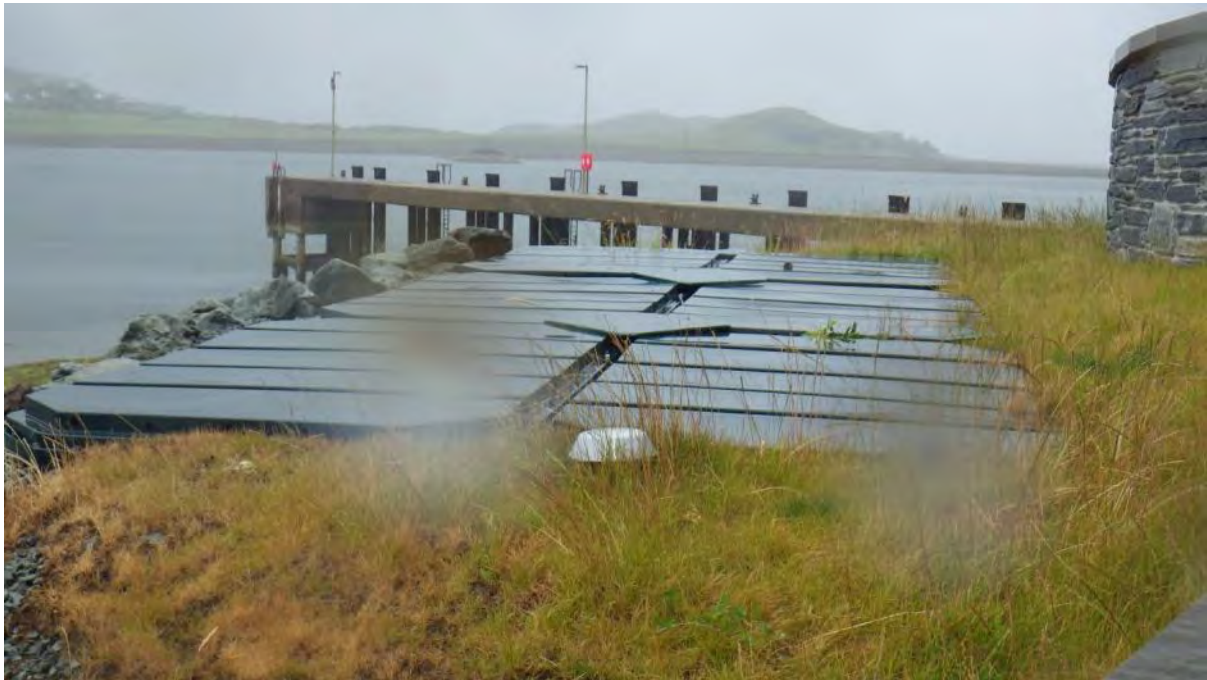
Figure 9. Septic tank over the wall from car park at Sconser Pier. Associated with WP20.

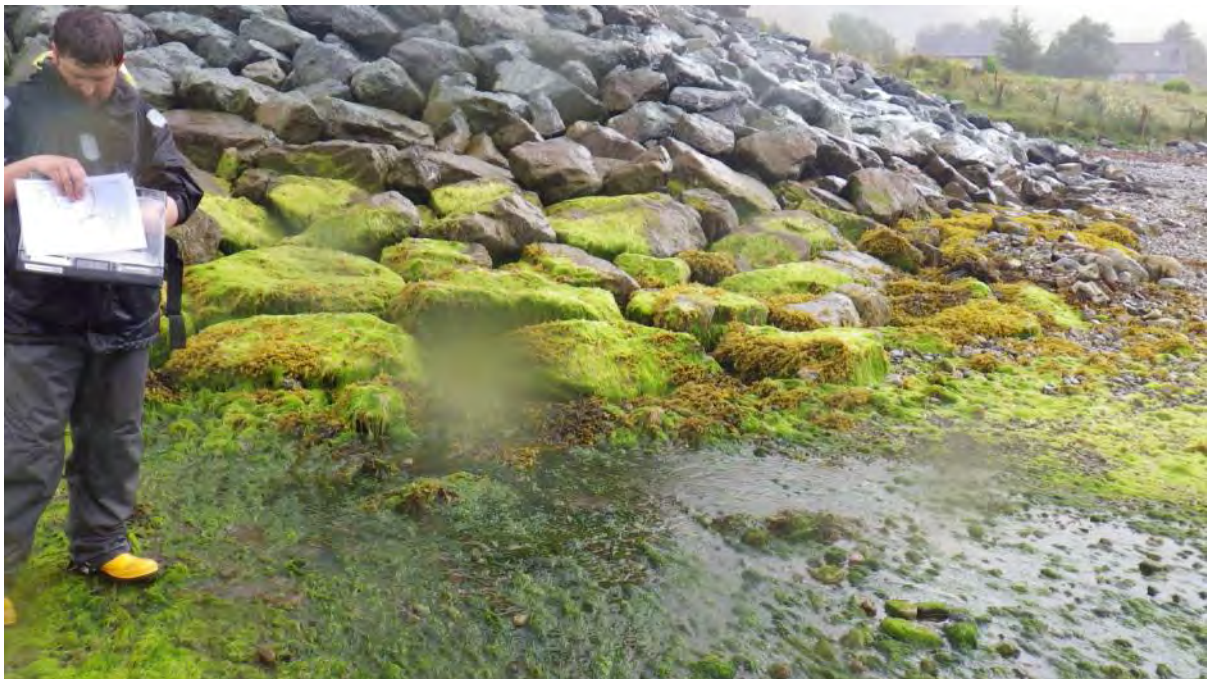
Figure 10. Water flow from below septic tank at car park, Sconser Pier. Site of LSF5. Associated with WP22.

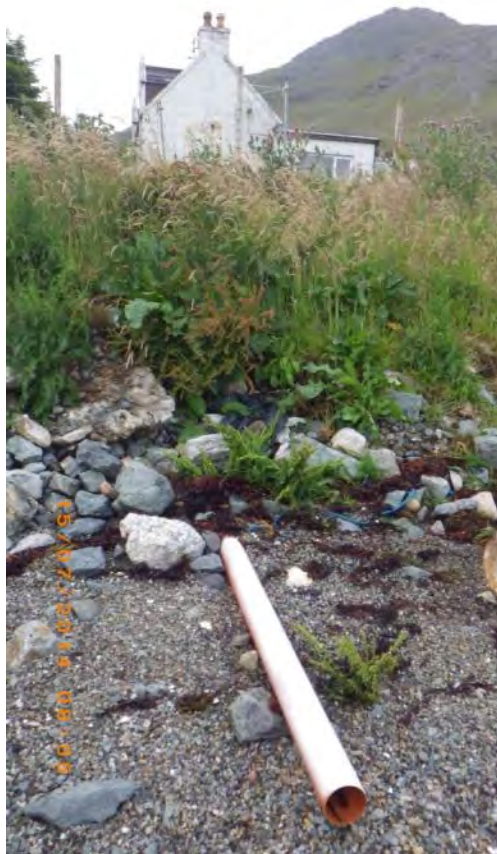
Figure 12. Discharge to seawater, pipe below house protruding onto shore. Site of LSSW2. Associated with WP 29.

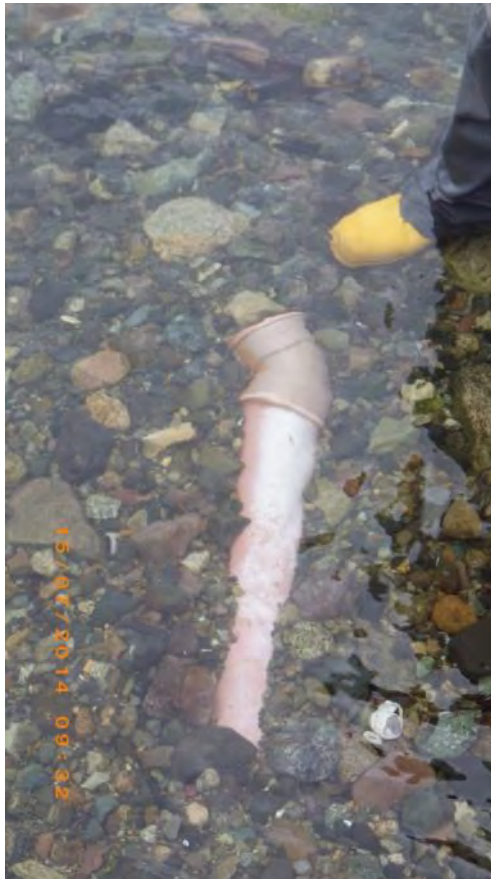
Figure 13. Submerged discharge pipe. Site of LSSW3. Associated with WP39.

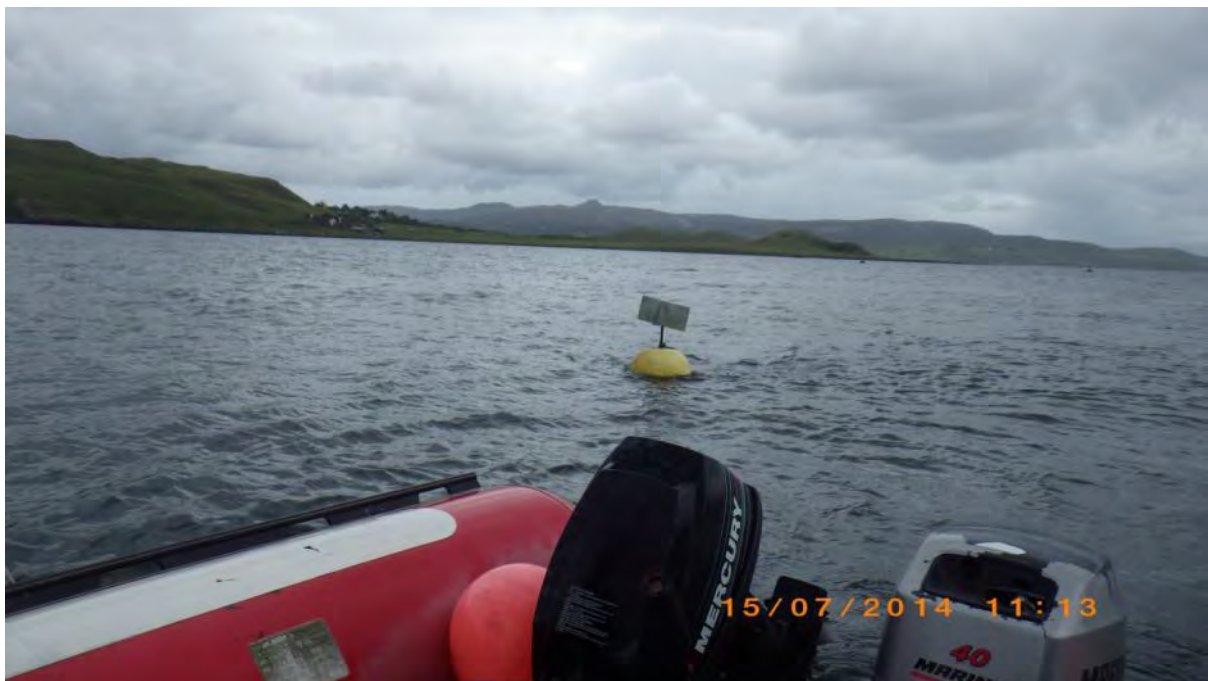
Figure 14. Alternate RMP point marker buoy. Site of LSSW7. Associated with WP52

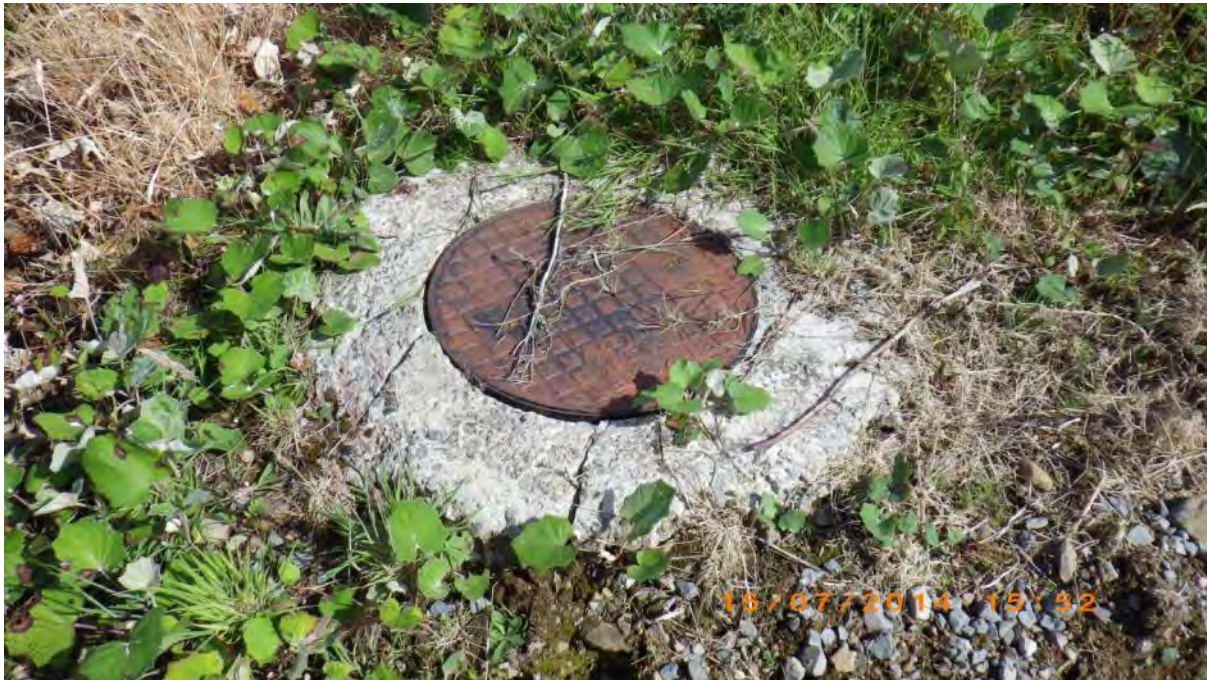
Figure 17. Possible soakaway. Associated with WP70.

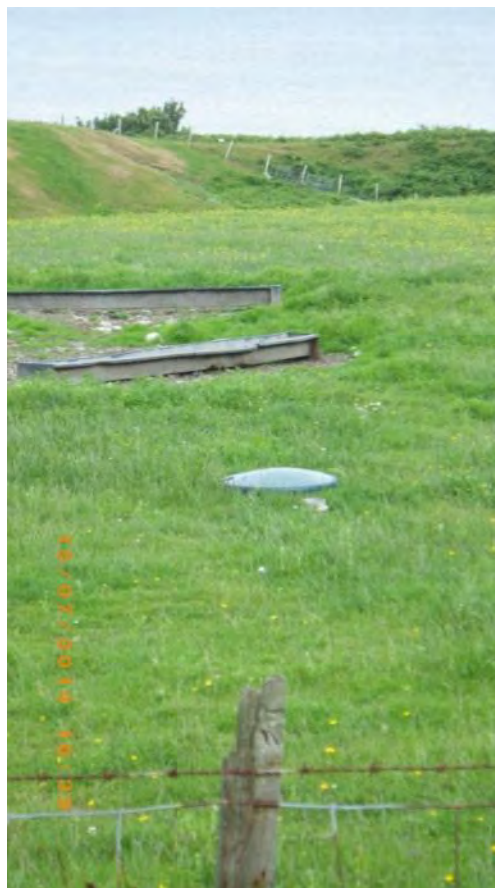
Figure 18. Possible septic tank site. Associated with WP79.

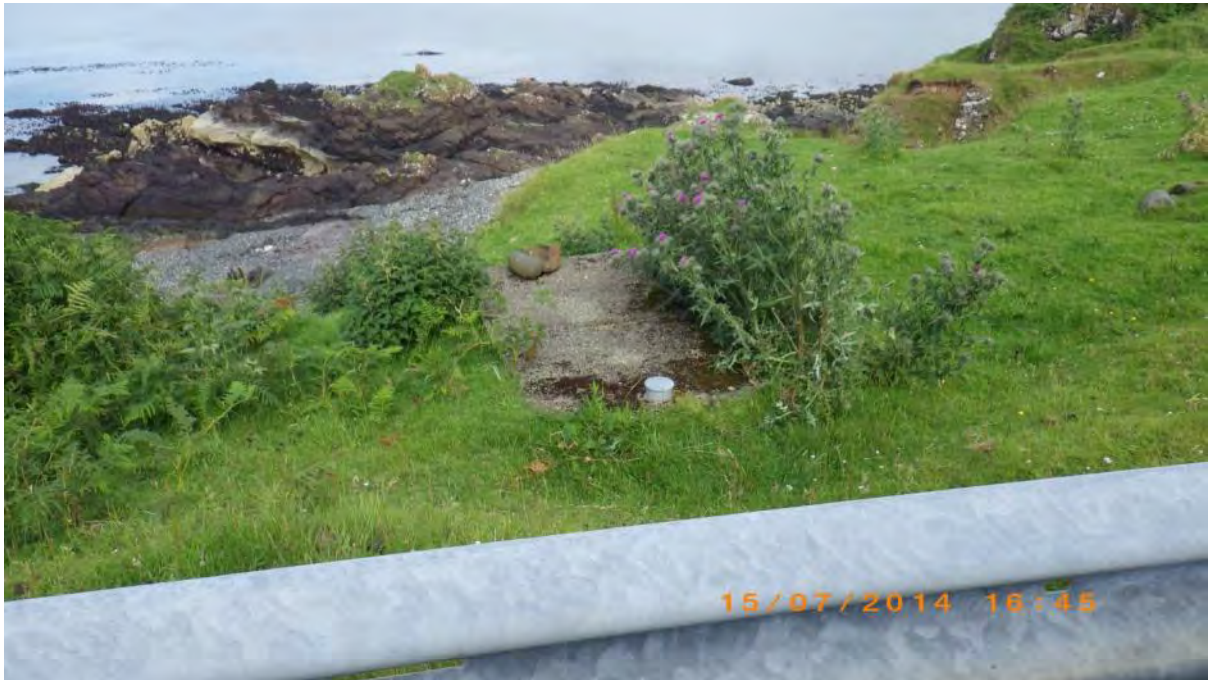
Figure 19. Suspected site of septic tank. Associated with WP82.
