Scottish Sanitary Survey Project

Restricted Sanitary Survey Report North Baleshare UB 490 March 2010

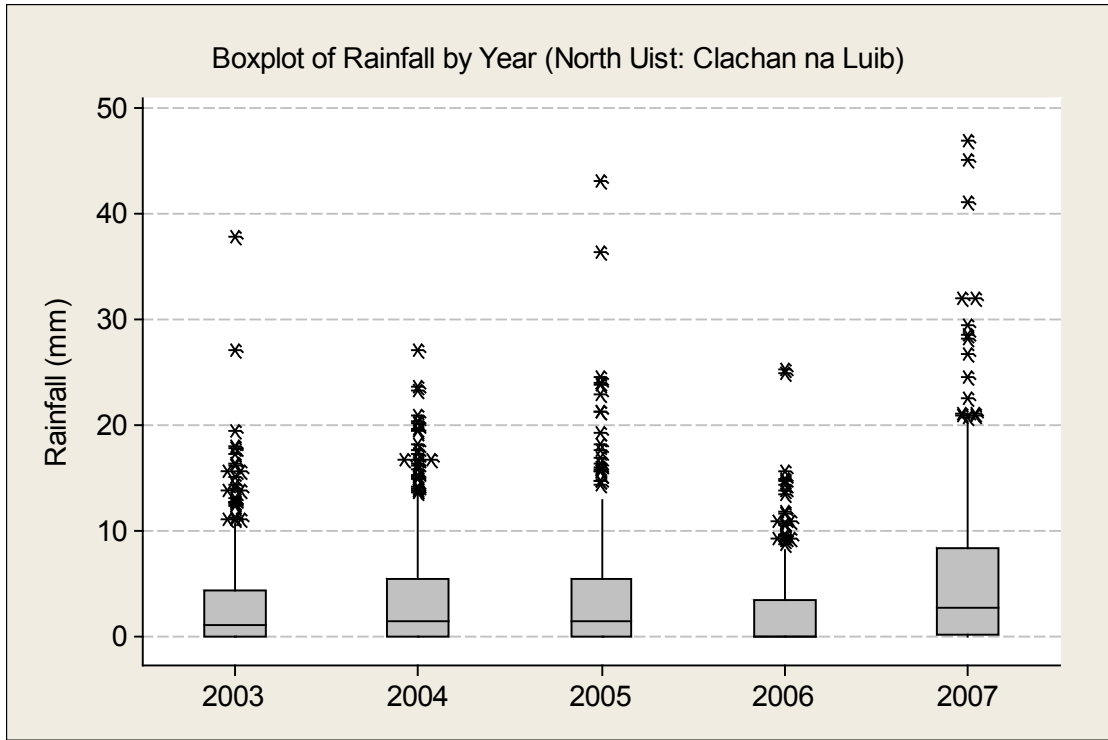
Figure 5.1 Boxplot of daily rainfall at North Uist by year

Figure 5.1 shows that there was significant variation in the median daily rainfall from year to year. Overall, 2006 was a dry year in this area and saw the lowest median rainfall. The highest individual rainfall events occurred in 2005 and 2007.

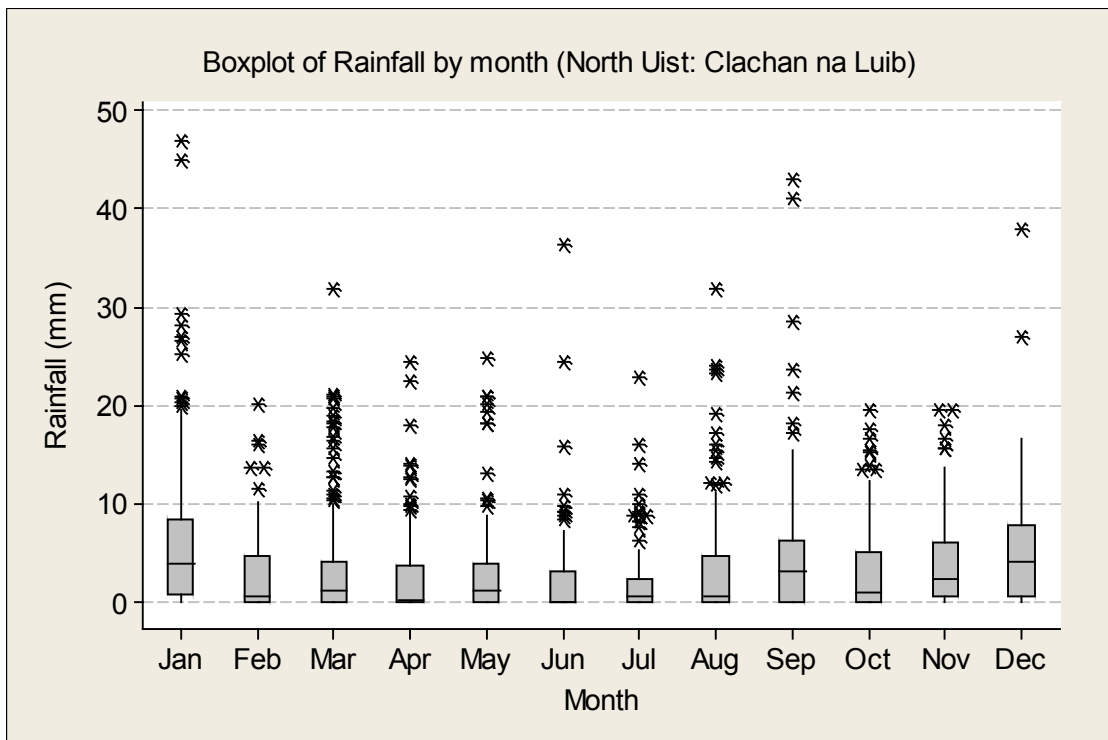
Figure 5.2 Boxplot of daily rainfall values at North Uist by month

The wettest months were December and January, but the high individual rainfall events occurred throughout the year, although not in all individual months. For the period considered here (2003 – 2007), 36% of days for which records were available experienced no rainfall while 47% of days experienced rainfall of 1mm or less. Although the mean rainfall was 4 mm per day, there were 8 occasions where daily rainfall exceeded 30mm. The highest daily rainfall recorded (47mm) fell in January 2007.

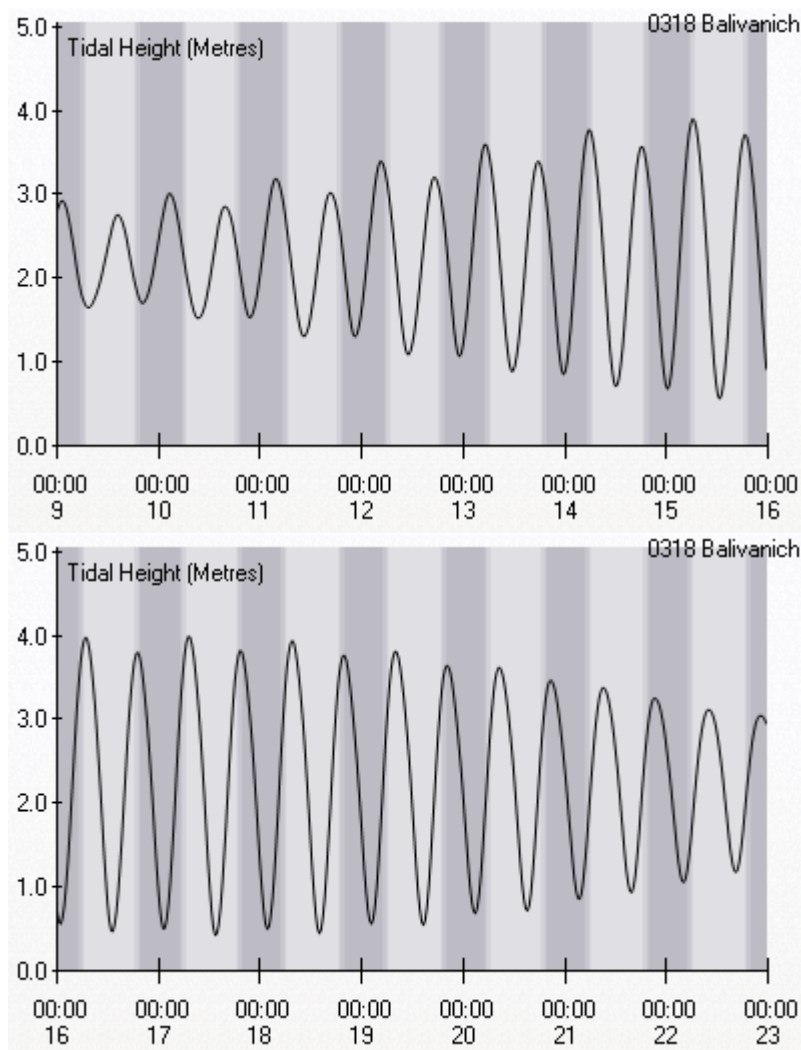
Figure 8.2 Tidal curves for Balivanich

The two tidal curves below are for the port of the Balivanich, the nearest secondary port. This is located approximately 1 km south-west of the western end of Beul au Toim and is thus relatively close to the fishery. The curves have been output from UKHO TotalTide. The first is for seven days beginning 00.00 GMT on 9th March 2010. The second is for seven days beginning 00.00 GMT on 16th March 2010. Together they show the predicted tidal heights over high/low water for a full neap/spring tidal cycle.

The tide type is Semi-Diurnal.

MHWS	4.1 m
MHWN	3.1 m
MLWN	1.5 m
MLWS	0.5 m

Predicted heights are in metres above chart datum. The tidal range at spring tide is therefore approximately 2.6 m and at neap tide 2.6 m.

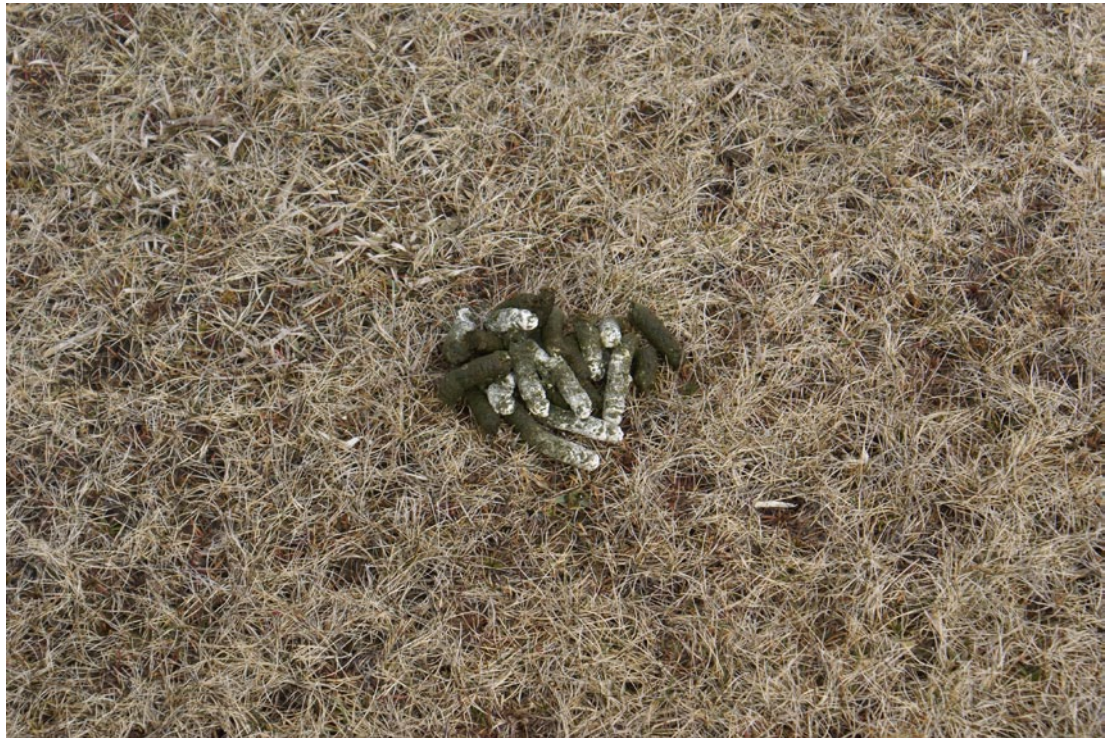
Figure 5 Evidence of waterfowl

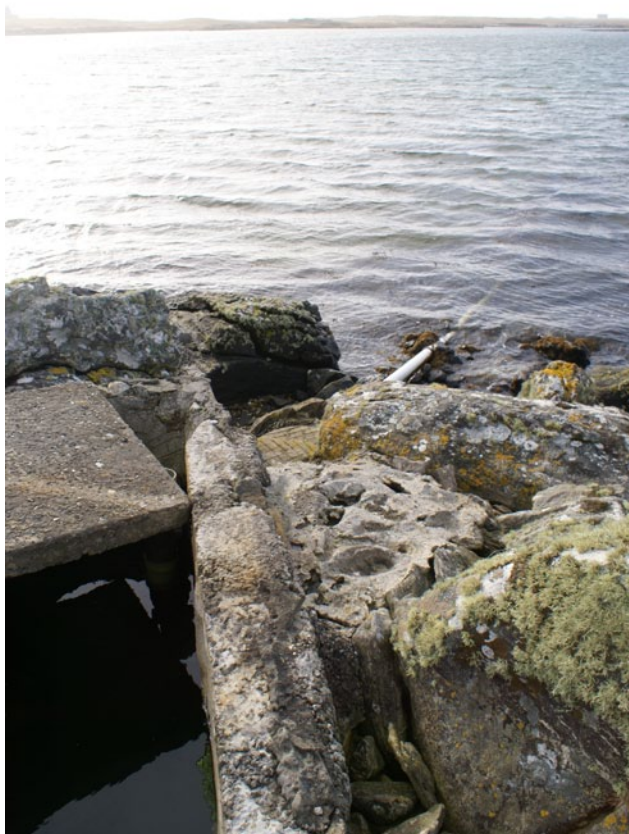
Figure 6 Outflow pipe at back of Hebridean Smokehouse. Water sample NBFW2
Figure 7 Fresh water input, water sample NBFW3

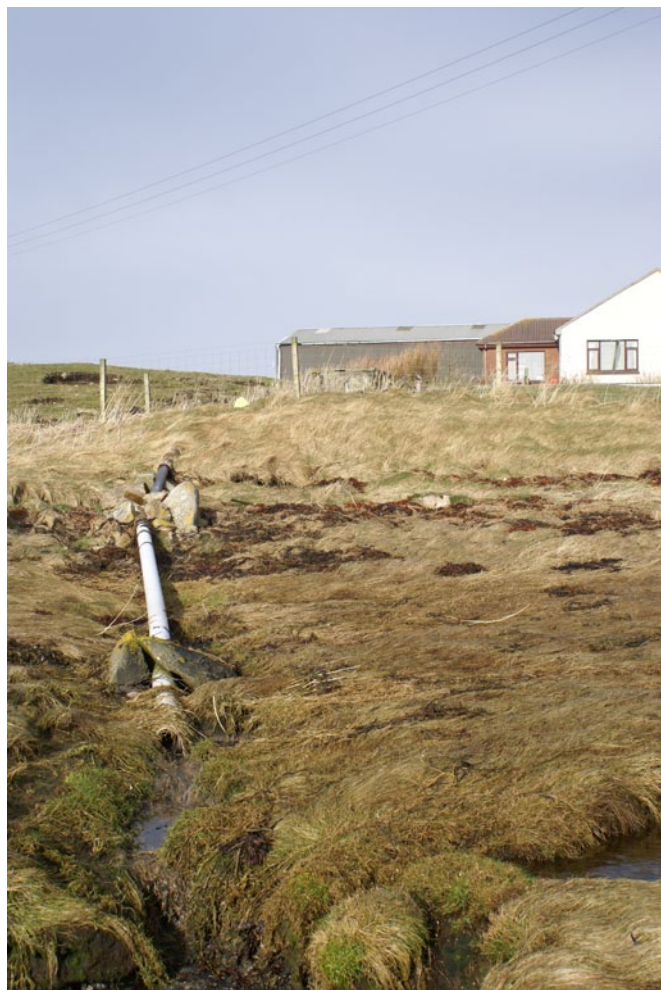
A single sewage outfall pipe was observed during the shoreline survey. A fresh water sample was taken from the outfall and returned a very high result of 46000 *E. coli* cfu/100 ml.

Figure 8 Septic outflow from large B&B, Fresh water sample NBFW4
Figure 9 Minor run field off at building site, Fresh water sample NBFW5
