Scottish Sanitary Survey Project

Restricted Sanitary Survey Report Oitir Mhor Bay AB 419 February 2009

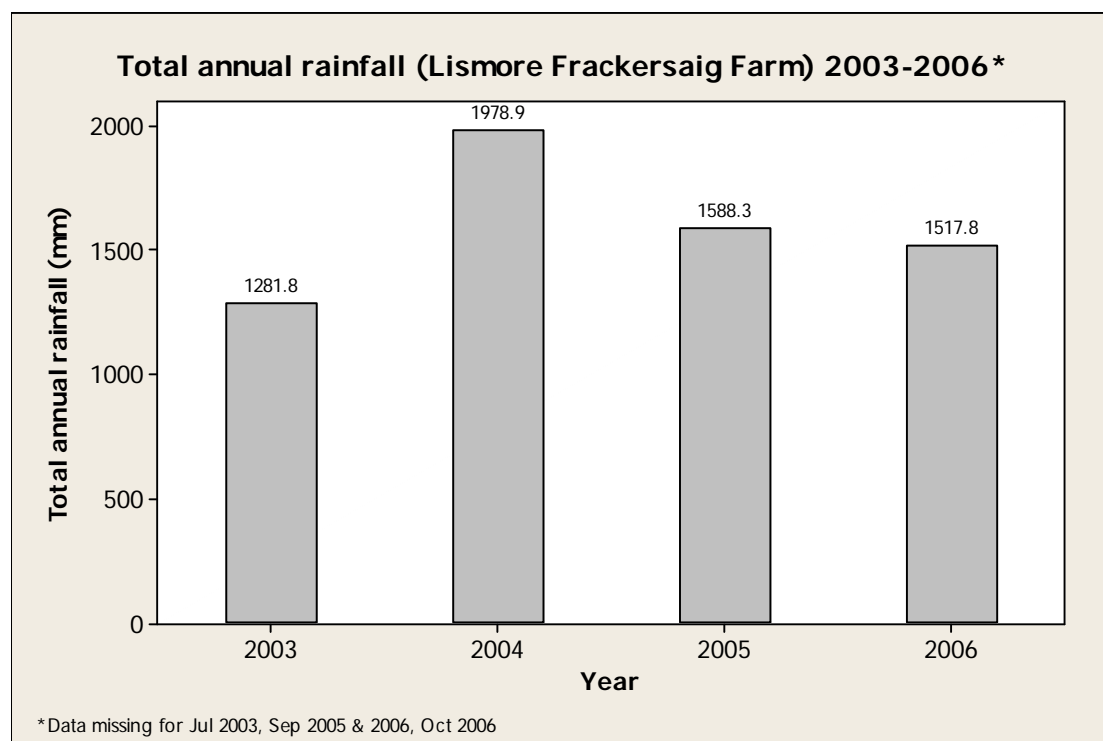
Figure 5.1 Total annual rainfall at Lismore Frackersaig Farm 2003 – 2006 (no records for Jul 2003, Sep 2005 & 2006, Oct 2006).

Total annual rainfall and mean monthly rainfall were calculated, and are presented in Figures 5.1 and 5.2. As there were no records for July 2003, September 2005 & 2006, October 2006, the mean for these months was calculated by dividing the total monthly rainfall by the number of years for which records were provided.

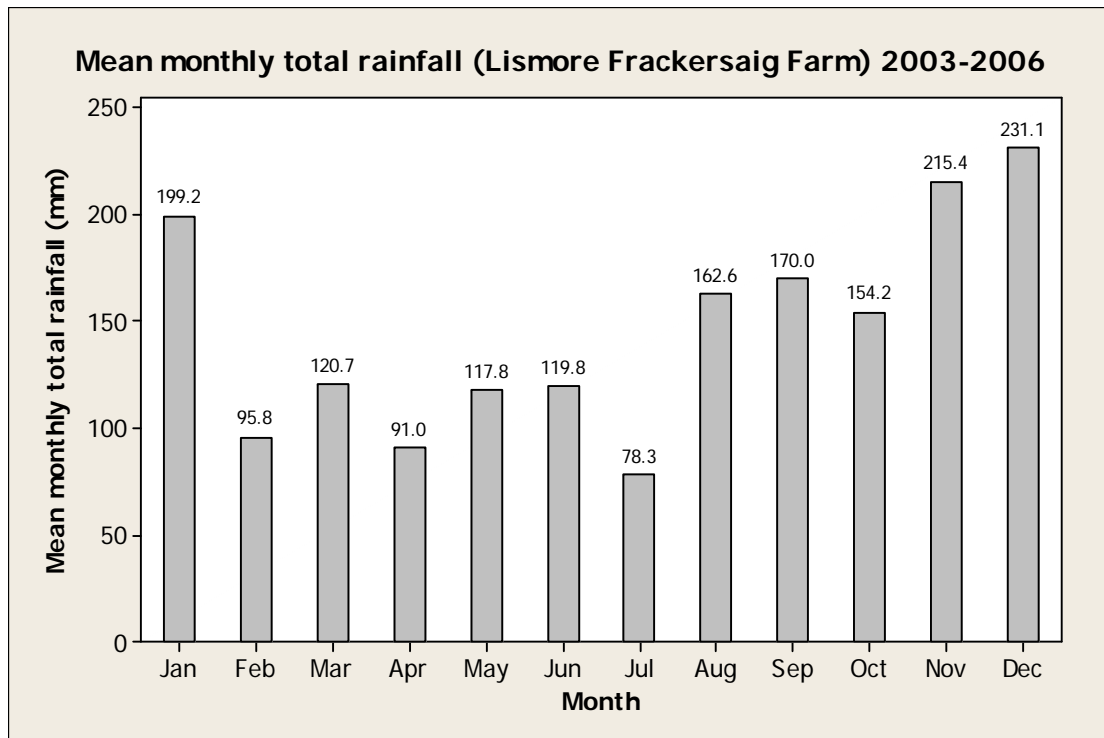
Figure 5.2 Mean total monthly rainfall at Lismore Frackersaig Farm 2003 – 2006
(no records for Jul 2003, Sep 2005 & 2006, Oct 2006).

The wettest months were January, November and December. The largest increases in rainfall over the previous months occurred in August and November. For the period considered here (2003 – 2006), only 26% of the days experienced no rainfall while 16% of days experienced rainfall of 1mm or less.

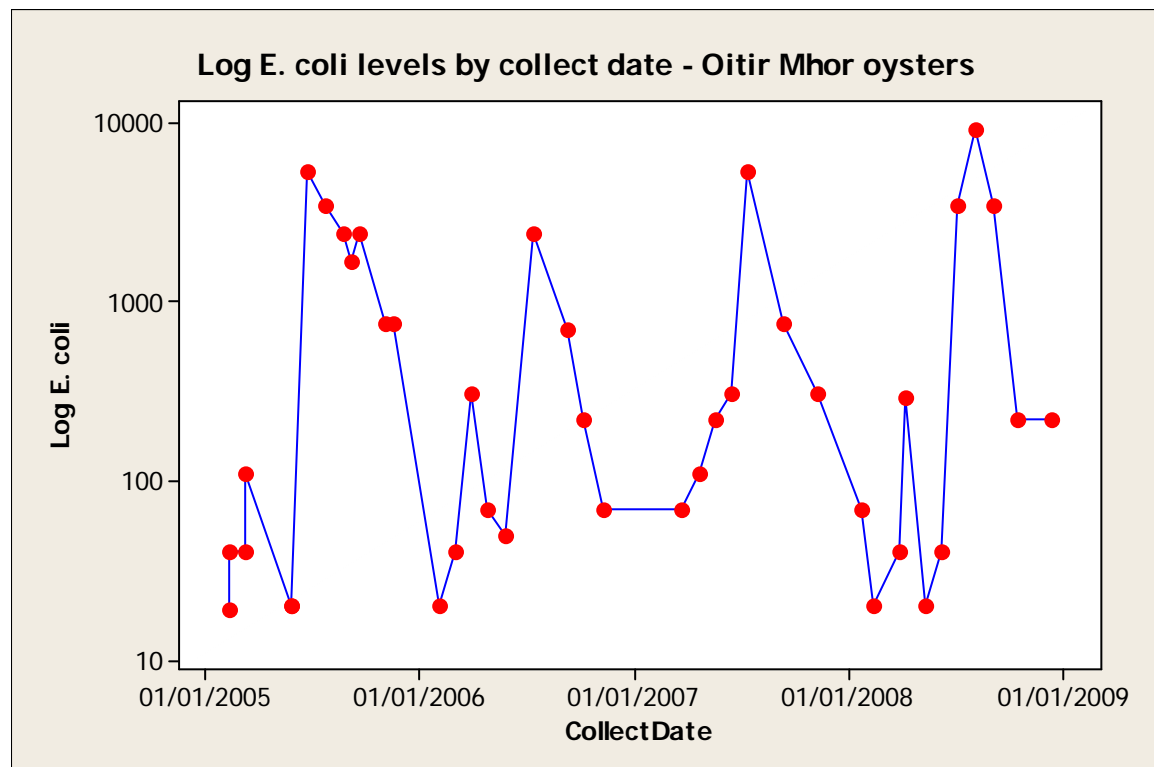
Figure 7.1 Scatterplot of Log *E. coli* result (mpn/100g) for pacific oysters vs collection date

Figure 7.1 presents a scatterplot of the individual results against date for all pacific oyster samples taken from Oitir Mhor Bay. There were insufficient results available to produce the same for the periwinkle samples taken from Oitir Mhor Bay.

A distinct trend can be seen in the plotted log results, with two seasonal peaks in *E. coli* concentrations, one in spring and another, stronger, peak in summer. This pattern is clearly observed in 2005, 2006 and 2008. In 2007, the lower early peak in results is missing, though the main peak is still clearly seen.

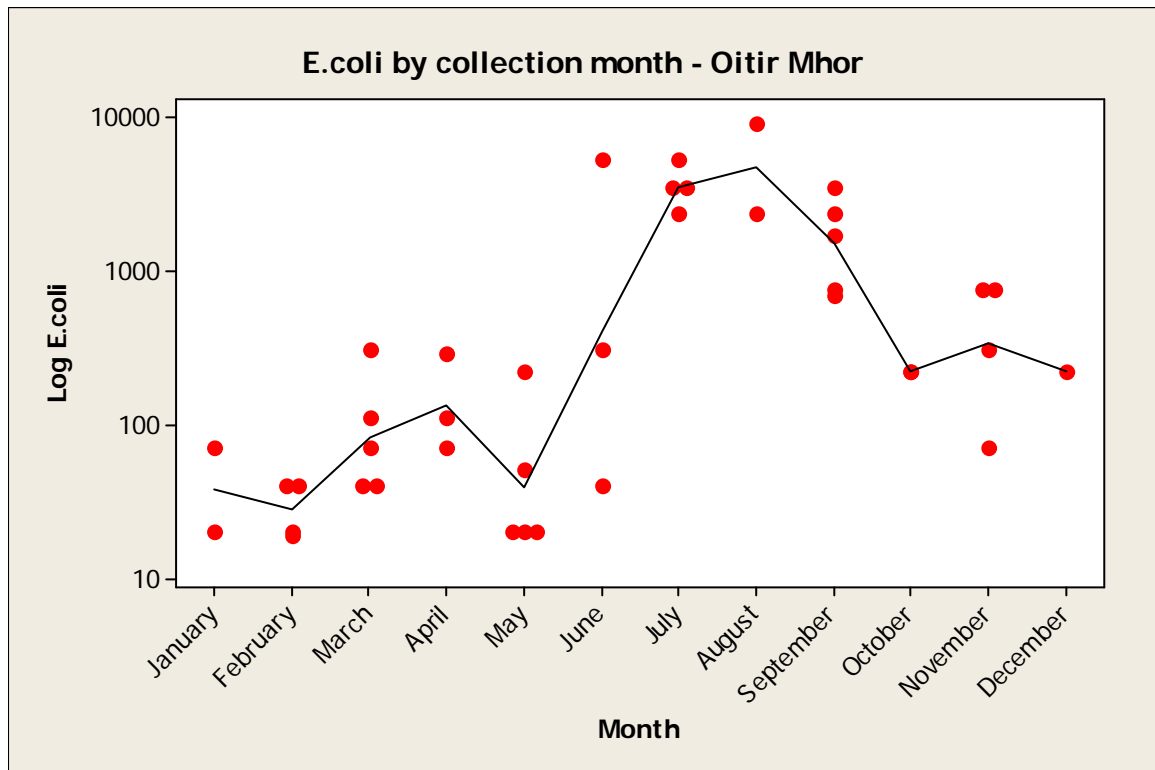
Figure 7.2 Value plot of Log E. coli result vs sampling month

Monitoring results were then plotted by month of sample collection as seen in Figure 7.2. An initial peak in values occurs in March and April with a larger peak following in July and August that is beginning to tail off in September. Results remain elevated into November before dropping off to lower levels in January. No more than five results were reported any given month and care should be taken in the interpretation of these historical results as they are based on a limited and skewed number of observations.

These peaks do not directly coincide with seasonal variations in recorded rainfall, however this does not rule out the possibility that contamination peaks in shellfish may be indirectly related to rainfall-related surface runoff.

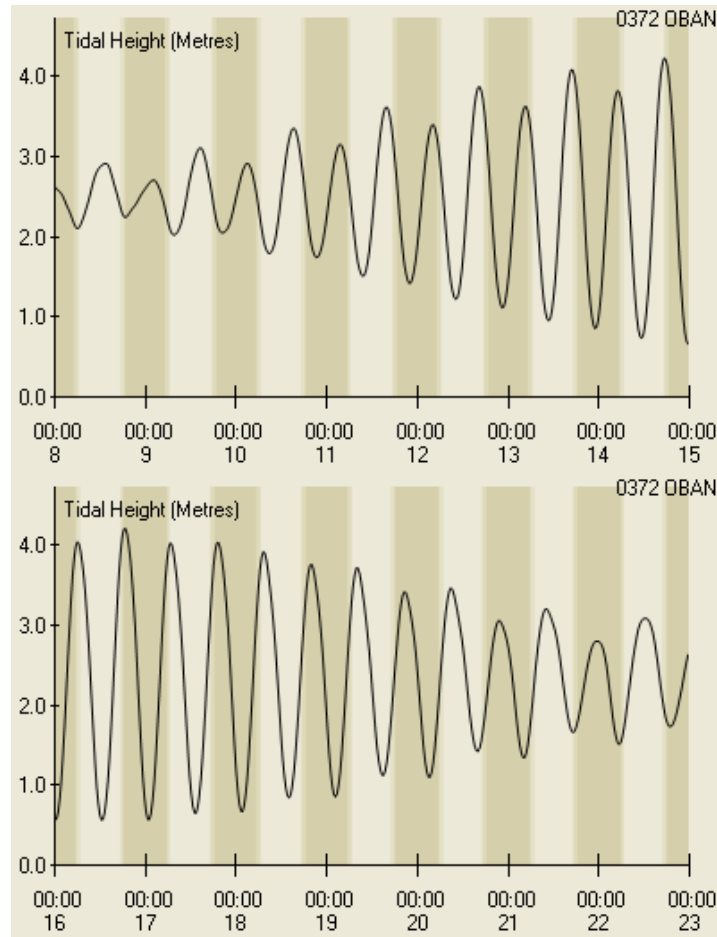
Figure 8.3 Tidal curves for Oban

The two tidal curves below are for the port of Oban the nearest standard port—they have been output from UKHO TotalTide. The first is for seven days beginning 00.00 GMT on 8th October 2008. The second is for seven days beginning 00.00 GMT on 16th October 2008. Together they show the predicted tidal heights over high/low water for a full neap/spring tidal cycle.

The tide type is Semi-Diurnal.

MHWS	4.0 m
MHWN	2.9 m
MLWN	1.8 m
MLWS	0.7 m

Predicted heights are in metres above chart datum. The tidal range at spring tide is therefore approximately 3.3 m and at neap tide 1.1 m.

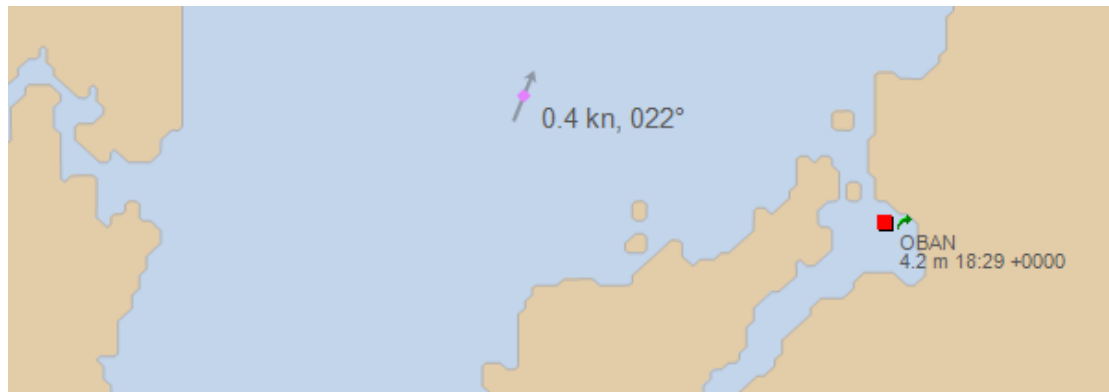
Figure 8.4 Maximum ebb tide flow and direction on a large spring tide at SN0371 (from Admiralty TotalTide)

Flow rates are slow, indicating relatively weak tidal flows in the middle of the Firth of Lorn. Flows around the tip of the island of Kerrera at the entrance to Oban Bay and Kerrera sound can be much higher with flow rates of up to 2.5 kn at spring tides reported (Clyde Cruising Club 2007). Contamination discharged to Oban Bay would potentially move a significant distance north into the Firth of Lorn on a flood tide, however interaction of currents with Kerrera island and the other smaller islands and rocks in the area would be complex making prediction of contaminant movement here difficult without

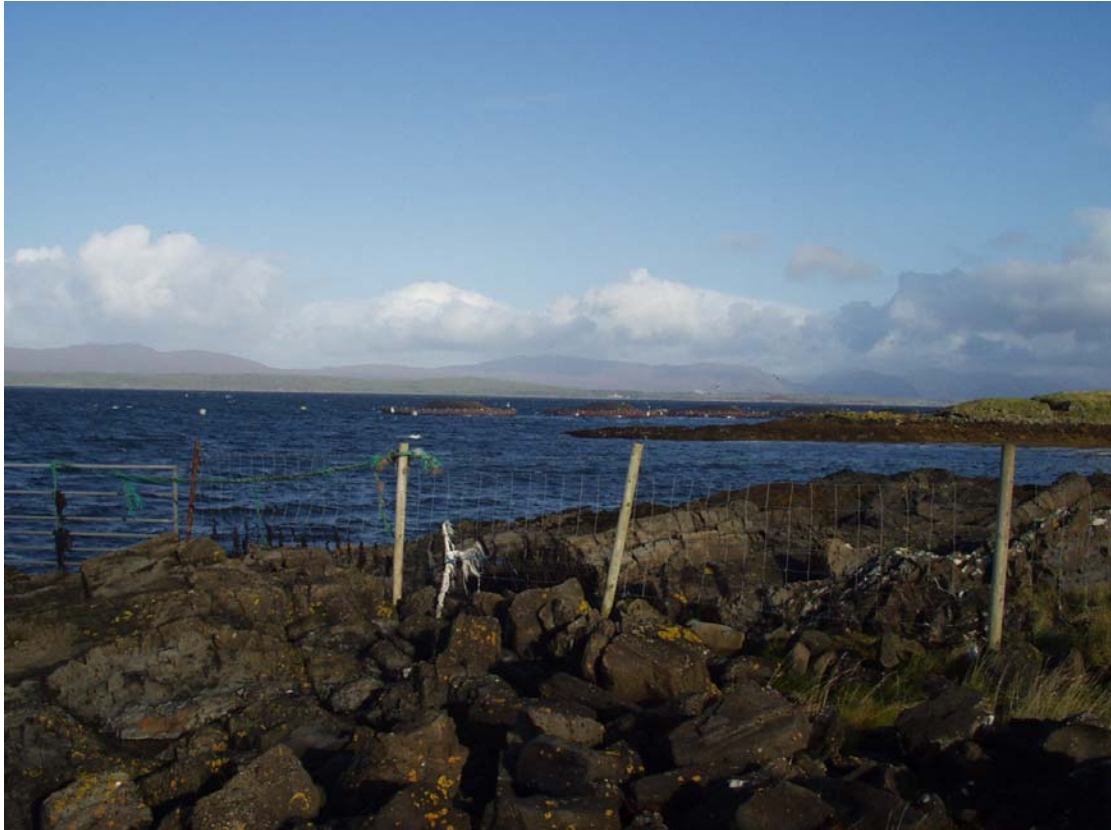
Figure 4. Offshore fish farm (six cages and one barge)

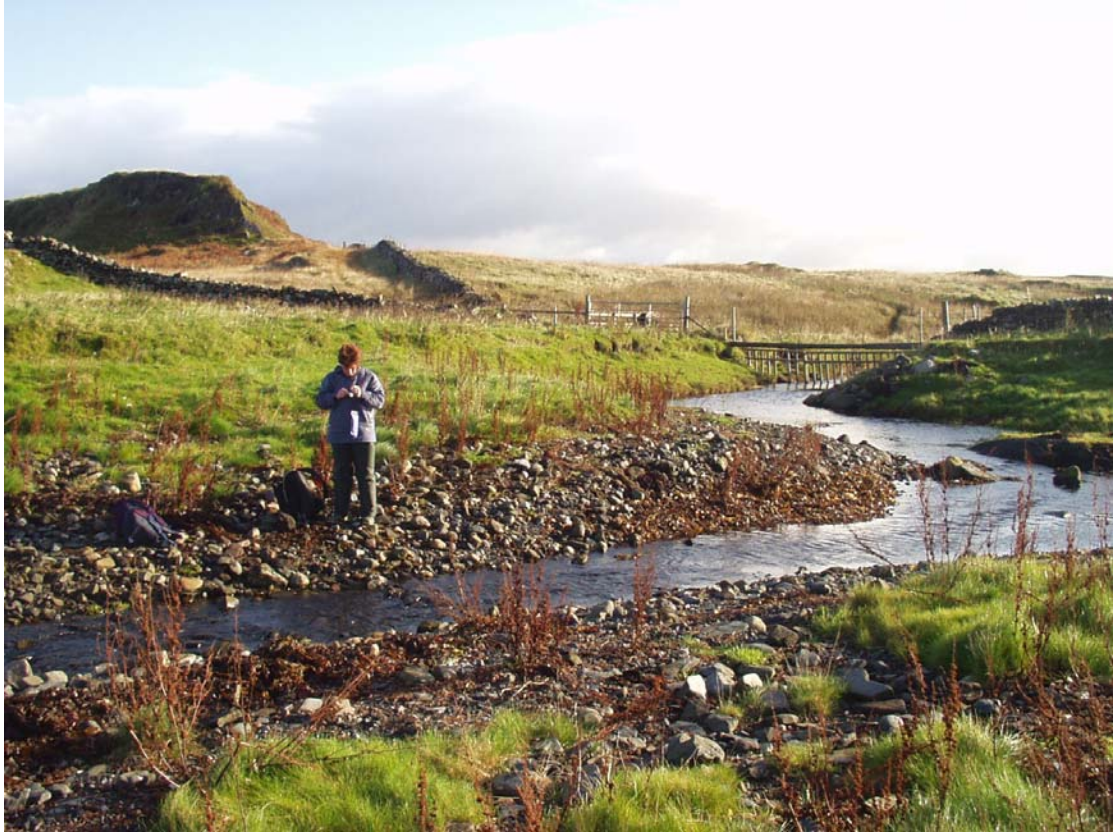
Figure 6. Fresh water stream (Fresh water sample 1)

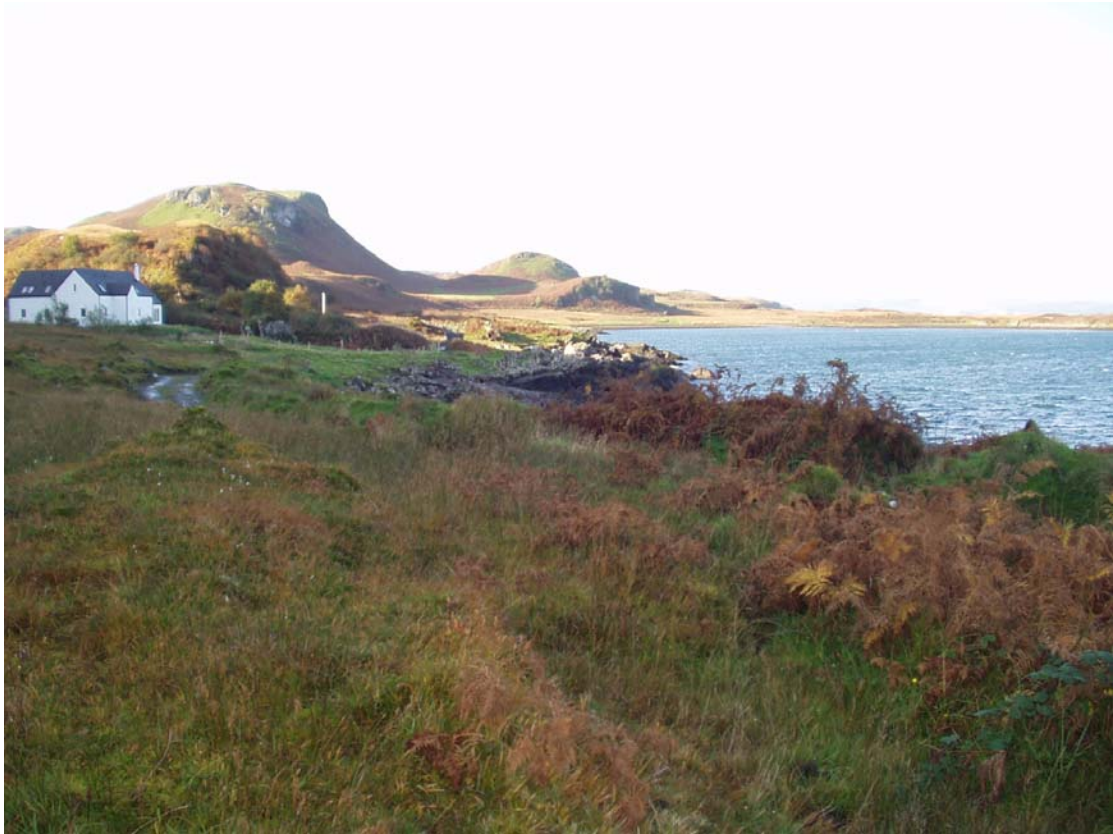
Figure 8. New unoccupied house, built in 2007

The septic tank for the new house is most likely to discharge to soakaway as no discharge pipe was observed. Should this become clogged and fail to operate properly, septic waste from the property would impact the eastern half of the shoreline along Oitir Mhor Bay.

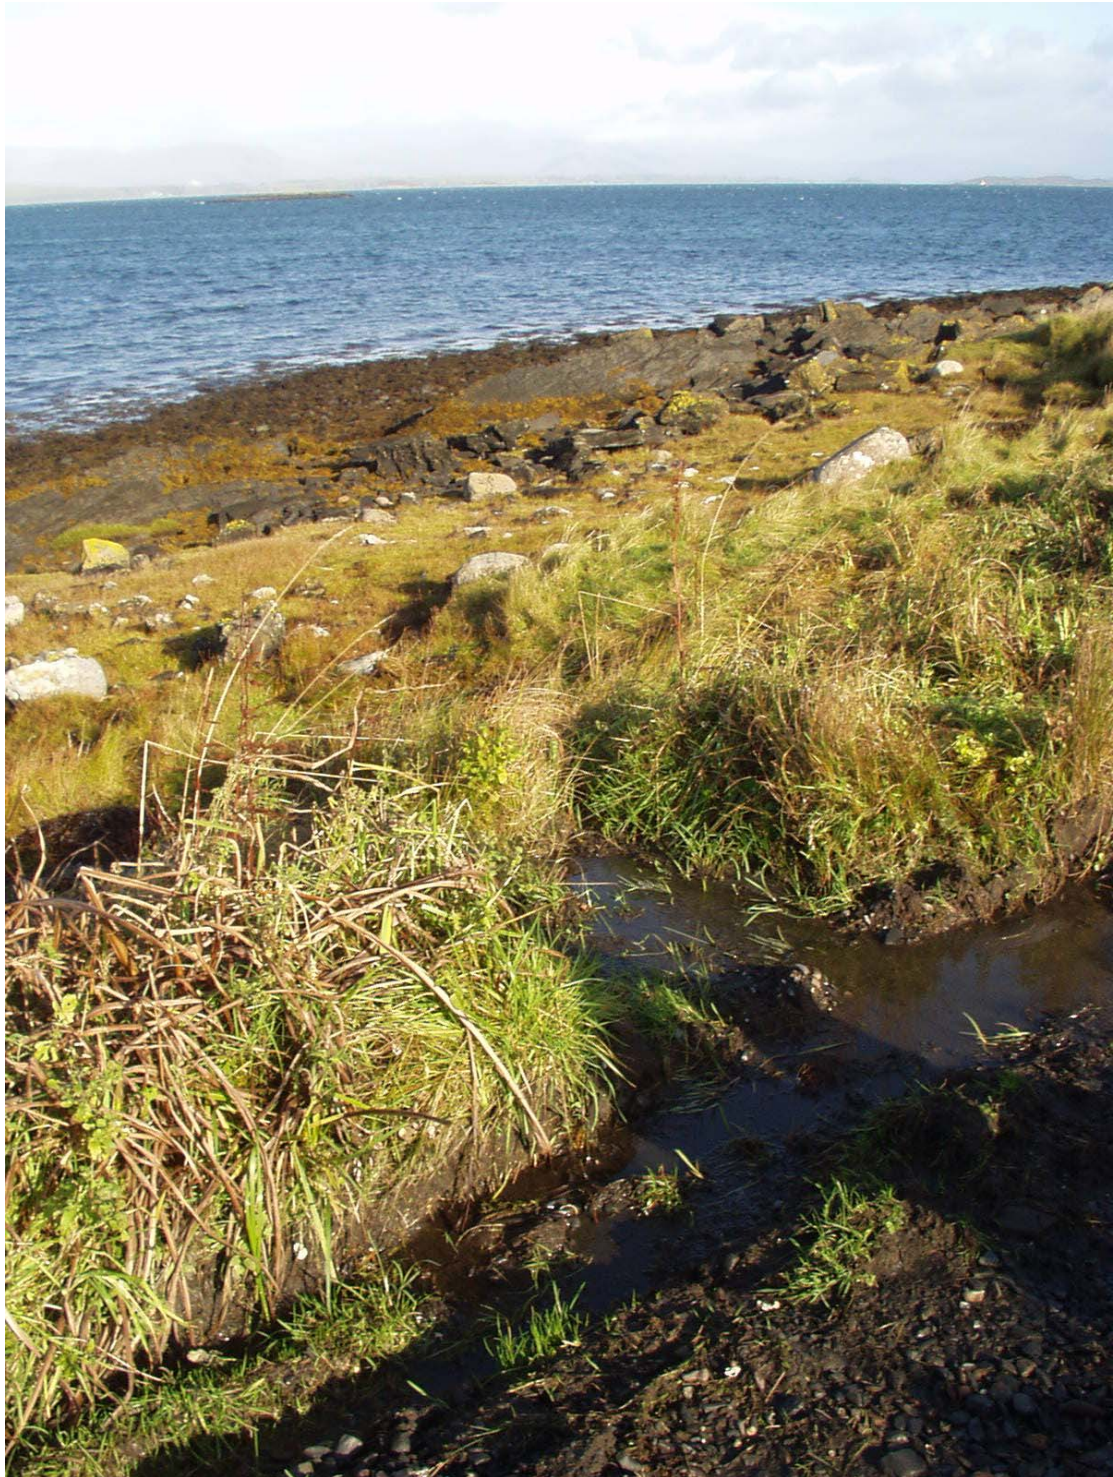
Figure 10. Fresh water stream (Fresh water sample 4)

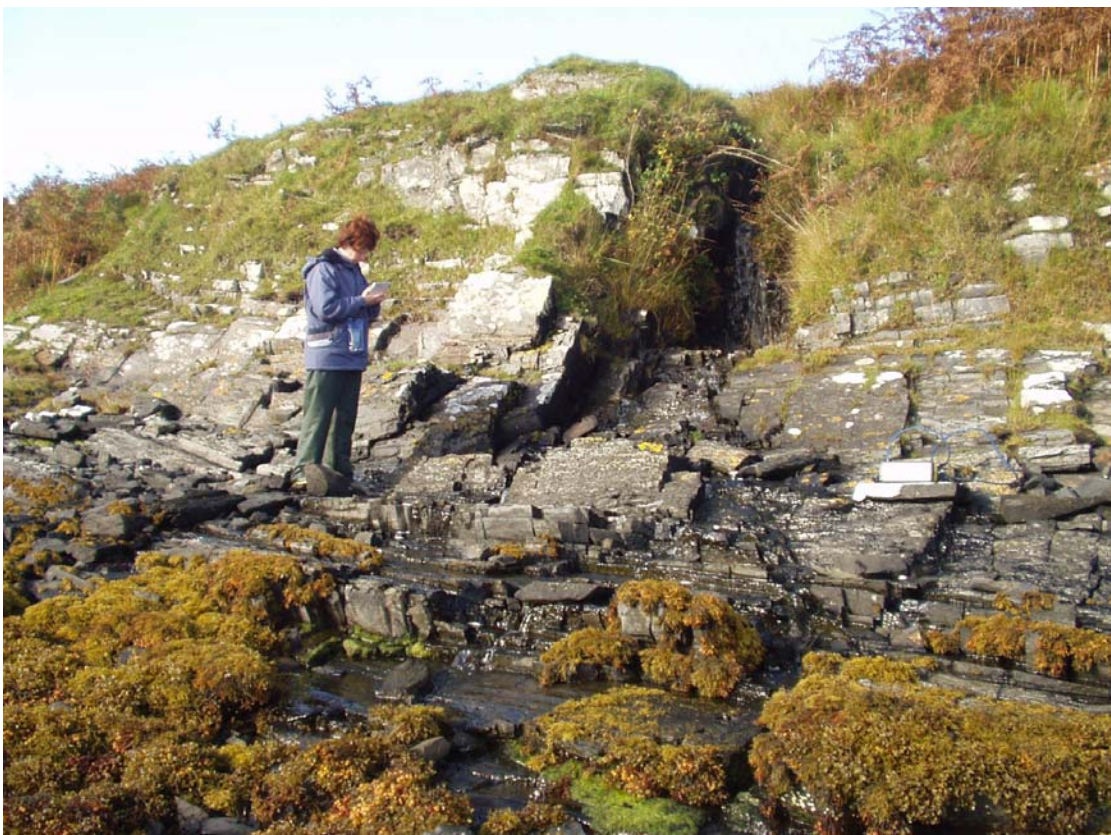
Figure 12. Fresh water stream (Freshwater sample 5)
