# Scottish Sanitary Survey Project

Sanitary Survey Report  
Oitir Mhòr Bay  
AB 308  
March 2011

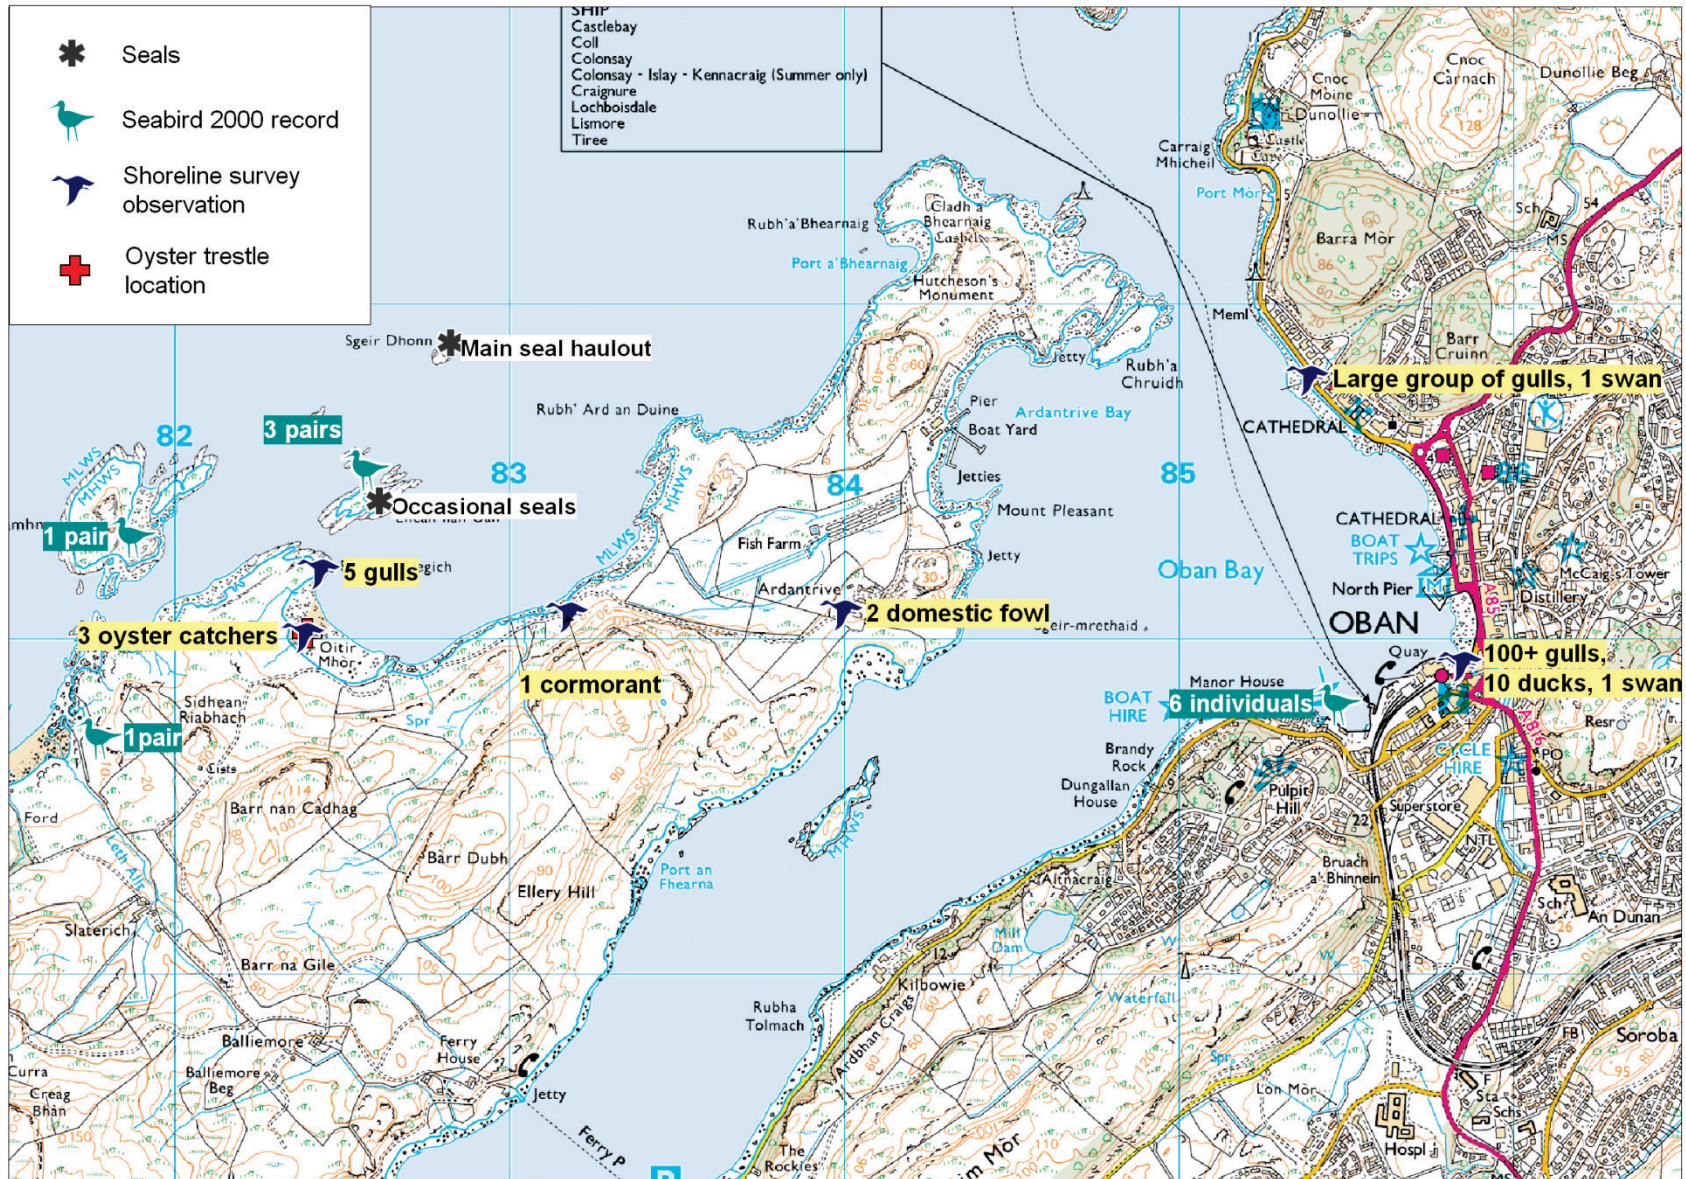
**Figure 8.1 Map of wildlife distributions at Oitir Mhòr Bay**

A variety of wildlife species are known to be present in the area and may contribute to background levels of faecal contamination present in the waters of Oitir Mhòr Bay. Of these, seals and seabirds such as gulls are most likely to occur in the vicinity of the fishery and may directly deposit faecal material to the waters near the shellfish farm. However, the presence and movements of these animals are likely to be highly variable and their impact at any given time difficult to predict.

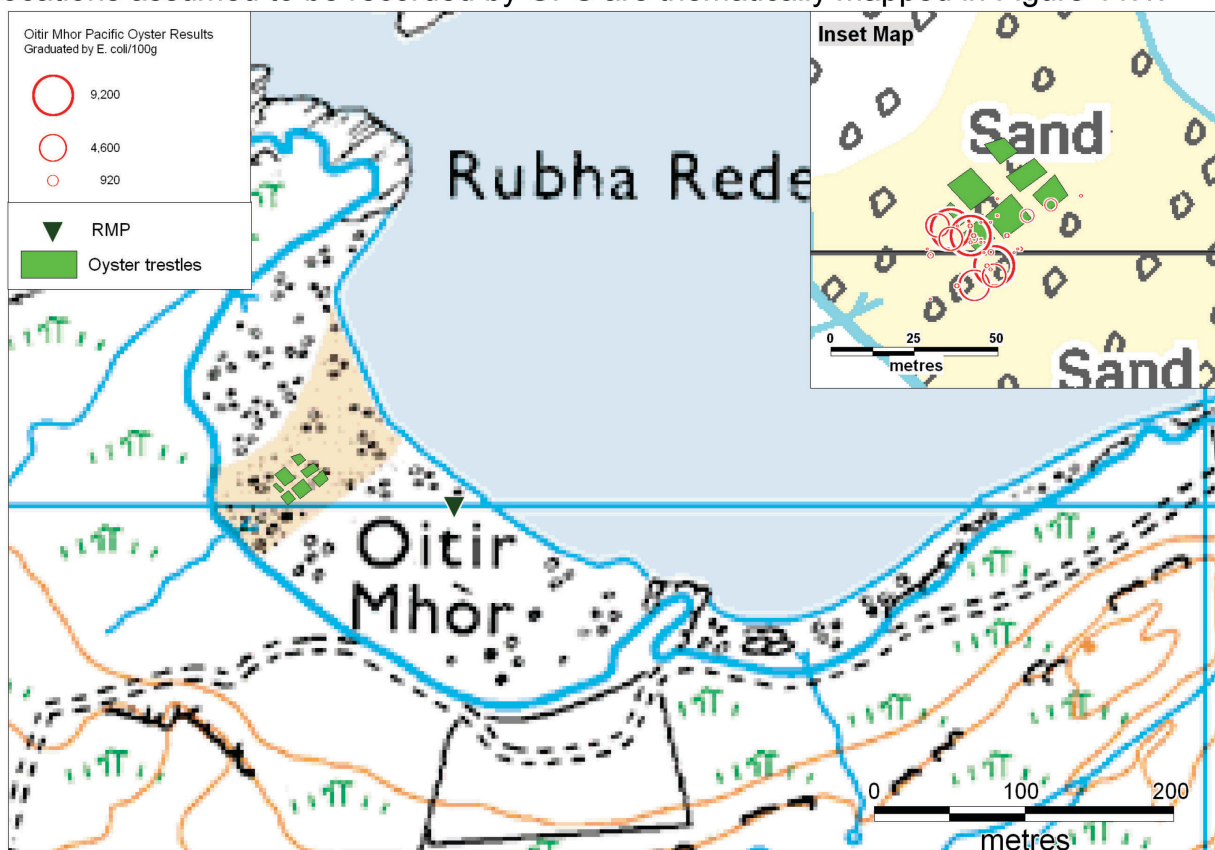
**Figure 11.1 Map of geometric mean *E. coli* results when sample location was accurately recorded by GPS.**

Until 2007, all samples were reported from the nominal RMP. After this time, sampling officers were equipped with GPSs with which sampling location was recorded to nominal 1 m accuracy at the time of collection. The results for the locations assumed to be recorded by GPS are thematically mapped in Figure 11.1.

Although Figure 11.1 gives the impression that higher results occur nearer to the MHWS mark, few samples were taken from further down the shore and so no firm conclusions can be drawn from this data with regard to spatial effects.

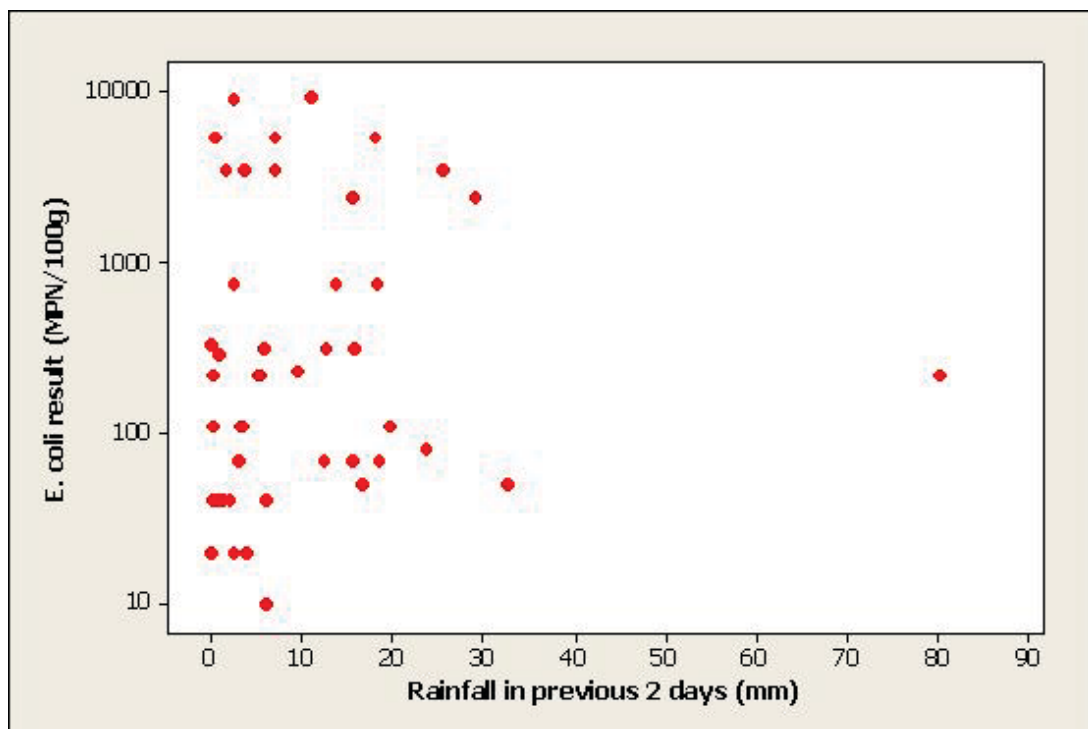
Figure 11.5 Scatterplot of result against rainfall in previous 2 days

No significant correlation was found between *E. coli* result and rainfall in the previous 2 days (Spearman's rank correlation=0.229,  $p>0.05$ , Appendix 6).

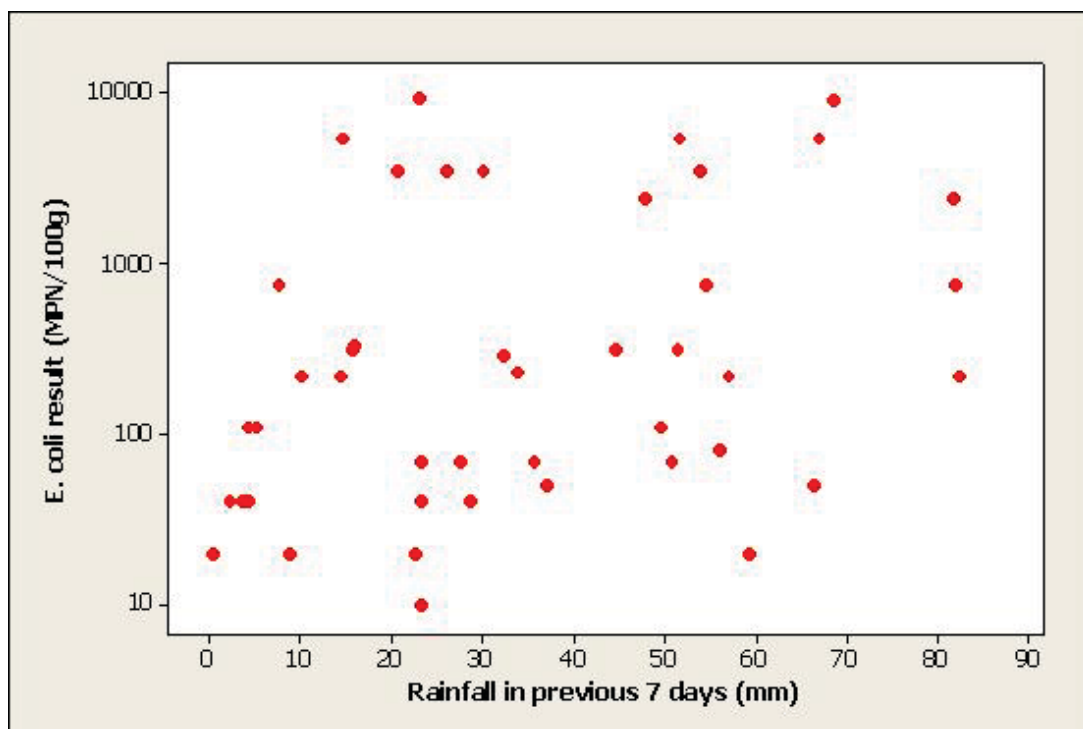
**Figure 11.6 Scatterplot of result against rainfall in previous 7 days**

A positive correlation was found between *E. coli* result and rainfall in the previous 7 days (Spearman's rank correlation= 0.334,  $p < 0.025$ , Appendix 6). However, low results were still seen at rainfall levels up to 65 mm in the 7 days preceding sampling and results  $> 230$  *E. coli* MPN/100 g occurred at rainfall levels less than 10 mm.

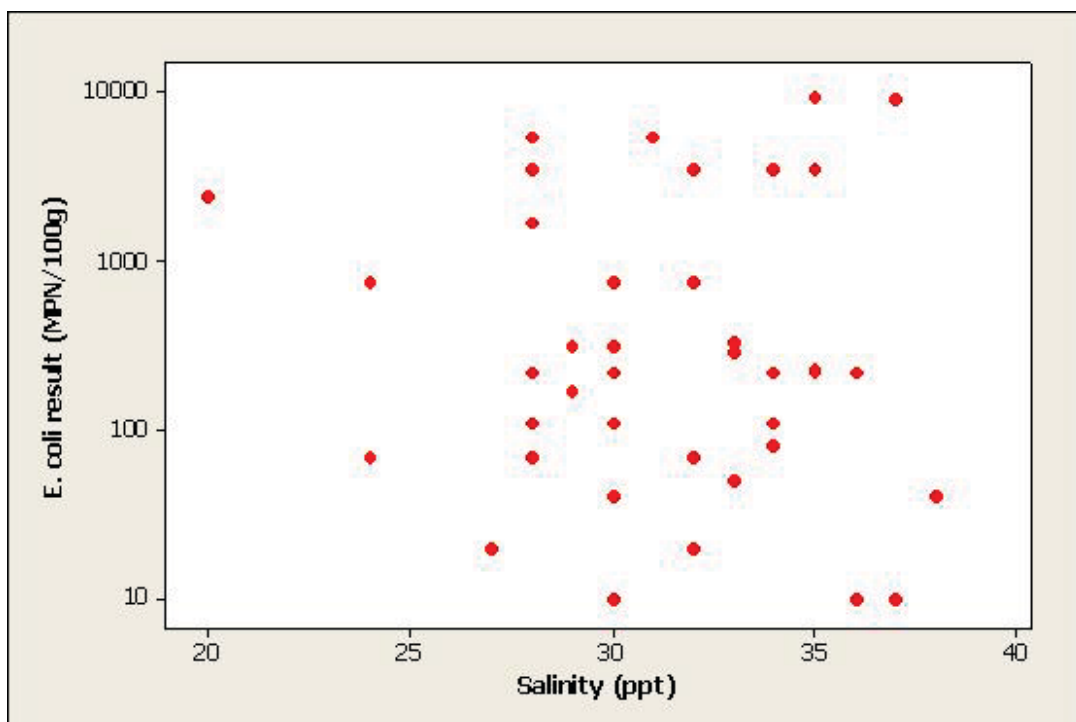
Figure 11.10 Scatterplot of result by salinity

No significant correlation was found between the *E. coli* result and salinity (Spearman's rank correlation= -0.031, p>0.25, Appendix 6).

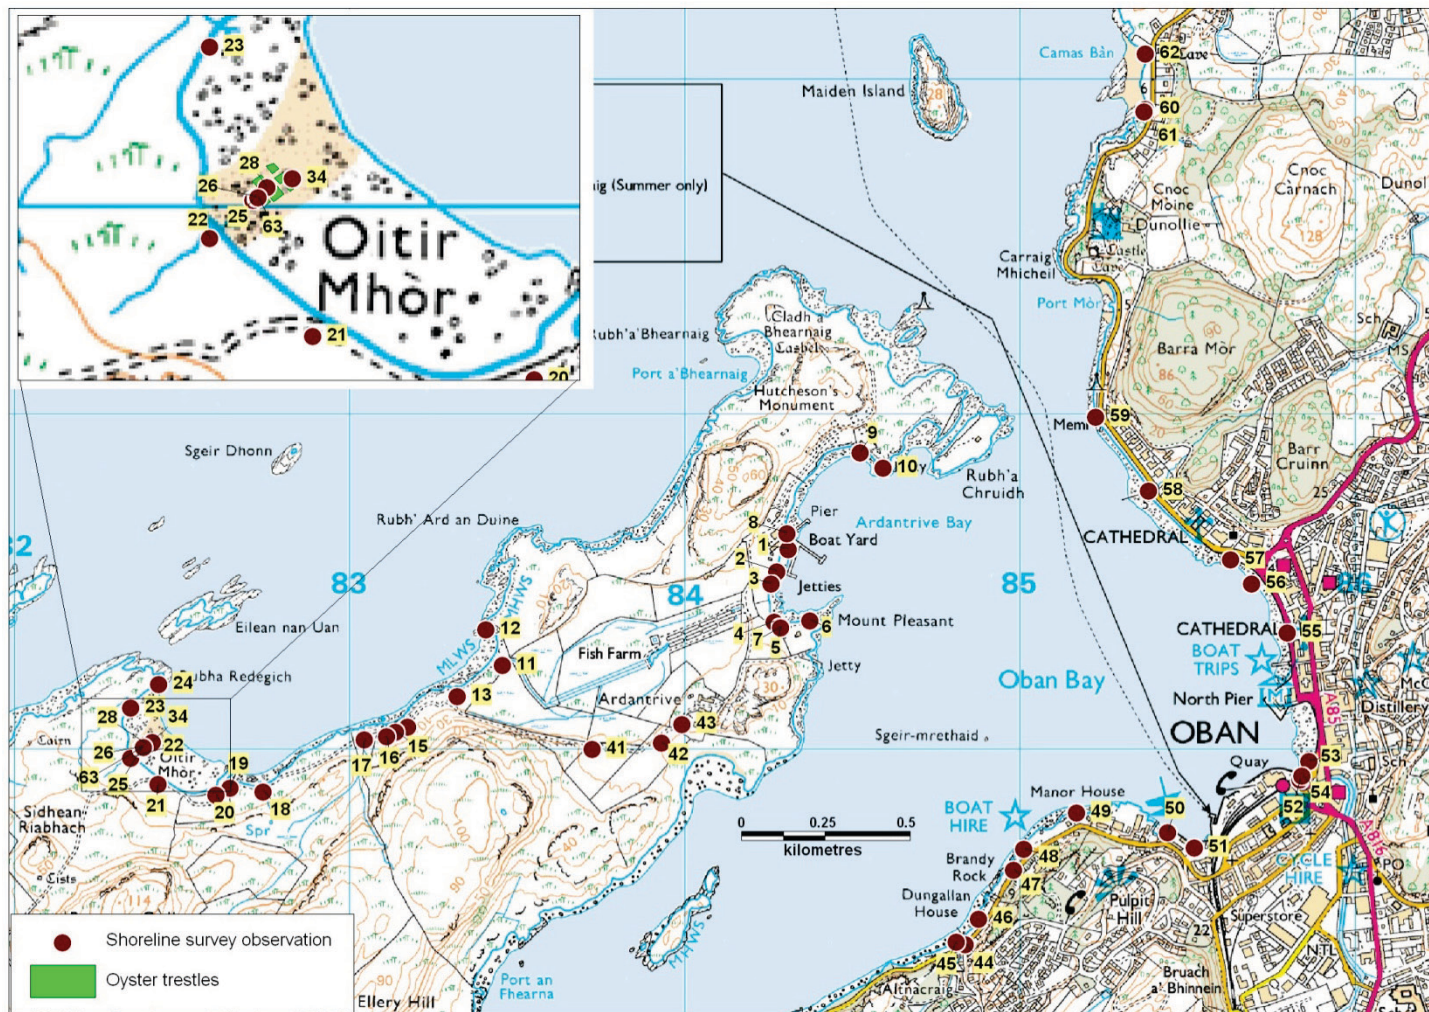
Figure 1 Map of Shoreline Observations

Recorded observations apply to the date of survey only. Animal numbers were recorded on the day from the observer's point of view. This does not necessarily equate to total numbers present as natural features may obscure individuals and small groups of animals from view.

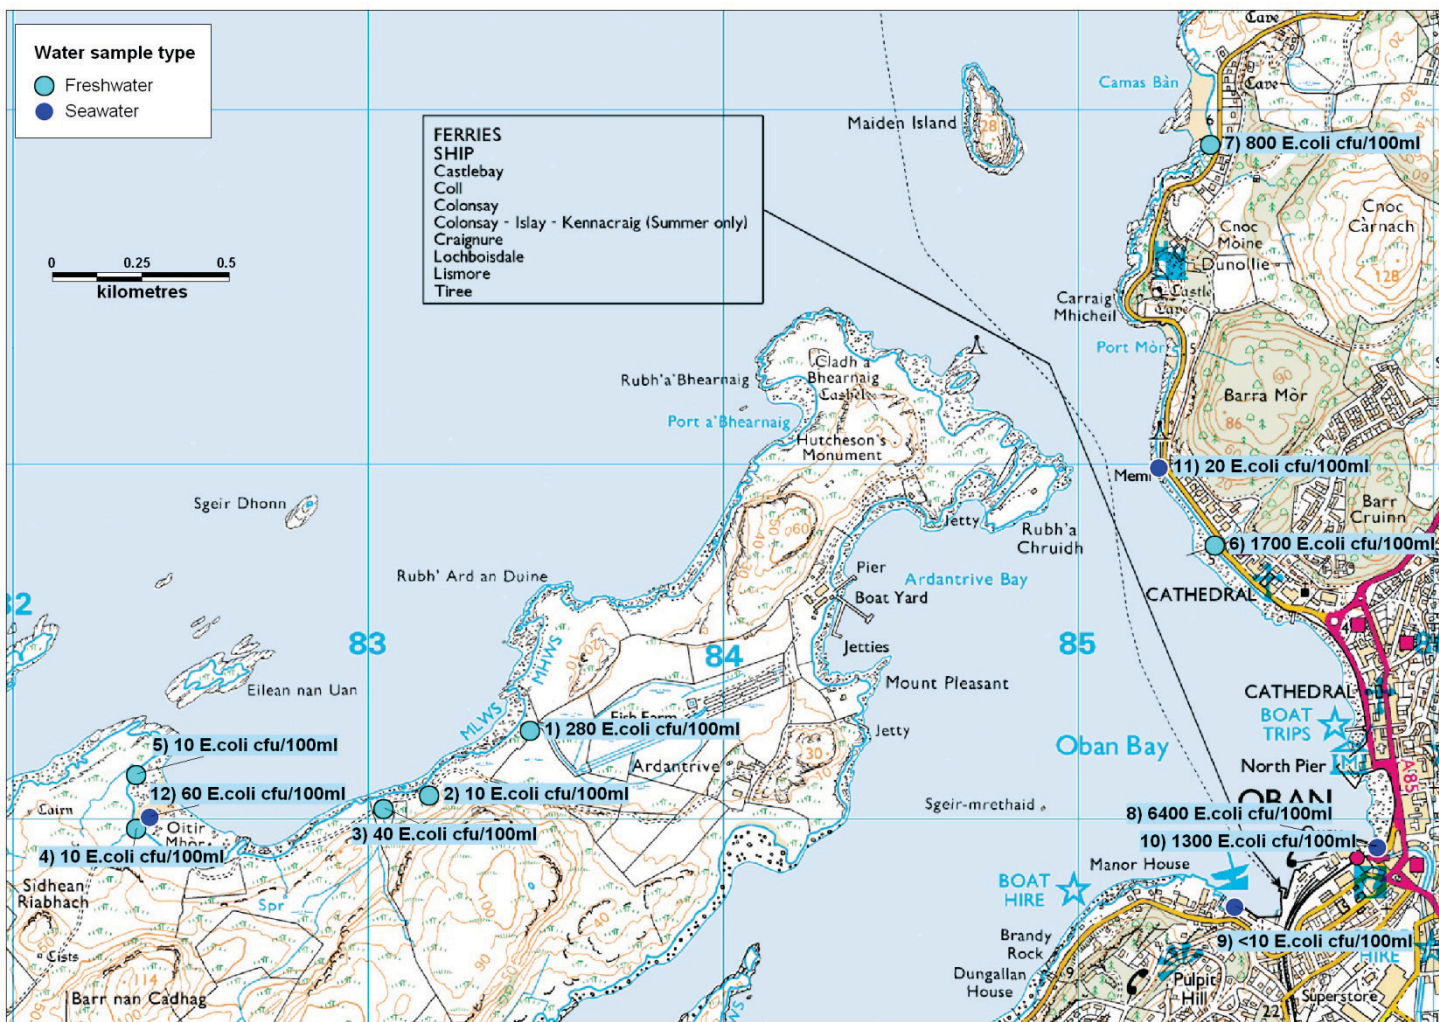
Figure 3. Water sample results map

Water and shellfish samples were collected at sites marked on the map in figures 3 and 4 respectively. Bacteriology results follow in Tables 2 and 3.

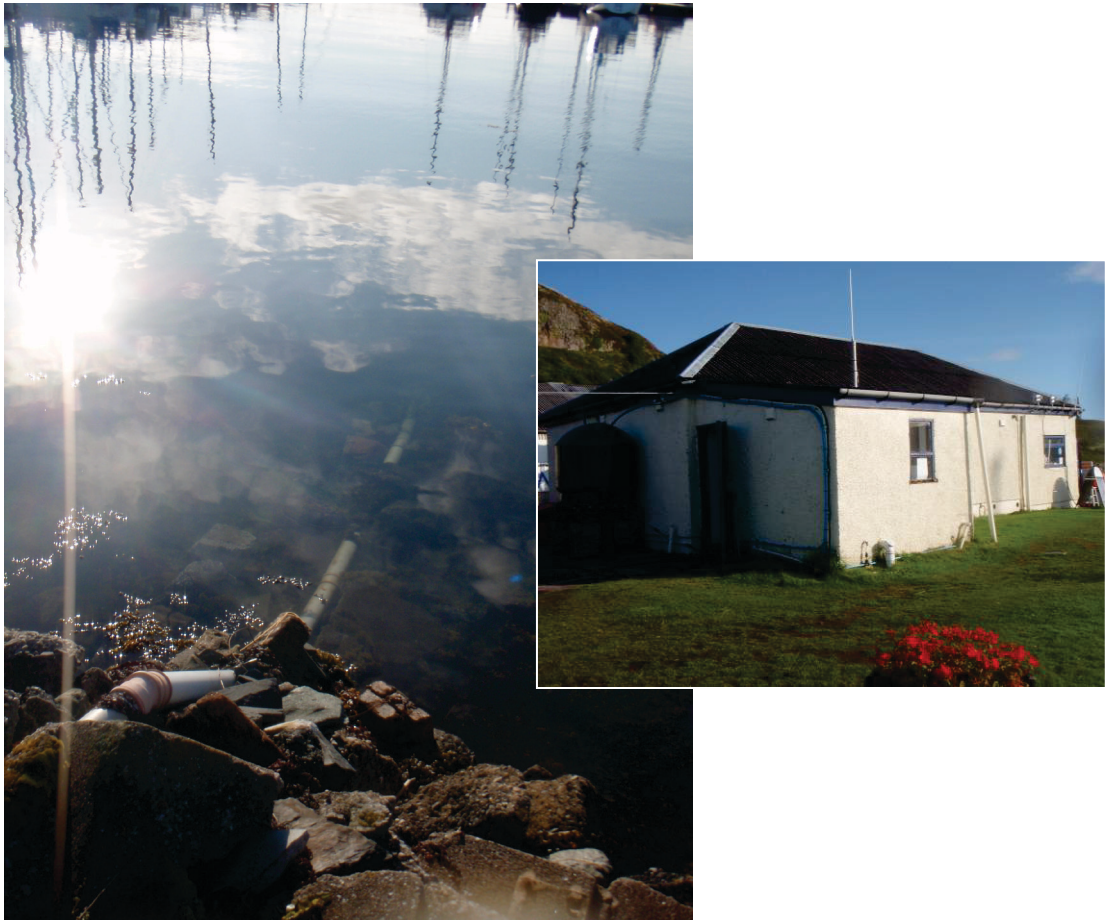
Figure 5. Toilet block and outfall pipe at Oban Marina

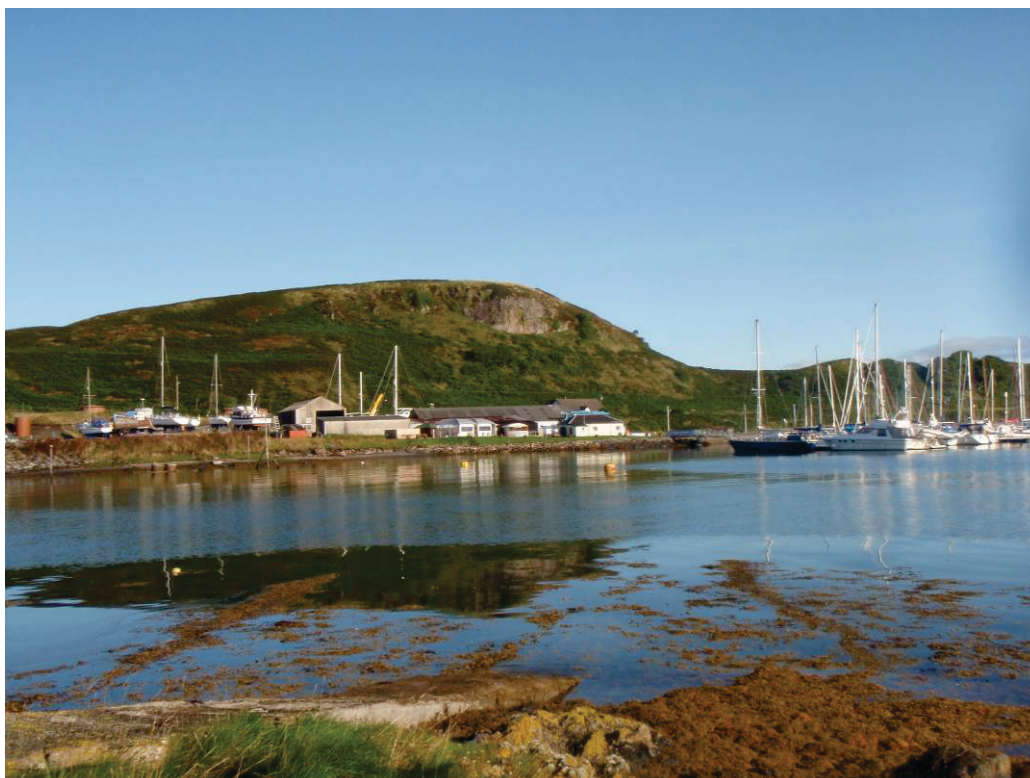
Figure 8. Oban marina with boat yard, boat shed, café and toilet block

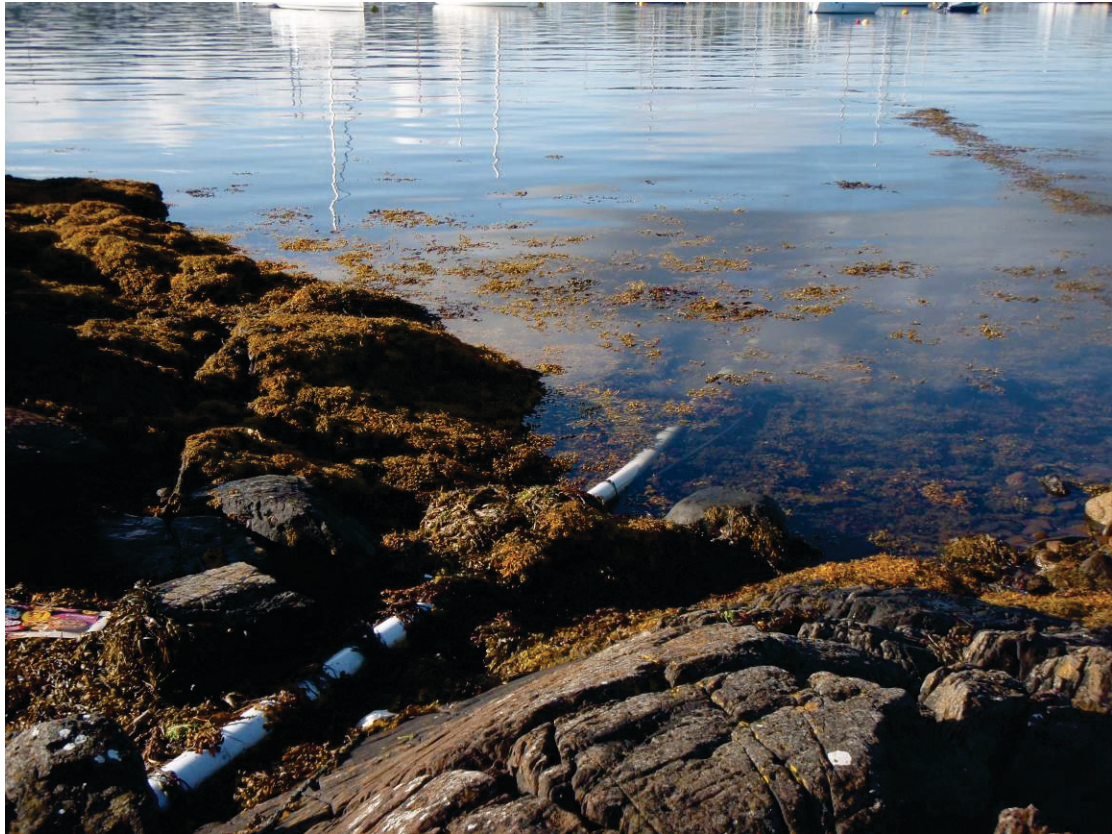
Figure 9. Septic tank outfall pipe from house/holiday home

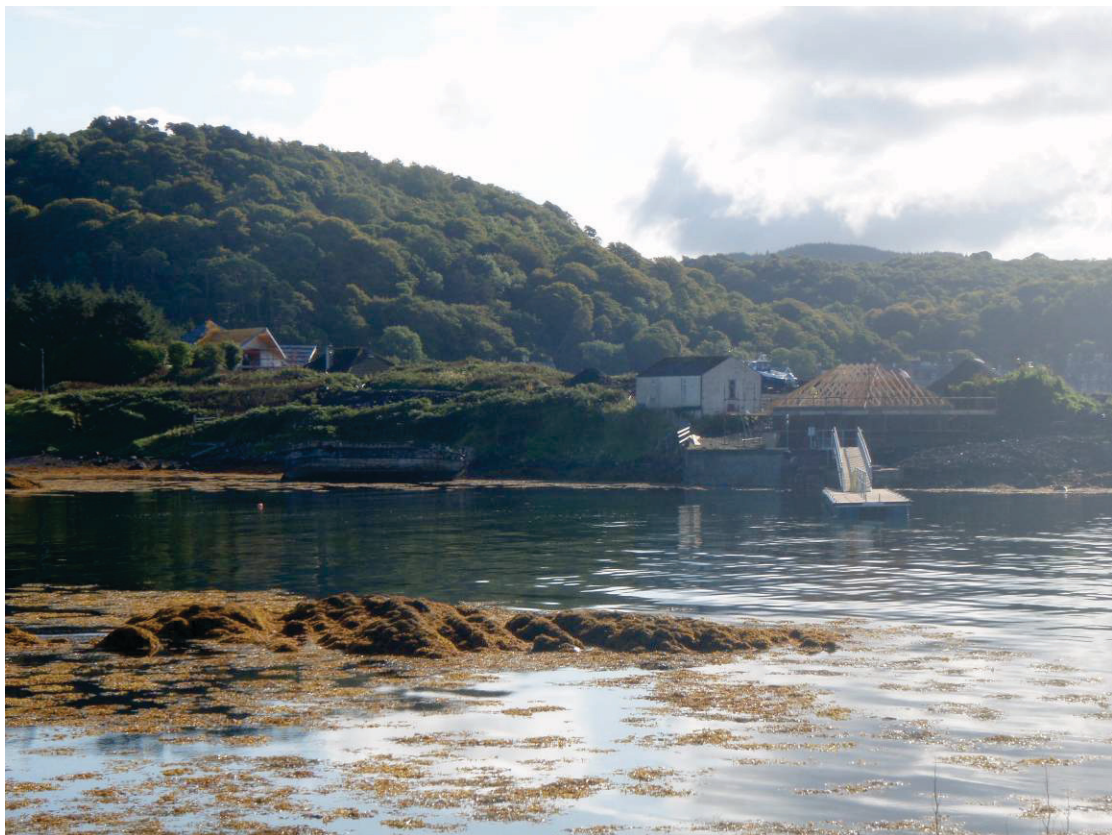
Observation Number	Date	Time	NGR	Associated photograph	Associated sample	Description
1	25/08/2010	08:27	NM 84310 30600	Figure 5		Marina toilet and shower block
2	25/08/2010	08:31	NM 84275 30532	Figure 6		Pipe pumping water to station
3	25/08/2010	08:32	NM 84258 30497			Pipe, likely to be land drain
4	25/08/2010	08:36	NM 84268 30382			Stream, W40/D2, flow 0.355m/s
5	25/08/2010	08:42	NM 84287 30367			Stream/land drain
6	25/08/2010	08:44	NM 84375 30386	Figure 7		House plus two outbuildings. No sign of septic tank
7	25/08/2010	08:50	NM 84288 30366			Broken bits of pipe where stream comes out
8	25/08/2010	08:57	NM 84306 30647	Figure 8		Oban Marina, large shed and slipway. Stream flowing through pipe. House on bank
9	25/08/2010	09:06	NM 84525 30888	Figure 9		House, possibly only used as a holiday home. Septic tank with outlet pipe
10	25/08/2010	09:11	NM 84593 30843	Figure 10		Small island with one house currently under construction. Old house had a septic tank.

Figure 10. Construction of one new house and demolition of old house on Rubh'a Chruidh Island

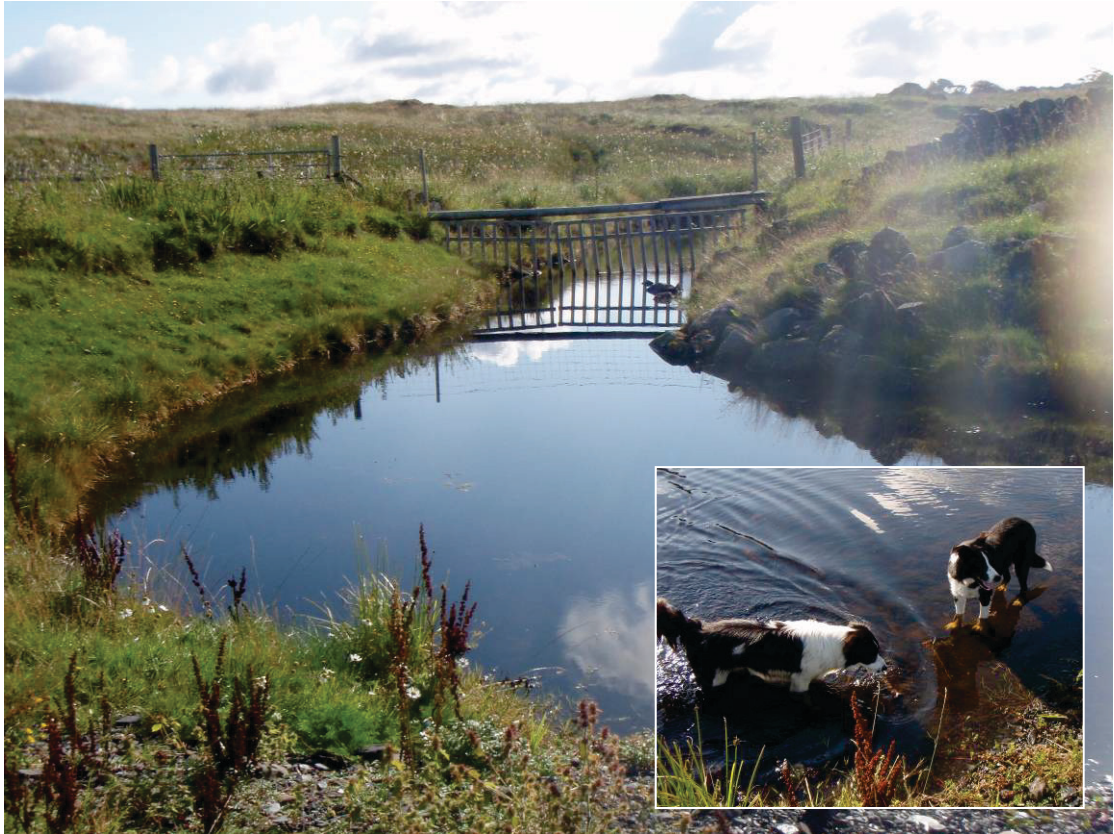
Figure 11. Large stream flowing into Oitir Mhor Bay. Inset: two dogs belonging to farm in stream

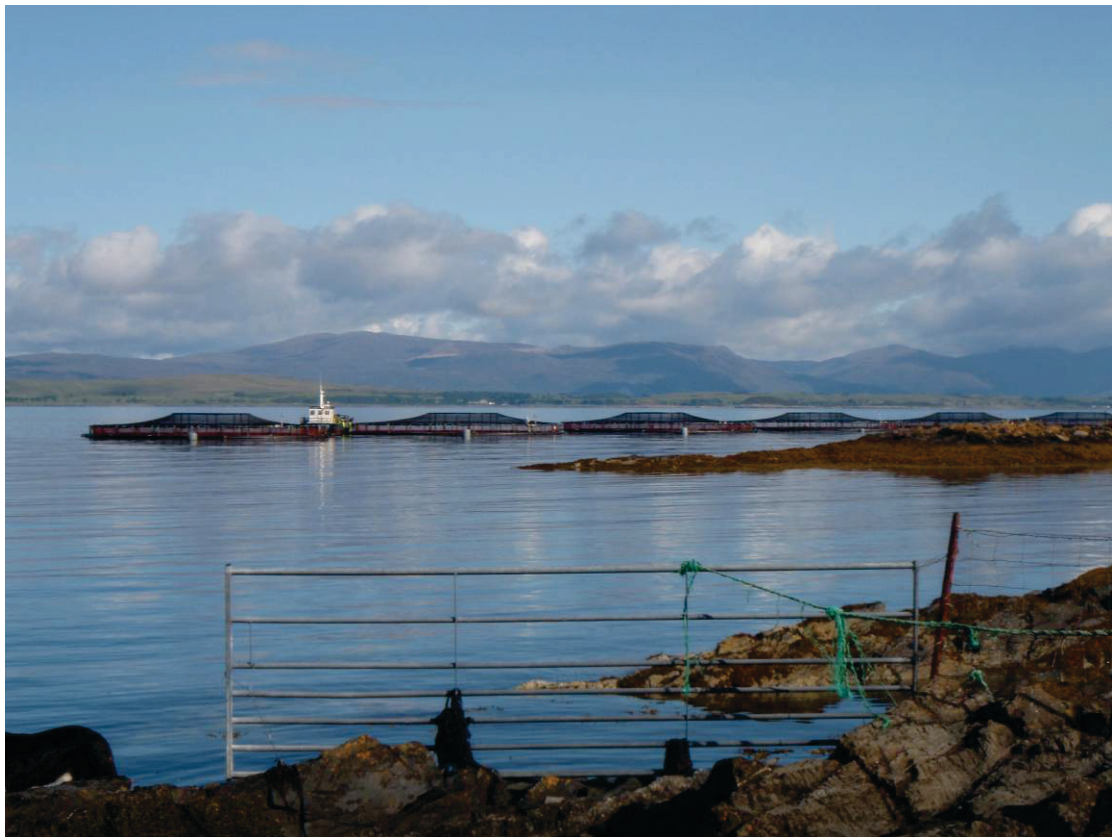
11	25/08/2010	09:36	NM 83456 30253	Figure 11	OMB FW01	Stream, W190/D12, flow 0.172. Freshwater sample OMB FW01. Two dogs playing in stream, possibly affecting sample
12	25/08/2010	09:48	NM 83407 30360	Figure 12		Fish farm with 6 cages. Boat and workers on site at time of survey.
13	25/08/2010	09:54	NM 83322 30160			Stream
14	25/08/2010	09:58	NM 83173 30069	Figure 13	OMB FW02	Stream, W30/D4, flow 0.113m/s. Freshwater sample OMB FW02. Mull Ferry passing by. Boat trip on Sgeir Dhonn to observe seals. 1 cormorant
15	25/08/2010	10:05	NM 83138 30054			Stream
16	25/08/2010	10:06	NM 83111 30040	Figure 14		House, no sign of septic tank
17	25/08/2010	10:07	NM 83045 30031	Figure 15	OMB FW03	Stream over track, fast flowing. W35/D12, flow 1.009m/s. Freshwater sample OMB FW03
18	25/08/2010	10:19	NM 82743 29875			Stream, W35/D6, flow 3 secs to fill 2 litres. Two different

Figure 12. Fish farm comprising of six cages.

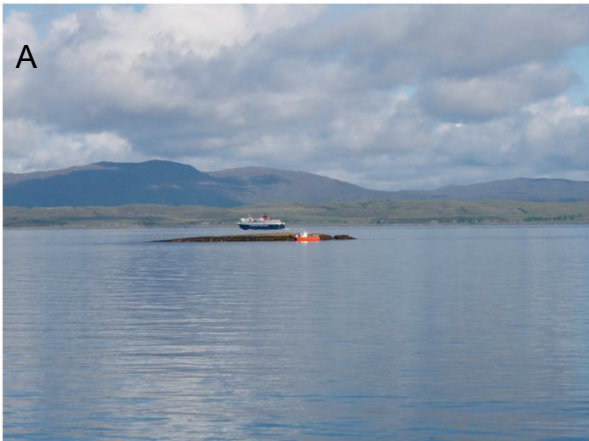
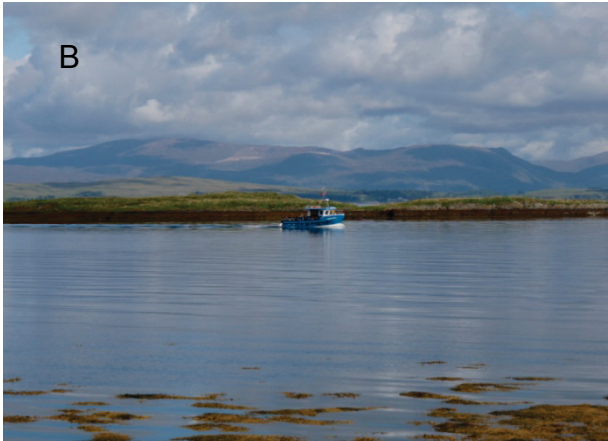
Observation Number	Date	Time	NGR	Associated photograph	Associated sample	Description
						boats now on Sgeir Dhonn
19	25/08/2010	10:31	NM 82644 29887			Standing water
20	25/08/2010	10:32	NM 82602 29865			Land drain
21	25/08/2010	10:36	NM 82428 29899	Figure 13		Land drain. Tourist boat crossing over close to oyster trestles. Ewan says there is also a yacht which regularly moors in Oitir Mhor Bay
22	25/08/2010	10:39	NM 82347 29976	Figure 16	OMB FW04	Stream flowing directly onto site. W34/D10, flow 3 secs to fill 500ml. Freshwater sample OMB FW04
23	25/08/2010	10:48	NM 82347 30127		OMB FW05	Stream, W54/D5, flow 6 secs to fill 1 litre. Freshwater sample OMB FW05
24	25/08/2010	10:55	NM 82431 30197			5 gulls on small island
25	25/08/2010	11:05	NM 82381 30006		OMB SW01	Seawater sample OMB SW01 (sample later lost). Retaken 26/08/10 (see waypoint 63)
26	25/08/2010	11:39	NM 82384 30008	Figure 17	OMB SHELLFISH 1	3 oyster catchers. Oyster sample OMB SHELLFISH 1

Figure 13. A) Sgeir Dhoon Island with tourist boat to observe seals, and Mull Sound ferry in background. B) Tourist boat crossing close to oyster trestles

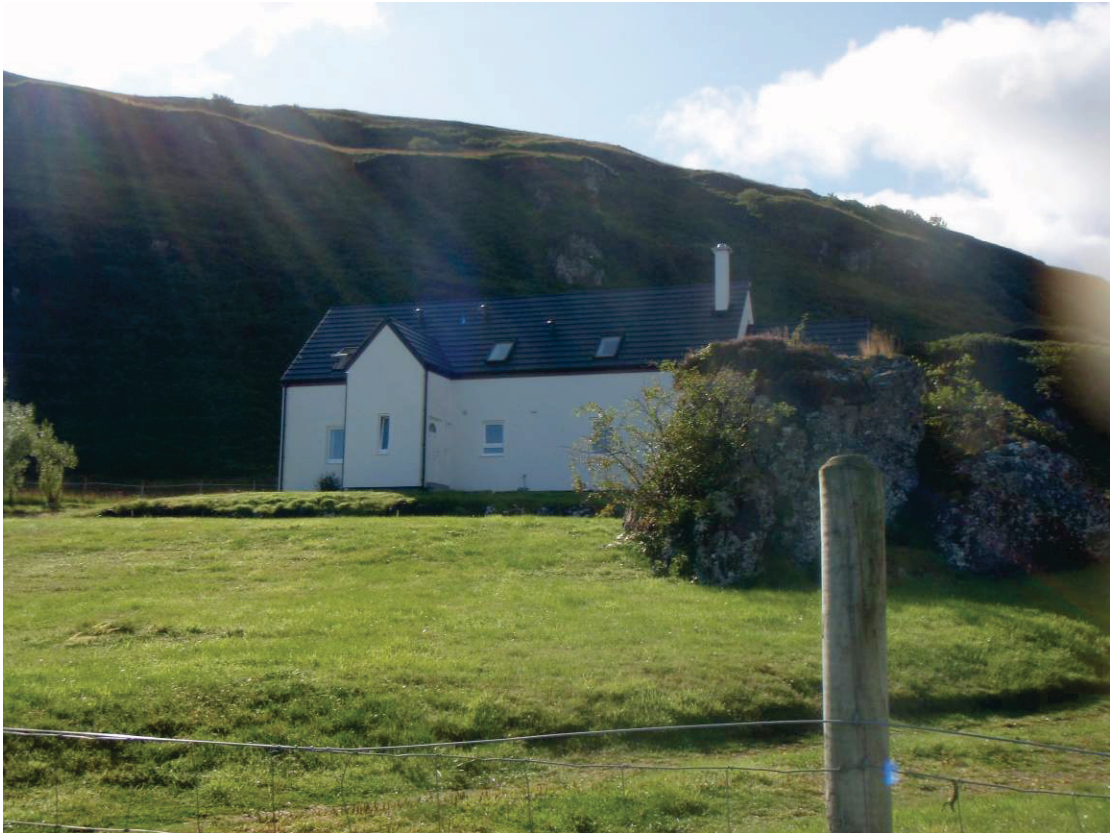
The septic tank for the new house observed during the 2008 shoreline survey is most likely to discharge to soakaway as no discharge pipe was observed. Should this become clogged and fail to operate properly, septic waste from the property would impact the eastern half of the shoreline along Oitir Mhòr Bay.

Figure 14. House on shore of Oitir Mhor Bay. No septic tank was observed

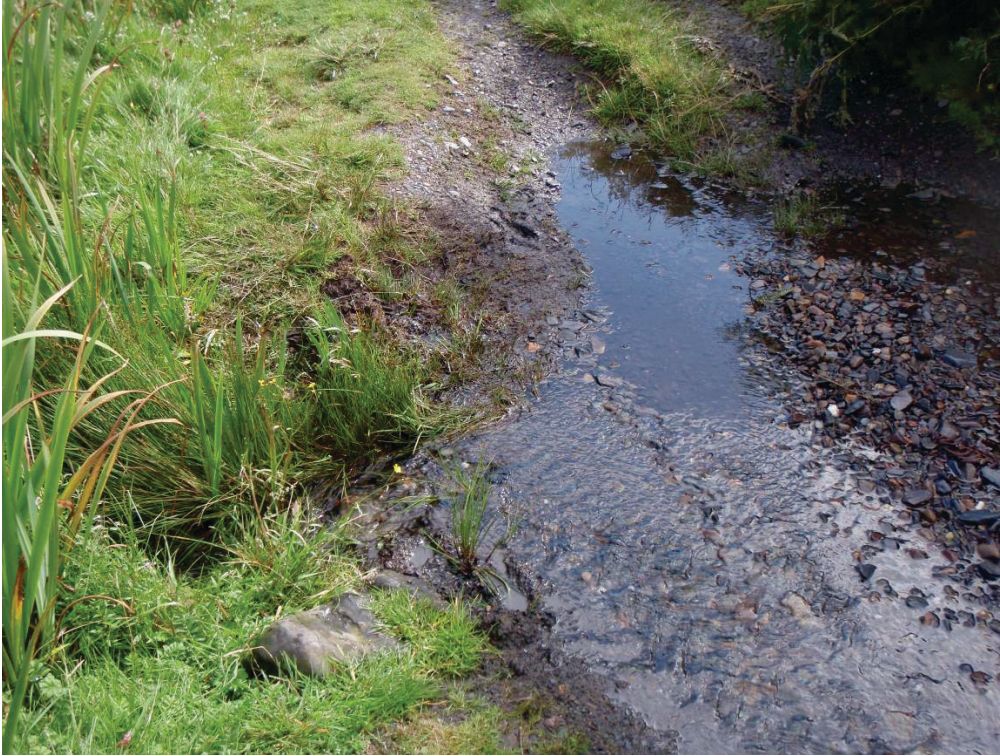
Figure 15. Stream crossing main track flowing into Oitir Mhor Bay

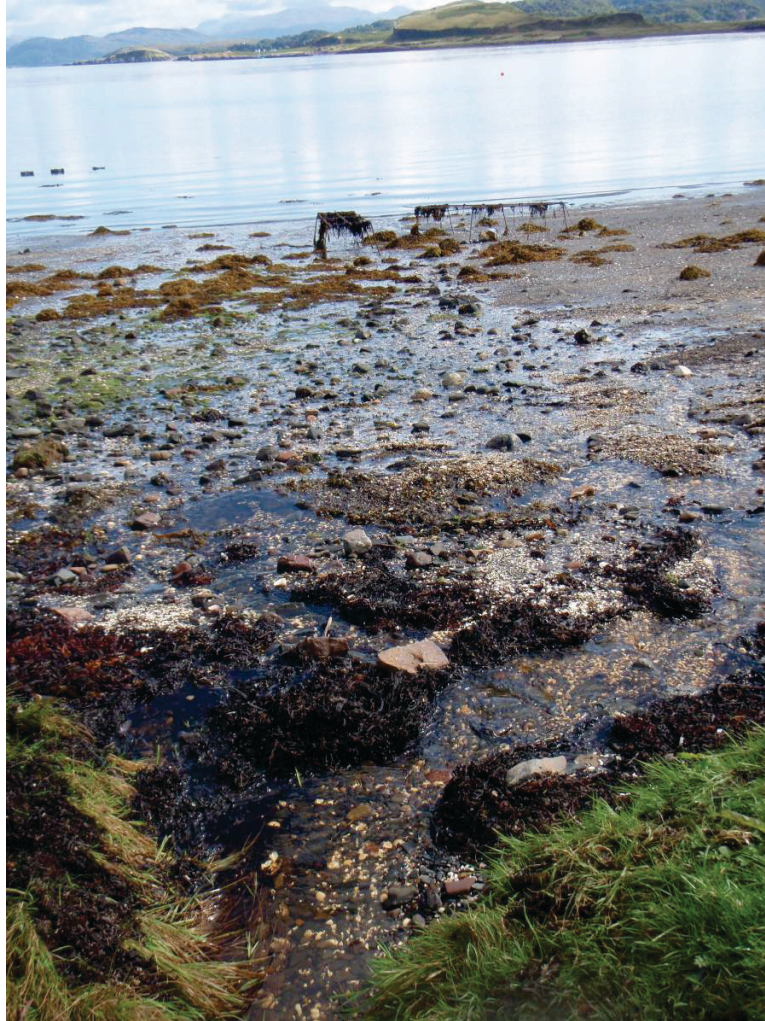
Figure 16. Stream flowing directly onto oyster trestle site

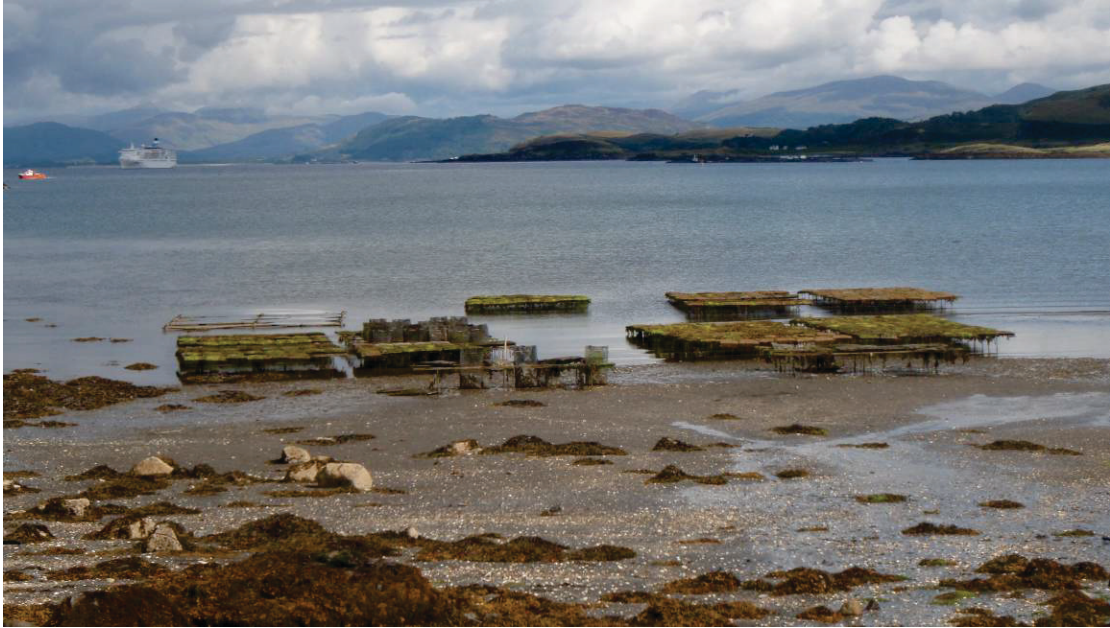
Figure 17. Oitir Mhor Bay Oyster Trestles

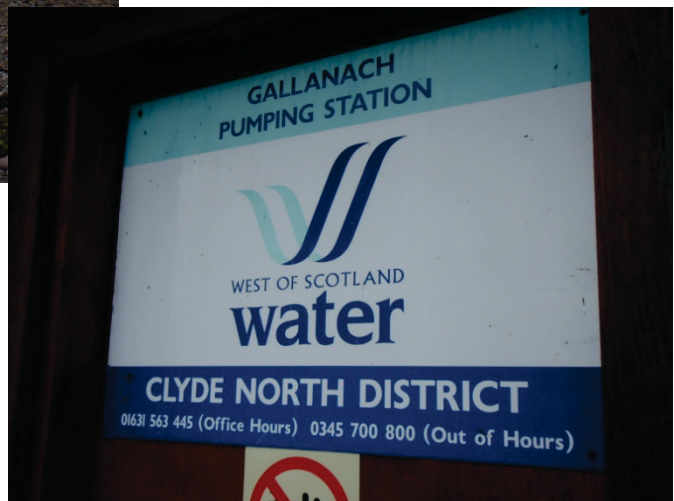
Figure 18. Gallanach Pumping Station and outfall pipe

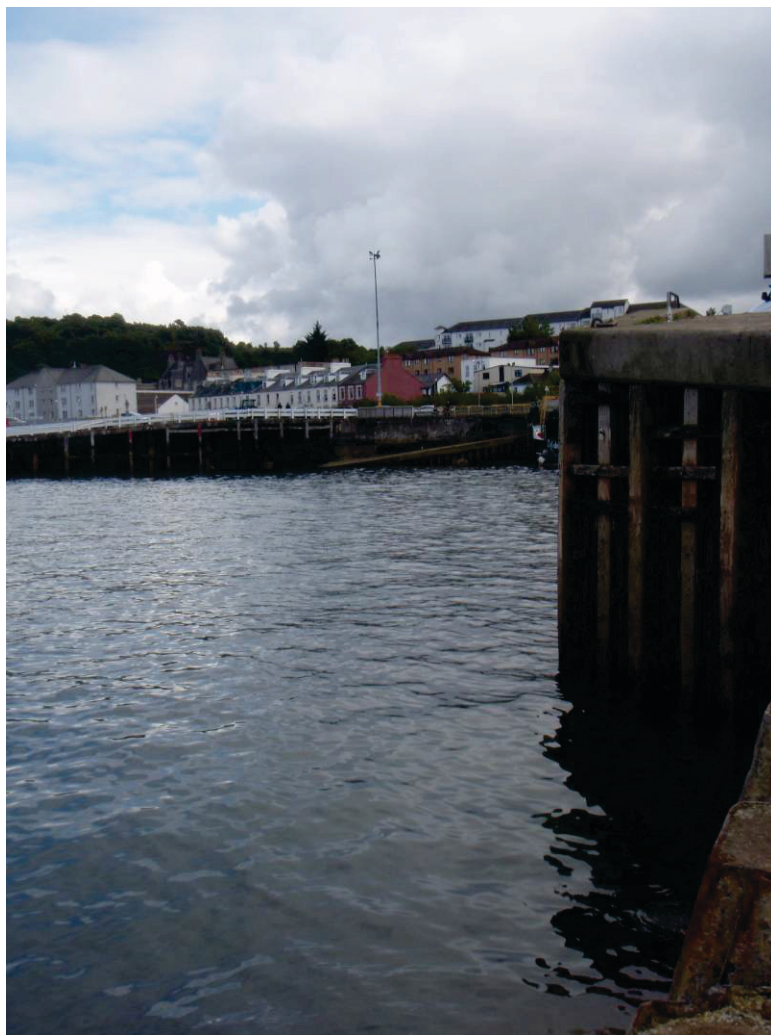
Observation Number	Date	Time	NGR	Associated photograph	Associated sample	Description
50	25/08/2010	14:08	NM 85442 29754	Figure 20	OMB SW02	Seawater sample OMB SW02 taken from slipway by lifeboat station, as close to location of CSO as possible.
51	25/08/2010	14:14	NM 85522 29708	Figure 21		CSO. Not accessible to take freshwater sample
52	25/08/2010	14:21	NM 85838 29911	Figure 23		Large stream flowing into Oban harbour. 100+ gulls on beach
53	25/08/2010	14:26	NM 85864 29966	Figure 22		Drain cover on beach. Buoy marking CSO outfall
54	25/08/2010	14:28	NM 85843 29922	Figure 23	OMB FW08 OMB SW03	Stream, freshwater sample OMB FW08, seawater sample OMB SW03, 10 ducks, 1 swan, dogs being walked on beach
55	25/08/2010	14:42	NM 85799 30351	Figure 24		Pipe running off beach, possibly redundant
56	25/08/2010	14:45	NM 85694 30496	Figure 25		Possibly overflow pipe with grill over the end
57	25/08/2010	14:49	NM 85631 30568			Pipe running under road, moderate flow. Likely to be land drain

Figure 20. Location of seawater sample SW02 on slipway close to pier

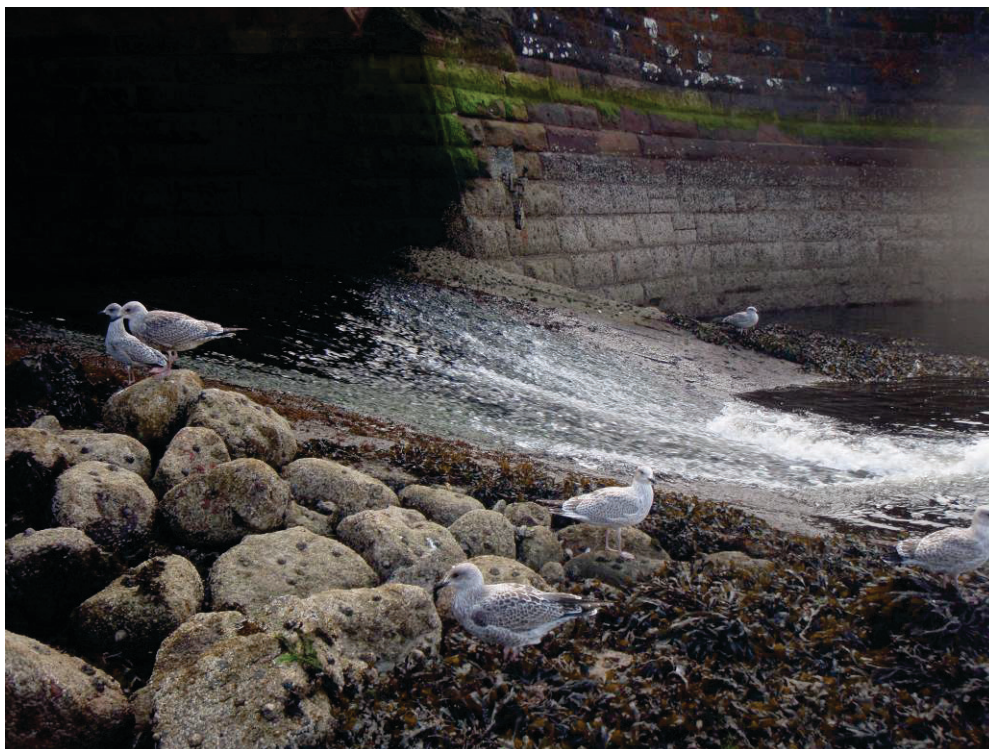
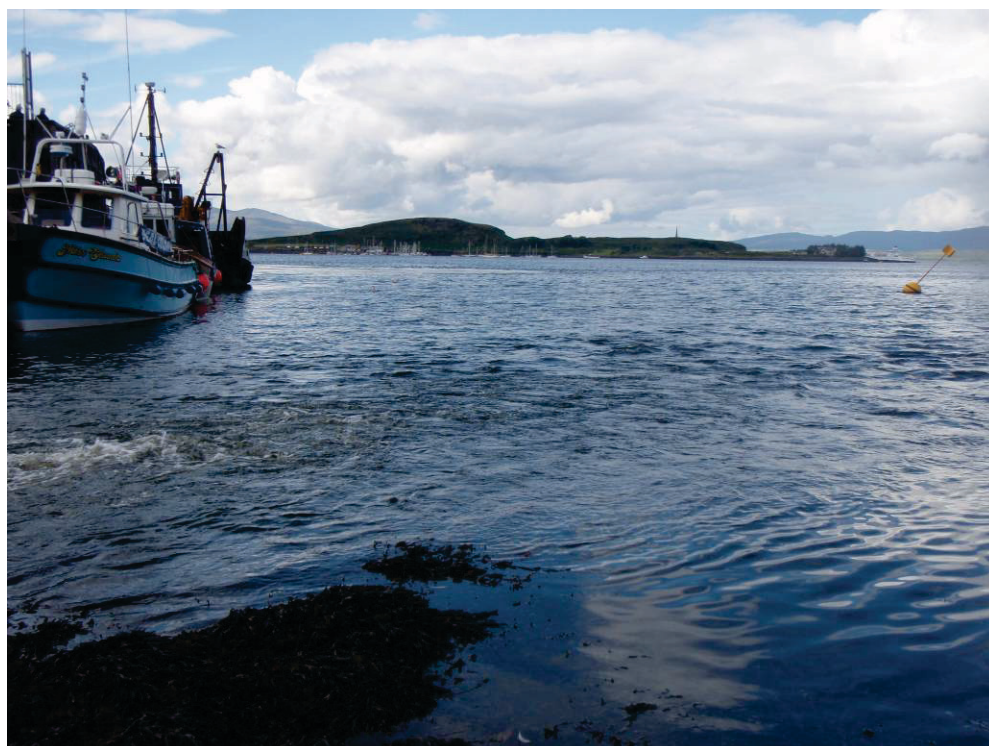
Figure 23. Large stream flowing into Oban Marina, location of freshwater sample FW08 and seawater sample SW03
